FOXHOLE FARM HALWILL BEAWORTHY DEVON

Desk-Based Assessment & Historic Building Recording

South West Archaeology Ltd. report no. 180404

By E. Wapshott & B. Morris
Report Version 01
04th April 2018

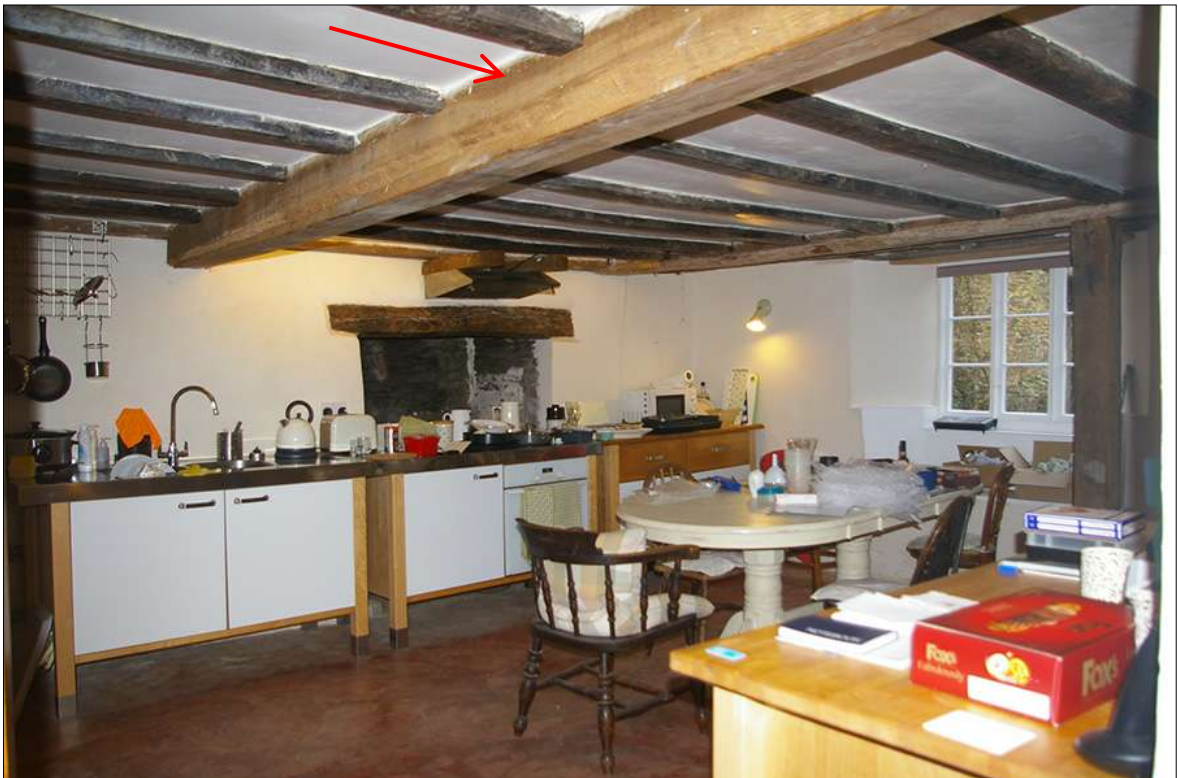
FIGURE 10: THE PARLOUR, VIEWED FROM THE SOUTH-WEST CORNER. THE REPLACED BEAM IS INDICATED.

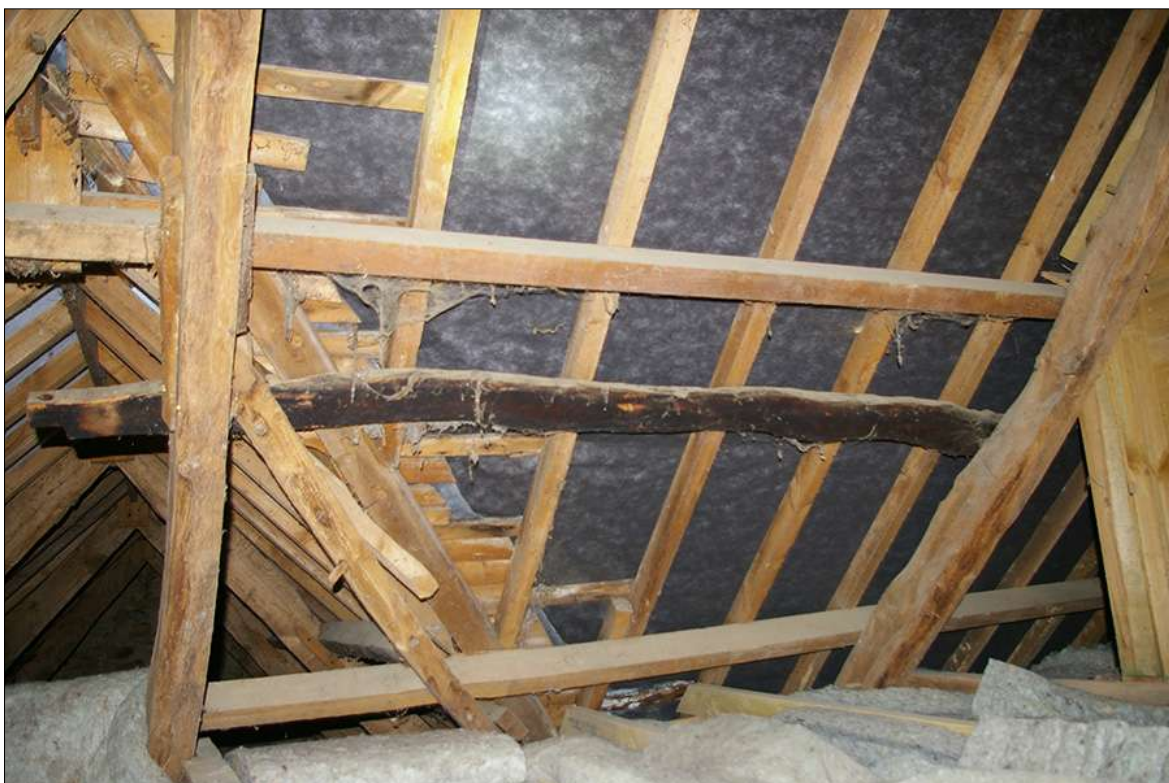
FIGURE 12: DETAIL OF THE ROOF STRUCTURE ABOVE THE PARLOUR BEDROOM, SHOWING A RE-USED SMOKE-BLACKENED RAFTER; VIEWED FROM THE SOUTH-EAST.

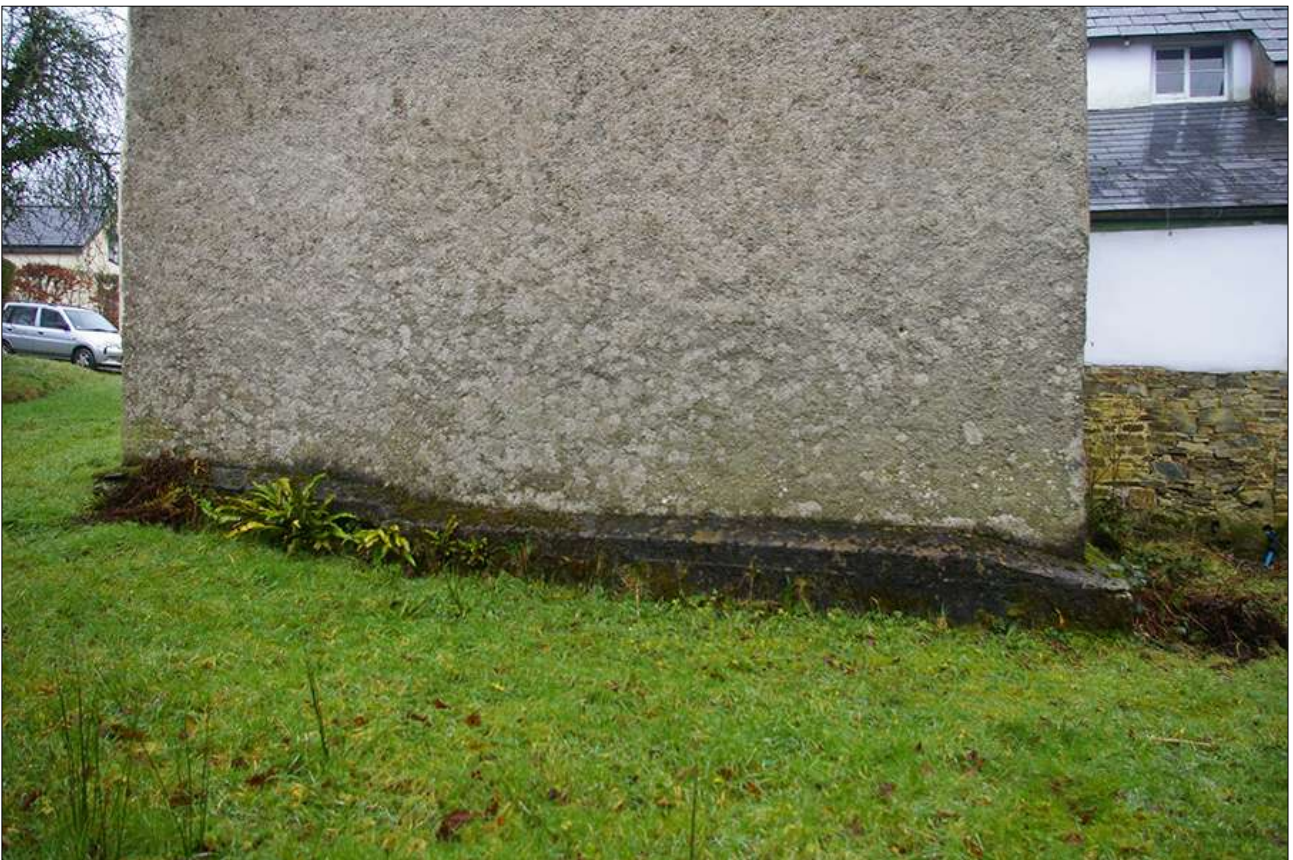
BASE OF THE WEST ELEVATION OF THE CROSSWING; VIEWED FROM THE WEST. NOTE THE CONCRETE PLINTH.

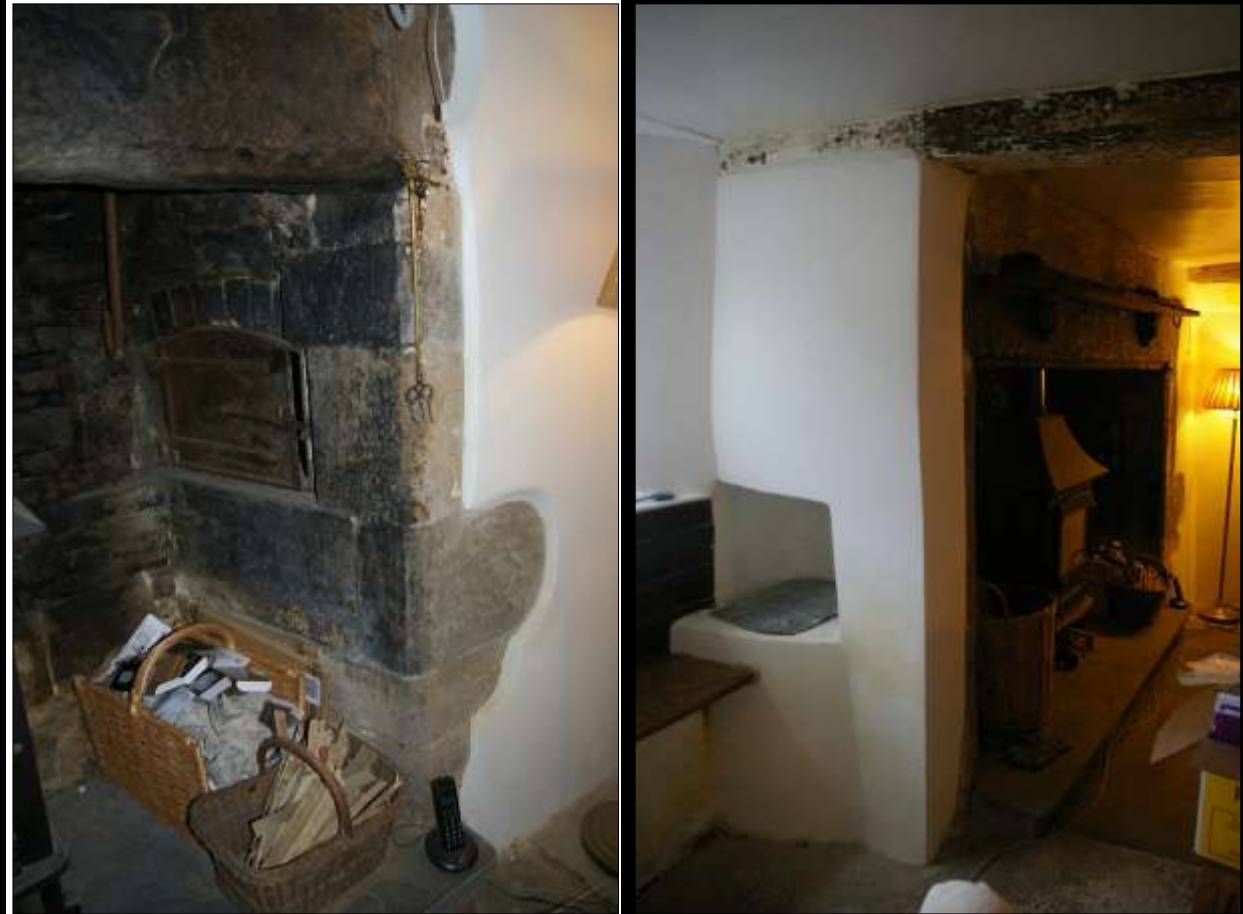
In the Hall itself, a large bread oven of stone rubble was forced into hearth; the right-hand jamb had to be removed to allow for the oven, replacing the granite upright with dressed freestone blocks. The Hall screen was replaced in stonework, since the service rooms were now replaced and all domestic areas had shifted north and west. The crosswing was remodelled, with a thin cob partition dividing the ground floor into a Stairhall and Dairy. The earlier stair, perhaps from the removed turret, was reworked to fit the new Stairhall, extended and adapted with new beaded 18th century rails and posts. The stair blocked the old access door, so a new doorway was forced through the south-east corner of the crosswing.

LEFT: HALL, FP1, SHOWING THE DRESSED FREESTONE AND BREAD OVEN; VIEWED FROM THE NORTH-WEST.

RIGHT: HALL, FP1, SHOWING BOILER/COPPER (S2) FORCED INTO THE SIDE OF THE FIREPLACE; VIEWED FROM THE NORTH.

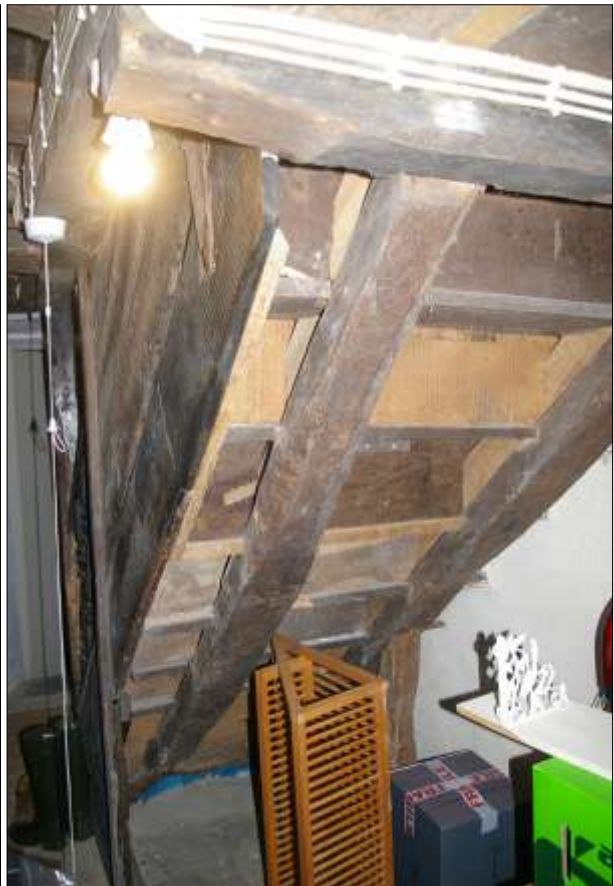
RIGHT: STAIRHALL, THE UNDERSIDE OF THE STAIRS WITH OBVIOUS REPAIRS; VIEWED FROM THE NORTH-EAST.
