PENDREA BARNs
St BURYAN
PENZANCE
CORNWALL

Historic Building Recording

South West Archaeology Ltd. report no. 200514

14th May 2020

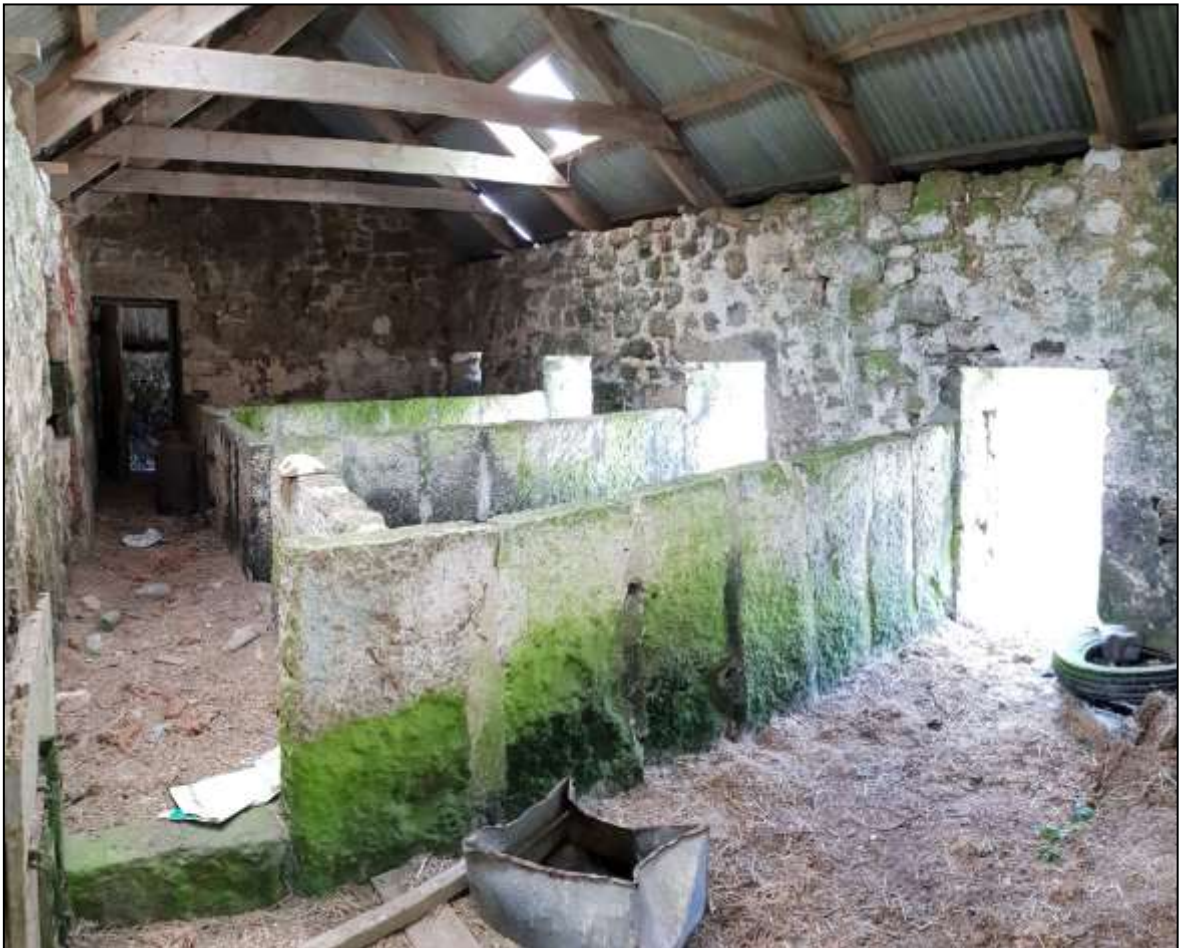
FIGURE 10: INTERIOR OF B2B FROM LARGER PEN AT NORTH-EAST END, WITH GRANITE SLAB PARTITIONS TO PENS AND FEED PASSAGE DOWN THE SOUTH-EAST SIDE (LEFT); VIEWED FROM THE EAST.

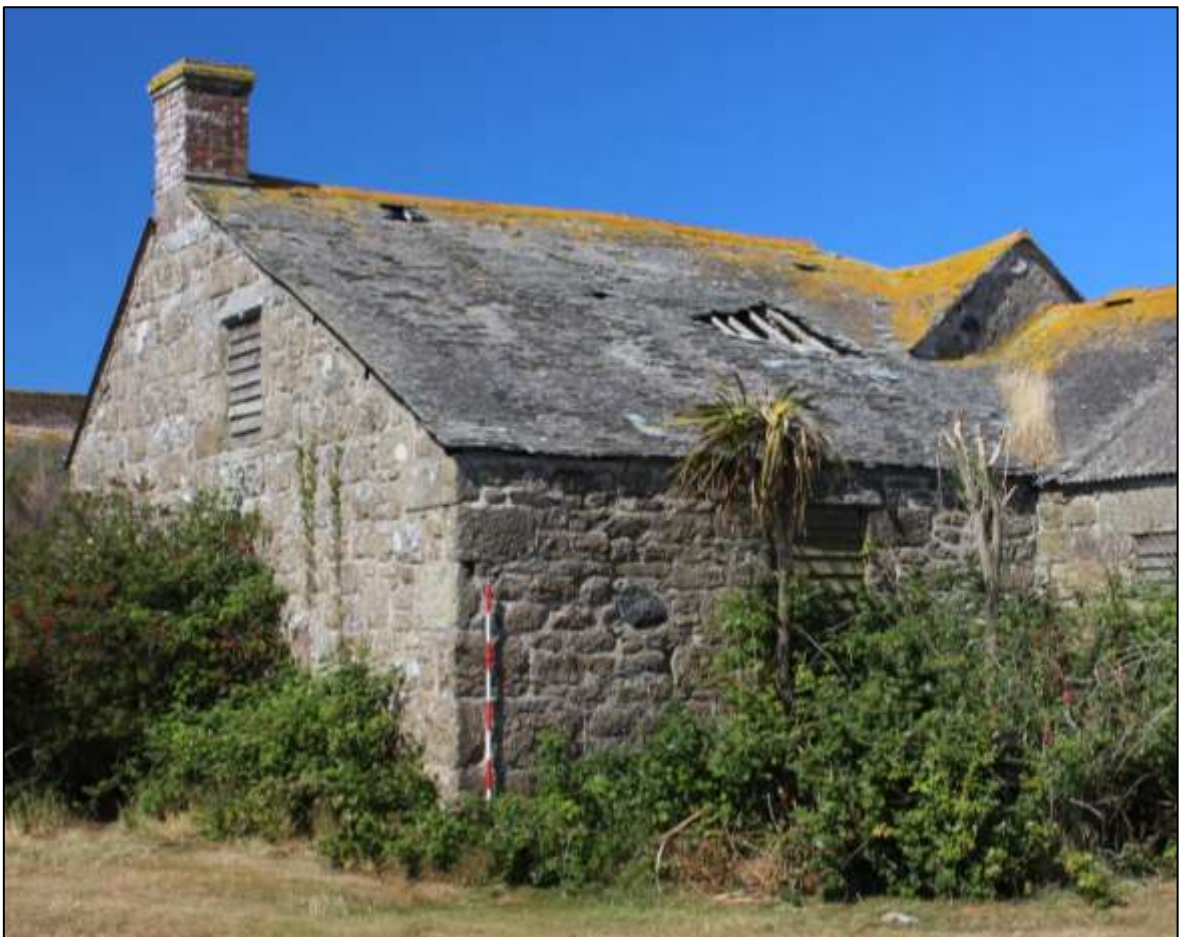
FIGURE 13: B3, NOTE COMPLEX ROOF ARRANGEMENT ABUTTING B2 ON RIGHT AND HIGHER GABLE OF B4 BEHIND; VIEWED FROM THE EAST.

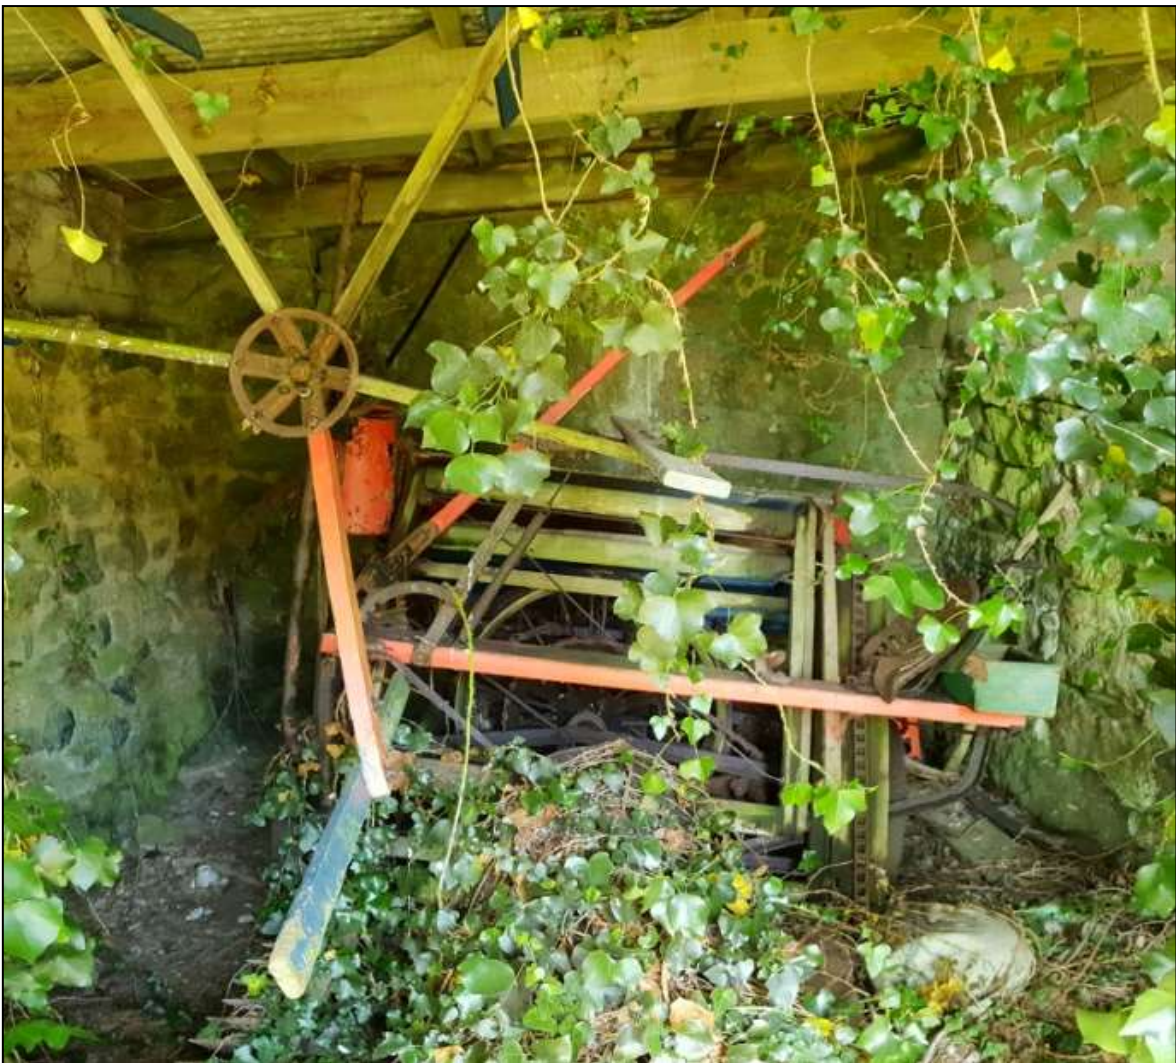
FIGURE 24: B8, INTERIOR WITH REAPER/BINDER; VIEWED FROM THE SOUTH-WEST.

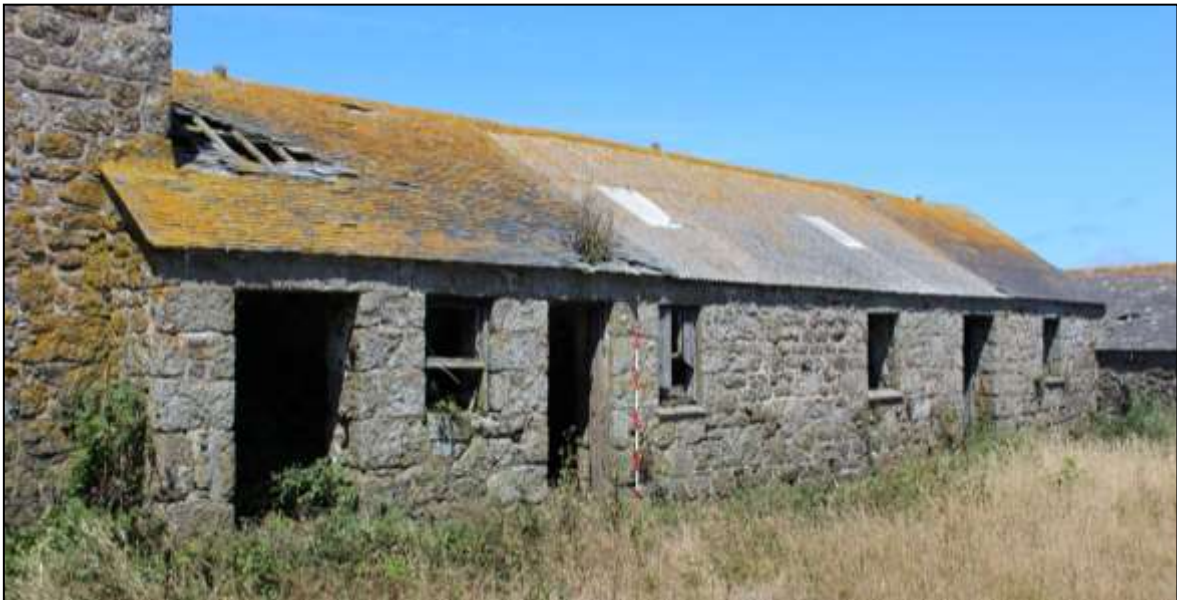
FIGURE 30: B10A (LEFT) AND B10B (RIGHT), SOUTH-EAST ELEVATION; VIEWED FROM THE SOUTH (SCALE 2M).

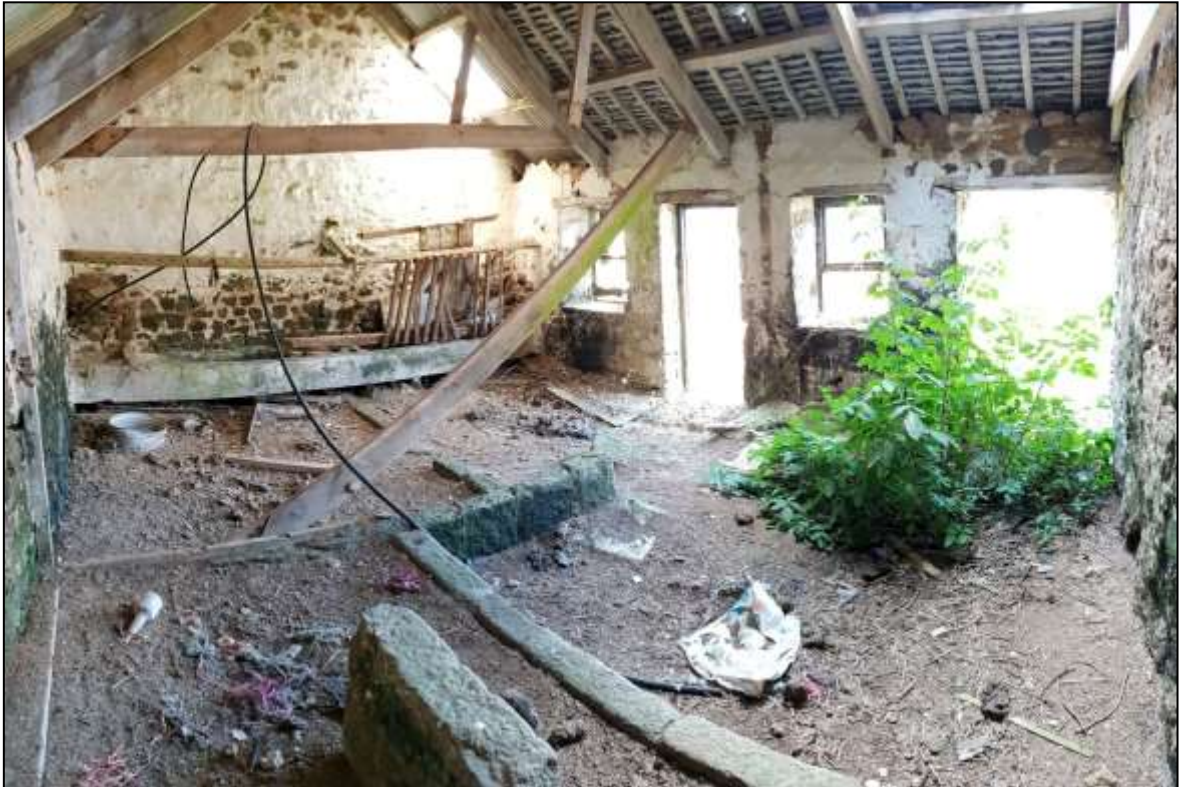
FIGURE 31: B10A, INTERIOR, THE REMAINS OF LOOSEBOXES FOR HORSES AS INDICATED BY THE GRANITE KERBS. VIEWED FROM THE WEST.

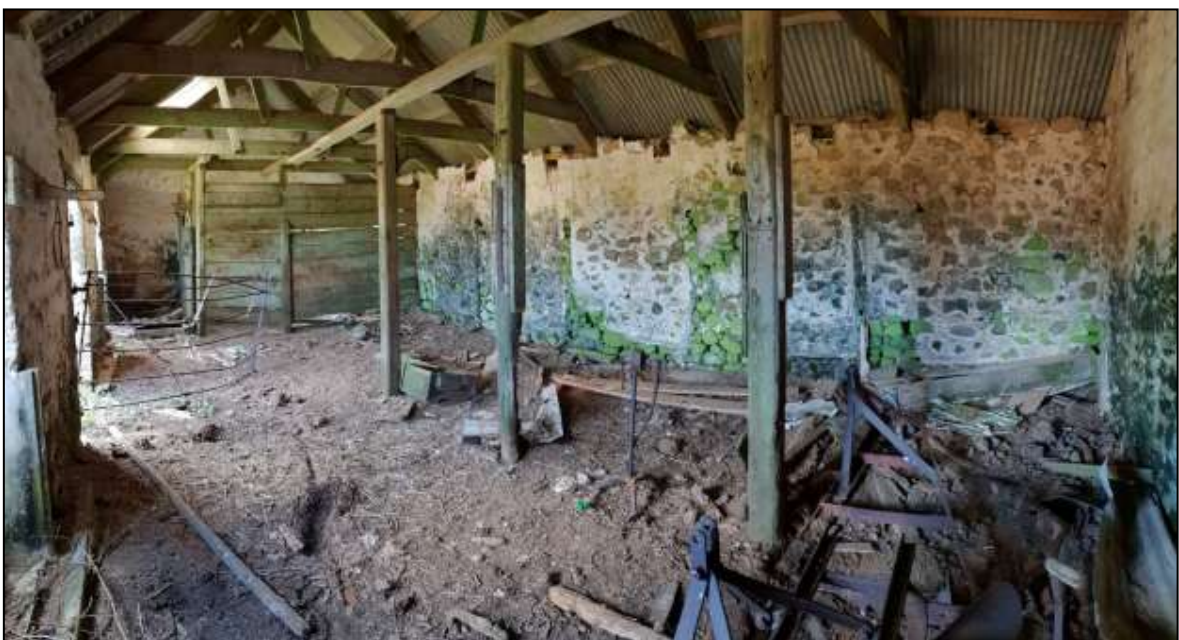
FIGURE 32: B10B, INTERIOR. NOTE THE POSTS SUPPORTING STALL DIVIDERS, SINCE LOST EXCEPT TO THE SOUTH-WEST END. WOODEN TACK RAIL ON WALL TO UPPER LEFT AND 19TH CENTURY WROUGHT IRON GATE AT CENTRE LEFT. VIEWED FROM THE EAST.

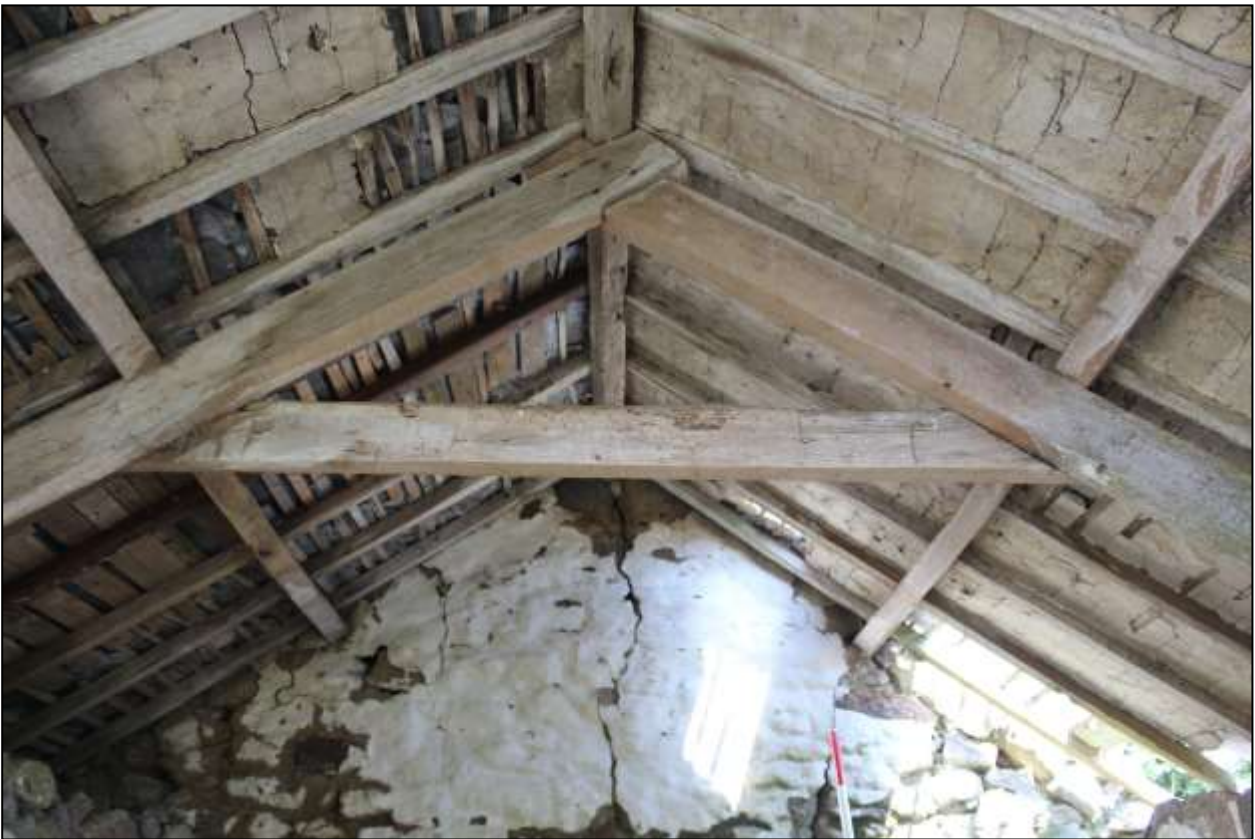
101. B1 INTERIOR, THE SURVIVING ROOF STRUCTURE OVER THE NORTHERN PART OF THE BUILDING; VIEWED FROM THE SOUTH-WEST.

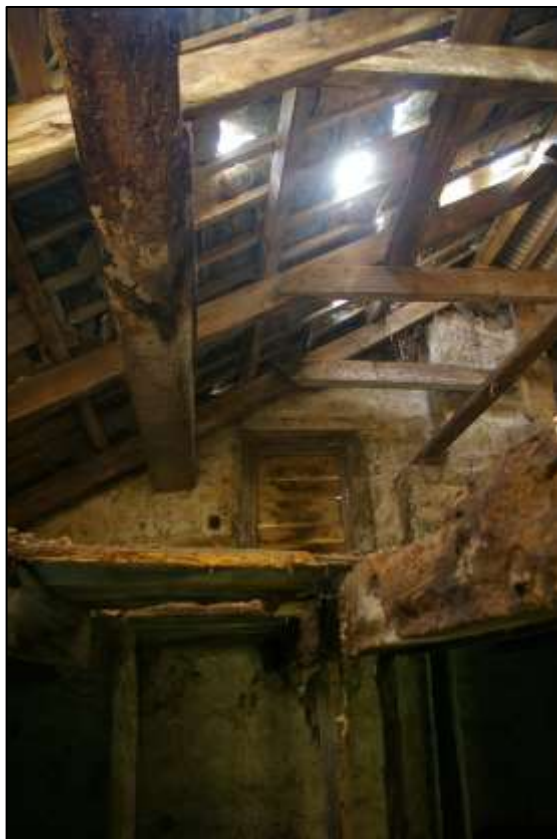
129. RIGHT: B3 FF INTERIOR, THE ROOF STRUCTURE VIEWED THROUGH THE MISSING FLOOR; VIEWED FROM THE NORTH-WEST.
