# ASHREIGNEY METHODIST CHAPEL

HISTORIC BUILDING RECORDING

SOUTH WEST ARCHAEOLOGY LTD. REPORT NO. 181102

*South West Archaeology Ltd. was commissioned to undertake historic building recording for the Ashreigney Methodist Chapel. This work was undertaken in advance of the conversion of the building to a residential property.*

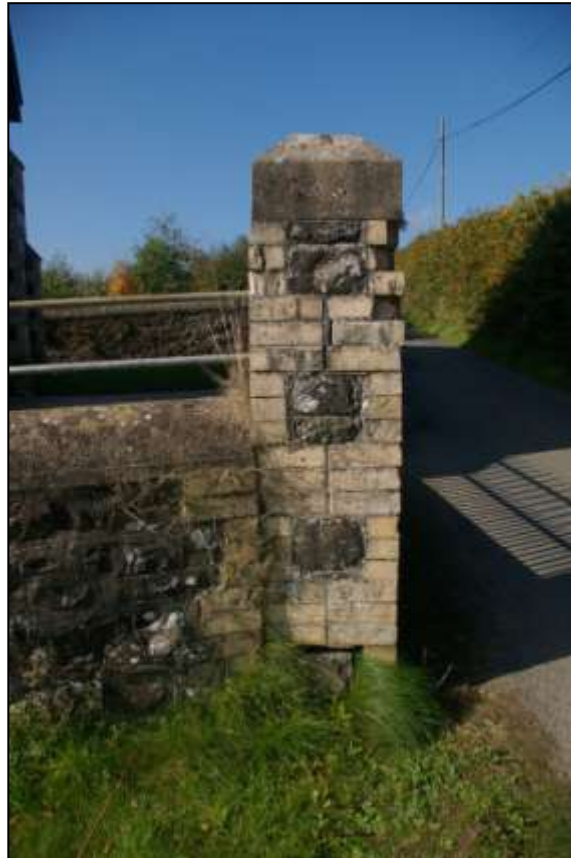
19. VIEW OF HOW THE EAST SIDE WALLS AND RAILINGS ABUT, THE SIDE WALLS SEEMING TO BE LATER, POSSIBLY A REPAIR; FROM THE EAST.

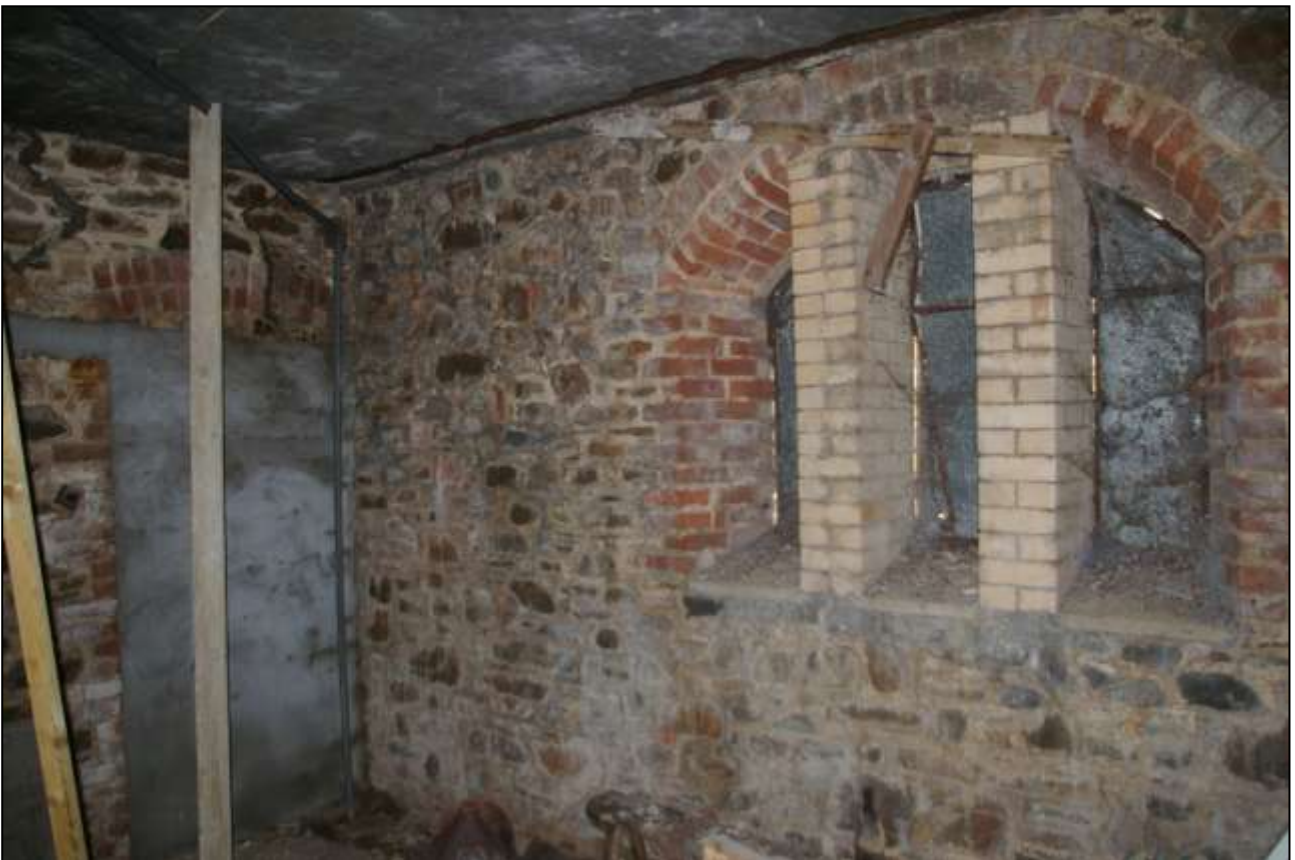
28. VIEW INSIDE THE BOILER ROOM, SHOWING WEST WINDOW, BLOCKED EXTERNALLY AND THE BLOCKED REAR DOORWAY; FROM THE NORTH-EAST.

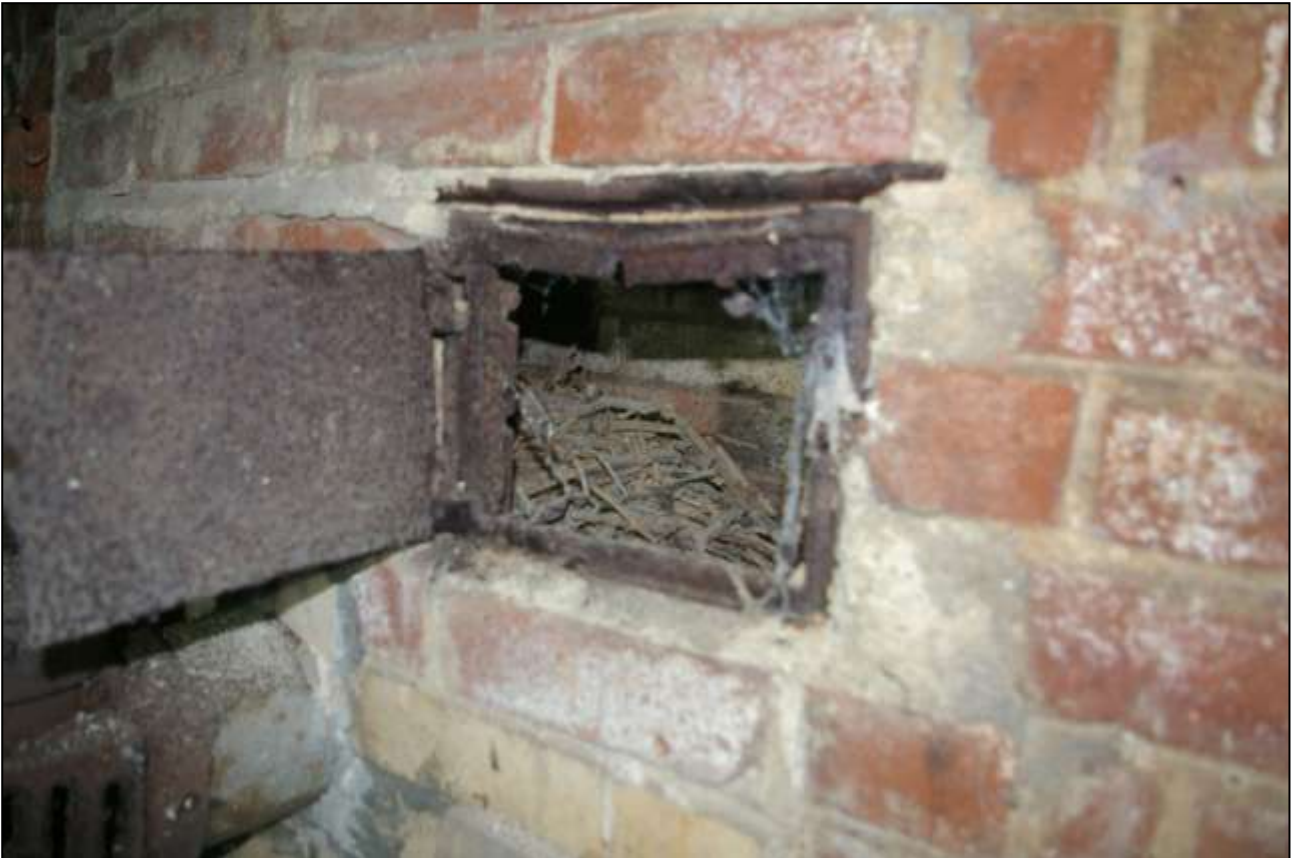
32. VIEW THROUGH THE HATCH SHOWING THE FLUE BLOCKED WITH JACKDAW NESTS; FROM THE NORTH-WEST.

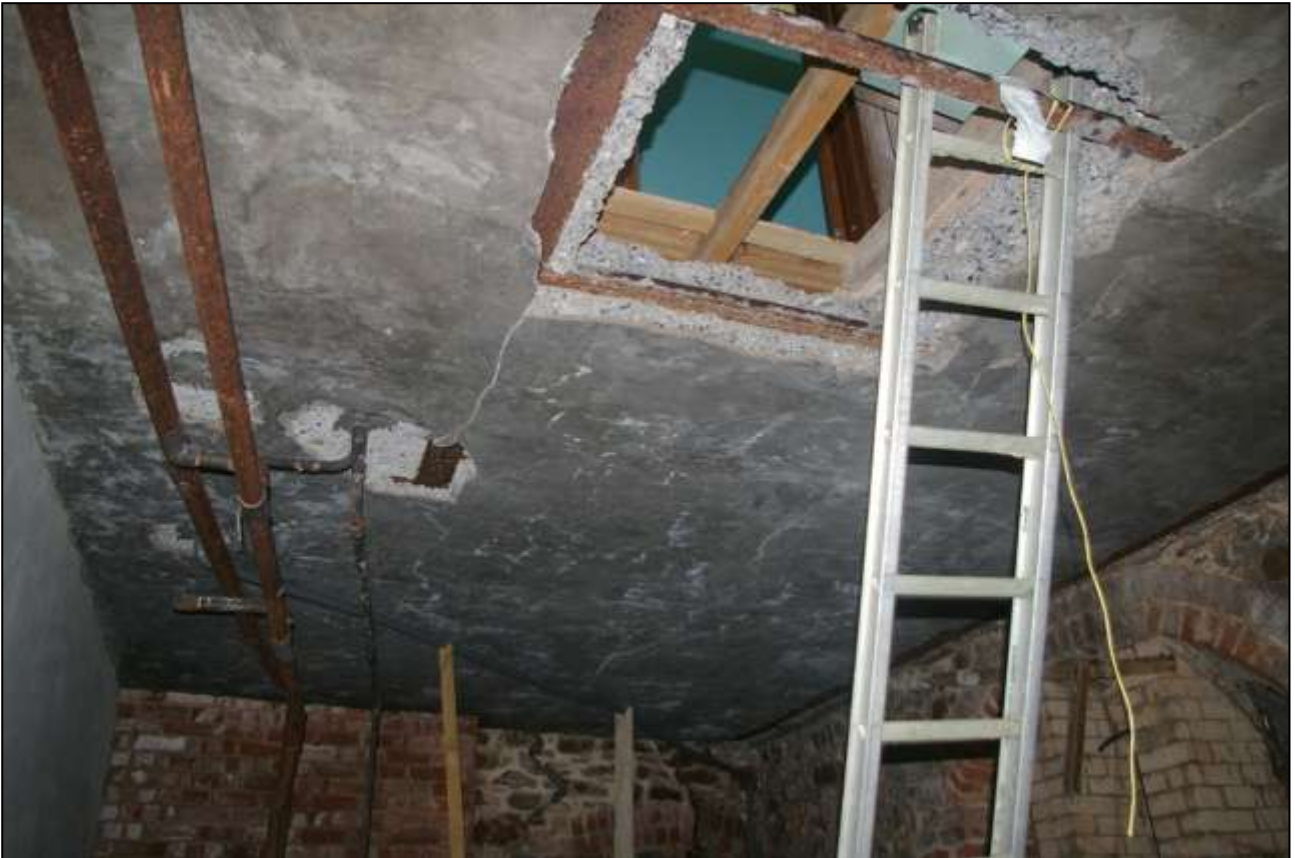
39. THE CONCRETE CEILING IN THE WESTERN END OF THE REAR CROSSWING, WHERE WOODEN JOISTS HAVE FAILED IN THE PAST, A LATER ALTERATION? FROM THE NORTH-EAST.

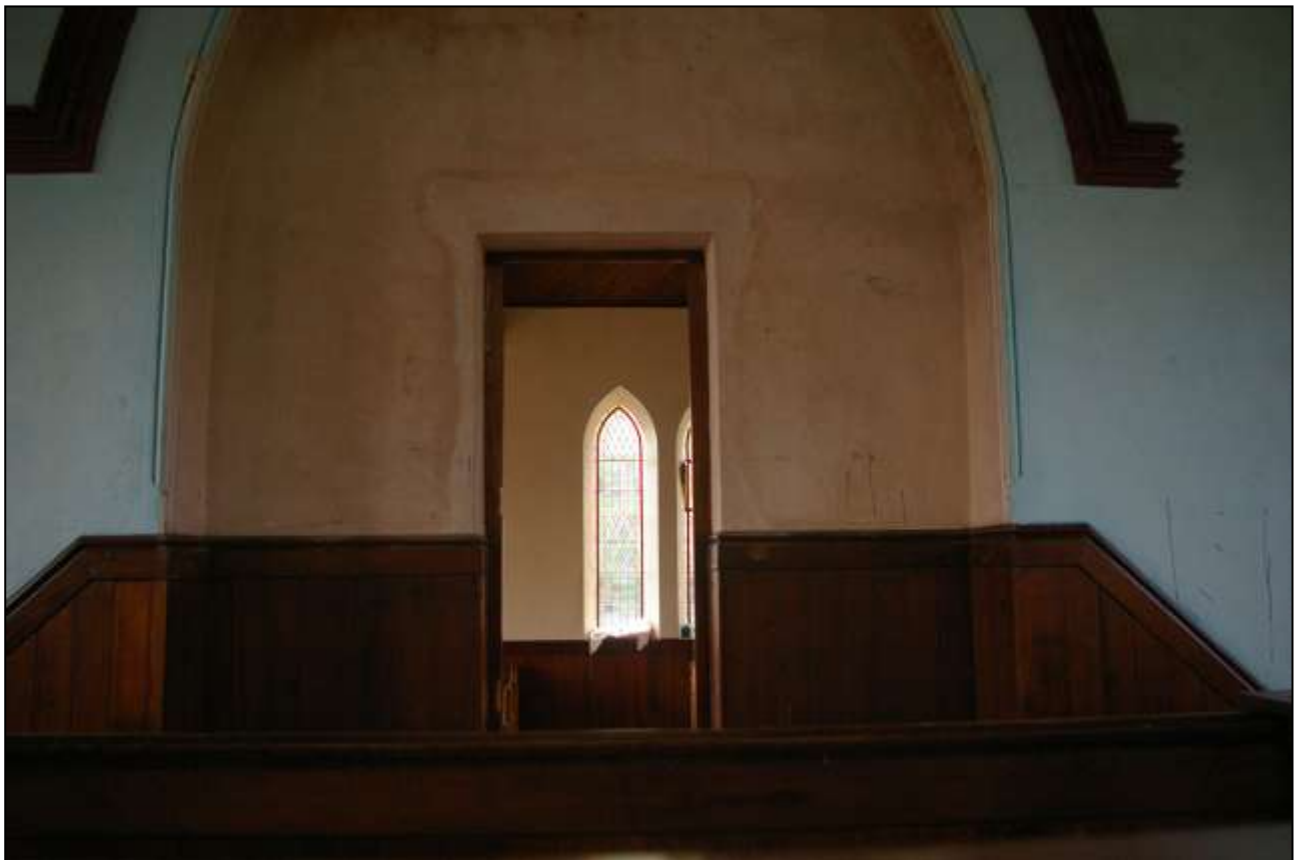
- An opening has been knocked in the recessed arched space behind the pulpit connecting through to the community hall.

71. THE MODERN FORCING OF AN OPENING TO THE BACK OF THE ALCOVE ABOVE THE PULPIT; FROM THE NORTH.

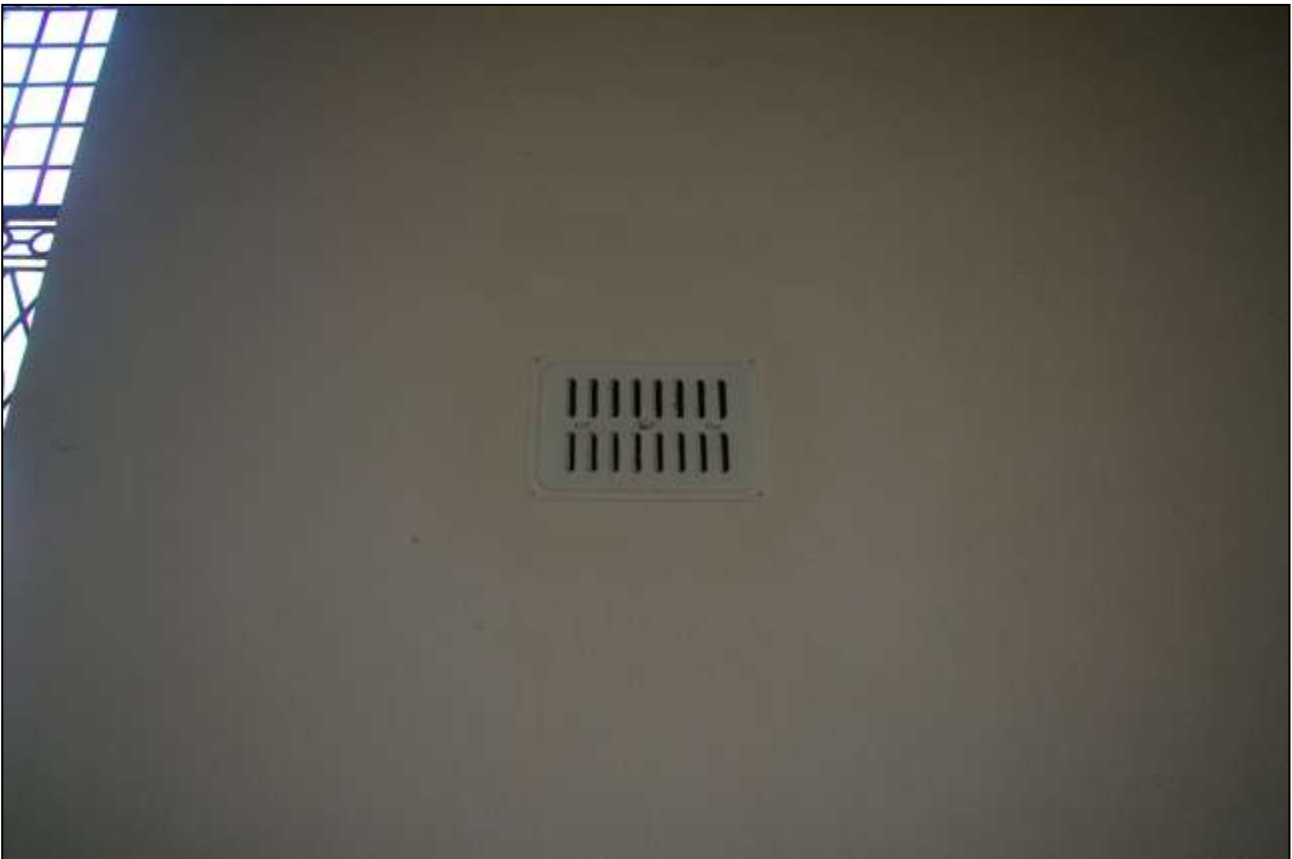
94. THE MORE MODERN METAL AIR VENT GRILLS ON THE WEST WALL; FROM THE NORTH-EAST.
