# TRELEW FARM MYLOR CORNWALL

Historic Building Recording

South West Archaeology Ltd. report no. 180910

## Trelew Farm, Mylor, Cornwall Historic Building Recording

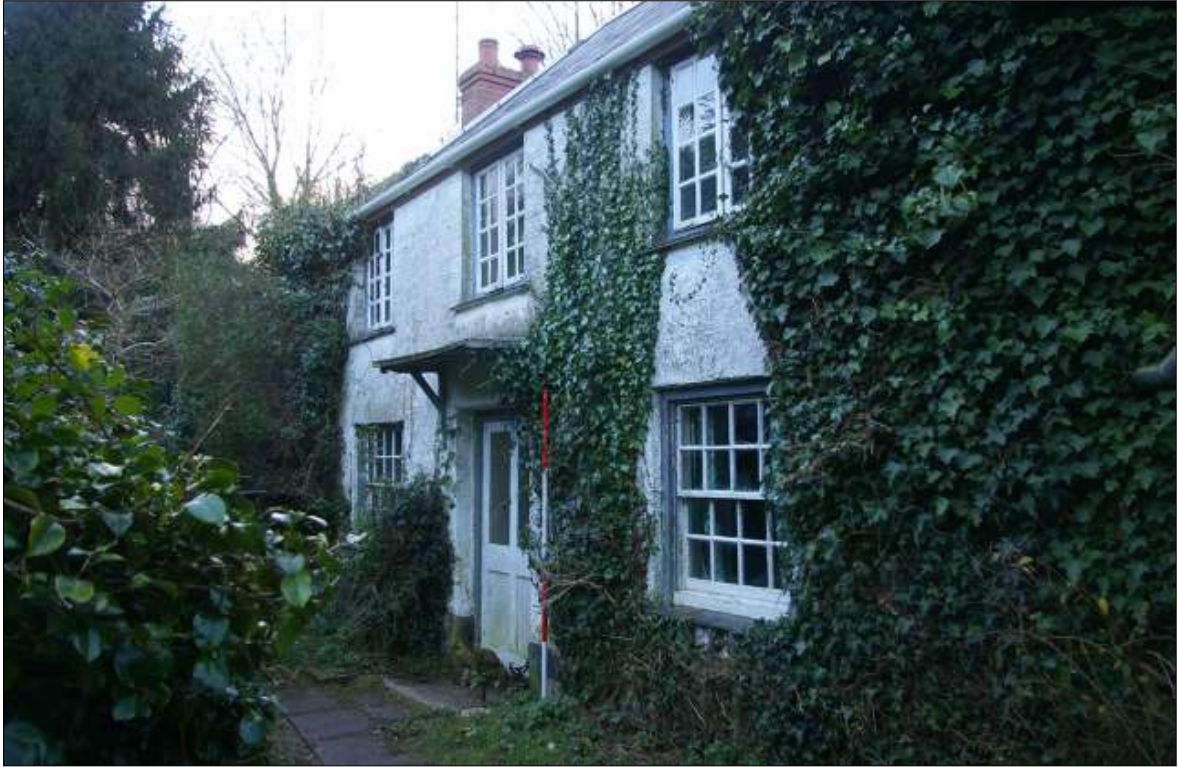
FIGURE 8: THE EAST ELEVATION, VIEWED FROM THE NORTH-EAST (SCALE 2M).

The principal elevation is to the east (Figure 8), facing across the narrow coombe, and has a symmetrical 2/1/2 arrangement of windows with a central doorway. At ground-floor level the windows are early 19<sup>th</sup> century hornless sashes under flat granite lintels, the lintels scored to mimic voussoirs. The window to the south is wider, with a 10 over 10 sash (possibly widened in c.1800); the window to the north is an 8 over 8 sash. The central doorway features a four-panel 19<sup>th</sup> century door set into a heavy frame; the upper two panels of the door have been replaced with opaque glass. At first-floor level the three windows are all mid 18<sup>th</sup> century frames, with one fixed light and one casement, each set with eight panes of crown glass. The south elevation features a single window at ground floor to the west, with one fixed light and one casement, each with six panes of the glass; these are 19<sup>th</sup> century replacements in an 18<sup>th</sup> century frame. The slate windowsill has been engraved 'R.M. OARE 1877'. There is a small window a first-floor level. In the north elevation the side of the Cottage rises above the lean-to and features a single partly-blocked window at first-floor level. The west (rear) elevation features an off-centre doorway and three windows (Figure 10). The door has been forced into the elevation and features a heavy 19<sup>th</sup> century frame and plank boarded door with recent canopy. South of the door is an 18<sup>th</sup> window similar to those in the east elevation, but with six panes rather than eight, and a small forced single-pane window for the toilet. North of the door is a replacement 19<sup>th</sup> century horned sash window in an original opening with a timber lintel.

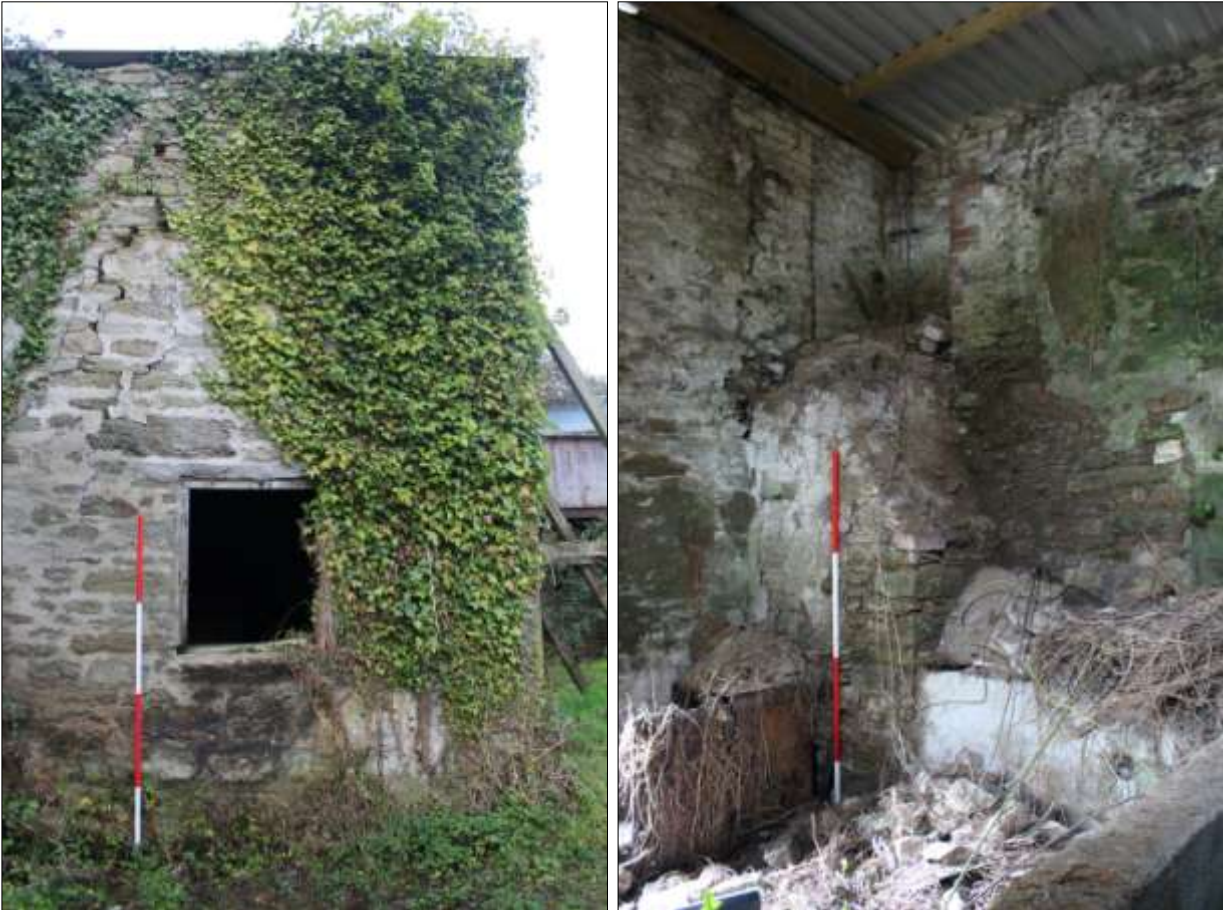
- The partly-collapsed chimney and oven in the south-west corner of the interior, and the exterior buttressed stack;
- The three-centred brick arch to the first-floor loading door.

LEFT FIGURE 21: THE EAST ELEVATION OF FB1; VIEWED FROM THE EAST (SCALE 2M).

RIGHT FIGURE 22: THE INTERNAL SOUTH-EAST CORNER OF FB1; VIEWED FROM THE NORTH-WEST (SCALE 2M).

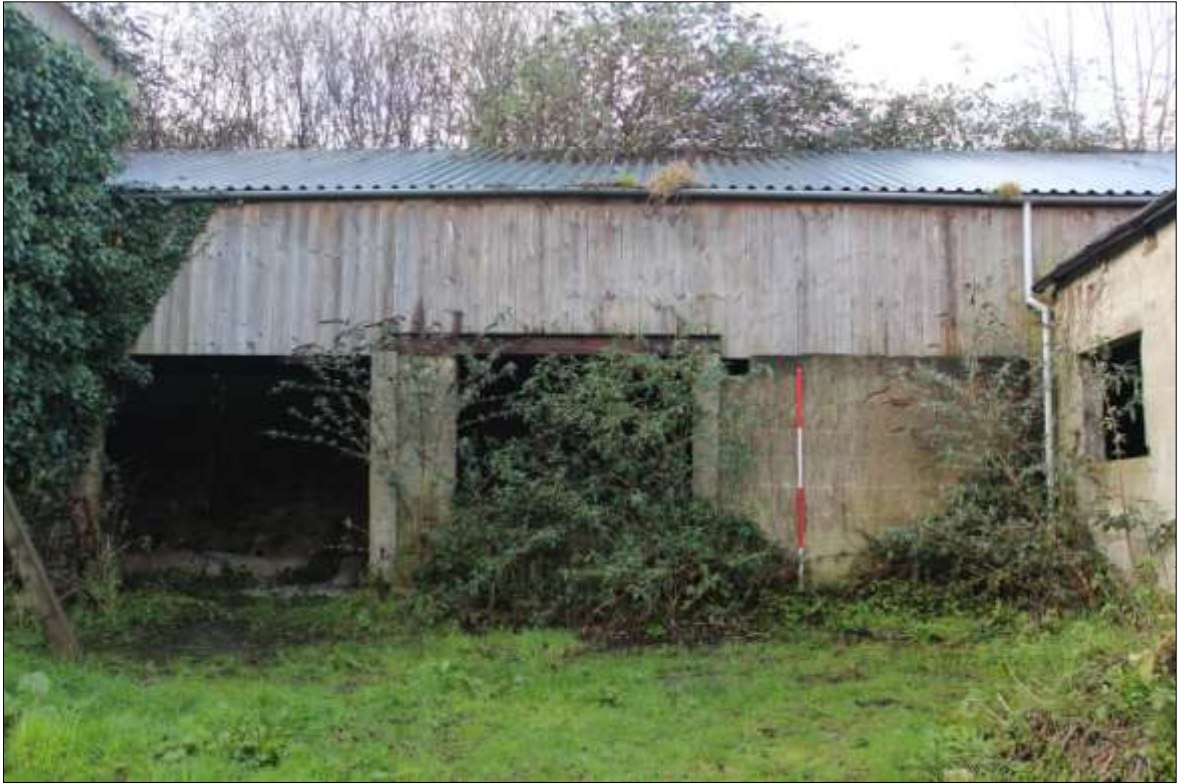
A former two-storey structure, now with gables removed and a mono-pitch roof of box-section plastic-coated steel sheets carried on a modern timber frame. The building is cut back into the slope and the upper walls stand on the lip of a vertical rock-cut face c.2m+ high. The lower wall stands in front of the rock face, with a gap 0.3-0.5 between the wall and the rock. The upper walls are of roughly-dressed, squared and coursed killas stone rubble, very accomplished in places. Serious structural failings are apparent, with several large sections replaced in modern concrete block and some of the remaining historic walls leaning out. The exterior of the building is set down into the slope and concealed by dense shrubs. Its interior is open to the roof, the lower part divided by a single stone rubble wall into two unequal parts. FB2a to the south is the larger; FB2b to the north is the same width as FB3. The upper south wall features a door, blocked in stone; the upper north wall features a door opening, but this wall has partly collapsed. The lower south wall is crudely capped with large slate slabs, probably from a slate flag floor. The build of the lower north wall is not as accomplished as elsewhere within the structure, otherwise the build of the lower wall and the partition between FB2a and FB2b is similar to that of the upper wall. At its eastern end the partition wall stops short of the east wall to form a doorway; the stonework above head height is disturbed, rebuilt after the removal of a lintel. The lower west wall features three blocked possible fireplaces, each slightly different in size. The fireplaces to the north and south have thin timber lintels and are blocked in stone; the flue to the fireplace to the south has been forced or rebuilt. The central fireplace has a brick segmental arch and was blocked in concrete block. The fireplaces lack flues above the level of the lower wall; when viewed from above the fireplace in FB2b appears to lack build to the rear of the opening, perhaps indicating another function.

FIGURE 23: THE EAST ELEVATION OF FB2; VIEWED FROM THE EAST (SCALE 2M).

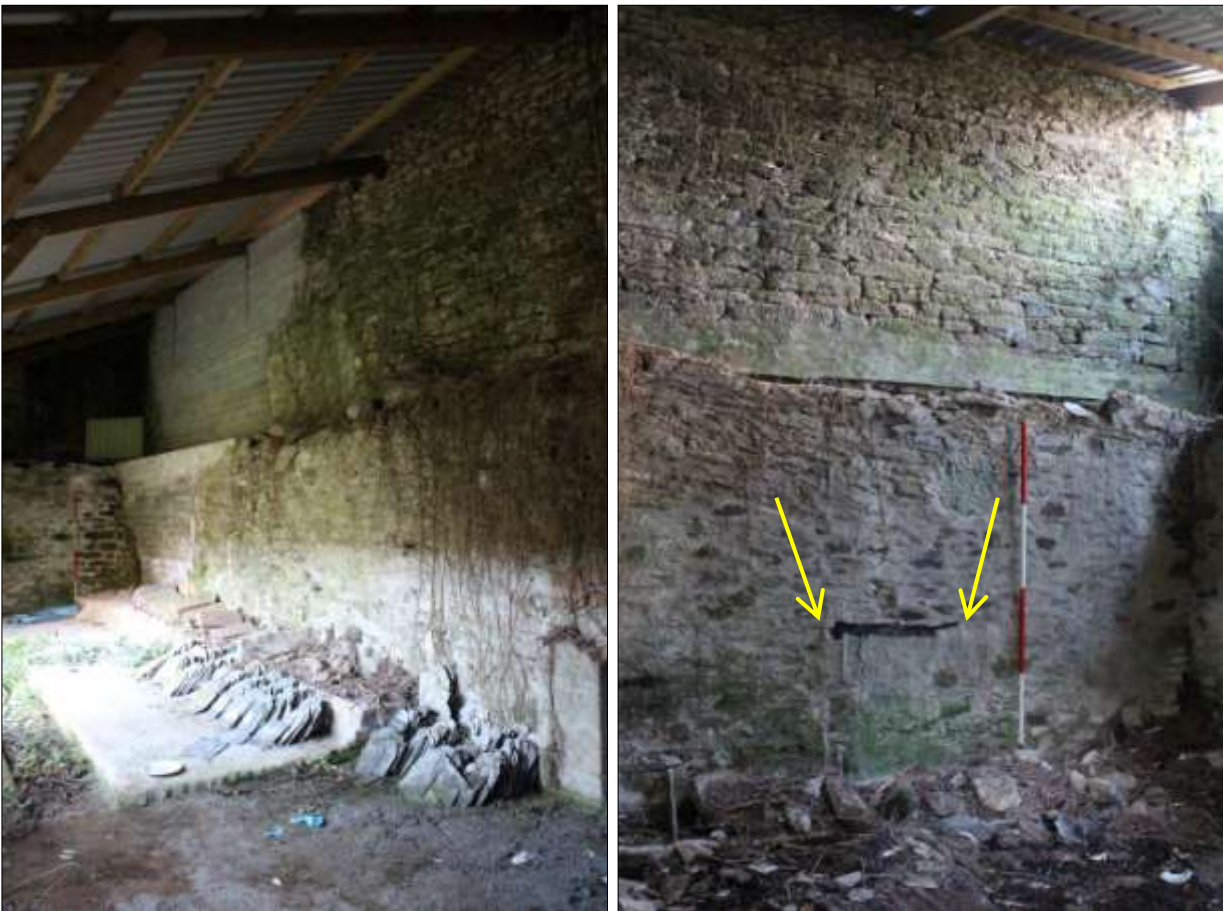
LEFT FIGURE 25: THE BACK (WEST) WALLS OF FB2A; VIEWED FROM THE NORTH-NORTH-EAST (NO SCALE).  
 RIGHT FIGURE 26: THE BACK (WEST) WALLS OF FB2B, SHOWING THE BLOCKED FIREPLACE (INDICATED); VIEWED FROM THE EAST (SCALE 2M). NOTE THE QUALITY OF THE STONEMWORK IN THE UPPER WALL.

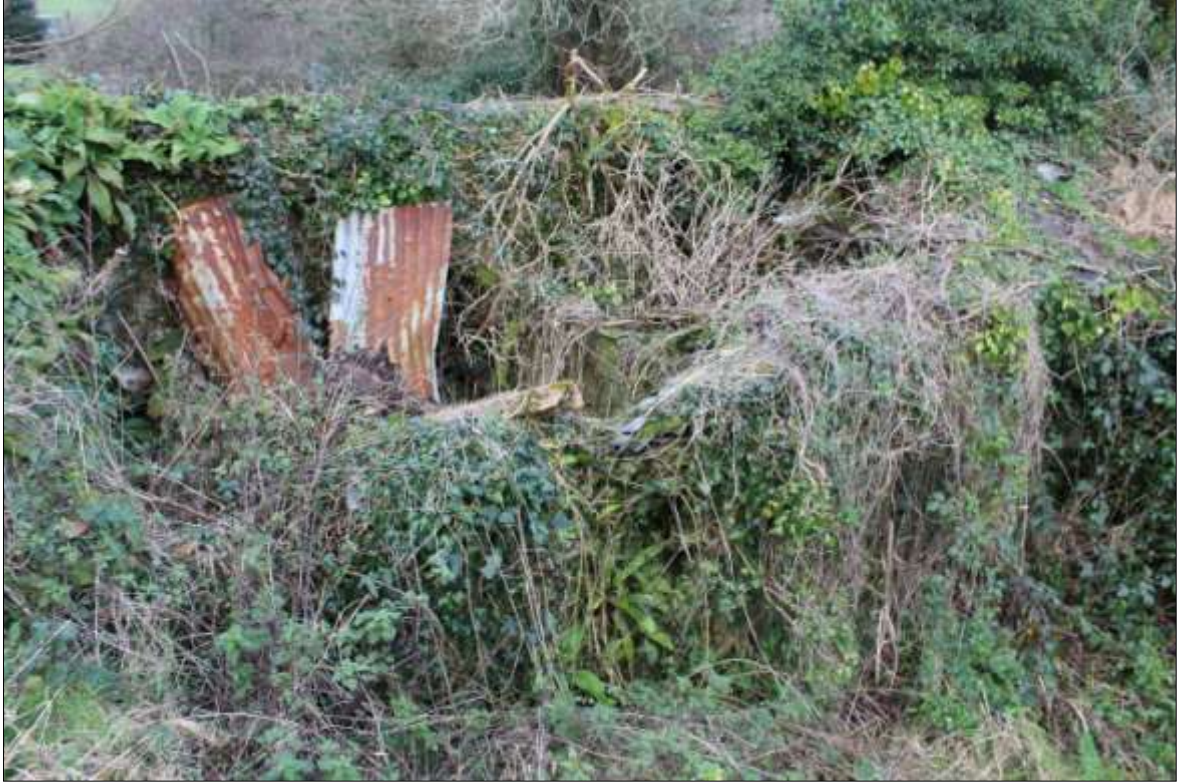
A sprawling ramshackle irregular single-storey building of stone, concrete block and timber, with slate and corrugated steel and asbestos roofing, partly collapsed and full of clutter. The historic structure at its core is located to the north-western side, and is very overgrown with ivy and other plants making observation more difficult. It is a small rectangular two-cell structure of poorly-built stone (killas) rubble construction. The cell to the west (FB4a) has two door openings in the south wall and is divided internally by a concrete block wall. The east wall projects beyond the front (south) wall to form one side of a yard. The cell to the east (FB4b) may be built up against the other structure, as suggested by the historic maps. It also has two doorways in the south wall, but the south-east angle of the build has been rebuilt in concrete block. There is a window or narrow doorway in the north wall. The roof over FB4a has collapsed, but is likely to have been identical to

that of FB4b, repaired with corrugated iron sheets. The roof of FB4b is a pitched asymmetric roof of scantle slates (identical to those noted in FB2a) with wooden pegs, laid on sawn and regular battens in diminishing courses. The roof is carried on simple half-lapped and nailed trusses. The interior of FB4a is totally overgrown. The interior of FB4b is full of rubbish and crude wooden mesh cages. One of these wooden cages has reused two raised and field boards from the Cottage.

FIGURE 29: FB4A; VIEWED FROM THE SOUTH-WEST (NO SCALE).

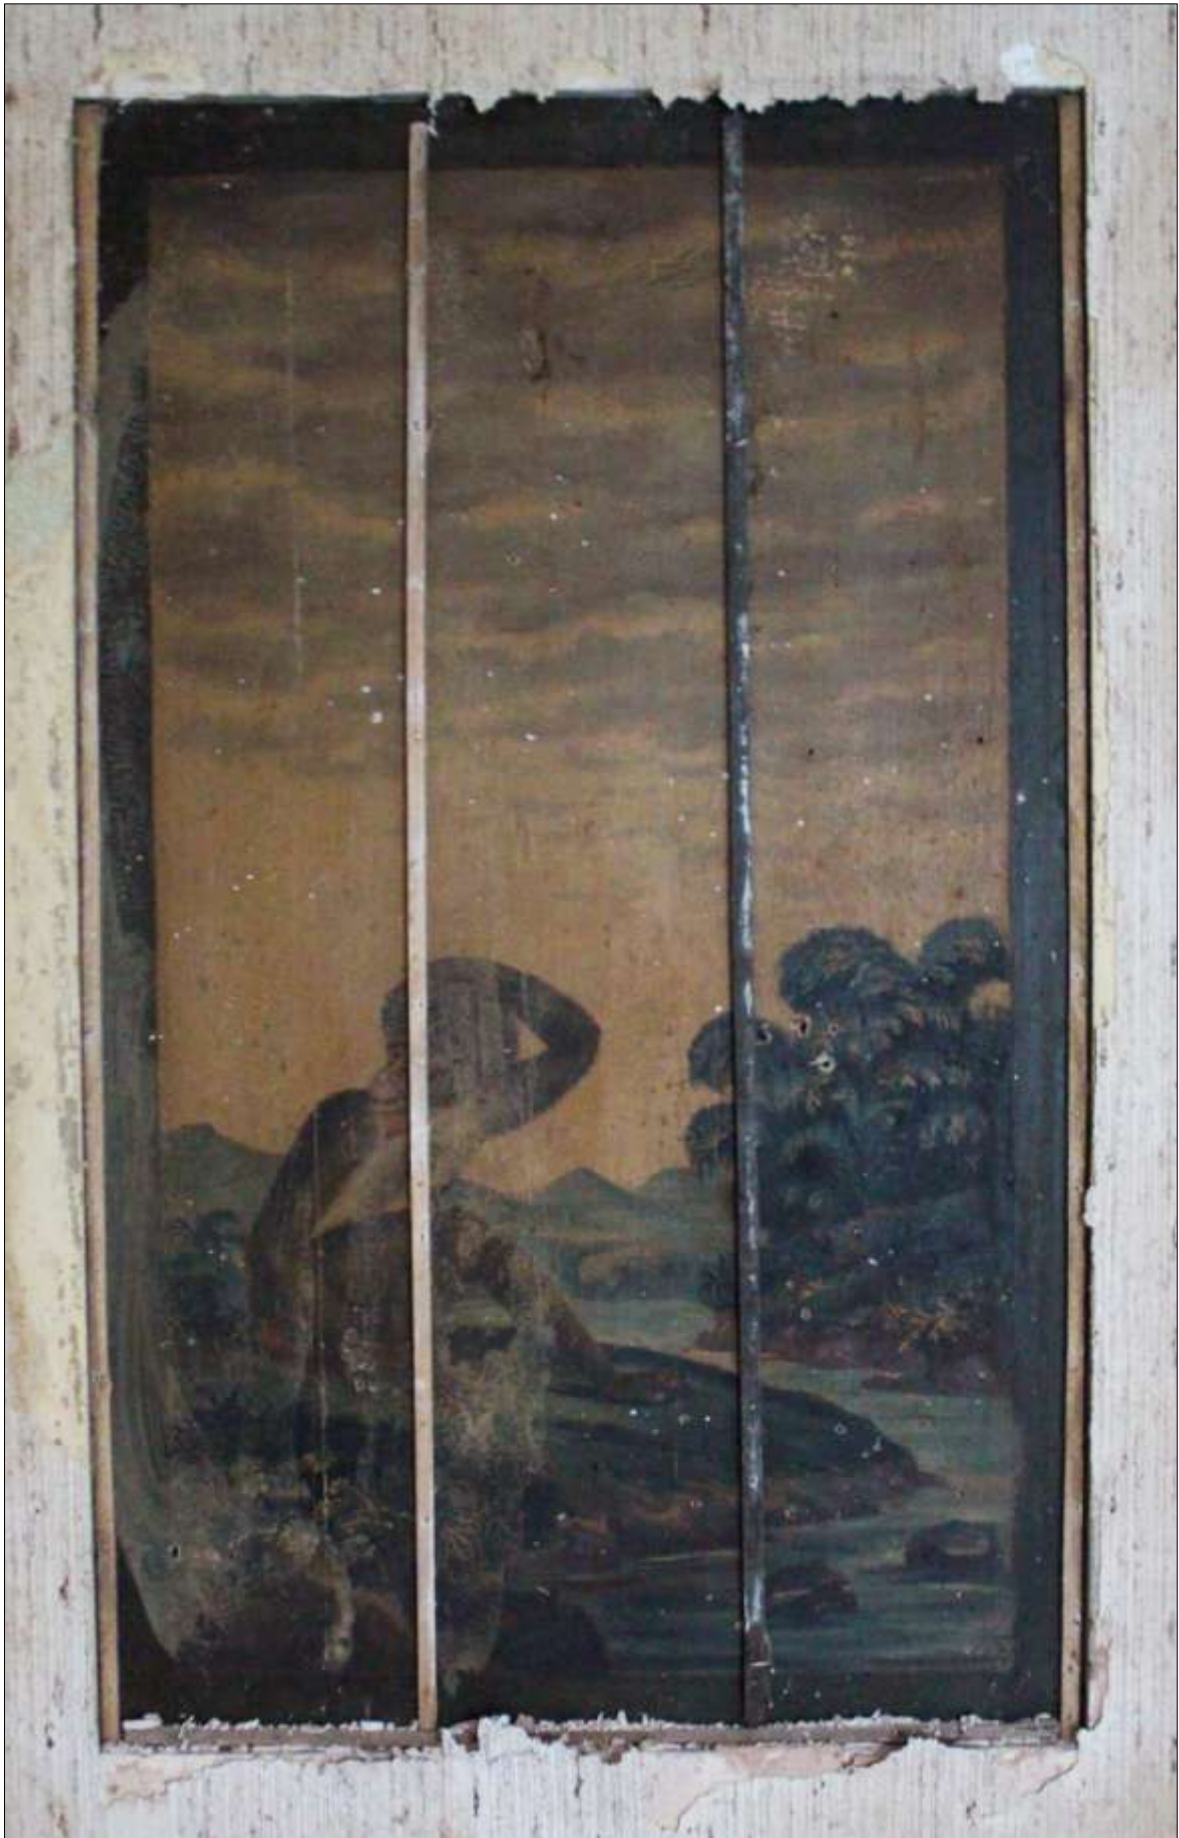
FIGURE 38: THE PAINTED WALL PANEL IN R2, VIEWED FROM THE EAST.

- Works to the Cottage should seek to retain and conserve the 18<sup>th</sup> century features, and sensitively restore areas of loss (i.e. fireplace in R1) based on comparable structures;
- Further study of the painted wall panels should be undertaken in order to fully define the paint schema, conserve those damaged elements that can be saved, and determine how they might best be preserved (i.e. covered over again or revealed?);
- Work should attempt to locate the panels described in the *Listing* as 'now in Truro Museum';
- Monitoring work should be undertaken in order to record any historic fabric that might be revealed during the works, especially during any demolition works (e.g. the fireplaces and oven);

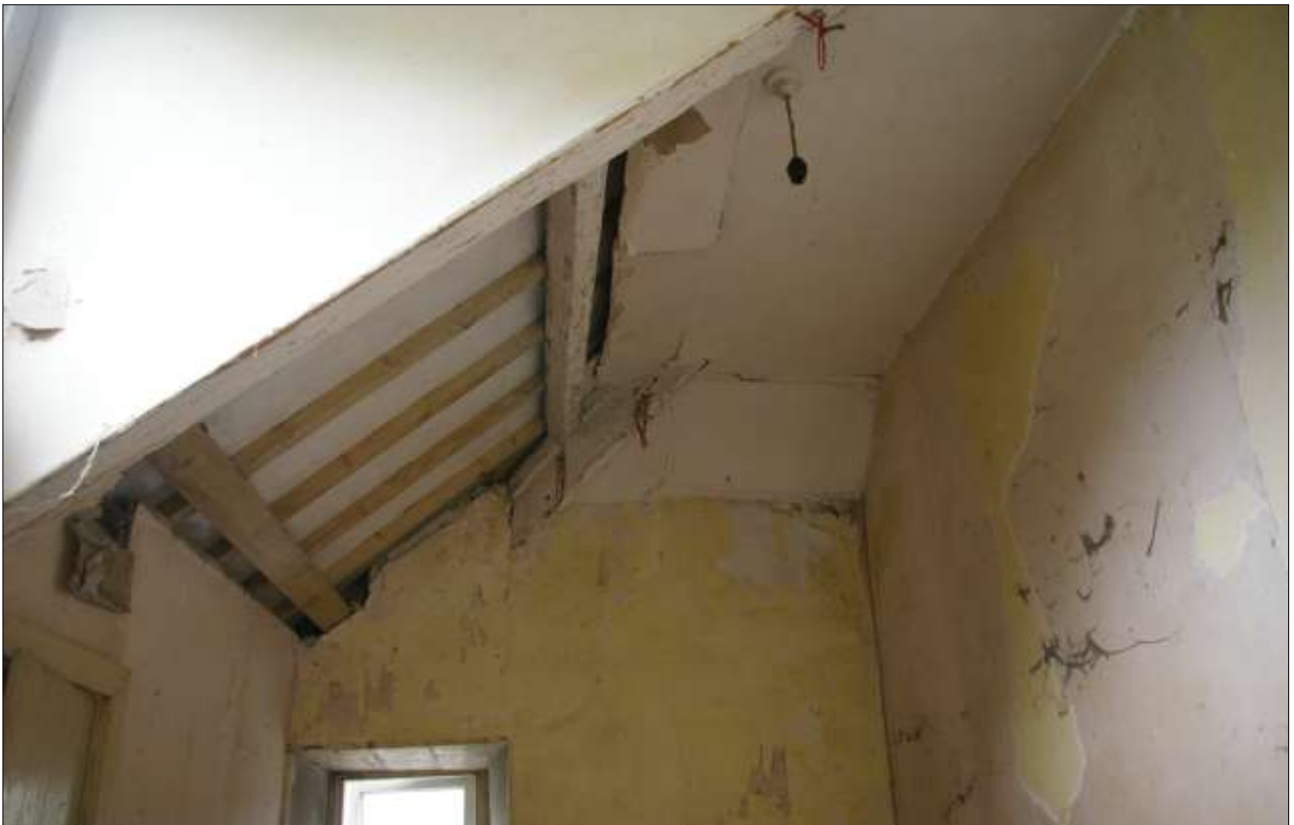
THE CEILING IN R9 SHOWING THE C21 REPLACEMENT ROOF ELEMENTS; VIEWED FROM THE SOUTH.

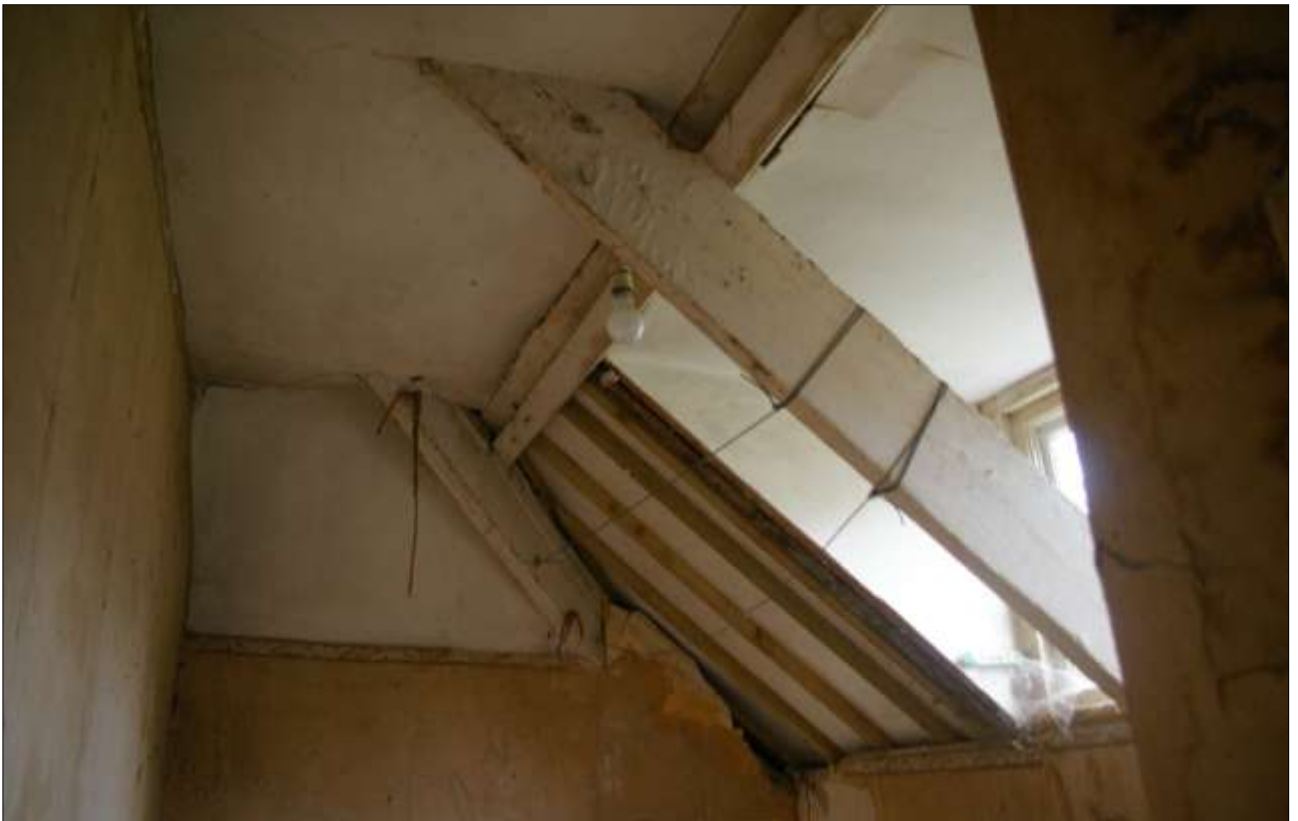
THE CEILING IN R10 SHOWING THE DORMER AND THE C21 REPLACEMENT ROOF ELEMENTS; VIEWED FROM THE NORTH.

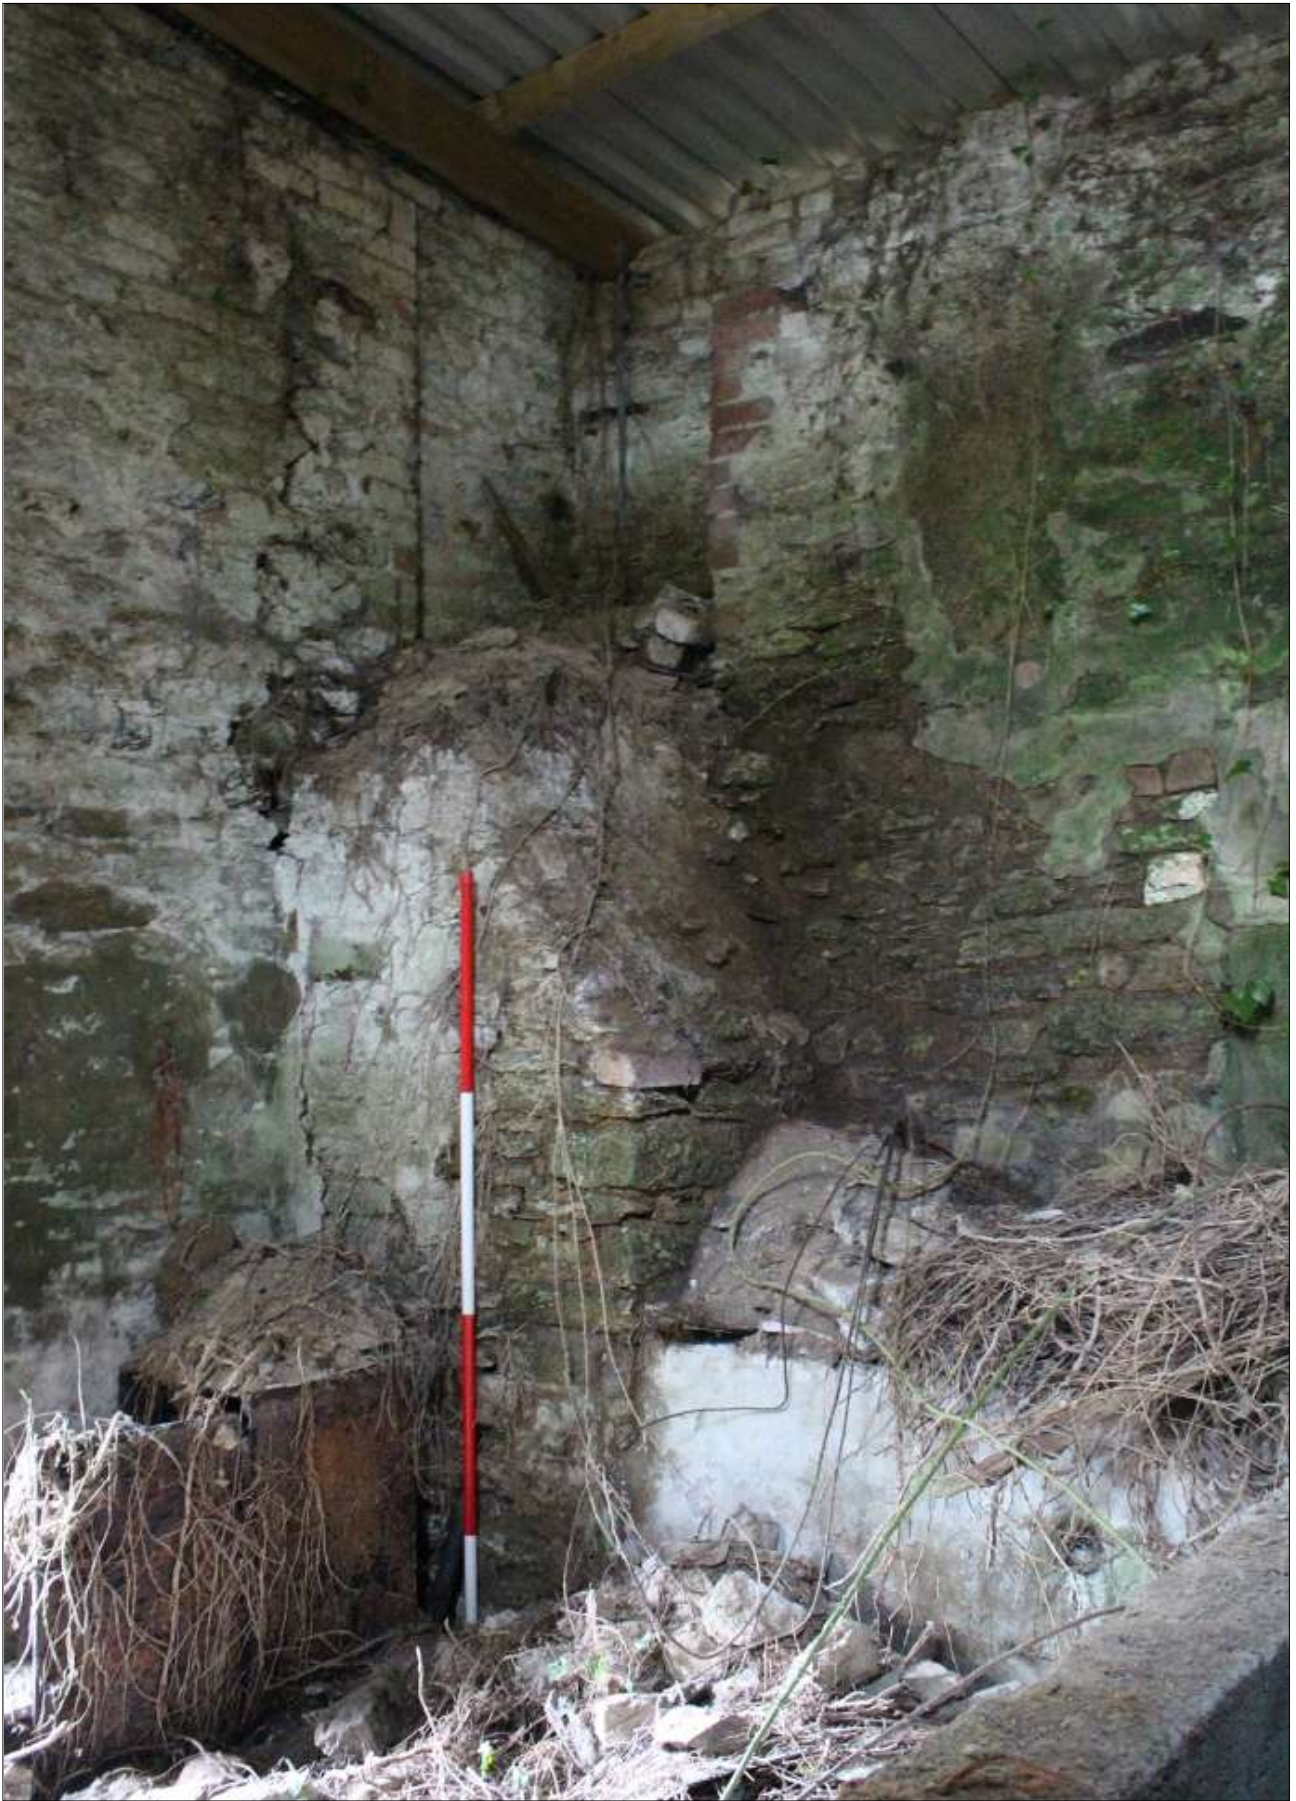
THE INTERNAL SOUTH-EAST CORNER OF FB1 SHOWING THE BLOCK OF MASONRY (BOILER/OVEN?); VIEWED FROM THE NORTH-WEST (SCALE 2M).

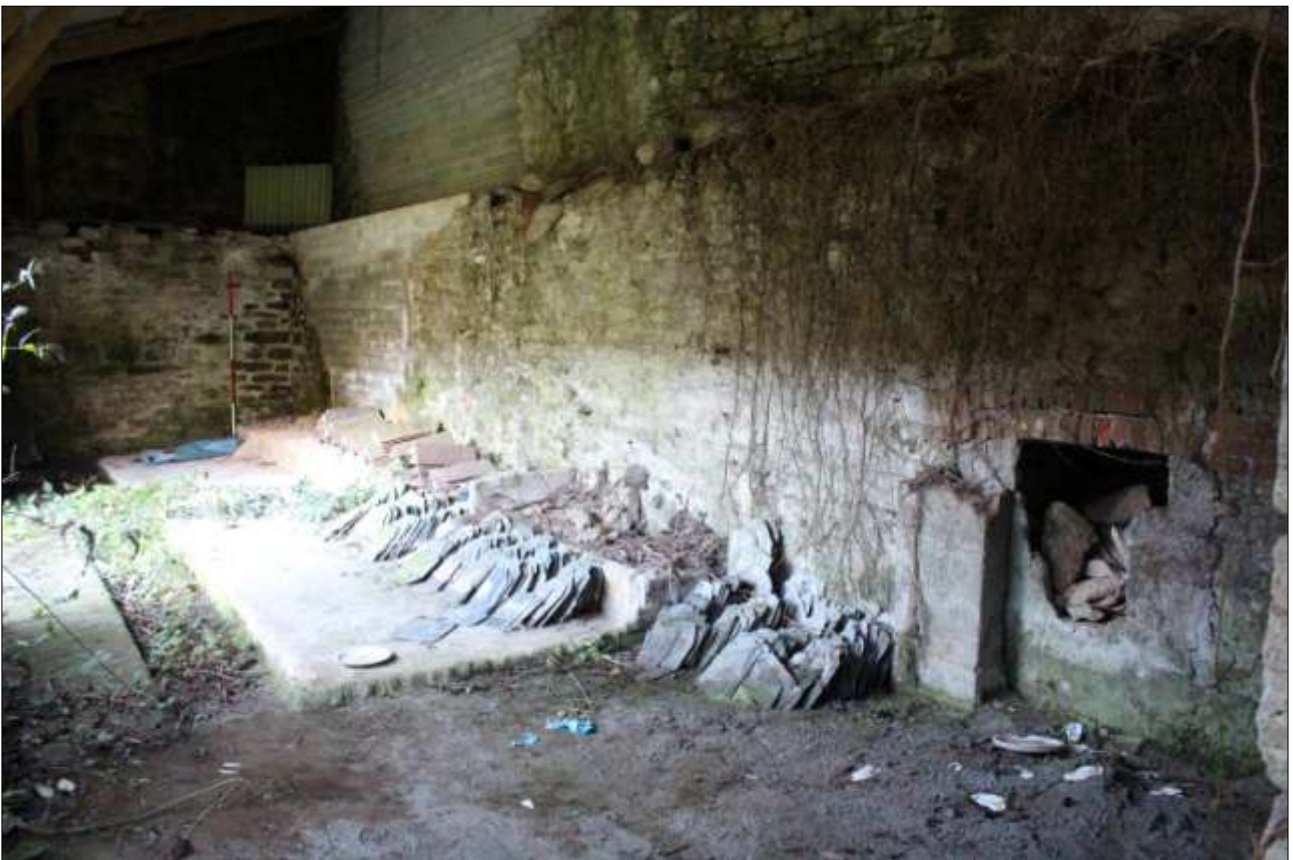
BO4	GF blocked opening in the west wall north of BO3. The former opening is 0.9m high and 1.0m wide, with a segmental brick arch with brick springers. This is likely to have been a three-centred arch similar to D9, but appears to have failed and flattened. Blocked in concrete, the blockage has been smashed and there is a wide flue to the west that rises up to FF level; it is not clear where this flue went, as the FF wall above has been rebuilt in concrete block. Possible hearth?
	BO6	GF blocked opening. Blocked in concrete block.
Other Details:		The interior of FB2a has been repurposed as a milking parlour and dairy. The southern (larger) part of the space has the remains of four cattle stalls with integral concrete feed troughs, with space for eight cows. The walls of the concrete stalls have been demolished and removed, leaving the concrete floor with drain and troughs. The northern (smaller) part of this space has a level concrete floor, and it is probable that this was the dairy.

THE INTERIOR OF FB2A, WITH BO4 TO THE RIGHT; VIEWED FROM THE NNE (SCALE 2M).

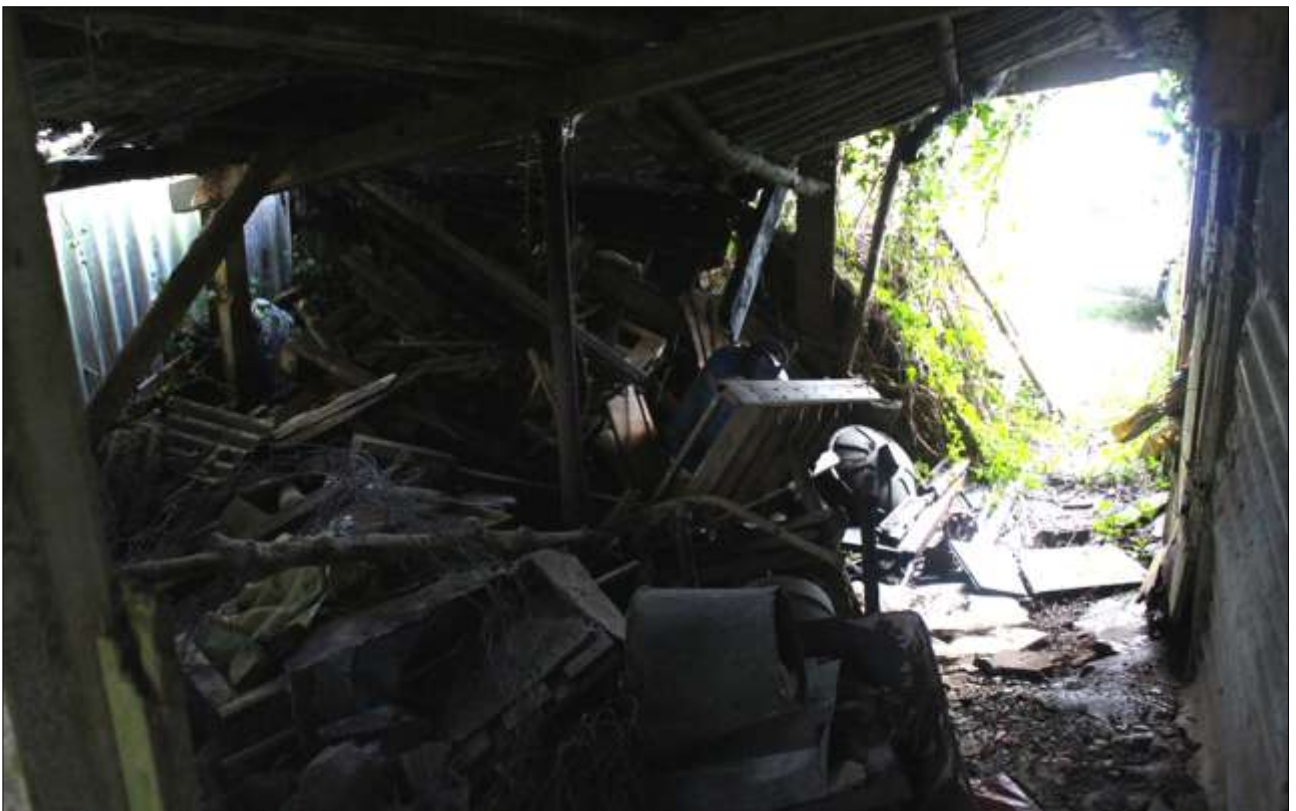
<b>FARM BUILDING 7</b>		
Function/Summary:		C20 kennels and storage adjacent to FB4. Partly ruinous.
Fabric Description:		Ramshackle single-storey structure of concrete block and reused timber.
Roof Covering:		Corrugated steel sheeting, failing.
Dating Evidence:		Mid-late C20; fabric and map evidence.

THE INTERIOR OF ONE OF THE RAMSHACKLE SHEDS (FB7) ATTACHED TO FB4B; VIEWED FROM THE NORTH.
