**OLD WHIM HOUSE**  
**PENSTRAZE**  
**CHACEWATER**  
**CORNWALL**

HISTORIC BUILDING RECORDING

SOUTH WEST ARCHAEOLOGY LTD. REPORT NO. 181026

By E. Wapshott, N. Boyd & S. Walls  
Report Version: FINAL

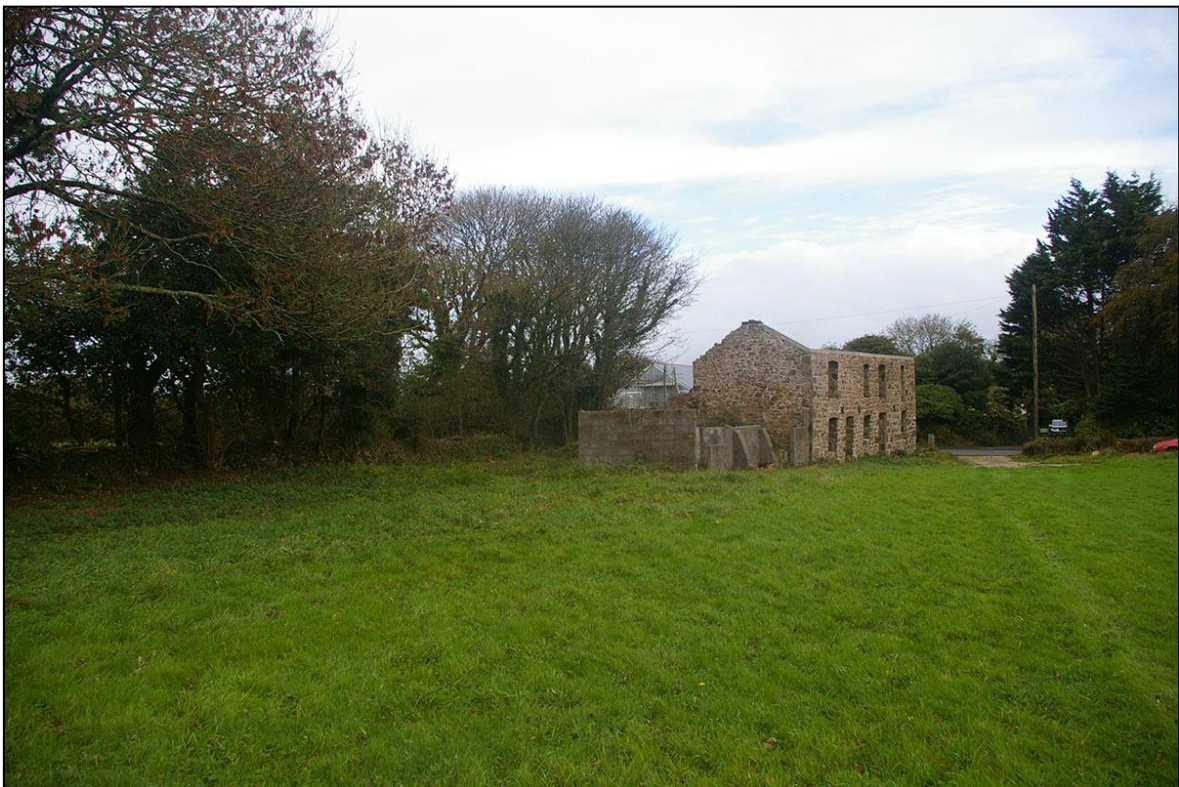
The site was very overgrown for a long period of time. It has been mostly cleared, with piles of cutback foliage seen along the northern boundary. The buildings were completely covered in ivy and foliage until recently, still recorded as totally subsumed into the hedge as late as 2014 on Google Streetview. A wide gateway leads directly off the road and a further gate enters the plot to the south-west.

FIGURE 6: WIDE ANGLED VIEW SHOWING CONTEXT AND SETTING OF BUILDING; FROM THE WEST, SOUTH-WEST.

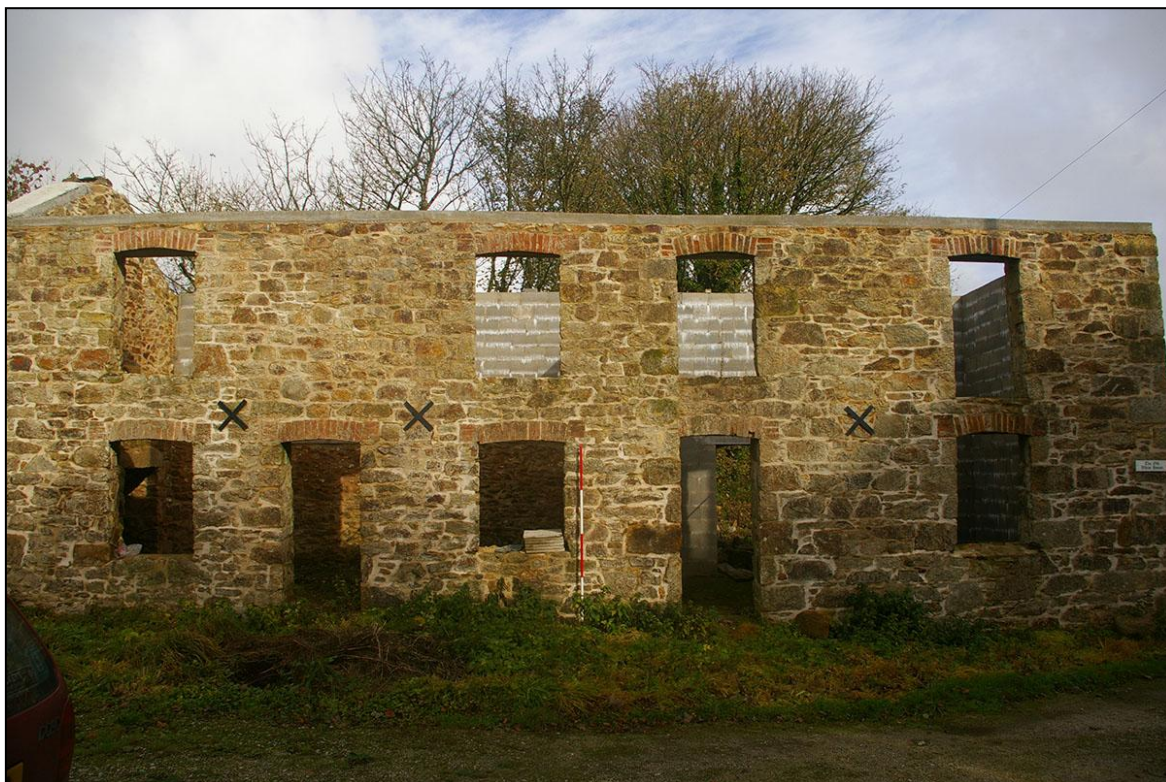
The south wall appears to abut the west wall and may have been rebuilt above first floor level. The windows of the south wall may have been slightly widened, causing their brick arches to drop. There may be a blocked opening in the west wall to the south side and another behind the fireplace. The west stack may have been rebuilt. The upper part of the north wall has been totally replaced with concrete block. Significant elements of the east wall have also been rebuilt, including its upper, also of concrete block. A doorway has been forced to the south side of the east wall. The building has had x-ties installed to brace it. The whole has been heavily re-pointed in cement.

FIGURE 7: THE SOUTH ELEVATIONS OF BUILDING 1 AND 2; FROM THE SOUTH.

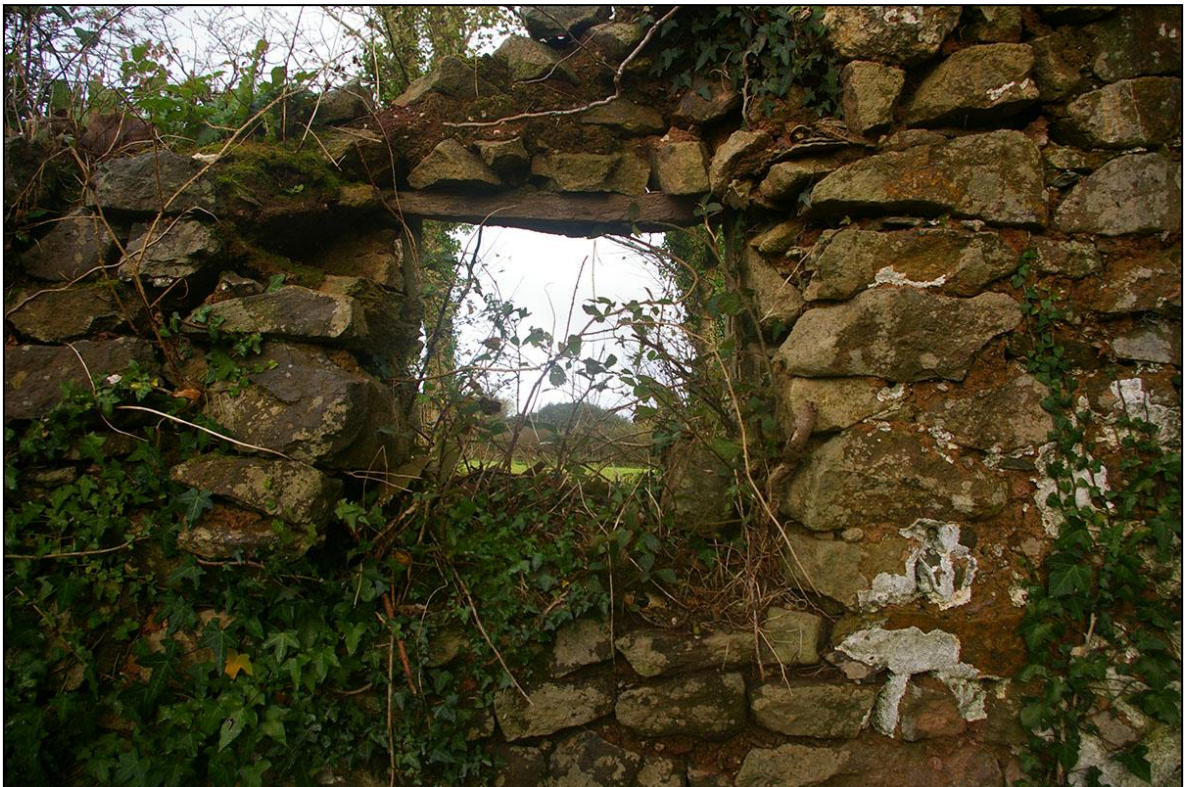
- Small window in north wall with remains of window frame and timber lintel identifies this as possible animal housing.

FIGURE 8: THE WINDOW IN BUILDING 3, WITH WEATHERED TIMBER LINTEL; FROM THE SOUTH.

| Openings – Windows: | 1 | W10 - Small low rectangular opening, remains of timber window frame to east side and very weathered and failed timber lintel above. |

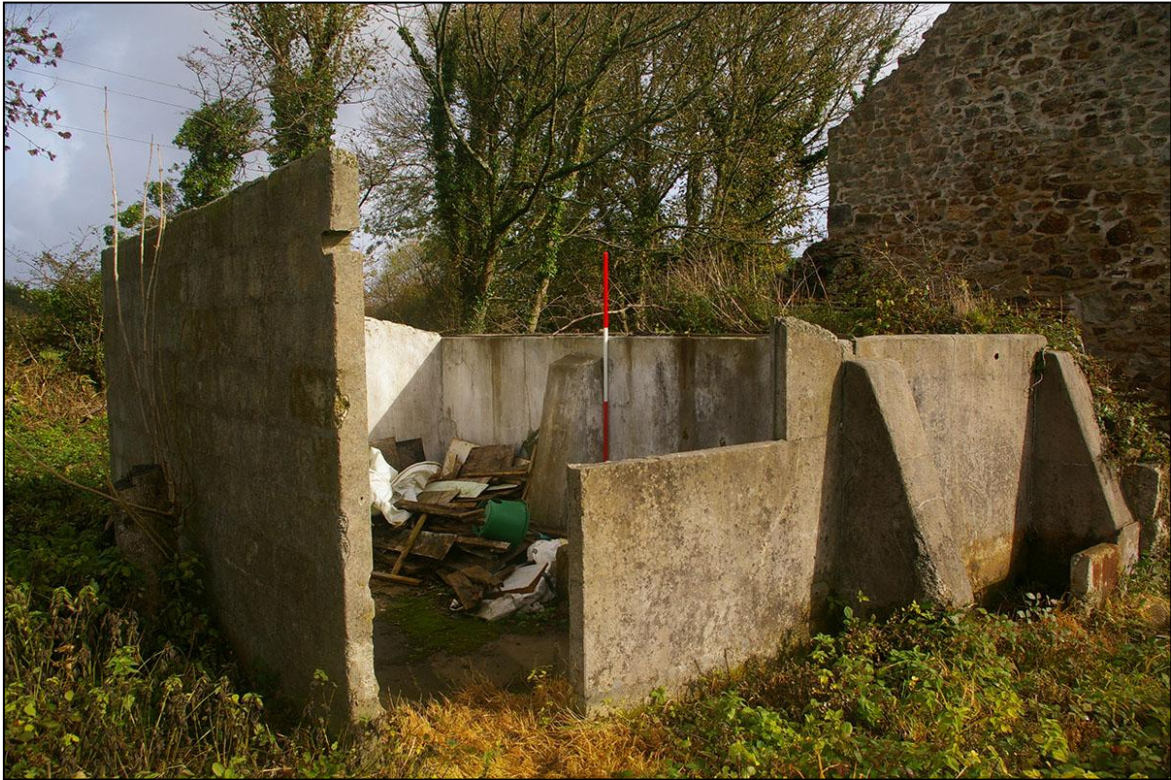
Small, single storey, two-bay agricultural shed with a purpose-built rectangular water cistern to the east and a small single space animal house to the west, with trough. Built of concrete blocks, rendered externally and the animal house is rendered and whitewashed internally. A door at the west end opens between animal house and field.

FIGURE 9: BUILDING 4; FROM THE SOUTH-WEST.

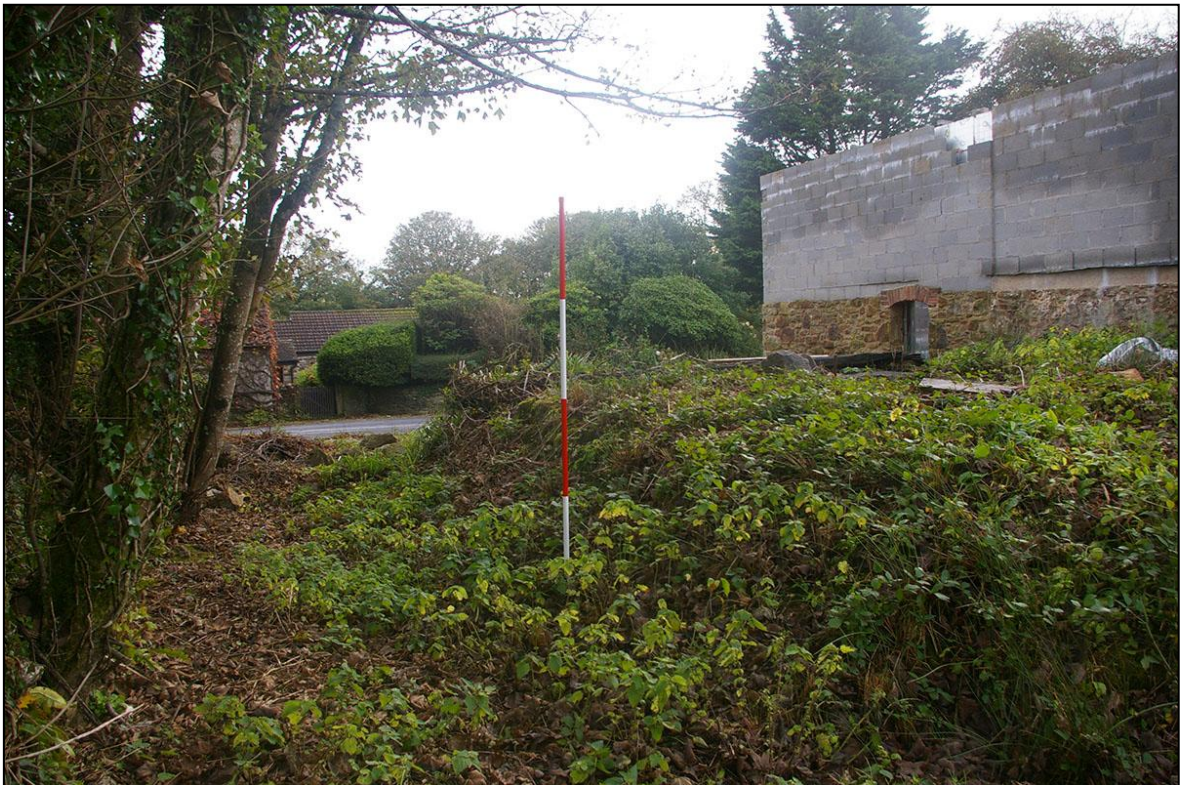
The whim comprises a large mound made of layers of dark, packed earth mixed with layers of broken and crushed quartz. It is possible that this material is mining-waste, used to create a hard-wearing structure.

The mound is approximately 1.25m high, dropping to just over 1m to the west and at its widest is 7.40m wide north-south by 8.10m east-west. It has a rounded northern edge, straight, steeply sloping sides to east and west. There is no surviving evidence of a ramp to access the raised platform. There are a lot of tumbled granite blocks and one gatepost style pier just off the north-east corner of the mound.

The top of the mound is fairly level and offset to the north side is the sunken granite framed whim pit. This comprises long granite slabs bracing a shallow pit, now c.0.4m deep but in-filled with soil. This pit contains an iron fixing with bolts and pins and an iron shaft and cog fitment for the drive shaft, run by the removed gearing, is sunk within the mound structure and sits in a buried granite lined channel which runs back to Building 1 and is held in a shale-braced socket in the north wall of Building 1, at approximately 0.7-1.25m above the internal surface. The covering of the drive shaft suggests something was traversing around the pit driving the gears, requiring freedom of movement. Between the whim pit and the building is a gap of 3.10m and to the outer northern curving edge, 2.10m, this creating a really quite small turning area, combined with the raised and enclosed character this somewhat brings into question whether this was a horse-powered whim, more likely powered by a donkey or pony.

FIGURE 10: THE WHIM MOUND, FROM THE WEST-NORTH-WEST (2M SCALE).

It is recommended that given the proposal will provide a better opportunity to understand the relationship between building and Whim mound. Archaeological monitoring of any works to the whim such be undertaken in order to provide further detail and record of its construction, such as the shaft, and its granite casing that may be exposed.

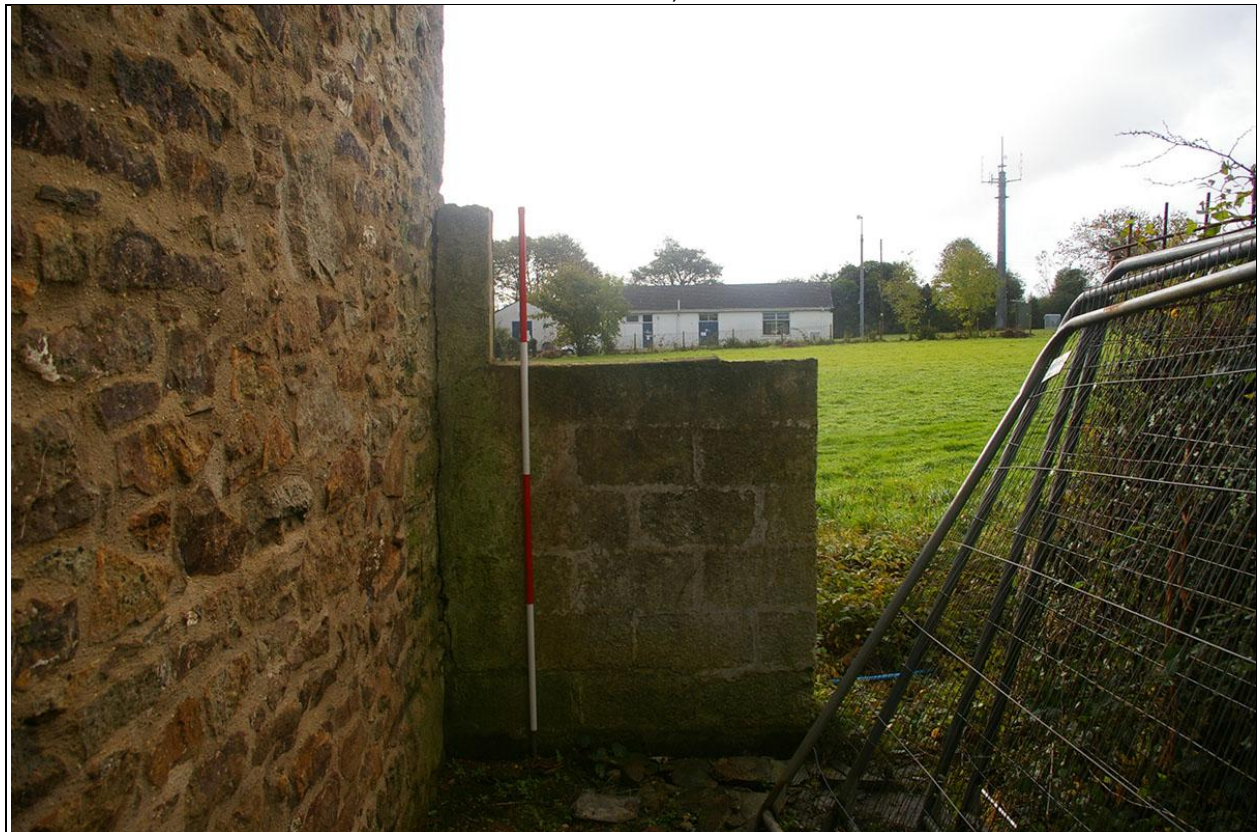
The south wall is concrete block, this may have been open-fronted or a short stub of stone wall has been replaced. The floor has also been replaced in concrete.

THE REPLACED FRONT WALL OF BUILDING 3, OR INFILLED OPENING, USING CONCRETE BLOCKS; FROM THE NORTH.

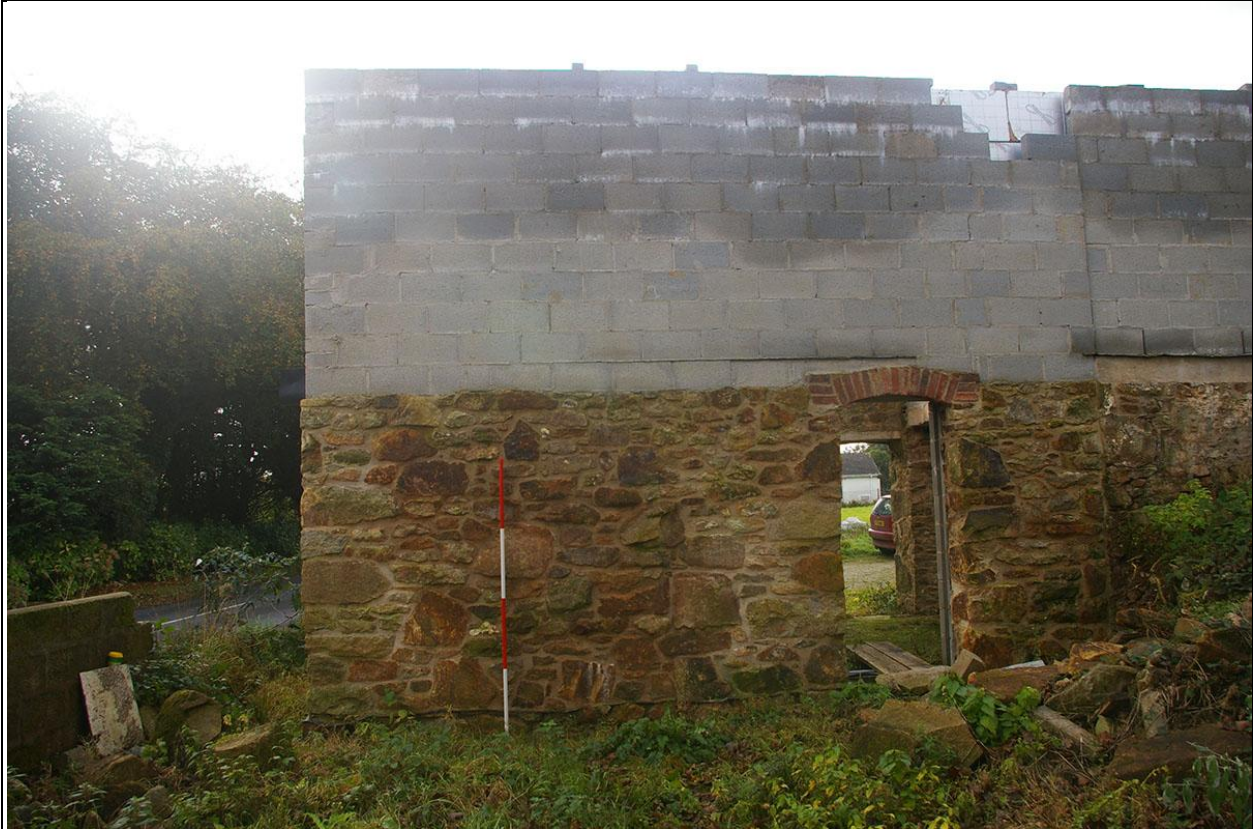
THE NORTH ELEVATION OF BUILDING 2, SHOWING IT HAS BEEN TOTALLY REBUILT DUE TO THE INTEGRAL DAMP COURSE; FROM THE NORTH.

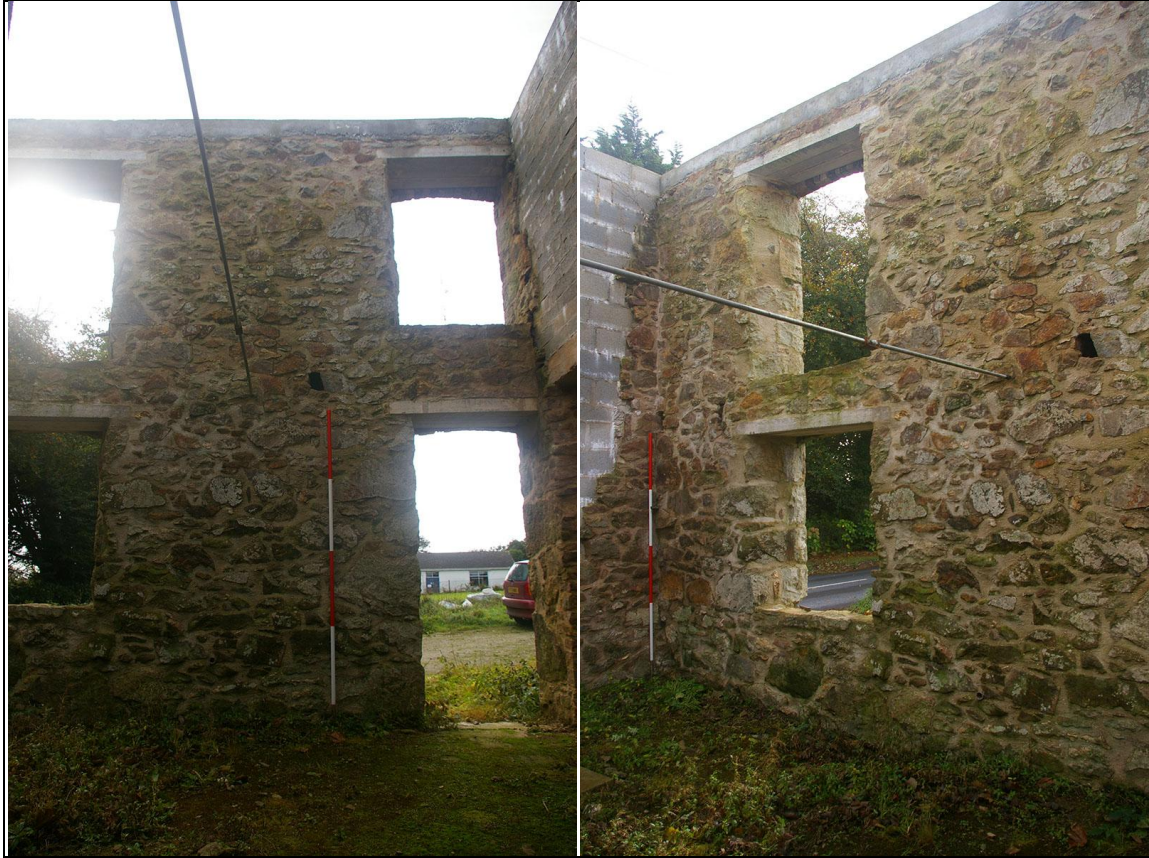
LEFT: THE INNER FACE OF THE SOUTH WALL OF BUILDING 2 AND ITS UNCOMFORTABLE RELATIONSHIP WITH BUILDING 1; FROM THE NORTH.  
RIGHT: AS ABOVE, SHOWING THE APPARENT REBUILDING AROUND THE 'WINDOW' OPENINGS; FROM THE NORTH-WEST.

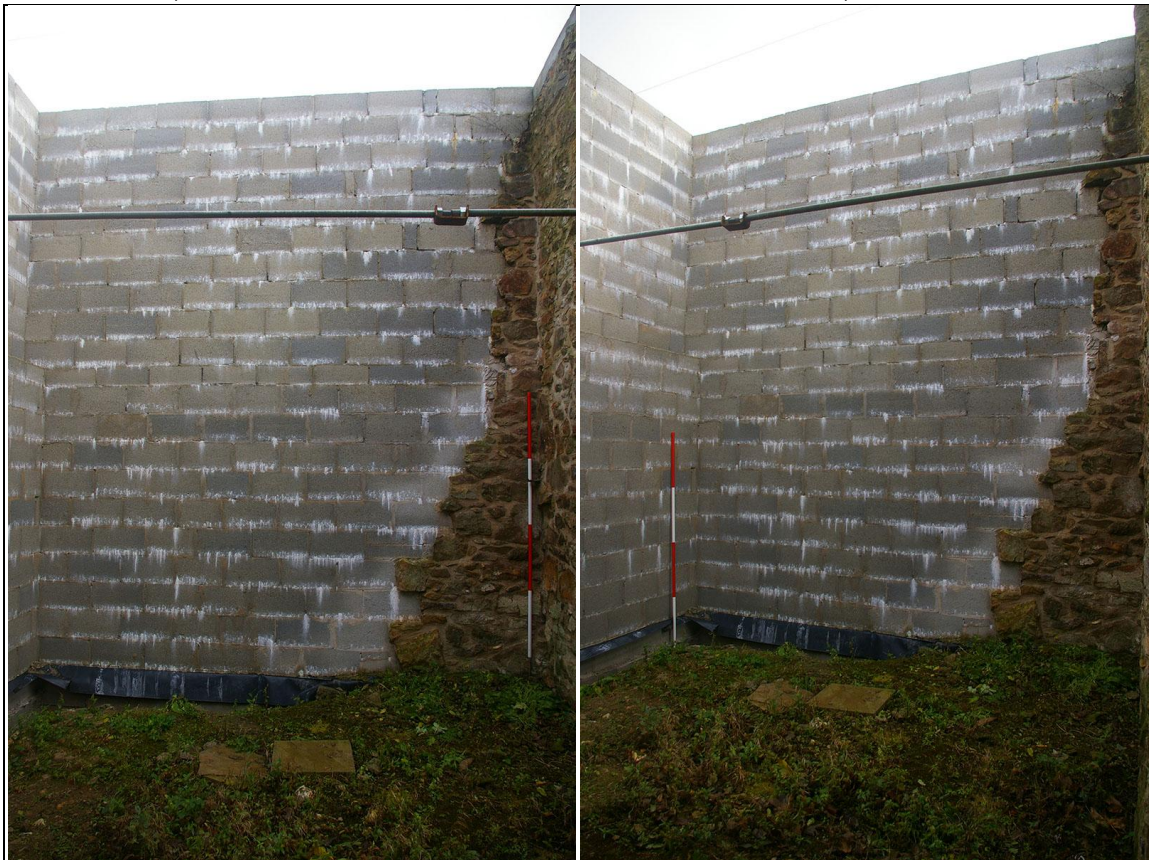
LEFT: THE EAST WALL OF BUILDING 2, TOTALLY REPLACED IN CONCRETE BLOCK; FROM THE WEST.  
RIGHT: THE EAST AND NORTH WALLS OF BUILDING 2, BOTH REBUILT, TO THE EAST IN CONCRETE BLOCK, TO THE NORTH CONCRETE BLOCK CLAD IN STONE RUBBLE; FROM THE SOUTH-WEST.

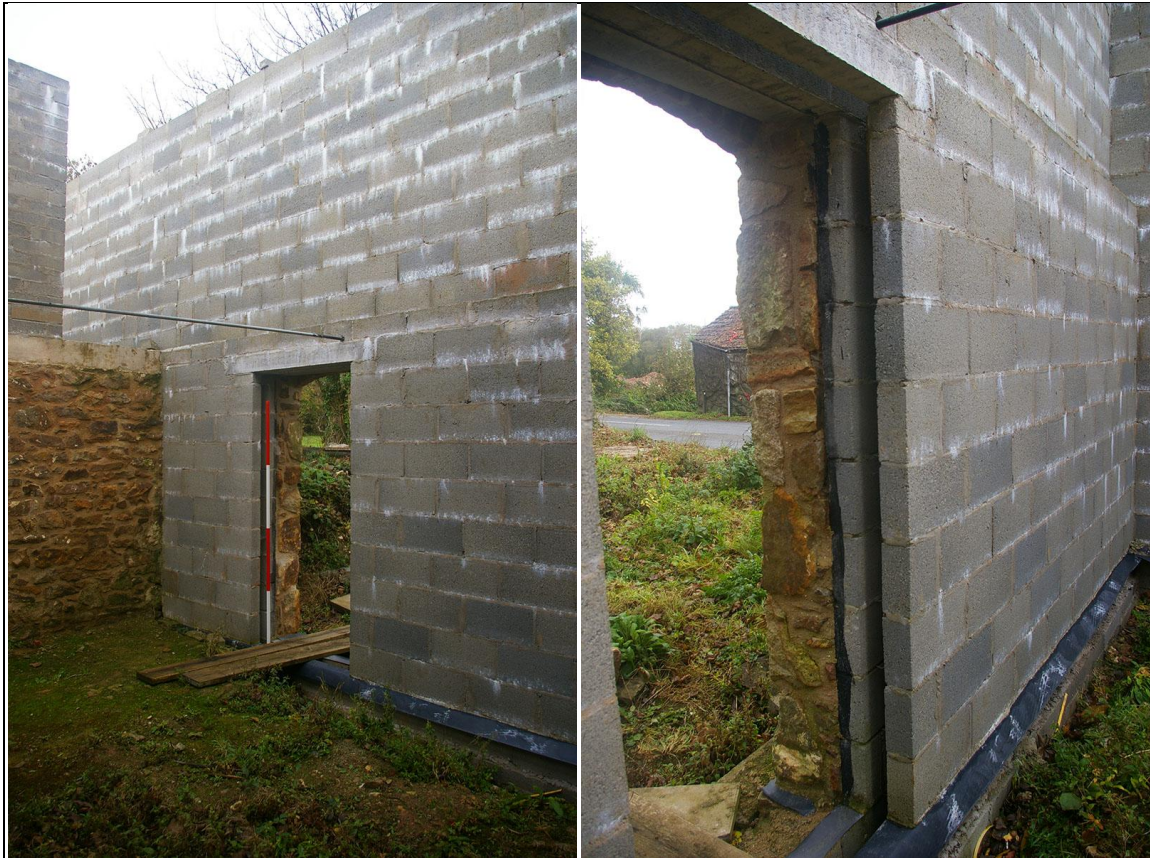
LEFT: THE NORTH WALL OF BUILDING 2, WITH THE REAR DOOR AND PARTITION WALL TO BUILDING 1; FROM THE SOUTH-EAST.  
RIGHT: DETAIL OF THE MODERN CONCRETE BLOCK CAVITY WALL CONSTRUCTION IN BUILDING 2; FROM THE WEST, SOUTH-WEST.

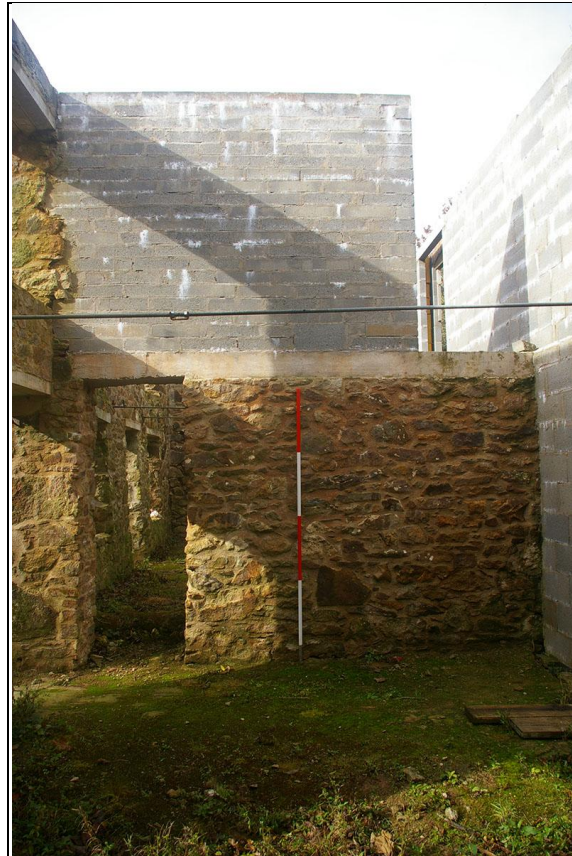
| Fabric Description: | | <p>Stone killas rubble internal partition wall, very heavy build, loosely set large stones, added as abuts north and south elevations of cottage. Sections of this may again have been totally rebuilt recently. Shallow very wide stack with low ground floor fireplace, very small and square, low, reused heavy granite lintel with pintle hole. This fireplace does not really fit the dimensions of a late 19<sup>th</sup> century grate or hearth, seeming too small. The hearth shows no signs of former fittings but has a collapse of former red clay cob within it.</p> |

| | | Concrete ring beam wraps around stack, block work above, presumably replaces cob.<br>This clearly replaces an original eastern gable which would have matched the west, its ragged remains can be seen to return within the south-west corner of Building 2, adjacent to W8, on the first floor. |

THE PARTITION WALL TO BUILDING 1, REBUILT OR HEAVILY REPOINTED STONE BELOW AND CONCRETE BLOCK ABOVE; FROM THE EAST.

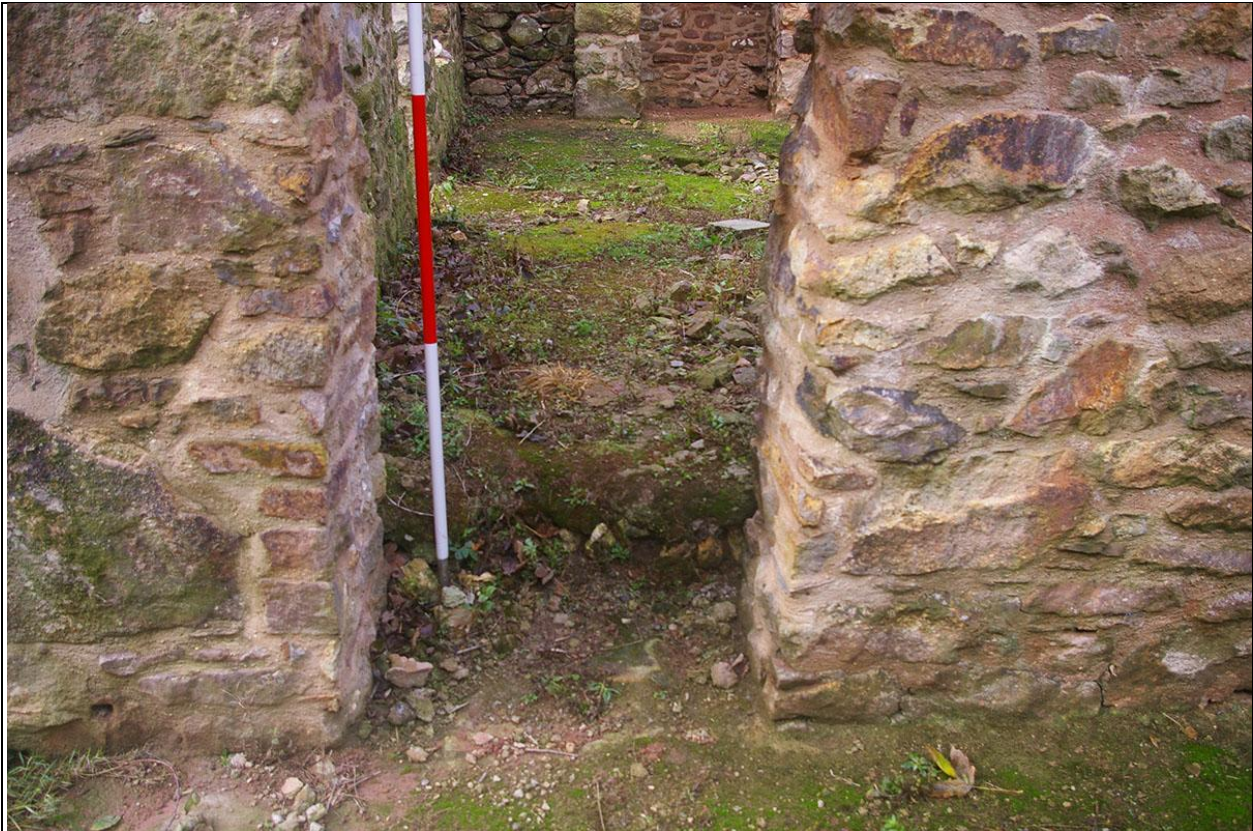
The stone structures have retained no evidential value, having been totally stripped, intensively 'restored' and largely rebuilt. Building 1 appears to retain its hard-packed red clay floor. Building 3, built next to Building 1 in the later 19<sup>th</sup> century or early 20<sup>th</sup> century may be contemporary with the whim structure. Building 4 is of 20<sup>th</sup> century date and unlikely to have any significance. Building 2 has had its floor dug down and replaced with concrete, any deposits likely lost or disrupted.

THE SIGNIFICANT STEP CHANGE, PACKED RED CLAY IN BUILDING 1, BUILDING 2'S FLOOR DUG DOWN DEEPLY AND NEW CONCRETE FLOOR  
POURED; FROM THE EAST.

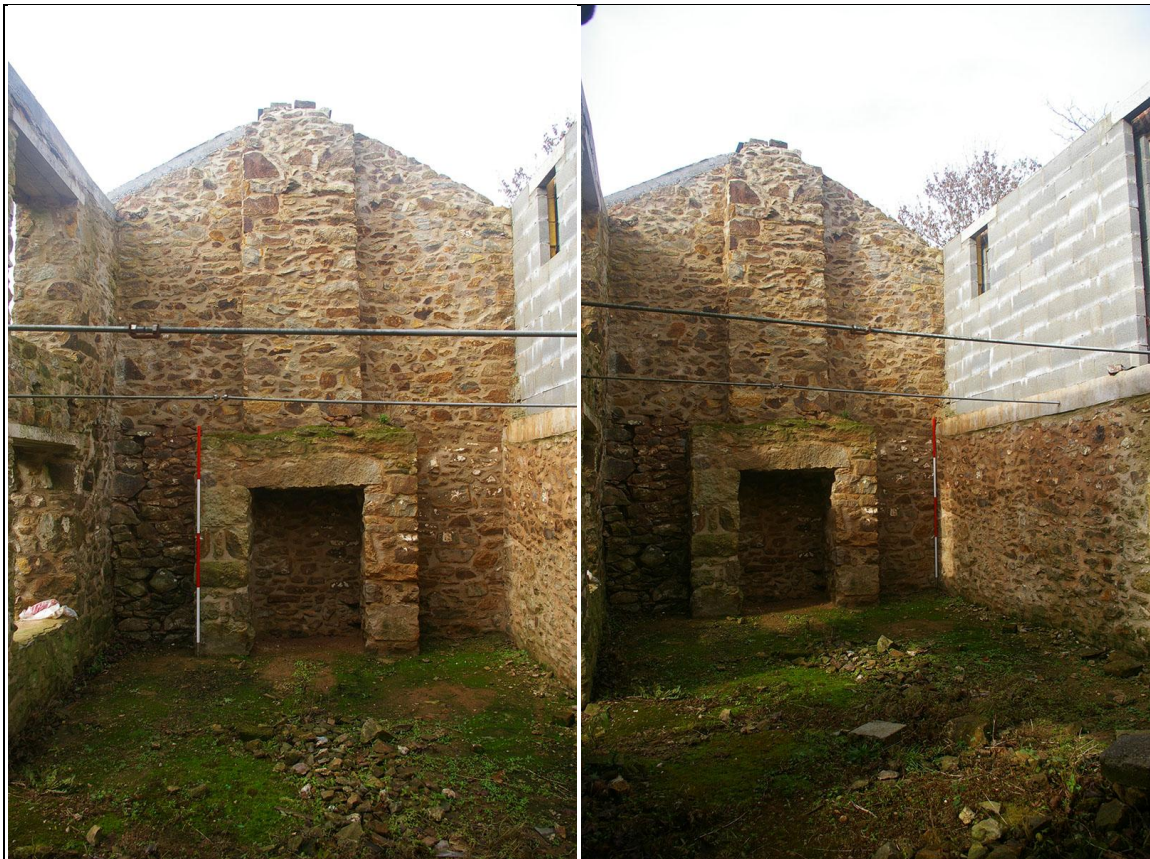
| Fireplaces: | 2 | FP1 - Fireplace to west: Small square shaft above rectangular 'hearth' totally rebuilt in hard cement mortars, smaller looser stones, different build, proportions appear odd, as stack steps in so much. Heavy cheeks to 'hearth', that to the south with massive dressed blocks, crude reused granite lintel. This is very shallow and tall, possibly for a stove, certainly it would not have worked as a domestic open fireplace, could this be industrial for machinery. Possible blocked opening to rear or patched repair. Some whitewash remains to external of cheeks but no real soot staining at all.<br>FP2 - Fireplace to east: Wide very shallow stack, truncated at first floor. Heavily re-pointed or possibly rebuilt. Very small hearth. |

LEFT: THE INNER FACE OF THE WEST GABLE OF BUILDING 1, SHOWING REBUILT STACK AND THE POSSIBLE OPEN HEARTH; FROM THE EAST.  
RIGHT: THE WEST AND NORTH WALLS OF BUILDING 1, SHOWING THE CHANGES IN CHARACTER TO BUILD ON BOTH WALLS; FROM THE  
SOUTH-EAST.

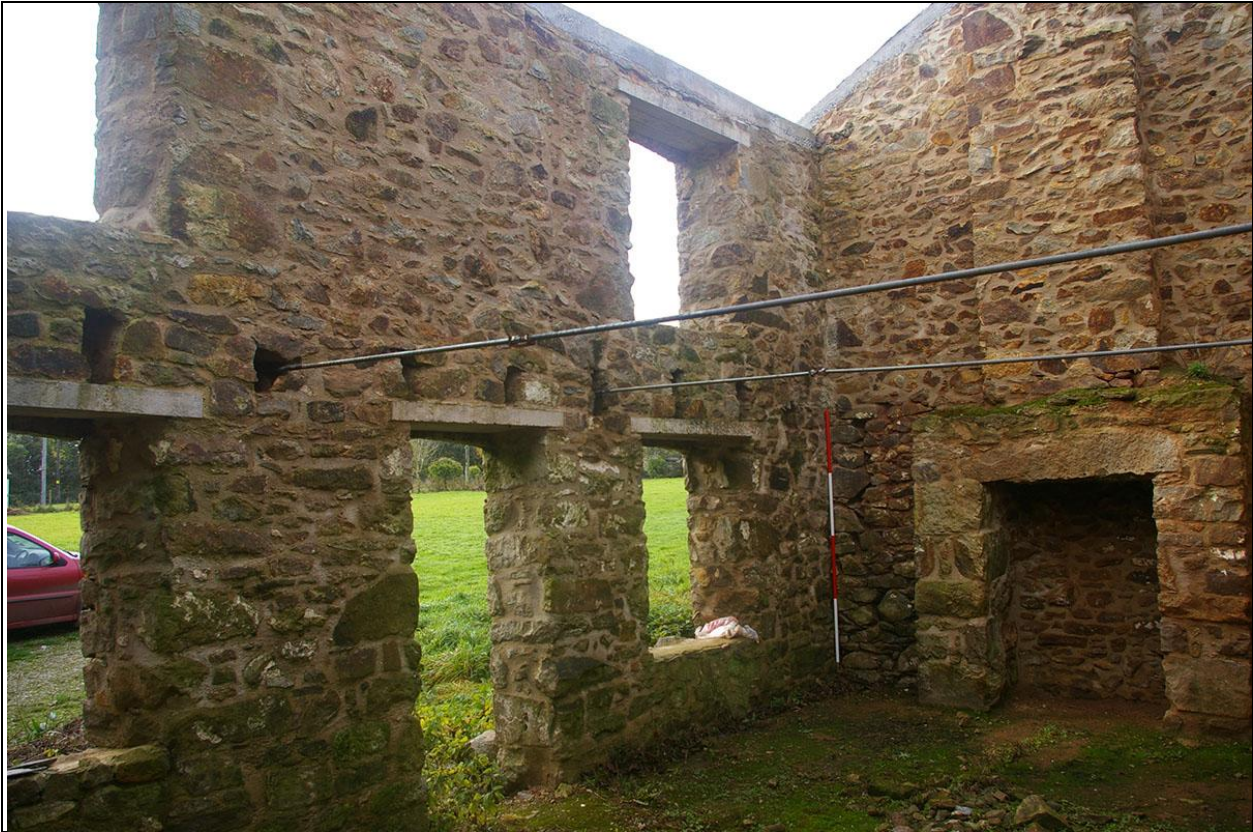
THE WEST AND SOUTH WALLS OF BUILDING 1, SHOWING A SIMILAR CHANGE IN CHARACTER AT APPROX 2M HEIGHT, BELOW HEAVIER IRREGULAR BUILD, GREEN MOSSY STONES, REPOINTED, ABOVE LOOKING REBUILT; FROM THE NORTH-EAST.

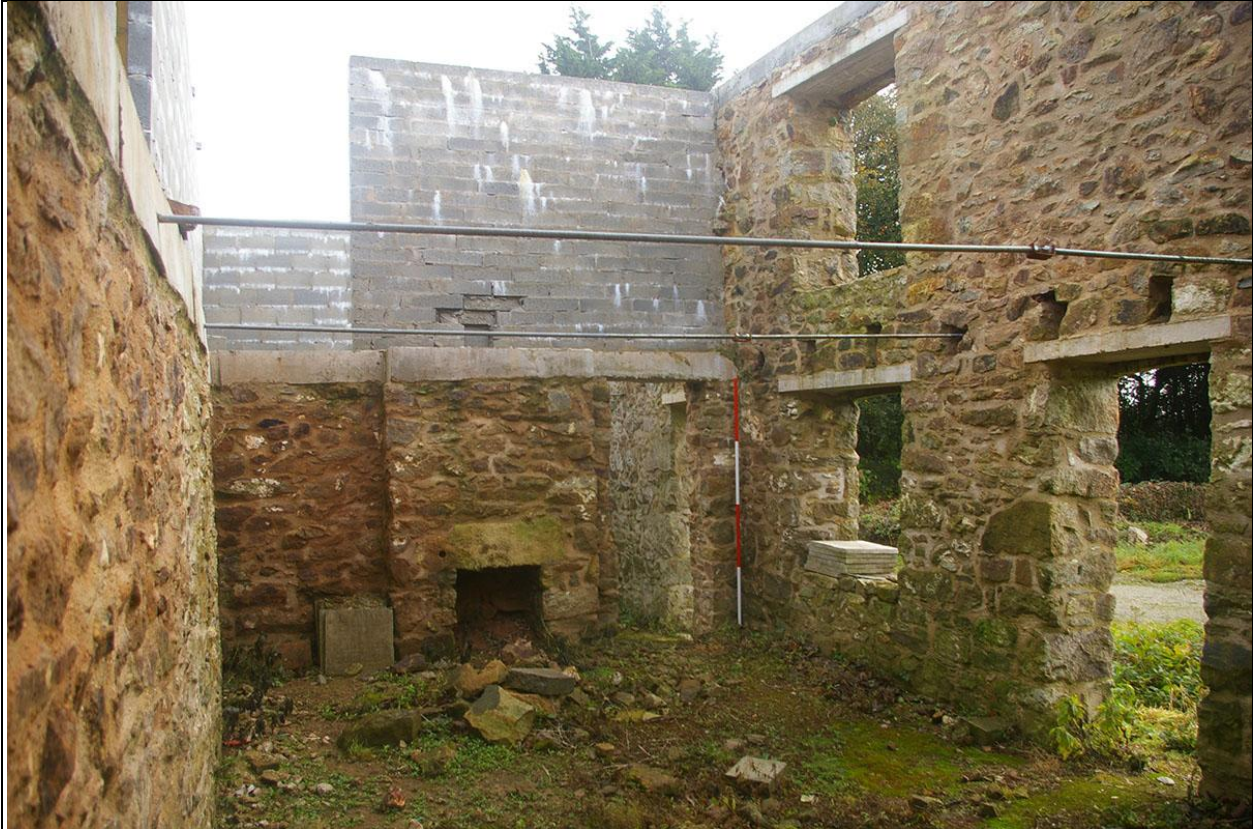
THE EAST WALL, SHOWING THE VERY DIFFERENT CHARACTER OF THE STONEMWORK FROM THE SOUTH AND EVEN NORTH OR WEST WALLS, ALSO HEAVY REPOINTING IN CEMENT AND CONCRETE RING BEAM AND BLOCKS ABOVE; FROM THE NORTH-WEST.

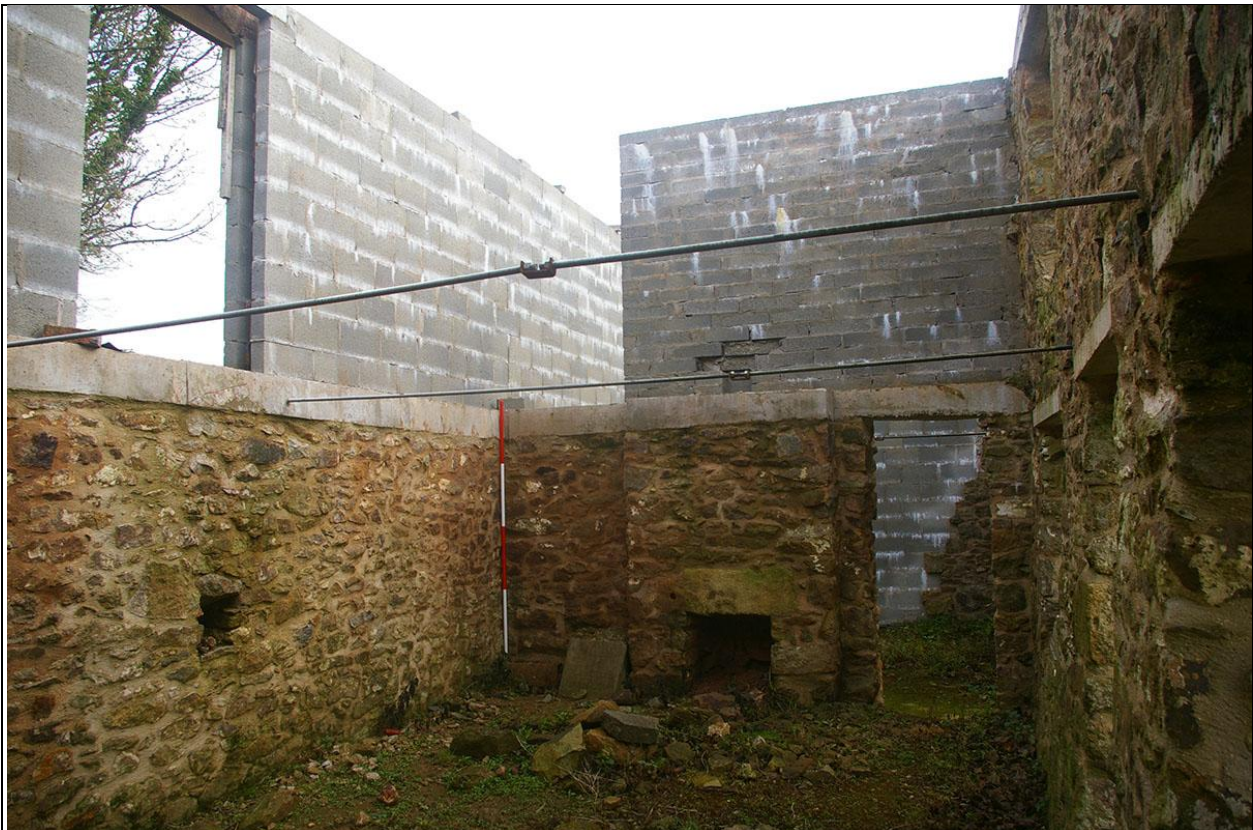
THE NORTH AND EAST WALLS, SHOWING HOW MUCH LARGER THE STONES USED IN THE EAST WALL ARE AND HOW MUCH MORE IRREGULAR THE BUILD, AS WELL AS THE LOW, SMALL BOXY FIREPLACE; FROM THE SOUTH-WEST.

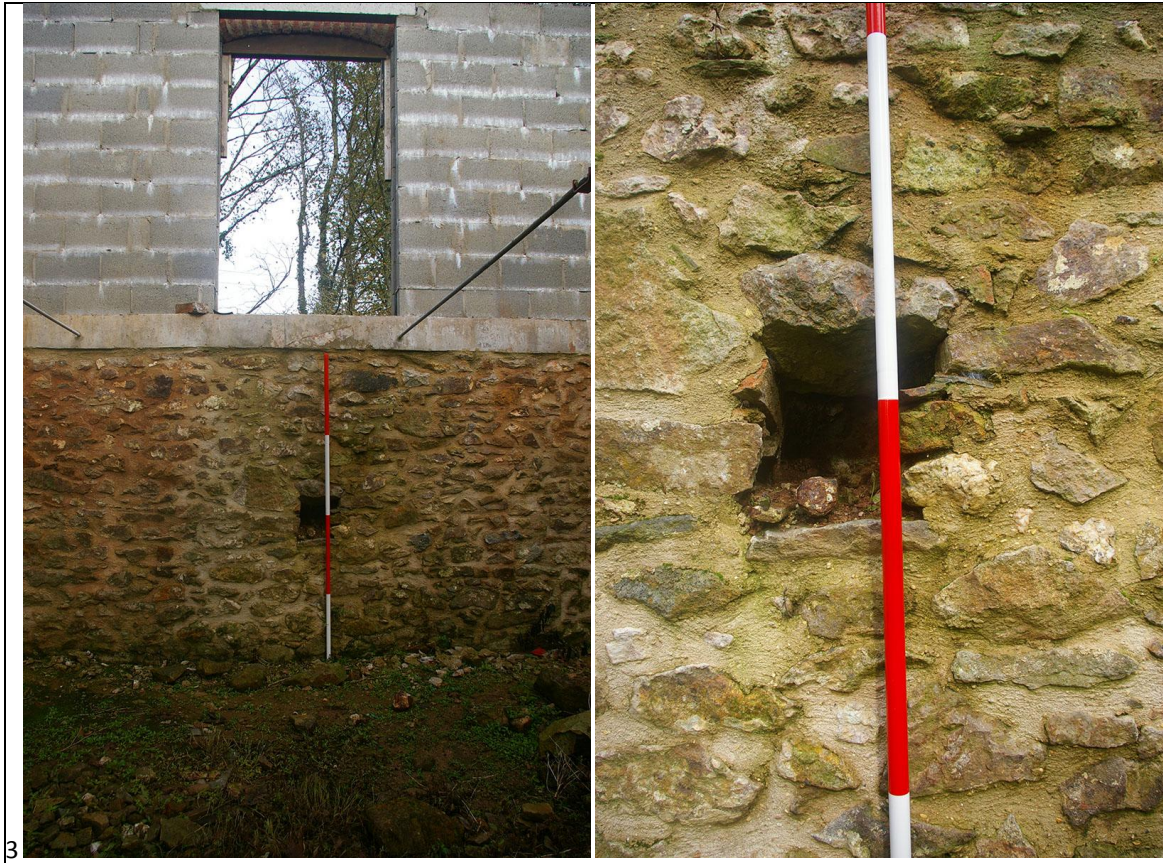
- Socket in north wall with slab lintel and sill, still contains iron drive shaft for adjacent whim.

LEFT: THE OPENING FOR THE DRIVESHAFT IN BUILDING 1, NORTH WALL; FROM THE SOUTH.  
RIGHT: THE OPENING IN DETAIL, SHOWING THE WIDENING FOR THE DRIVESHAFT; FROM THE SOUTH.

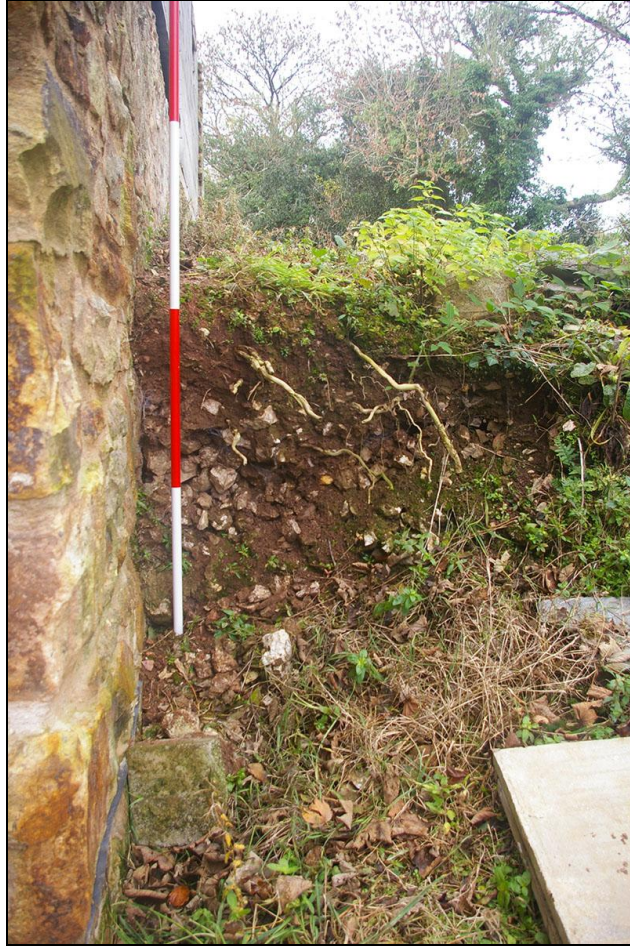
AREA OF DAMAGE ON MOUND, SLIGHTLY CLEANED BACK TO SHOW LAYERS OF PACKING, WITH 2M SCALE; FROM THE EAST.

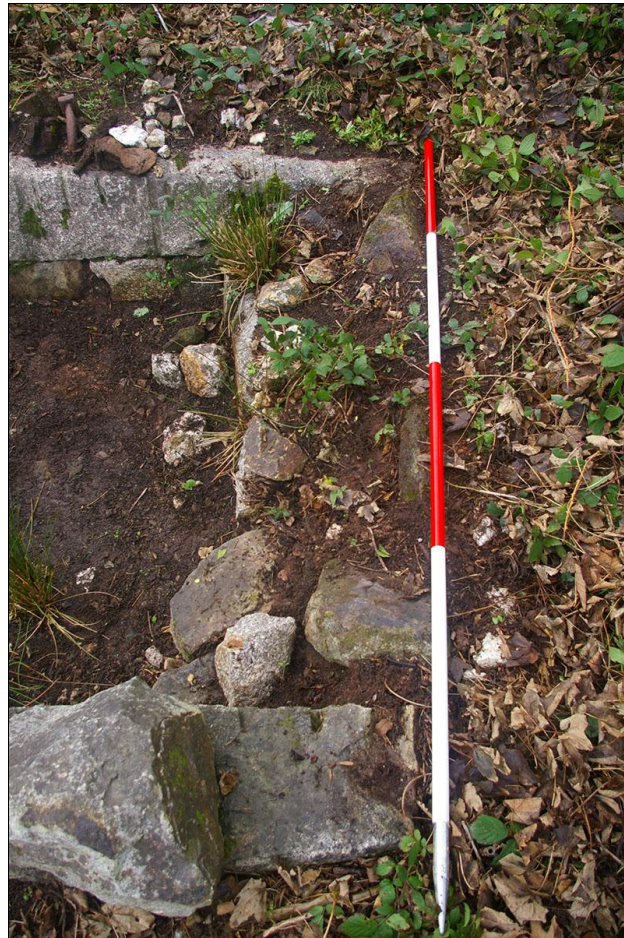
THE STEPPED NORTH SIDE OF THE WHIM PIT, IN BETTER CONDITION THAN THE SOUTH; FROM THE EAST, WITH 2M SCALE.

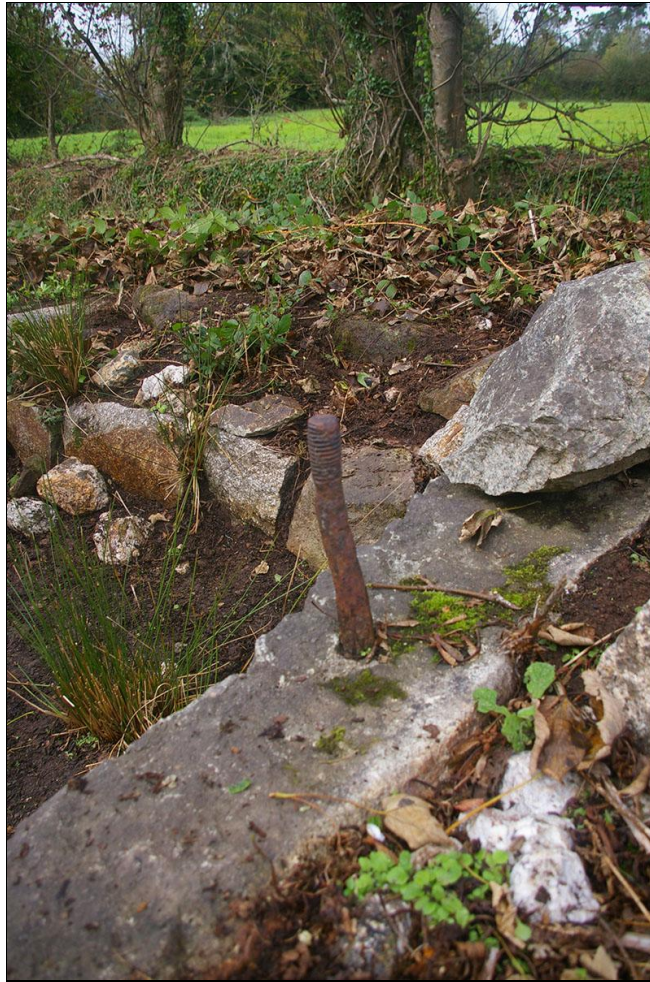
METAL FIXING WITH CORRODED SCREW THREAD, SET IN THE GRANITE POST TO THE EAST SIDE; FROM THE SOUTH-EAST.
