**TOWN BARTON
BEAWORTHY
WEST DEVON
DEVON**

Historic Building Recording

South West Archaeology Ltd. report no. 190620

01.07.2019

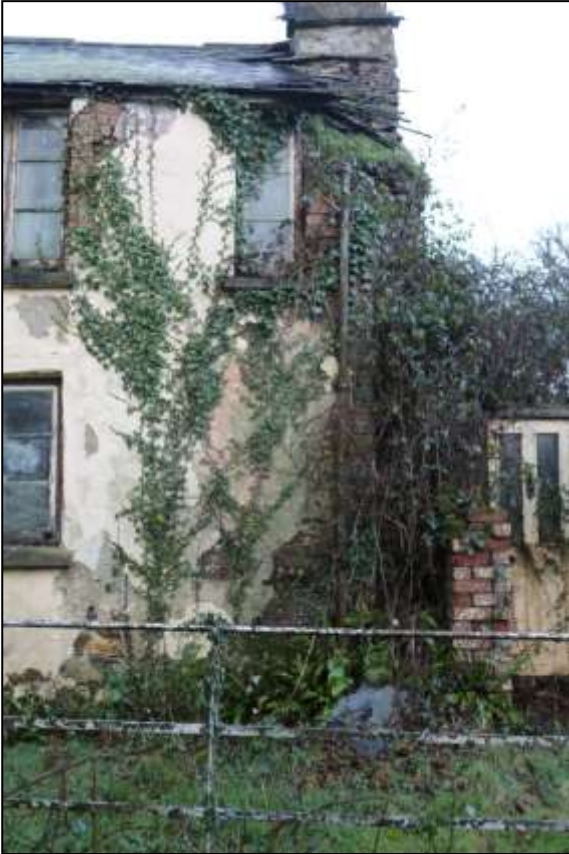
- 5. LEFT: DETAIL OF BRICK REPAIRS TO FRONT WALL AT FIRST-FLOOR LEVEL R11; VIEWED FROM THE SOUTH-EAST.
- 6. RIGHT: RIGHT: FRONT DOOR (D2) TO CROSS-PASSAGE IN REMAINS OF BRICK PORCH; VIEWED FROM THE SOUTH-EAST.

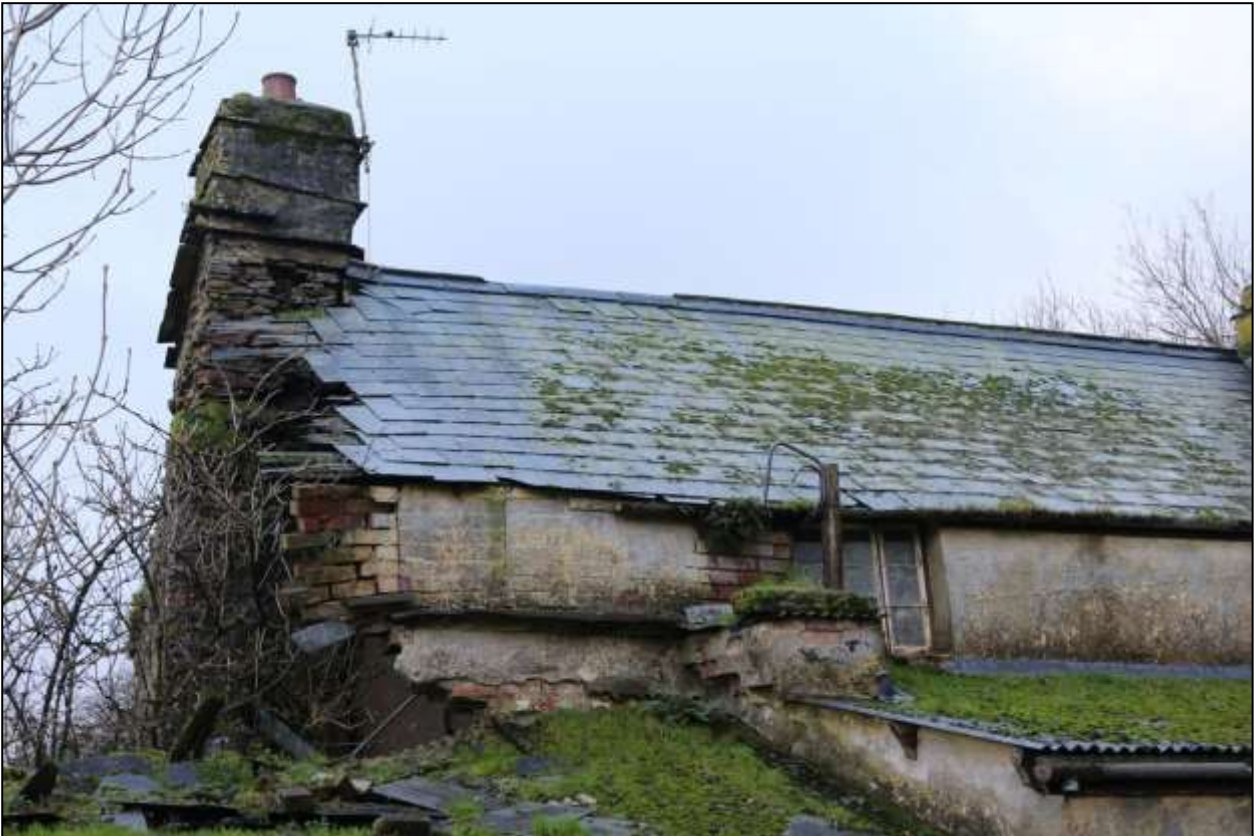
15. LATE 19TH OR EARLY 20TH CENTURY BRICKWORK ON REAR WALL OF STAIRCASE 2B, REPLACING THIN FAILED COB WALLING. NOTE SMALL BLOCKED WINDOW (BO5), PREVIOUSLY LIGHTING STAIRCASE AND UPPER LANDING. VIEWED FROM THE NORTH.

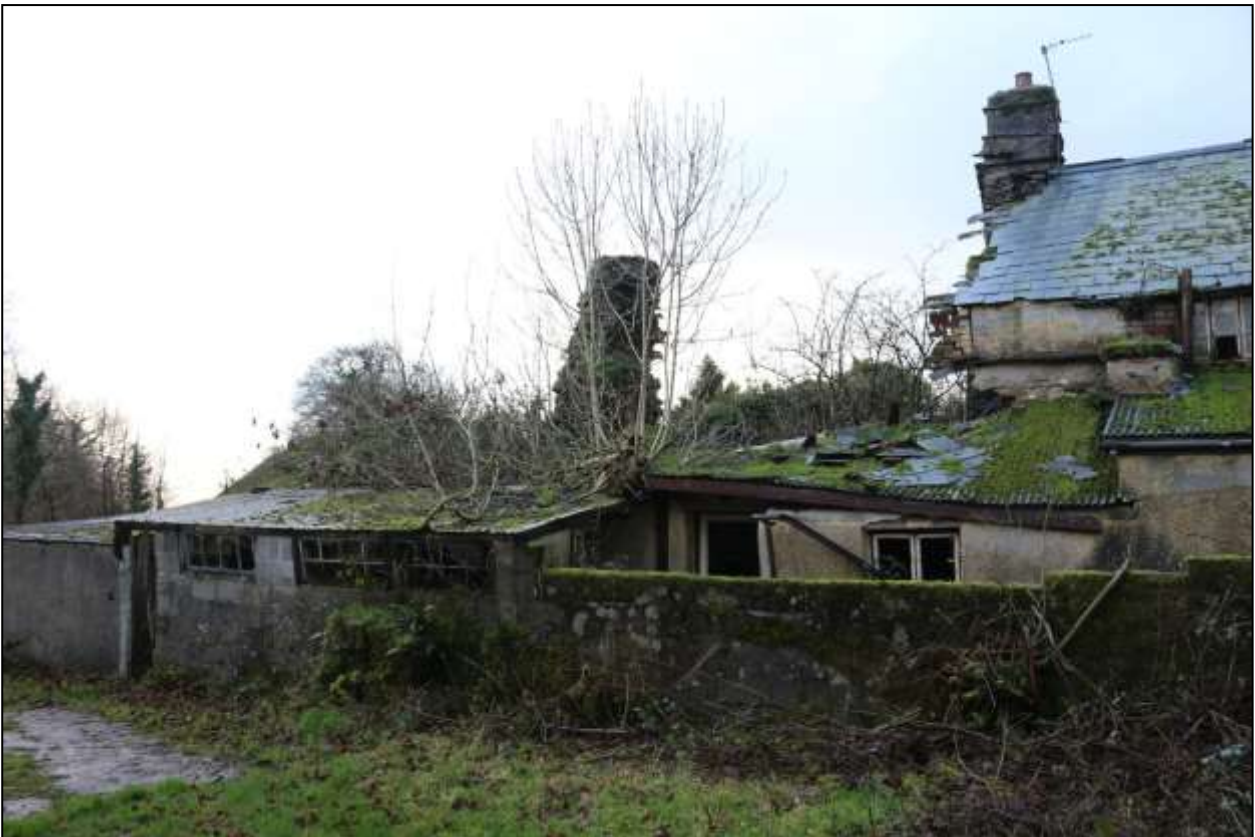
16. GENERAL VIEW OF COLLAPSED EASTERN HALF OF HOUSE. SEMI-COLLAPSED LEAN-TO IN RIGHT FOREGROUND CONTAINS R6; R7 LIES IN THE VEGETATION TO LEFT OF ASH TREE GROWING IN ROOF. VIEWED FROM THE NORTH-WEST.

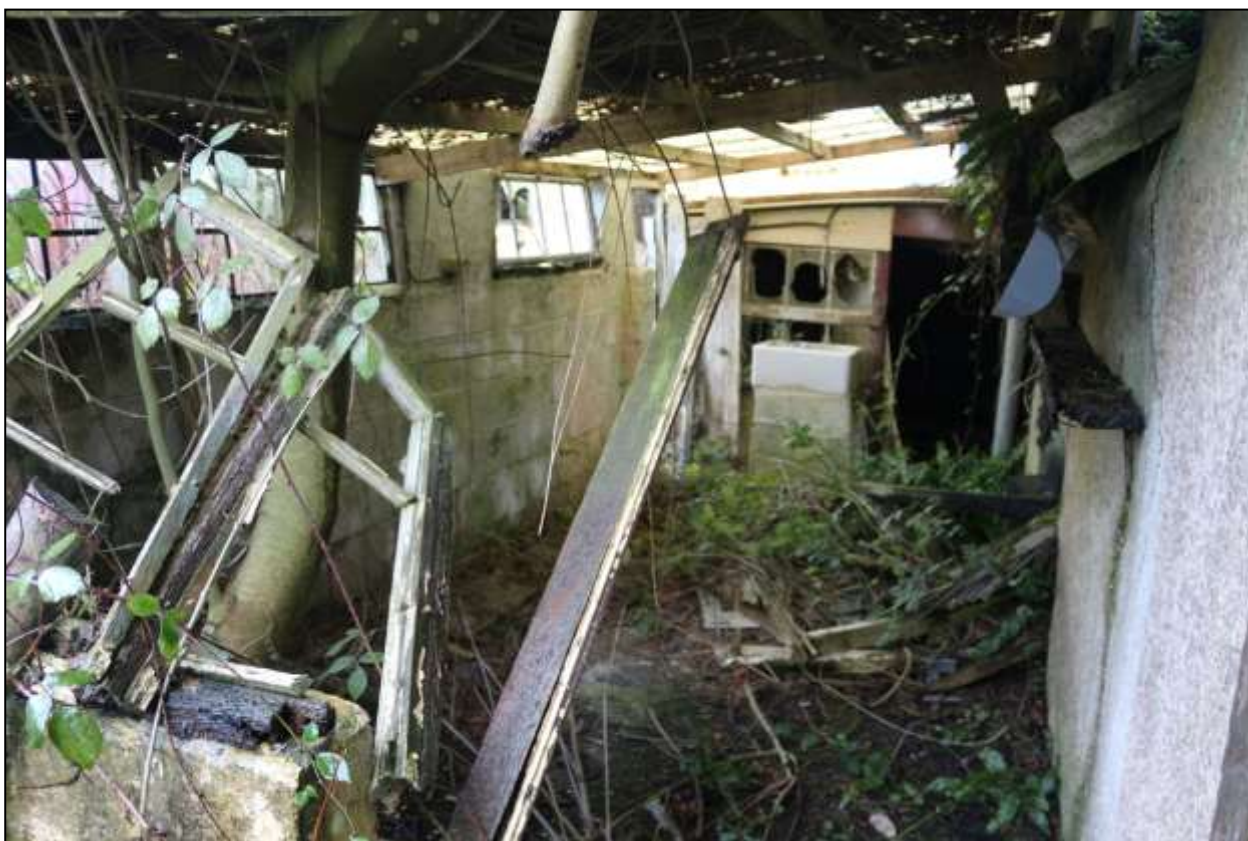
35. THE PARTLY-COLLAPSED 1950S AGRICULTURAL BUILDING ABUTTING THE OLDER COB LEAN-TO CONTAINING R7. NOTE TWISTED TRUNK OF ASH TREE, GROWING UP THROUGH ROOF IN LEFT FOREGROUND. VIEWED FROM THE SOUTH-WEST.

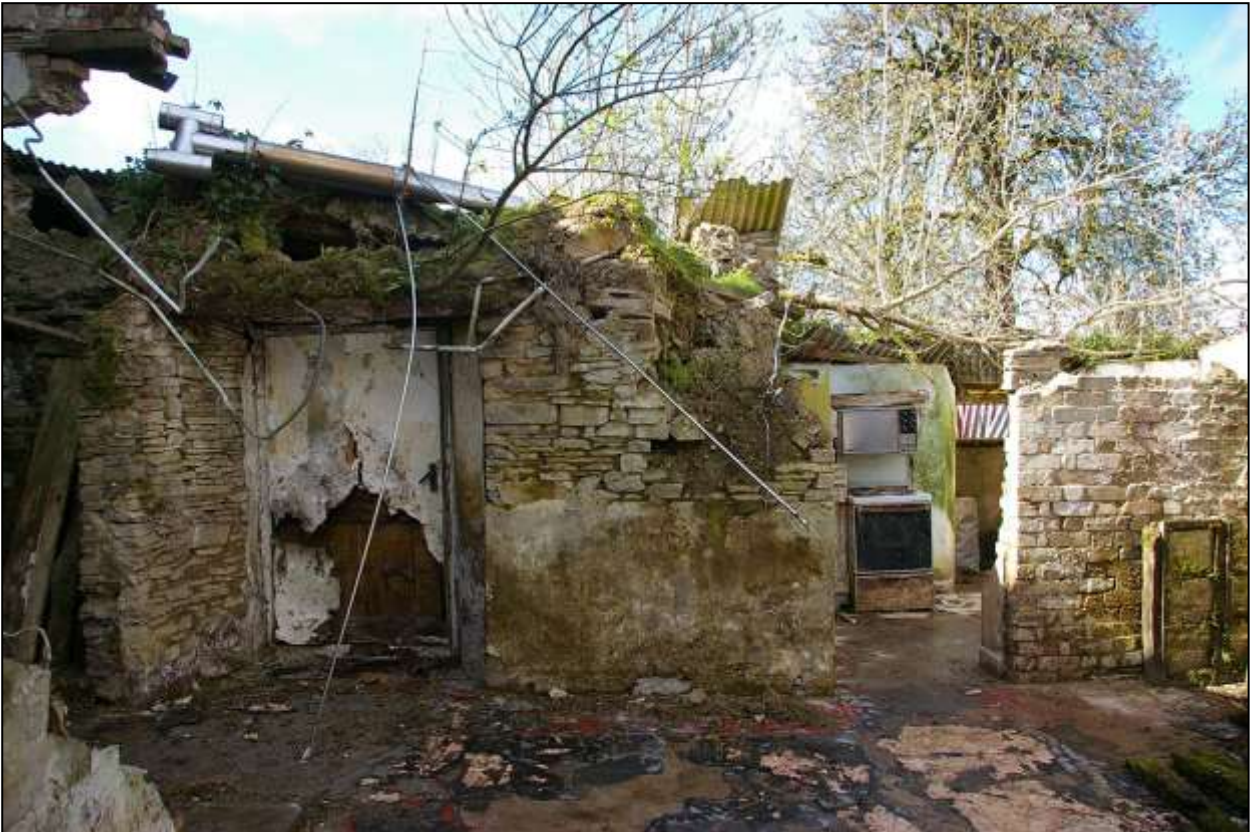
61. REAR (NORTH-WEST) WALL OF R2, SHOWING THE FORMER CROSS PASSAGE DOORWAY ON THE LEFT (D3) AND A LATER DOOR TO R7 ON THE RIGHT (D4). BRICKWORK FACES DECAYED COB. VIEWED FROM THE SOUTH-EAST.

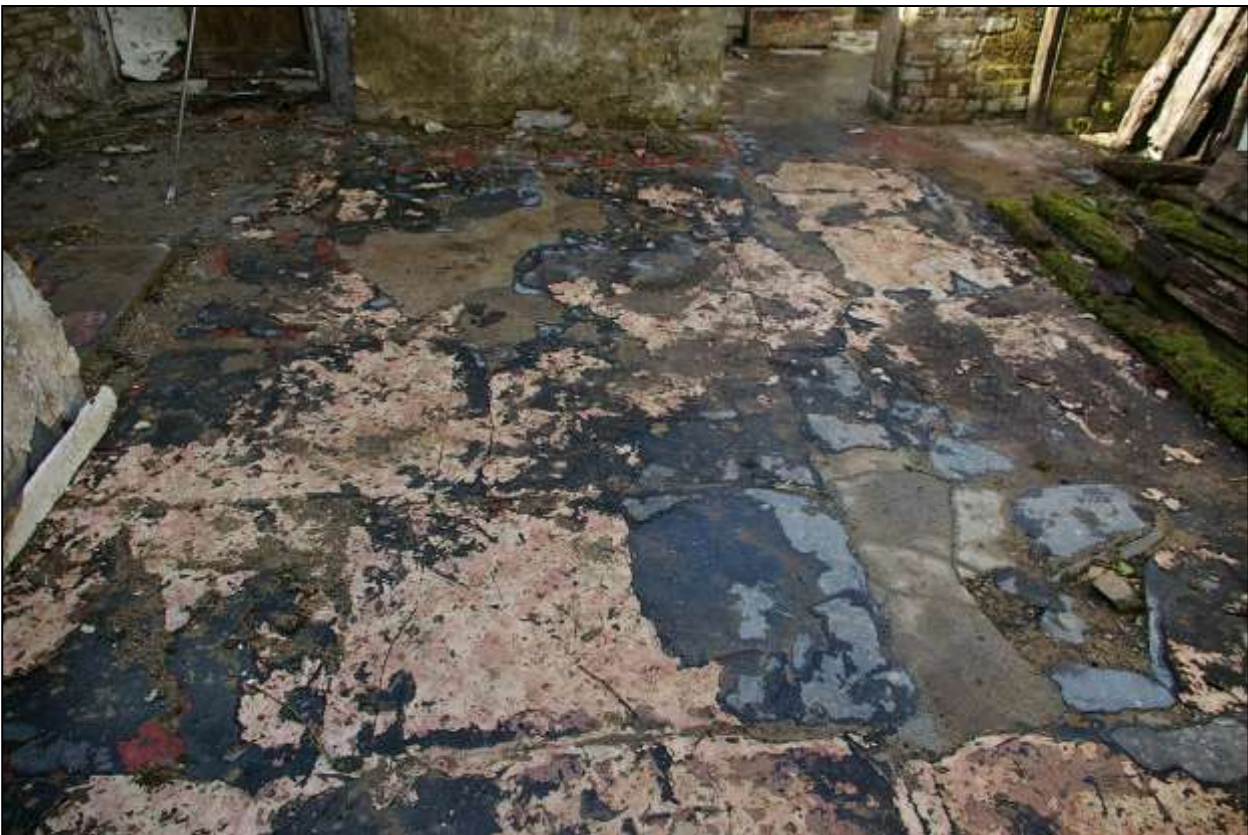
72. VIEW OF THE HEAVY SLATE SLAB FLAGSTONE FLOOR, OF VERY FINE QUALITY BUT MUCH DAMAGED AND PATCHED, WITHIN R2; VIEWED FROM THE SOUTH-EAST.

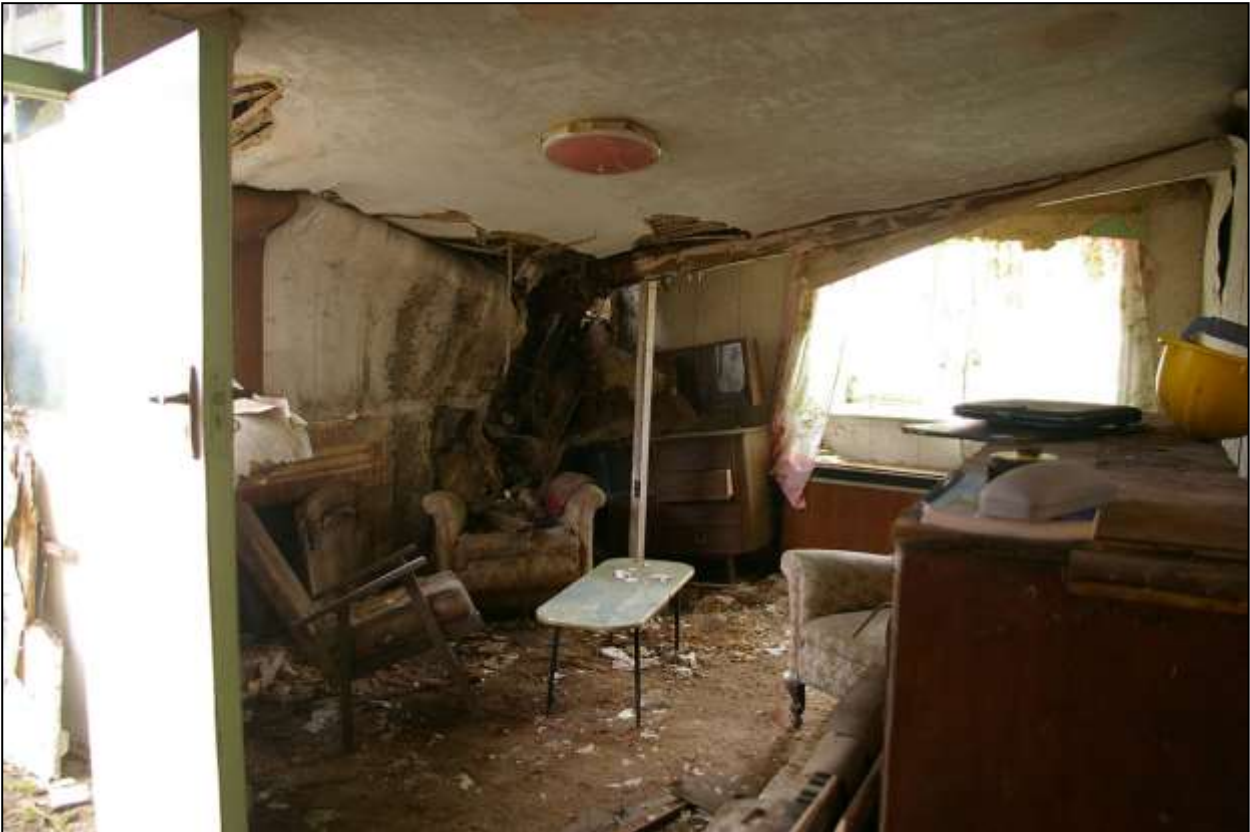
73. R3, SHOWING THE CEILING COLLAPSE IN THE SOUTH-EAST CORNER; VIEWED FROM THE WSW.

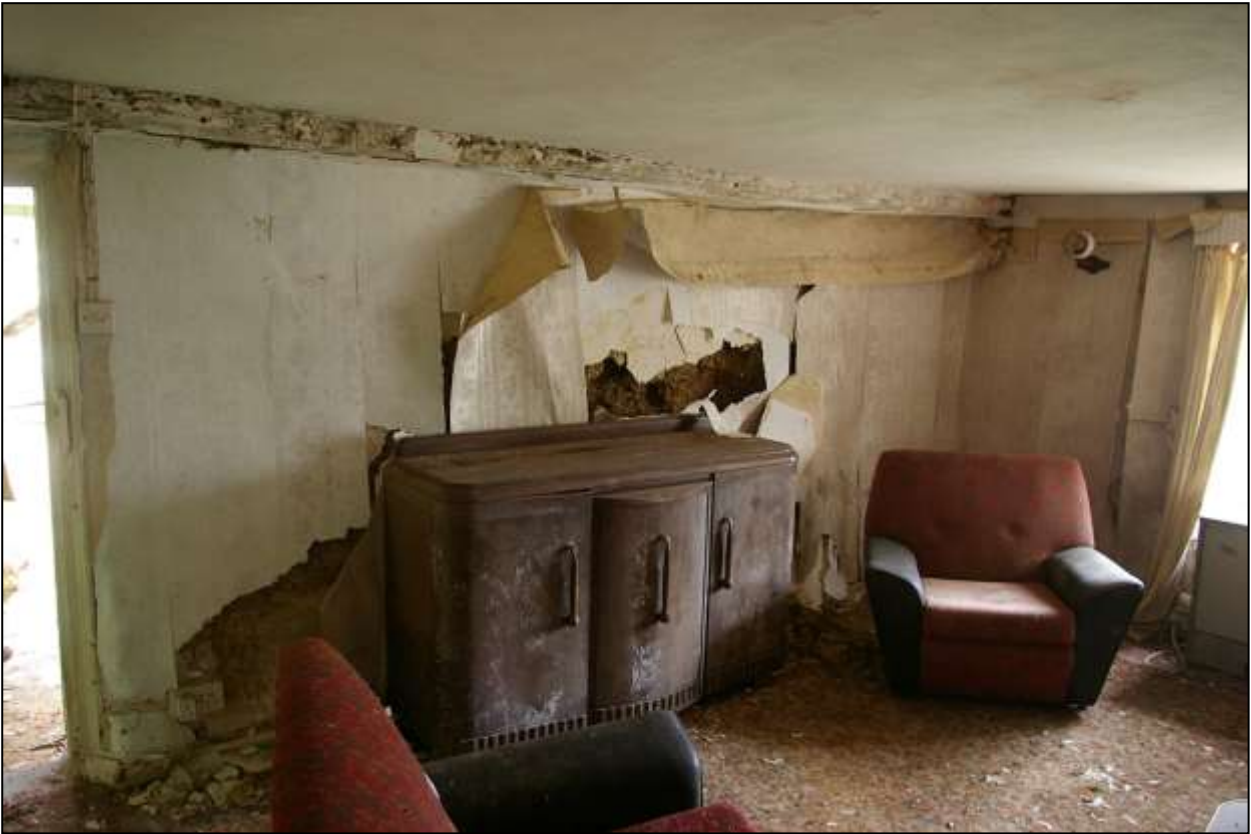
90. NORTH-EAST WALL OF R4. NOTE COB EXPOSED WHERE PLASTER HAS FALLEN AWAY. VIEWED FROM THE NORTH-WEST.

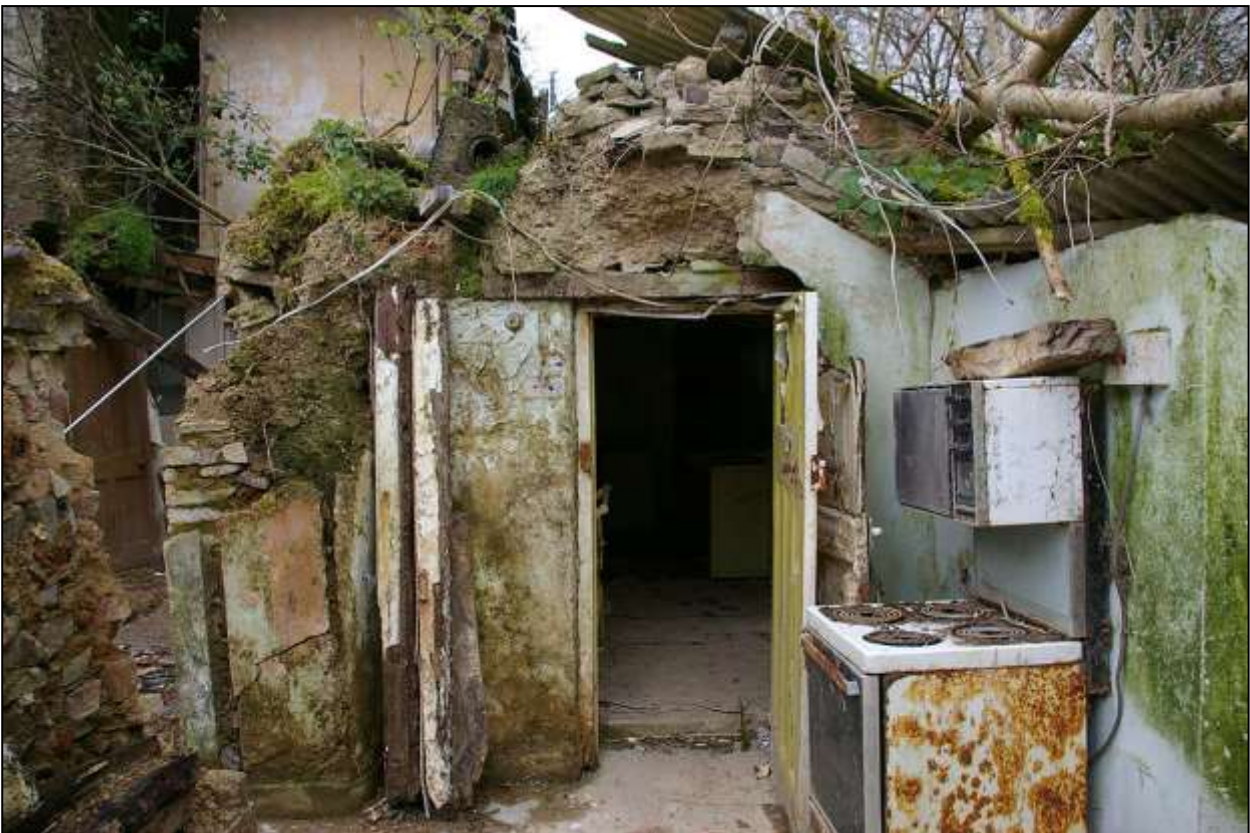
109. R7, WITH LARGELY COLLAPSED MEDIEVAL COB BACK WALL OF HOUSE TO LEFT AND COB DIVIDING WALL ABOVE DOOR TO R6 IN CENTRE (D11). VIEWED FROM THE NORTH-EAST.

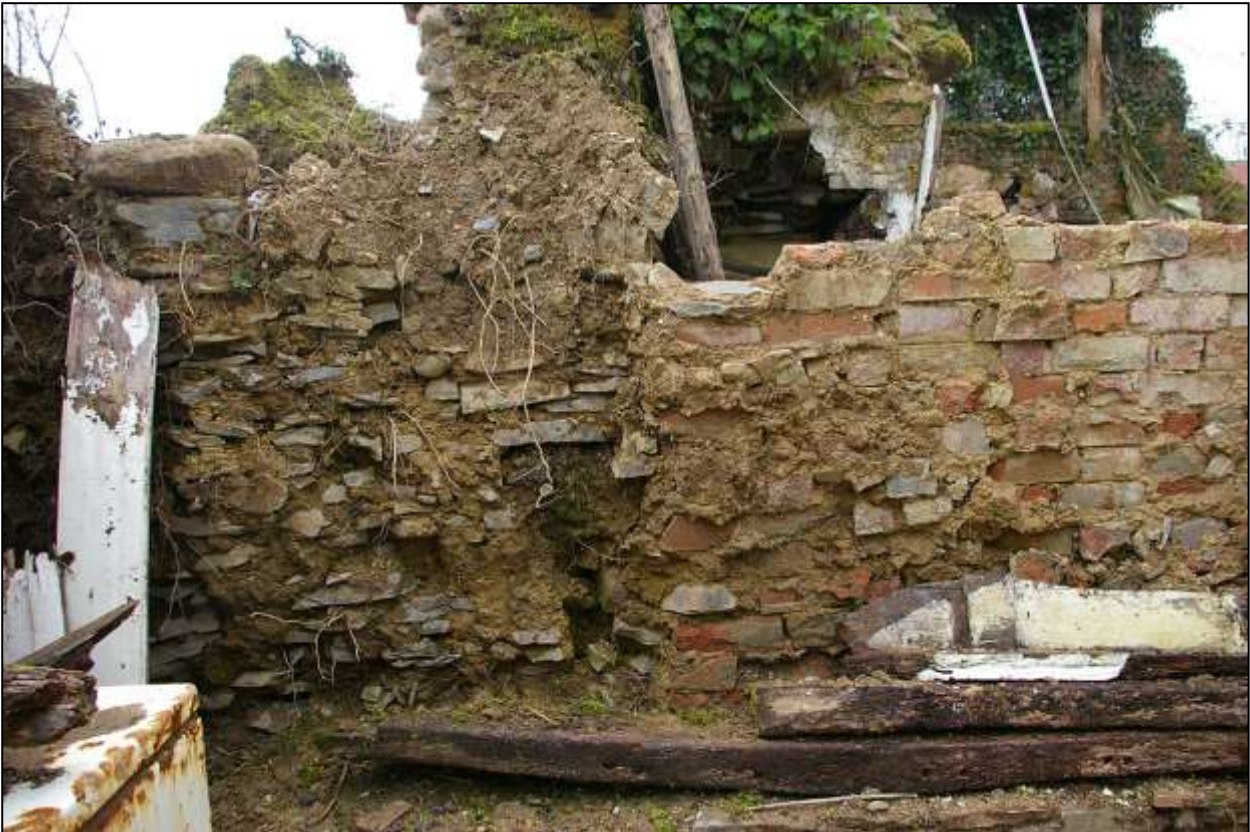
110. R7, THE REAR SIDE OF STONE AND BRICK RE-FACING OF THE (NOW LOST) COB WALL; THE LOOSE TIMBERS IN THE FOREGROUND ARE RESTING ON THE STONE RUBBLE PLINTH OF THE COB WALL. VIEWED FROM THE NORTH-WEST.

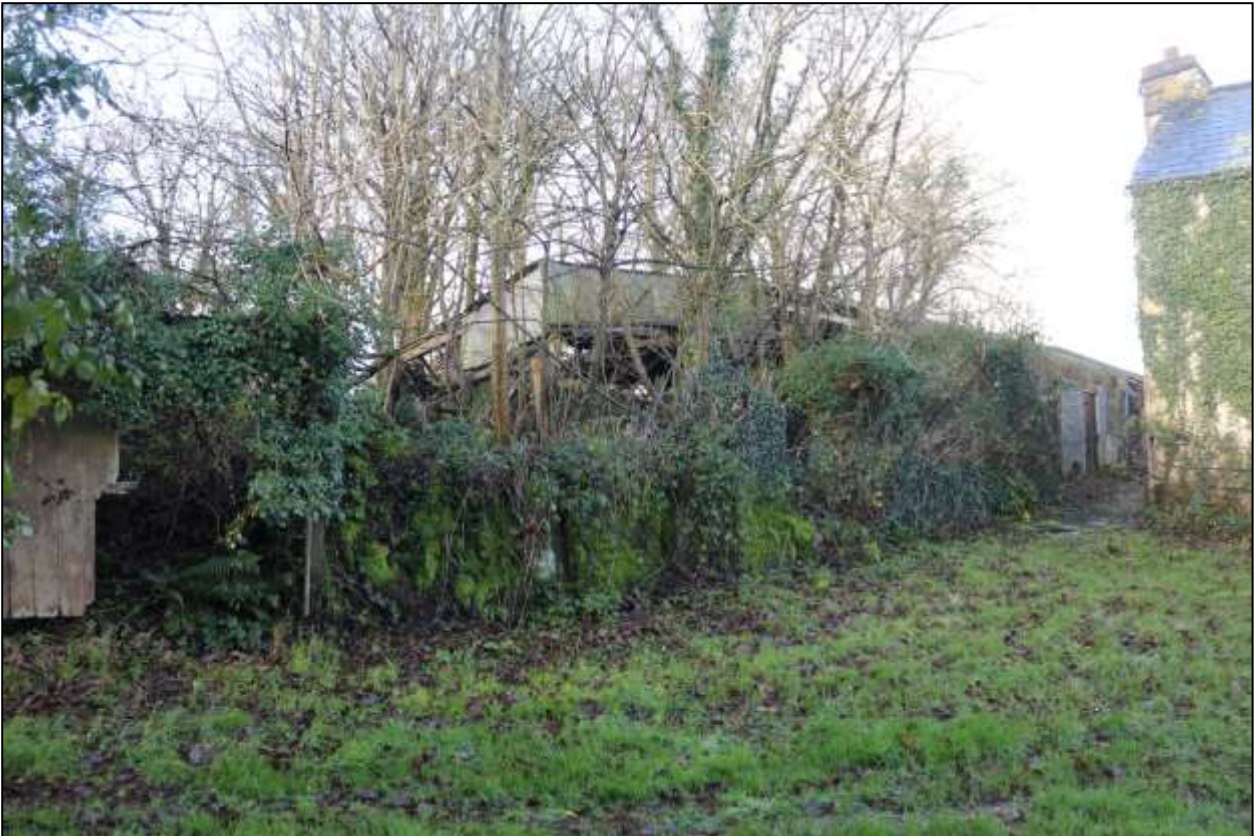
138. RUIN OF THE THRESHING BARN ON SOUTH-WEST SIDE OF THE HOUSE. LOW WALLS ARE THE RUBBLE STONE PLINTHS FOR A COB BUILDING ALMOST ALL OF WHICH HAS COLLAPSED INWARDS. REMAINS OF TIMBER AND CORRUGATED IRON GARAGE ON LEFT ABOUT THE BARN. SOUTH-WEST CORNER OF FARMHOUSE TO RIGHT. VIEWED FROM THE SOUTH.
