**BELLHAY COTTAGE
CHURCH ROAD
CARDINHAM
CORNWALL**

Historic Building Recording & Archaeological Monitoring

South West Archaeology Ltd. report no. 191129

By E. Wapshott & A. Allen
Report Version: FINAL
Issued: 29th November 2019
Finalised: 9th December 2019

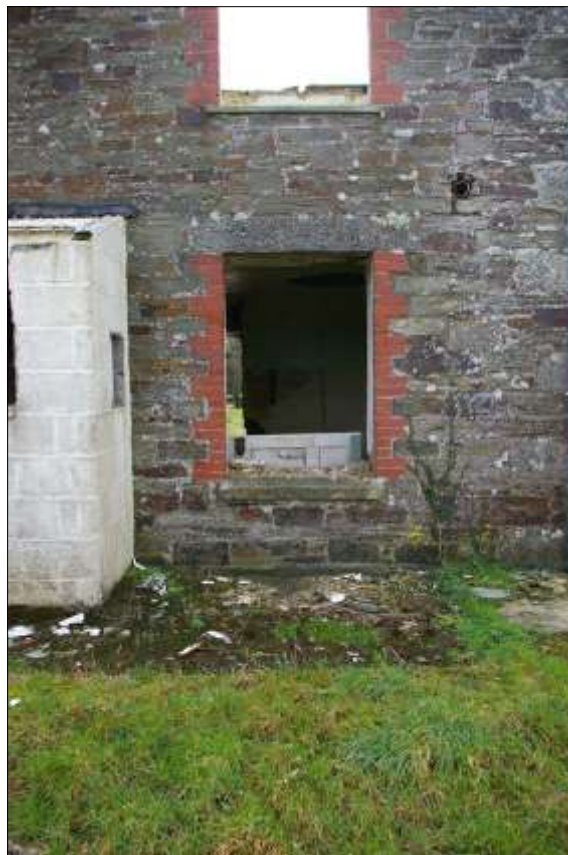
8. DETAIL OF W4 IN THE NORTH ELEVATION, SHOWING GRANITE LINTELS AND SILLS, WITH ADDITIONAL BRICK REVEALS, A LATER REPAIR; FROM THE NORTH.

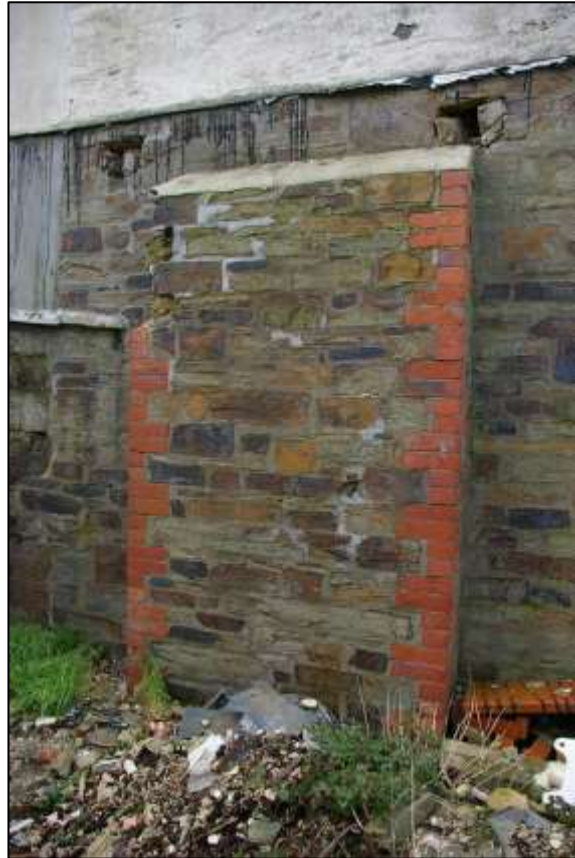
14. LEFT: DETAIL OF THE LARGE STACK TO THE MAIN HOUSE, WITH 2M SCALE; FROM THE NORTH-EAST. 15. RIGHT: THE RECENTLY CAPPED STACK WITH BRICK AND CEMENT REPAIRS, TO THE 19TH CENTURY EXTENSION, TO THE EAST, NORTH-EAST.

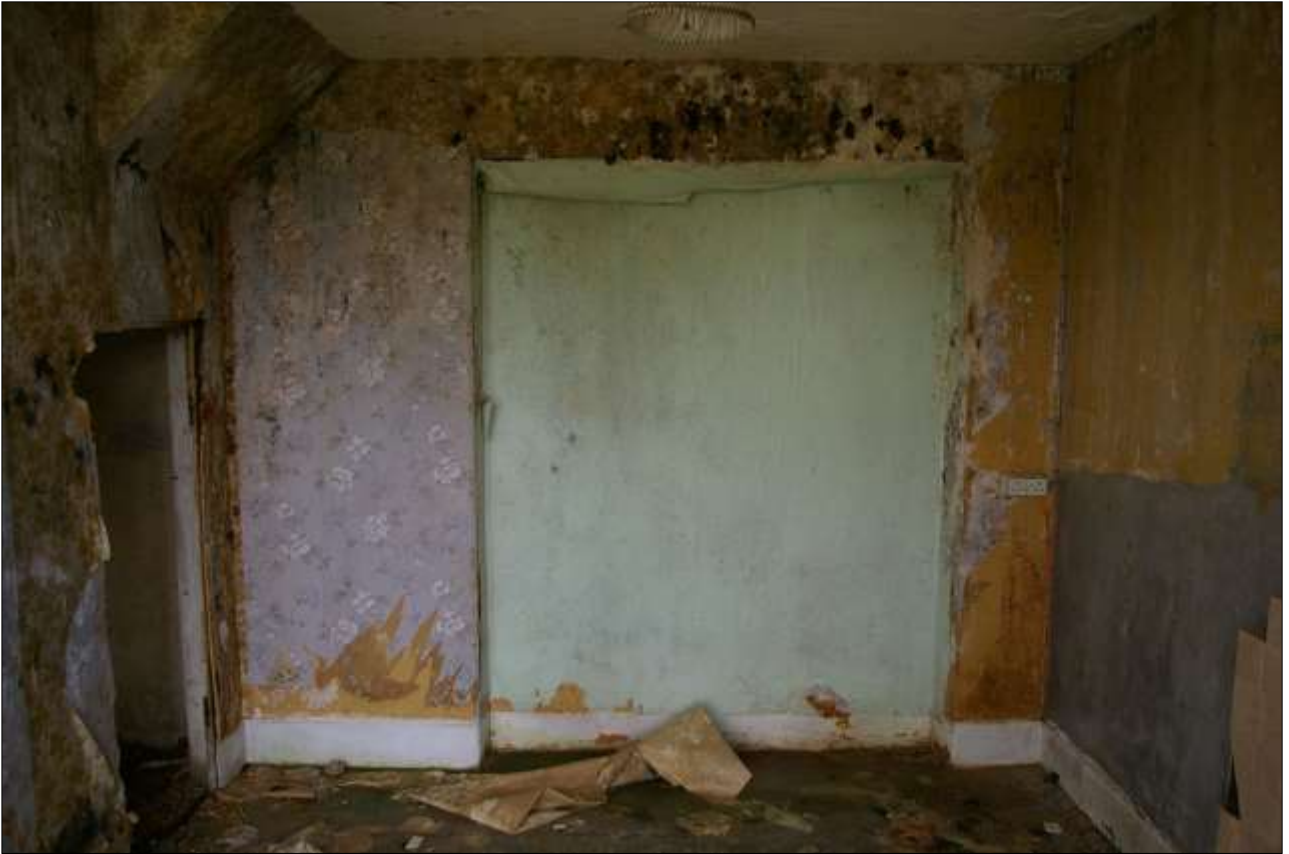
Significant Details:		There is a large blocked opening to the north wall, in the former external north elevation, this is offset and has straight sides, is shallow. There is no evidence of bead mouldings or any original detailing and this may be another blocked window or doorway, as this was a kitchen the 19 th century extension may replace an earlier small outshut to the rear.
Dating Evidence:		The plaster skirtings, bead mouldings are indicative of age, the other features both bay window and fireplace are later additions.
Comments:		The character of this room is now 'modernised Victorian' due to the fireplace and bay window when in fact it is a late Georgian kitchen, but no features from this phase survive.
Room 4		Description
Function:		Parlour
Walls:		Lime and clay plastered walls, the east wall is a timber frame and stone rubble noggin partition with yellowish clay and lime plaster, painted and wallpapered in historic layers. Very deep plaster skirtings, visible from the scars on walls were lost or hacked out, the depth indicates the higher status of this space.

40. THE NORTH WALL OF ROOM 3, WITH LARGE BLOCKED RECTANGULAR OPENING, POSSIBLY A FORMER WINDOW; FROM THE SOUTH.

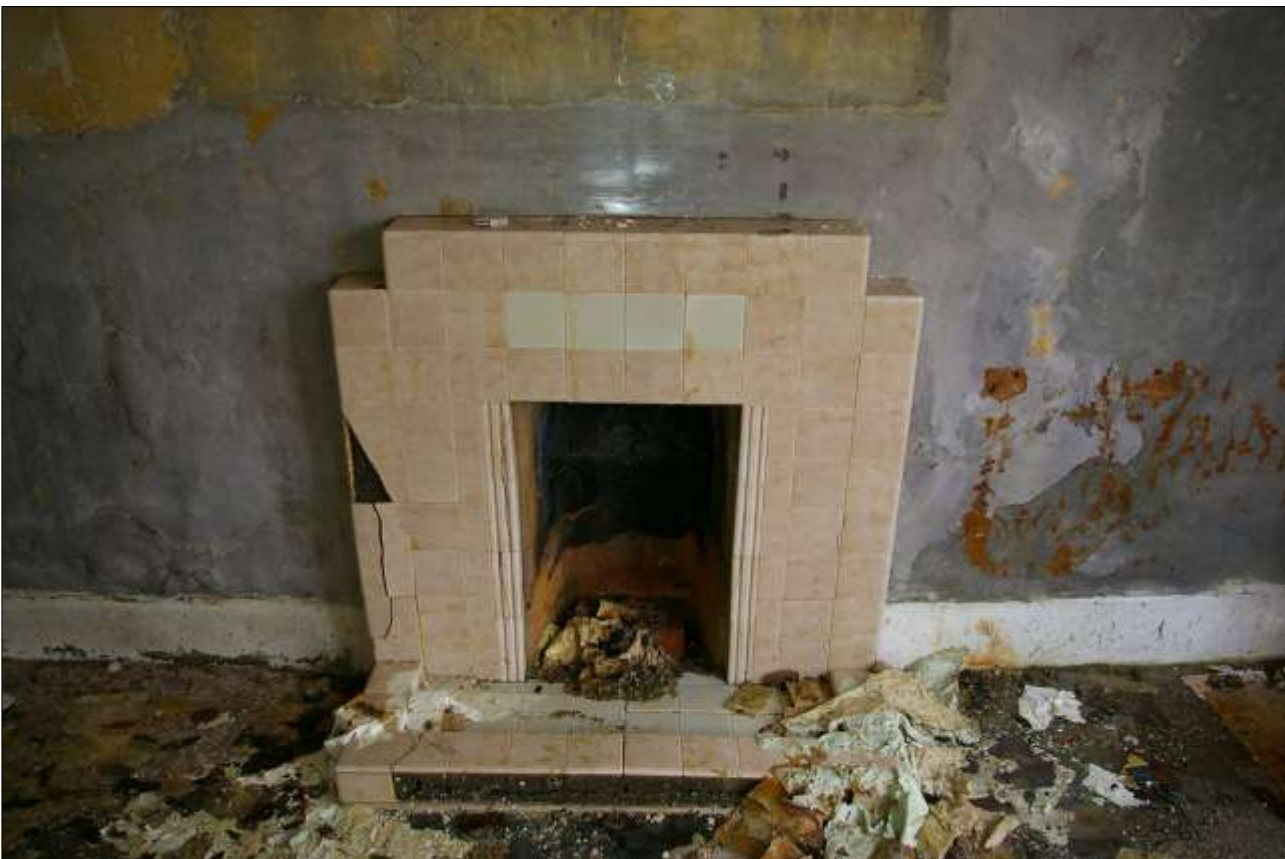
43. THE SMALL MID-20TH CENTURY, C.1950S FIREPLACE WHICH IS INSET INTO THE BLOCKED LARGE HEARTH TO THE KITCHEN, ROOM 3; FROM THE WEST.

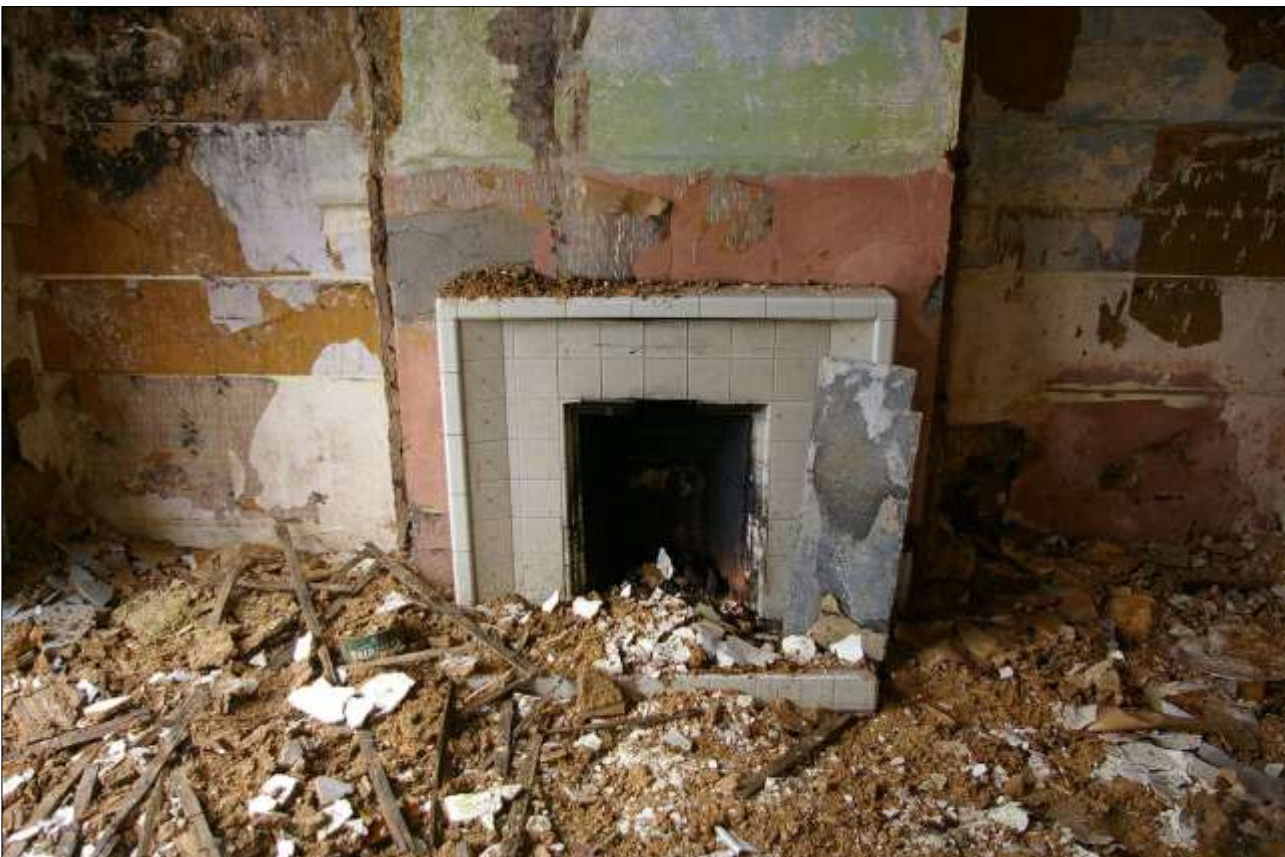
49. THE SHALLOW STACK IN THE PARLOUR, TILED MID-CENTURY, 1950S, SET INTO A BLOCKED OPEN HEARTH; FROM THE EAST.

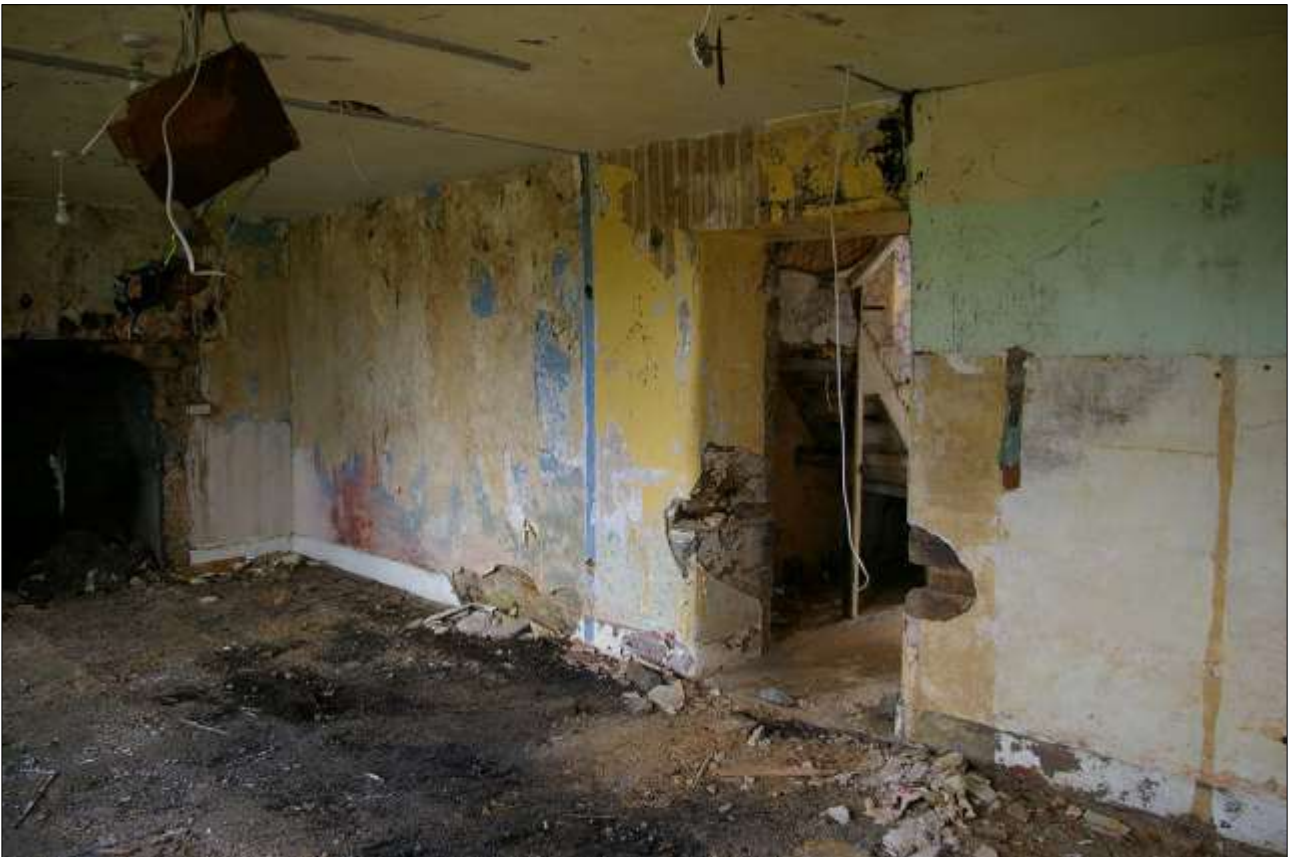
53. ROOM 6, THE 19TH CENTURY EXTENSION, LARGE OPEN SPACE, PARTITION WALLS REMOVED; FROM THE NORTH-WEST.

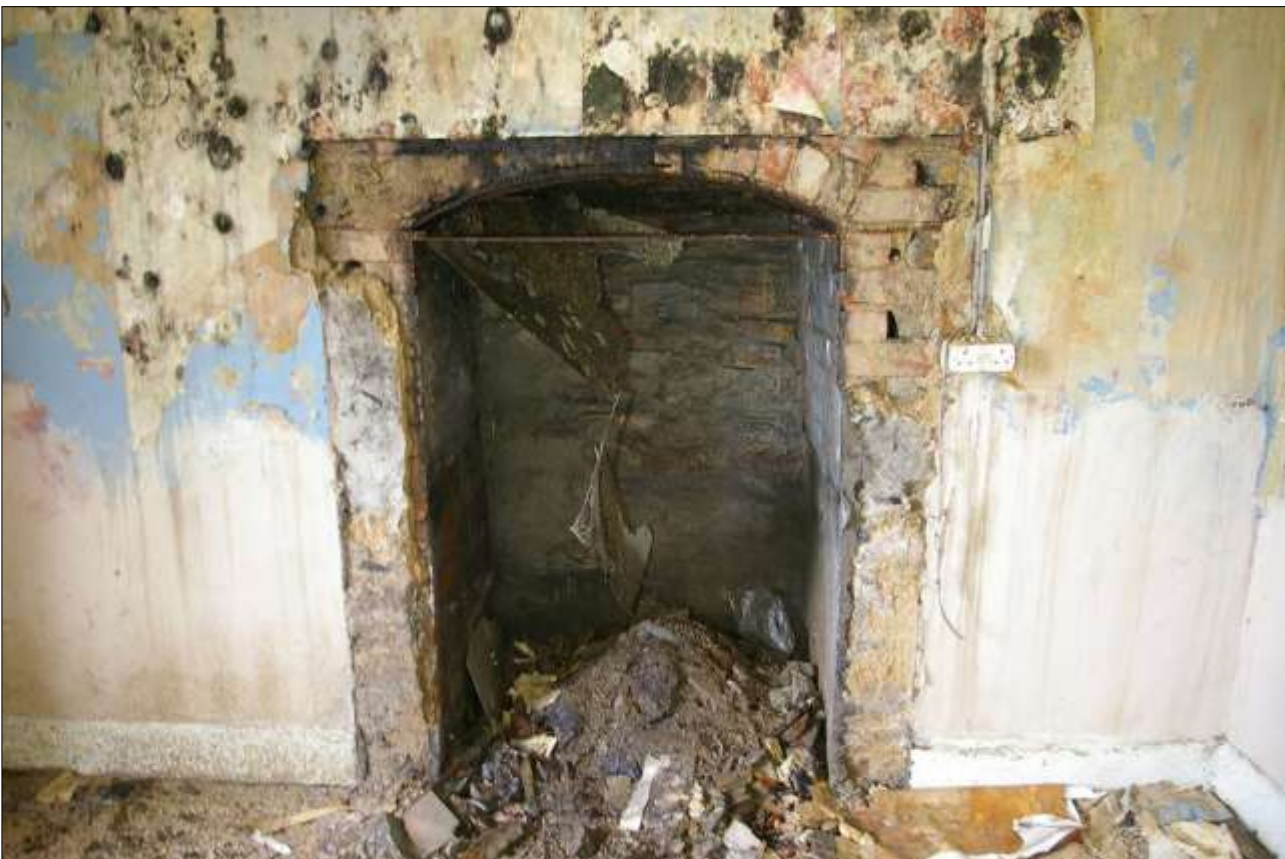
55. THE BRICK LINED SHALLOW BASKET ARCHED FIREPLACE, WITH IRON ARCHED BAR LINTEL, IRON FRAMING AND COLLAPSED REGISTER PLATE; FROM THE WEST.

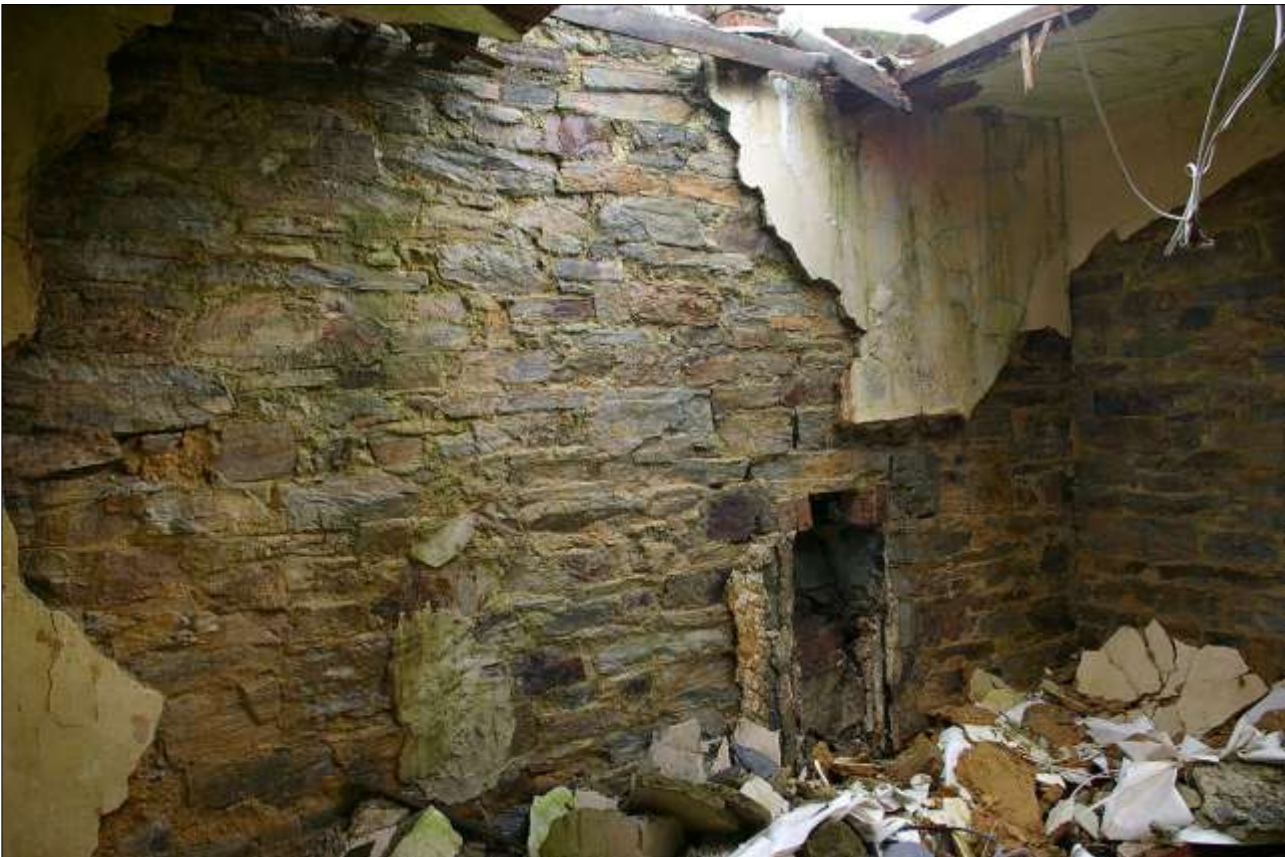
67. ROOM 8, THE EAST WALL AND SOUTH WALL. THE SMALL REDUCED OPENING IN THE EAST WALL IS AN ORIGINAL FIREPLACE WHICH HAS BEEN NARROWED FOR A LATER SMALLER GRATE; FROM THE NORTH-WEST.

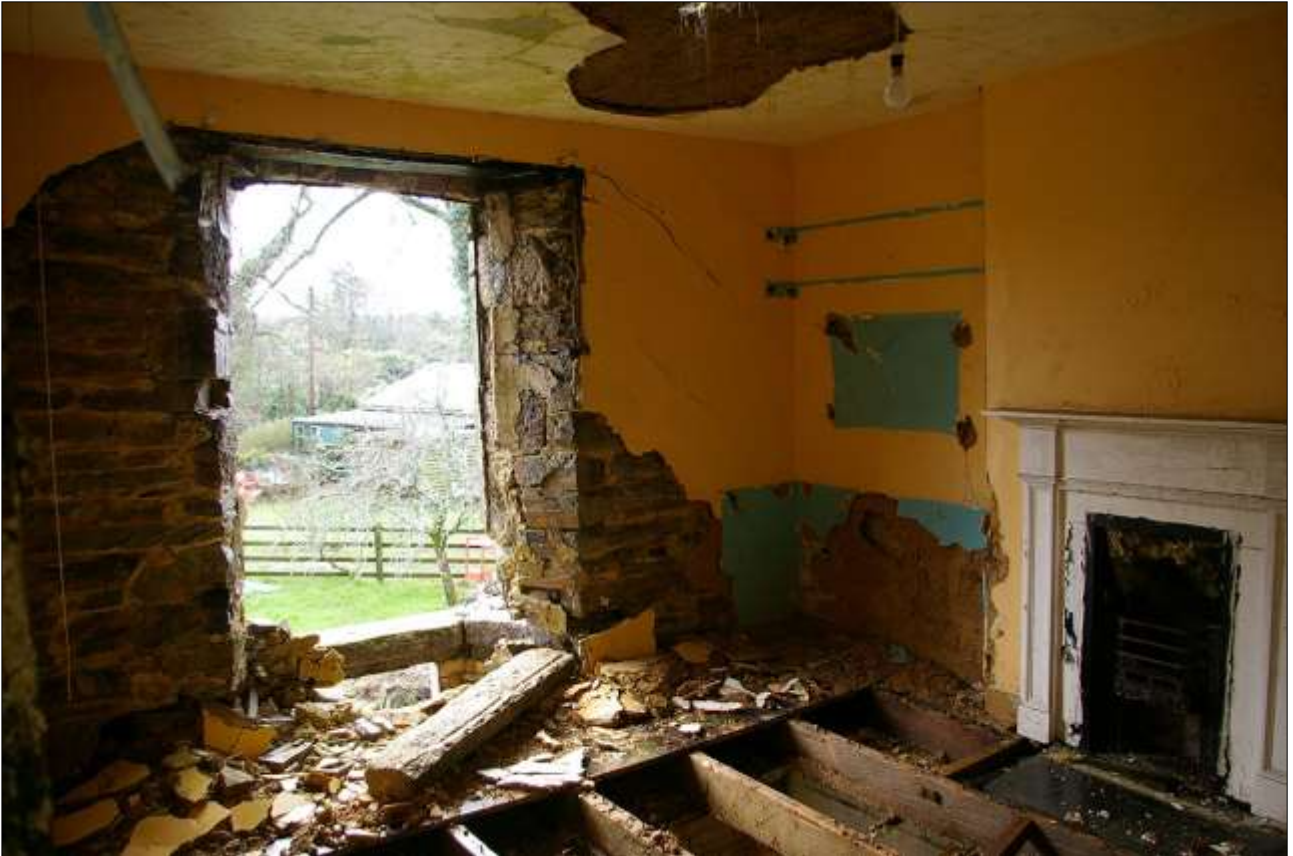
71. THE SOUTH WALL OF ROOM 10, THE WINDOW WITH COLLAPSED STONE CARVED SILL, SHALLOW SLOPING SIDES; FROM THE NORTH-EAST.

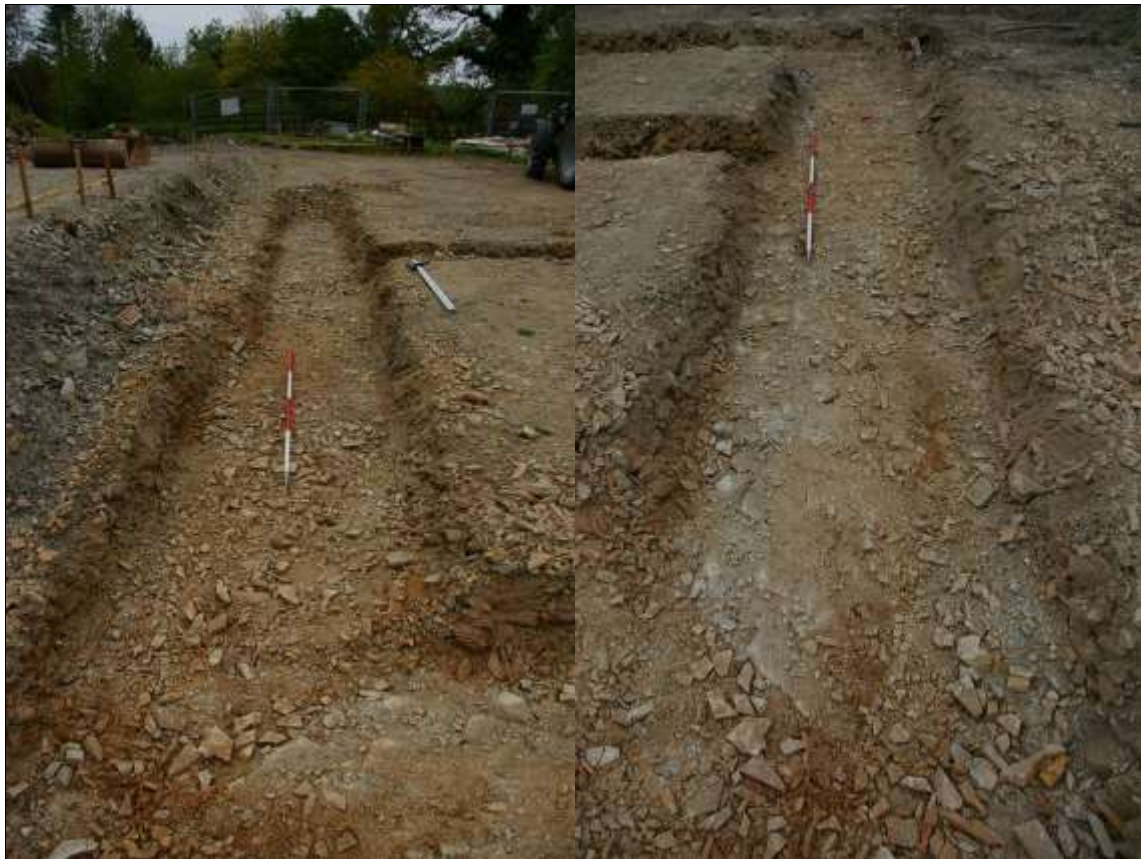
2. LEFT: THE EASTERN FOUNDATION TRENCH SHOWING DEGRADED BEDROCK; FROM THE SOUTH (2M SCALE).
