WEEK
BERRY POMEROY
SOUTH HAMS
DEVON

Historic Building Recording and Archaeological Evaluation Trenching

South West Archaeology Ltd. report no. 190902

By E. Wapshott & P. Webb

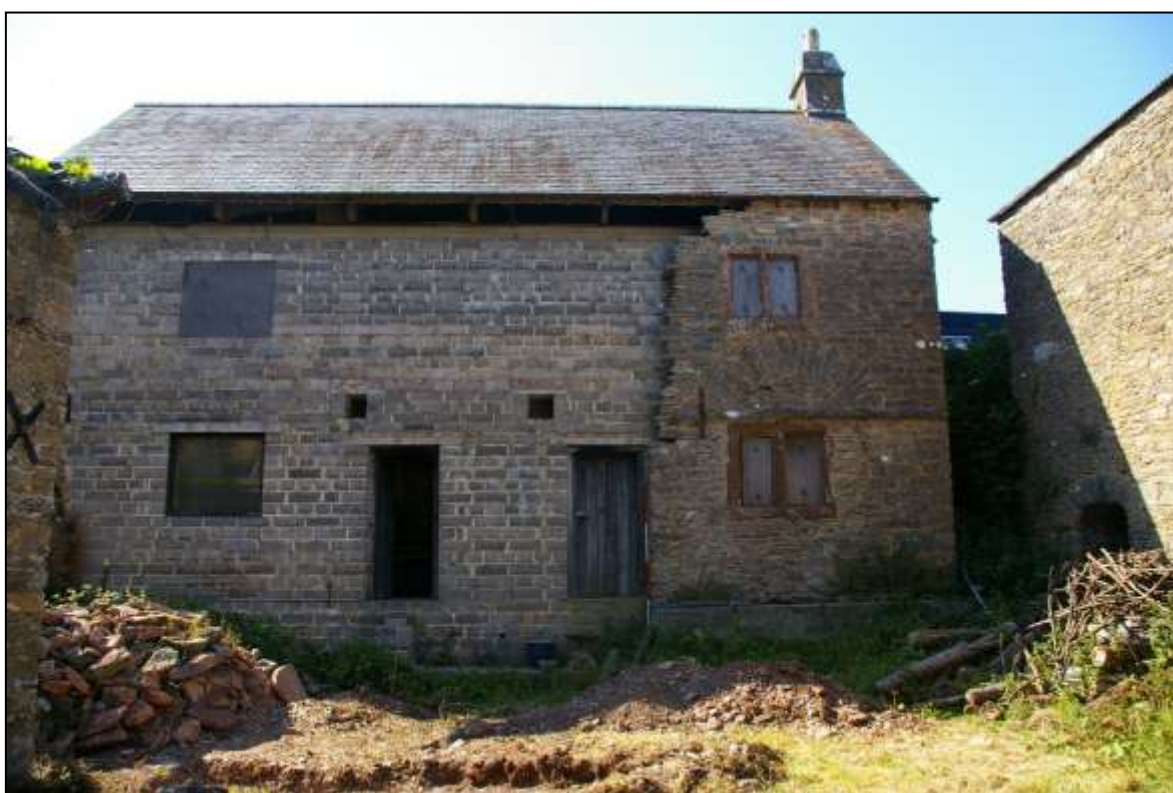
FIGURE 3: THE SOUTH-EAST ELEVATION OF B1 SHOWING THE EXTENSIVE MODERN REPAIRS; VIEWED FROM THE SOUTH-EAST (2M SCALE).

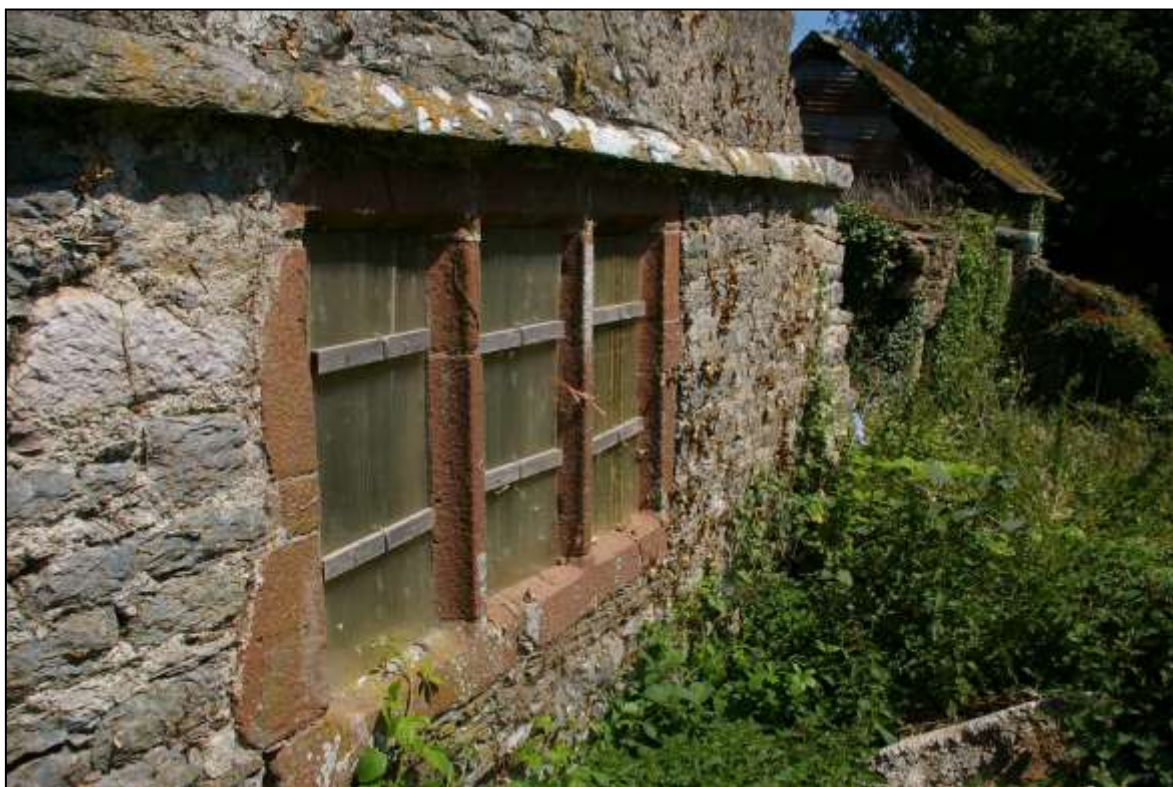
FIGURE 5: EXAMPLE OF THE RE-USED RED SANDSTONE WINDOW MULLIONS, IN THIS CASE FOR WINDOW W5 IN THE SOUTH-WEST ELEVATION OF B1; VIEWED FROM THE WEST.

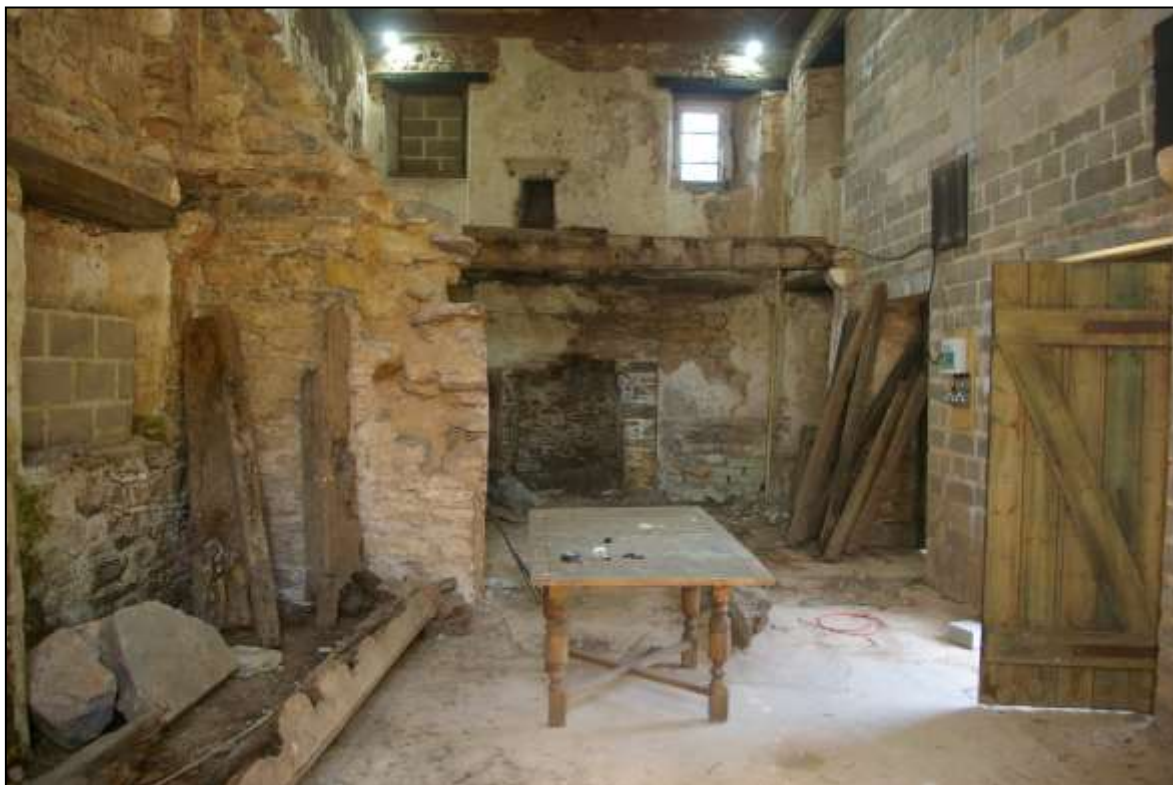
The interior of the building has lain empty for much of the 20th century during which time it has been damaged; leading to internal features not surviving in good condition, and almost all detail being lost. The space is divided unequally by a now ruinous heavy two storey stone rubble partition; there being historically larger ground and first floor rooms to the south-western end compared to those of the north-eastern end.

FIGURE 6: INTERIOR OF B1, SHOWING THE SURVIVING REMAINS WHICH INDICATE ITS DIVISION INTO TWO GROUND-FLOOR AND FIRST-FLOOR ROOMS; VIEWED FROM THE SOUTH-WEST.

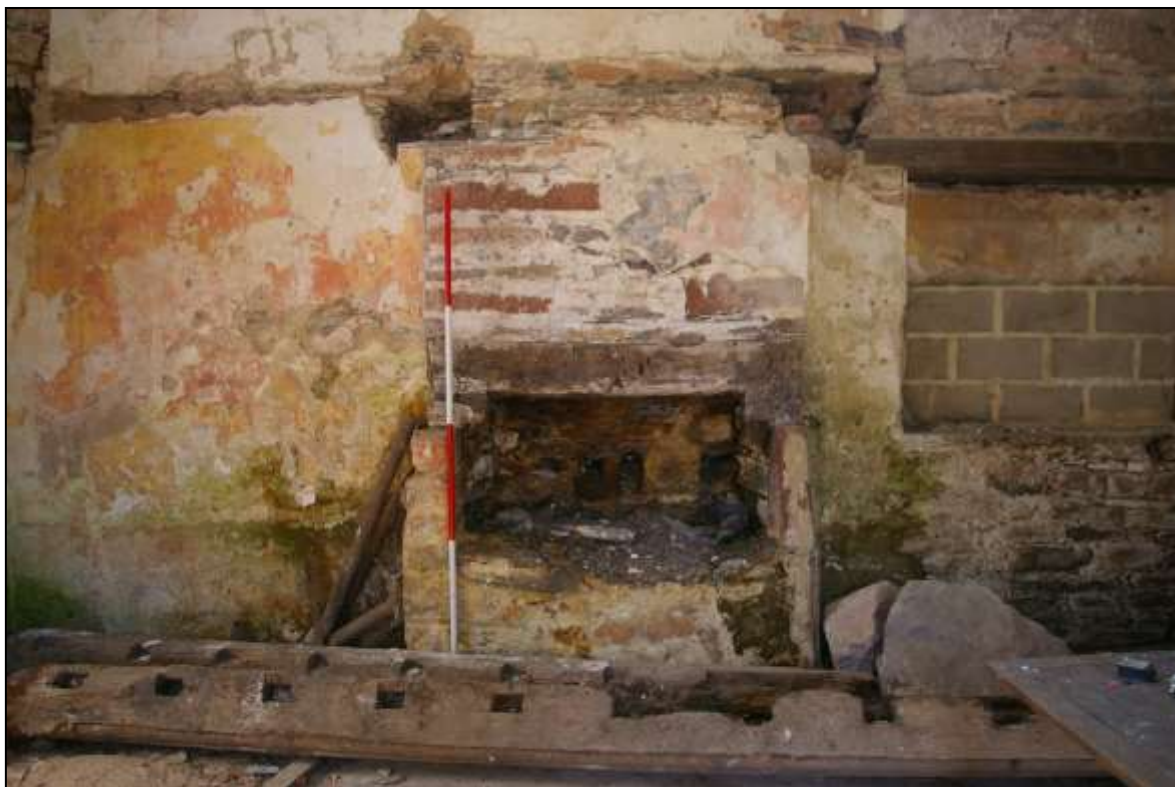
The south-western ground-floor room was heated by a raised rubble-built hearth (FP1) set into the north-western wall, part of its projecting north jamb being a re-used window mullion and the timber bresummer a re-used lintel. The floor surface of this space has retained in part some fine large slate flagstones; whilst stored within the space are the remains of two ovolo-moulded carved ceiling beams and several carved joists. The walls at this end retain some thick cob/lime mix plaster and even historic paint layers. The ceiling/floor of the first-floor room at this end has been wholly lost, though the walls retain no evidence of heating, and the space's light would have been reduced when the third light of W6 was reduced.

FIGURE 7: DETAIL OF FIREPLACE FP1 WITHIN THE SOUTH-WESTERN GROUND-FLOOR ROOM OF B1; VIEWED FROM THE SOUTH-EAST (2M SCALE).

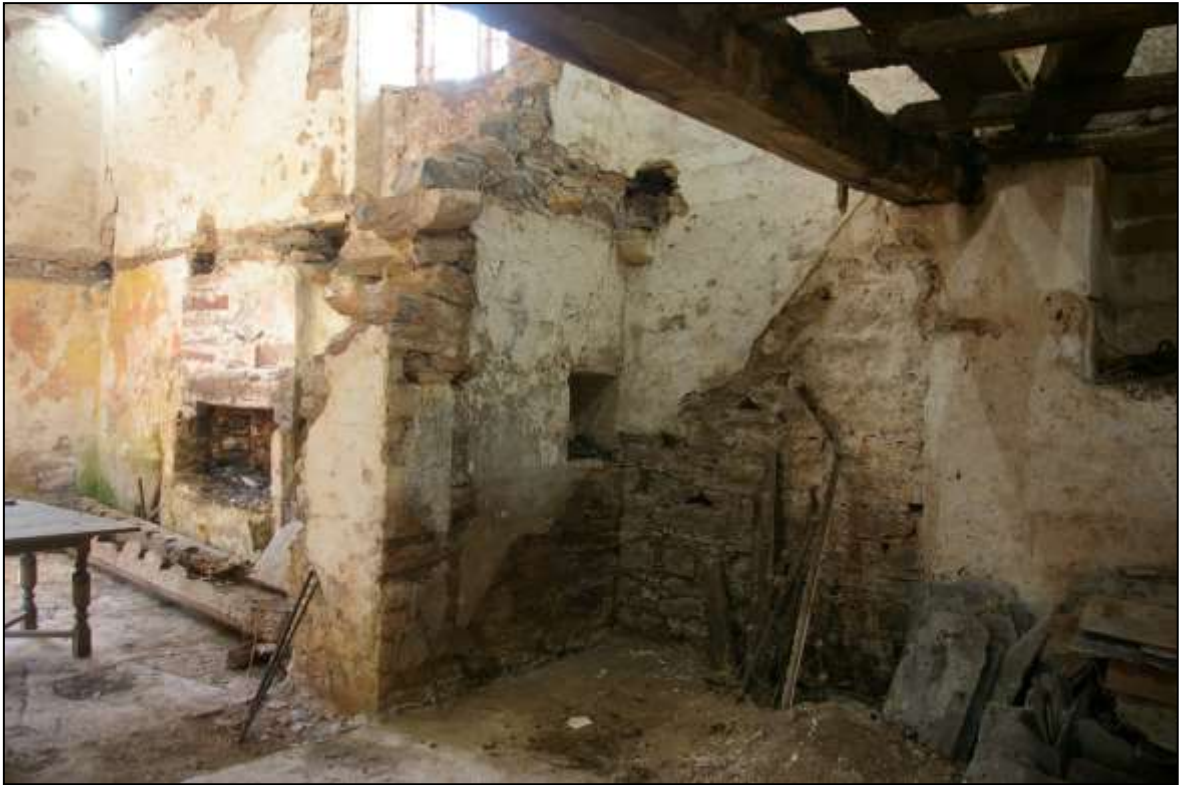
FIGURE 8: DETAIL OF THE INTERIOR OF B1, SHOWING THE SCAR OF THE REMOVED STAIRS TO THE FIRST FLOOR; VIEWED FROM THE SOUTH-EAST.

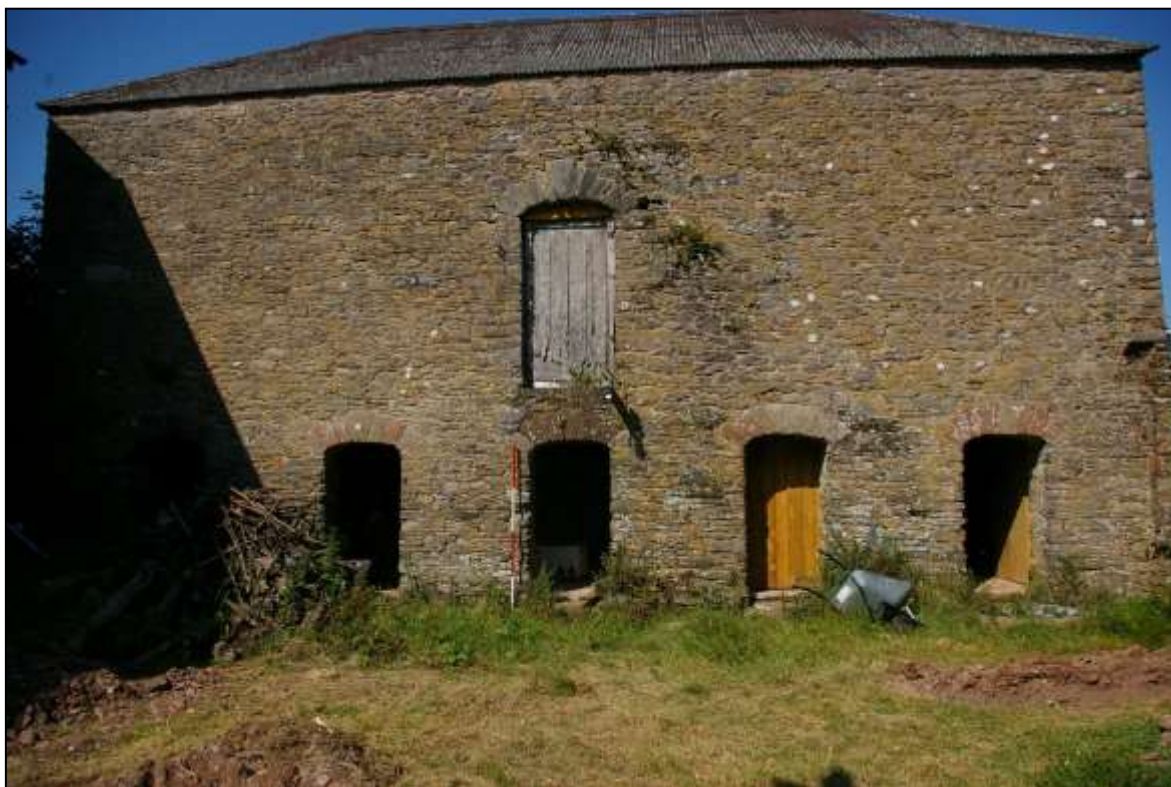
FIGURE 9: BANK BARN B2, SHOWING THE MULTIPLE PHASES OF ALTERATION WITHIN THE SOUTH-WEST ELEVATION; VIEWED FROM THE SOUTH-WEST (2M SCALE).

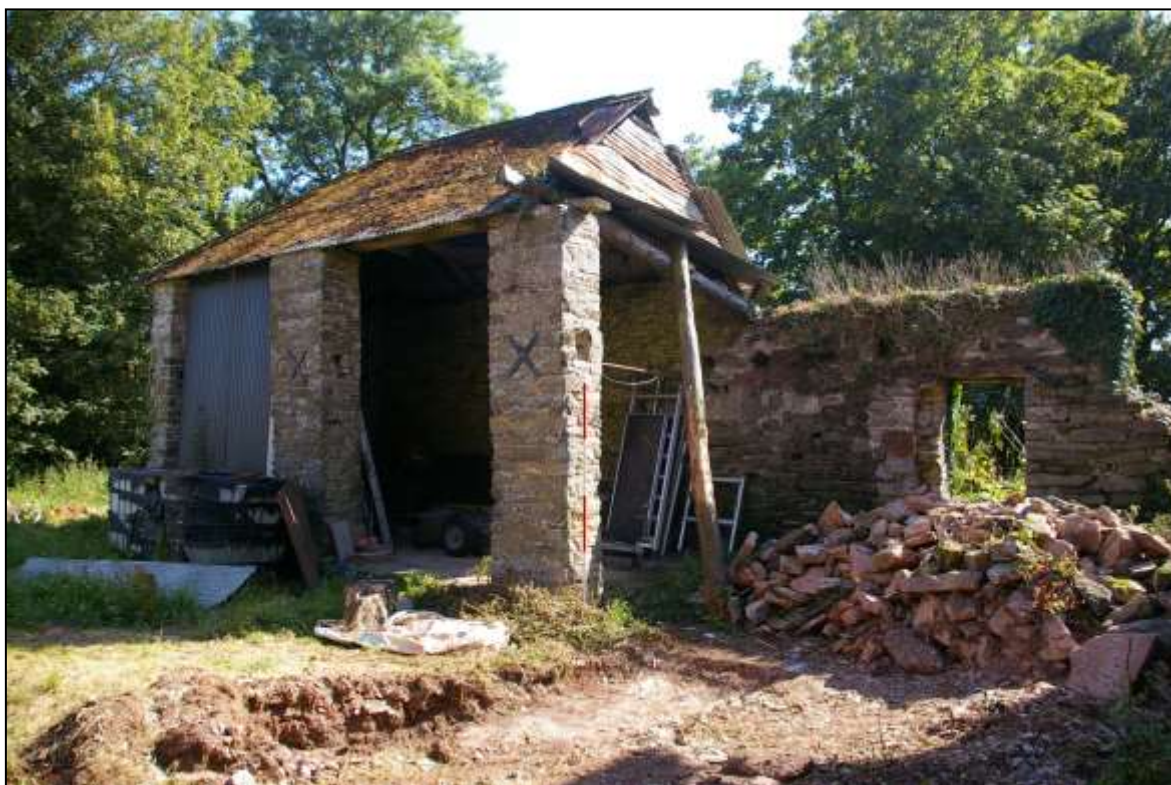
FIGURE 10: LINHAY B3, DEMONSTRATING THE COLLAPSED NORTH-WESTERN END; VIEWED FROM THE NORTH (2M SCALE).

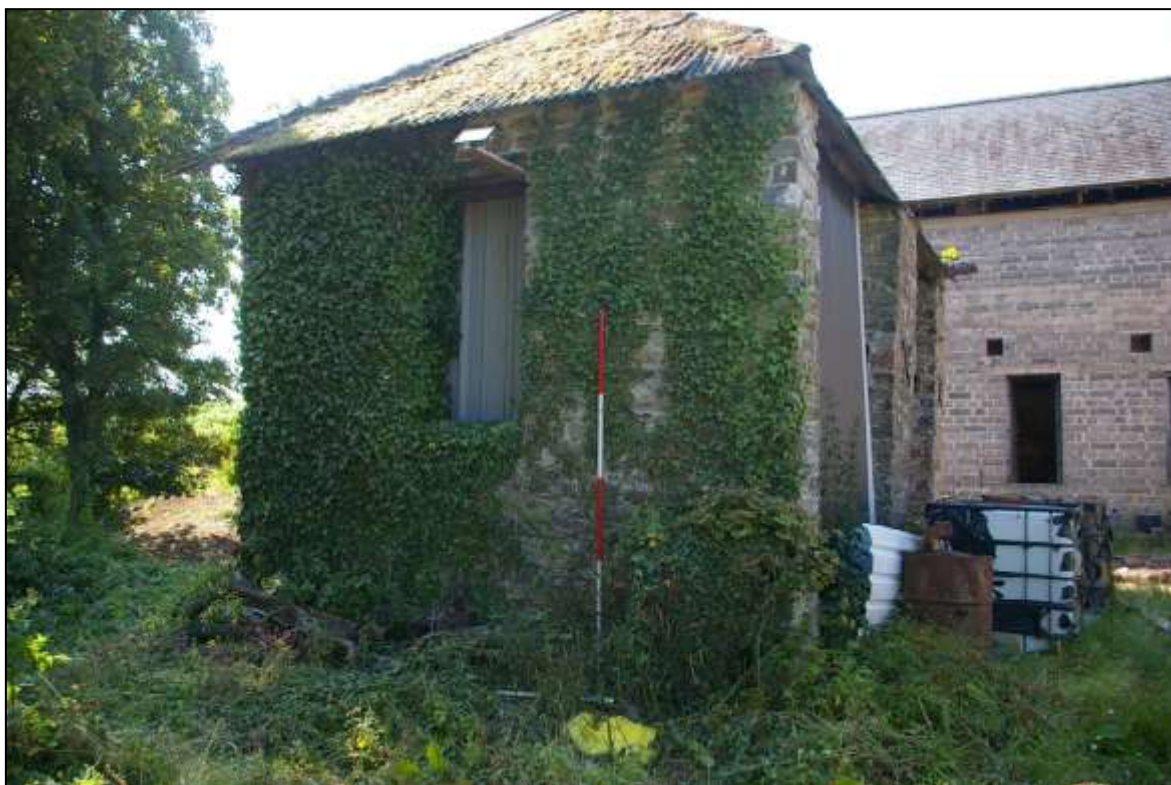
The south-east elevation stands to one and a half storeys; and is constructed of dense loose shale and slate slab rubble, the upper part recently rebuilt in cement mortars. A modern loading door (D12) has been created in this elevation with railway sleeper lintels.

FIGURE 11: SOUTH-EAST ELEVATION OF B3; VIEWED FROM THE EAST (2M SCALE).

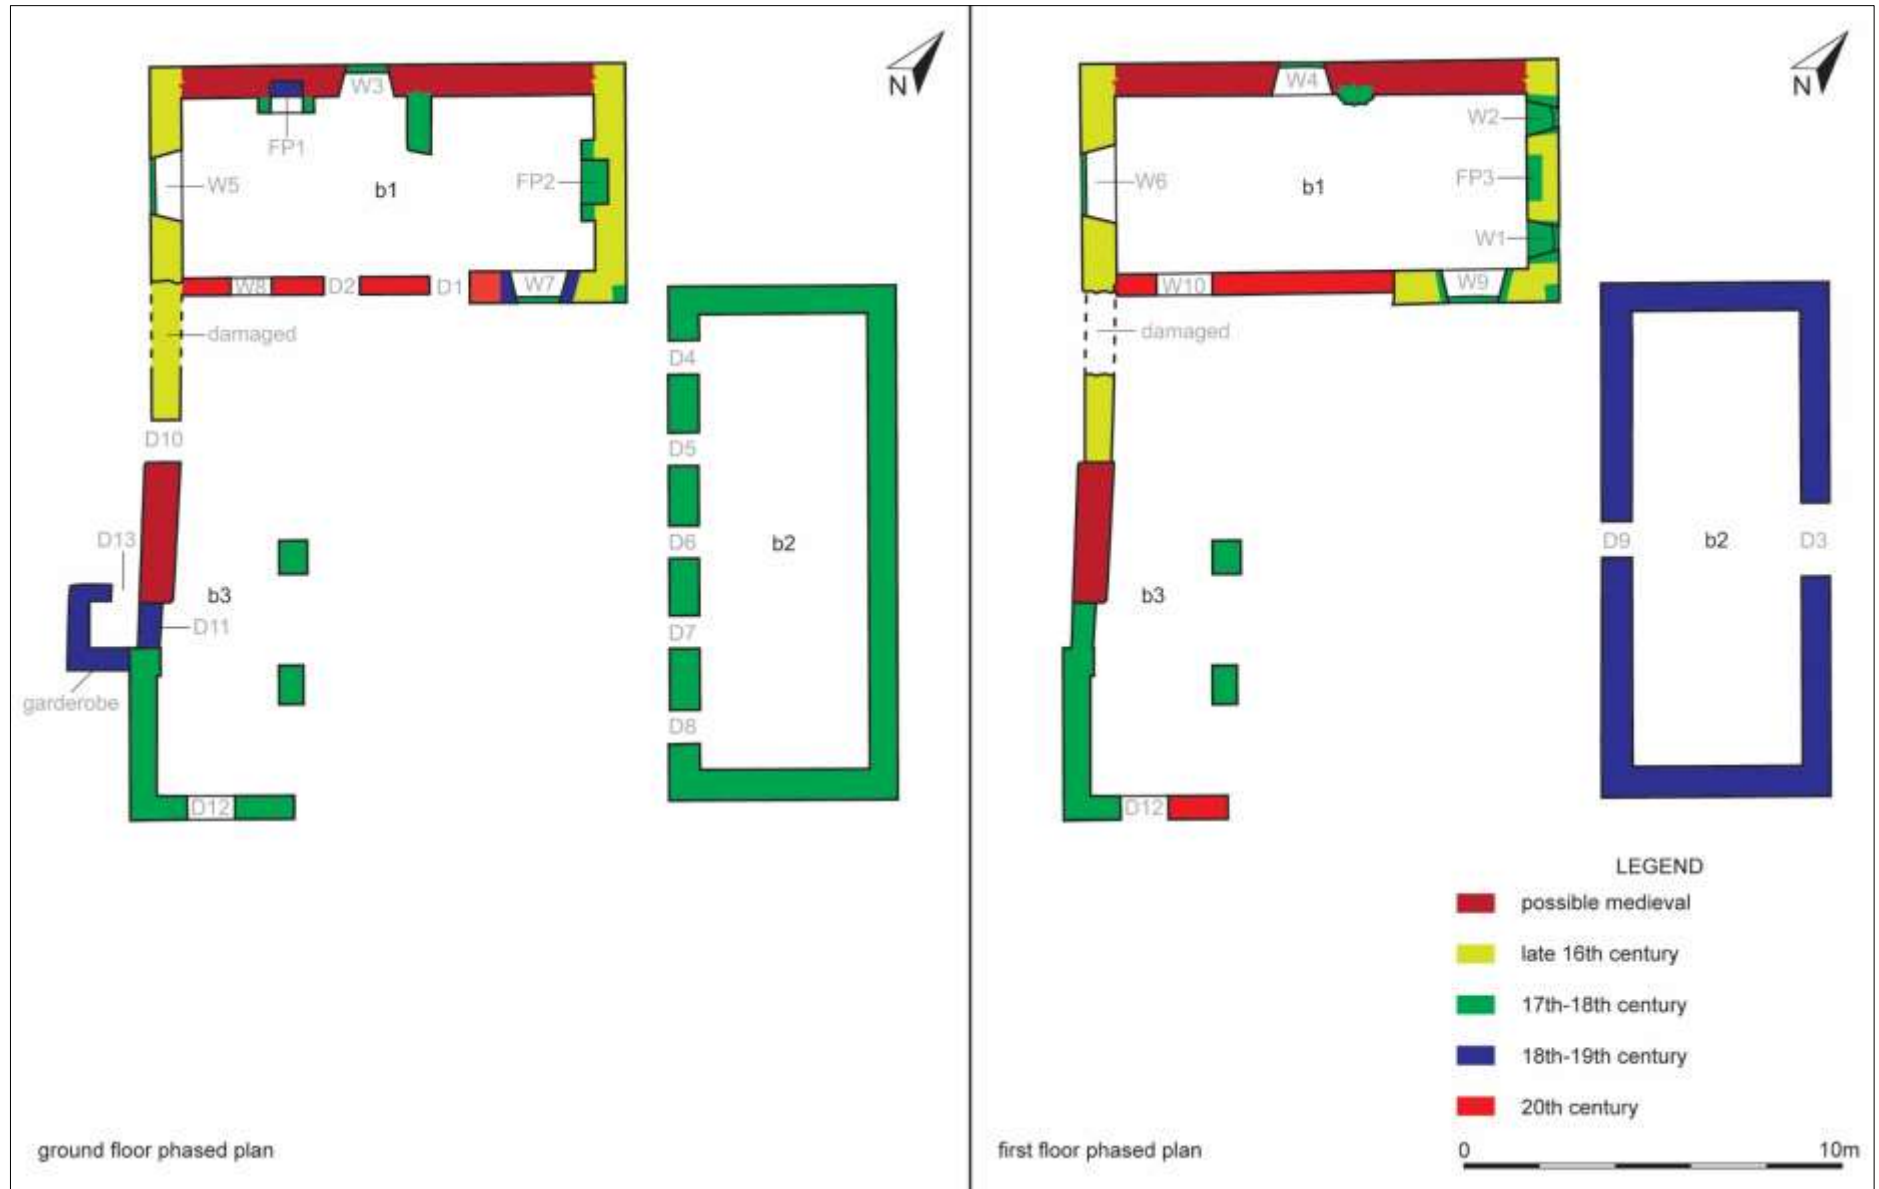
FIGURE 12: GROUND-FLOOR AND FIRST-FLOOR PLANS SHOWING DEVELOPMENTAL PHASING AND POSITIONS OF FEATURES DESCRIBED IN THE TEXT.

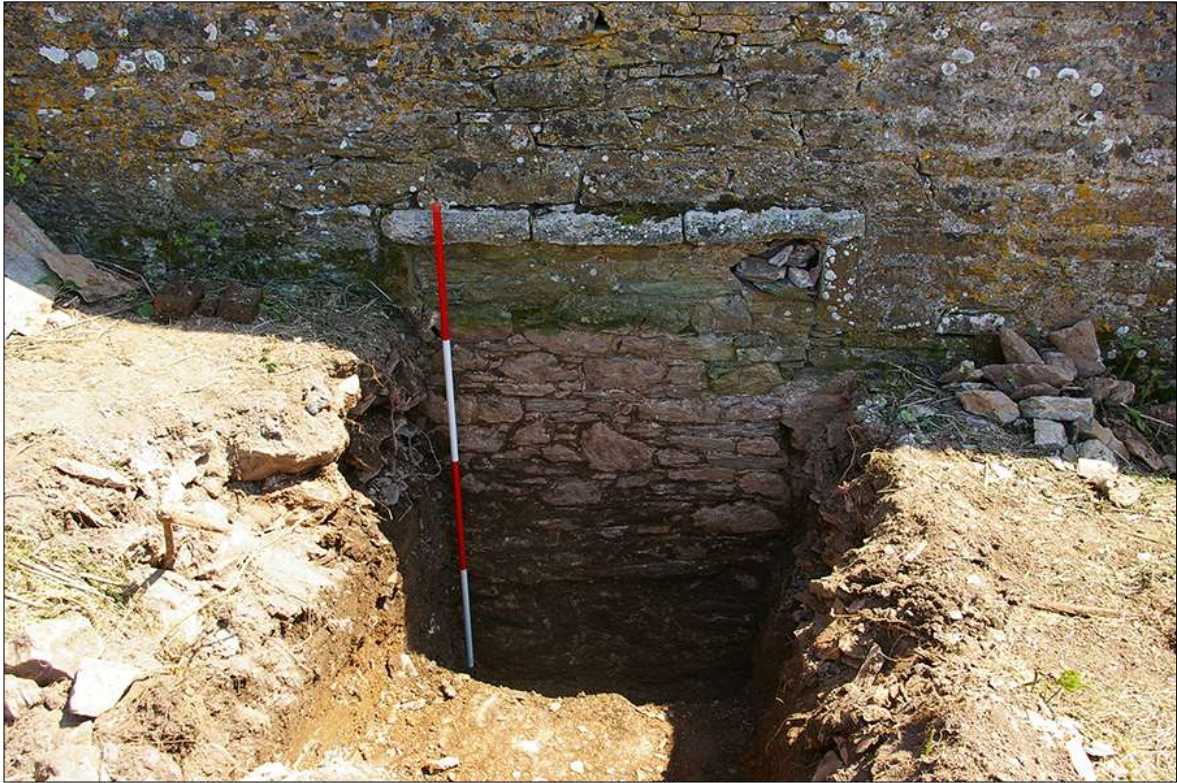
16. DETAIL OF THE BLOCKED AND PARTIALLY BURIED W3 WITHIN THE NORTH-WEST ELEVATION OF B1; VIEWED FROM THE NORTH-WEST (2M SCALE).

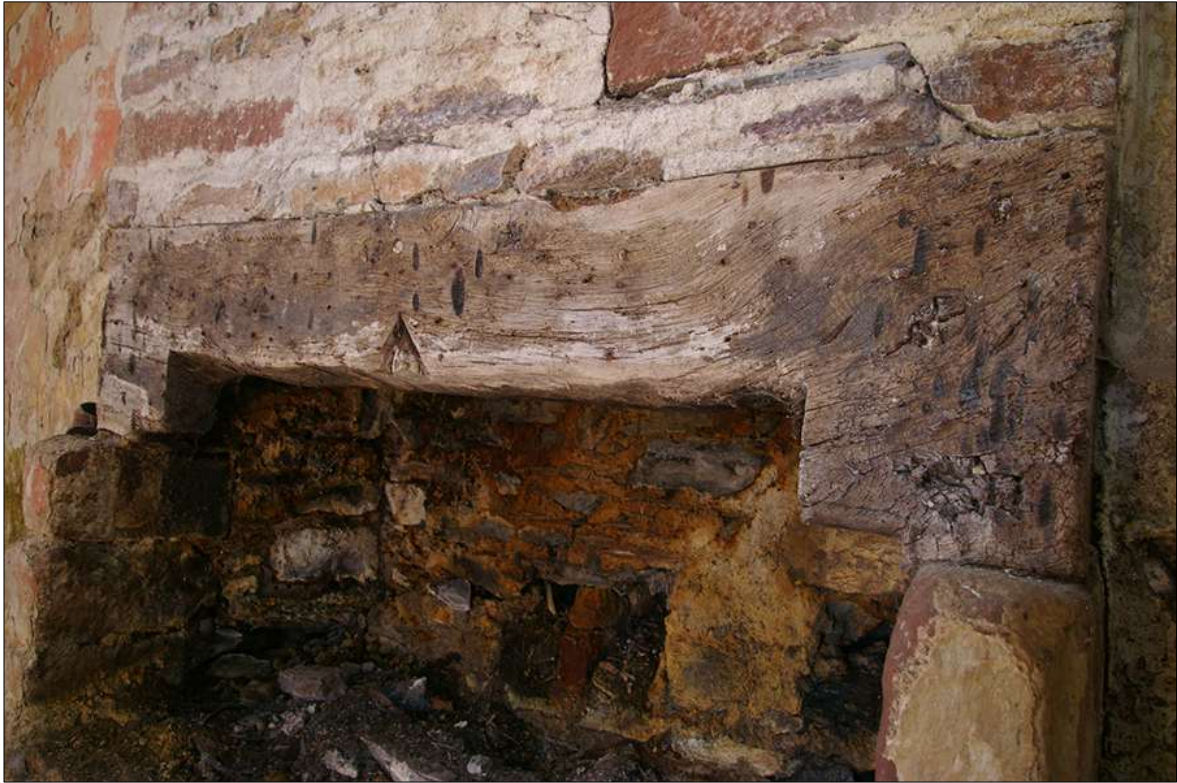
48. DETAIL OF THE RE-USED TIMBER LINTEL OF FIREPLACE FP1, WITH CUT OFF OVULO MOULDING AND TRUNCATED CENTRAL MULLION SUGGESTING THAT IT IS FROM A TWO-LIGHT WINDOW; VIEWED FROM THE EAST.

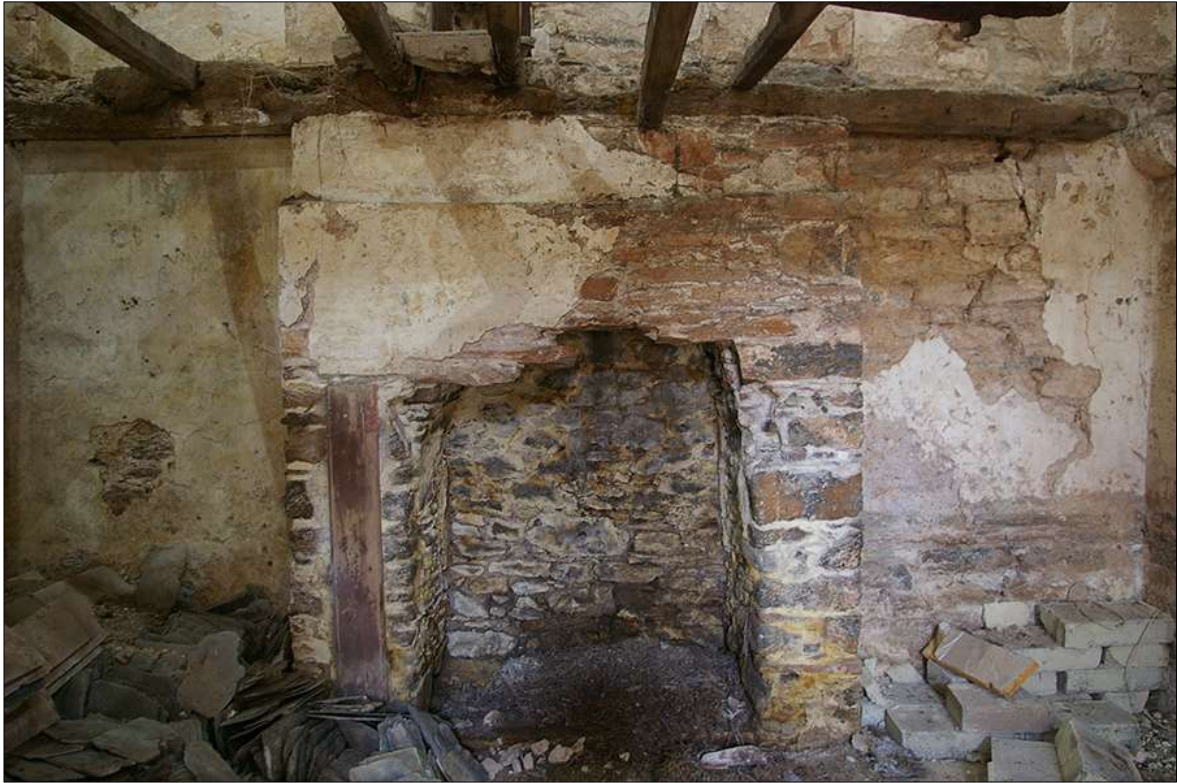
62. DETAIL OF FIREPLACE FP2 IN THE NORTH-EAST WALL OF THE NORTH-EAST ROOM OF B1, SHOWING RAGGED PATCHED SIDES AND EXTENSION OF THE STACKS JAMBS OUTWARDS; VIEWED FROM THE SOUTH-WEST.

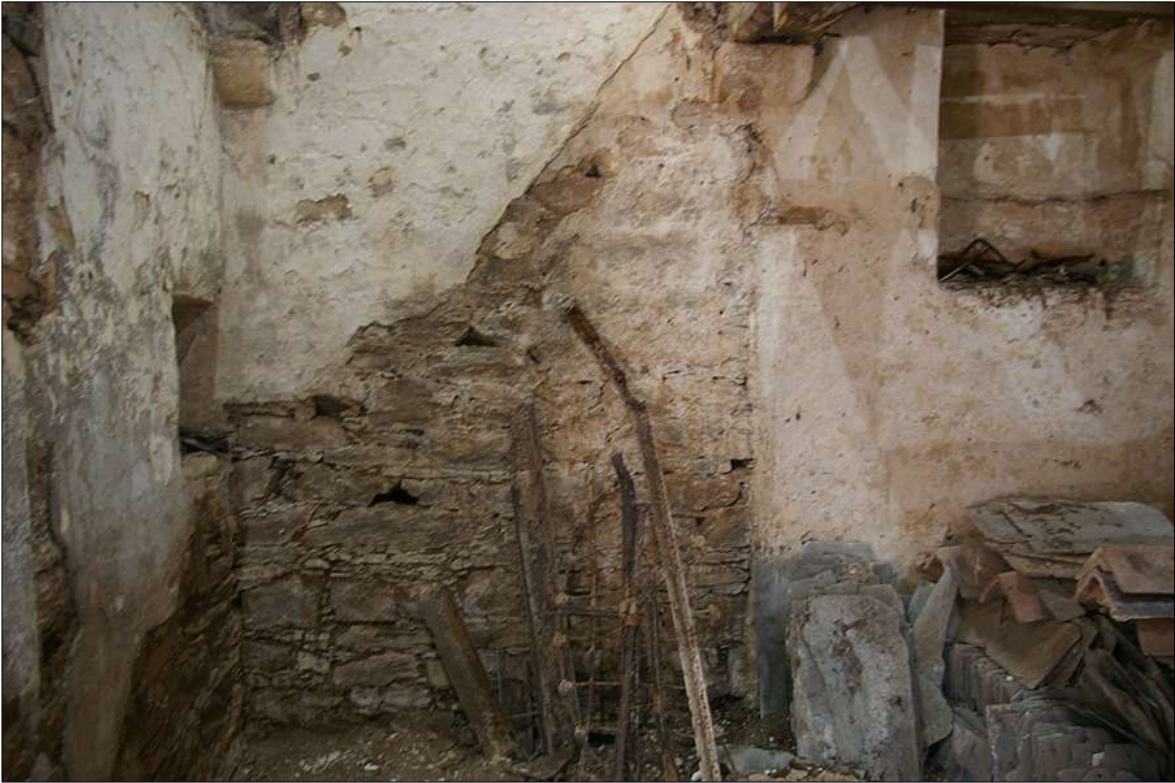
76. DETAIL OF THE SCAR OF THE FORMER STAIR AGAINST THE NORTH-WEST WALL OF THE NORTH-EAST GROUND-FLOOR ROOM WITHIN B1; VIEWED FROM THE SOUTH-EAST.

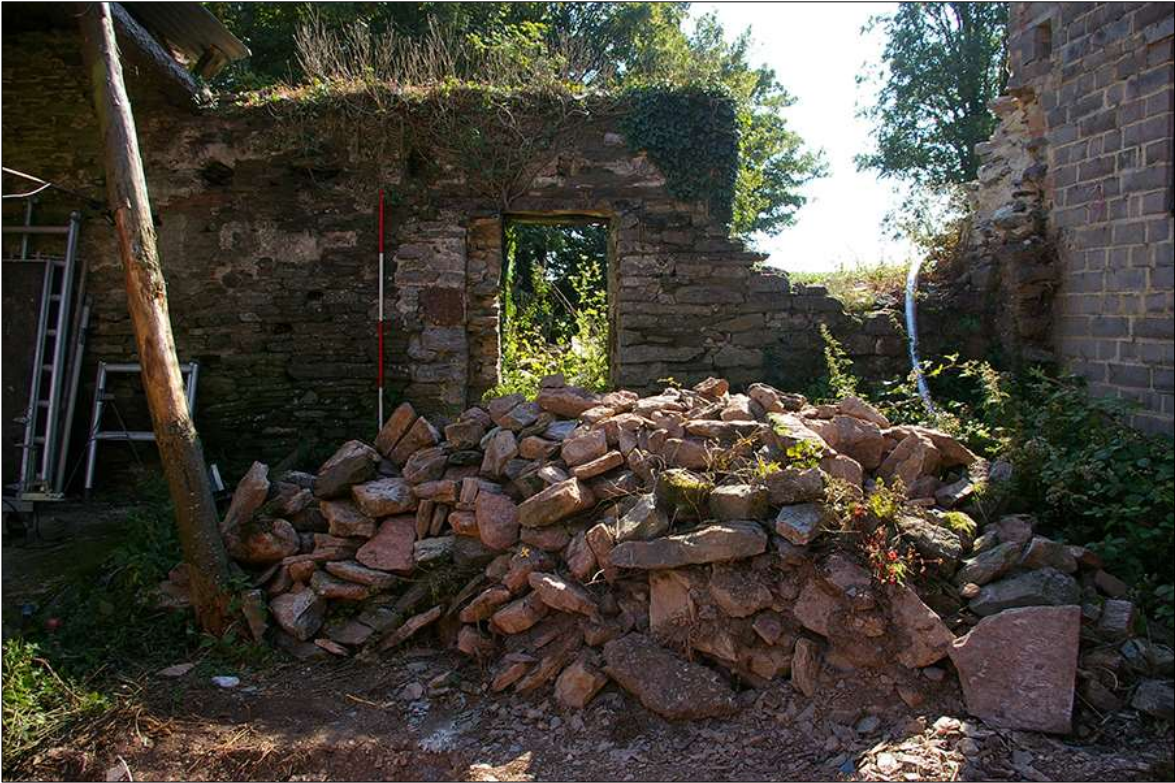
113. INTERIOR FACE OF THE SOUTH-WEST ELEVATION (NORTH-WEST END) OF B3 SHOWING THE EXTENT OF STORM DAMAGE; VIEWED FROM THE NORTH-EAST.
