# ASH HOUSE HENSTRIDGE SOMERSET

Historic Building Recording

South West Archaeology Ltd. report no. 190326

## Ash House, Henstridge, Somerset Historic Building Recording

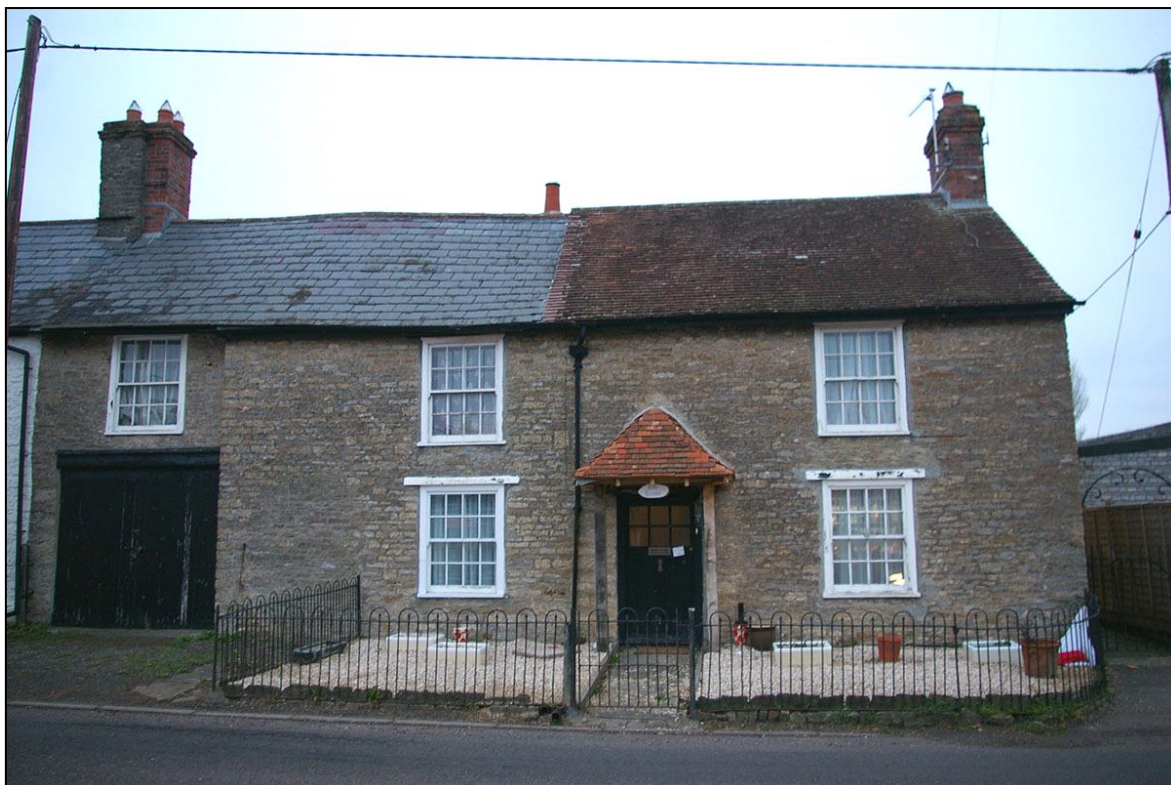
FIGURE 6: THE SOUTH ELEVATION; VIEWED FROM THE SOUTH.

The south elevation faces onto the A30. It is an awkward composition reflecting the history and development of the house. The stonework of this wall is of neat regularised stone rubble repointed in grey cement. The wall is curving rather than straight and steps back at the western end; the projecting corner features small roughly-dressed quoins. The stonework of the last section, which links the cottage to the Old Bakehouse, is more ragged and less accomplished. There is a blocked doorway in the central bay, still addressed by its path, reflecting the fact the cottage formed two dwellings into the mid 20<sup>th</sup> century.

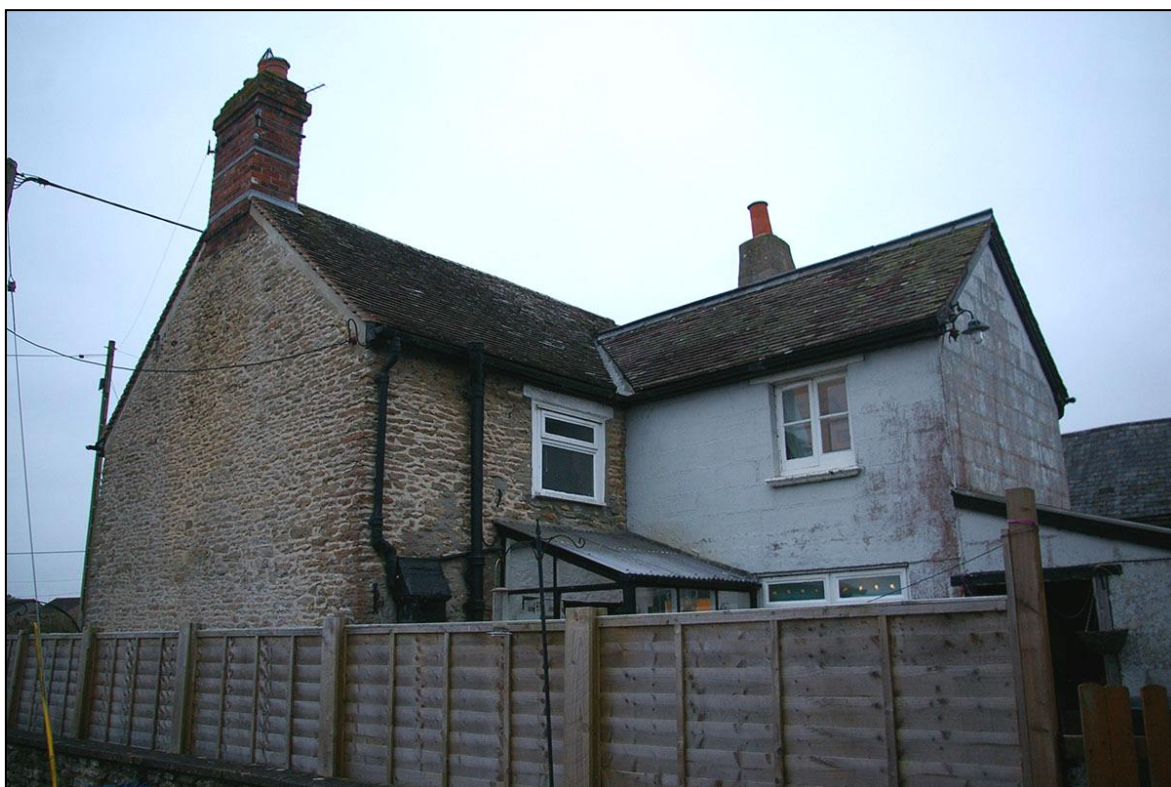
FIGURE 7: THE EAST GABLE AND REAR BLOCKWORK EXTENSION; VIEWED FROM THE NORTH-EAST.

The east gable of the house is blind, with an internal axial stack with rebuilt brick shaft at the apex. The wall is of well-sorted, tightly-packed and roughly-coursed stone rubble with no clear quoins; this style of stonework is replicated across the north elevation east of the rear extension. This gable wall has been repointed in lime and its eaves patched with cement. The north elevation east of the rear extension features a doorway at ground-floor level with a white PVC window above, both openings feature heavy timber lintels. The door is enclosed by a late 20<sup>th</sup> century glazed porch with mono-pitch roof.

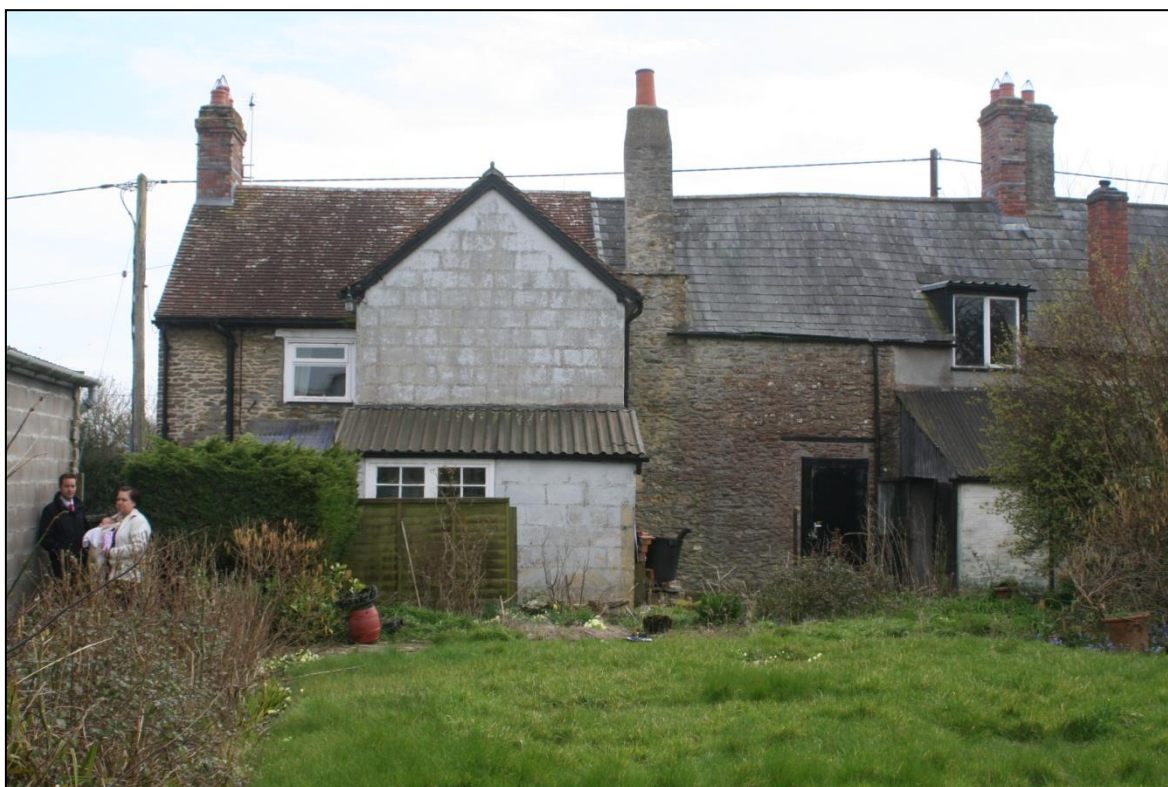
FIGURE 8: THE NORTH ELEVATION OF THE COTTAGE WEST OF THE REAR EXTENSION; VIEWED FROM THE NORTH.

West of the rear extension, the stonework of the north elevation of cottage is heavier and more vernacular stone rubble than that seen elsewhere: the stones are larger and set in a clay bond with clay and lime mortar, now badly repointed in cement. The eaves height is lower here than to the east. The elevation features a tall tapering 17<sup>th</sup> century lateral stack with dressed stone drip moulds/weathering; a hole to inspect/clean the flue has been forced into the base of the stack and the opening patched in brick. At its western end this wall is linked to the Old Bakehouse by a stretch of rendered concrete block with a modern two-light casement window clumsily inserted at first-floor level as a dormer. Otherwise, the elevation is blind save for a doorway with a thin timber lintel at ground level; this is fitted with a 19<sup>th</sup> century frame and partly boarded over, but sits within a larger and partly-blocked opening. The rendered section of this wall is abutted by a single-storey 19<sup>th</sup> century brick extension with a mono-pitch roof of corrugated iron sheets. This extension has a door in the east wall and a narrow fixed four-light window in the north wall.

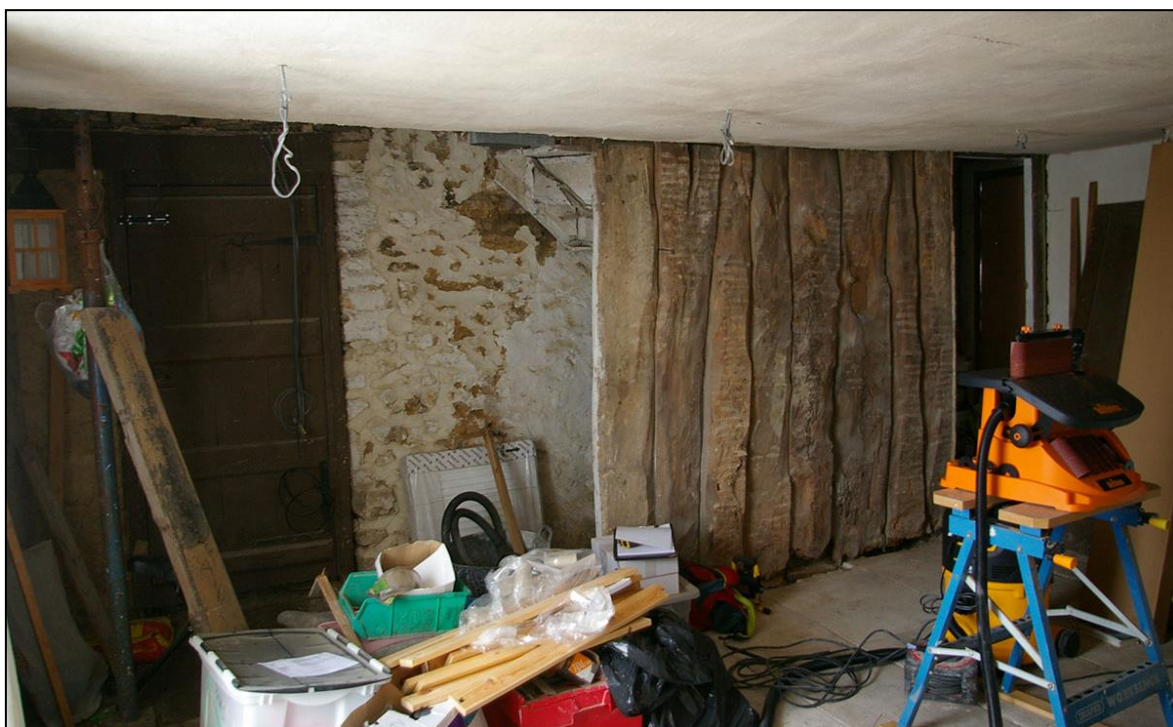
FIGURE 10: THE WEST SIDE OF R2, SHOWING THE RUSTIC SCREEN AND DOORWAY TO R3; VIEWED FROM THE SOUTH-EAST.

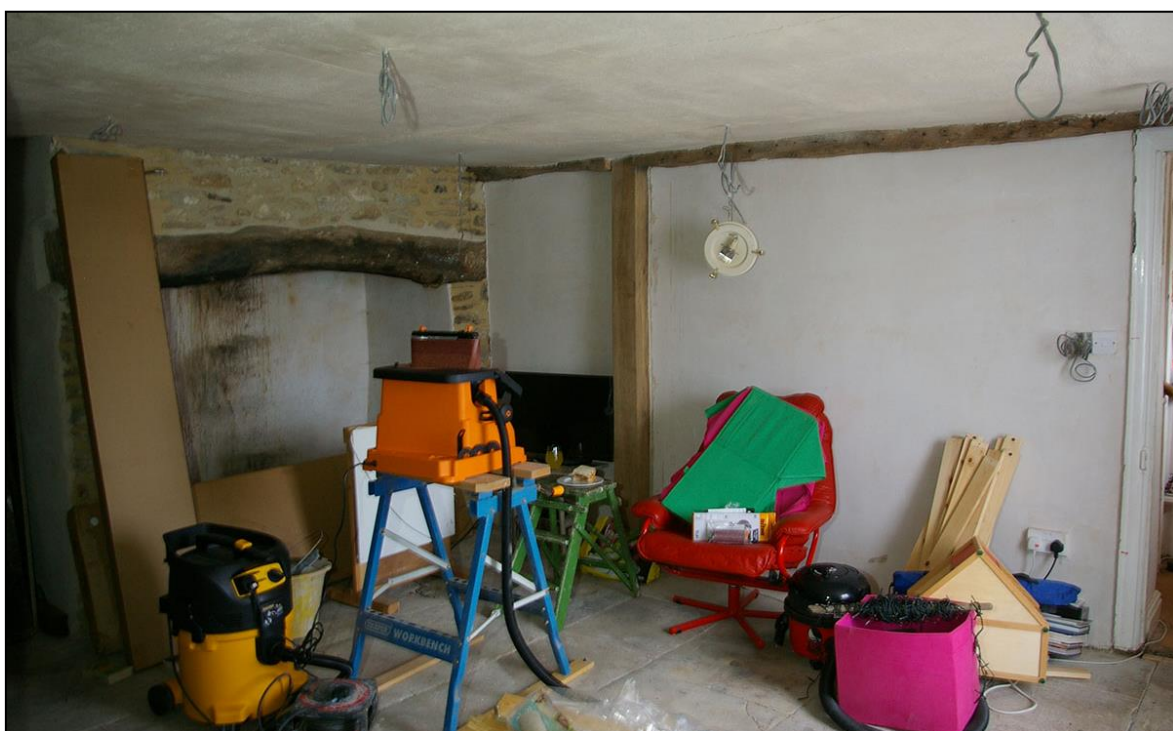
The room features a very fine flagstone floor of regular, squared slabs; this appears to have been patched and extended along its southern side, indicating it pre-dates a rebuilding of the south wall. The ceiling has been replaced, formerly consisting of a mix of hardboard and plasterboard with polystyrene tiles (Client, *pers. comm.*). The west wall of R2 is c.1m thick and slightly battered; the east wall is thinner and only rises to first-floor level; a rough timber beam with sockets runs along its inner face which would indicate this stone wall replaced an earlier timber partition. The walls are newly plastered and the former narrow beaded skirting boards removed; there is no sign of the blocked doorway in the south wall. Doors from this room provide access to R1 to the east, R3 to the west, and to the stairs (R14) in the north-west corner. The doorway to R3 is forced, set with a 19<sup>th</sup> century door of wide planks with ledges on 20<sup>th</sup> century hinges. The doorway to R14 is set with a 19<sup>th</sup> century four-panel door, but was formerly concealed behind asbestos panels in R2 and hardboard in R14; most of the walls in R3 and R14 were lined with hardboard (Client, *pers. comm.*).

FIGURE 11: THE EAST SIDE OF R2, SHOWING THE 17<sup>TH</sup> CENTURY HEARTH AND FINE FLOOR; VIEWED FROM THE SOUTH-WEST.

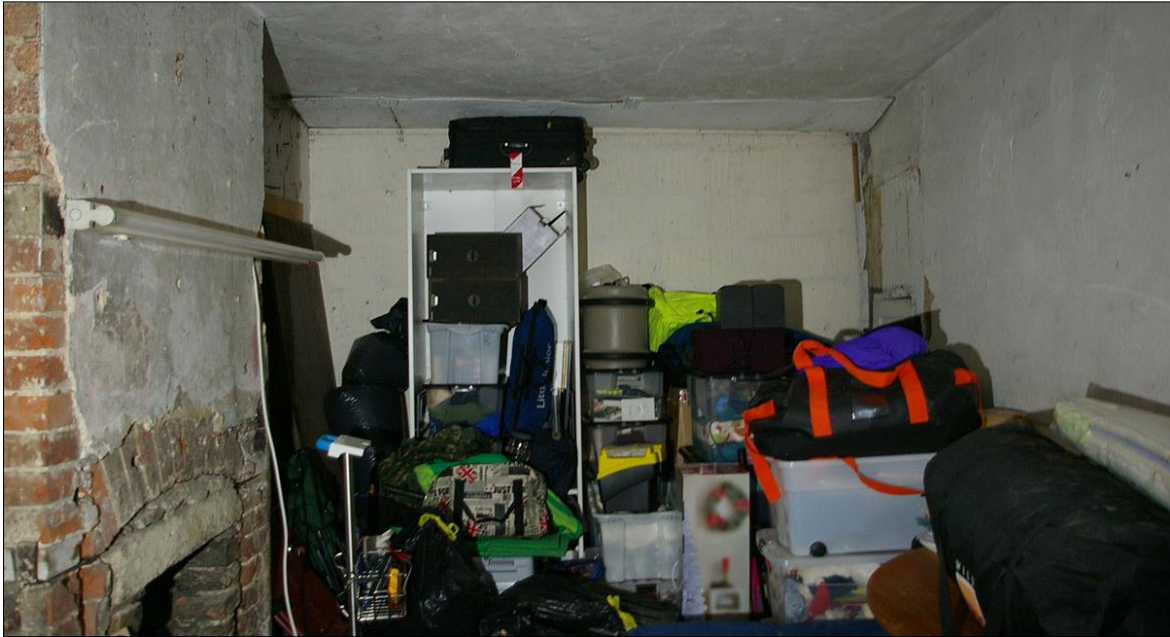
R3, a former 20<sup>th</sup> century garage, has lime plastered and painted walls. The wall to the south features a 20<sup>th</sup> century plank boarded garage door and the north wall is of concrete block (presumably a rebuild). A brick stack of c.1800 has been built against the west wall, the gable end of the Old Bakehouse. The fireplace has a segmental arch of bricks supported by an iron plate, later partly infilled with brick with a stone lintel. There is a later boarded cupboard in the north-east corner set within a blocked doorway that opened onto the stairs (R14). The floor is a shiny dark grey cement-based mix patched with hard grey modern cement.

FIGURE 12: THE GARAGE, ROOM 3, SHOWING THE BRICK STACK ADDED AGAINST THE ADJACENT HOUSES' GABLE END WALL; FROM THE SOUTH.

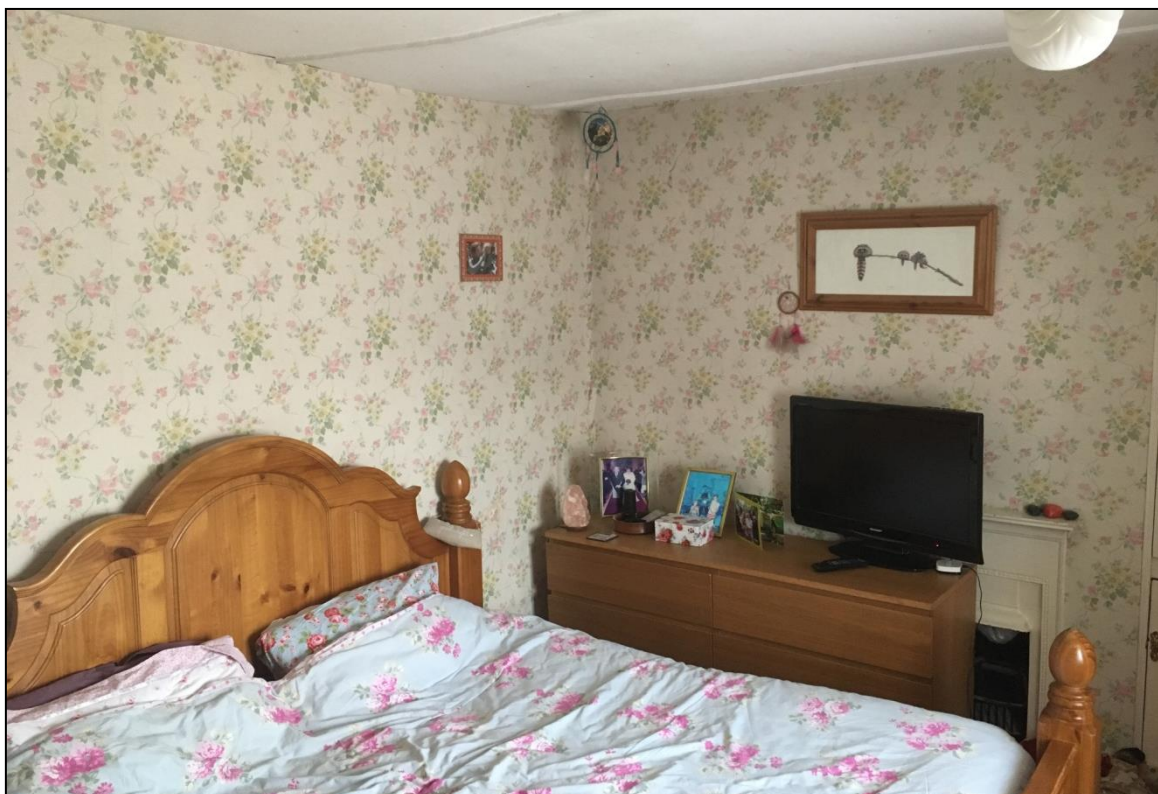
FIGURE 14: R11; VIEWED FROM THE SOUTH-WEST.

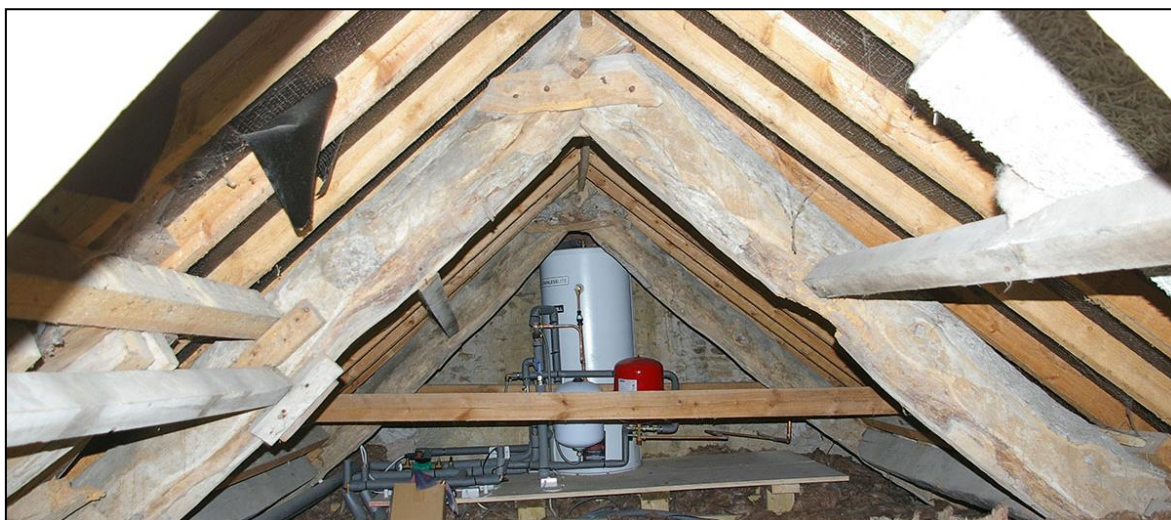
There are two loft rooms (R16 and R17) set high into the roof space above the level of the collars. Access is via R15, where the apex of the gable wall was reduced in the 20<sup>th</sup> century to provide access and a modern truss installed to carry the purlins. R16 has been boarded out and plastered. R17 contains the boiler and modern plumbing but is otherwise unaltered. Three historic trusses are visible in R17: heavy, early 18<sup>th</sup> century trusses, possibly reusing some 17<sup>th</sup> century timbers and some massive 17<sup>th</sup> century purlins. The ridges of the trusses are pegged but have been braced by spiked yokes, the low collars half-lapped and spiked, with through-and-through purlins with tapering ends threaded through the blades, some very large and square in profile, others crude and embarked. There has been much 19<sup>th</sup> century patching and alteration, and the battens and rafters are all modern, the roof lined and insulated. It is of interest that the roof is the mix of vernacular techniques, with spiked joints and threaded purlins for example; this would point to a fairly early 18<sup>th</sup> century date.

FIGURE 16: THE EASTERN ROOF TRUSSES IN R17; VIEWED FROM THE WEST.

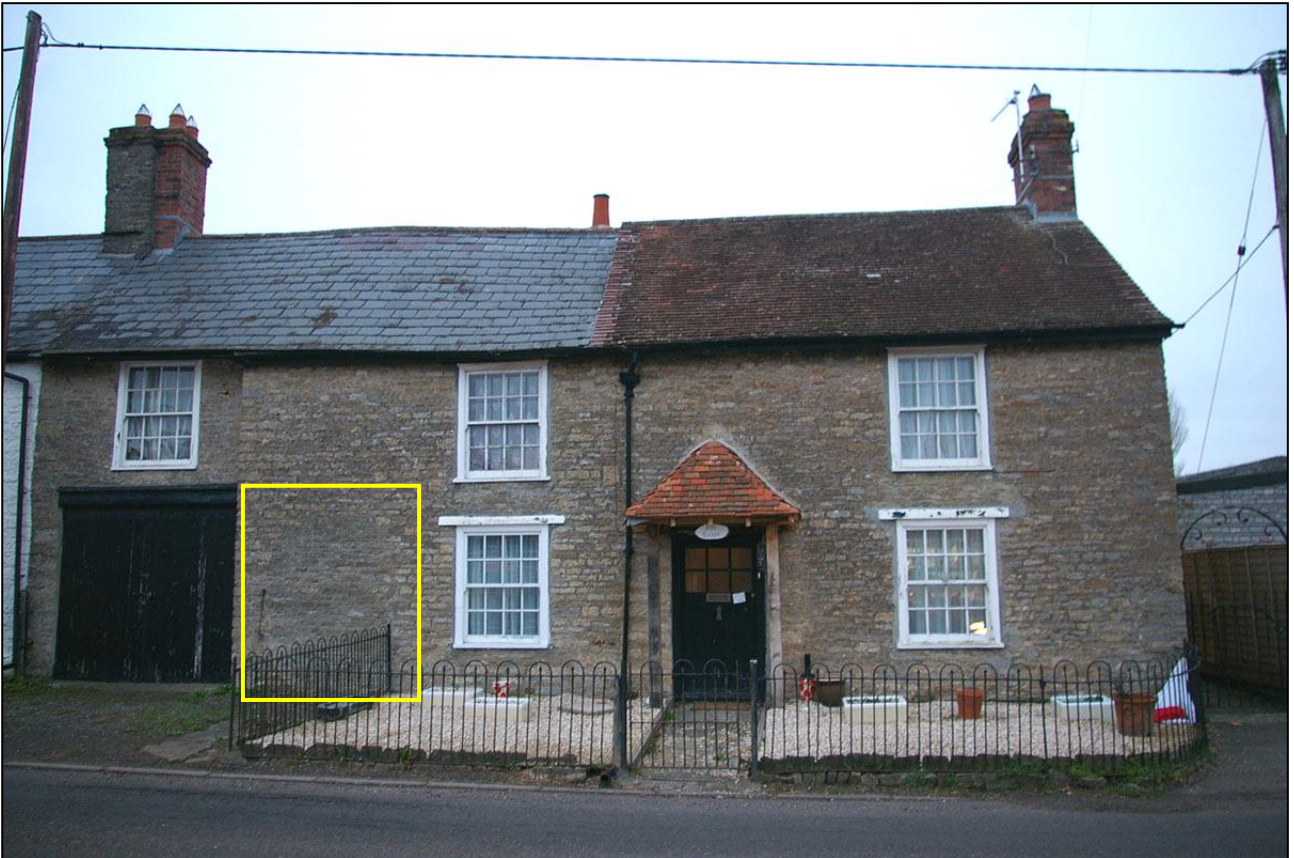
THE SOUTH ELEVATION OF ASH HOUSE, SHOWING A BLOCKED DOOR OPENING TO THE WEST END (INDICATED); VIEWED FROM THE SOUTH-SOUTH-EAST.

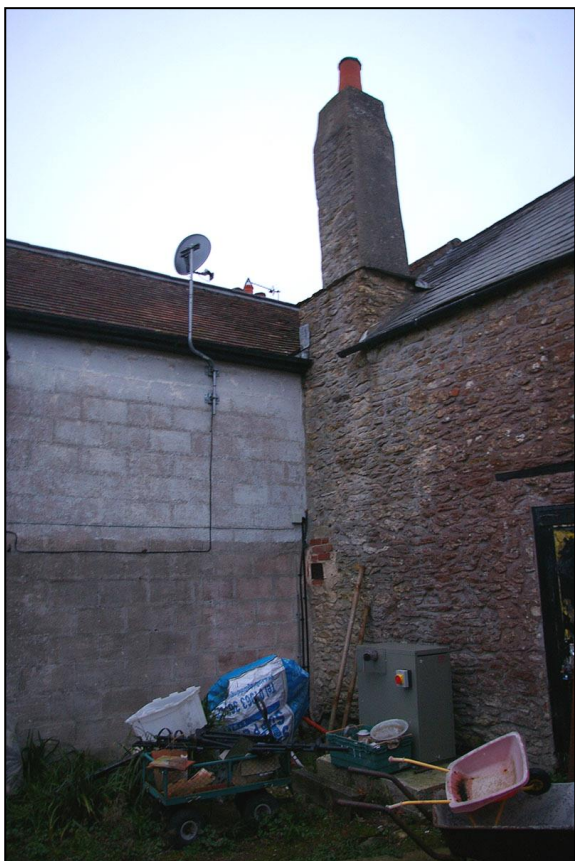
THE LATERAL STACK AND ADJACENT REDUCED OPENING ON THE NORTH WALL OF ASH HOUSE; VIEWED FROM THE NORTH-WEST.

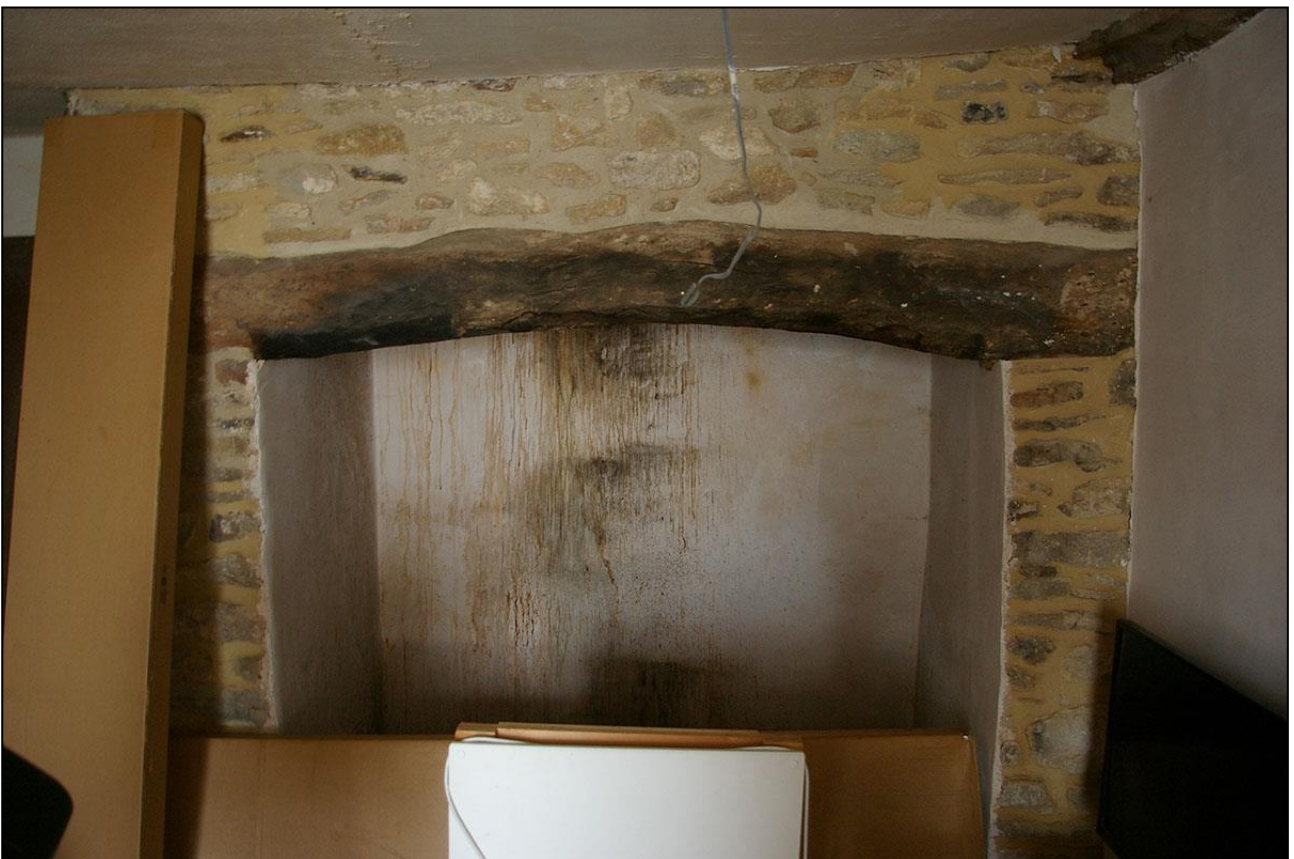
R2, THE FIREPLACE, NEWLY REPOINTED AND PLASTERED, THE LARGE BRESUMMER BEAM HACKED ON THE UNDERSIDE; VIEWED FROM THE SOUTH.

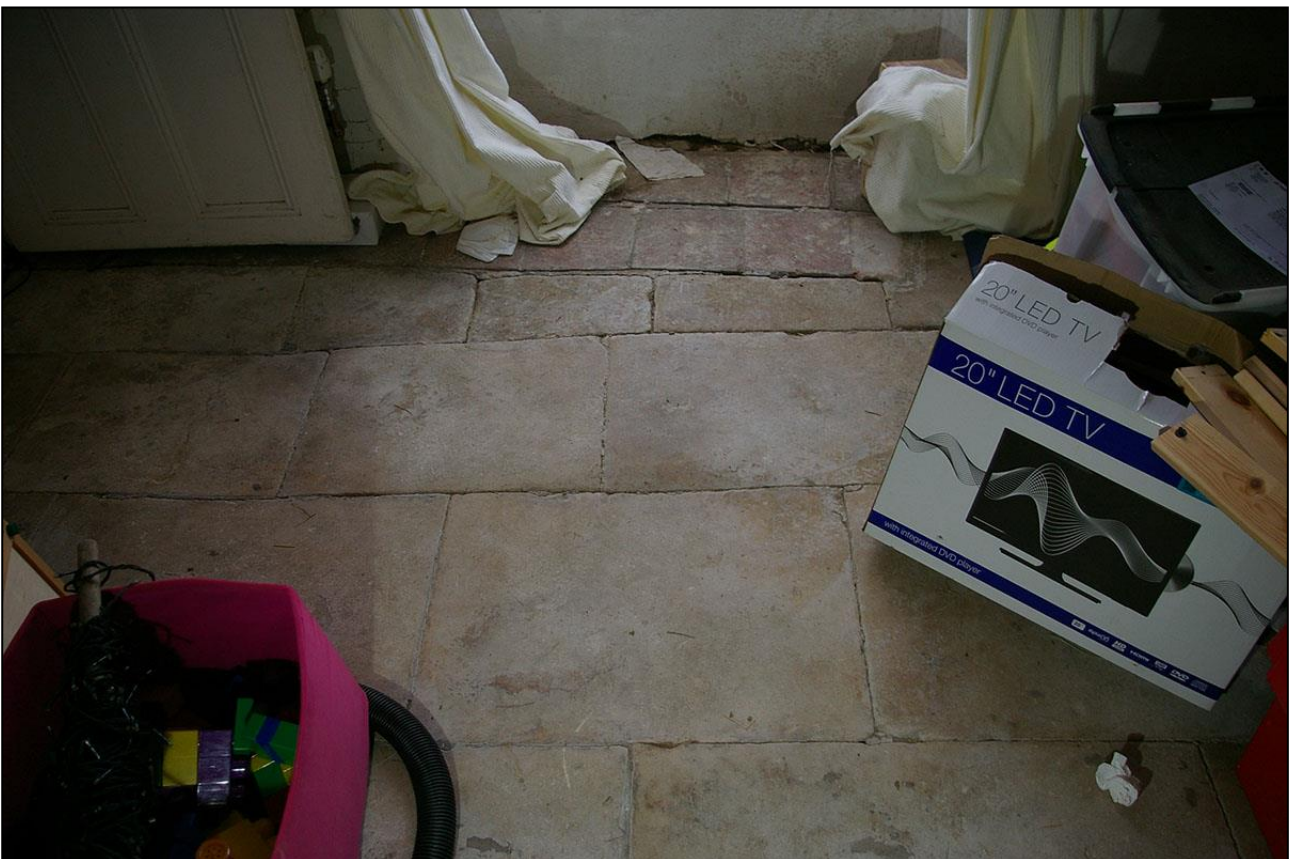
R2, THE FINE STONE FLOOR, WITH STONE AND BRICK PAVERS RESET AGAINST THE FRONT SOUTH WALL SHOWING THE ORIGINAL WIDTH OF THE ROOM, EVIDENCE THAT THE FRONT WALL HAS BEEN REBUILT AND PUSHED OUT; VIEWED FROM THE NORTH.

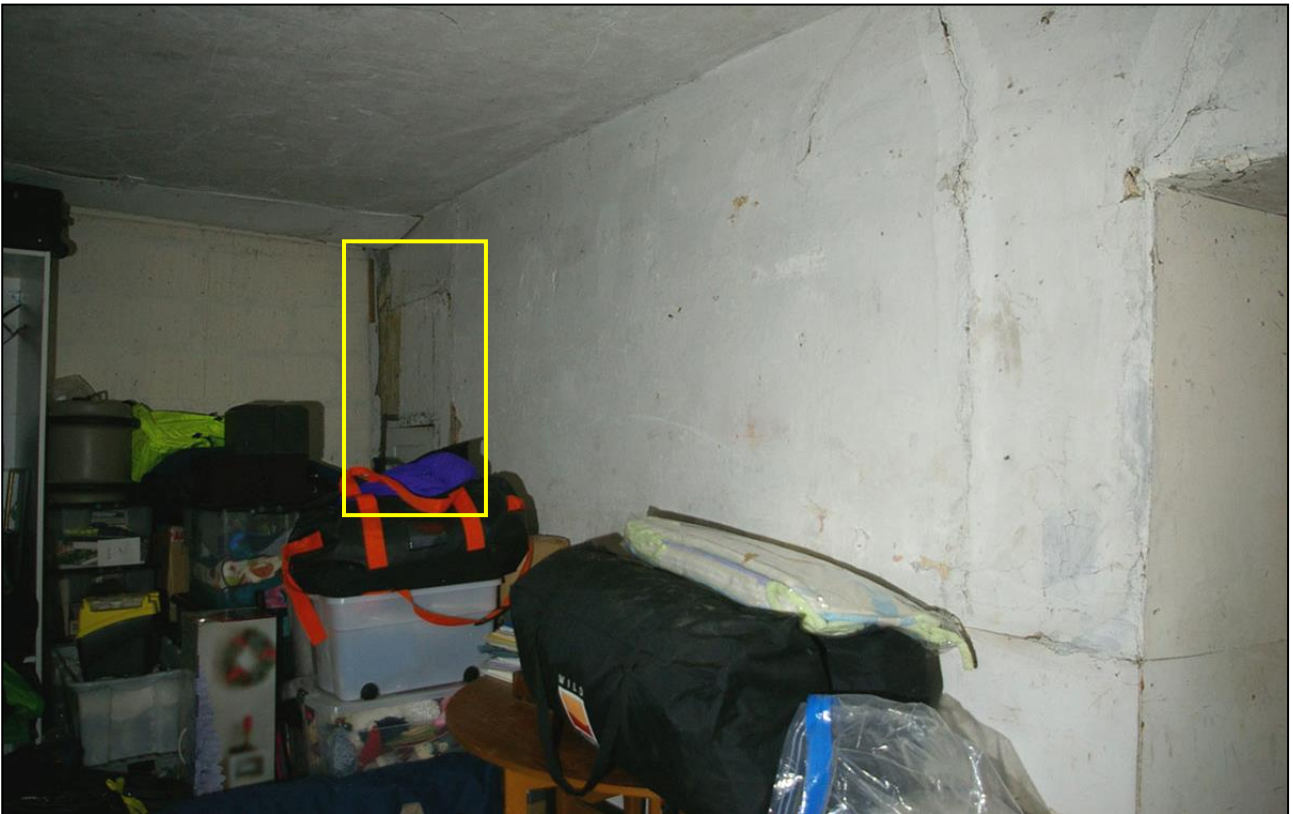
R3, THE HEAVY BATTERED FORMER GABLE END WALL OF THE 17<sup>TH</sup> CENTURY BUILDING, SHOWING ORIGINAL DOOR TO THE NORTH END (INDICATED), NOW FITTED AS A CUPBOARD; VIEWED FROM THE SOUTH-SOUTH-WEST.

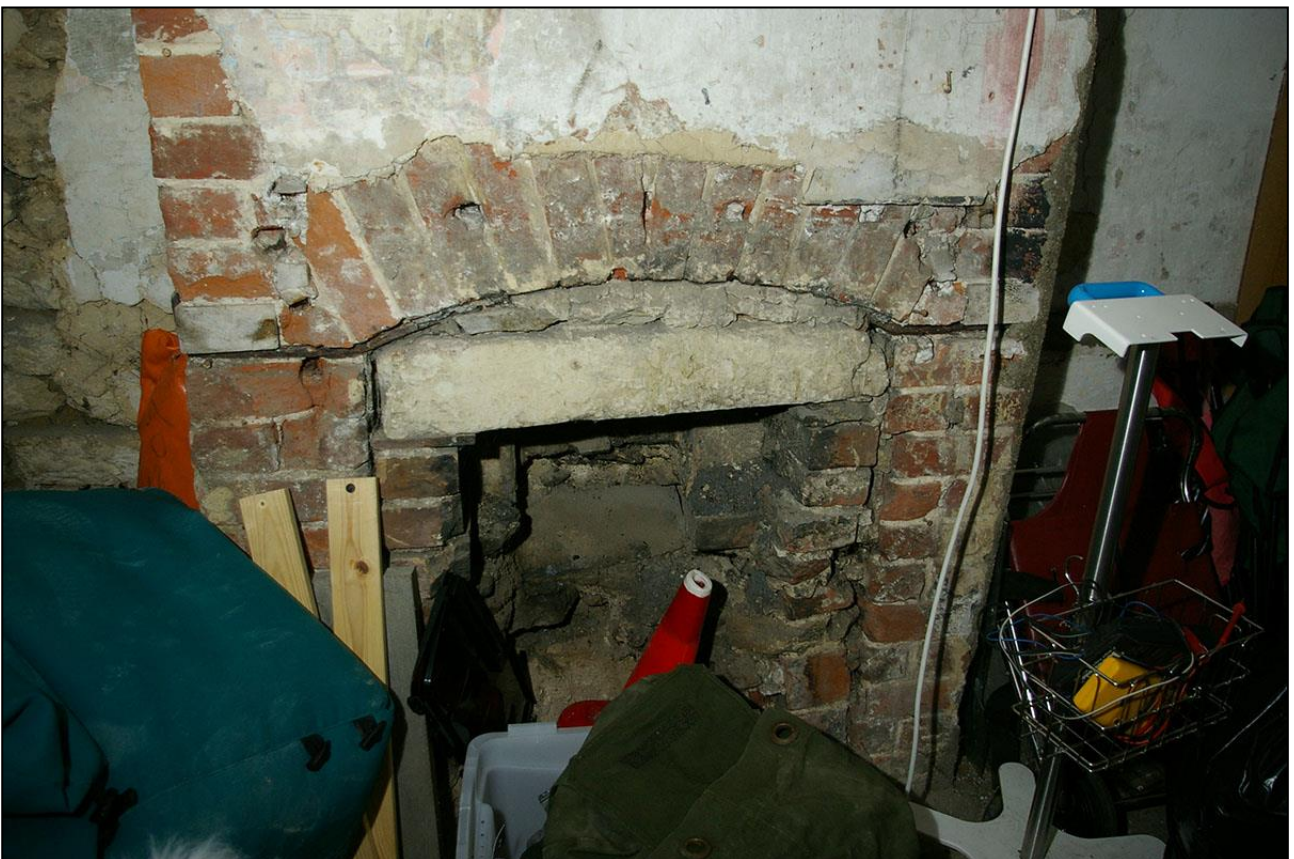
R3, DETAIL OF THE BRICK STACK SHOWING THE LARGE BOX HEARTH WITH SEGMENTAL BRICK ARCH AND IRON BAR SUPPORT, WITH LATER INFILL; VIEWED FROM THE SOUTH-EAST.

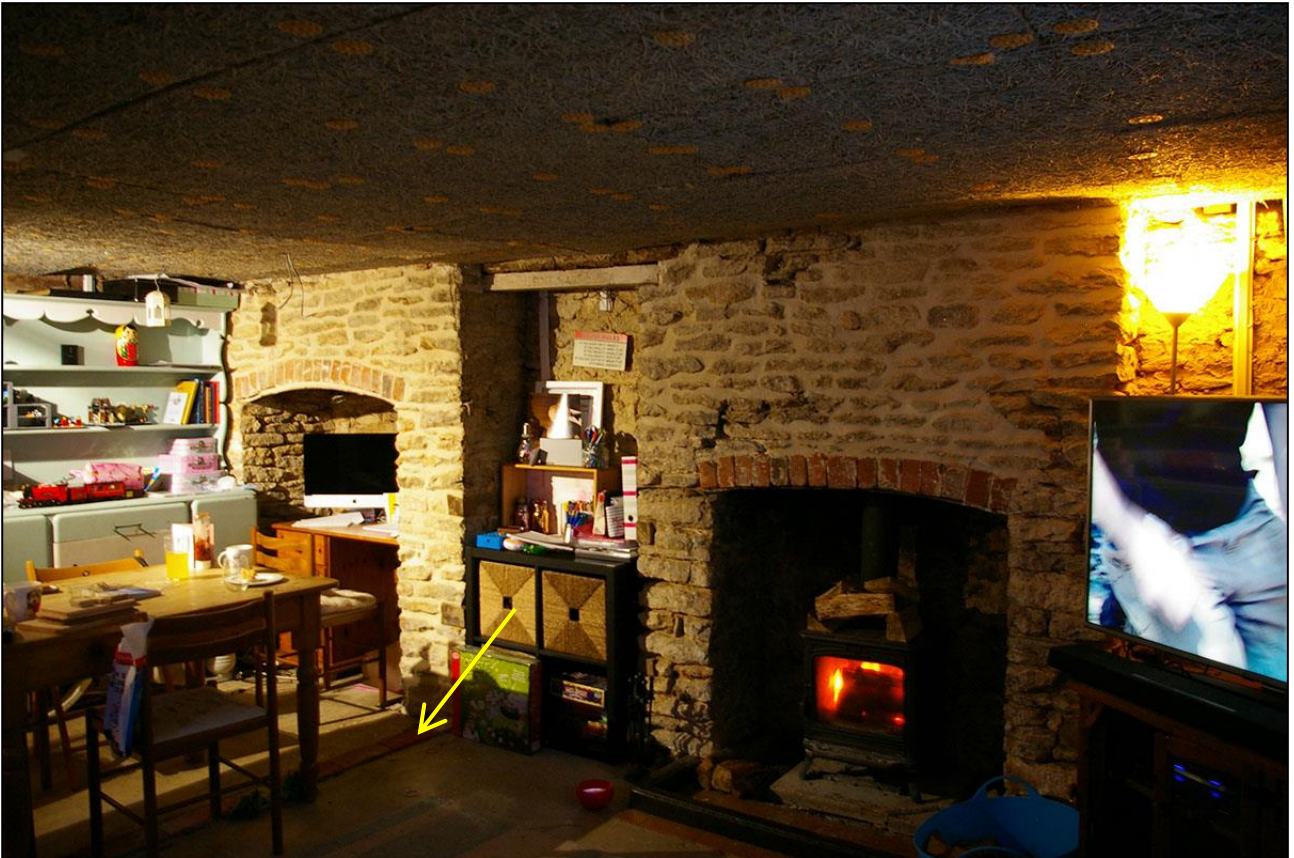
R4, FORMED BY THE REMOVAL OF A BRICK PARTITION (INDICATED), WITH TWO STONE STACKS; VIEWED FROM THE SOUTH-WEST.

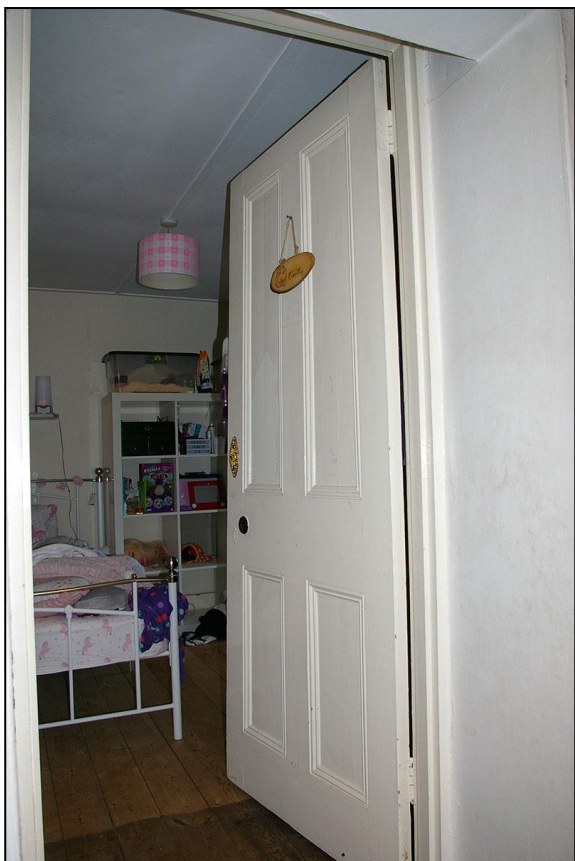
R13, THE FORCED OPENING IN THE BACK WALL PROVIDING ACCESS TO THE 20<sup>TH</sup> CENTURY EXTENSION; VIEWED FROM THE SOUTH-SOUTH-WEST.

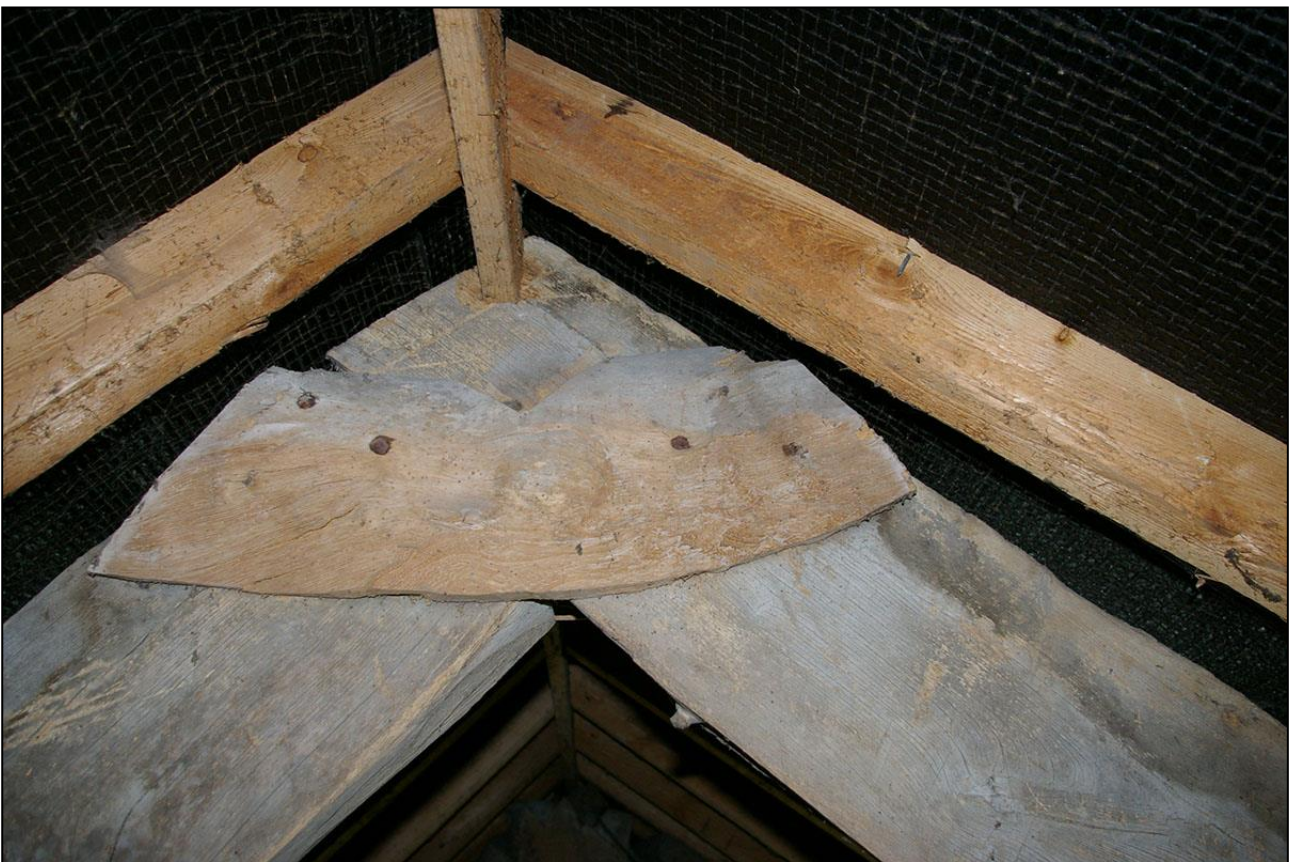
R17, DETAIL OF ONE OF THE RIDGES, WITH SPIKED YOKES BRACING THE OVERLAPPING RIDGE JOINT, ALSO CUT WITH A DIAMOND SET FOR A RIDGE POLE, ALTHOUGH REPLACED, AS THE ROOF HAS BEEN ALTERED; VIEWED FROM THE WEST.

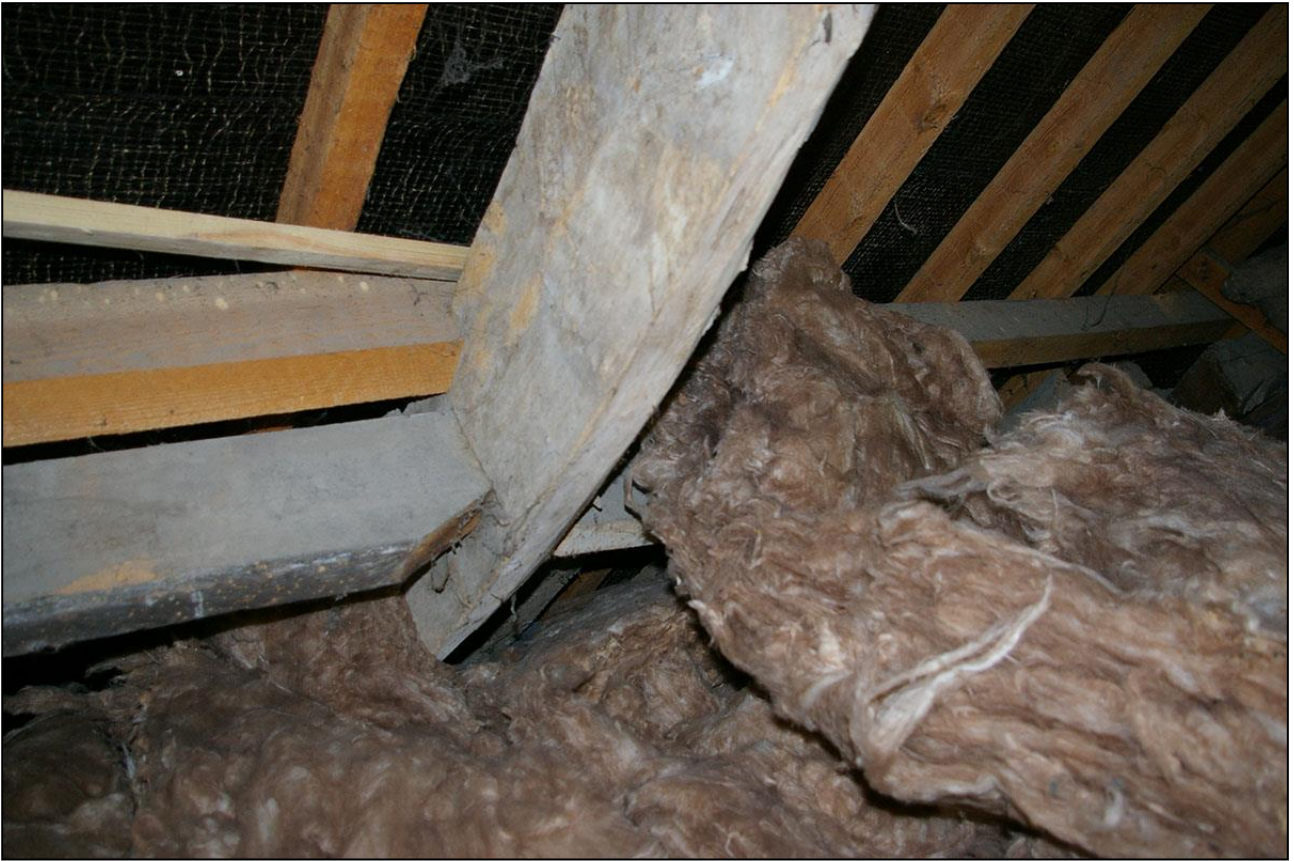
R17, THE HEAVY SQUARE PROFILE PURLINS, AN EARLIER SET OF THROUGH-AND-THROUGH TYPES; VIEWED FROM THE SOUTH-WEST.
