THE SYNAGOGUE NEW STREET PENZANCE CORNWALL

Updated - Historic Building Assessment

South West Archaeology Ltd. report no. 190402

By N. Boyd & E. Wapshott
Report Version: **FINAL**

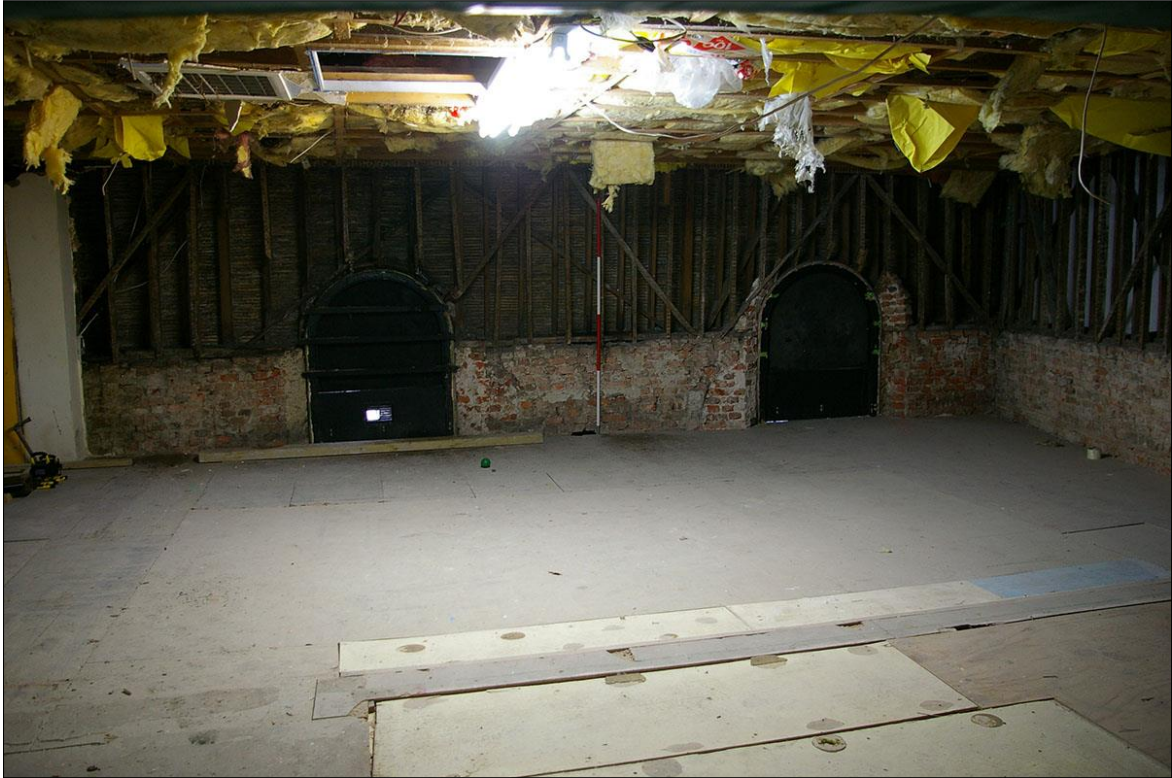
FIGURE 4: THE EAST WALL OF THE SYNAGOGUE, SHOWING THE PHASES OF BRICK AND STUDWORK; FROM THE WEST.

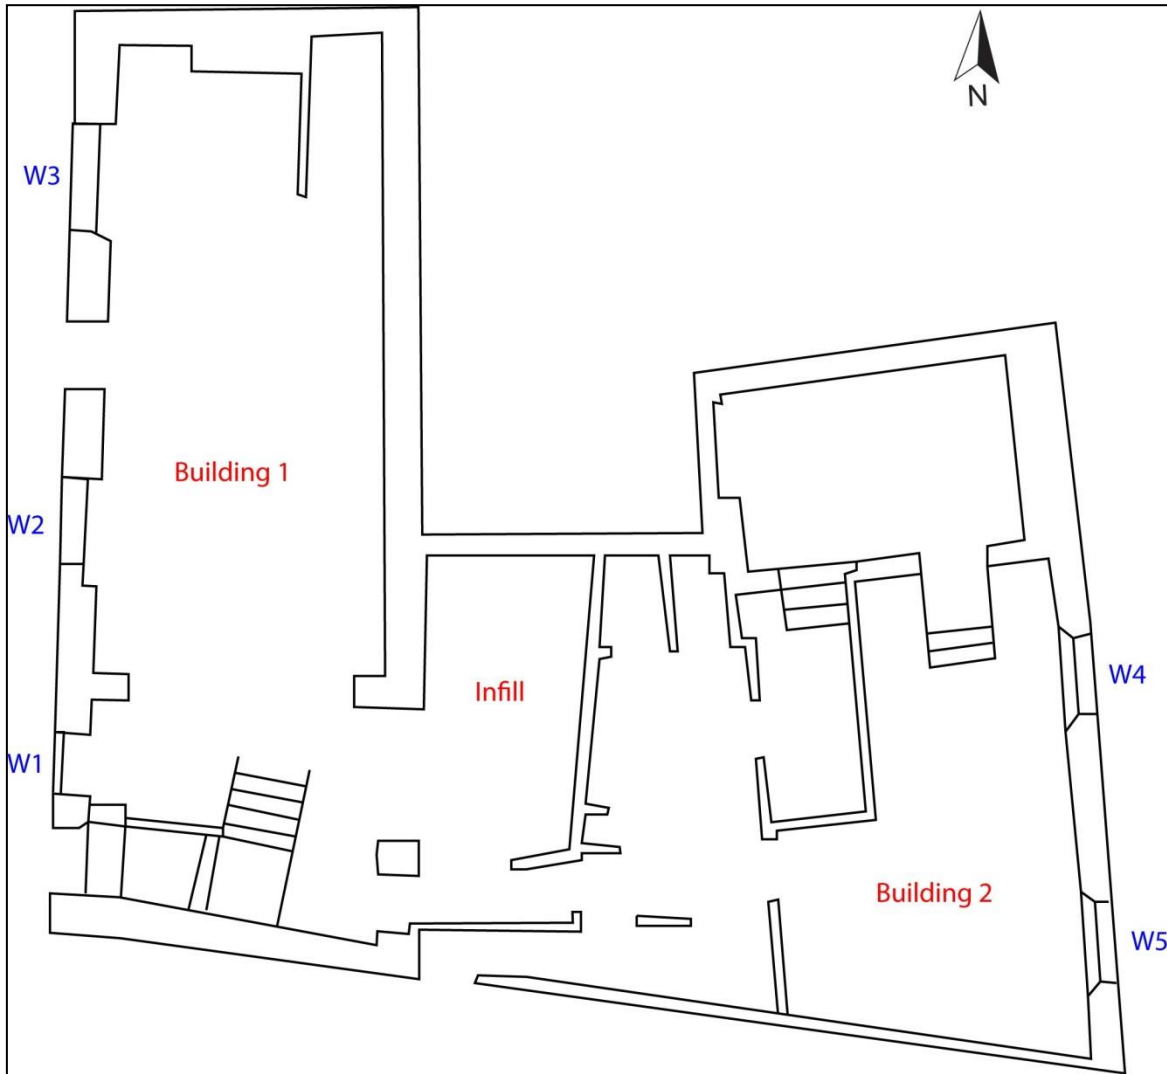
8	W10	N/A – modern timber window with upper hopper and large single pane below, later 20 th or 21 st century.
9	W11	N/A – modern timber window with upper hopper and large single pane below, later 20 th or 21 st century. Frosted panes.
	W12	N/A – modern timber window with upper hopper and large single pane below, later 20 th or 21 st century. Frosted panes.

FIGURE 5: PLAN OF WINDOWS ON THE GROUND FLOOR.

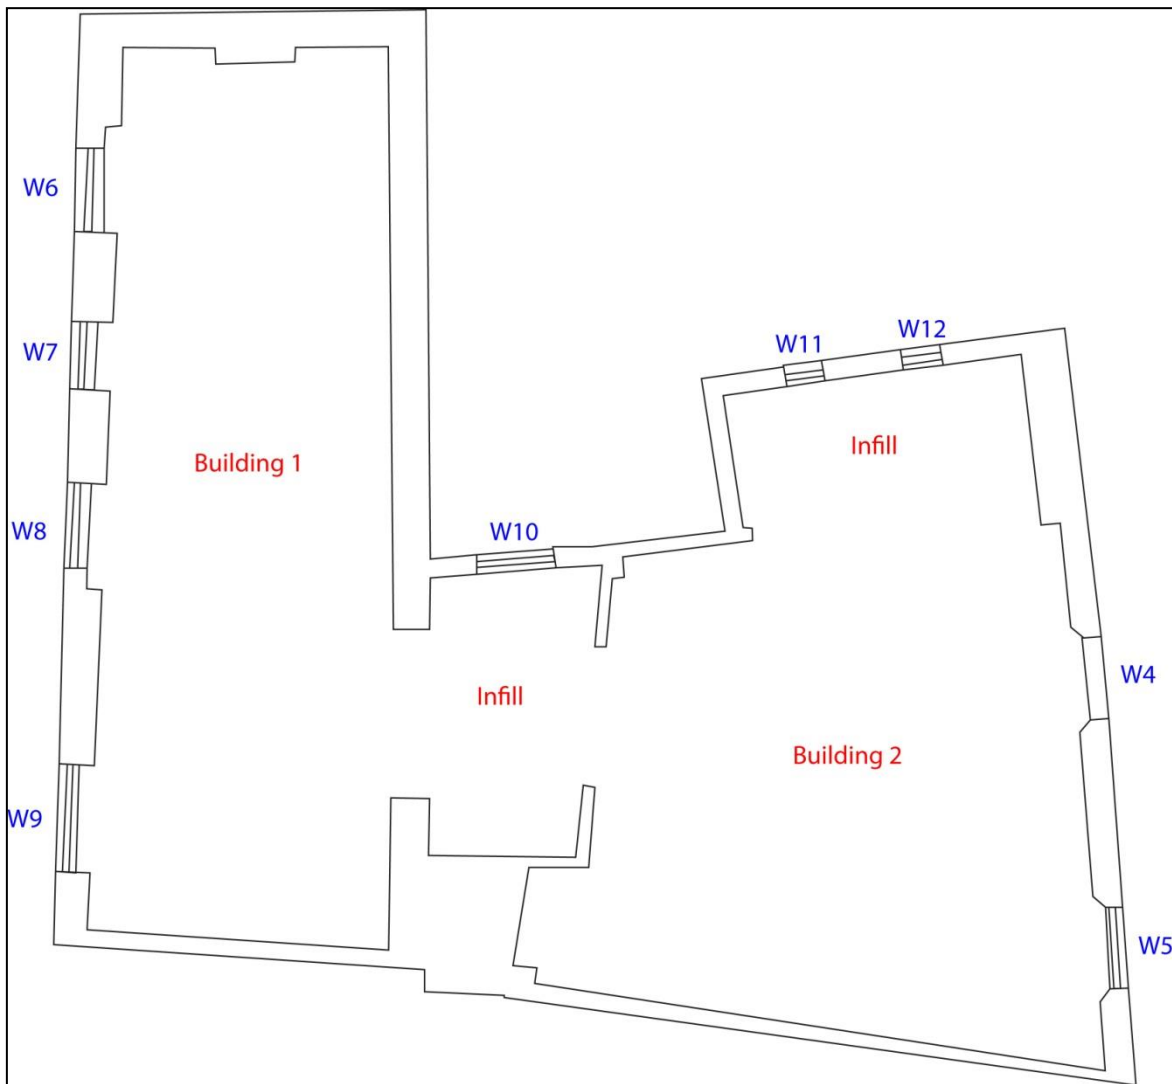
FIGURE 6: PLAN OF WINDOWS ON THE FIRST FLOOR.

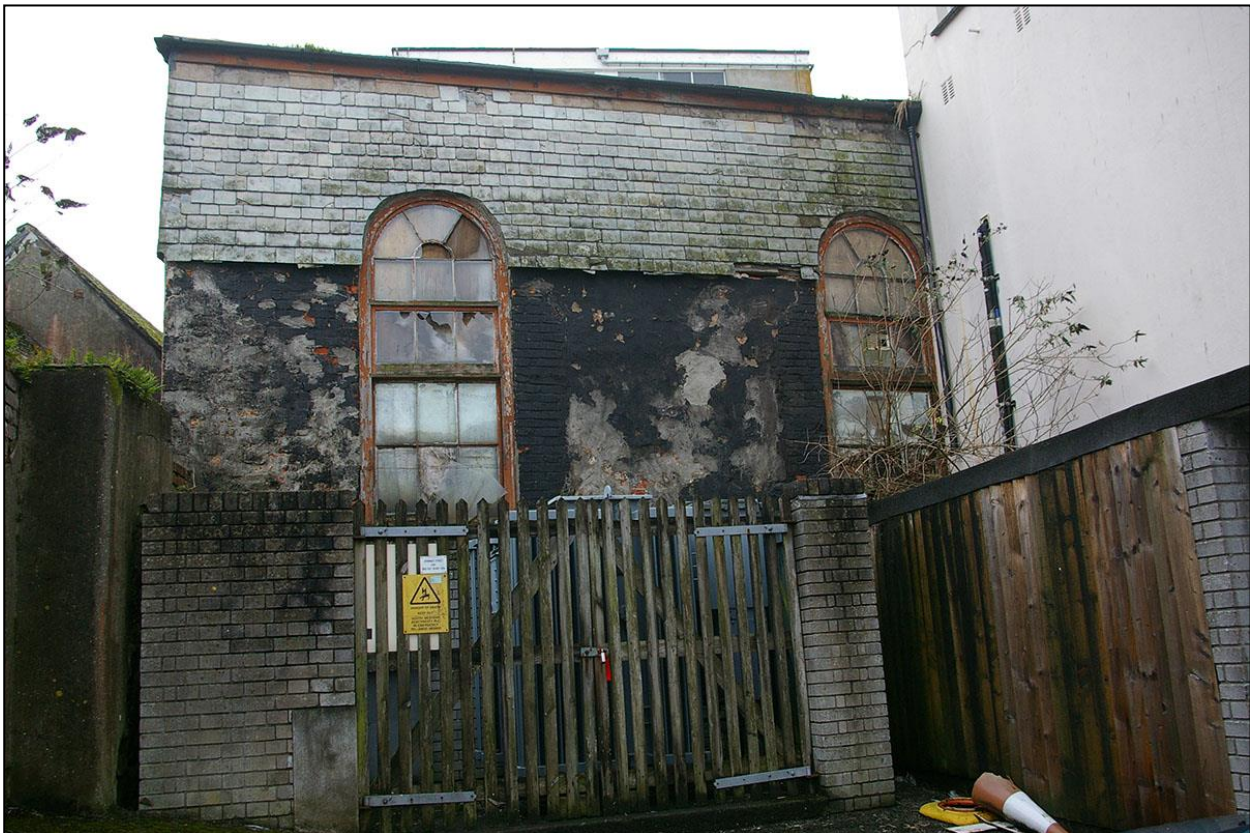
block and cut earlier lower round arched windows, which were set slightly closer together. The windows are probably the originals, adapted in the later 19 th century. There is potentially some original glass but much is broken or reset. Externally they are painted brown with a grey paint showing through, very weather worn.
6	W2	The southern of two windows in the west wall, the street frontage, set within a larger partially blocked opening, with beaded plank panelling below the window, screening the external ashlar infill. The window itself is a wide single light sash, 1x3 panes, the upper sash being a 20 th century replacement, the lower 19 th century, with fine moulded shallow ogee moulded glazing bars, in a chunky beaded frame. The side infill to the window opening is cement rendered and looks fairly recent, so whilst this window may be 19 th century, it may have been reset here from elsewhere in the building, the original window better matching window 3, as there is awkward secondary ashlar infill on the exterior and the voussoirs and keystone clearly overshoot the current opening.

THE EAST ELEVATION OF THE FORMER SYNAGOGUE WITH THE LARGE, ALTERED, ROUND-ARCHED WINDOWS; FROM THE EAST.

The former synagogue windows were heavily altered in the 19th century, poorly repaired in the 20th century and are in very poor condition; however, these windows should be retained and conserved, as they are a vital indicator of this being an 18th/19th century nonconformist religious building. A specific design element to consider is how the floor levels within the synagogue meet

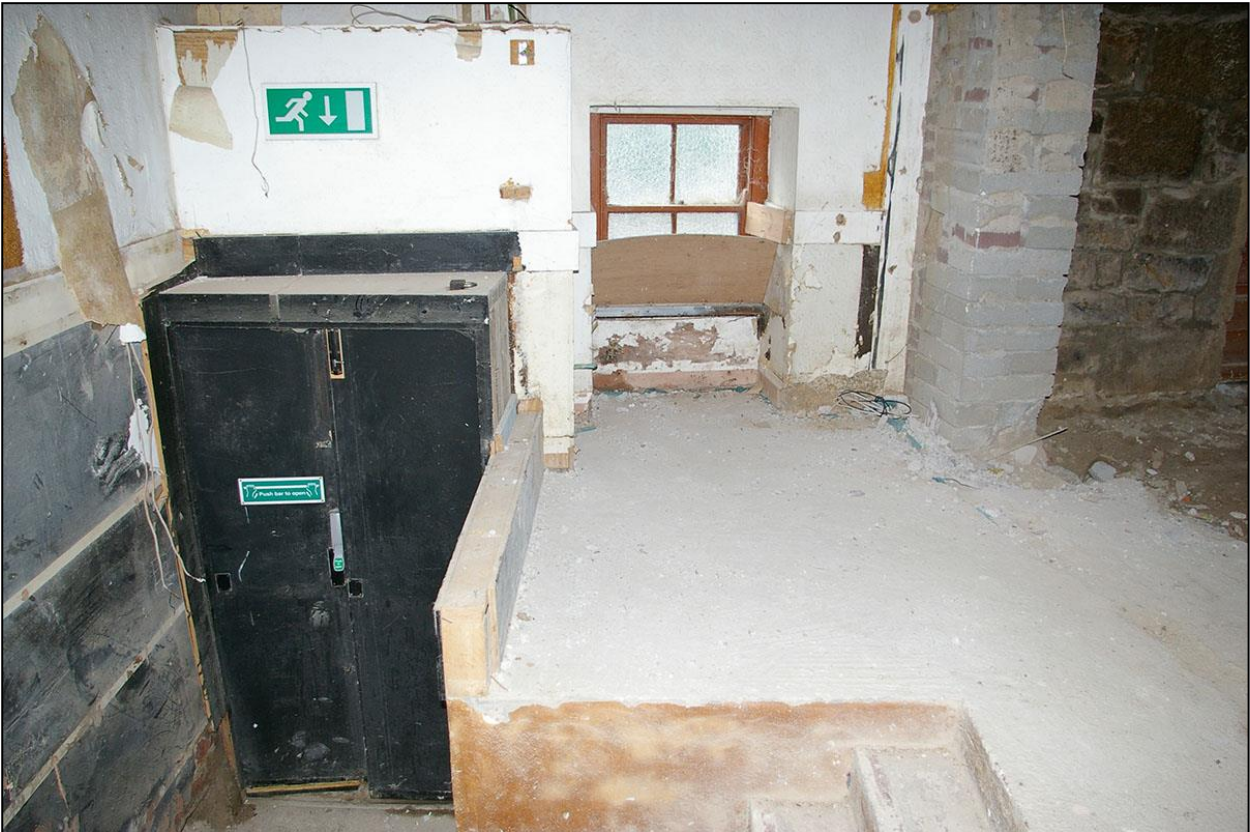
ROOM 1 IN NO.1 NEW STREET, THE BLOCKED CARRIAGE ARCH, WITH INSET DOORWAY ACCESS TO THE DEVELOPMENT SITE AND WINDOW, SHOWING SIGNIFICANT INFILLING BY CONCRETE, TOTALLY ALTERING THE FLOOR LEVELS BY AS MUCH AS 1.5M; FROM THE EAST.

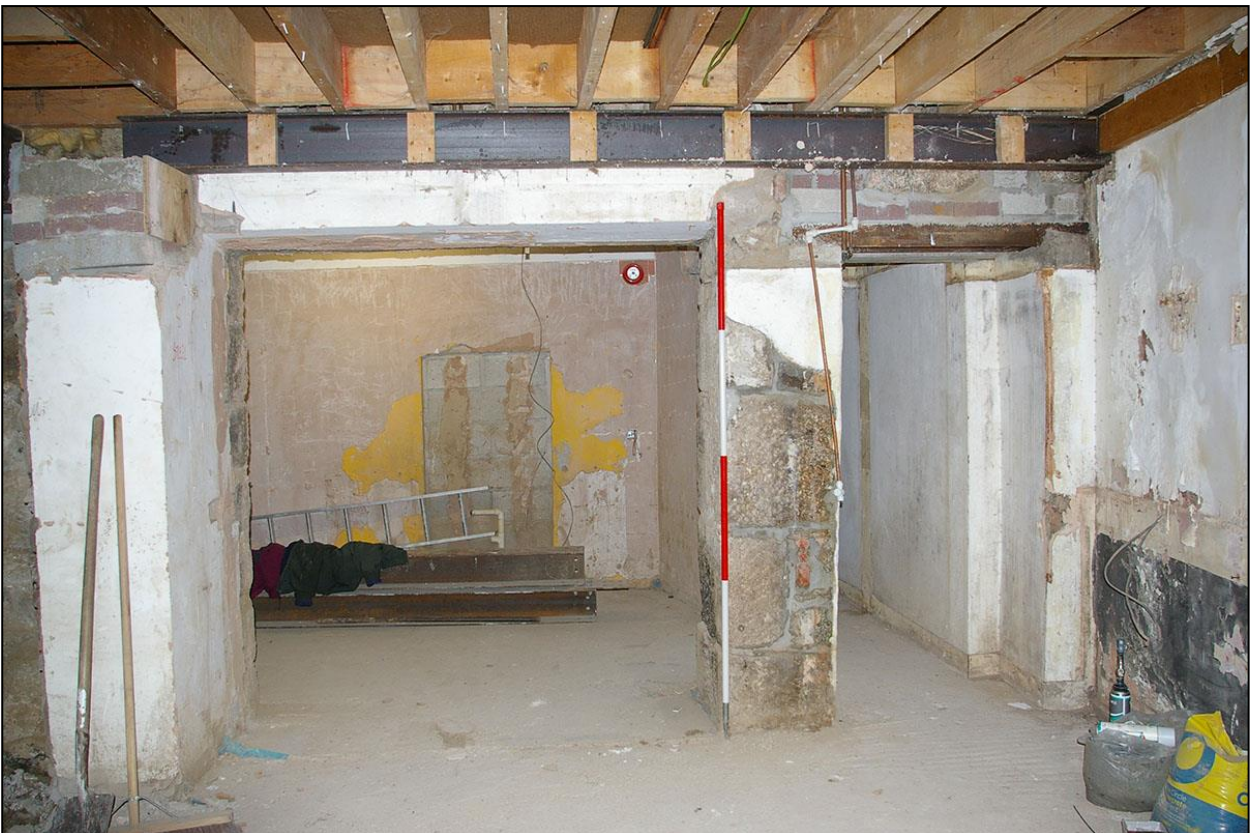
THE ALTERED OPENINGS IN THE REAR WALL OF ROOM 1, NO.1 NEW STREET, THE FORMER ACCESS INTO THE REAR YARD; FROM THE WEST (2M SCALE).

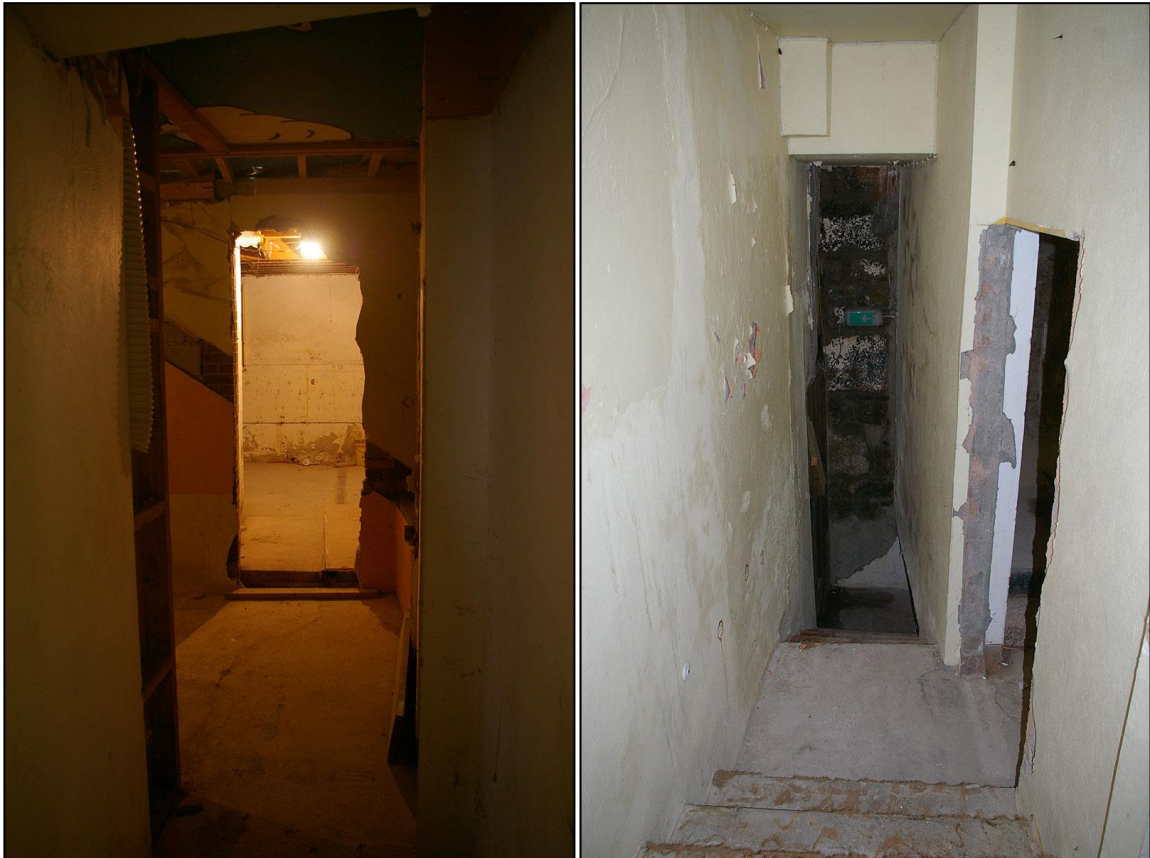
LEFT: VIEW THROUGH VARIOUS FORCED OPENINGS FROM ROOM 2, THROUGH ROOM 3 TO ROOM 4; FROM THE WEST.
RIGHT: THE STEEP CONCRETE STEPS LEADING DOWN TO THE DOORWAY TO THE ALLEYWAY, EVIDENCE OF SIGNIFICANT CHANGES IN LEVELS;
FROM THE EAST.

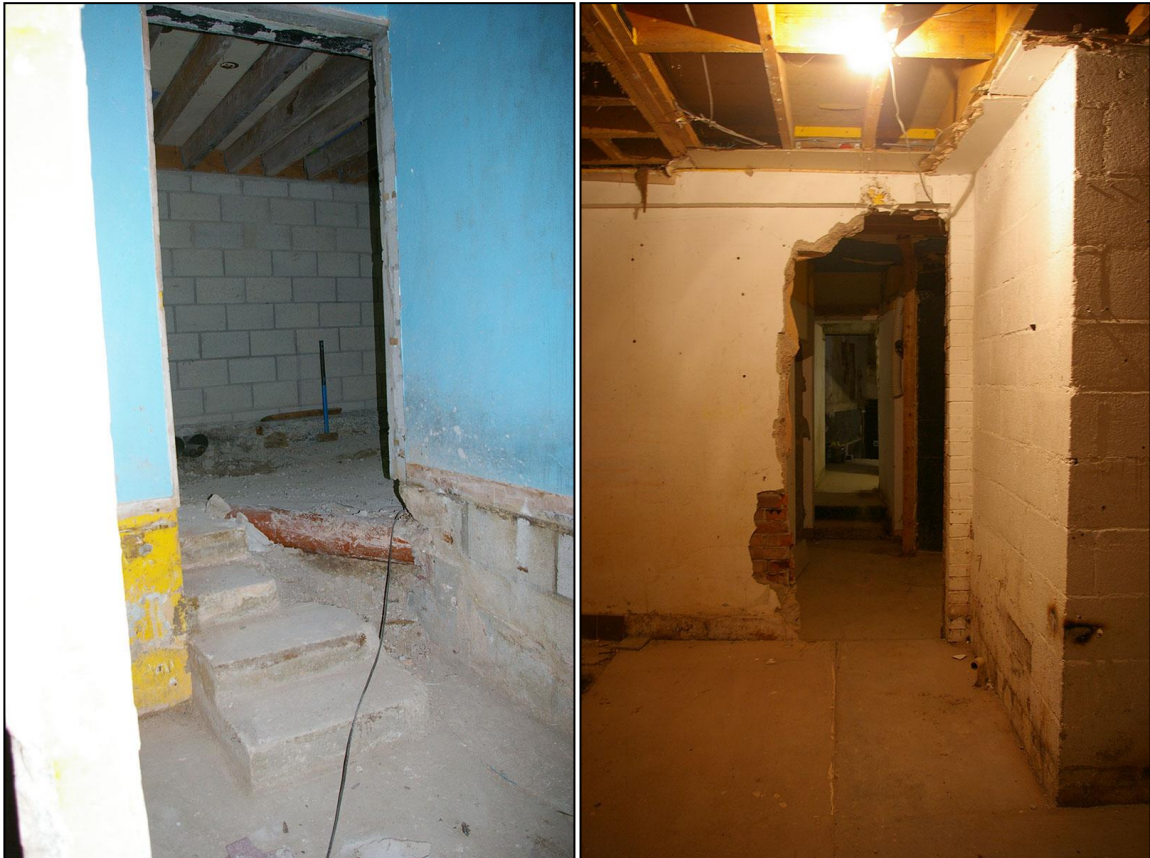
LEFT: ROOM 3B, A MODERN CONCRETE DISABLED TOILET WITHIN THE WEST SIDE OF THE FORMER SYNAGOGUE; FROM THE SOUTH-WEST.
RIGHT: FORCED OPENINGS, LOOKING FROM ROOM 4, THROUGH ROOM 3 TO ROOM 2; FROM THE EAST.

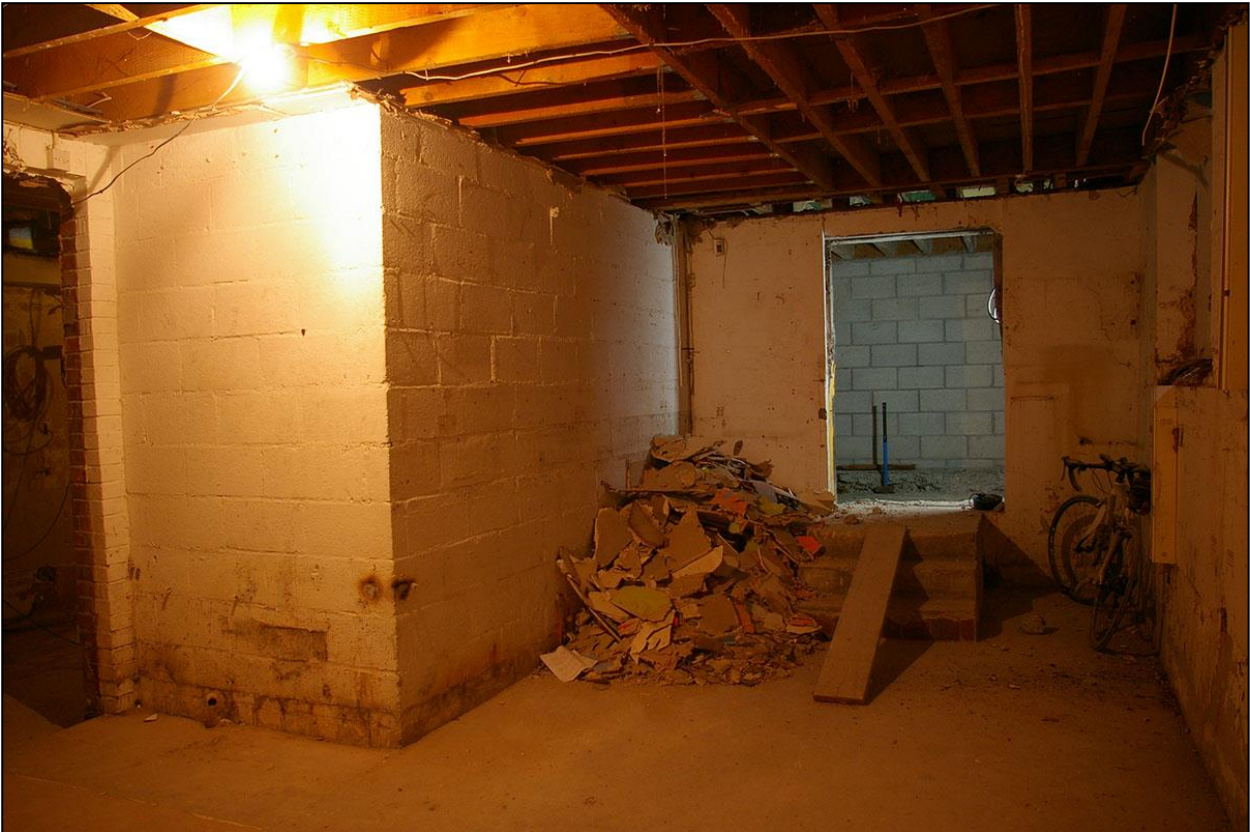
THE FORMER SYNAGOGUE; MODERN STRUCTURES BUILT WITHIN IT, WALLS REMOVED, OPENINGS FORCED AND ALL FITTINGS STRIPPED OUT; FROM THE SOUTH-EAST.

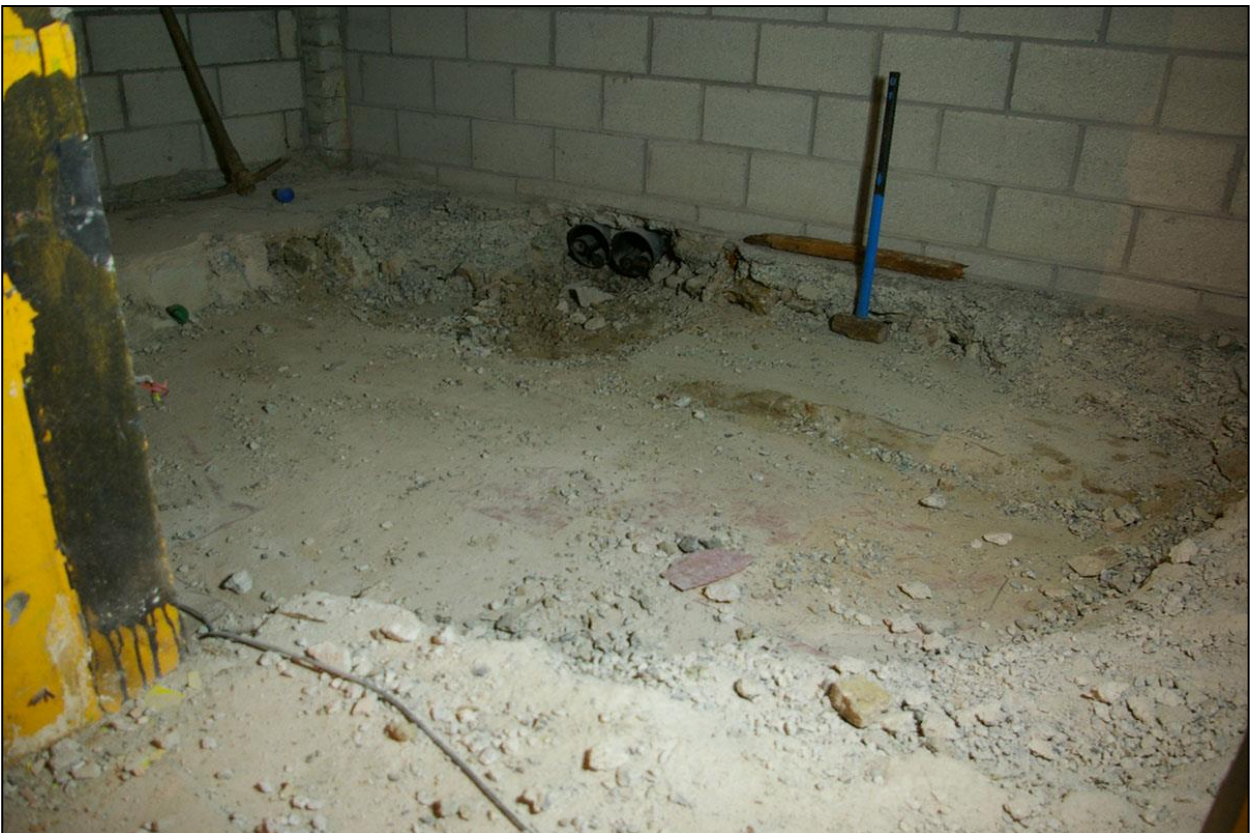
THE CONCRETE BLOCK EXTENSION ON THE NORTH OF ROOM 5, WITH RAISED CONCRETE FLOOR SHOWING DEEP MODERN LAYERS, WITH A MID 20TH CENTURY LINO SURFACE BURIED BEHIND MORE RECENT CONCRETE; FROM THE SOUTH-EAST.

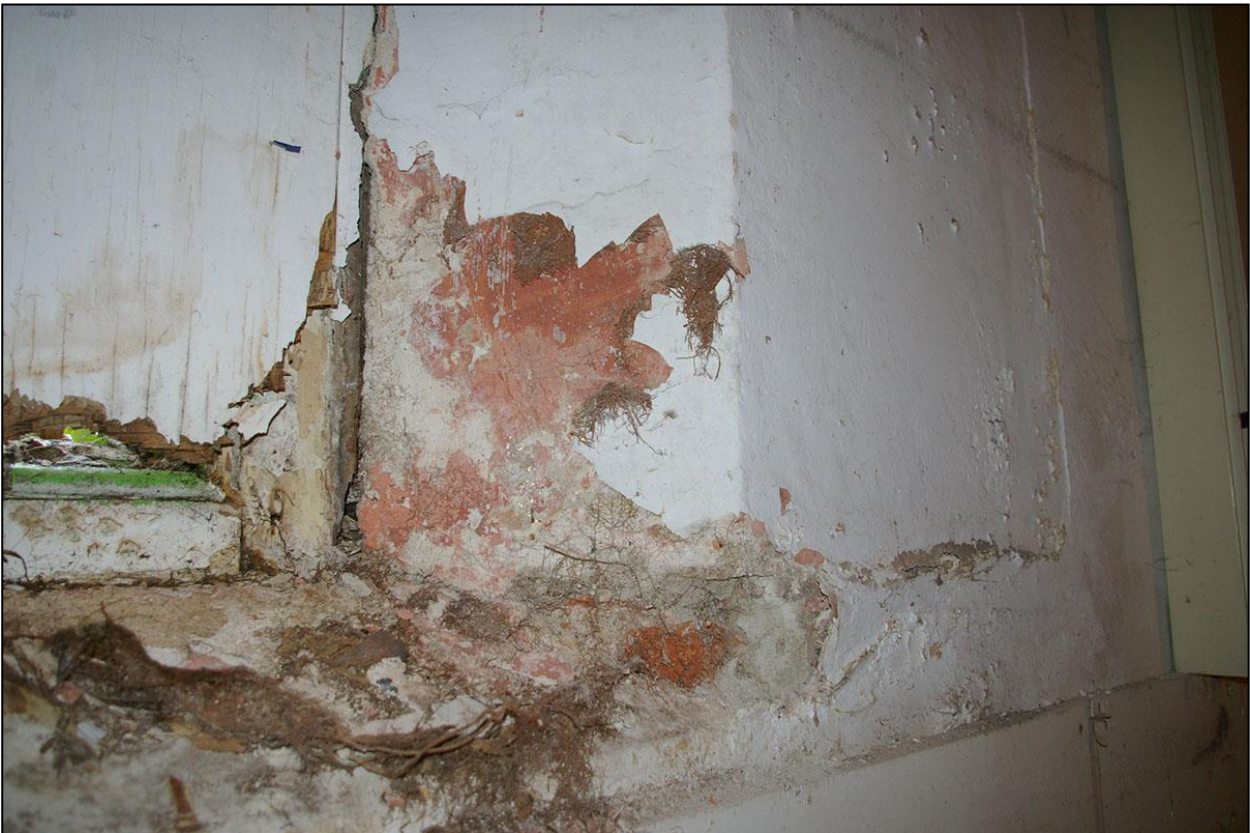
DETAIL OF ONE OF THE WINDOW EMBRASURES, WHERE THE MODERN PLASTER AND PAINT HAVE FALLEN OFF AND EXPOSED AN EARLIER LIME PLASTERED LAYER PAINTED A DARK RED COLOUR.

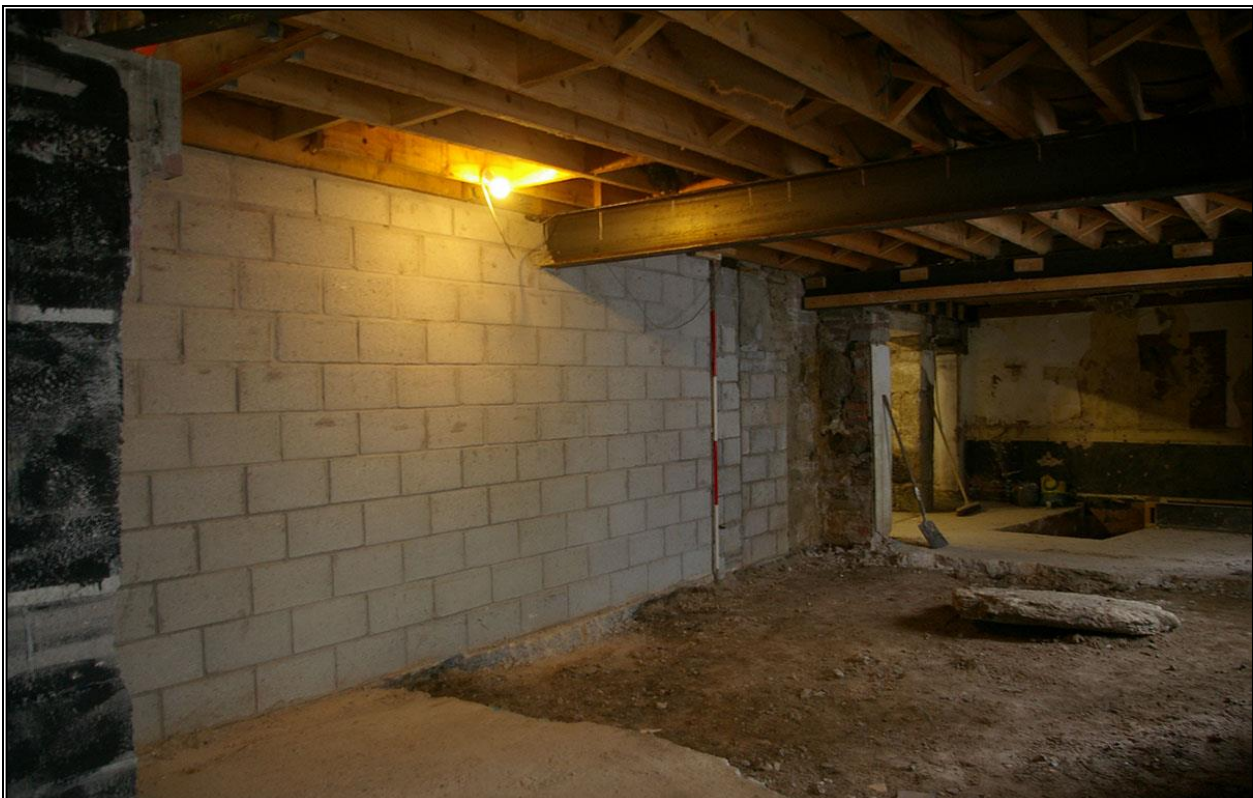
THE REAR, EAST WALL OF ROOM 6, NO.1 NEW STREET, SHOWING THE MAJORITY OF THE WALL HAS BEEN REPLACED WITH CONCRETE BLOCK; FROM THE NORTH-WEST (2M SCALE).

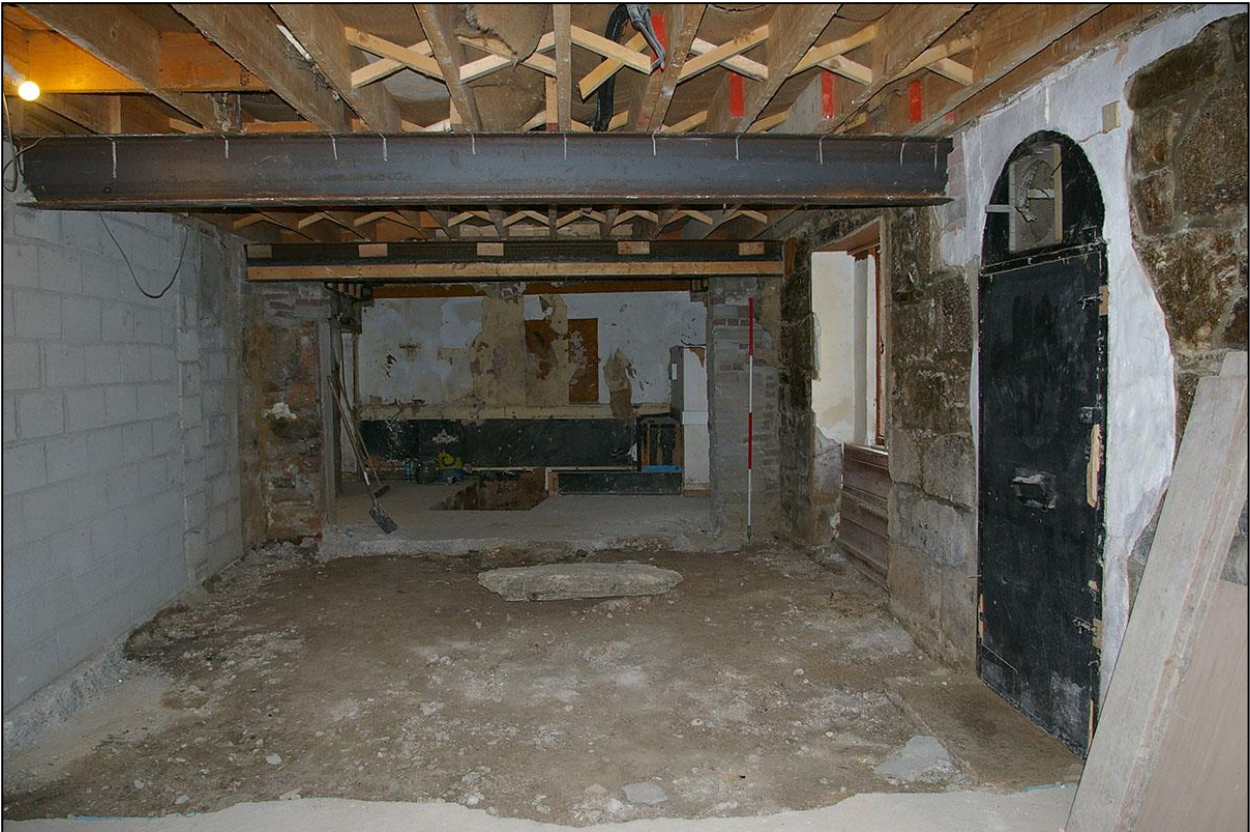
ROOM 6, SHOWING WALLS STRIPPED BACK INDICATING PHASING AND SHOWING TRUNCATED SOUTH GABLE AND CONCRETE FLOOR EXCAVATED; FROM THE NORTH (2M SCALE).

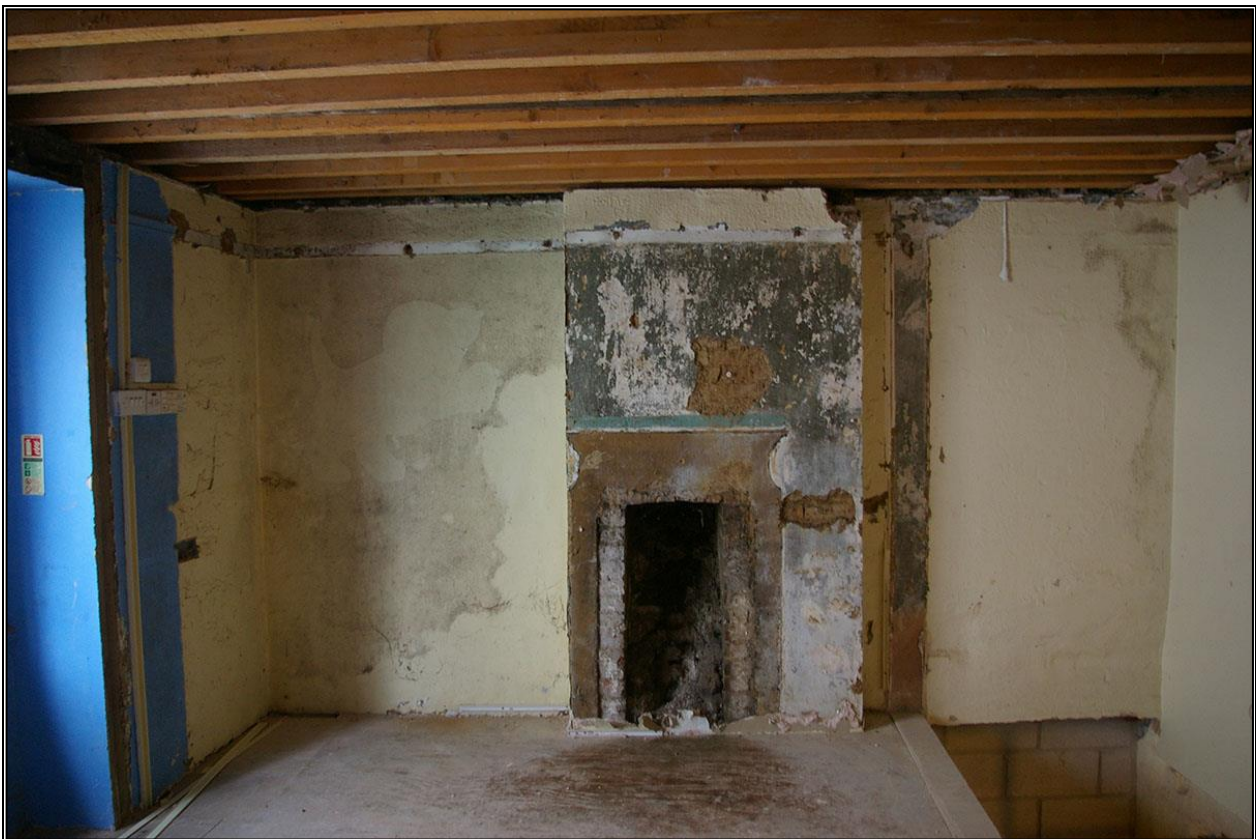
THE NORTH GABLE OF ROOM 7, WITH STONE RUBBLE AND BRICK STACK, PLASTERED HERE, WITH AT LEAST TWO PHASES OF HISTORIC PAINT, GREEN AND BLUE, WITH PARTIALLY BLOCKED FIREPLACE, ALTERED TO FIT A GRATE; FROM THE SOUTH.

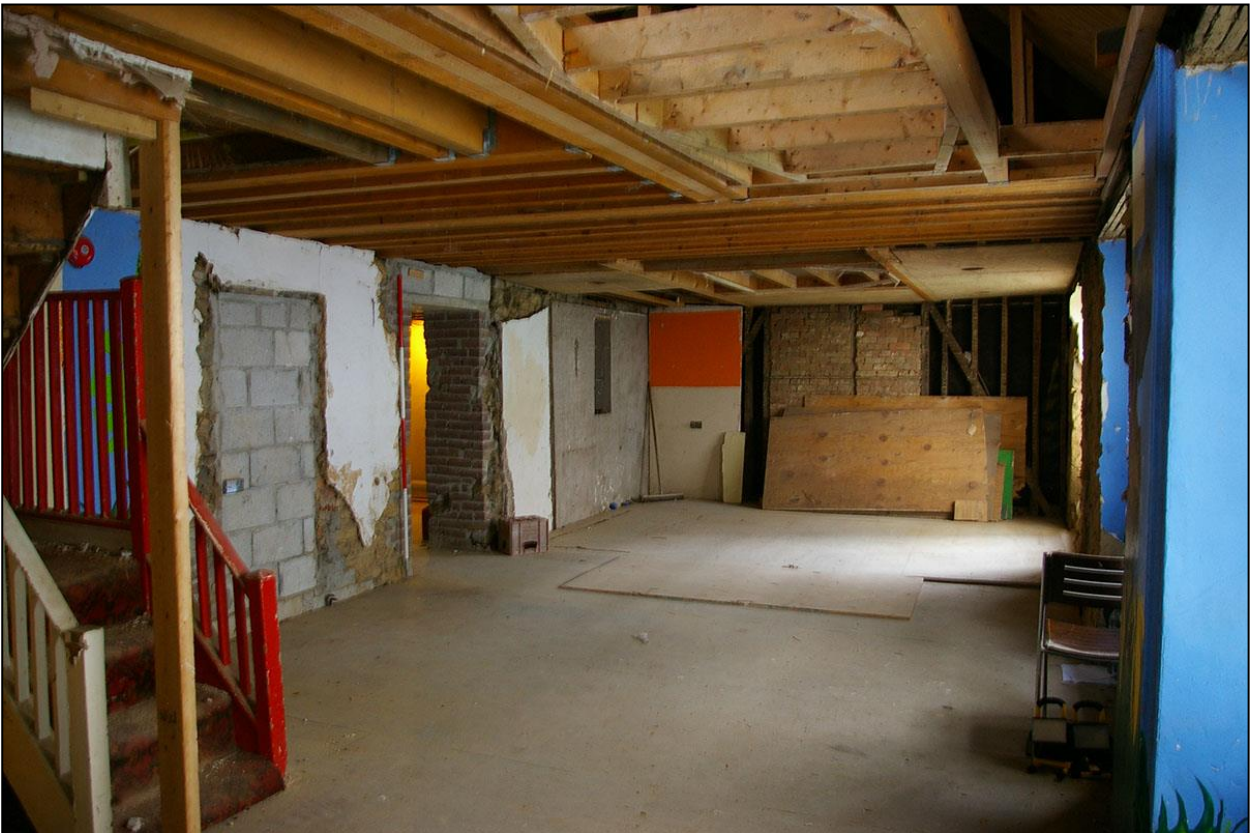
ROOM 7, SHOWING IT HAS BEEN STRIPPED OUT, THE FLOOR AND CEILING REPLACED; FROM THE NORTH-WEST.

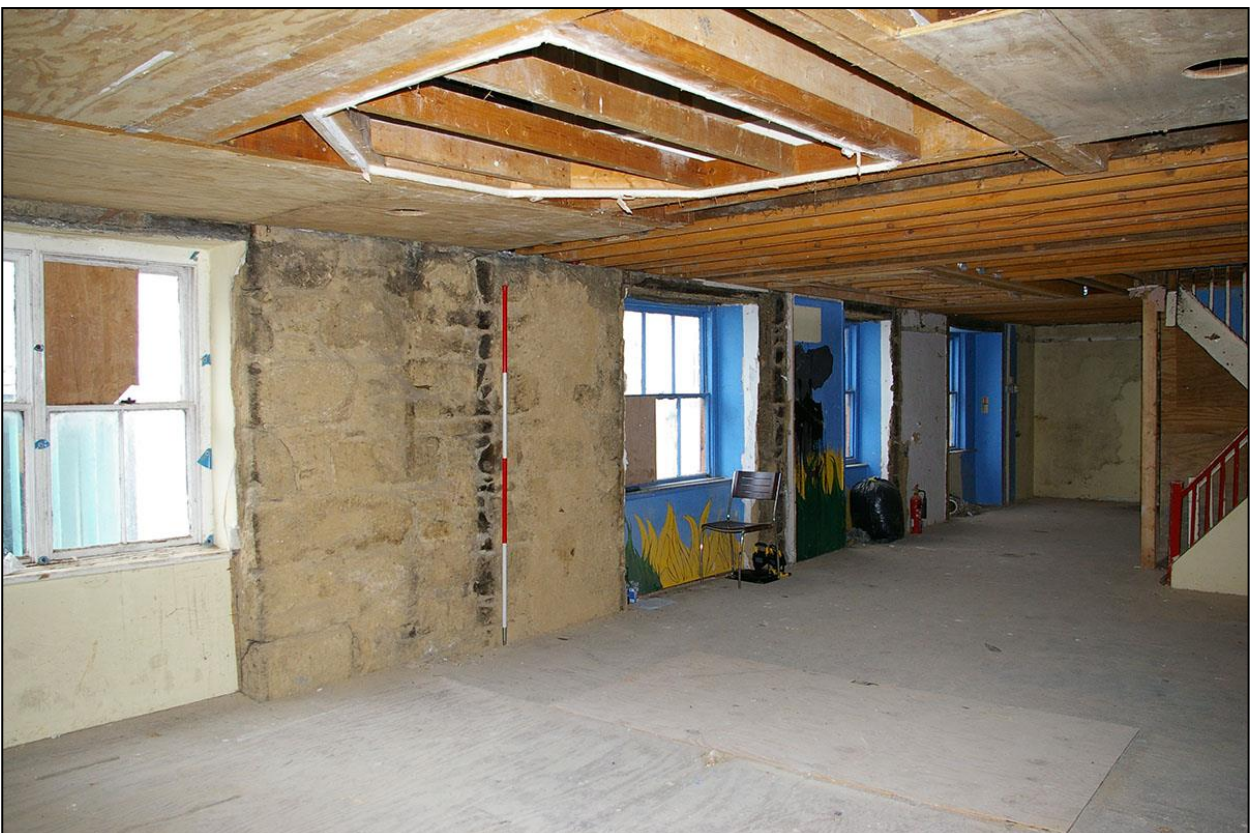
THE WEST WALL OF ROOM 7, SHOWING THE WIDE SECTION OF STONEMWORK ON THE WEST WALL WITH RAGGED BUILD LINE SHOWING WHERE THE BUILDING HAS BEEN EXTENDED; FROM THE SOUTH-EAST (2M SCALE).

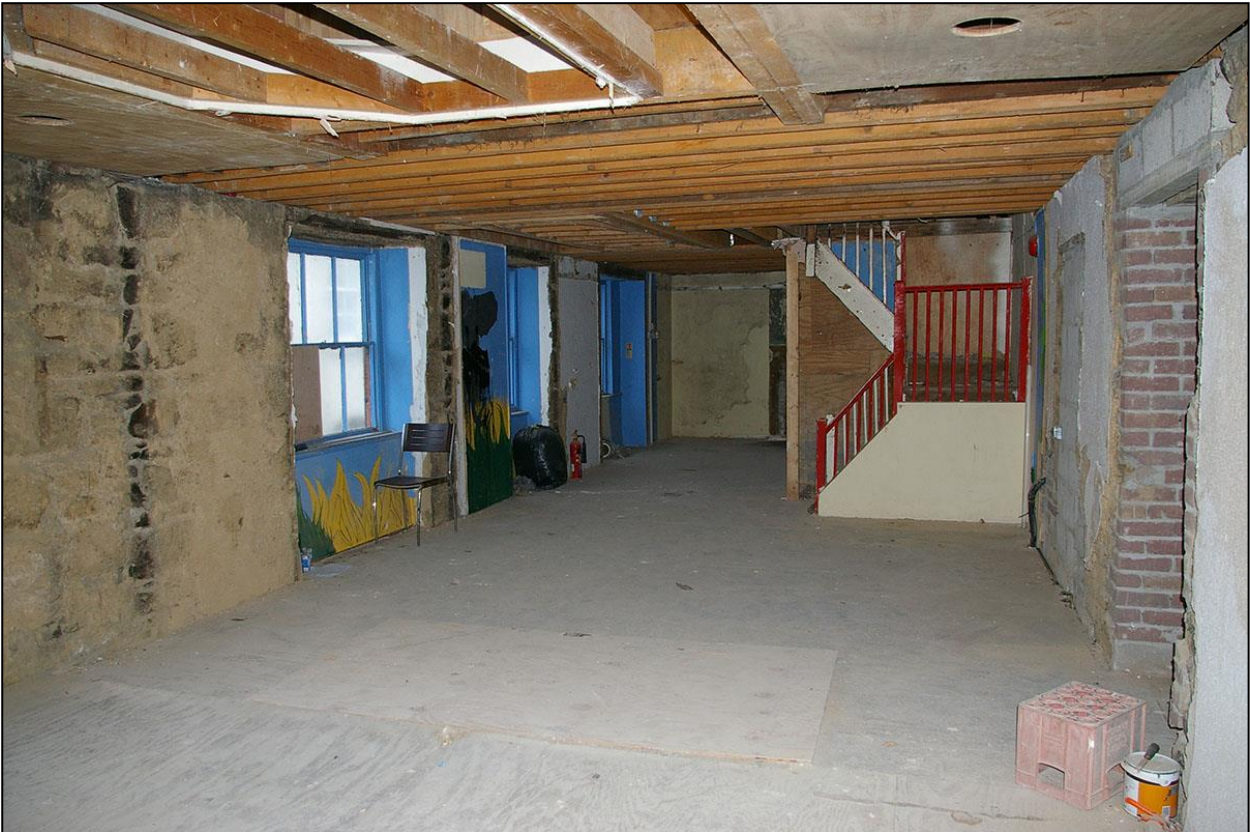
THE FIRST FLOOR OF NO.1 NEW STREET, ROOM 7, TOTALLY STRIPPED OUT, WITH NO CLEAR LAYOUT SURVIVING; FROM THE SOUTH-EAST.

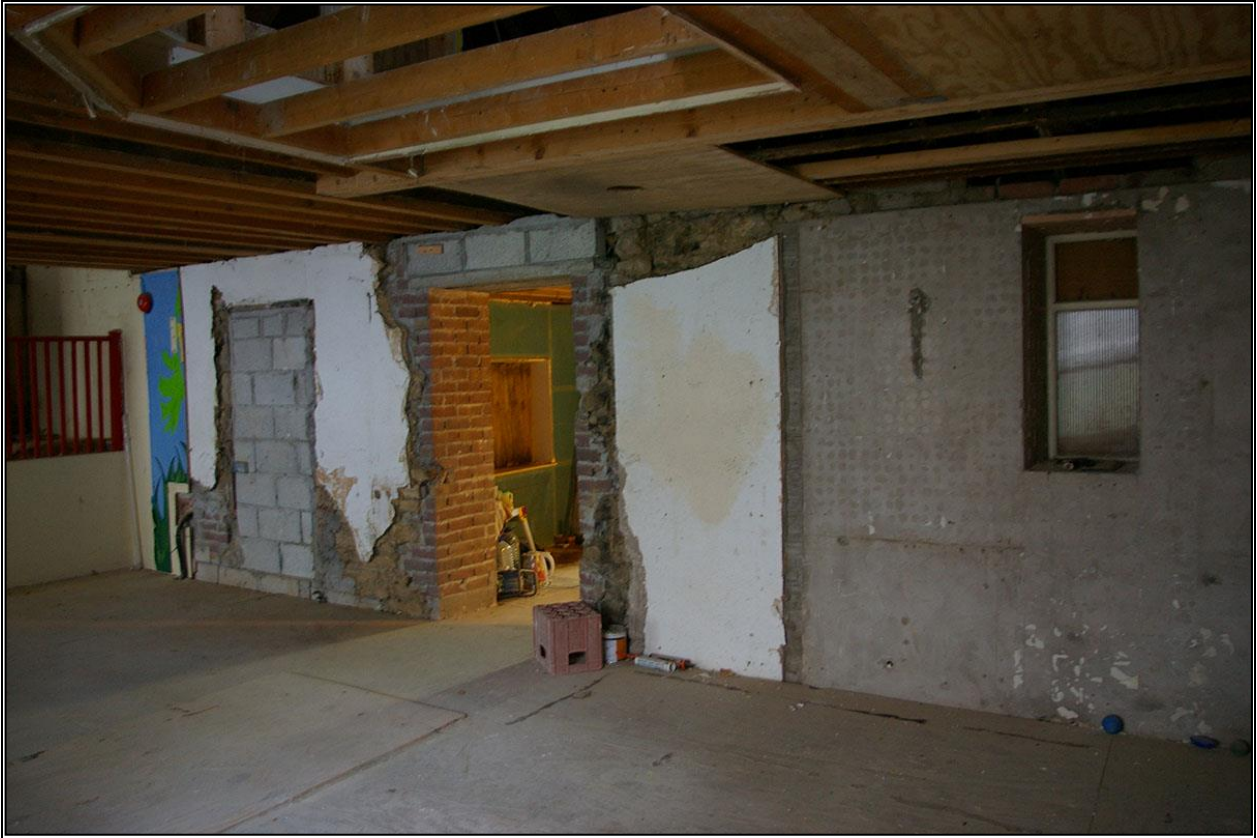
THE FORCED OPENING IN THE EAST WALL LEADING TO THE CONCRETE LINKING STRUCTURE; FROM THE SOUTH-WEST.

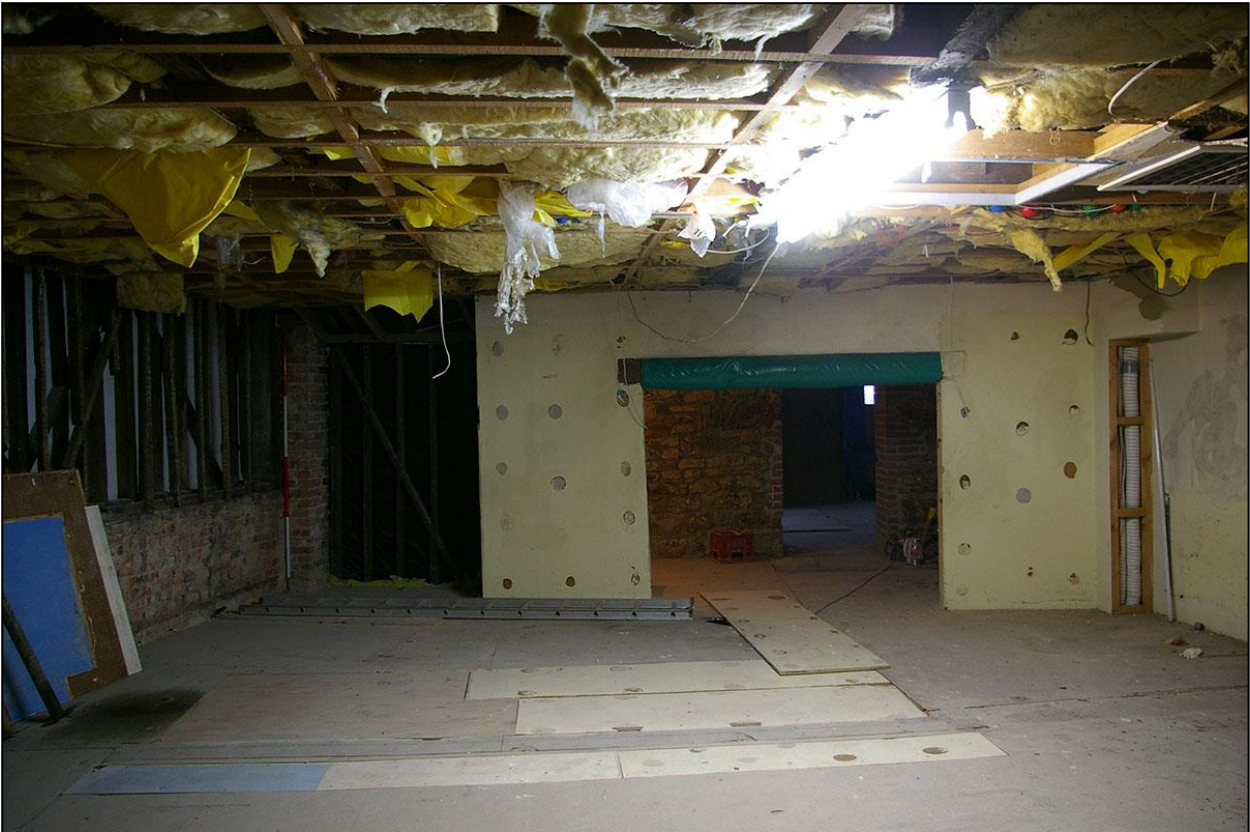
THE WEST WALL OF THE FORMER SYNAGOGUE, ON THE FIRST FLOOR, ROOM 9, SHOWING SIGNIFICANT SECTION TRUNCATED AND REPLACED WITH PLASTERED CONCRETE BLOCK; FROM THE EAST (2M SCALE).

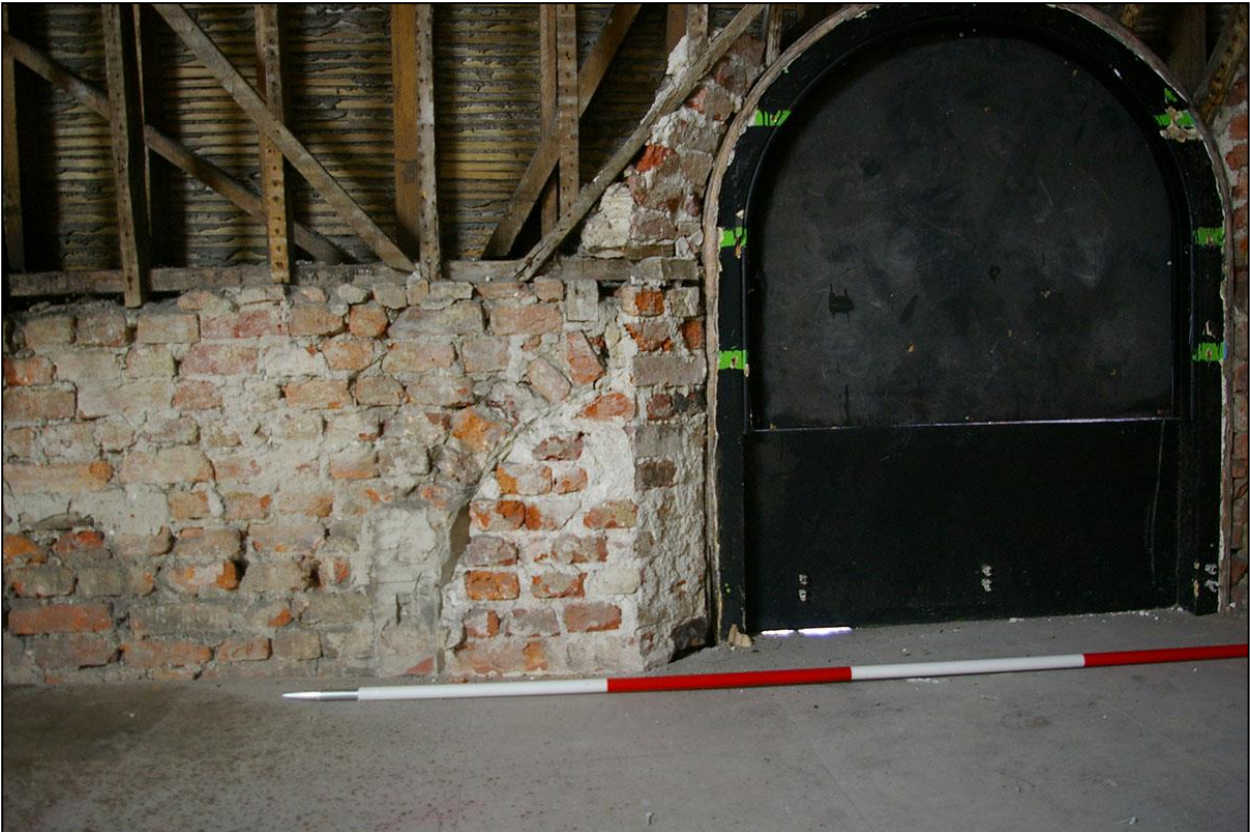
DETAILED VIEW SHOWING THE EARLIER, LOWER AND NARROWER ROUND ARCHED WINDOWS, FROM THE FIRST SYNAGOGUE, RAISED BY THE STUDWORK AND ENLARGED IN THE 19TH CENTURY; FROM THE WEST (2M SCALE).
