THE SYNAGOGUE NEW STREET PENZANCE CORNWALL

Updated - Historic Building Assessment

South West Archaeology Ltd. report no. 190402

By N. Boyd & E. Wapshott
Report Version: **FINAL**

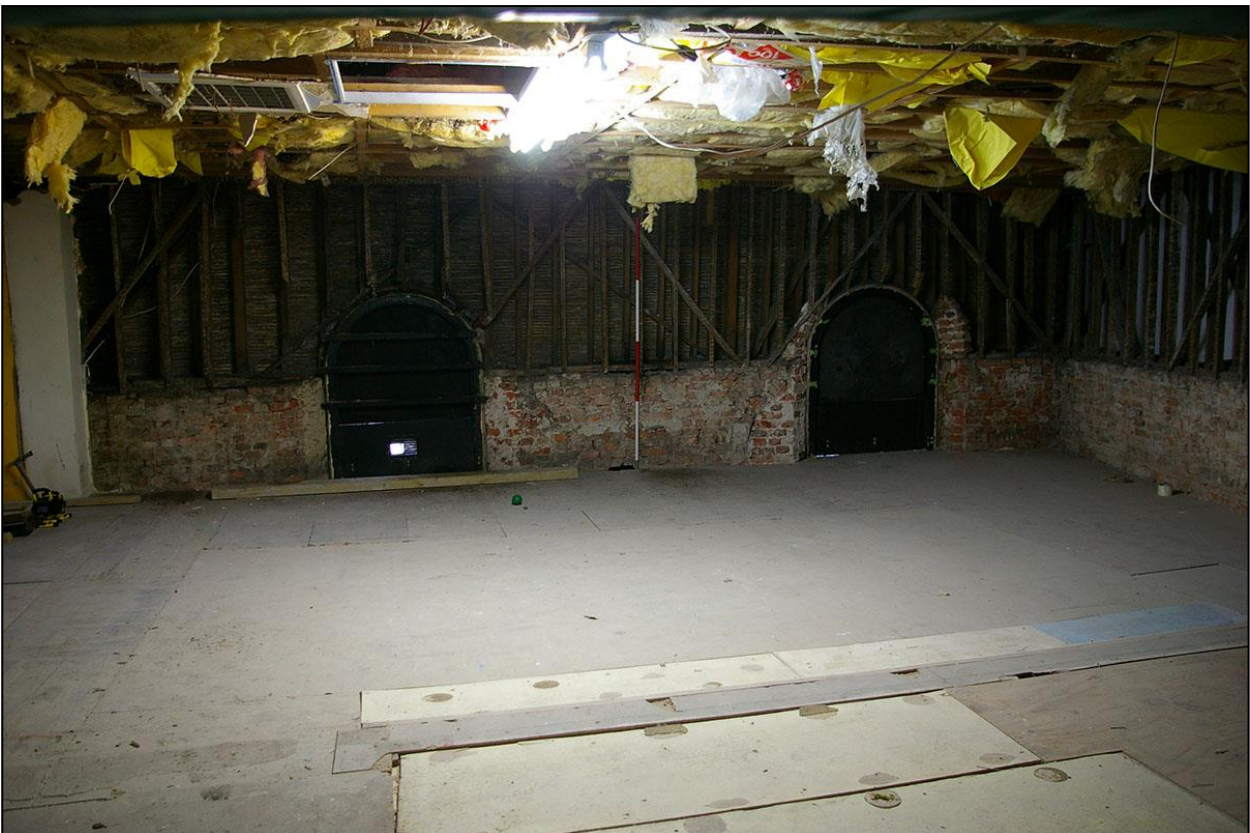
THE EAST WALL OF THE SYNAGOGUE, SHOWING DIFFERENT COLOURS AND BONDS OF BRICKWORK, EVIDENCE OF MUCH ALTERATION IN THE SMALL STRUCTURE; FROM THE WEST (2M SCALE).

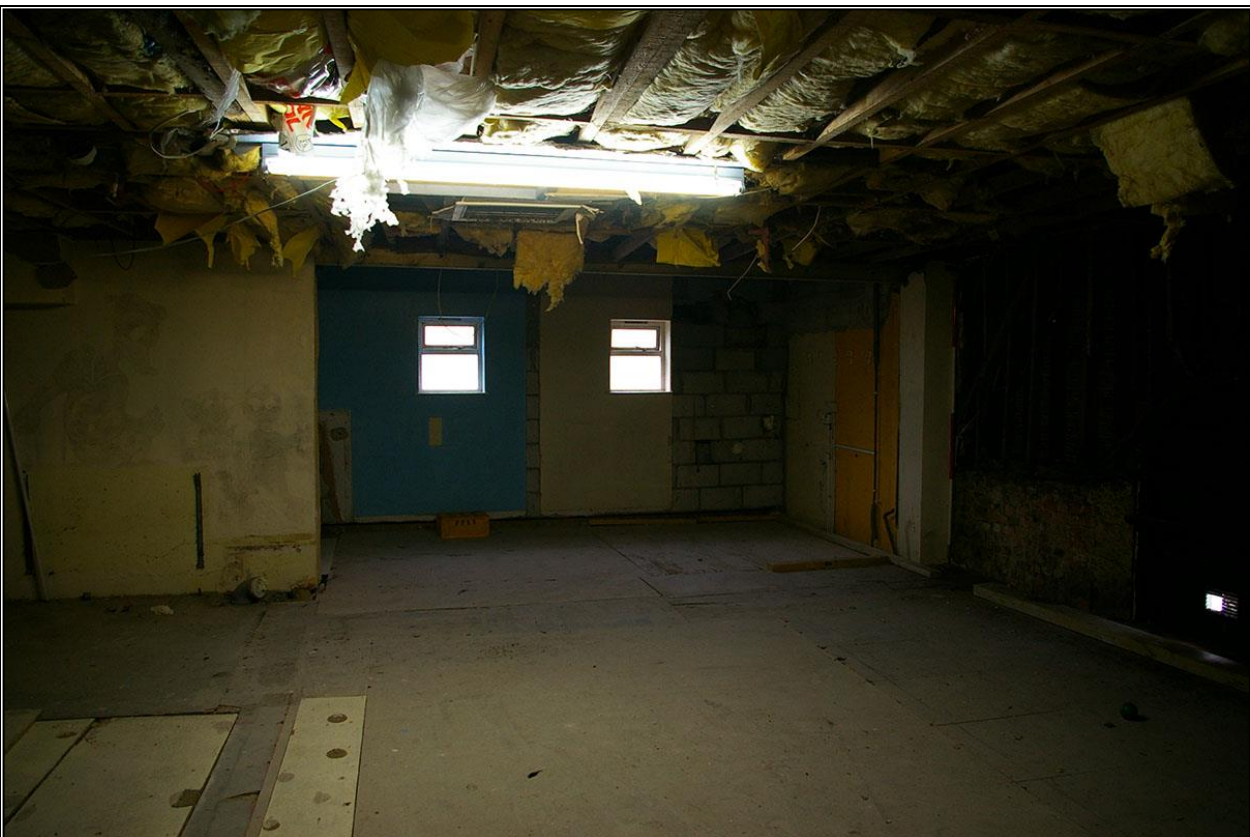
THE CONCRETE BLOCK EXTENSION ON THE NORTH END OF THE FORMER SYNAGOGUE AND THE TRUNCATED WALL; FROM THE SOUTH.
