**GLYNN WEIR  
CARDINHAM  
BODMIN  
CORNWALL**

Updated Heritage Statement and Statement of Significance

South West Archaeology Ltd. report no. 191108

By N. Boyd & E. Wapshott  
Report Version FINAL  
8<sup>th</sup> November 2019

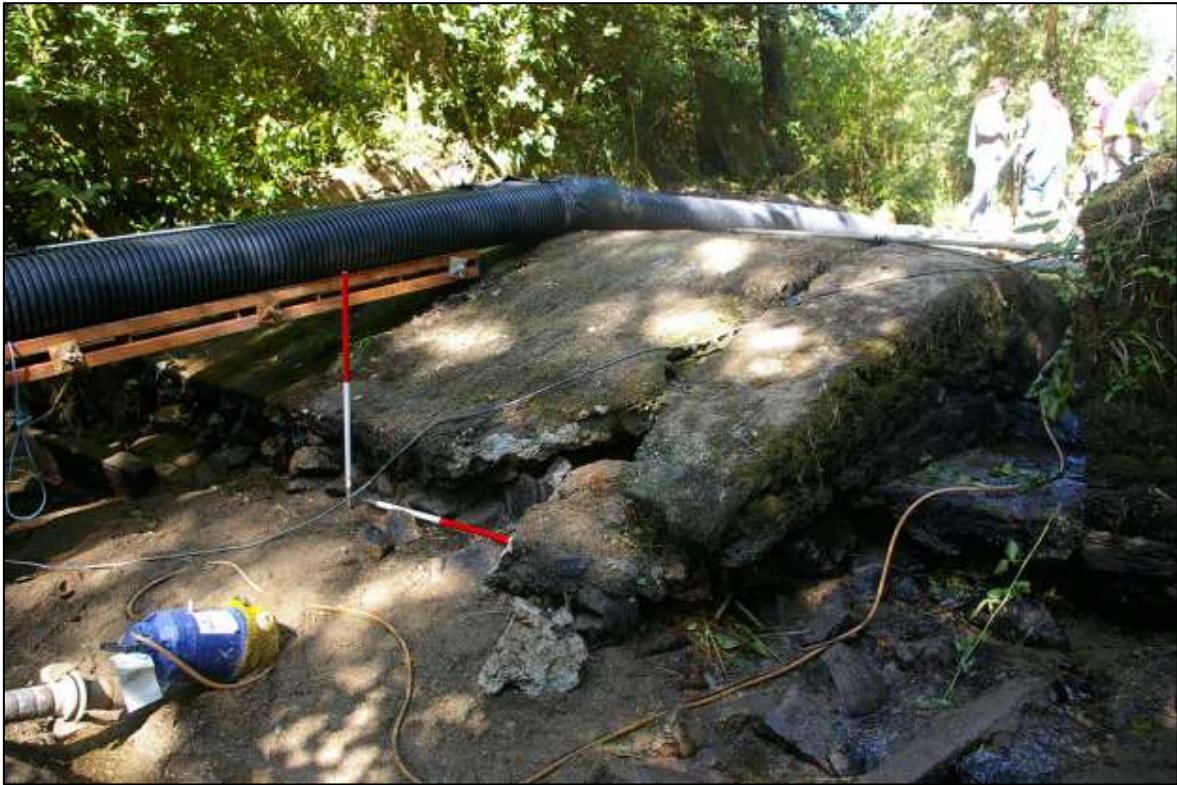
FIGURE 6: THE EXPOSED WEIR; FROM THE EAST-SOUTH-EAST (1M SCALES).

Once the water was drained from the river during works, far more detail on the structure and its narrative was exposed and could be recorded. Firstly, the concrete appearance of the weir is a 'capping' layer (104); the river pebbles and gravel inclusions in the upper layer of this concrete, show this material was mixed onsite, using bast from the riverbed. This concrete layer is reinforced with square-profile re-bar mesh, of solid not spiralled form, so may be c 1970s or older. The thin depth of the concrete and its somewhat irregular 'smoothed' or 'smeared' appearance would suggest it was poured loosely over the mesh.

Below the concrete capping is a thick, very loose and degraded layer (103); of greyish-white soft limecrete, very gritty with slate fragments and quartz and granite grit; suggesting this may have been sourced or mixed with mining waste deposits. This limecrete has been used as the bond for piles of river stones, clearly dredged from the riverbed in and around the weir and along the river's length. This thick, very crude layer raises the weir to its current 'Ogee' form and appears to be addressing flow issues with the river and possibly water level problems with the leat and lake it was designed to serve. Whilst the limecrete here may have been brought in, including lots of crushed quartz and granite fragments, it could be mixed with or have originated from mine waste deposits; this alteration of the weir is very localised and immediate in character and materials and slapdash, a change made by estate staff or the gardeners?

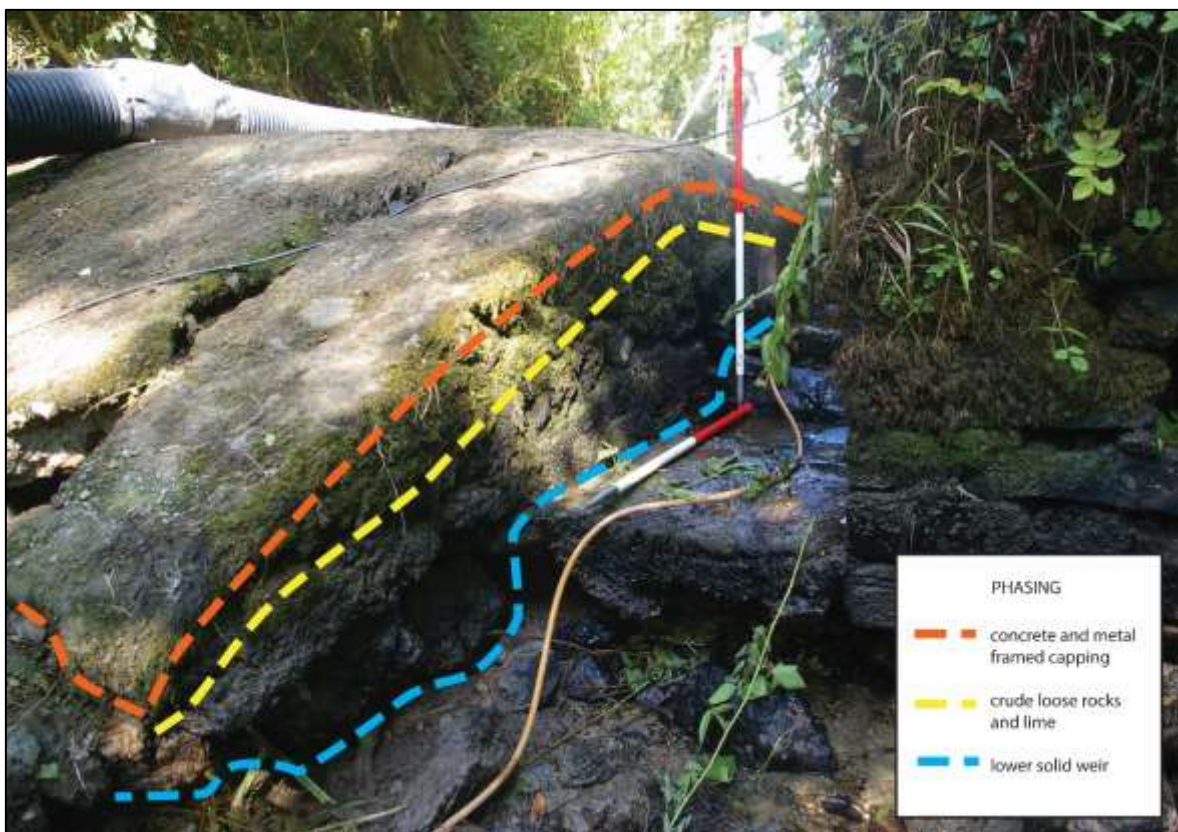
Beneath these two upper layers is a lower, much shallower elongated sloping weir; of 'crump' weir form (102). The first phase clearly needed to be adapted quite quickly after construction, but the quality of build is quite different from the later repairs. Aesthetics have been considered in this build, in the wing walls and leat flanking walls. This phase is of blocky shaped stones, like the wing walls, mixed and capped by a much more solid and smooth textured harder concrete, without obvious inclusions of stones or pebbles. Massive timbers brace the weir, wing walls and fish pass, which is framed in large flat slates. Further back from the weir, upstream to the north, a small section of more chunky shaped stones can be seen eroding out of the bank, suggestive of the riverbanks here having once been retained, either for strength or for aesthetics, framing the weir and leat. The weir appeared on the historic mapping between the 1st and 2nd Edition OS

There is a fish pass cut into the weir at the east end, c.0.2m wide; once the water was drained it best exposed the profiles of the different phases of alteration and repair. The fish pass is a narrow rectangular cut in the weir with a straight drop, which is currently not working to the benefit of the fish stocks in the river. The slight oblique angle of the weir to the water flow and the fish pass have created an effect where an eddy of water gathers and pours over the side of the fish pass, as well as down its vertical line. This eddy has caught what was likely a slight lip in the concrete and worked at it, pushing a large chunk of the weir apart. The weir, possibly due to its significant change in height and shape, is moving the water in such a way across its form that it is scouring and undermining its own structure. The riverbed, once drained, is significantly washed away under the east wing wall and weir, hence the collapse at the front end.

FIGURE 7: THE WEIR IN PROFILE, SHOWING THE HISTORIC PHASING; FROM THE EAST-SOUTH-EAST (1M SCALES).

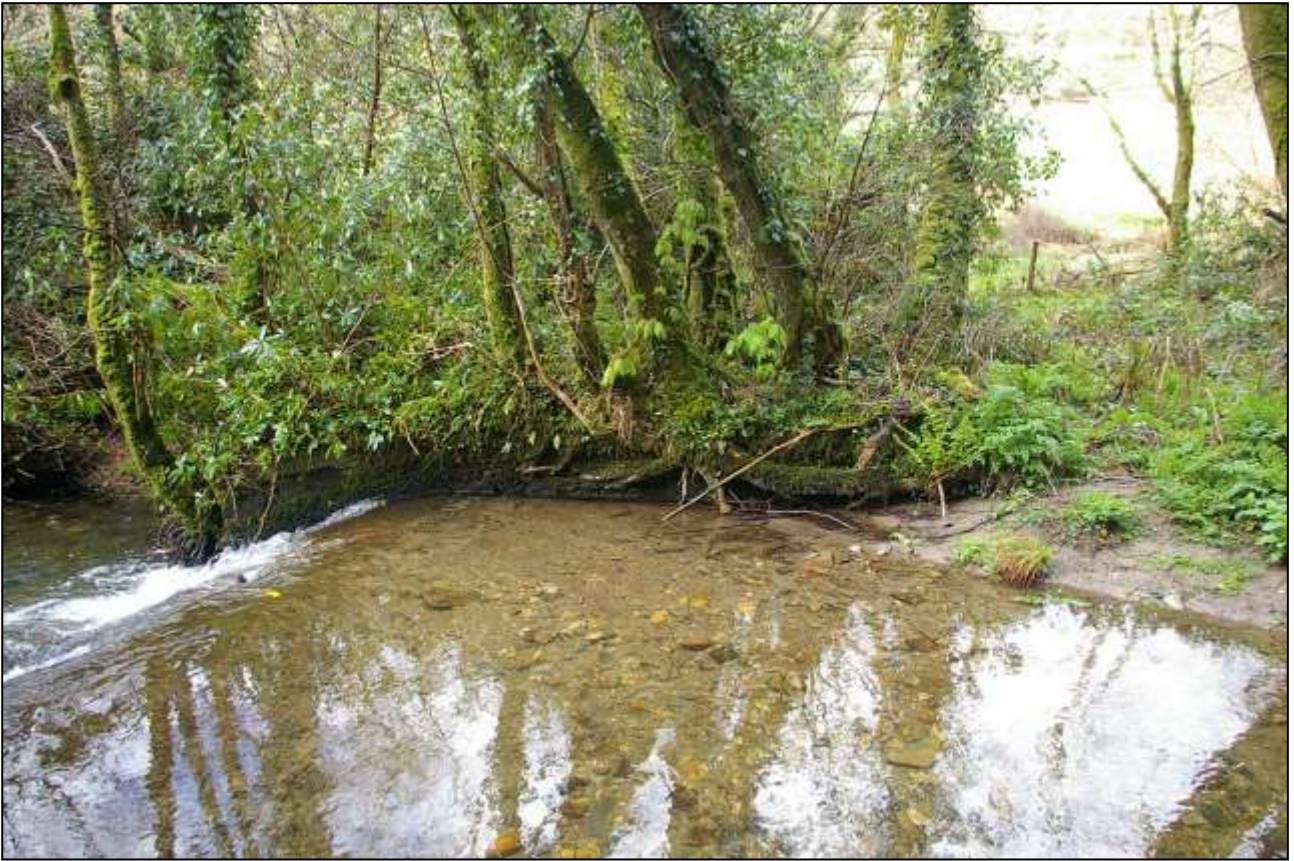
7. THE WESTERN ABUTMENT OF THE WEIR, SHOWING DARK COLOURED, COURSED STONEWORK, TOPPED BY A CEMENT CAP; FROM THE EAST, NORTH-EAST.

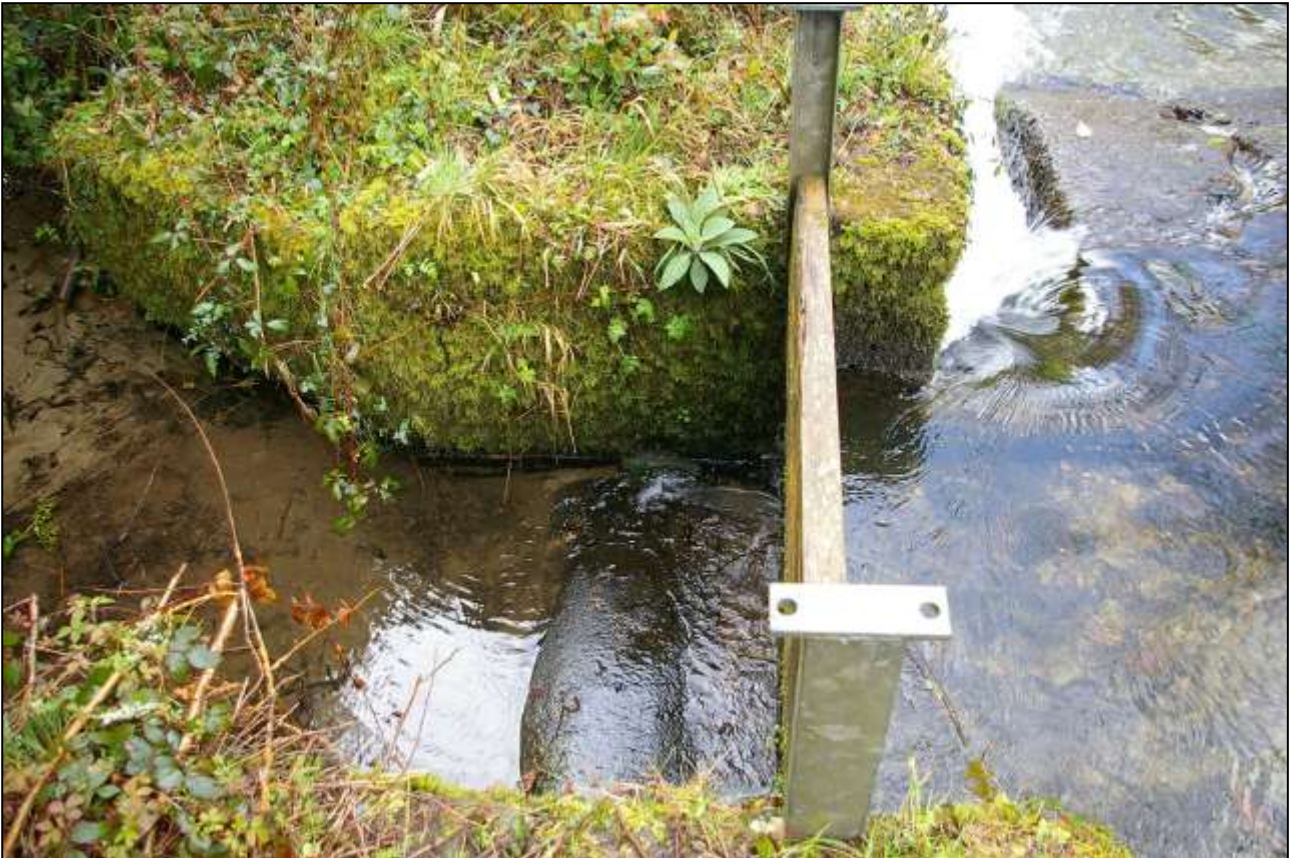
The sluice gate sits above the weir on the east bank and serves a deep leat, c.1m wide, which is still operational and feeds a large ornamental lake to the south, south-east. Its north flanking wingwall is the part of the abutment on the east side which has been crudely patched in the past

9. THE SLUICE GATE TO THE WORKING LEAT, WITH GALVANISED I-PROFILE GIRDERS AND MODERN BOARDS, FIXED WITH CEMENT TO OLDER STONE AND CONCRETE CAPPED ABUTMENT WALLS; FROM THE NORTH.

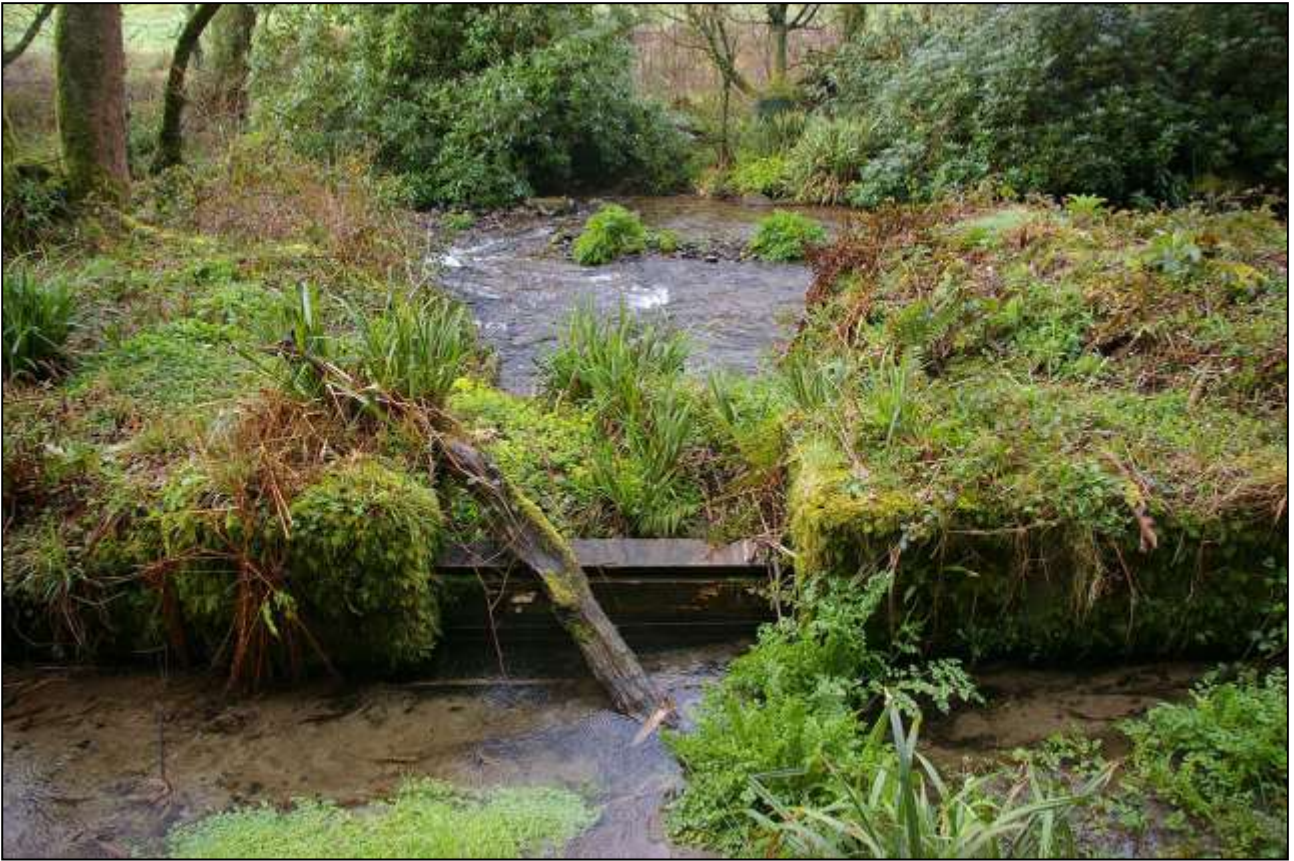
15. THE SILTED UP OVERFLOW GATE TO THE LEAT; FROM THE EAST.

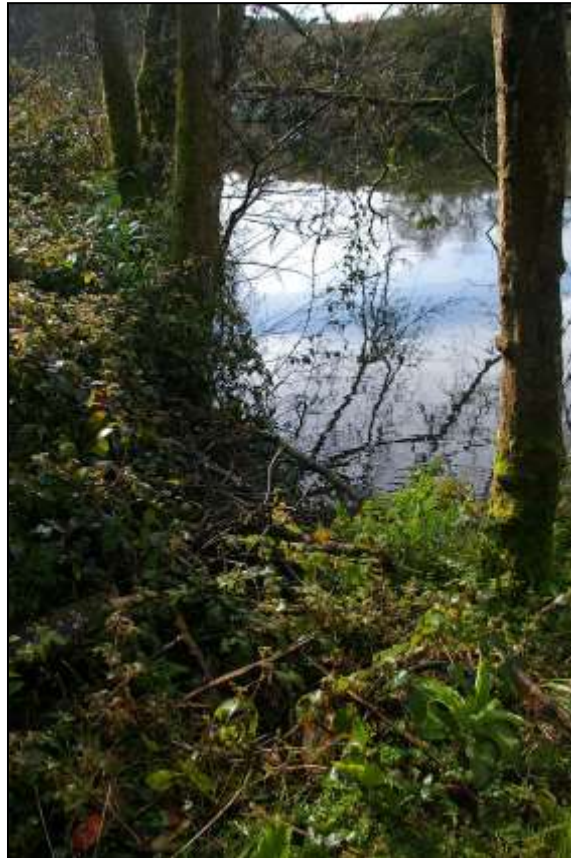
20. THE CULVERT WHICH CARRIES THE LEAT WATER INTO THE LAKE, IN ITS NORTH-EAST CORNER, INFILLED WITH FALLEN TWIGS AND BRANCHES; FROM THE NORTH-WEST.

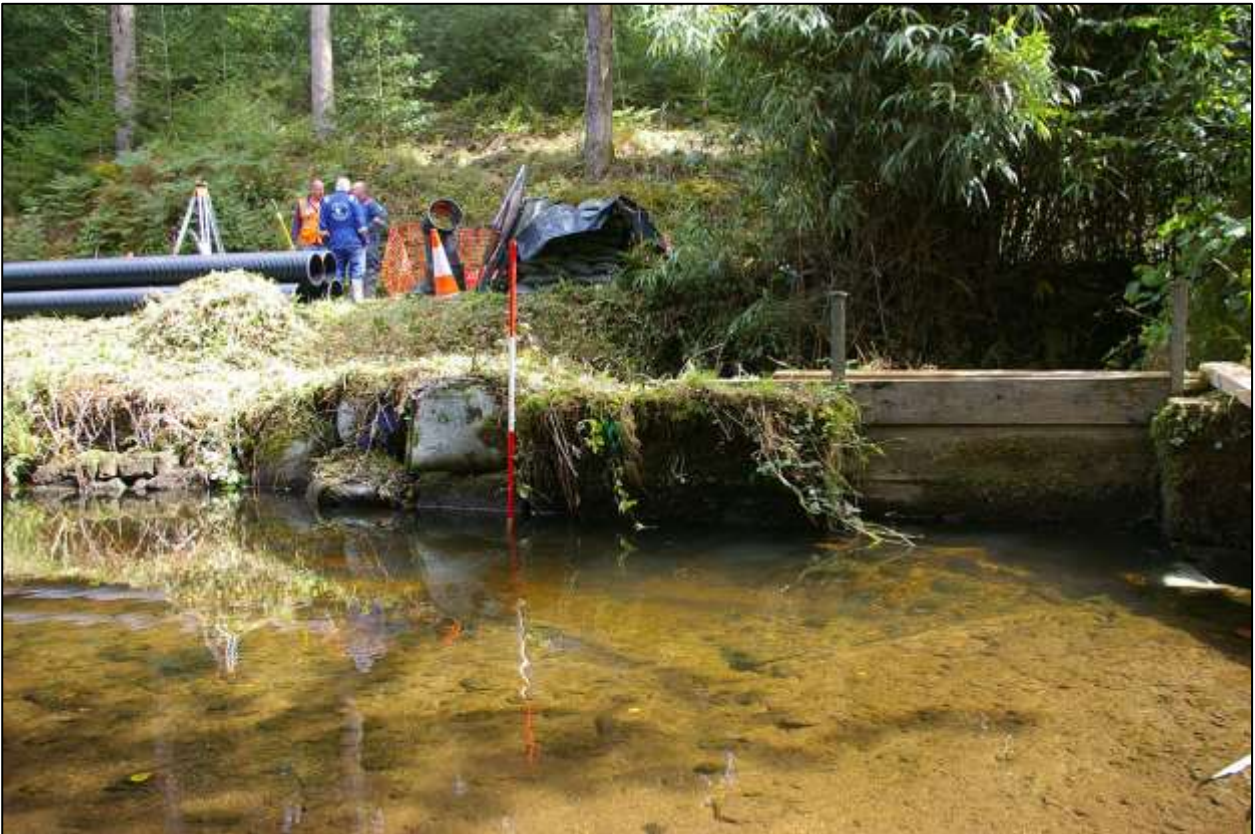
with dumpy bags of rubble and cement. The sluice gate runners are I-profile galvanised girders, set into the bank with later cement. The boards which sit within the runners are thick and chunky and relatively recent in appearance, likely less than about 20 years old. The leat curves to the southeast away from the river, the abutment walling angled to respect the flow of water, clearly patched with cement and concrete along its length on the west side of the leat, more overgrown so likely less altered from the original form on the east side, appearing to be stone-reinforced banks, with at the north end, near the entrance shaped stonework visible. The leat is quite silted up, with c.0.45-0.5m of sludgy sandy beige brown silt in the base. The water in the leat flows slowly but constantly into the lake. Along its length there is some build-up of green invasive weed species. The leat runs in a straight line south along the base of the eastern slope, into the top of the lake, the river runs away to the south, south-west, as the valley widens, with a wedge shaped mossy meadow with small shrub trees on land between, with some historic ornamental planting.

30. THE FLANK WALL OF THE LEAT AND SLUICE GATE, SHOWING ITS REPAIR WITH DUMPY BAGS FULL OF RUBBLE AND ROCKS, WITH SOME CEMENT PATCHING; WITH 2M SCALE; FROM THE SOUTH-WEST.

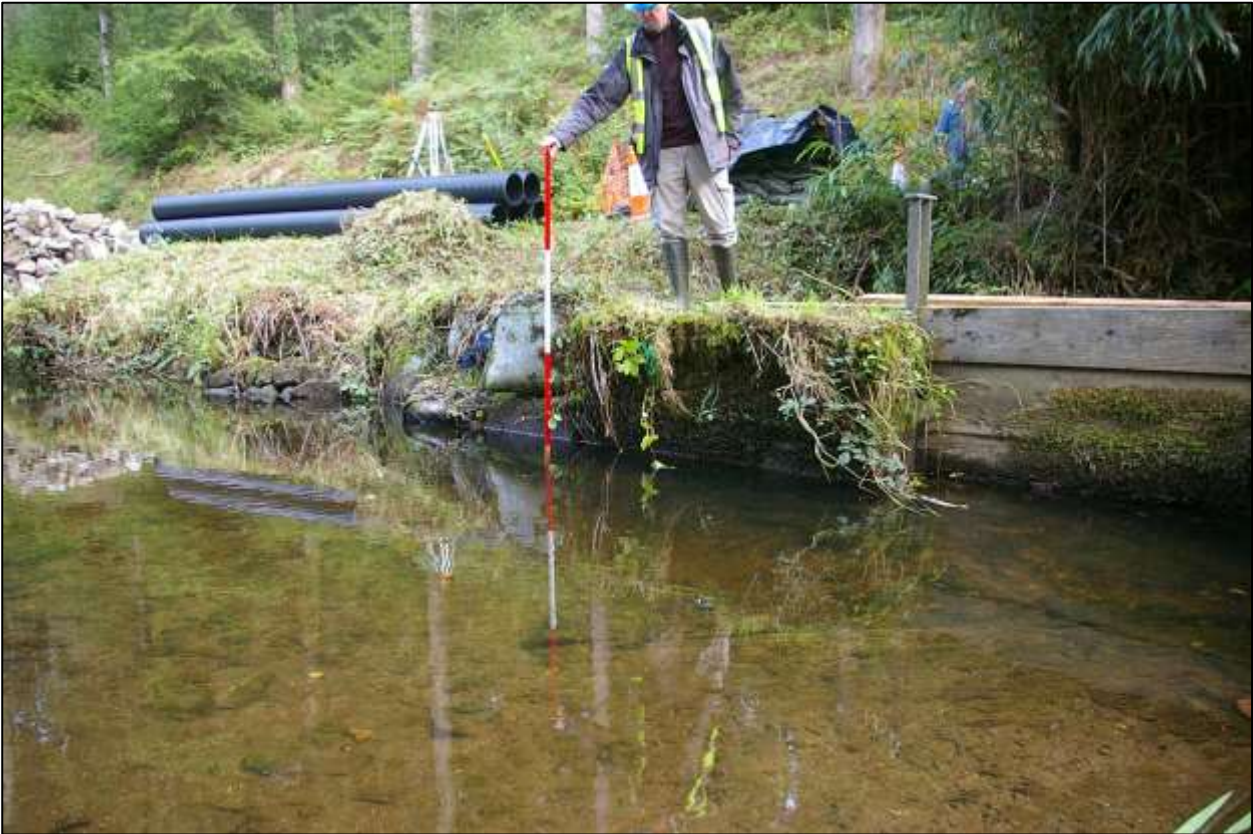
32. THE SHORT SECTION OF GOOD FLANK WALL TO THE SLUICE, COVERED IN CEMENT RENDER, WITH 2M SCALE; FROM THE SOUTH-WEST.

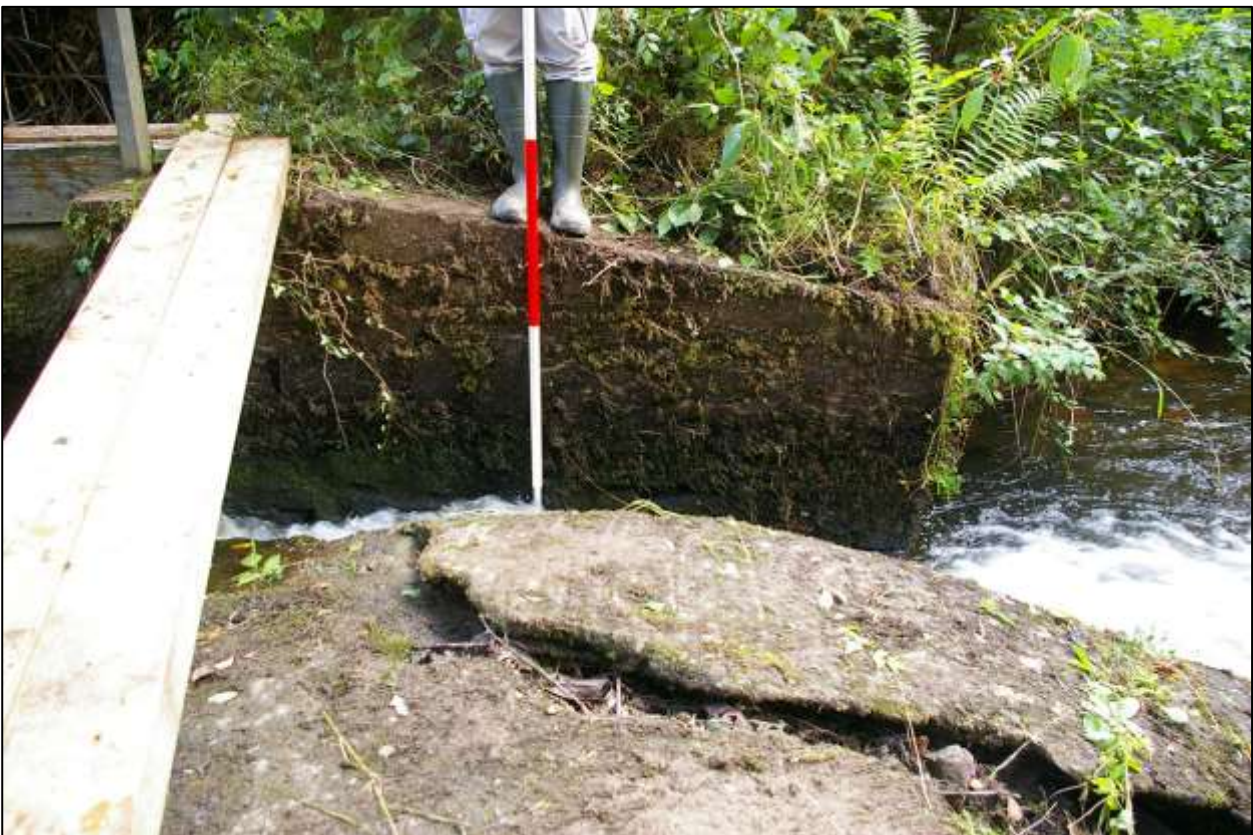
33. THE LOWER ANGLED SECTION OF FLANK WALL, WHICH BRACES THE WEIR, OF DRESSED SLATESTONE BLOCKS AND CEMENT RENDER CAPPING AND SIDES; WITH 2M SCALE; FROM THE WEST-SOUTH-WEST.

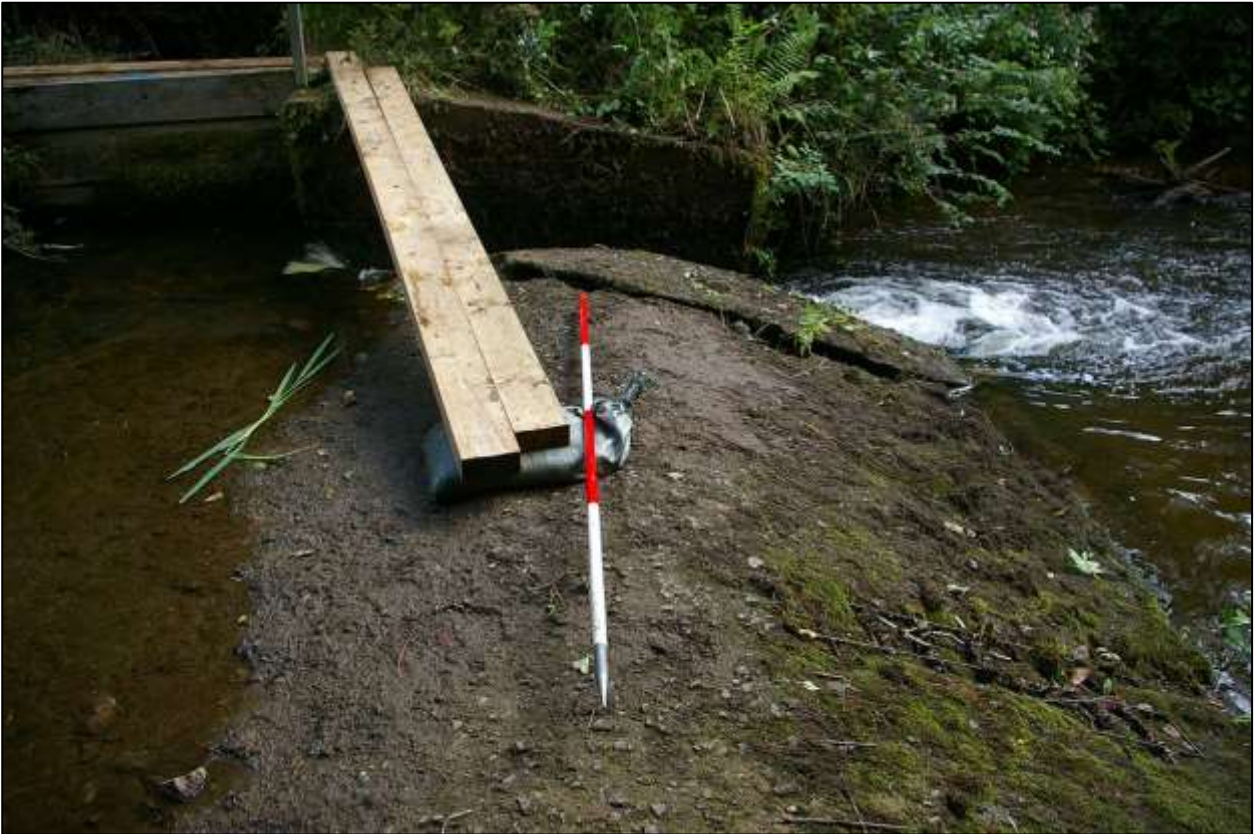
The ogee raise suggests not enough water was being fed to the lake and it required speedy adaption. The concrete capping in the c.1970s seems to be a very reactionary response to issues with the failing structure and does not exhibit considered design or quality of build, so would not suggest specialists were brought in but likely estate staff.

34. THE CONCRETE CAP OF THE WEIR, WITH WATER DRAINED OFF, SHOWING A RELATIVELY MODERN TOP-COAT, HELD IN PLACE BY STEEL SQUARE MESH; WITH 2M SCALE; FROM THE EAST-SOUTH-EAST.

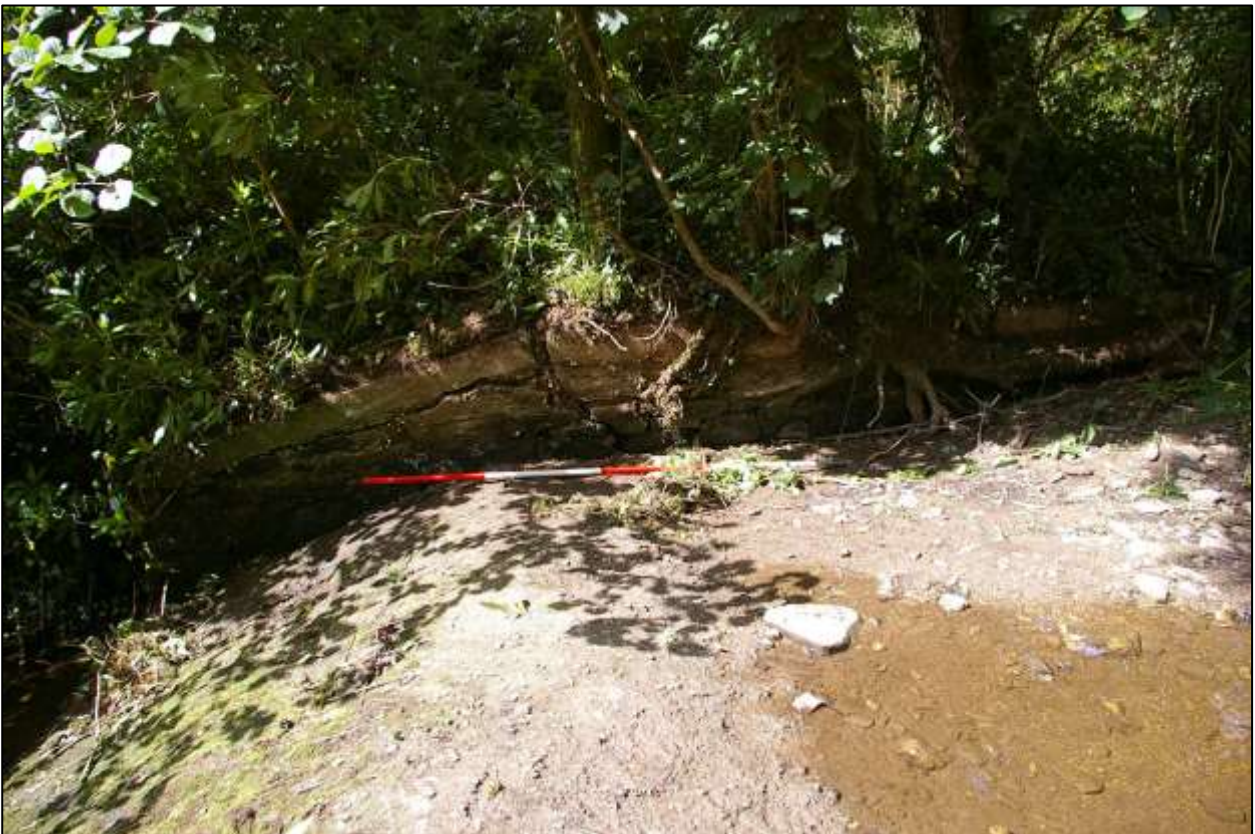
The flanking walls of the weir are very much obscured by mossy overgrowth but are of roughly dressed/shaped stone blocks in a crudely coursed build; capped by later concrete. These may be of more considered design, since the weir is part of a wider landscaped garden. Above the weir, the east abutment wall has been blown out by water damage in the recent past and strengthened using cement and dumpy bags, which are becoming overgrown, likely within the last 20 years or so. Whilst the need to patch the banks is understandable, the materials used here were not appropriate for a historic feature. The walls may be capped in places with more modern concrete or cement.

35. THE WEST FLANK WALL TO THE WEIR, SHOWING HEAVY BLOCK CONSTRUCTION, CAPPED WITH CONCRETE, WITH THICK POORLY EXECUTED CEMENT REPOINTING; WITH 2M SCALE; FROM THE EAST.

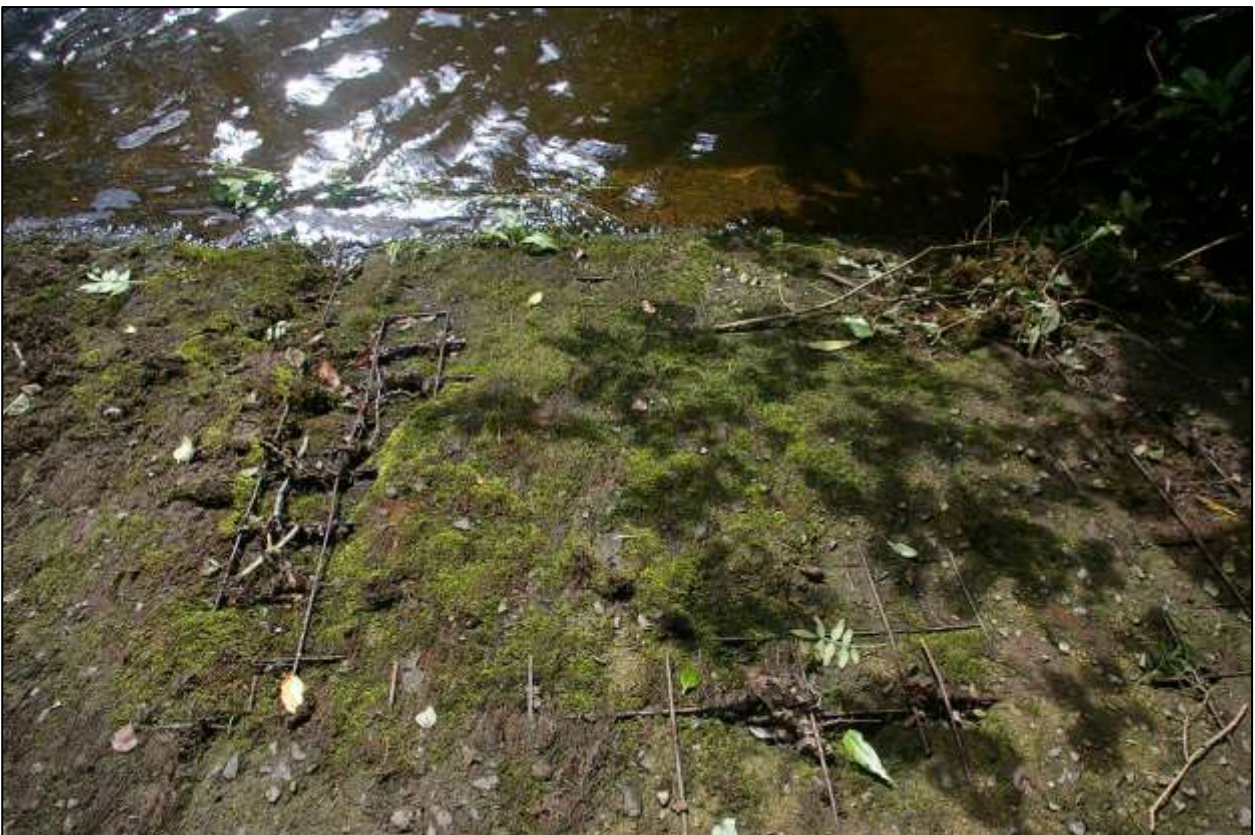
- Weir crest capping materials are now pebble inclusion concrete, shows the concrete was mixed onsite using bast from the riverbed. Combined with iron mesh, an odd combination of localised and modern solutions to the repair.

37. DETAIL OF THE STEEL MESH WHICH IS HOLDING THE UPPER CONCRETE CRUST OVER THE DAM, CLEARLY A FAIRLY RECENT REPAIR TO THE STRUCTURE; FROM THE NORTH-NORTH-WEST.

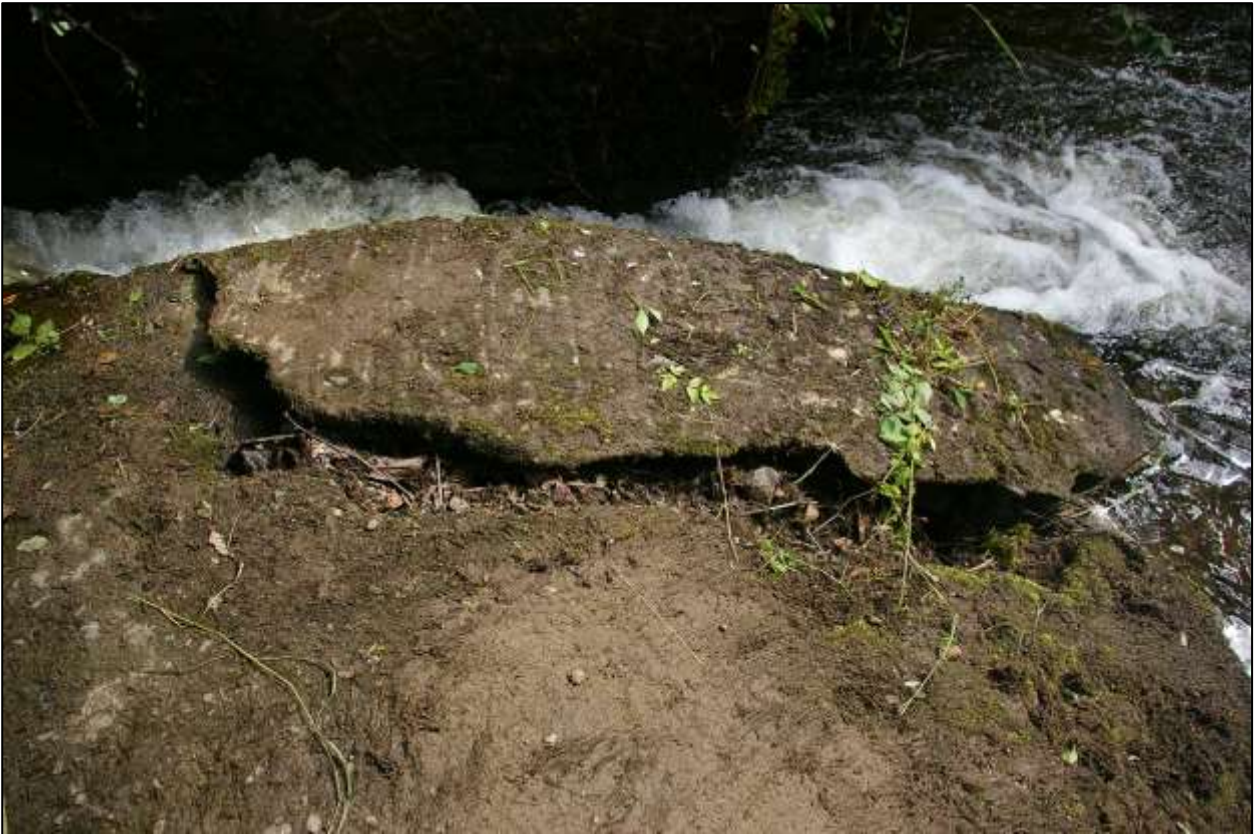
There is a large visible crack in the weir, approximately 0.5-0.6m into the weir from the eastern abutment, approximately 0.2m from the fish pass. The slight oblique angle of the weir to the water flow and the fish pass have created an effect where an eddy of water gathers and pours over the side of the fish pass, as well as down its vertical line. This eddy has caught what was likely a slight lip in the thin concrete capping layer and worked at it. This has now burst open, forcing water into a narrow channel and into the looser limecrete build of the second phase of construction, washing out stones from under the concrete cap, leaving it hollow beneath. The crack is now as much as 10-15cm or so wide in places, weakening the weir and disrupting the flow of the water.

38. THE LARGE CRACK IN THE CONCRETE, TO THE EAST END OF THE WEIR; FROM THE WEST.

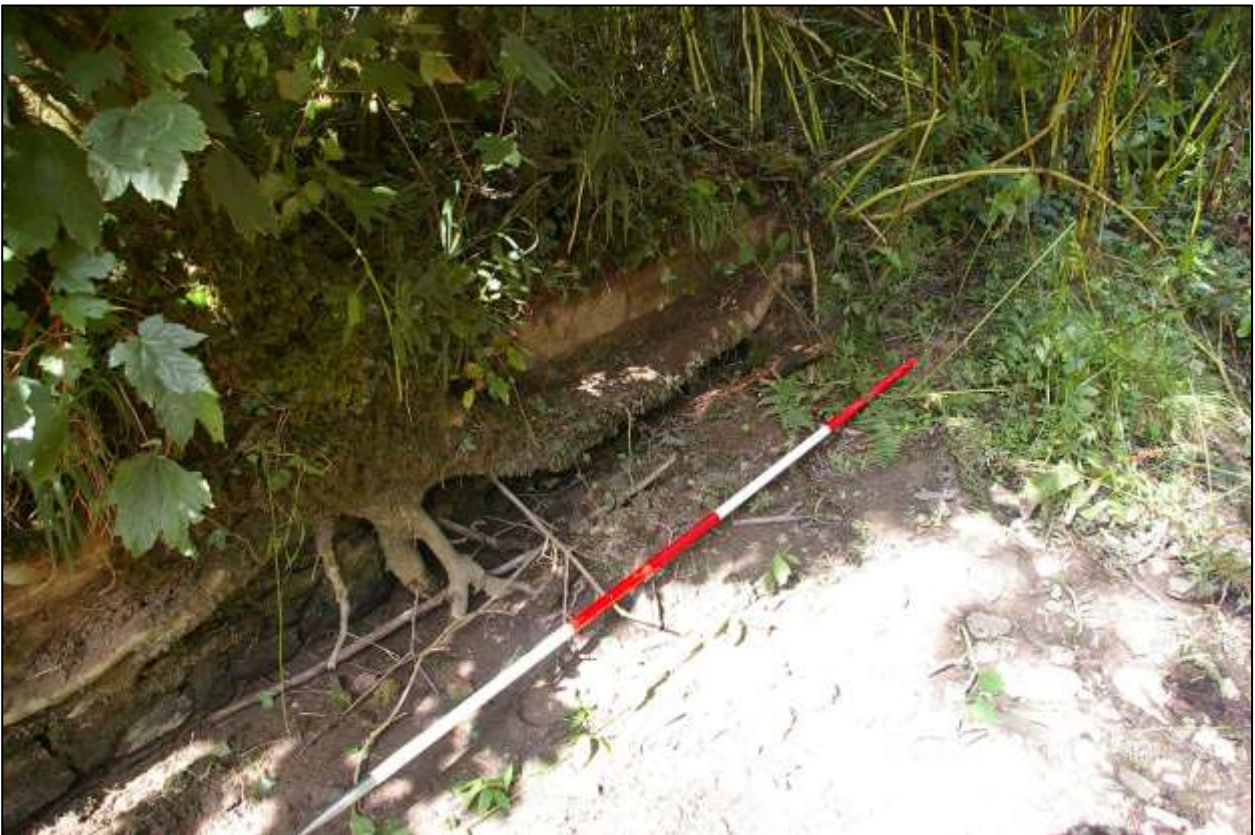
The weir, possibly due to its significant change in height and shape, is moving the water in such a way across its form that it is scouring and undermining its own structure. The riverbed, once drained, is significantly washed away under the east wing wall and weir, hence the collapse at the front end, the front rectangular upright concrete kerbs, which likely framed the vertical drop, are now loose, lying away on a bed of scoured stones. The east bank below the weir has suffered from being blown out by the river, making a very thin spit of riverbank between the river and leat. The west wing wall is being damaged by the roots of a large tree and is slowly tipping into the river.

39. DETAIL SHOWING THE MASSIVE ROOT OF A TREE WHICH HAS GROWN INTO THE WEST FLANK WALL OF THE WEIR STRUCTURE, WITH 2M SCALE; FROM THE EAST-SOUTH-EAST.

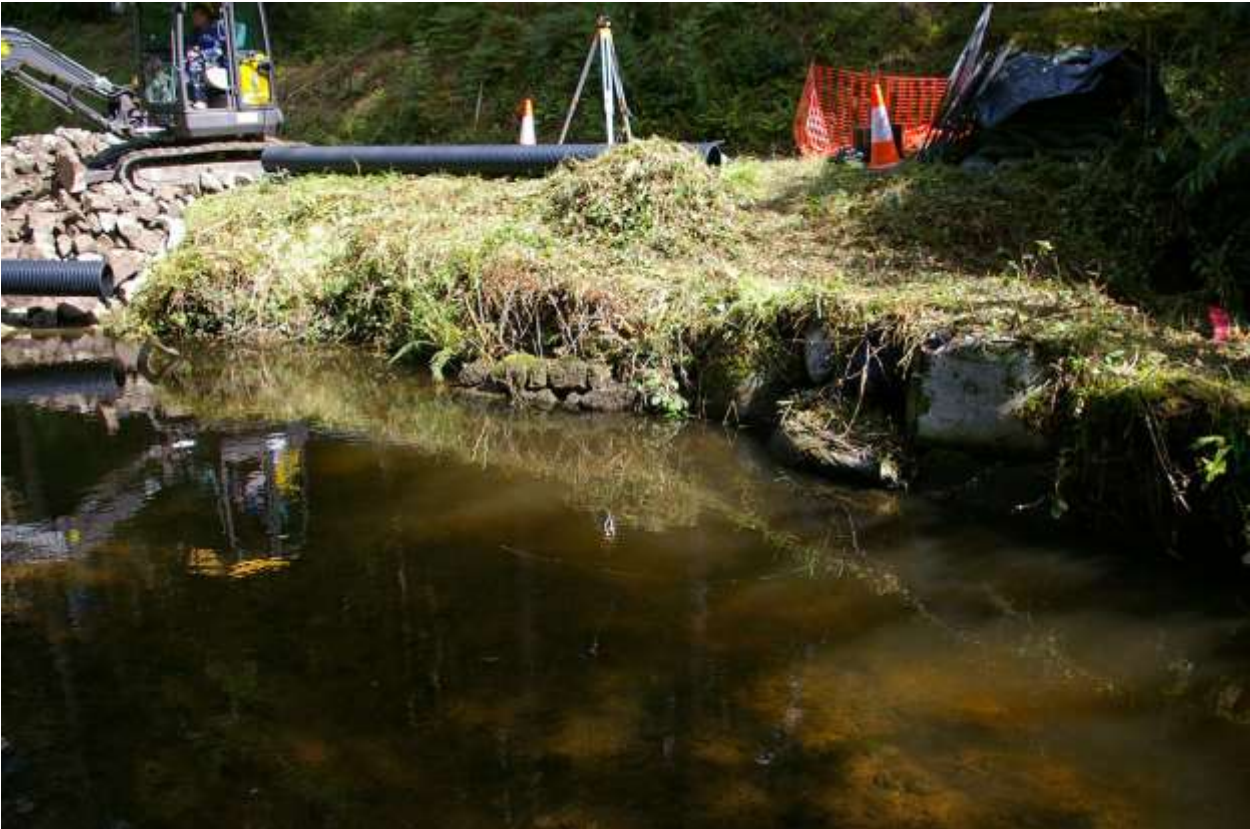
40. LONG VIEW OF THE RIVER BANK, RUNNING NORTH AWAY FROM THE WEIR, UPSTREAM, SHOWING A SMALL SECTION OF MORTARED ROUGH BLOCKS, WHICH ARE COMING FREE FROM THE BANK, SHOWING THE SCOURING PROBLEM ON THE EASTERN SIDE OF THE RIVER HERE; FROM THE SOUTH-SOUTH-WEST.
