**TRAVIS PERKINS  
MAYOR'S AVENUE  
DARTMOUTH  
DEVON**

Desk-Based Assessment & Updated Historic Building Recording

South West Archaeology Ltd. report no. 190906

By E. Wapshott & B. Morris  
Report Version 03  
6<sup>th</sup> September 2019

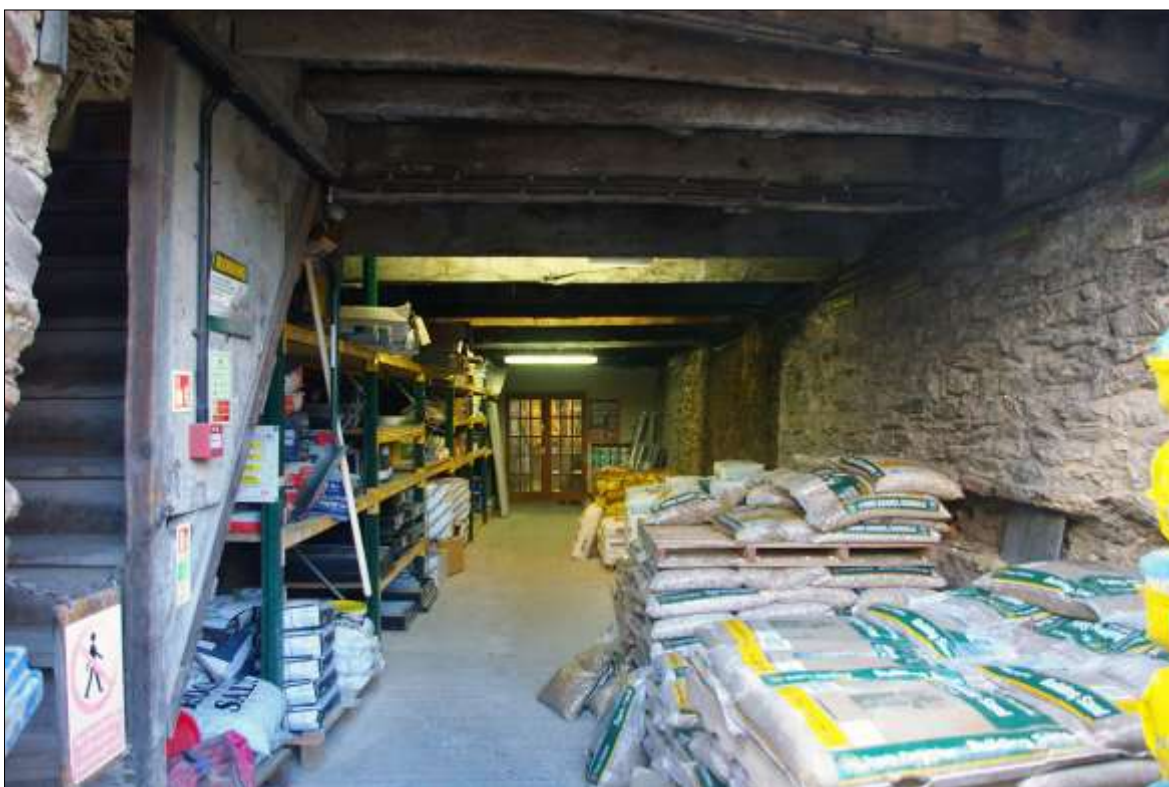
FIGURE 29: THE GROUND-FLOOR INTERIOR OF B3; VIEWED FROM THE SOUTH.

The stone piers are well-built and solid blocks of slatestone masonry 0.75m wide that rise to first-floor height; the stonework graduating somewhat, and the piers have a slightly battered profile. They rise to just below the current eaves, and then are raised in a loose lime-mortared rubble, suggesting a steeper former roofline. As with those in B1, these piers have chunky timber ties and pads associated with the beams socketed into them and for surface mounted weatherboarding within the bays. They now appear mortared with lime but where several beams socketed into the

piers have failed through water damage the core build seems to be with a brownish-beige clay bond, possibly mixed with some lime. The north and south walls are of inferior mixed slatestone rubble set in a lime mortar. The bays between each pier are infilled with stone rubble, concrete block, with framed timber weather-boarding to the two northern bays (W16 and W17). The south wall features a forced or widened opening ground-floor level carried on a reused timber lintel (D13) with a slightly narrower loading door above (D19); above the loading door is a projecting gabled pentice of corrugated sheet steel covering a flywheel (S23); the timbers carrying the flywheel extend back to the first roof truss. The north wall has blocked doorways at ground- and first-floor level, with 17<sup>th</sup> century yoked timber lintels reused upside down (BO34 and BO46).

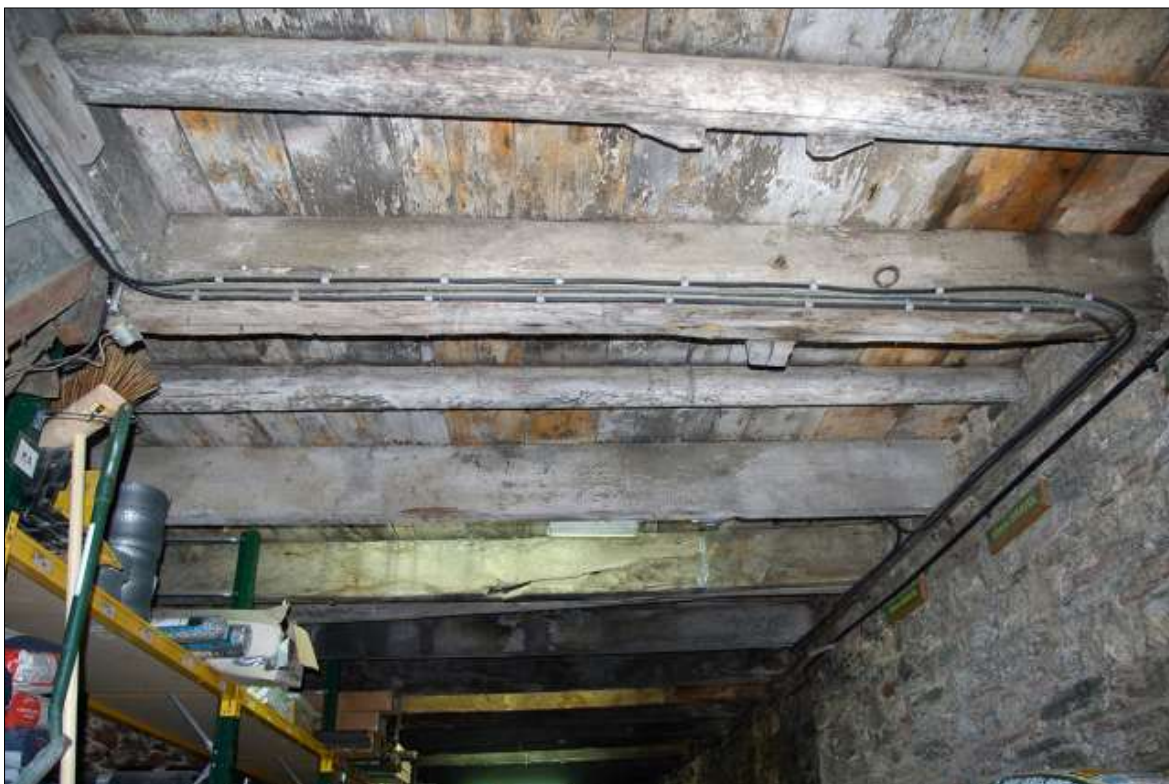
FIGURE 30: SOME OF THE JOISTS IN B3, SHOWING THE REUSE OF SHIPS TIMBERS; VIEWED FROM THE SOUTH.

The joists supporting the first floor contain a range of reused elements, 17<sup>th</sup> and 18<sup>th</sup> century in date (S4), with larger beams with deep chamfers and partition slots, peg holes and sockets for timber framing. The heaviest beams are set into the piers in the east wall; less substantial beams, including another ships mast cut in half and another possible base of a ships mast, seen supported within the later stone rubble infill. One heavy beam has anchor graffiti imagery cut into it. The bays in the east wall between the piers are spanned by very heavy chamfered beams; these survive even in those bays now blocked, generally in good condition. The removal of external cladding and racking to the east (exterior) elevation, exposed some very damaged oak beams, of a

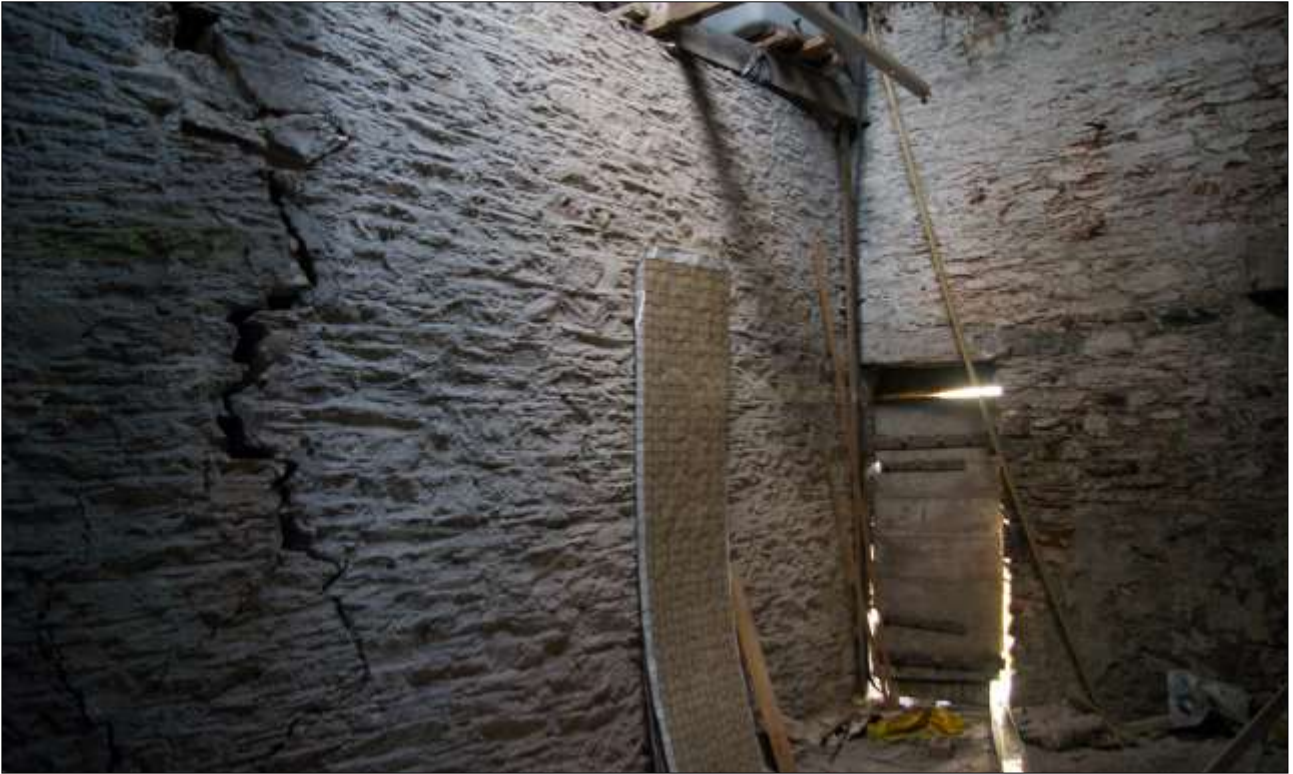
74. B1 FF R2, VIEW OF THE STRUCTURAL CRACK IN THE WEST WALL, AND D22 IN THE NORTH WALL; VIEWED FROM THE SSE.

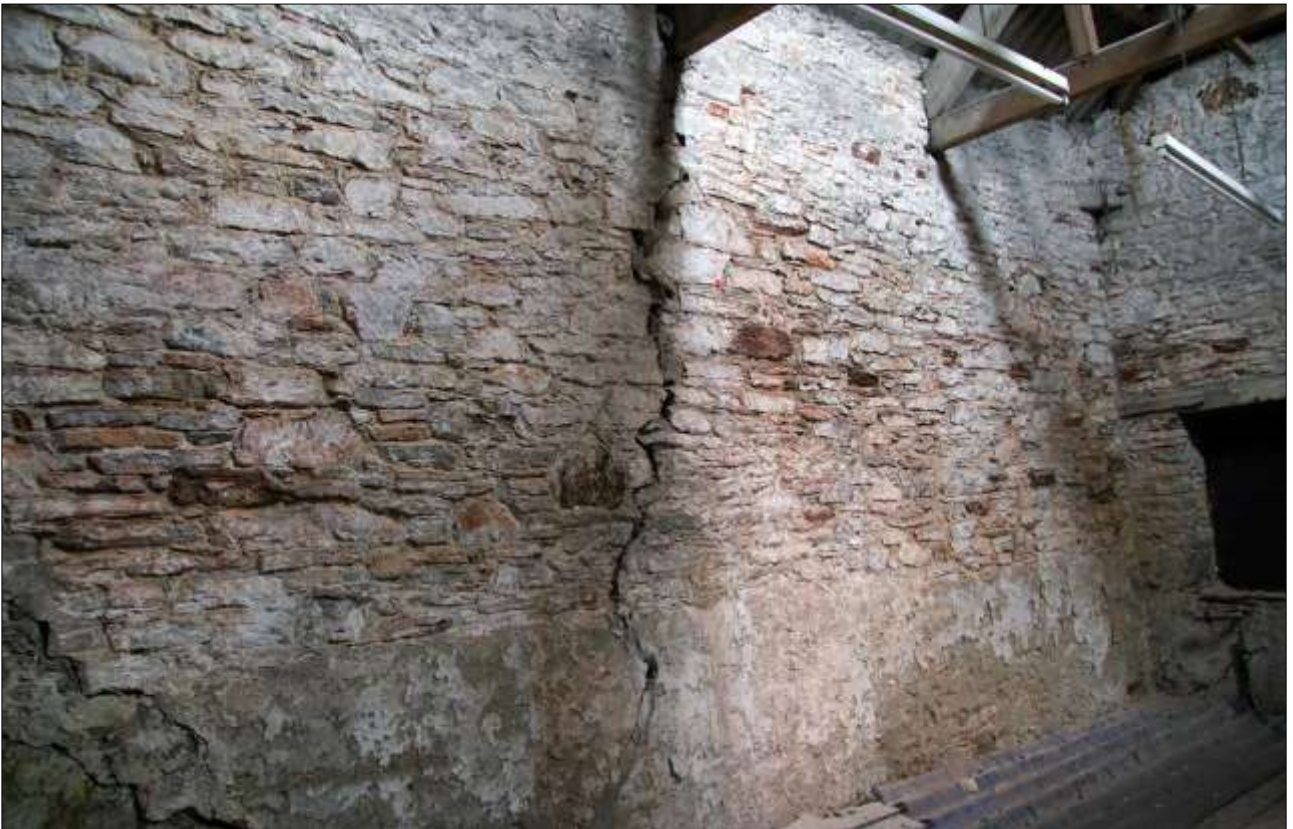
83. B1 FF R3, THE WEST WALL OF R3 SHOWING ITS STRUCTURAL CRACKS; VIEWED FROM THE SOUTH-EAST.

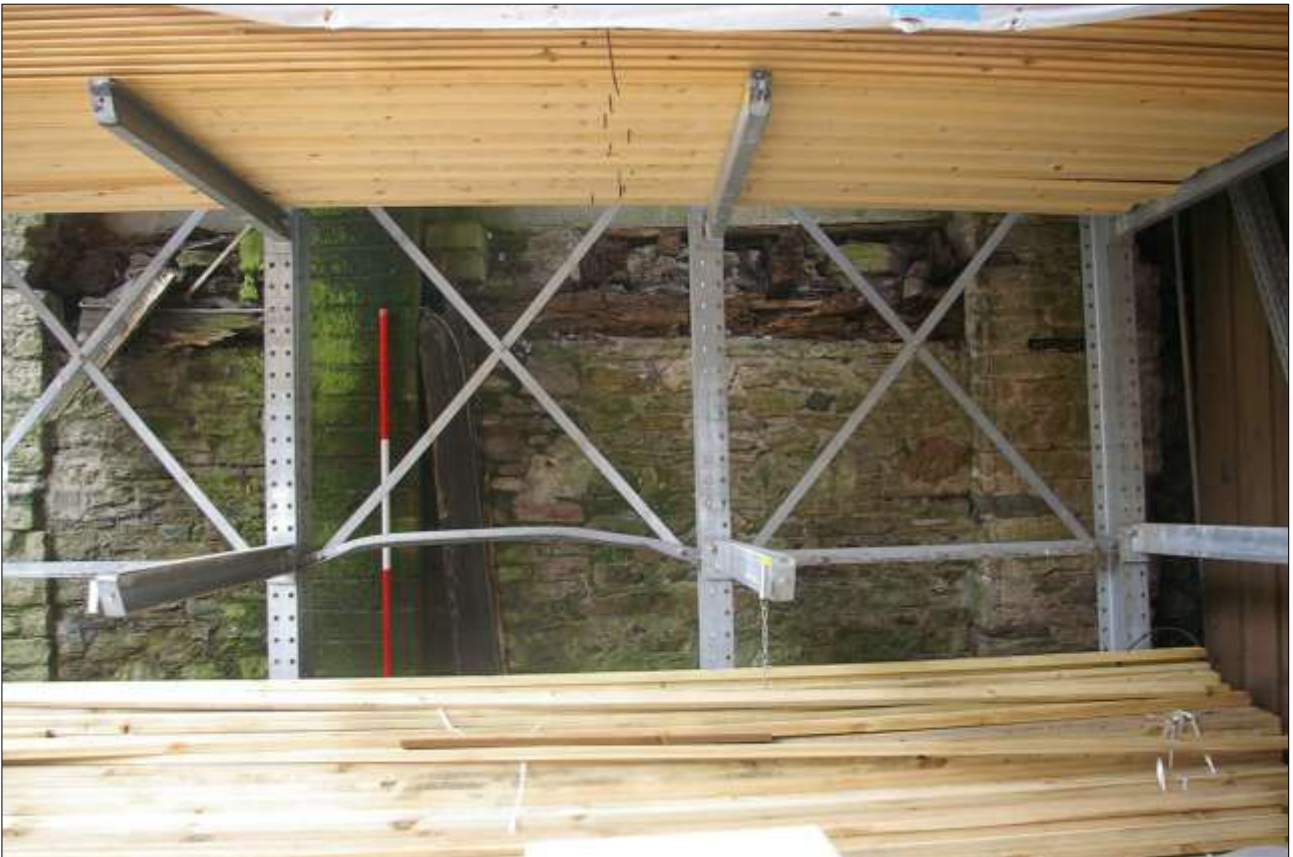
144. THE EAST ELEVATION OF B3, DETAIL OF THE BLOCKED OPENING AND DECAYED TIMBERWORK; VIEWED FROM THE EAST (SCALE 2M).

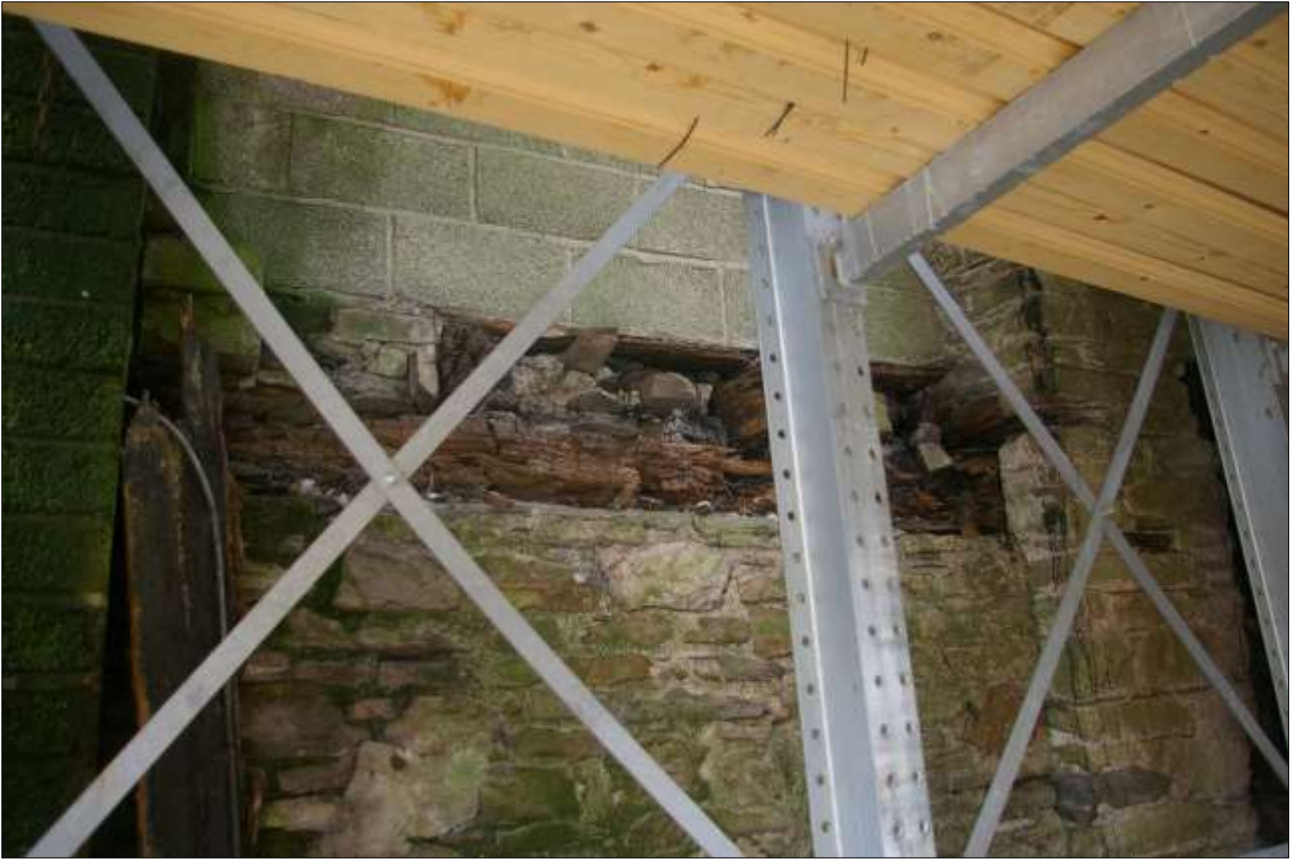
145. THE EAST ELEVATION OF B3, DETAIL OF THE DECAYED TIMBERWORK; VIEWED FROM THE SOUTH-EAST.

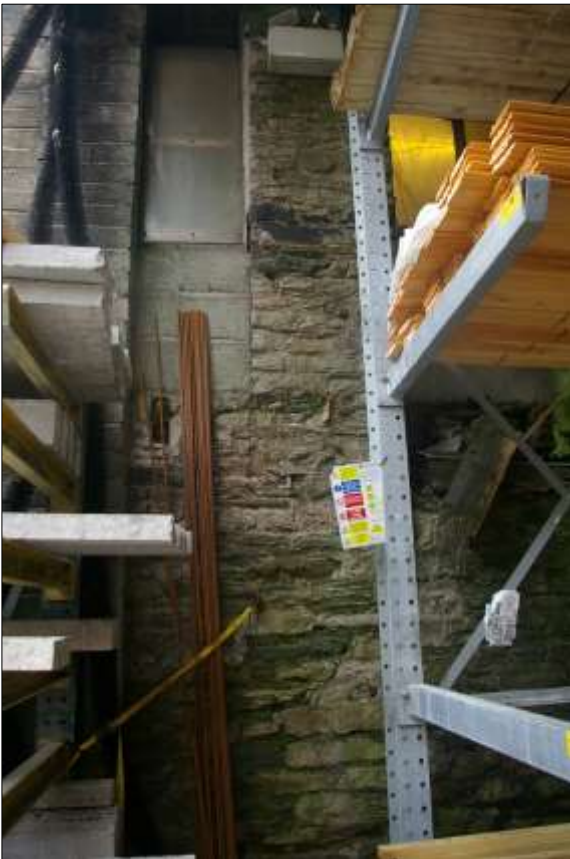
146. THE EAST ELEVATION OF B3, DETAIL OF THE STONE AND CONCRETE PIERS; VIEWED FROM THE EAST.
