THE BARNs
CHELFHAM BARTON
BRATTON FLEMING
NORTH DEVON

Historic Building Recording and Archaeological Monitoring

South West Archaeology Ltd. report no. 201013

By Dr S. Walls, E. Wapshott & A. Allen
Report Version: FINAL
Issued: 13th October 2020
Finalised: 22nd July 2021

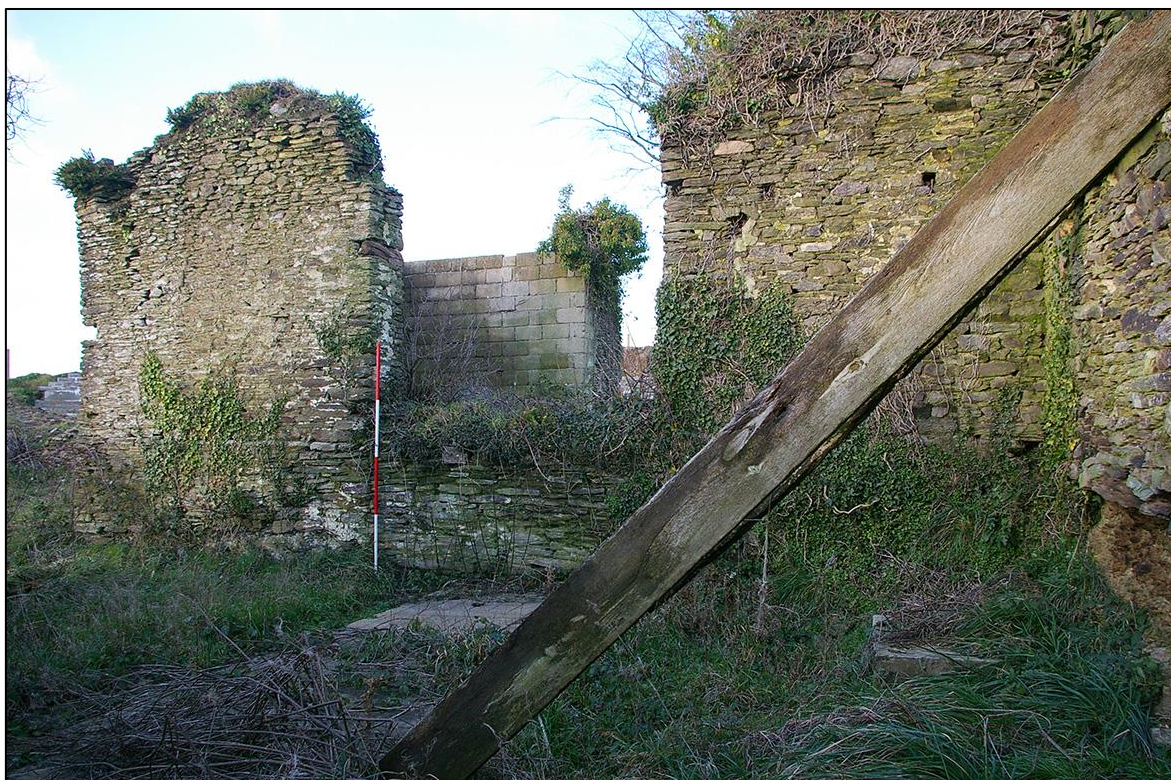
FIGURE 13: B2A, SOUTH WALL, SHOWING THRESHING DOOR; FROM THE SOUTH-EAST (2M SCALE).

timber window frame. To the centre the wall has been raised to a pointed gable with a slit vent at the apex, where abutted by B4 and appears to have been adapted to address B4, to the east. The south end of the wall contains a threshing opening with timber lintel and heavy oak doorframe, again where the building has been extended with a looser stone rubble beyond. The floor slopes gently to the south and is covered by a thin poured, concrete layer. There is a deep step more than c.1m depth to the south end where the barn has been extended and the ground terraced; a former has been gable removed. The lower area of floor retains the damaged remains of a threshing floor.

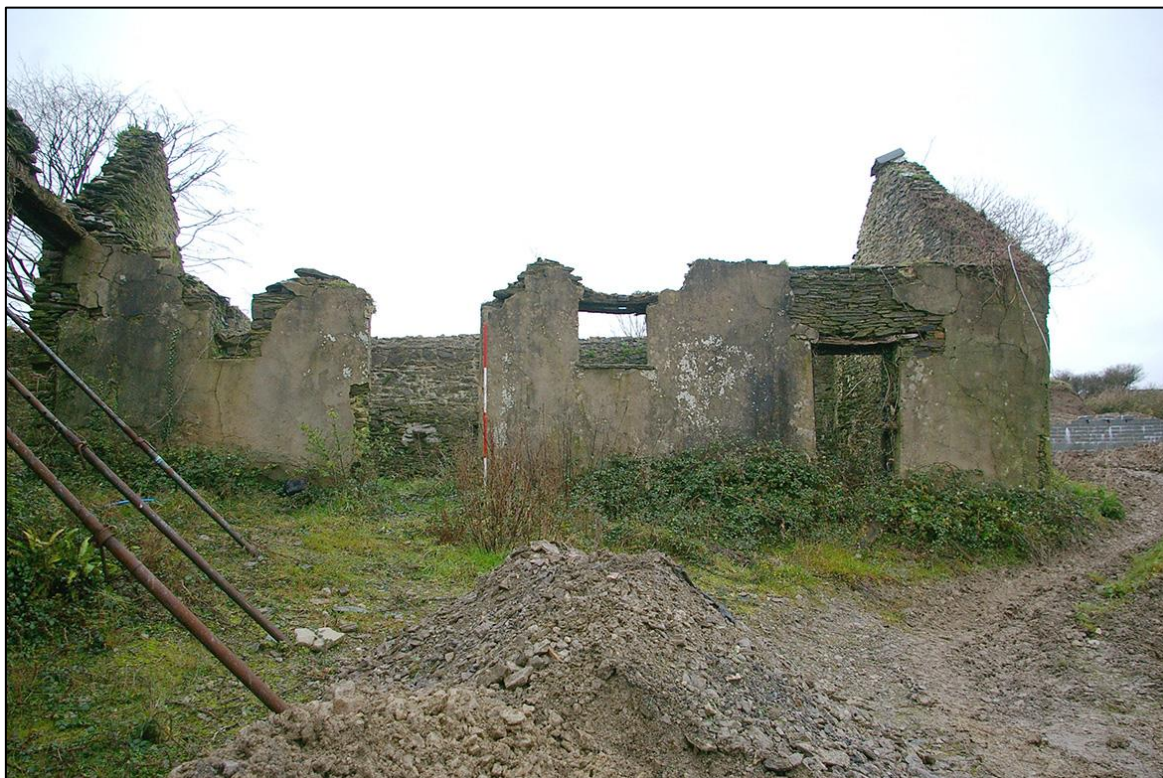
This is a narrow rectangular building on an oblique south-west to north-east alignment, built up against B2B. It is of single-story height, comprised of north, east and south walls; with tall gable to the east with joist sockets, indicating a fodder loft within the roof space. The walls are of loose slate stone rubble, in a mix of lime bonds and mortars, with cement re-pointing. The north and east walls are blind, the north wall incorporates an earlier set of foundations on a different alignment, next to B2B. The south wall, which has been partially rebuilt in cement mortars, contains two doors and two windows, the door to the east end is narrower with a plank door surviving, the window wider, with sloping reveals and the remains of a timber frame. The west door is wider with a chunky timber frame and heavier timber lintel being lower in height and the window to the west end is very narrow, with a surviving timber frame (Figure 16). The interior has

FIGURE 16: B4, SOUTH ELEVATION FACING THE FARMHOUSE; FROM THE SOUTH-WEST (2M SCALE).

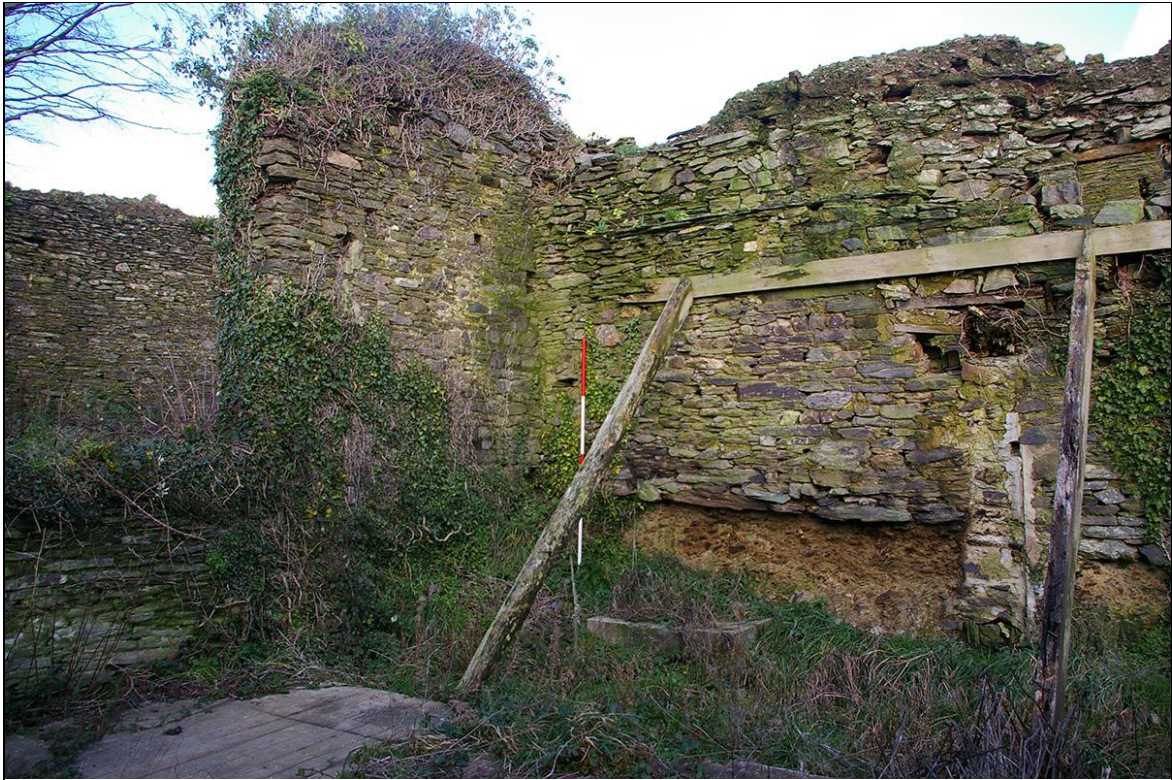
FIGURE 18: VIEW OF B2A AN 18TH CENTURY THRESHING BARN, ABUTTING THE EARLIER HEAVY SLATE WALLING OF B2B, WITH SLAB WEATHERING COURSE; FROM THE SOUTH-WEST (2M SCALE).

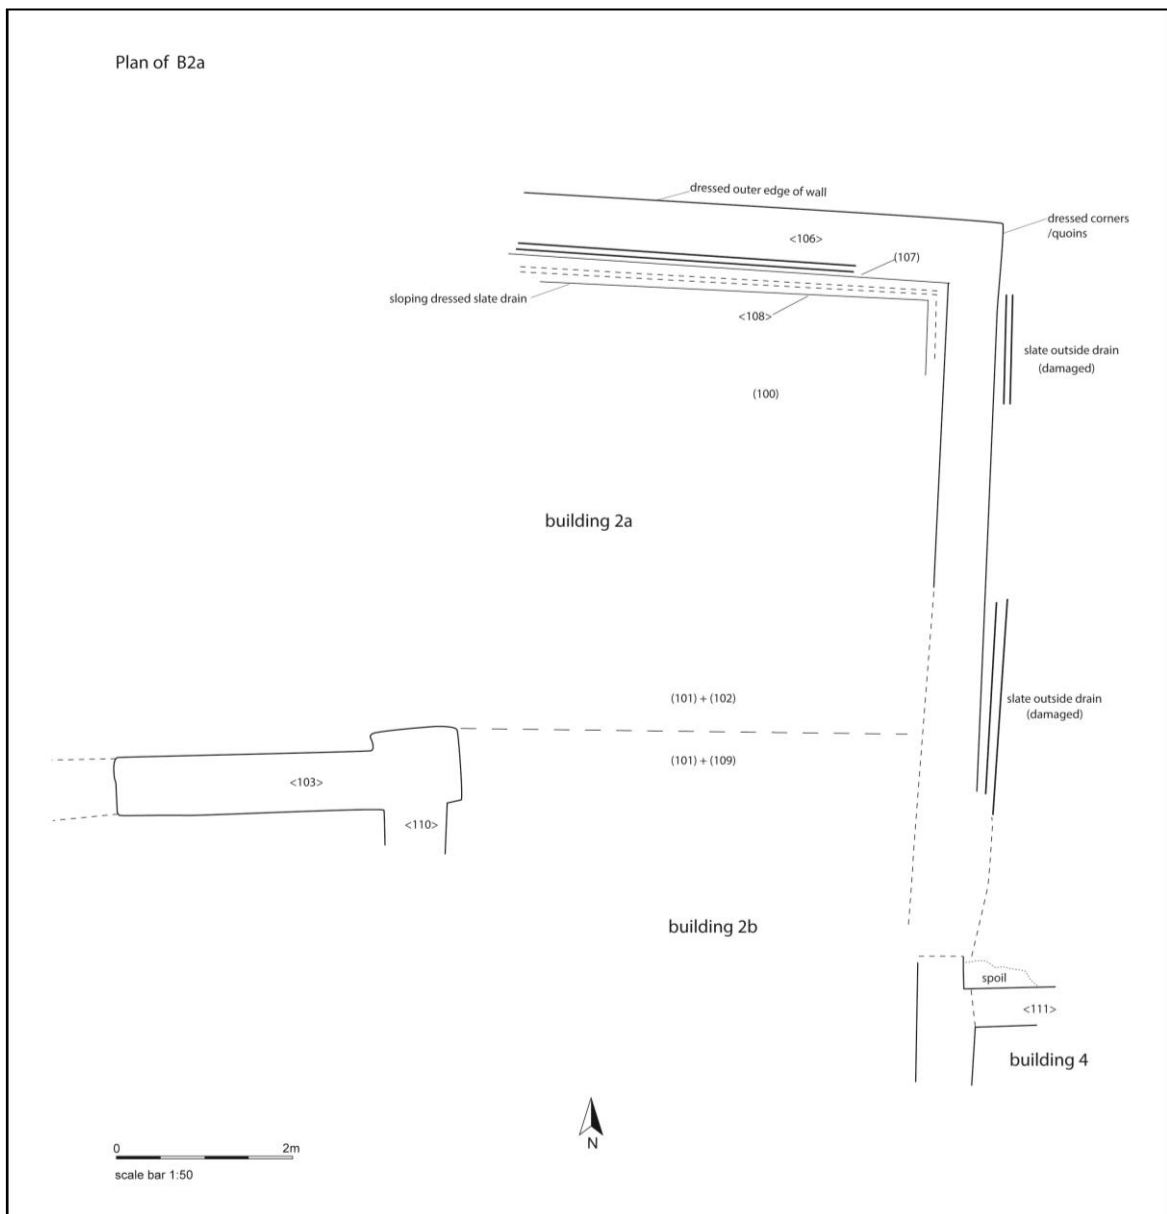
The machine cleaned back the foundations of the north and east walls and exposed along the north wall the damaged remains of a dressed slate slab internal drain/gulley and to the east wall a more damaged internal and external drain. These features had been obscured previously by the

internal and external concrete. The foundations themselves were seen to be surprisingly substantial, whilst broadly following the footprint of the barn, they were slightly offline, and the form of these foundations was markedly different from the build of the once upstanding buildings (Figure 20). The foundations were built of thick coursed slate slabs of massive size, laid in a thick clean clay bond {106}. The inner face of the north wall was lined with slate/shale packing of a noted blue colour (107), between it and the heavy dressed brown-grey slate slabs of the drain {108}.

The drain {108} could be seen to return to the south, along the inner edge of the east wall and very damaged continuing blue-grey sections of slate packing (107) could also be seen along the outer edge of the east wall. The foundations of the eastern wall were shallower and in places had been wholly replaced with more recent stonework, being slightly off-alignment with the once standing wall this can be seen to represent the plinth noted during the building survey, a later barn wall rebuilt on the base of an earlier wall.

FIGURE 21: THE POSITION OF THE SLATE DRAIN {108} AND PACKING (107) ALONG THE NORTH AND EAST WALLS OF B2A.

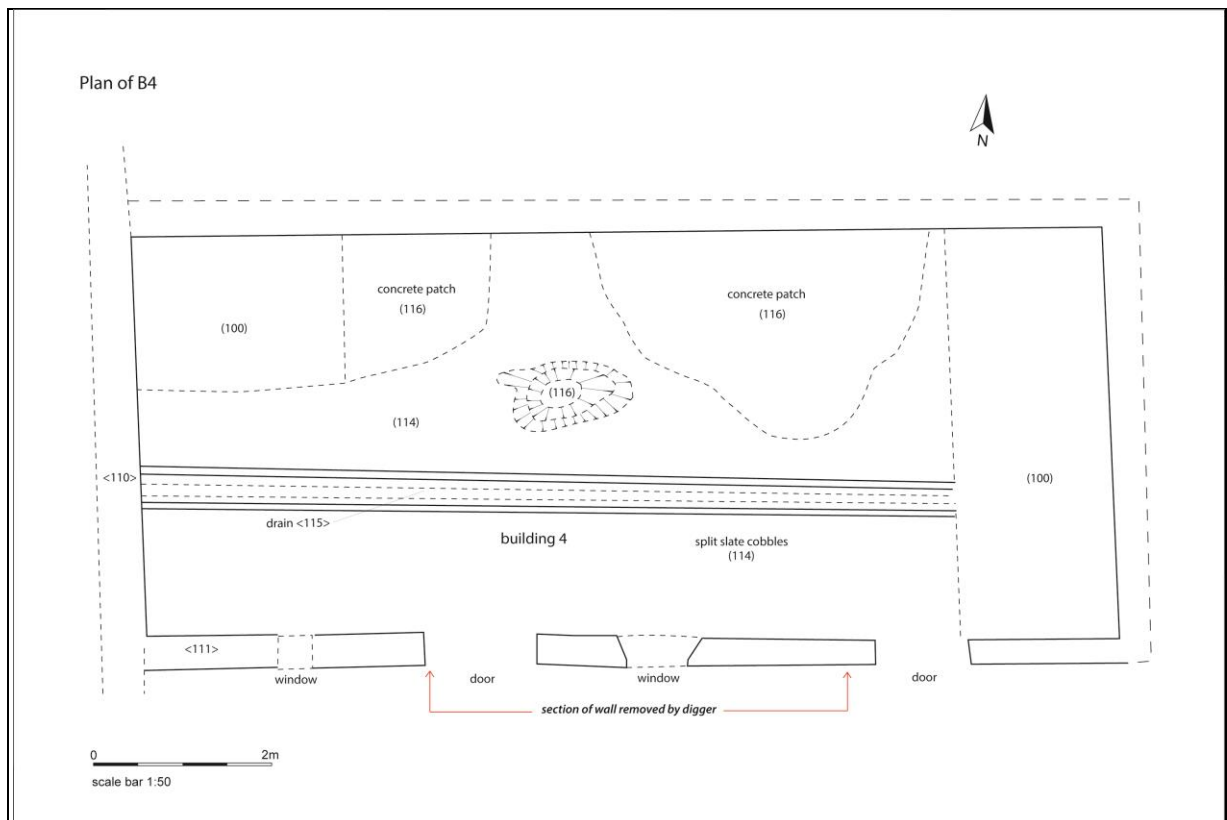
The cobbles in B4 were covered by soil, animal waste and thick pads of rotten and growing weeds. This was cleared by hand using shovels and trowel, so that the floor and drain could be planned. The cobbles were seen to be quite regular split slates, laid in a single uniform, thin layer (114). They were much patched in a grey-coloured fine textured concrete (115) and there was a large damaged section to the centre. There were some slight indents and small holes which may have been stall partition slots, but due to the general damage this could not be fully confirmed. There was a generous split slate drain [115], with upright slab sides and flat bottom of mixed slate stones, the drain was between 0.03-0.05m deep on average across the floor; noticeably shallower than functionally ideal.

Modern works had removed a corner of the cobbles to the north-west and also for a wider stretch to the east end of the building, showing that the cobbles were laid directly onto undisturbed rich brown subsoil and yellow-brown natural clay-silt, but had some packing of lime and possibly sand between them. A central section was also excavated via grading bucket and monitored to check this was the case across the footprint of the building and that there were no earlier walls, floors or features to record (Figure 22).

FIGURE 22: THE PLAN OF B4, SHOWING SURVIVING EXTENT OF COBBLES.

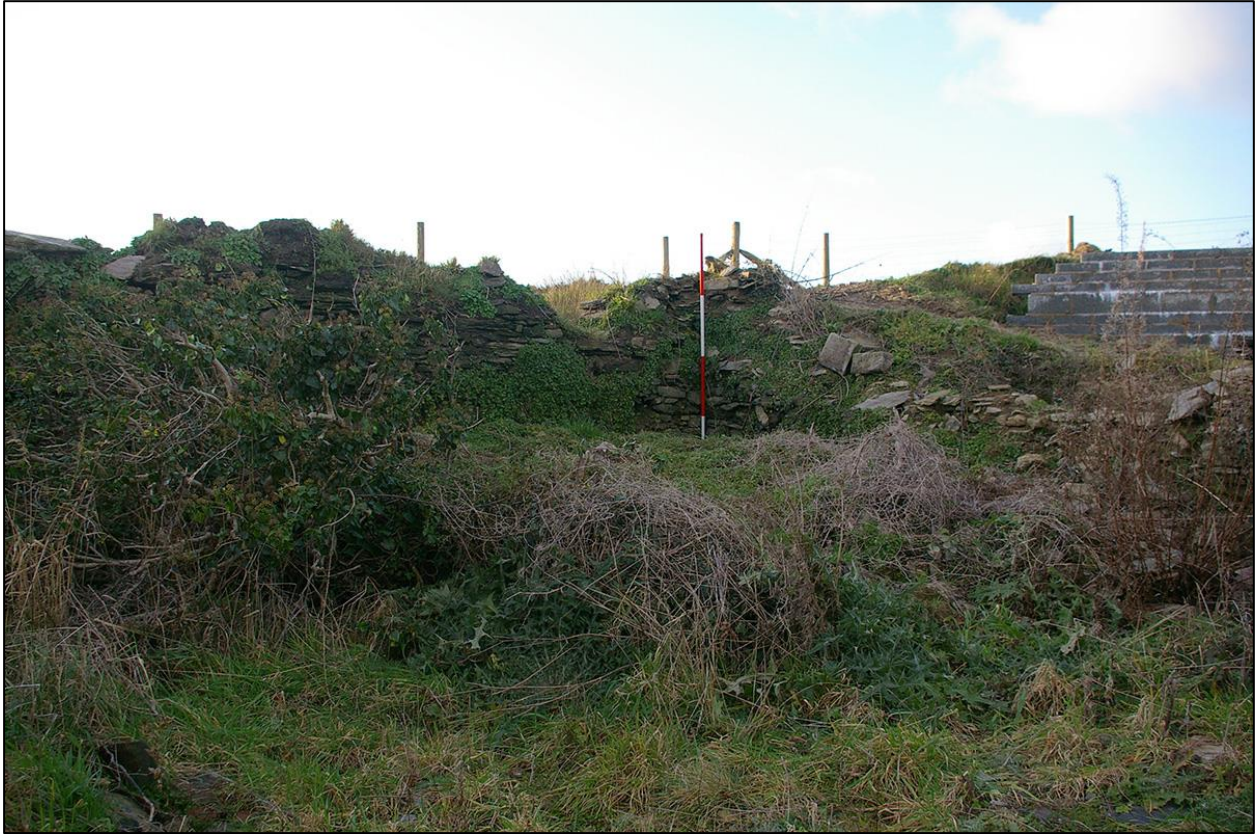
3. BUILDING 1 AND ITS RUINOUS WESTERN WALL, WITH COLLAPSED WINDOW OPENING. TAKEN FROM THE SOUTH EAST.

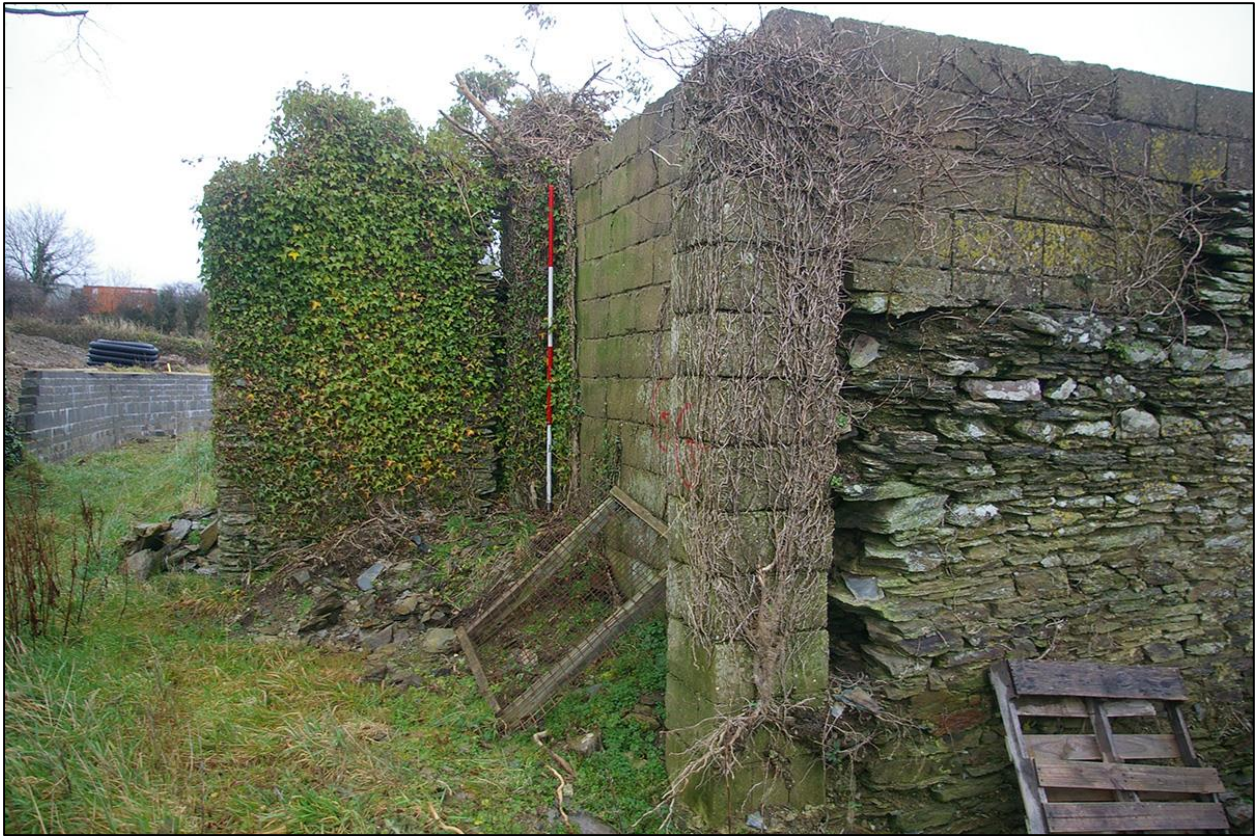
10. BUILDING 2A LOOKING AT THE REBUILT CONCRETE WALL IN THE WESTERN CORNER (WITH 2M SCALES). TAKEN FROM WEST.

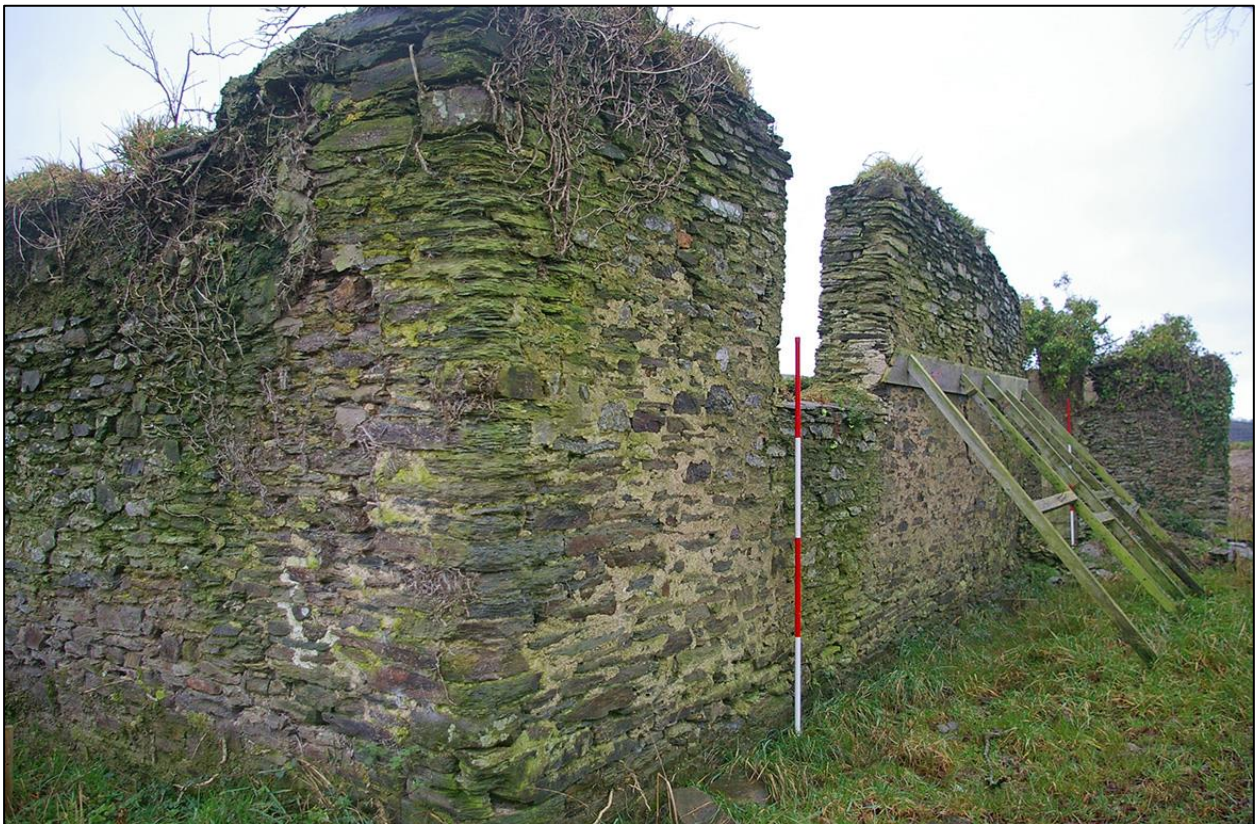
15. BUILDING 2A AND FORCED NORTHERN WINDOW. (WITH 2M SCALES). TAKEN FROM THE NORTH EAST.

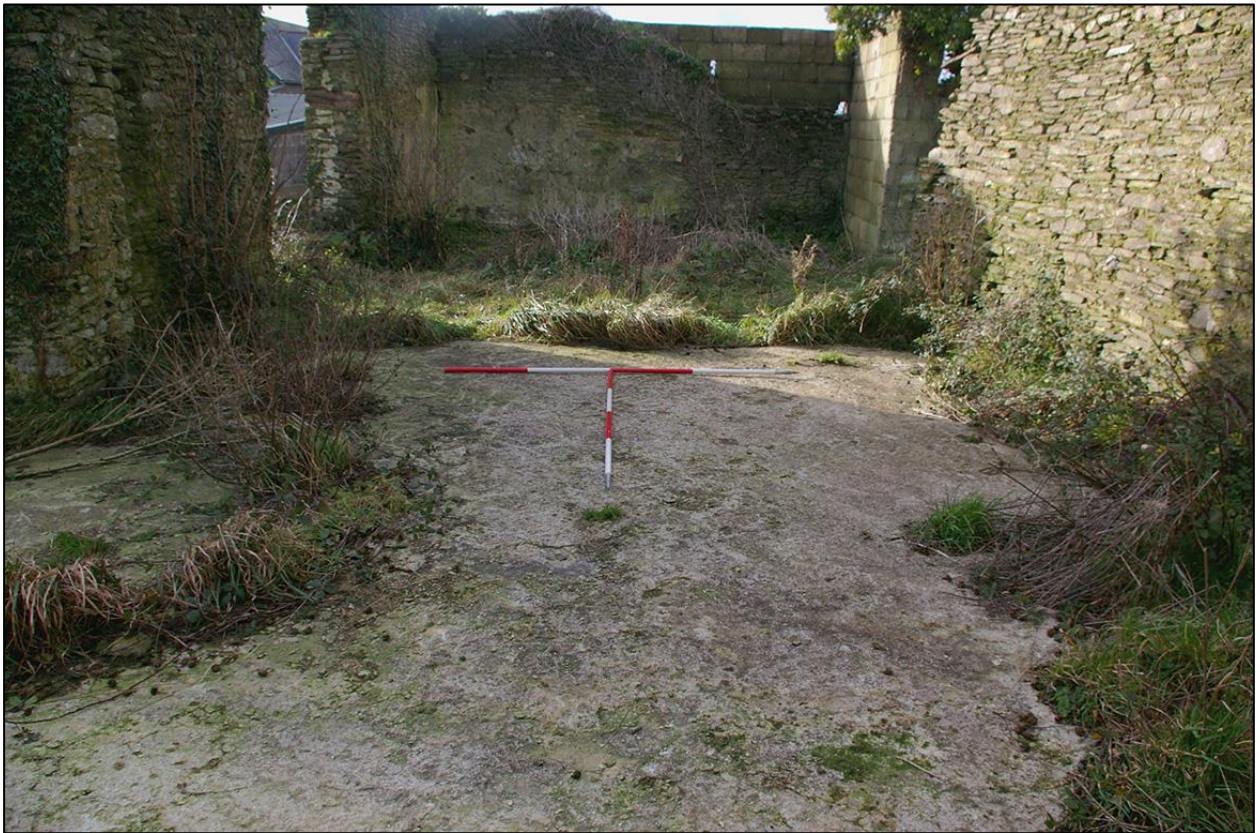
20. BUILDING 2A LOOKING ONTO CONCRETE EXTENSIONS AND THE UNEVEN THRESHING FLOOR. (WITH 2M SCALES). TAKEN FROM THE NORTH WEST.

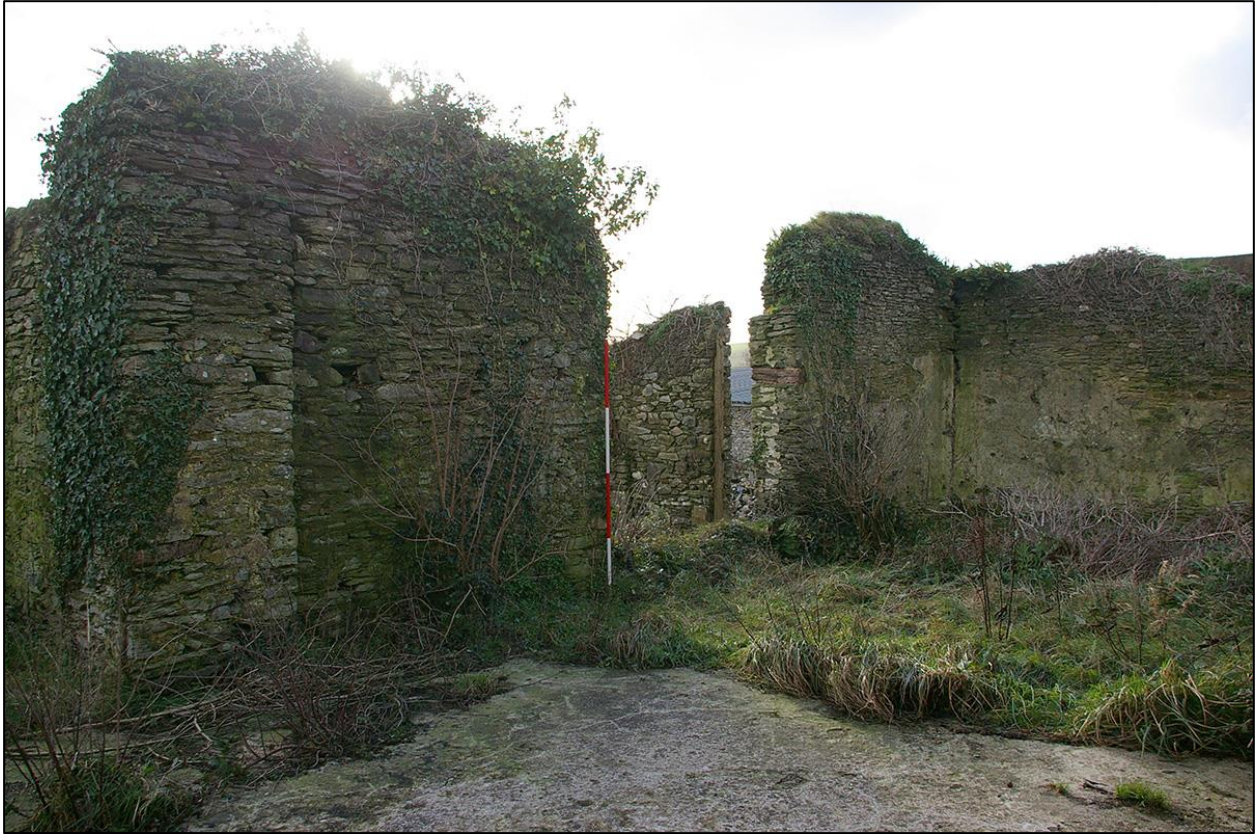
21. THE SOUTHERN WALL OF B2A; SHOWING THE STURCTURAL PILLAR ADDED LATER TO SUPPORT NEW ROOF FRAMES. (WITH 2M SCALES). TAKEN FROM THE NORTH NORTH WEST.

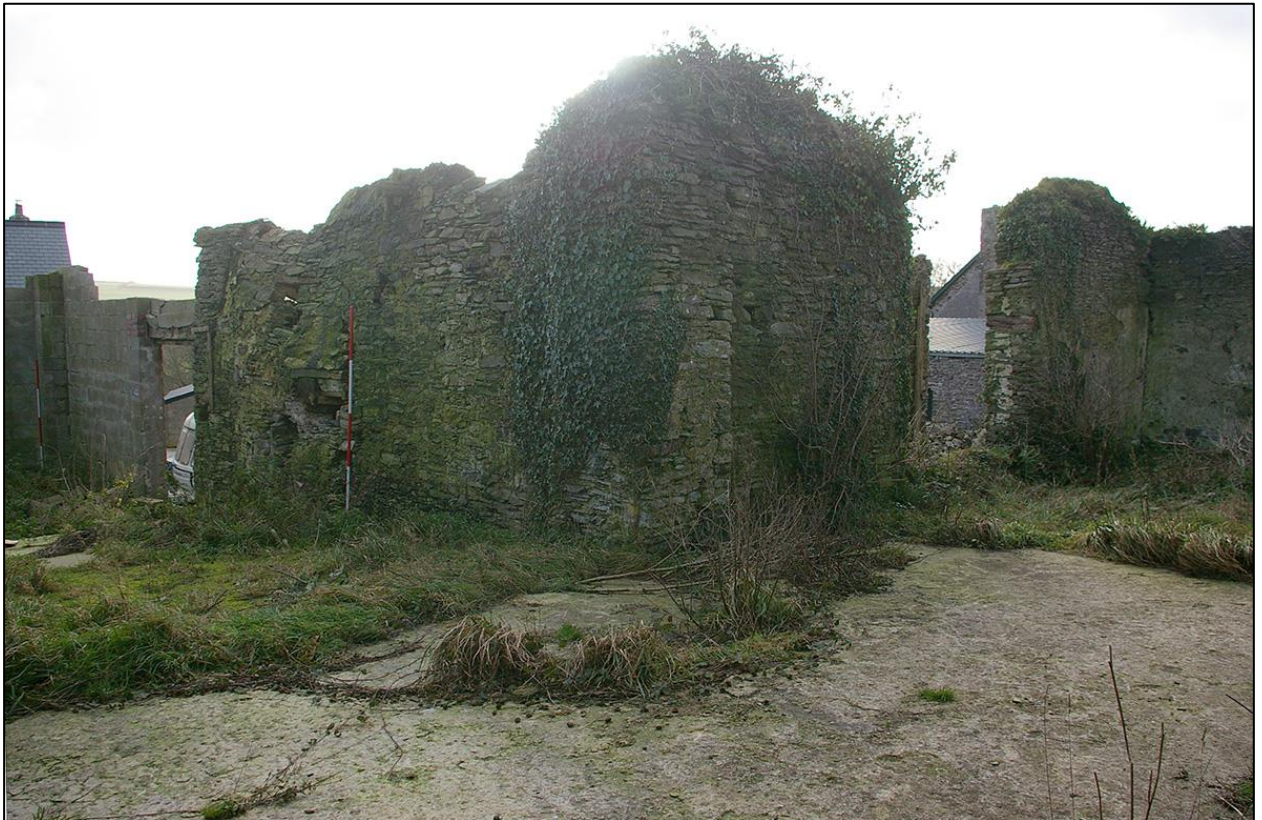
40. B2A AND B2B SHOWING THE LATER BRACING PIER. (WITH 2M SCALES). TAKEN FROM THE NORTH EAST.

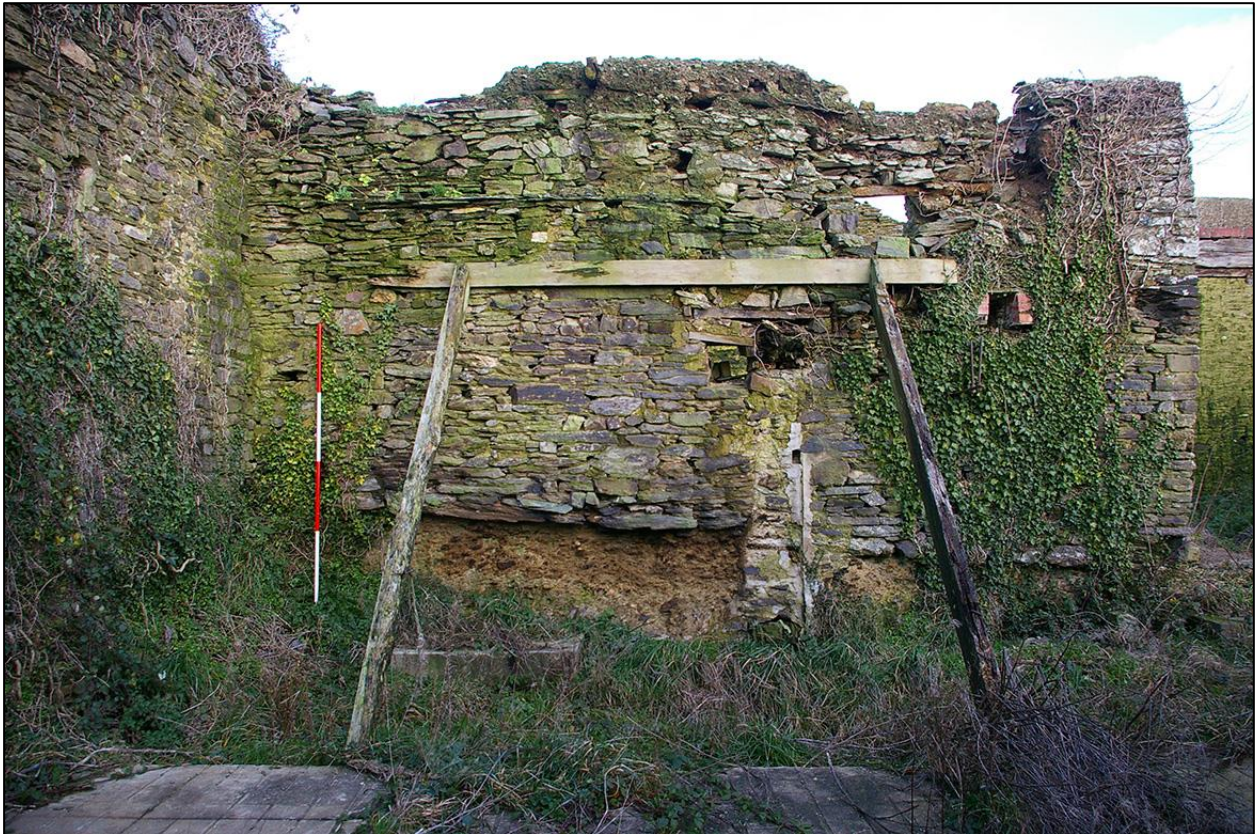
45. WESTERN FORMER EXTERIOR WALL OF B2b SHOWING WEATHERED SLATE RAIN COURSE AND THE BEDROCK FOUNDATIONS. TAKEN FROM THE WEST.

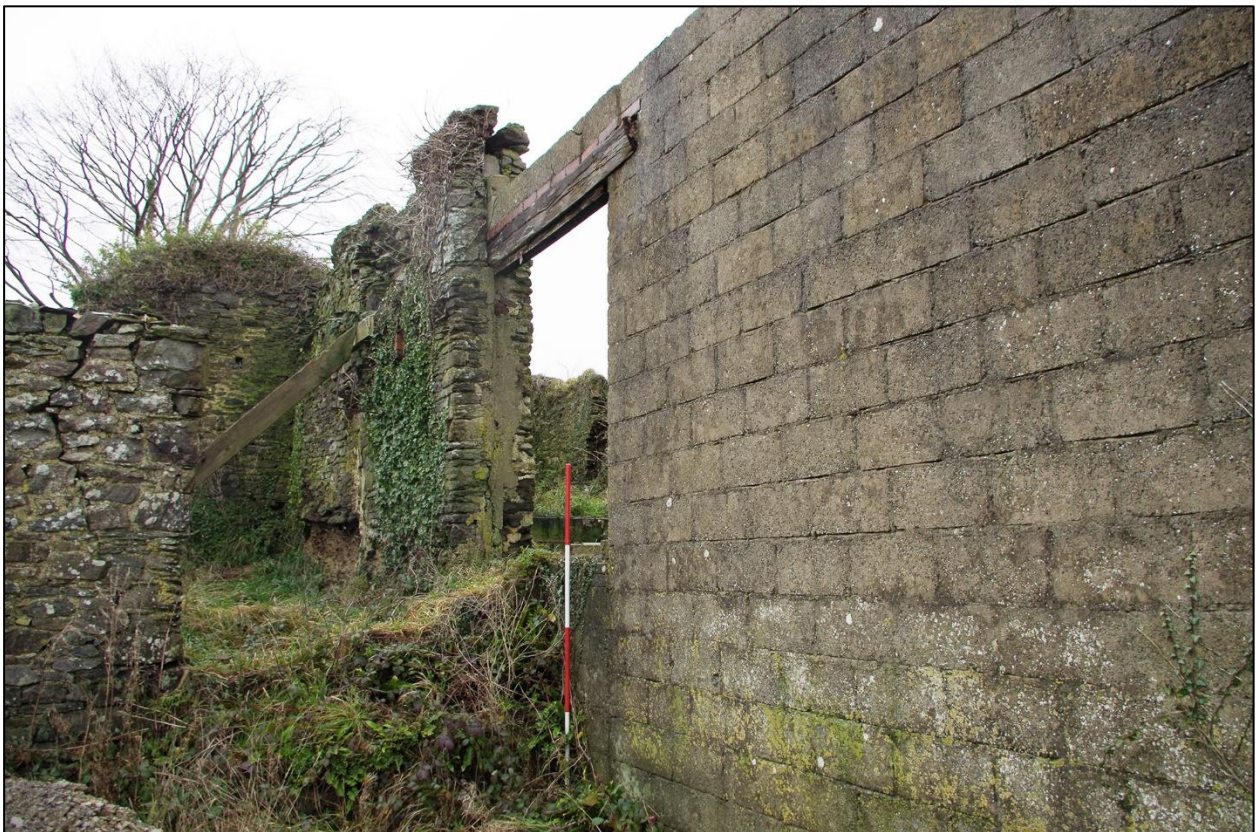
46. THE LATER ADJUSTED WESTERN CONCRETE BLOCK EXTERIOR OF B2b, AND OPENING INTO B3. (WITH 2M SCALES). TAKEN FROM THE SOUTH.

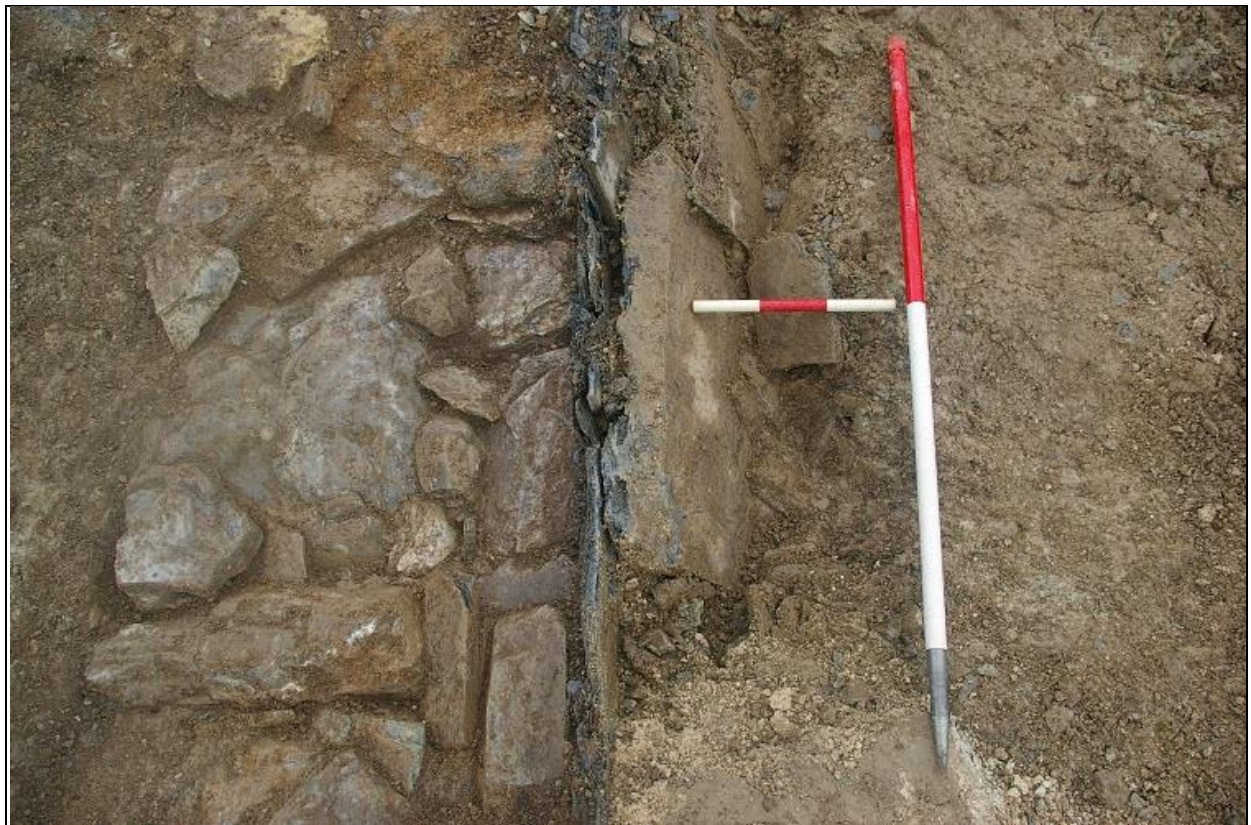
18. NORTH WALL OF B2A, CLEANED BACK TO SHOW BUILD FORM DETAIL; WALL {106}, SLATE PACKING (107) AND DRAIN {108},
0.3M SCALE AND 1M SCALE; FROM THE WEST.

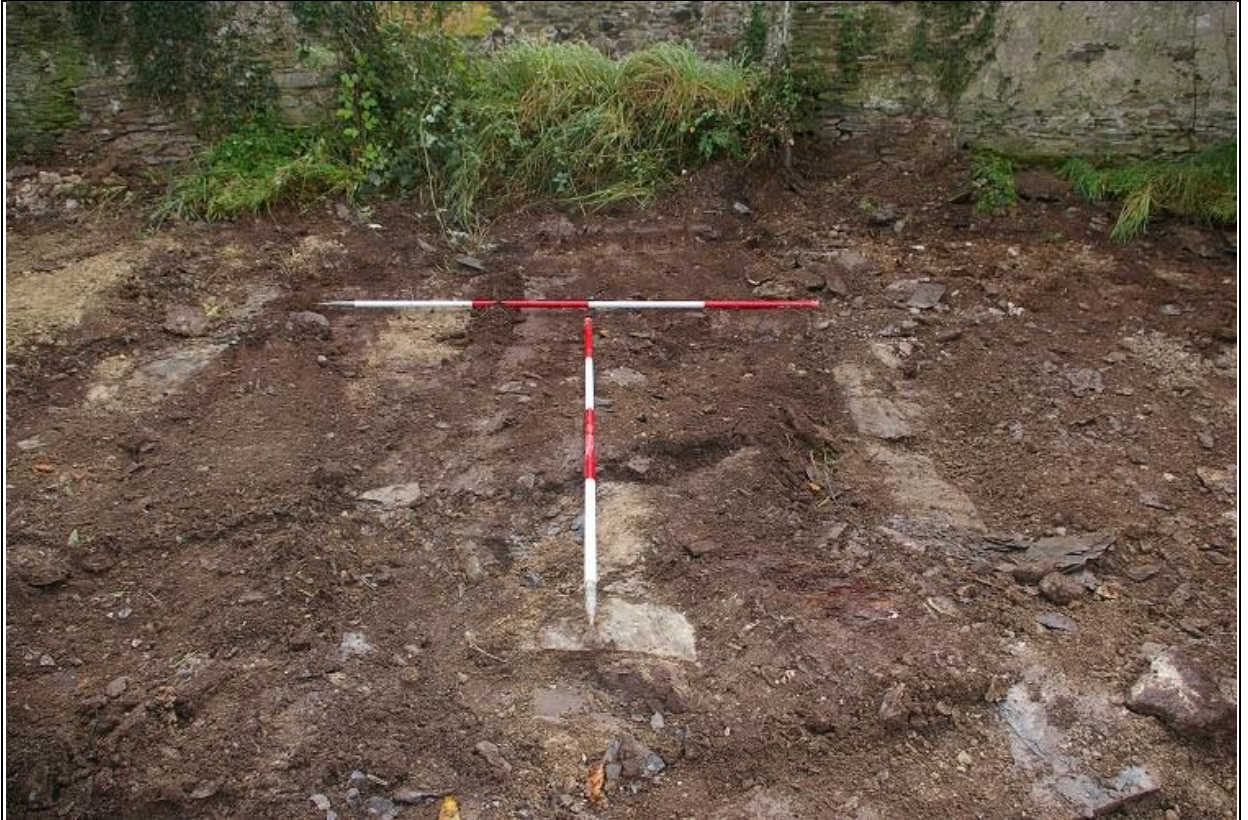
19. THE DWARF WALLS TO THE THRESHING FLOOR IN B2A, SHOWING RICH RED-BROWN ROTTEN WOOD DEPOSIT UNDER CONCRETE, MUCH DAMAGED IN LATER PHASES ON THE FARM (2X2M SCALES).

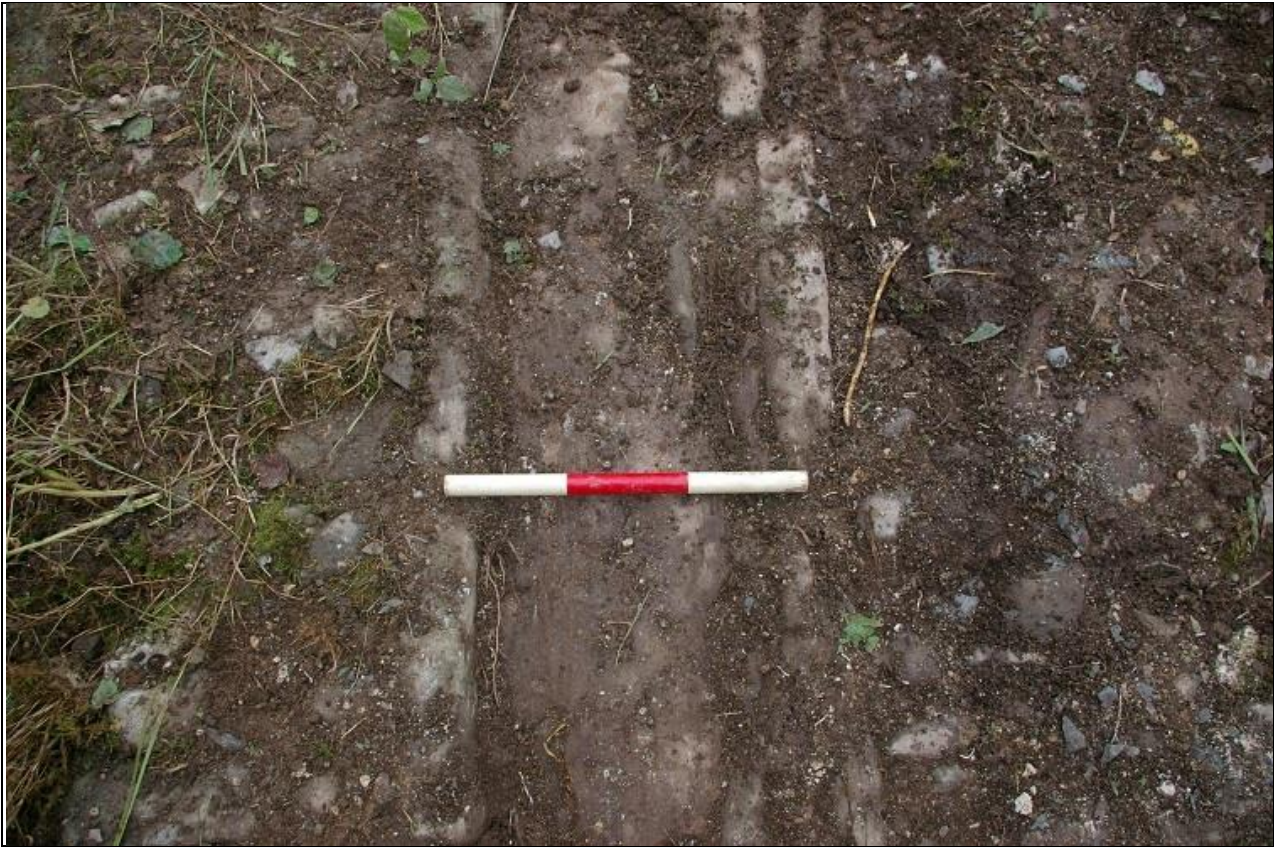
21. DETAIL OF THE SLATE SLAB DRAIN IN B4, WITH 0.3M SCALE; FROM ABOVE.
