**WESTACOMBE COTTAGE  
HEANTON PUNCHARDON  
NORTH DEVON  
DEVON**

Historic Building Recording of the Roof

South West Archaeology Ltd. report no. 200623

By E. Wapshott  
Report Version: **FINAL**  
Assessment issued: 27<sup>th</sup> November 2019  
Reissued with Roof Recording: 23<sup>rd</sup> June 2020

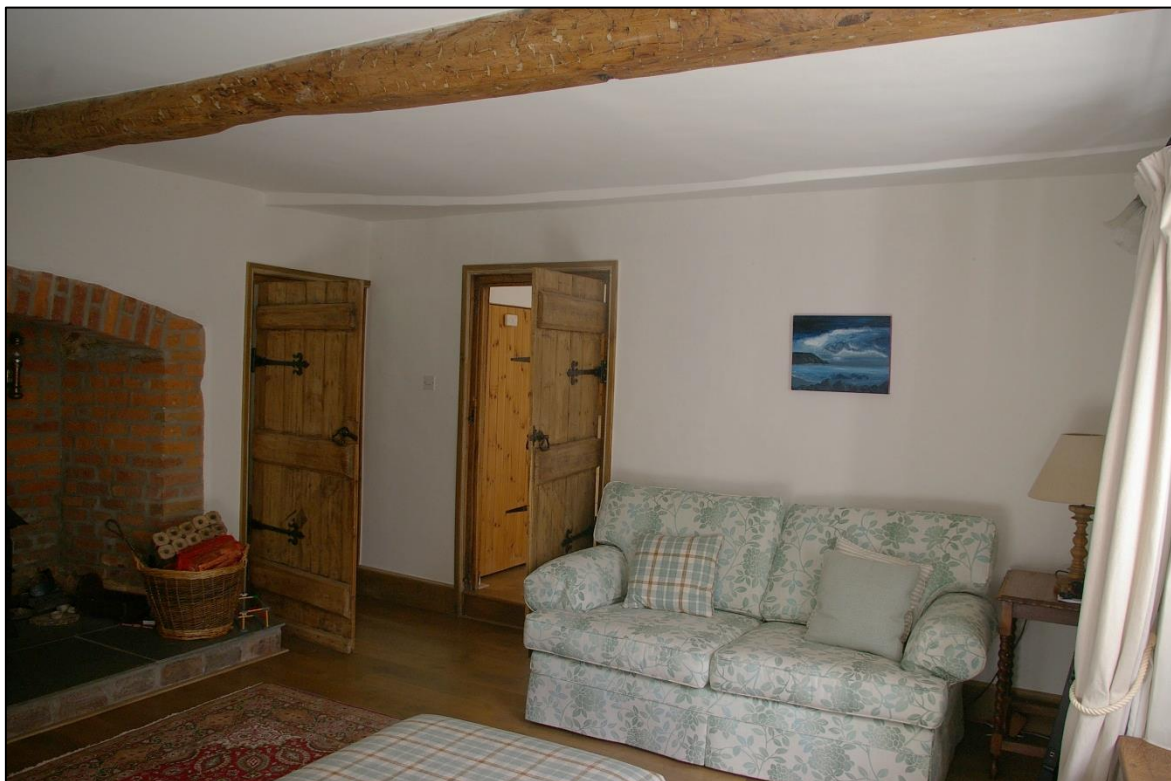
FIGURE 7: THE FORMER HALL, ROOM 3, WITH PLASTERED OVER POTENTIAL JETTY TO THE EAST; FROM THE SOUTH-WEST.

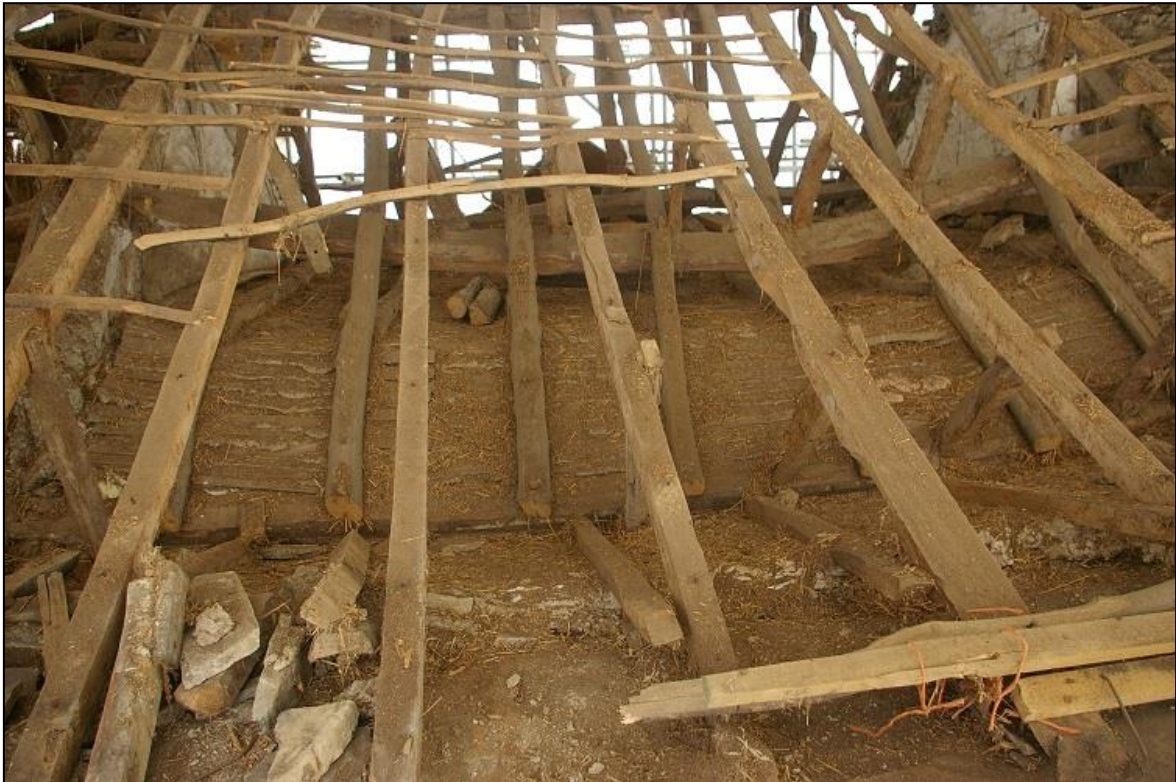
FIGURE 9: BAY 4 OF THE ROOF, WHICH HAS RETAINED ITS 17<sup>TH</sup> CENTURY INSERTED VAULT AND PLASTER FRIEZE, AS CAN BE SEEN THE CHAMBER WAS ORIGINALLY OPEN TO THE ROOF, HENCE THE PLASTERED AND PAINTED APEXES; FROM THE SOUTH.

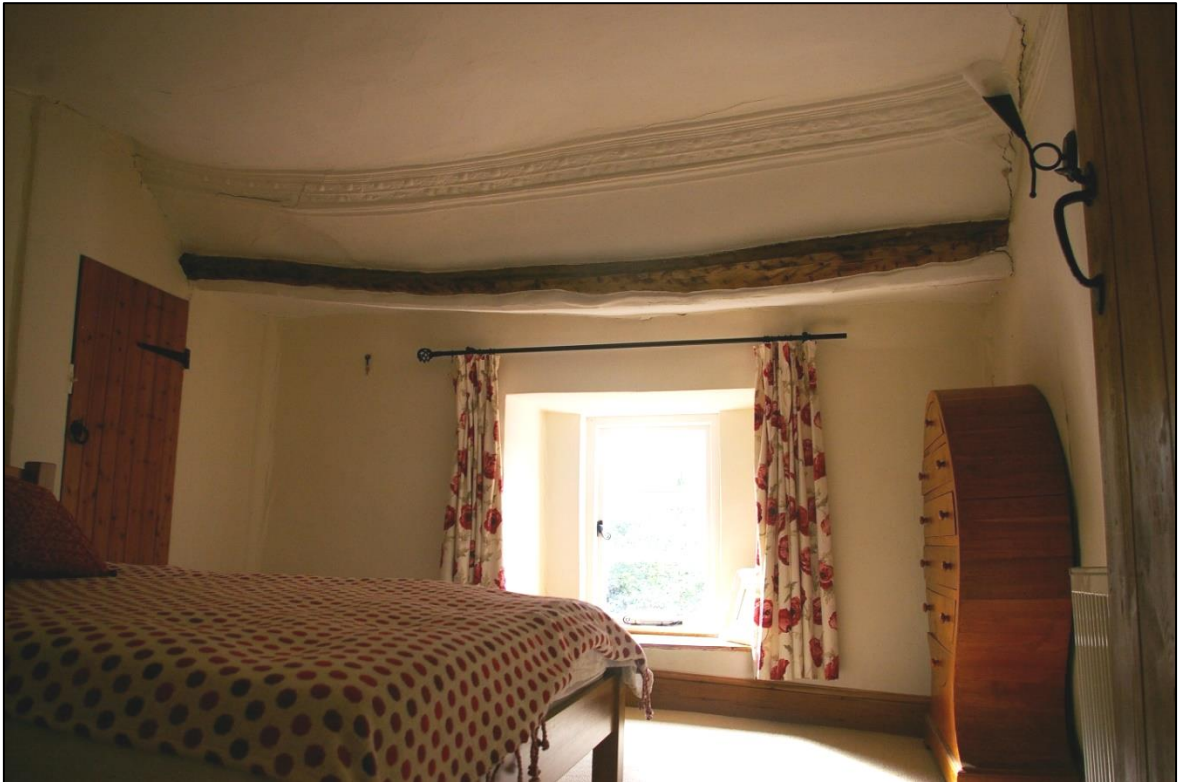
FIGURE 11: THE SOUTH WALL AND FAILING PURLIN AT THE EAVES IN ROOM 9, WITH FINE PLASTER CORNICE; FROM THE NORTH-WEST.

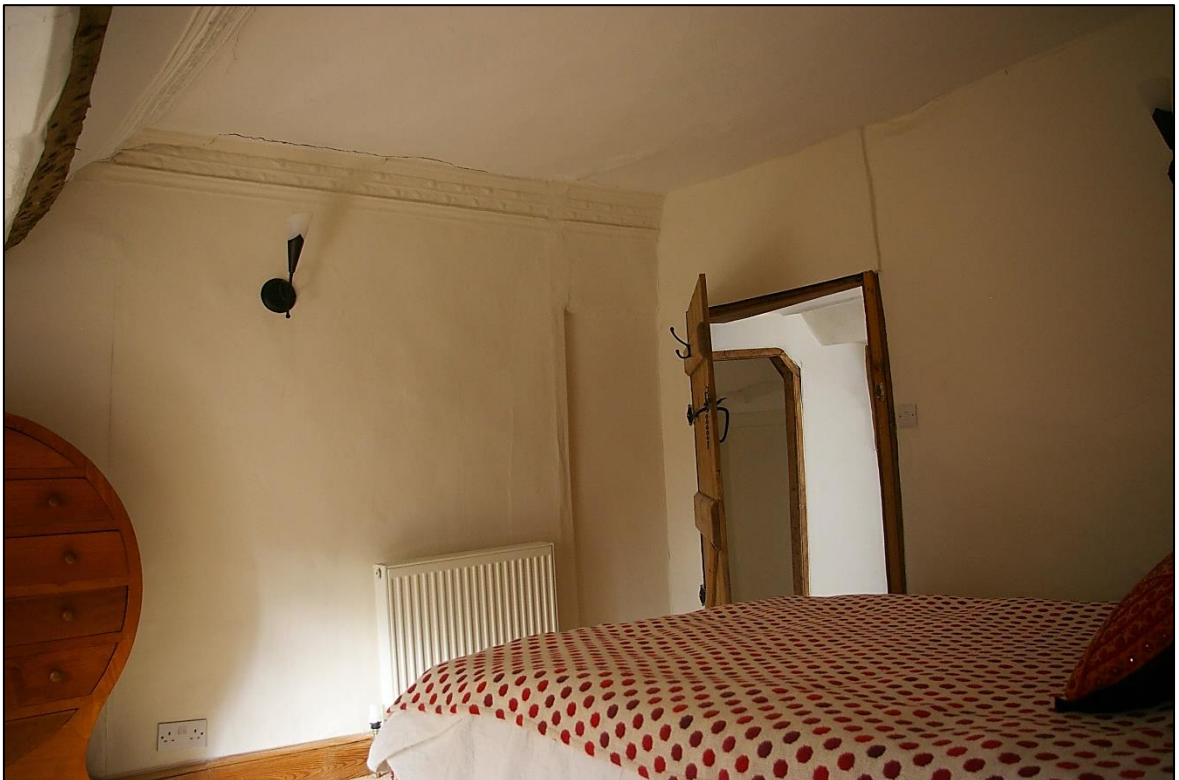
FIGURE 12: THE WEST WALL OF ROOM 9, WITH PLASTER CORNICE TRUNCATED BY THE COB PARTITION TO THE STAIRS AND WITH THE GOOD BLOCKED DOORWAY TO ROOM 12; FROM THE SOUTH-EAST.

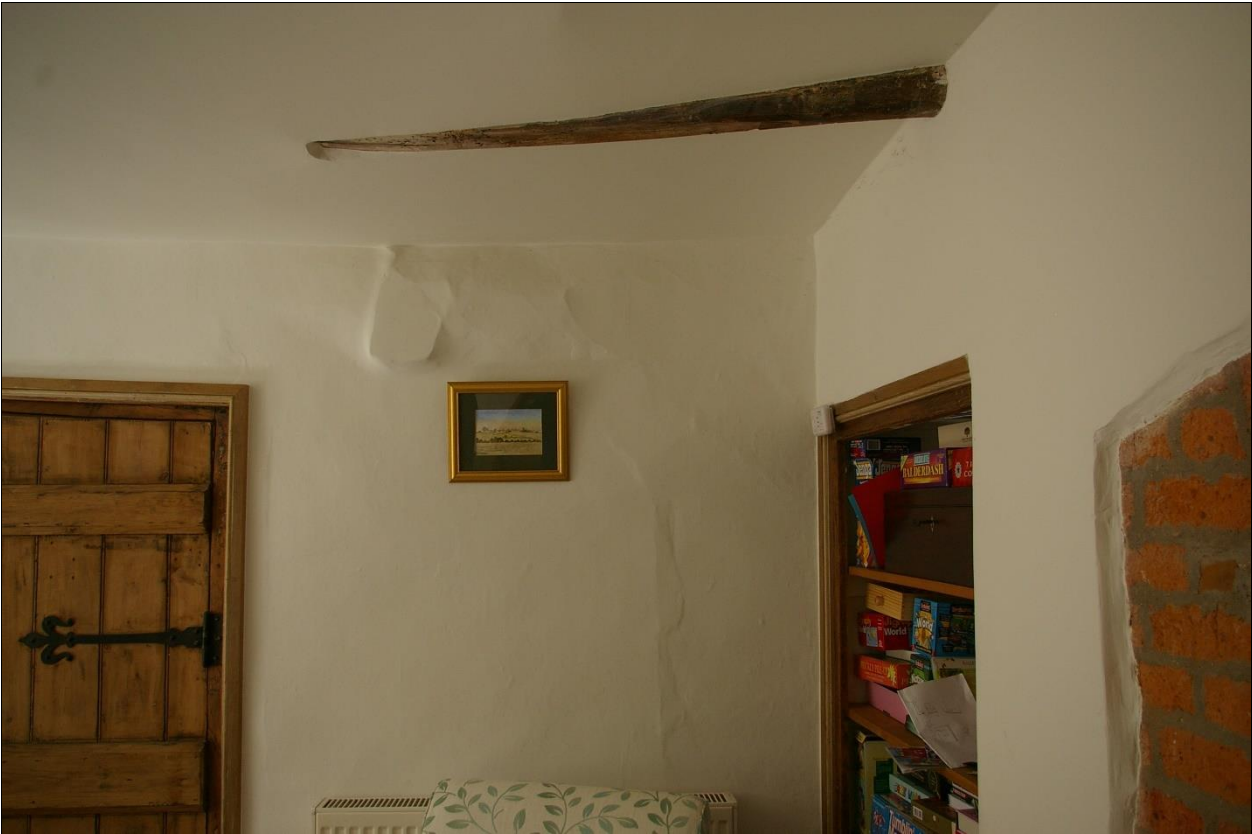
8. SCARRING SEEN IN THE WEST WALL OF ROOM 3, WITH TRUNCATED CEILING BEAM, ASSOCIATED WITH A BRACE TO THE CEILING AND A CHANGE IN FLOOR HEIGHT ON THE FIRST FLOOR, A STAIR (?) FROM THE FORMER OPEN HALL; FROM EAST.

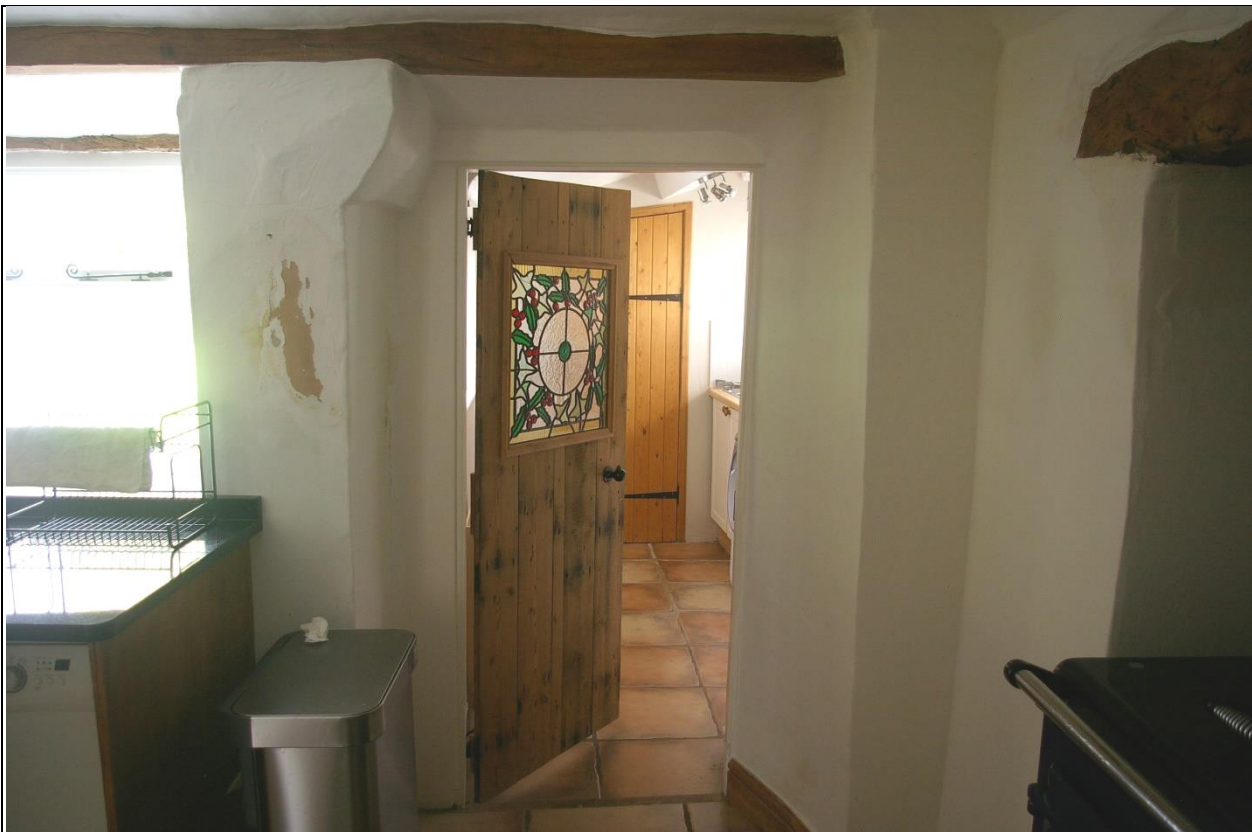
15. ROOM 5, LOOKING INTO ROOM 6, WITH LARGE FORCED OPENING AND INSERTED TIMBER LINTEL CARRIED ON CRUDE CORBEL; FROM THE SOUTH.

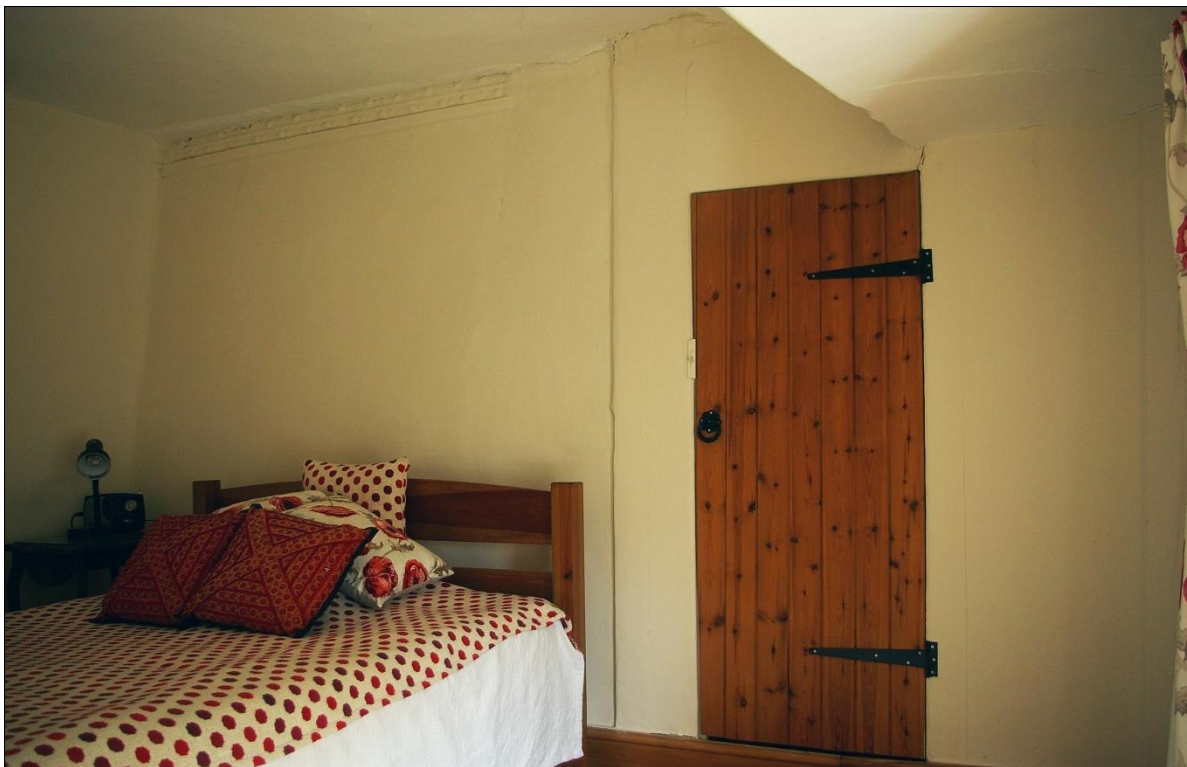
20. THE EAST WALL OF ROOM 9, WITH TRUNCATED CORNICE TO CUPBOARD AND TO COB PARTITION; FROM THE SOUTH-WEST.

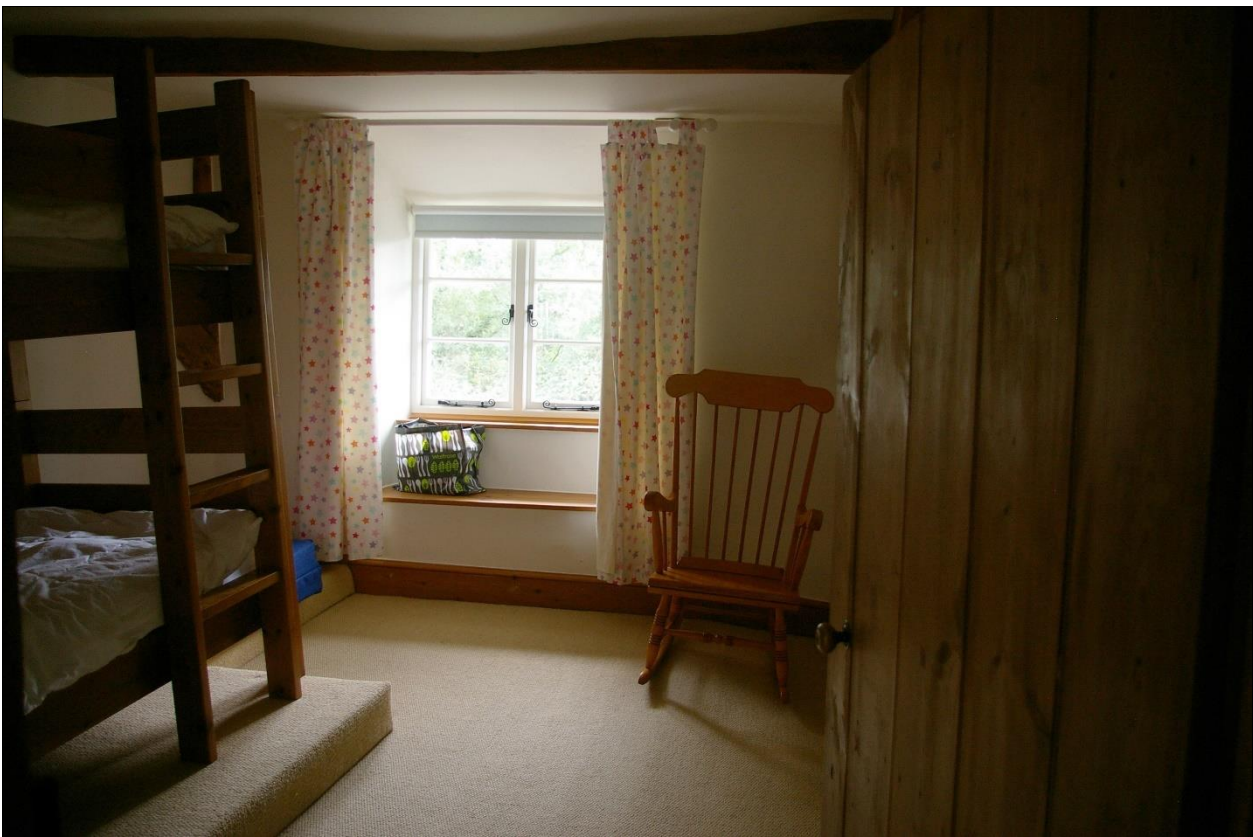
24. ROOM 13, WITH REPLACED PURLIN AND RAISED FLOOR OVER FORMER HALL AND POSSIBLE STAIR FABRIC, LEFT WITHIN CEILING VOID; FROM THE NORTH-NORTH-WEST.

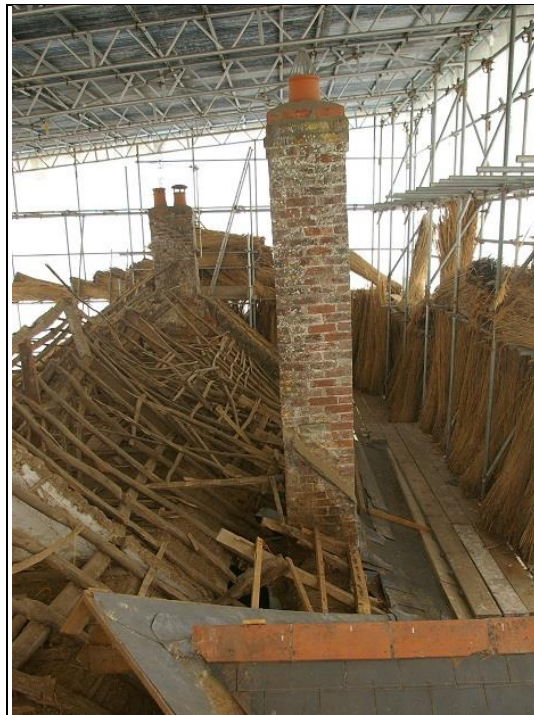
34. THE REAR LATERAL STACK, REBUILT IN POST-MEDIEVAL PHASE, LIKELY THE 19<sup>TH</sup> CENTURY IN BRICK AND LIME MORTAR; FROM THE EAST.

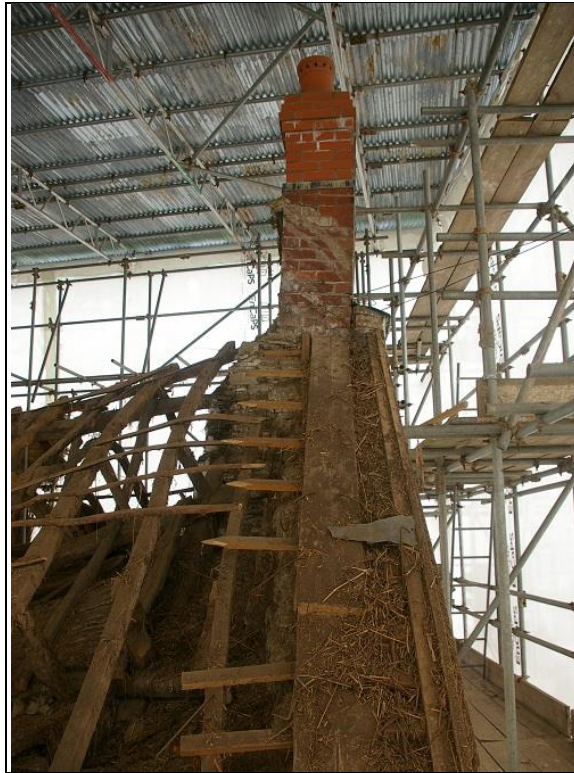
35. THE EASTERN GABLE END STACK, SHOWING THE SHAFT REBUILT IN THE POST MEDIEVAL PHASE, LIKELY THE 19<sup>TH</sup> CENTURY, BUT THE UPPER SECTION AGAIN REPLACED IN THE LAST TEN YEARS; FROM THE SOUTH.

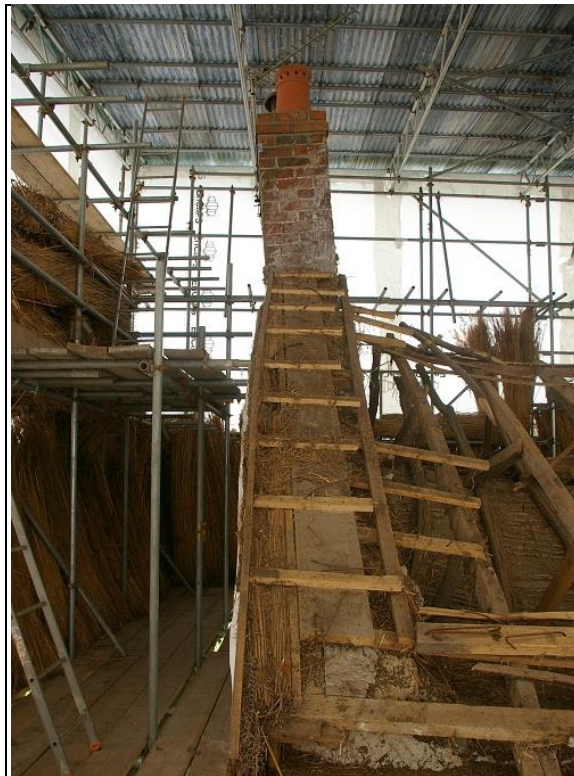
36. THE WESTERN CORNER GABLE STACK, SHOWING THE SHAFT REBUILT IN THE EARLY 20<sup>TH</sup> CENTURY, C.1910-1920; FROM THE SOUTH.

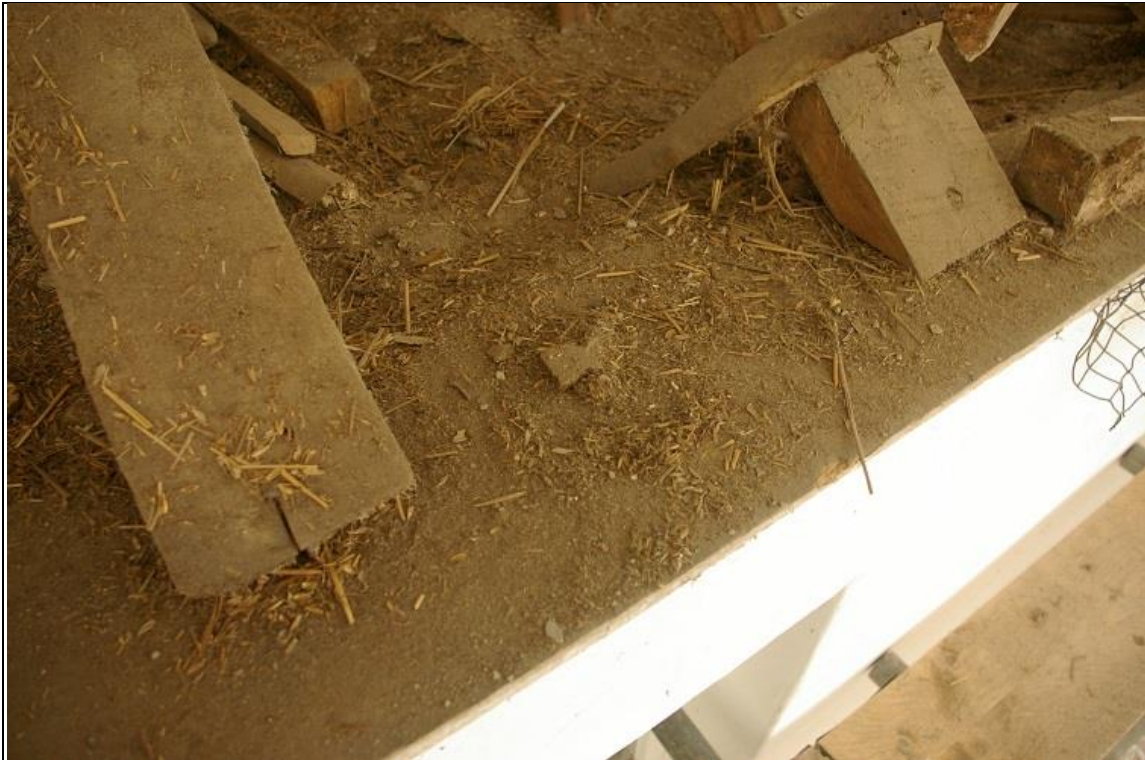
37. THE LATER 18<sup>TH</sup> OR 19<sup>TH</sup> CENTURY ROOF EXTENSION WHICH RESPECTS THE RE-FRONTING OF THE COTTAGE ARE SPIKED TO THE EARLIER CARVED WALL-PLATE/EAVES BOARD, WHICH HAS BEEN RE-SITED, PEGGED TO THE COB WITH LARGE SQUARE WOODEN PEGS; FROM THE SOUTH-WEST, SOUTH SIDE OF THE HOUSE.

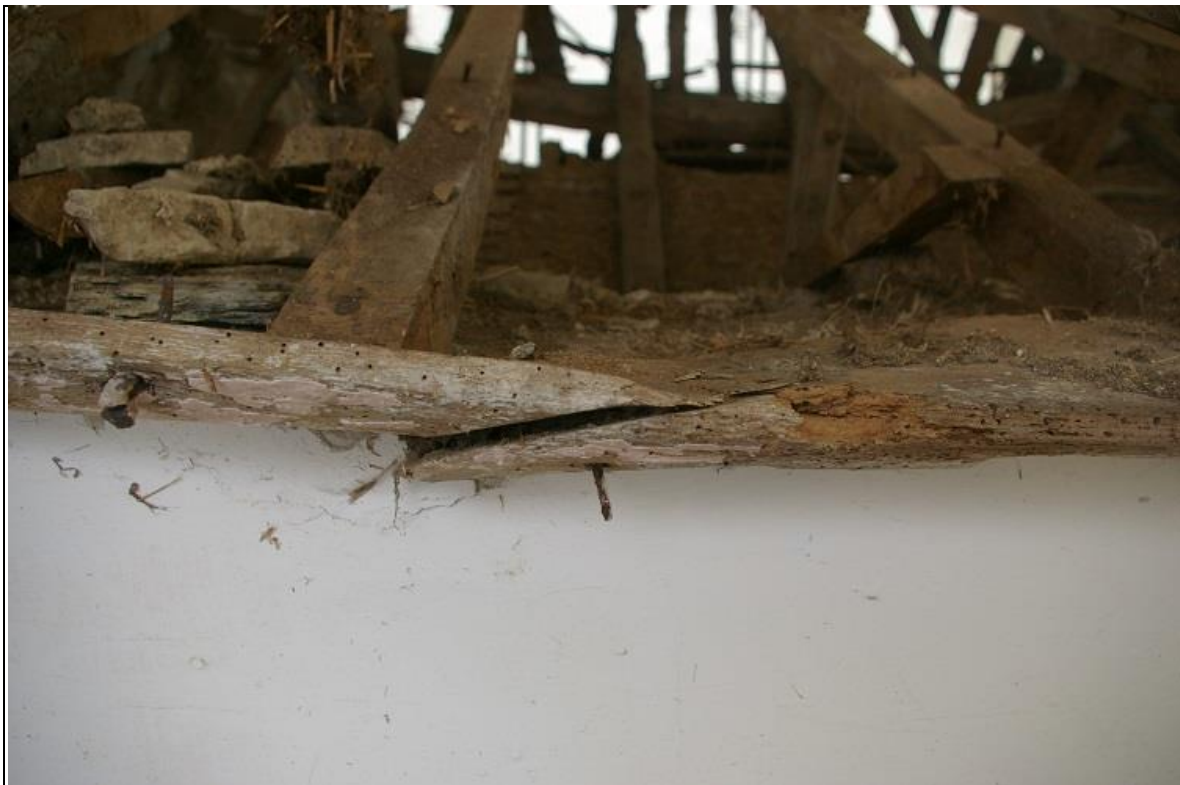
38. THE WALL-PLATE WHICH WAS REFITTED TO THE SOUTH SIDE OF THE HOUSE AFTER THE COTTAGE WAS RE-FRONTED WAS RE-ATTACHED USING CLENCH NAILS IN THE PEG HOLES; FORM THE SOUTH.

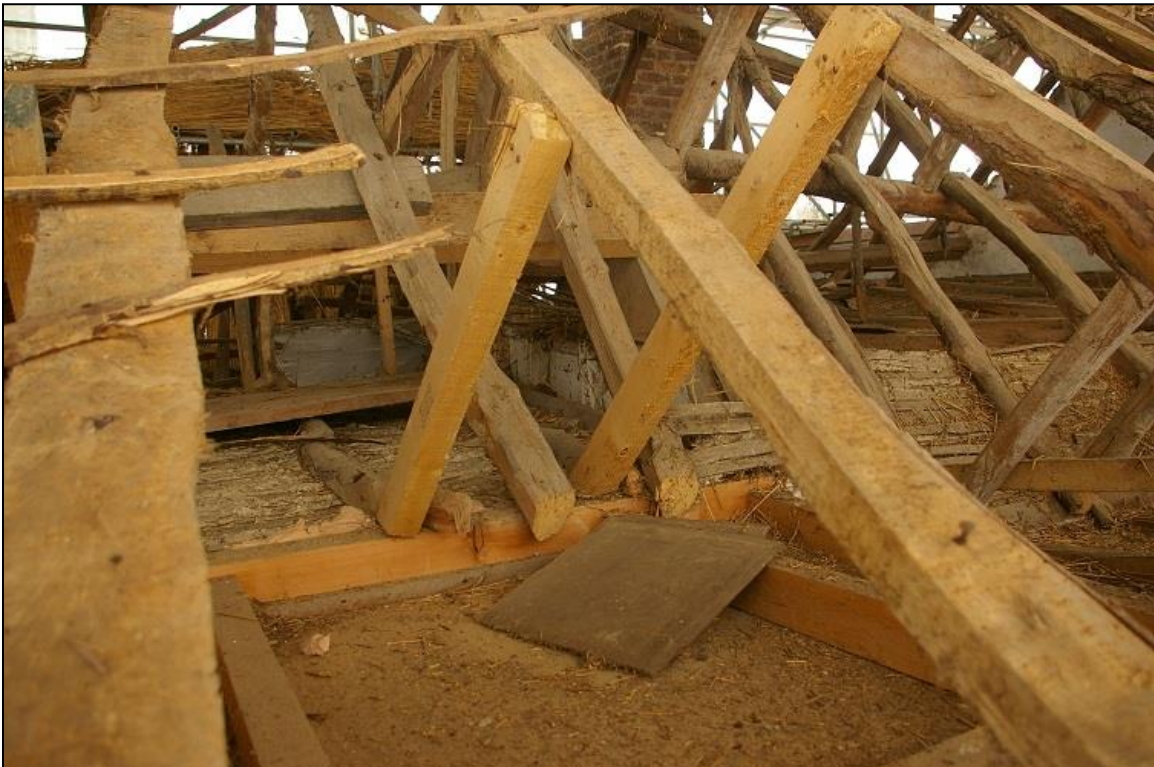
47. VIEW INTO THE ROOF OVER BAY 2, SHOWING THE WHITEWASH ON THE LOWER PART OF TRUSS 2 AND THE INFILL PARTITION, SUGGESTING A HIGHER PREVIOUS CEILING OVER BAY 2; FROM THE SOUTH-SOUTH-WEST.

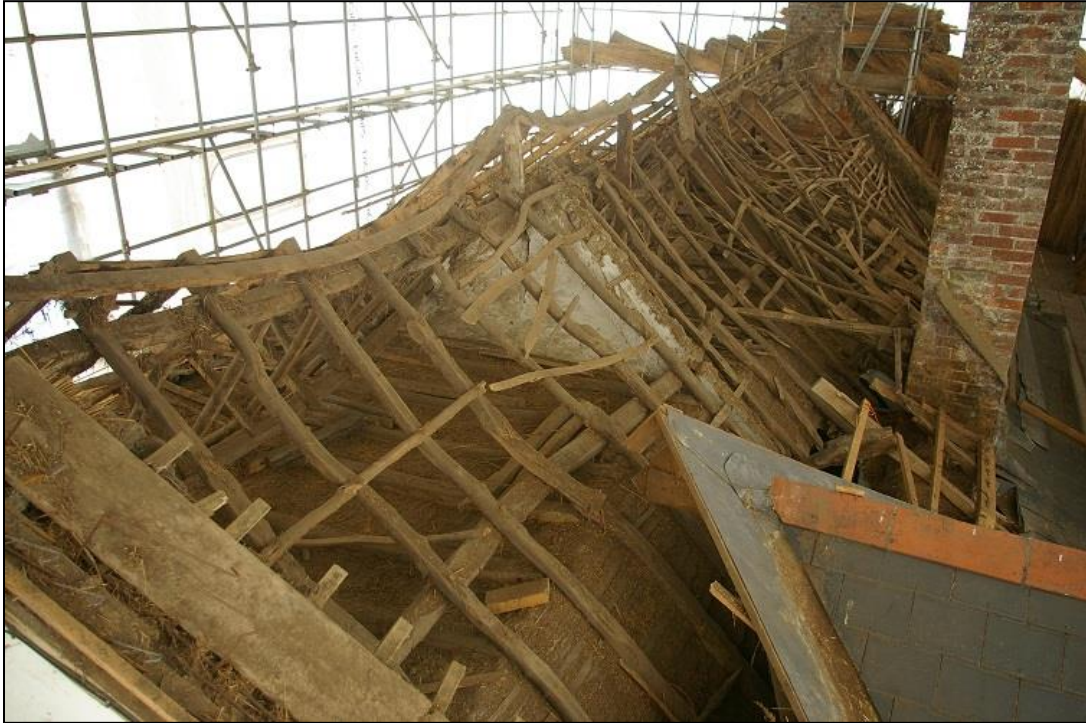
60. THE NORTH SIDE OF BAY 4; FROM THE EAST GABLE; FROM THE EAST-NORTH-EAST, SHOWING THE HIGHLY FRAGILE SUSPENDED VAULTED CEILING OVER ROOM 9.
