# BATSON HALL FARM

Updated - Historic Building Assessment

South West Archaeology Ltd. report no. 200224

## Batson Hall Farm, Batson, Salcombe, Devon Updated - Historic Building Assessment

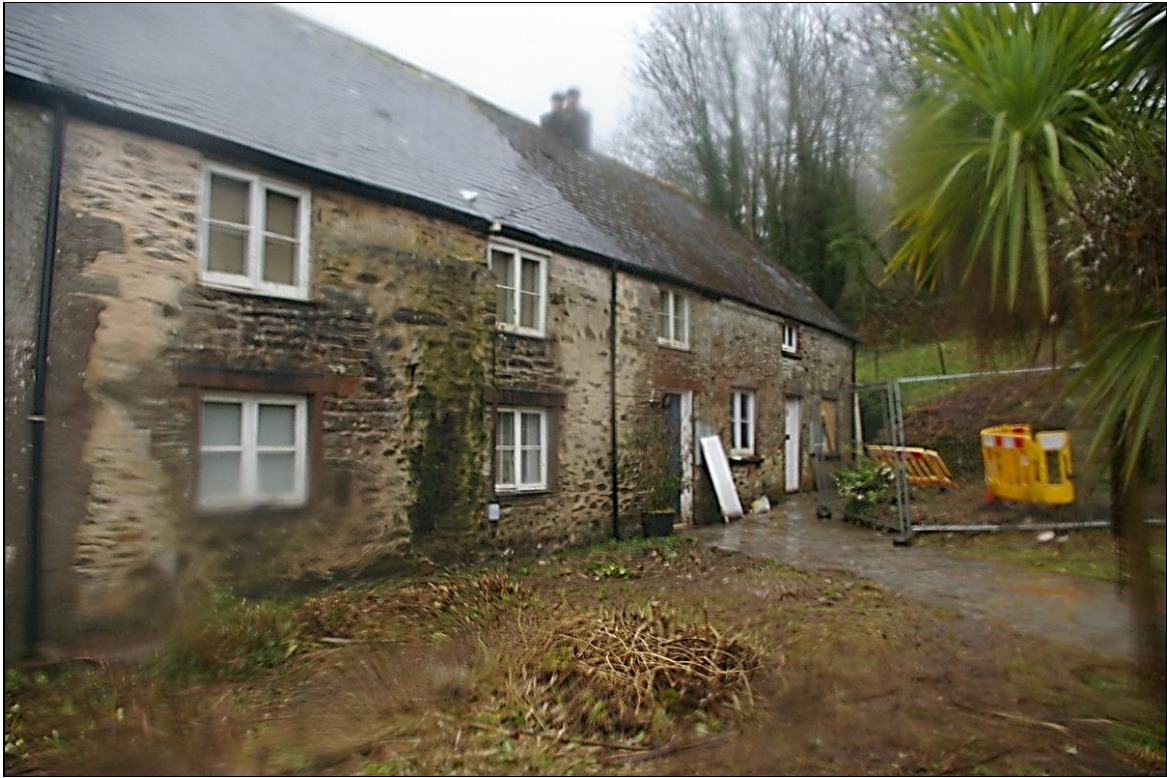
FIGURE 13: THE FRONT ELEVATION OF THE FARMHOUSE, CLEARED OF ALL VEGETATION, FEBRUARY 2020; FROM THE NORTH-EAST.

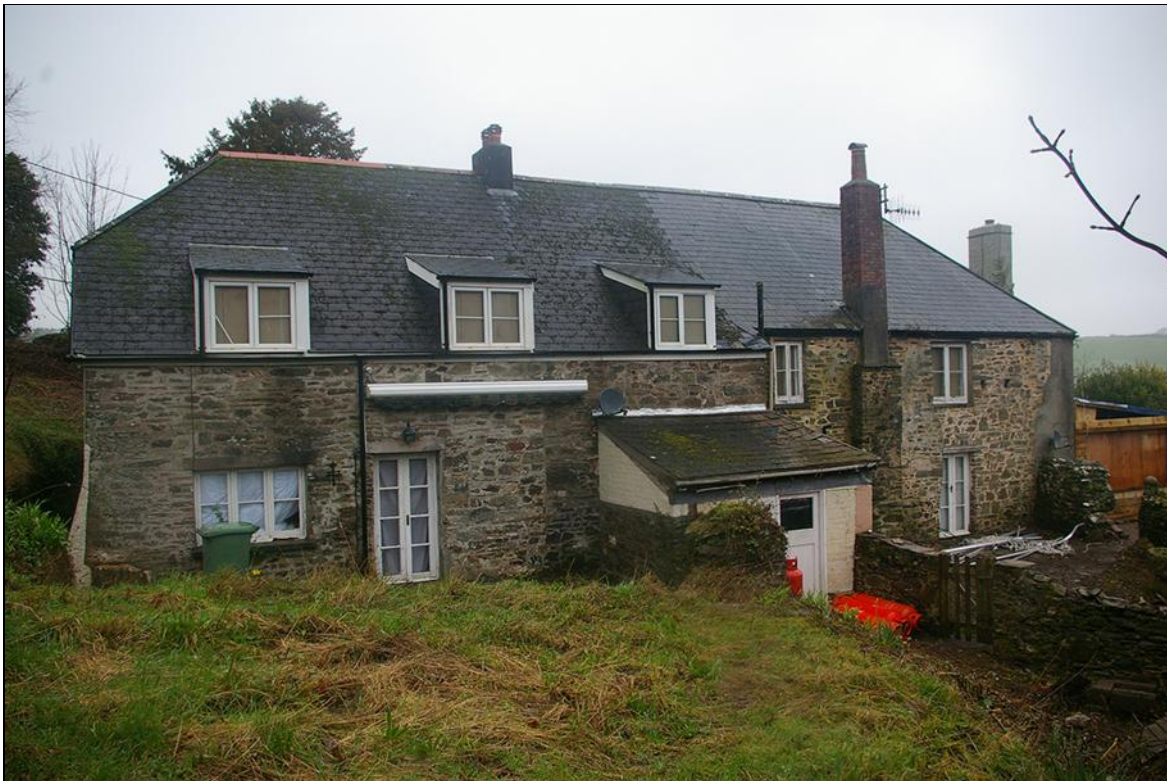
FIGURE 14: THE REAR ELEVATION OF BATSON HALL, FEBRUARY 2020; FROM THE SOUTH-WEST.

The south 'rear' elevation is also of irregular three window range. It has a clear build line and change in alignment near the lateral stack with some heavy slatestone quoins; beyond this to the east are the thicker battered remains of the earlier medieval manor house, visually compromised on the exterior by poor quality re-pointing. This is to be found quite low on the wall raised in looser post-medieval rubble in a thick lime re-pointing. The lateral stack is of regularised rubble

and abuts the earlier stonework, of later date, being shallow in depth, rising to low eaves height, with a step, the upper shaft rebuilt in modern engineering brick, partly rendered, with a tall beige stoneware chimney pot. To the east end of the range the walls step-back being regular and straight of loose post-medieval character mixed rubble in thick lime pointing, patched in lime and cement. The south-east corner, as to the north, is rendered, wrapping around from the east gable. The central section of earlier walling is then extended to the west by earlier grey platey slatestone stonework, like that to the north elevation. The range steps out to the south to the centre where it is abutted by a low lean-to outshut. The south-east projecting corner of this section is of the same fine dressed and faced slatestone, of medieval date, with further regularised slab stonework again extending it. There are heavy roughly dressed slab quoins here on the line of the thick partition wall between the farmhouse and cottage, evidence the range once finished here. The ground floor window to the east is a set of narrow French patio doors, of timber frame, with alloy handles and lock, these are 20<sup>th</sup> century. To the west beyond the lateral stack is a three light 2x2 pane 19<sup>th</sup> century timber casement with chunky chamfered frame, with pegged corners. To the first floor are a pair of two light 2x2 pane timber casement like the east and north elevations of 20<sup>th</sup> century character. There is then a two-light window in a plastic framed and part imitation slate clad dormer at first floor with PVC unit, within the projecting single bay, at the west end of the elevation.

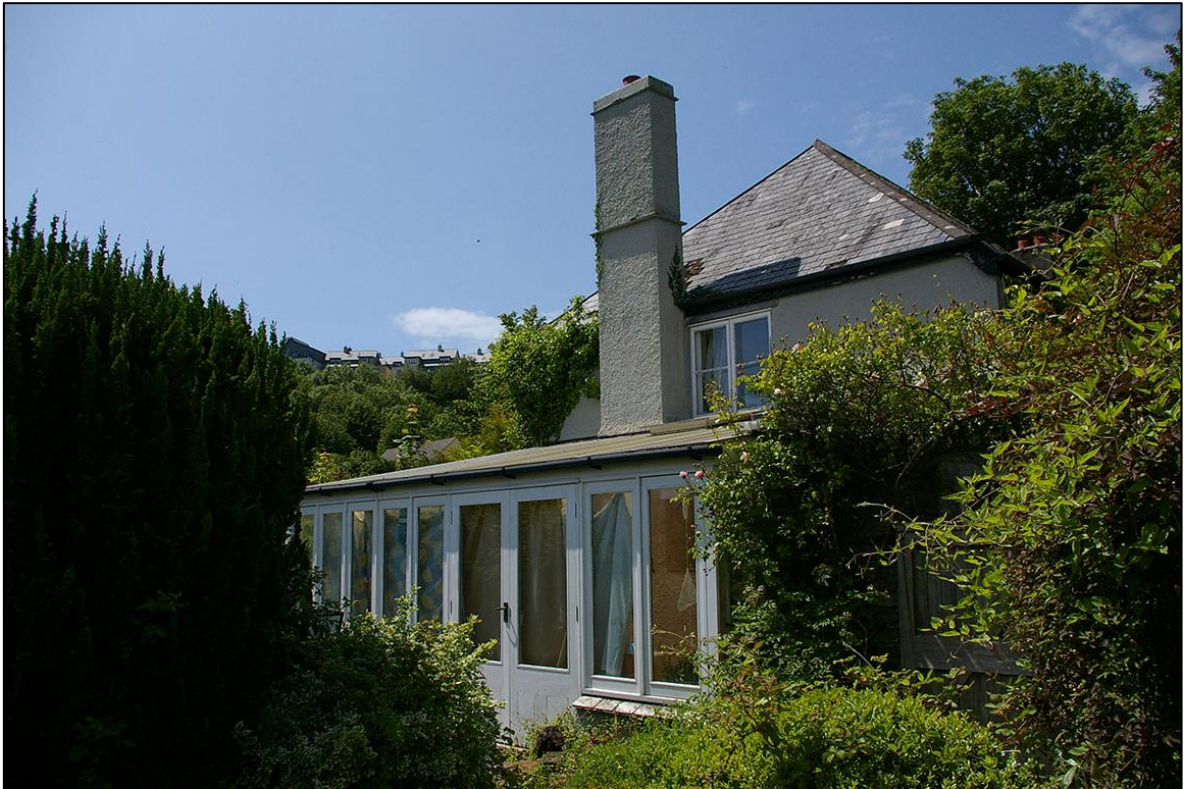
The east gable end of the house sits under a deep roof hip with a chunky rendered box stack; of stepped form with terracotta chimney pots this stack looks modern in character. It is partly enclosed within the modern timber, PVC and glass 'conservatory'. This end wall is pebble dash rendered and painted. It has one first floor two light casement window, like those seen on the north elevation this is of two lights, 2x2 panes, timber framed with alloy opening catches, 20<sup>th</sup> century in date. There is one wide forced doorway on the ground floor, with 1970s style glazed door, to the north side, which accesses the conservatory from the house and one small window to the south side of the stack, set with a fixed glazed pane.

FIGURE 15: THE EAST GABLE END OF BATSON HALL FARMHOUSE, JUNE 2019; FROM THE NORTH-EAST.

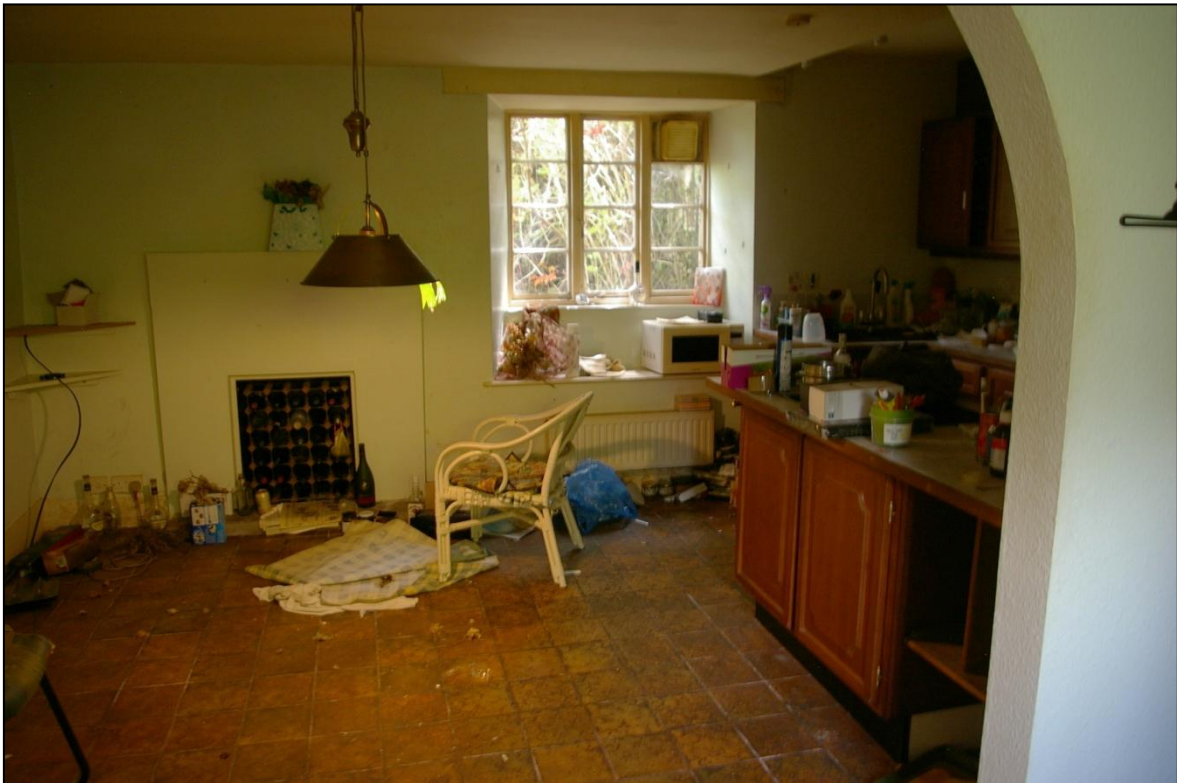
FIGURE 16: VIEW OF THE FITTED KITCHEN, WITH THE THREE LIGHT 19<sup>TH</sup> CENTURY CASEMENT AND WINDOW SEAT, BLOCKED FIREPLACE ON THE REAR WALL, MODERN QUARRY TILED FLOOR, BOARDED OUT CEILING; FROM THE NORTH-NORTH-EAST.

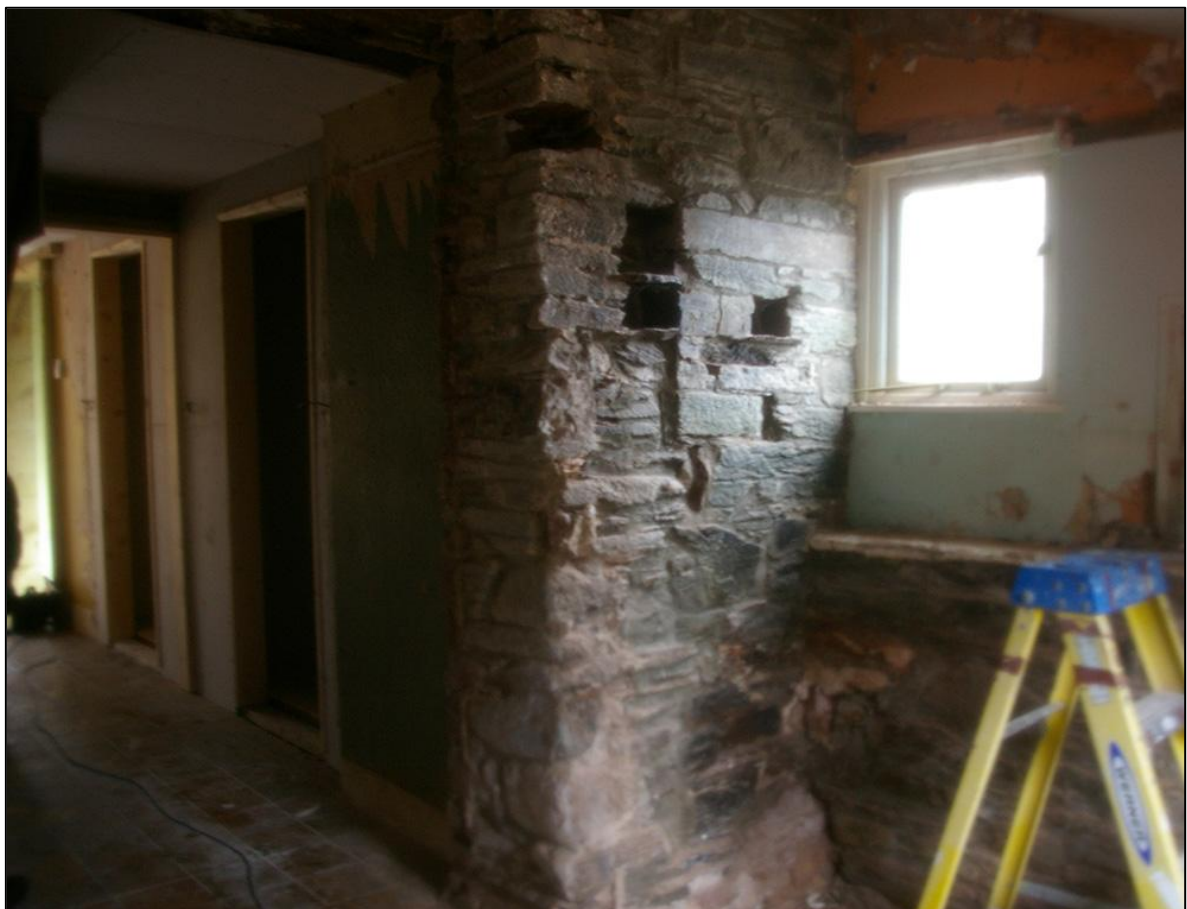
FIGURE 21: THE SHORT LENGTH OF GOOD DRESSED AND FACED MEDIEVAL STONEMWORK, WITH ABUTTING HEAVY SLATESTONE RUBBLE AROUND OPENING AND PUTLOG HOLES, REWORKED AS DOVE HOLES, WITHIN THE PROJECTION ON THE SOUTH ELEVATION OF THE FARMHOUSE, NOW ENCLOSED WITHIN THE OUTSHUT; FROM THE SOUTH-WEST.

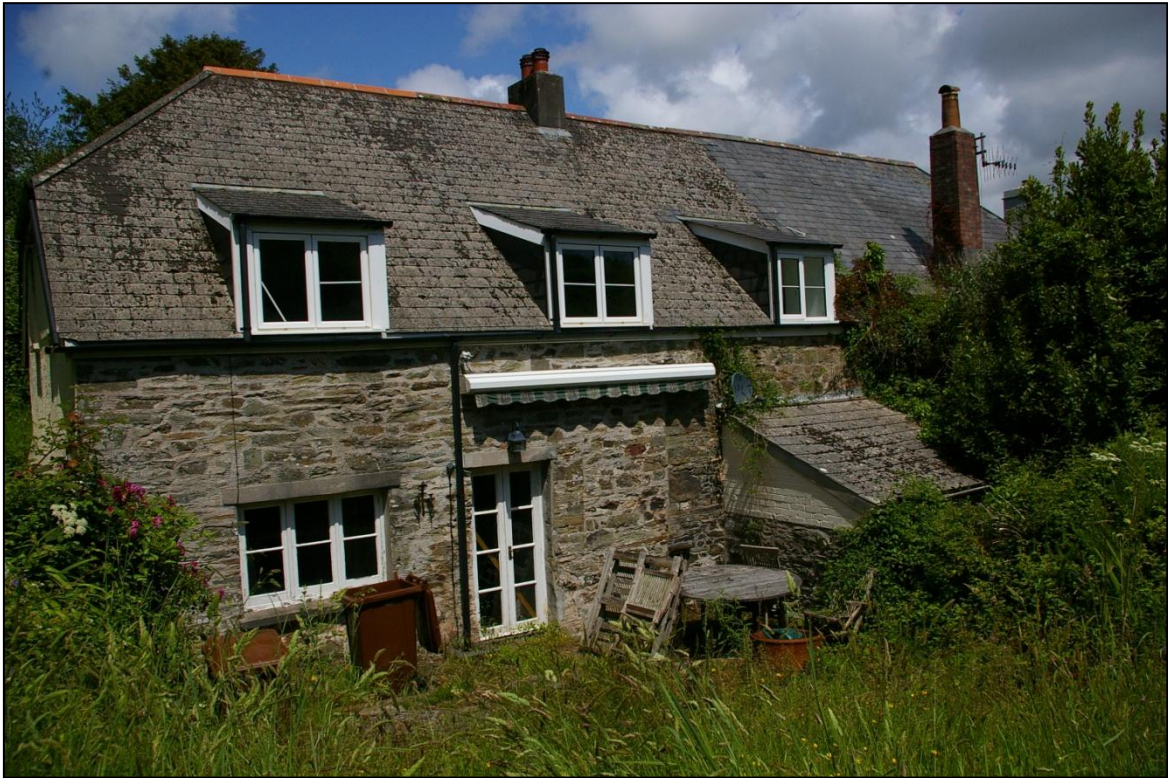
The south 'rear' elevation is of stonework, very similar in character to the north; thickly cement rendered to the exterior. Two dormers have been forced into the roof with modern PVC double glazed units. There is one good ground floor window to the west end, its thin timber lintel rendered, but with neat stone reveals. This window is another good three light 19<sup>th</sup> century casement, with beaded and chamfered frame. There is a narrow forced doorway, the sides patched with cement and with a rendered lintel, which has a pair of modern French glazed patio doors. Beyond, to the east end, is a very tall and wide blocked doorway with good shaped stone quoins, of a similar pale grey stone as seen in the blocked opening in the north elevation.

FIGURE 23: THE COTTAGE, SOUTH ELEVATION JUNE 2019; FROM THE SOUTH-WEST.

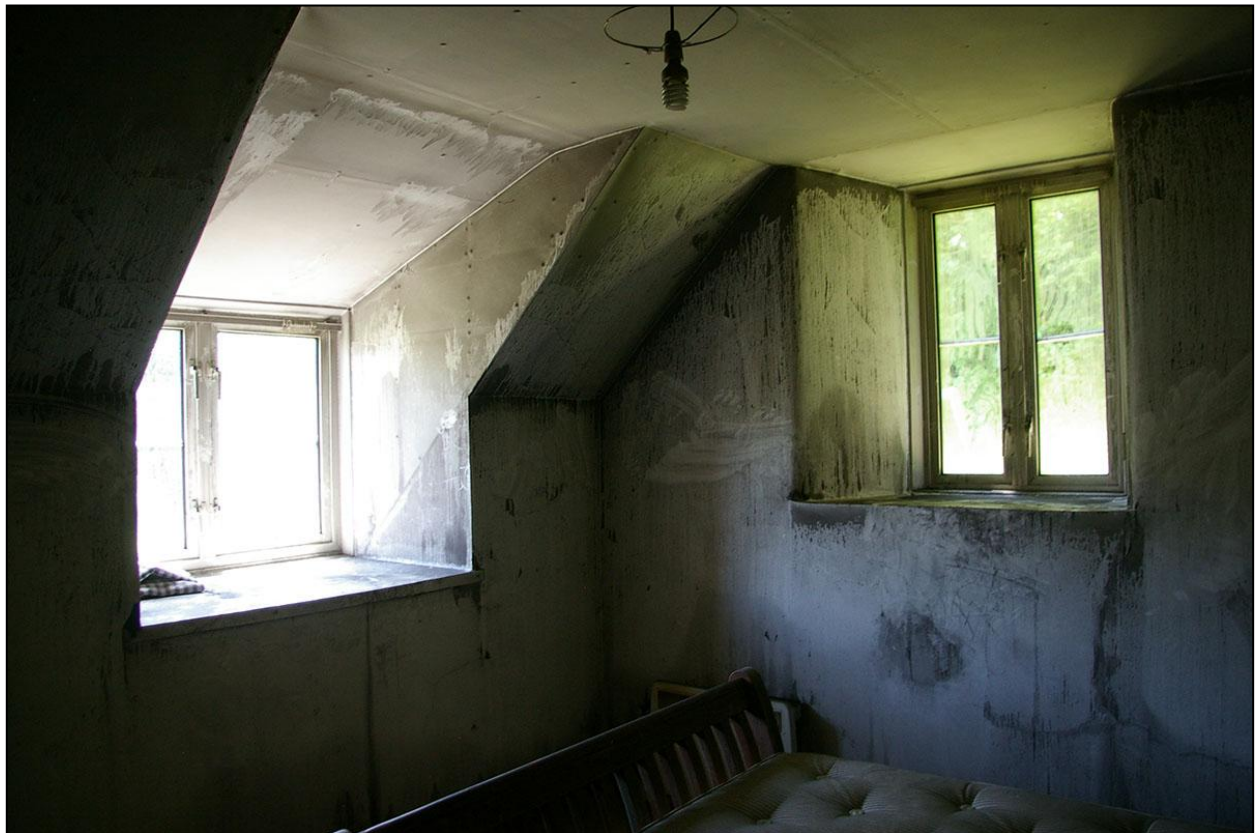
BEDROOM 1 WITH FORCED WINDOW OPENINGS AND PVC UNITS; FROM THE NORTH-EAST.

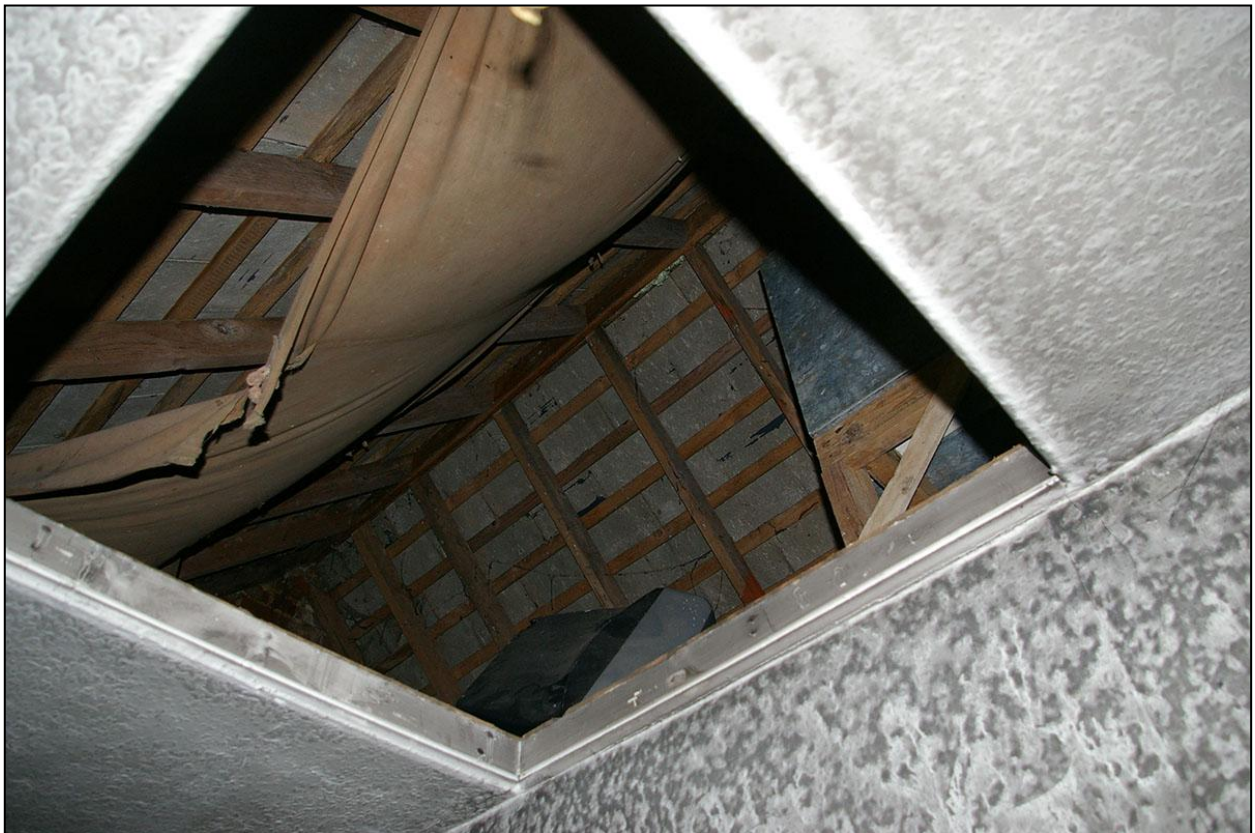
VIEW UP INTO THE LOFT, SHOWING THE MODERN COMMON RAFTER REPLACEMENT ROOF; FROM BELOW (NORTH-WEST).

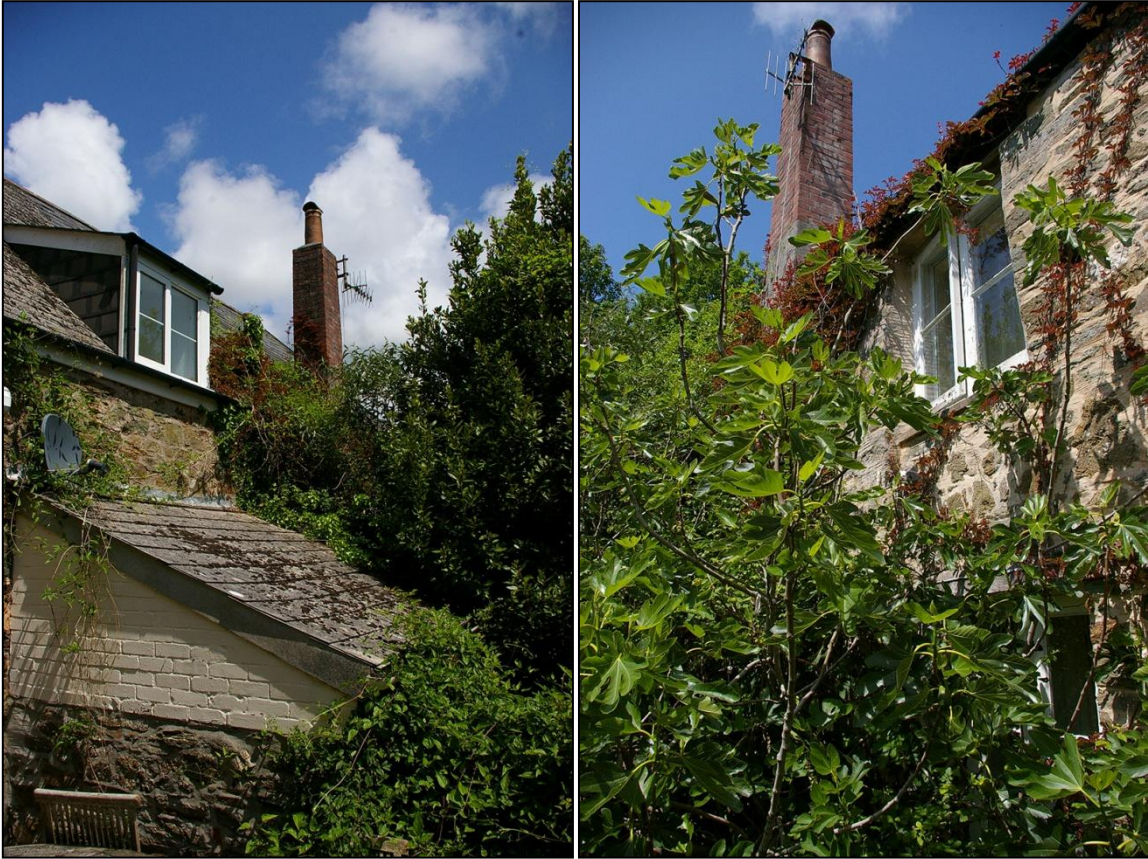
LEFT: VIEW BACK ALONG THE REAR OF THE FARMHOUSE, SHOWING LOOSE POST MEDIEVAL RUBBLE AT THE EAVES AND A REBUILT BRICK CHIMNEY SHAFT, AS WELL AS A DISTINCT CHANGE IN ALIGNMENT ON THE ROOF; FROM THE WEST, SOUTH-WEST.

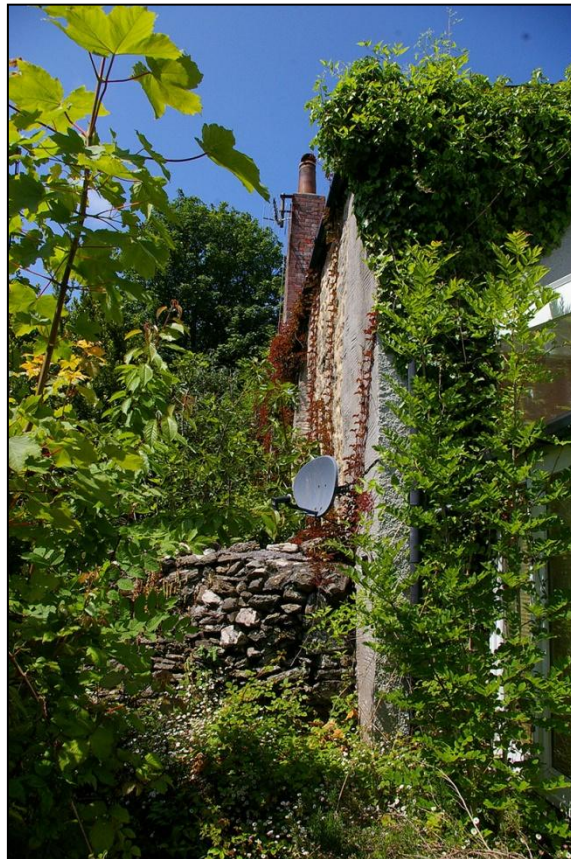
VIEW ALONG THE BACK OF THE FARMHOUSE, SHOWING HOW IT IS ALMOST TOTALLY OBSCURED BY OVERGROWTH; FROM THE EAST.

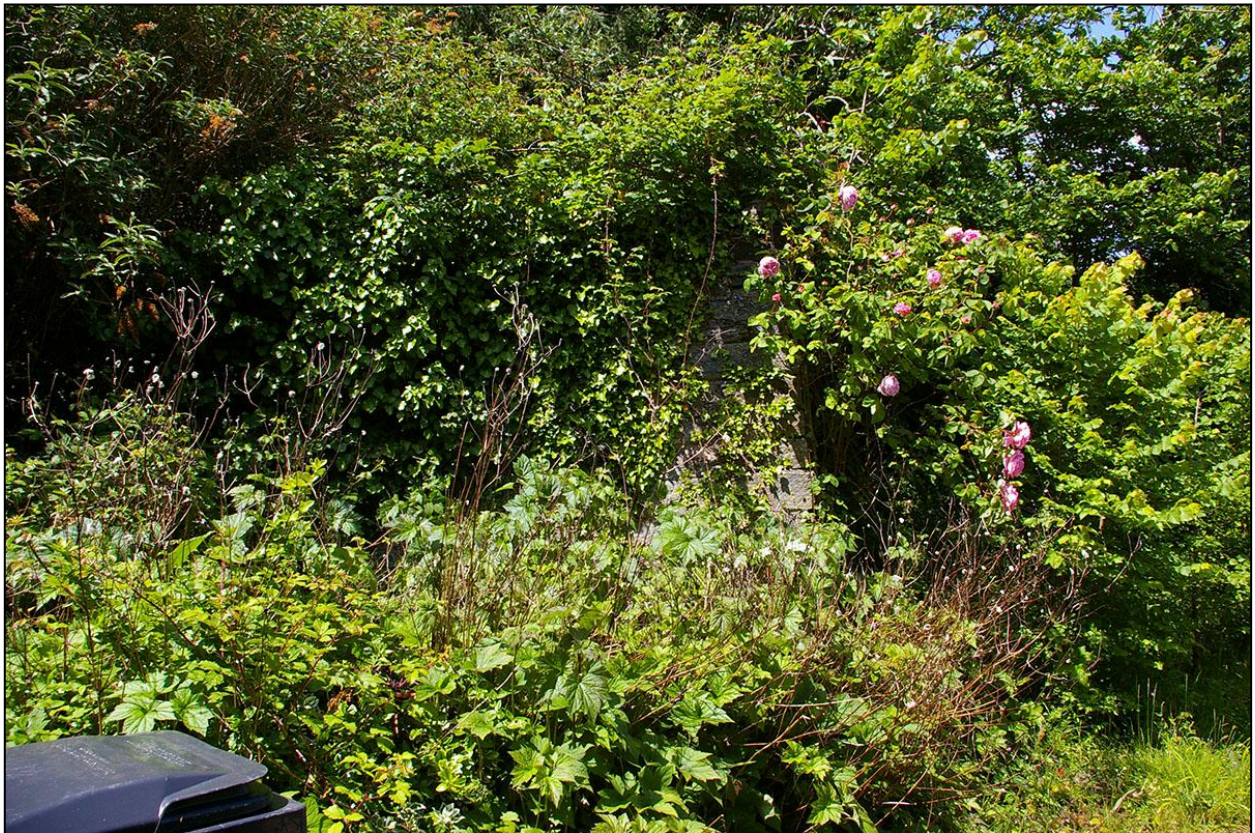
THE SQUARE RUIN, WHICH IS ALMOST COMPLETELY OBSCURED BY FOLIAGE; FROM THE SOUTH, SOUTH-EAST.

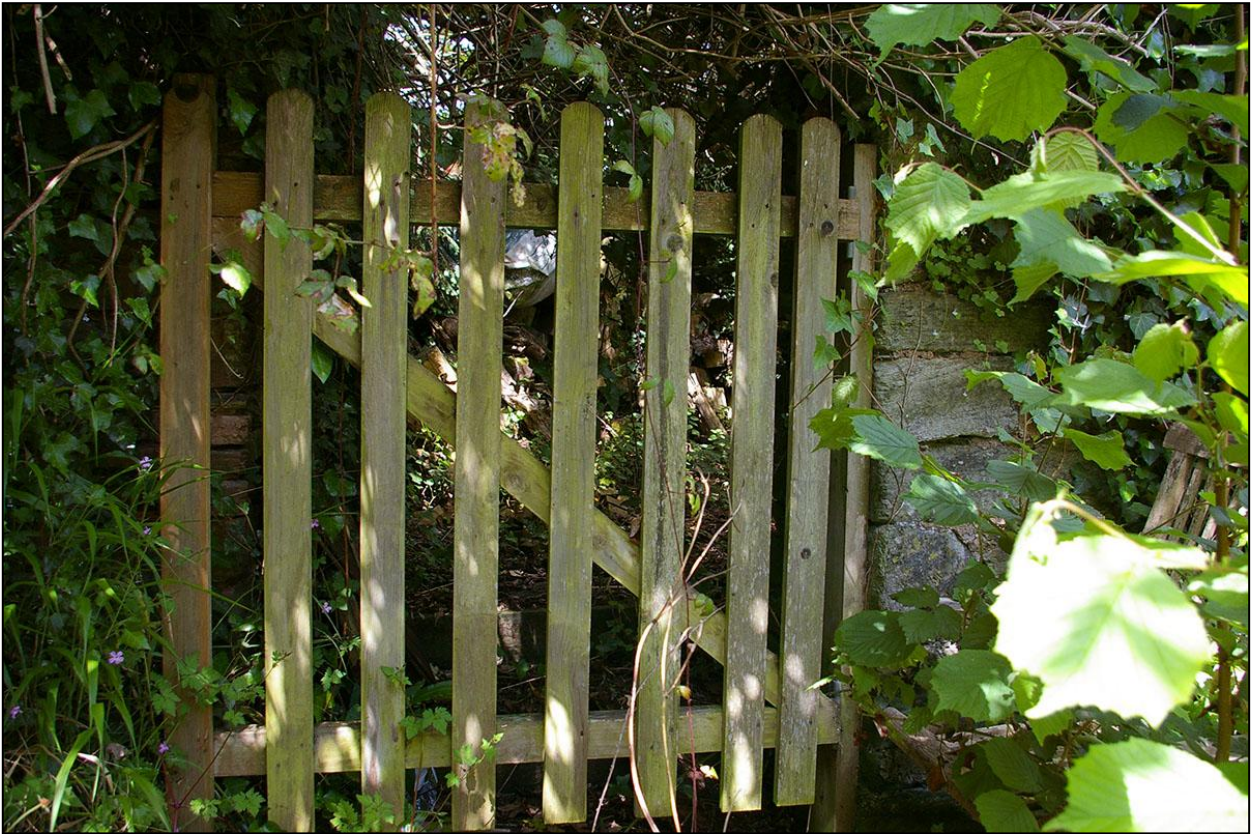
THE GATE IN THE SOUTH-WEST CORNER OF THE SQUARE RUINS, SHOWING FINE QUOINS TO THE EAST SIDE, BUT NARROW THIN BRICKS PATCHING THE WEST REVEALS; FROM THE SOUTH.

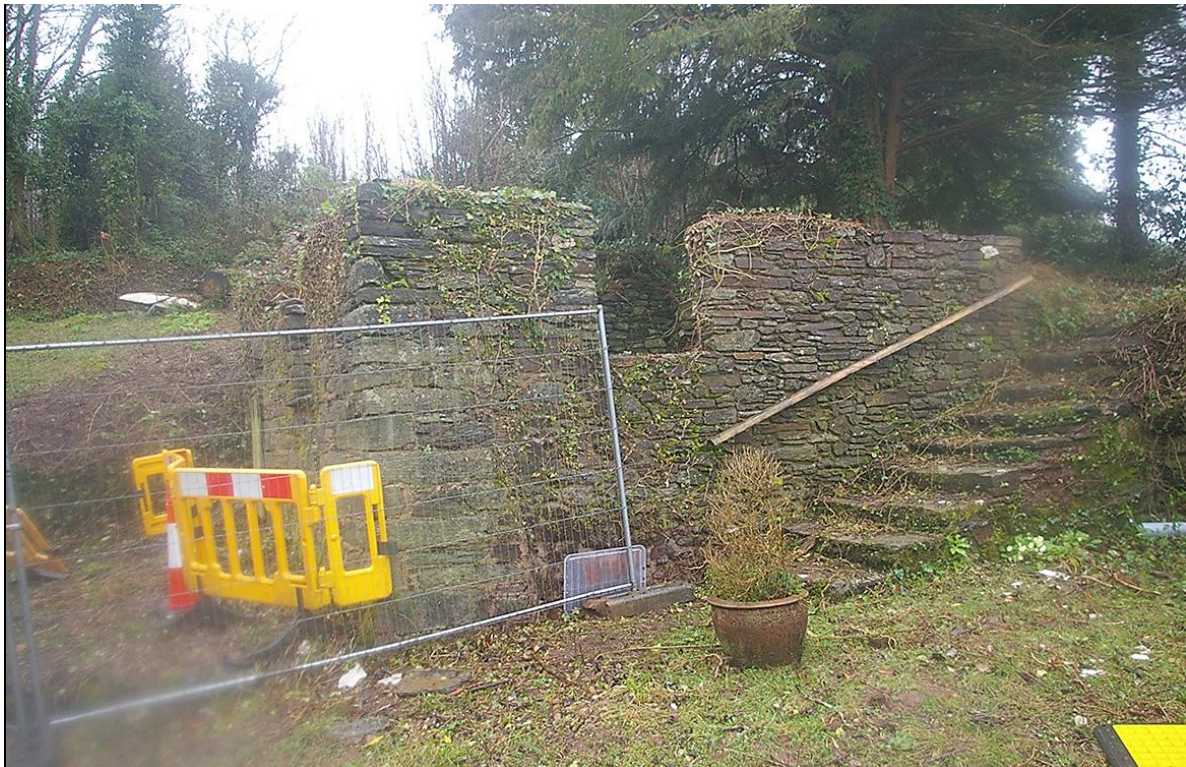
THE EAST WALL OF THE DETACHED MEDIEVAL BLOCK, SHOWING A LENGTH OF EARLY REBUILDING AND ONE MODERN REPAIR, WITH THE LATER 20<sup>TH</sup> CENTURY GARDEN STEPS; FROM THE SOUTH-EAST.
