BARN AT LOWER RIXDALE FARM

Historic Building Recording

Barn at Lower Rixdale Farm, Dawlish, Teignbridge, Devon

Results of historic building recording

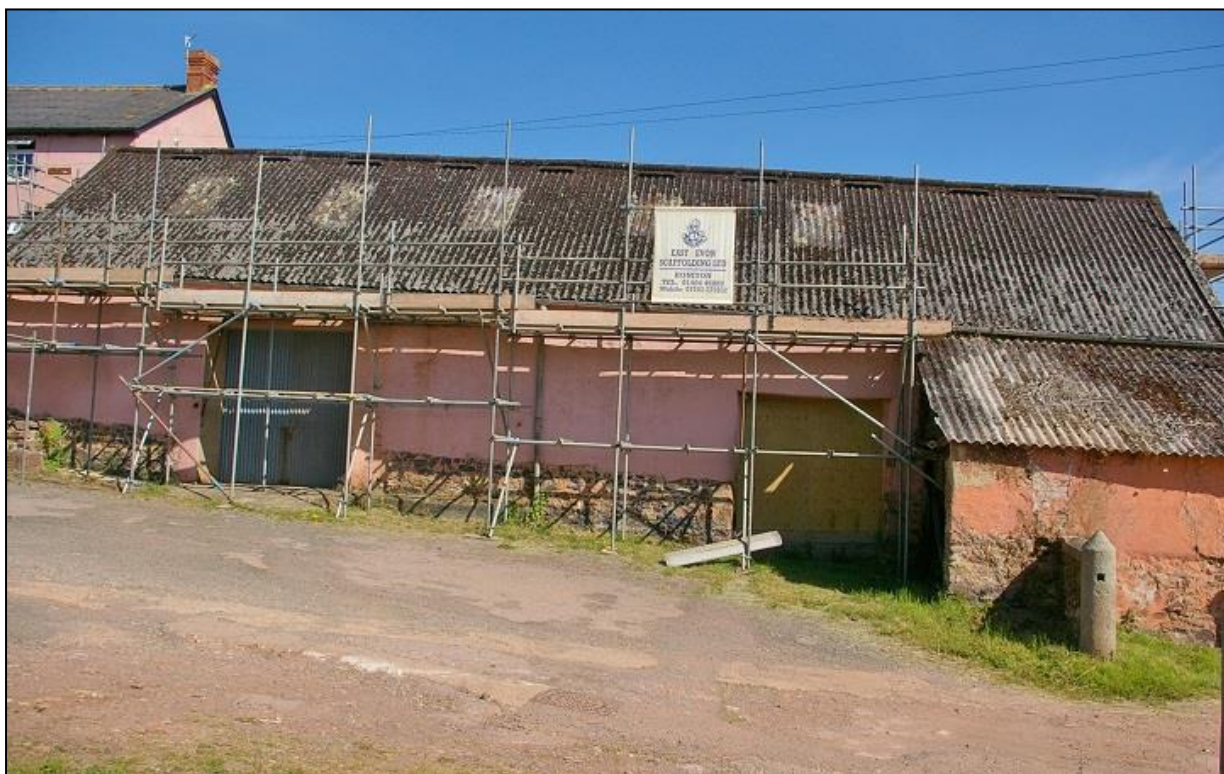
The south 'front' elevation faces out across the south farmyard, it is six bays in length, with the second and fifth bays being occupied by large double width threshing door openings; that to the west end much larger than that to the east. The walls are slightly battered, with a heavy stone rubble base, with clay bond and clay and lime mixed mortar, incorporating local conglomerate and trap and sandstone varieties.

There is a light change in the form of the stonework in bay three between the two threshing doors, to the south end, for half of bay 3, then bays 4-6 it is a little looser and more irregular but the stones used are larger, there are river pebbles included in this build. The stonework for bays 1,2 and half of bay 3 is tighter packed, showing a more careful selection of stones and the dressed stones to the corners and west threshing opening are faced to a neater grade. There are roughly dressed and faced quoins however, within the stonework to both doorways. The stonework to the west end, as far as bay three is 0.5 -1m high, it then deepens to 1.25m, rising to 1.3m to the south-east corner. Above is cob, it is externally rendered but cracked in places, where visible the cob is a pale brown colour, very clean in its consistency, with neatly chopped organic matter, likely straw and fragments of crushed stone. It is densely packed, with tamping layers visible in places. Within the abutting equipment shed the wall can be seen to have been externally lime plastered and whitewashed, before the modern render coating, with a thick lime pointing to the stonework.

FIGURE 7: THE SOUTH ELEVATION OF LOWER RIXDALE BARN; FROM THE SOUTH.

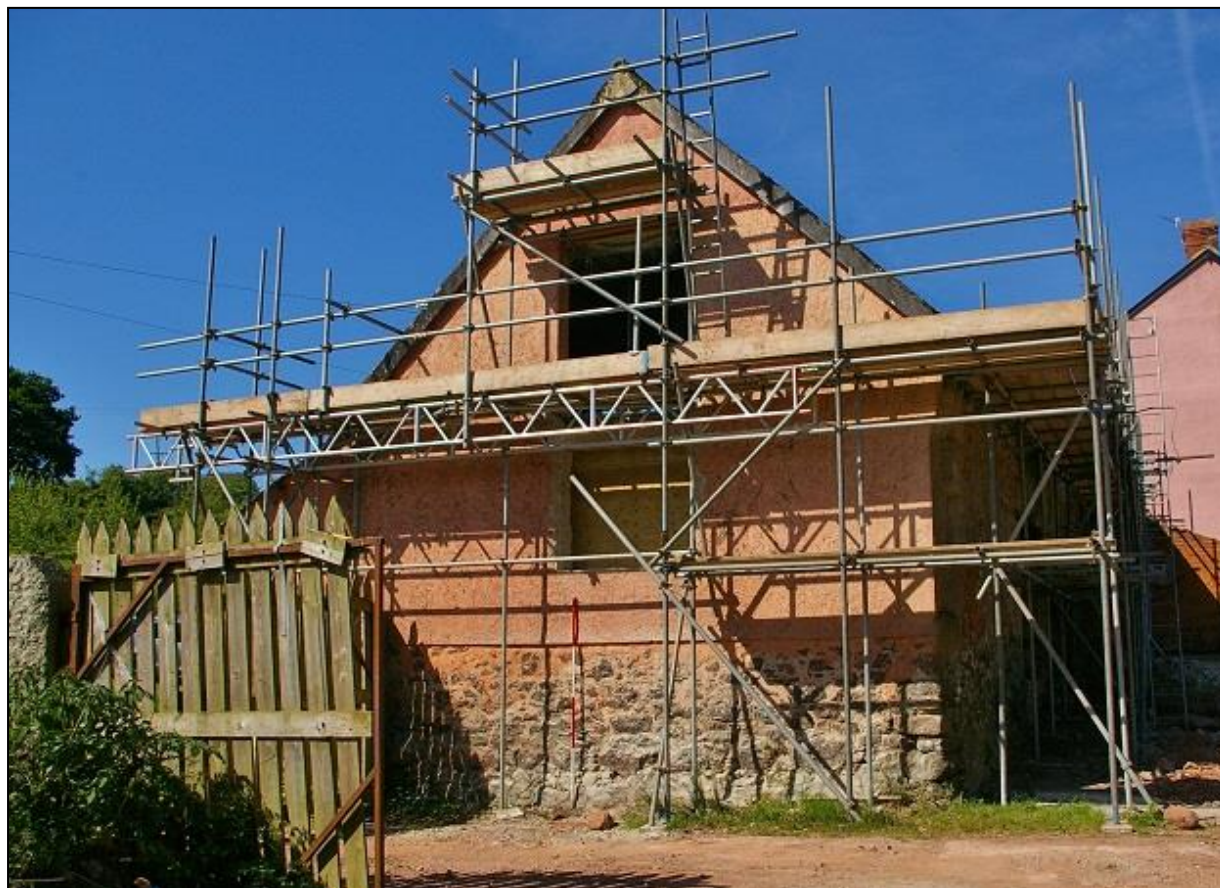
The east gable end has been wholly rebuilt in concrete blocks; this appears to be a fairly recent repair, within the last decade; it is externally rendered and a skim of modern stone rubble has been added to the base of the wall to mimic the traditional build; a low stub of original stonework survives at the base

on the interior face, c.0.3m, plastered in lime. The building was Listed in 1985, and it is felt this has probably happened since the listing process, which has led to a damaging loss of historic fabric and integrity and has destabilized the barn. There is a loading door in the elevation at loft height and another opening has since been cut beneath. The concrete block rebuild wraps around the north-east corner of the barn, but the base of the corner of the wall survives, with good roughly dressed quoins of volcanic trap.

FIGURE 8: THE EAST REBUILT AND RENDERED GABLE OF THE BARN, WITH 2M SCALE; FROM THE EAST-NORTH-EAST.

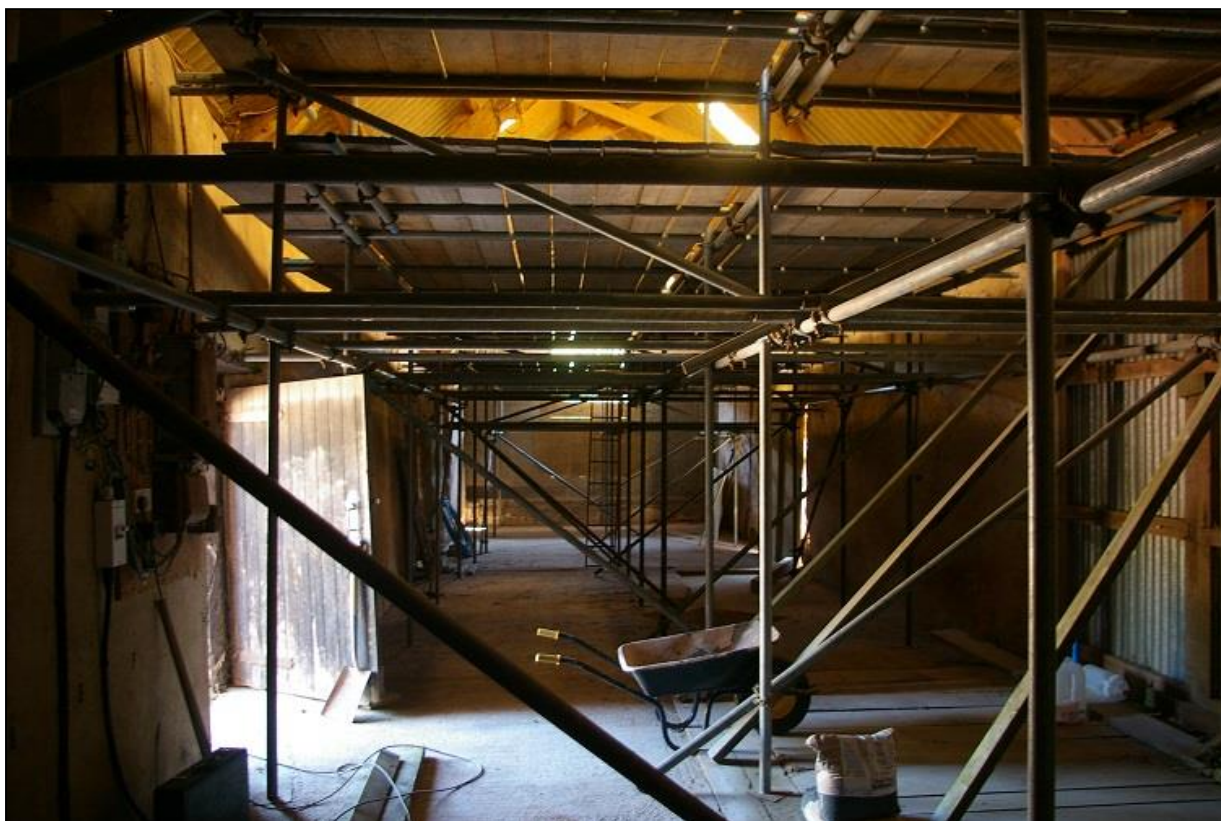
The internal faces of the barn walls have largely been rendered in modern cement, but sections of cob, with lime plaster survive. Where they do, there are distinctive layers, the cob is pale brown, as noted on the outer face of the south elevation, the lime plaster is grey coloured and mixed with horse hair, then topped with a thin coat of white lime and then lime washed. A section survives to the west end, bay 1, to both north and south walls; a section to bays 3 and 4 on the south wall; to bay 4 on the north wall and to bay 6 on the south wall. It is noted that the cob to the east end of the barn, most clear in bays 4-6 is of a slightly darker reddish-brown colour and denser in quality than to the west end. Trusses 3, 4 and 5 to this east end have exposed feet in places, the cement render cut around them; it can be seen that they project at least 2-2.5m down from the wall-plate and finish c.0.65m above the current floor level, where the timber pads have rotted they have been under-built with bricks slotted into the stonework. The end three trusses, 3, 4 and 5 were obviously intended to sit onto the stonework plinth on the inner face. There is some further internal patching in concrete block and brick where cob has fallen out, particularly to the east end of the north wall. There is a small rendered over square hollow in the wall, east of the north-east threshing door, with a chunky rendered lintel; this has been interpreted as a blocked 'keeping place' alcove for light.

FIGURE 9: THE INTERIOR OF THE MAIN BARN (B1.1), PHOTOGRAPHED FROM THE WEST END; WEST-NORTH-WEST.

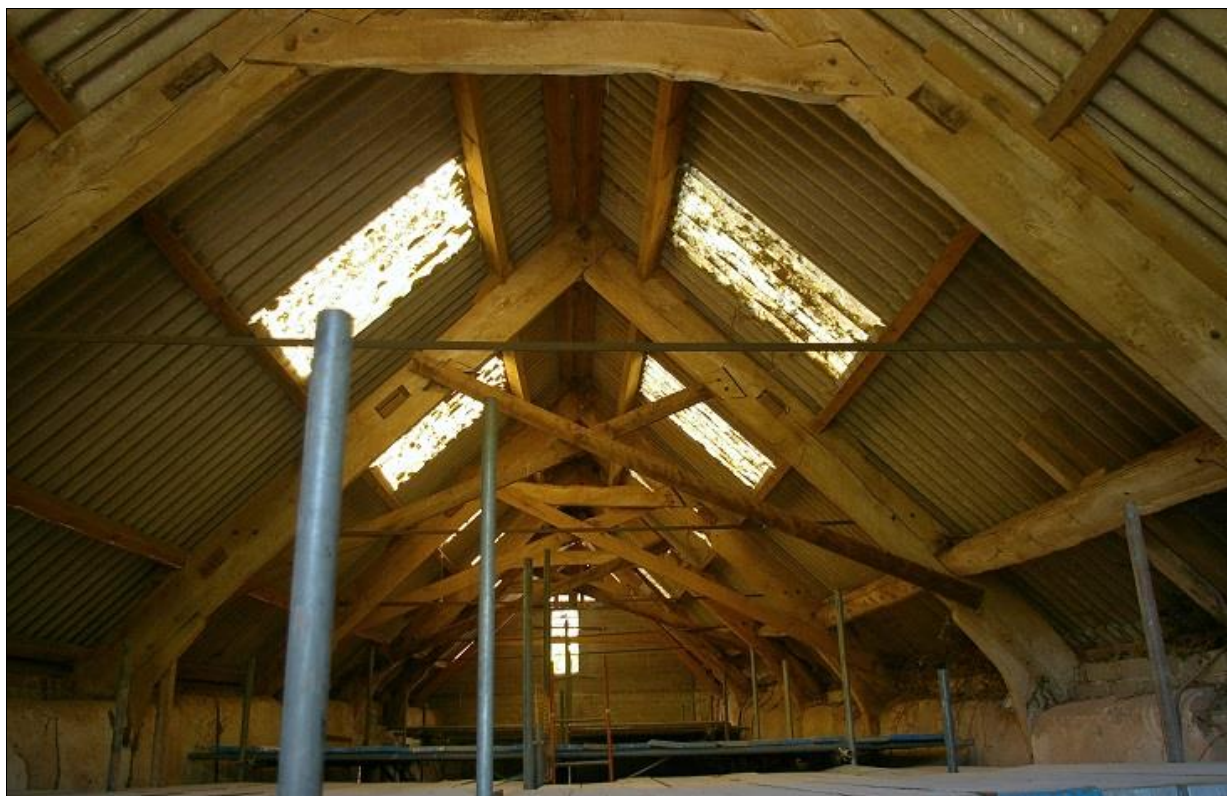
The roof comprises five jointed cruck-trusses, with an additional modern A-frame inserted into bay 1, at the west end, resting on bricks sat on the wall plate, of no clear structural function and probably installed to brace the gable end of the roof when the west gable was demolished and rebuilt. Trusses 1 and 2, to the west end of the barn are lighter in weight than those to the east and on rather than into the walls; they have a much darker patina than the three trusses to the east and a smoother straighter grain, likely oak. Their blades are chunkier and squarer in profile and Truss 1 has a mortice and tenon collar and Truss 2 has sockets for a former mortice collar, although it has a half-lapped replacement. Truss 1 and 2 also have two sets of trench sockets for purlins.

Trusses 3, 4 and 5 are broadly identical, these have not got a darkened patina, despite their age and are a rich yellow-toned wood, with a swirling grain; these may well be elm, not oak. They have threaded purlin sockets within the narrow but deep tapering blades, they have mortice and tenon ridge joints, but their collars are dovetailed half-lapped. The feet of these trusses sit far deeper into the walls and appear more integral to the structure. Bays 3, 4 and 5 retain massive base purlins, each with six pegs for rafters. Trusses 2, 3 and 5 have later nailed scissor braces, from the 19th century and all five trusses have a later iron bar tie, 1/3 of the way up the truss blade. It also becomes clear on the scaffolding at roof level that there is a marked crank in the alignment of the barn between bays 3 and 4, which is not merely due to wall droppage on the north side. Trusses 3 and 4, between bays 3, 4 and 5 also have a pair of large peg holes about c.0.2m above the in situ base purlin on both blades, evidence of a possible later phase of removed face-pegged tie beams, addressing the imbalance caused by the barns extension at bay 3, to the west. Truss 3 also exhibits distinctive notches high up under the ridge, evidence of having been propped or jacked up in the past, again likely supportive of an extension at this end and the removal of a gable wall between bays 2 and 3.

The current roof covering is of corrugated pressed fibre sheeting, with regular clear plastic corrugated panels as roof lights. All the rest of the purlins in the roof and the double ridge poles are mid to late 20th century tanted pine; there are no rafters.

FIGURE 10: THE ROOF OVER B1.1 IS OF FIVE JOINTED CRUCK TRUSSES; SOME OF THESE HAVE LATER SCISSOR BRACES ATTACHED; THERE IS ONE ADDITIONAL MODERN A-FRAME TO THE WEST END.

It is recommended that the condition within the planning permission to replace the modern A-frame with a new oak jointed cruck is reviewed in light of this report and a structural engineer and the architect examine in more detail the structural role of the modern A-frame within the barn. It appears to merely be propping the end of the roof, for when the gable was demolished and rebuilt in concrete block. Certainly, from a historical perspective a jointed cruck there would be meaningless so close to a gable and would throw off the balanced widths of the bays. It is important that the barn is read correctly historically; only bay 3 is slightly wider, as that is the point the barn was extended in the 17th century. There is no evidence in the first bay of the barn at the west end of truss feet being removed from the wall at this point and on the south side there is a good expanse of surviving cob and lime plaster which would show if modern repair had occurred. While it is clear the barn has been historically extended up the slope, closer to the house, by installing a truss here, where there wasn't one, would further change the story in future assessments and would lead people to question is the barn had been indeed extended again or even truncated.

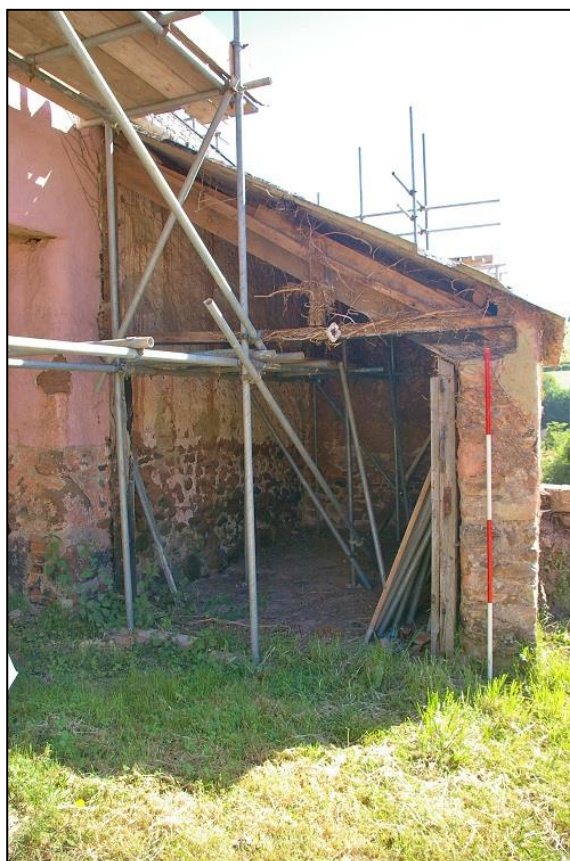
FIGURE 11: LEAN-TO EQUIPMENT SHED (B1.2), FACING INTO THE FARMYARD, ADDED ONTO THE FRONT OF THE BARN (B1.1)

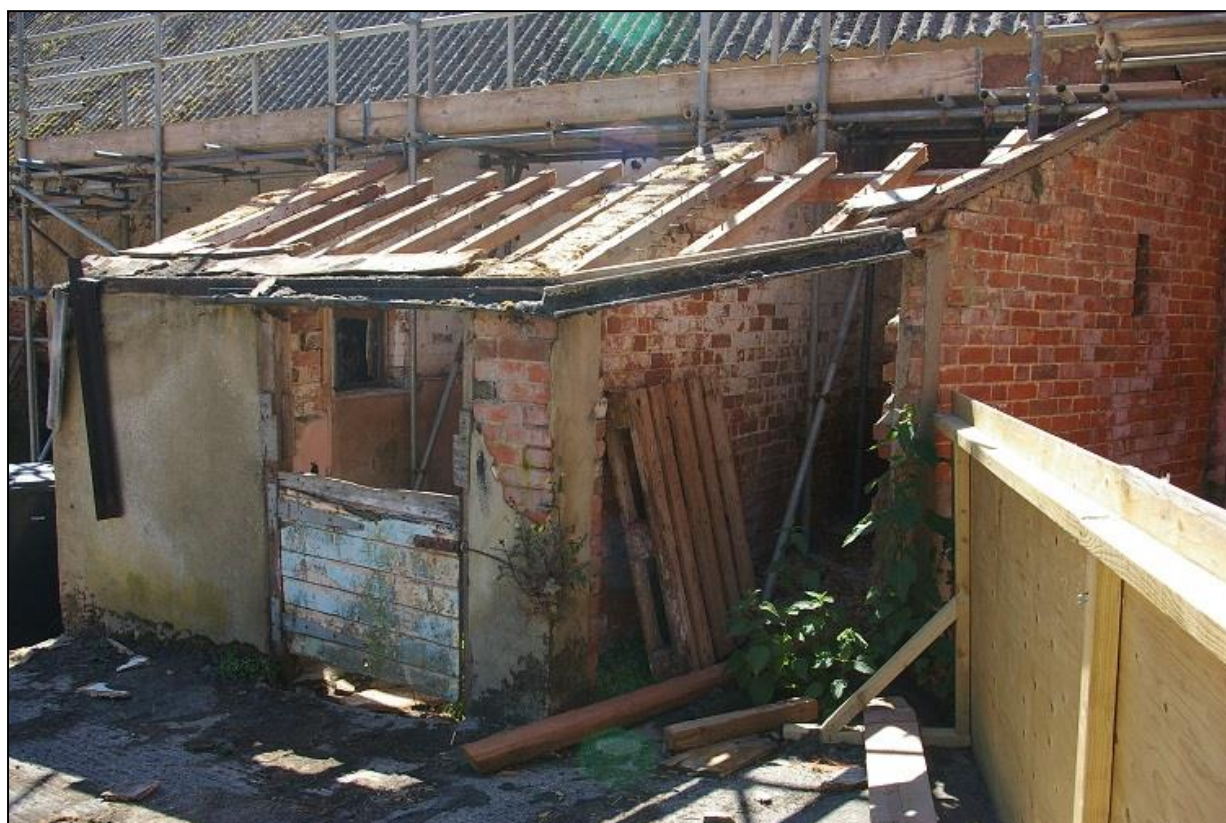
B1.3, has windows and plastered walls to the larger compartment, this may have housed a generator, or early milking machinery, or been a dairy, before the large shed to the north replaced that function. It is clear it has been used for animal housing in the past. The smaller angled compartment must have been used for storage of equipment, or again perhaps housed a piece of machinery, as it is narrow and dark, with restricted access.

FIGURE 12: B1.3, RECTANGULAR BRICK OUTSHUT ADDED TO BARN AND ADDITIONAL SPACE FORMED IN ANGLE WITH BANK, WITH ADDITIONAL BRICK WALL, FOR STORAGE AND HOUSING MACHINERY; VIEWED FROM THE NORTH-WEST.

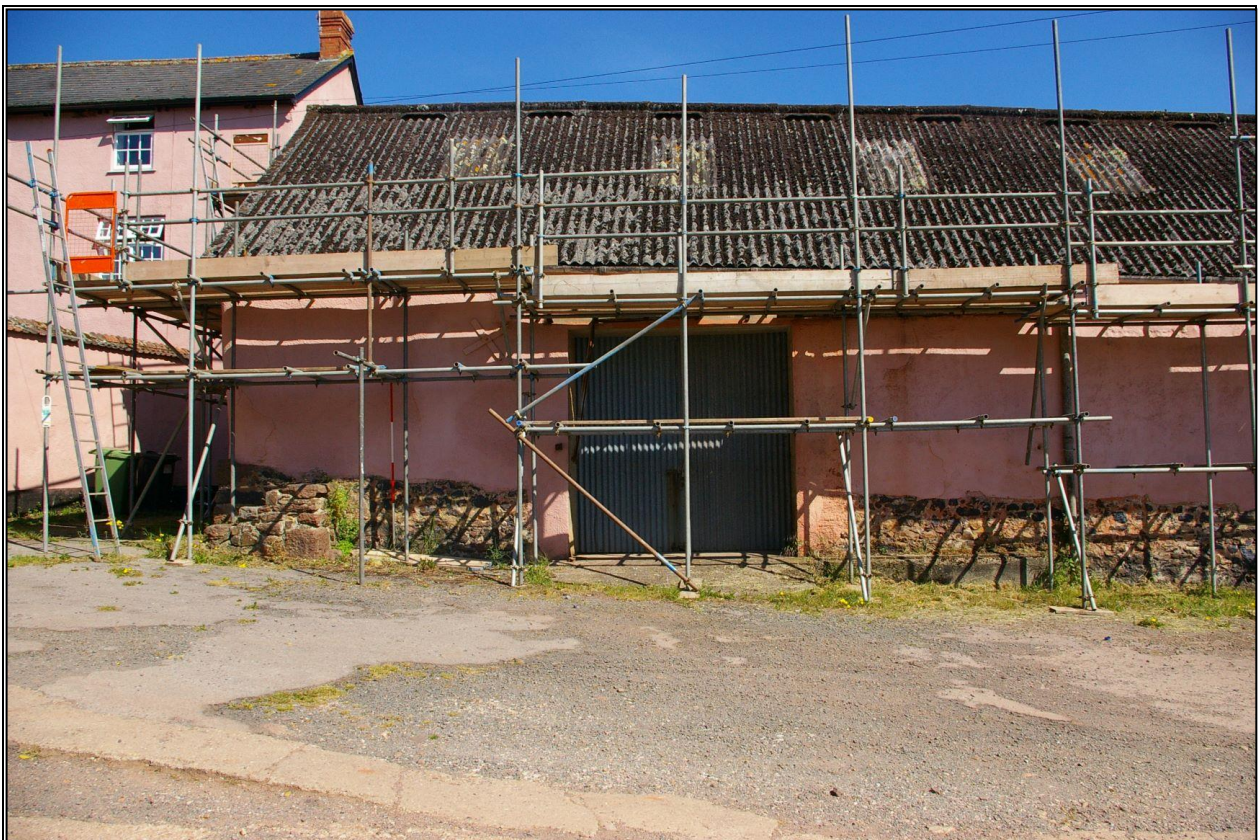
4. THE WESTERN END OF THE BARN (B1.1), WITH LARGER, BUT ALTERED THRESHING OPENING, WITH 2M SCALE; FROM THE SOUTH.

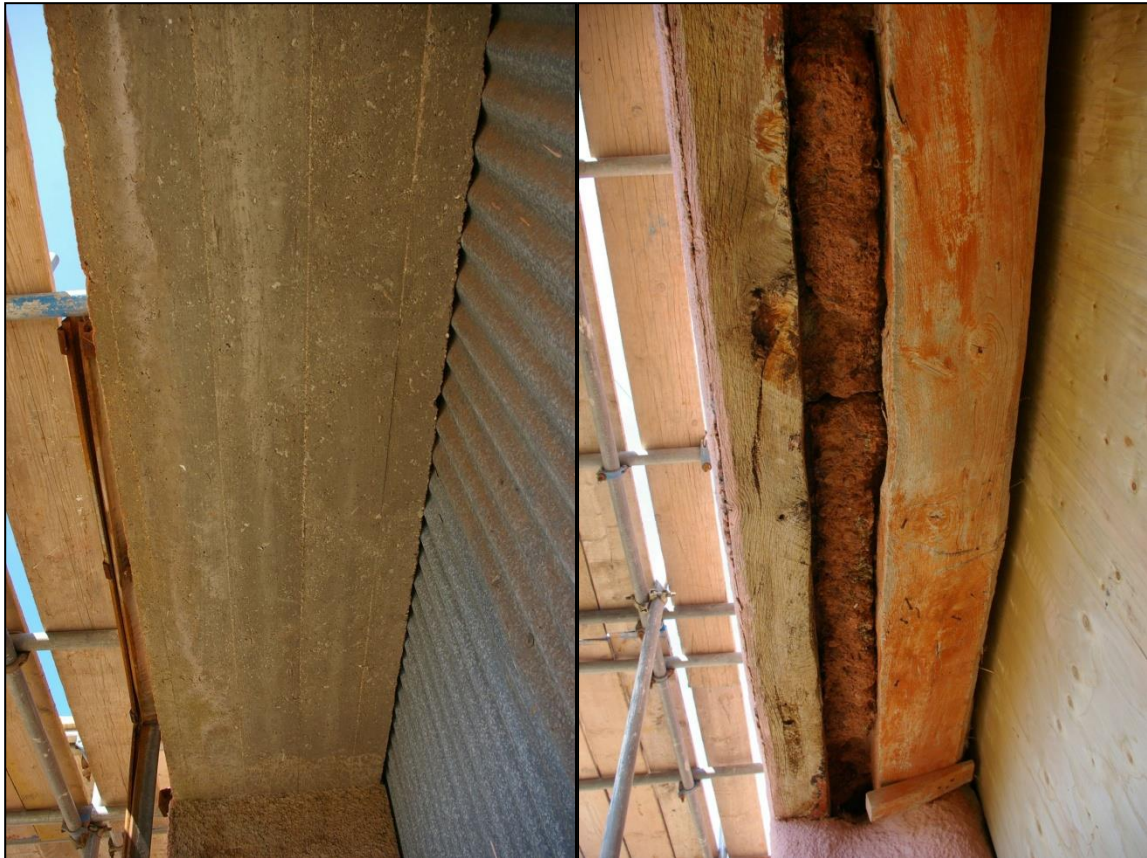
5. LEFT: THE WESTERN THRESHING OPENING HAS A CONCRETE REPLACEMENT LINTEL.
6. RIGHT: THE EASTERN THRESHING OPENING HAS HEAVY OAK CHAMFERED LINTELS; BOTH FROM THE EAST.

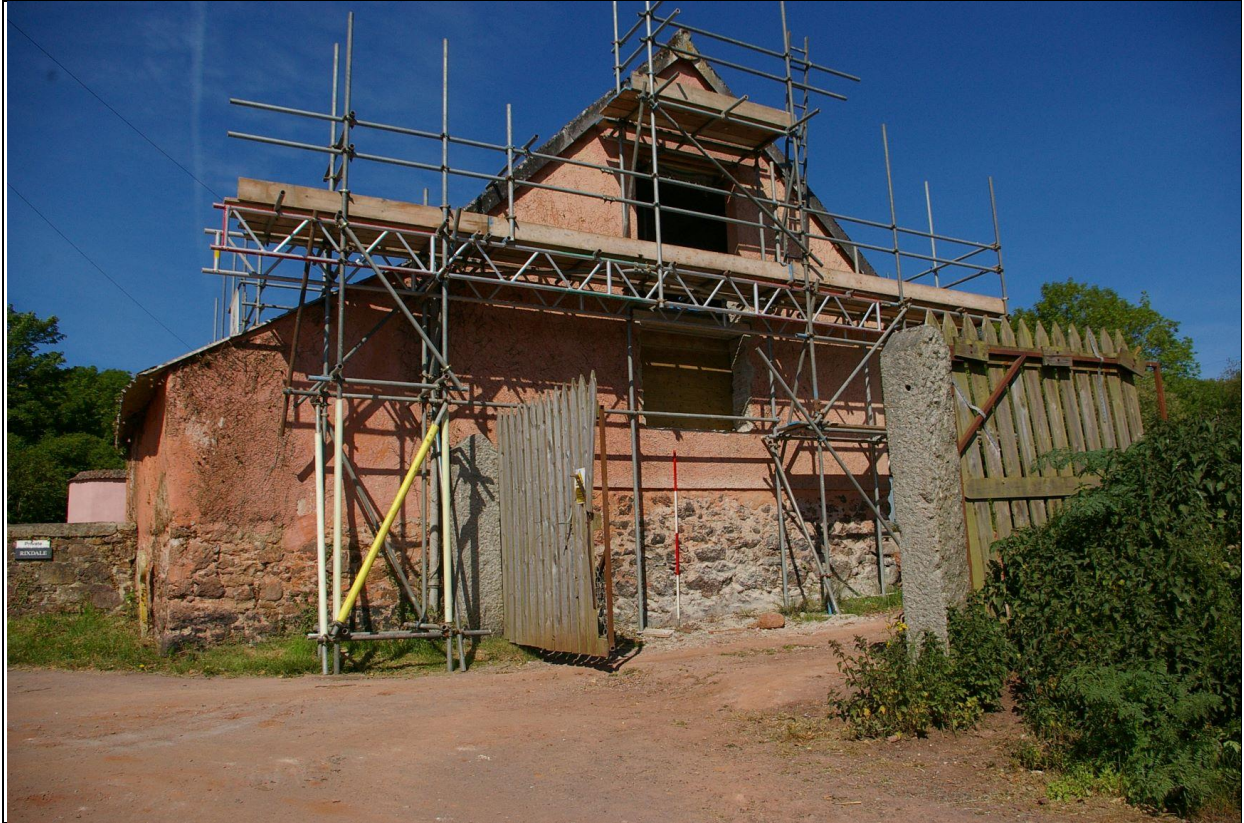
12. THE EAST GABLE OF B1.1, THE MAIN BARN, WITH 2M SCALE; FROM THE EAST-SOUTH-EAST.

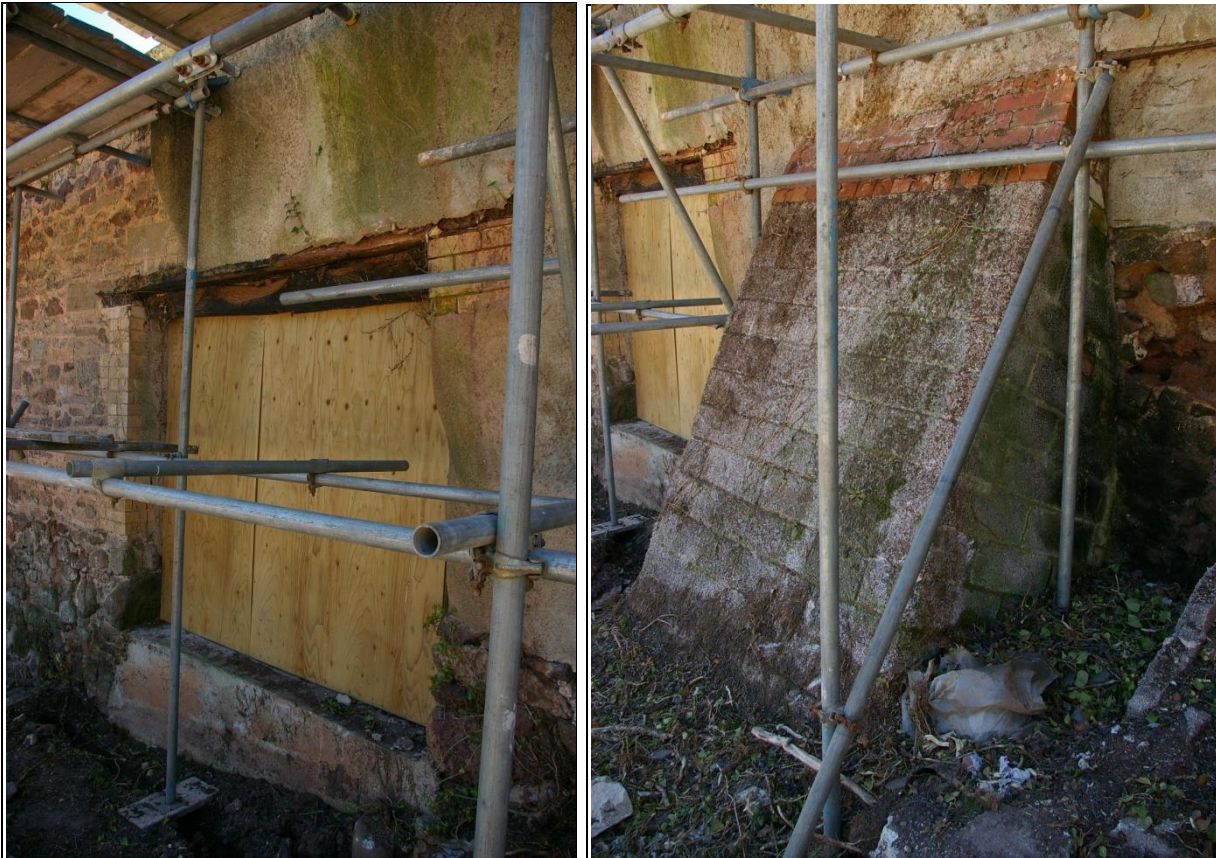
Bays 3 and 4 have had all cob replaced in under-built rubble, as to bay 5. There is scarring and patching here in concrete block and render which suggests a building has been removed, hence the structural weakness. We know from the mapping that this was the location of the former horse engine house. Interestingly the truss foot between bays 3 and 4 is exposed here, partly rendered over showing it sitting on a horizontal thick pad of wood about 2m above the external ground level. The winnowing door occupies bay 2 of the barn, it has fine shaped oak jambs, with wide chamfers ending in run out stops c.0.3m above the ground; these are undoubtedly medieval and of high quality finish. The lintel is

14. LEFT: DETAILED VIEW OF THE NORTH-EASTERN THRESHING OPENING, WITH HEAVY WEATHERED OAK LINTELS, BUT RAISED THRESHOLD IN CONCRETE BLOCKS; FROM THE WEST-NORTH-WEST.
15. RIGHT: THE LARGE CONCRETE BUTTRESS WHICH BRACES THE BARN, WHERE THE WALL HAS BEEN PATCHED IN STONE RUBBLE AND BRICK AND CONCRETE BLOCKS; FROM THE NORTH-WEST.

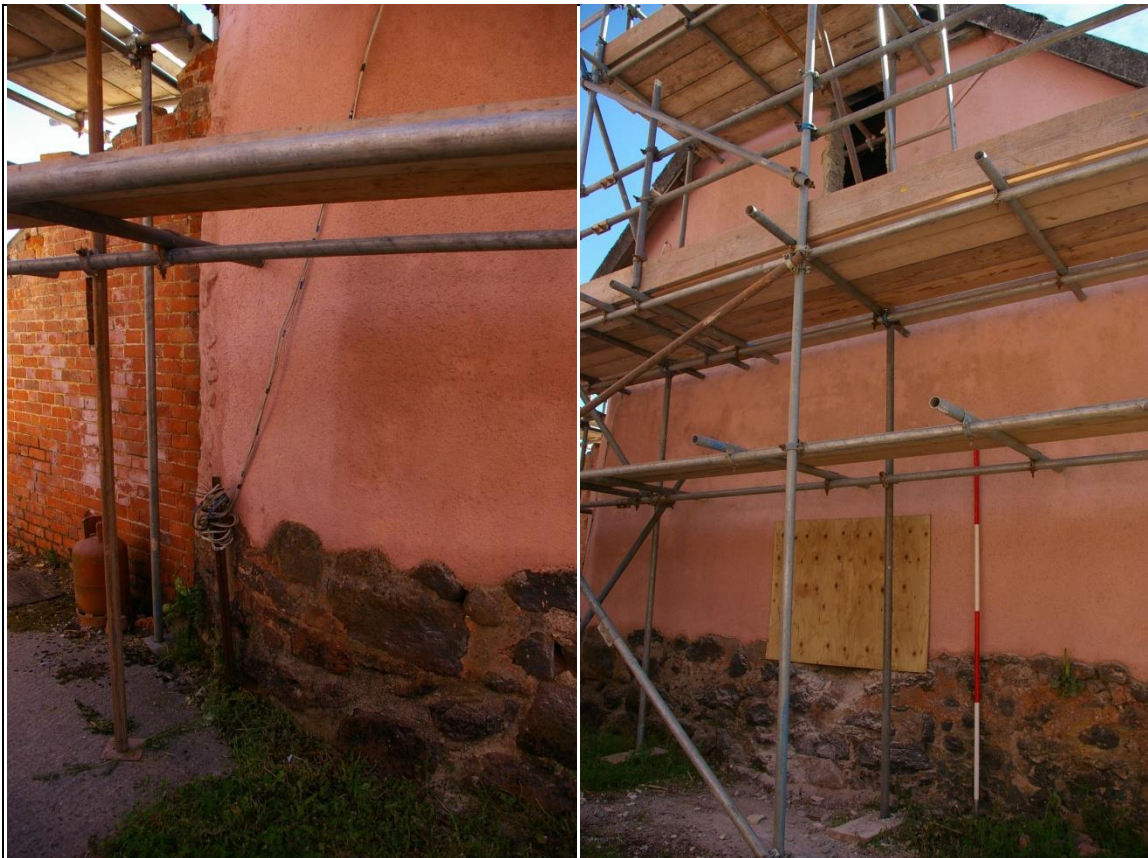
The west gable of the barn has also been rebuilt in concrete block and externally rendered, but its stone base, deeply terraced into the ground remains partly intact to c.0.75m on the exterior and 1.5m on the inside face, although obscured by render. The south-west and north-west corners have also retained their integrity too; it is only the central portion of the elevation which is rebuilt. The north-west corner is now built of stone rubble it is angled and relieved, mortared in lime; this is likely a 19th century repair associated with works to the farmhouse which stands within 2m of the corner of the barn. There is also a loading door cut into the concrete block at loft height here too. This work is contemporary to that undertaken on the east gable and most likely within the time the building was listed. This has led to a damaging loss of historic fabric and integrity, however different from the east end, there is a middle phase of iron braces holding the barn and gable together on the corners; these x-ties come across the south-west and north-west corners, at an angle. Clearly before the rebuild there were significant stresses on the barn structure at this end; bearing in mind how close the house now is and its rebuilding or remodeling in the 19th century after a major fire, this may not be a surprise.

22. LEFT: THE NORTH-WEST CORNER OF THE BARN, RELIEVED AND REBUILT IN RENDERED STONE RUBBLE, ABUTTED BY THE BRICK OUTSHUT B1.3; FROM THE SOUTH-WEST.

23. RIGHT: THE WEST GABLE, REBUILT IN CONCRETE BLOCK WITH SMALL LOADING DOOR AT APEX; FROM THE SOUTH-WEST, WITH 2M SCALE.

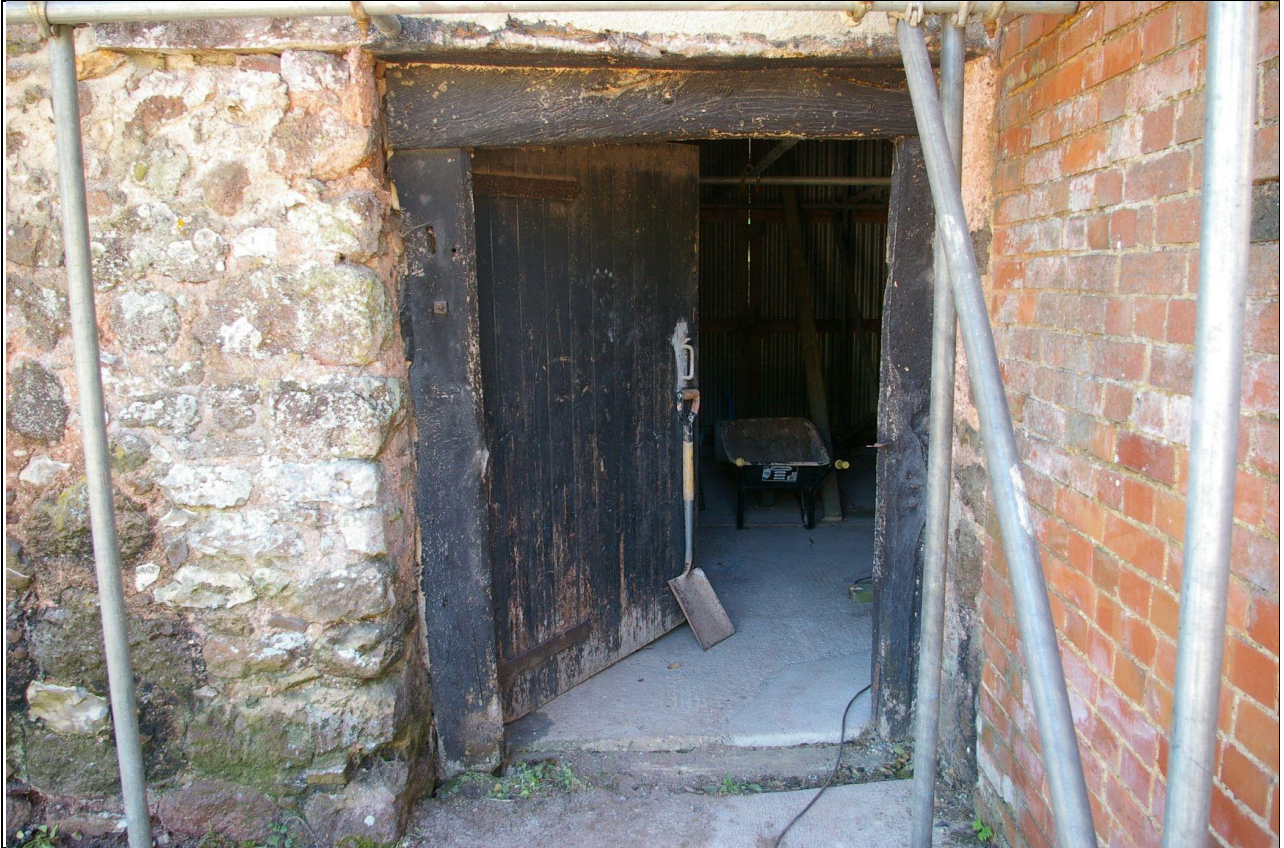
much rougher, with a crude attempt to chamfer and shape a larger beam, with the distinctive pattern of charring 'crackle' on it. The jambs are mortice and tenon jointed into the lintel and the corners pegged, of good vernacular construction but the quality of the jambs in contrast to the lintel would suggest this is a composite door and may have been moved within the structure or wider farmstead. The timber is painted in a weatherproof back tar. A fine chamfered lintel braces the opening, much wider than the current doorframe, c1.5m wide, the opening blocked to the east side. There are good shaped quoins to the west side of the doorway, more loosely set to the east, within the infill. The west end of the barn part of bay 2 and bay 1 are obscured externally by B1.3, the brick outshut.

24. LARGE WEATHERED OAK LINTEL, OVER OPENING REDUCED IN SIZE, WITH INFILL OF RUBBLE STONE, WITH A RESET DOORFRAME, WITH VERY FINE CHAMFERED JAMBS, BUT CRUDELY CHAMFERED ROUGH LINTEL, WITH CHARRING FROM A FIRE AND DIFFERENT LEVELS OF WEATHERING, FORMING A WINNOWING DOOR FOR THRESHING; FROM THE
