TREVEDDA FARM
LANTEGLOS HIGHWAY
FOWEY
CORNWALL

Heritage Assessment

South West Archaeology Ltd. report no. 200510

Draft issued: 29th May 2020
Finalised: 9th June 2020

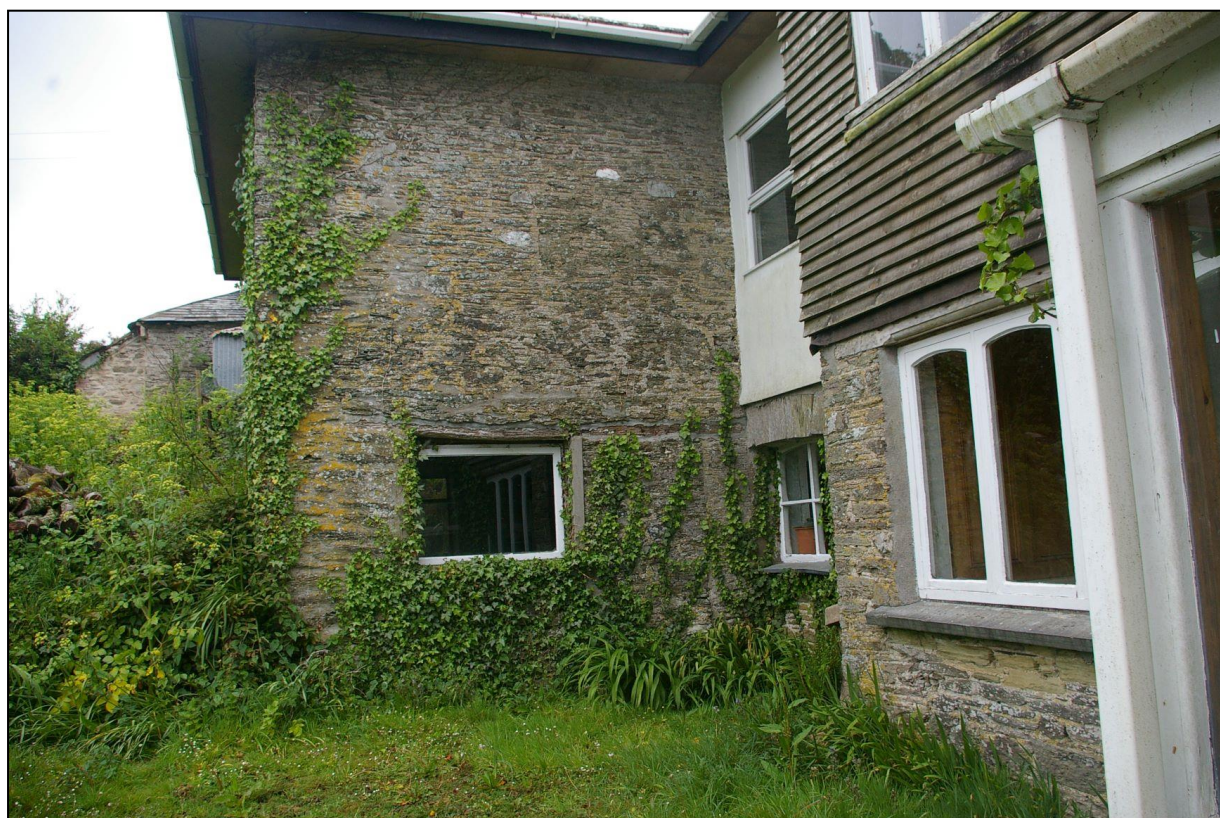
FIGURE 4: THE EAST RETURN OF THE WEST WING OF TREVEDDA, WITH WINDOW AND BLOCKED DOOR; FROM THE EAST-SOUTH-EAST.

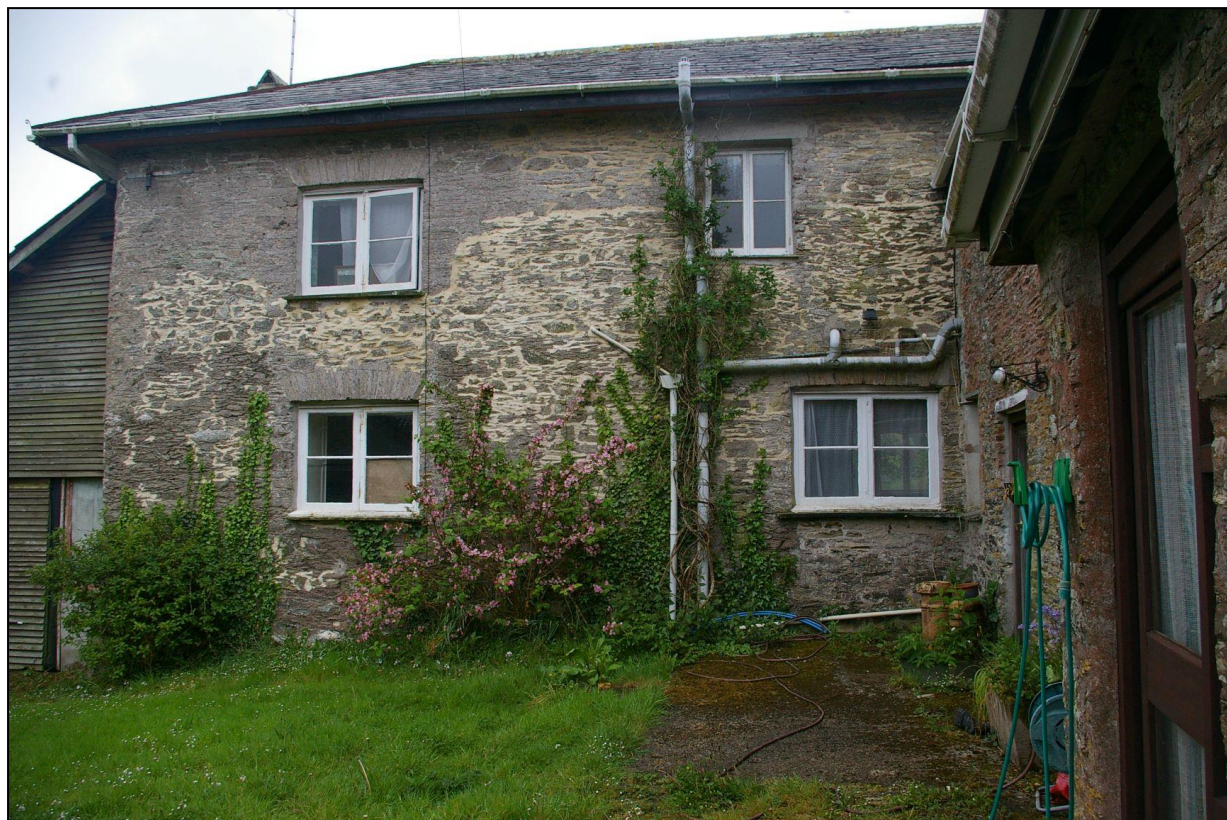
FIGURE 5: THE NORTH ELEVATION OF THE MAIN RANGE; FROM THE NORTH-NORTH-WEST.

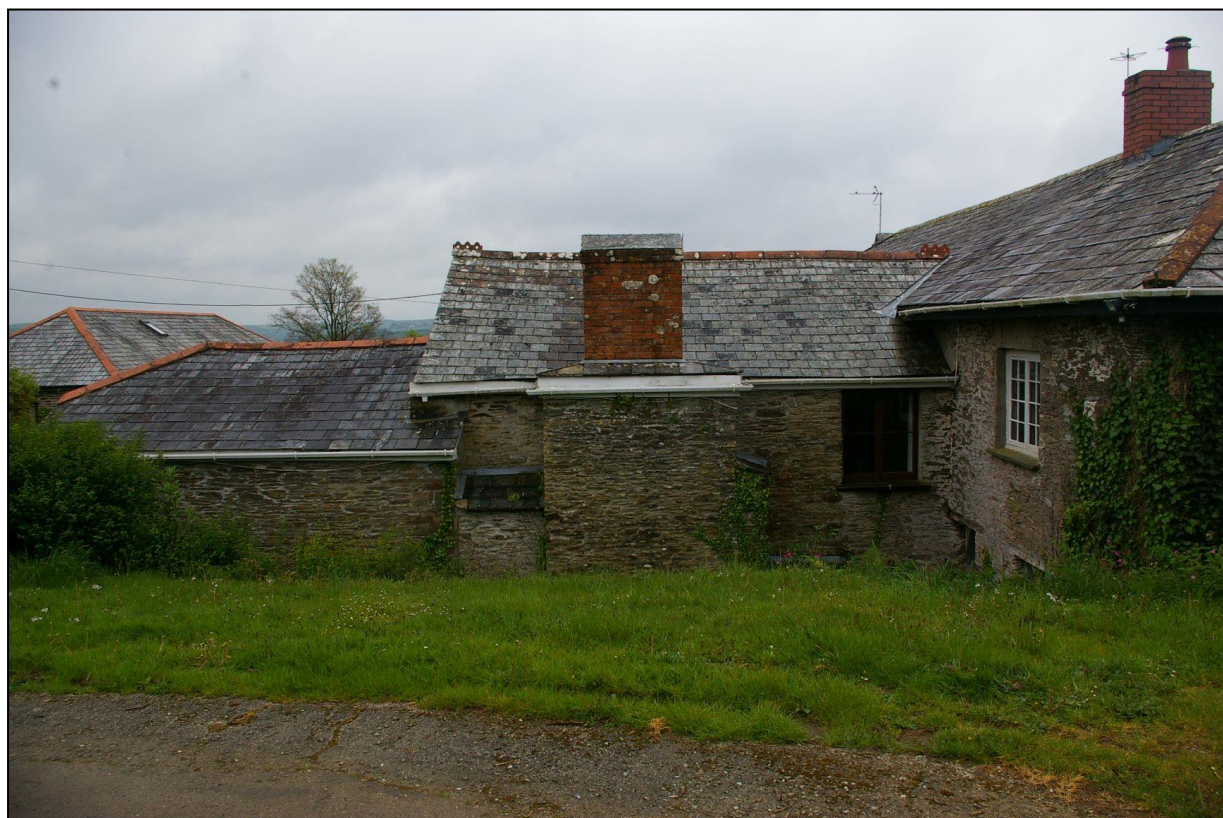
FIGURE 6: THE REAR NORTH-WEST SERVICE WING; FROM THE WEST.

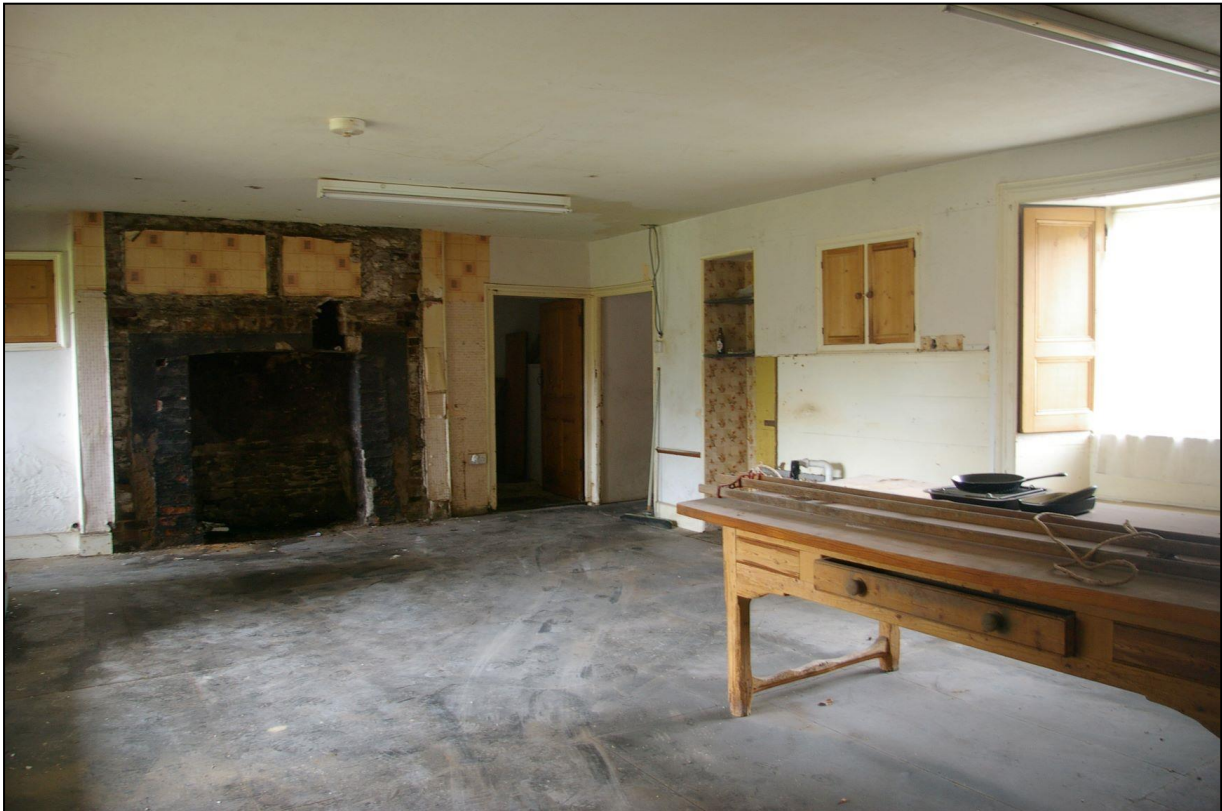
FIGURE 7: THE KITCHEN, ROOM 2A; FROM THE SOUTH-EAST.

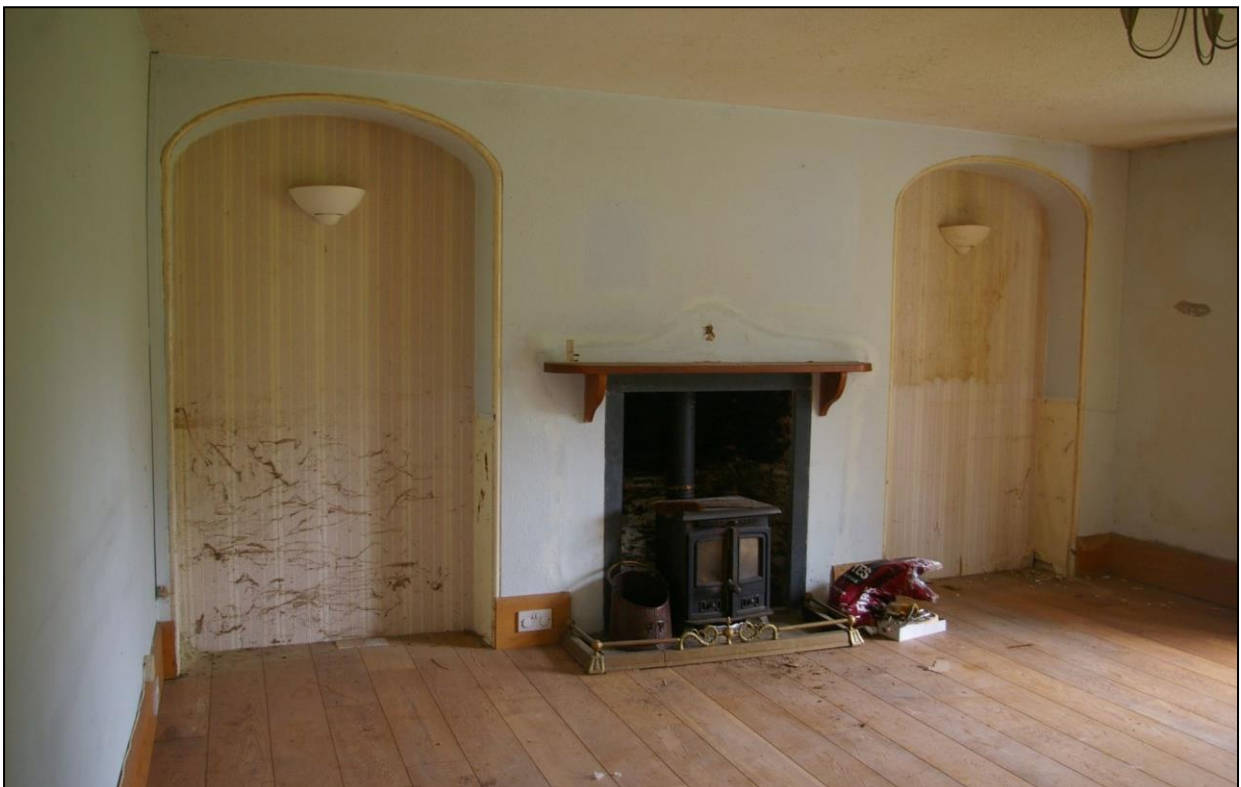
FIGURE 8: THE 19TH CENTURY DRAWING ROOM, ROOM 4; FROM THE WEST-NORTH-WEST.

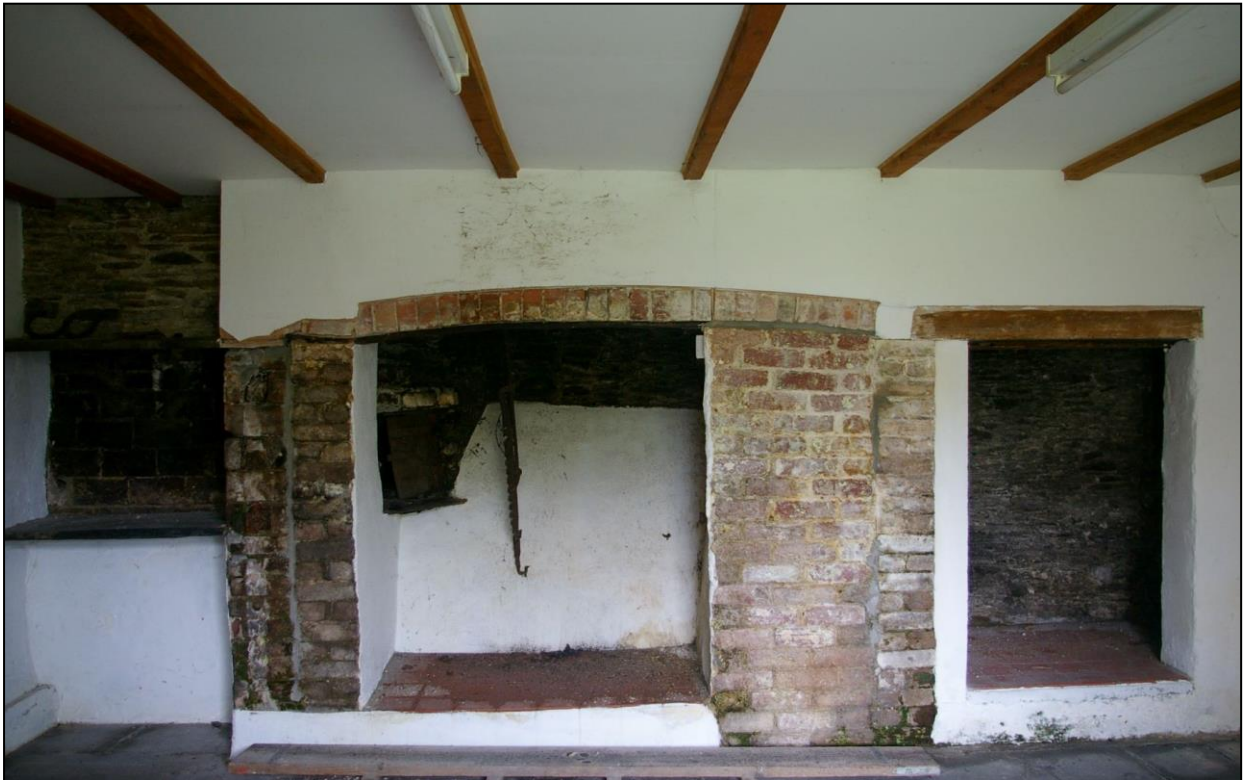
FIGURE 9: THE MUCH-ALTERED LATERAL STACK IN THE REAR WING, ROOM 7; FROM THE EAST.

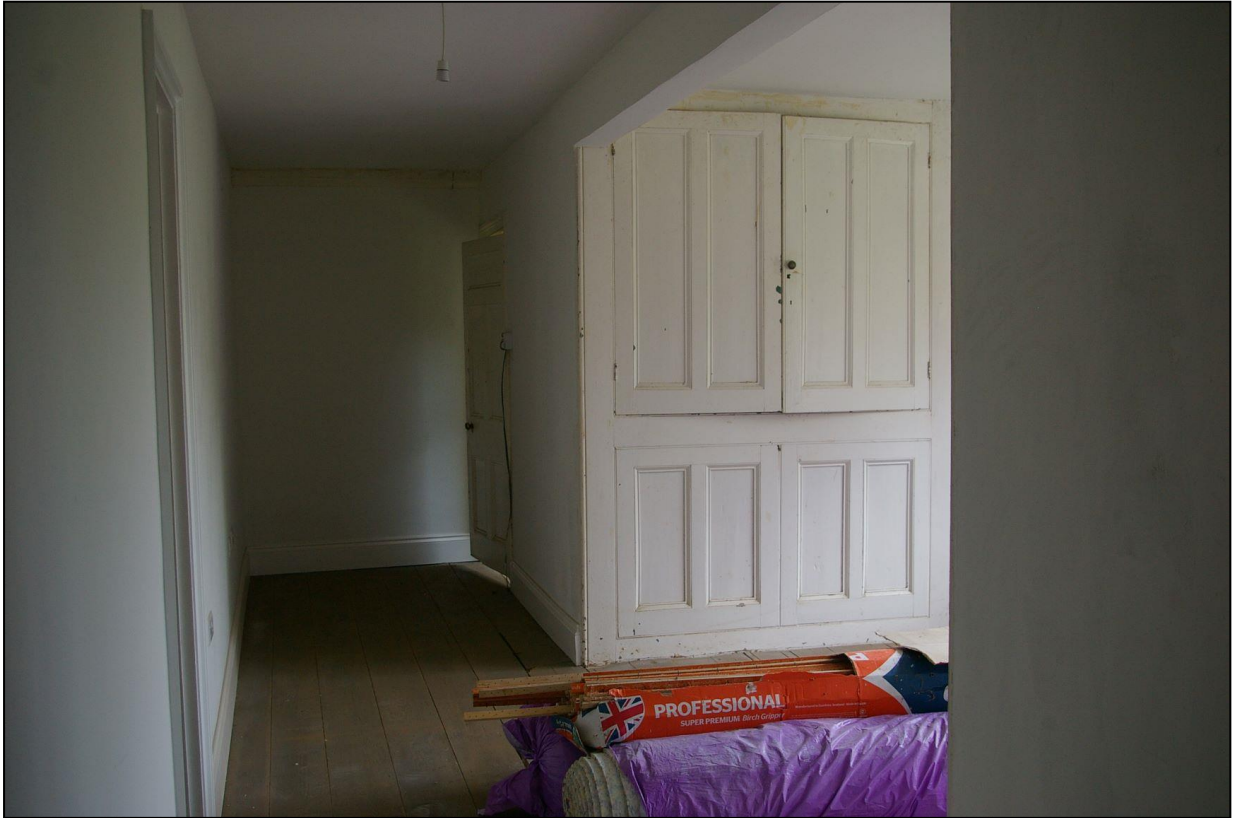
FIGURE 10: THE STAIRS FORM A FIRST FLOOR GALLERY WITH MATCHING PANELLED CUPBOARDS, ROOM 13, A FINE EXAMPLE OF EARLY-MID 19TH CENTURY INTERIOR CARPENTRY; FROM THE WEST-NORTH-WEST.

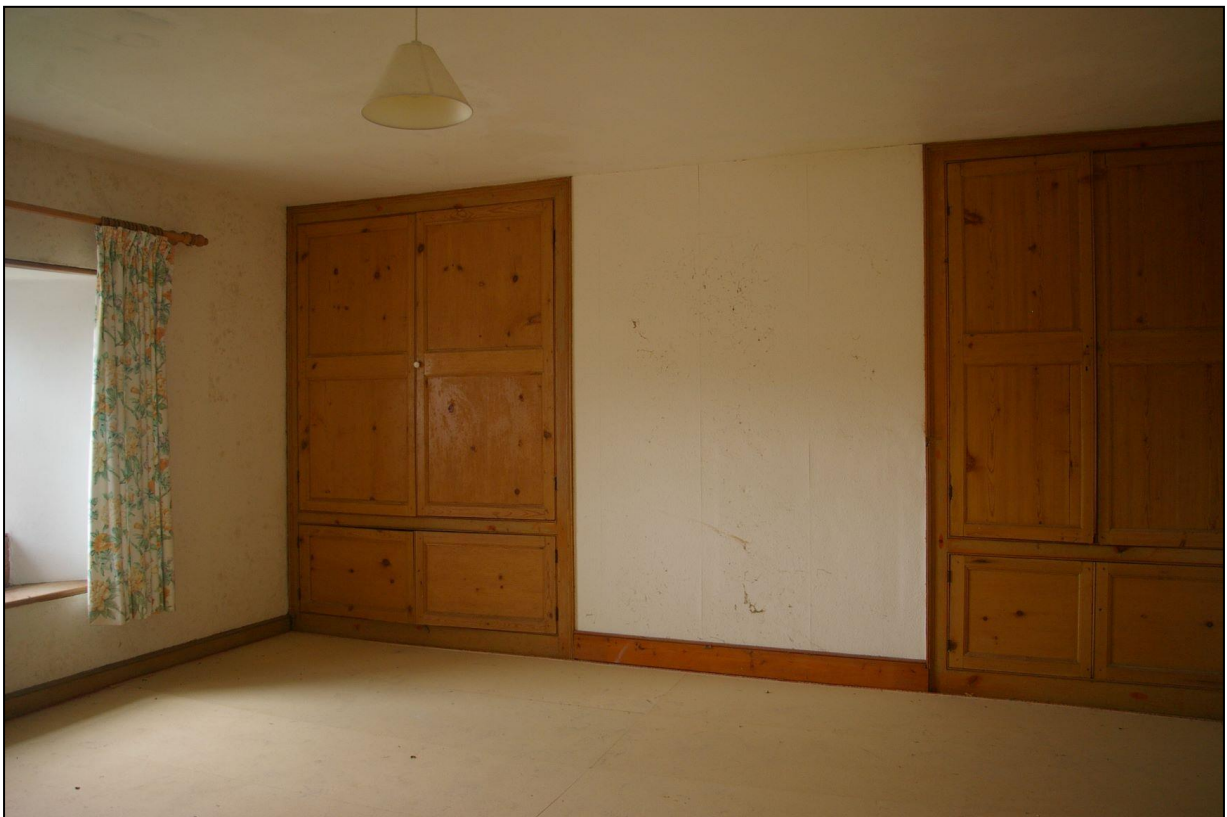
FIGURE 11: THE SECOND BEDROOM, ROOM 16; FROM THE SOUTH-WEST.

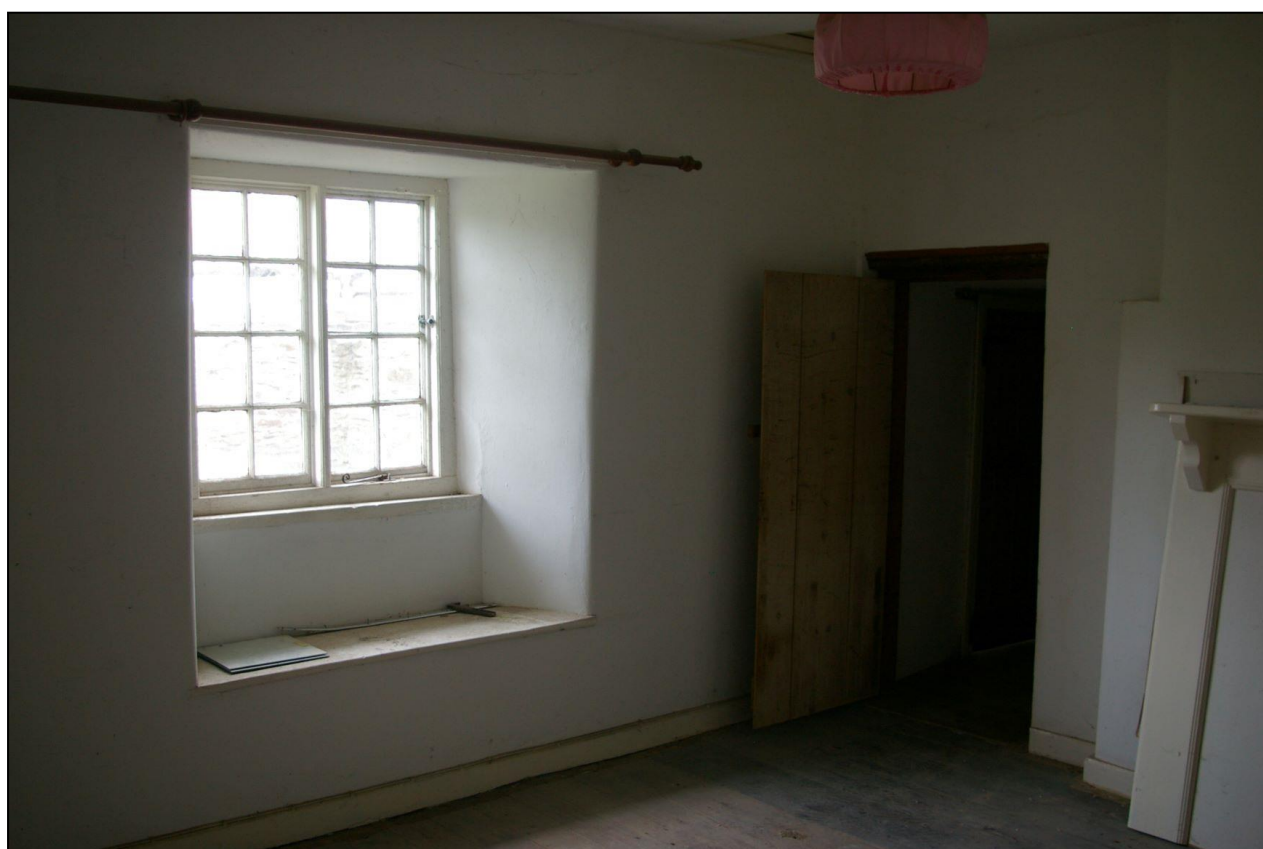
FIGURE 12: ROOM 19, WITH GOOD DOOR AND WINDOW, WITH WINDOW SEAT; FROM THE SOUTH-WEST.

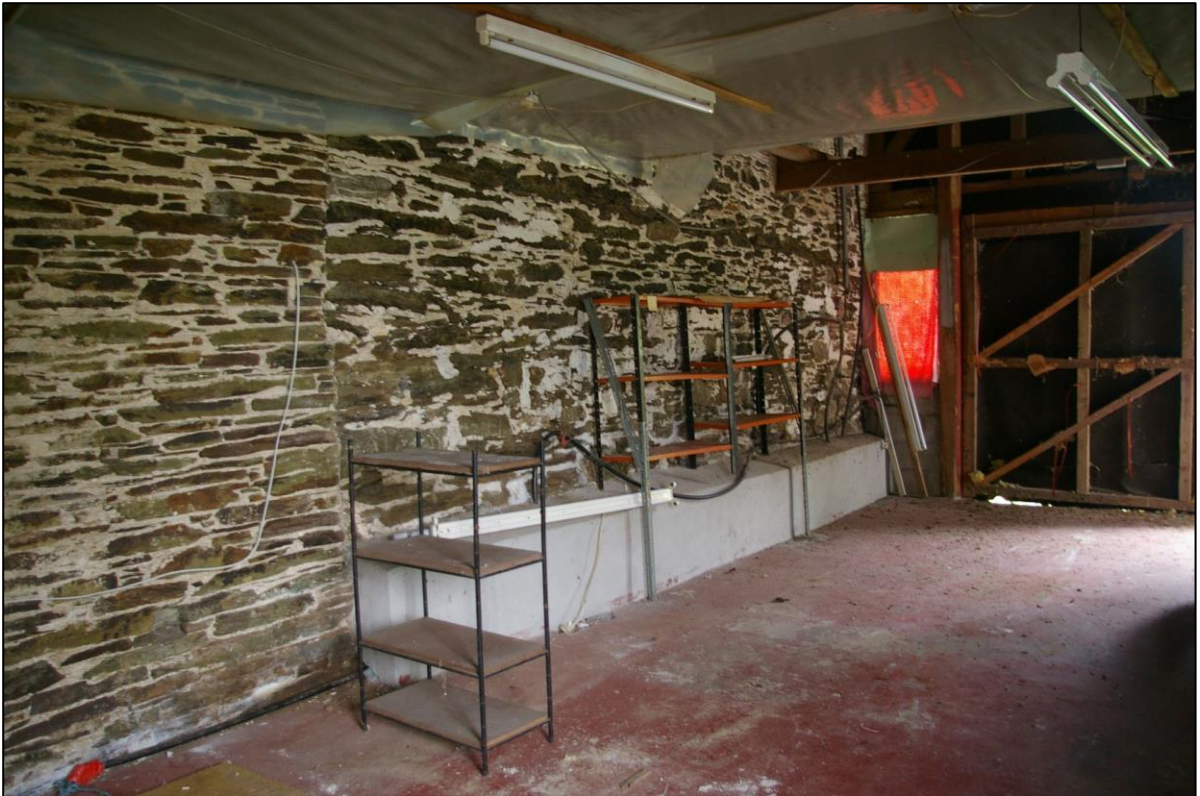
9. THE EAST WALL OF THE HOUSE, SHOWING THE BUILD LINE IN THE EAST WING; FROM THE SOUTH-EAST. FROM WITHIN OB1.

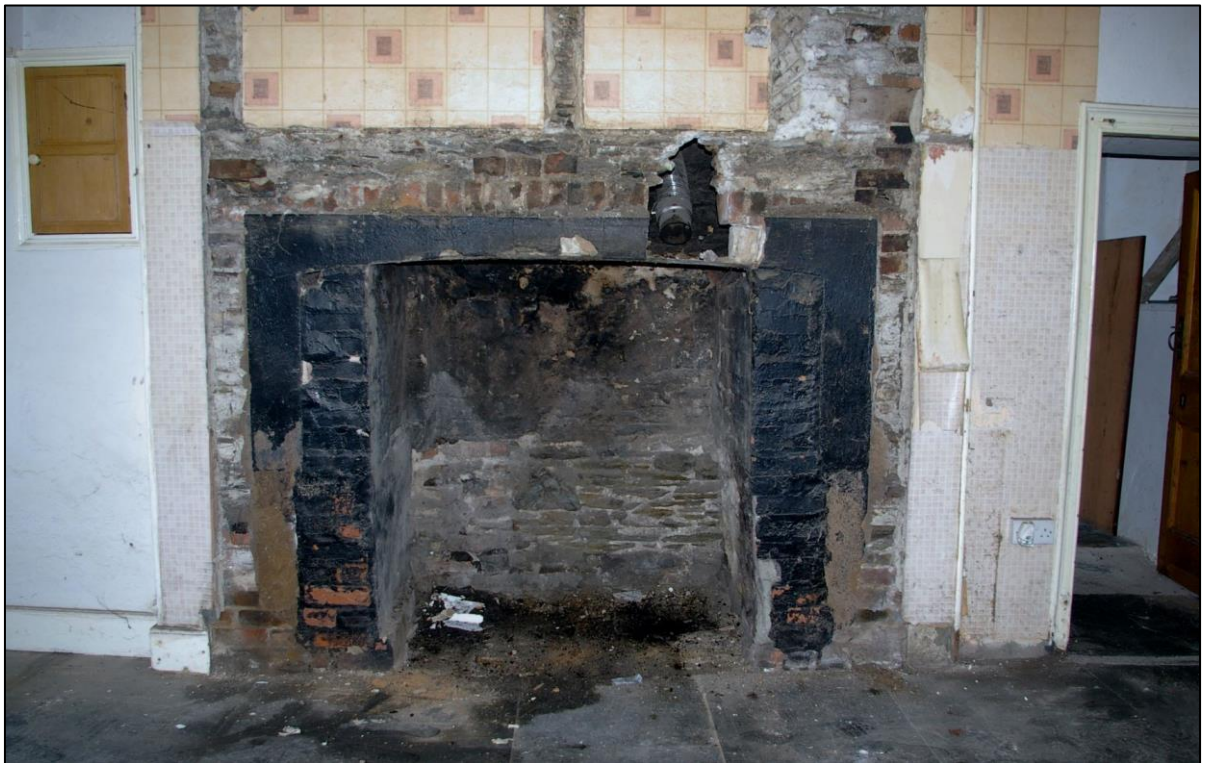
19. THE FIREPLACE IN R2A, FORCED INTO THE BACK OF AN EARLIER STACK; FROM THE EAST.

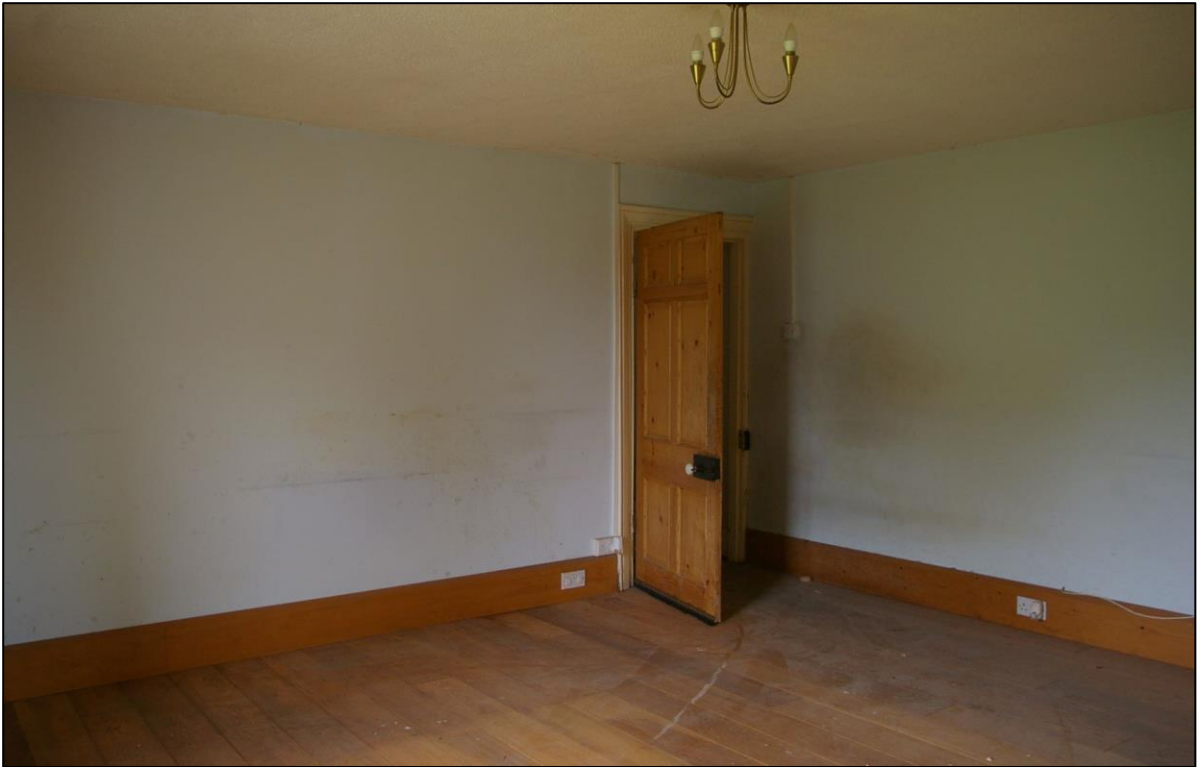
30. R4, HAVING BEEN MODERNISED IN THE 20TH CENTURY; FROM THE SOUTH-EAST.

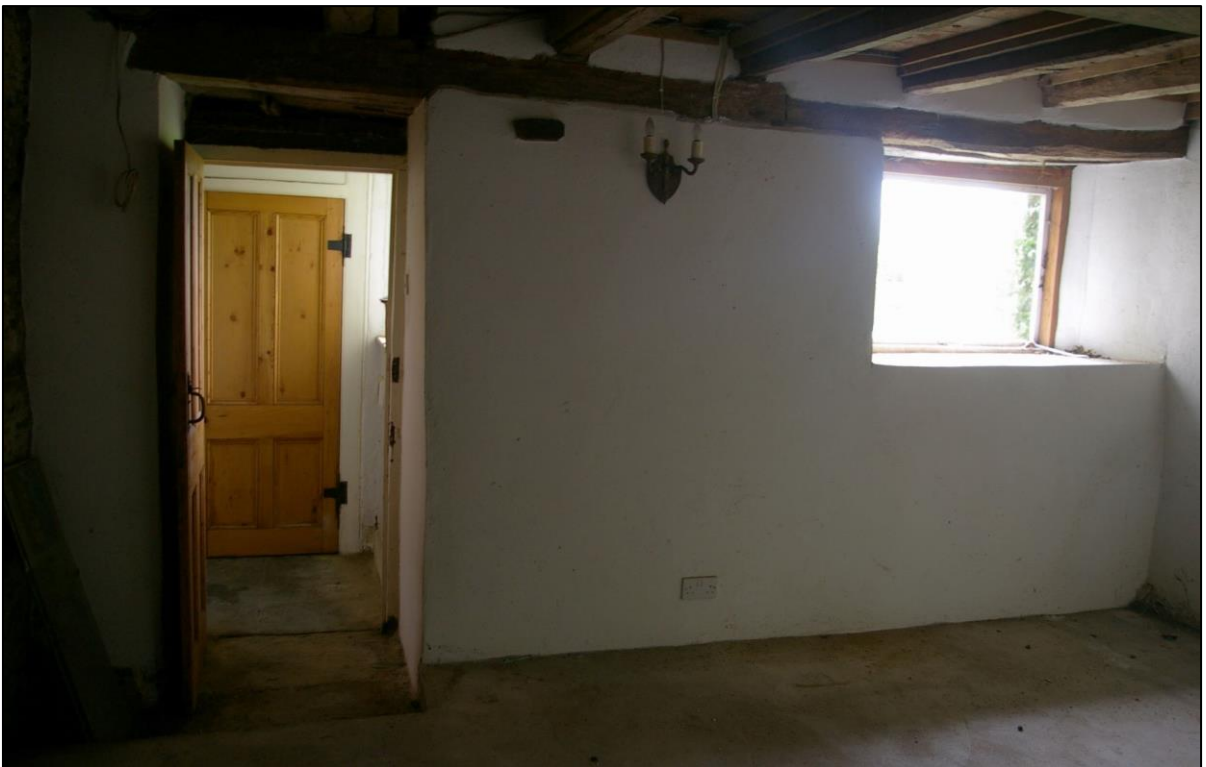
31. R5, THE EAST WALL, WITH BLOCKED OPENINGS AND MODERN WINDOW UNDER THE THICK CHAMFERED BEAM; FORM THE NORTH-WEST.

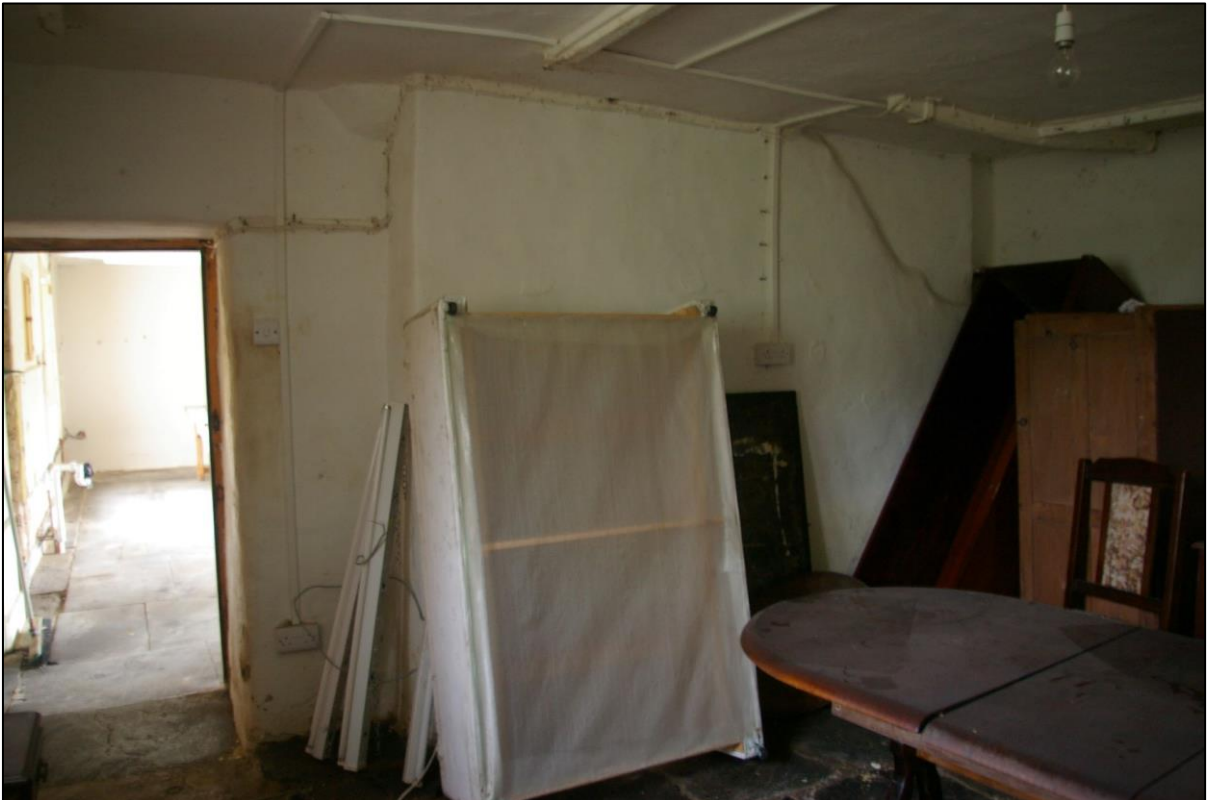
35. R6, THE EAST WALL WITH MASSIVE STACK AND BLOCKED FIREPLACE AND HOOKS TO CEILING; FROM THE NORTH-WEST.

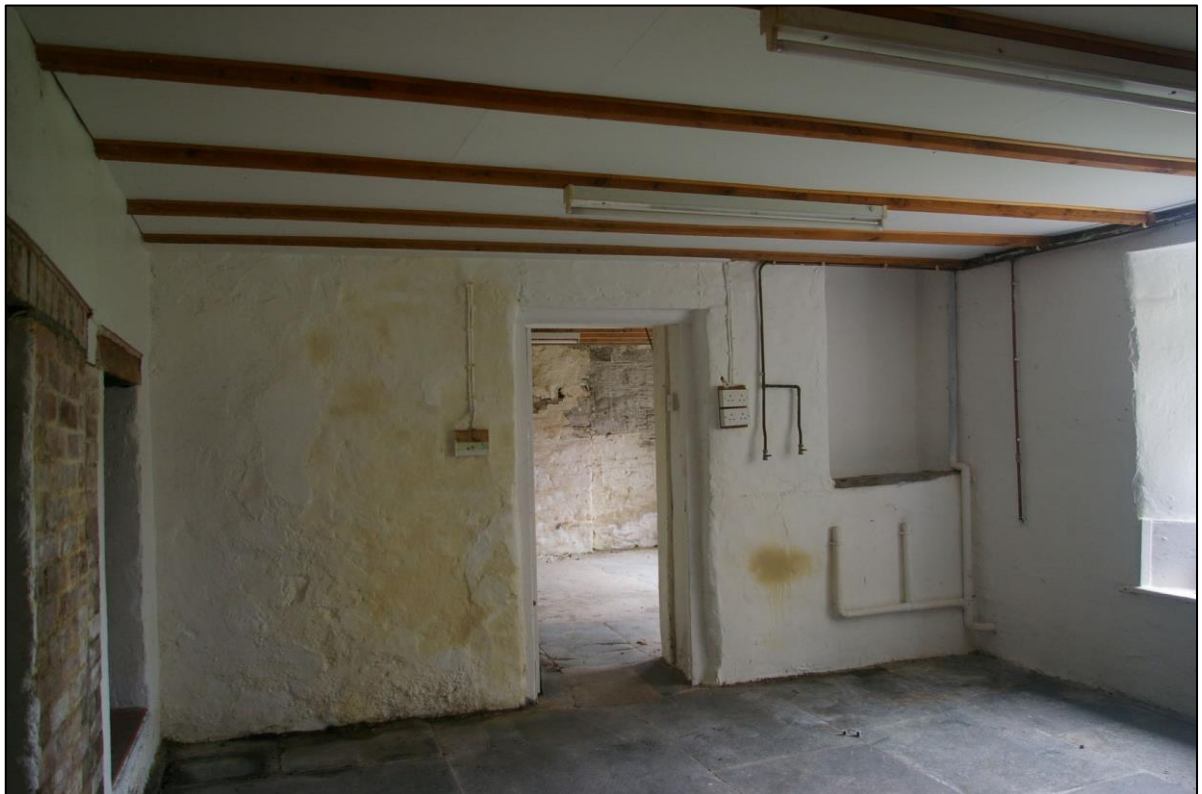
39. R7, THE NORTH WALL WITH EXTANT DOOR AND BLOCKED WINDOW; FROM THE SOUTH-WEST.

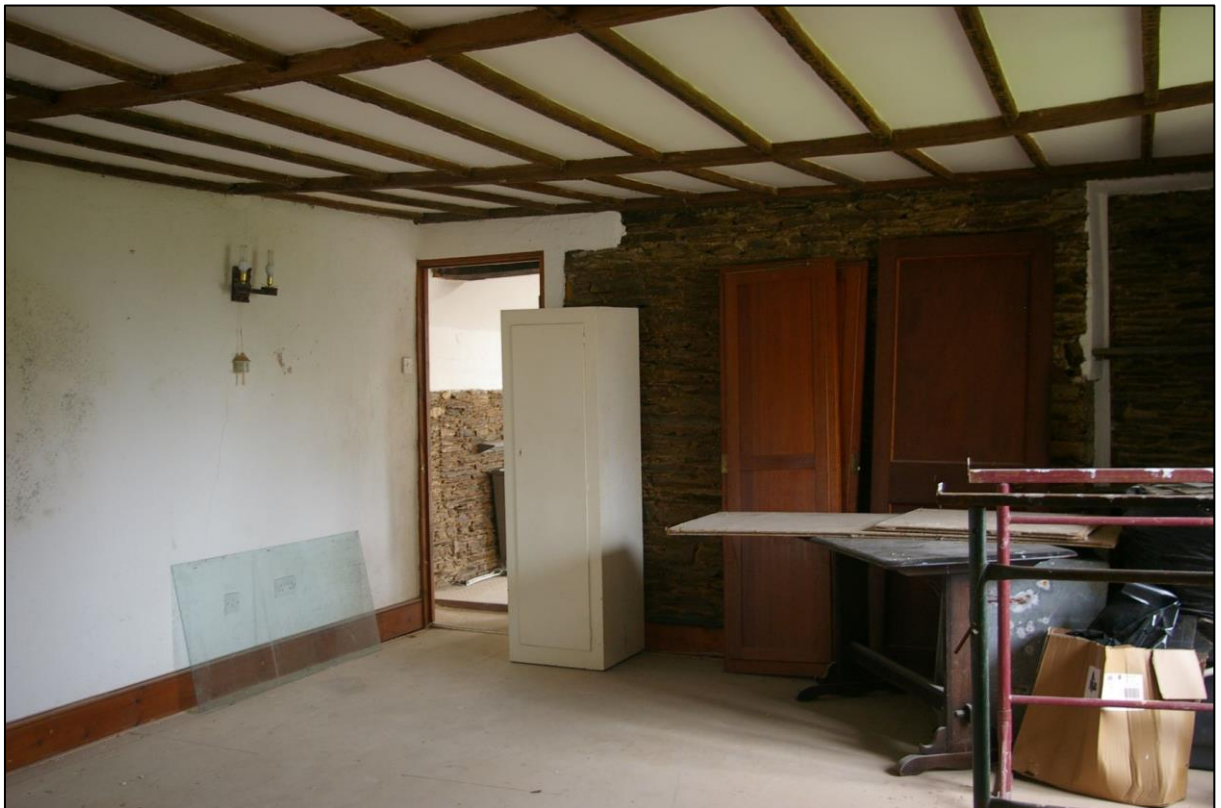
61. ROOM 20 THE NORTH WALL, EXPOSED STONE AND FORCED DOOR TO R21; FROM THE SOUTH-EAST.
