# THE PACKHORSE INN FORE STREET ST BLAZEY CORNWALL

Results of a Desk-Based Assessment, Historic Building Recording, Walkover Survey and Heritage Impact Assessment

South West Archaeology Ltd. report no. 180124

By E. Wapshott & P. Webb  
Report Version: FINAL  
31<sup>st</sup> March 2020

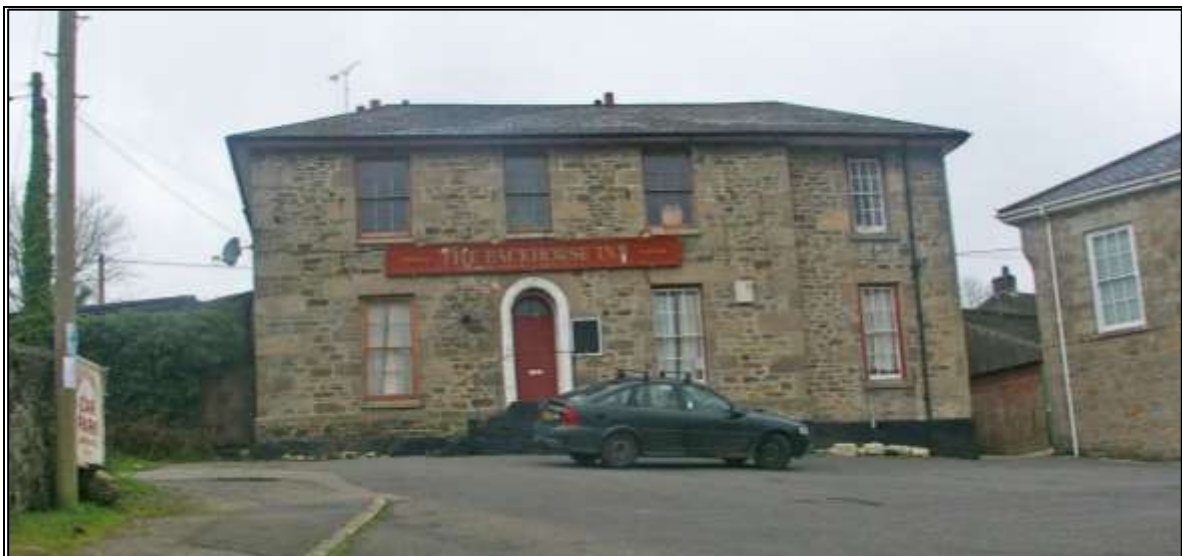
FIGURE 12: THE FRONT OF THE PACKHORSE INN; VIEWED FROM THE EAST.

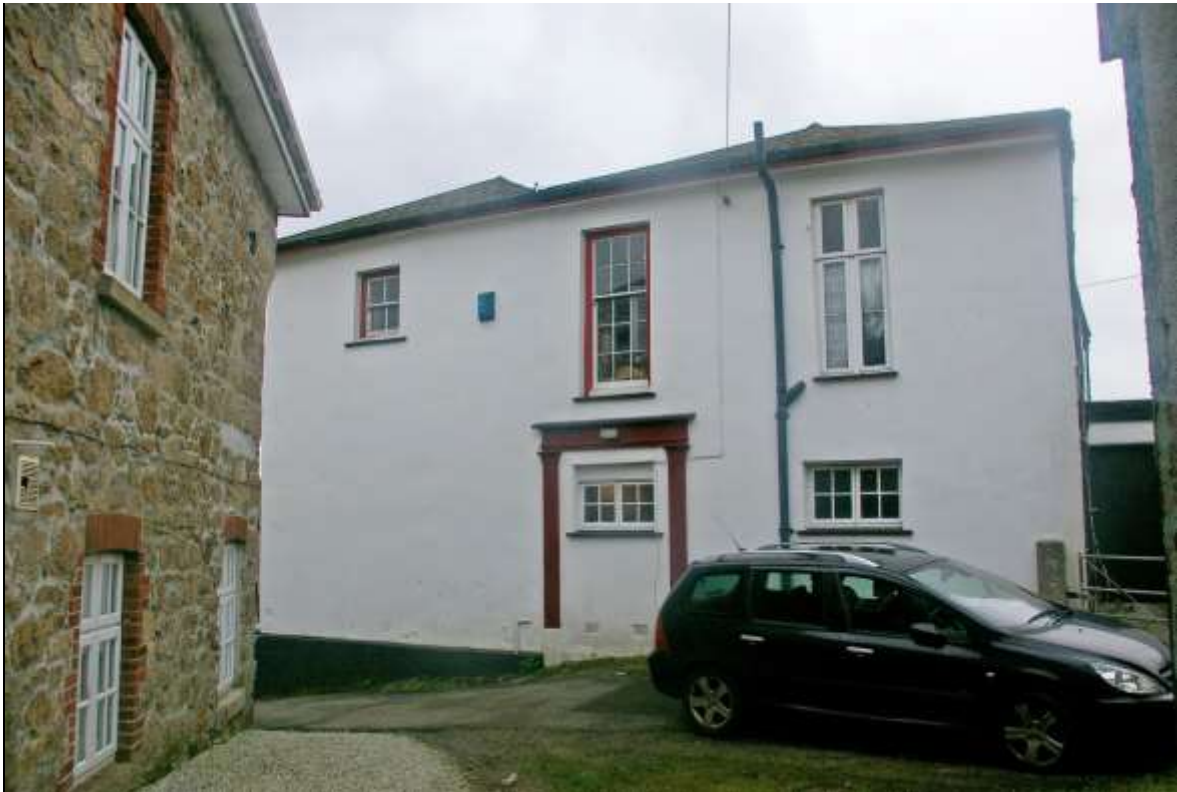
FIGURE 14: THE NORTH ELEVATION, SHOWING FINE SURVIVING DOORCASE; FROM THE NORTH-NORTH-WEST.

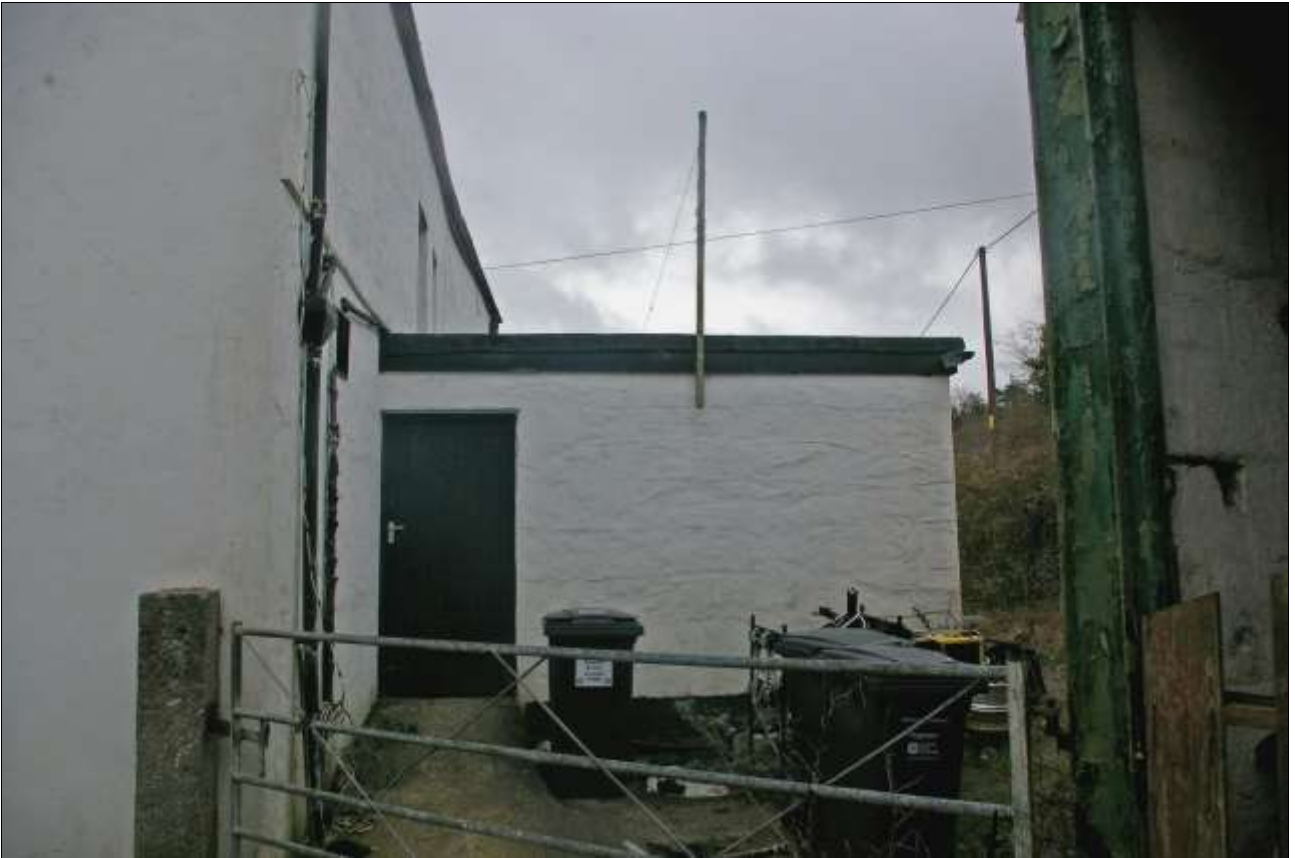
3. THE NORTH ELEVATION OF THE FLAT-ROOFED EXTENSION WITH DOOR TO THE BEER CELLAR; ABOVE, A SLIGHT KINK IN THE WEST ELEVATION OF THE MAIN BUILDING, EVIDENCE OF PHASING; VIEWED FROM THE NORTH.

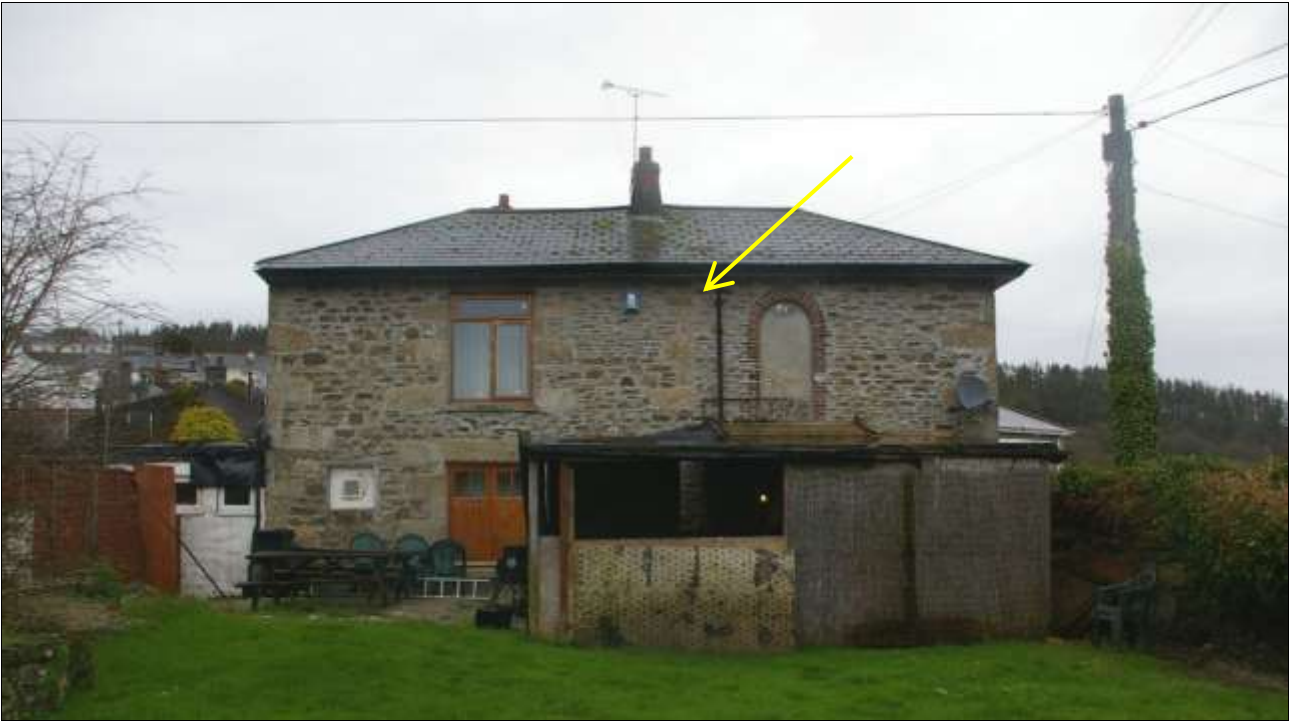
5. THE SOUTH ELEVATION OF THE INN SHOWING CLEAR PHASING; THE EAST BLOCK (LEFT) ABUTS THE QUOINS OF THE EARLIER WEST BLOCK (LEFT), AS INDICATED; VIEWED FROM THE SOUTH.

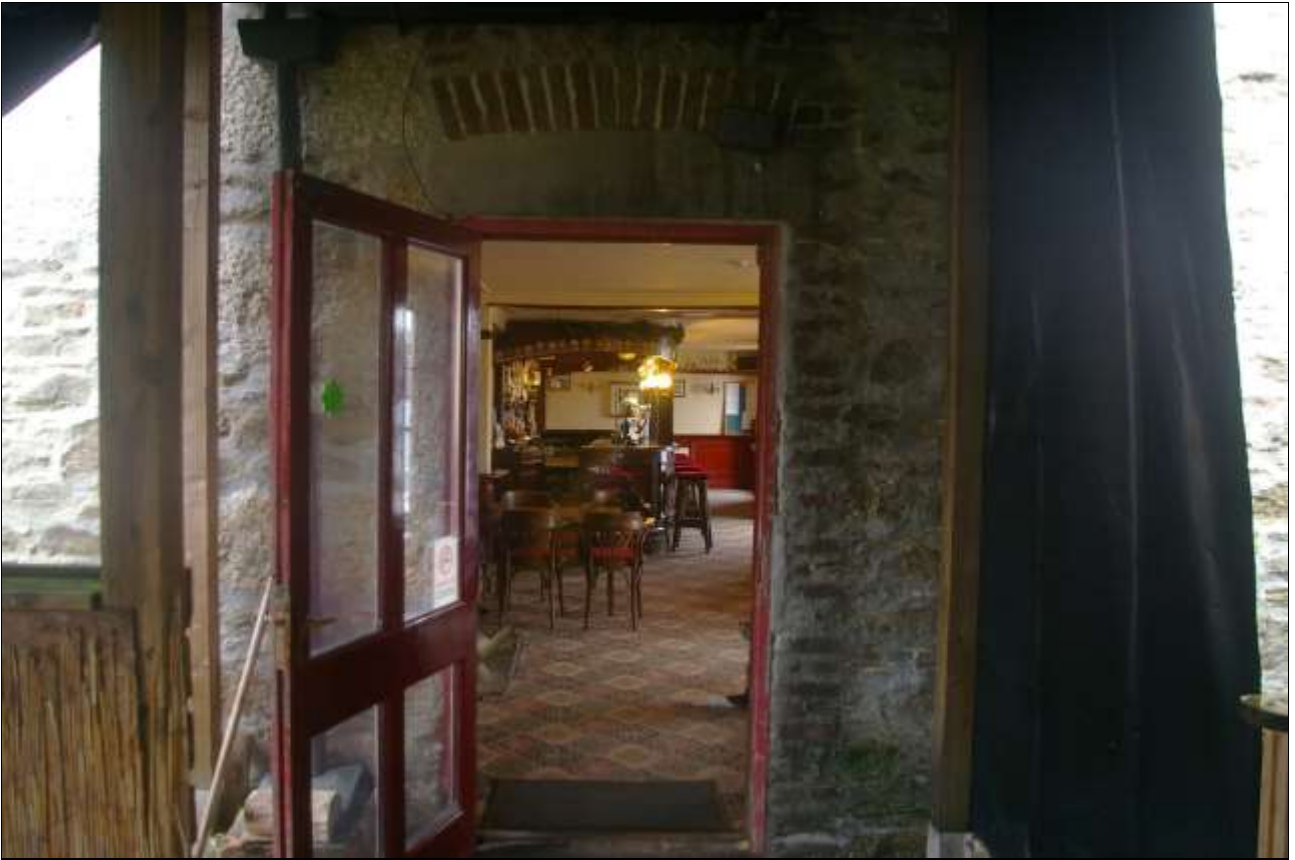
13. VIEW THROUGH D3, THE DOOR FORCED INTO AN EARLIER WINDOW OPENING, HENCE THE HIGHER BRICK SEGMENTAL ARCH AND NEED FOR REPAIR TO THE EAST SIDE; VIEWED FROM THE SOUTH.

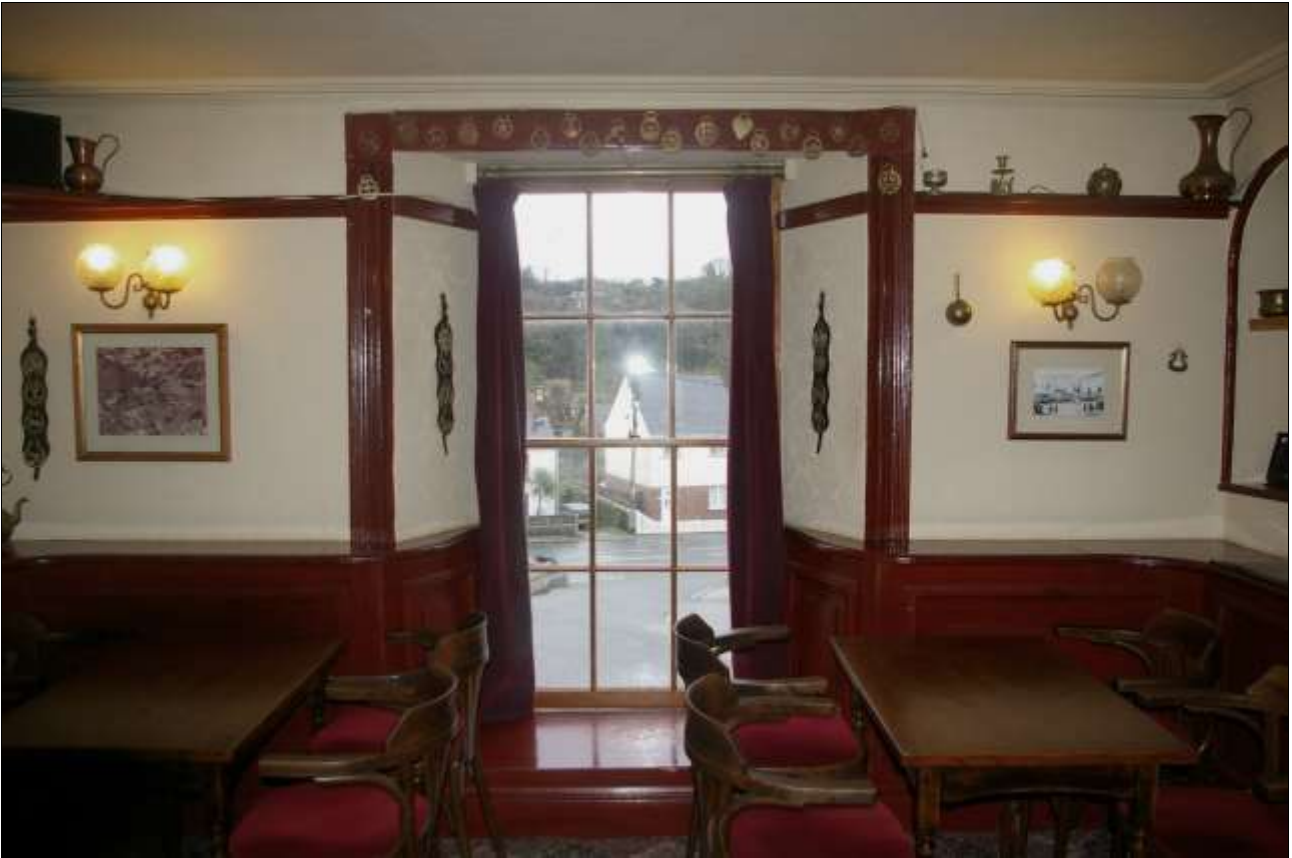
15. R2, DETAIL OF W1 IN THE EAST WALL, WITH FINE REEDED TIMBER SURROUND, CUT OFF BELOW TO ACCOMMODATE THE MODERN 'HERITAGE STYLE' PUB PANELLING; VIEWED FROM THE WEST.

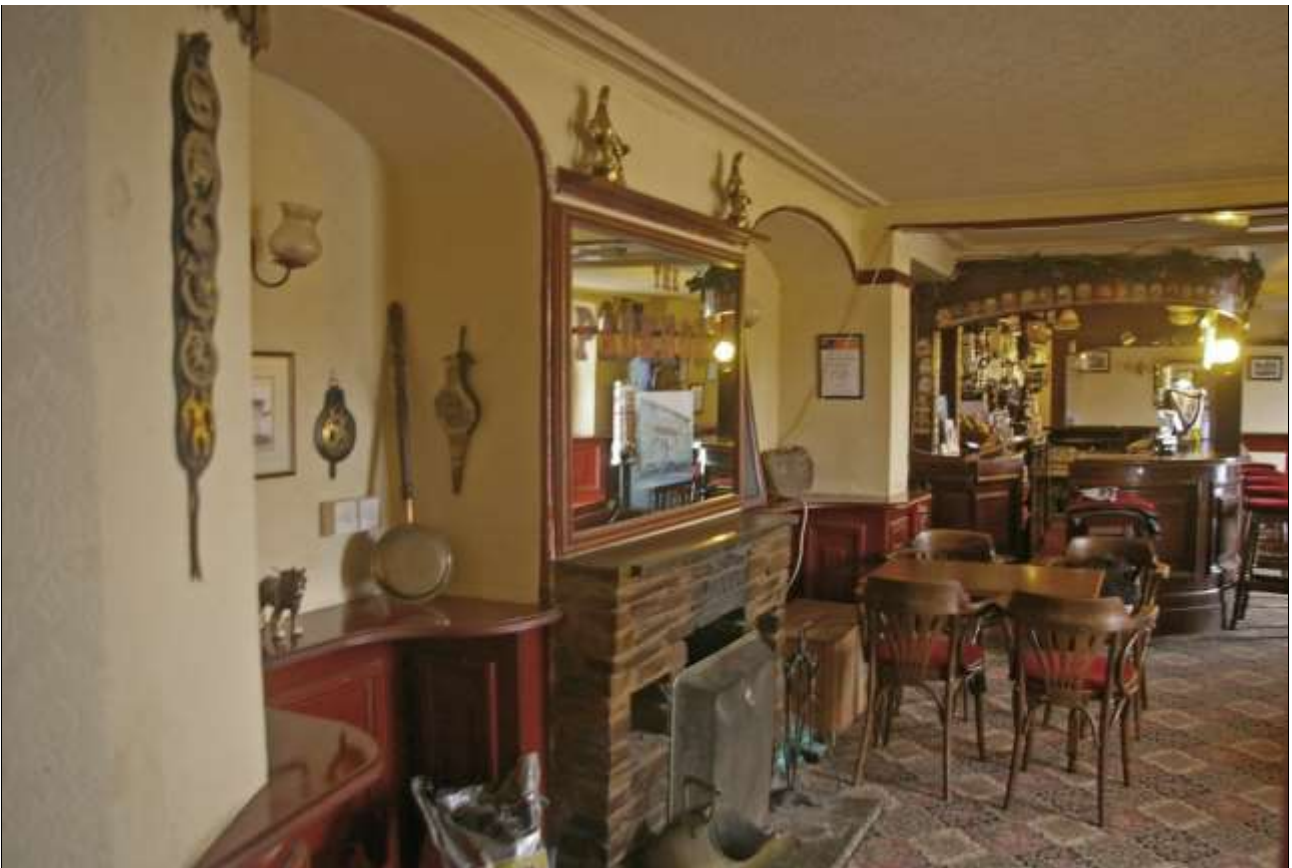
16. R2, DETAILED PROFILE VIEW OF THE BASKET ARCHES AND ALTERED FIREPLACE (FP1); VIEWED FROM THE SOUTH-SOUTH-EAST.

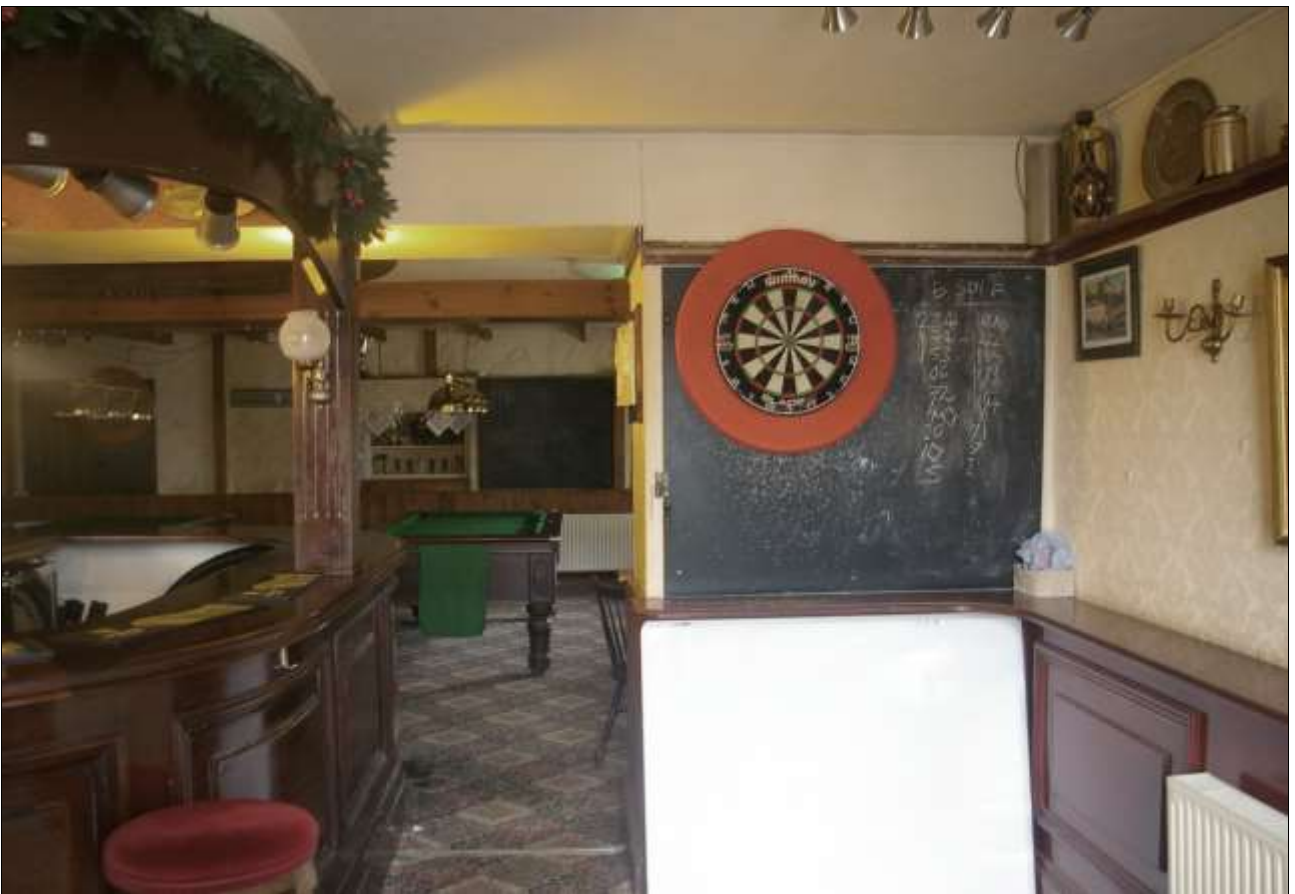
22. R3B/R4, LOOKING THROUGH THE LARGE FORCED OPENING TO THE WEST BLOCK; VIEWED FROM THE EAST.

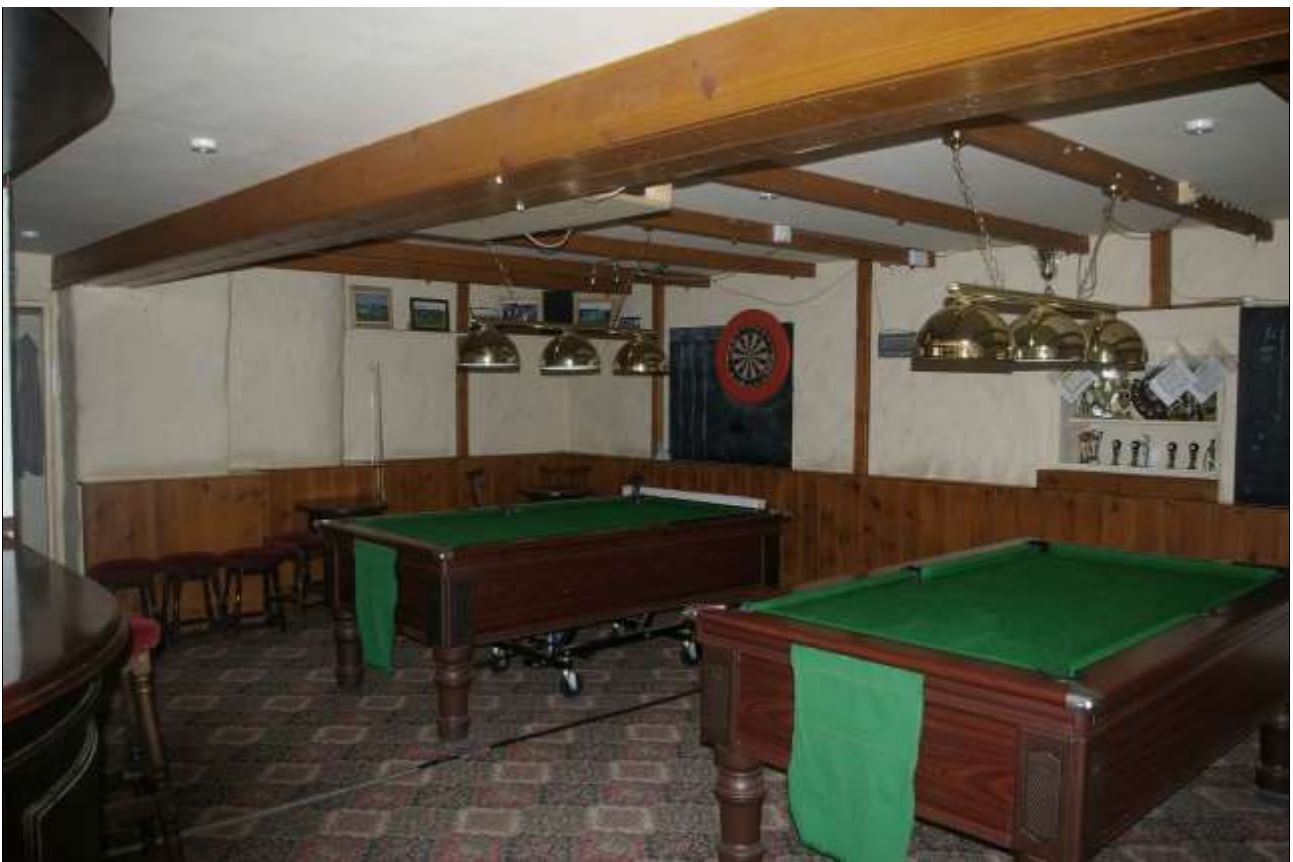
24. R4, SHOWING THE DOGLEGG WALL TO THE SOUTH AND BLOCKED WINDOW IN THE WEST WALL, USED AS A CUPBOARD; VIEWED FROM THE NORTH-EAST.

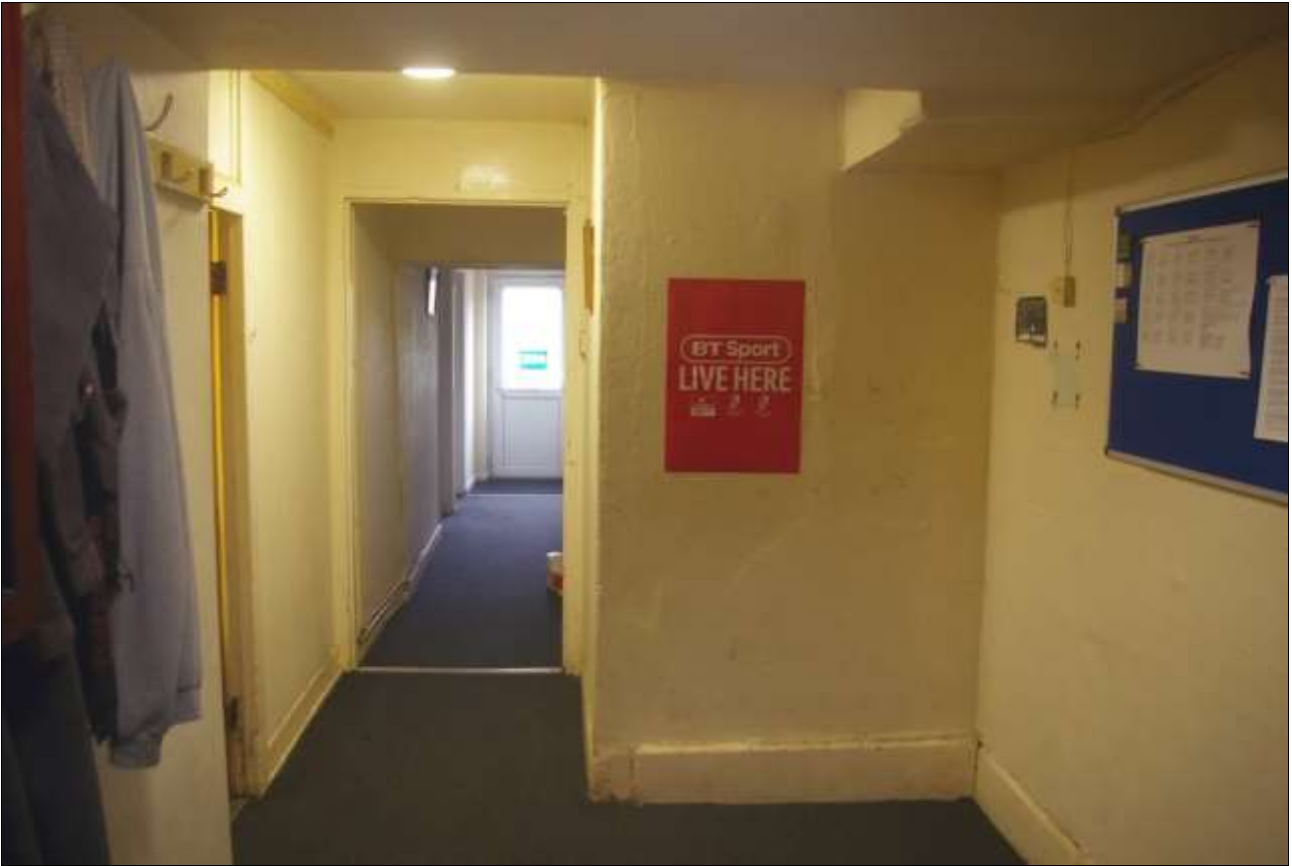
27. R5, SHOWING THE DOGLEG SECTION OF WALL WITH BLOCK OF MASONRY (STACK?) AND SCAR FOR FORMER RISING STAIR (CENTRE). GOOD DOORWAY (D7) TO LEFT; VIEWED FROM THE EAST.

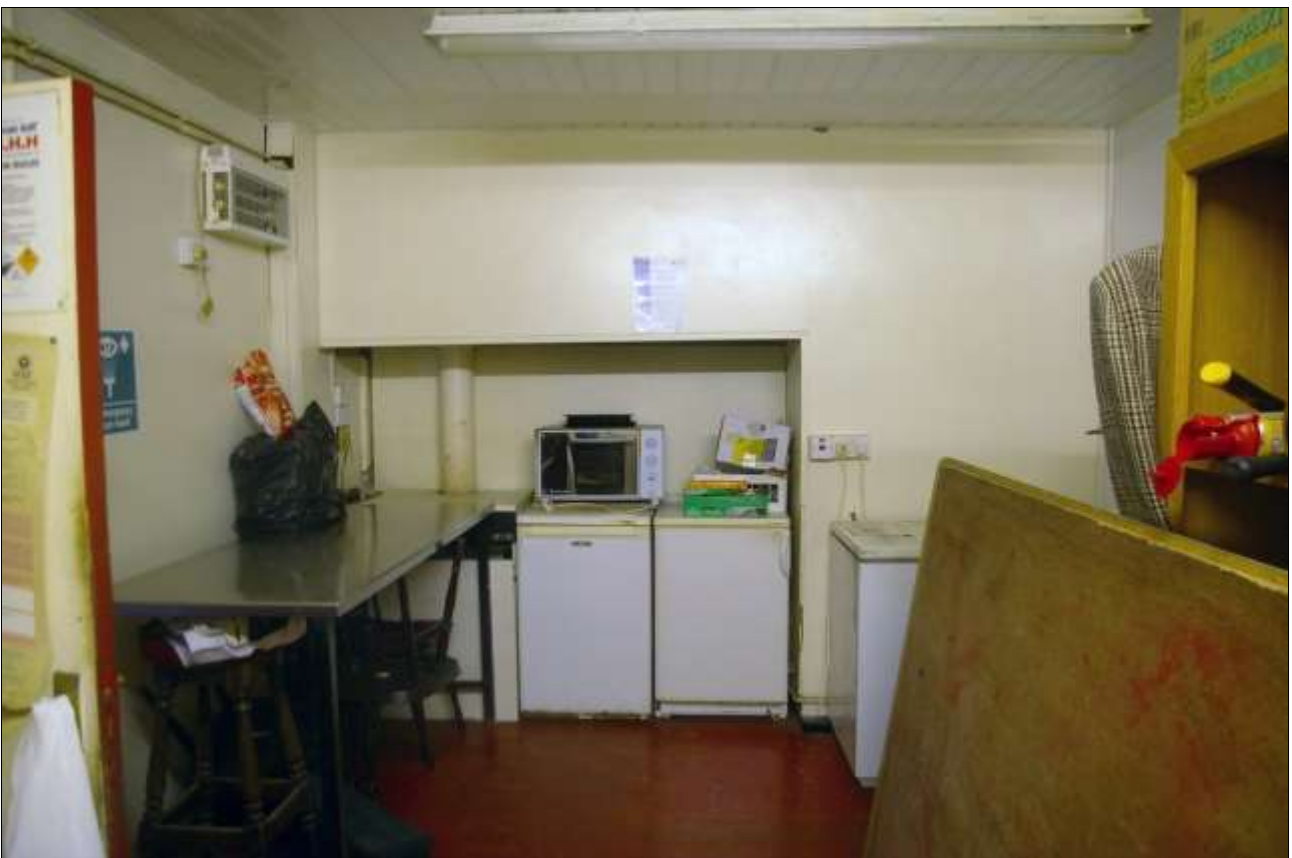
28. R6, THE STACK (FP2) WITH OPEN HEARTH BOARDED, IN ALL DETAILS OBSCURED; VIEWED FROM THE WEST.

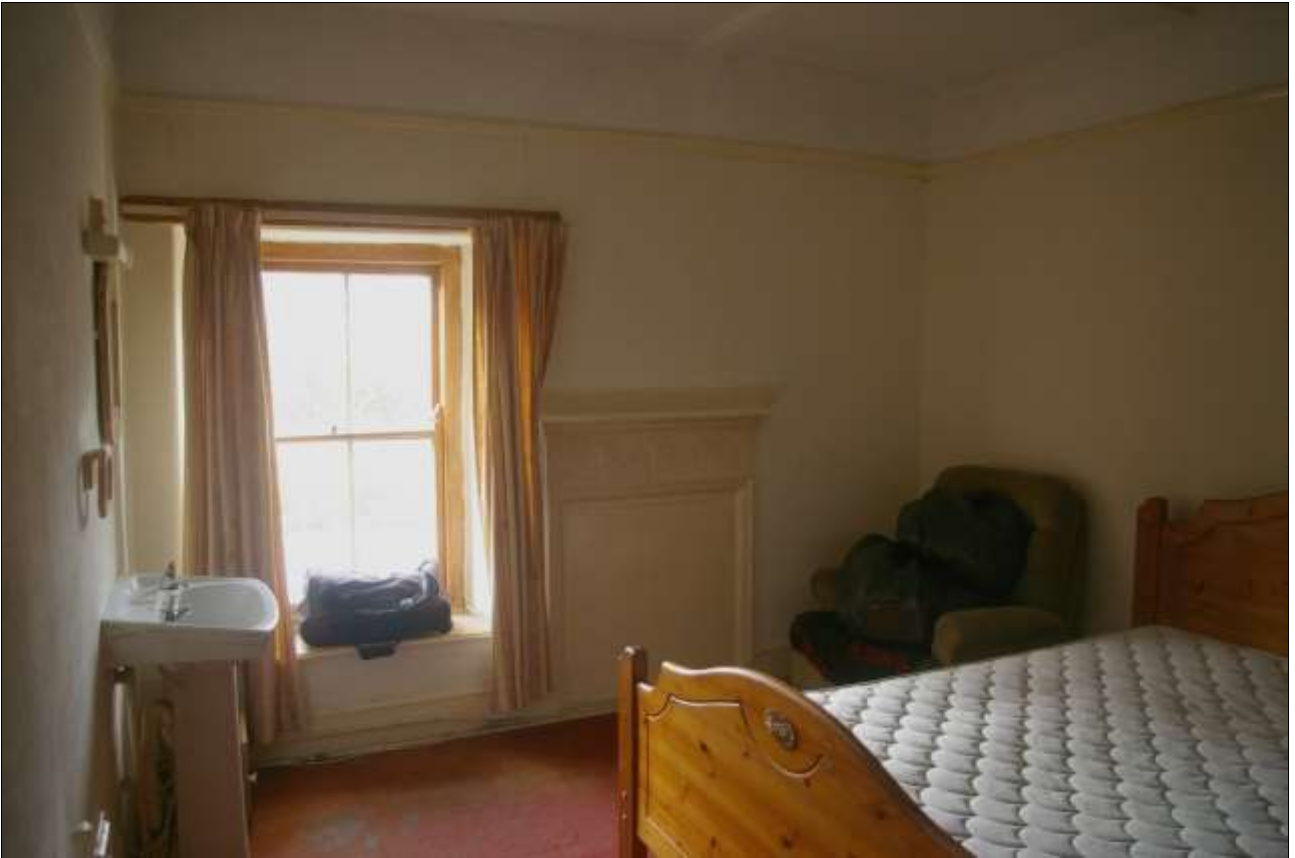
40. R11, REDUCED IN THE 20<sup>TH</sup> CENTURY WITH NEW PICTURE RAIL AND BOARDED CEILING INSTALLED, BUT OLDER FIREPLACE SURROUND TO BLOCKED HEARTH RETAINED (FP3); VIEWED FROM THE EAST-SOUTH-EAST.

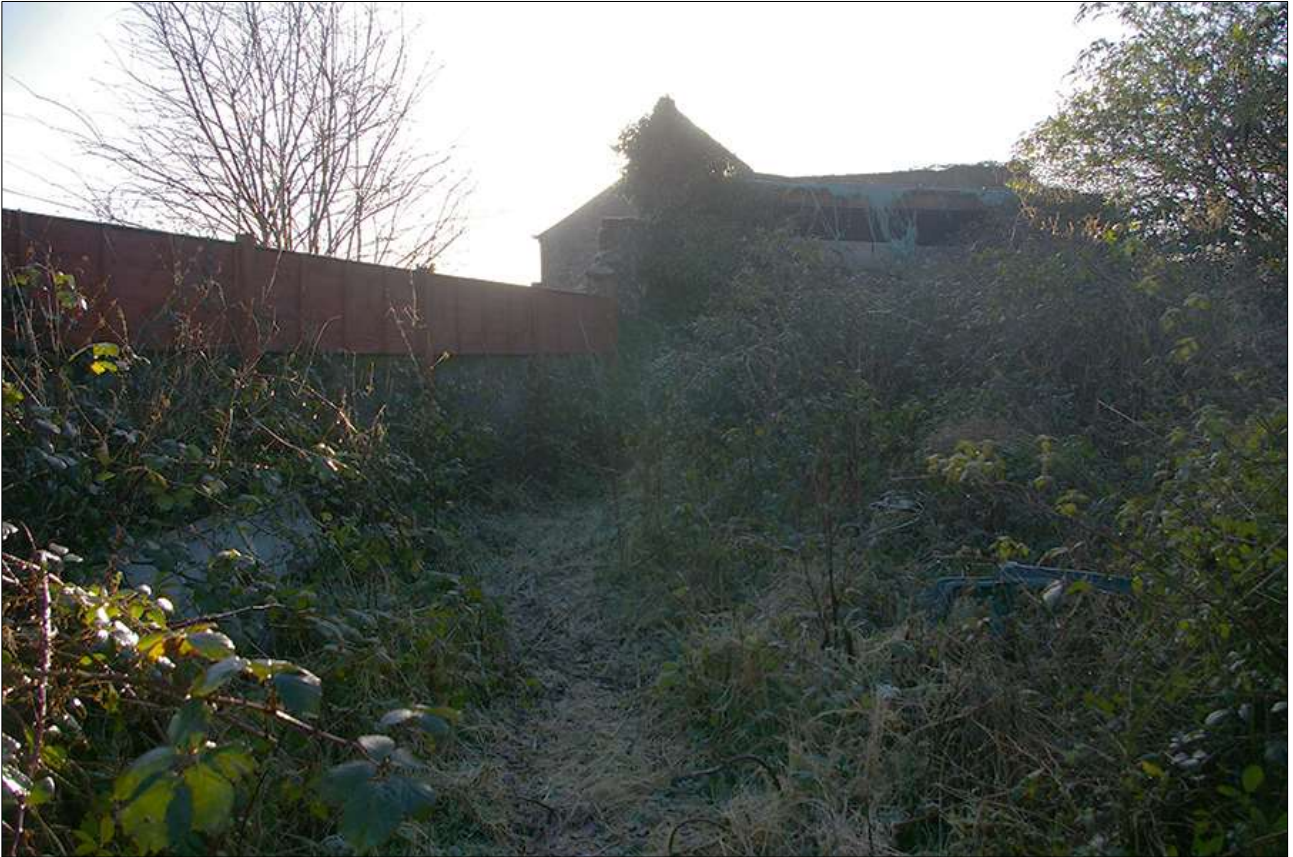
49. VIEW OF THE DERELICT OUTBUILDING TO THE SOUTH-EAST CORNER OF THE FIELD; VIEWED FROM THE NORTH-EAST.

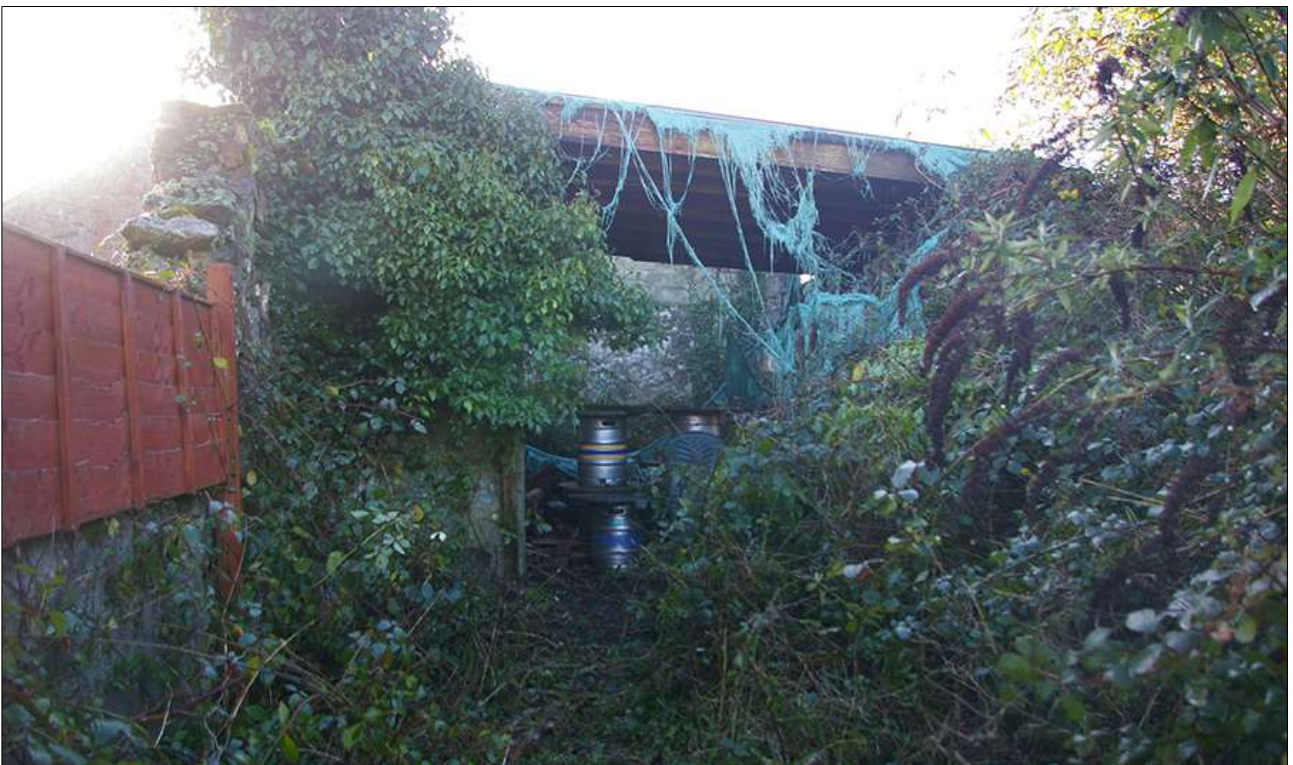
50. DETAIL OF THE DERELICT OUTBUILDING TO THE REAR OF THE PACKHORSE INN; VIEWED FROM THE NORTH.

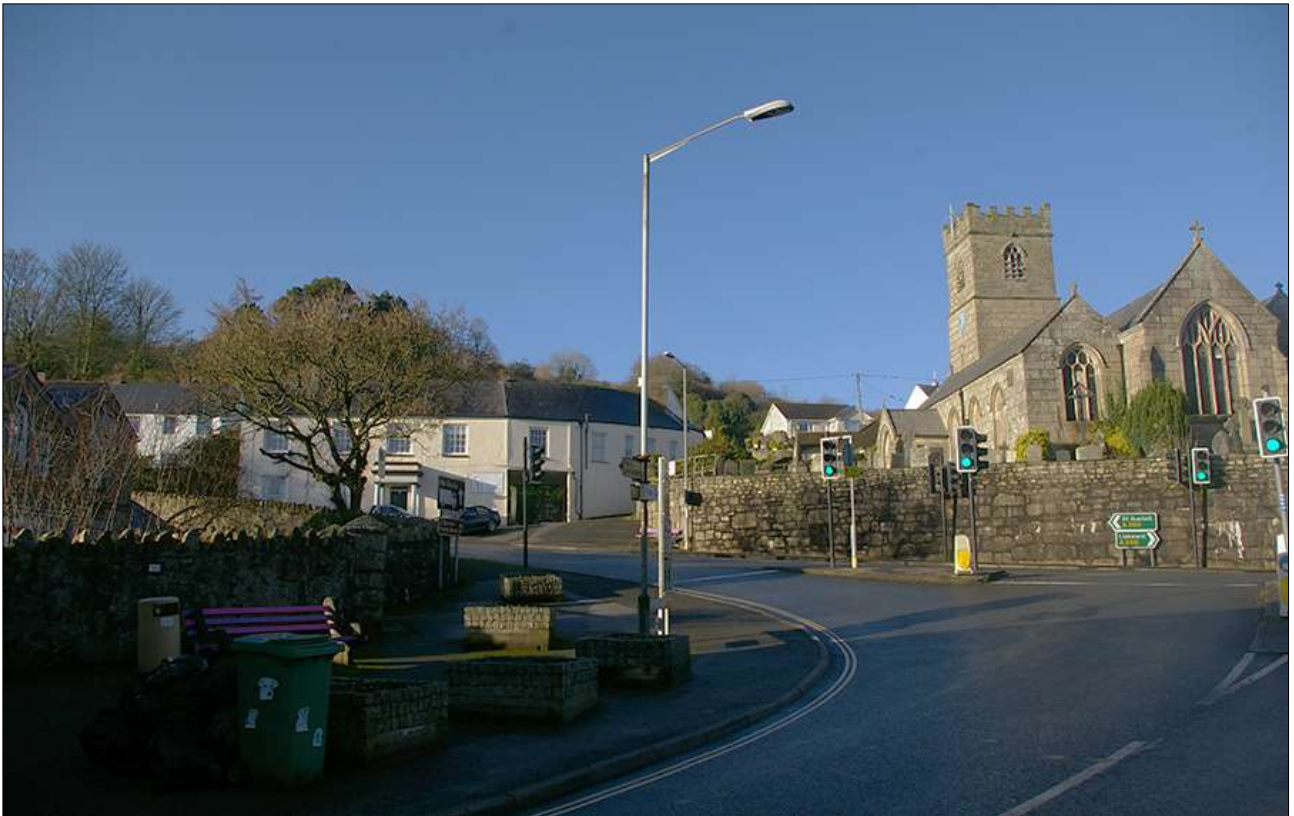
64. VIEW ACROSS THE JUNCTION OF FORE STREET, STATION ROAD AND DUKE STREET, SHOWING THE CHURCH OF ST BLAISE AND CORNISH ARMS INN IN RELATION TO THE INTRUSIVE ROAD FURNITURE; VIEWED FROM THE EAST.

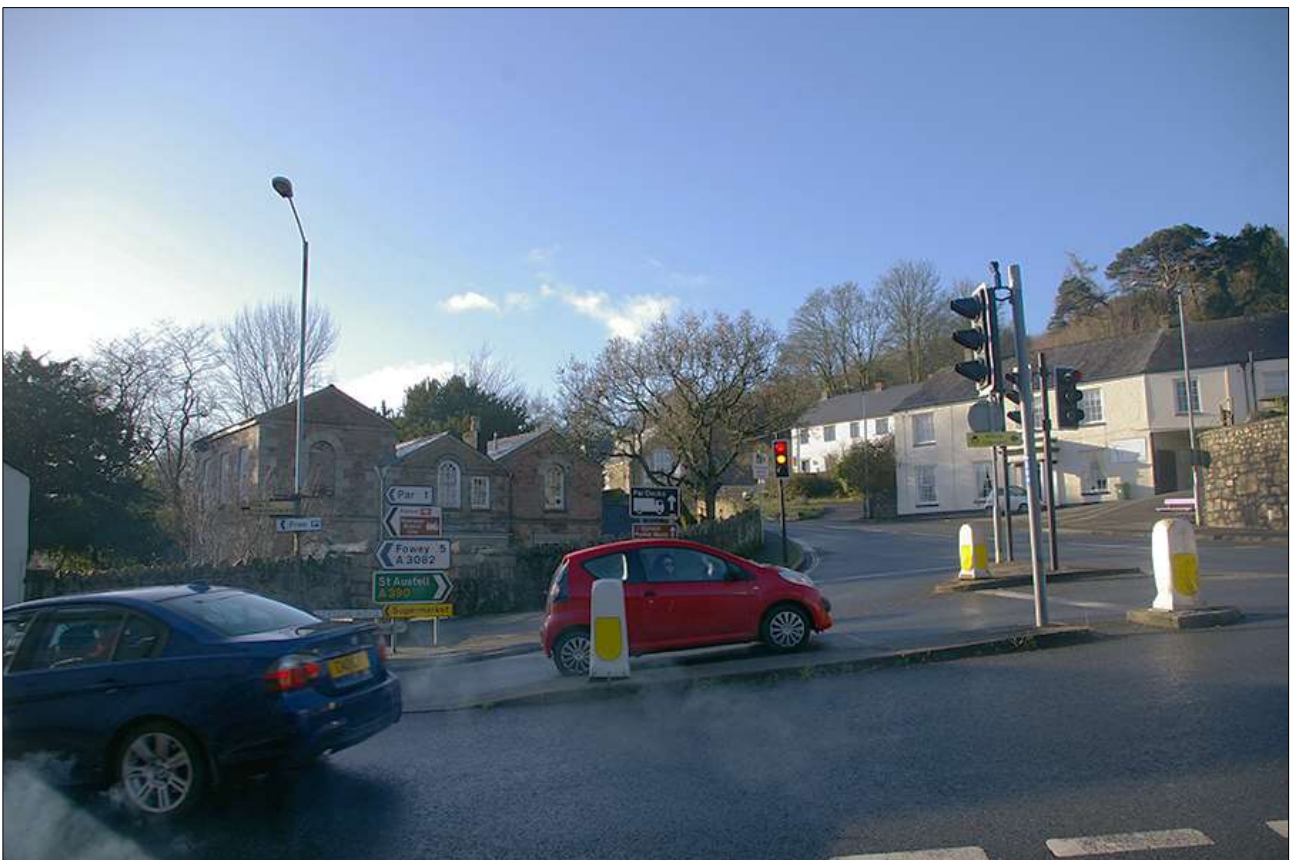
65. VIEW ACROSS THE JUNCTION OF FORE STREET AND STATION ROAD, SHOWING THE VICARAGE AND CORNISH ARMS INN AND THE INTRUSIVE ROAD FURNITURE; VIEWED FROM THE NORTH-EAST.
