**TREVEDDA FARM
LANTEGLOS HIGHWAY
FOWEY
CORNWALL**

Historic Building Recording

South West Archaeology Ltd. report no. 210120

Results of historic building recording

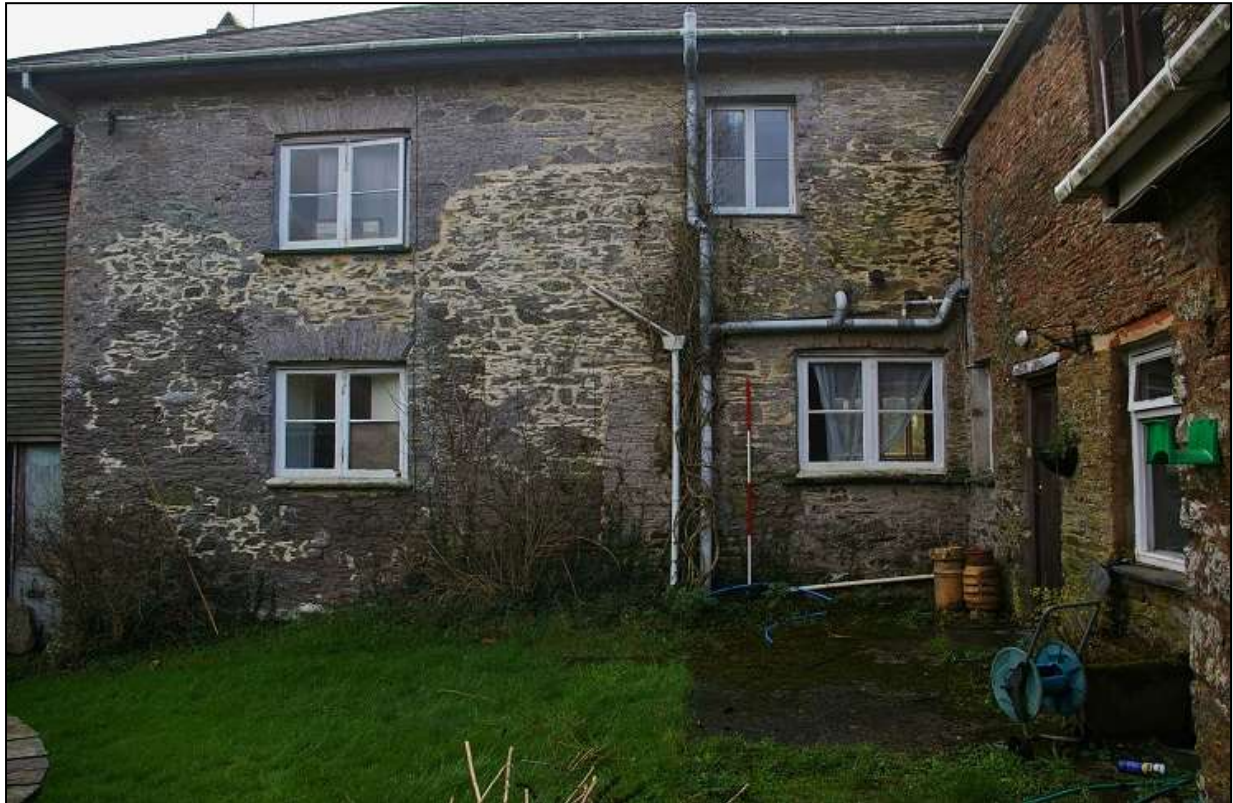
with good slate slab reveals and a curving or cranked oak lintel; this is directly opposite the opening in the south wall which serves the front door and is most certainly evidence for a former cross-passage. The door is blocked in loose rubble, with lime mortar (Figure 7).

FIGURE 7: THE NORTH ELEVATION OF THE MAIN RANGE, WITH 2M SCALE; FROM THE NORTH.

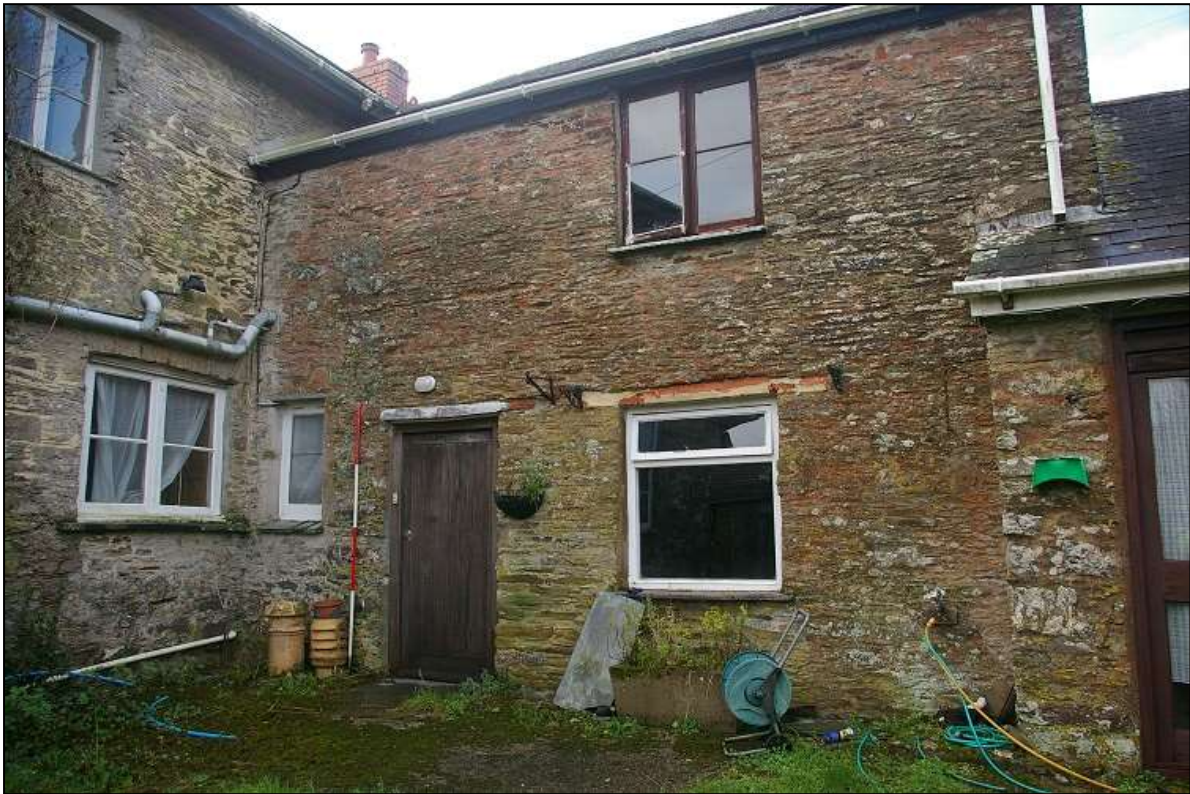
The east wall of the kitchen block/service wing abuts the earlier stonework at the quoins, with a doorway formed against the joint at ground floor, with narrow timber lintel and modern plank exterior door (Figure 10). The build of this wall is of relatively poor quality slate rubble, in a lime mortar and has various phases of cement re-pointing; it is not clear if this is a rebuild of a once ruined wall or wholly replaced; the platey character of the stonework is more typical of early post-medieval stonework and may well be 17th century but heavily altered in the 18th or 19th century. The first part of the range is of one and a half storeys height, of two window range; the ground floor window has a long thick oak lintel but is a modern fixed pane with awning casement above, the first floor window is a 20th century two light casement. The end block is of single storey height and wraps around the first part, being an extension of much cruder rubble build, pointed in cement, patched in brick and concrete block. The single storey element has been extended on the east side and altered with large modern fixed pane picture window and glazed door. Both separate elements of the wing have slate roofs and plastic guttering and downpipes.

FIGURE 10: THE EAST WALL OF THE REAR SERVICE WING, WITH 2M SCALE; FROM THE EAST-NORTH-EAST.

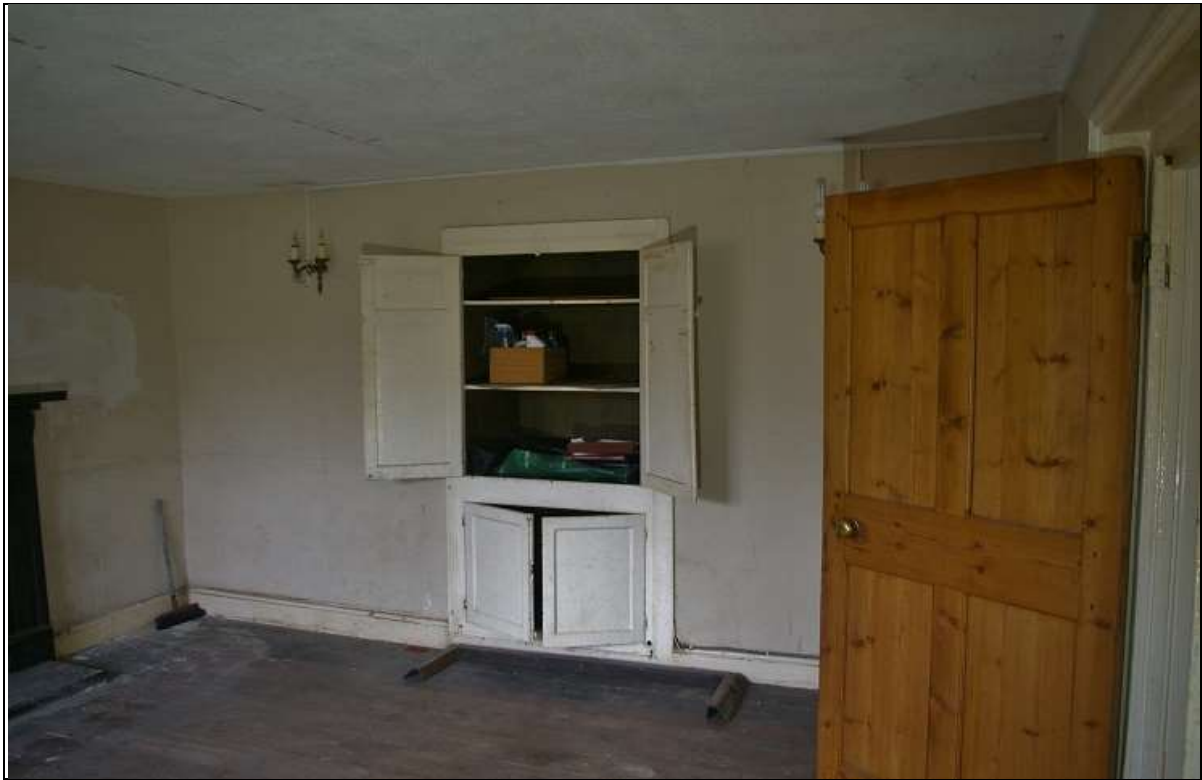
Room 4, presenting as a 19th century parlour, is accessed via a door in the east wall of the kitchen, with a surprisingly chunky partition between. The opening has a wider architrave on the kitchen side to make the doorway seem larger. The room is sub-square; the north wall is noticeably slightly battered, with wide even width thick floorboards and beaded skirting boards; the south wall is also slightly battered and very thick, indicating phasing within the eastern part of the house, as confirmed on the exterior walls. There is a large stack to the east wall built within the footprint of the building, abutting the end wall. The fireplace has a fine slate mantled surround, the hearth lined in brick, with an alcove to the north with thicker lower section of wall and a plank shelf. Scarring above this fireplace indicates a much larger opening is blocked here. There is a blocked doorway in the south wall, with an obscured partly arched or hacked top, inset with a paneled cupboard with thick plank shelves (Figure 13). To the north wall is a window, with fine wide moulded architrave and beaded frame, mullion and jambs, with paneled shutters, having closing bar fixings and window seat. There is fine hand printed wall paper within the shutter boxes, of cream with an arsenic green leaf or foliate swagged pattern and there is a historic salmon or terracotta pink coloured paint, both of which could indicate 18th or 19th century decorative schemes. This room occupies the footprint of the service end of the medieval range, below the cross-passage and this earlier phase survives in part in at least all of the walls in some capacity.

FIGURE 13: THE PARLOUR, WITH BLOCKED DOOR TO SOUTH, NOW SET WITH A PANELLED CUPBOARD; FROM THE NORTH-WEST.

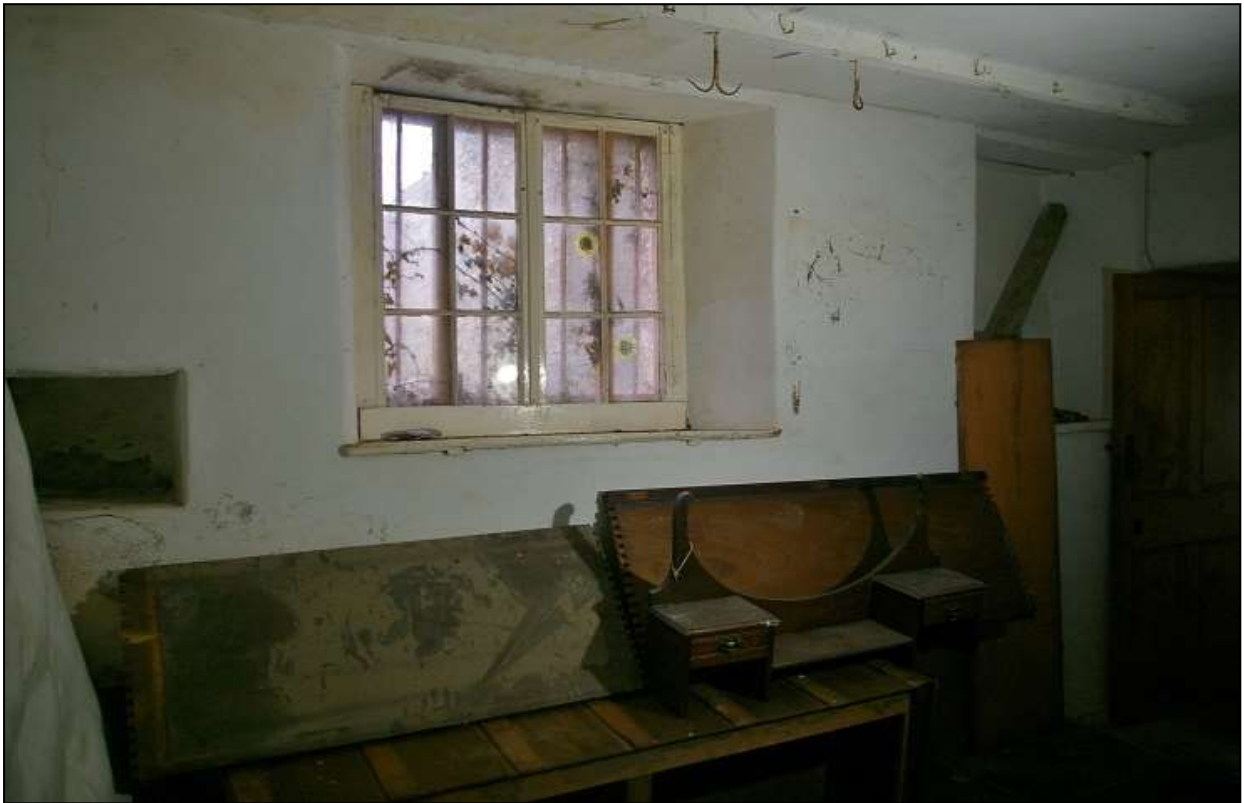
Room 6 is accessed from the west end of the Hall, via a door north of the fireplace, set into the corner. This room has battered walls and physical structural phasing which may indicate it is a cross-wing formed from an earlier inner room. It has a large stack possibly built between it and Room 2a; this appears to be shouldered on the south side and may have a blocked fireplace within this room. The west wall has a small slate-framed keeping place to the north-west corner and has a later 18th or early 19th century casement window high up to the south end; the north wall has a fine central 18th or very early 19th century casement window, with plank boarded window seat, with older unglazed mullion to the exterior and a blocked mullioned window to the north-east corner. The room's ceiling has been boarded out but the edge of heavy unshaped beams can be seen with thick iron hooks and loops for cold hanging meat can be seen and there is a very fine weathered slate flagstone floor, which dates to before the 19th century remodel. This room has the best pre-1800 surviving character of any room in the house and the highest potential for obscured details from earlier phases.

FIGURE 14: THE NORTH WALL OF ROOM 6, WHICH CONTAINS THE MAJORITY OF PRE-1800 FEATURES IN THE STANDING BUILDING; FROM THE SOUTH-WEST.

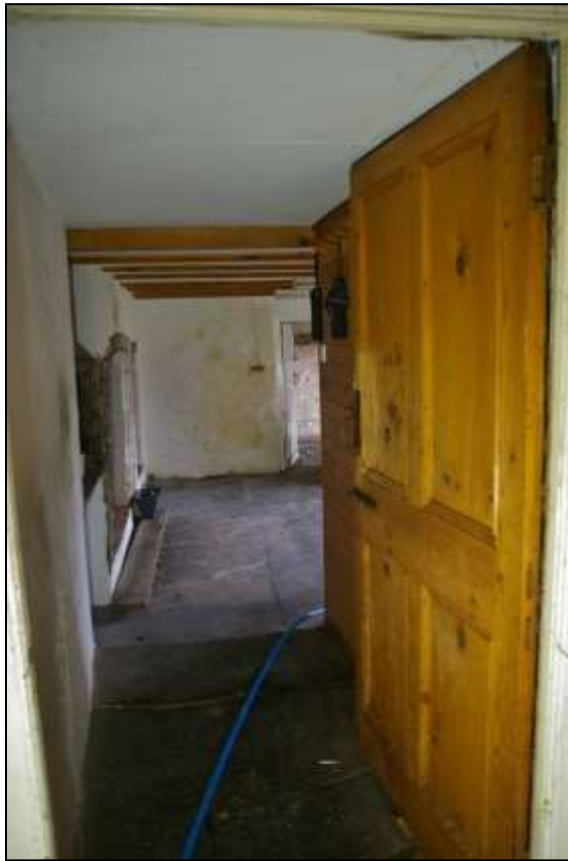
FIGURE 15: VIEW INTO THE REAR SERVICE WING, SHOWING THE LATERAL STACK AND SHORT PASSAGE WITH THICK WALLS AND WORN SLATE FLOOR; FROM THE SOUTH.

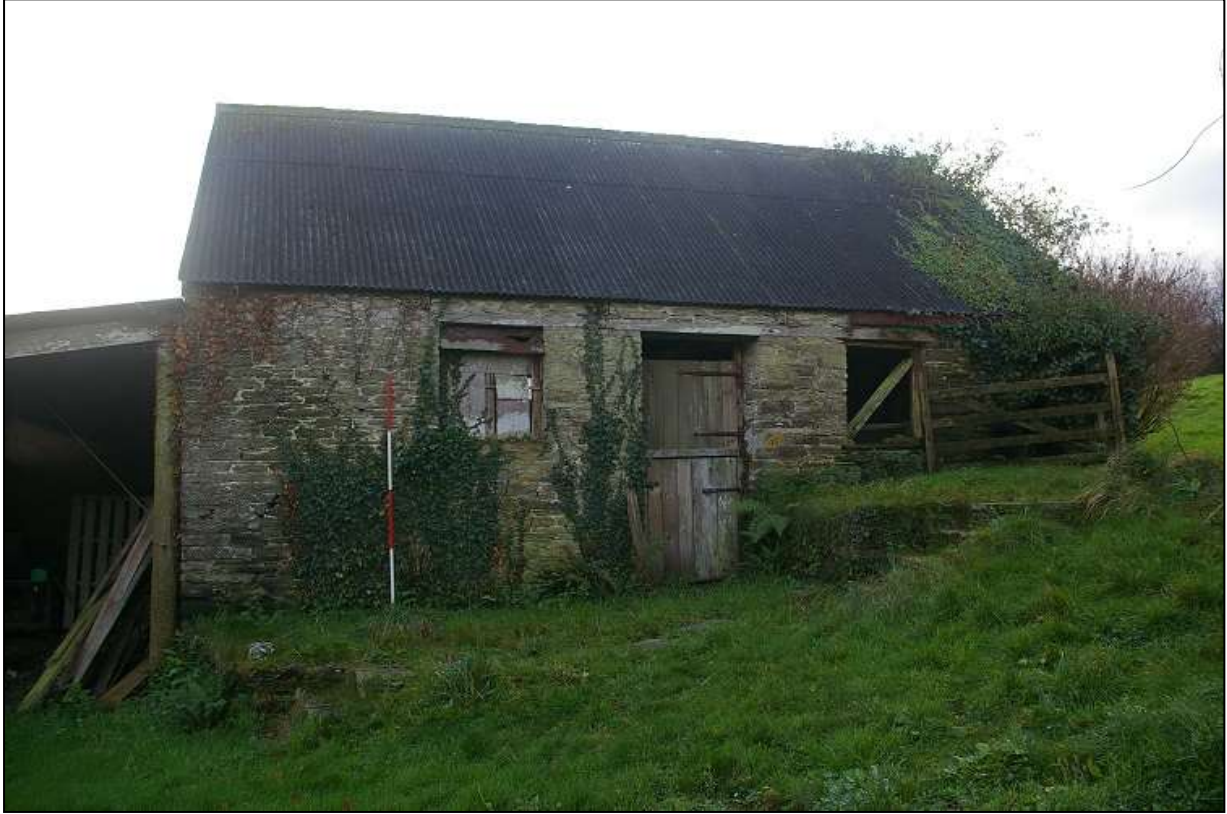
It does have several surviving window frames, particularly that to the west of the north front elevation is in good condition, but otherwise its historic stables fittings have been removed.

FIGURE 23: THE STABLES, FRONT NORTH ELEVATION WITH WINDOWS FLANKING A CENTRAL DOOR, WITH 2M SCALE; FROM THE NORTH-EAST.

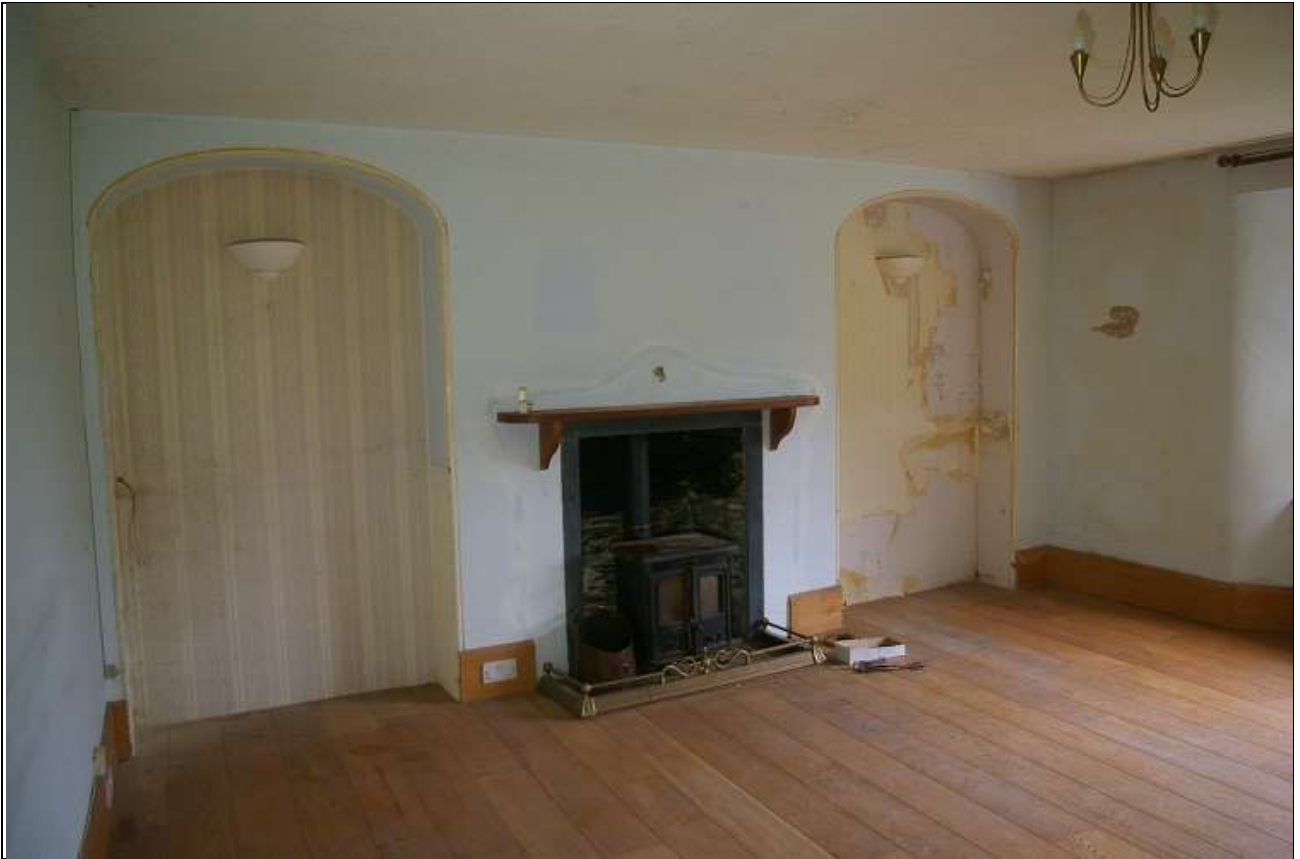
12. ROOM 3, THE DRAWING ROOM, WITH BASKET ARCH ALCOVES, THE FIREPLACE MUCH ALTERED; FROM THE WEST-NORTH-WEST.

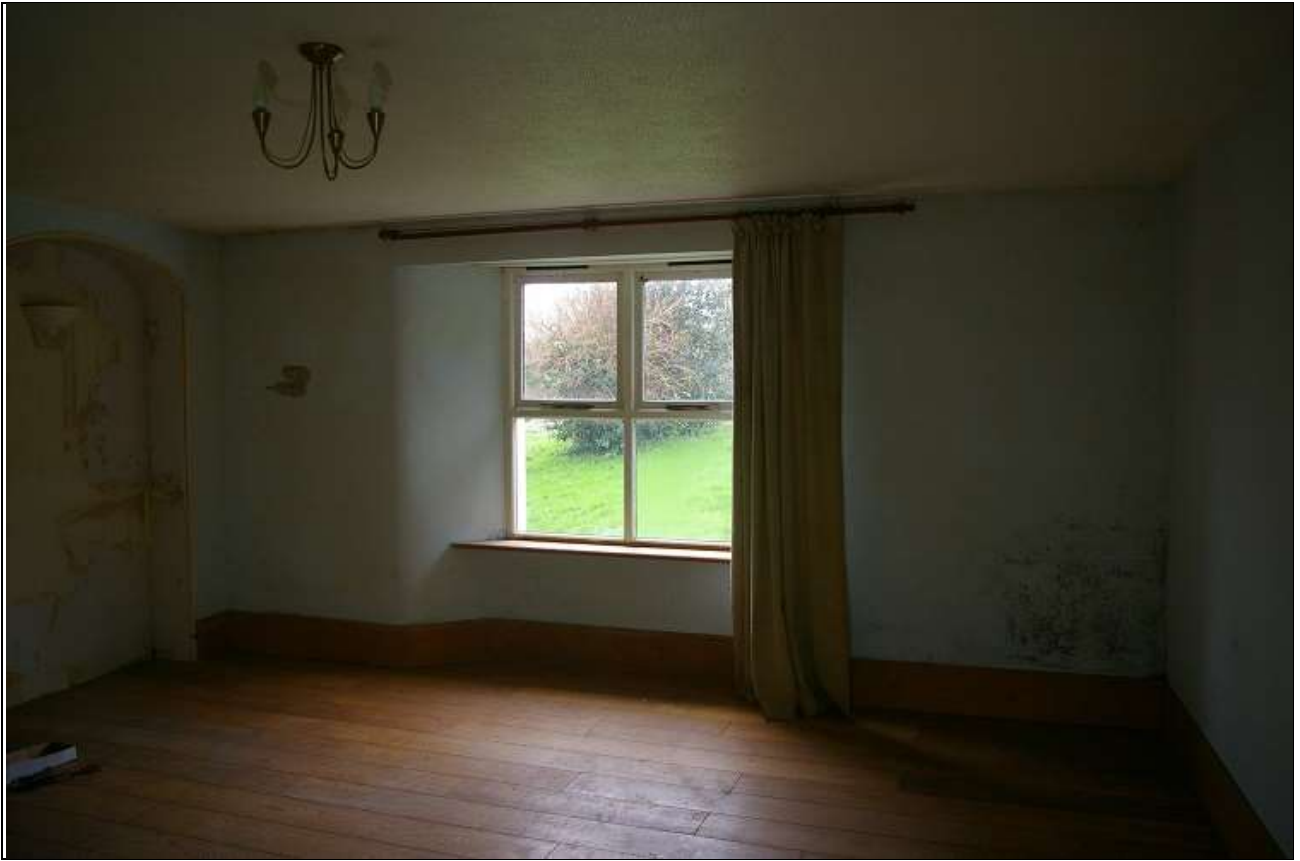
14. THE DRAWING ROOM WITH MODERN REPLACEMENT WINDOW; FROM THE NORTH-WEST.

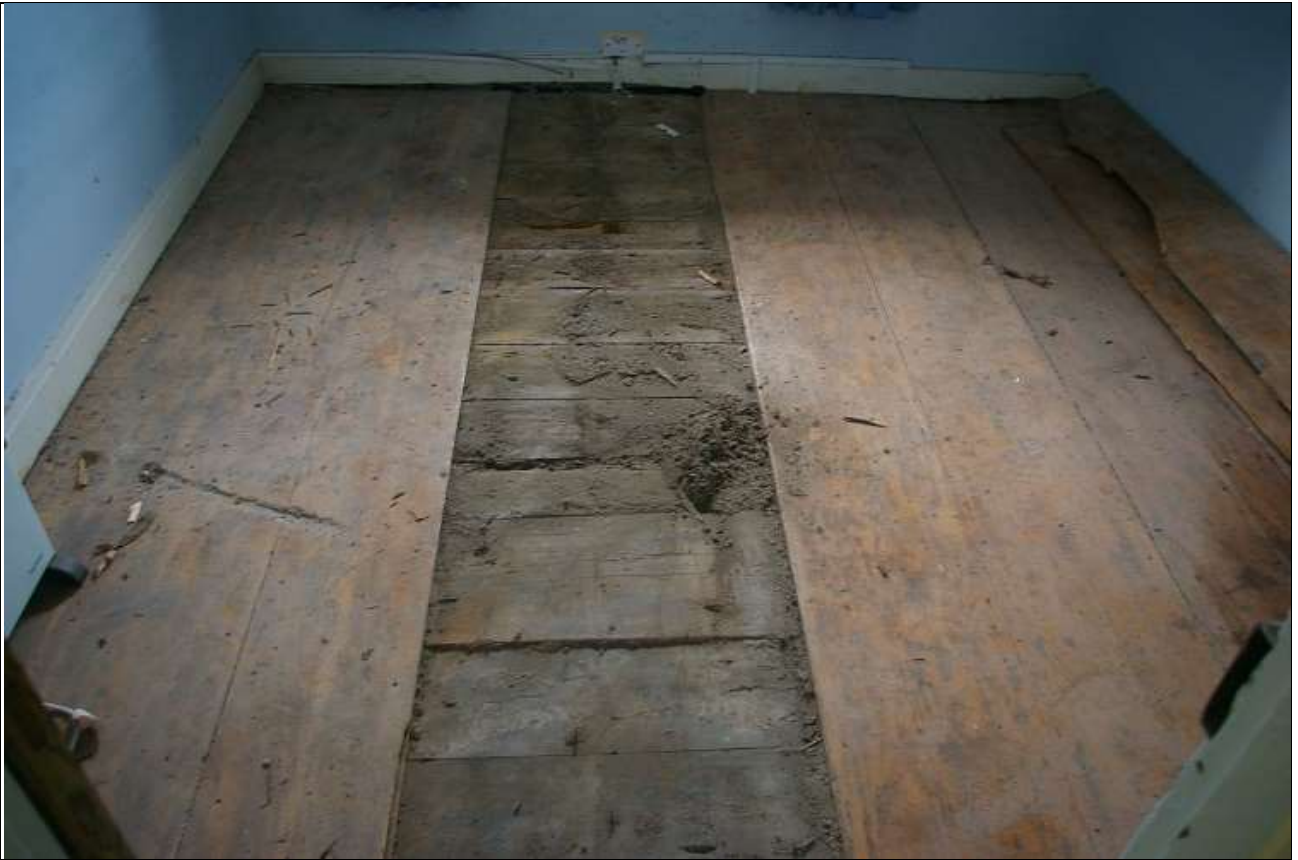
56. THE FLOOR IN R16, REUSED 17TH CENTURY OR EVEN LATER 16TH CENTURY BOARDS, RE-LAID OVER AN EARLIER FLOOR OF A MIX OF EVEN WIDTH AND WIDE BOARDS; FROM THE EAST.

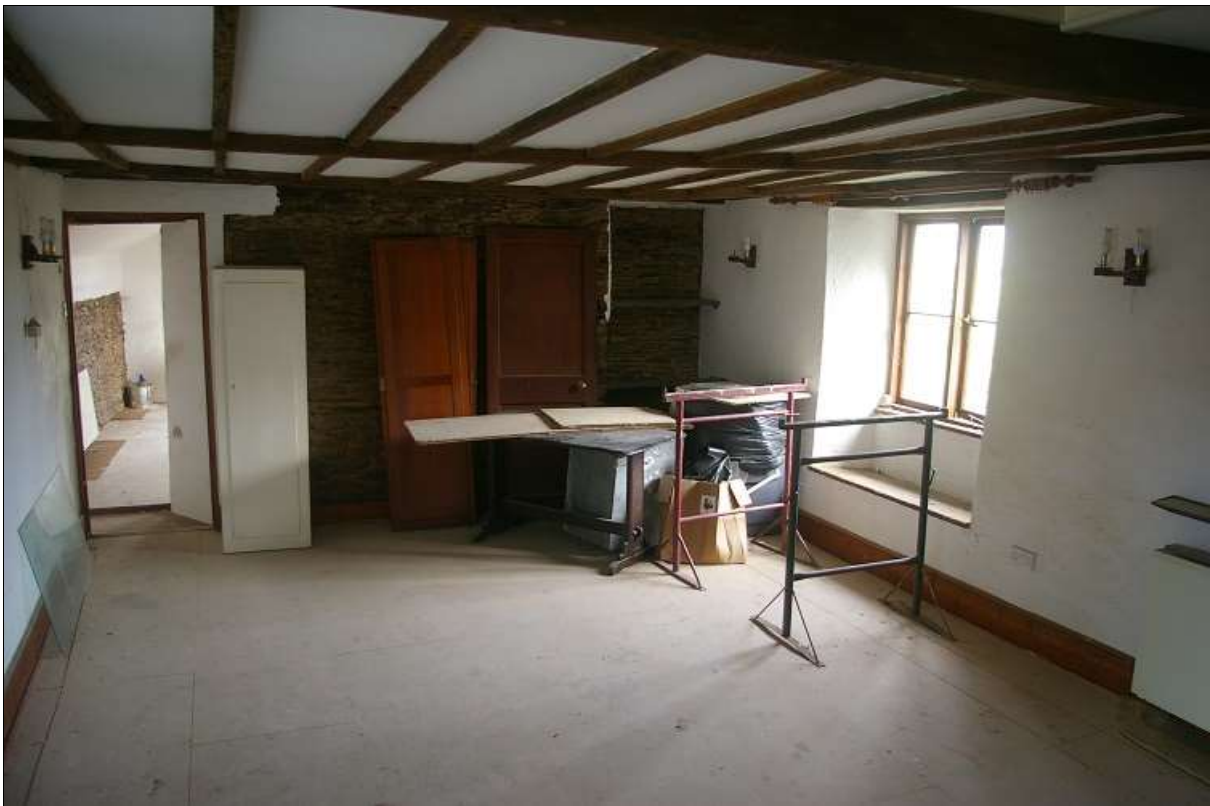
65. R19 OVER THE KITCHEN, THE NORTH ALTERED WALL, WITH FORCED DOOR AND BLOCKED OPENING TO THE EAST AND LANK WINDOW SEAT BELOW REPLACEMENT WINDOW IN THE EAST WALL; FROM THE SOUTH-WEST.

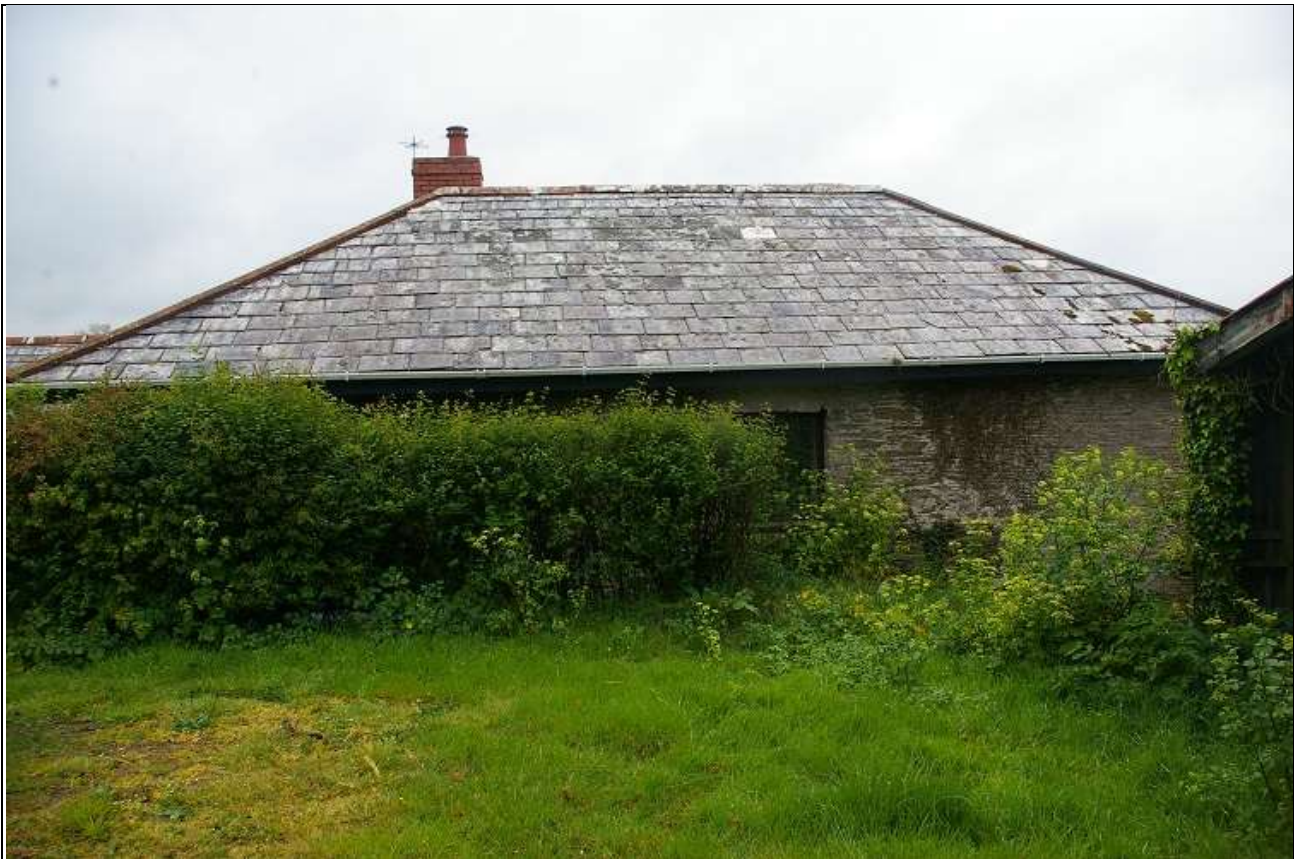
79. THE WEST ELEVATION LARGELY OBSCURED BY THE RAISED GROUND LEVEL AND TERRACED BANK; FROM THE WEST.

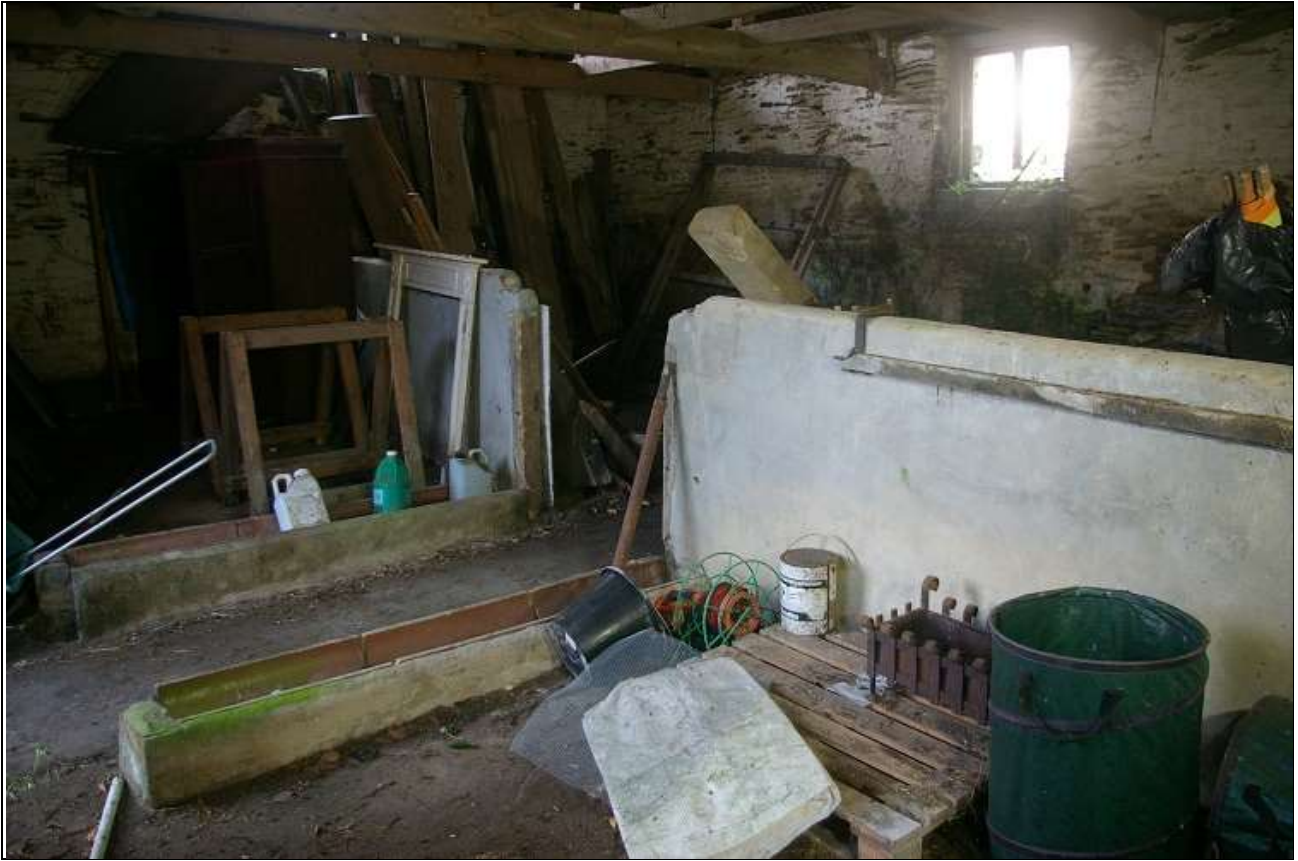
92. THE INTERIOR OF THE STABLES, DIVIDED INTO CONCRETE PENS, NOTE THE STORAGE OF A FINE MANTLED FIRE SURROUND, POSSIBLY FROM R12, WHICH SHOWS A SCAR OF ONE HAVING BEEN REMOVED; FROM THE NORTH-WEST.
