THE STABLES PORTHILL NORTHAM DEVON

A Historic Building Assessment, Analysis, and Recording

South West Archaeology Ltd. report no. 190820

Results of a historic building assessment, analysis and recording

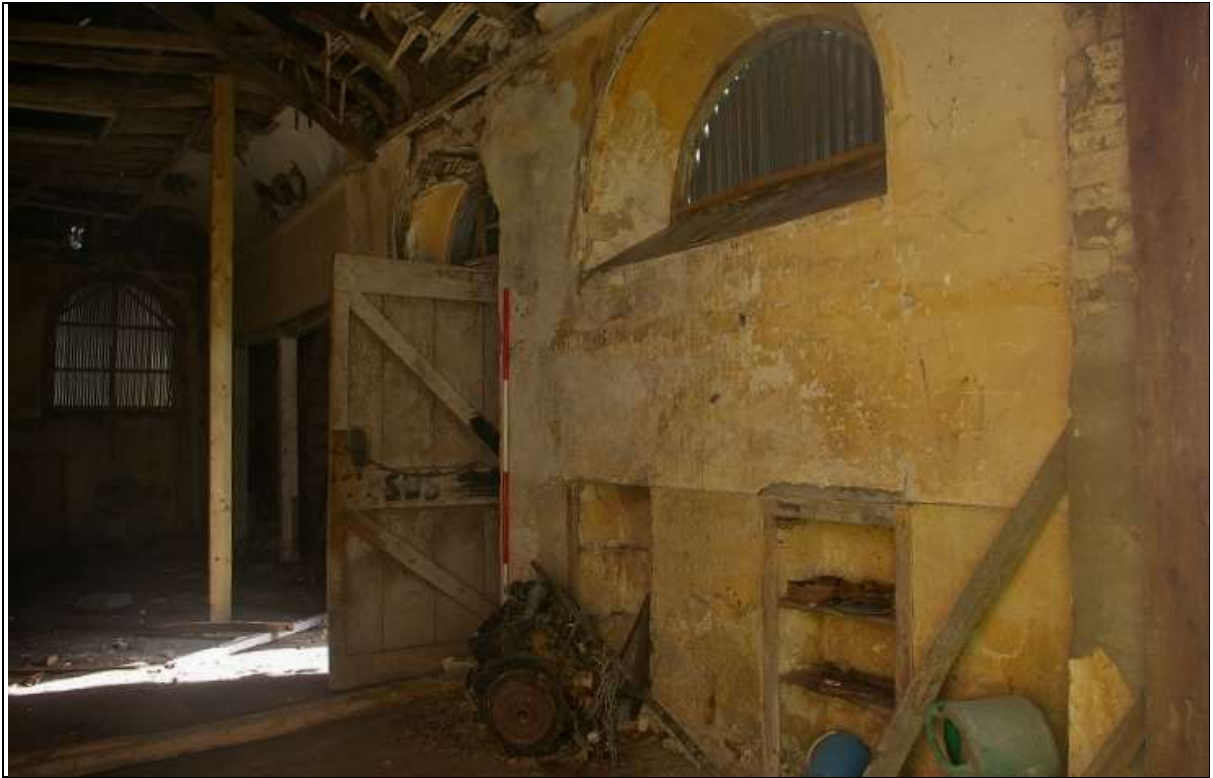
The east elevation to the south end has a large semi-circular headed window and a round-headed doorway, both with beaded frames. Both the window and a fanlight above the door have casement openings to aid air flow. On the inner face at this point within the building under the large semi-circular window can be seen a pair of small framed cupboards with shelving, for brushes for horses etc. These and the window can be seen to have been inserted into a large blocked opening. The doorway on this side has a fine inner ogee moulded architrave and beaded frame, it can be seen to have been forced into the stone rubble wall.

To the north end of the east wall a rubble partition, plastered to both sides blocks off Element B, these spaces previously being contiguous. Within this section a beaded timber frame and posts creates a sunken alcove, scarring on the walls here would indicate shelving and racks/pegs and there are two saddle trees attached to the posts. An opening into the loft has been forced here, but there was previously no access between.

FIGURE 6: THE EAST WALL OF THE STABLES RANGE, ELEMENT A, SHOWING THE DOOR, WINDOW AND FRAMED INTERNAL PARTITION TO THE NORTH END; FROM THE SOUTH-SOUTH-WEST, WITH 2M SCALE.

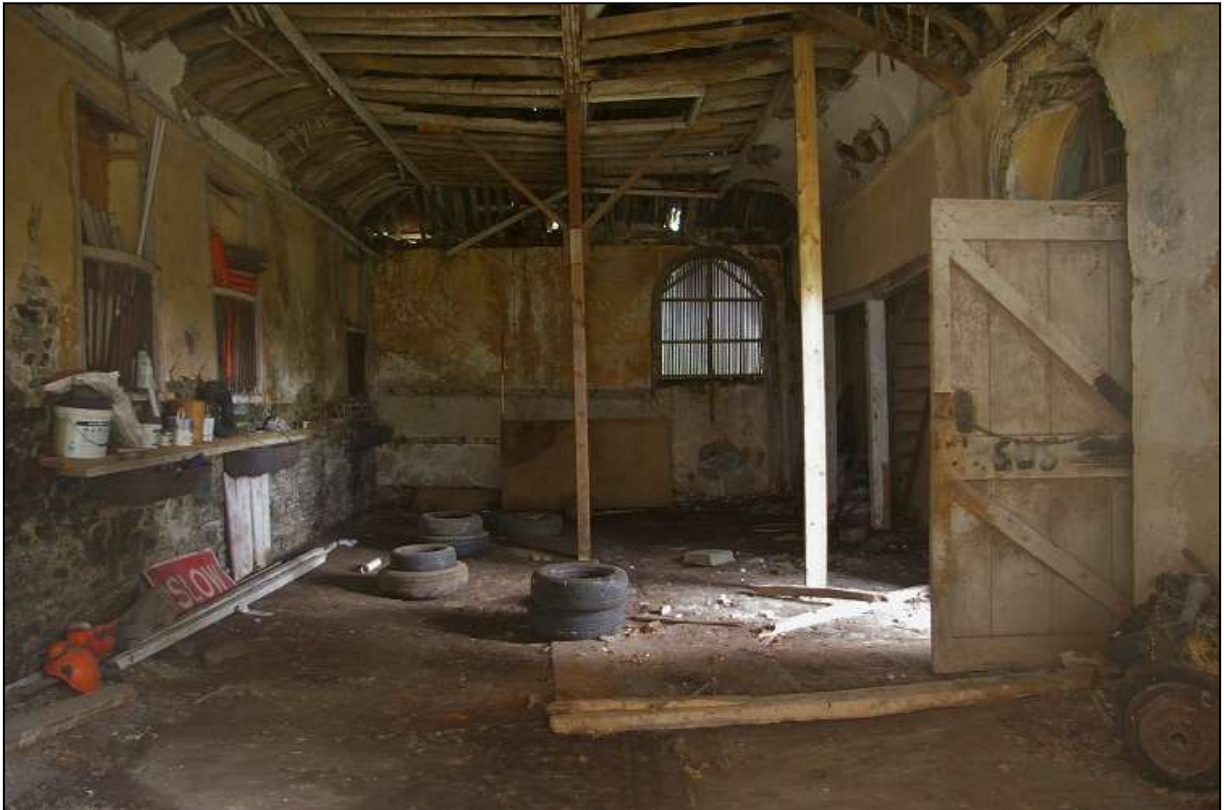
The floor of the stables is of split slate cobbles and river pebbles, sloping to a slightly off-centre drain. The floor is largely intact and the sockets for the stall partitions are easy to identify, each partition appears to have been sat on a series of longer split slates, forming a solid base for the plank boarding.

FIGURE 7: THE STABLES RANGE, WITH DRAMATIC VAULTED CEILING; FROM THE SOUTH, WITH 2M SCALE.

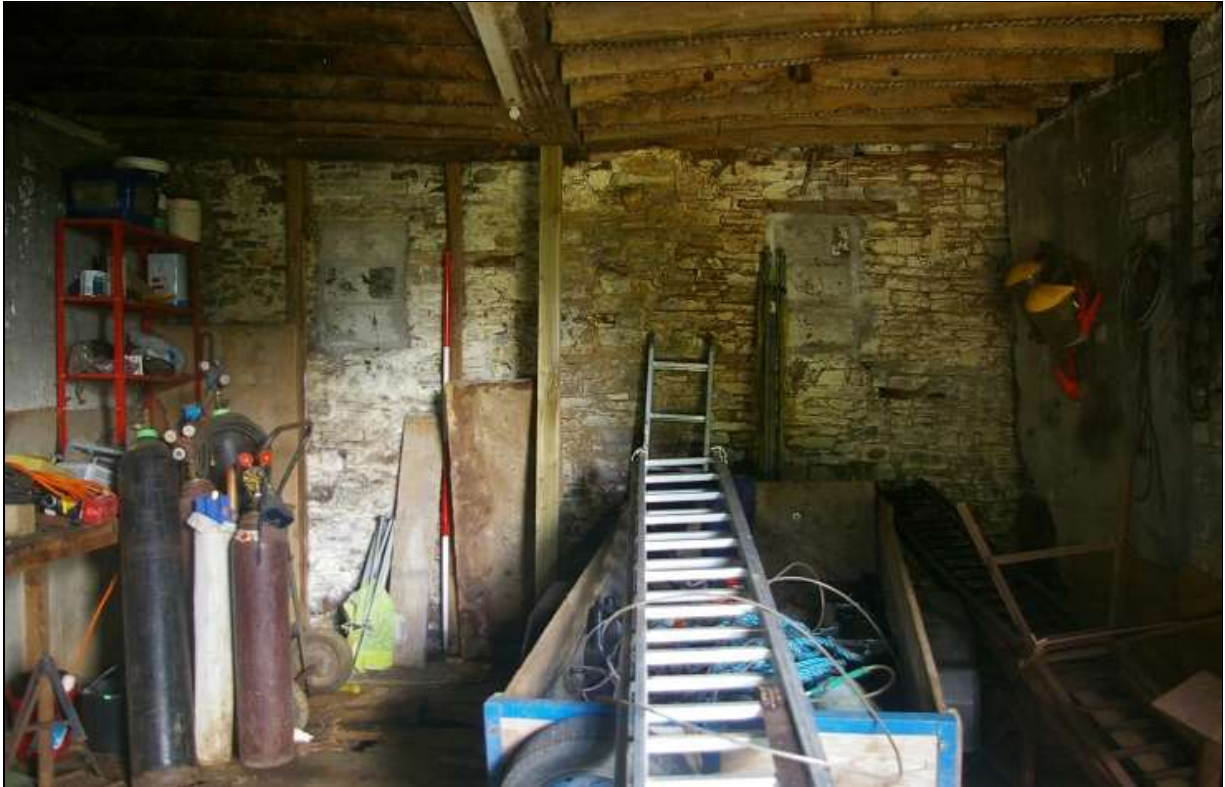
Room 2 has been remodelled into a workshop with a long fitted bench against the plastered partition wall to the west. The floor is of raised suspended timber planks, with a pit for car maintenance, underneath this is disturbed loose stone and possibly damaged cobbling. The rear north stone wall is of exposed stone and has two part blocked and one fully blocked, altered slit vent, with chunky timber lintels, typical of storage barns or warehousing. The western of the slit vents in turn is forced into a blocked doorway. The east wall is of thick beaded plank boarding, altered to allow for an inserted brick stack, which has back to back, very shallow fireplaces. The stack is of relatively modern bricks in hard cement sand/lime mixed mortar, so is likely to be later 19th or even early 20th century.

It has a shallow basket brick segmental arch, with iron bracing bar over the open hearth. The hearth is tall and narrow and may have fitted a stove or flued heater, of specific function.

FIGURE 8: THE REAR NORTH WALL OF ROOM 2, IN ELEMENT B, SHOWING THE SERIES OF BLOCKED OPENINGS, WITH 2M SCALE; FROM THE SOUTH.

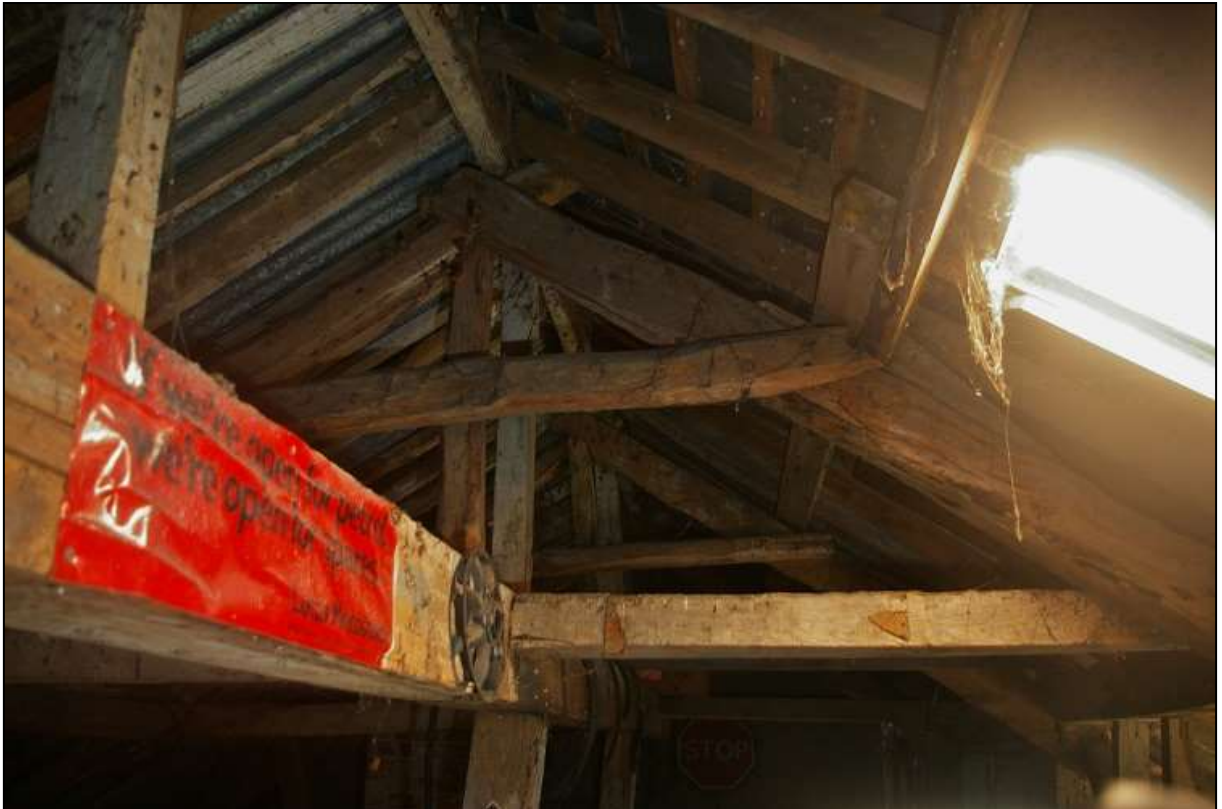
The loft above the coach house has a fine pair of panelled doors, closing a loading door space, set on LH hinges. The framework of this loft, with angled projecting jettied frontage carried on massive base and top rails, with many upright struts, half of which have been removed to aid with air flow. Later beaded plank panelling has been nailed over this frame and more crude rounded struts and joists, as in the stables have been fitted, forming another cavetto plaster ceiling within the verandah roofspace. Within the loft itself there is a massive central beam, carried on upright mortice jointed posts which rise from the ground floor and lower cross beams; this runs east-west and has clearly been truncated in the 1960s. This framework forms a boxed profile and is heavily over-engineered in a way one would expect for a significant load-bearing warehouse. Later crude more agricultural pegged and clench nailed A-frames have been installed over and around this framework, forming the current loft within a steeply pitched roofline. There is a lot of modern timber within this roof and the section over the verandah looks to be totally replaced above the arched ceiling detail. It is clear the

warehousing was of very different form to the current building, which has been adapted in a more agricultural form to provide a coach house and then garage.

FIGURE 9: THE ROOF ABOVE ELEMENT B, THE LOFT, WITH MASSIVE FRAMEWORK AND RUSTIC POOR QUALITY A-FRAMES ABOVE, TO A CHANGE ROOFLINE; FROM THE WEST.

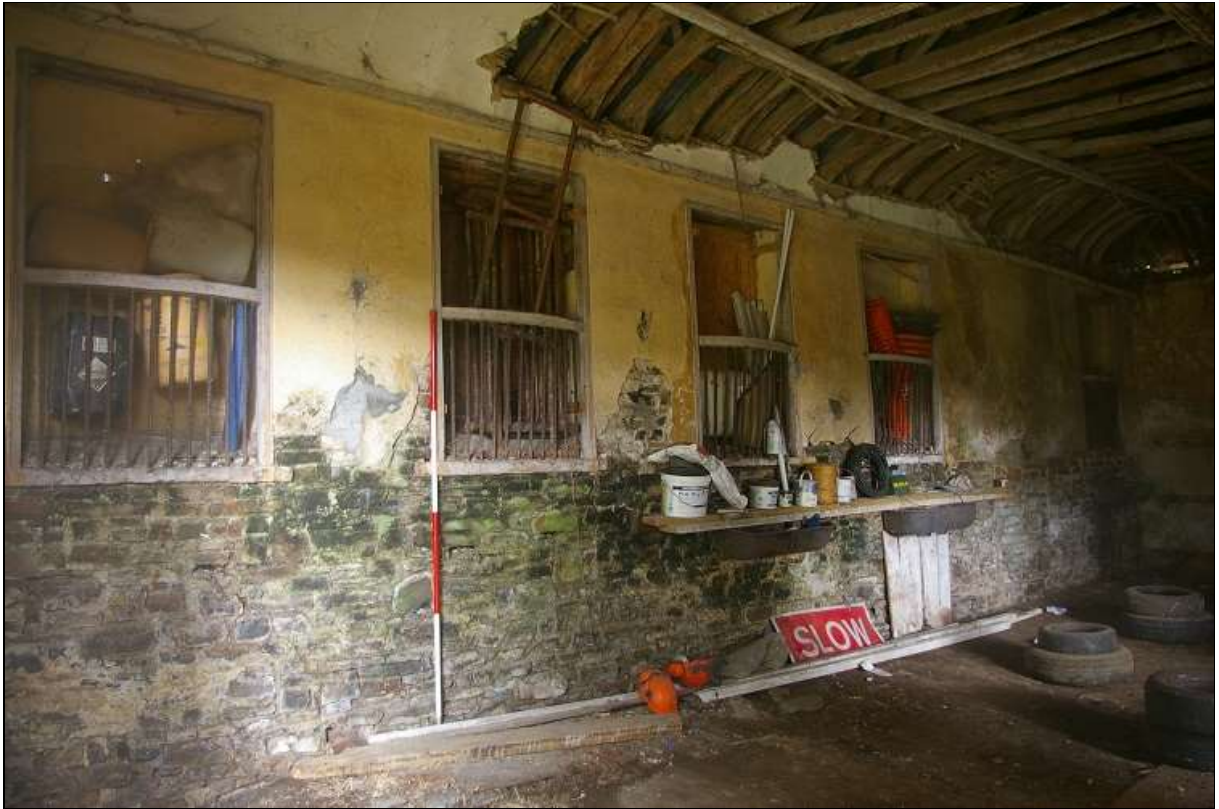
FIGURE 10: THE TROUGHS AND FEED BOXES, WITH HAYRICKS DEVELOPED IN ELEMENT A OF THE BUILDING TO THE WEST IN THE 19TH CENTURY (2M SCALE).

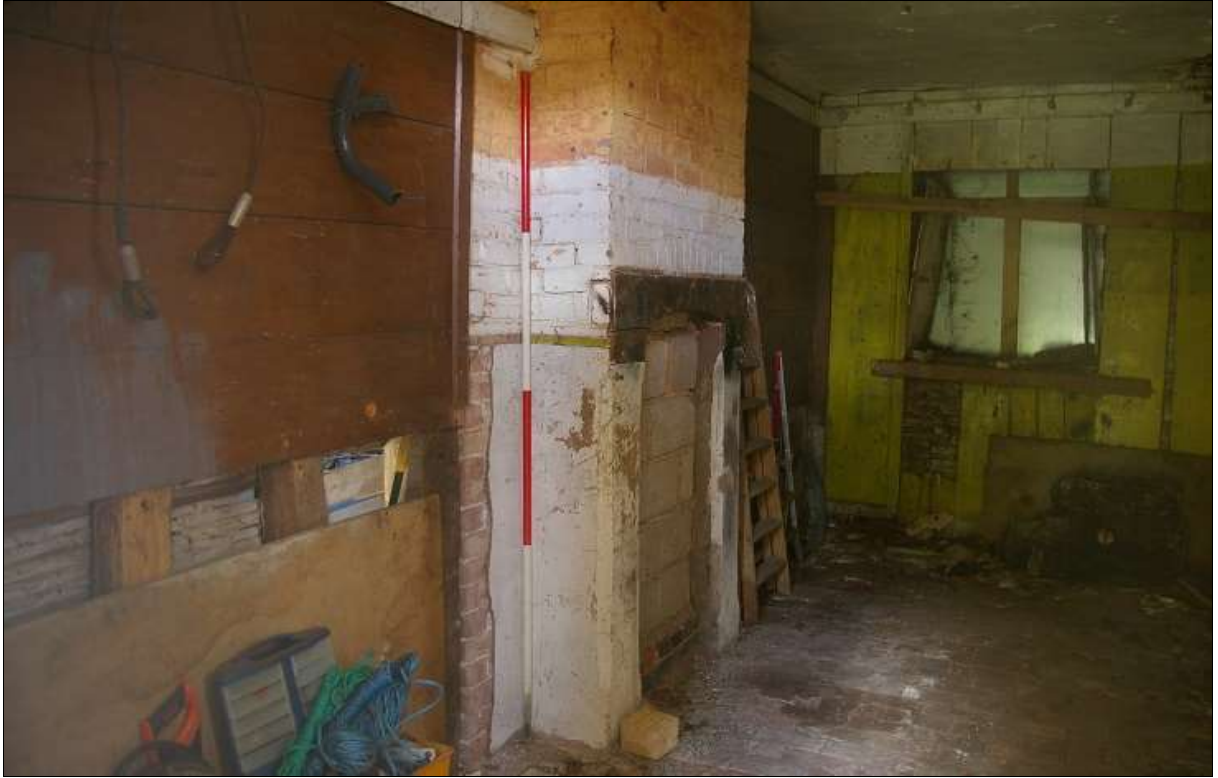
Room 3 has a brick inserted floor, set in lime and sand, again with the back-to-back stack, on this side the brick has been rendered with a chamfer detail, matching the posts outside and there is a timber surround. A large rectangular narrow, tall window has been forced into the north wall, which is of stone and shows evidence of the continuation of slit vents, now lost, with the east wall being a modern boarded and framed wall, where the building was truncated in the 1960s. There are a number of very good rows of pegs and hooks attached to the walls, several presumably reset, these are for harness, tack and reins.

FIGURE 11: ROOM 3, ELEMENT B, THE HARNESS ROOM, WITH ITS FIREPLACE AND BRICK FLOOR, WITH 2M SCALE; FROM THE SOUTH-EAST.

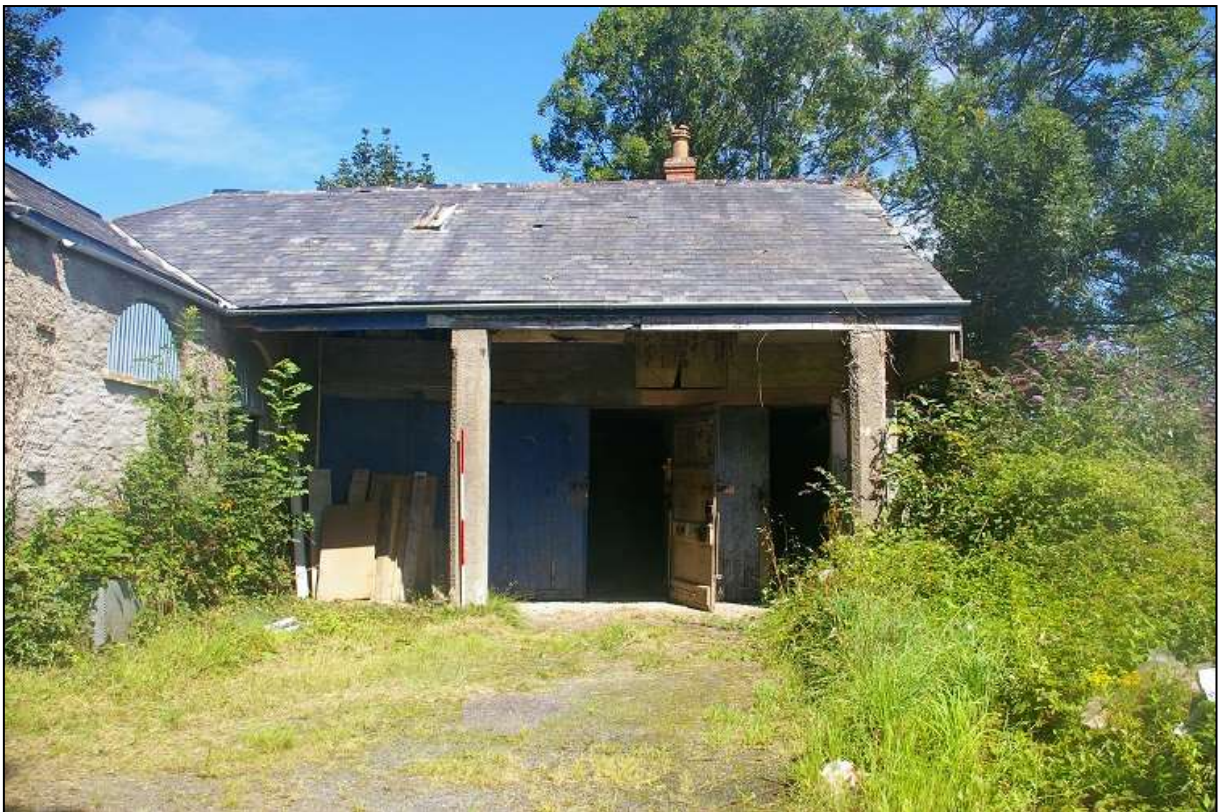
Element B – the loft and its associated timber framing provides the strongest evidence of an earlier mercantile past as a warehouse. The ground floor spaces here have already been so heavily altered they offer lots of opportunity for change.

FIGURE 13: ELEMENT B, WITH 2M SCALE; FROM THE SOUTH.

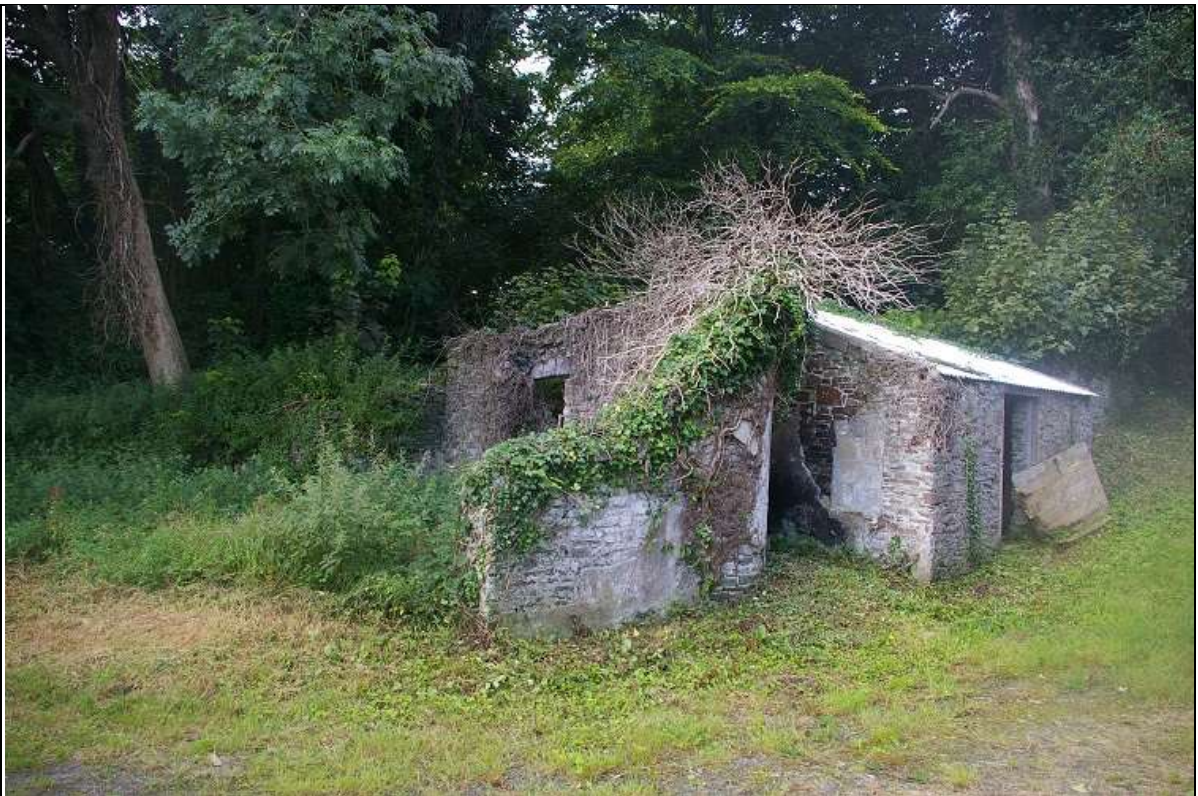
6. THE RUINED BARNs SOUTH-WEST OF THE STABLES RANGE; FROM THE NORTH-EAST.

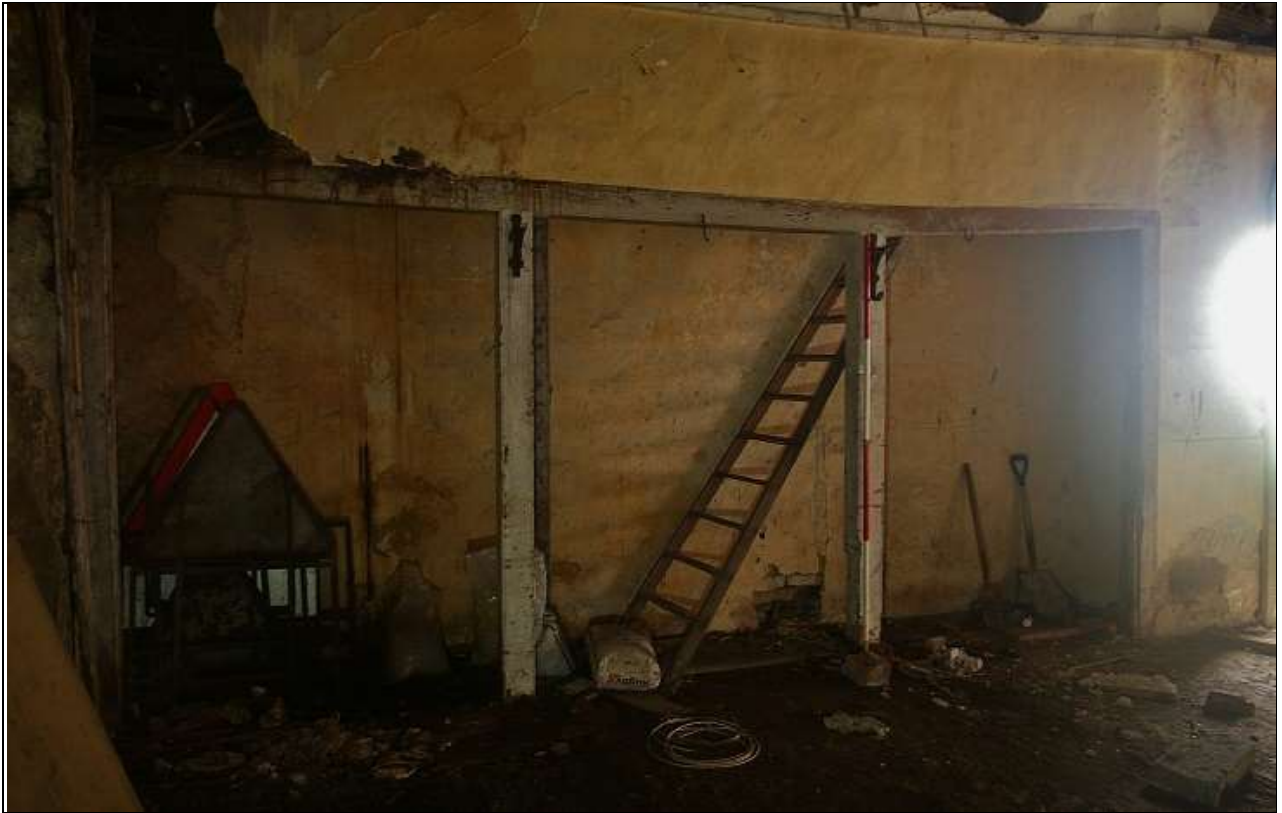
15. THE NORTH END OF THE EAST WALL OF ELEMENT A, THE PARTITION WALL, INSERTED TO DIVIDE THE RANGE, WITH 2M SCALE; FROM THE NORTH-WEST.

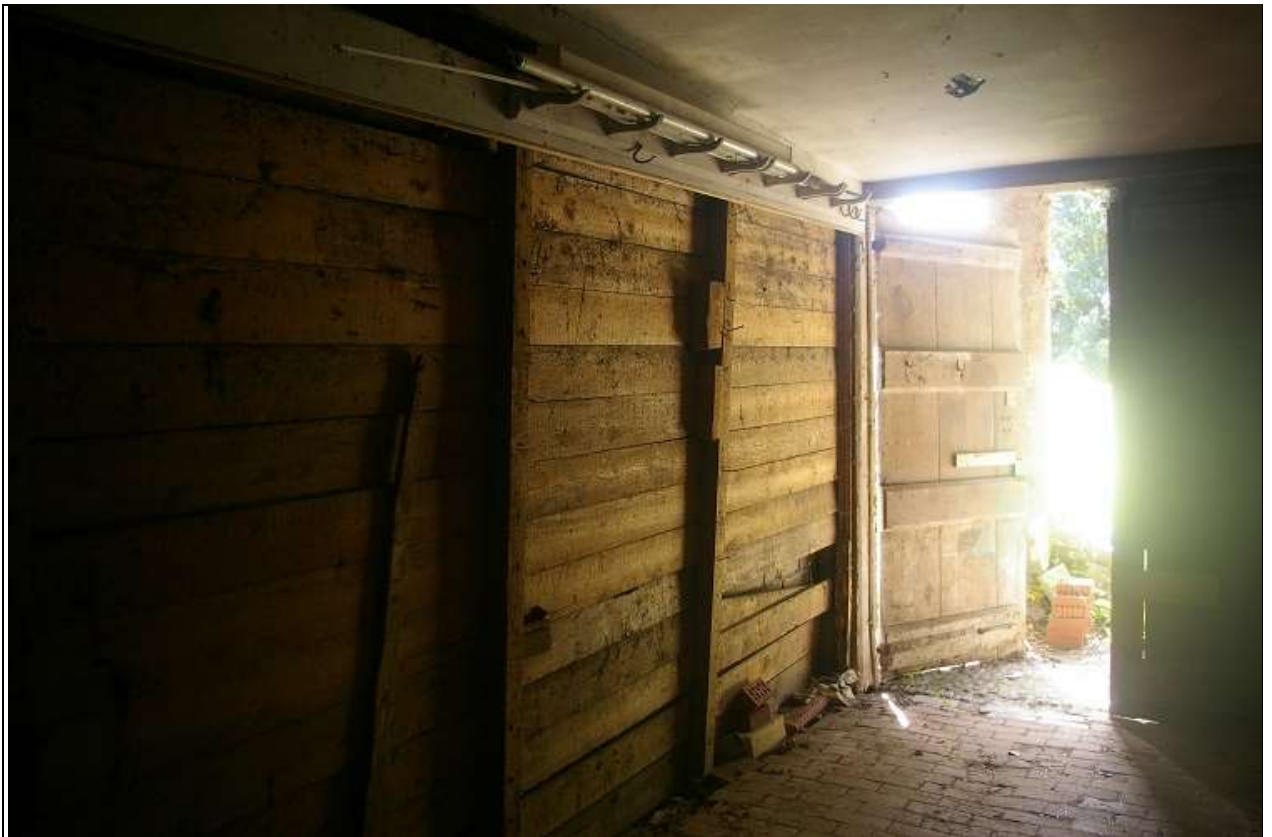
28. THE EAST BOARDED WALL OF THE ELEMENT B, ROOM 3, WHERE THE BUILDING HAS BEEN TRUNCATED; FROM THE NORTH-WEST.
