THE CHURCH OF ST. MARGARET

NORTHAM

Results of Historic Building Recording

The Church of St. Margaret, Northam, Devon Historic Building Recording

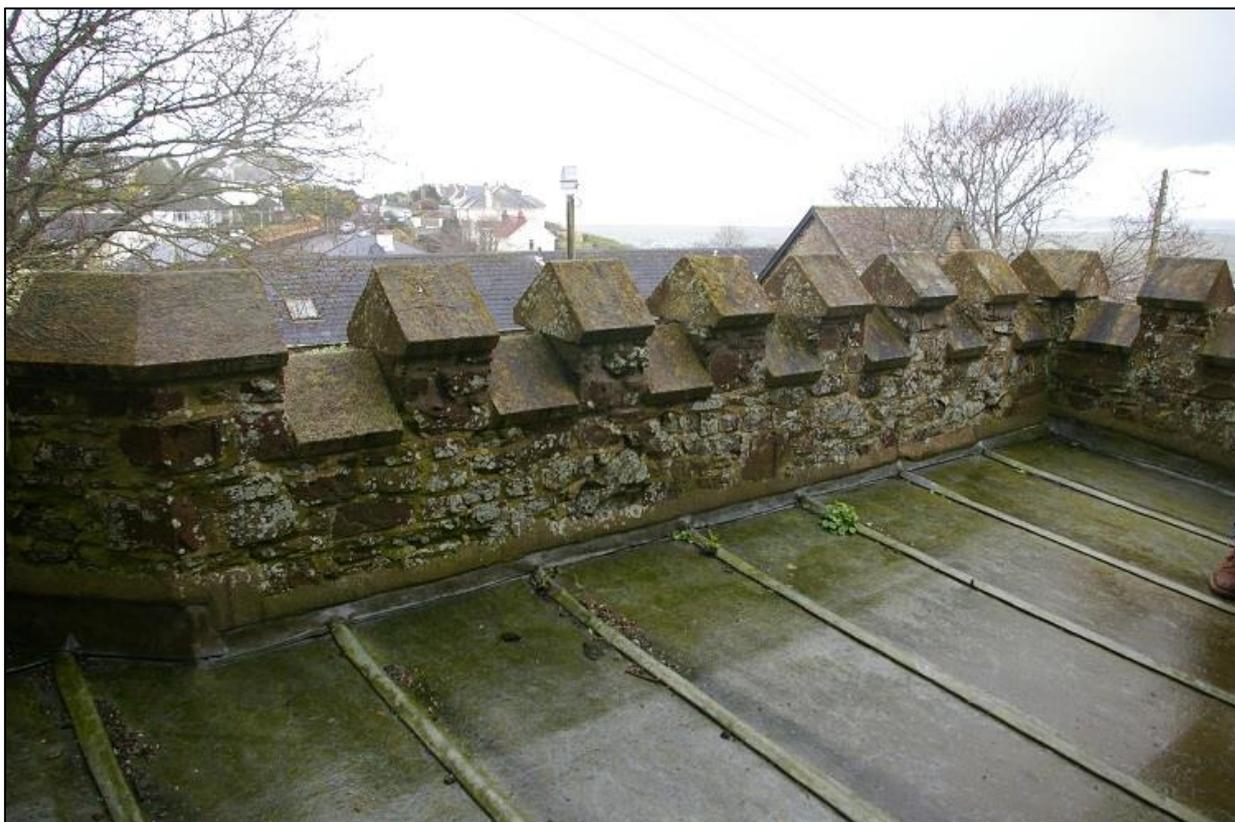
The single storey building has a raised, crenellated parapet of slatestone rubble with limestone dressings. The merlons have been rebuilt or heavily repaired at some point in the later 20th century with inappropriate hard cement-mix mortars which are forcing water further into the building. Several of the merlons are loose and unstable, requiring reconstruction. The vestry has been repointed in a hard mortar at some point and in places this is clearly coming away, again allowing for water ingress.

The roof behind the parapet is a shallow mono-pitch leading to a deep lead box gutter against the west gable of the north aisle, immediately under the window. This gutter also serves the heavy lead hopper and down pipe to the south of the window, which drains the large valley gutter between the nave and north aisle. This gutter and downpipe are both damaged and in need of conservation. The shallow pitch has allowed standing water on the lead, which has a green moss covering despite regular cleaning. The flashings on the lead roof have all been cemented, again pushing water beneath, and are very shallow; the roll joints in the leadwork do not have timber cores, but have merely been folded and the 'lap' between the lead sheets is short; again water is getting beneath.

FIGURE 2: THE ROOF AND CRENELATIONS OF THE VESTRY; FROM THE SOUTH-EAST.

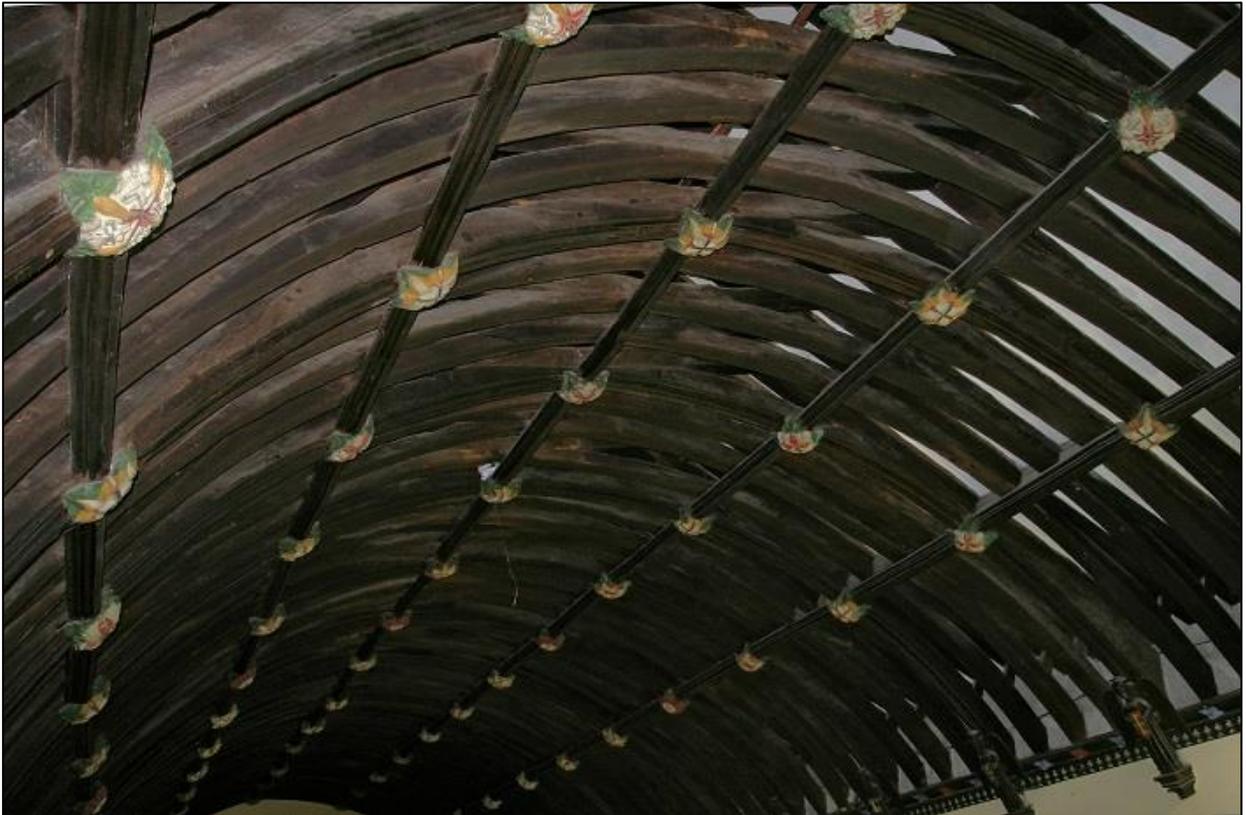
Internally, the nave roof is stained a dark colour, obscuring patina with a tar, or creosote type substance and from the floor of the church, at a considerable height, it is difficult to fully distinguish between the timbers, but for their difference in surface texture and scantling weight. The early timber is adze cut and therefore slightly cruder in shape, the mouldings chunkier; the 19th century timbers more regular in shape. Clearly the majority of the arch bracing, shields and mouldings are also original. The wood used in the 19th century phase, probably pine or green oak, would be different from the medieval wood, which would likely have been oak or elm and this may account for the staining, to disguise obvious colour differences. The nave roof is unusually open beneath, allowing us to see the supportive beams above the arch bracing; often roofs were enclosed by plasterwork infilling between the moulded ribs forming a barrel shaped vault, sealing the roof above. Instead, the roof has lath and plaster panels between the base trusses. It is not clear, with only limited examination of a small part of this roof internally, from a single scaffold tower, if there is evidence of further plaster between the ribs at some point. This can be confirmed from the exterior, however, as there is clear evidence of laths on the back of some of the barrel-vaulted arch bracing, suggestive there was a more typical closed vault in the 16th century.

FIGURE 3: THE INTERIOR OF THE NAVE ROOF; FROM THE NORTH-WEST.

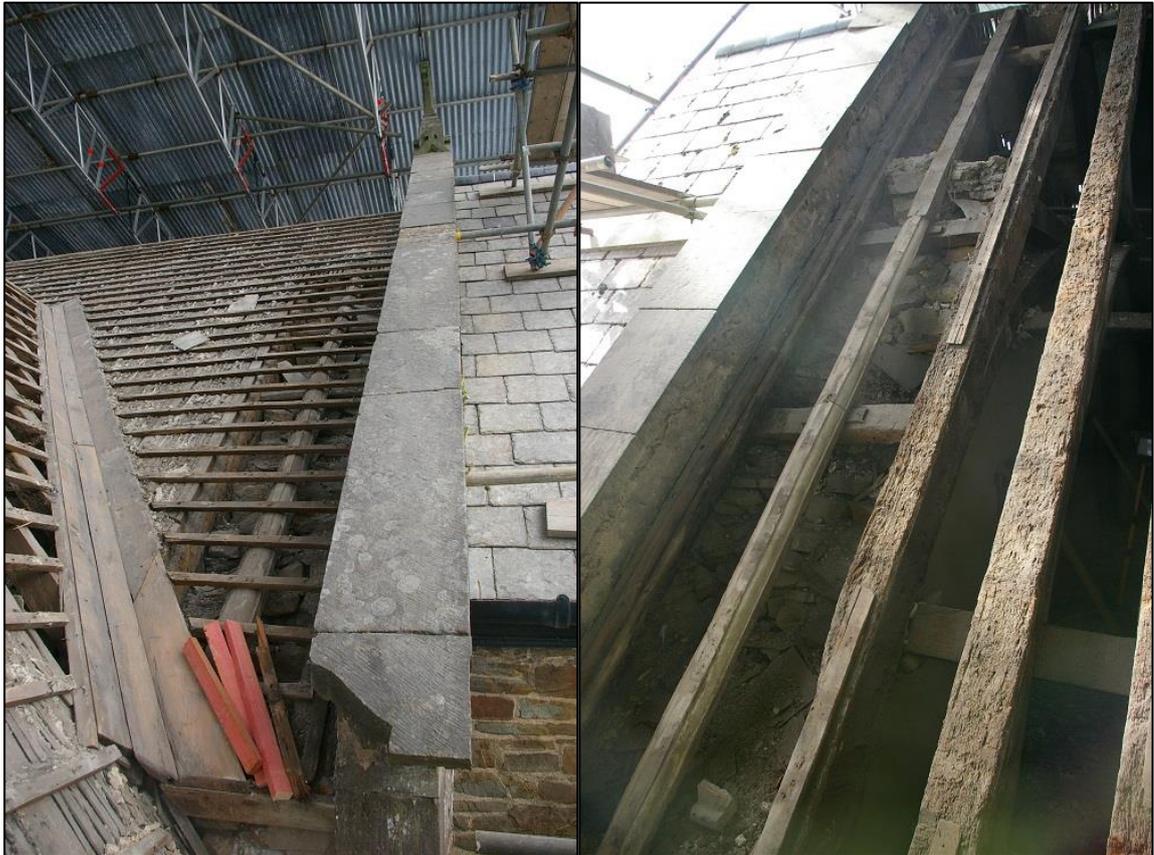
The 'opening up' again exhibited the two distinct phases of trusses in the roof, with heavy adze shaped truss blades and a few smooth, lighter weight, machine sawn truss blades; again highlighting the majority of surviving medieval roof, supplemented with some 19th century superstructure, replacing those timbers which could not be saved. There are also at least two timbers reused as truss blades, identified as having chunky $\frac{1}{4}$ ovolo mouldings on them, now 'upside down'; their decorative nature suggesting they were part of the internal framework; at least one having a truncated mortice and tenoned end. One similar timber was noted on the south pitch, where the nave and chancel adjoin.

FIGURES 4A & 4B: LEFT; SOUTH SIDE OF THE ROOF, WITH REUSED MOULDED TIMBER. RIGHT, NORTH SIDE OF THE NAVE ROOF, WITH A SIMILAR MOULDED TIMBER, CLEARLY REUSED FROM ELSEWHERE OF TYPICAL 16TH CENTURY MOULDED FORM.

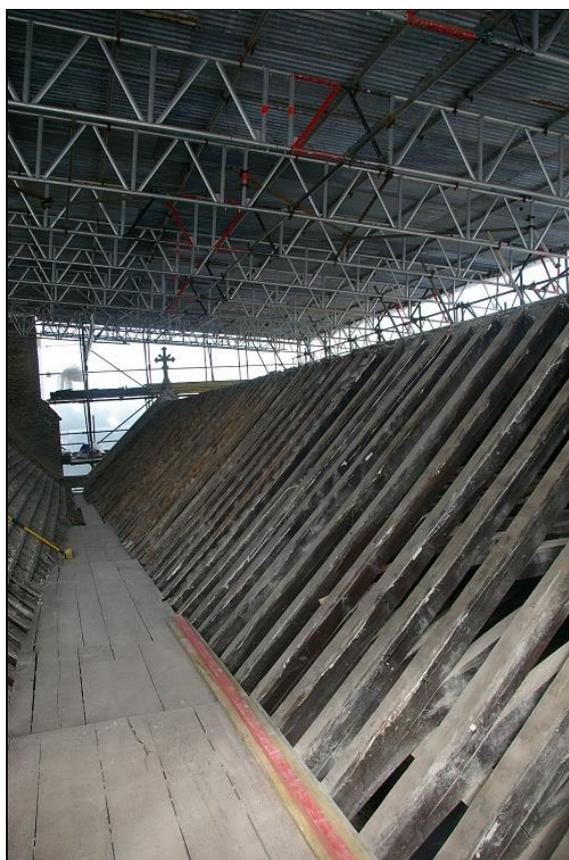
The weight of the beams to the north aisle roof are much lighter and many are obviously 19th century replacements, in fact much of this roof looks to date to the later renovations, but some of the internal arch bracing and vaulting is adze cut and appears to be 16th century. There are some heavier timbers to the east end which may be original. One timber on the south face has regular shallow joist or wide split batten notches in the back of it, suggestive of it having been part of an earlier roof. The slates over the north aisle are irregular in size and type, as with the nave roof. Again, nail rot of the iron nails is obvious and heavier, larger Delabole slates appear to represent the earliest of the current phases on this roof. Originally, as with the nave, the north aisle would have had a pegged graded scantle roof of good quality Delabole.

FIGURE 5: THE NORTH AISLE ROOF STRIPPED OF SLATE; FROM THE EAST-NORTH-EAST.

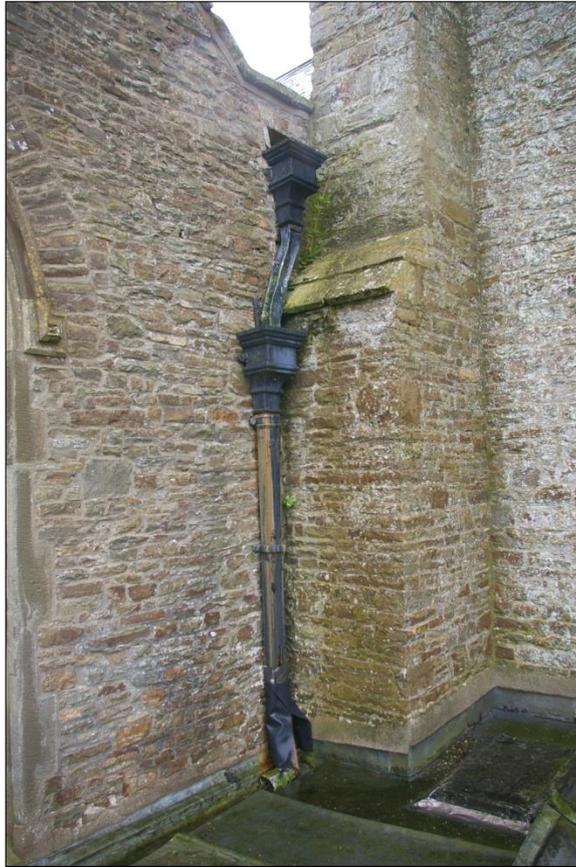
1. THE LEAD GUTTER AND DOWNPIPE THAT SERVES THE VALLEY GUTTER BETWEEN NAVE AND NORTH AISLE AND LEADS INTO THE BOX GUTTER THAT RUNS ACROSS THE ROOF OF THE VESTRY; VIEWED FROM THE NORTH-WEST.

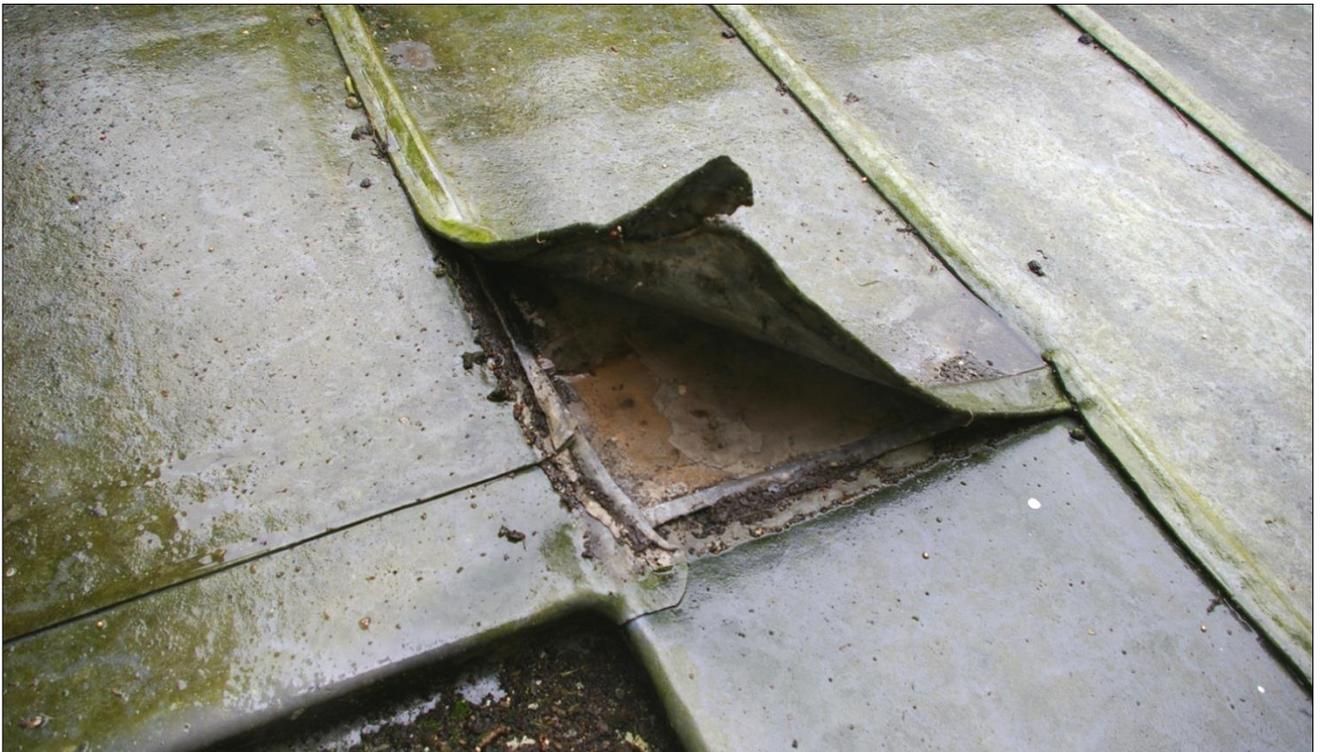
Where the lead was lifted, as part of the 'opening up', wide, beaded pine boards were seen beneath, covered with a thin fibre sheeting, which has laminated and displays evidence of water ingress. A former skylight has been poorly covered over in the south-east corner of the roof, no doubt allowing further ingress into the structure.

2. THE LEAD SHEETING LIFTED ON THE VESTRY ROOF, SHOWING THE PINE BOARDS BENEATH; VIEWED FROM THE SOUTH-EAST.

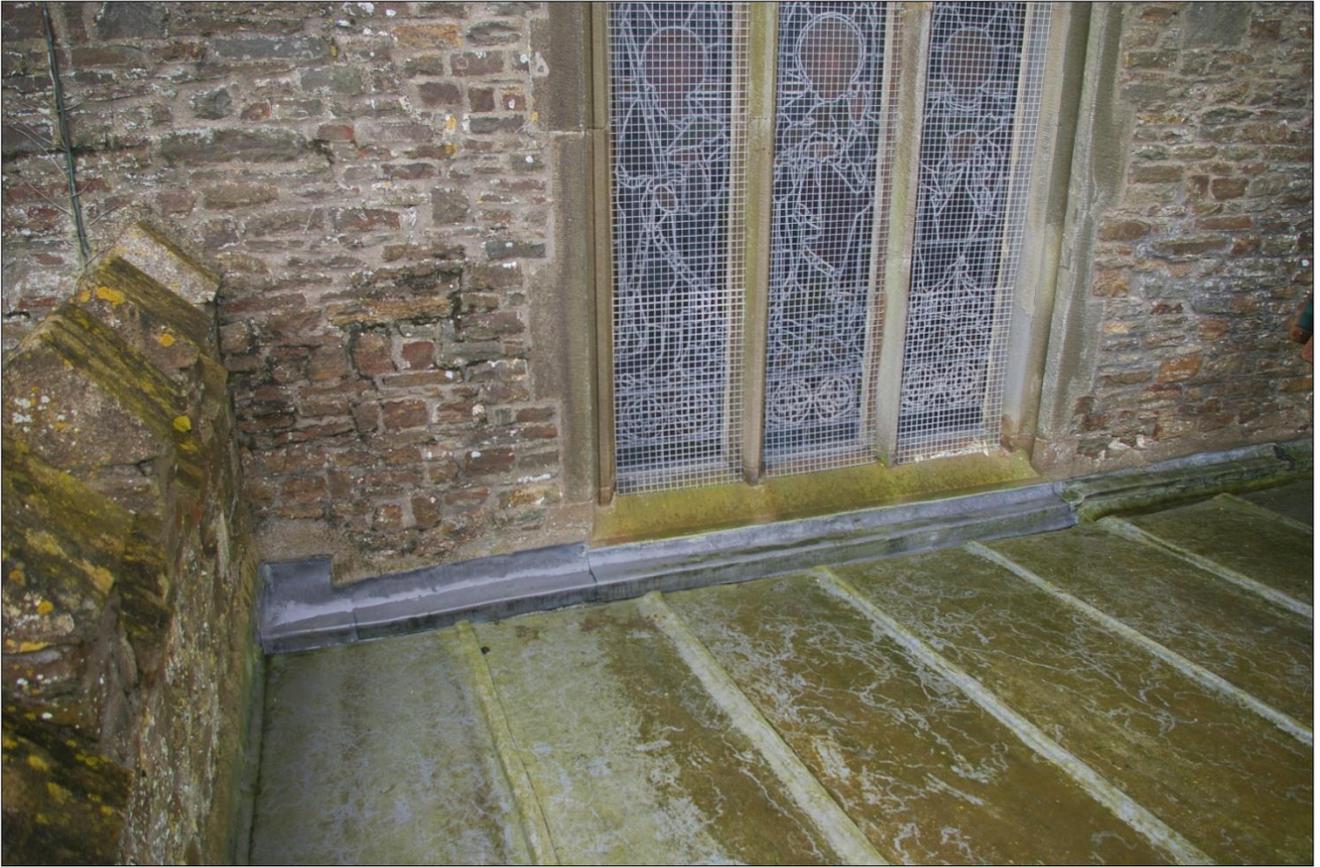
3. THE LEAD BOX DRAIN AND SHALLOW MONOPITCH OF THE ROOF UNDER THE WEST WINDOW OF THE NORTH AISLE; VIEWED FROM THE WEST-NORTH-WEST.

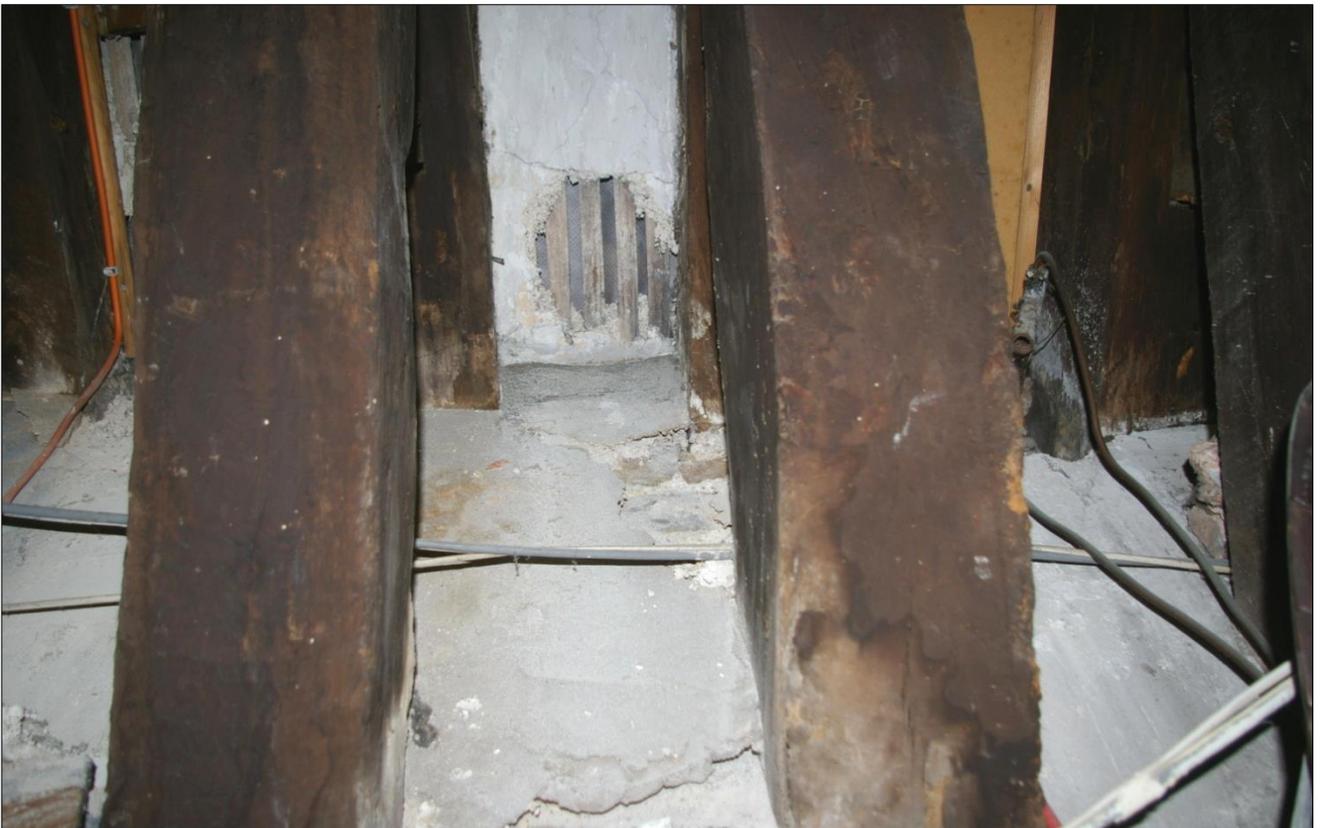
4. THE INTERIOR OF THE NAVE ROOF SHOWING THE LIME PLASTER BETWEEN THE TRUSSES AND VERY THIN LATHS; VIEWED FROM THE SOUTH.

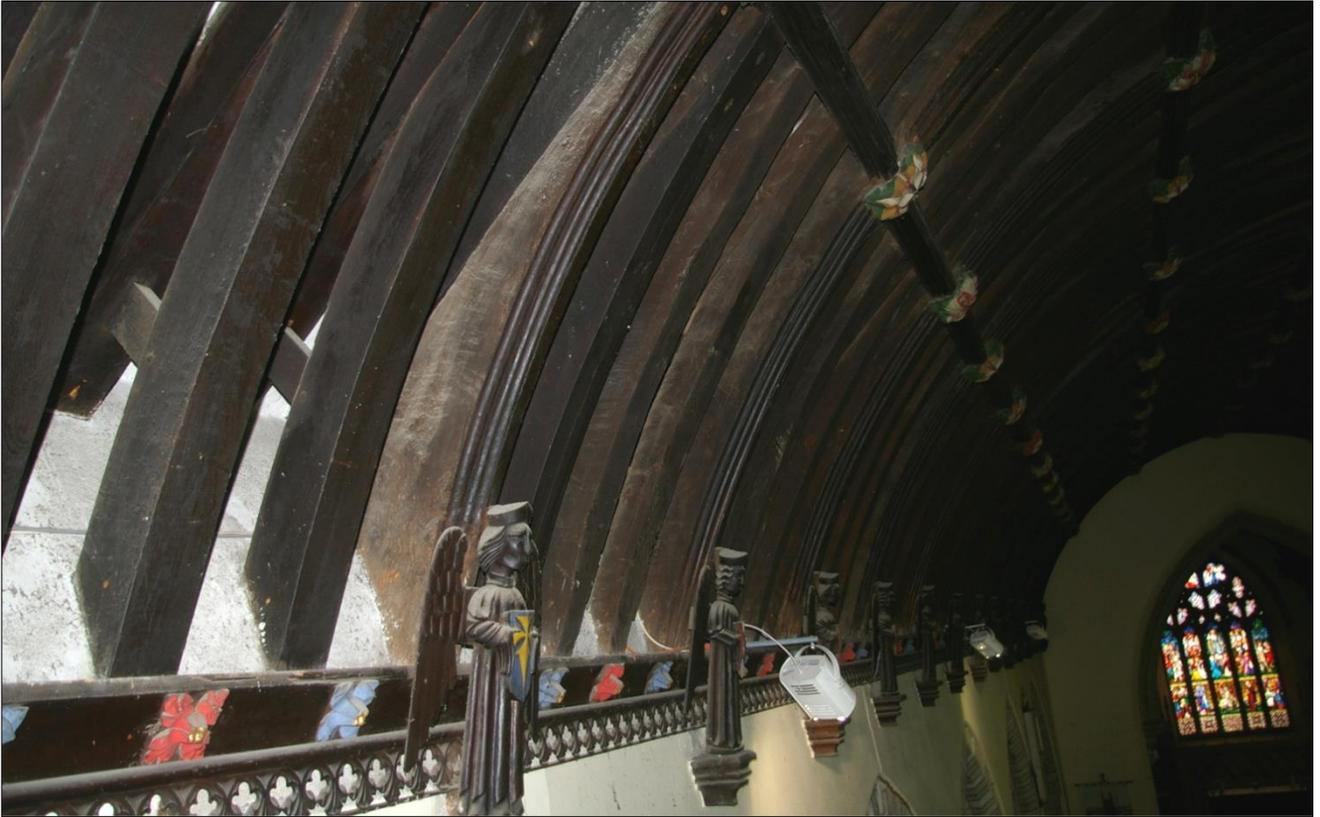
5. THE NORTH SIDE OF THE NAVE ROOF, CLEARLY SHOWING THE DIFFERENCES IN TEXTURE AND SLIGHT VARIATIONS IN COLOUR, WHERE MEDIEVAL TIMBERS HAVE BEEN INCORPORATED INTO A 19TH CENTURY ROOF REPAIR; VIEWED FROM THE WEST-SOUTH-WEST.

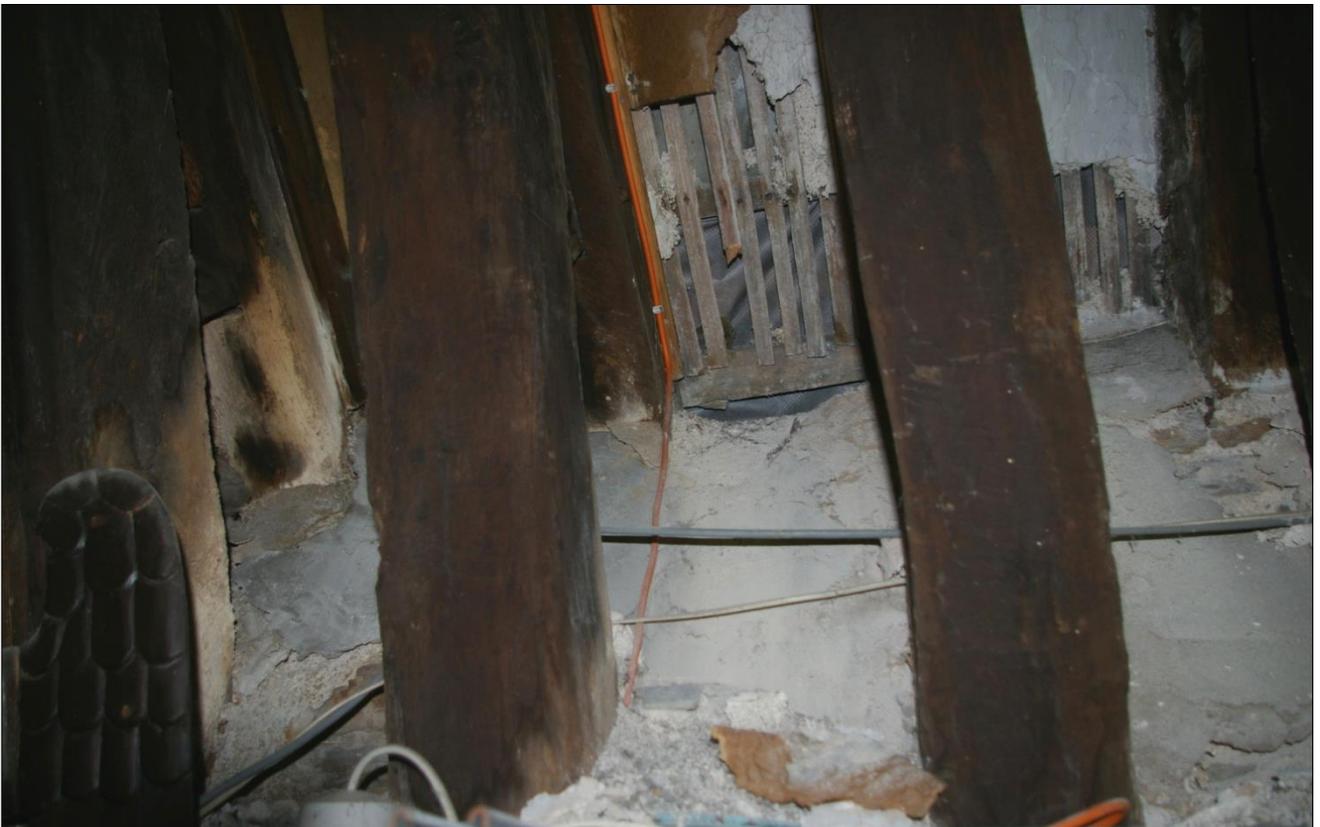
6. THE CEMENT RENDER TREATMENT OF THE WALL TOPS, THE RUBBLE BUILD IN LIME MORTAR BEHIND IT, AND AN ATTEMPT TO COVER THE FAILING LIME PLASTER WITH FIBRE PANELS; VIEWED FROM THE SOUTH-EAST.

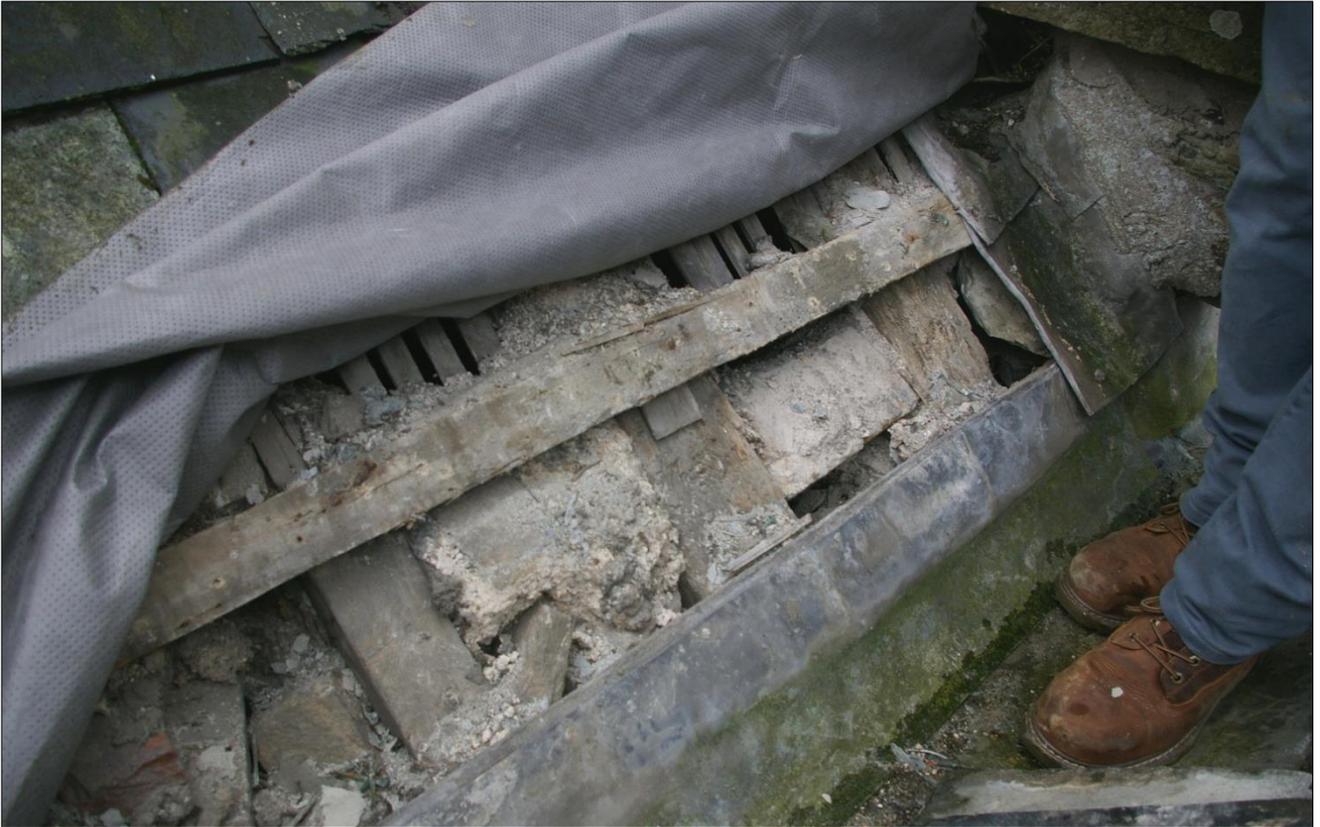
7. EXTERIOR FACE OF THE ROOF WITH SLATES LIFTED AND FELT REMOVED. THERE ARE TWO HEAVY ORIGINAL TRUSS BLADES AND ONE NARROW 19TH CENTURY TRUSS BLADE; VIEWED FROM THE EAST-NORTH-EAST.

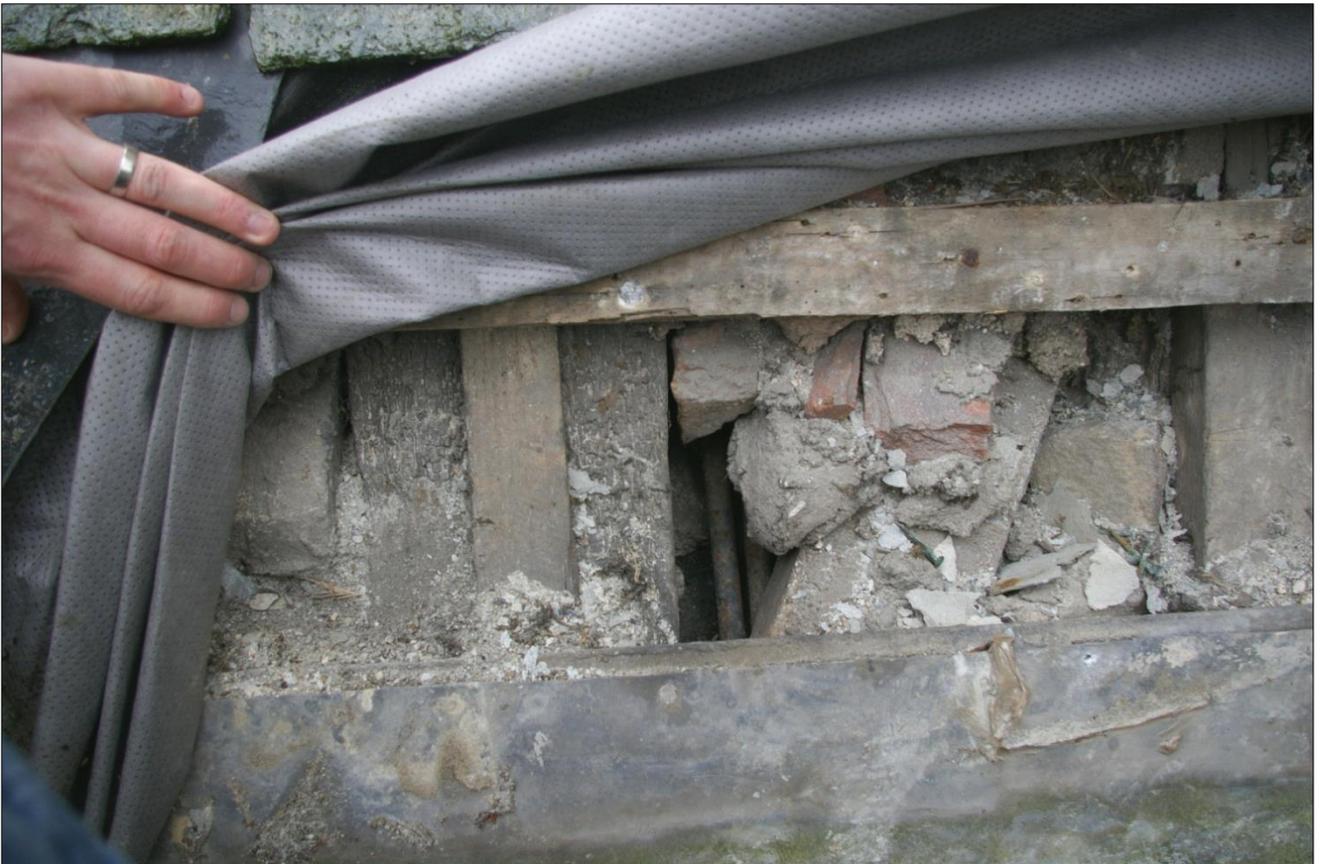
8. MEDIEVAL HEAVY TRUSS BLADE, JUST BEYOND THE LIGHTER 19TH CENTURY ONE; THIS MEDIEVAL TRUSS HAS HAD A LIGHT PINE BATTEN FOR THE SLATES ATTACHED TO ITS REAR WITH IRON NAILS; VIEWED FROM THE NORTH-NORTH-EAST.

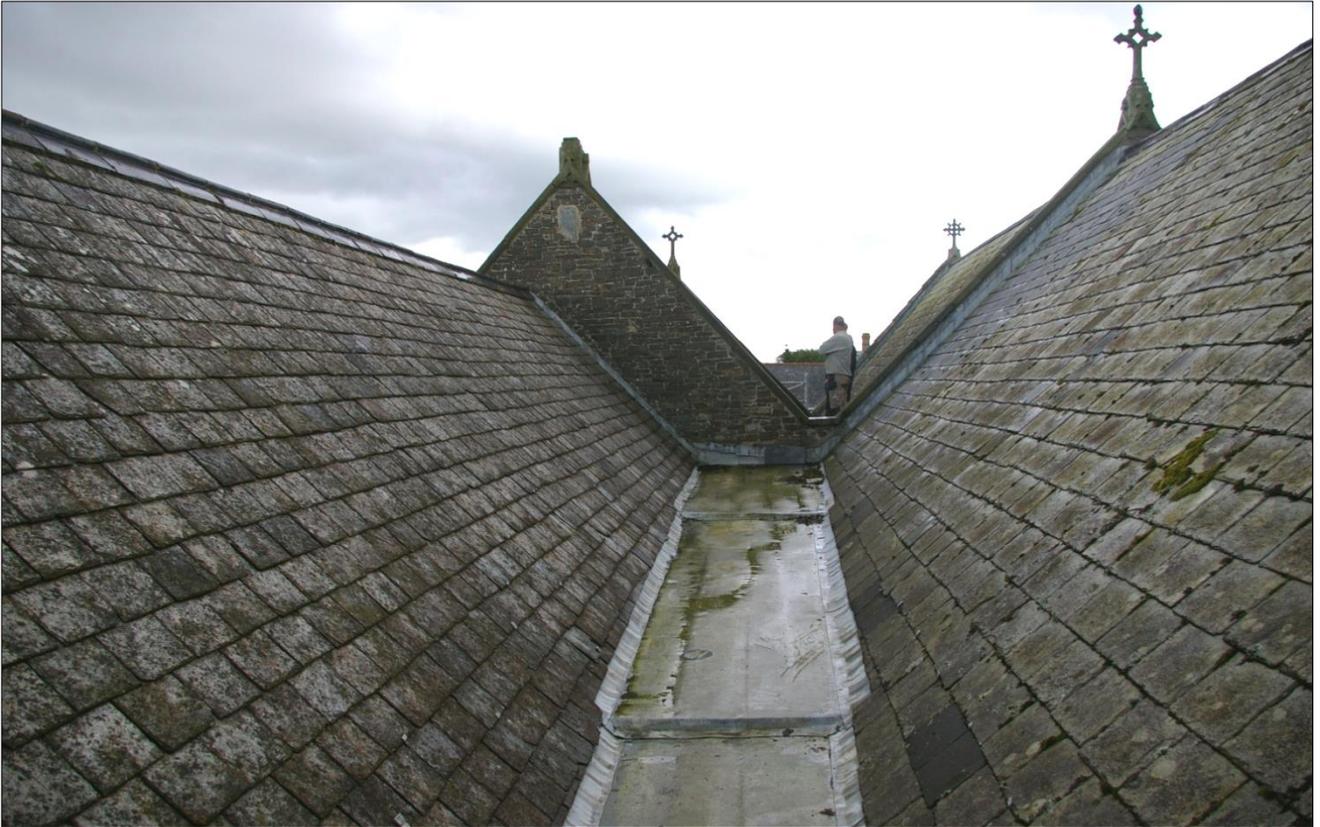
9. THE WIDE END OF THE VALLEY GUTTER WHERE THE NORTH AISLE AND NAVE MEET THE EASTERN PART OF THE CHURCH; VIEWED FROM THE WEST.

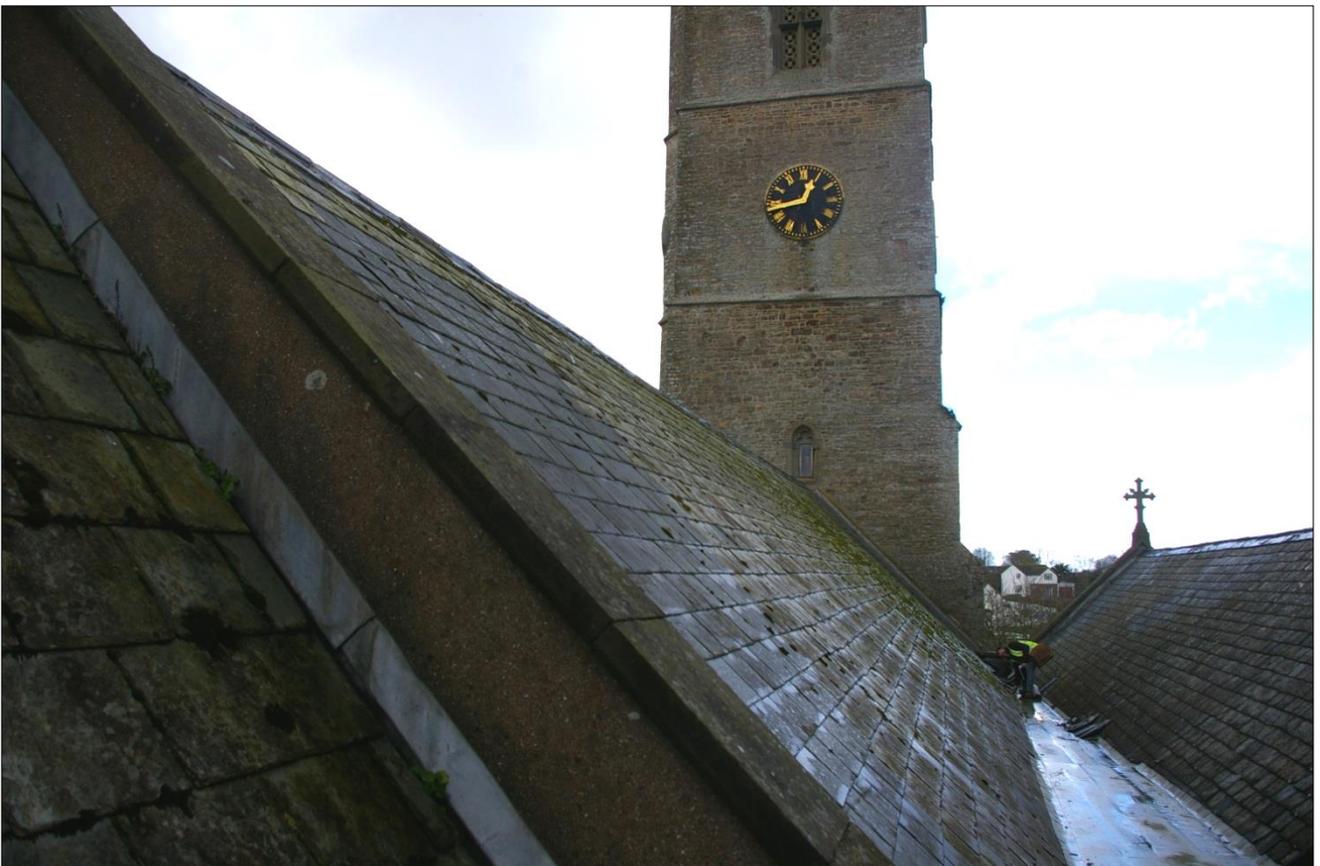
The valley gutter at the west end of the church, between the nave roof and north aisle roof, is of unusually tapered form, indicative of the phasing in this structure. To the west end, adjacent to the tower, it is c.0.4m wide, widening to the east end, at the coping between nave/chancel and north aisle/lady chapel to c.1.2m. What this means is that whilst the nave roof alignment fits the walls below on an east-west line; the roof above the north aisle is cranked, lying slightly south-west, north-east, and runs away on its south side from the wall alignment. The valley gutter is leaded and beneath is constructed of massive planks with chamfered edges, oak and elm, with many cut marks and carpenters marks; these have evidence of water damage on their north sides and are nailed loosely to narrow pine cross-braces, presumably a 19th century fixing. They are c.0.4m wide and c.10cm deep to the centre, the sides chamfered and tapered to sit in the angle between the roofs; multiple boards infill at the wider end, all appear to be historic reused offcuts. These timbers are massive and earlier in date, likely reused here. The lead gutter and flashings are again shallow but this structure is largely suffering due to the wind funnel created along its length and the open position of the church on the knoll before the Northam Burrows, with no protection from the direct sea winds. The width of the gutter will naturally retain water along its length, the very shallow drop providing ineffective drainage. Standing water even in small quantities poses a threat to a historic timber roof structure.

10. VIEW BACK ALONG THE VALLEY GUTTER AND TO THE TOWER, SHOWING HOW IT NARROWS AND HOW THE ROOFS ARE OFFSET; VIEWED FROM THE EAST-NORTH-EAST.

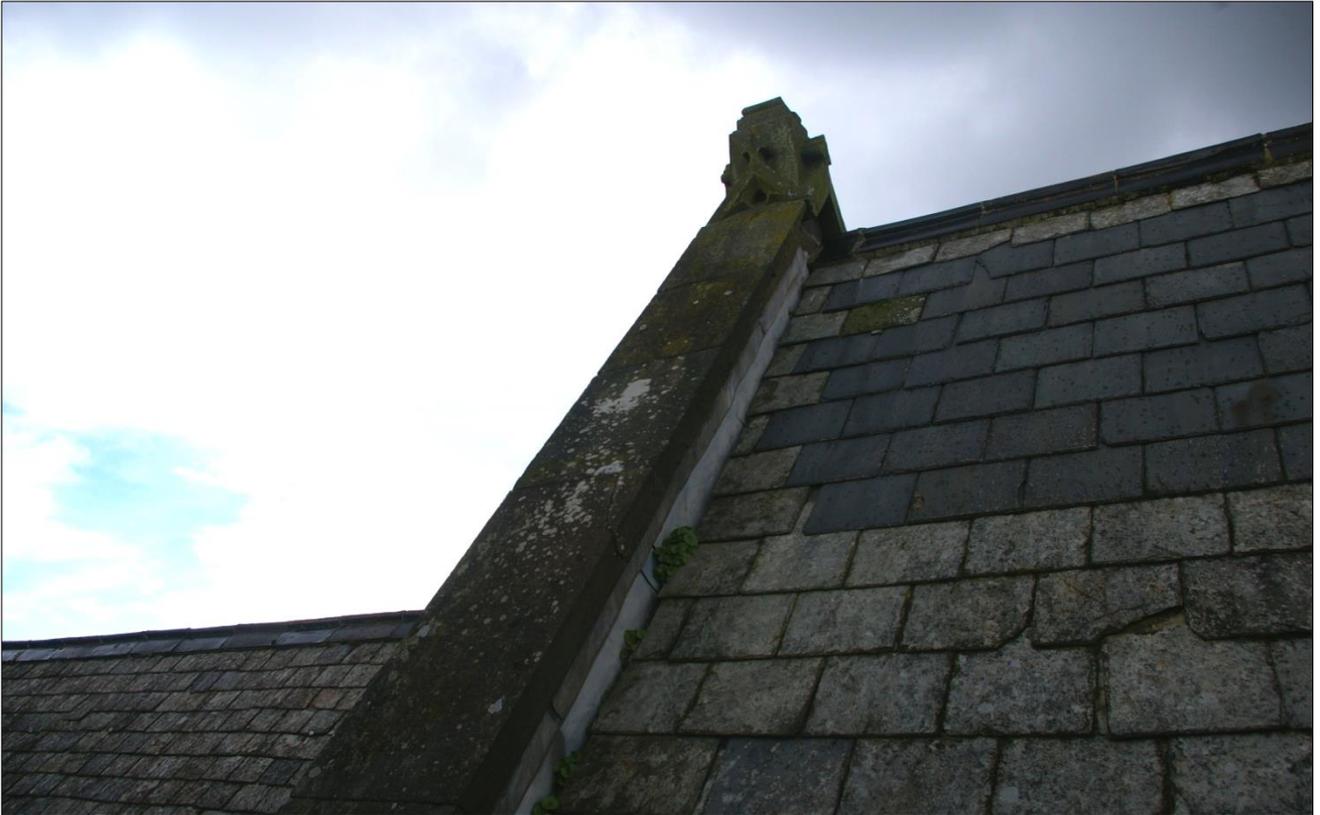
11. THE RAISED GABLE BETWEEN THE NORTH AISLE TO THE LEFT AND THE HIGHER PROFILE OF THE ROOF OF THE LAY CHAPEL TO THE RIGHT, SHOWING HOW OFFSET THE ROOF OF THE NORTH AISLE IS IN COMPARISON TO THE REST; VIEWED FROM THE SOUTH-EAST.

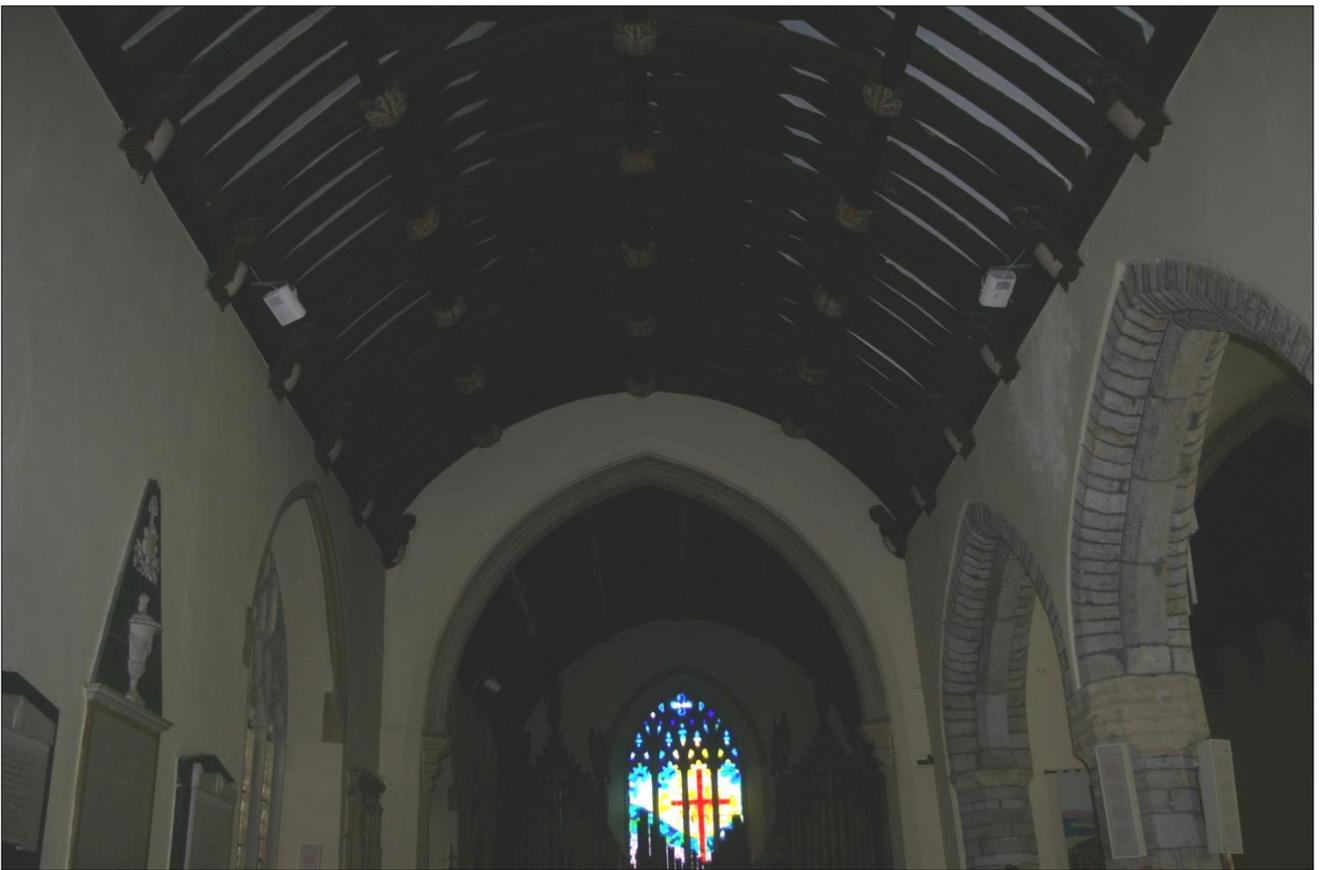
12. VIEW FROM WITHIN THE NORTH AISLE SHOWING THE OFFSET ROOF; VIEWED FROM THE WEST.

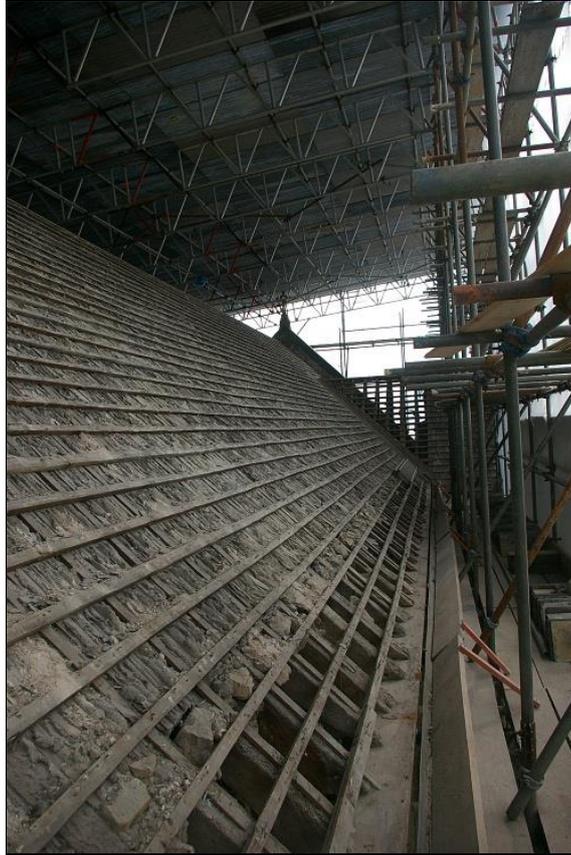
13. THE NORTH FACE OF THE NORTH AISLE ROOF; FROM THE EAST-NORTH-EAST.

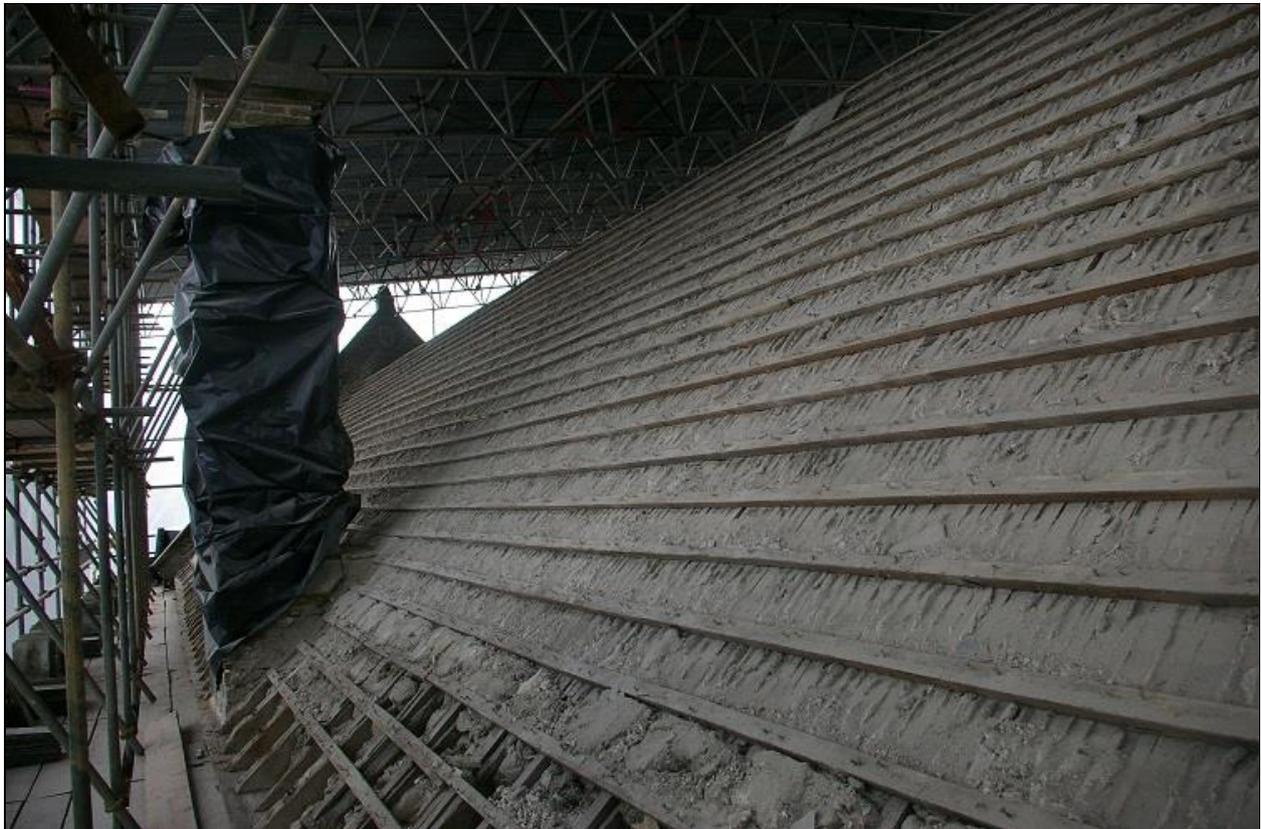
14. THE NORTH FACE OF THE NORTH AISLE ROOF; FORM THE WEST-NORTH-WEST.

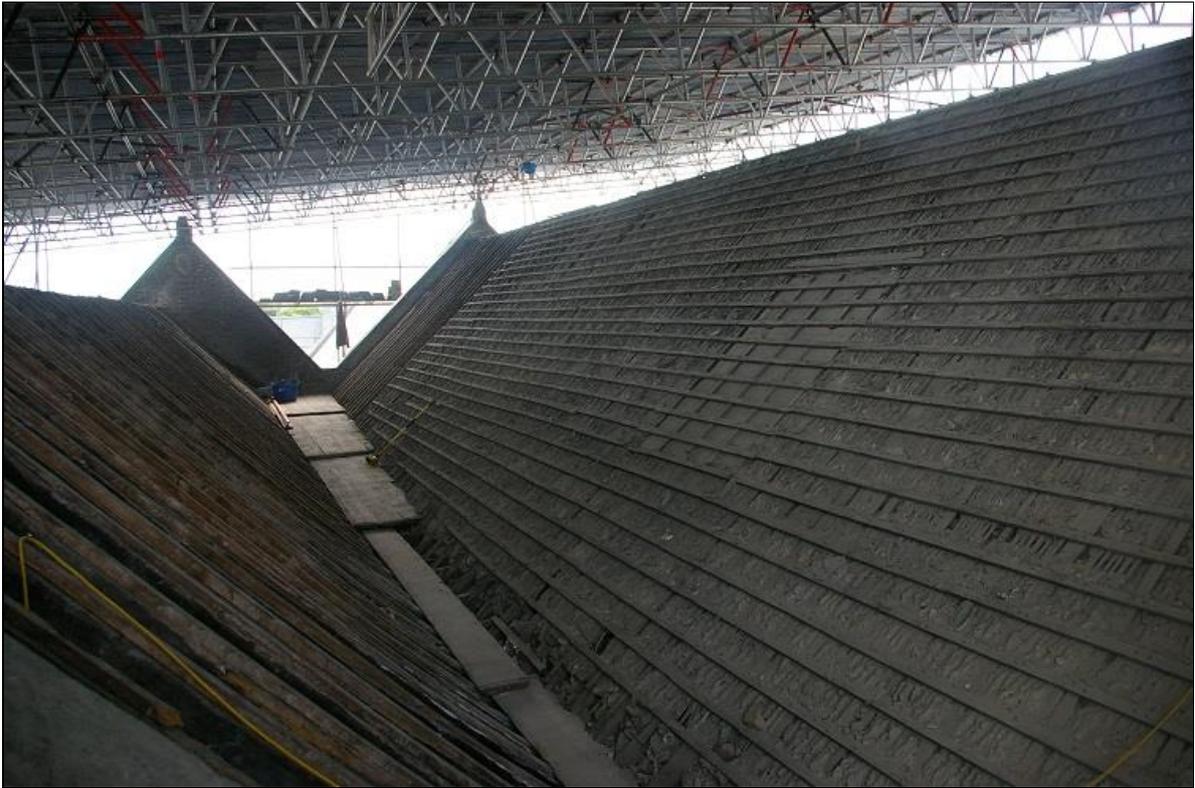
15. THE NORTH AISLE AND NAVE ROOFS STRIPPED OF SLATE; FROM THE WEST-NORTH-WEST.

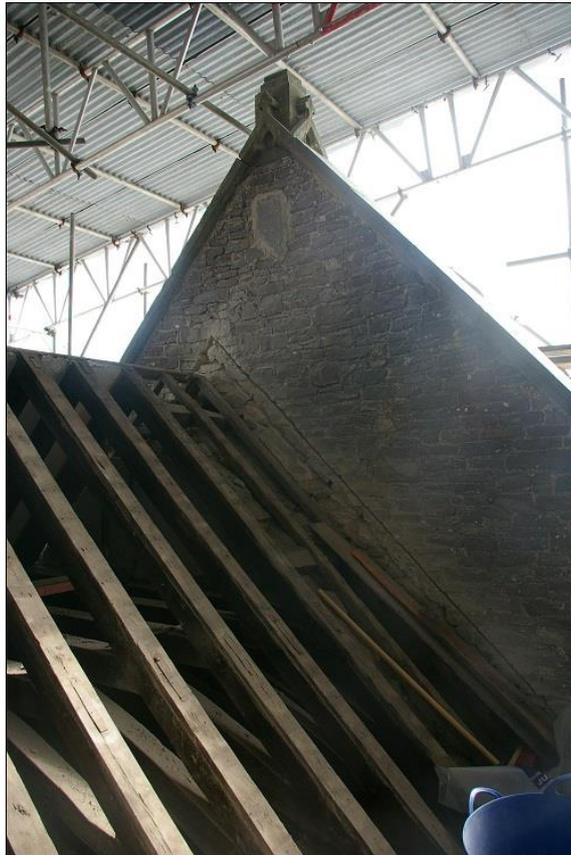
16. THE ROOFLINE SCAR AND SOCKET HOLE ON THE NORTH AISLE, EAST END; FROM THE SOUTH-WEST.

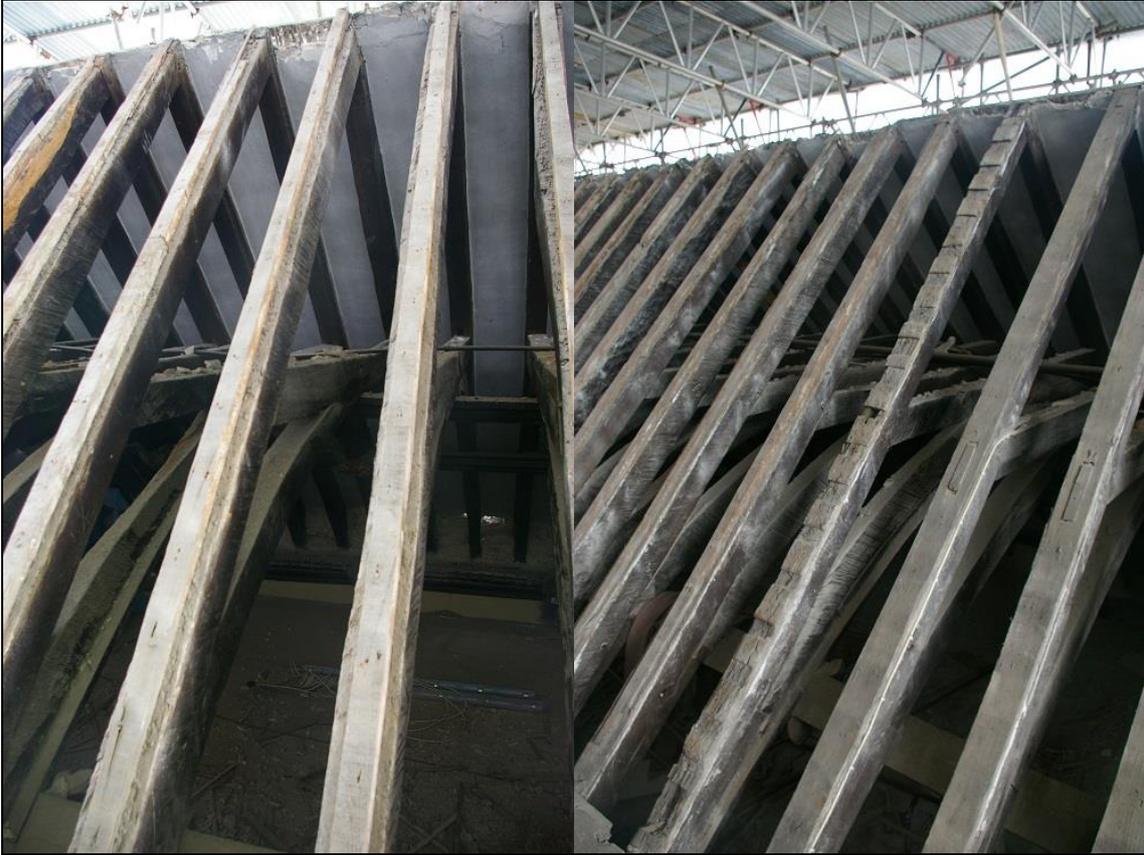
17. LEFT: SAW MARKS ON TRUSSES OF NORTH AISLE, INDICATING 19TH CENTURY DATE.

18. RIGHT: ONE OLDER ADZE CUT TRUSS BLADE ON THE SOUTH FACE OF THE NORTH AISLE ROOF, WITH SHALLOW NOTCHES FOR RAFTERS/BATTENS.

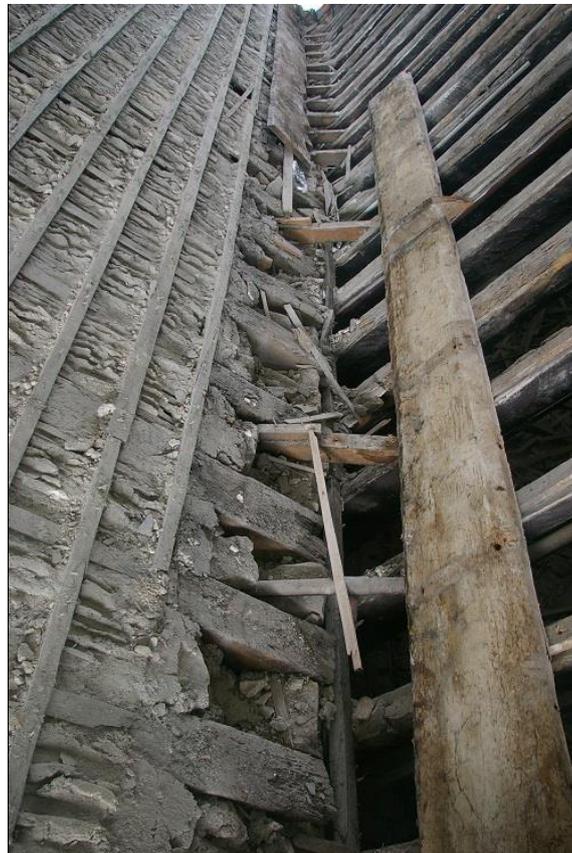
19. THE EXPOSED PLANKS OF THE VALLEY GUTTER; FROM THE EAST.
