THE CHURCH OF ST. MARGARET

NORTHAM

Results of Historic Building Recording

The Church of St. Margaret, Northam, Devon Historic Building Recording

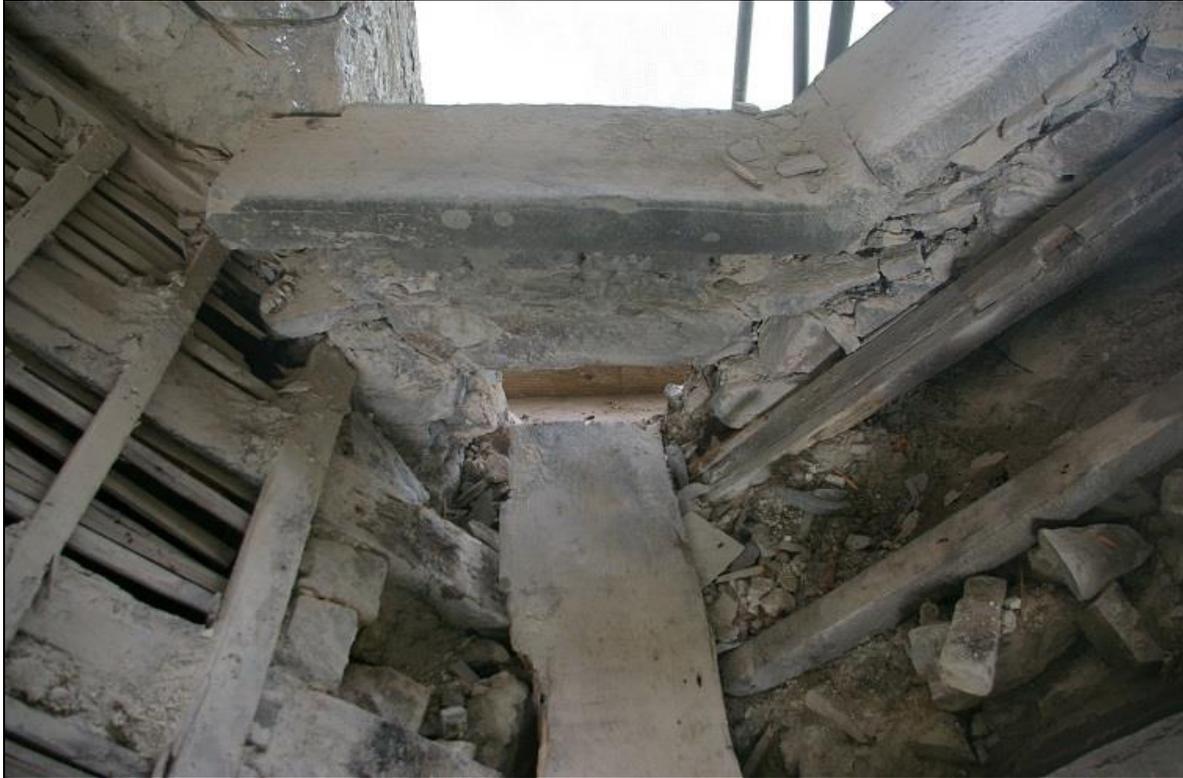
20. THE VALLEY GUTTER AND DRAIN TO THE WEST END; FROM THE EAST.
