**THE BICKFORD CENTRE  
23 SOUTH STREET  
GREAT TORRINGTON  
DEVON**

HISTORIC BUILDING RECORDING & MONITORING

South West Archaeology Ltd. report no. 230519

Revised after archaeological monitoring of works: 19<sup>th</sup> May 2023

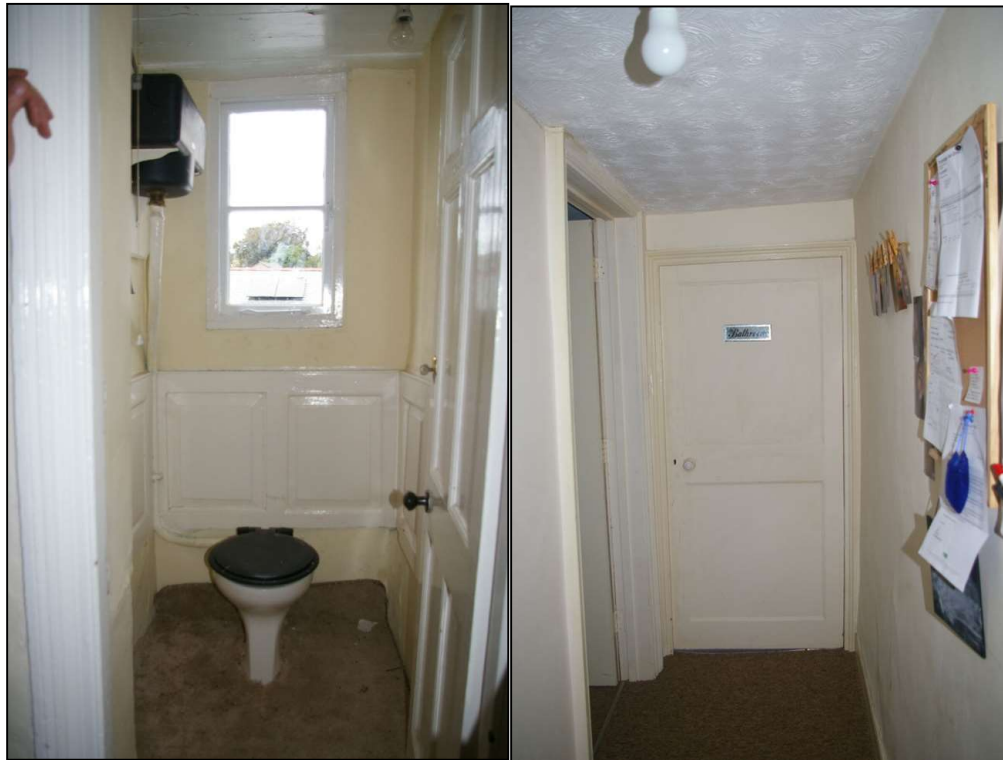
FIGURE 6 A & B: (LEFT) - R11A, THE LONG-DROP TOILET, WITH RESET, 18<sup>TH</sup> CENTURY PANELLING AND (RIGHT) - DOOR TO R16 ON THE SECOND FLOOR, ALSO AN 18<sup>TH</sup> CENTURY FEATURE.

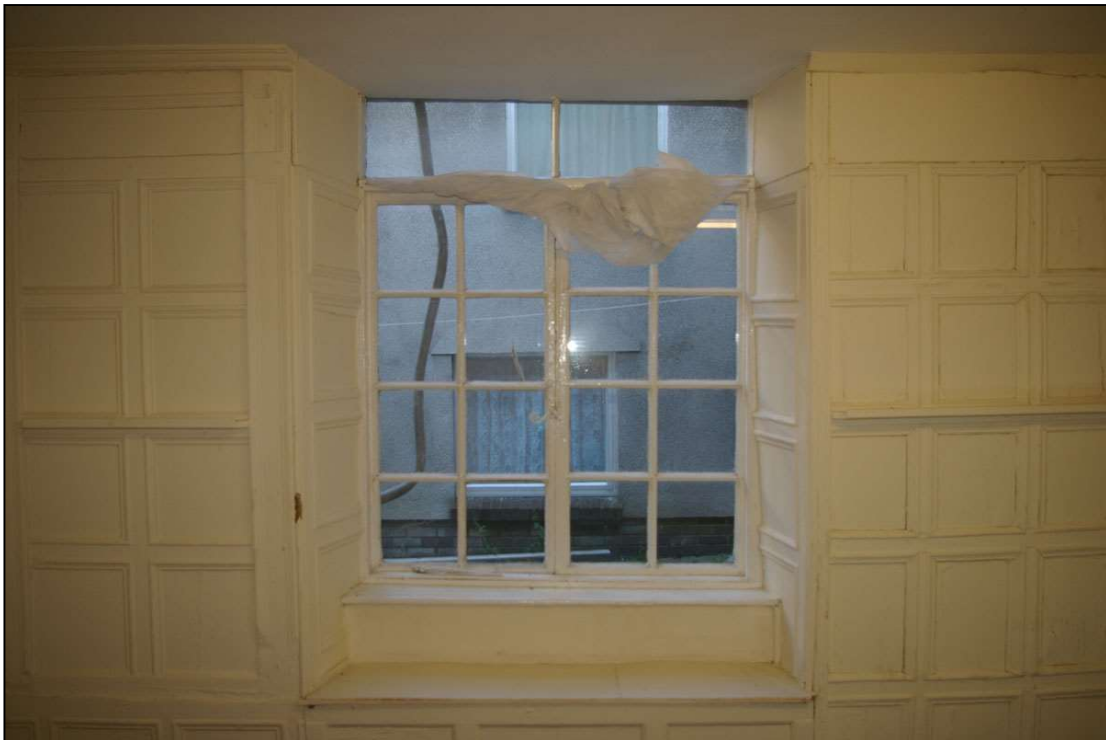
FIGURE 9: W13 IN ROOM 17, WITH RECYCLED AND RESET 18<sup>TH</sup> CENTURY PANELLED SECTIONS TO THE SIDES. THE SHUTTERS, CUT AND NAILED SHUT, AND EARLY 19<sup>TH</sup> CENTURY PANNELLING FORMING A WINDOW SEAT; FROM THE WEST.

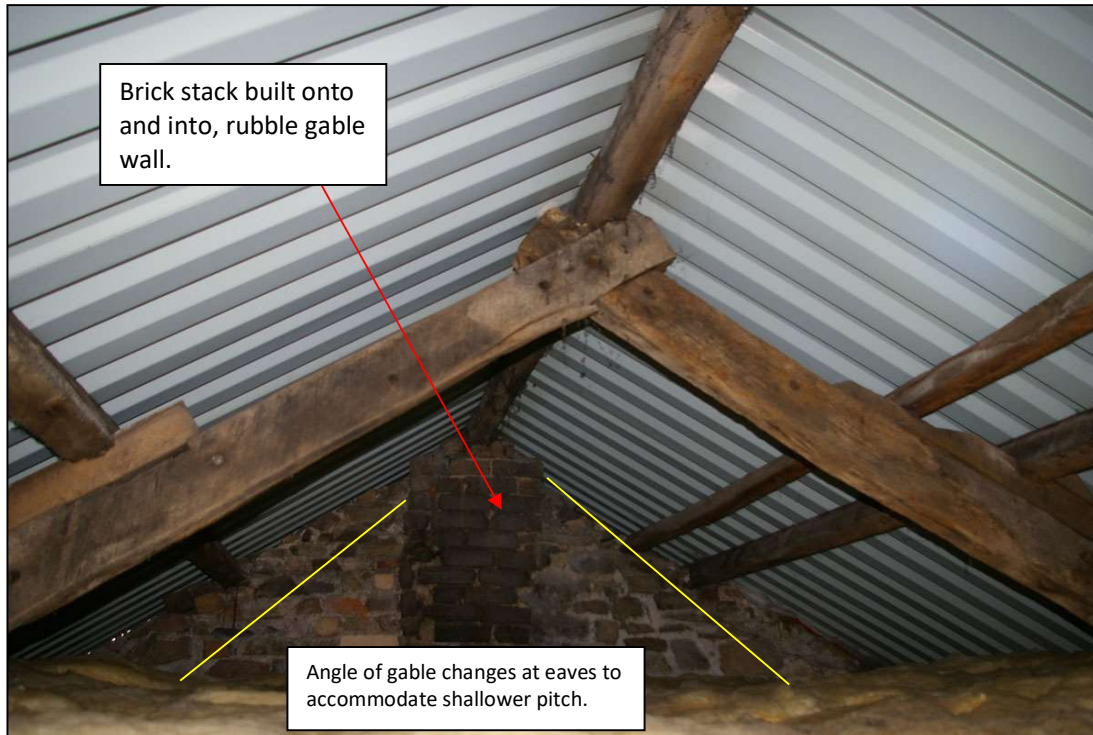
FIGURE 10: THE ROOF STRUCTURE OVER BUILDING 2, SHOWING REUSED BLADES IN THE TRUSSES AND PEGGED RIDGE, THE NORTHERNMOST TRUSS OF 3; FROM THE SOUTH-WEST.

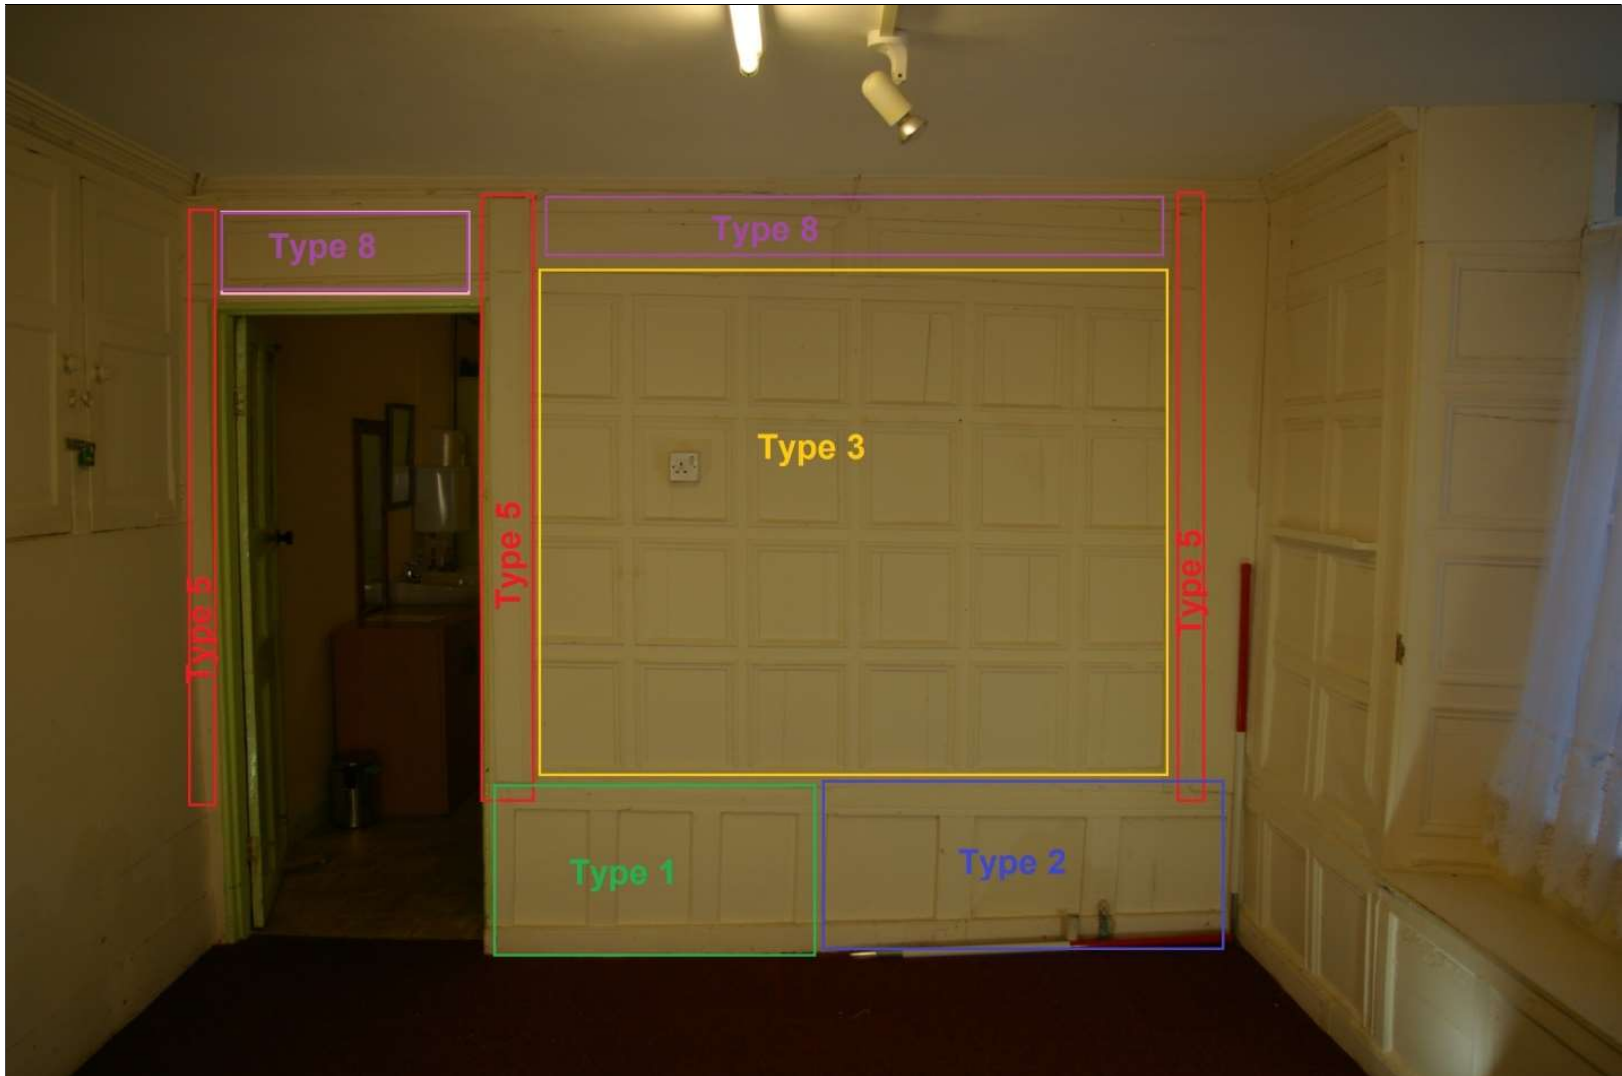
FIGURE 13: THE NORTH WALL OF R17, ANNOTATED PHOTOGRAPH, SHOWING RESET PANELLING; FROM THE SOUTH (1M SCALE).

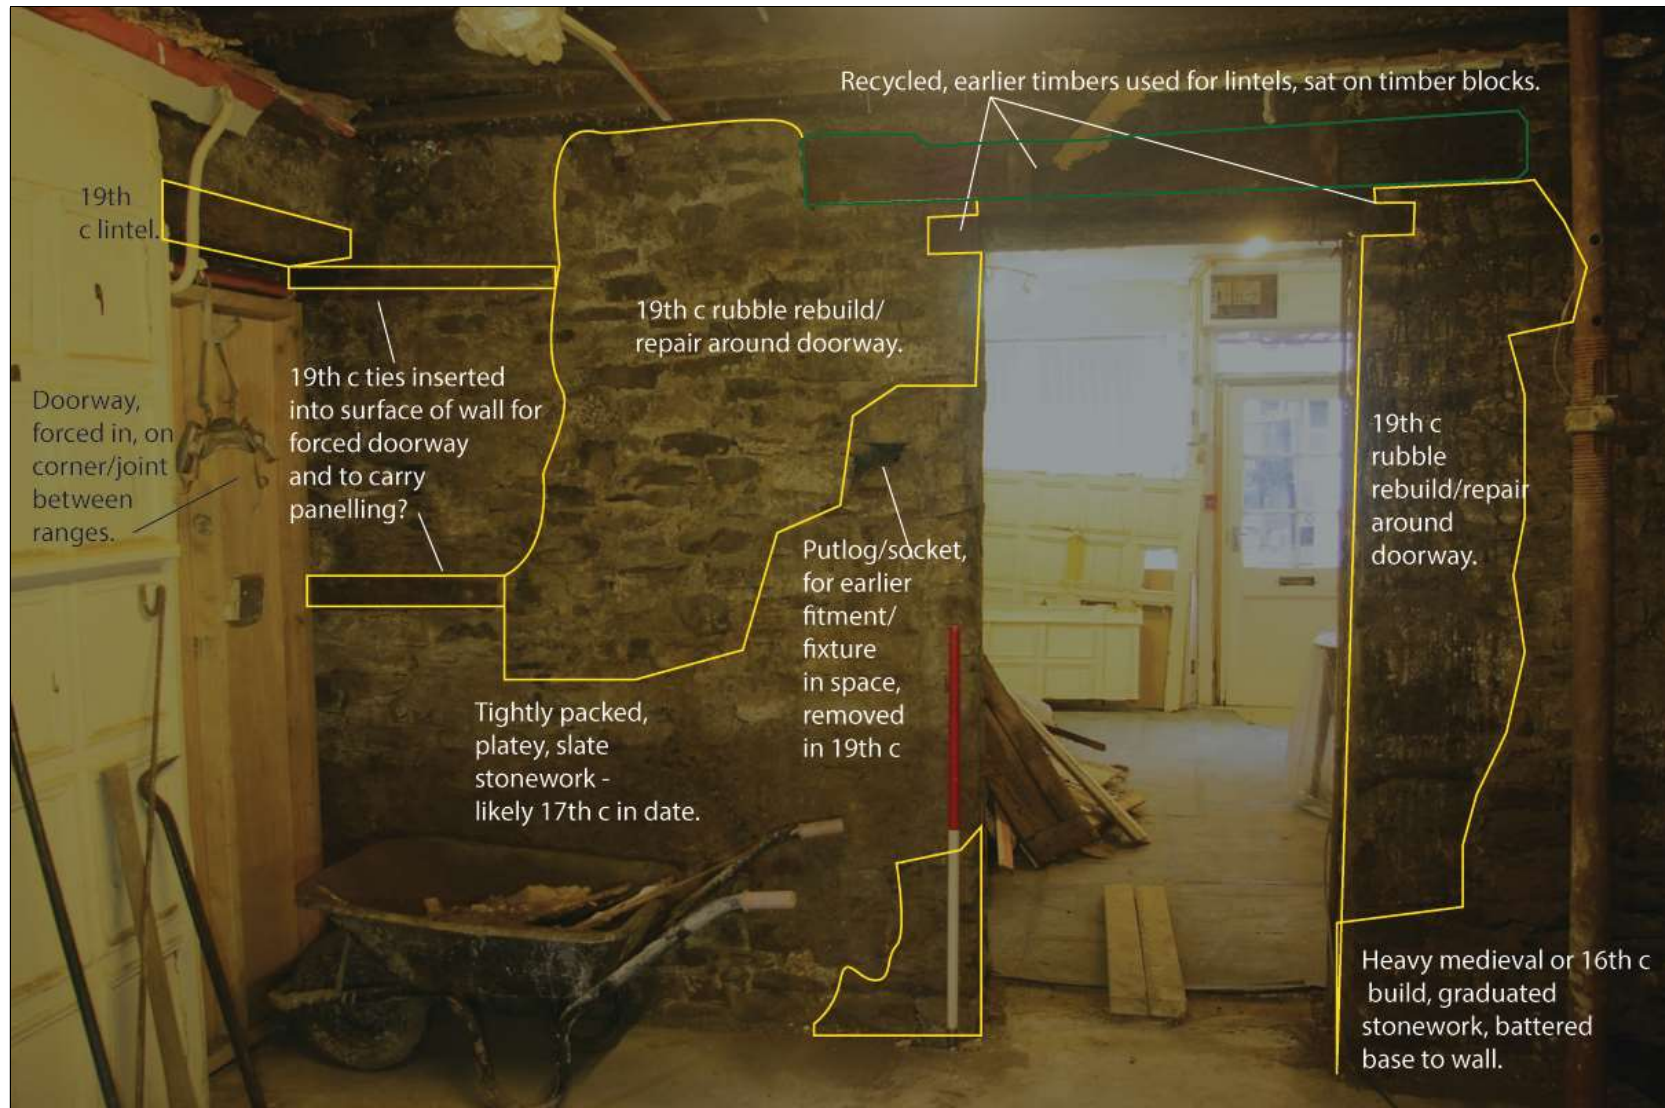
FIGURE 21: ANNOTATED DIAGRAM OF THE EXPOSED STONWORK OF R17, SOUTH WALL.

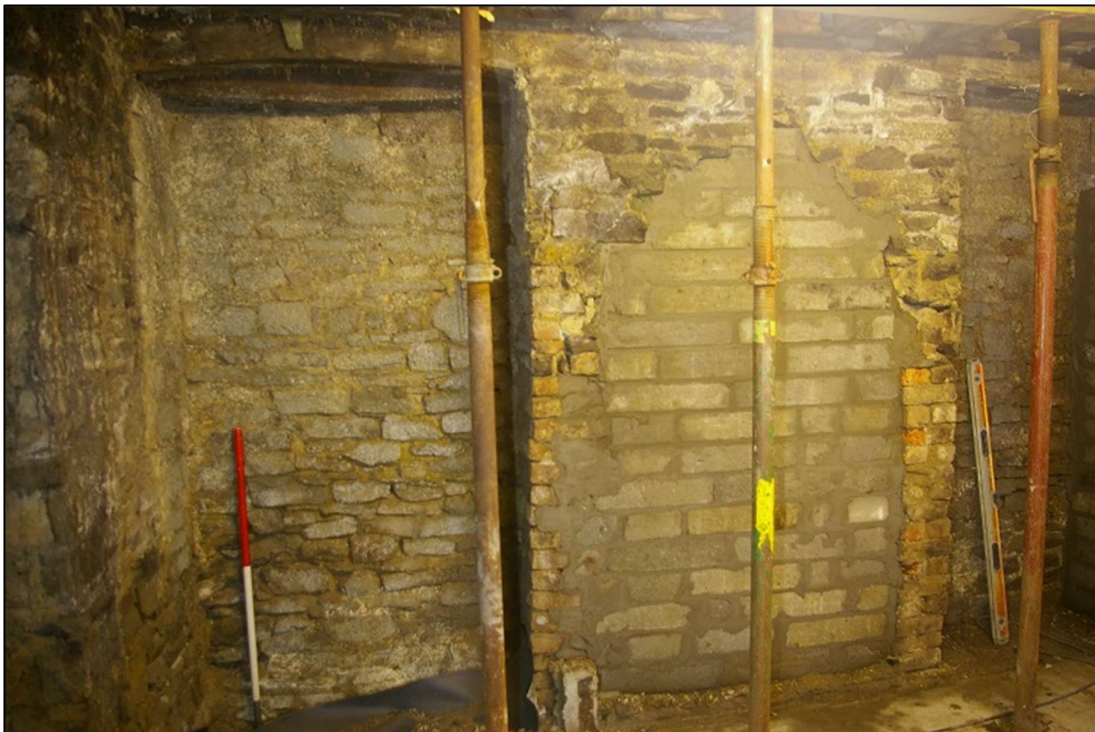
The west wall was also stripped, exposing the two alcoves to the side of the fireplace and the stack. The stack can be seen to be of post-medieval date, but pre-1800, braced in situ with heavy recycled timbers at first floor, to allow for carrying a floor in No.23. The stack can be seen to be built up against and to be serving the adjacent building, No.25, but in the 19<sup>th</sup> century a fireplace was forced into the rear of the stack in No.23, the sides rebuilt in brick to accommodate this, with loose rubble repair above, a failed brick arch, since replaced the shallow hearth infilled with blockwork for structural support. The bricks of the rebuilt sides were a mix of pale red-yellow and a darker, red-brown and seemed to be frog less in form, some unusually small in size, likely handmade or locally made, in a gritty, coarse, lime and clay, pale brown coloured mortar. Whilst the alcove to the south of this stack exposed neatly coursed stonework, carefully toothed into the earlier rear wall, to the north the alcove did represent a blocked doorway, with loose rubble, mixed with brick. There is the stub of a short section of returning wall to the north-west of this section of wall and beyond the build appears a little different, suggesting some phasing even within this block, in the pre-1800 fabric, although the details of this have been obscured by extensive 19<sup>th</sup> and 20<sup>th</sup> century works to the building. This wall was to be repaired and left in situ.

FIGURE 22: THE EAST WALL OF THE BACK-BLOCK WHICH NOW SERVES NO.25; FROM THE EAST (1M SCALE).

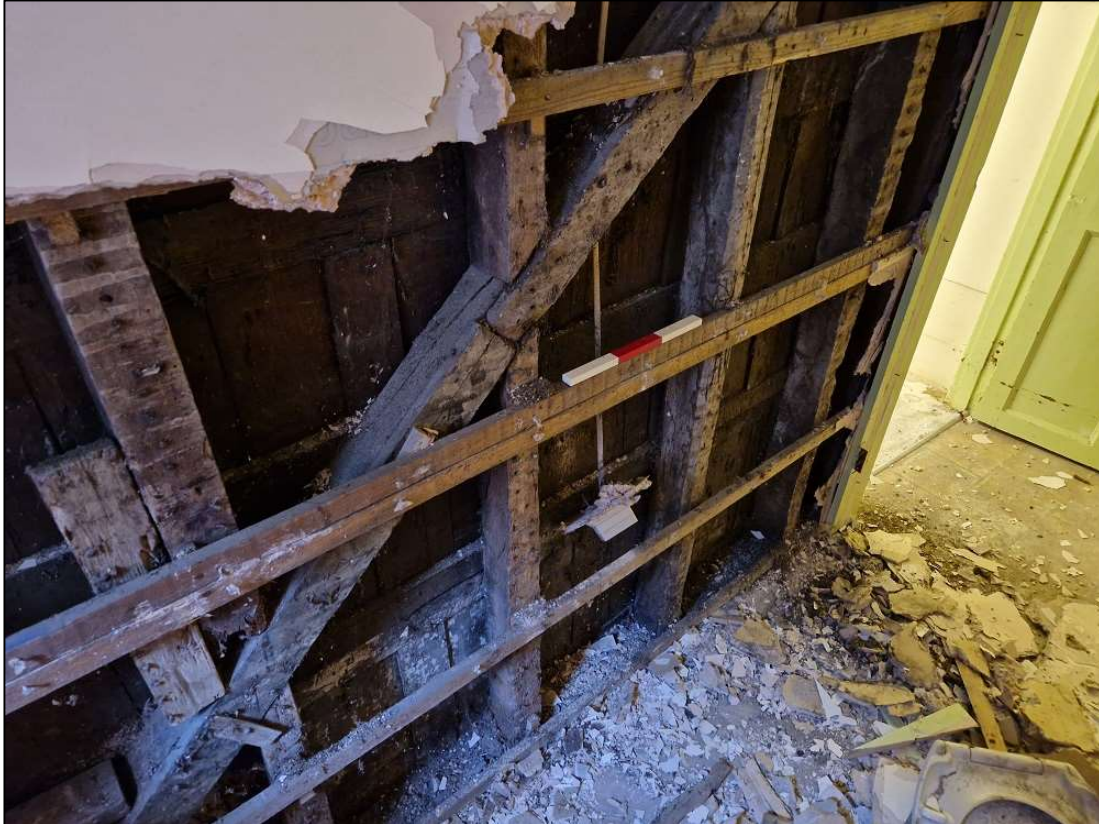
The 20<sup>th</sup> century plasterboard was pulled off on the north side, within R18 and the walling/framework photographed. This inspection confirmed the date of this partition, it also noted a lot of old straw in this area and in the void in the floor above, suggesting, this area R18/R19 was likely used as a stable with opening to the yard at some stage in the post-medieval period. It also confirmed that the modern boarding had been attached to the partition via modern horizontal braces, nailed in place. The window in R18, within the fragment of surviving 17<sup>th</sup> century walling, could be seen to be an altered slit-vent style opening, of vernacular character, chopped out on its exterior reveals to form a single light, 'toilet' window.

FIGURE 23: THE TIMBER-FRAMED PARTITION BETWEEN R17 AND R18; FROM THE NORTH-EAST (0.3M SCALE).

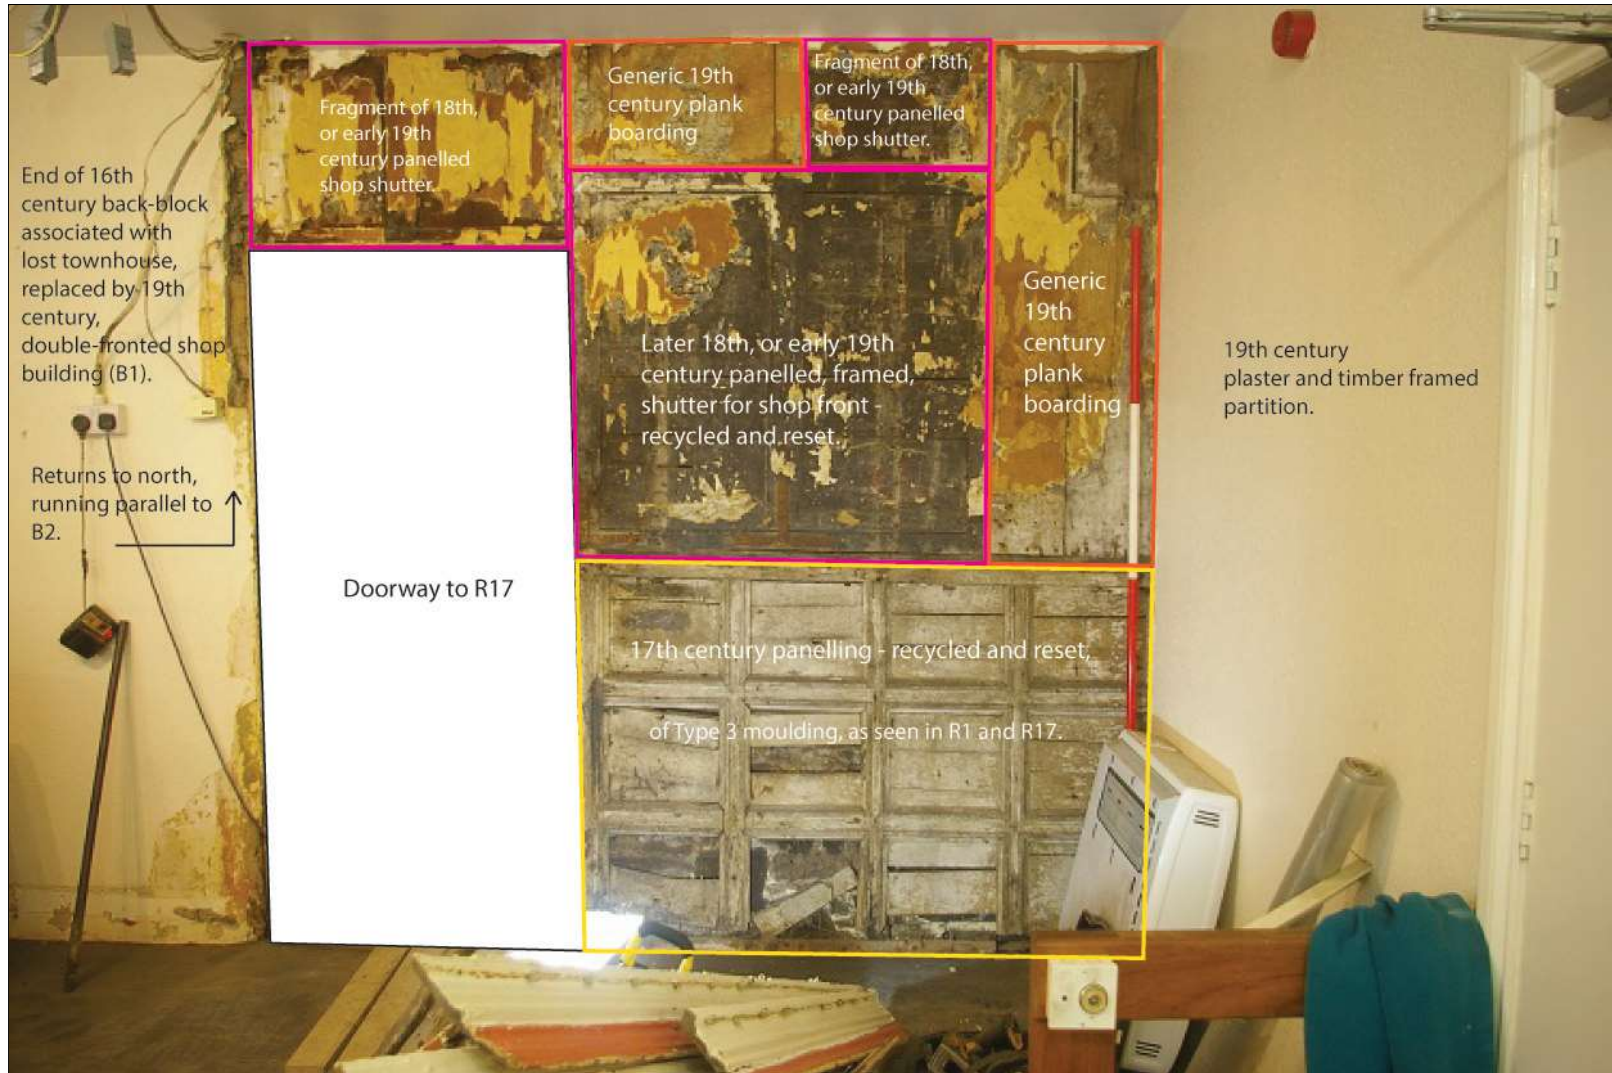
FIGURE 25: ANNOTATED PHOTOGRAPH OF NORTH WALL OF R2, SHOWING AREAS OF RECYCLED PANELLING AND PLANK BOARDING; FROM THE SOUTH (2M SCALE).

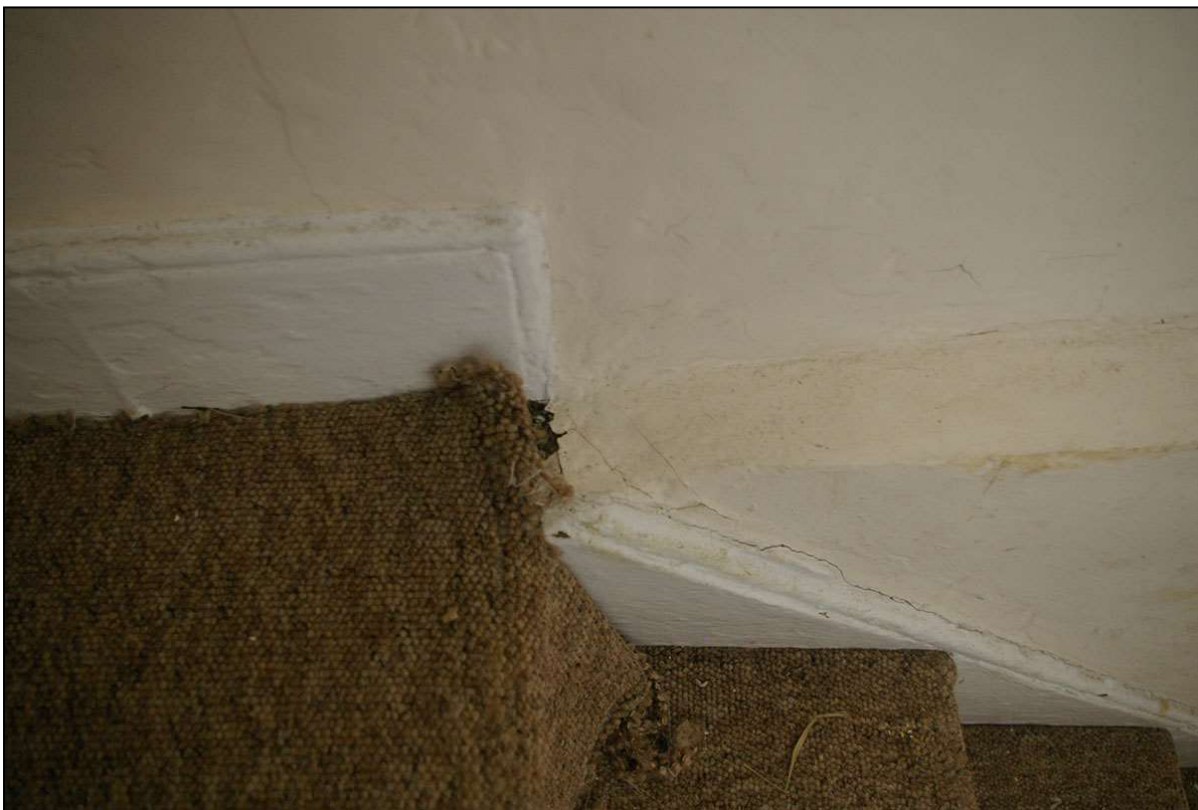
19. THE THICK SECTION OF GROUND FLOOR WALL, SHOWING A LEDGE DESIGNED FOR A FIRST FLOOR, SHOWING THIS STAIRCASE IS INSERTED INTO AN EARLIER SECTION OF BUILDING; FROM THE SOUTH-WEST.

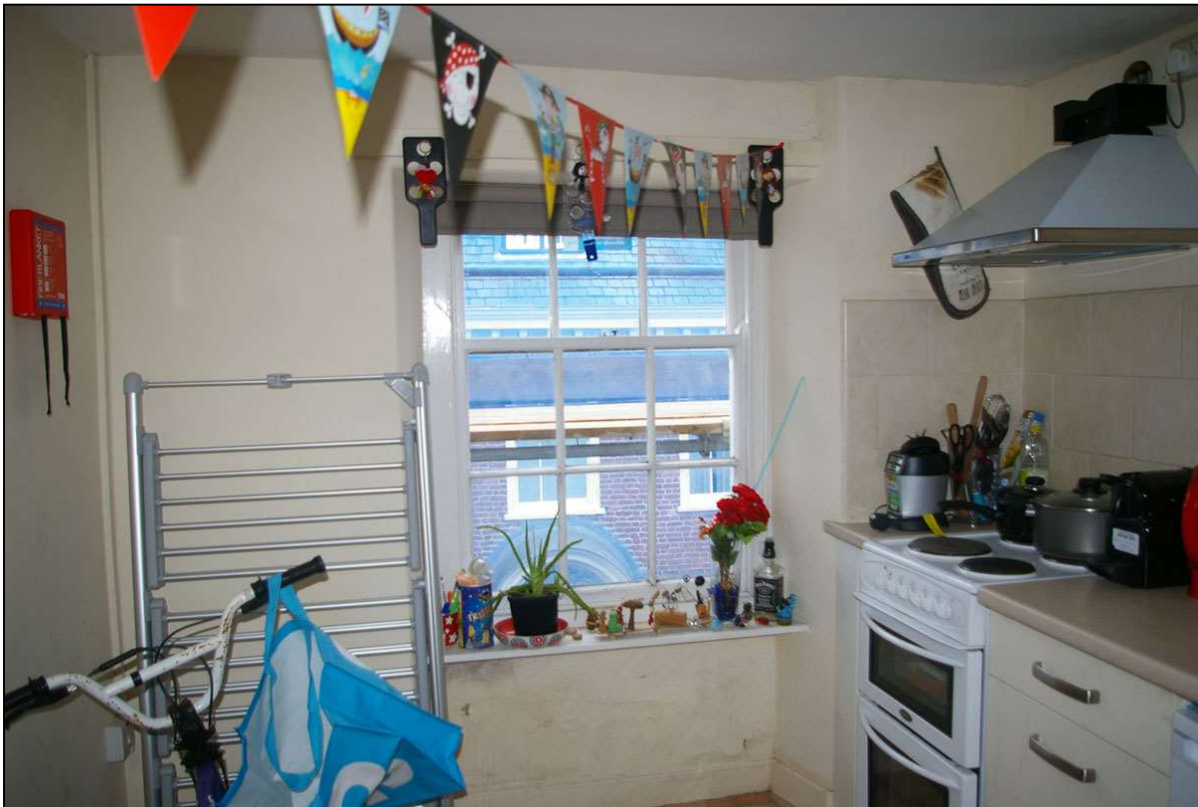
27. THE LATER HORNED SASH WINDOW WHICH LIGHTS THE KITCHEN, R14. ALSO SHOWING AN AWKWARD STEP IN THE WALL, THICKER TO THE WEST AND MAY SUGGEST INFILL BETWEEN BUILDINGS, FURTHER PHASING; FROM THE NORTH.

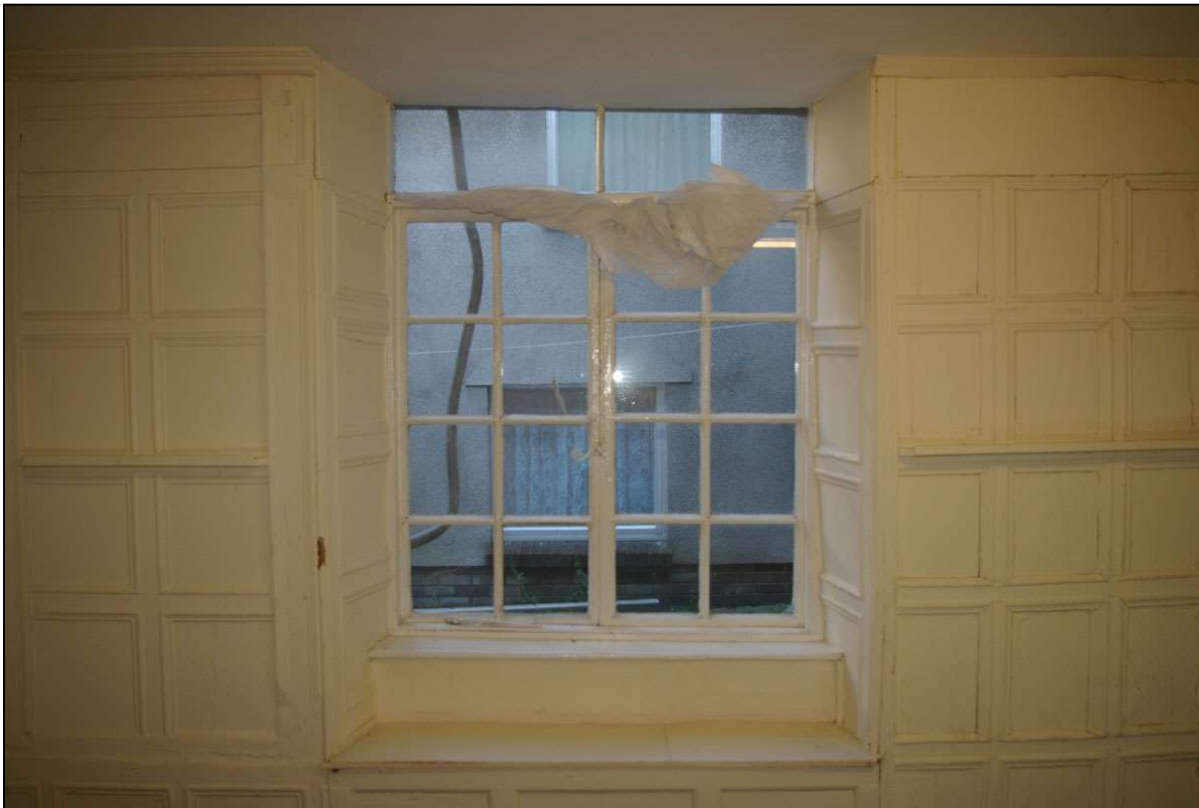
31. W13, WITH RECYCLED AND RESET 18<sup>TH</sup> CENTURY PANELLED SECTIONS TO THE SIDES, SHUTTERS, CUT AND NAILED SHUT AND WINDOW SEAT; FROM THE WEST.

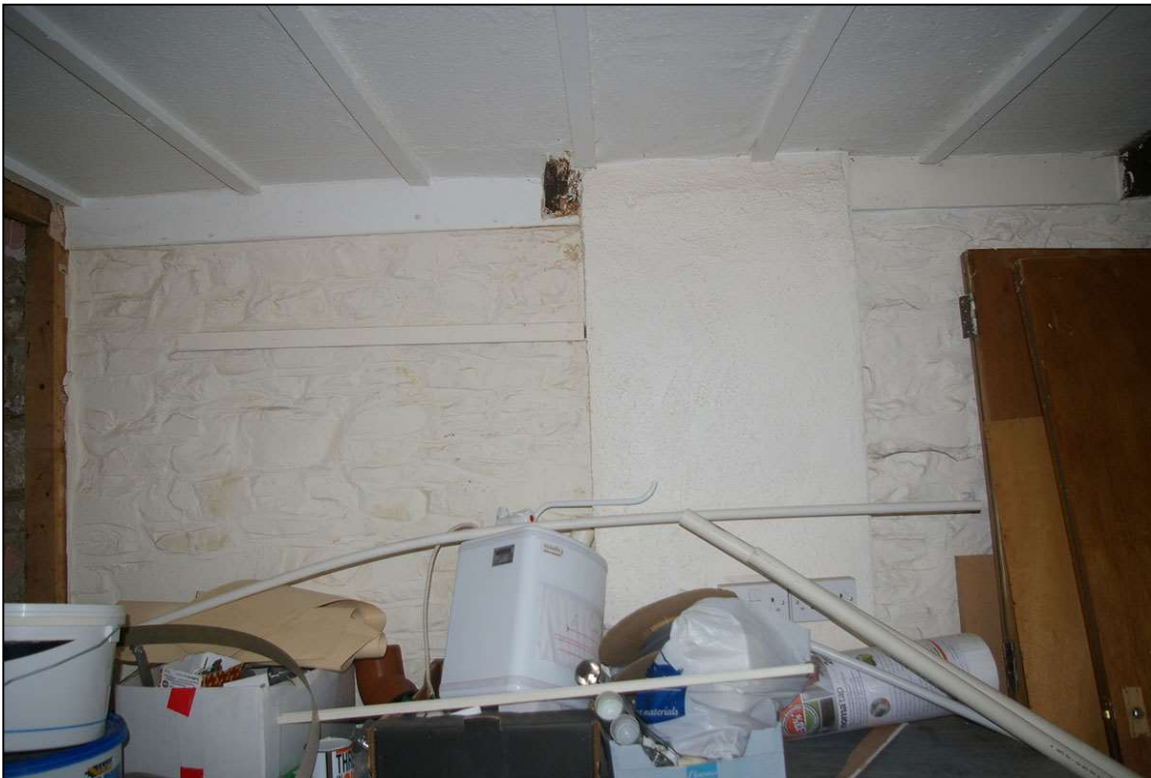
49. THE NARROW BRICK RENDERED STACK BUILT ONTO THE EARLIER HEAVY STONE RUBBLE WEST WALL OF ROOM 20; FROM THE EAST.

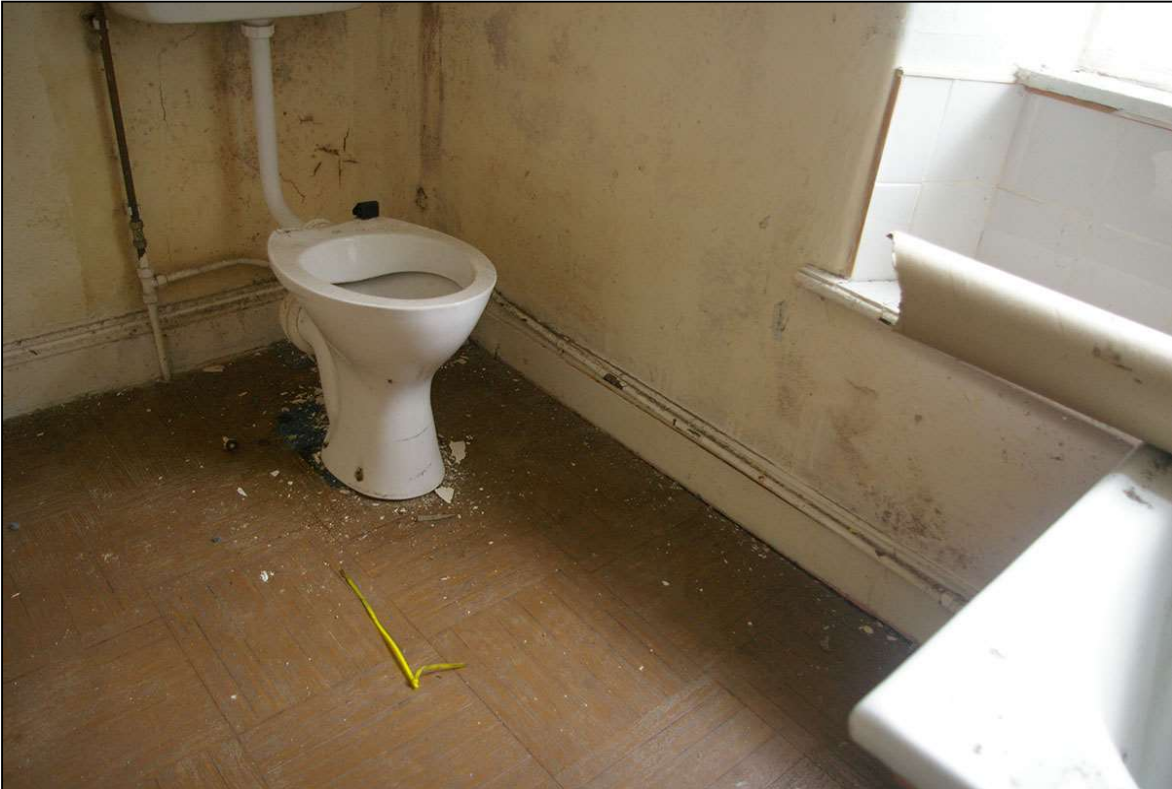
52. R20, THE BEADED SKIRTING RUNS BEHIND, AND IS CUT BY, THE MID-20<sup>TH</sup> CENTURY TOILET SUGGESTING IT MAY BE VICTORIAN OR EDWARDIAN; FROM THE SOUTH-WEST.

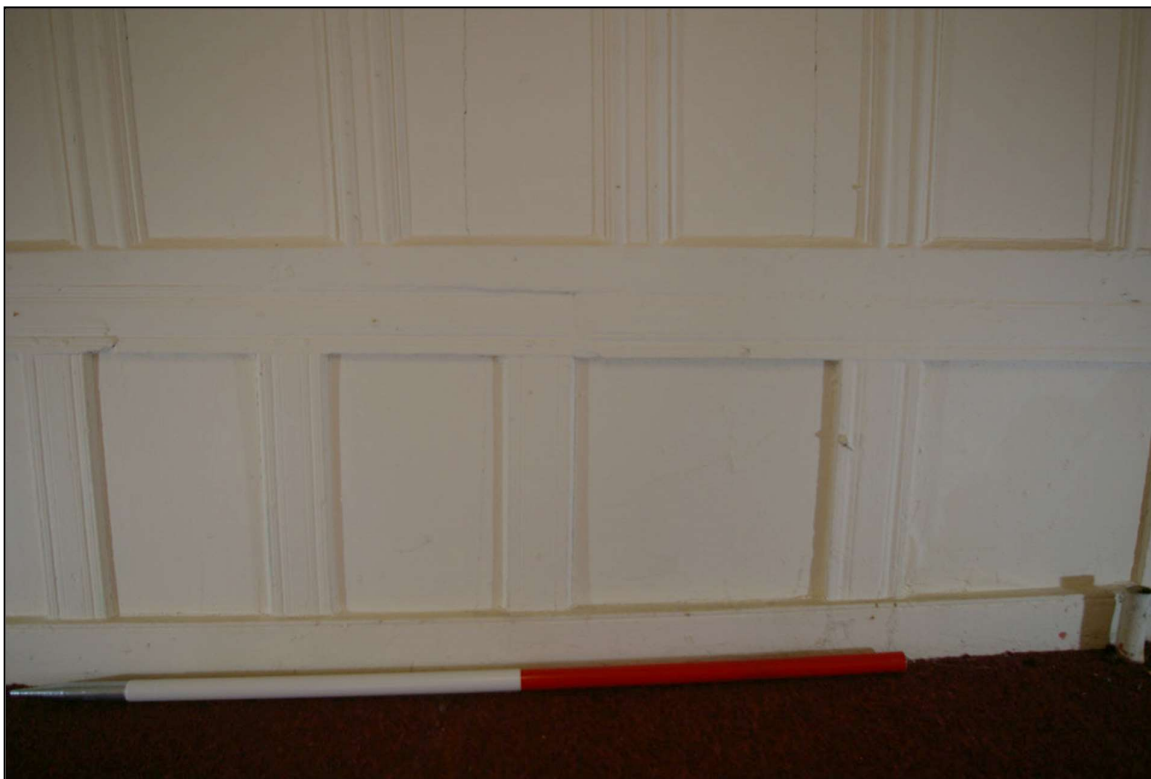
64. THE CUT AND DAMAGED SECTION OF PANELLING, WITH 1M SCALE; FROM THE SOUTH.

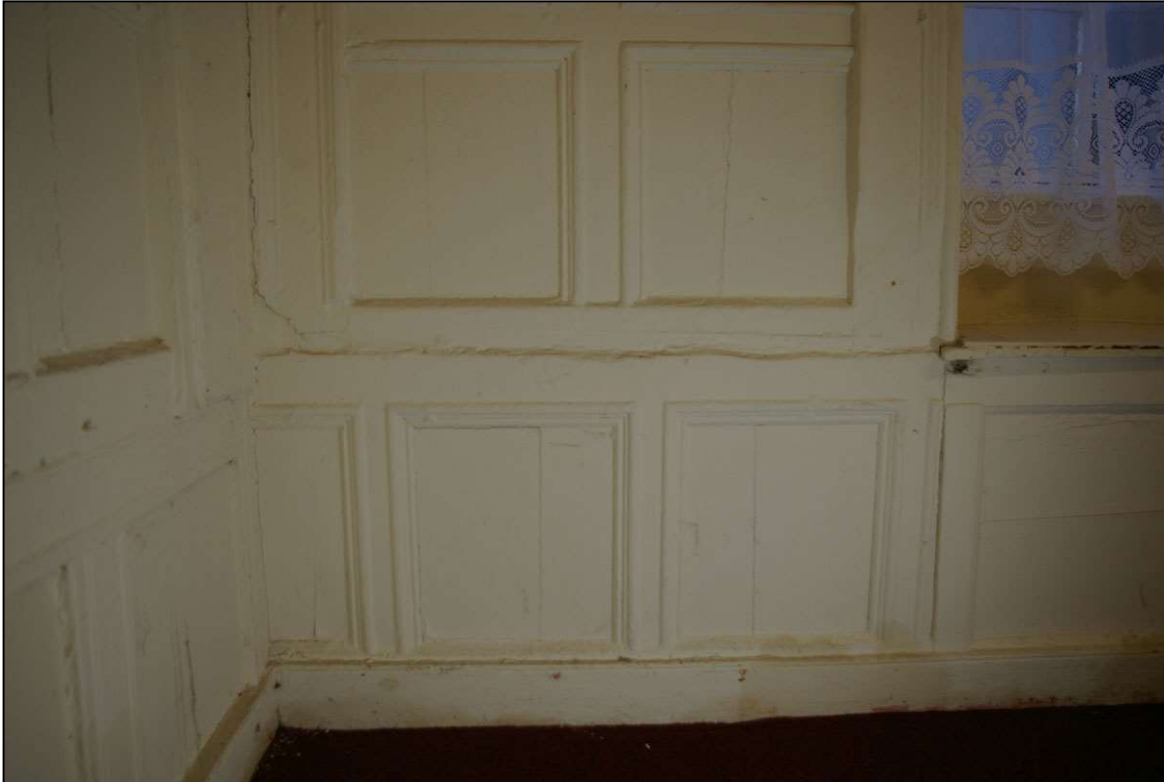
69. THE RAGGED JOINTS BETWEEN THE SECTIONS OF PANELLING ON THE EAST WALL; FROM THE WEST

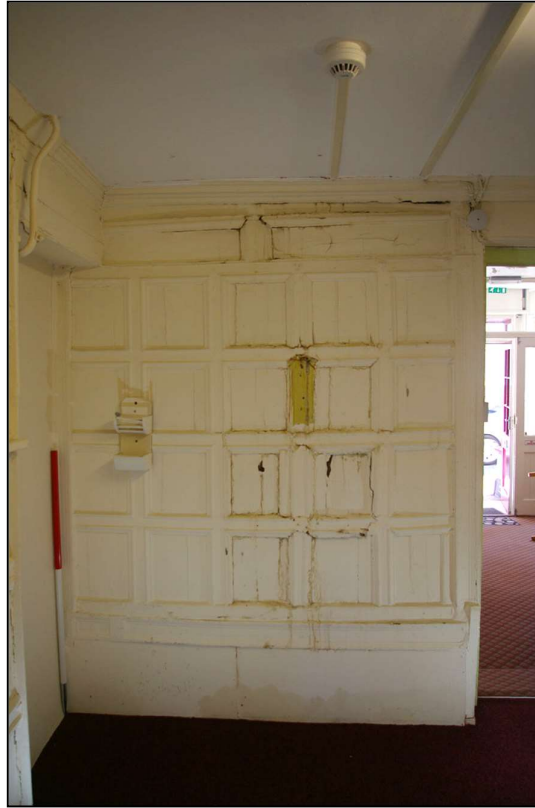
77. THE SOUTH WALL, EAST END, WITH 1M SCALE, D7 AND D24, SHOWING THE WATER DAMAGE TO THIS WALL; FROM THE NORTH.

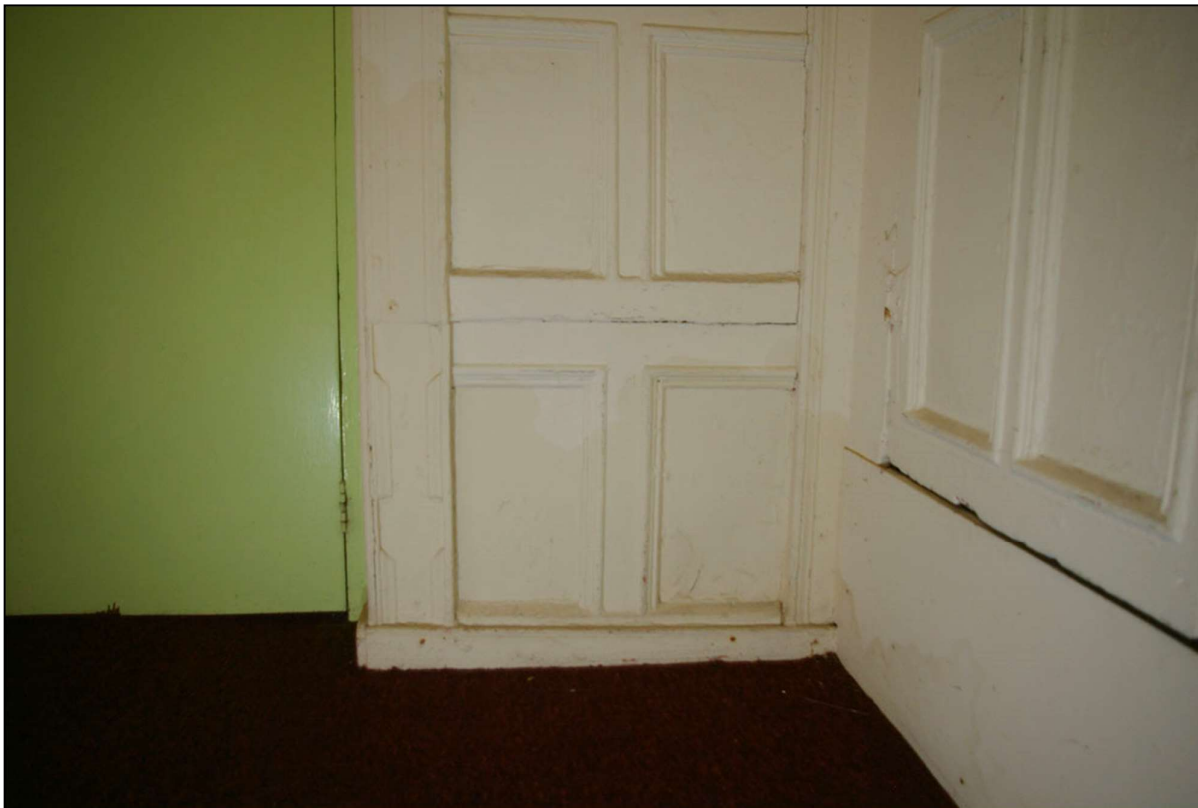
84. THE CUT AND RESET PANELLING IN THE SOUTH-WEST CORNER; FROM THE NORTH.

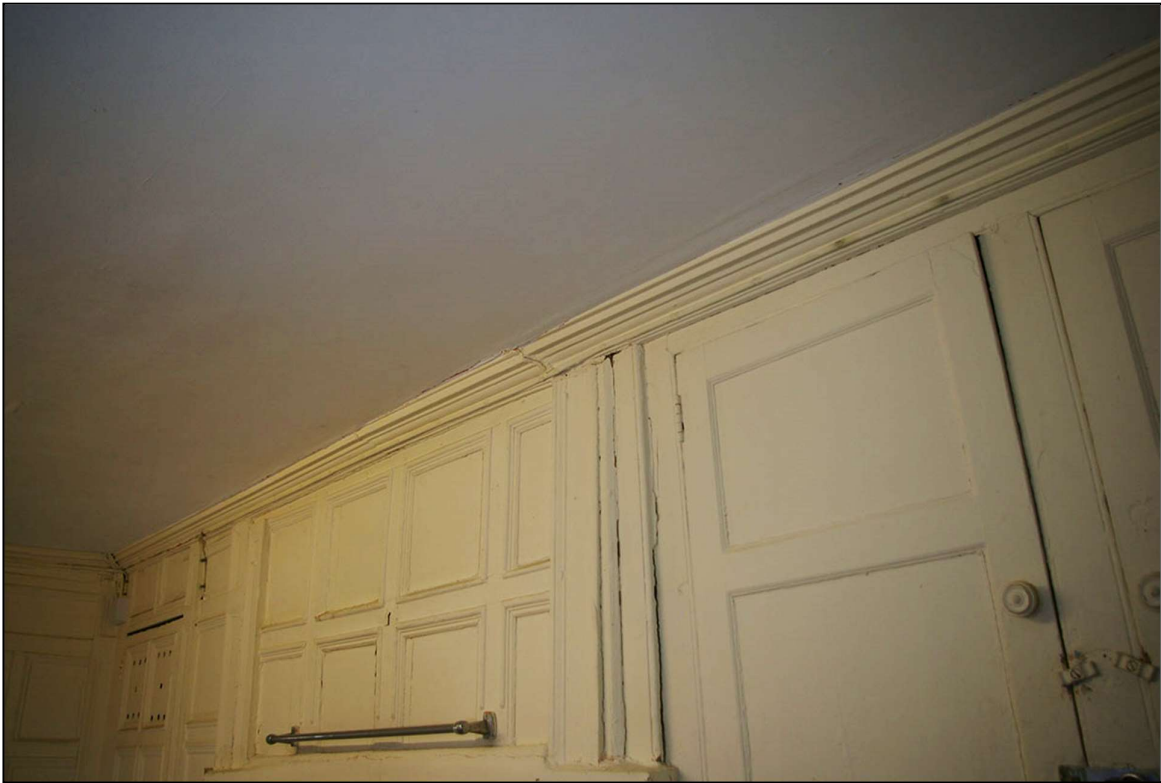
90. THE CUT AND RESET WOODEN CORNICE ALONG THE WEST WALL; FROM THE NORTH, NORTH-EAST

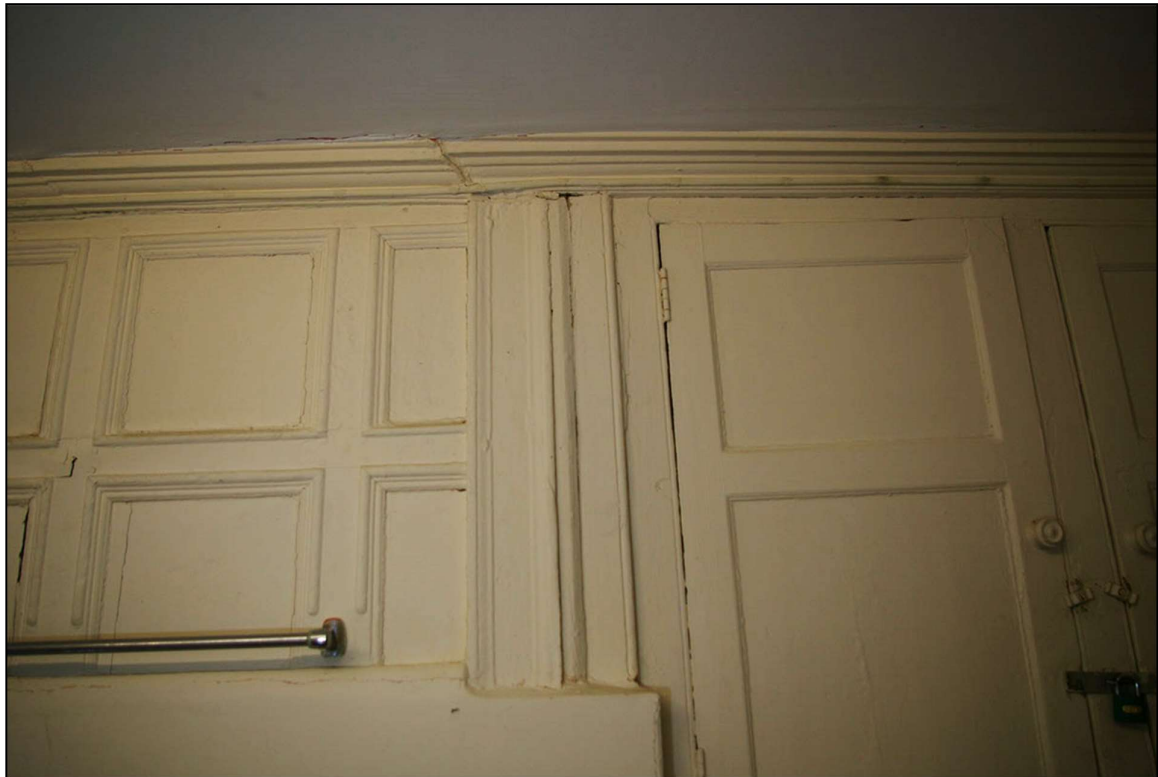
91. THE CUT AND RESET PILASTERS BETWEEN THE PANELLING AND CUPBOARD TO THE NORTH OF THE FIREPLACE; FROM THE EAST.
