**LAKE FARM  
WINGATE LANE  
HATHERLEIGH  
DEVON**

Historic Building Appraisal

South West Archaeology Ltd. report no. 221216

### Results of a historic building appraisal

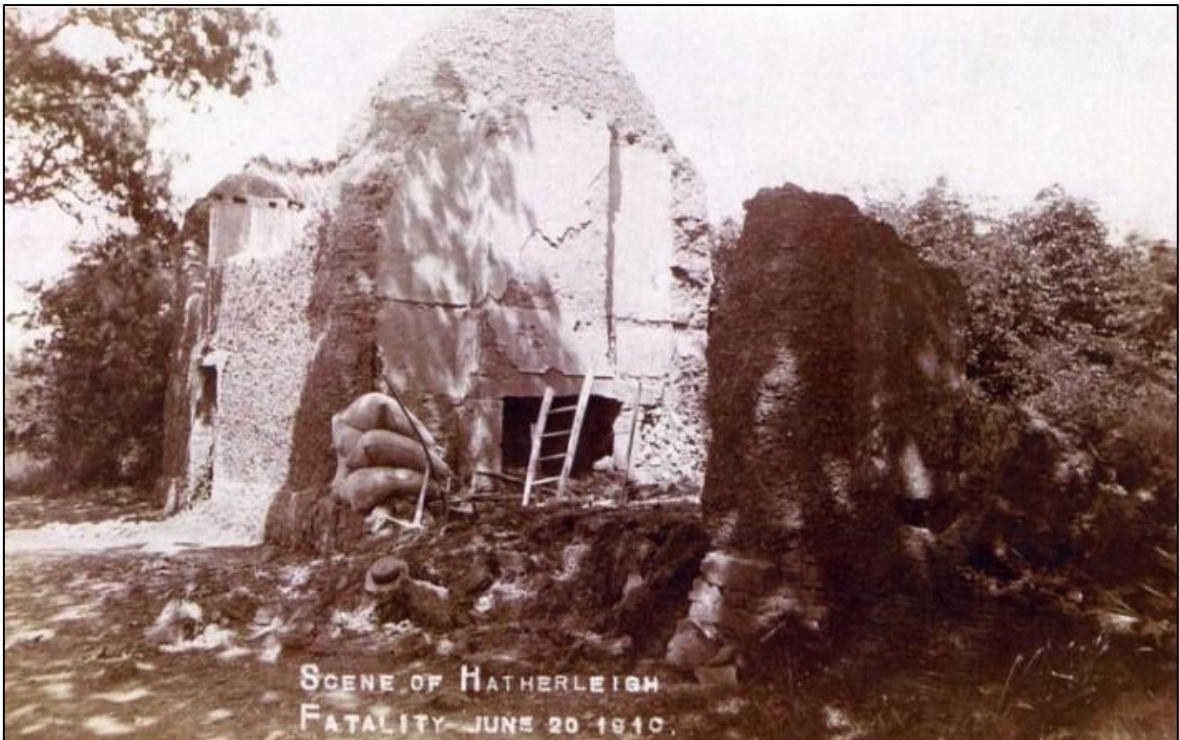
FIGURE 10: 1910 IMAGE OF THE PARTLY-COLLAPSED COB BUILDING RESPONSIBLE FOR THE DEATHS (NORTH DEVON RECORD OFFICE ARCHIVES AND ACCESSED VIA HATHERLEIGH HISTORY ARCHIVE WEBSITE 2022).

The reporting of the deaths of James and Alexander Saunders was accompanied by a photograph of the building in question (Figure 10). While not entirely conclusive, it is most likely that this structure can be identified as part of the south range shown on the tithe map and the historic OS maps, for a number of reasons. Firstly, the site of the tragedy is noted as *Lake Farm*, not *Lake Cottage*. Secondly, to the front of the building we can see an area that is open and level (the yard) with apple trees behind. This is almost certainly the *Lower Orchard* immediately to the south of the south range. Thirdly, the stone footings of this building can still be seen to the west end of the

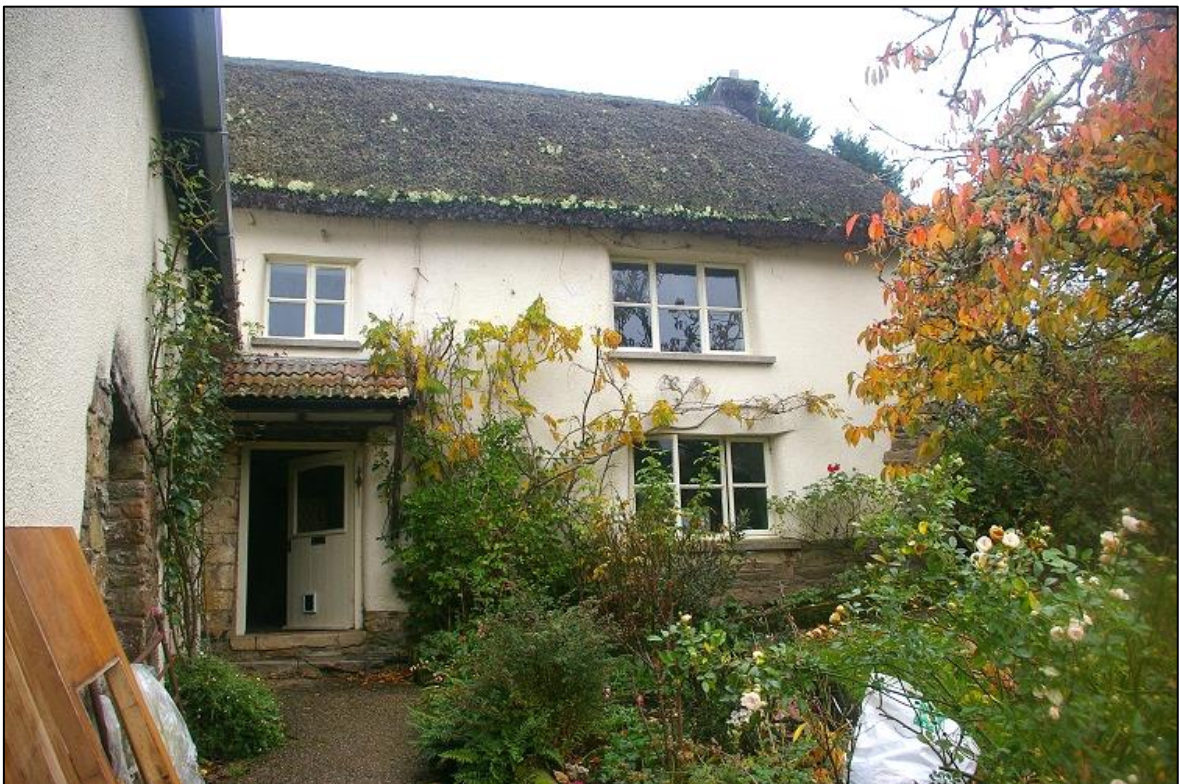
FIGURE 11: THE HOUSE ELEMENT OF THE L-SHAPED RANGE; VIEWED FROM THE SOUTH.

The current house presents as a cob range of low two storeys height, the cob on a rubble plinth, the elevations rendered in cement, with a thatched roof. It is a blocky, wide, rectangular range, on an east-west alignment, awkwardly attached to the earlier barn to its south-west corner. Its roof is half-hipped to the east around a chunky rendered stone gable stack, and hipped to the west, with a lateral rear stack to the north-west end of the building.

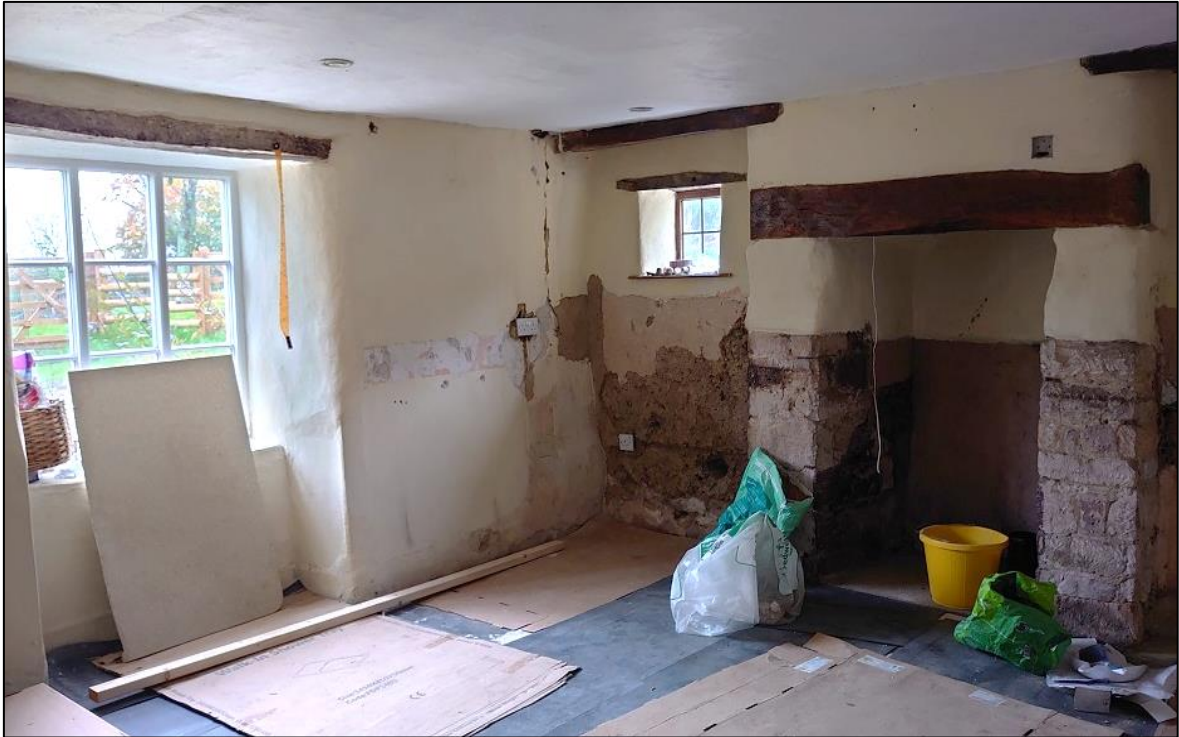
FIGURE 13: R2, THE FORMER KITCHEN OF THE HOUSE, WITH ITS SMALL DOMESTIC, PARLOUR-STYLE FIREPLACE, WITH RAISED AND REPLACED BRESSUMMER BEAM; VIEWED FROM THE SOUTH-EAST.

In the thick cob partition wall to the west is the tall narrow doorway to R2, with thick rustic (recycled) timber lintels; there is evidence of a door and doorframe having been removed here. R2 was most recently used as a kitchen but historically may have been an unheated service room, then a heated living space, perhaps a 17<sup>th</sup> century parlour, as indicated by the small fireplace with good, dressed jambs in the north wall. The fireplace does appear to be an addition to this space, and while the dressed jambs survive intact the replacement bressummer beam has been reset higher in the cob to accommodate a later stove. Either side of the fireplace deep alcoves appear to have been hacked out of the wall, framed by timber lintels, the cob poorly patched to each side. These may have been used as cupboards, or for shelving, and the west alcove now has a small window set into it. This room is built around and onto the back of a large stack that addresses the barn. There was a doorway to the west wall, which is now set with a window, under a chunky rustic timber lintel.

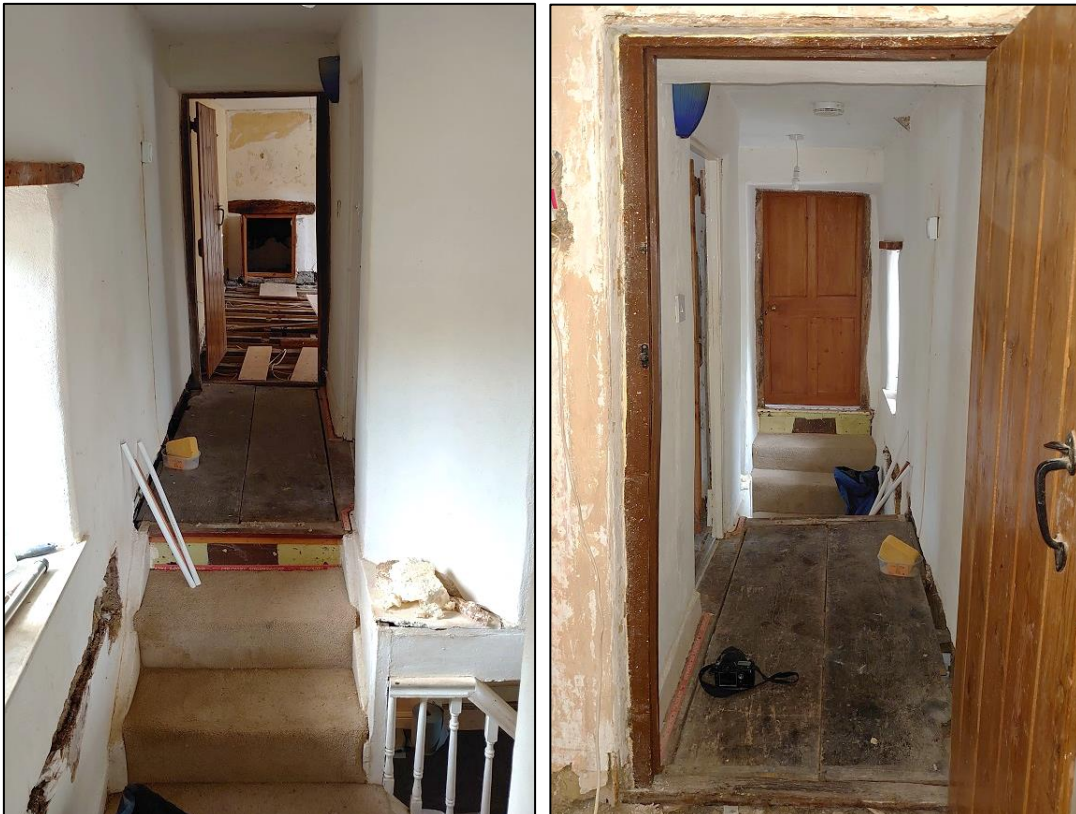
The stairs rise to a short first-floor landing (R9). The stairs have been assembled to address and connect the two separate elements of the building, and much reused timber (planks, beams) is in evidence here. The narrow landing is floored with massive oak planks, heavily smoke blackened and perhaps reused from the barn. Over these a lath-and-plaster partition now encloses and forms a small bedroom (R10).

FIGURE 14: R9, VIEWS EAST (LEFT) AND WEST (RIGHT) ON THE FIRST FLOOR OF THE HOUSE.

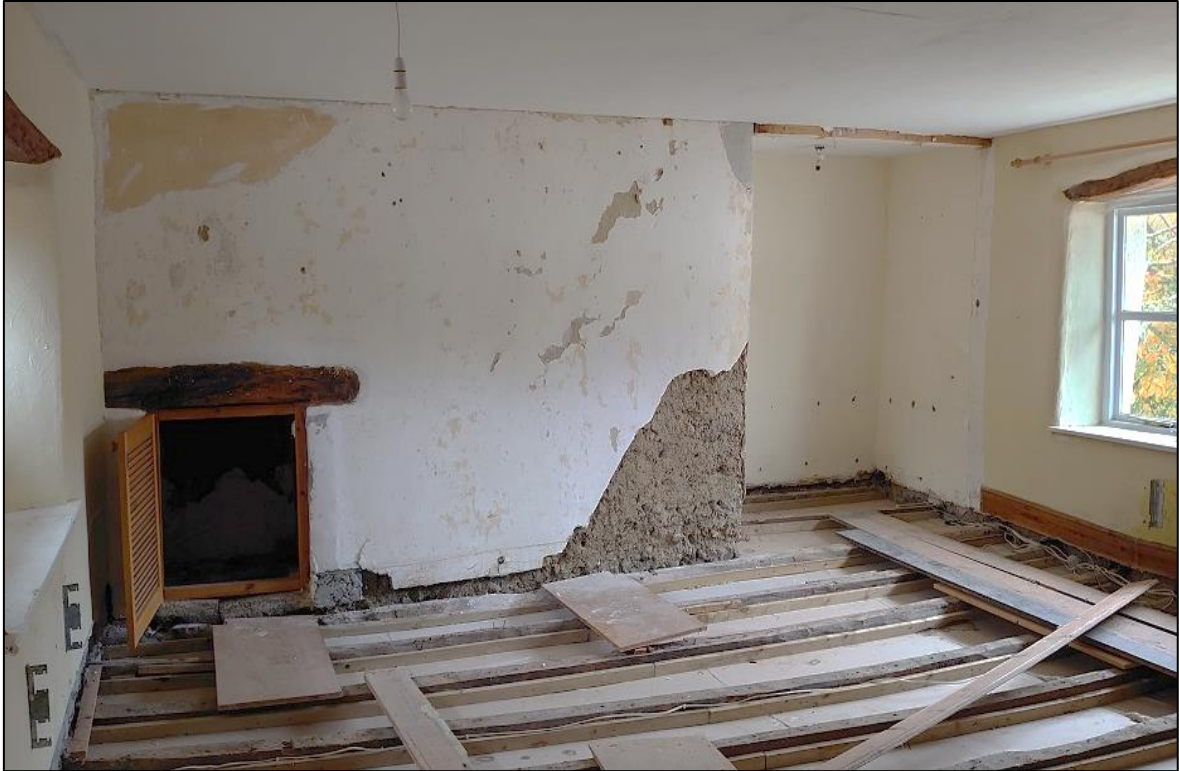
FIGURE 15: R11, THE MAIN BEDROOM ON THE FIRST FLOOR, WITH FIREPLACE BUILT INTO THE STACK; VIEWED FROM THE WEST.

in the south-east corner of the room, now a cupboard, with a beaded door frame with damaged LH hinges; the door is missing. The floor in this bedroom has wide even-width pine floorboards of 19<sup>th</sup> century date. The boards are currently being treated for woodworm, and the regular sawn on-edge Victorian joists, with the lath-and-plaster ceiling of the room below, are visible. The ceiling in this room is high, exposing the base of chunky truss blades of post-medieval character.

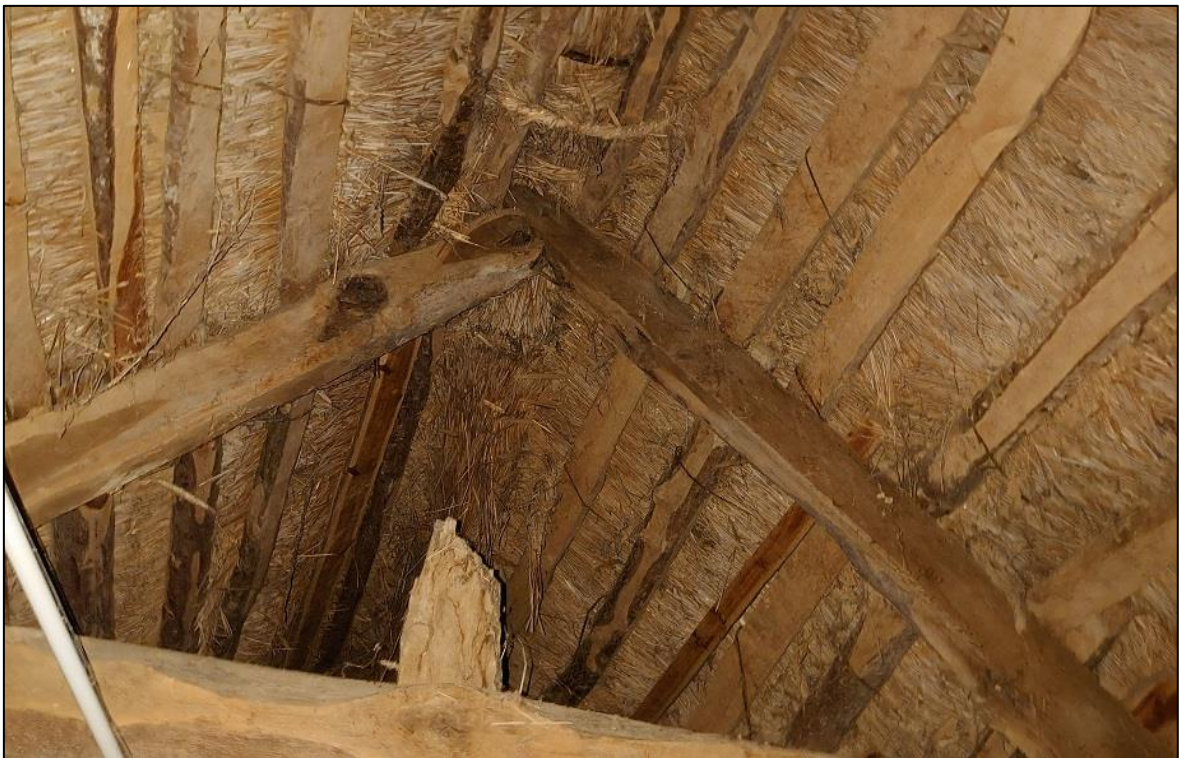
The roof over the current house was almost completely replaced in the later 19<sup>th</sup> century, or even the first decades of the 1900s. It is still thatched but all the timbers and rafters appear relatively modern and are split pine trees, many still being embarked, and are perhaps from the adjacent plantation. The trusses are lightweight A-frames with an overlap at the ridge, pegged at the ridge and with face-pegged collars, held in place by spikes which are turned over on the rear face. The two trusses to the west end present slightly differently. The blades of the trusses are sawn and show clear evidence of the marks and at least one blade is reused, of different patina, with evidence of having been cut down from a wider timber. The westernmost truss is more rustic and irregular in shape and profile, with a much narrower collar and appears to be earlier and more obviously 19<sup>th</sup> century in character. The style of the roof is fairly archaic but likely just traditional to the area, with willow withies used to fix the rafters together and to stitch the ridge.

FIGURE 16: VIEW OF THE ROOF STRUCTURE OVER THE HOUSE.

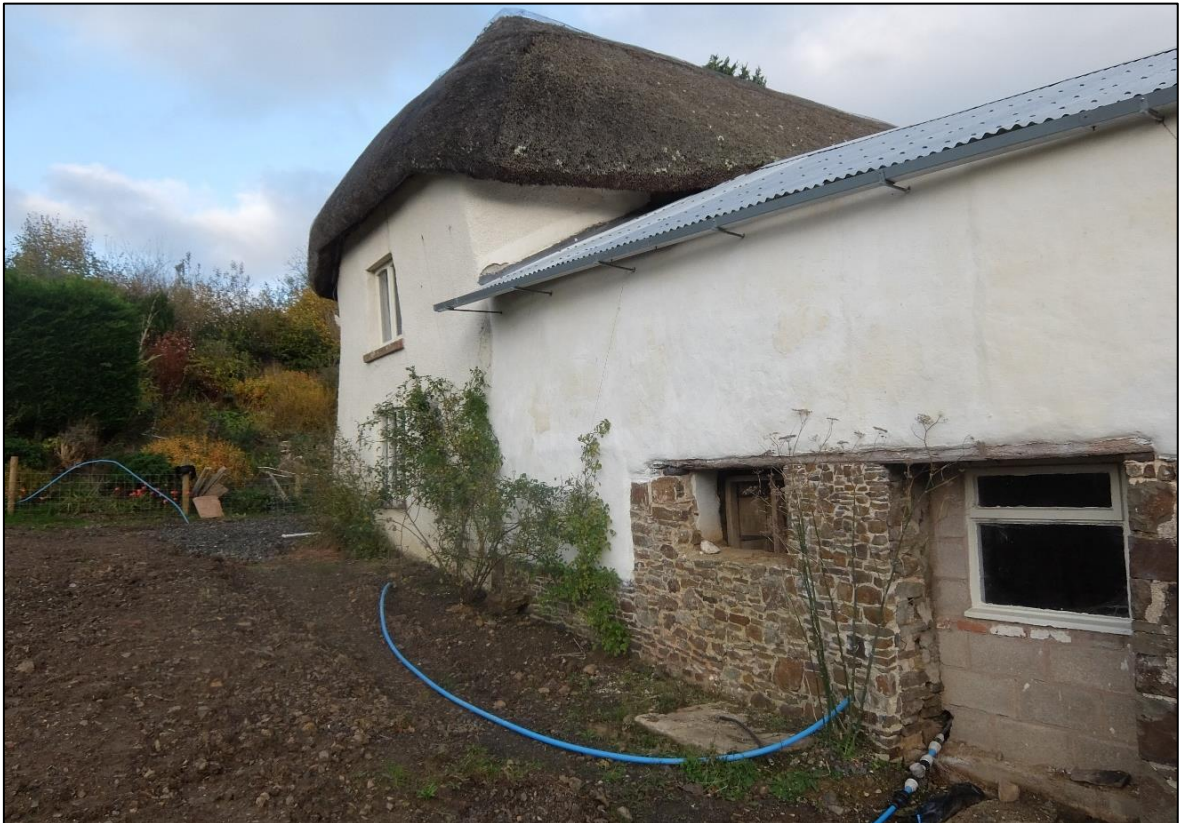
on the north-west corner of the barn, where it adjoins the current farmhouse, has been replaced with modern cob block build and has been rendered over to blend in its appearance.

FIGURE 17: THE JUNCTION BETWEEN THE HOUSE (LEFT) AND THE BARN (RIGHT) SHOWING THE PHASES OF REBUILDING AND FORCED OPENINGS; VIEWED FROM THE SOUTH-WEST (CLIENT PHOTOGRAPH).

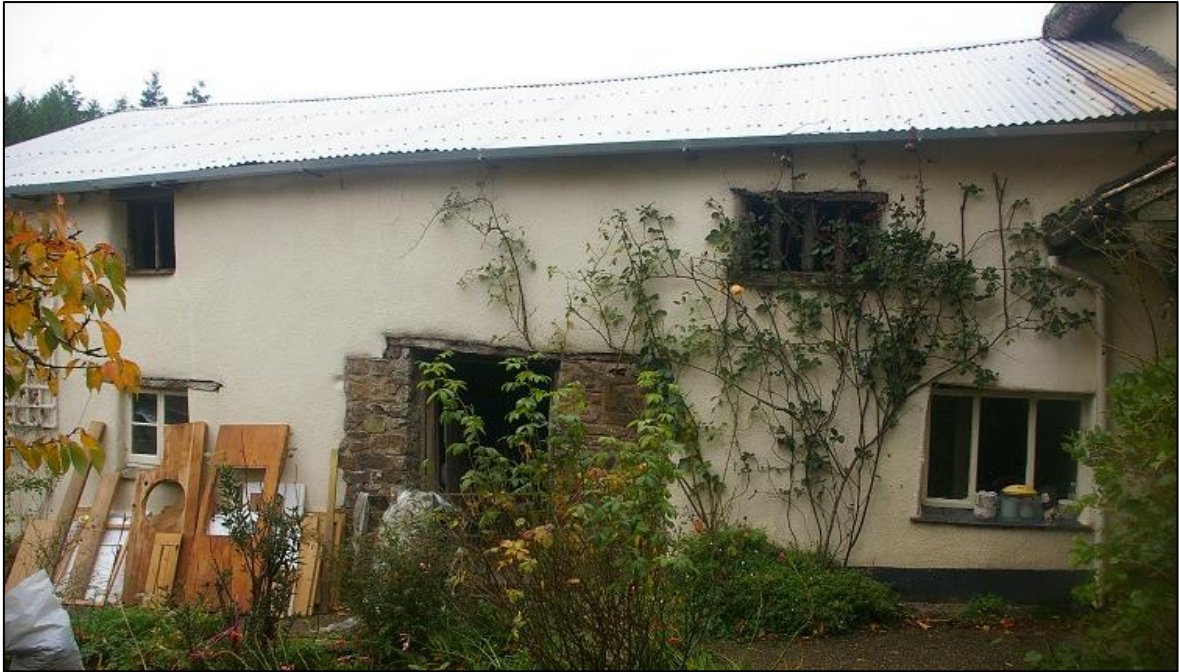
The east (yard) elevation is more domestic in character; the thick painted render obscures detail but it is clear that the walls at the north end of this building are thicker and slightly battered. There are five openings in this elevation: a central door and four windows. At ground-floor-level to the south end is an early 19<sup>th</sup> century two-light timber casement window. To the centre there is a forced doorway, which is framed by underbuilt 19<sup>th</sup> century stonework including a few bricks, under a thin, reused timber lintel and with a later 19<sup>th</sup> century ledged and braced plank door in a chunky plain doorframe. There appears to be an infilled keeping place in the rubble, with slate slab sides, lintel, and sill. To the north end there is a low wide window with a fixed 20<sup>th</sup> century three-light timber frame within a possible blocked doorway, now with a sloping slate sill. At first-floor level and at the eaves is a later 18<sup>th</sup> or early 19<sup>th</sup> century chamfered pegged two-light window frame with chamfered central mullion. To the north is a 16<sup>th</sup> or 17<sup>th</sup> century four-light mullion window with ovolo moulding, with chunky timber sill and lintel.

FIGURE 18: THE BARN ATTACHED TO THE HOUSE; VIEWED FROM THE EAST.

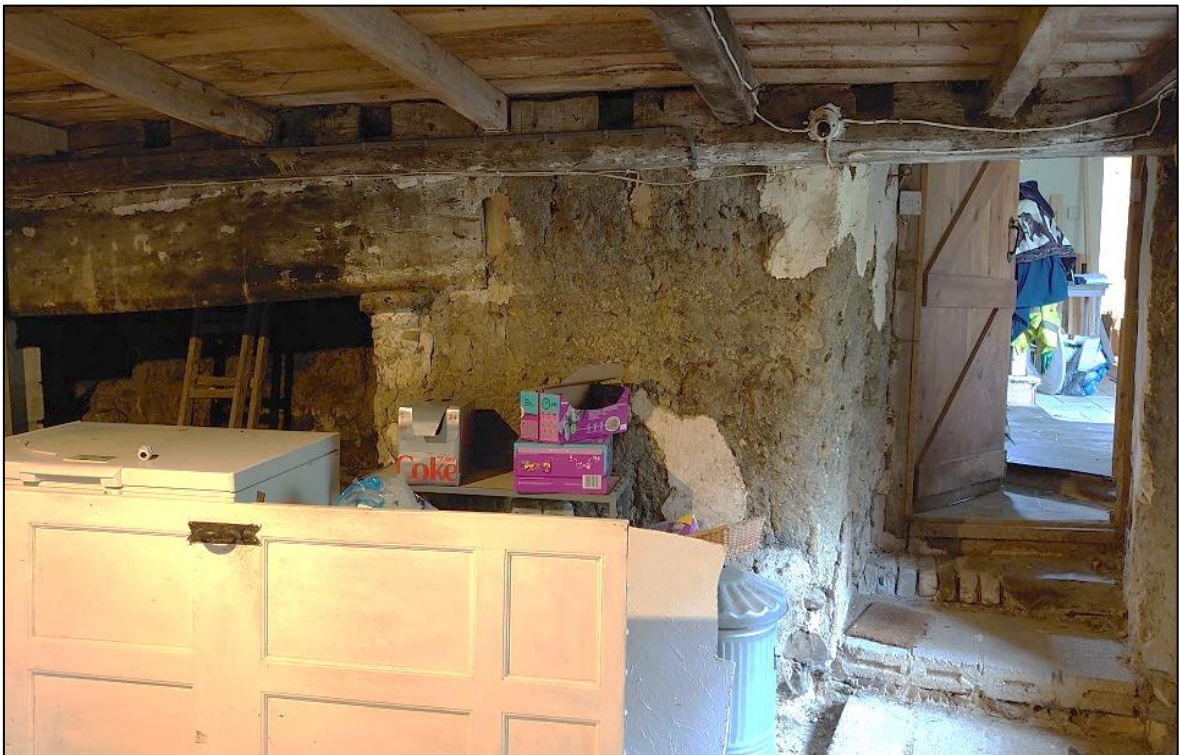
Internally, the building can be divided into three spaces. To the north end of the range there is a former kitchen (R13). This is closed off from the rest of the building by an 18<sup>th</sup> or early 19<sup>th</sup> century chunky plank screen set under a 16<sup>th</sup> or 17<sup>th</sup> century chamfered beam with heavy socket holes for joists; the screen has a good integral plank door with ledging bars and thumb latch. There is a 16<sup>th</sup>-17<sup>th</sup> century inserted ceiling of three massive, chamfered beams with carved stops and square profile joists, all of which are smoke blackened. Many of the joists have been replaced with 19<sup>th</sup> century timber, above which is a thick plank floor of pine boards. The walls are of cob, with smoke-blackened cob plaster, and later post-medieval phases of lime plaster and whitewash in places. To the north-west corner is a massive open fireplace, with chamfered timber lintel, serving a tapering cob stack. To the north-west corner of the fireplace is a large pyramidal scar, patched with loose rubble in lime mortar, likely to be a former bread oven. The corner of the

building is failing and the wall to the west and north-west is partially rebuilt in cob block and the fireplace bressummer beam is propped on mortared concrete blocks. To the north-east corner of the kitchen a later 19<sup>th</sup> century door has been forced into the cob walls, with brick steps leading up to a ledged and braced plank door with a thumb latch, which provides access to the hallway (R1) of the house.

FIGURE 19: R13, THE SMOKE-BLACKENED 16<sup>TH</sup> OR 17<sup>TH</sup> CENTURY KITCHEN WITHIN THE BARN; VIEWED FROM THE SOUTH-EAST.

has already been altered, providing the key historic features are respected. It is also to be acknowledged that the previous owners built the large extensions (R4-R8), seemingly without permission, as well as other works which may not have aided the condition or appearance of the building. There is, therefore, a benefit to be had in allowing some sensible rationalisation and restoration of this structure. There are also some woodworm and structural challenges in the poor-quality post-medieval floor structures and some flexibility is required here to repair and maintain the structure through the introduction of new material. It is also acknowledged that intervention in this structure may be needed to address the failing stack in the barn.

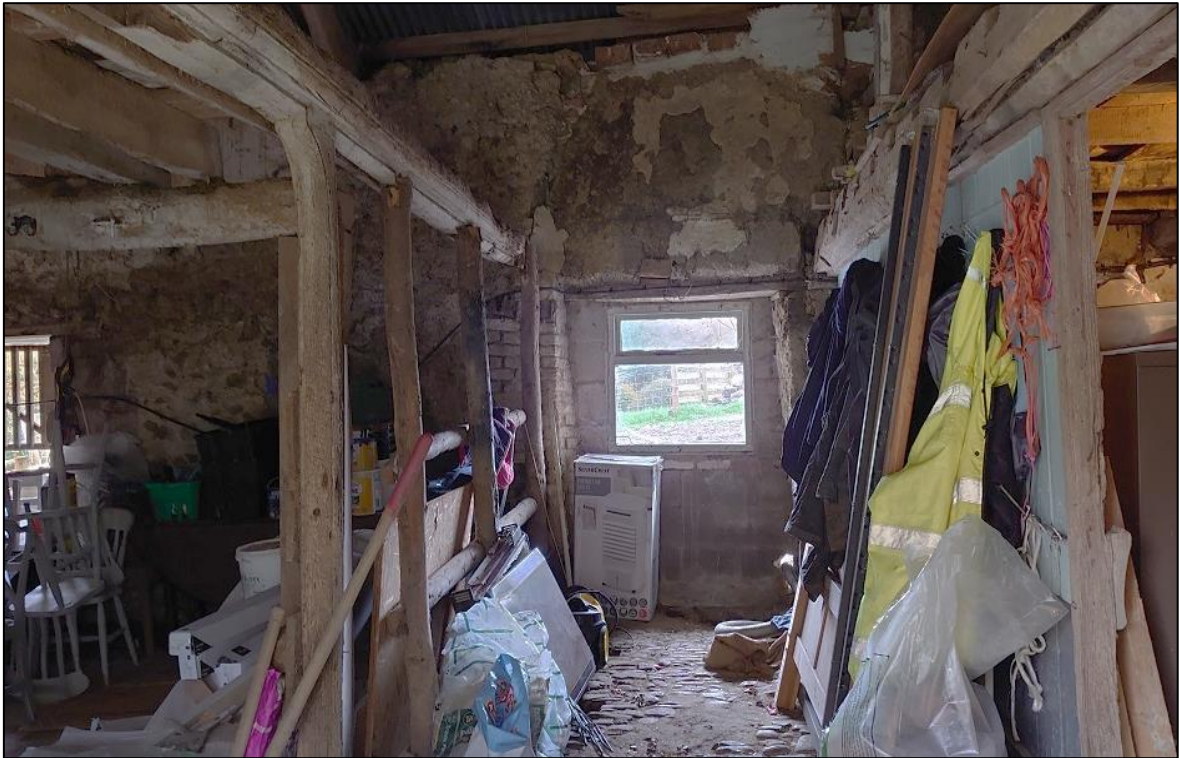
FIGURE 20: R14A, THE 'CROSS-PASSAGE', FORMED BETWEEN 19<sup>TH</sup> CENTURY PLANK SCREEN (LEFT) AND INSERTED AND REUSED MEDIEVAL SCREEN (RIGHT); VIEWED FROM THE EAST.

To the middle of the building, separating R13 from R14b, is a 'cross-passage' between opposing 19<sup>th</sup> century doors (R14a). However, this is a post-medieval creation within this range. There is a typical post-medieval cobbled floor to this space.

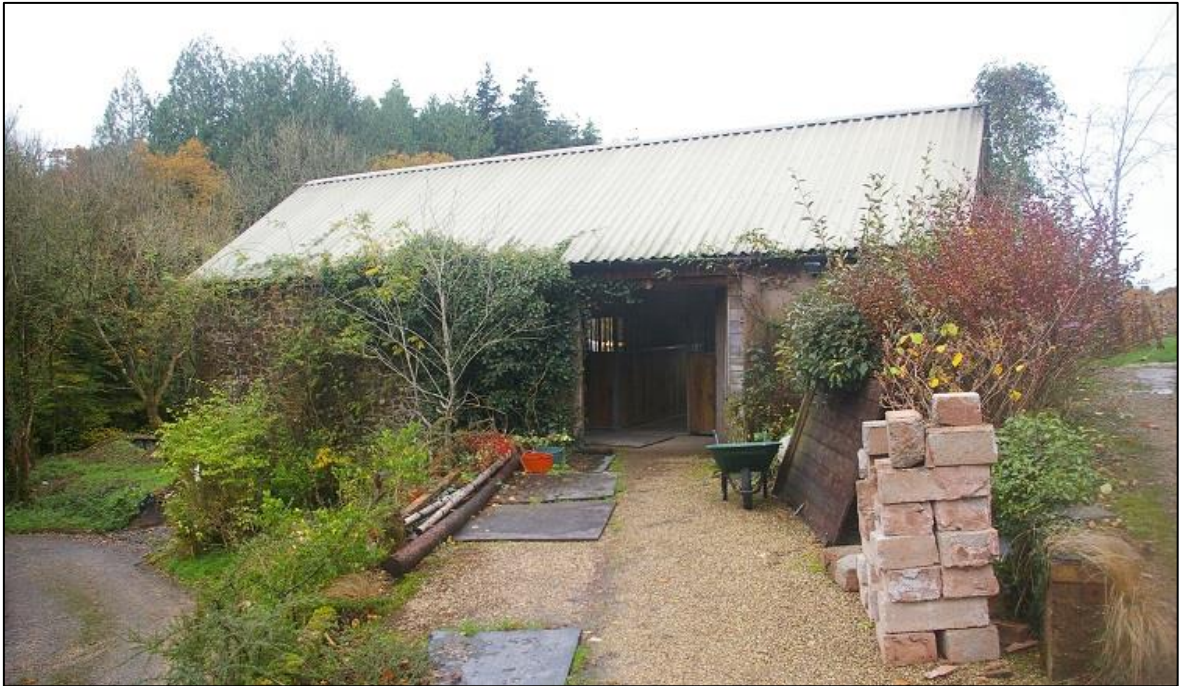
The last of the historic buildings surviving onsite (briefly addressed here for context) is the former threshing barn, once part of the long L-shaped west range. Rendered externally, it may be built in cob but significantly remodelled in the post-medieval period in stone rubble in a lime mortar. The roof timbers are 19<sup>th</sup> century A-frames, and the roof has been replaced with corrugated sheeting. The previous owner undertook unsympathetic works, rebuilding the north and west walls in concrete block and converting the space to a workshop, infilling and raising the floor levels, and demolishing the horse engine house to the rear, levelling a yard area. The current owners have now fitted it out with stalls.

FIGURE 21: THE STABLES, FORMERLY THE THRESHING BARN; VIEWED FROM THE EAST.

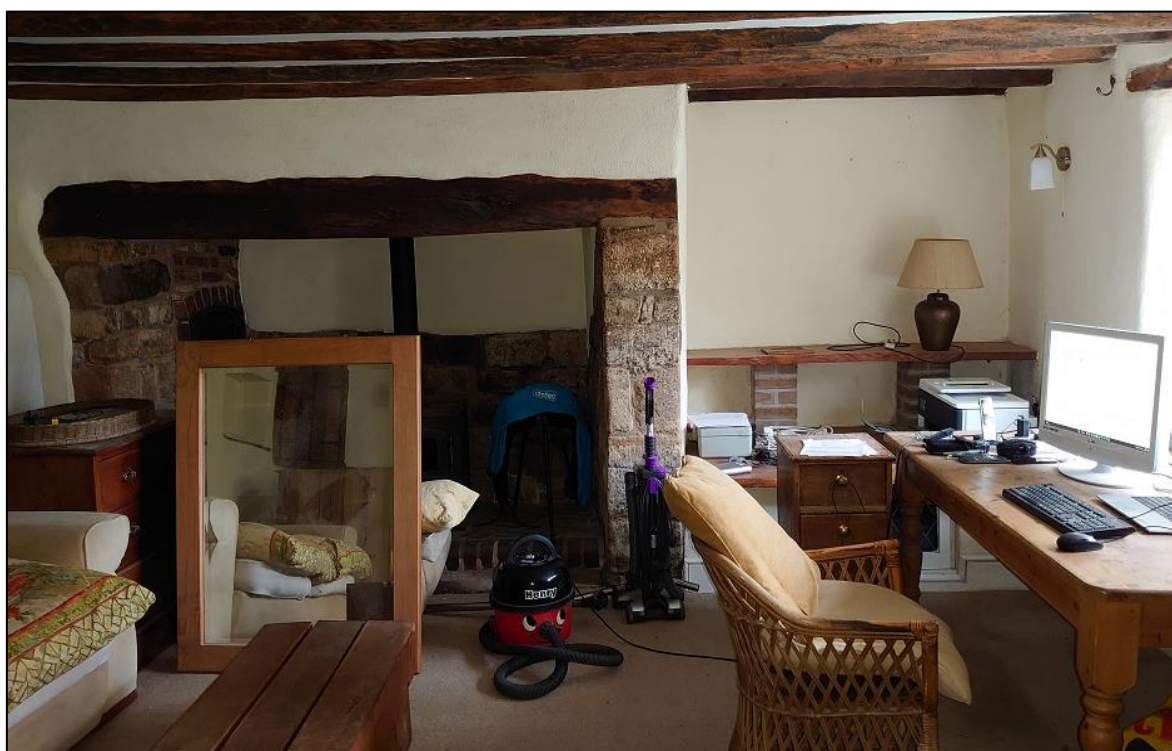
East of the hallway is a large sitting room (3). The doorway between the two has been forced and enlarged during the most recent remodel of the house prior to its last sale. R3 contains another fireplace, this time of larger scale and suitable for cooking. This fireplace also has finely dressed stone jambs but its bressummer beam has been replaced and a post-medieval brick bread oven with iron door has been inserted into an opening for an earlier bread oven. Whilst the jambs are stone the rest of the stack is cob (as in R2). To the front of the hearth there are some surviving stone flags; the rest of the hearth has been raised in brick and a wood burner installed. To the west end of the north wall there is a small, blocked window, now an alcove, and there may be more blocked windows in this elevation. The large window to the south was formerly a doorway, and the many changes to this opening (under a very thin timber lintel) has led to structural issues and the lintel is sagging noticeably. The ceiling of this room is now of plasterboard between thin rustic joists of surprisingly poor quality. The joists have nail stains and lath-and-plaster marks. These timbers are clearly post-medieval in form and scantling and are presumably replacements; they are not very sturdy and, given the width of the room, and the ceiling is sagging as a result.

FIGURE 22: R3, THE LARGE FIREPLACE IN THE FORMER DETACHED BLOCK; VIEWED FROM THE WEST.
