DERELICT COTTAGES OLD PORTREATH ROAD REDRUTH CORNWALL

Historic Building Recording

South West Archaeology Ltd. report no. 231020

Derelict Cottages, Old Portreath Road, Redruth, Cornwall

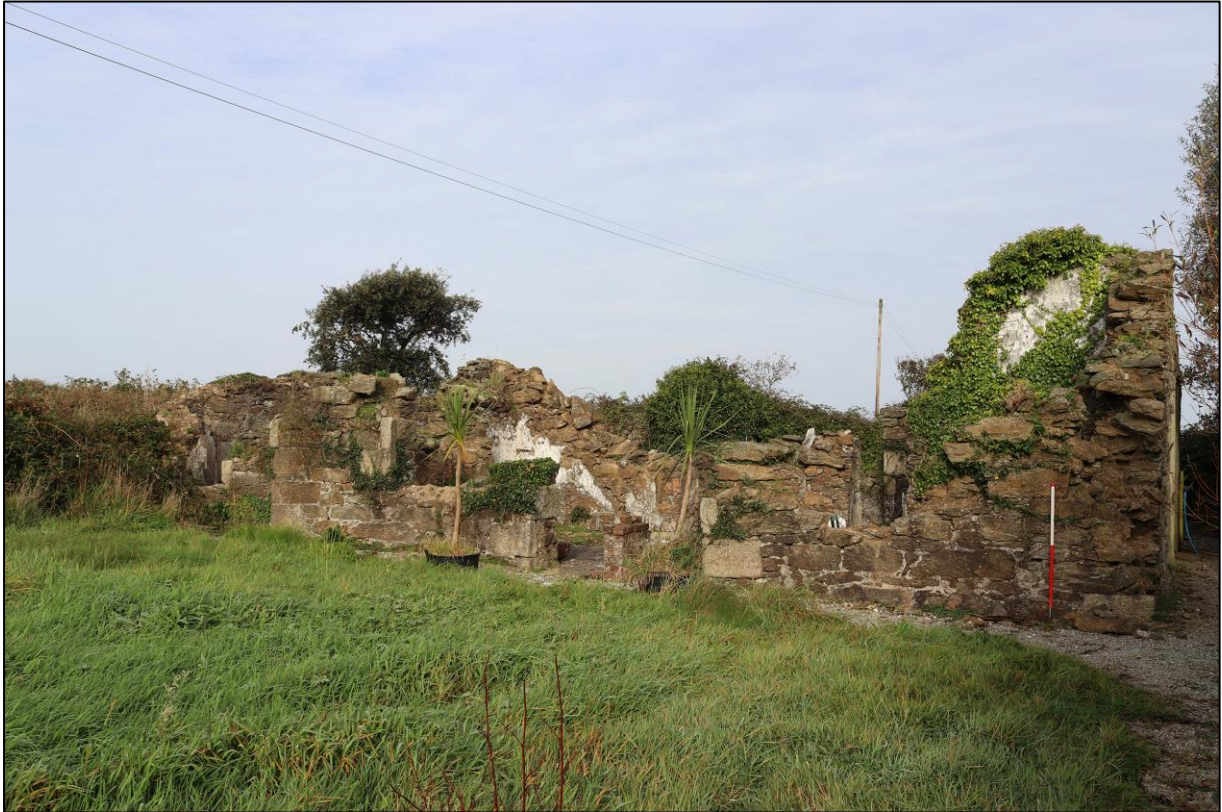
Remains to its southern frontage do show signs of earlier proportions and symmetry. A split central door opening is flanked to the east and west with large ground-floor window openings. The level of the ruins here do not rise above ground floor level, though it is likely the building had reflected first floor

window openings, perhaps much smaller. The central door opening had dressed granite quoin blocks to both sides just surviving, though evidence to the internal door partition, may suggest the opening was later altered/ forced wider to accommodate two separate doors for two separated dwellings, or the door opening was originally very wide associated with a possible earlier, agricultural function. The surviving walls are thick 0.6m in depth, the majority built in killas stone rubble, local to the area. The masonry slightly differs to the west end and there is a distinct build line surviving to the fabric, evidencing this end is a later extension. This extension abuts a series of surviving quoins to the earlier range, with evidence of several separate lime mortar repointing works, protecting an original reddish-brown, friable earth mortar – though the finishes varied across the elevations.

FIGURE 7: THE RUINOUS SOUTH FRONT, FROM THE SOUTH-EAST WITH 1M SCALE.

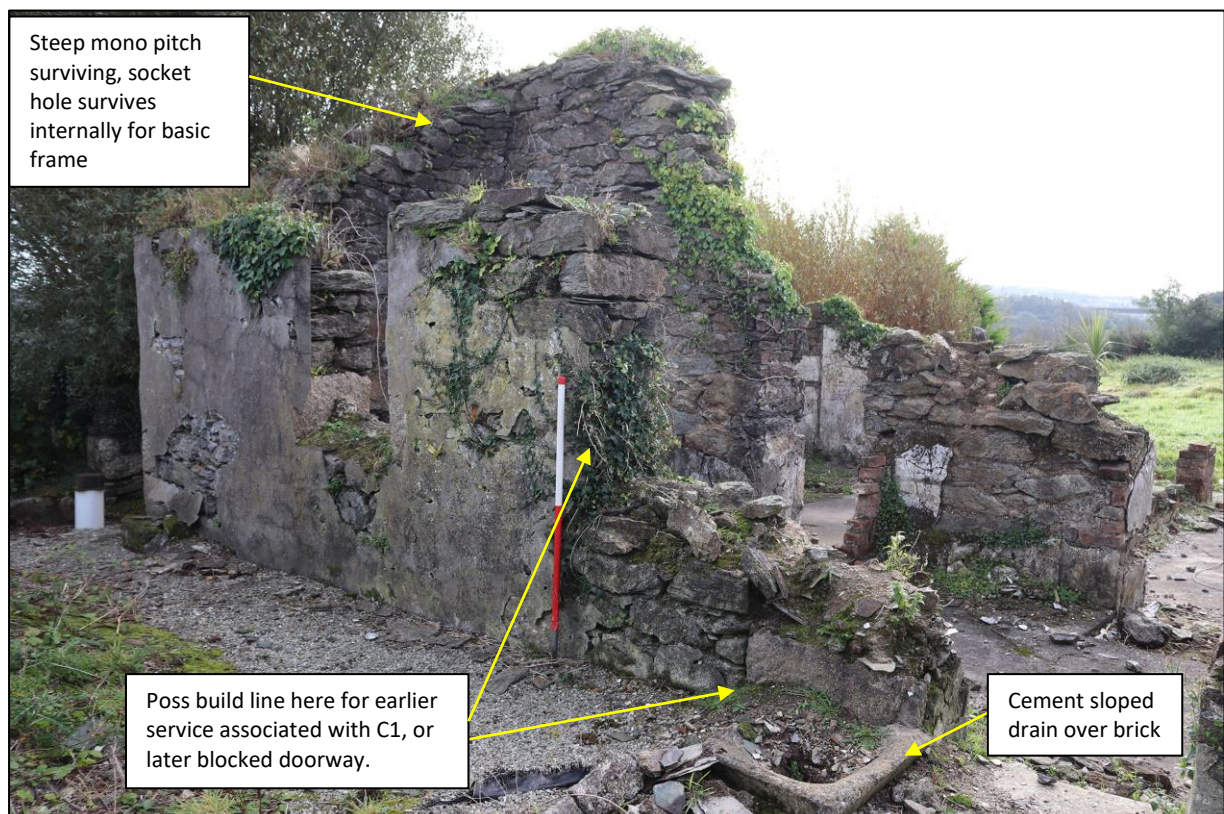
The north elevation of the extended western block included a central blocked doorway. This blocked opening still retained its rustic timber lintel and had been blocked with killas rubble and lime mortar. The opening did not exist with any distinct detailing, aside from a select few slate blocks, used for quoin dressing to the east side. This end of the elevation was much the same as the east lean to, built using killas rubble, though unrendered, and lime mortar repointing was clear above a dark red-brown earth mortar.

FIGURE 8: THE NORTH ELEVATION, POSSIBLY SHOWING SOME STRUCTURAL PHASING. FROM THE NORTH-WEST WITH 1M SCALE.

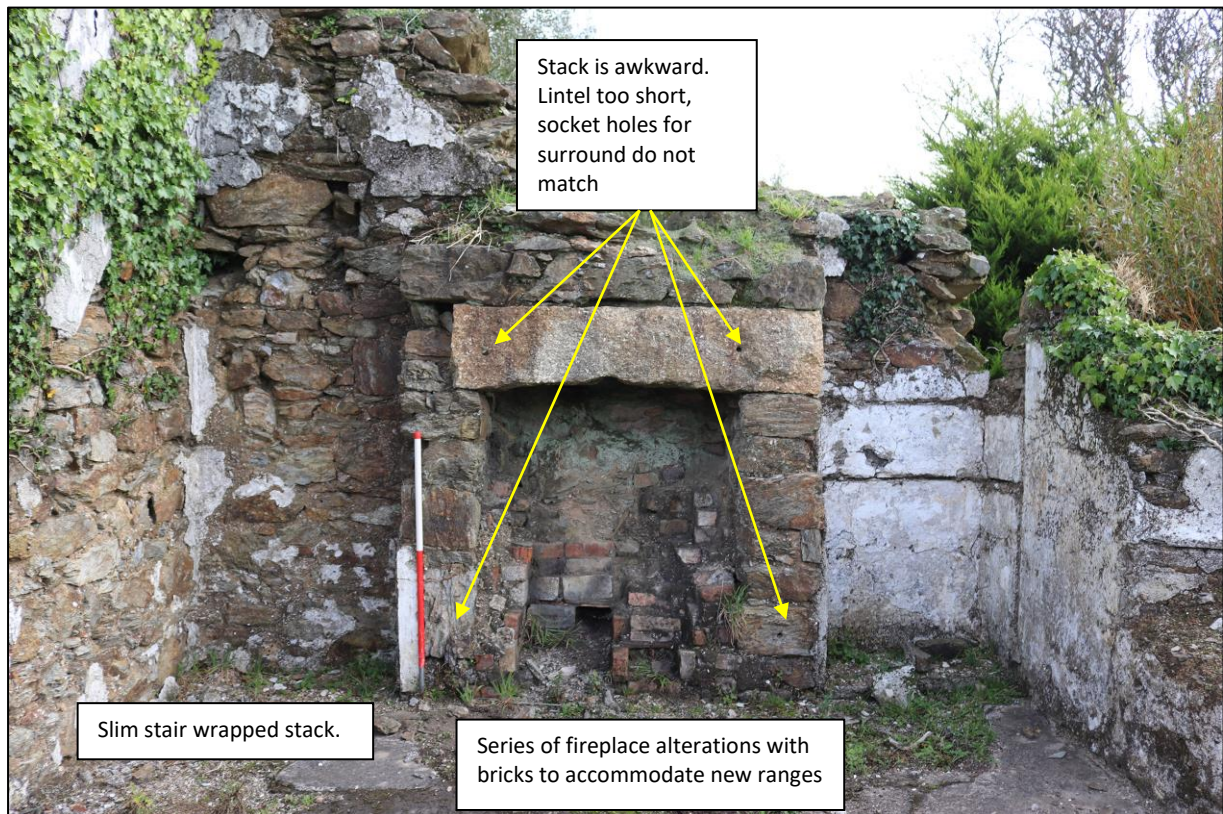
FIGURE 9: THE INTERNAL STACK OF C1. TAKEN FROM THE WEST WITH 1M SCALE.

Limited internal features survive and the only fabric to survive above ground-floor height, across the site, existed to the north-east corner. A large, projecting stack existed centrally to the east elevation, remains of which only survived to above the lintel. The stack was built using killas rubble, though it was clear it had had several alterations to the fireplace, with several phases of brick alterations to fit later stoves. These bricks included white ceramic brick labelled *Rogers & Co* (part of the Wheal Remfry Brickworks & China Clay Works c.1870s), small frog-less red bricks, and glazed brick. The stack has a large granite lintel, though is considered very short against the north jamb, appearing as generally quite awkward, and so may have been reset in a later widened stack. Socket holes do survive to the lintel, as do two opposing socket holes of a similar dimension to two killas rubble blocks either jamb, suggesting an earlier mounted fireplace surround. Though they currently do not match with the lintel, implying the fireplace has been altered/widened. Either side of the stack are two alcoves – the southern alcove has scars to a thick, cement-based render (seen across the internal spaces) for former shelving. The northern alcove likely sat under a small set of stairs that wrapped the north and east elevations with small socket holes seen to this corner. The floor of the cottage has been infilled with a cement-based material, though areas do survive exposed, particularly to the north-east corner, where the cement has been possibly wrapped around the base of a step with slim square newel post. The

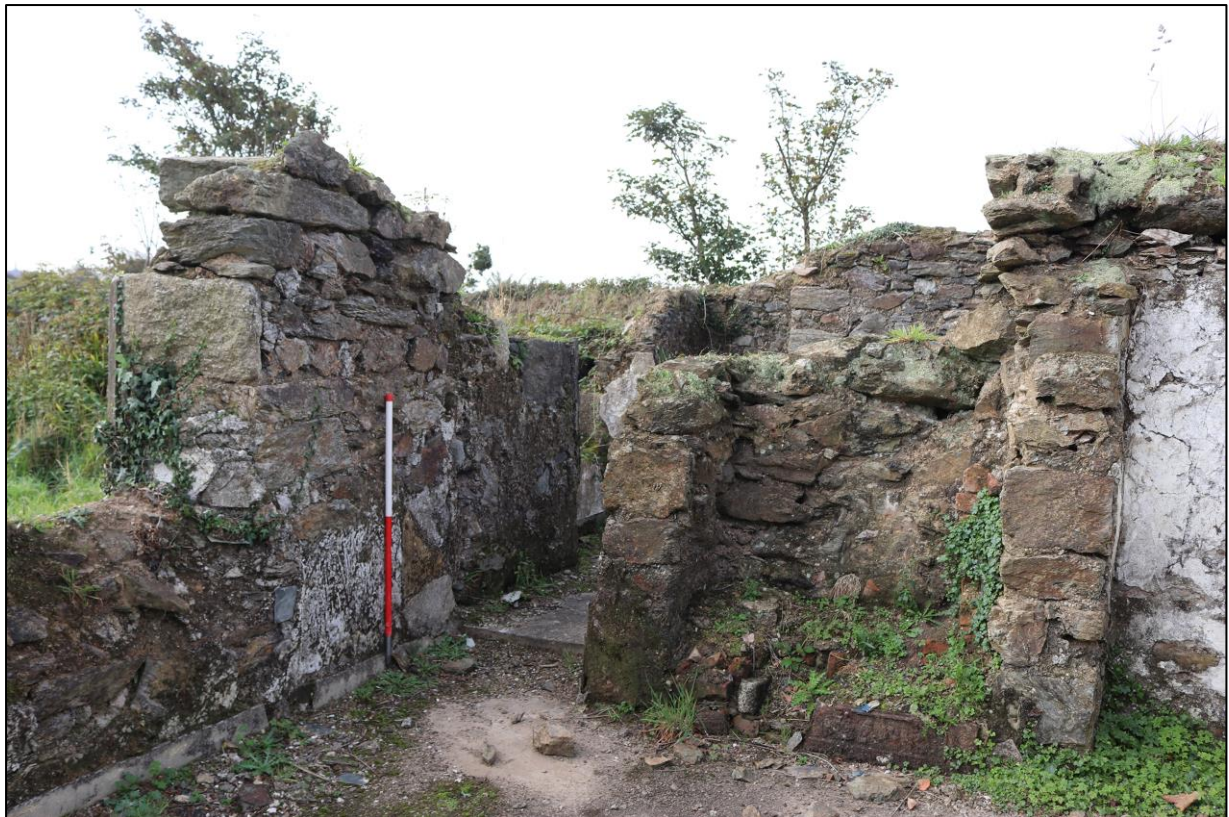
Cottage two (C2) occupies the west space of the main range. Both cottages were reflected in style/layout, though the ground-floor space to C2 was slightly smaller. A smaller stack was reflected centrally to the west elevation, though survived without its lintel, and was slightly smaller than that seen to C1. It too had undergone several phases of alteration, and the iron base plate for a small stove had been left in situ to the base. Cement render survived at an angle to the north elevation, following the line of the staircase. To the south jamb under the cement render were original, small, slate tiles, complete with tack holes, that had likely been reused from an earlier roof, presumably used by the plasterer for a flat surface. The roof likely had at least two phases of repair/ reworking. The south side of the fireplace had been forced through for access to a small western block extension. Another narrow doorway, opposing the main front entrance was located to the north rear elevation, similar to C1, for access to the extended lean-to space. This opening has been patched with brick, and its narrow width suggests that it was later forced, similar to C1.

FIGURE 10: BREACHED OPENING TO THE SOUTH-WEST CORNER OF C2 AGAINST SOUTH SIDE OF STACK, TAKEN FROM EAST WITH 1M SCALE.

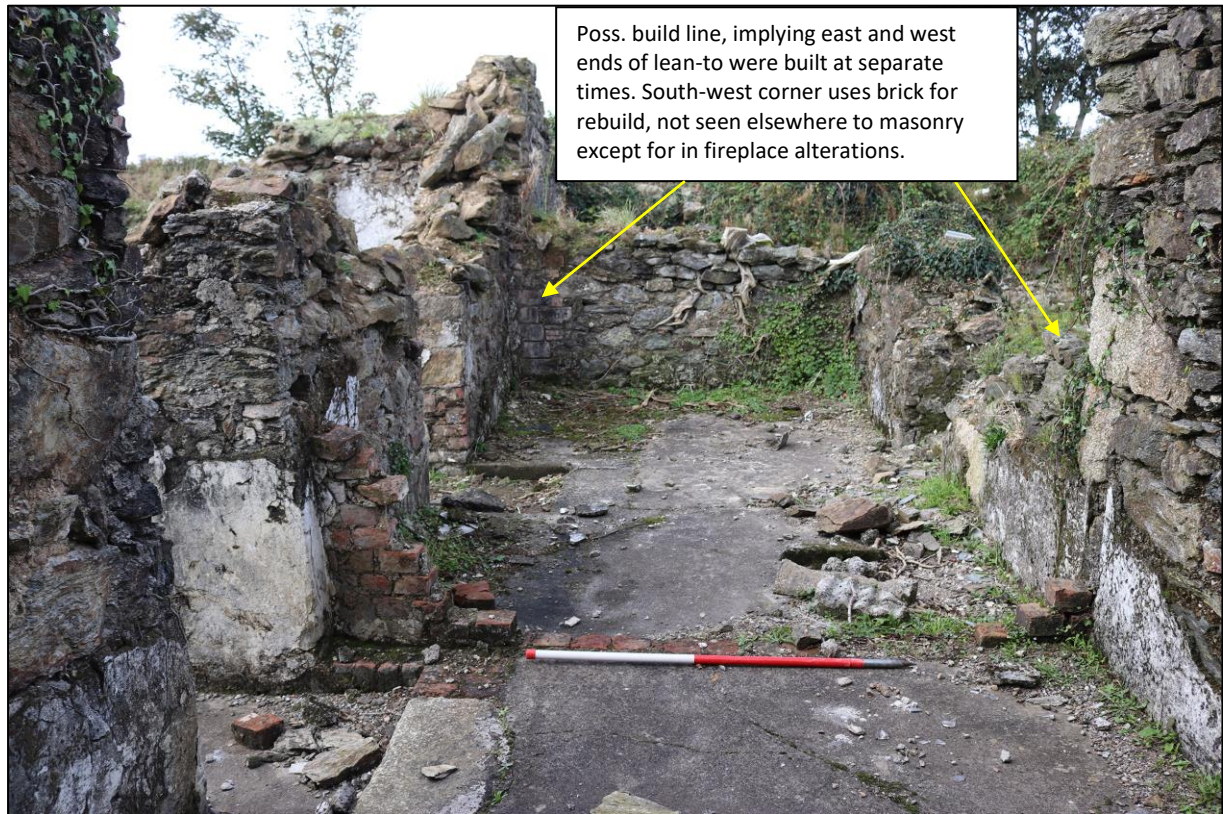
space was much smaller for C2 with a narrow door opening to a small cement-surfaced courtyard. It is possible the lean-to was developed in two sections, the first for C1. This is evident by a possible build line to the west end on the edge of the division; internally this is marked with several granite quoin stone to the west edge of the surviving fabric; the masonry between ends was slightly different in form – much heavier to the east than the west side. Moreover, the north-west corner of this west end had been built using reused white bricks, many labelled *St Day* not seen elsewhere to the masonry. *St Day* brickworks was founded in 1860, closing c.1912. It is unclear if the west end had any window openings in the north or west elevations.

FIGURE 11: THE WEST END OF LEAN-TO, SHOWING POSSIBLE BUILD LINE TO NORTH. FROM THE EAST WITH 1M SCALE.

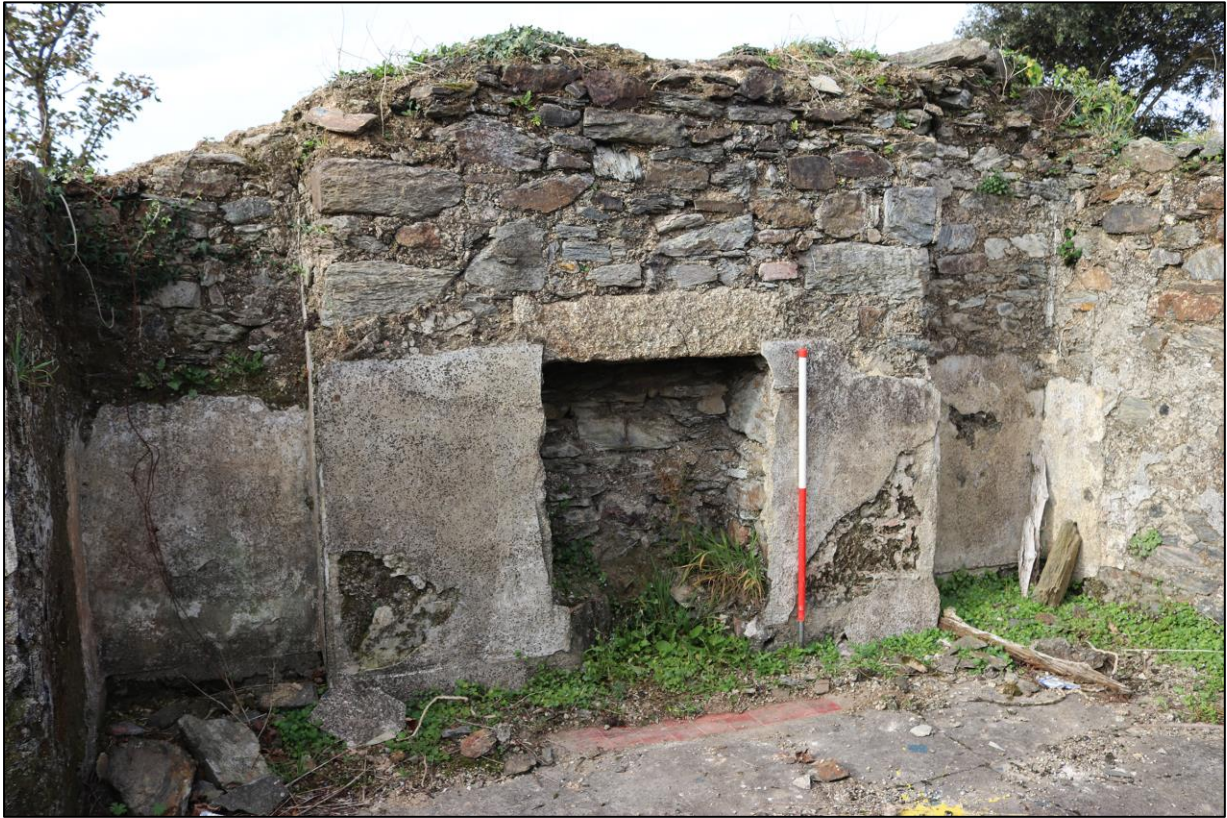
It is clear from the external south elevation this end of the building abuts the former main range. It is a single room space, and much smaller than that to C1/ C2, likely only built to extend C2. To the west elevation is a small, projecting stack, rendered to both sides, though a small granite lintel is exposed. The fireplace has been altered and reduced with angled cement splays to fit a small burner. This stack included small glazed red quarry tiles set into cement floor acting as a decorative threshold of mid-20th century design.

FIGURE 12: PROJECTING STACK TO WEST ELEVATION OF WEST BLOCK, INCLUDING PATCHING WITH BRICK AND SHORT LINTEL, FROM THE EAST WITH 1M SCALE.

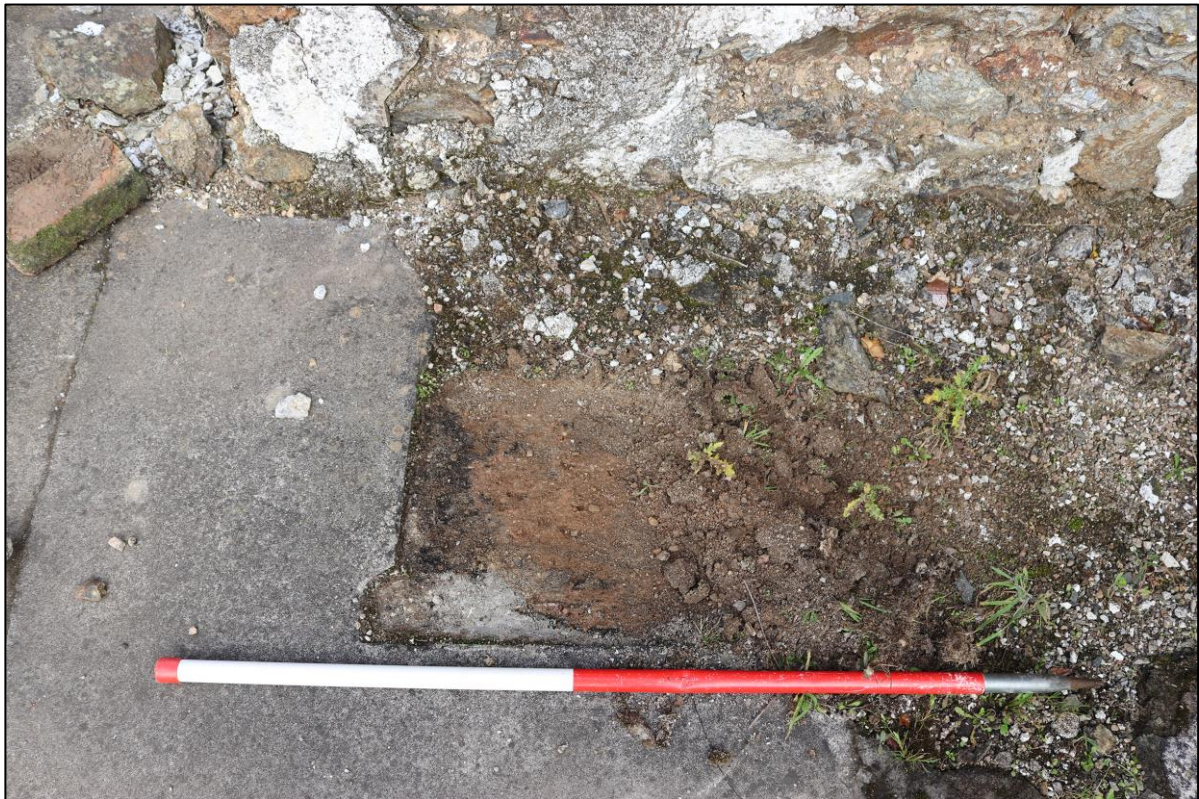
Beneath the screed layer to the internal ground-floor, a packed earth floor was seen, implying sealed archaeological deposits do exist. As such, archaeological monitoring to further development and groundworks is advised, this could further our ability to understand an earlier form/ internal layout, whilst informing on possible earlier functions. This will further provide some heritage mitigation if development seeks to demolish the existing footprint.

FIGURE 14: BENEATH SCREED LAYER A PACKED EARTH FLOOR IS VISIBLE. THE SHAPE TO THE WEST SIDE REFLECTS THE POSSIBLE BASE OF A NARROW STAIRCASE THAT ROSE AGAINST THE NORTH ELEVATION. THIS IS REFLECTED SIMILARLY TO C2. TAKEN FROM ABOVE FROM NORTH WITH 1M SCALE.

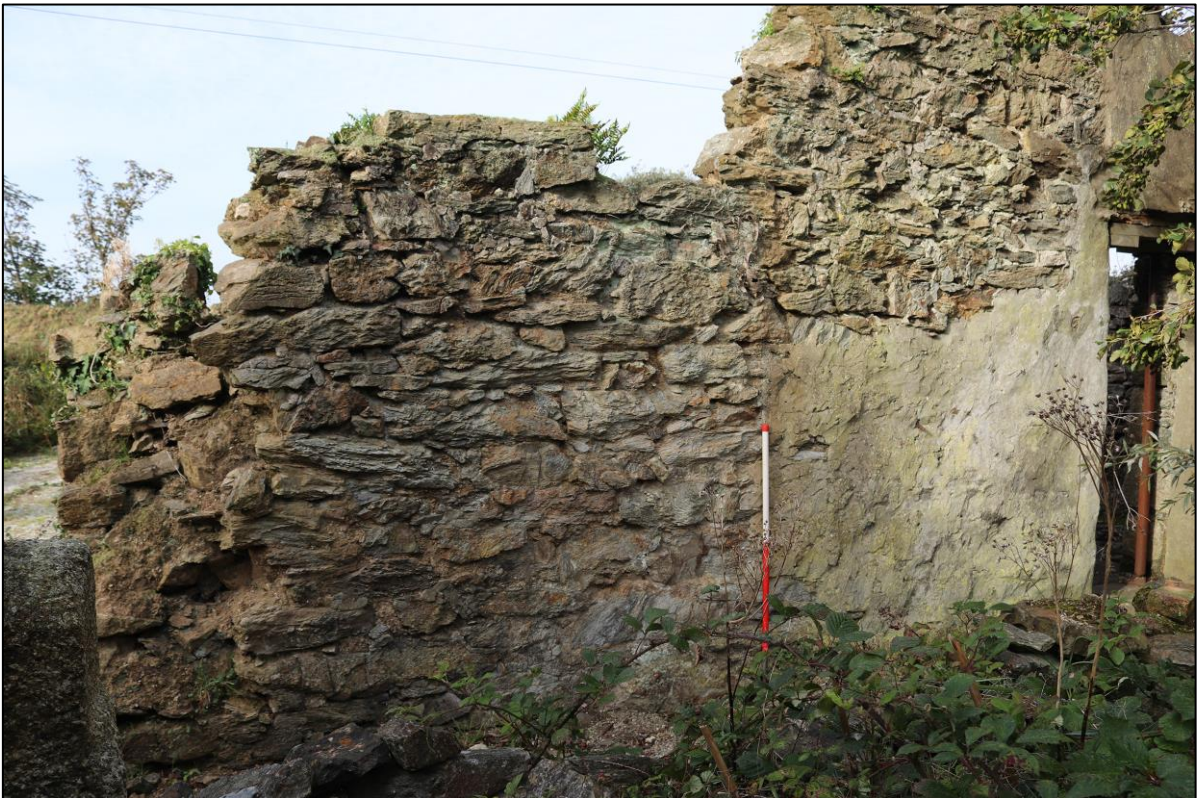
6. THE SOUTH-WEST CORNER, GRANITE QUOINS HAVE BEEN ROBBED OUT. TAKEN FROM THE EAST WITH 1M SCALE.

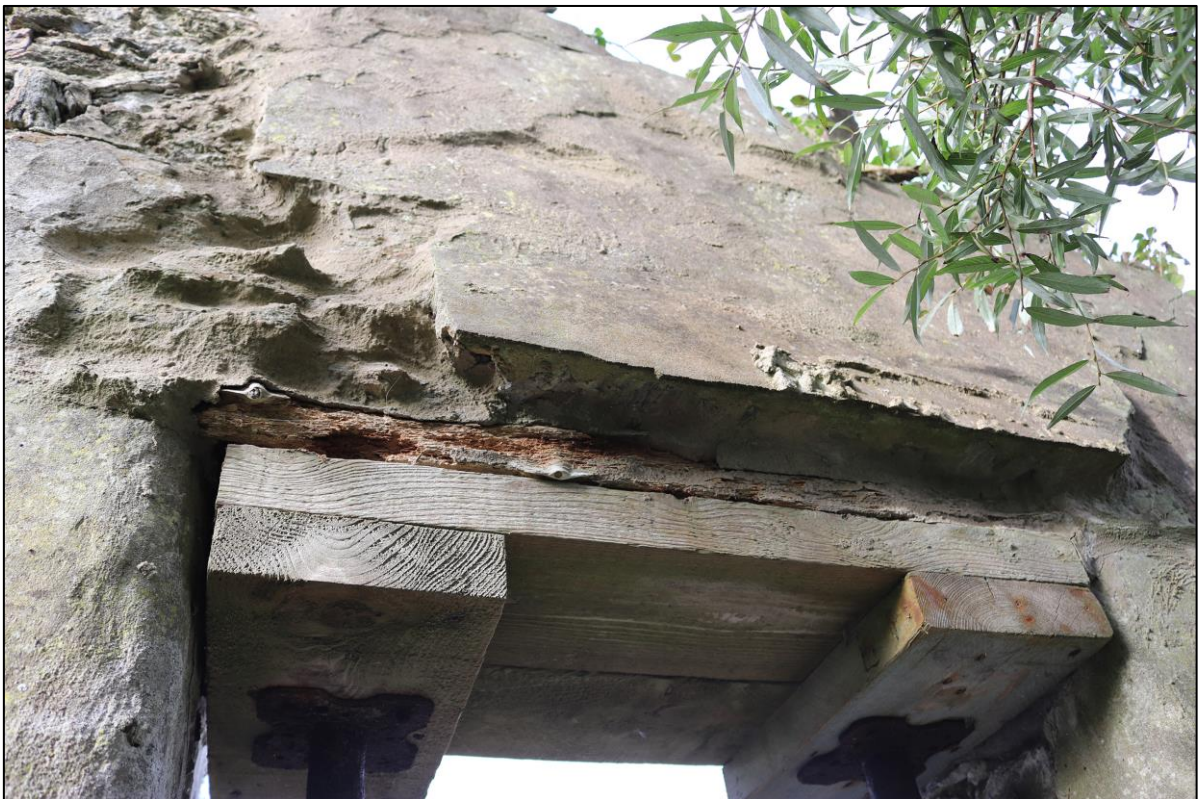
8. OPENING TO THE EAST SIDE OF NORTH LEAN-TO MODERN PINE SLABS PROP OLDER RUSTIC LINTEL. ABOVE HAS BEEN SHAPED WITH RENDER TO CREATE RUN-OFF.

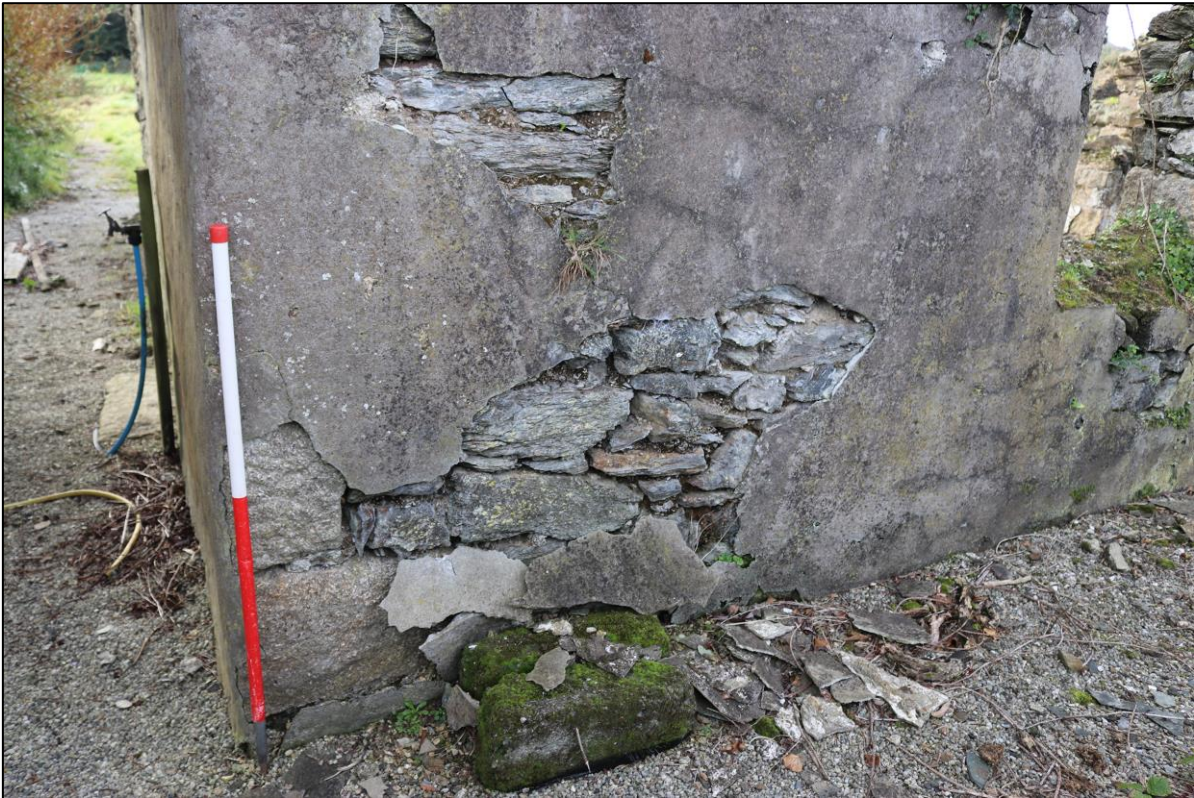
11. CORNER OF NORTH LEAN-TO, KILLAS RUBBLE AND GRANITE QUOINS UNDER MID-20THC RENDER; FROM THE NORTH WITH 1M SCALE.

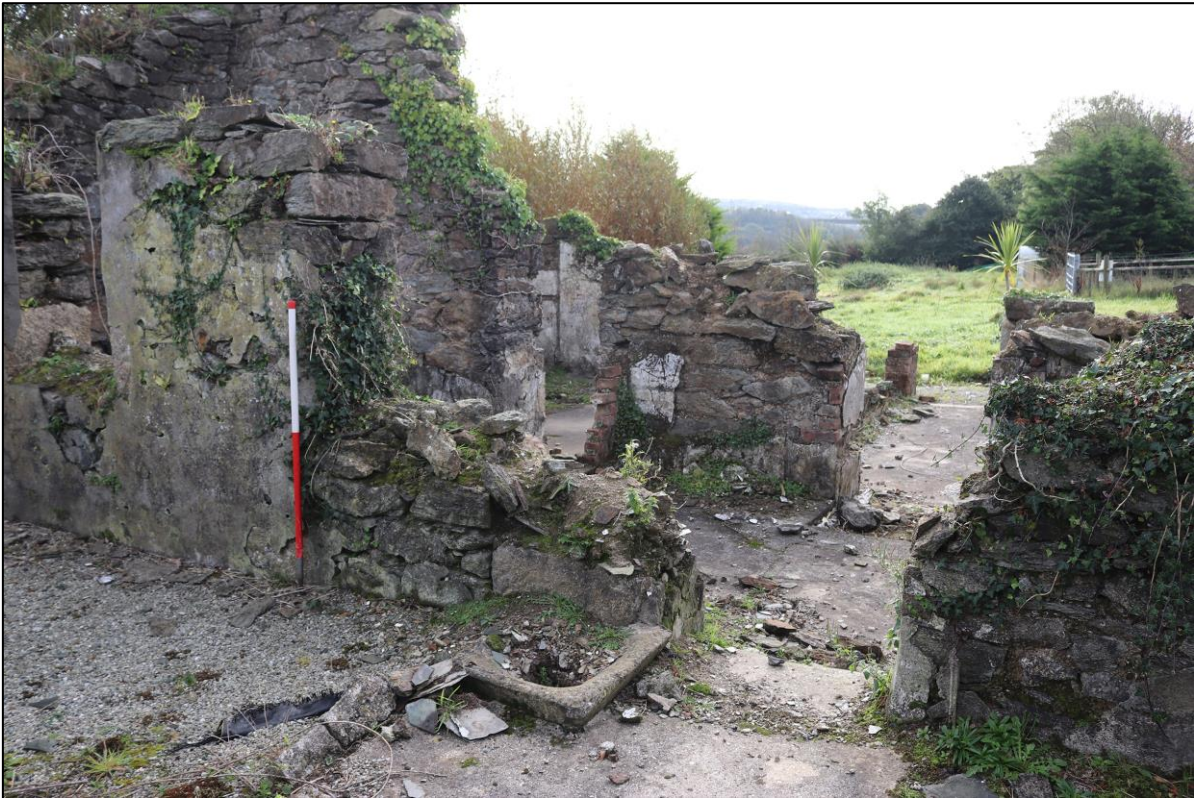
13. PAIR OF FORCED DOORWAYS TO NORTH INTERNAL ELEVATION AND OPENING TO C2 COURTYARD; FROM THE NORTH-WEST WITH 1M SCALE.

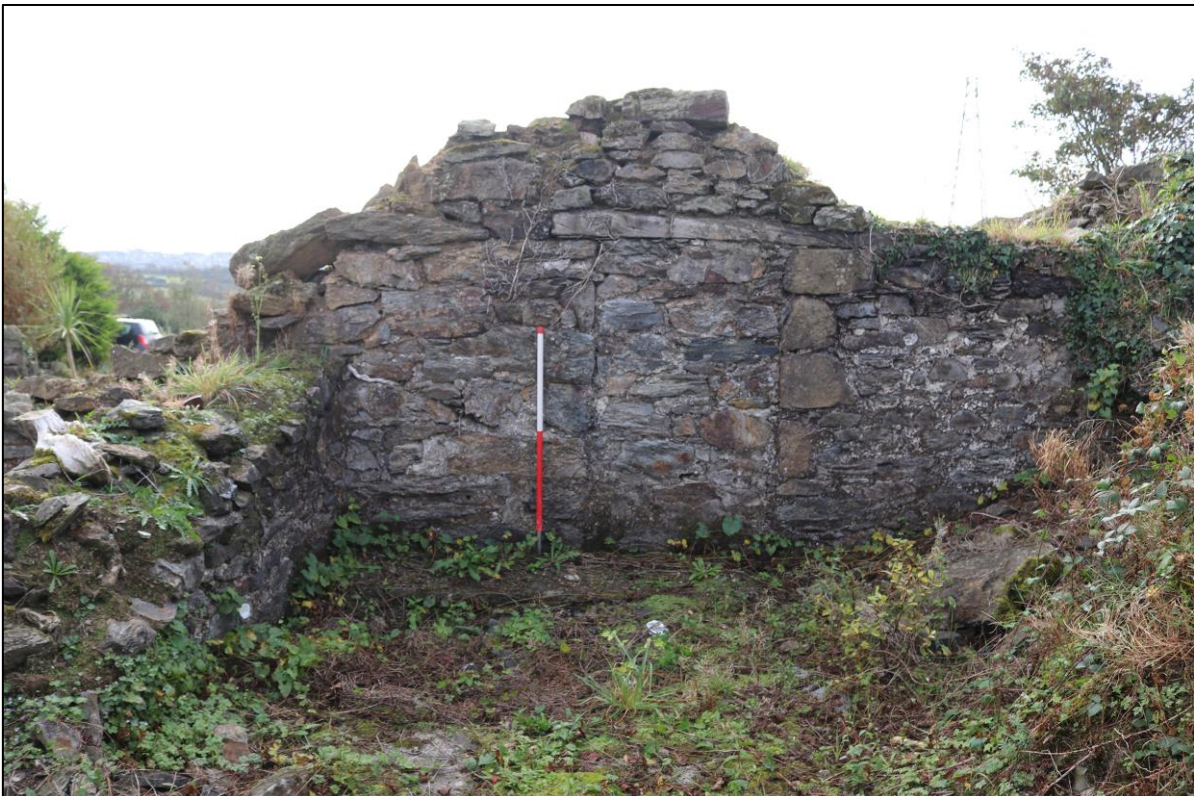
16. BLOCKED DOORWAY TO WEST BLOCK; FROM THE NORTH WITH 1M SCALE.

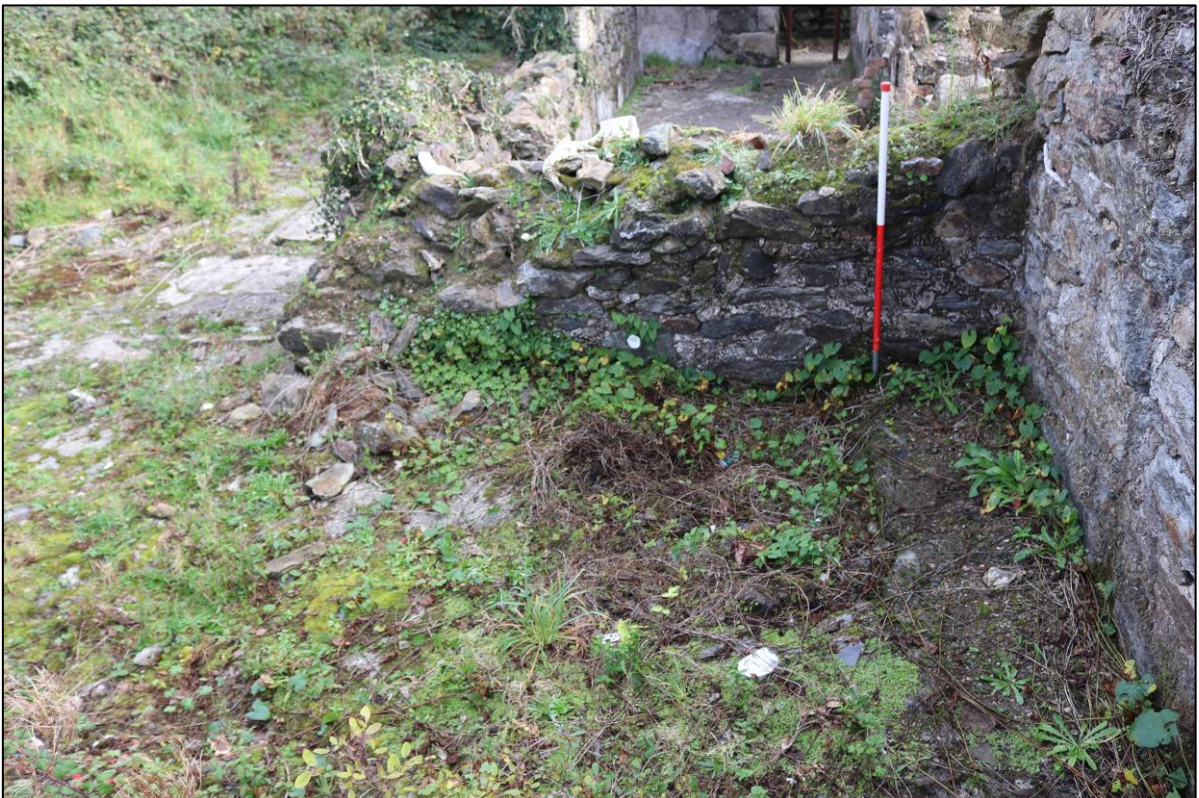
18. THE FLOOR OF THE NORTH WEST BLOCK WAS HEAVILY DISTURBED INCLUDING THIS OVERGROWN DAMP PIT; FROM THE WEST 1M SCALE.

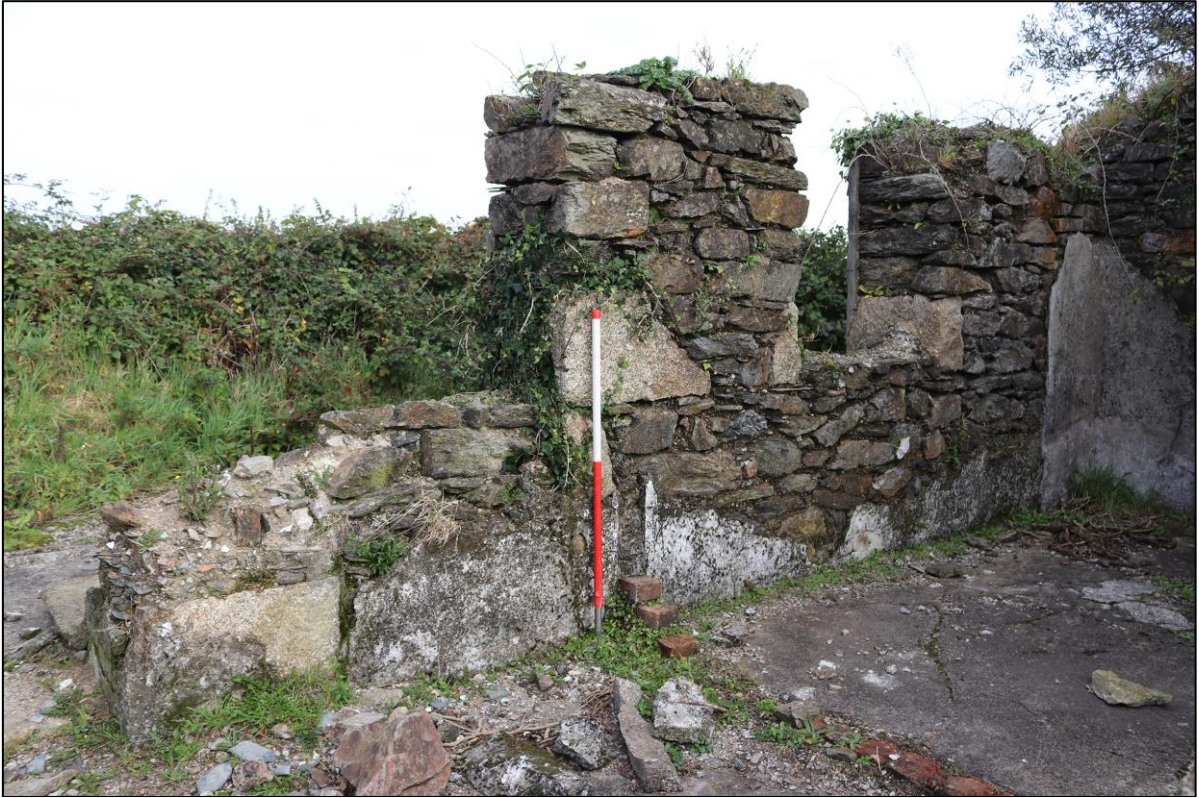
25. THE NORTH- EAST END BUILD LINE APPARENT, IMPLYING TWO PHASES OF LEAN-TO. FROM THE SOUTH WITH 1M SCALE.

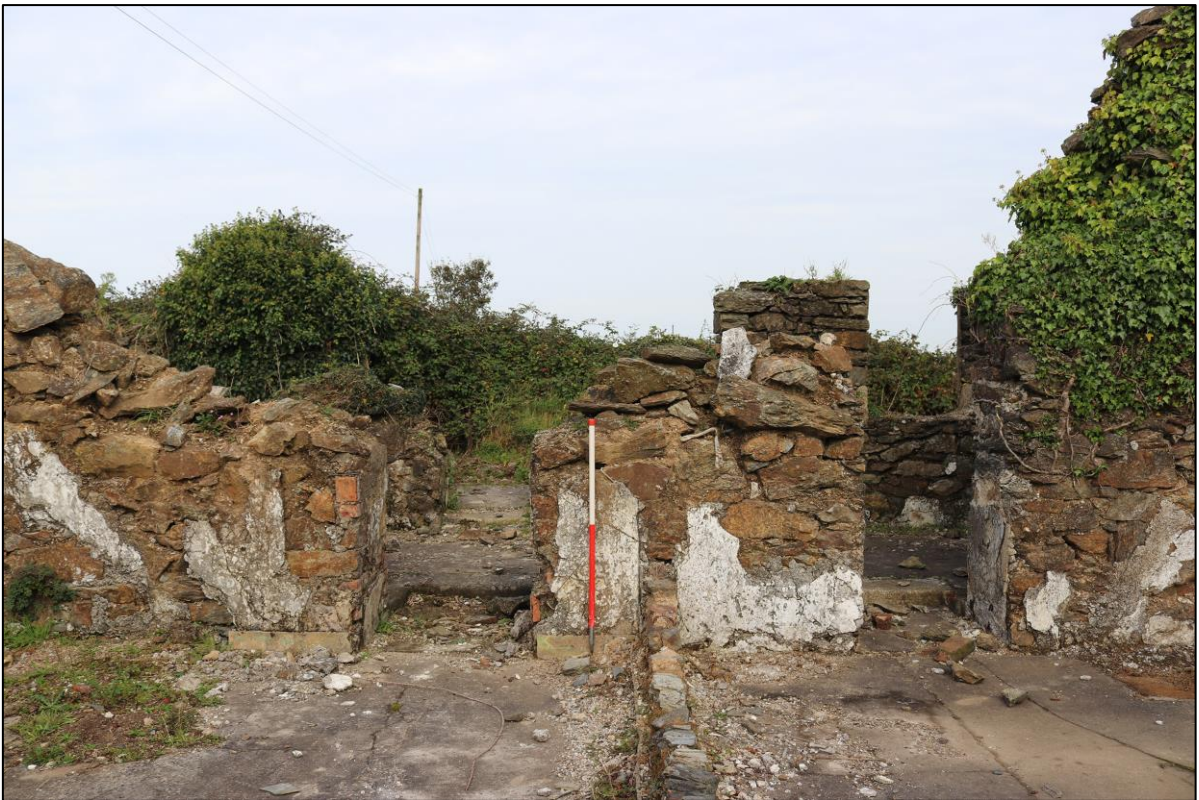
34. THE PAIR OF FORCED OPENING TO THE NORTH ELEVATION FOR REAR SERVICES; FROM THE SOUTH WITH 1M SCALE.

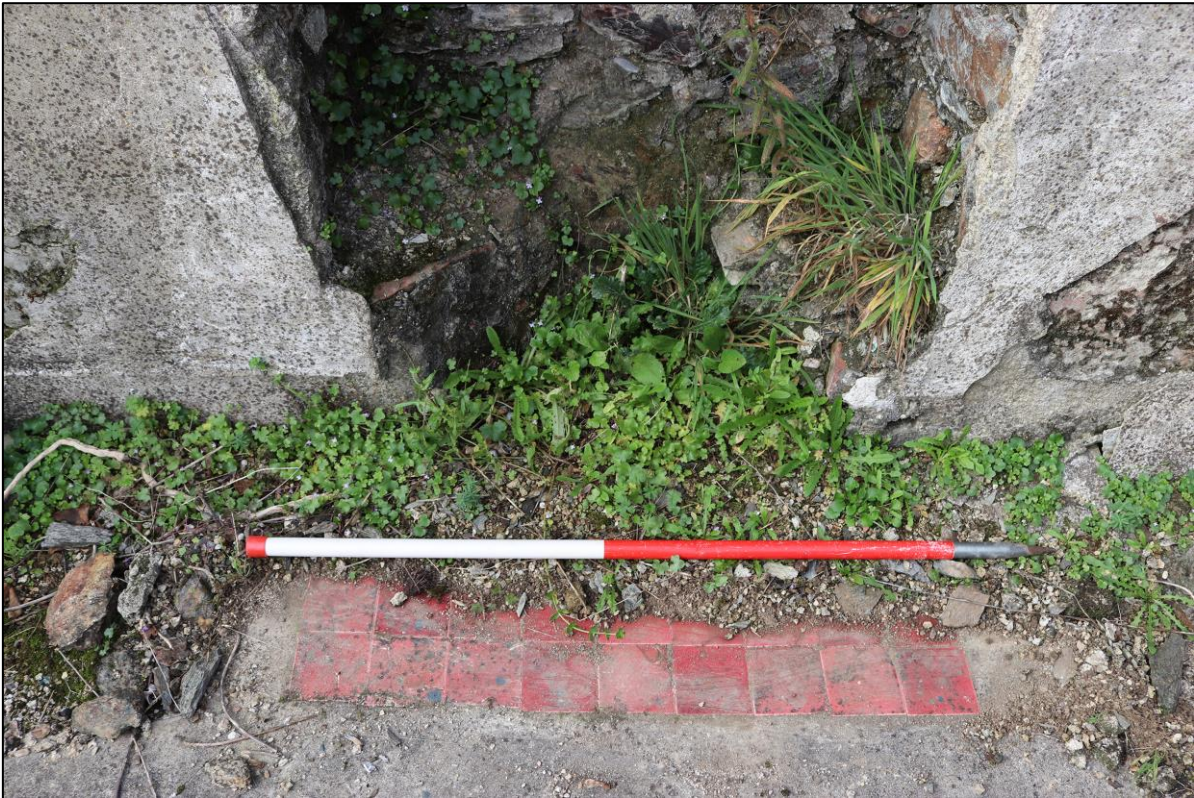
37. THE STACK HAD BEEN REWORKED IN MID-20TH INCLUDING QUARRY TILE THRESHOLD.
