North Hooe Mine, Bere Alston, Devon

Historic Building Recording

Executive Summary

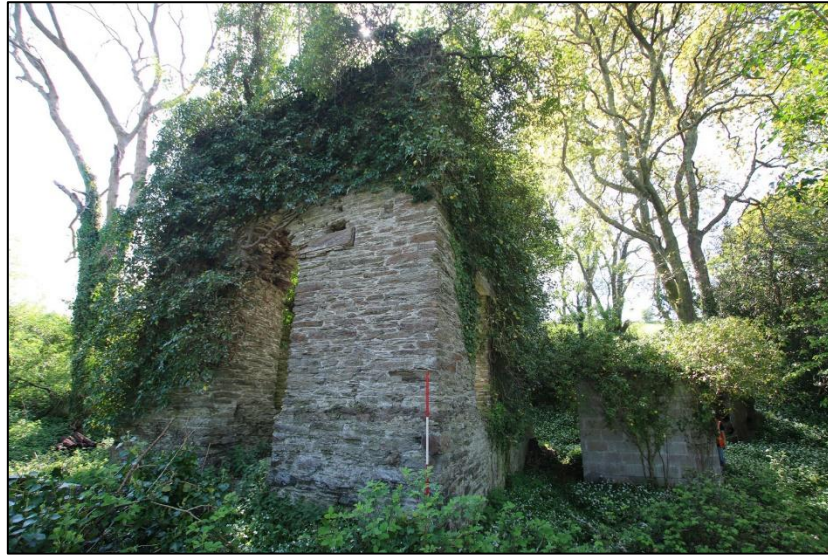
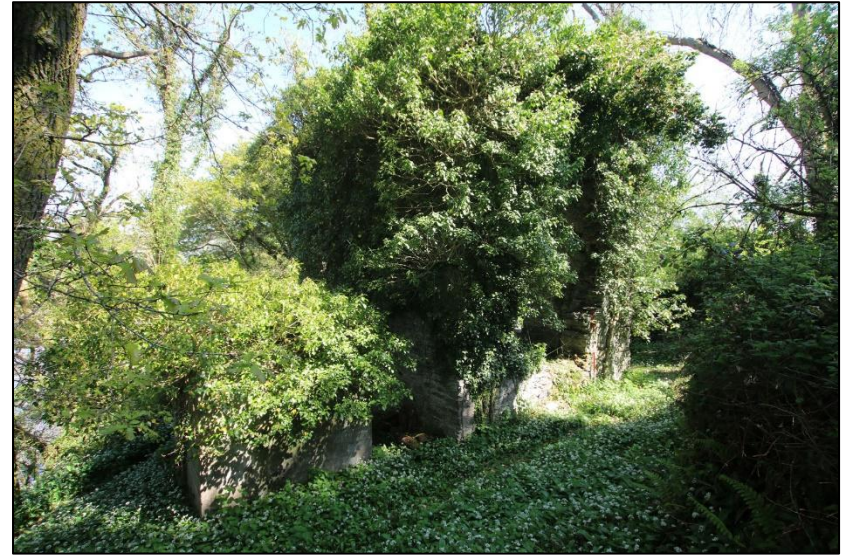
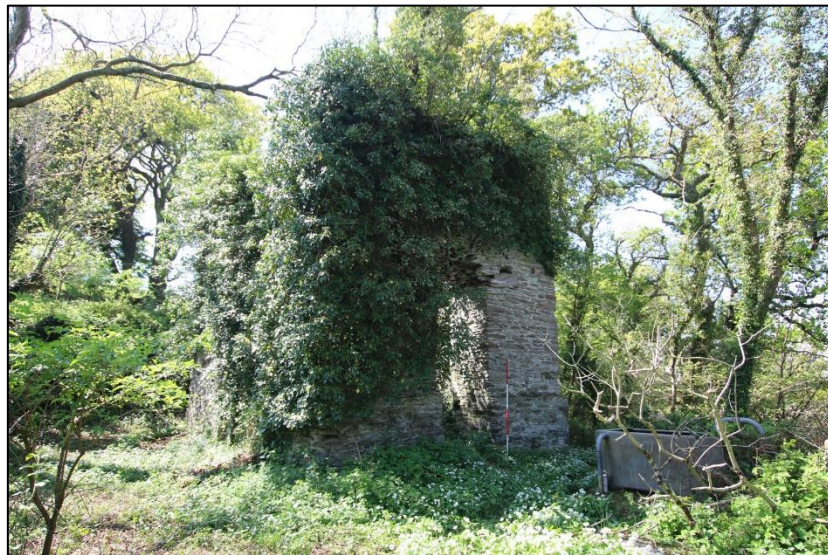
The engine house is in poor and declining condition. The principal issue is the failure of the timber lintels over the openings, which has led to the partial or complete collapse of the masonry above. It appears likely this has been aggravated by deliberate intervention (i.e. the loss of the walls above bob height, and steam pipe opening). The solution is fairly straightforward: the careful removal of vegetation, the replacement of lintels, and the consolidation and partial reinstatement of the stonework.

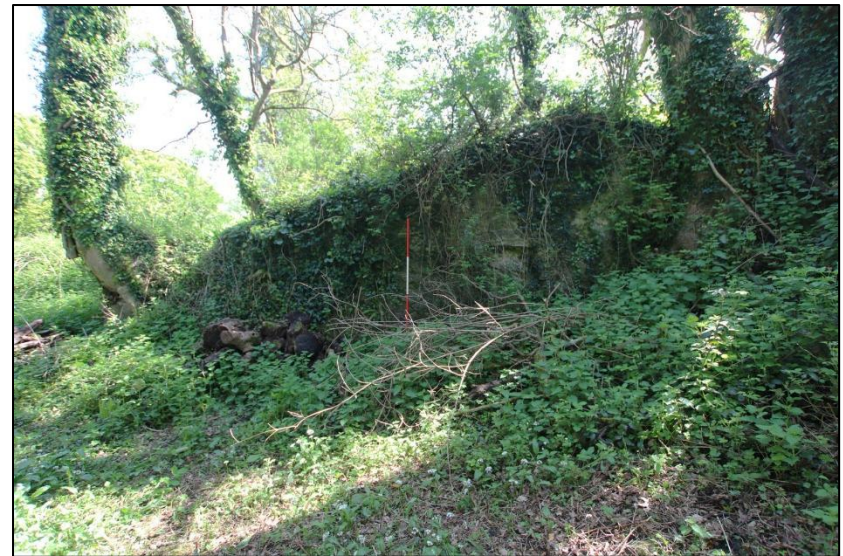
FIGURE 26: THE SURVIVING STRETCH OF BOILER HOUSE WALL; FROM THE NORTH-WEST (SCALE 2M).

Not much remains of the boiler house; it is in poor but stable condition. Its surviving fragment of wall and the entrance to the flue should be cleared of ivy and consolidated.

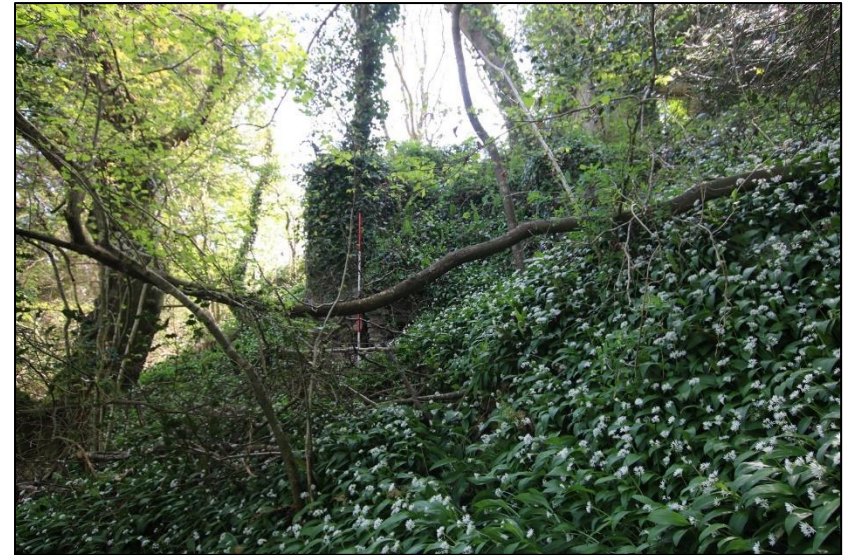
FIGURE 27: THE END OF THE BALANCE BOB PIT WALLS; FROM THE NORTH-WEST (SCALE 2M).

The walls of the balance bob pit are in fair and stable condition, though the loss of the timber lacing should be corrected. The battered fragment of wall abutting it to the east is in poor but stable condition. Again, these walls should be cleared of vegetation and consolidated.

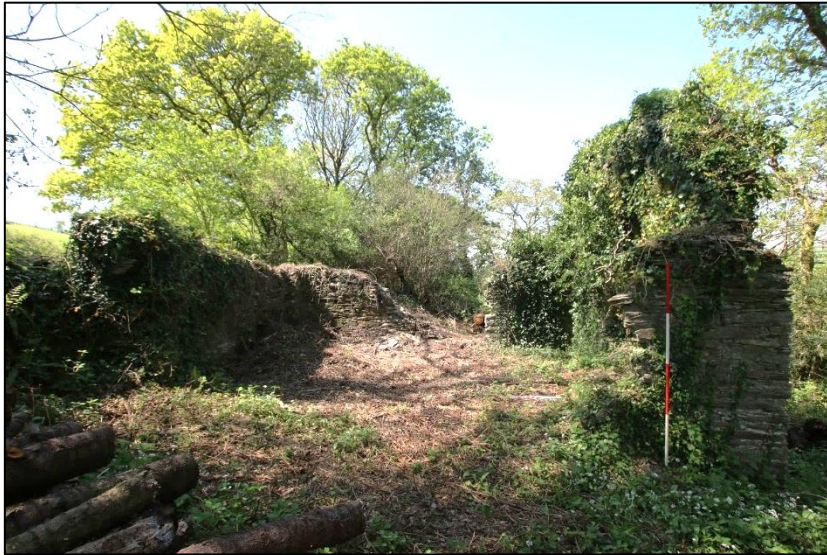
FIGURE 31: THE SMITHY; FROM THE EAST (SCALE 2M).

The east ('front') elevation has largely collapsed; the MAP would suggest this had a central door with window to the north, and, once the timber elements failed, the unsupported masonry would have been vulnerable to loss. The west ('back') has also partly collapsed; to the north side of the collapse enough survives to indicate the presence of a door here, with timber lacing.

The walls of the smithy are in poor and declining condition, again partly, it would seem, through deliberate intervention (in the 1900s?). The walls should be cleared of vegetation and consolidated.

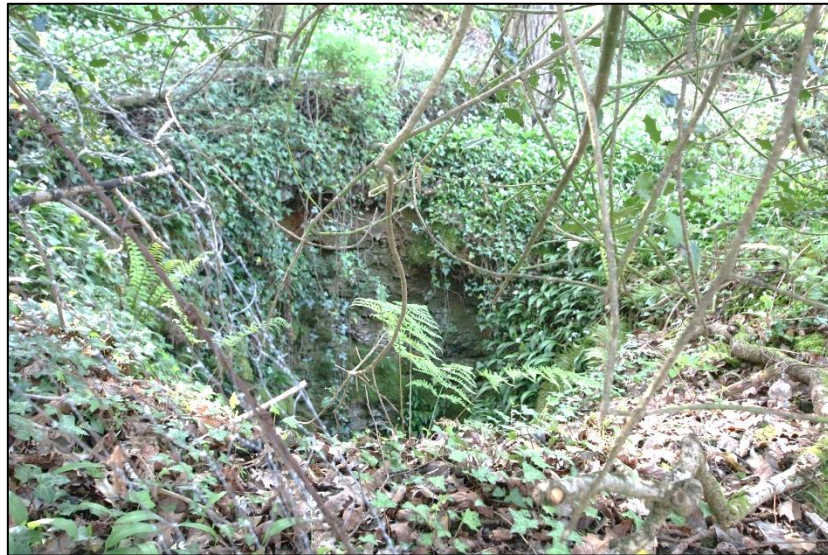
FIGURE 41: THE UNCAPPED SHAFT; FROM THE ENE (NO SCALE).

Located NNW of the engine house and main pumping shaft is a second (uncapped) shaft. As observed from a safe distance, the shaft appears to be rock-cut almost to the surface, a sub-rectangular vertical hole c.3m across. It is surrounded by a clear and obvious berm 1-2m wide and up to 1m high on the downslope (north-east) side.

This shaft is first shown on the 2nd edition OS map, so either it was opened during the aborted early 1900s phase of works or – more likely – a capping had failed and the shaft was newly exposed.

The shaft appears to be stable and in no risk of deteriorating. However, the fencing around the shaft is in very poor condition and should be reviewed.

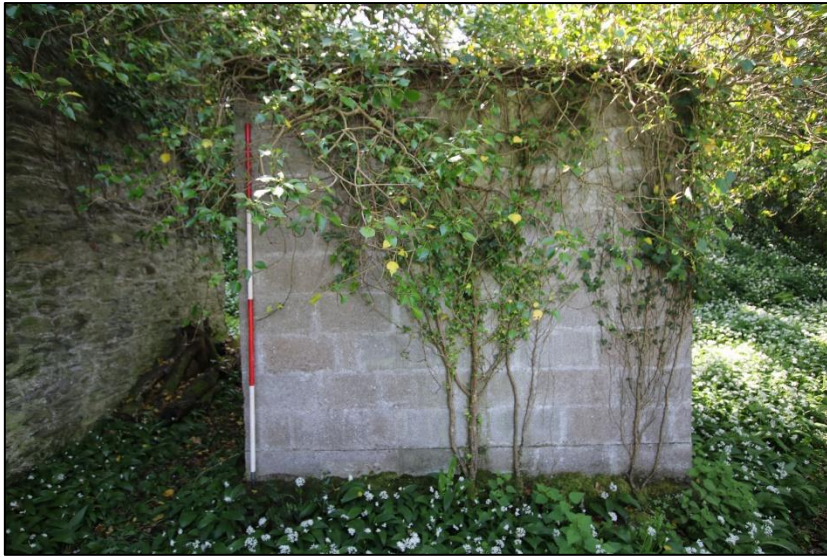
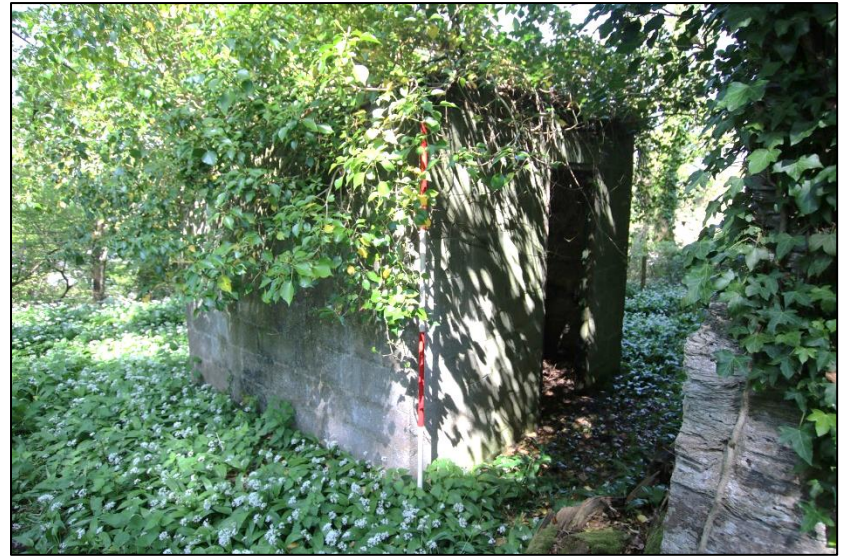
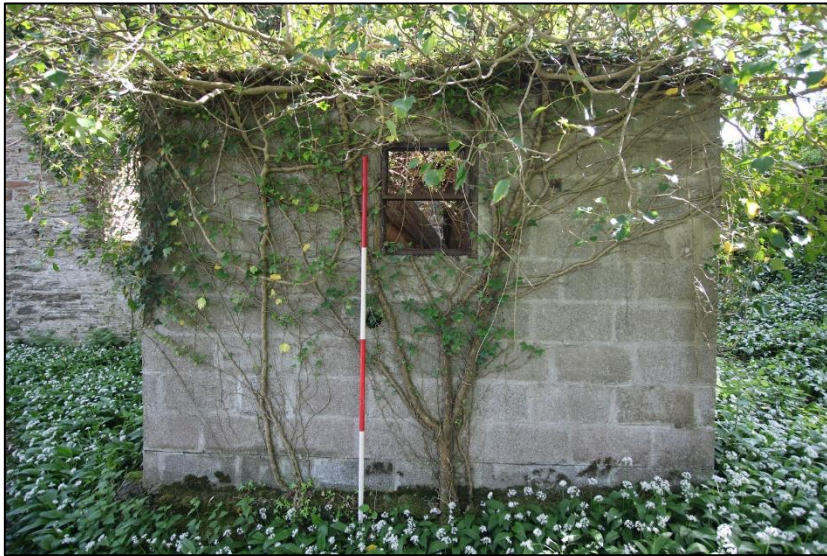
Located immediately adjacent to the north-west elevation of the engine house is a small single-storey C20th building containing C20th pumping equipment. On a concrete raft foundation, the structure is 3.27x2.65m across and built of a single skin of concrete blockwork bound with a hard cement mortar; the blocks used are 18"x9"x4" (440x215x100mm). The structure has a mono-pitch roof, sloping very slightly to the north-west, of corrugated asbestos-cement sheets supported on simple sawn pine joists. The joists have failed and the roof has partly caved in.

The walls of the structure are sound, but the roof has collapsed into the building, affecting the machinery inside. As and when the roof is made sound, the building could be considered in fair and stable condition.

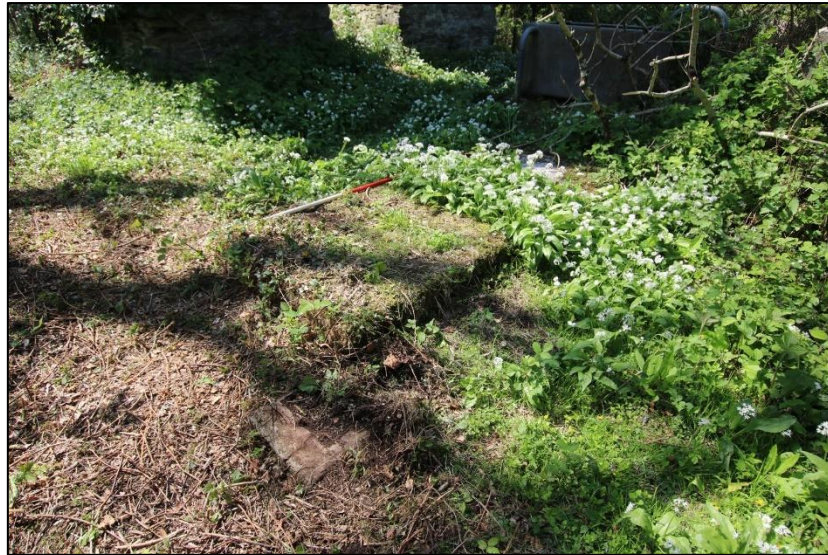
FIGURE 49: THE PAIRED CONCRETE PLINTHS; FROM THE EAST (SCALE 2M).

The concrete plinths are likely to date to the early 1900s, and the quality of the concrete is unlikely to be particularly high. Nonetheless, they appear to be in fair and stable condition. No interventions are required.

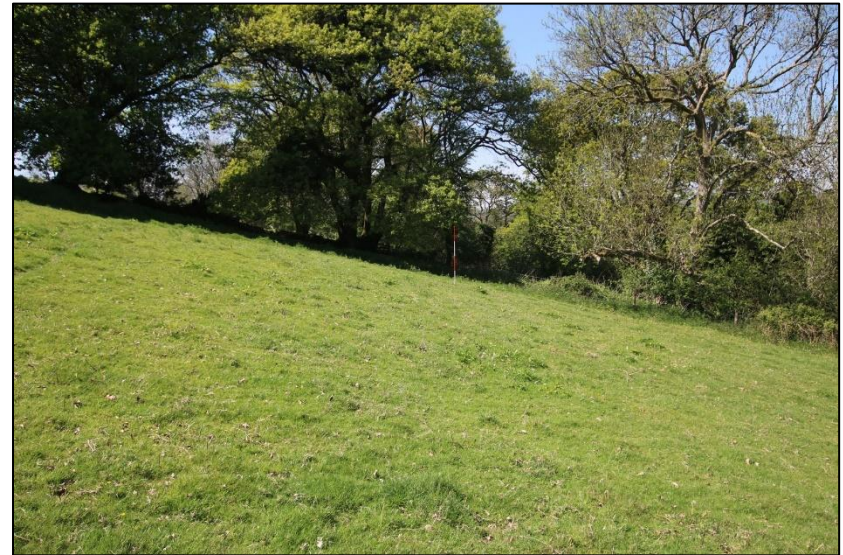
FIGURE 51: THE SITE OF THE CAPTAIN'S HOUSE; FROM THE ESE (SCALE 2M).

The captain's house survives solely as a below-ground archaeological feature; it can be considered to be in a stable condition. No interventions are required.

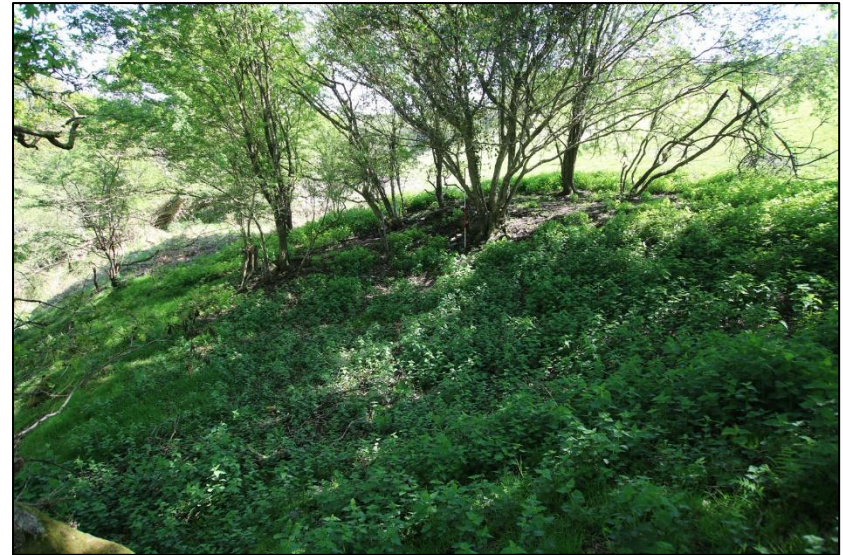
FIGURE 52: THE CRUSHER HOUSE TERRACE; FROM THE WEST (NO SCALE).

The crusher house has been almost totally lost; only its terrace and a short section of wall survive, the rest as a buried archaeological feature. The surviving visible fragments of wall are in poor condition, but can be considered to be stable, assuming the shrubs/roots are not removed. No interventions are required.

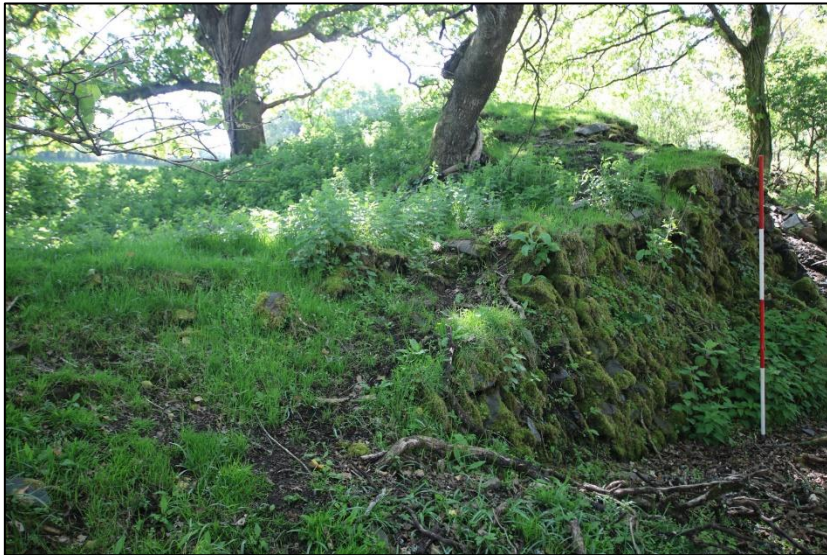
FIGURE 55: THE RETAINING WALL BELOW THE CRUSHER HOUSE; FROM THE NORTH-EAST (SCALE 2M).

The retaining wall to the north-west has suffered a partial collapse fairly recently and can be considered to be in a poor and declining condition. That structure would benefit from partial rebuilding.

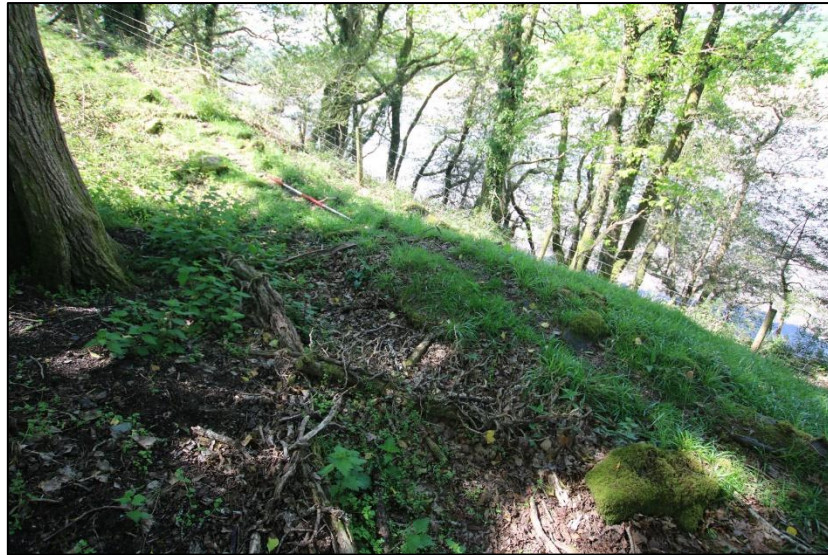
FIGURE 60: THE LINE OF THE POSSIBLE TRAMWAY; FROM THE SOUTH-EAST (SCALE 2M).

The tramway survives as a linear earthwork with some elements of stonework visible. It can be considered to be in a poor but stable condition. No interventions are required.

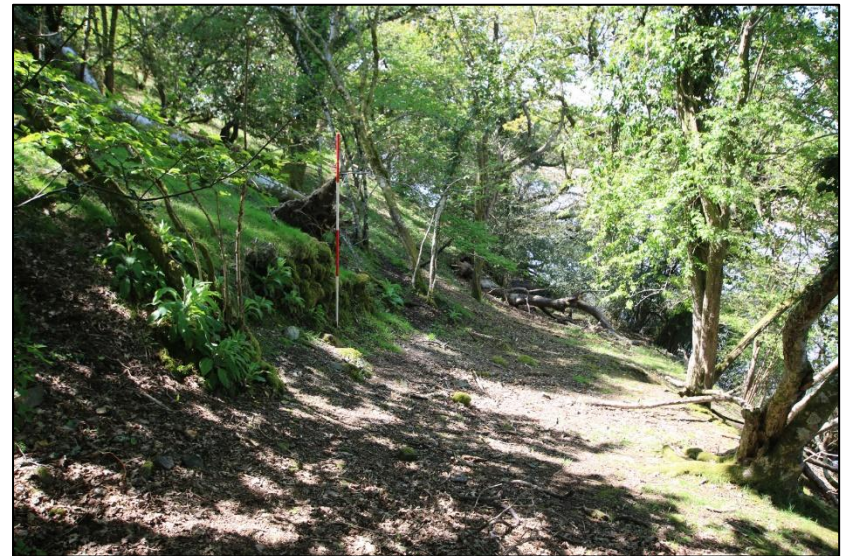
FIGURE 62: THE RAMP; FROM THE EAST, LOOKING DOWN TO THE RIVER (SCALE 2M).

At the eastern end of the site there is a wide, well-defined inclined ramp orientated roughly east-west and dropping down to the level of the river, labelled on the MAP as the coal quay. The ramp is between 4-5m wide and cut into the south (upslope) side by up to 0.6m. Towards the top the south side is retained behind a low wall of loosely coursed pitched stone.

The ramp survives as a linear earthwork with some elements of stonework visible. It can be considered to be in a fair and stable condition. No interventions are required.

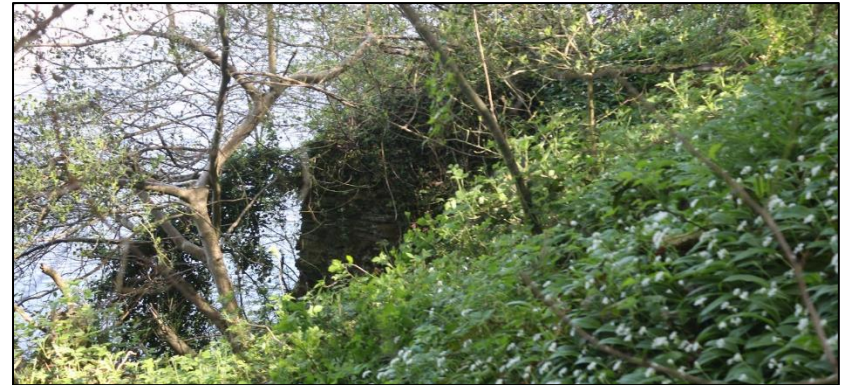
FIGURE 70: THE STRUCTURE; FROM THE SOUTH-WEST.

The function of this structure is difficult to determine, given the terrain and vegetation cover. Nance & Nance¹⁵ suggest it was a wharf, but elsewhere it is noted that there is an adit, c.20m long, driven from the riverbank, which connects to the shaft under the engine house, so perhaps this was built to block the entrance to this adit¹⁶. The line of the adit, but not its exit, are shown on the c.1860s MAP.

The structure appears to be in a fair and stable condition. There remains some uncertainty here, as the structure was difficult to access and its downslope side was not readily visible. If it does mark the entrance to the adit, the interplay between the waters of the river, and the water in the mine, may become an issue.
