**BEAFORD MILL**

Historic Building Appraisal of Mill Building

# Beaford Mill, Beaford, Torridge, Devon

## Results of a historic building appraisal of the Mill building

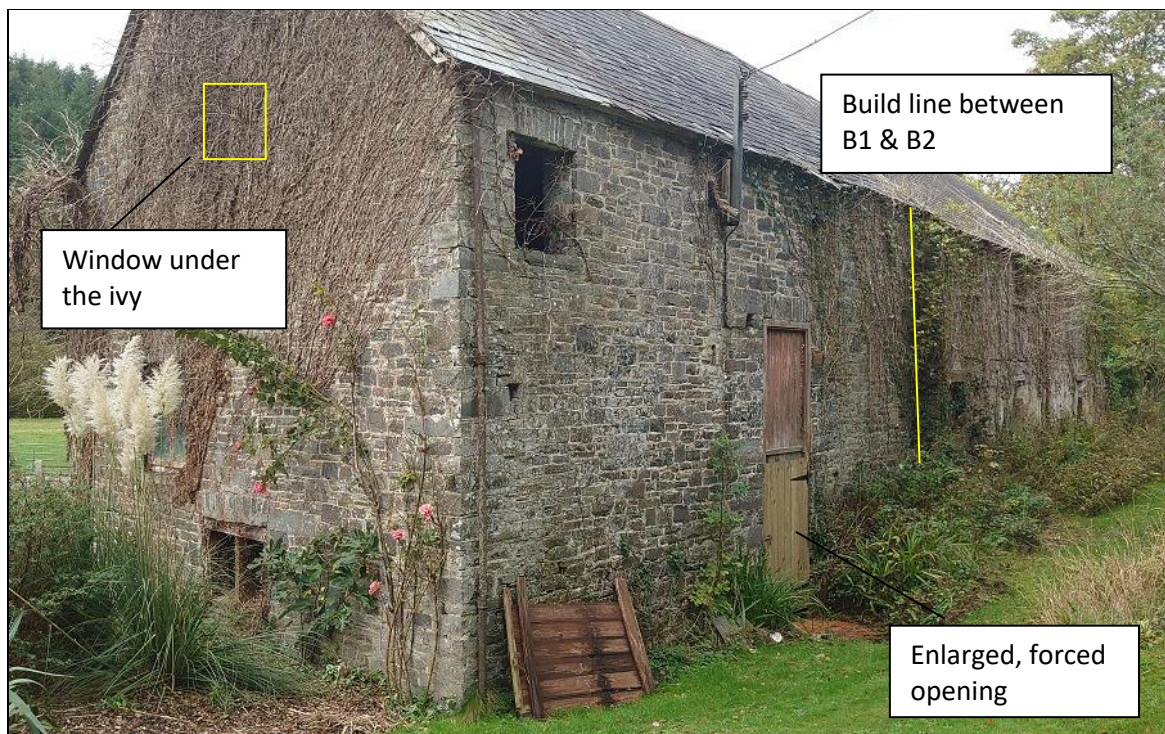
The north long elevation faces onto an area of grass and a steep bank rising to the orchard; this overgrown area may contain remains of the malthouse, brick floors appear to survive under the grass sward. This elevation has a slight overhang at the eaves, with the remains of a timber wall plate and barge boards, carrying cast iron guttering, the hopper and downpipe of which survive to the east end. There is a larger window at the attic level, set awkwardly close to the corner of the building, located to light the access stairs, this is now open but appears to show pintles for at least a shutter. To the first floor, offset to the west side is another longer window, or small loading door, which has been cut down below to form a continuous opening to the ground floor, awkwardly reset with a set of timber stairs accessing the first floor. Above is a timber frame and boarded loading door, on the ground floor is a modern plank door on modern hinges. It would appear a timber walkway and different configuration of steps may have accessed the mill here. The current opening allows restricted access to the ground floor of the mill, if one pushed past the steps; this change is again associated with changes in ground level outside. To the west end of the Mill at first floor there is also a small, blocked socket/air vent for machinery. Several small socket style holes in the stonework of this elevation suggest formerly attached timber framed structures. The western end of the building is externally still obscured by ivy; however, it appears it is abutted by Building 2's later rubble wall – it appears the west wall of Building 1 may have been removed, rebuilt or heavily remodeled in a phase of later change.

FIGURE 11: THE NORTH ELEVATION AND EAST GABLE ELEVATION OF BUILDINGS 1 AND 2; FROM THE NORTH-EAST.

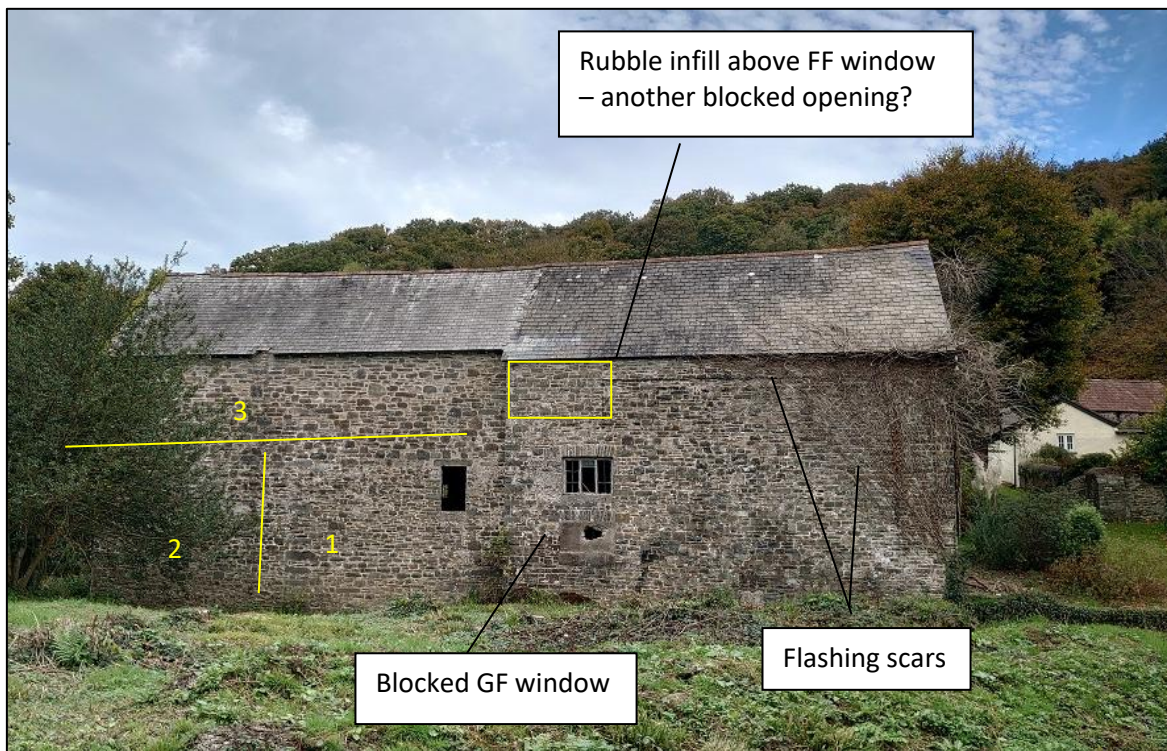
The south wall provides evidence of two phases of build to its deep ground floor build: with a neater regularised rubble build to the east end, similar, but possibly not as densely packed as the stonework to Building 1 – this phase clearly abuts the older quoins of Building 1. To the west end of this stonework is a vertical arrangement of stacked roughly faced slate slabs, seemingly surviving quoins, with a rough vertical build line seen beyond, defining a phase of extension to the west. Within the stonework to the east is a loading door with slate slab sill and lintel, it appears this may also have been altered, with clear rebuild around the sides, possibly widened from a slit vent. Beyond the vertical build line is a phase of rubble build of platey, small stones and with more use of slate; this has dressed block quoins at the corner, and some faced and dressed ashlar stones used as quoins, wrapping around to the west elevation. This western end of ground floor is blind, with no openings. Above these two ground floor phases of stonework the building has been raised with a deep loft storey. This is of loose, rubble build using much larger stones, of irregular shapes. All three phases of build on this wall are mortared in lime, patched and repointed in cement. Looking along this elevation from the west, the south wall of Building 2 can be seen to be straight in profile, of more obviously ‘modern’ build, not with the slight battered profile of Building 1 beyond, which appears more vernacular.

FIGURE 12: THE MILL BUILDING, THE STONEMWORK EVIDENCING STRUCTURAL PHASING; FROM THE SOUTH. THE FLASHINGS AND POTENTIAL BLOCKED WINDOW ARE ILLUSTRATED ON BUILDING 1. THE COMPLEX PHASING OF BUILDING 2'S SOUTH ELEVATION IS ALSO ILLUSTRATED.

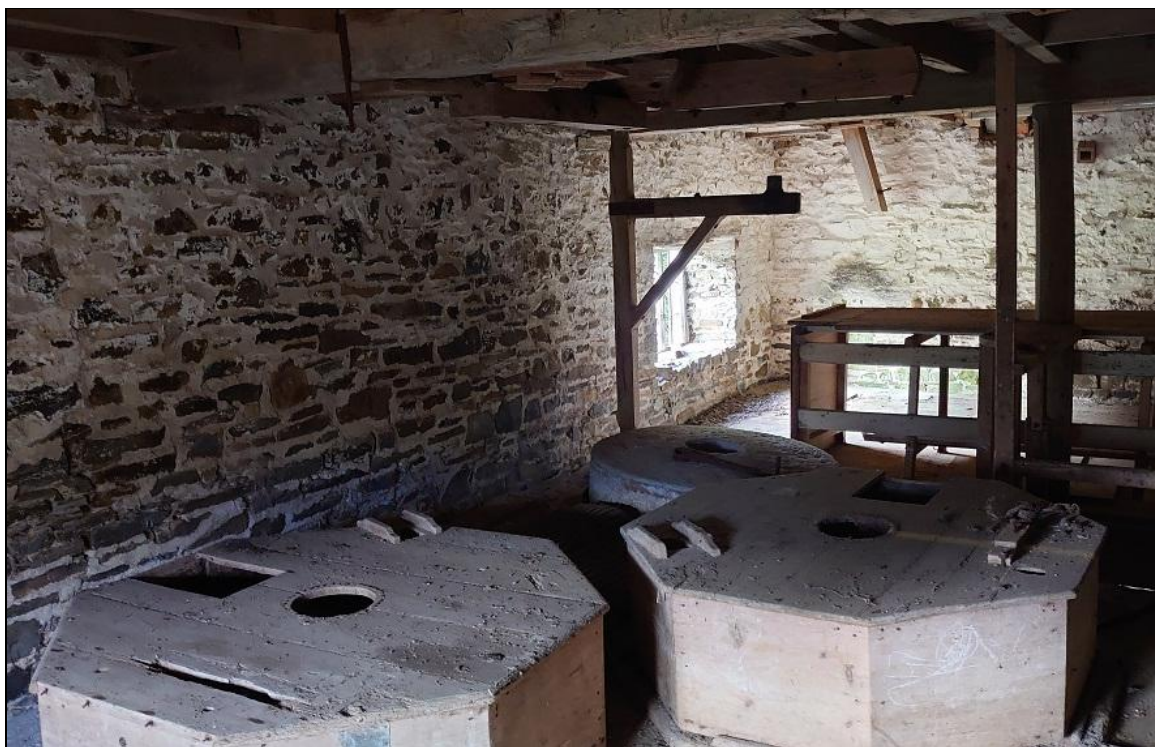
The first floor has very wide even width boards, which have rotted in places and are overlaid with MDF sheeting. The walls have a historic whitewash coating and possibly even areas of thin lime plaster, to the west end – to the east and south there is some evidence of whitewash but a lot more exposed stone. In the west wall is a series of sockets and slits for belts for machinery, entering into Building 2. There is a large socket in the north-west corner and a possibly keeping place for a lamp. There is a hatch in the centre of the floor between this level and the ground floor – the hatch has a full height frame built around it with guard rail and a hoist above. A large, fitted table frame stands to the west side, near the window in the south-west corner of the space; this window has a deep sill and is of good 18<sup>th</sup> century character. To the east and south are two large boxed-in mill stones and one exposed millstone, all in situ, still attached to the pins and framework below. A smaller square window in the east wall lights these mill stones, this is a 19<sup>th</sup> century casement. The ceiling beams holding the floor above are less heavy than those on the first floor, there is some additional iron strap work and fittings associated with the machinery, now removed. A ladder-like framework of open steps – formed from chunky planks on carriage braces in the north-east corner, access the loft, lit from above by the window in the north wall of the attic.

FIGURE 13: FIRST FLOOR OF THE REAR BLOCK OF THE MILL, WITH ENCASED MILLSTONES IN SITU; FROM THE EAST-NORTH-EAST.

- First Floor Building 1 – a partition could be considered along the line of the fitted table framework – but the mill stones should remain in place. The surviving 18<sup>th</sup> century three light window should be conserved and repaired if at all possible. The 19<sup>th</sup> century casement may be beyond conservation but if so a like-for-like window should be considered to inform on the narrative of change and the two dominant phases in the building. It may be possible to install another opening on the north wall of this space – largely screened from the rest of the landscape and this would protect the more visible and important southern elevation from change, the proportions of any opening should be carefully considered, and any frames set back, with minimal glazing, ensuring clear difference between new and original openings. Treatment of the exterior reveals of any modern openings and the types and styles of windows will need to be carefully consulted upon with the conservation officer. The opening for the stairs could be enlarged to gain a safe closed string turning stair to the attic level.

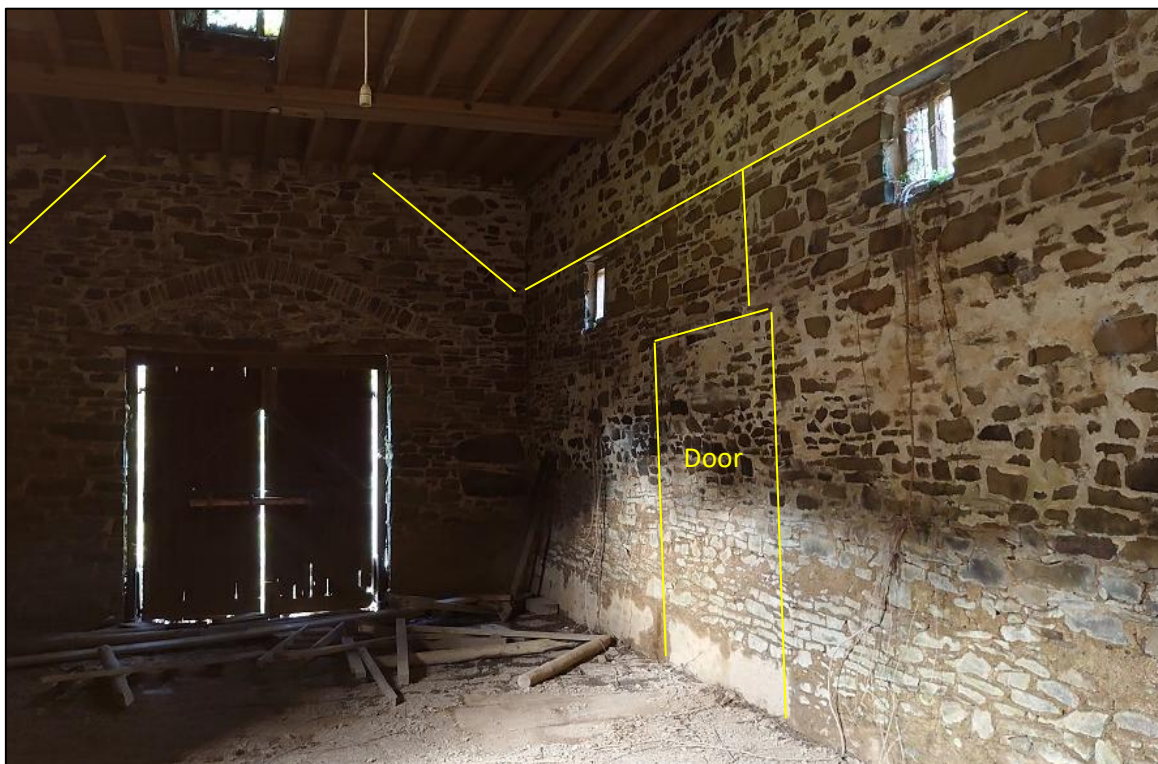
FIGURE 14: THE INTERIOR OF THE LARGE EXTENSION ON THE WEST SIDE OF THE MILL, BUILD LINES AND A BLOCKED DOORWAY ARE MARKED; FROM THE SOUTH-EAST.

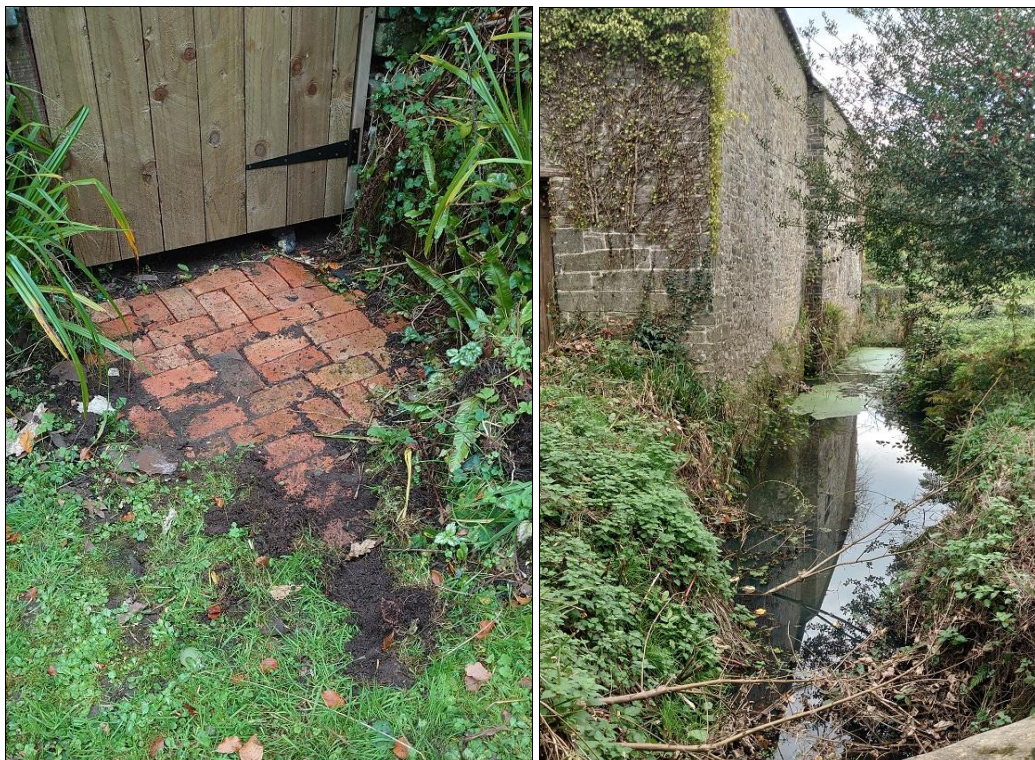
FIGURES 17 & 16: THE BRICK FLOOR TO THE NORTH OF THE MILL BUILDING UNDER THE GRASS (LEFT) AND THE LEAT TO THE SOUTH OF THE BUILDING (RIGHT).

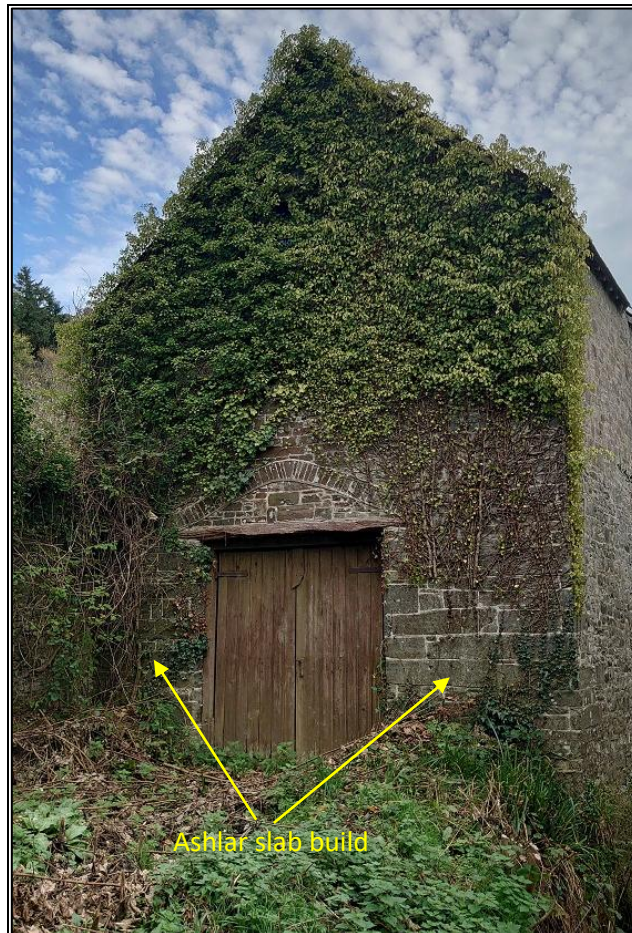
FIGURE 18: THE WEST WALL OF BUILDING 2, SHOWING DIFFERENCES IN BUILD, POSSIBLY USING RECYCLED ASHLAR AND LARGE DOUBLE DOORS TO THE INTERIOR, THE DATESTONE IS BELIEVED TO BE UNDER THE IVY; FROM THE WEST.

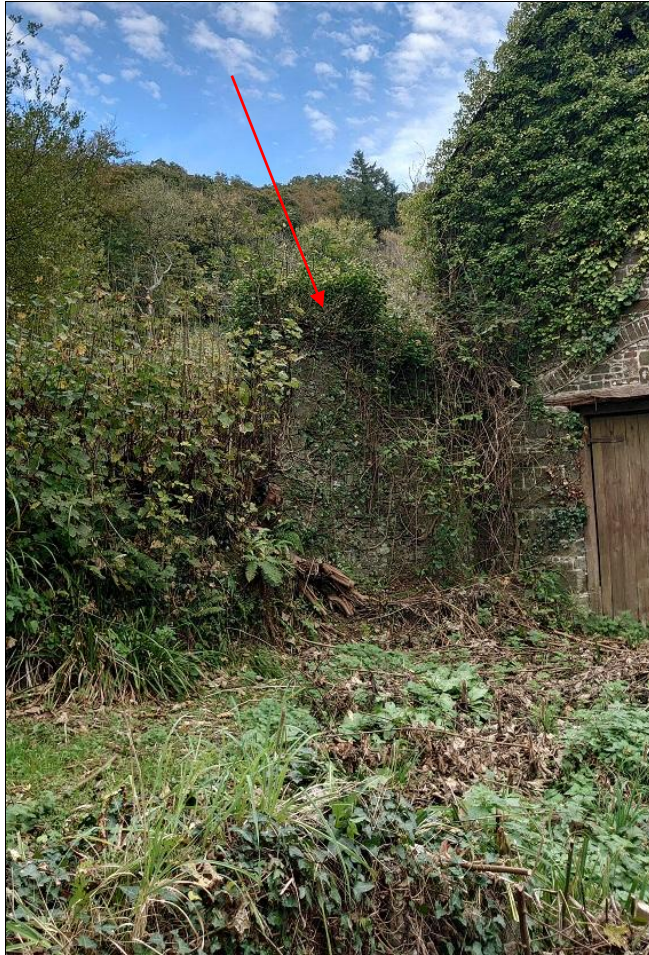
FIGURE 19: THE FRAGMENT OF BUILDING 3, ATTACHED TO THE END OF BUILDING 2; FROM THE SOUTH-WEST.
