# BUILDINGS AT HIGHER LANGDON FARM JACOBSTOW CORNWALL

Results of a Desk-Based Assessment  
&  
Historic Building Recording

Report No.: 110414  
Date: 14.04.2011  
Author: E. Wapshott

**Location:** Buildings at Higher Langdon Farm  
**Parish:** Jacobstow  
**County:** Cornwall

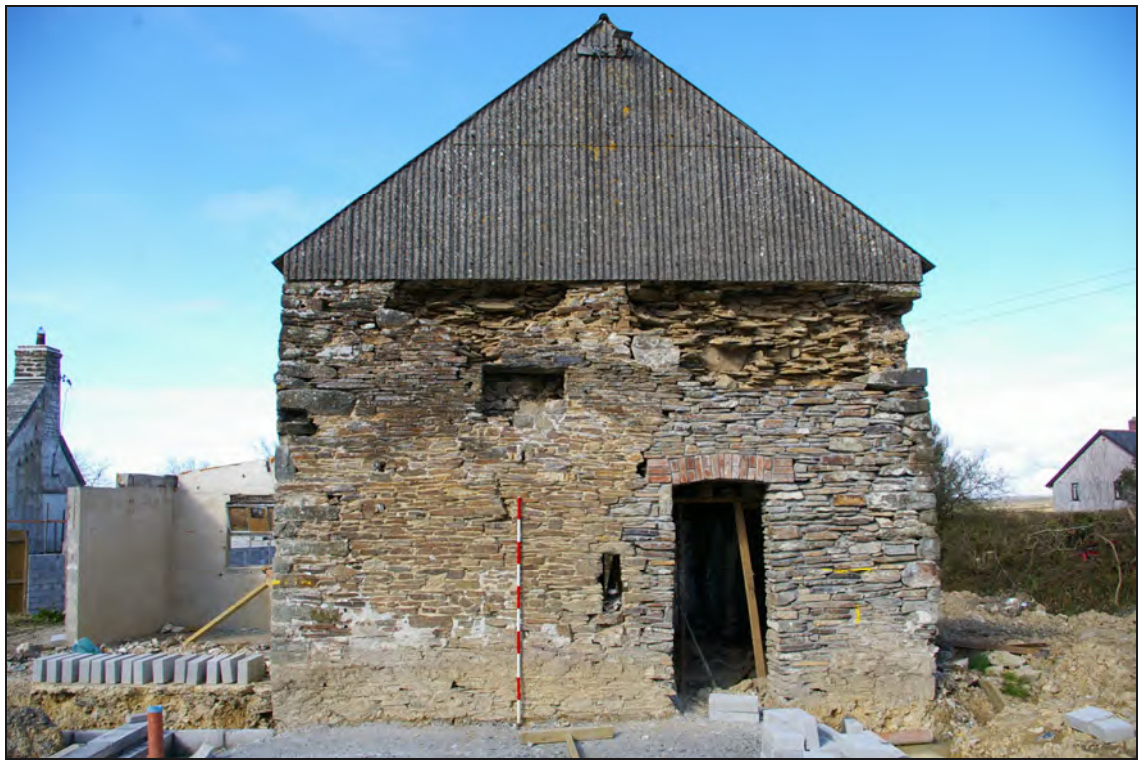
Figure 6: The south elevation of the granary, viewed from the south.

The gable end of the roof is boarded-in to the apex, using corrugated fibre sheeting. The elevation is of rubble construction, very closely packed slate-stones, in a creamy-yellowish lime mortar, with substantial blue/grey faced sandstone quoins. The stonework of the elevation has

been much repaired and partly re-built to the east side; however there is a large proportion of stone missing at eaves height, presumably damaged upon removal of the formerly attached engine house. There is a large off-set slate lined socket which would have held the main roof beam of the engine house; which has been forced into the elevation; here also is a central slit vent with stone lintel and sill, this splays to the interior and is built into the wall, not forced. The vent is approximately 1m from the modern floor level within the newly-constructed foundations of the former engine house. A doorway with a brick segmental arch has recently been forced through the elevation.

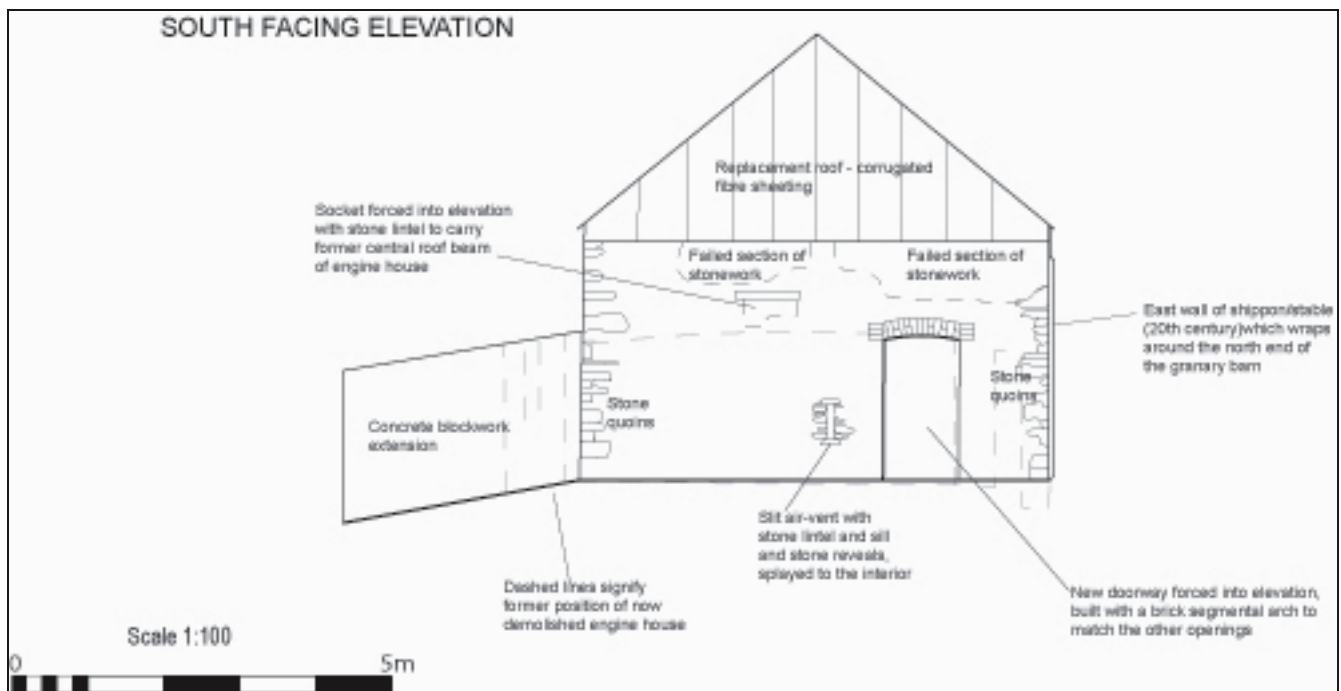
Figure 7: The south elevation of the granary, scale 1:100.

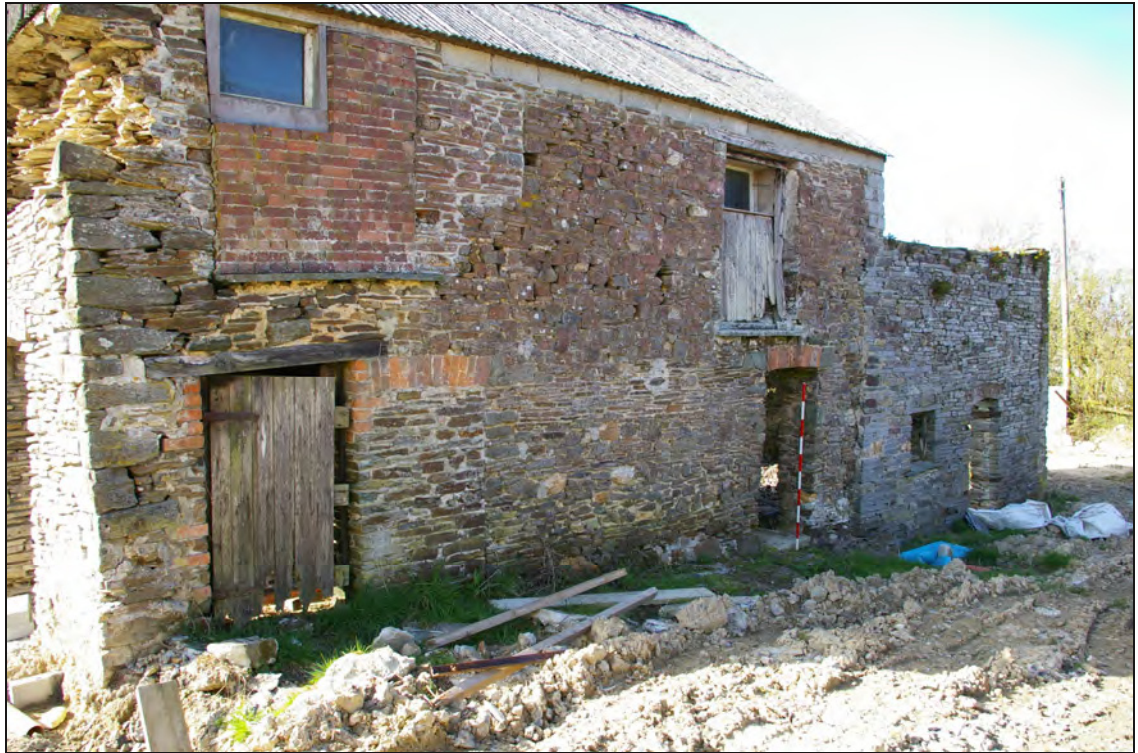
A roof of pitched corrugated fibre sheeting covers a rubble stone wall of various phases. There are two first-floor openings, to the south blocked with brick and a small single pane of glass, to the north, partly blocked using timber planking and a larger pane of glass, both with thin timber lintels and slate sills. The openings appear to have been forced into the later blocky stonework and an area of wall to the right of the southern opening has had to be rebuilt. On the ground floor there is a narrow doorway to the south, with a timber planked door, thin timber lintel and part brick reveals; this has cut an earlier opening with a segmental brick arch (using pale orange handmade bricks) and blue/grey sandstone quoins, with an unusual wedge shaped header stone, cut to fit the brick arch. There is another ground-floor opening to the north, with the same stone quoins to the reveals and a brick segmental arch, with blue/grey sandstone headers; between these two ground-floor doorways there is a recurrence of the closely packed slate-stone rubble stonework, with a creamy-yellowish lime mortar. Above the line of the doorways the stonework changes, becoming blocky and more loosely packed with noticeable gaps, of red/blue sandstone, in a dark greyish-brown mortar or clay bonding. The substantial blue/grey sandstone quoins of the south elevation wrap around to the east and can be seen to the north end of the elevation. The wall has been raised using a course of concrete blocks to accommodate the new roofline. The quoins to the north are partly obscured by the abutting more modern eastern elevation of the shippon/stable and are repaired in concrete block to eaves height.

Figure 8: The east elevation of the granary and the shippon/stable, viewed from the south-east.

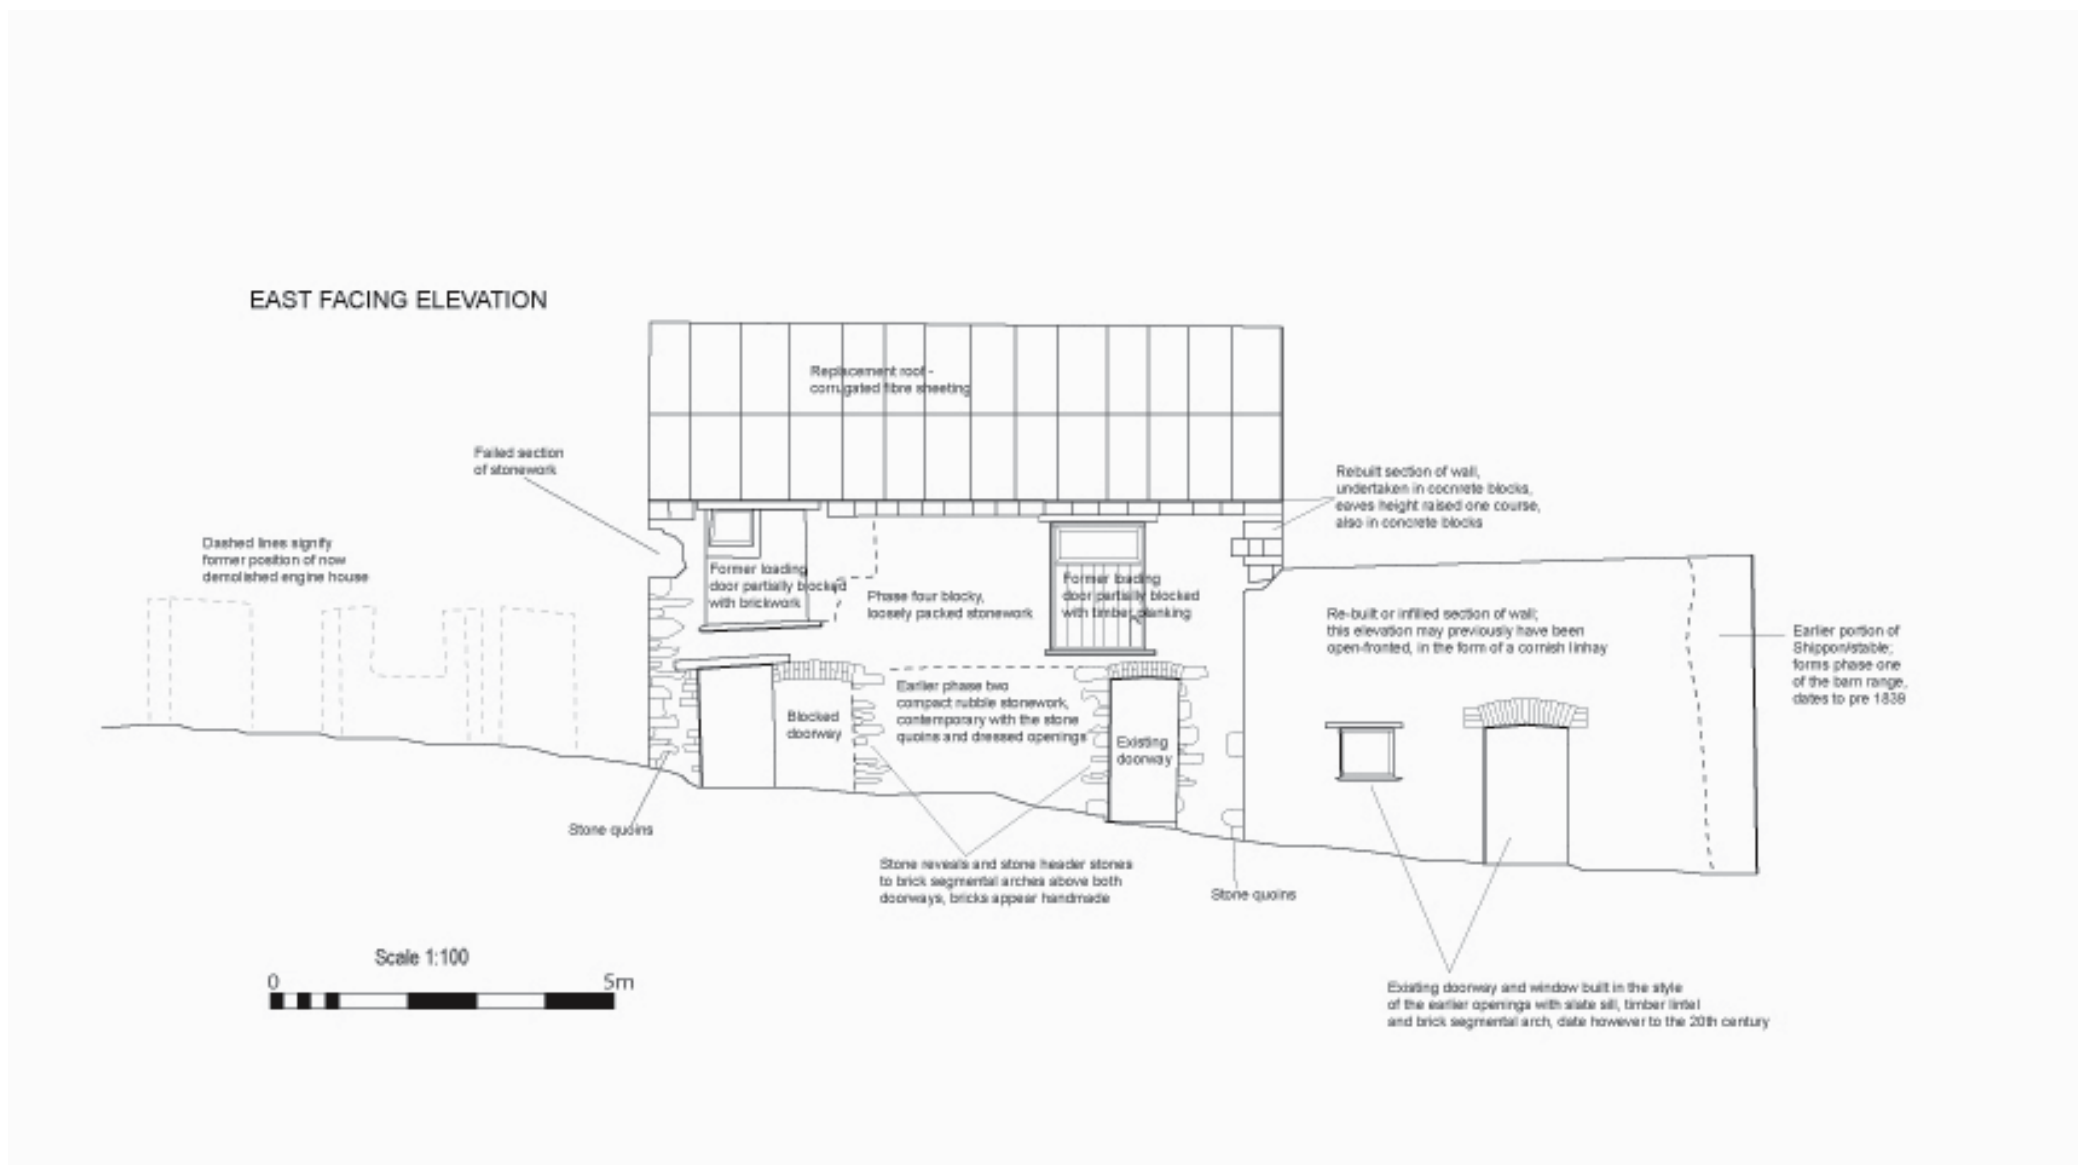
Figure 9: The east elevations of the granary and the shippon/stable, scale 1:100.

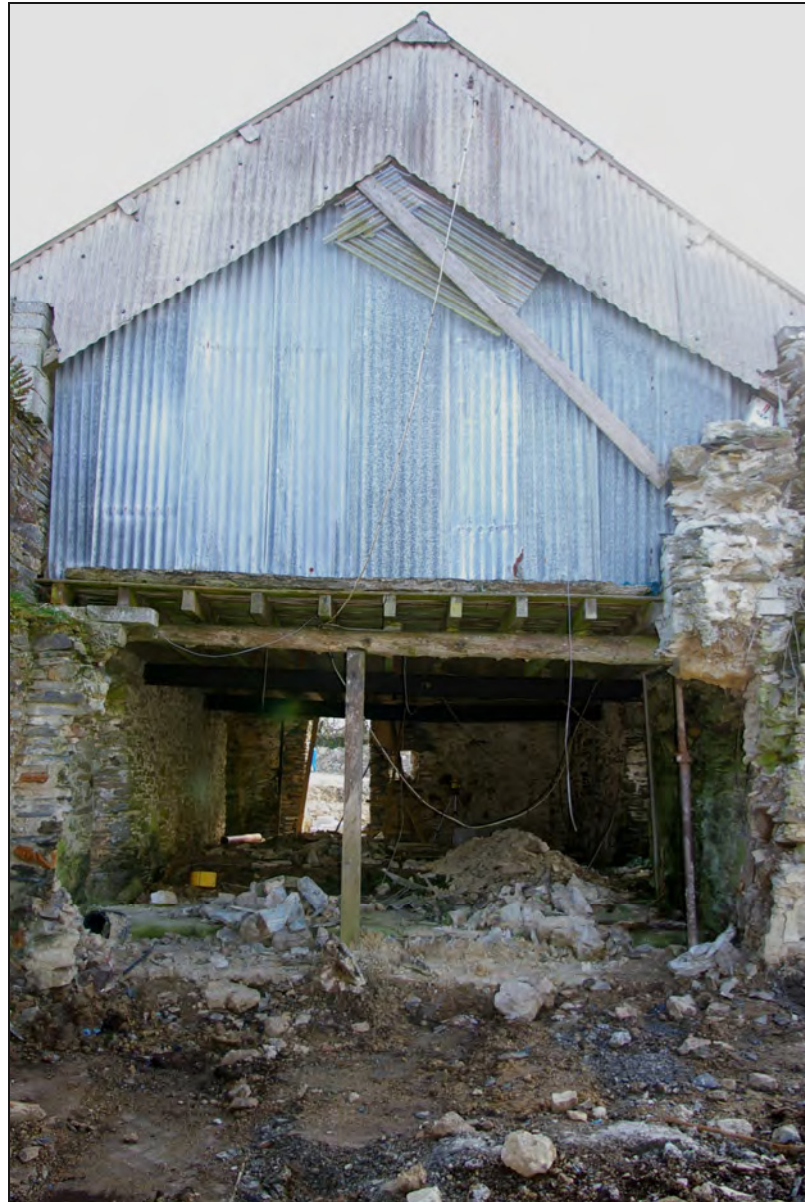
The gable end of the roof is boarded using a mixture of corrugated fibre sheeting, plastic and tin. This sheeting extends down to first floor level with exposed joists projecting at the base. Below the exposed end of flooring there was a stone wall, now demolished and exposing the ground-floor of the barn. The gable ends of the east and west walls have faced blue/grey sandstone quoins. The east wall of the shippon/stable abuts the north elevation, the wall to the west has partially been demolished, a small section at first-floor height remains tied-in to the northern gable-end of the granary.

Figure 10: The north elevation of the granary, with view into the interior, viewed from the north.

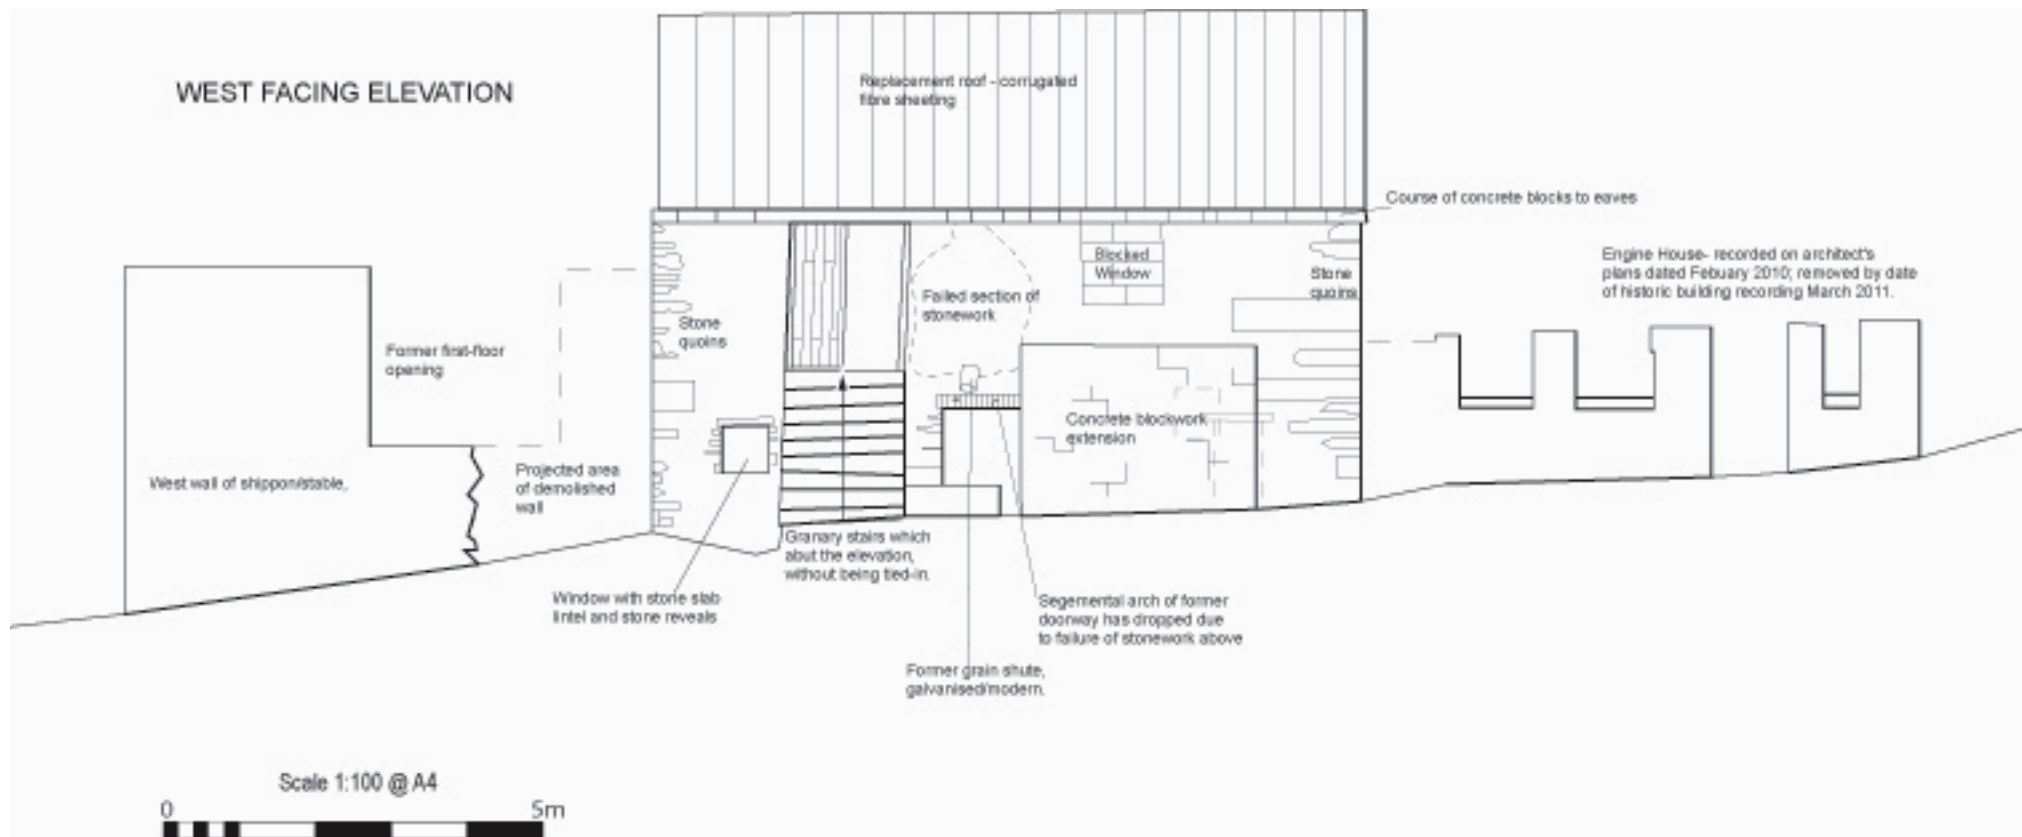
Pitched corrugated fibre sheeting forms the roof above a rubble stone elevation of various phases. There has been much repair to this elevation, with further recent damage obscuring the majority of the stonework; where the earlier build is visible it appears to be of the same nature as the east and south elevations, with tightly packed thin slate-stone stonework, with the blue/grey sandstone quoins to the north and south ends. On the ground-floor to the north is a small window with a stone lintel and slate sill and a partly remaining timber frame, to the centre of the elevation is a doorway with a brick segmental arch, of the same style as those on the east wall. This doorway has blue/grey sandstone quoins to the reveals, although much is now obscured by debris. Above this the wall has collapsed and the arch has been flattened and is now supported by timber posts. A galvanised grain chute has also been forced through the wall, above the doorway. A set of later stone steps with slate slab treads abut the wall and are not tied-in, they rise to the first-floor loading door, which has been forced through the wall, with a replacement former railway sleeper for a lintel and a pair of timber doors.

Further to the south at eaves height is a small blocked window and to the south end of the elevation there is a partially demolished block-work extension, rendered internally, with a modern three over three pane metal hopper-casement window in its north wall; the stonework of the elevation, above the roofline of the extension has the remains of render flashings from the single pitch lean-to roof, now removed. The elevation has been raised using concrete blocks to accommodate the increased modern roofline.

Figure 11: The west elevations of the granary, shippon/stable and extension; scale 1:100.

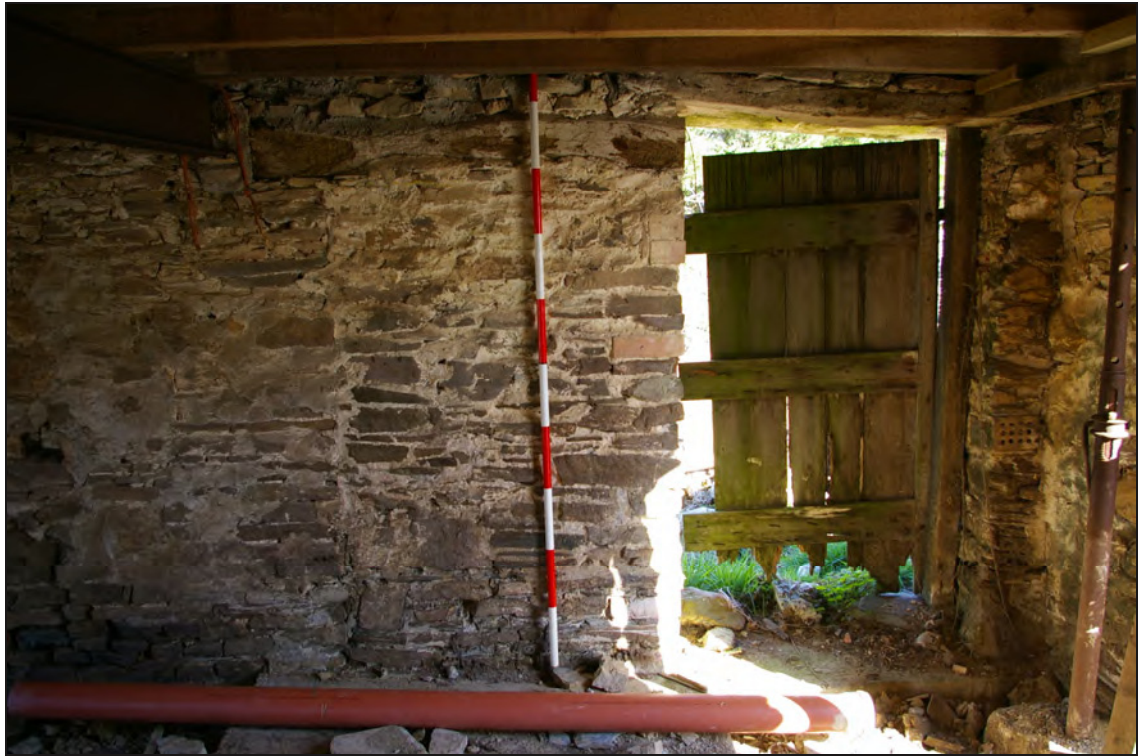
The interior of the barn has no surviving historic structure; the floor is reduced in levels to the north, the historic floor having been removed apart from a small section in the middle of the building, although this is now much obscured by building debris and by existing modern concrete floors. The walls are of exposed stone with some remaining whitewash. The doorway

Figure 12: Interior view of the multiple phases of openings at the south end of the east wall of the granary, viewed from the west.

to the west has a large internal timber lintel, relieved over the doorway to allow for headroom, this matches the internal timber lintels over the doors to the east wall at the north end and the blocked doorway to the south. The forced door in the south end of the east elevation has a very narrow timber lintel and internal timber lacing to the reveals. The slit vent in the south wall has a wide splay to the inside of the barn and there is a further possible slit vent blocked in the south end of the west elevation, now obscured on the outside by the render within the concrete block extension. This appears to be cut by a further blocked opening, possibly a low doorway which has a narrow timber lintel and is roughly opposite that on the east wall. The small window in the west wall has a large internal timber lintel which is rotten and has failed. Two large iron girders span the building to the south, with a rough pine beam to the north, all of these lie in large sockets in both the east and west walls which would have held substantial timber beams, these sockets have been packed with loose stone or cemented to hold the floor. The joists run north-south and are relatively modern.

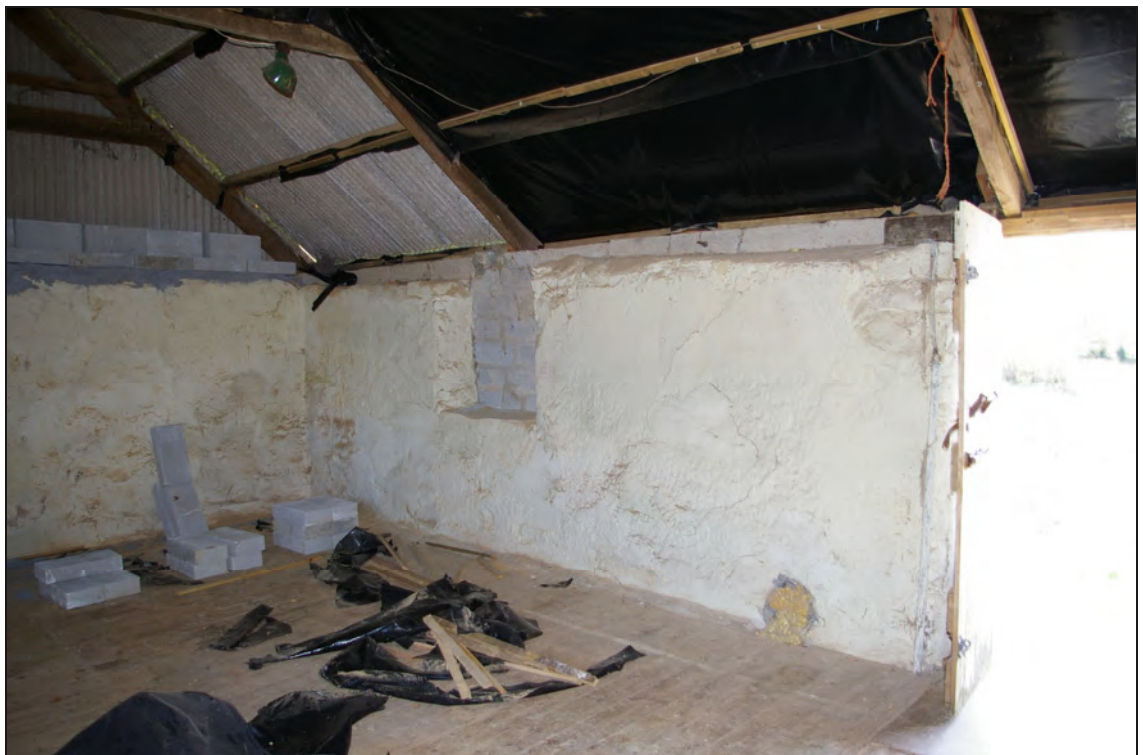
Figure 13: Interior view of the first floor west wall of the granary, viewed from the north-east.

The north wall is of corrugated sheeting with MDF or similar sheeting to the interior. The west wall is plastered with a top course of concrete blocks to the roofline. The blocked window has splayed reveals and a slate internal sill but any lintel has been removed. The south wall is plastered, with a top course of concrete blocks and boarding to the apex of the gable. There are no discernable features. The east wall has the two openings, to the south blocked by brickwork which remains exposed to the interior side, with internal slate sill, with a small square single pane of glass in a timber frame, to the north the opening is blocked and partly boxed in using MDF or timber boarding, with a large rectangular timber framed single pane window. The floor boards are of late 19<sup>th</sup>/early 20<sup>th</sup> century date, and have a layer of render/cement sealing them to the wall, as this first-floor space was used as a granary. The roof structure is timber, of modern A-frame construction and is battened and padded in black plastic again to protect the grain.

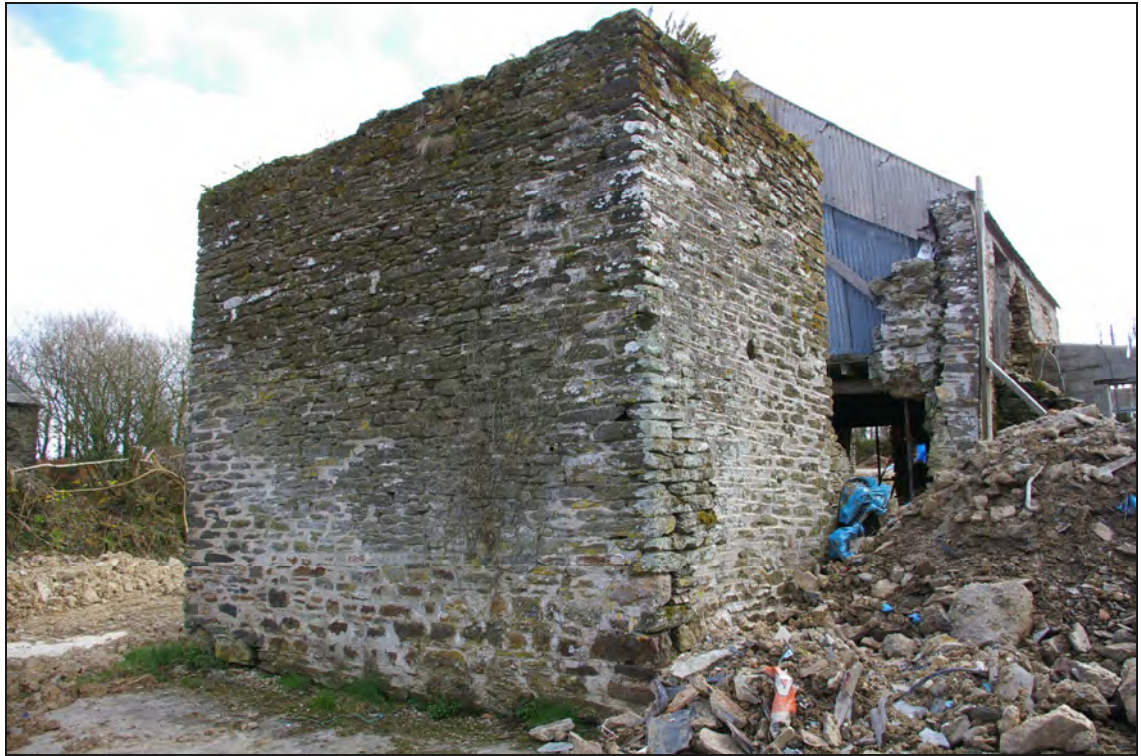
A substantial elevation of very good quality large semi-coursed slab-like slate-stones, with a drain hole built into the east side at ground level, with a stone lintel. Blockier stones have been used to form informal quoins to the east and west corners. The stonework appears to be bonded using clay, with a grey lime mortar; it has received several phases of cement mortar repairs.

Figure 14: The north elevation of the shippon/stable, viewed from the north-west.

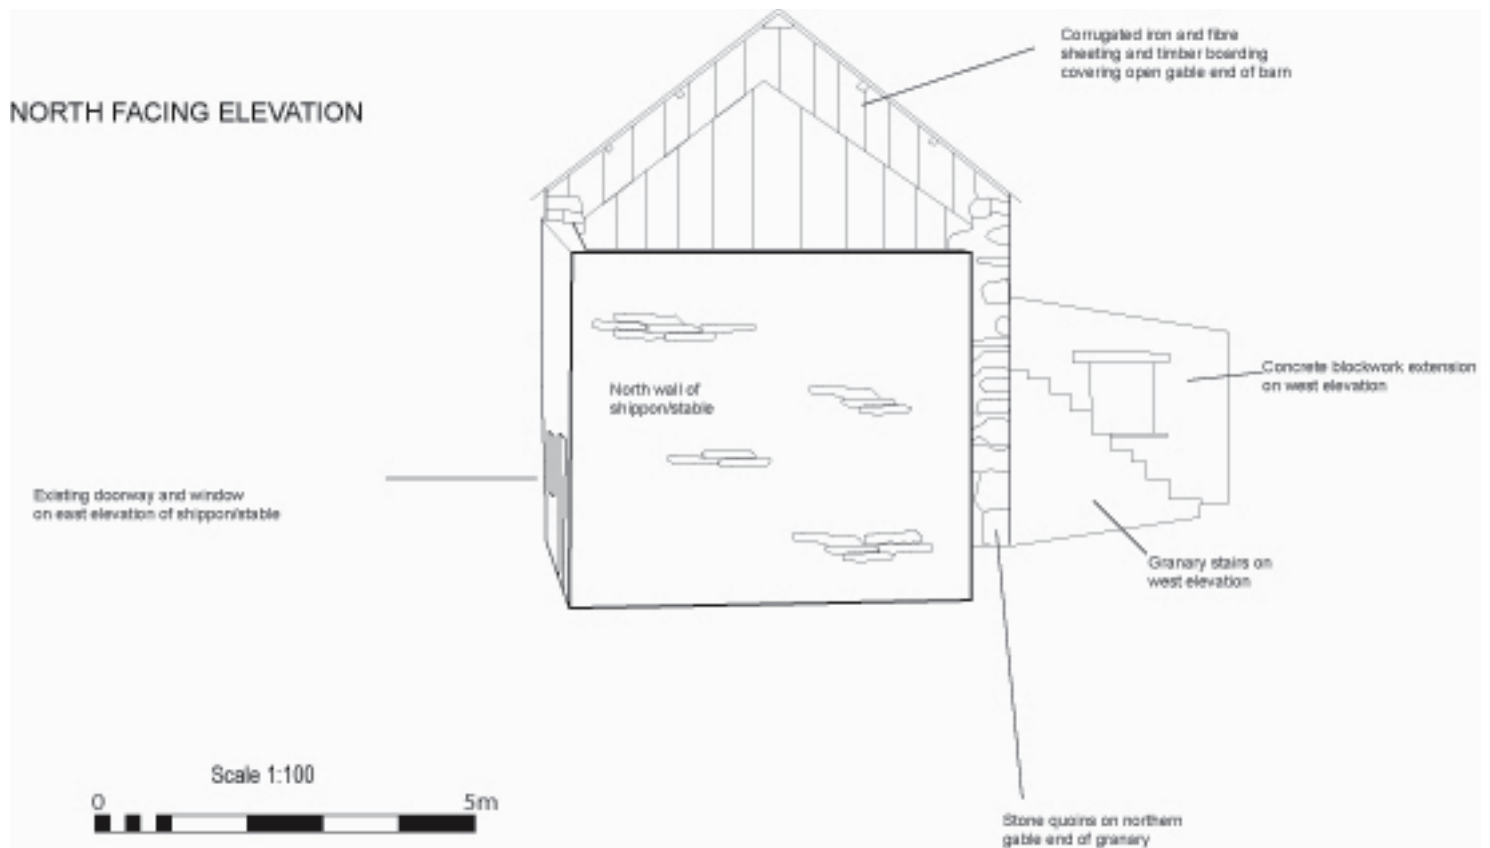
Figure 15: The north elevations of the shippon/stable, with the granary barn to the rear; scale 1:100

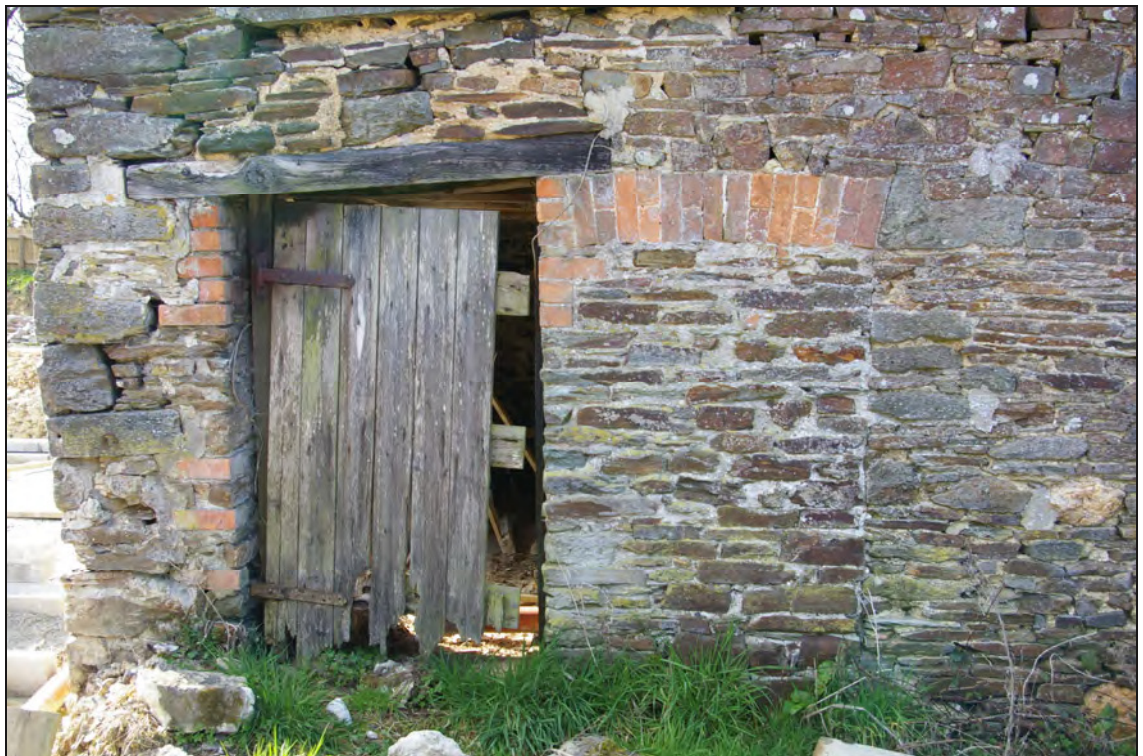
Figure 16: Detail of the doorway and blocked doorway at the south end of the east elevation of the granary, viewed from the east.

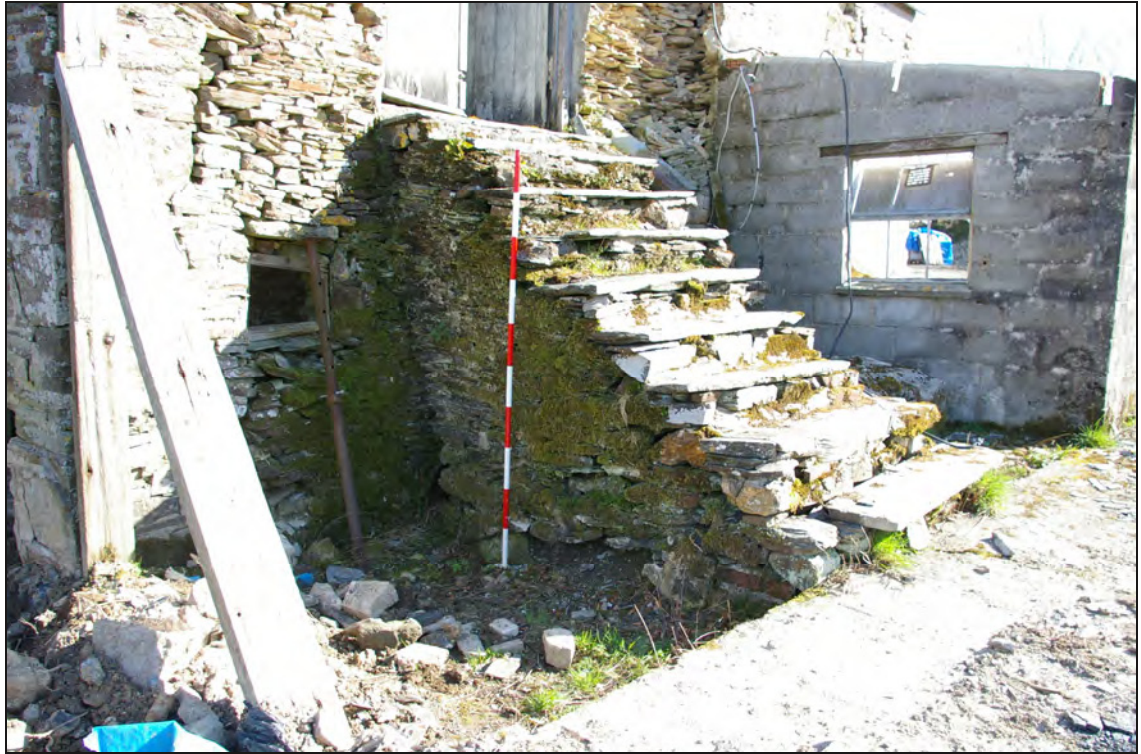
Figure 17: View of the relationship between the granary stairs and the west elevation, viewed from the north-west.

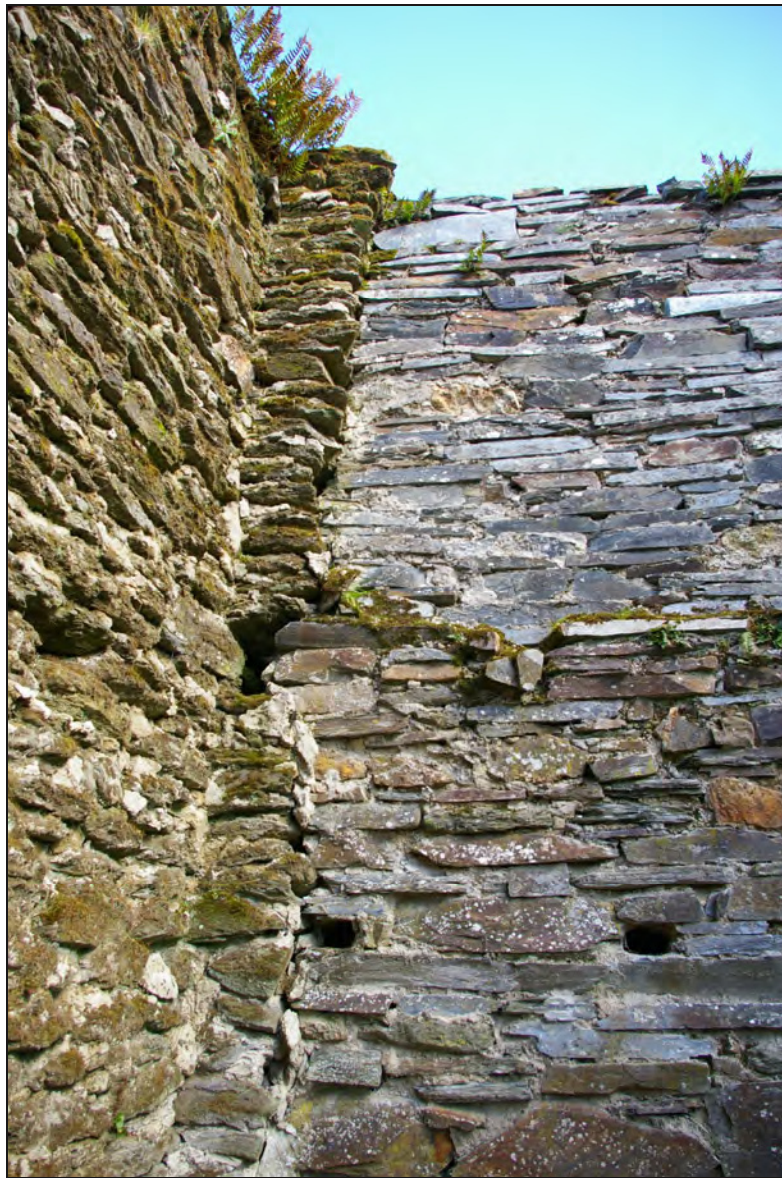
Figure 18: View of the east wall of the shippon/stable abutting the north elevation, viewed from the south-west.

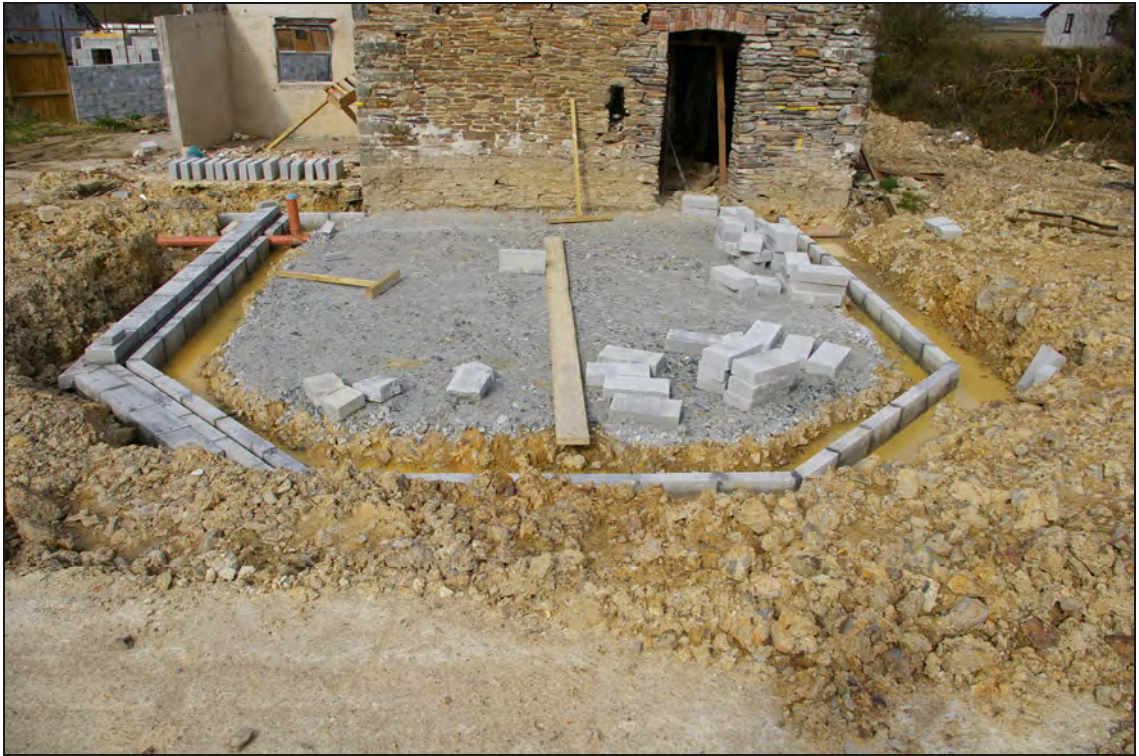
Figure 19: View of the new foundations on the site of the former engine house, viewed from the south.
