# **Archaeological Building Recording**

**25 Kathleen Street**

**Hartlepool**

December 2009

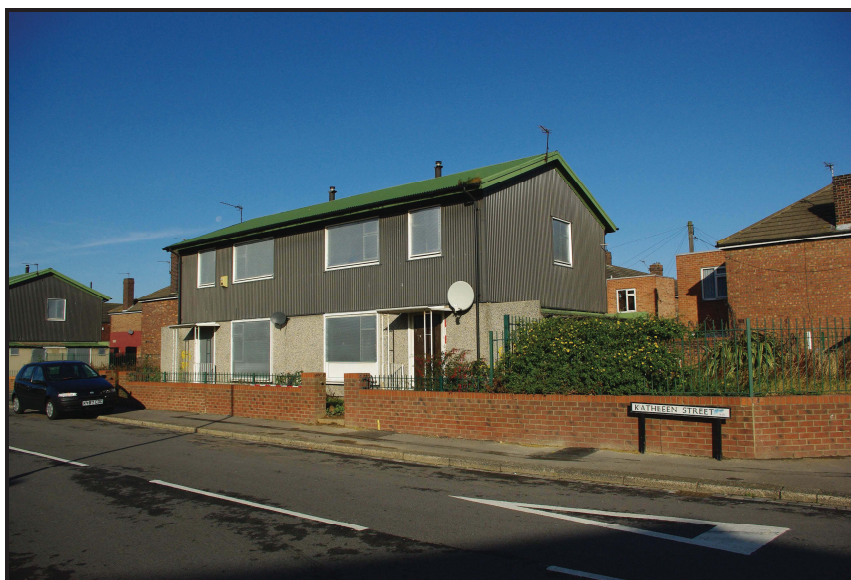
4.1 The sample housing unit used in the survey was No. 25 Kathleen Street (Plate 2), which sat to the north of the demolition zone (since been demolished) on the corner of Kathleen Street and Kendal Road.

*Plate 2 – No. 23 & 25 Kathleen Street (Photo no. 2)*
