**SURVEY OF BUILDINGS AT  
MANOR FARM,  
NORTH STREET,  
DIGBY,  
LINCOLNSHIRE  
(DINS11)**

Work Undertaken For  
Stonewell Homes Ltd

April 2011

A.P.S. Report No. **48/11**

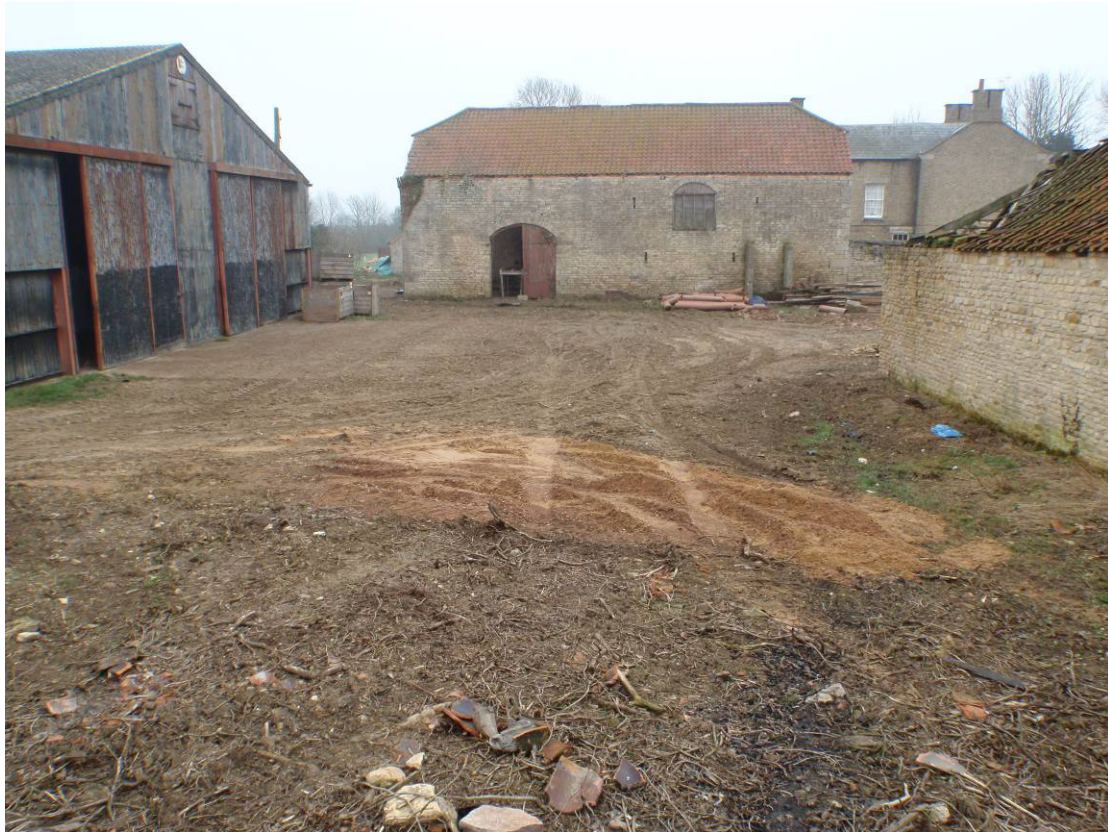
Plate 1 – Building 1 - West side of barn, cowhouse and modern shed, looking east

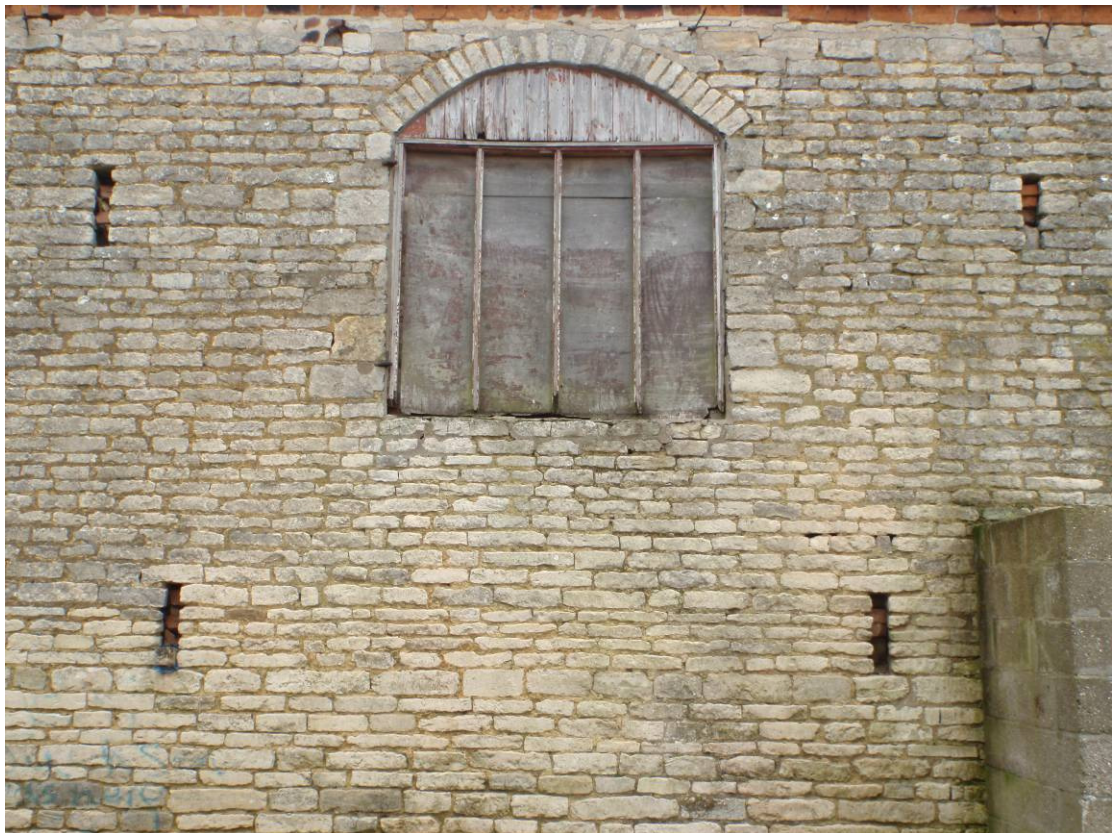
An opening set high in the west wall and south of the doors would probably have functioned as a pitching door. It has an arched, stone lintel and contains a wooden frame boarded from the inside (Plate 4).

Plate 4 – Building 1 - West side of barn, pitching door and ventilation holes, looking east

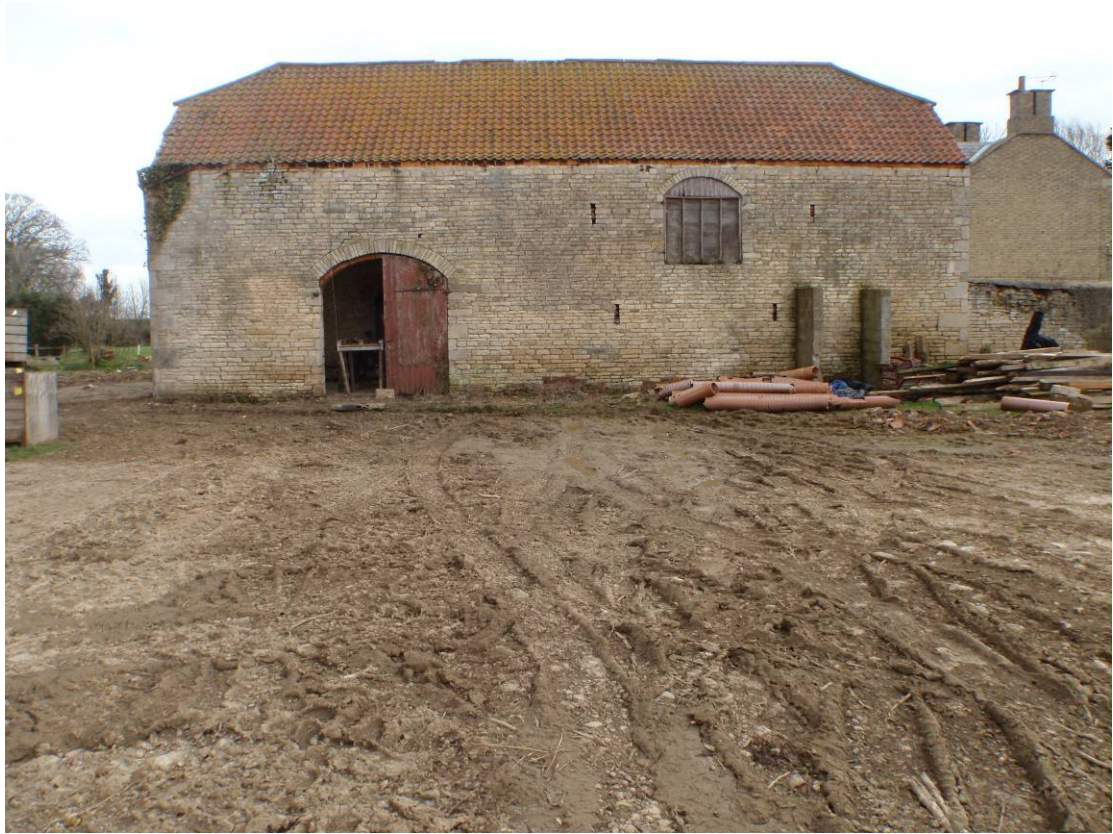
Aligned north-south, with internal dimensions of 17.18m by 6.10m, the building is constructed from coursed limestone rubble, with dressed stone quoins at each corner extending the full heights of the walls (Plates 5, 6 & 7). A course of red brick is visible at eaves level in the west facing elevation and areas of brick occur at the base of the same wall (Plate 5).

Concrete supports for a modern oil tank (no longer in place) abut the west wall of the barn, near the southwest corner (Plate 5). A stone wall extends between the same corner and the east wall of Building 2, to form a boundary with the adjacent Manor House.

Plate 5 – Building 1 - West side of barn, looking east

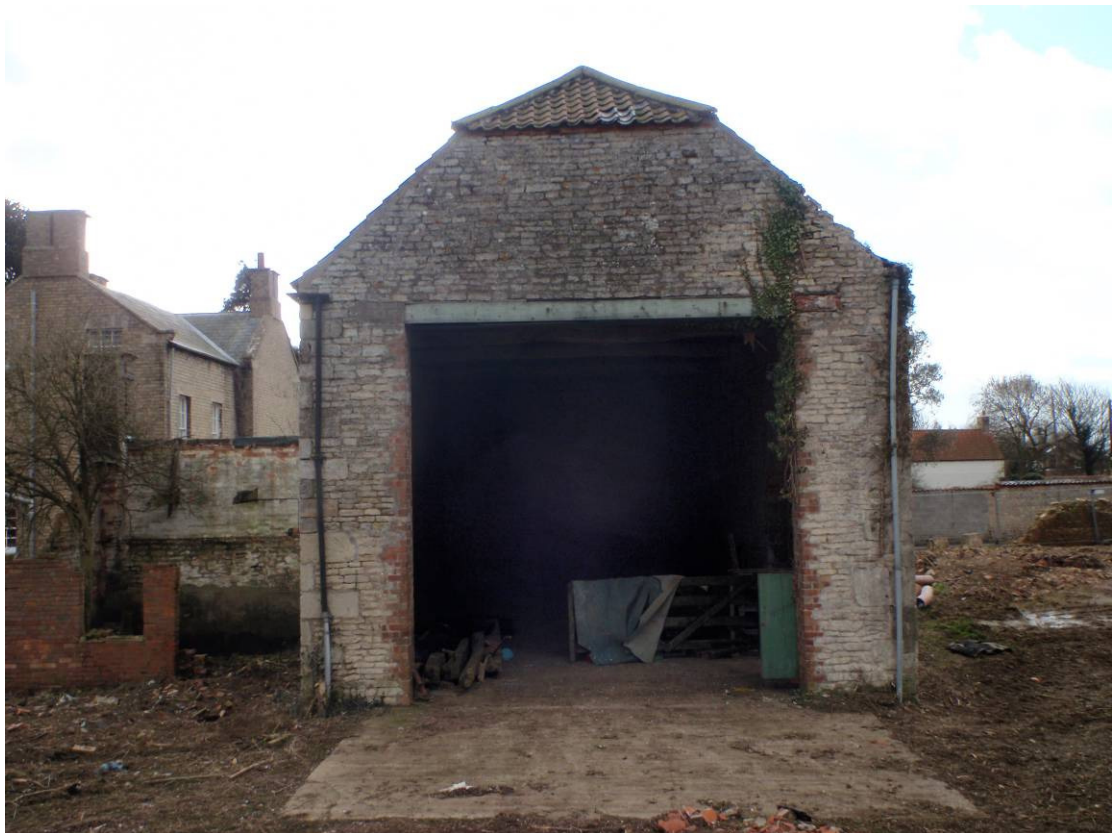
The majority of the north wall has been removed to create a large opening – presumably to allow access by modern farm machinery (Plate 6). The sides of the opening are finished in modern brick and the remaining half gable is supported by a timber lintel. The west door is intact, indicating a sectional design, sliding along the adjacent walls on metal runners. The runners of the east door survive but the door itself has been removed. A concrete floor extends throughout the barn (Plates 13 & 14).

Plate 6 - Building 1 - North side of barn, looking south

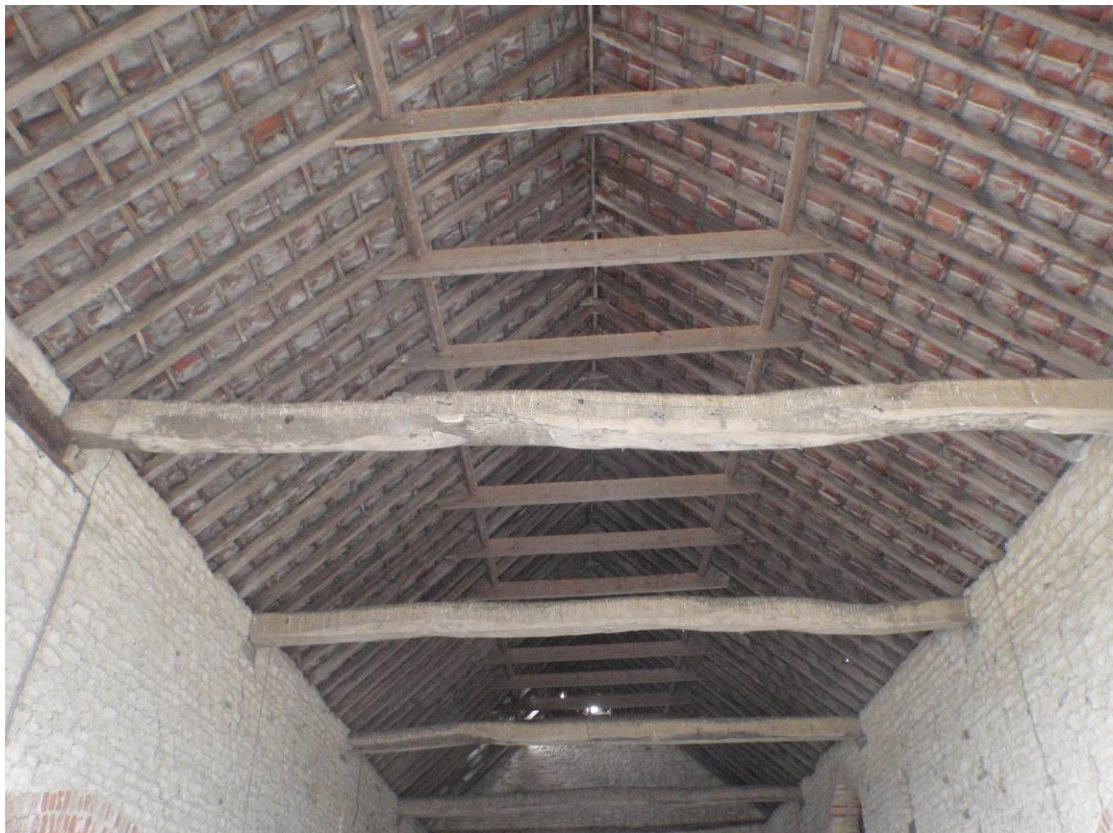
The roof is half-hipped and covered by pantiles (probably modern) (Plate 5). Internally, four tie-beams span the building at just below eaves level, apparently independent of other elements in the roof structure. The latter comprises common rafters and purlins, with tie-beams between the rafters at every third pair, clasping the purlins (Plate 8).

Plate 8 – Building 1 - Interior of barn, roof, looking south

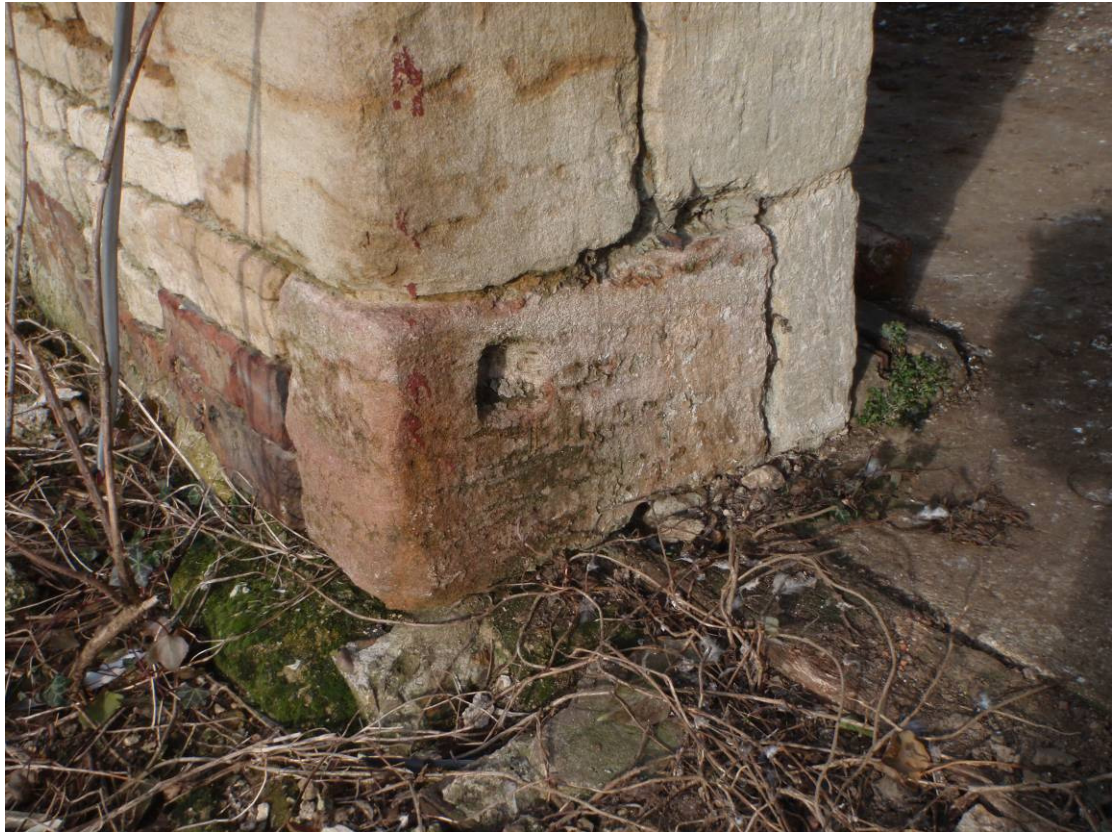
to stone arches and brick doorstops (Plates 2, 3, 9 & 10). The western doorway is unaltered, with traditional planked doors, but the eastern doorway contains a brick-built infill, pierced by a smaller, rectangular doorway and planked door. A small indentation on the northern inner face of the west door provides the only indications of a possible threshold mechanism (Plate 11).

Plate 11 - Building 1 - West side of barn, indent on north side of doorway, looking northeast

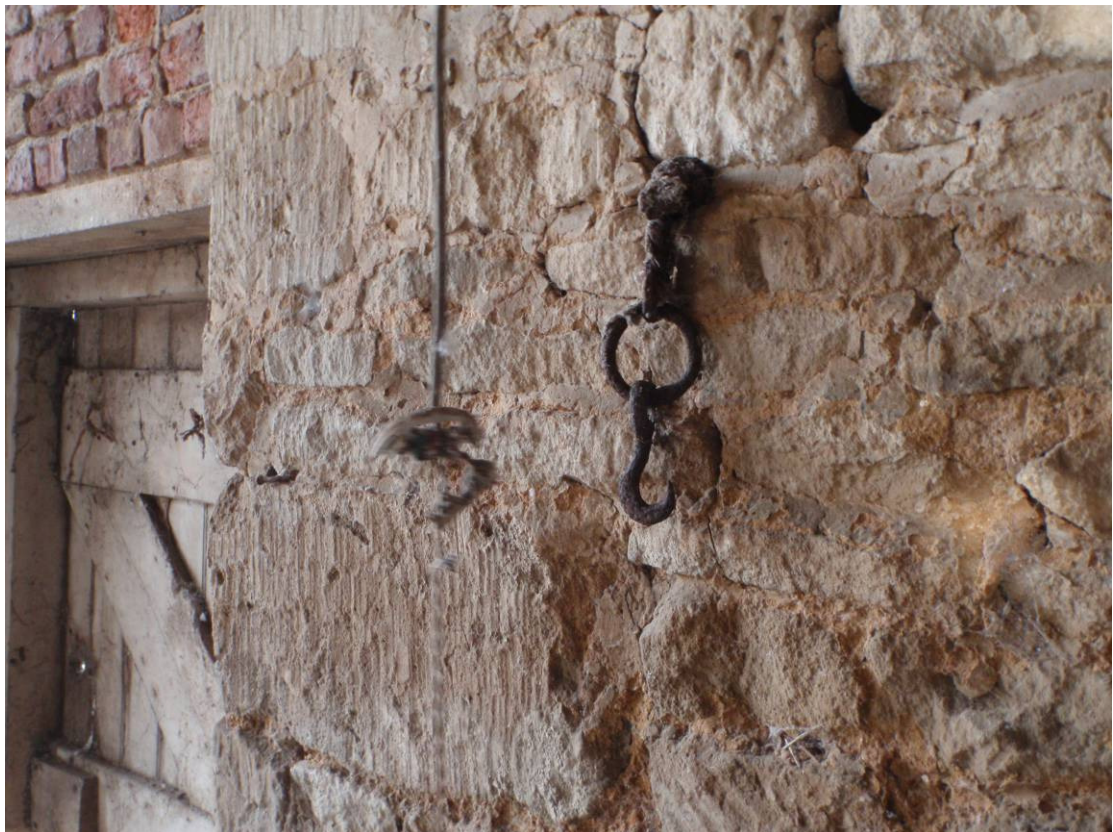
There are four ventilation openings in each of the long walls, on both sides arranged with two above and two below (Plate 4). Externally, two of the openings on the east side are obscured by an adjoining east-west range. An iron ring and hook is attached to the wall, at a point just south of the east door (Plate 12).

Plate 12 – Building 1 - Interior of barn, iron fitting in east wall, looking northeast

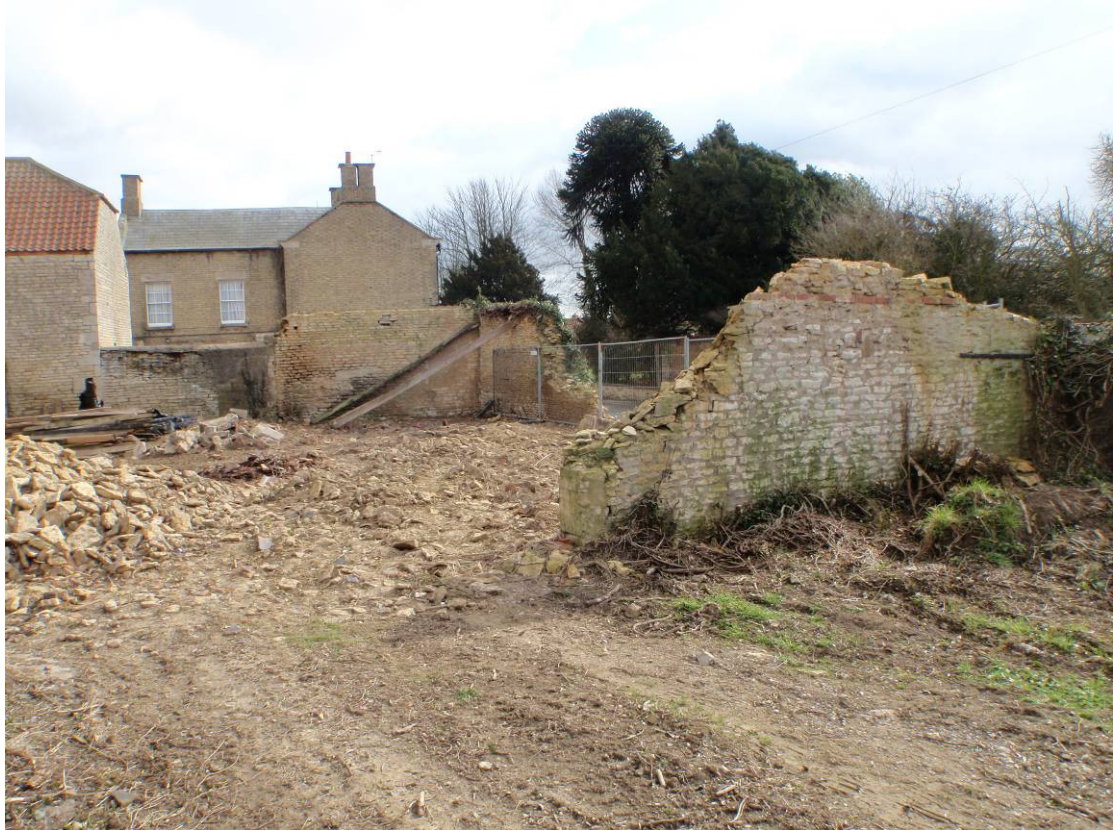
Plate 15 – Building 2 - Collapsed building, general view, looking southeast

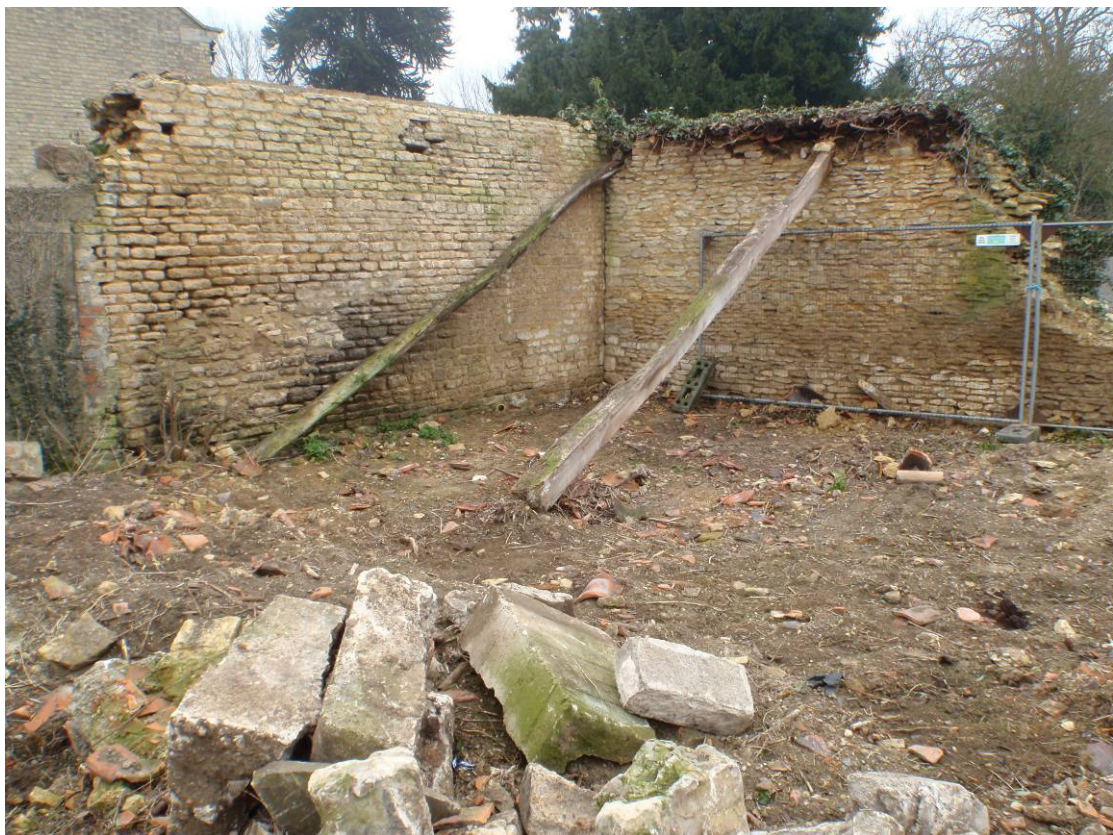
The fragmentary remains of Building 2 (see Figure 6) are located in the angle between North Street and the western boundary of grounds associated with the adjacent Manor House (Plate 15). From the available evidence the building would appear to have been open to the north indicating probable use as a cartshed and/or implement store. Constructed in coursed limestone rubble, the walls survive to their full height of around 3.15m only on the east side of the building (Plate 16), having collapsed to ground level over much of the southern side (Plate 17), and standing to approximately half of their original height to the west (Plate 18). A pantile roof (probably hipped) is indicated by fragmentary, *in situ* remains, on walls at the southeast corner of the building, and loose pantiles are spread across the internal area (Plate 16 & 19).

Plate 16 – Building 2 - Interior of collapsed building, eastern end, looking southeast

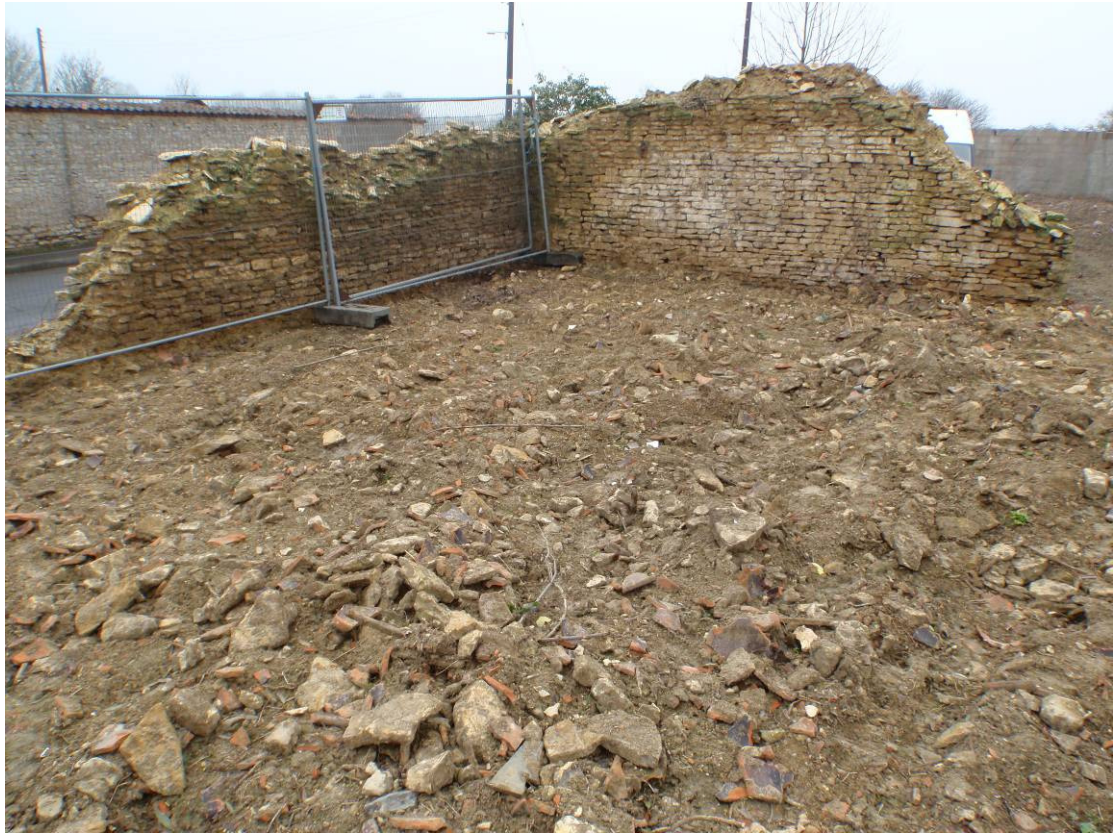
Plate 19 – Building 2 - Interior of collapsed building, western end, looking southwest

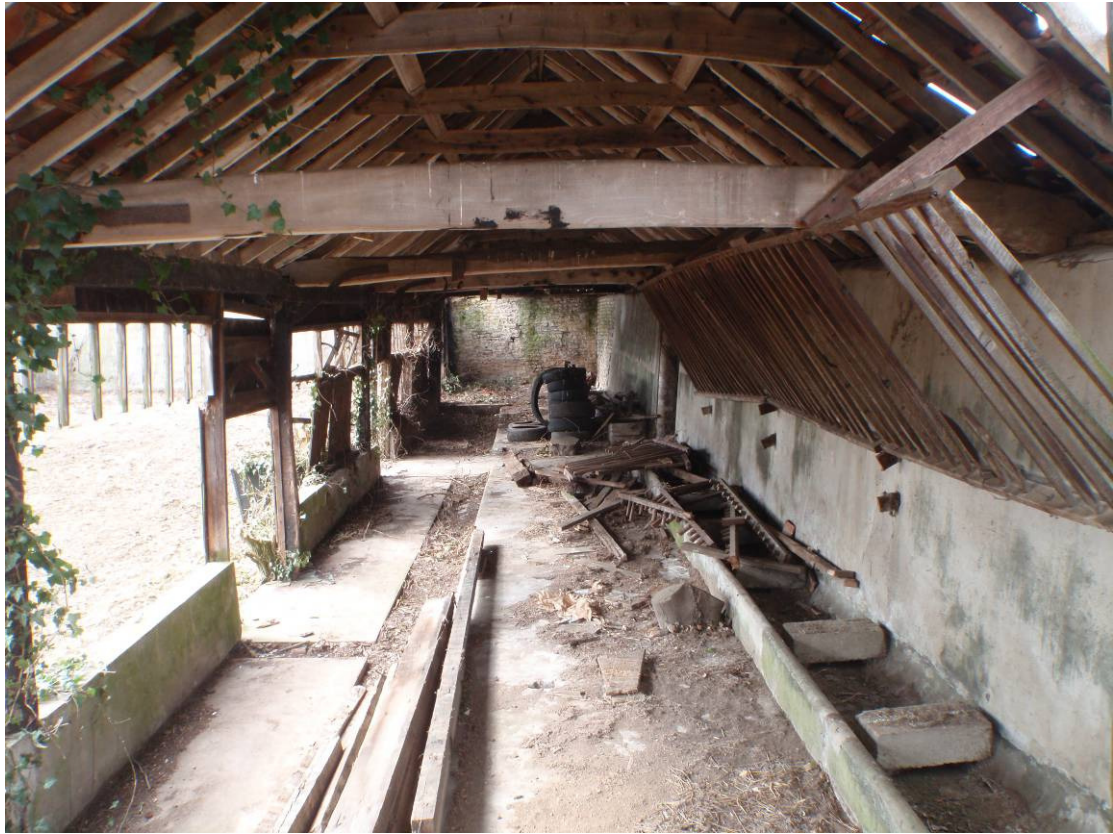
The walls of the cowhouse are rendered in concrete and concrete mangers are ranged continuously along the north side of the building, divided into individual feeding areas by loose concrete blocks (Plate 29). Concrete flooring extends south from the mangers, falling slightly to meet east-west manure channels (also formed in concrete) to either side of the through passage (Plates 29 & 30). South of the manure channels, a walkway extends along the side of the building. It is crossed by two connecting channels leading to external drains. One of the drains (relating to the channel on the eastern side of the cowhouse) was visible at the time of the survey, but the other was obscured by vegetation and building debris. There are no surviving stall divisions, but their former positions are apparent from sockets in the concrete floor, indicating that the animals were stalled in pairs.

Wooden hayracks survive on the north wall over a distance of around 7m and further fragments are spread across the floor of the building (Plate 29). The interior of the north doorway is formed from bull-nosed bricks of probable 19<sup>th</sup> century date (Plate 31).

Plate 29 – Building 3 - Interior of cowhouse, looking west

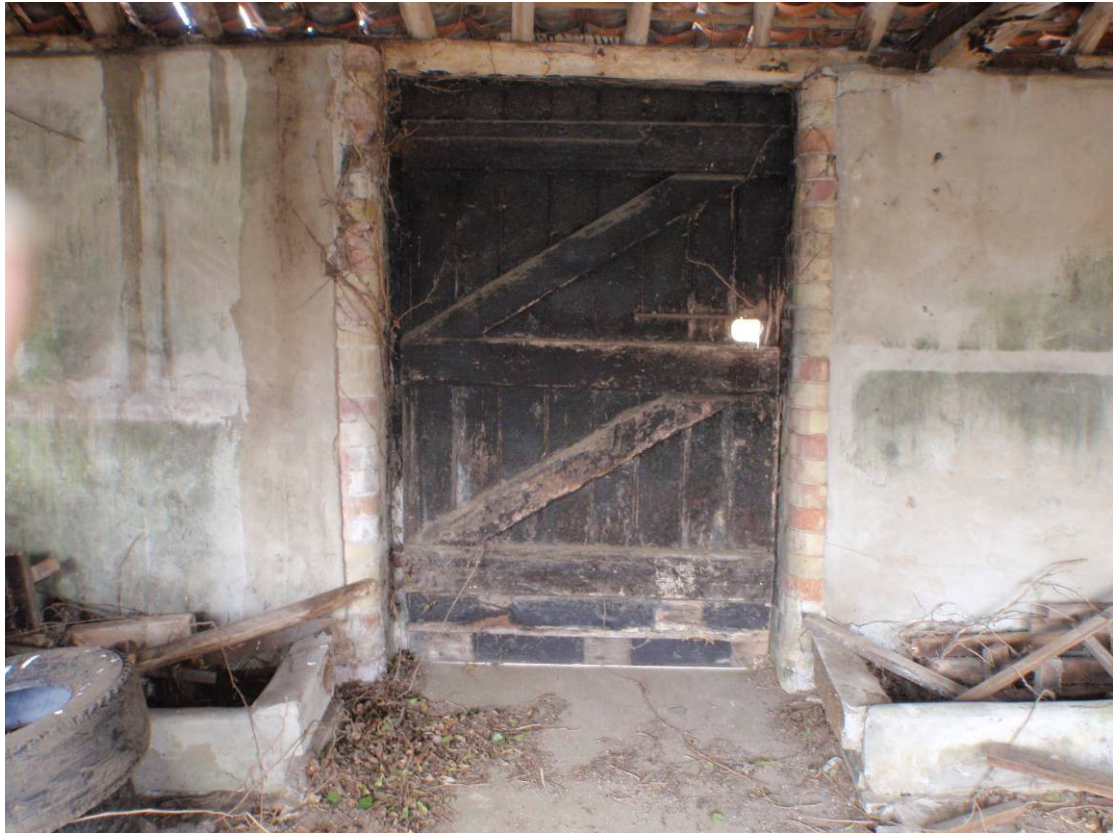
Plate 31 – Building 3 - Interior of cowhouse, north door, looking north

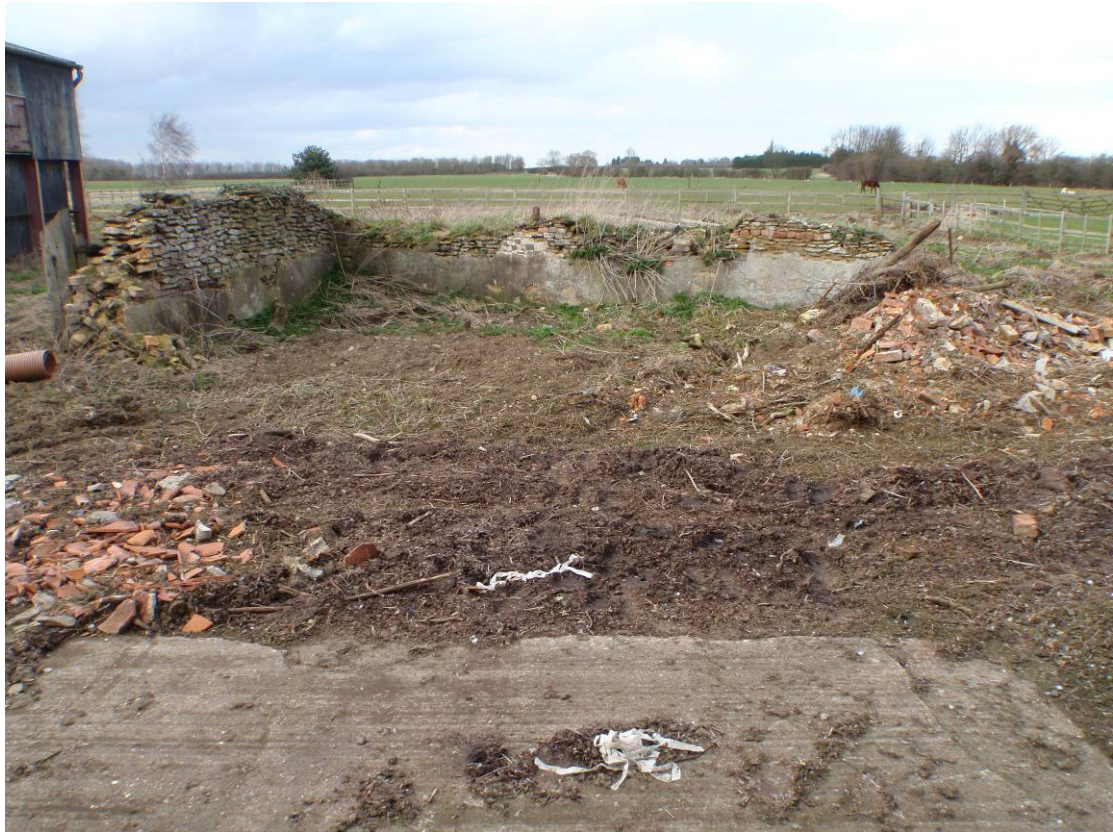
There is a collapsed stone structure (Plate 34) immediately north of the barn adjacent to a raised structure denoted on the survey (see Figure 4) as a loading dock (Plate 35).

Plate 34 – Other buildings - Collapsed structure north of barn, looking north

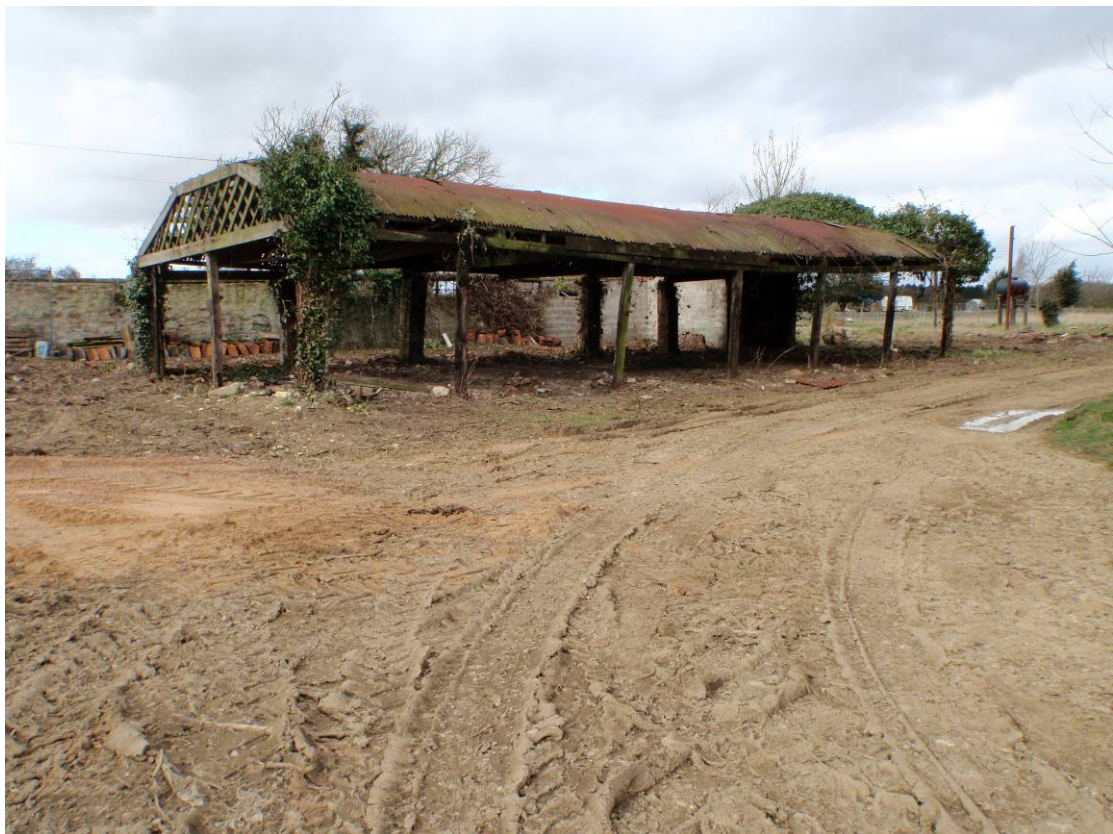
To the east of the section of stone wall is an open-sided Dutch barn. Originally used for storage purposes, both the corrugated iron roof and the timber frame are now in a state of dilapidation (Plate 37)

Plate 37- Other buildings - Open structure north of the cowhouse, looking northwest
