**HISTORIC BUILDING RECORDING
MANOR FARM,
CHURCH END,
PIDDINGTON,
HACKLETON,
NORTHAMPTONSHIRE
(PIMF13)**

Work Undertaken For
Francis Jackson Homes Ltd

APS Report No. **84/13**

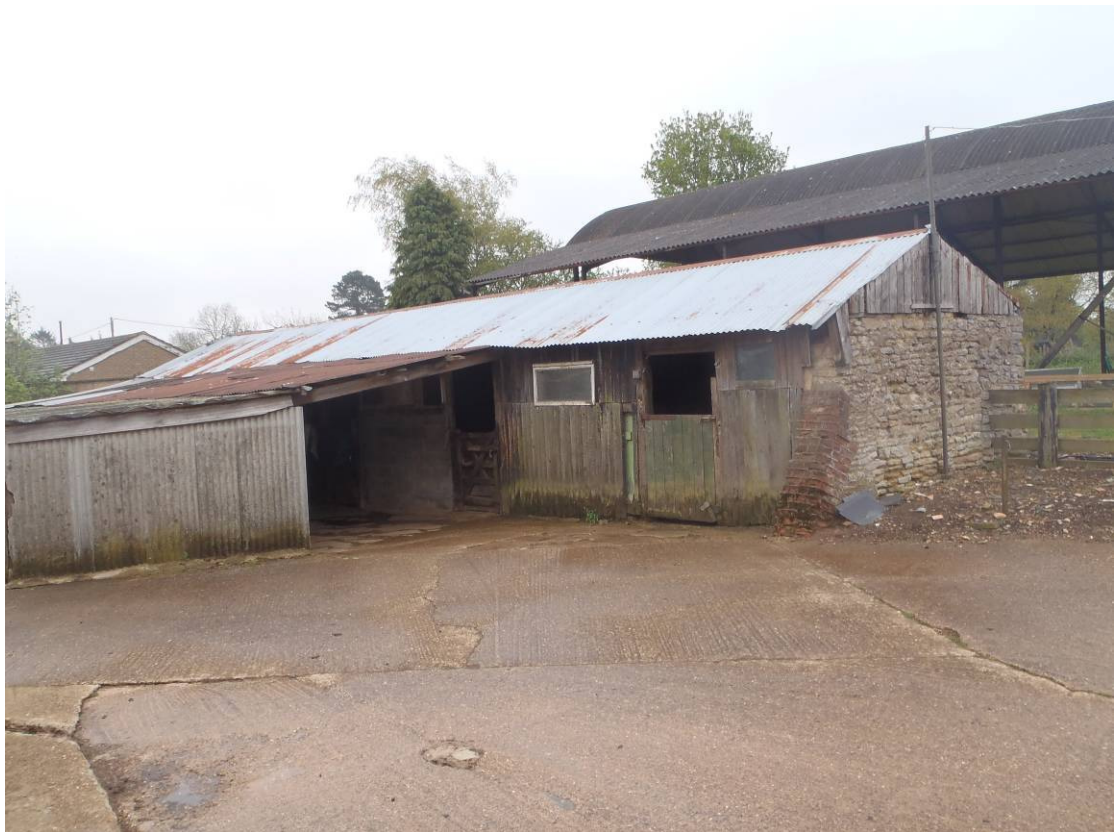
This wall is mostly of coursed limestone rubble with vertical weather boarding in the gable. The elevation is plain except for a buttress of 20th century machine-made brick on the northern side (Plate 4).

Along the northern side of the building is a modern lean-to with walls of wood, perspex and corrugated sheeting (Plate 4).

Plate 4 Building 1, north and west sides, looking southeast

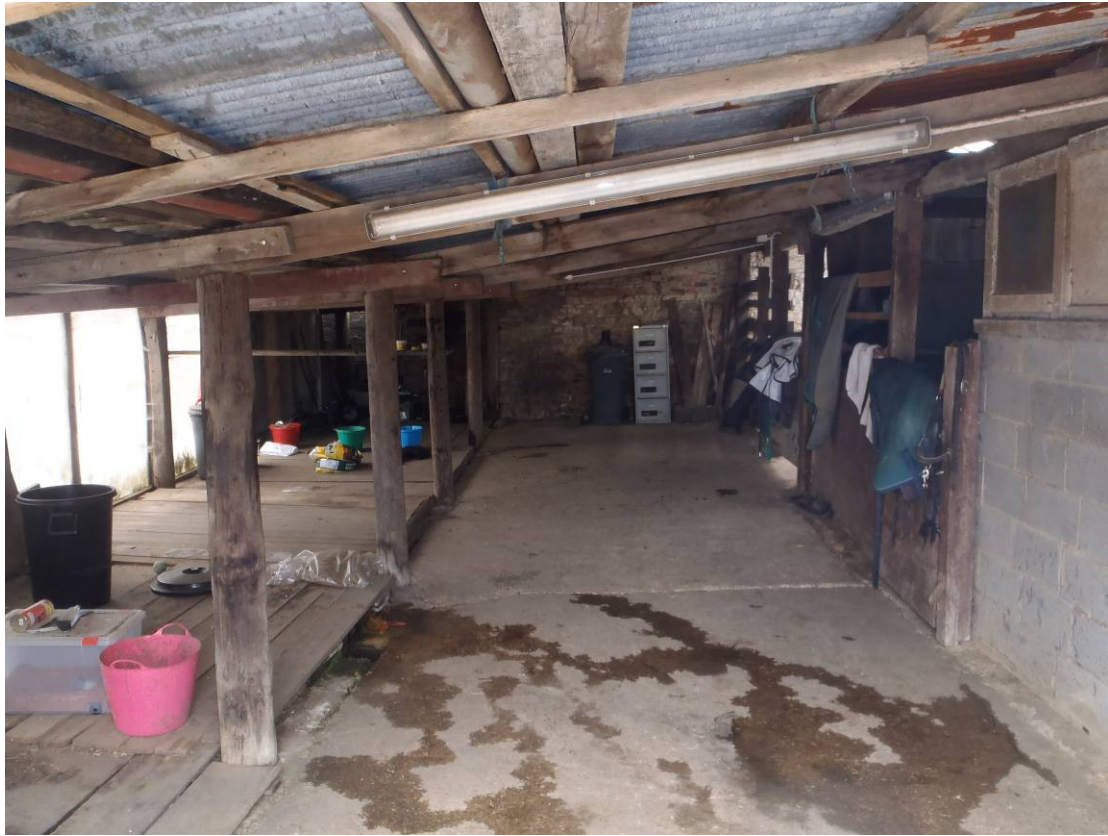
A mixture of modern wood and breeze block provides the northern wall (Plate 5). This wall contains four door openings, each of them lower leaves of stable doors. There are also several inserted windows.

Plate 5 Building 1, northern part of building, looking east

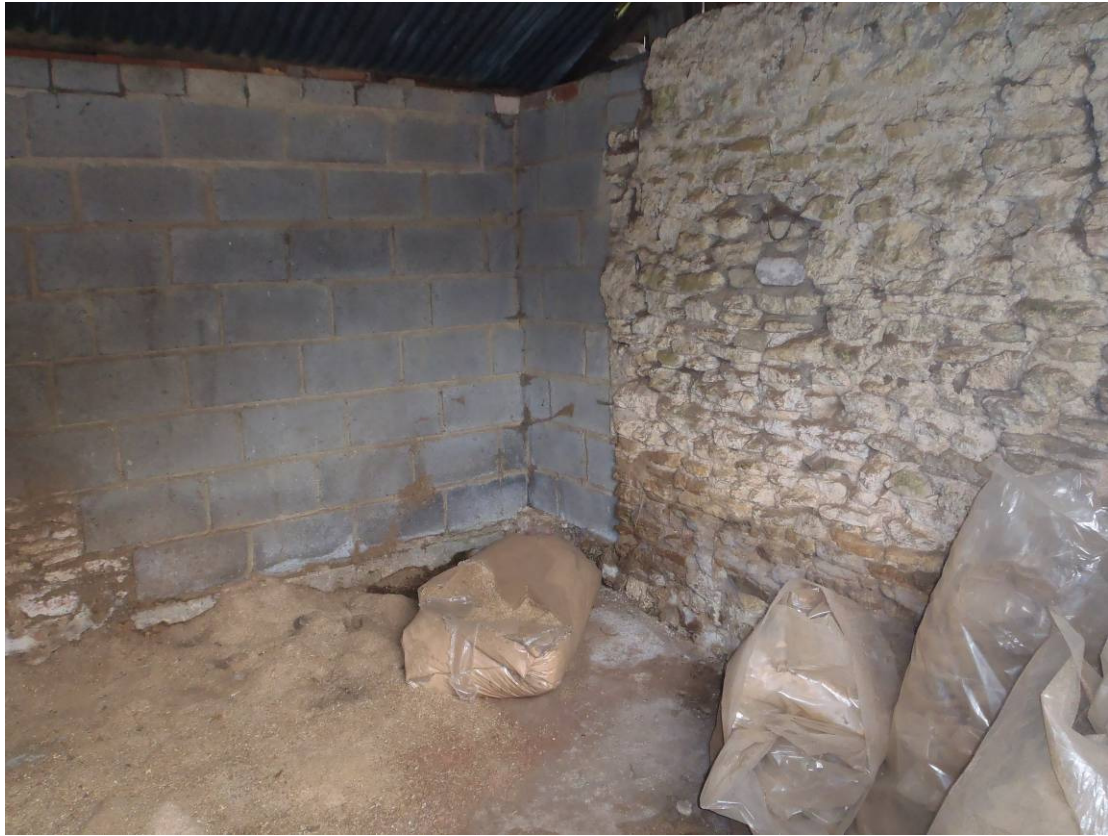
In the southwestern corner of the western room is a large area of breeze block infill (Plate 7). This breeze block is not evident on the exterior, though the southern side coincides with an area where the external coursing becomes irregular (see above).

Plate 7 Building 1, southern part, stable compartment at western end showing patching/infill, looking southwest

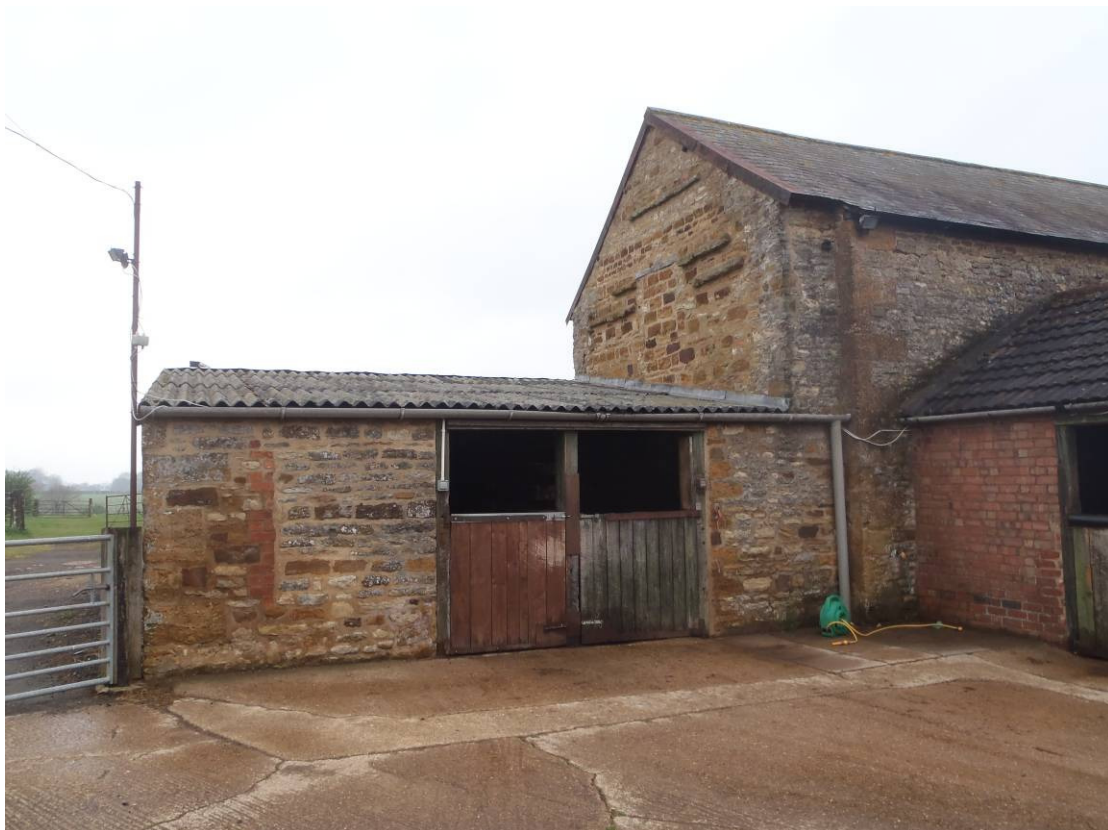
Forming the frontage of this building, the eastern elevation is mostly of coursed limestone rubble with quoins and string courses of ironstone (Plate 8). In the southern part of the elevation there is a straight join edged with brick. North of this is a pair of adjacent doorways, each containing a lower half of a stable door. Quoining, in ironstone, is only present on the north side of the pair of doors. The wall continues without interruption northwards to form part of the eastern elevation of Building 10.

The north side of Building 2 is against Building 10. Scarring of removed walling in the upper part of the southern elevation of Building 10 suggests that Building 2 was originally 2 storeys high (Plates 1 and 8).

Plate 8 Building 2, eastern elevation, looking west

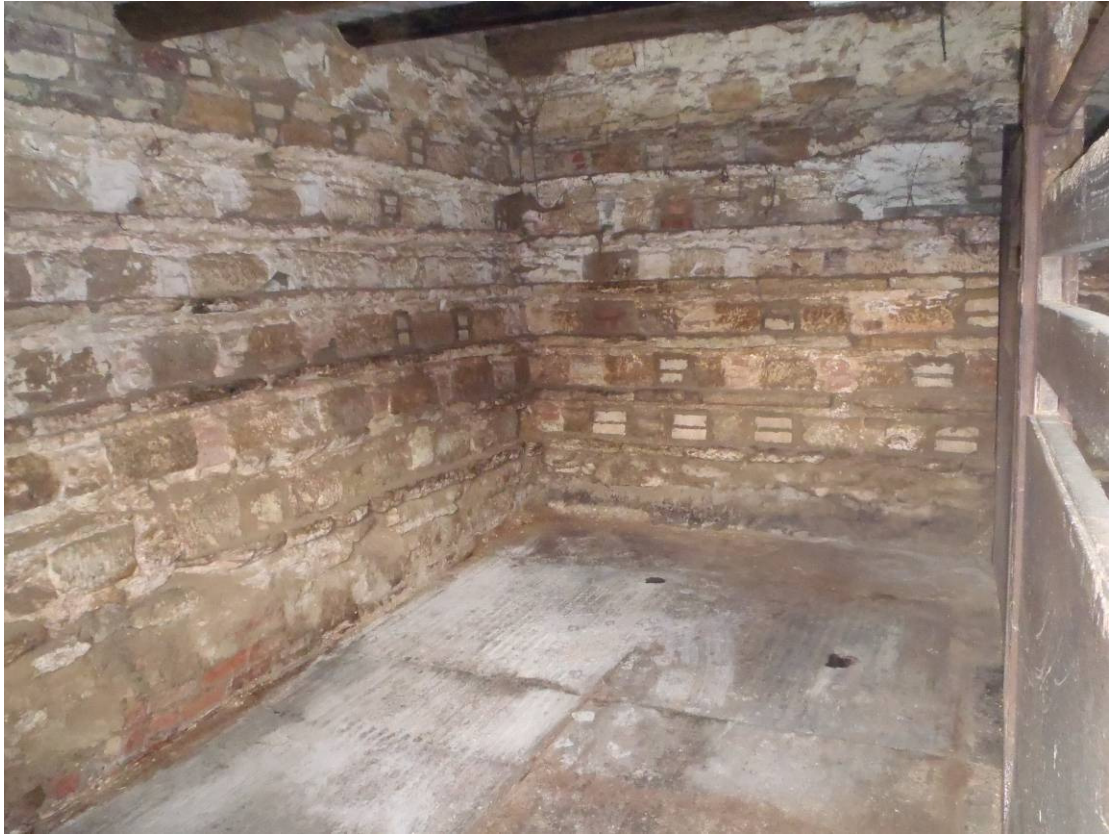
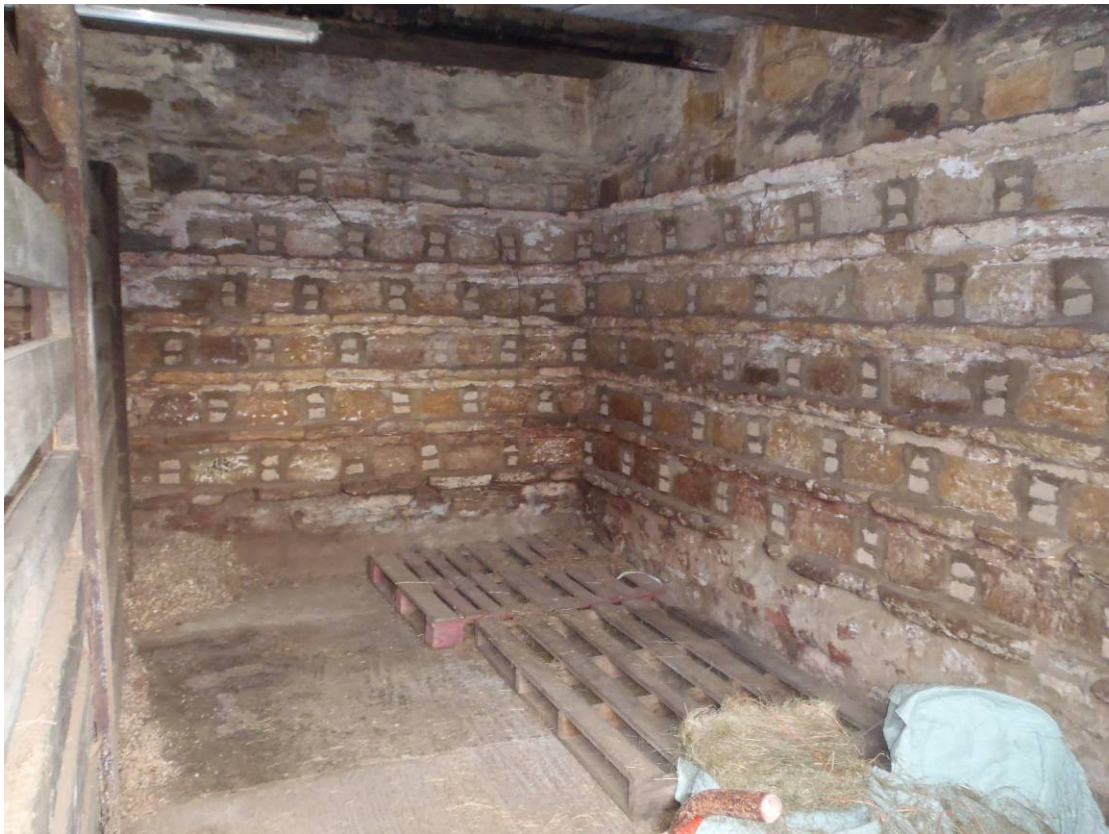
rails. Around the walls of both compartments are slight projecting horizontal ledges, forming multiple courses rising up the heights of the walls (Plates 9 and 10). The intervening horizontal bands between these ledges contain numerous evenly-spaced small rectangular niches which have subsequently been infilled (Plates 9 and 10). These identify this building as a former dovecote.

Plate 9 Building 2, southern compartment, looking southwest

Plate 10 Building 2, northern compartment, looking west

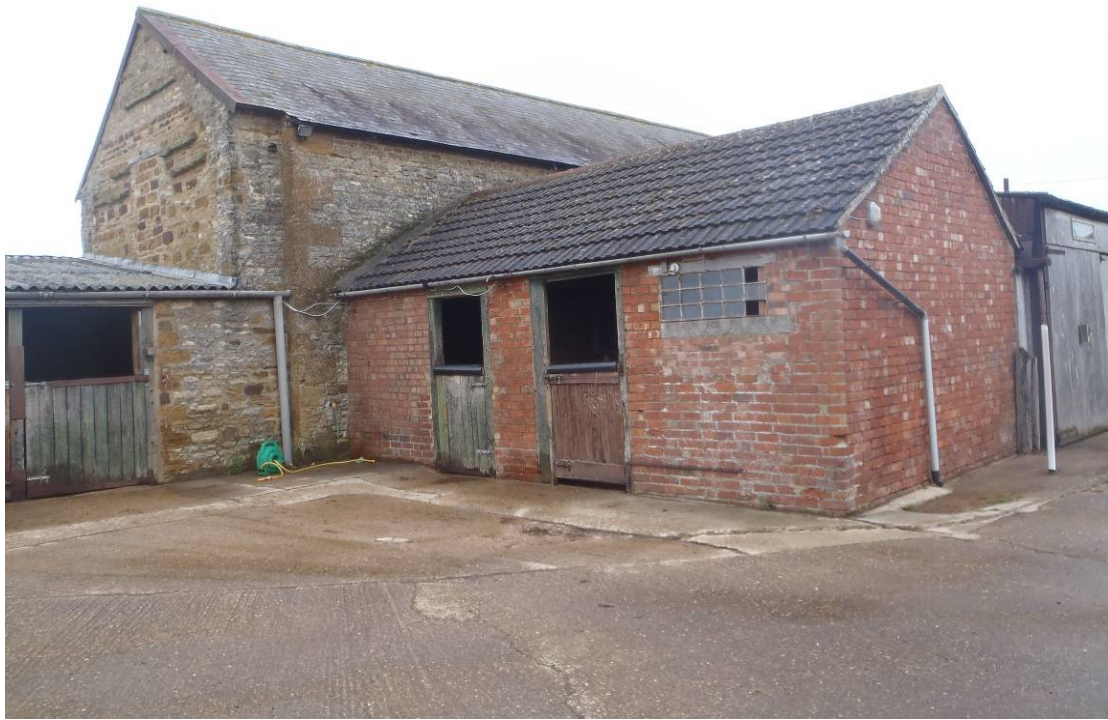
This is located immediately northeast of Building 2, and attached to the east side of Building 10. It is a single storey structure of 19th century handmade brick with a ceramic tile roof (Plate 11).

This provides the main entrance façade of the building. Towards the centre of the elevation are two doorways, each containing split stable doors (lower sections only). To the east of these is a crittall or similar steel-framed window with concrete lintel and sill. This is set within a partially blocked window, the infill being of 20th century brick (Plate 11).

Plate 11 Building 3, south and east sides, and Building 10 to rear, looking northwest

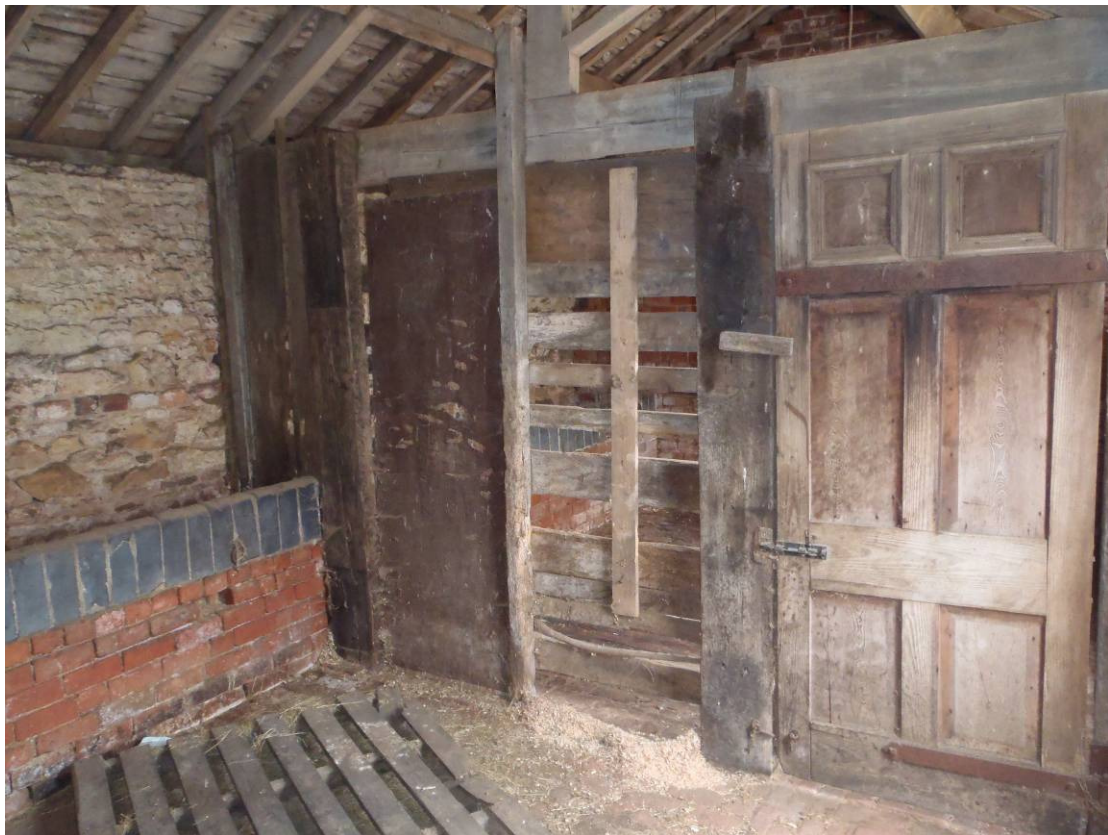
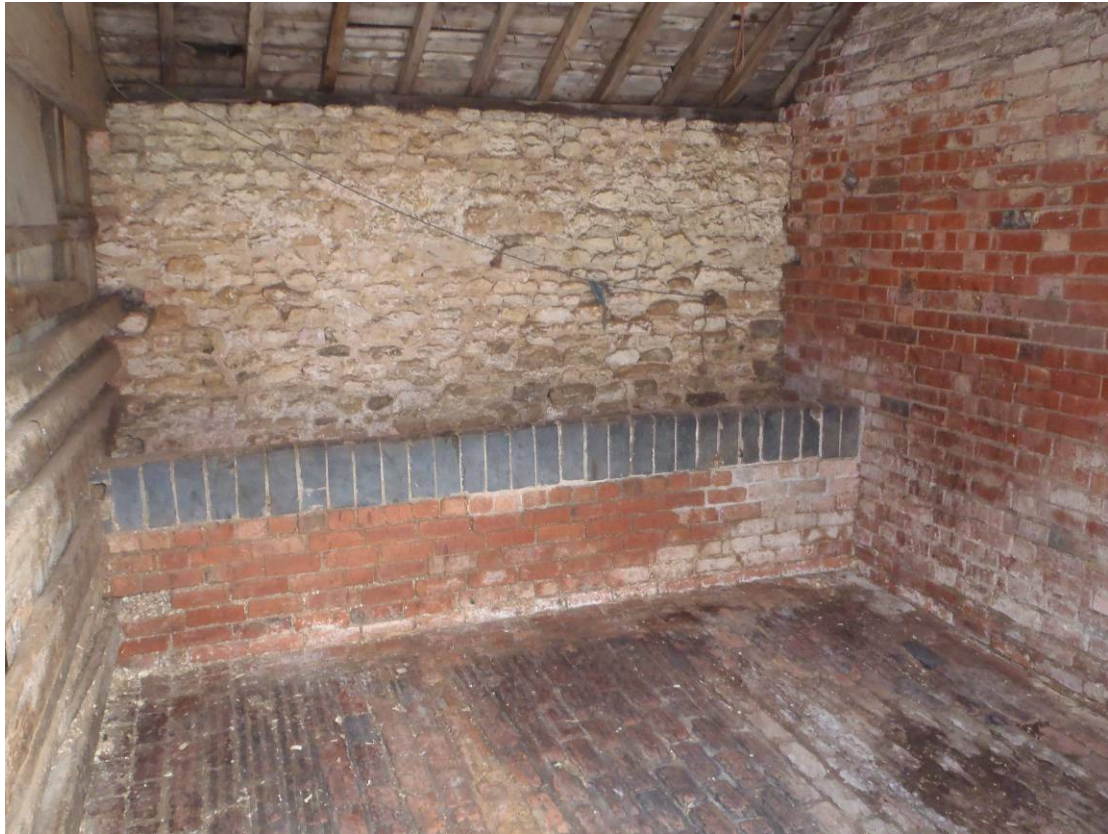
The building has a floor of handmade bricks and is divided into two rooms by a wooden partition (Plate 12). At the southern end of the partition is a 6-panel

door of probable 19th century date. Above the partition is a king-post roof truss. The rear, north, wall of both rooms is of coursed limestone rubble. Running alongside this wall, through both rooms, is a feeding trough of early-mid 19th century brick, topped with a soldier course of blue brick (Plates 12, 13).

Plate 12 Building 3, western compartment, looking northeast

Plate 13 Building 3, eastern compartment, long north

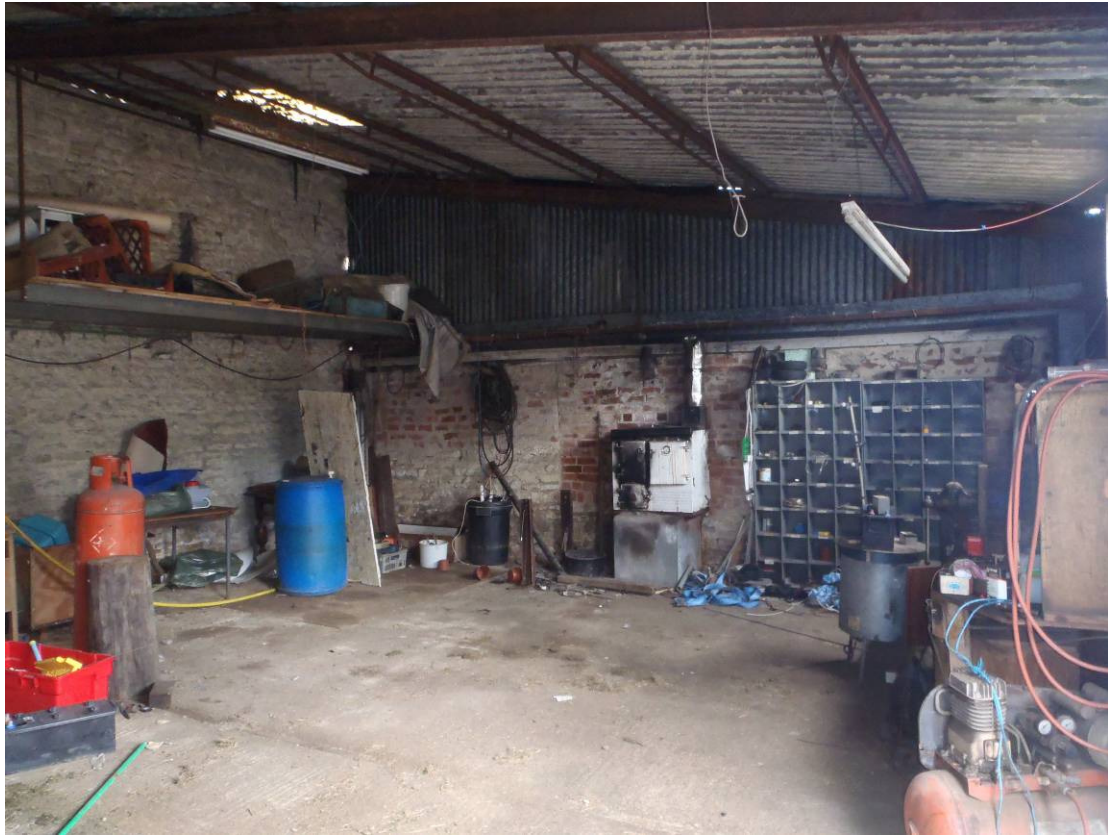
This building forms a single large room with a concrete floor. The upper part of the north wall is of corrugated iron sheeting (Plate 15). Below this the wall is of brick and stone. At its western end the wall is of stone in its lower half and 19th century brick above. This section of walling ends in a straight join and, beyond this to the

Plate 15 Building 4, interior north side, looking north

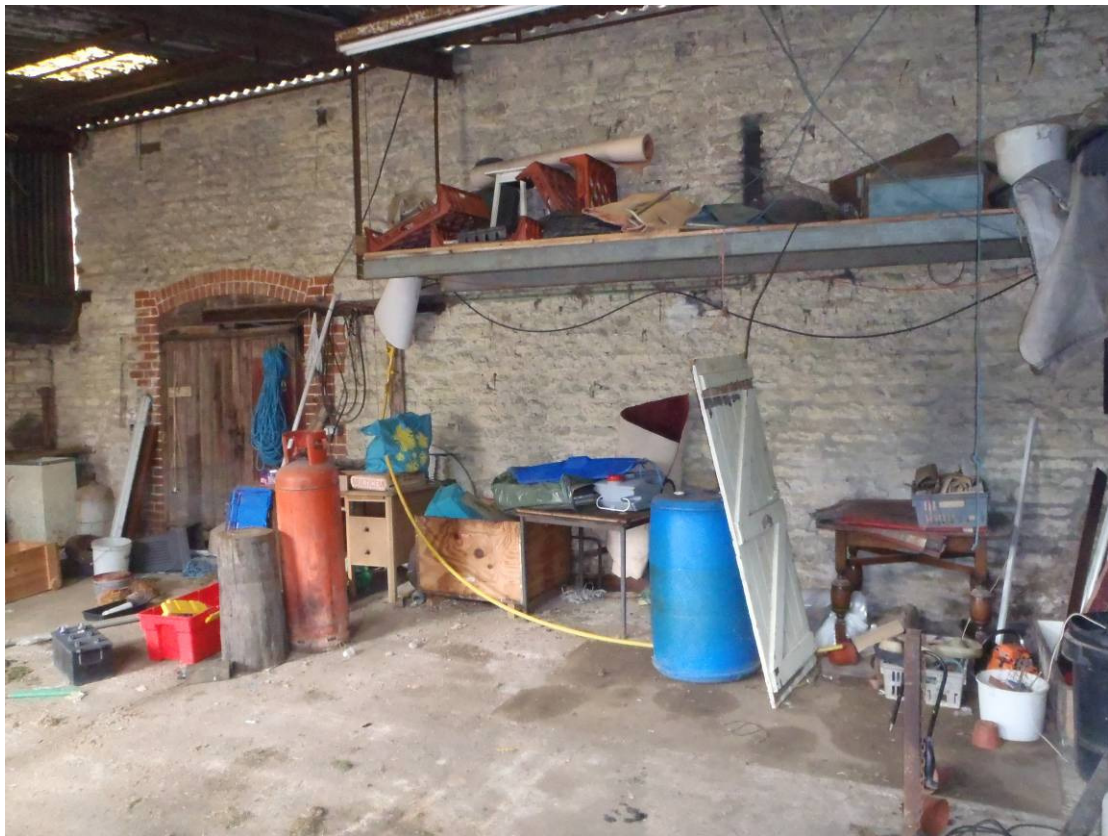
The west wall is of coursed limestone rubble and, towards the southern end, contains a large double door with mid-late 19th century brick edging (Plate 16). A little to the south of this doorway is a ragged join.

Plate 16 Building 4, western side, showing door to Building 10, looking southwest

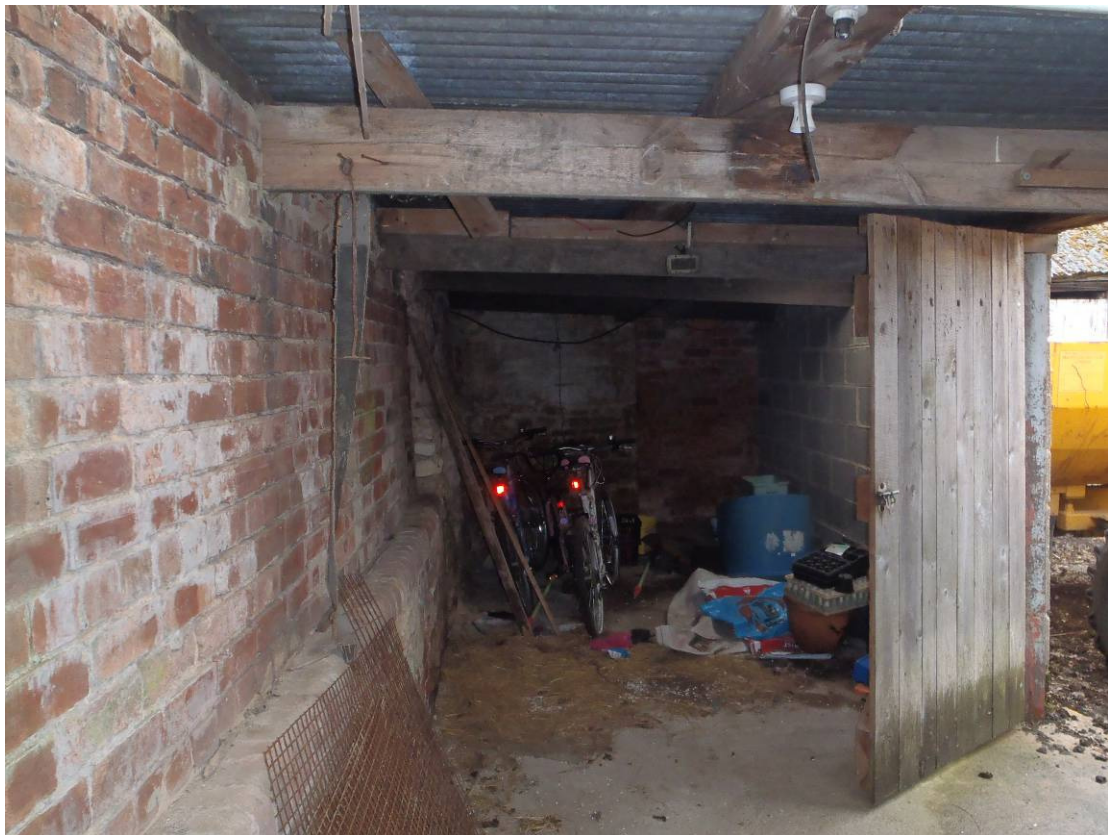
and brick above then, after a straight join, continues eastwards as mostly brick, with stone in the lowest courses. East of the straight join the wall thins in its upper part (Plate 18).

Plate 18 Building 5, interior, looking west

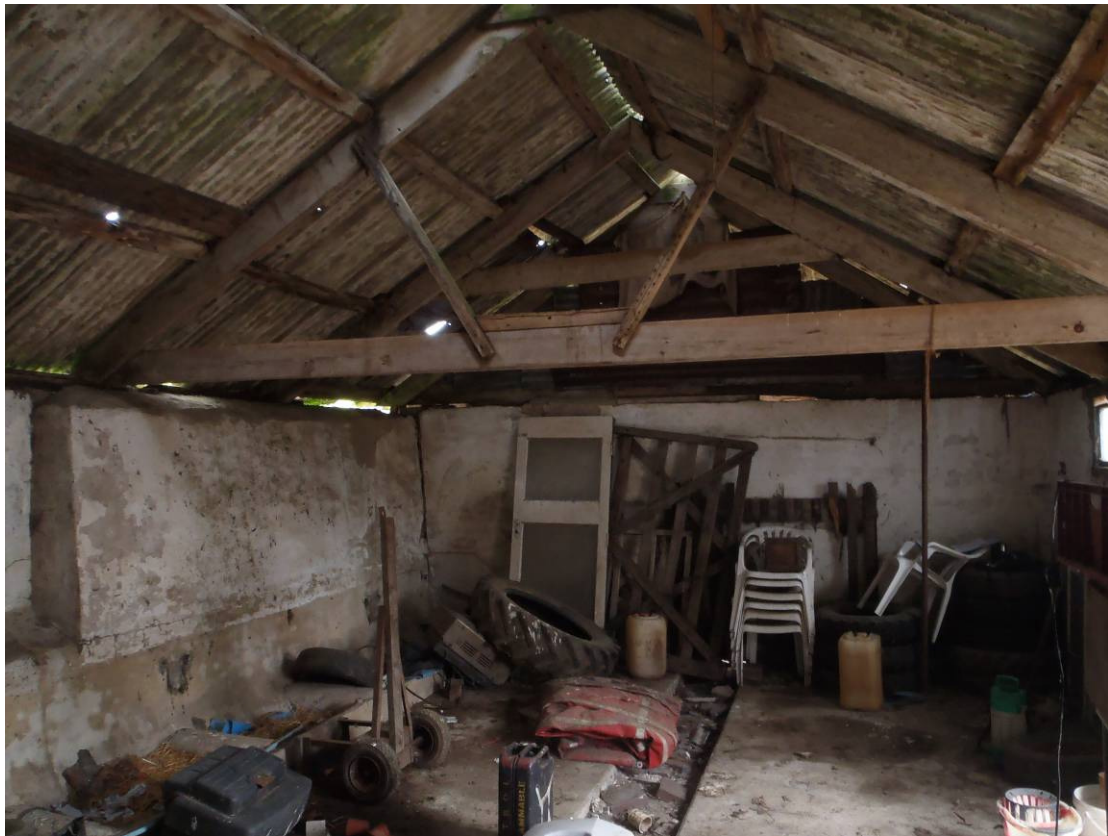
This building forms a single room with a concrete floor. Along the western side of the room there is a concrete trough and running north-south through the centre of the room is a drain channel in the floor. Most of the walls are rendered, though the upper part of the south wall is of coursed limestone rubble. At the eastern end of the south wall is a doorway to adjacent Building 10. In its southern half, and commencing about 1m above ground level, the west wall recesses to a depth of 0.35m. An east-west tie beam crosses the middle of the room (Plate 20).

Plate 20 Building 6, looking north

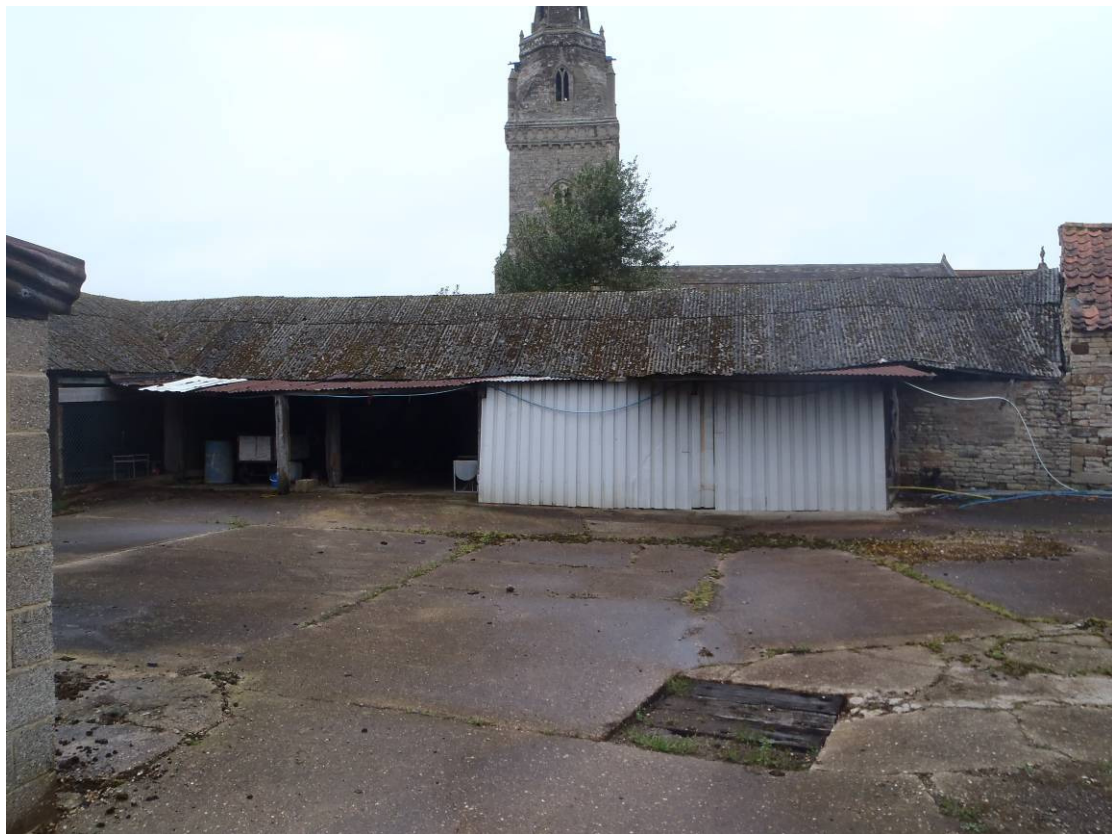
Most of the southern elevation of the building is either open, at the west end, or provided by modern metal sheeting, to the east (Plate 22). The western part of the

Plate 22 Building 7, south side, looking north
