HISTORIC BUILDING RECORDING THE FORMER BERIDGE ARMS, STATION ROAD, SUTTERTON, LINCOLNSHIRE (SUSR14)

Work Undertaken For Visual Development (Lincs) Ltd

June 2014

APS Report No. 64/14

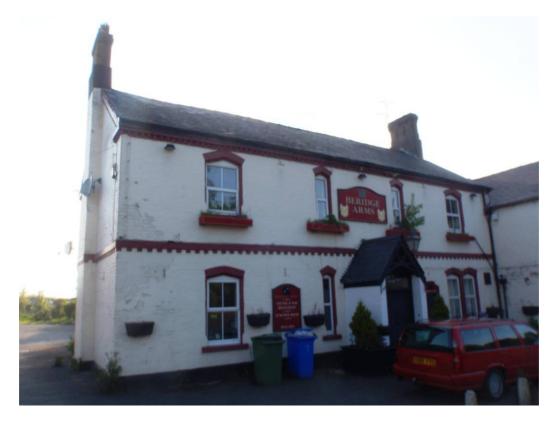
The front elevation is of Flemish bond, has four bays and is abutted at the north by the south-facing elevation of a further building (Building 3). The elevation has a low brick plinth at ground level; located between the ground and first floor is a platband with dentilation below and a decorative sawtoothed course is located directly below the eaves. The southeast corner of the building is chamfered at ground floor level.

The porch is framed by two narrow lancet windows with distinctive arches; these are mirrored to the first floor, although those at first floor level are marginally wider. To the south of the elevation is a further window with a similar arch repeated on the floor above. North of the porch a further ground floor window is double arched with that above, on the first floor, being single as at the south. All the windows are modern uPVC replacements.

Plate 5: North elevation of Building 1, with centrally set porch and distinctive arched windows

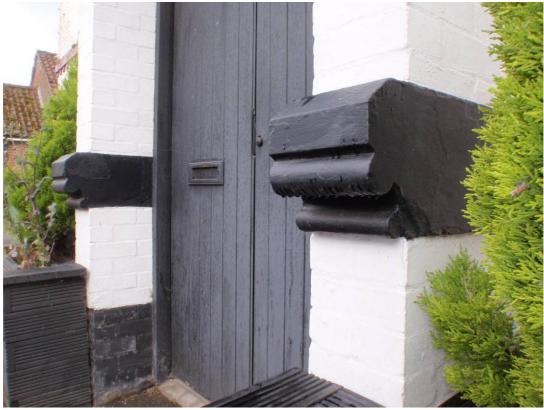
A porch constructed of modern machinemade brick is centrally set on the front elevation of the building. The porch features a pitched Welsh slate roof with concrete coping tiles and a scissor truss to the front elevation. Decorative corbels set in each wall may be re-used but appear relatively unworn (Plate 6).

Plate 6: Re-used corbels in side walls of porch

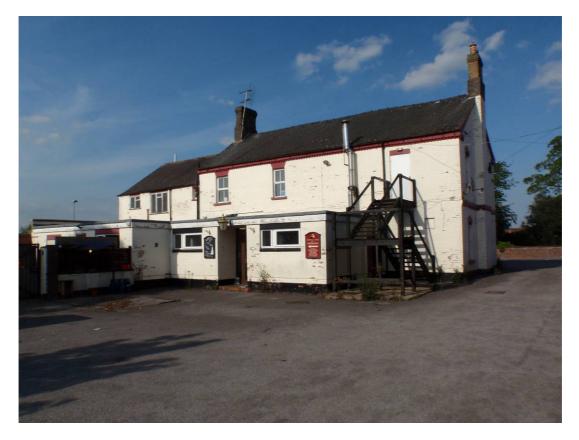
Most of the ground floor is masked by a modern single storey flat-roofed extension (Building 4) that forms the rear entrance to the pub from the rear car park. To the north of the elevation there are two windows at first floor level with flat segmental arches that are directly under the saw-toothed course in the eaves. An inserted doorway at first floor level in the south of the elevation leads to an external wooden staircase functioning as a fire escape.

Plate 7: South and west elevation of Building 1, looking northeast, with modern single storey addition, and Building 3 abutting to the north

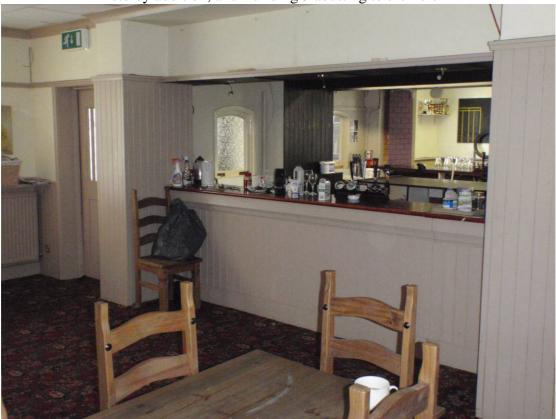
The ground floor interior comprises the modern pub bar, divided into two rooms. These are entirely modern, probably of 1980s or later date (Plate 8). The upper storey retains the original 19th century room layout comprising a central northsouth corridor leading to a bedroom at the southern end. Two bedrooms flank the corridor to east and west. Windows have splayed reveals, but contain modern uPVC. There are blocked fireplaces in the southwest and northeast room (Plate 9).

Plate 8 Ground floor interior of Building 1, looking southeast

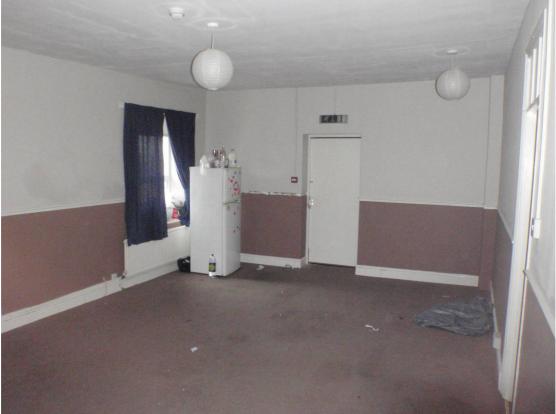
Plate 9 Building 1, upper storey, south room, looking southwest

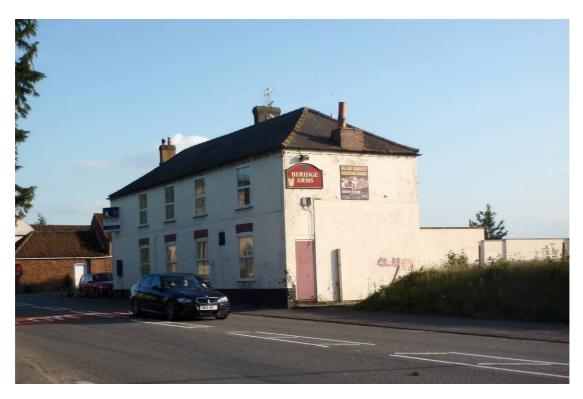
The east elevation is adjacent to the road and has four ground floor windows with shallow gauged arches that are mirrored to the first floor. All the windows are modern uPVC replacements (Plate 10).

Plate 10: View of pub building (Building 2), looking southwest

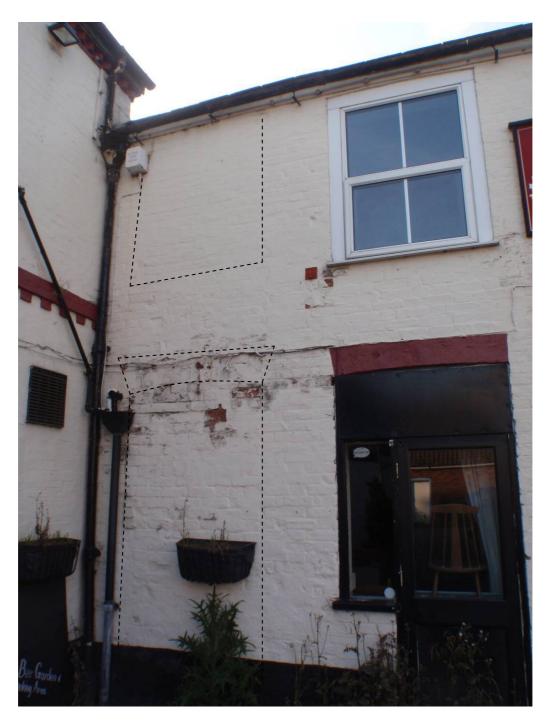
The south-facing elevation of Building 2 abuts Building 1 at the western edge. Immediately to the east, on the ground floor, is a bricked-up doorway with flat segmental arch, with either a blocked door or window to the first floor above (Plate 11).

Plate 11: South elevation of Building 2, with blocked window and doorway

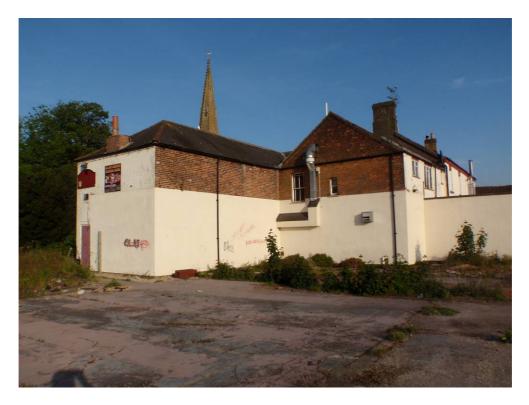
A modern doorway, with concrete lintel, has been inserted into the east of the elevation (Plate 10 & 12). Immediately adjacent to the west, the wall has been rendered to approximately two-thirds of the height of the façade. Above the render is a roof scar that suggests a former building has been demolished. The rendered section appears to indicate where another flat roofed building abutted this previously but has since been removed.

The render on the north façade continues on to this elevation, again to approximately two-thirds of the height of the wall (Plate 12). Above is the only section of unpainted wall and this shows that the construction is of English Garden Wall bond. A dentilation course in the eaves is just visible behind the guttering.

The north elevation forms the gable end of this building (Plate 12). The façade is rendered to the same height as adjacent walls. There are two windows evident at first floor level. The larger window to the east of the elevation has a shallow gauged arch with a horned sash window that appears to have the original glazing. The smaller window to the west has a flat segmental arch with a limestone cill, and is also a horned sash.

Plate 12: North and west elevations of Buildings 2 & 3, looking southeast, with northern elevation of Building 1 just visible at rear of Building 3

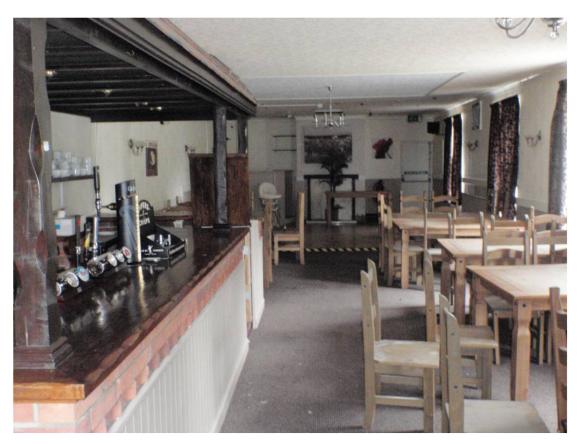
The ground floor was latterly used as a restaurant, and is equipped with modern fittings and décor (Plate 13). The landing of Building 2 (see above) gives access to a corridor down the west side of this building. This corridor gives access to a series of four rooms, set out in the original 19th century layout. Door surrounds are mostly original and windows have splayed reveals, but contain modern uPVC. There are blocked fireplaces in the northern and southern rooms (Plate 14).

Plate 13 Building 2, ground floor, looking north

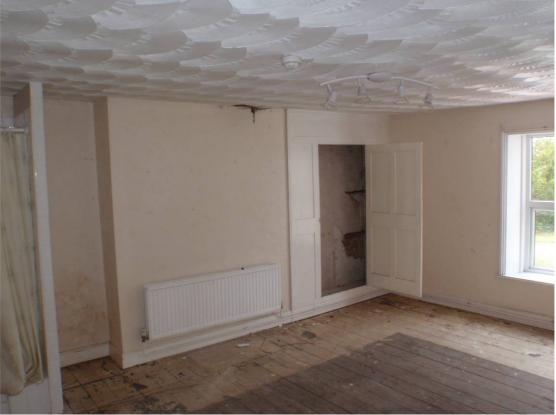
Plate 14 Building 2, upper storey, northern room, looking northeast

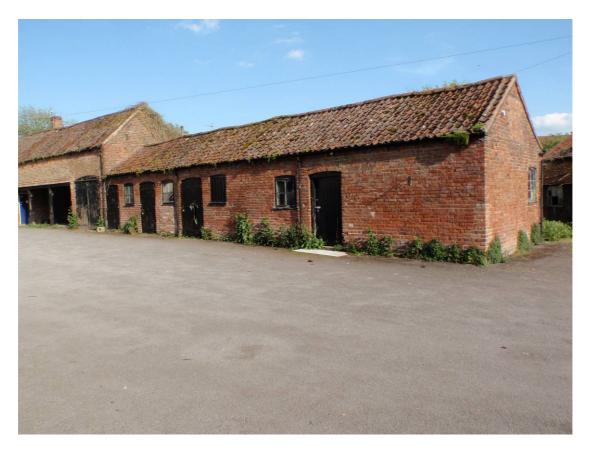
To the west of Building 6, the single storey Building 7 is probably of the same general Georgian period but slightly later than the attached buildings which it butts against. The three easterly rooms of the building originally functioned as individual stables and have surviving or indications of stable doors, while one has a slatted ventilator grill (cf Brunskill 1999, 75; Barnwell and Giles 1997, 55). The two rooms at the western end of the building may have functioned as a tack rooms or loose boxes. A blocked upper window in the west gable may have been a pitching hole.

Plate 18: Building 7, with blocked window in west elevation (far right of picture) just evident

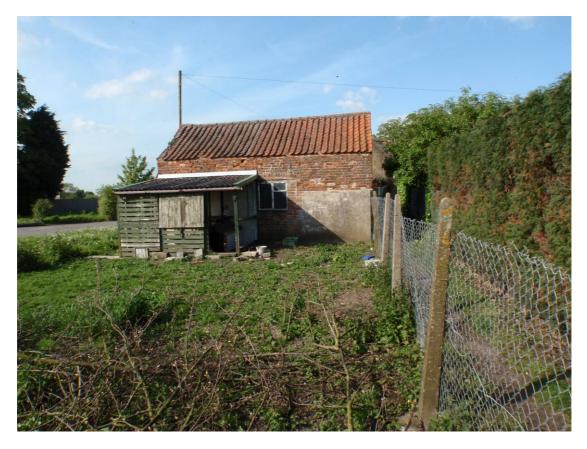
Plate 20: Southwest side of Building 8 with attached chicken shed and area of render

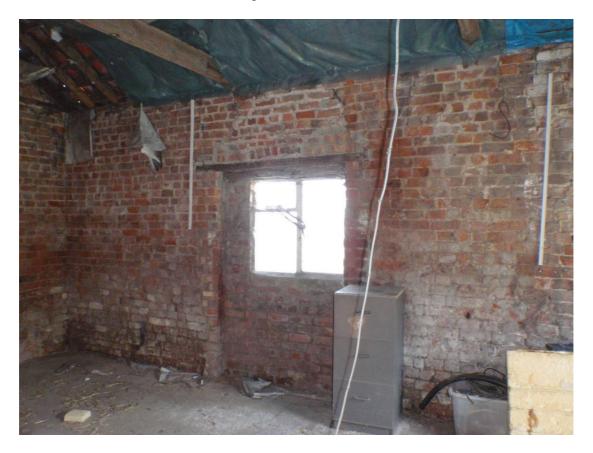
Plate 21 Building 8, interior showing window in blocked doorway, looking south

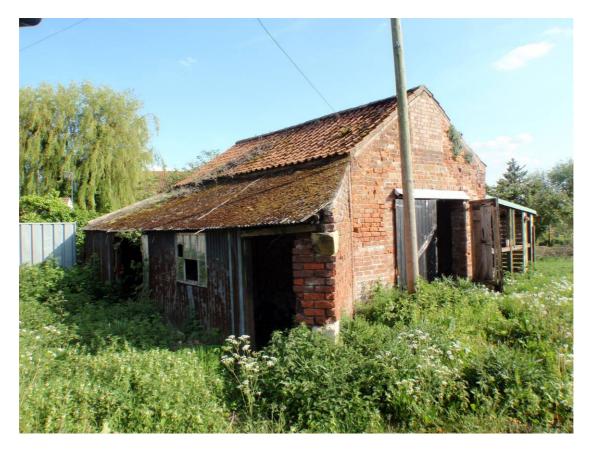
As noted above, there are two extensions to the building. On the northeast side of the building is an extension formed from corrugated iron sheeting (Plate 22). This makes use of the two brick walls that extend from the building, noted above. The corrugated northeast wall of the extension contains two openings and a window. The covering is a catslide running down from the main building roof.

Plate 22: Extension to northeast of Building 8, looking south

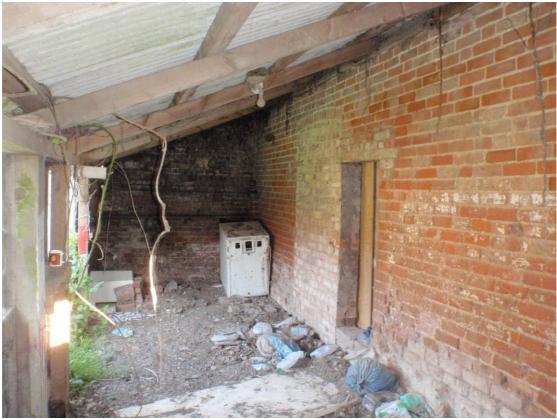
Plate 23: Extension on northeast side of Building 8, showing blocked door and new entry, looking southeast
