**HISTORIC BUILDING RECORDING
FORMER WORKSHOPS AND STORES,
MARKET STREET,
LONG SUTTON,
LINCOLNSHIRE
(MSLS 14)**

Work Undertaken For
STP Properties Ltd.

August 2014

APS Report No: **78/14**

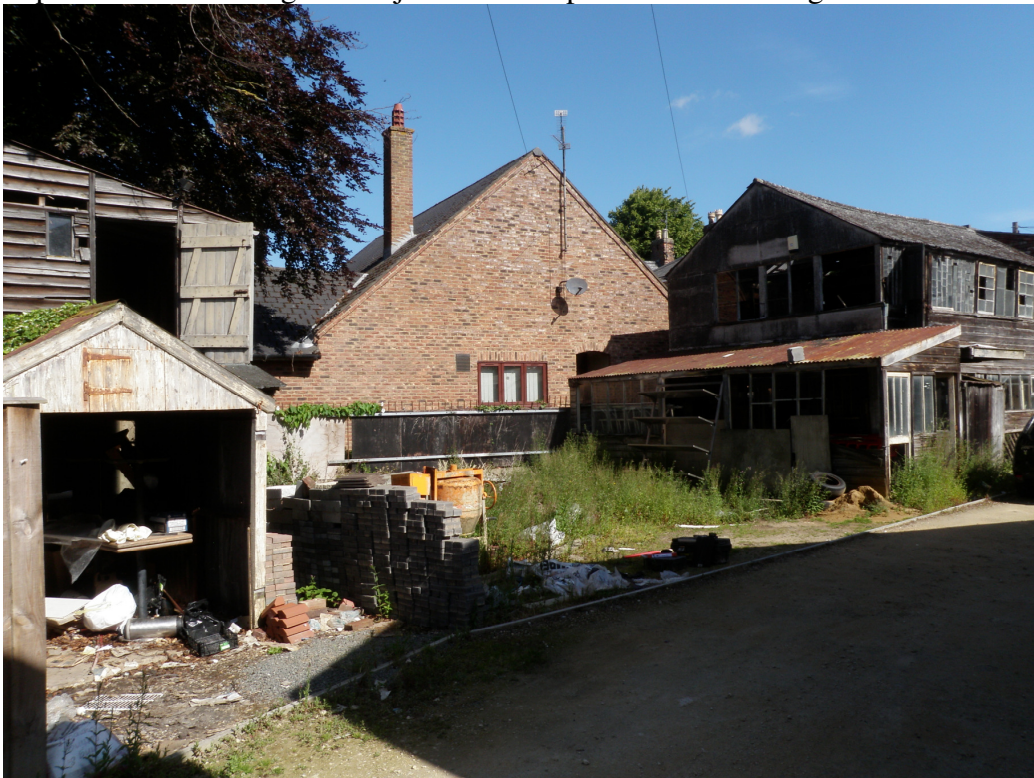
Plate 1. General view of Buildings 1 (left) & 2 (right) looking north from the entrance on Bull Lane.

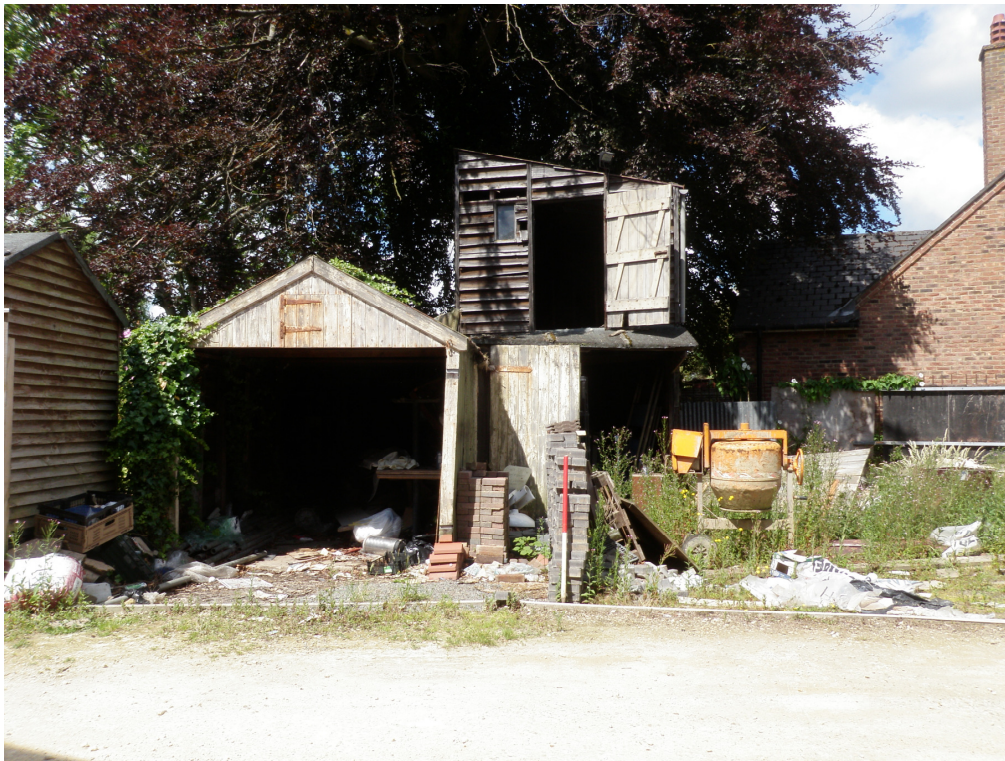
Plate 2. General view of building 1

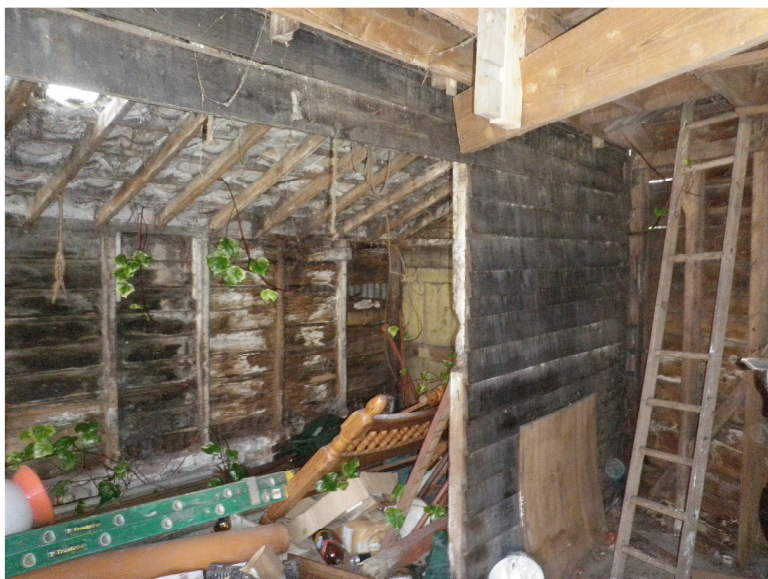
Plate 3. Cut away in northeastern wall showing pantile roof and previously external timbers

Seen internally in Plate 3, the roof of Shed A is of pantiles with a central skylight. It is mono-pitched, sloping down to the southwest and aside from slight damage from the large Copper Beech tree above, is in reasonable waterproof repair.

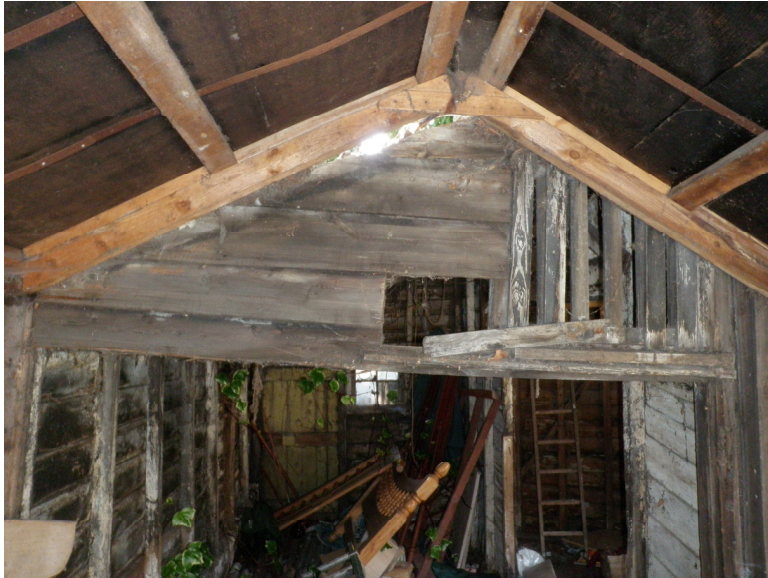
Plate 4. Cut away in southeastern wall from Shed B showing original access door and window

The walls of Shed A have been considerably altered in that they have been cut away on their northeast and southeast sides to form a single open storage space in conjunction with Sheds B and C. The view in Plate 4 shows where the weatherboard timbers have been removed and at least one phase of repair has been necessary. The original access was through the door visible at the rear which is now locked and leads into the grounds of 2a Bull Lane.

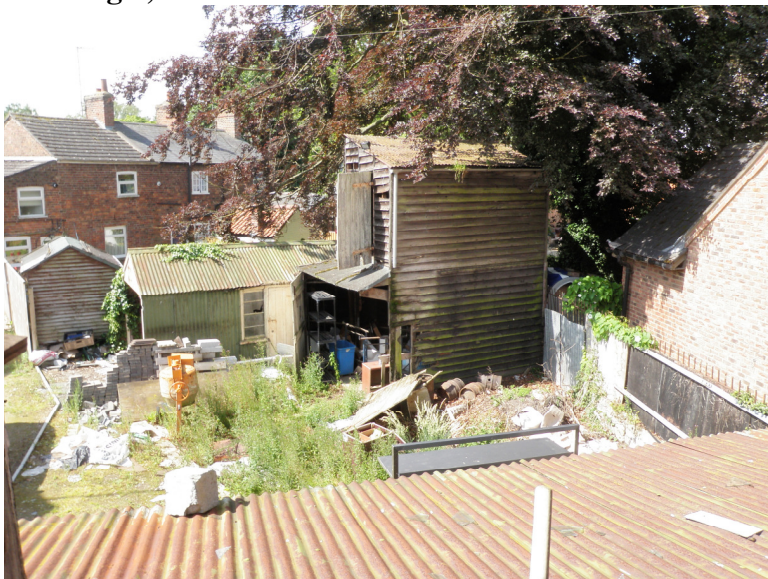
Plate 5. General view of Building 1, Sheds B and C showing the corrugated iron roofs, the corrugated iron northeastern wall of Shed B and the wooden weatherboard of the two storeys of Shed C. Taken from the first floor of Building 2 Shed A.

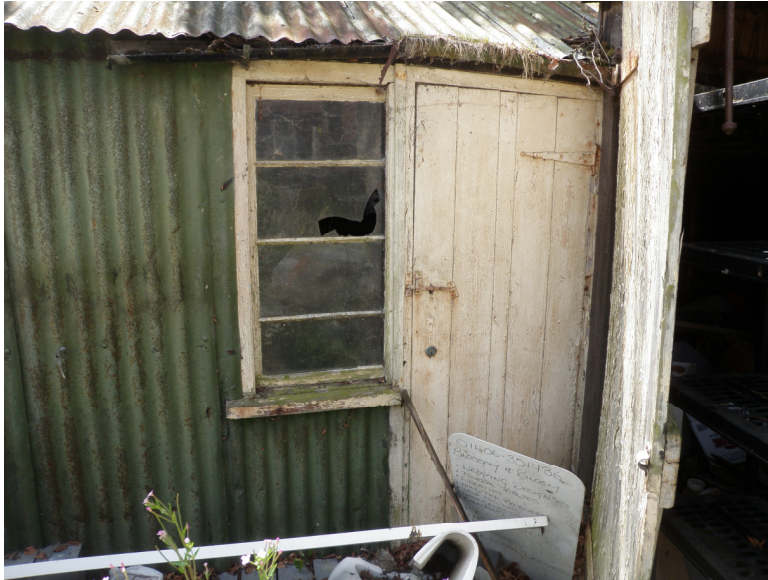
Plate 6. The corrugated iron wall of Shed B with door and window. To the right of the door is 1.45m wide opening allowing free access between the sheds.

The upright white piece of wood on the right of the picture seems to be attached to allow a door to be hinged on (see description of Shed C for details)

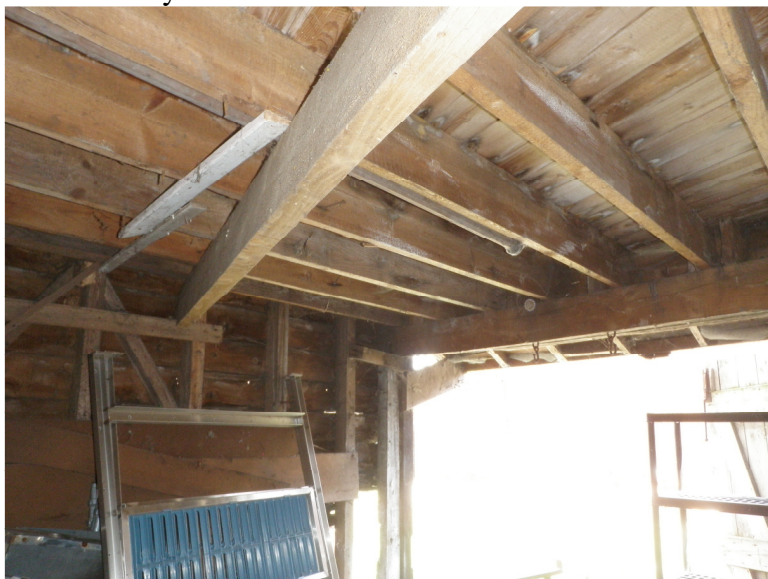
Plate 7. The sturdily constructed interior of Shed C looking towards its entrance. Note the modern timbers that support the first floor that show this structure to be of fairly recent (post-war) construction

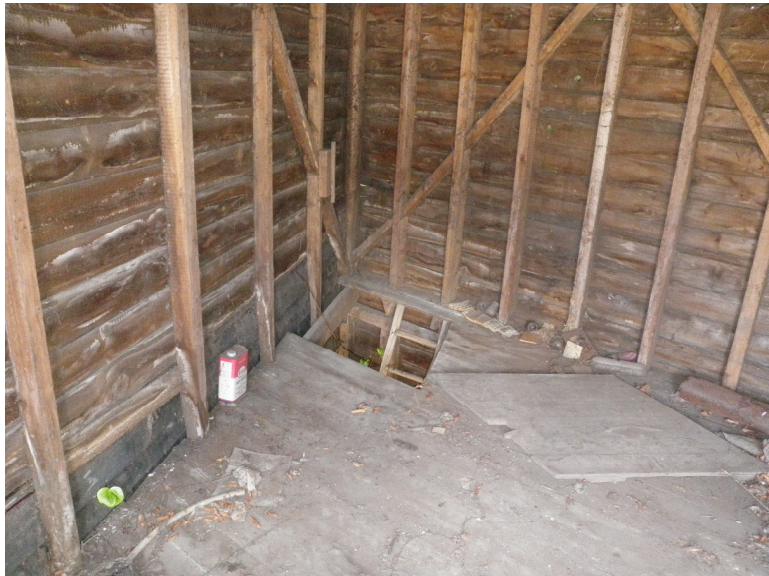
Plate 8. Access to the upper floor of Shed C by means of a hole cut in the floor at the eastern corner of the shed.

It is certain that this was never the intended access when the shed was built.

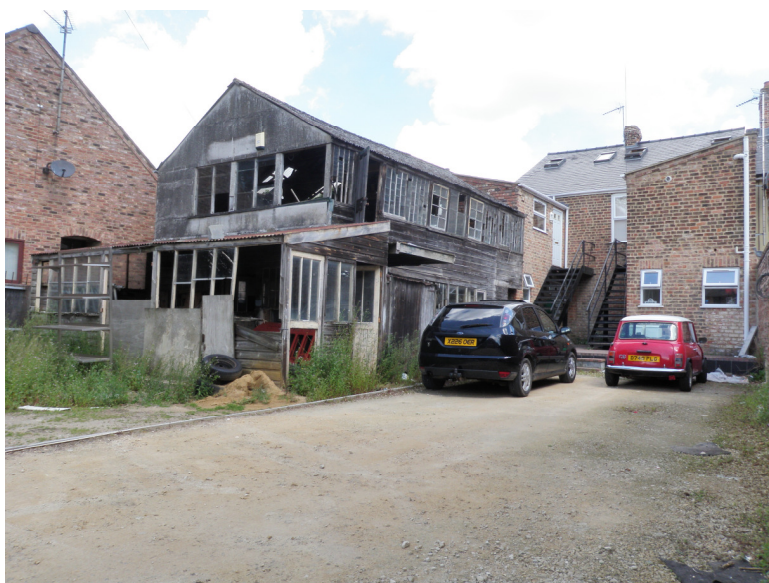
Plate 9. General view of Building 2 showing the buildings fronting onto Market Street at the rear of the photograph.

The low single storey building at the front (Shed B) is a later addition.

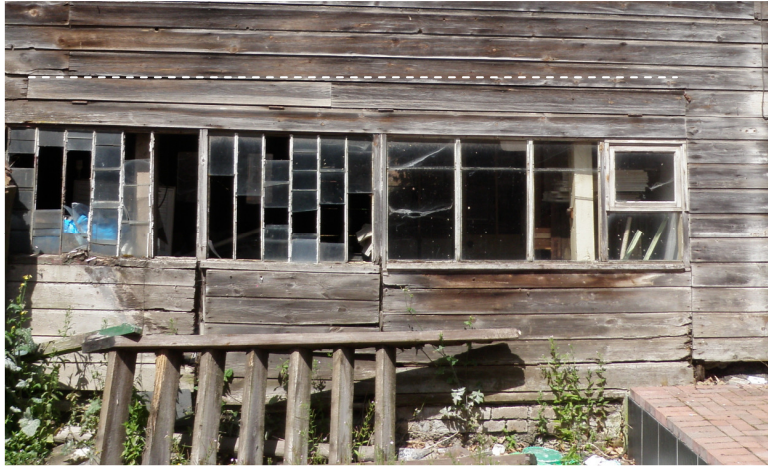
Plate 10. Ground floor windows on the southeast face of Shed A. Note the variations in form and the vertical cuts through the timbers. A long, hinged piece (below the dashed line) that serves no purpose shows re-use of wood from the original form of the structure.

The appearance of the windows, along with the cuts through the timbers, indicates that they were, on the ground floor at least, not original to the structure. It is likely that the windows on the northwest side (see Figure 5 & Plate 12) were repeated on this side as the originals, but did not let in sufficient light for the intended purpose of the building. The walls around the southeast windows appear to have been rebuilt using the original timbers cut out to form the openings. The hinged planks above the windows that serve no functional purpose are further evidence of re-use (Plate 10).

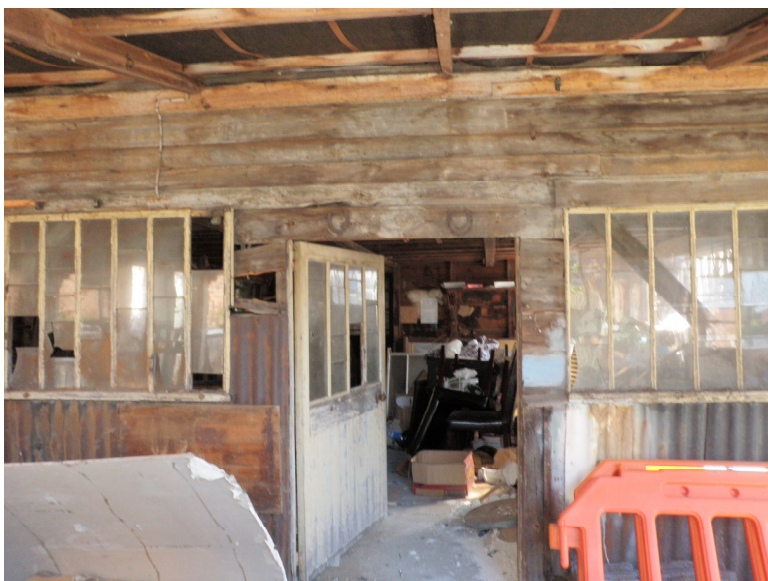
Plate 11. The original exterior wall at the southwest end of Shed A and the original entrance. Note the horseshoes over the doorway and the corrugated iron lower walls.

Building 2, Shed B was a later addition attached to the original exterior at the southwest wall. It had been constructed some time after the original section of the building. This could be seen internally as the original outer face of Shed A had weathered considerably (See Plate 11).

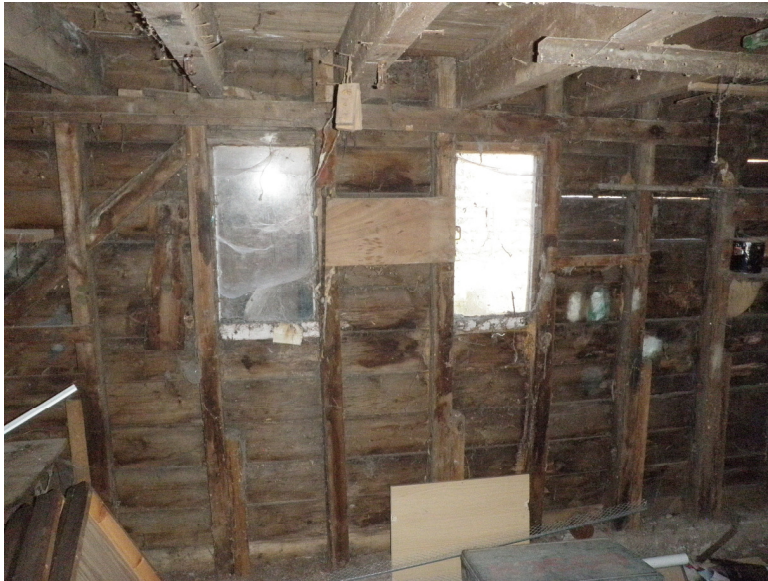
Plate 12. The windows on the northwest wall of Shed A are original and were possibly mirrored on the southeast wall prior to its alteration

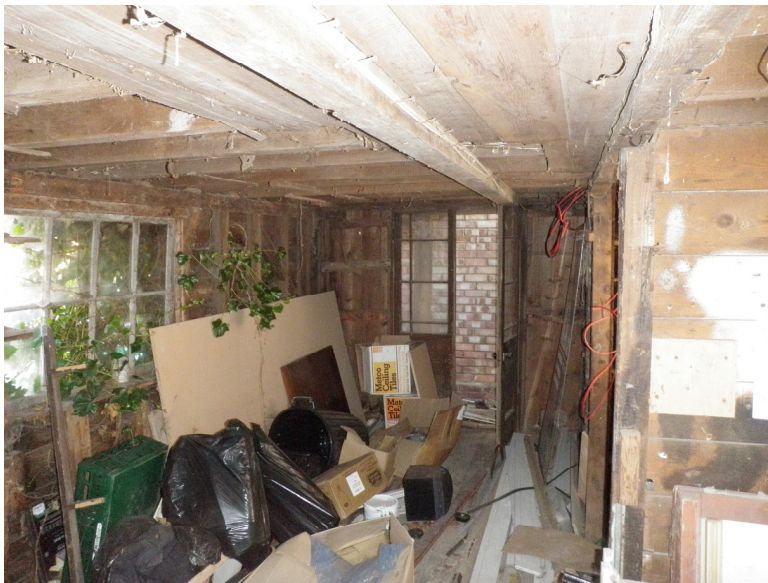
Plate 13. Internal view of the ground floor of Building 2, Shed A. Note the internal dividing wall on the right of the picture and an original doorway at the back left corner.

The internal space on the ground floor had been divided; firstly as part of the original structure to form a coal shed and store room with external access. The store and coal shed show timberwork that is contemporary with the original structure of the shed as a whole. Latterly another portion had been plaster-boarded out to form a small office and kitchen area (See Figure 5). This appears to have been a fairly recent addition as the plasterboard was in good condition. A secondary access to the ground floor was provided at the northern corner (Plate 13).

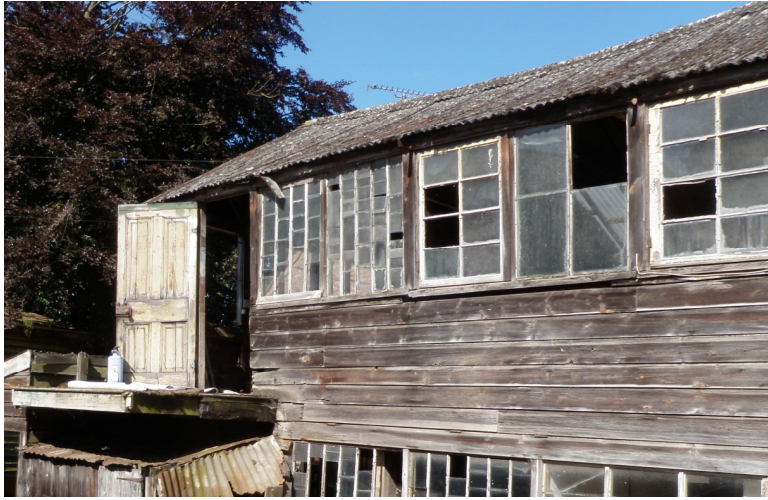
Plate 14. The upper floor of Building 2 Shed A. The access was by a wooden staircase which had since fallen away

The upper floor was accessed at the southern corner by a flat platform that previously had an attached outside wooden staircase that had fallen away. The doorway and tops of the windows reached to the bottom edge of the pitched, corrugated iron roof.

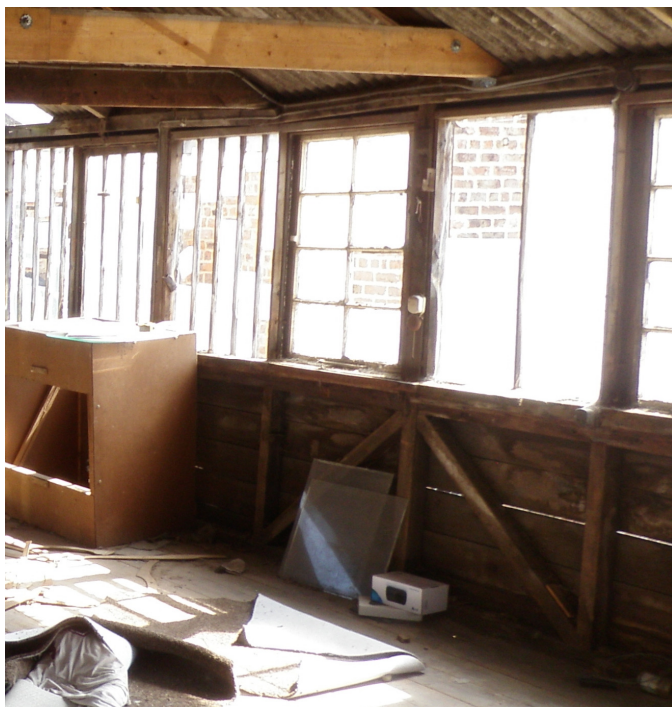
Plate 15. Internal view of the windows and supporting timber structure of the upper floor of Building 2, Shed A

Although the glazing of individual windows appear to have been changed and replaced over time, the apertures for each window division were uniform and appeared to form part of the overall structure.

There were signs of general repair, such as the roof support joist, visible at the top of Plate 15.

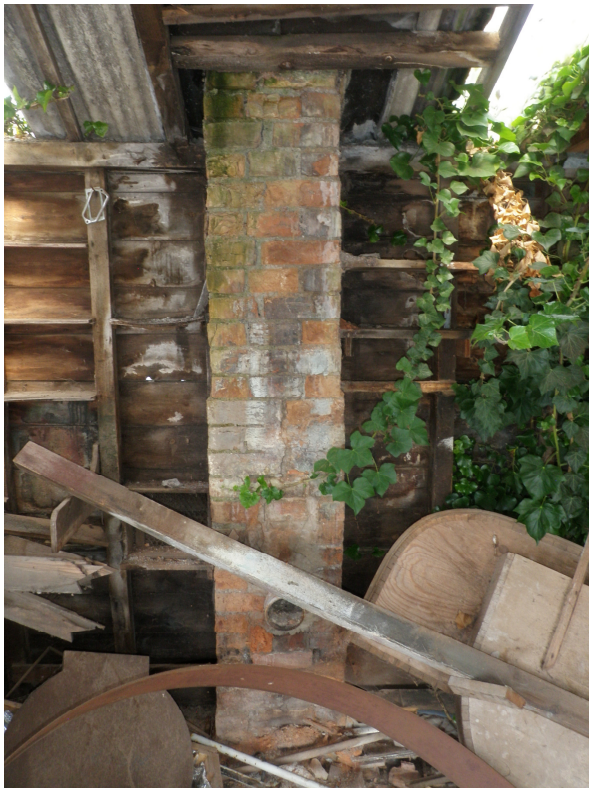
The entire space was one open area that had been used as a machine shop for cutting timber. An unusual feature for this timber structure was a brick built “chimney” present only on the upper floor. This appeared to be for the extraction of sawdust produced during the timber cutting.

Plate 16 (left). The brick structure with a plastic inlet at the base probably used as a dust extractor. Note the extra light afforded by skylights cut into the roof on either side of the “Chimney”

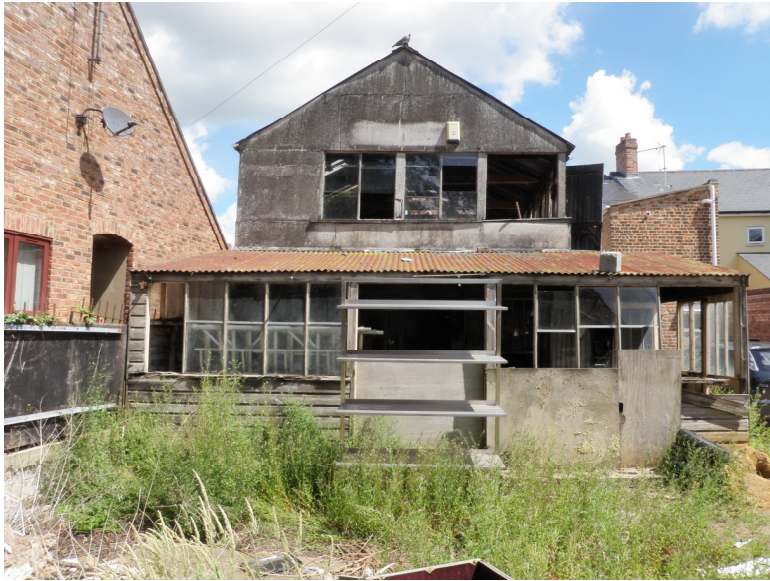
Plate 17. Building 2 Shed B. End view showing its relationship and larger ground floor width compared with Shed A

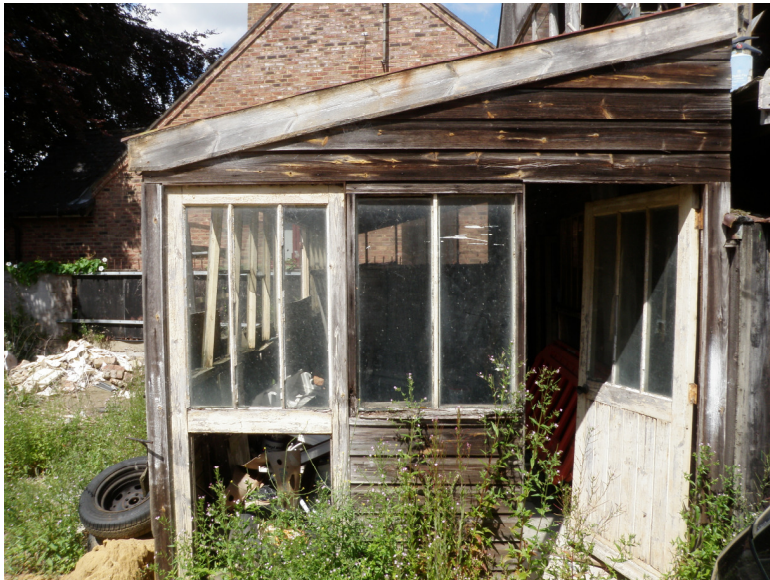
Plate 18. Side view of Building 2, Shed B showing the pitch of the corrugated iron roof

Further access to Shed B could be gained by means of two doors on the southeast wall of the building. The exact reason for there being two doors in this wall remains unclear (Plate 18).

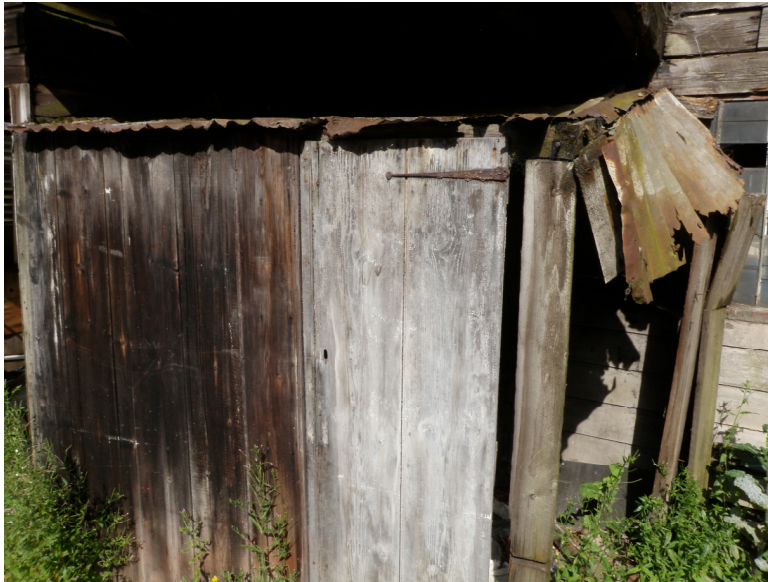
Building 2, Shed C was little more than an extra storage area that had been created by nailing re-used pieces of timber to the wall of Shed A beneath the flat platform that allowed access to the upper floor of Shed A. It was very basic and roofed with similarly left over corrugated iron.

Plate 19. The very basic structure of Shed C. Note the re-use of an old hinged door as part of the outer wall.
