**HISTORIC BUILDING RECORDING  
MOUNT PLEASANT  
MAIN STREET  
SUTTON CHENEY  
LEICESTERSHIRE  
(SCMP14)**

Work Undertaken For  
King West Ltd

October 2014

A.P.S. Report No: **103/14**

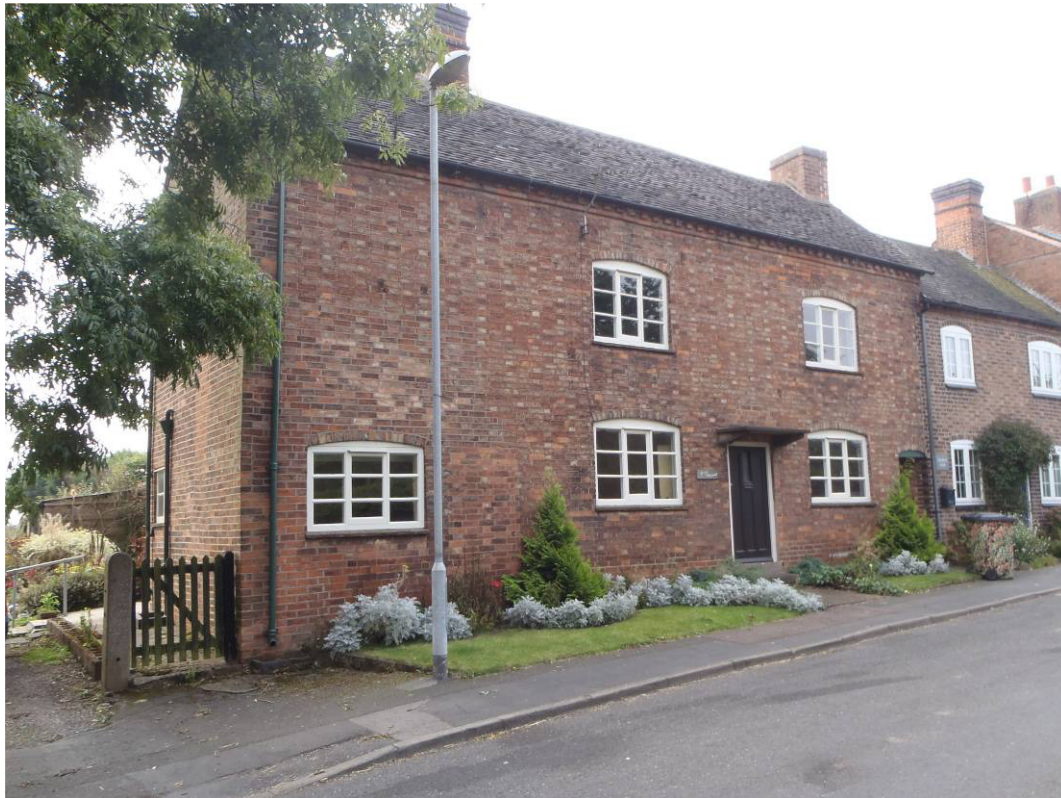
Plate 1. General view of the northwest elevation of Mount Pleasant, looking south from Main Street

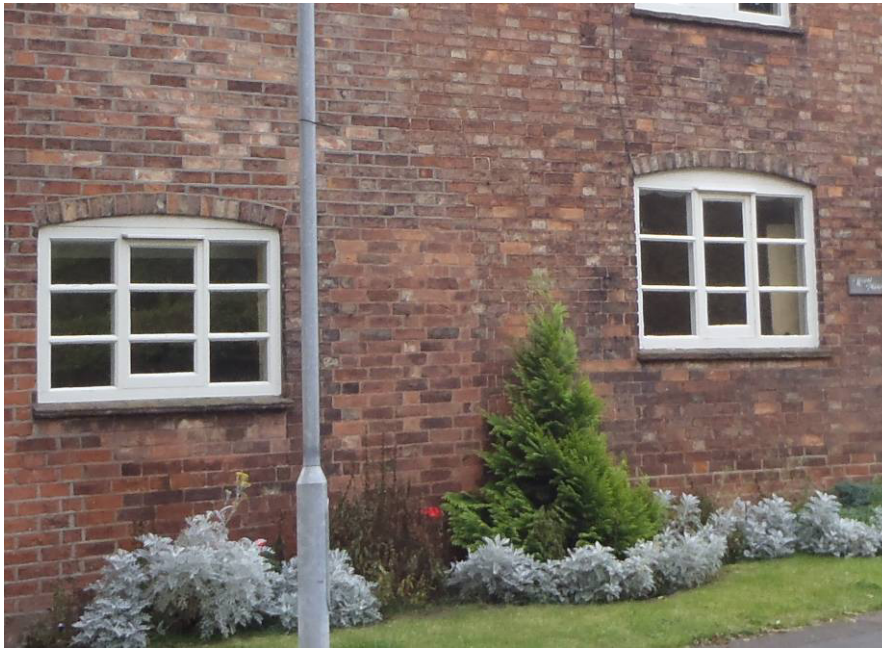
The wall of the northeast unit (Kitchen/Diner) has a blocked doorway of a similar size and flat-topped style to the main doorway. The window to the northeast of this door is also a three light casement with a cambered brick head and creasing tile cill. It is slightly smaller than its counterparts and set lower to the ground. Beneath the window on its southwestern (right) side is an area of apparent brick patching or infill. This might suggest an earlier narrower and taller window, but this is countered by the arched head which extends the full width of the window. There is no corresponding window in the first floor of the northwest elevation.

**Plate 2.** Detail of the northwest (front) elevation highlighting the blocked doorway and the difference in levels between the windows

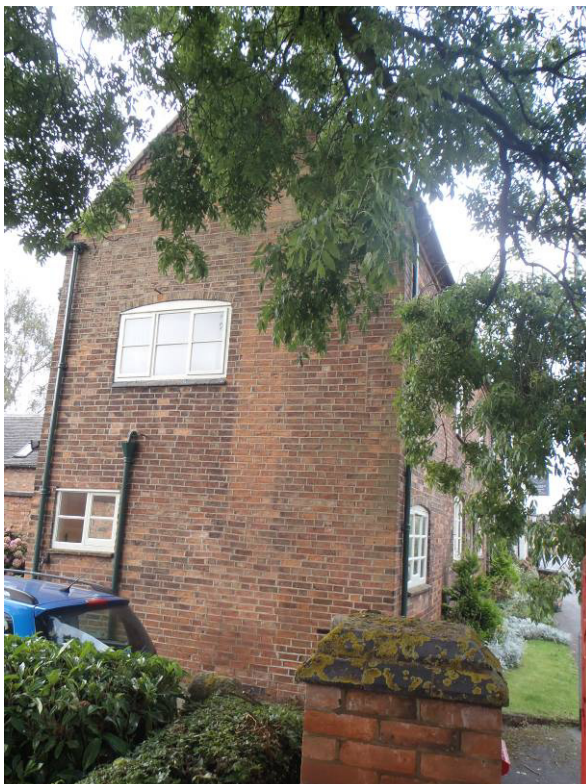
The ground floor window in the northeast elevation is a two light timber cross casement window, the aperture for which has been cut into the existing brickwork. There is no cambered head. The first floor window, a three light timber casement with a cambered brick head, has a steeply sloping cill of canted blue brick and is integral to the surrounding brickwork. Above this in the gable is a blocked window aperture, also with a cambered head suggesting this floor was once in use as attic rooms.

**Plate 3 (left).** General view of the northeast (side) elevation showing the windows Looking west

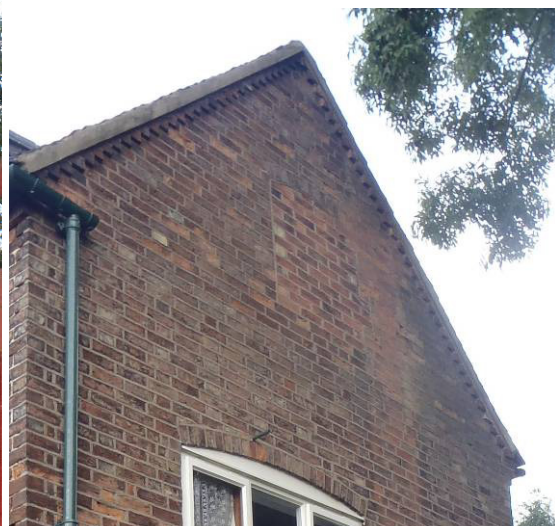
**Plate 4 (Below).** Detail of the change in brickwork and the blocked window in the gable. Looking northwest

The brickwork in the northeast elevation is uniform, Flemish Garden Wall bond until the gable where the type changes to what appears to be more recent brick. This is bonded in a variant of Flemish Garden Wall (five stretchers to one header rather than three stretchers to one header per course as is seen on the other elevations). At the eaves the brick is set in sawtooth dentilation. Running the height of the elevation, to the north (right) of the windows is a vertical band of light brick. For the most part this is just some form of bleaching, as the colour partially crosses bricks, but there is some evidence of brick replacement in this band. Additionally, at the base of the band is a short section of blue brick.

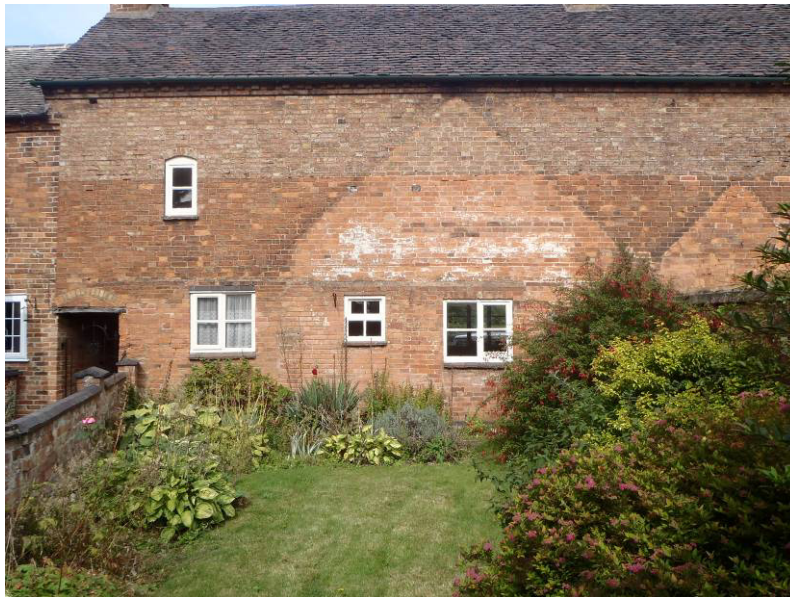
**Plate 5.** General view of the southeast (rear) elevation showing the scars of previous structural elements and the conspicuous changes in the brickwork

Previous structural elements of the building that were demolished some time between 1930 and 1958 are visible as scars on the southeast elevation of the main building. The central wall between the two structures remains as the garden wall (behind the shrubbery to the right of Plate 5). The scars of the pitched roofs cover two uniform phases of brickwork showing that within this upper space they abutted the building.

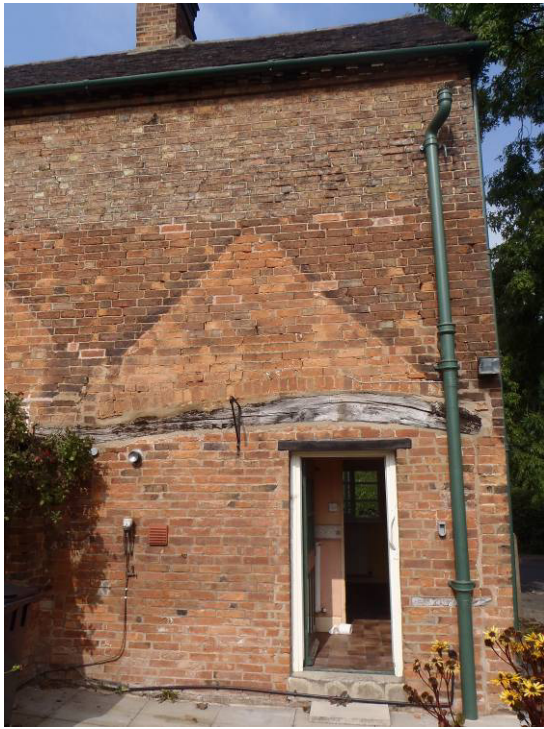
Aside from the occasional brick laid as a header and infrequent queen closers the entrance has been bricked up in stretcher bond. The new doorway with its straight wooden lintel has been built as an integral part of this phase of alteration. A small timber beam has been left to the right of the doorway, possibly as a means of attaching a gate.

**Plate 6.** Detail of the rear entrance into the lobby area through a blocked-up original ground floor entrance. Looking northeast

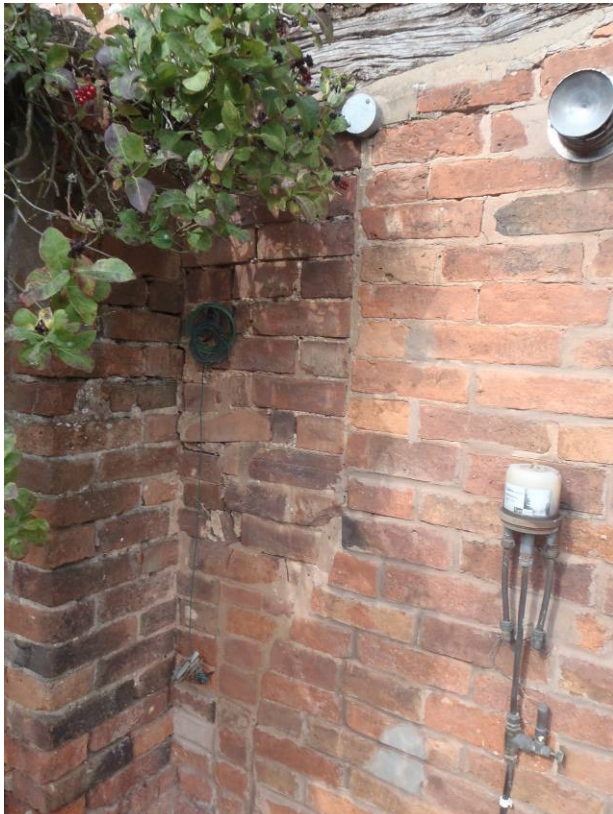
The garden wall would have originally been the southwest wall of this structure that stretched all the way to the outbuilding labelled as a store. That this was an integral part of the whole building is evidenced by how the garden wall is keyed into the main structure (Plate 7).

**Plate 7.** Detail of the edge of the blocked entrance showing how the garden wall, keyed into the rear wall of the main building was an integral part of the structure. It formed the southwest (long) wall of this removed portion of the building. Looking west

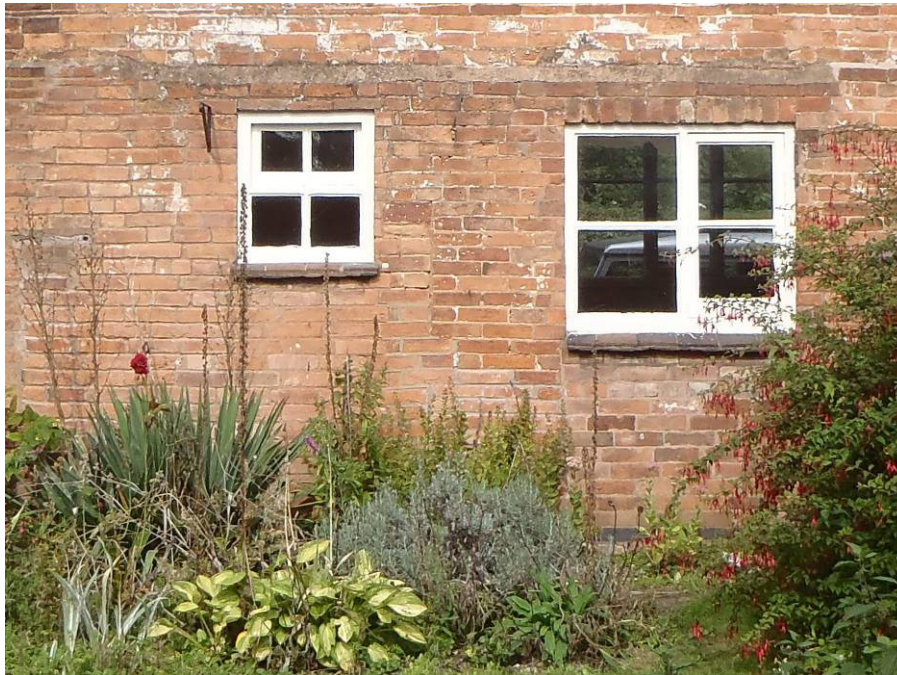
Although the ground floor appeared to have been open, at least to some degree, there is no overarching wooden lintel or evidence that there has been one. It has been bricked up in two phases unlike its neighbouring building. It is possible that these separate phases represent the installation of the windows.

**Plate 8.** Detail of the windows within the bricked up area inside the building scar of the southwest structure. Looking northwest

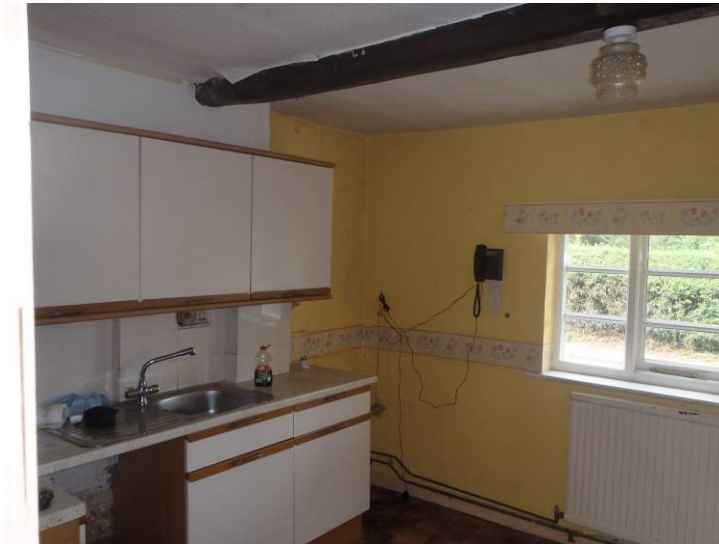
**Plate 9** (left). The kitchen with original timber beam.

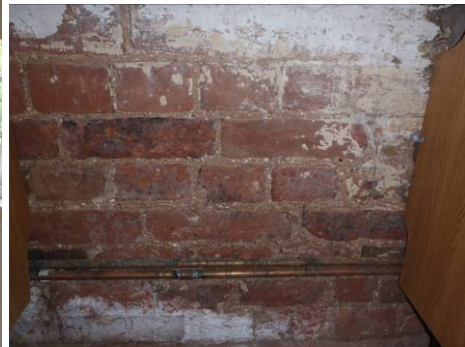
**Plate 10** (below). Detail of the wall between the northeast and central units

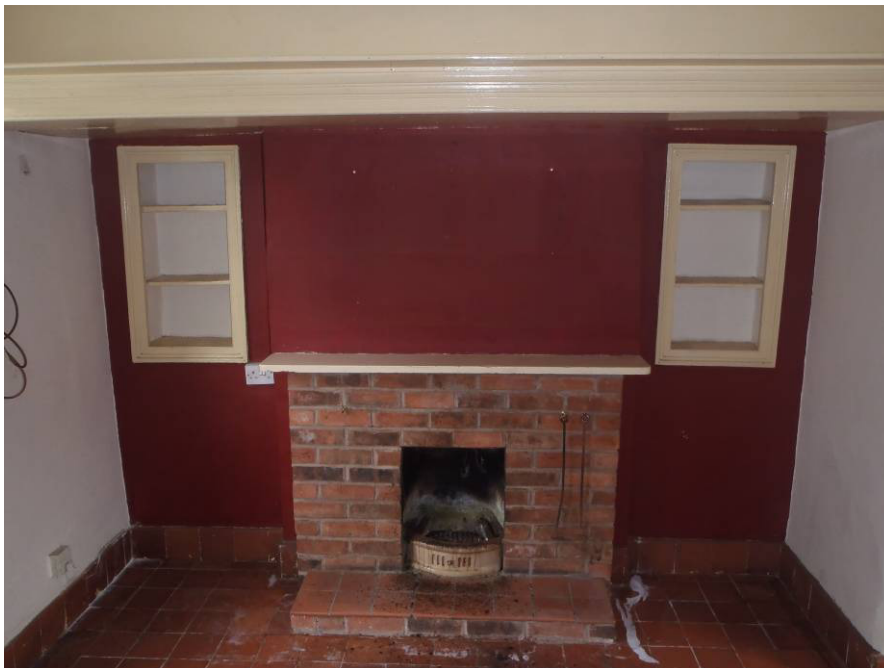
**Plate 11.**

Access to the central unit was through the lobby also. The room was open as a single unit with a quarry tiled floor and windows front and rear. The most notable feature of this room was the fireplace. The entire northeast wall of the room beside the doorway was taken up with what appeared to be the remains of a large inglenook. At some time the inglenook was replaced by a smaller central hearth with recessed shelves on either side. The architrave top to the inglenook was likely added along with the smaller replacement hearth. This style of inglenook fireplace is reminiscent of 18<sup>th</sup> century architecture.

A large inglenook fireplace that has been altered to provide a smaller central hearth and a chimney breast. There are recessed shelves on either side

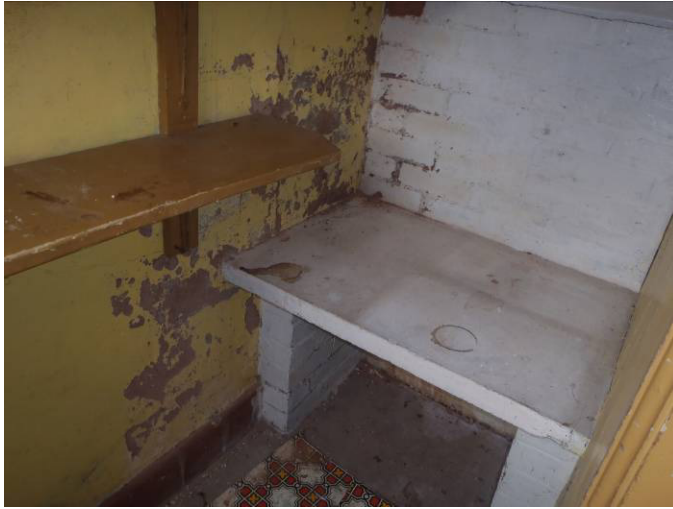
The access to the pantry was at the southwest corner of the central unit and located below the landing. Within the pantry what now has been set up as a cold shelf against the back wall may have been the entrance to the cellar at the front of the building. Any access has since been blocked as the floor is now solid concrete.

**Plate 12.** The pantry and the cold shelf covering what may have been the access to the cellar

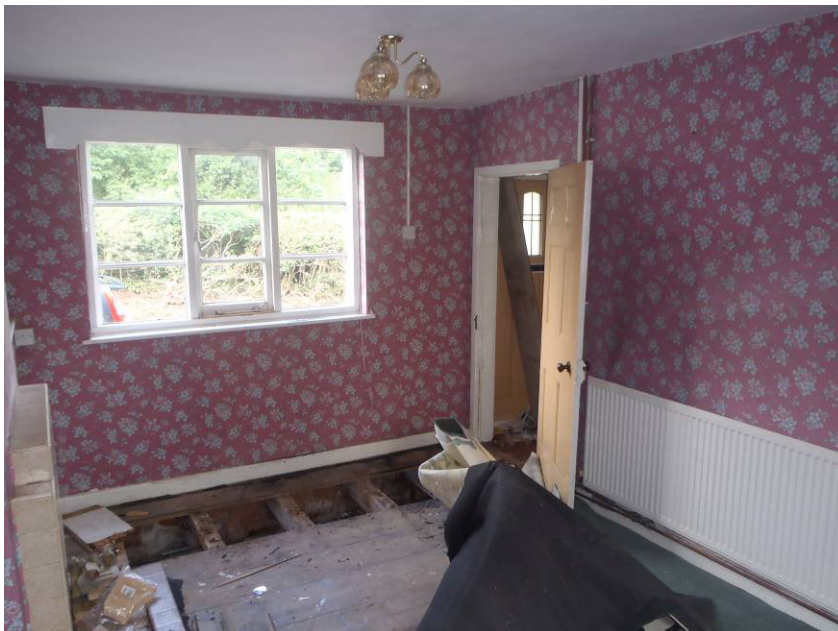
**Plate 13.** The southwest unit (Lounge 1) of the ground floor looking toward the front entrance to the building. Some floorboards had been removed allowing a view of the cellar

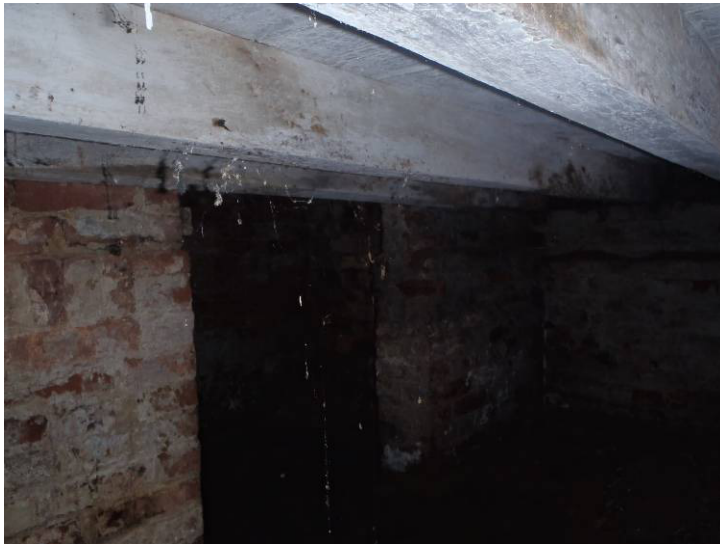
**Plate 14.**

The cellar itself only reached two thirds of the way back from the front of the building and its access is now blocked. It was possible to observe that it is of brick construction with an earth floor and is divided into compartments.

The cellar below the southwest unit and the access through to where the entrance was located in the pantry area

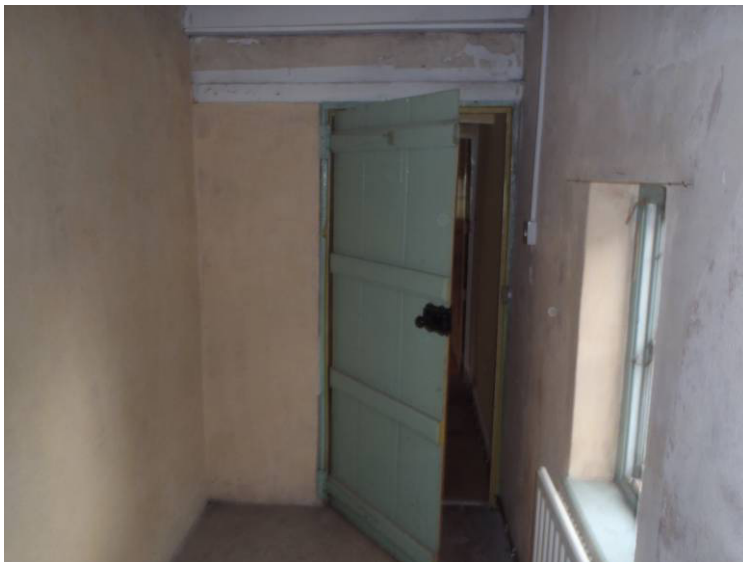
**Plate 15.**

The store area looking back toward the landing showing the lime plastered walls and poured concrete floor

The store area is unfurnished with the walls rendered in lime plaster. There are exposed joists in the ceiling that are visible on the outer rear elevation (Plate 5).

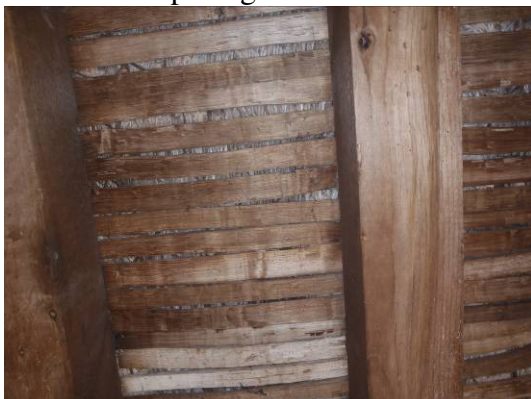
**Plate 16.**

The floor is of uneven poured concrete over reeds. This structural element is visible from below in the passage between Mount Pleasant and Church View.

The underside of the floor of the store area showing the reed construction. Looking upward from the passage between Mount Pleasant and Church View

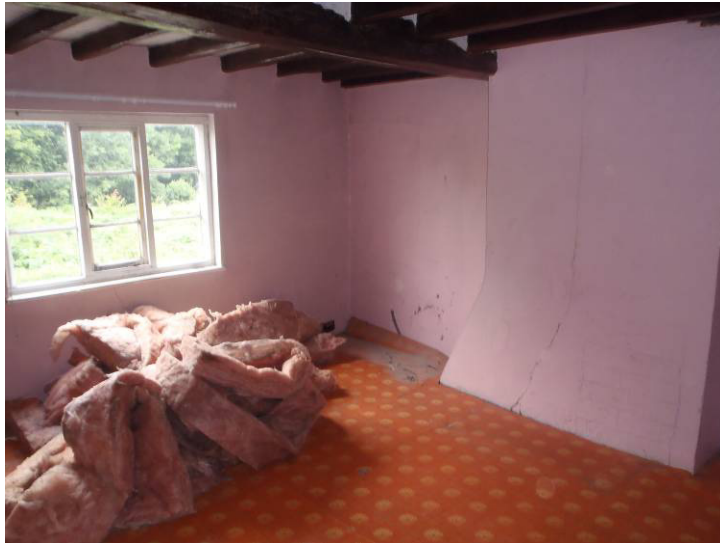
**Plate 17.**

On the northeast side of the stairs is Bedroom 1 occupying the central unit. On the northeast side of the rake-over chimney breast was an exposed timber beam crossing the ceiling with the associated joists exposed from front to back. Also on the northeast side was a blocked doorway through to Bedroom 3. The fireplace in this room was also blocked.

Bedroom 1 in the central unit showing the exposed beams, the rake-over chimney breast and the blocked doorway to bedroom 3

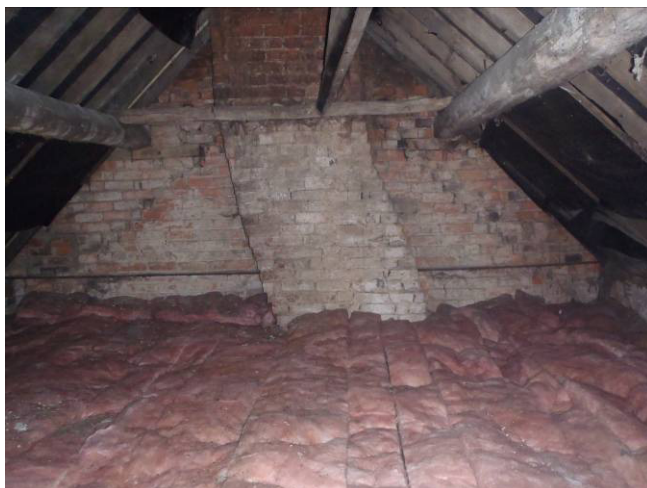
**Plate 18.**

Access to the uppermost storey is in the central unit. The stairway entrance has been boarded up but enough had been removed to gain entry. The northeast unit with the bricked up window was inaccessible so its form and function as a room was not visible. Of note is the brickwork in the gable end of the southwest unit. The additional courses on the chimney and the gable show that although of some age, the roof is not original.

Southwest gable end showing the additional courses of brickwork on the chimney and gable and the timber structure of the roof

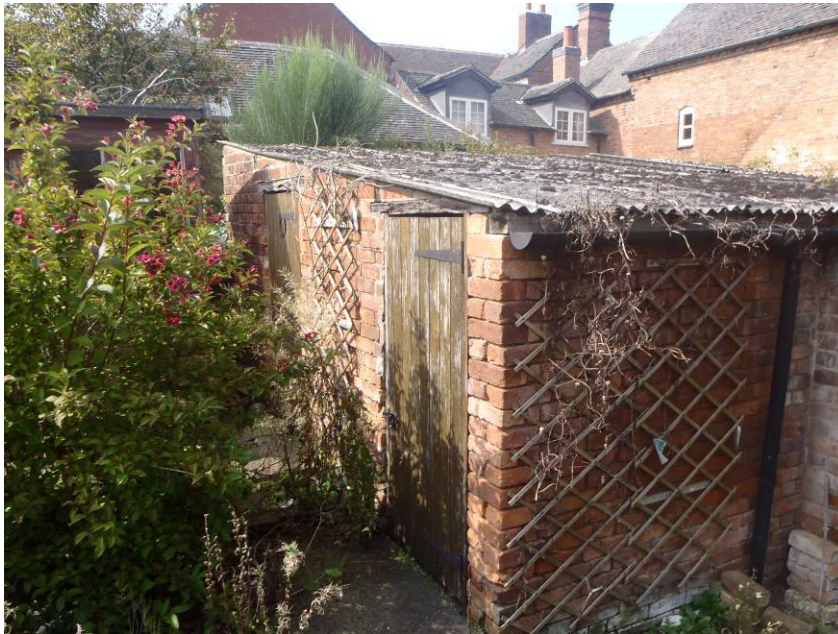
**Plate 19.**

The original portions of the outbuildings with the attached garage on the right of the picture

The original parts of the outbuildings are split into two separate compartments, both built with brick laid in Flemish Garden Wall bond. The small northeast partition is a concrete floored coal shed. The rear store, with a brick floor has another internal doorway that leads through to what is now the garage. The rear wall, with its blocked up windows is integral and continues along to the house as the central garden wall.

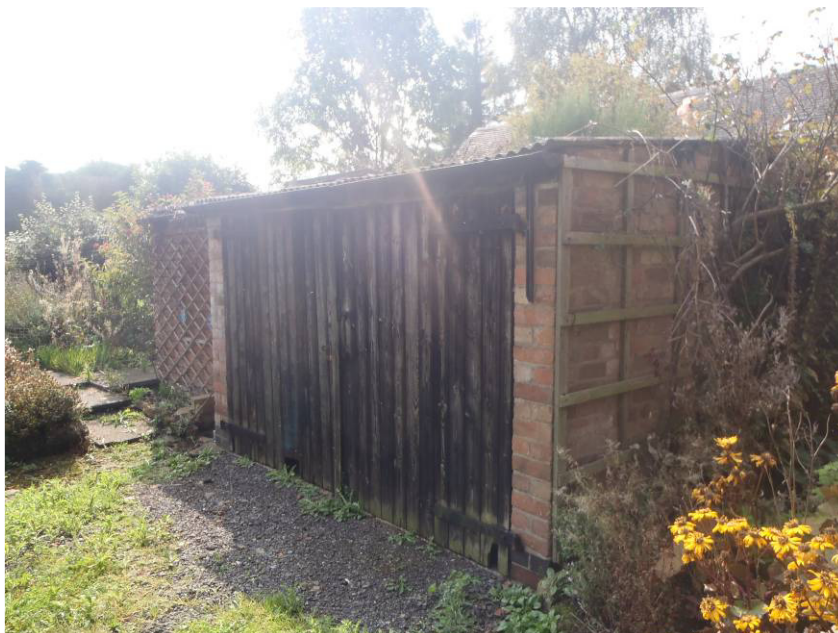
**Plate 20.**

The garage is a later addition and butts against the rear wall and the shed. The area previously occupied by the demolished buildings is now a patio.

The garage, a modern addition attached to the remains of previous structures now used as outbuildings and stores. Looking south
