**HISTORIC BUILDING RECORDING
HECKINGTON WINDMILL
HALE ROAD
HECKINGTON
SLEAFORD
LINCOLNSHIRE
(HEWM12)**

Heckington Windmill Trust

January 2015

APS Report No: **23/14**

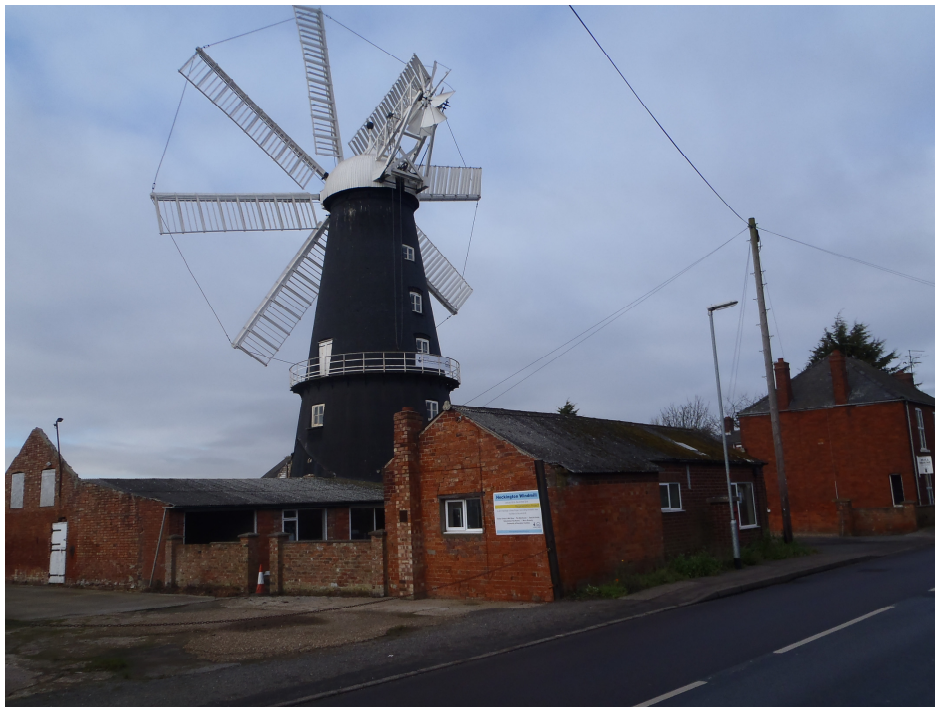
Plate 1. Heckington Mill and its entrance ways (at the left and right of the picture) from Hale Road. Looking northwest

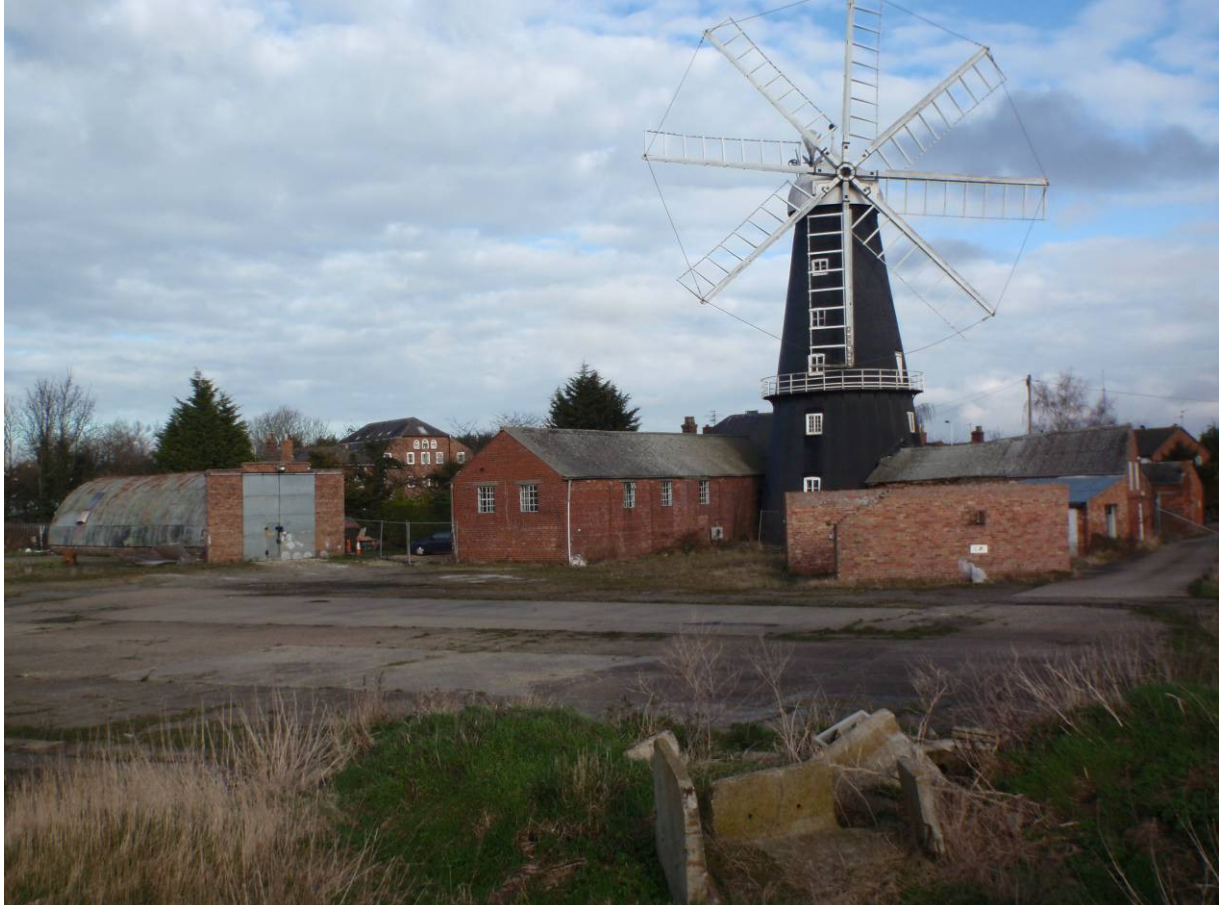
Plate 2. Mill complex, looking northeast, showing attached granary and brewery with the Nissen hut to the left, further to the north

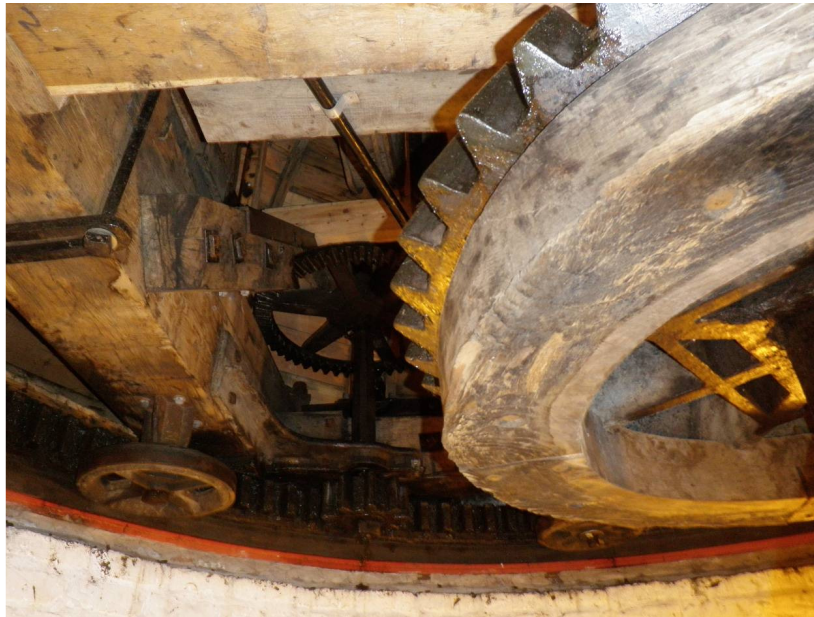
As previously mentioned the cap that now sits atop the windmill is not the original, having been replaced by the cap from another mill in Wyberton. A small mezzanine floor is present just below cap level, to provide access to the working machinery. Any alterations are therefore those that have been necessary during the working life of the mill in order to keep it in full working order and the mechanism is likely to have degraded through general wear and tear.

Plate 3. The windmill mechanism

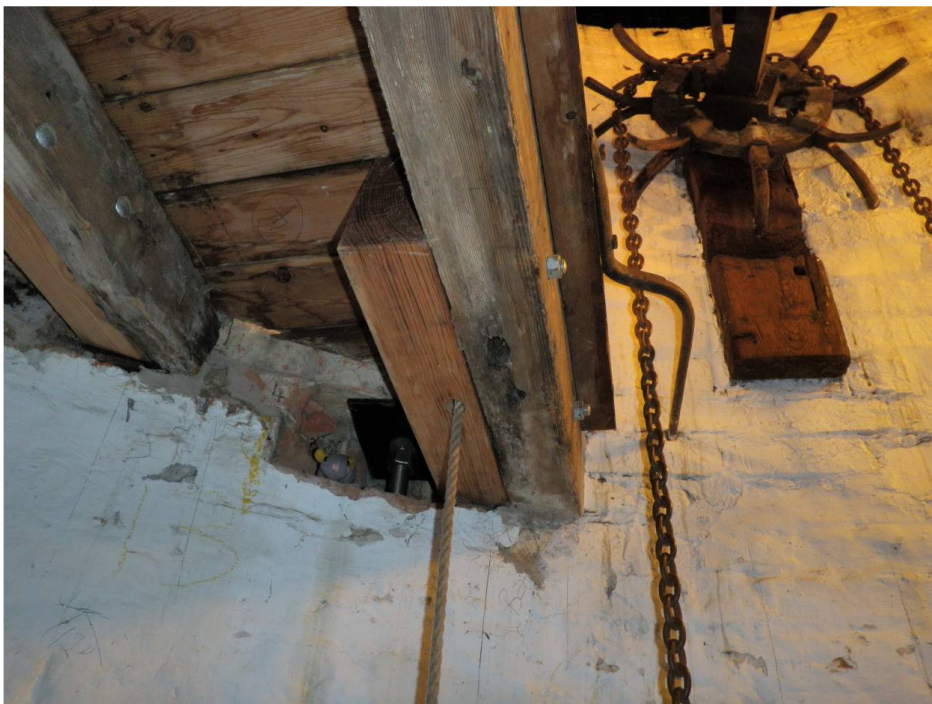
The re-built brickwork from the modern cap repairs can be clearly observed between the dust floor and the cap. The mechanism that operates the sack hoist is also present at dust floor level and is a continual chain that runs over a wheel and passes all the way through the mill via the sack traps present on each floor.

Plate 4. Dust Floor. The re-built brickwork with modern pinning and the mechanism for driving the sack hoist on the right

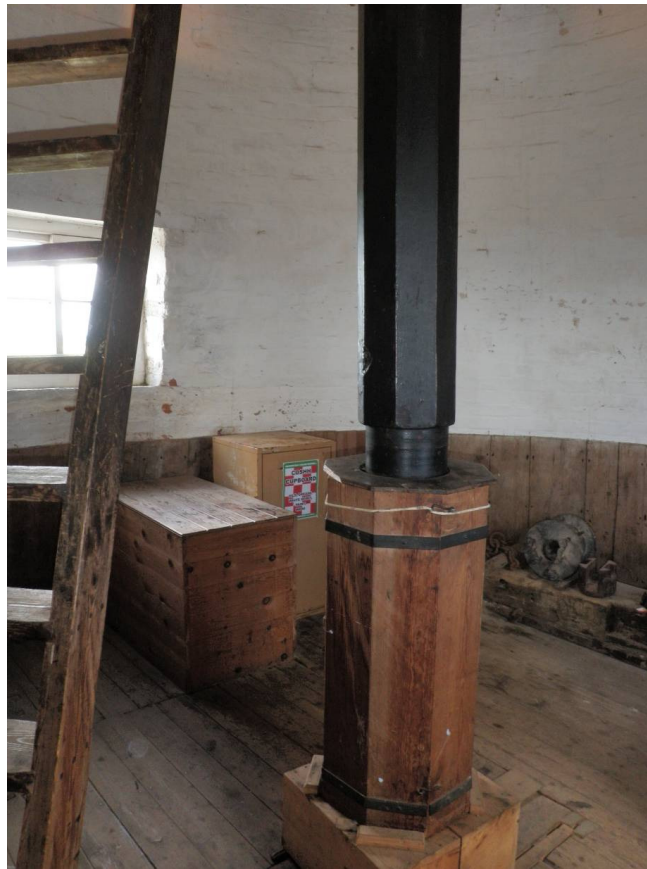
Plate 5. The Upper Bin floor with partially boarded walls

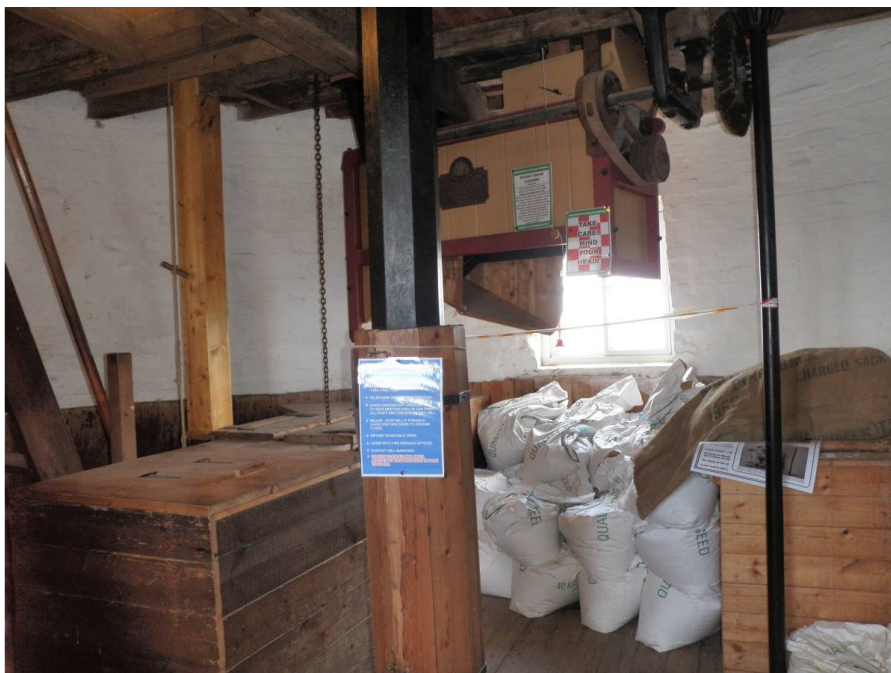
Plate 6. The Lower Bin floor with raised sack traps for ease of handling

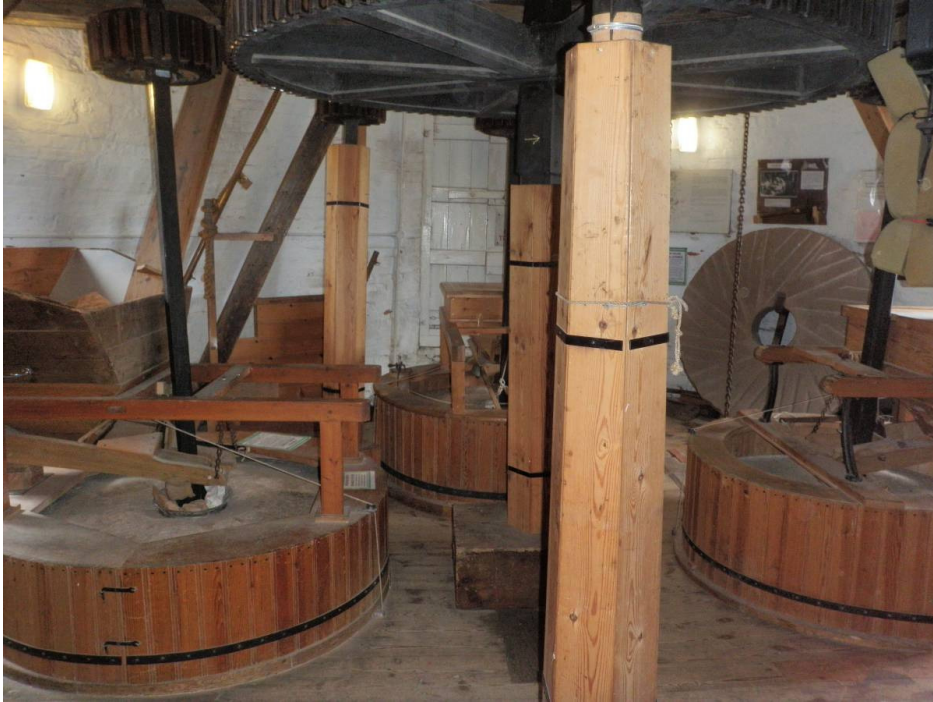
Plate 7. The stone floor showing the three sets of millstones and one of the double access doors, at the rear, on to the external reefing stage

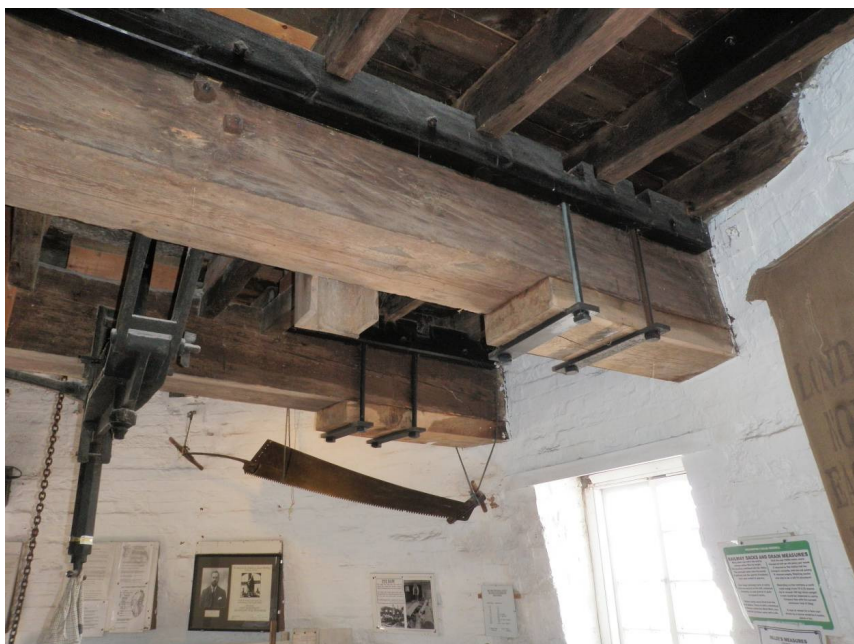
A mixer for the production of balanced animal feed extends from this floor to the ground floor. The beams supporting the stone floor are substantially larger than those observed elsewhere in order to compensate for the additional weight of the millstones above. Additional metal bracing is likely to be a modern addition.

Plate 8. The Meal Floor. The beams supporting the stone floor

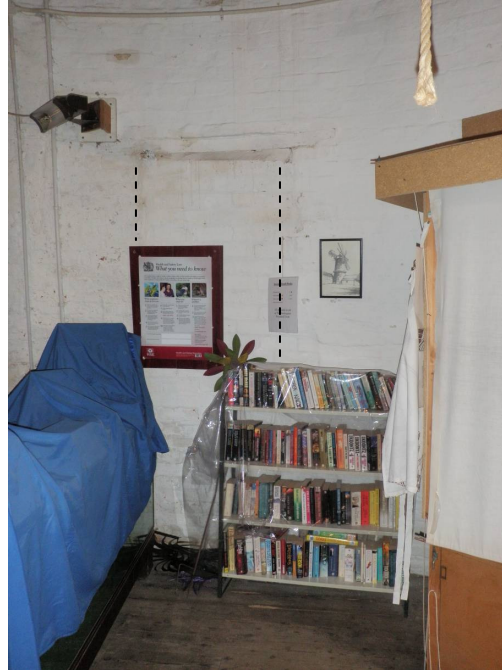
The ground floor is raised above the exterior ground level in order to make easy access for vehicles at the loading stage. The ground floor of the windmill is now mainly used as a museum/memorabilia display and shop and therefore much of the fabric has been covered with display materials. The only visible change of use is a blocked doorway, present to the south side, which originally led into the granary area.

Plate 8. Ground Floor. Blocked doorway on south wall of windmill

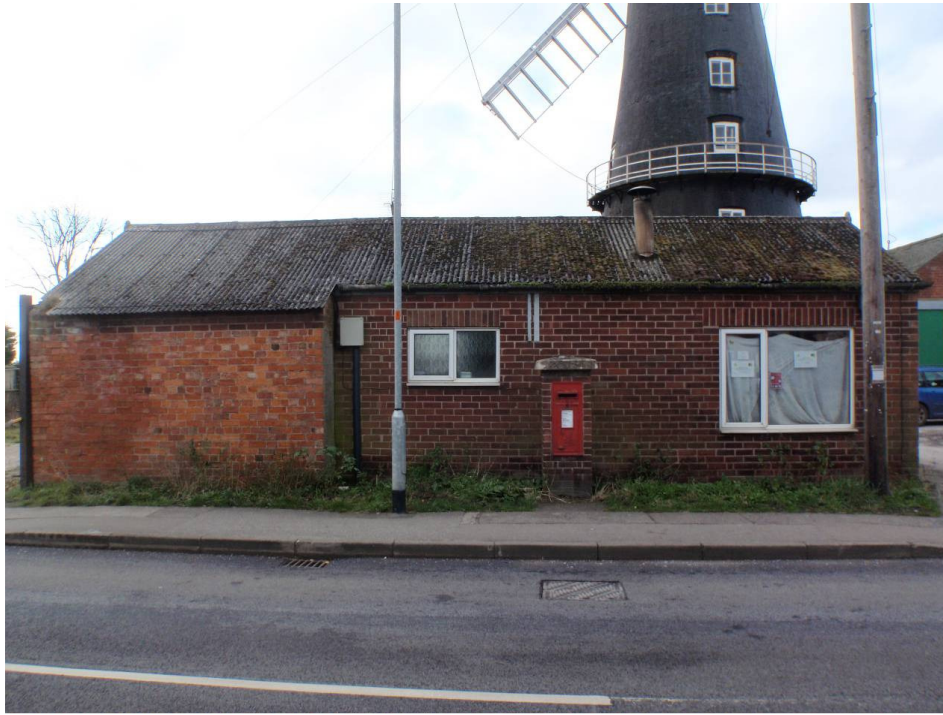
The northern part is a modern structure constructed with cavity walls in stretcher bond with machine made bricks. This structure has a number of window openings all of which have a simple full brick soldier course above. The windows within these openings are all modern uPVC. The door is located on the western elevation and like the windows is also uPVC.

Plate 10. Eastern elevation of bakehouse showing two distinct construction phases

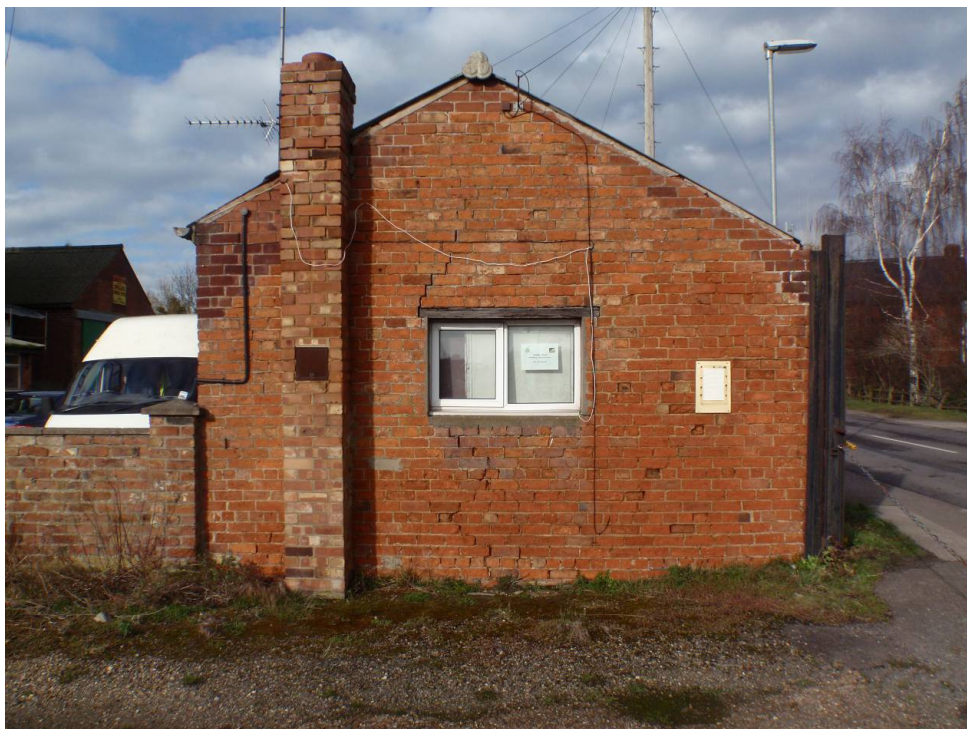
The southern section of the building appears to be slightly earlier in date than the northern addition. Modern brickwork visible in the eaves and within the verge on the gable end suggest that the roof has been raised, probably contemporary with the construction of the section to the north. A modern chimney stack has been added to the southern gable end. The apex of the roof verge, on each gable, bears a decorative trefoil.

Plate 11. South facing gable of bakehouse with modern brickwork in verge, additional chimney stick and trefoil decoration in apex of roof

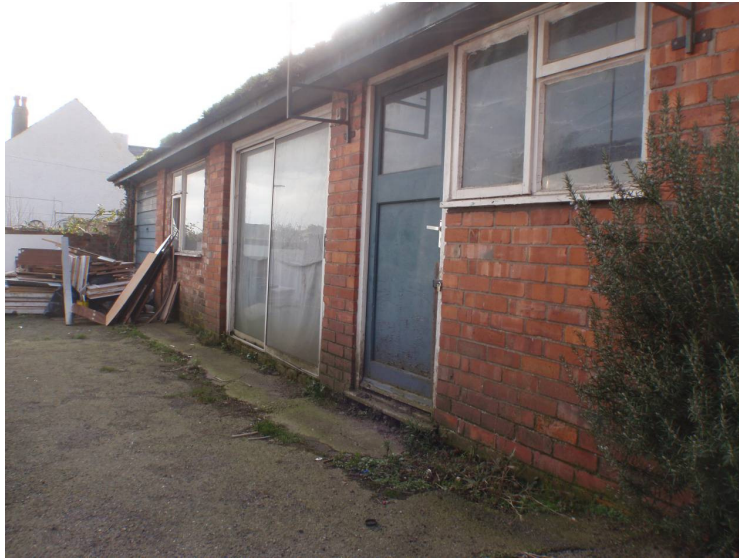
Plate 12. Eastern elevation of cart shed

The east elevation is again constructed of machine made bricks which have been laid in a modern stretcher bond pattern. This elevation has a number of door and window openings within it. Starting at the northern end and moving southwards there is a modern timber casement window and adjacent two-panelled modern door. Beyond this is a modern double sliding patio door made of uPVC. The next opening is a modern timber casement as noted before but this has been placed within a larger opening which has clearly been reduced in size as evidenced by the change in brick type and also the fact that it has been recessed slightly back from the main wall face. The final opening has an up and over modern garage door within it.

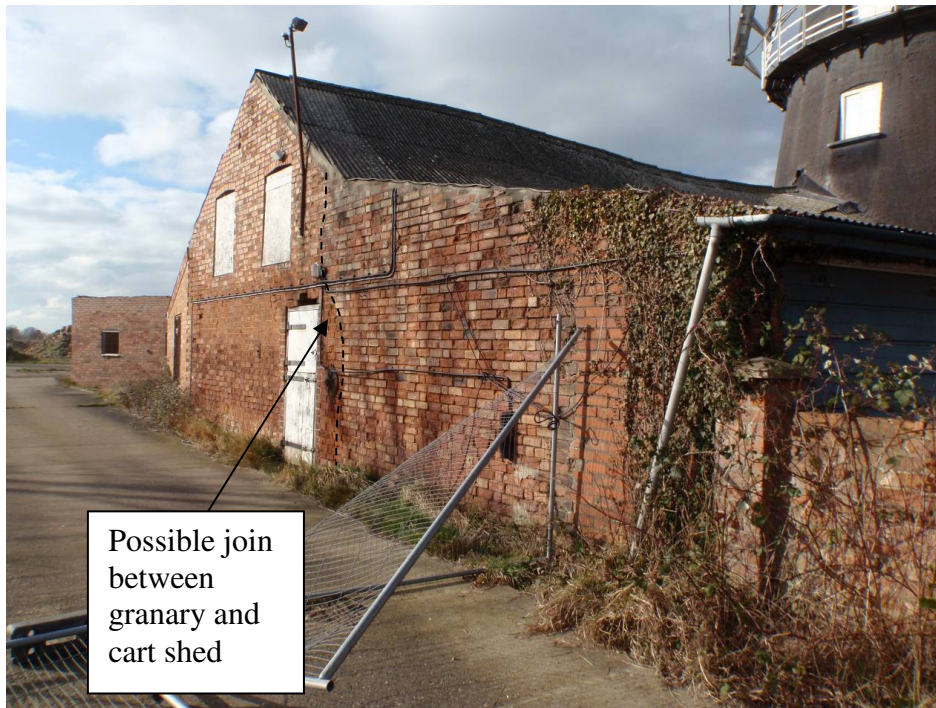
The south wall of this structure was partly obscured by vegetation but it was possible to see that the eastern end of the wall was a different type of brick to the rest of the wall which it is simply butted up to. The bonding pattern of the brickwork was also different; the main wall being a type of Flemish garden wall bond, while the butted on section is stretcher bond. Where the main wall abuts the Granary it is not clear if both sections of wall were constructed together. Both use the same bonding pattern, Flemish garden wall bond but there appears to be a toothed joint between the two. This could indicate that one structure was constructed against the other or that weathering and erosion of mortar joints has made it appear that way. The former is the most likely.

Plate 13. Southern elevation of cart shed showing the different types of brick and bond in the cart shed construction and the possible join between the granary and the cart shed

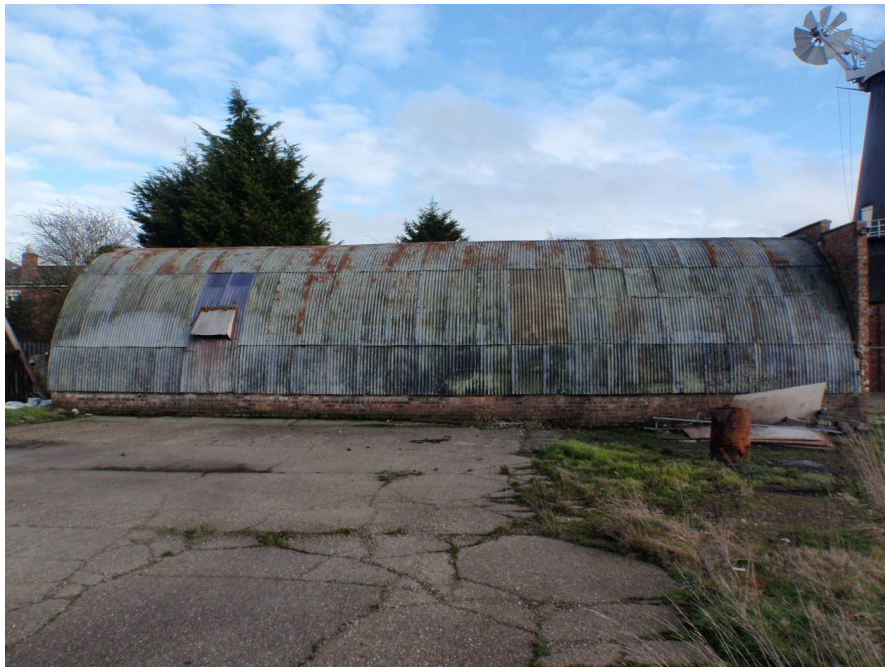
Plate 14. The Nissen hut, looking east, noting the projecting elevation to the right and the flush gable to the left.

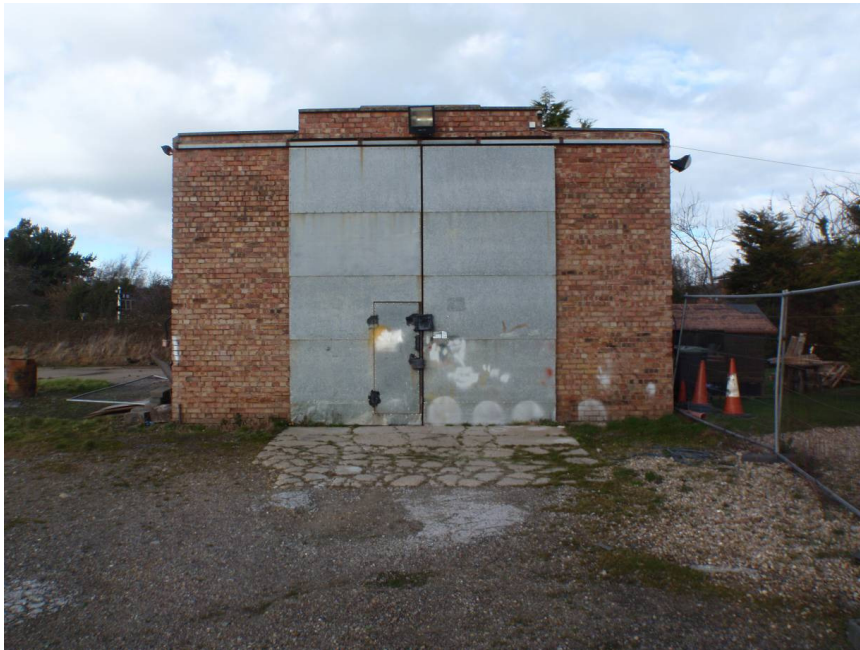
The south elevation comprises of a brick elevation constructed in common brickwork laid in a type of English garden wall bond. The top of the brickwork is finished with a concrete coping course. The main feature of this elevation is the large sliding metal clad door which

gives access to the building. The left hand side sliding door has a smaller access door to enable the building to be accessed without having to open the sliding doors. This wall has a large brick buttress internally either side of the door to provide additional strength to the wall supporting the lintel and the running gear for the door mechanism.

Plate 15 . The south elevation and 'front' entrance of the Nissen hut

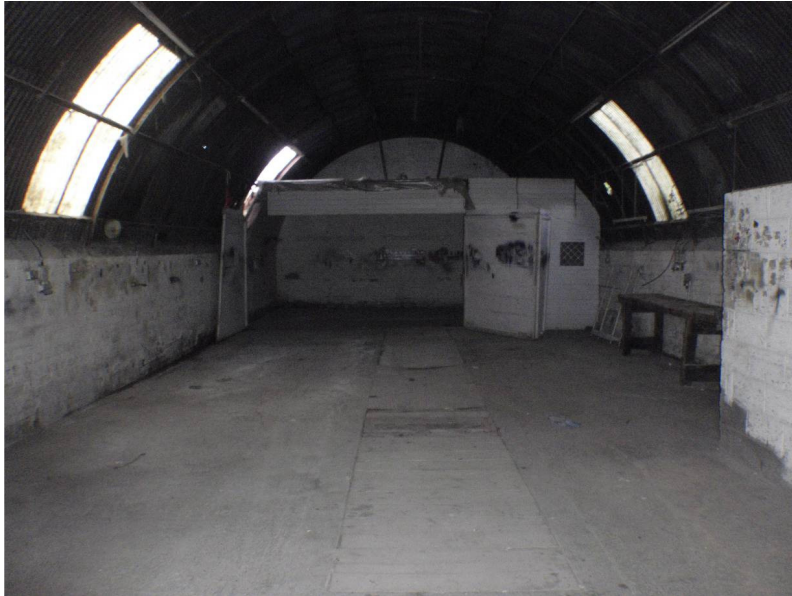
The interior of the structure is open plan reflecting the building's use as a vehicle workshop and storage area. The former is also indicated by the large central inspection pit formed within the concrete floor. The area has been partitioned off and the roof lined at the very northern end to form a vehicle spray booth. At the southern end on the east elevation a small room has been formed from concrete blocks and originally served as a small office one end with a w.c. at the other.

Plate 16. Interior of the Nissen hut, looking north toward the partitioned area used as a spray booth

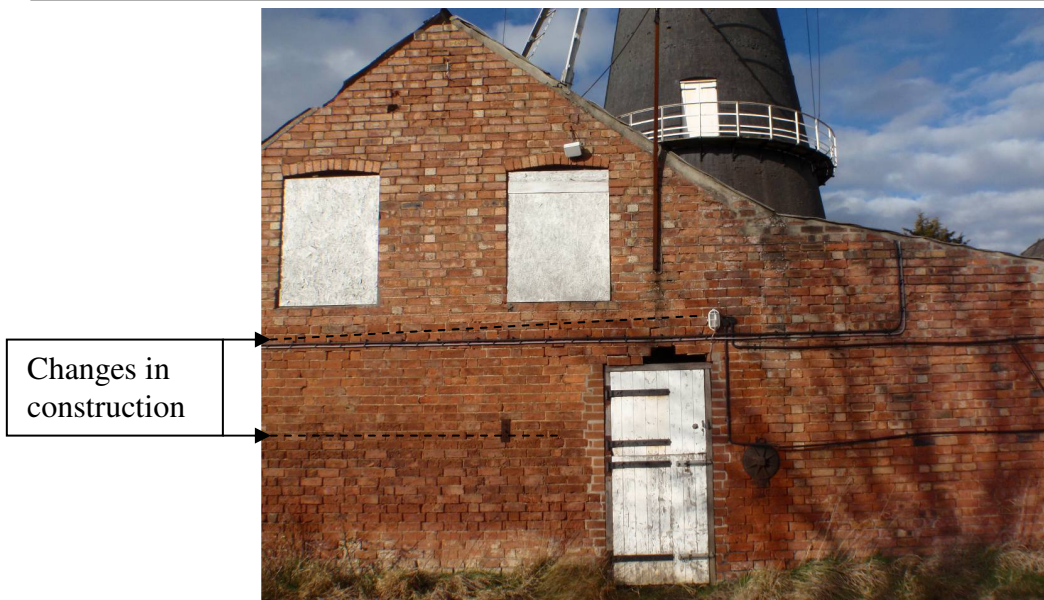
There was no access to the east external elevation as this is obscured by the cart shed (see above). The south elevation is easily accessible and exhibits a number of different phases of construction. The eastern end of the elevation likely had the cart shed added to it as evidenced by the toothed joint between these two structures (see above). The next obvious change is to the gable which although in Flemish garden wall bond is constructed in what appears to be a more modern common brick. This gable has been rebuilt in its entirety with the exception of two small nibs in each corner. This gable incorporates two window openings with segmented arched heads. Below the gable is another section of different brickwork approximately 11 courses deep which may have been repointed when the gable was rebuilt giving it a slightly different appearance to the brickwork beneath it. The remaining central section of wall at low level is more weathered than that above but is still in Flemish garden wall bond.

Plate 17. The Granary. South elevation showing several phases of construction

On the right hand side of this elevation a small stable door or Dutch door which is a later insertion as evidenced by the brickwork and repointing around it and also the fact that the brickwork above it has not been supported by any type of lintel and instead relies on the door frame for support which in this case has been inadequate.

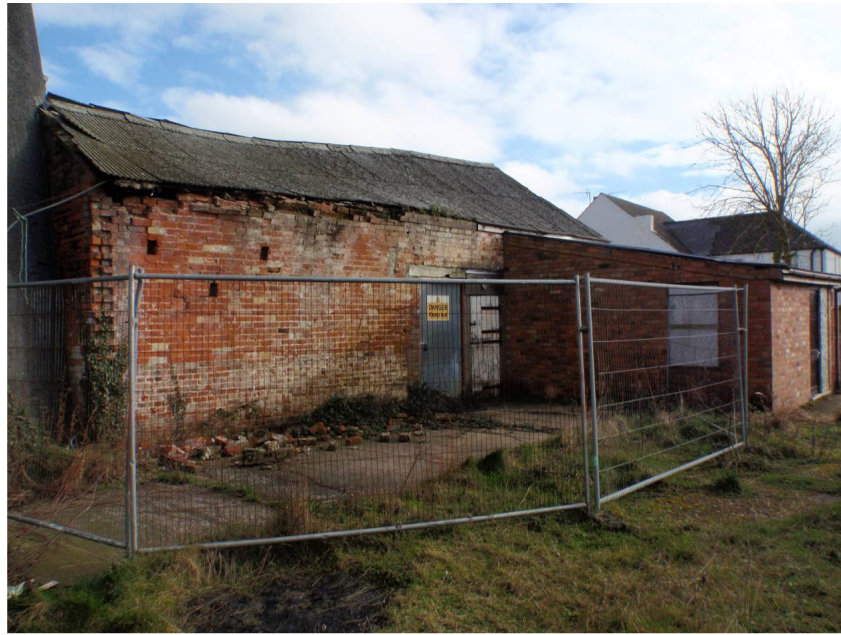
The west wall of the granary has partly collapsed in the northwest corner and is missing a few high level brick courses for almost the length of it with lower down brickwork leaning dangerously due to the failure of the roof structure above. The northwest corner of the granary returns to butt up against the mill. Most of the surviving brickwork is laid in Flemish garden wall bond, although there is a section at low level (approximately 15 courses) which is laid in a type of English garden wall bond with slightly smaller bricks.

Plate 18. West elevation of the granary showing the modern extension to the southwest corner, the partial wall collapse and the scars at the left that suggest a wall and possible machinery have been removed

At the northern end of the west elevation there are three notches in the brickwork which indicate that a structure or piece of agricultural equipment may have been fixed to or against it. At the northwest corner the tothing of the brickwork confirms that a structure once extended out from this wall and the hardstanding directly in front of the wall may have been the floor for this now demolished extension.
