**HISTORIC BUILDING RECORDING
FORMER FLAX FACTORY,
METHERINGHAM HEATH LANE,
METHERINGHAM,
LINCOLNSHIRE
(MHFF 15)**

Work Undertaken For
Future Biogas Ltd.

February 2015

APS Report No: **20/15**

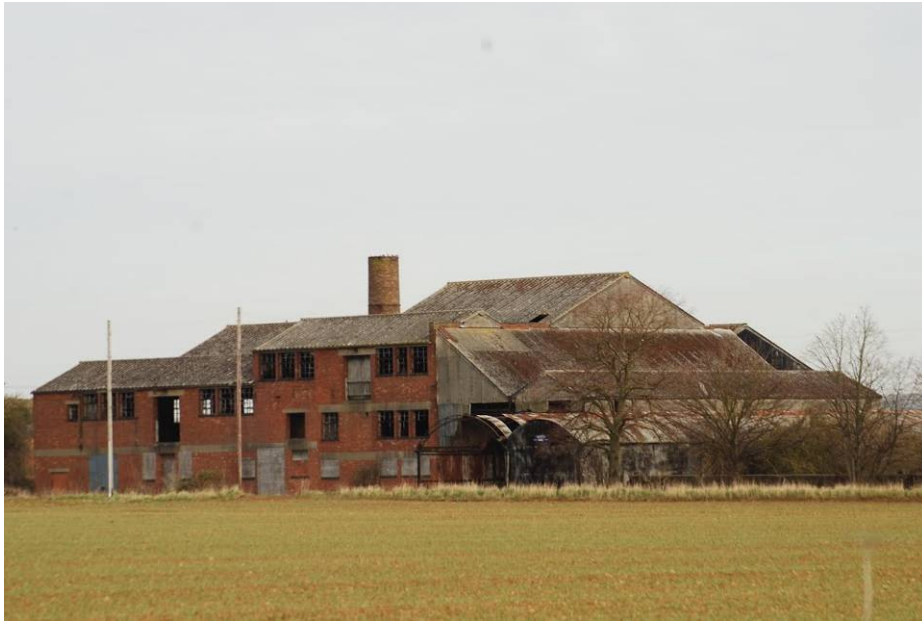
Plate 1. General view of the south and west elevations of the processing area of the flax factory.

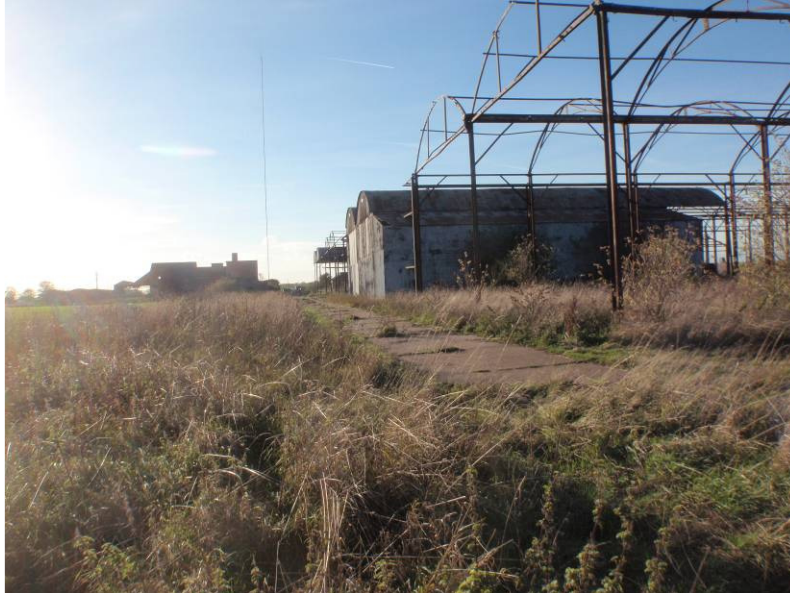
Plate 2. General view of the Dutch barns at the northeast of the site with the processing plant in the distance. Looking west

Originally, these steel framed structures had corrugated iron walls and roofs cladding the frames and were open at the northern end. The frames remain unchanged, however the corrugated iron walls have undergone alteration as is common with structures of this type.

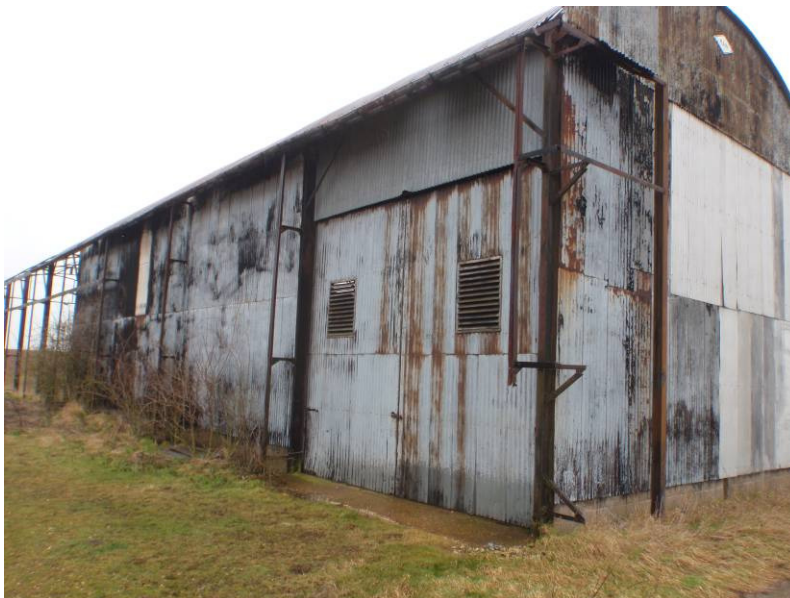
Plate 3. The second barn from the east, entirely enclosed and accessed from the southwest corner. Looking northeast

The second barn from the east was closed off at the north end, half way along the structure and accessed at the southwest corner by means of a set of double doors with vents. This indicates continued agricultural use after the closure of the factory. The manufacturer's nameplate in the southern elevation reads "Main" indicating that these barns were fabricated by A.J. Main and Co. of Glasgow and London (Thompson, nd).

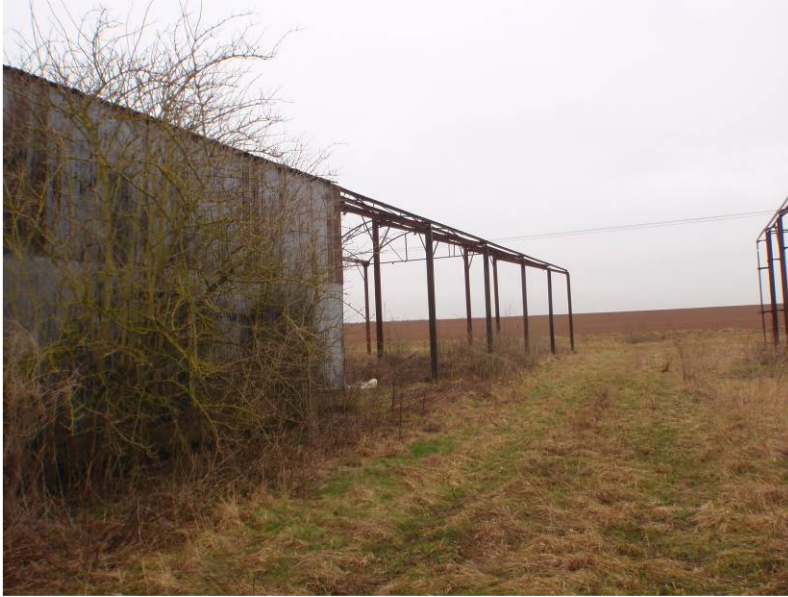
Plate 4. The frame of the second barn from the west showing the additional struts for the mono-pitched roof (removed).
Looking northwest

The mono-pitched roof structure on the east side of the two central barns provided extra storage space and was bolted onto the side of the main frame. Within the main structures there are concrete floors but underneath the eastern roof space the ground is simply grass indicating these were later additions to the overall structure.

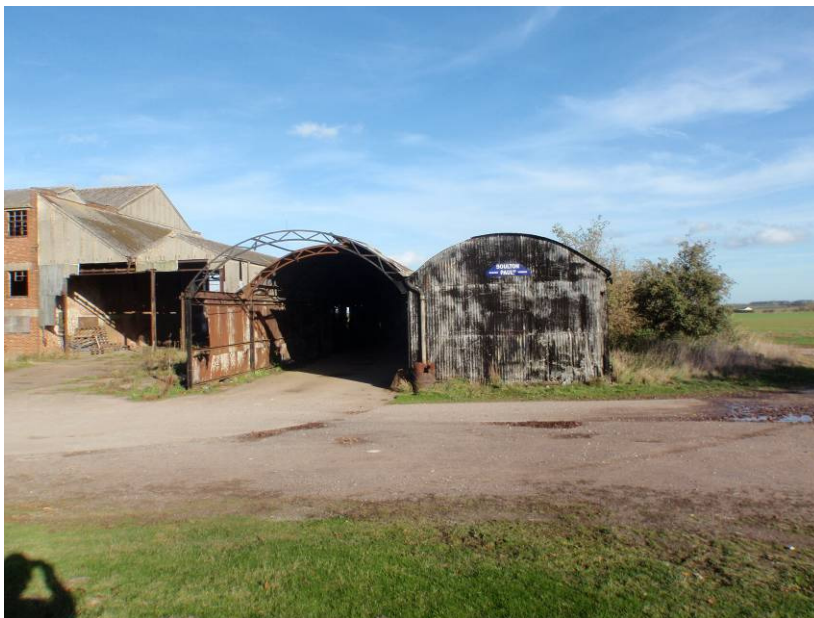
Attached to the southern elevation via a lean-to structure are three smaller Dutch barns that also appear to be original to the complex. These barns were manufactured by Boulton & Paul Ltd of Norwich, better known for their subsidiary company's manufacture of aircraft.

Plate 5. Two of the smaller Dutch barns at the south of the complex. The northernmost is set back and not visible in this plate.
Looking ENE

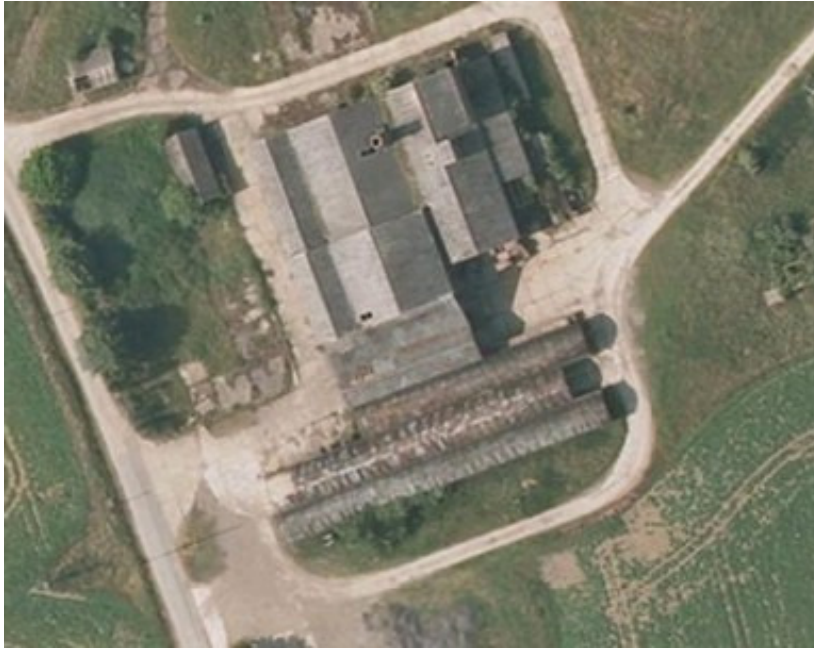
Plate 6. Aerial view of the factory as it stood circa 2014.

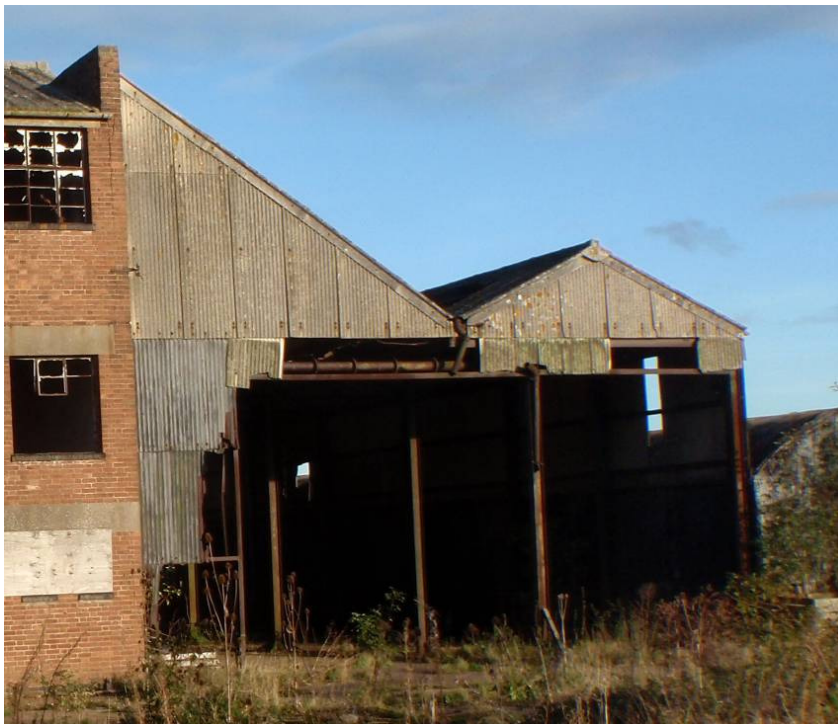
The south elevation of the main factory complex is covered by a steel frame and corrugated iron lean-to structure and would have served as the main unloading area for the unprocessed flax. A pitched roof structure at the south with seven steel upright girders and associated cross beams joined, on its northern edge, to a mono-pitched roof attached to the main brick building.

Plate 7. The lean-to steel framed corrugated iron sheds at the southern elevation of the main factory complex. Looking east

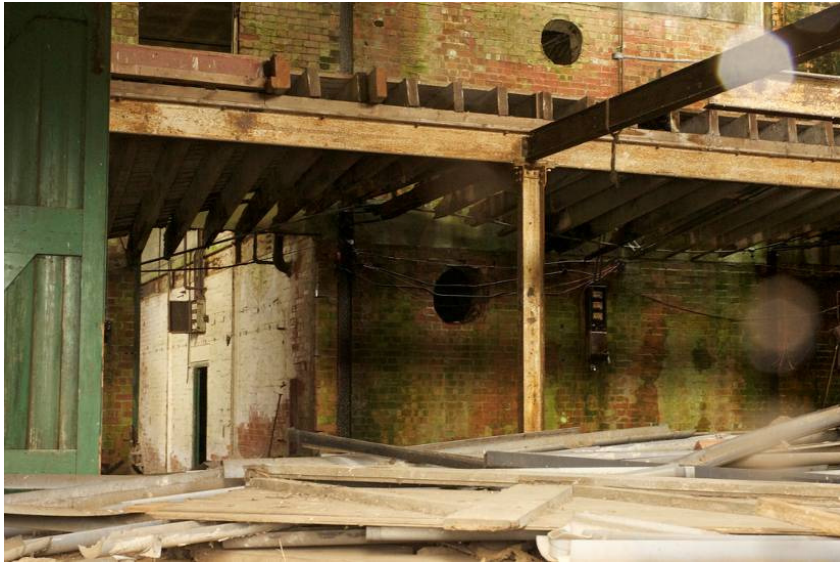
The brickwork on the southern elevation extends in a square fashion rather than following the apex roof line. The lean-to steel and iron structure butts directly to the top of this brickwork.

Plate 8. Southern elevation from within the lean-to structure. Looking northeast

Within the lean-to structure there was a covered area where it abuts the south wall. This also provided an additional floor space above and may have served as an upper level. The circular apertures show no evidence of ever having contained glass and may be for ventilation as much as for providing additional light.

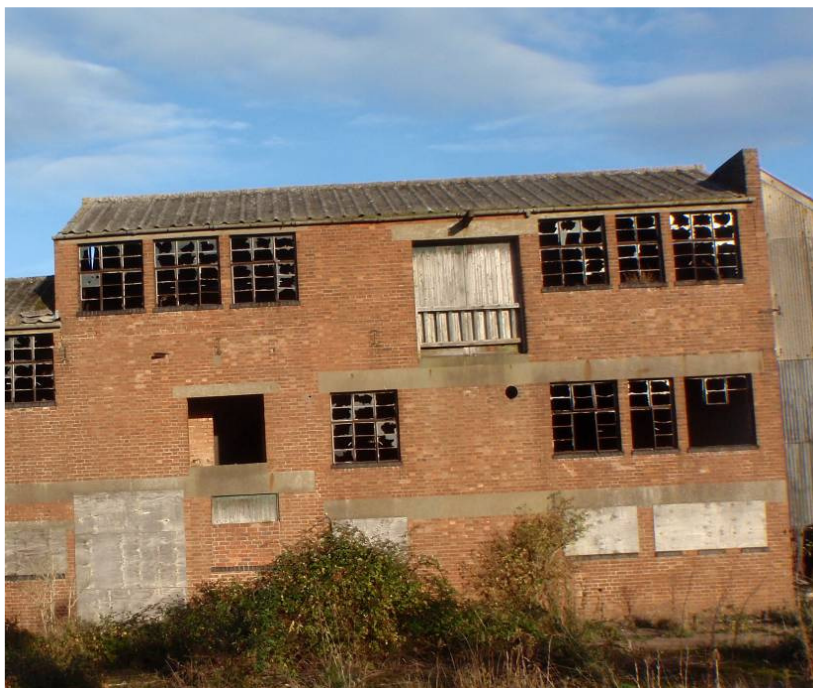
The southern subdivision of the west elevation comprises the three storey part of the flax factory. Each storey is of roughly equal height. The bricks are laid in Flemish bond, except for where they have been used to partially block a window, (at the north end of the elevation) where they are laid in stretcher bond. All of the apertures for both windows and doors have concrete lintels. Where the apertures are on the same level a single concrete lintel covers several windows. The cills are constructed from blue engineering bricks laid on their side. On the ground floor, there were three, small windows at the south next to a longer aperture. The windows above these on the first and second floor are directly aligned with those on the ground floor. The remaining steel frames of the Crittal windows were present on the first and second floor.

Plate 9. The southern subdivision of the west elevation showing the change in building levels at the left of the picture. Looking east

Three of the apertures on the southern subdivision of the west elevation served as doors. A large aperture was boarded over at the north end of the ground floor. Above and to the south of this on the first floor was another opening. Although the same size as the window apertures it differed in that the cill was of plain concrete and there was no metal frame evident. Internal brick partitions were visible through this opening.

On the second floor a large aperture with wooden double doors and a wooden railing offered direct access to the upper part of the building. Above and central to this was a short wooden boom/gibbet for winching material to and from the door.

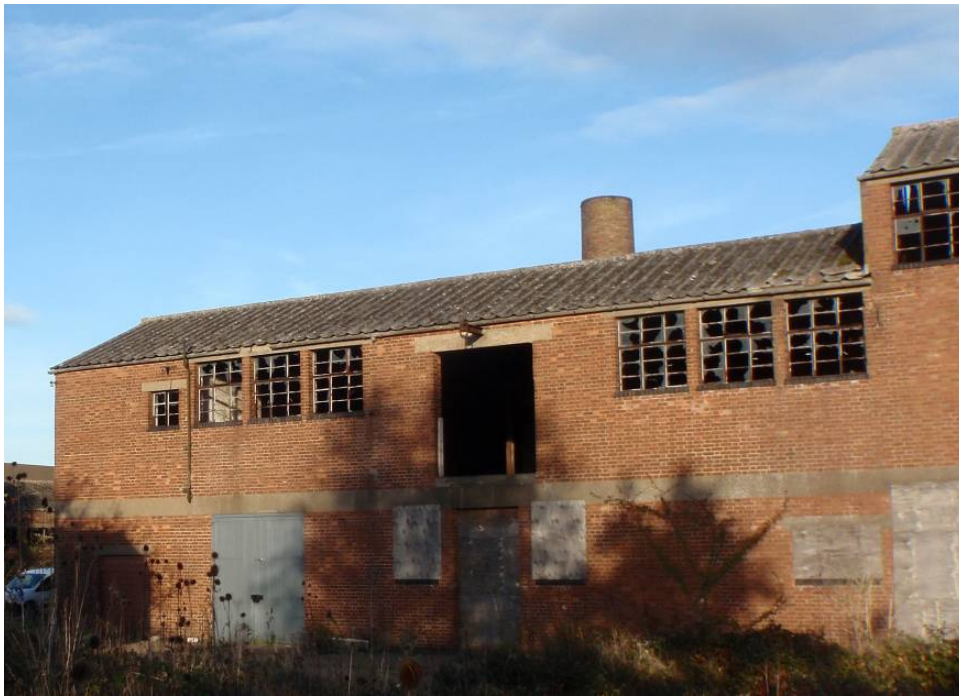
The northern subdivision of the west elevation is a two storey structure. The height of the bottom storey corresponded to the southern subdivision while the upper storey was larger, extending approximately two thirds of the way up the southern subdivision.

The windows and door on the ground floor were boarded up. All were spanned by a single concrete lintel. On the upper floor, two sets of three Crittal windows were placed either side of an upper loading door. A smaller window was situated at the north end.

Plate 10. The northern subdivision of the west elevation. Looking east

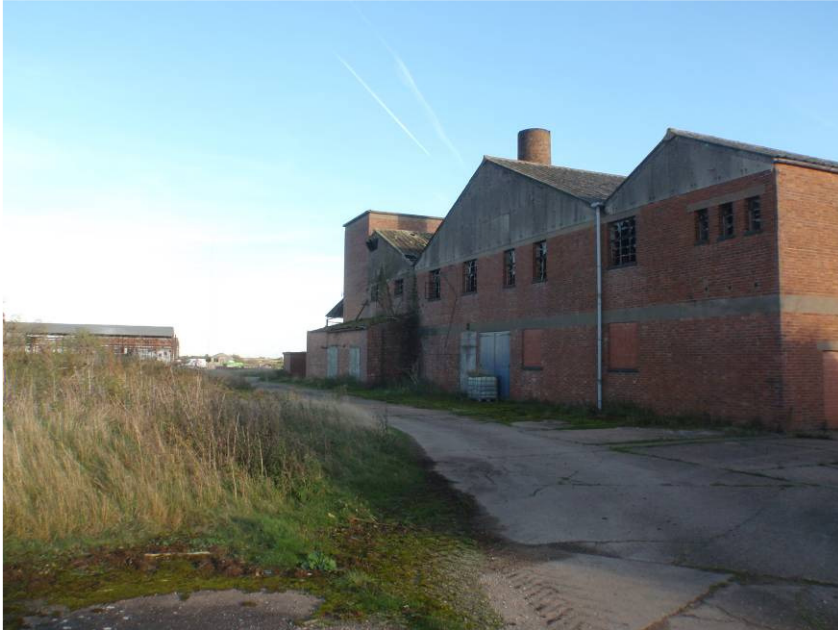
The north elevation showed the gable ends of the three units. At the level between the ground and first floor a single concrete lintel spanned the apertures of all windows and doors in the western and central units. Each of the ground floor windows had been bricked up.

Plate 11. The north elevation showing the boiler chimney. Looking southeast

Aside from the three small windows at the west end of the elevation, the larger windows on the upper floor were all on the same level. This suggests a uniform floor level between the west and central unit. The roof space of the central unit is larger than the western unit. Each gable end is clad in corrugated iron. The apex of the central roof is approximately 2m higher than that of the east and west units. This may be to accommodate larger machinery associated with the main boiler. The chimney in the central unit suggests that this is where the boiler was situated. The large loading door on the ground floor was probably where the “retted” and dried flax would have been taken in for “scutching”.

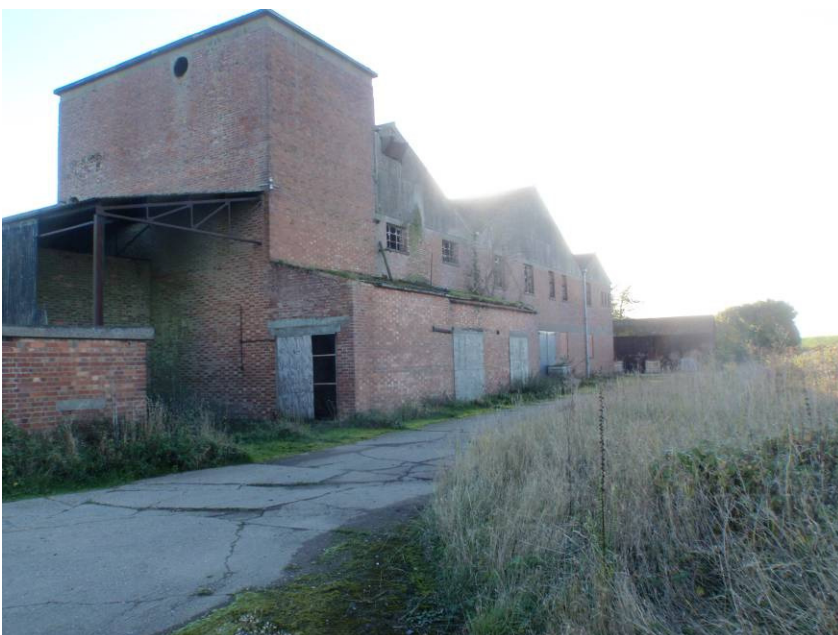
Plate 12. The north elevation showing the eastern unit and tower structure. Looking southwest

The eastern unit on the northern elevation differed from the others in its external structure. Along the north elevation was a single story structure with a mono-pitched roof. Two sets of double doors in the north face of this structure gave access along with another in the eastern elevation. The gable end of the eastern unit was truncated by a tower. This was probably a water tower associated with the retting tanks.

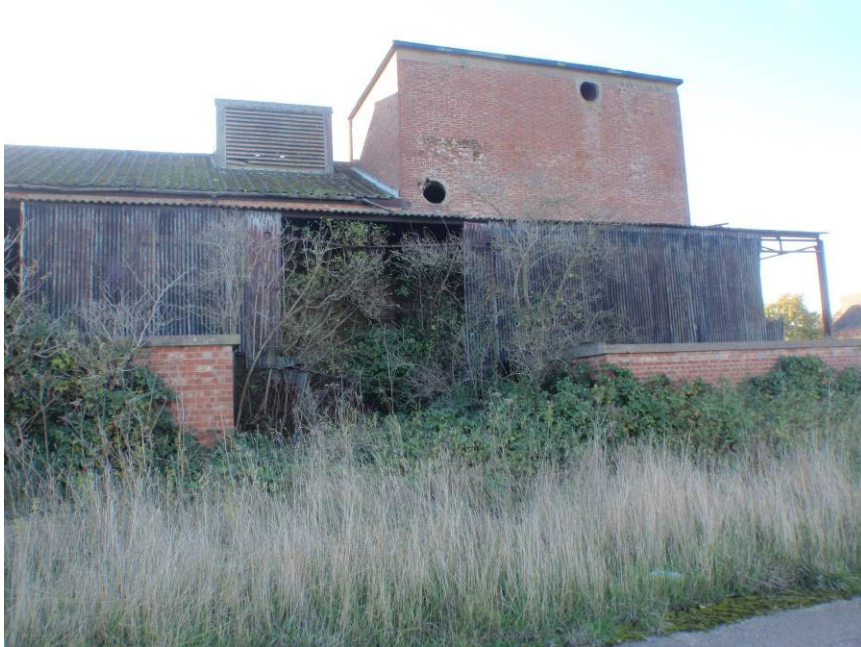
Plate 13. The northern end of the east elevation showing the corrugated iron lean-to structure. Looking northwest

Attached to the east elevation was a lean-to structure. Fashioned from a steel frame, this was a corrugated iron walled area, possibly used to stack the flax straw prior to being taken in to be de-seeded as the first part of the process. In the roof of the east unit was a large ventilation stack. The circular apertures in the water tower probably served the same purpose.

The low brick walls extended beyond the lean-to structure and they may pre-date it. These low walls were constructed in English bond.

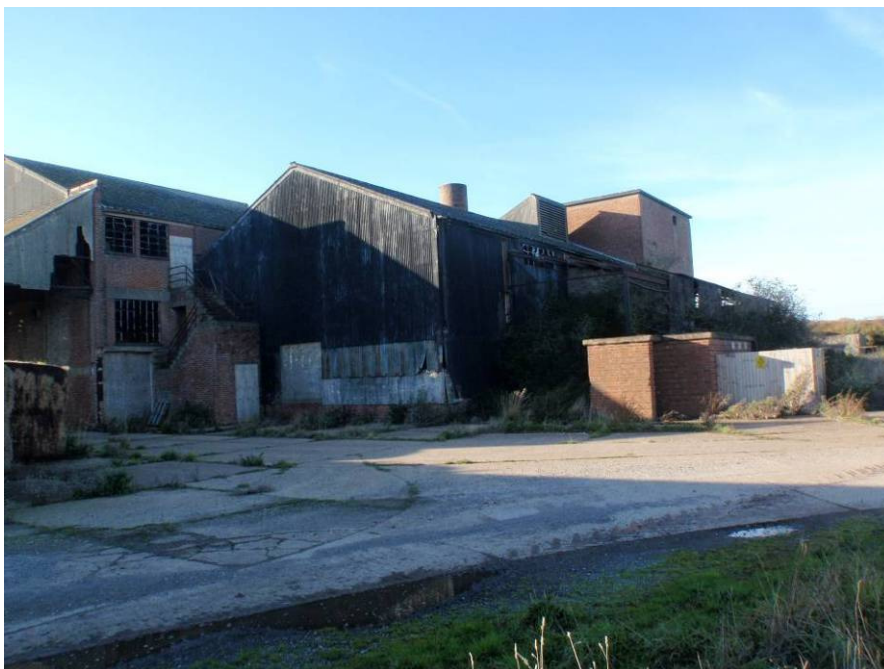
Plate 14. The eastern unit and the south end of the central unit. Looking northwest

To the south of the water tower, the remaining section of the eastern unit was a steel-framed, corrugated iron structure built on a low, brick foundation. This appears to be where the de-seeding of the flax straw took place. To the east of this was an electric sub-station that may post-date the rest of the complex.

The southeast corner of the central unit had external access by means of an external brick staircase with doors on the first and second floors.

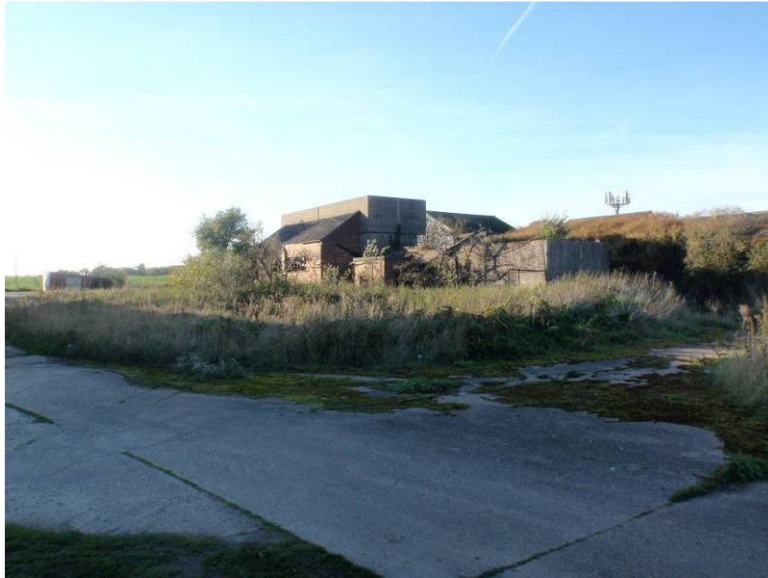
Plate 15. General view of the retting tanks where the second phase of the processing of the flax straw would have taken place. Looking northwest

The largest portion of these structures comprised concrete tanks into which the flax straw was placed before water was poured over them. The tanks had to be concrete as the process was corrosive to brickwork and metal (Decktowel nd).

The brick structures with mono-pitched roof would have been the pump rooms where the machinery that regulated and heated the water was contained.

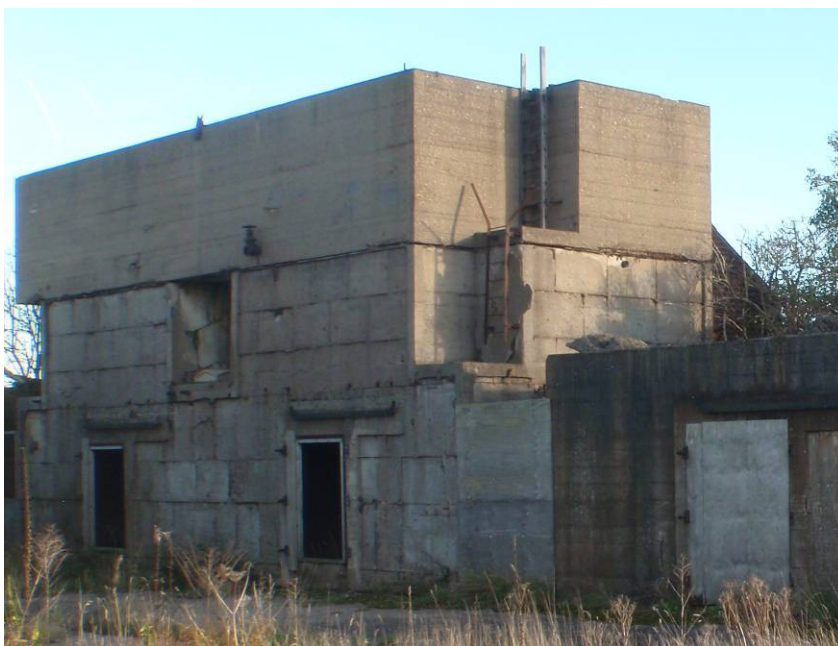
Plate 16. Detail of the retting tanks showing the main tank at the east of the structure. Looking southeast

The two doors at the base provided access for loading and unloading of the flax straw. The

top could be accessed via the external iron ladder at the side of the structure. All around the structure was the remains of pipe-work that would have controlled the flow of water. On the north elevation there was a stop-tap where the central and upper portions of the structure met. The doors on the large tank on the east side were not present but the sealable doors on the smaller tanks to the west survived. Internal examination of any of the different sections was not possible when these photographs were taken.

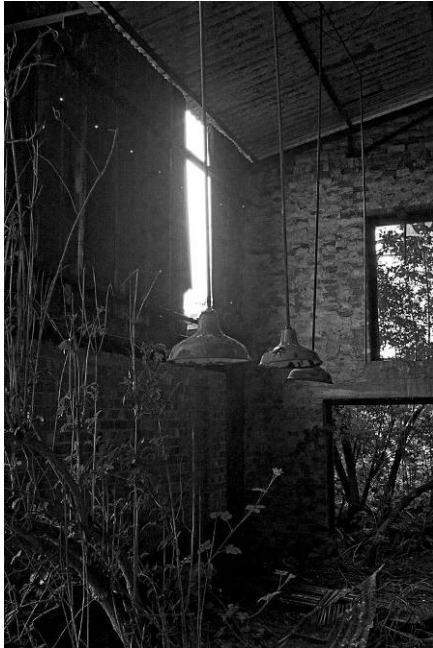
Plate 17. Internal view of one of the structures. The light fittings would have overhung a conveyor or long table.

Although it is not entirely certain where this image was taken from, the trees and overgrowth visible in the apertures and the mono-pitched roof suggest that this was at the northern end of the east elevation. The light fittings would have overhung a conveyor belt or long table, associated with the initial process of de-seeding the flax.

The opening visible in the rear wall in the picture was possibly where the de-seeded flax was unloaded for the next process.

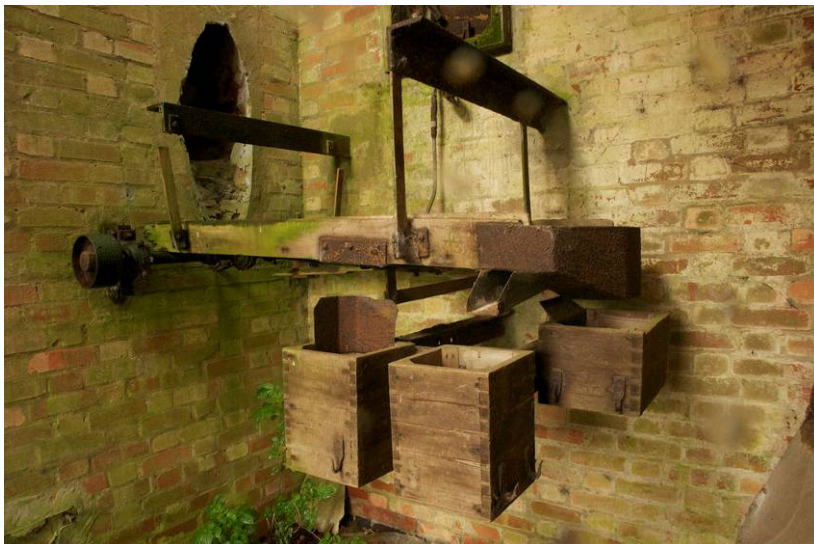
Plate 18. Detail of what appears to be a seed hopper.

The seeds from the de-seeding of the flax straw would have been held in hoppers, probably adjacent to, or very near where this process took place. The piece of equipment in Plate 18 appears to be for seed collection. The exact location of this is unclear.

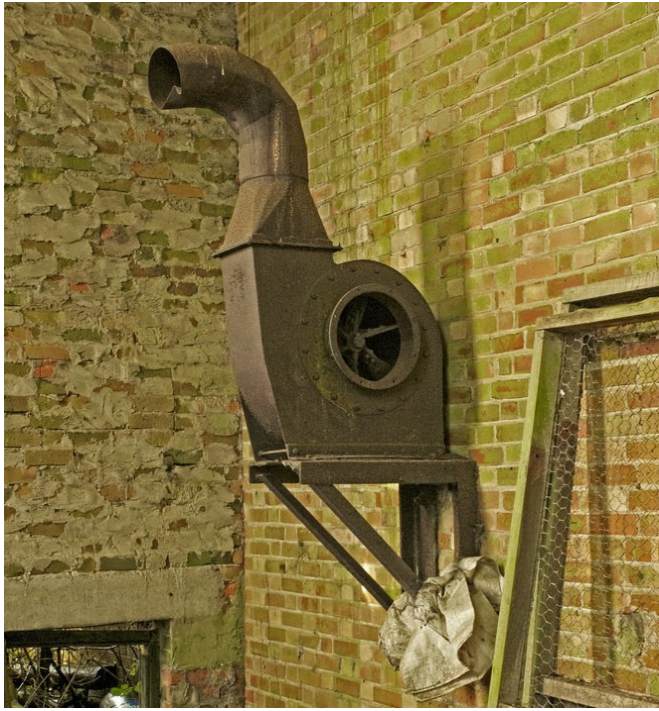
Plate 19. Part of a centrifugal fan used for dust extraction during the de-seeding process.

Probably located in the eastern unit, there were the remains of a centrifugal fan that would have been attached to a hood over the de-seeding machine in order to extract the dust that this process created (Plate 19). This type of fan was specifically used in the de-seeding process (see discussion).

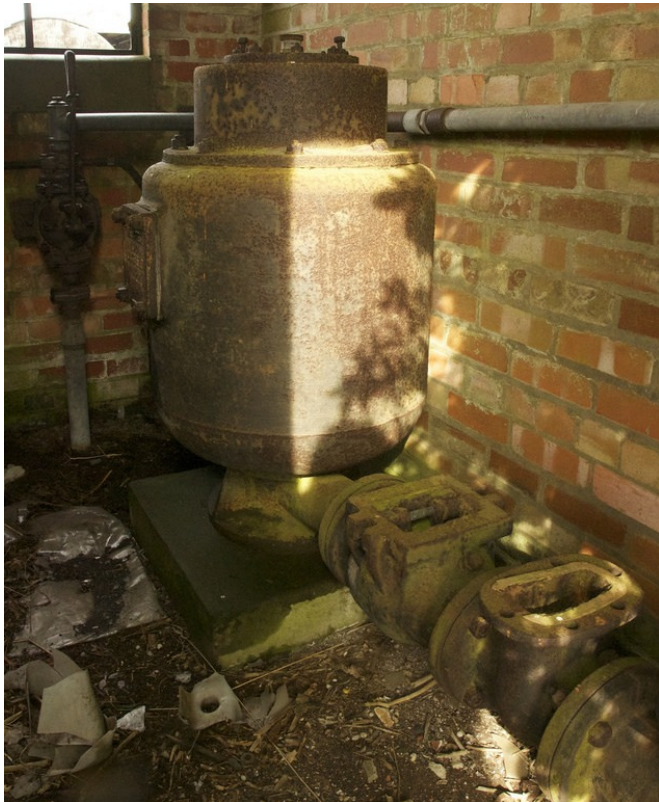
Plate 20. Detail of a boiler, probably located adjacent to the “retting tanks”. The heated water would have been pumped from here to the tanks.

Following de-seeding, the flax straw was “retted”. This involved stacking the sheaves in retting tanks and immersing them in water. The water was heated to speed up the process (see discussion). The boiler in Plate 20 is likely to have been used for this and was probably located in the mono-pitched brick structure butting the concrete retting tank.
