**HISTORIC BUILDING RECORDING
THE ELMS FARMHOUSE
GUNBY ESTATE
BRATOFT
LINCOLNSHIRE
(GUTE16)**

Work Undertaken For
The National Trust

April 2016

APS Report No. **29/16**

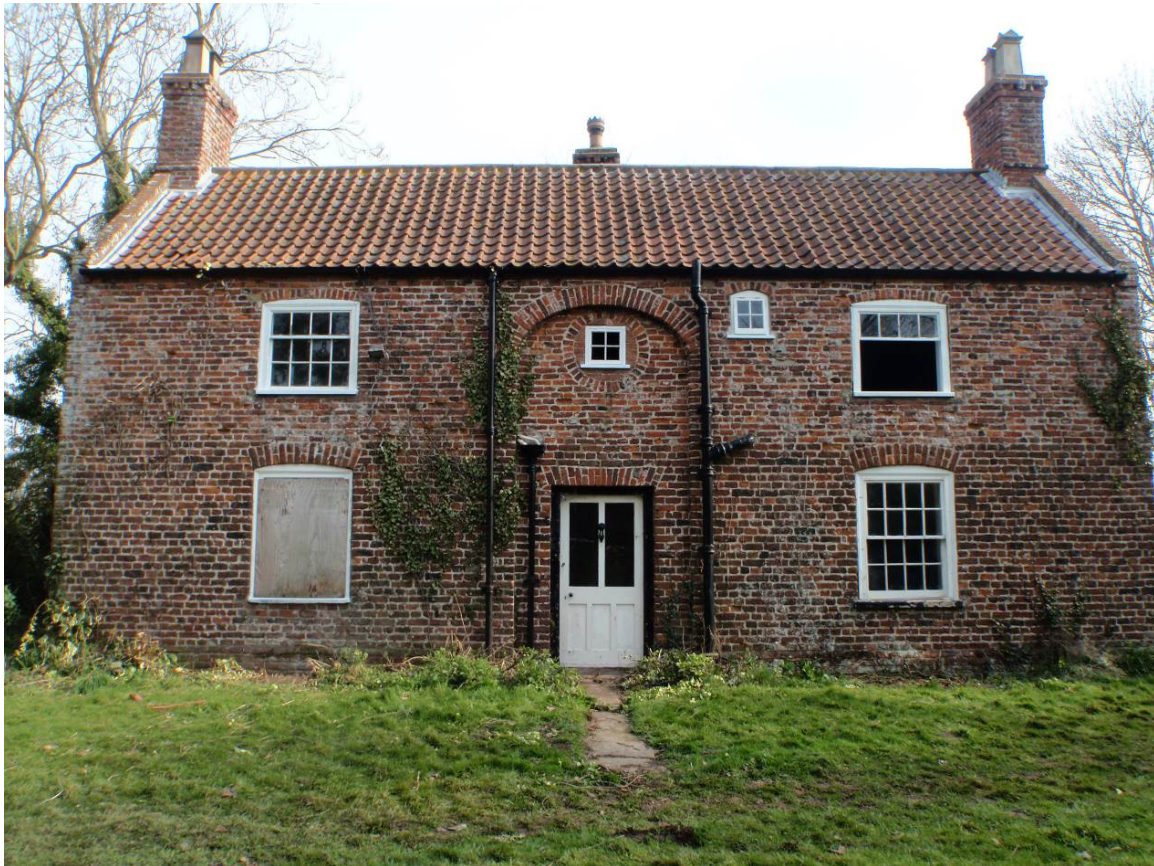
Plate 1. General view of the southern elevation showing the main entrance and façade of The Elms Farmhouse

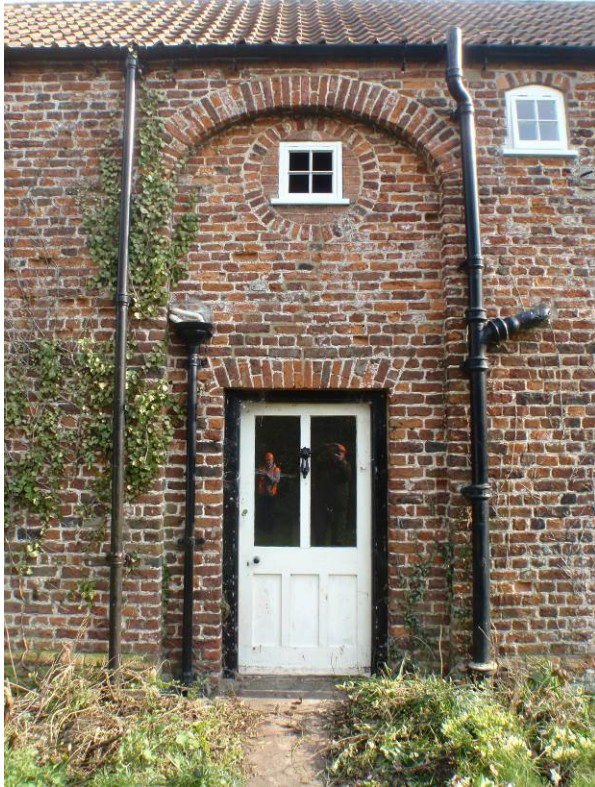
The doorway is central to the elevation within a two storey recess with a brick, three centre arch just below the eaves. The brick arch is of header and soldier coursing. Below the arch, in the upper part of the recess is a circular ‘bulls-eye’ opening, edged with the same handmade bricks as the wall. It has been partially infilled with later 19th century brick and a small pivoting window.

Plate 2 (left). Detail of the central doorway within the two storey recess under the three centre arch. The bulls-eye opening has been partly infilled and a small square window inserted

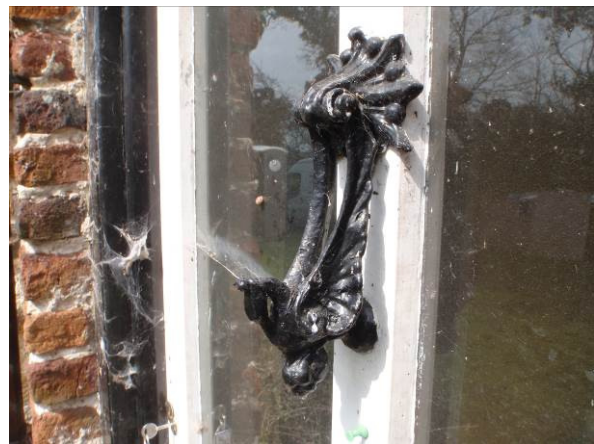
Plate 3 (below). Detail of the cast-iron Victorian door knocker in the form of a bird with outstretched wings

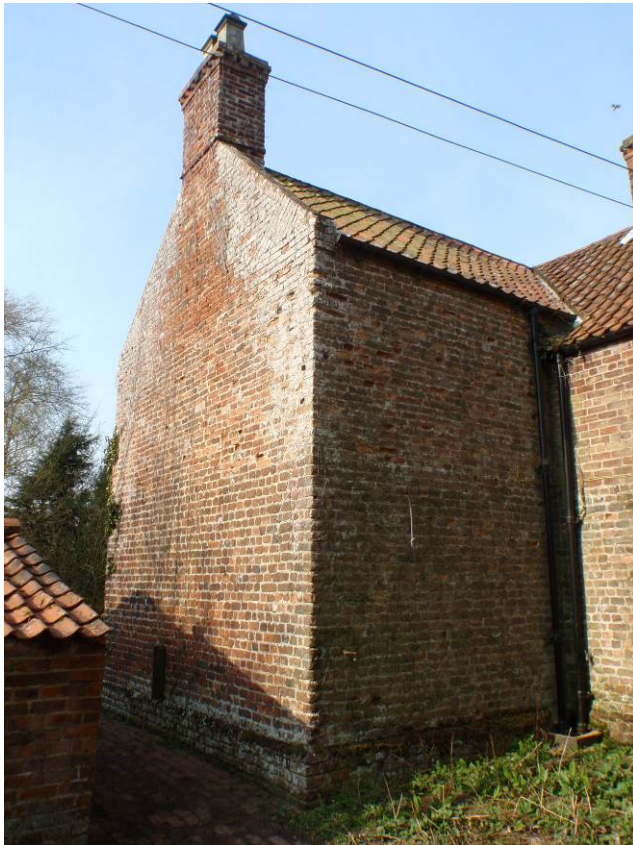
This elevation is plain apart from a brick ‘kneeler’ at eaves level on the base of the gable that corresponds to the triangular tumbled sections mentioned above. There are some iron fastenings of unknown function set into the wall near the east edge

Plate 4 (left). The east elevation and the north elevation of the East-West Range. The east elevation has two triangular 'tumbled' sections at eaves level with associated 'kneelers' in the north elevation

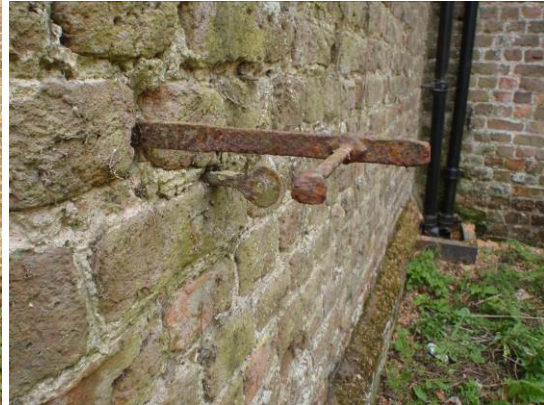
Plate 5. Detail of the iron fastenings of unknown function within the east side of the north elevation of the East-West Range

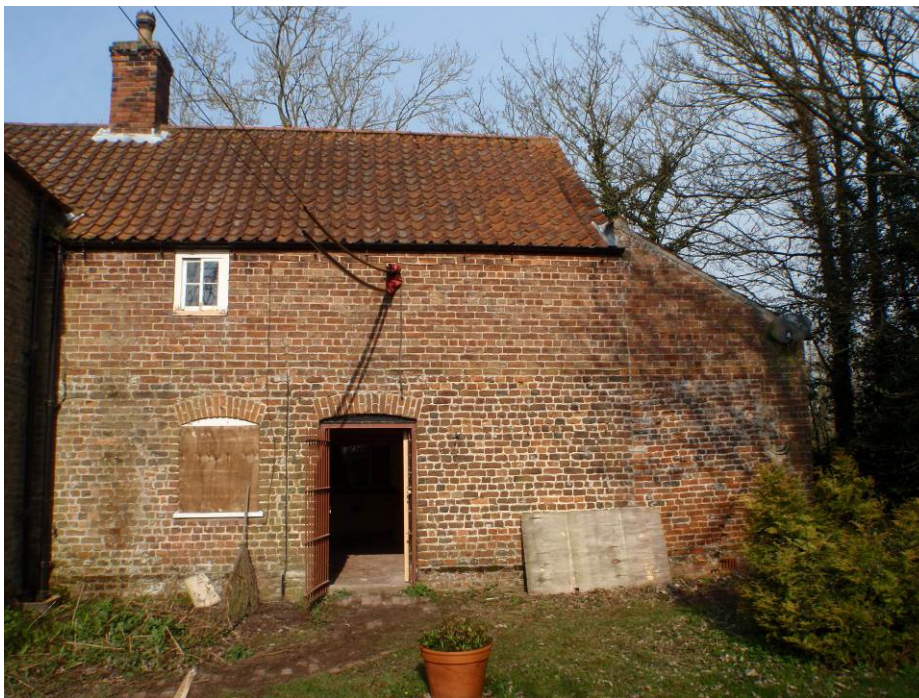
The lower half of the elevation has handmade bricks and a plinth as on the adjacent north elevation of the East-West Range, which the bricks are keyed into. Where the two sections join there are cast iron rainwater goods as on the south elevation. The North-South Range was then heightened by one storey. To the north end of the elevation is an area of extension, meeting with a straight join for the height of the 'older' part to the south.

Plate 6. The east elevation of the North-South Range showing four of the probable five phases of construction.

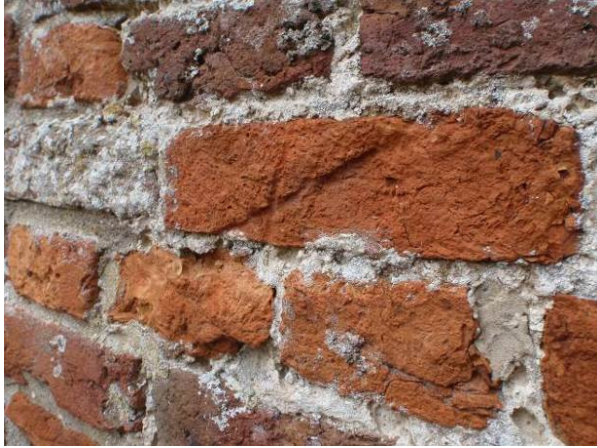
In the lower part of the northern extension the bricks are handmade and probably of early 19th century date. They are redder than the older bricks. These drop down in narrowing steps at the north end with no discernible bond type. Set within them, at the base, is a 19th century ceramic vent in the pattern of a series of lancet windows.

Plate 7
Detail of the 19th century brick in the northern extension to the North-South Range showing the diagonal stack marks

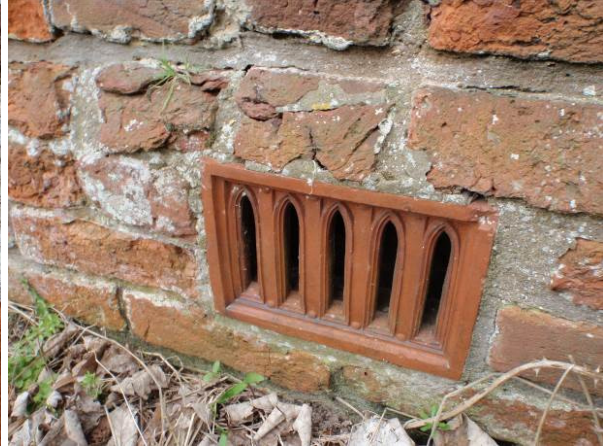
Plate 8
Detail of the ceramic vent at the base of the extension to the North-South Range

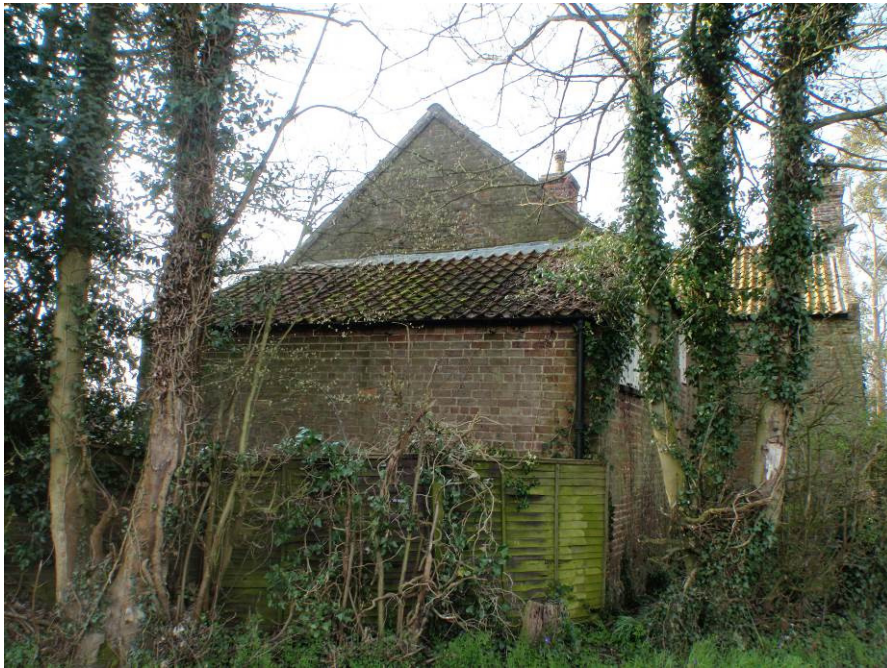
In the lower part of the elevation are two windows, both of which have been boarded up. The smaller of the two, to the west, appears to be original. The larger window, to the east, has a row of infill bricks below it (one course down to the plinth) and has been cut through the existing brickwork.

Plate 9. A general view of the north elevation showing the extension and the original gable end of the North-South Range

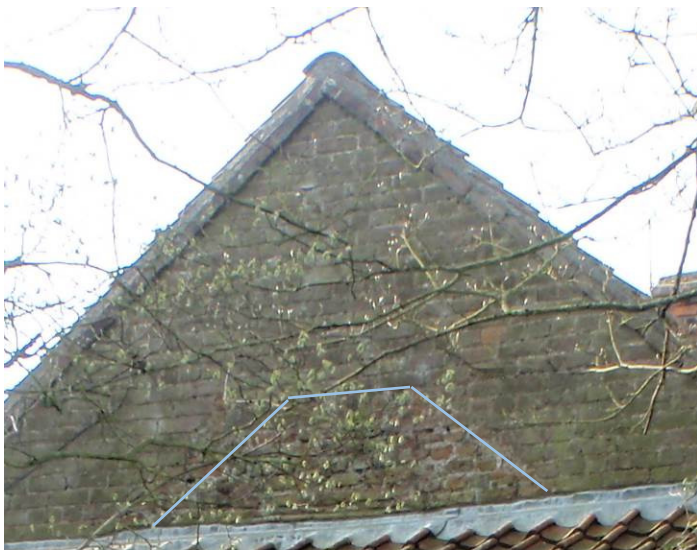
The mono-pitched pan tile roof leads to the gable end of the North-South Range. Within this gable end elevation, just above the extension is a trapezoidal infill, wider at the bottom, narrowing upwards to a horizontal header course. This appears to be an infilled area for a pitched, but flat-topped extension that was superseded by the present one.

Plate 10. A detail of the north gable end of the North-South Range. The trapezoidal brick infill is highlighted

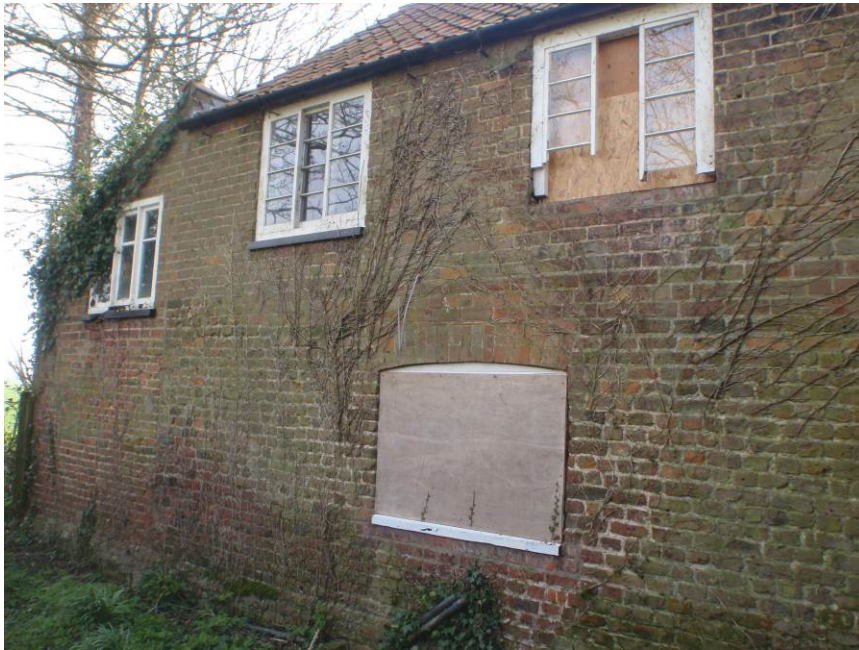
To the south of the extension, within the original lower part of the North-South Range, there is a three light Yorkshire sliding sash window that has been boarded up. This is either a 19th century addition or a replacement for an earlier, smaller window. This is evidenced by the infill bricks below and the segmental arch above, which are of late 19th century brick. The two windows in the upper storey are also three-light Yorkshire sliding sash.

Plate 11. General view of the west elevation of the North-South Range

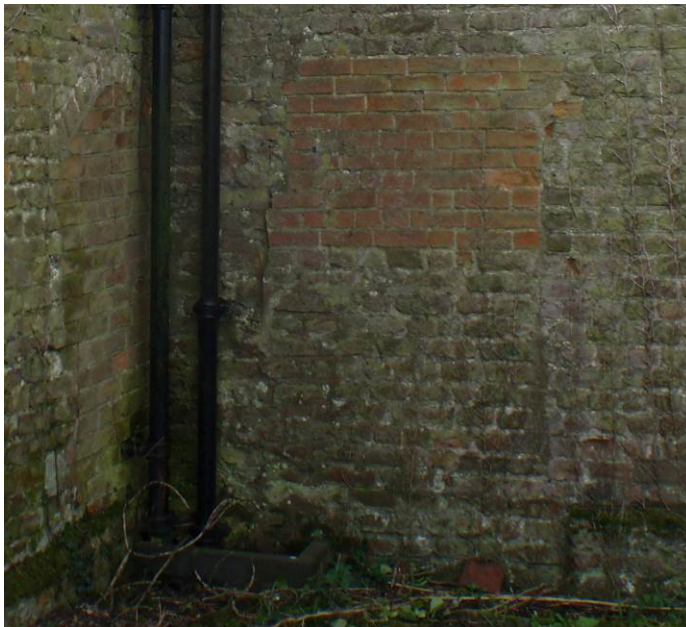
Plate 12 (left). Detail of the dome topped oven feature in the west elevation linking with the blocked opening that was infilled in two phases in the adjacent north elevation

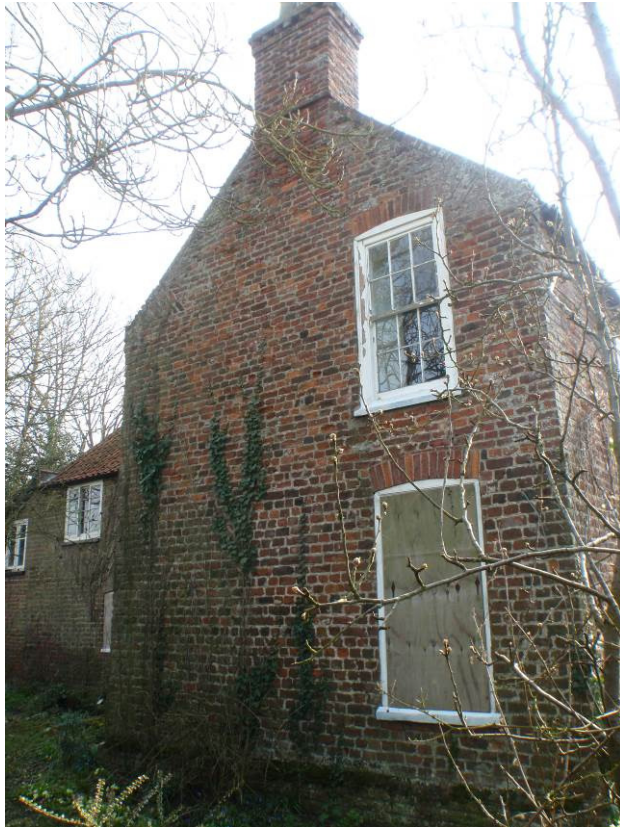
Plate 14 (left). General view of the west elevation of the East-West Range.

Toward the south of the elevation there is a boarded up six over six sash window. This is a later insert as can be observed from the infill course of late 19th century bricks below the window. The soldier course in the segmented arch above the window is of the same brick. The six over six sash window on the upper storey is slightly off-set from that below and is also a later insert, cutting through the triangular section of the tumbled brickwork of the gable. It also has a soldier coursed segmental arch above of the same late 19th century bricks as the ground floor window.

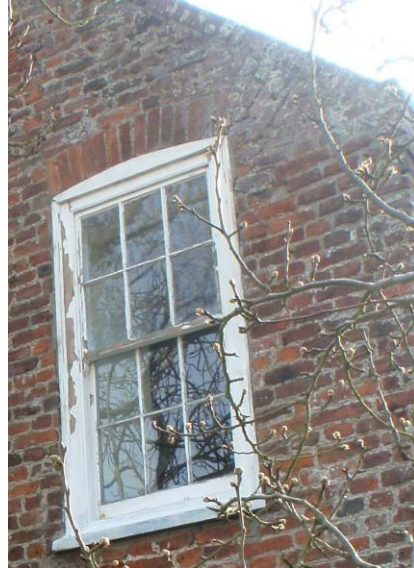
Plate 15 (below). Detail of the upper window cutting the triangular section showing that it is a later insert

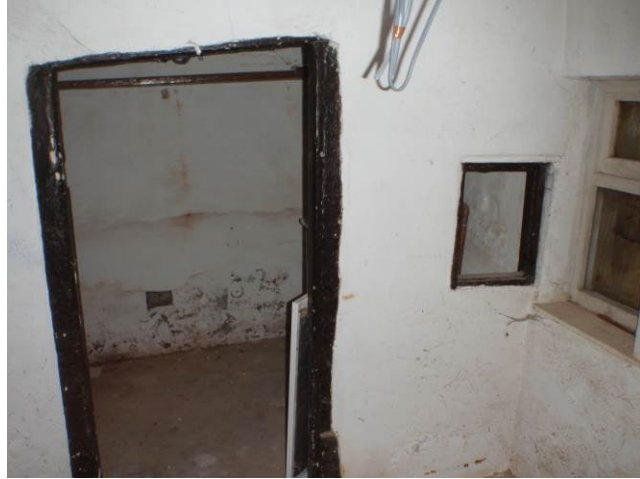
Plate 28 (below). The uneven doorway and hatch to the boiler room to the west and the 20th century window in the original 19th century aperture

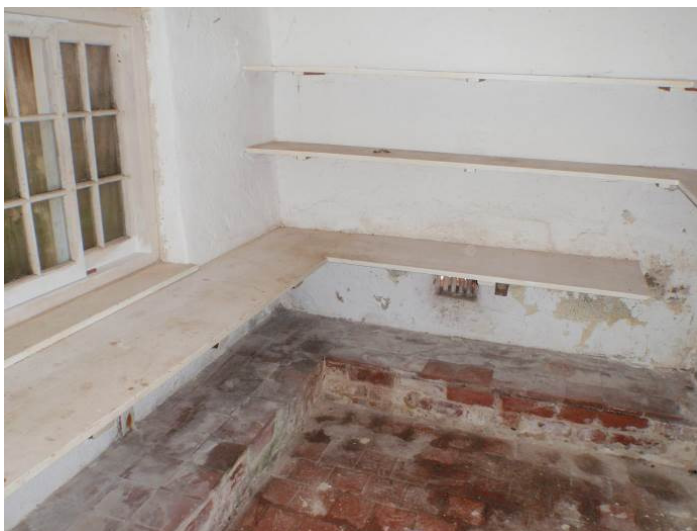
To the east of the central cell is a room utilised as a pantry proper. The door surround and its fittings are original, but the door has been removed. The floor in the pantry is quarry tiled with a brick 'cool shelf' capped with quarry tiles along the north and east wall. The window is a later insert than the original phase of construction and the Yorkshire sliding sash window appears to be contemporary with the aperture. The walls have wooden shelves, but there is no indication as to what date they were added.

Plate 29. Eastern room of the pantry area with the brick and tile 'cool shelf'. The window on the north wall is a later insert

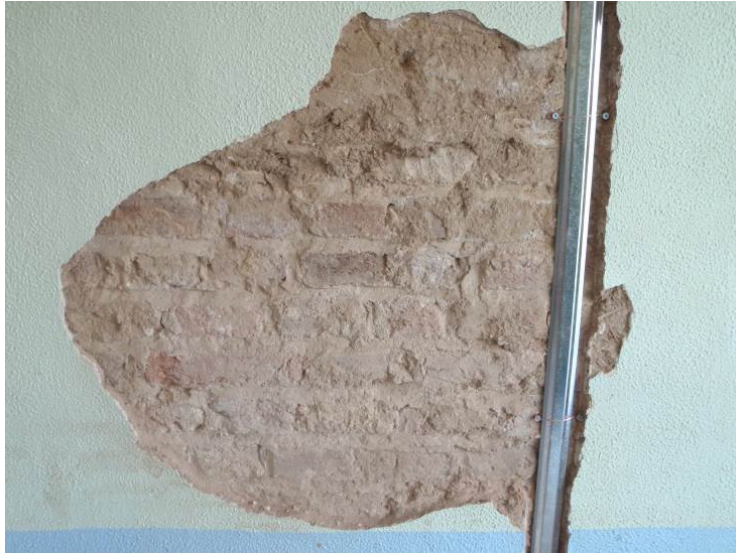
On the south wall, exposed by work necessary for wiring, was an area of the original mud plaster. This may extend around the entirety of the room but the painted walls make this uncertain.

Plate 32. An area of exposed original mud plaster in the south wall of Room 4

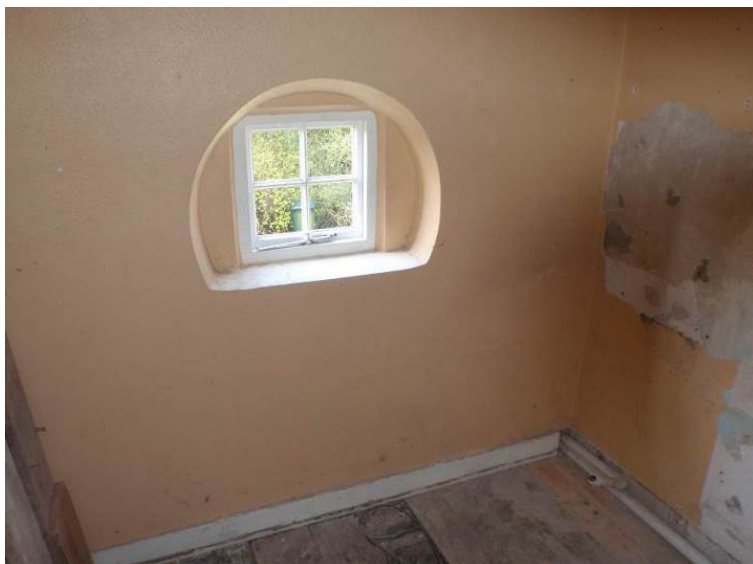
Plate 33. The partly infilled bulls-eye window in Room 5

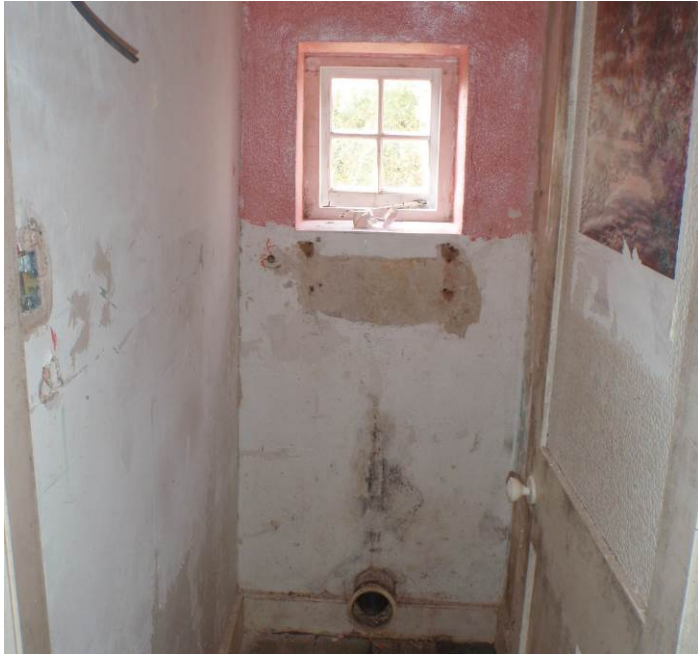
This room, recently used as a lavatory, was formed by 20th century partitioning of a portion of the west side of Room 7. The door is mid-20th century and the floor is of wooden planks. There is a small square window cut into the south wall and the woodwork of the window appeared to date from around 1900. As the window appears to have been purposefully inserted for the lavatory at some time in the mid-20th century it is likely that the frame and window have been recycled from elsewhere.

Plate 34. Room 6, used as a lavatory and the probable recycled window within a mid-20th century aperture

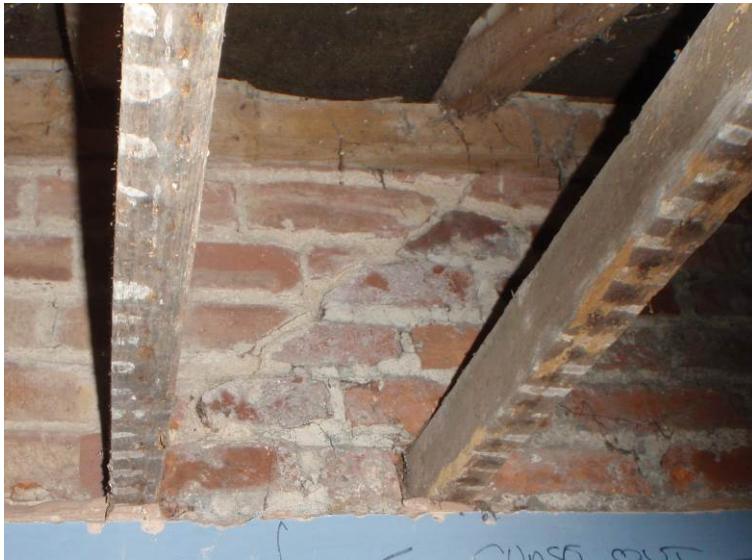
Plate 44. Internal view of the north gable end of the upper part of the North-South Range showing the eaves line of a previous northern extension

A third phase of construction was noted from examination of the north elevation and, internally, the original northern gable end, exposed in Room 10. The scar of a north extension was visible as an area of infilled brickwork. It appeared to have a pitched roof with a flat top. The infilled brickwork was of early 19th century date surrounded by later 19th century brickwork. This suggests that the infill brick was re-used when the extension was entirely demolished and could date the construction of the original northern extension to the early 19th century.

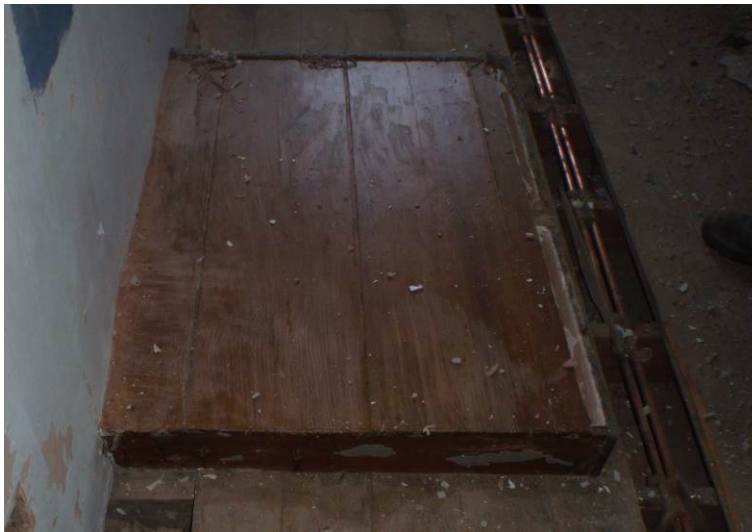
Plate 45. The blocked hatch in Room 10 leading to the Pantry Area below
