**SURVEY OF BUILDINGS AT
CAISTOR HOSPITAL,
NORTH KELSEY ROAD,
CAISTOR,
LINCOLNSHIRE
(CACH 07)**

Work undertaken for
Pick Everard
on behalf of
Cannon Kirk

September 2007

A.P.S. Report No: **124/07**

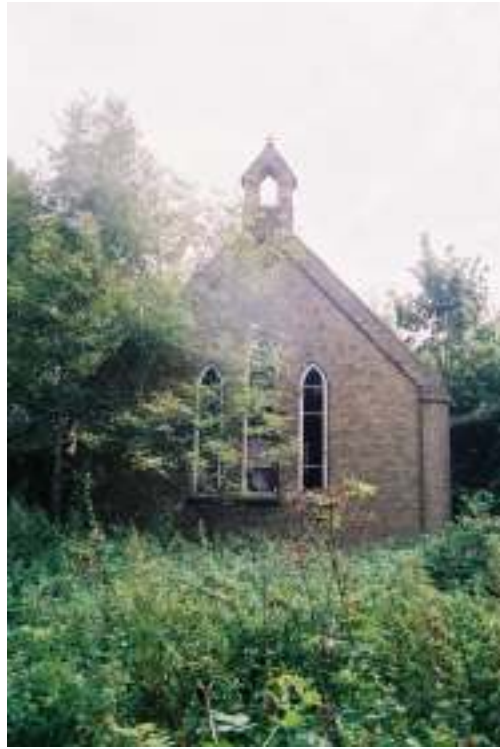
The chapel has clasping buttresses at each corner with three buttresses on the north and south sides which surround the windows. There is a sloping plinth which surrounds the structure and decorative brickwork is evident at eaves height. At the apex of the roof towards the east is a stone cross which is mirrored by a bellcote at the west end (Plate 1).

Plate 1 – View showing the west façade of St Lawrence's Chapel

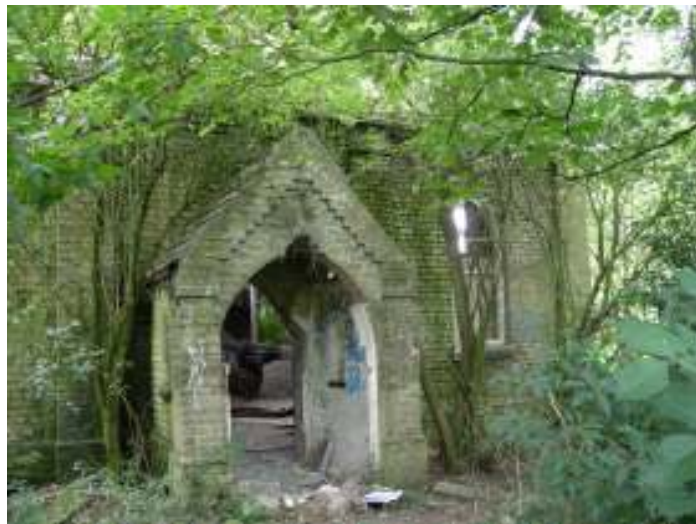
On the northern side of the chapel is a later porch (Plate 2). It is bonded to the chapel with a straight join but otherwise matches the chapel in most respects. Two small lancets are located on each side of the porch and the entrance is a simple two-centred arch.

St Lawrence's Chapel clearly shows no alteration from its original purpose, except for a later north porch which judging by its style was probably constructed soon after the chapel.

Plate 2 – The north porch of St Lawrence's Chapel

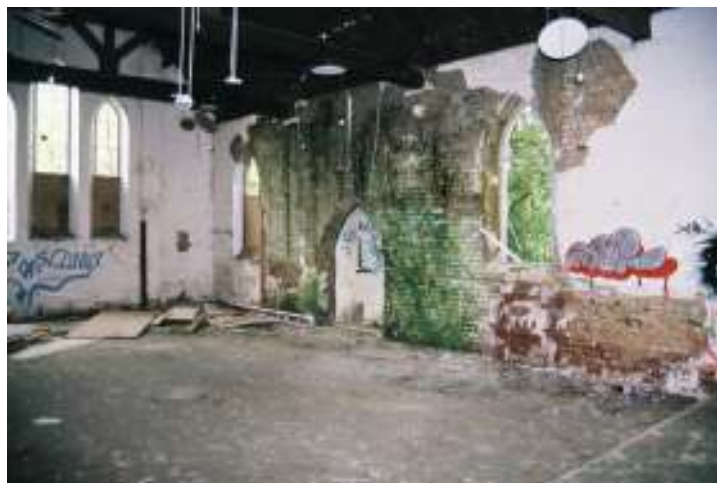
The interior is a plain rectangle. A raised area at the east end indicates the location of the altar. At the west end is an internal buttress, of unknown function, adjacent to which is a small niche, perhaps for vestments (Plate 3).

Plate 3 – Interior view of the chapel, looking northwest

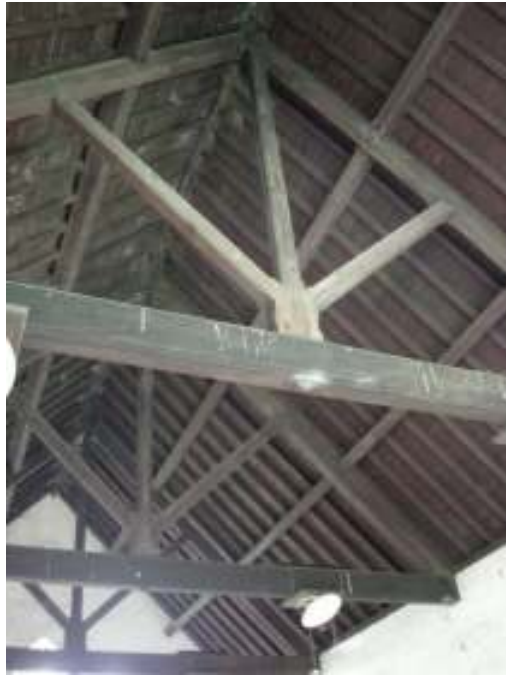
The roof comprises King post trusses on tie-beams (Plate 4). The tie-beams are chamfered and have straight-cut stops.

Plate 4 – Roof detail in the chapel

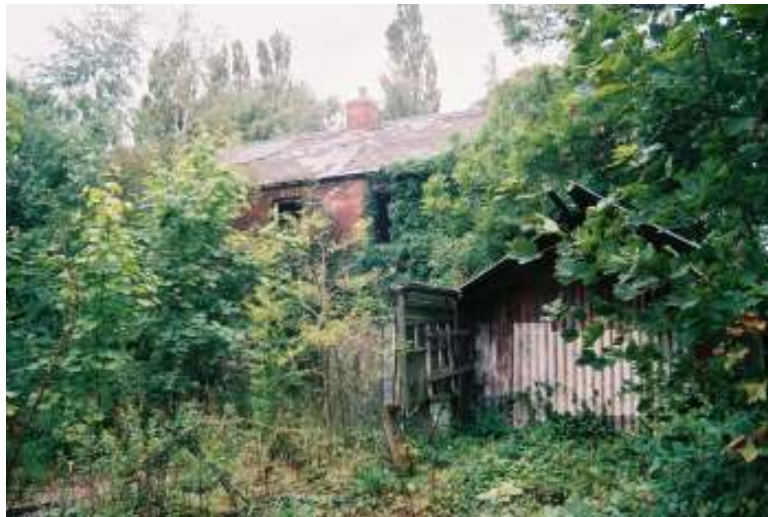
The front façade (Plate 5) of the house faces to the east and has a central, now blocked, door flanked by two sash windows on the ground floor and three windows on the first floor, all with brick flattish arches. A chimney is placed centrally to the structure.

Plate 5 – The east façade of Rowan House

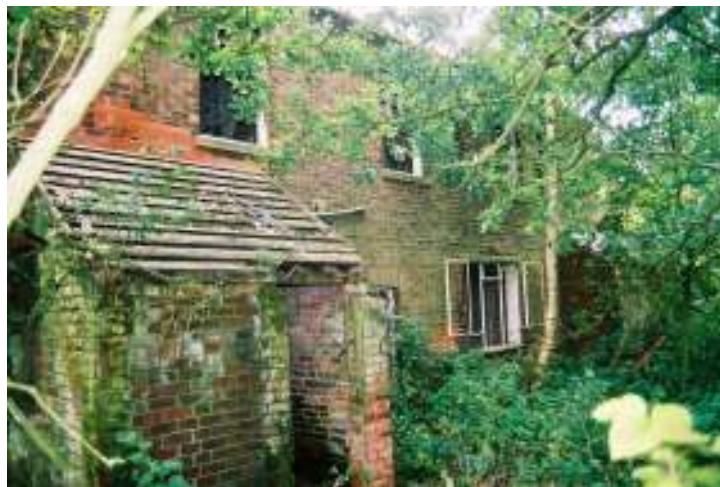
The west façade retains three original sash windows at first floor level and a single window and door are original on the ground floor (Plate 6). South of the door a large rectangular crittall window has been inserted.

Plate 6 – The west façade of Rowan House

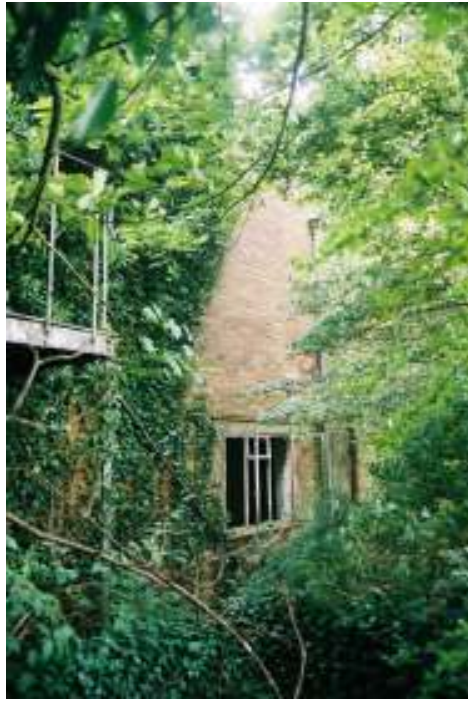
On the south side of the building is a later addition of *c.* 1950s. The southern façade is otherwise plain. The northern façade has an inserted fire exit at first floor level and two original windows on the ground floor (Plate 7), one for a pantry which extends west beyond the building.

Plate 7 – The north façade of Rowan House

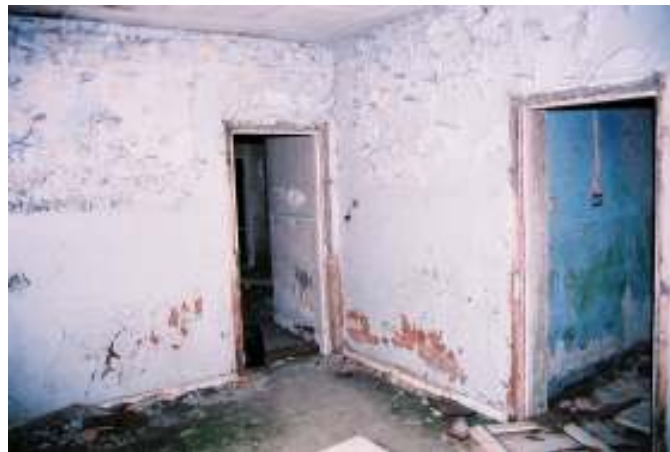
Room A (Plate 8) is located at the northeast corner of the house and comprises a simple rectangular room with a built-in cupboard at the northwest. A door to the west leads to rooms B, C and D. Rooms B and C are unadorned simple rectangular areas with access to the outside via room C. Also in room C is a modern cupboard of floor to ceiling height and evidence for a heating system is also apparent (Plate 9). The southern wall of room C is a simple stud partition. Room D has a shelf around three sides constructed of white glazed brick (Plate 10).

Plate 8 – Room A, looking southwest

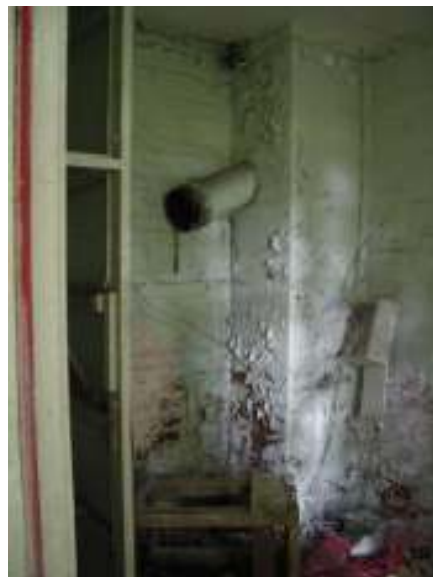
Plate 9 – Room C, looking southeast

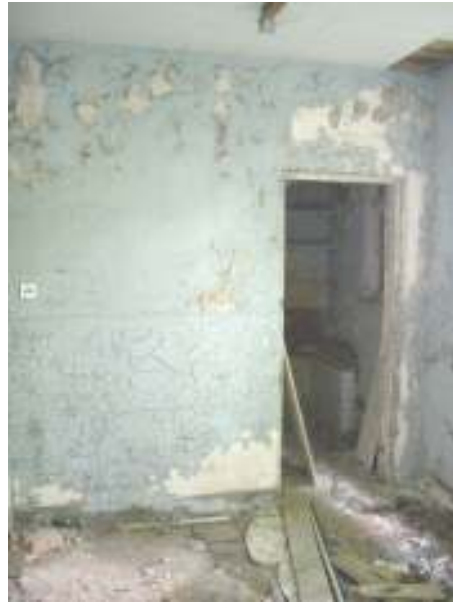
Plate 10 – Rooms B and D, looking west

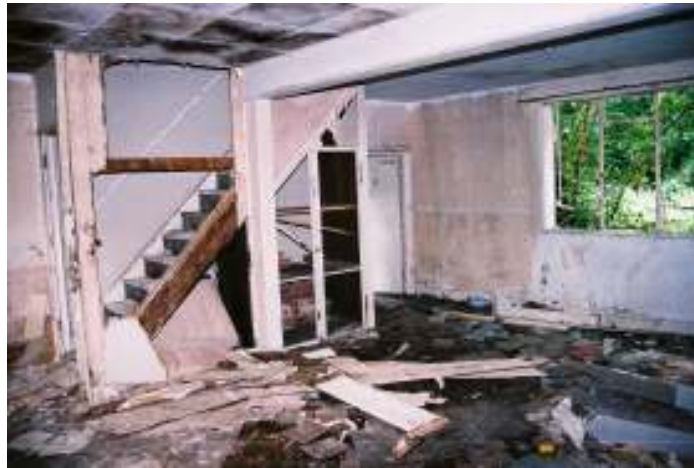
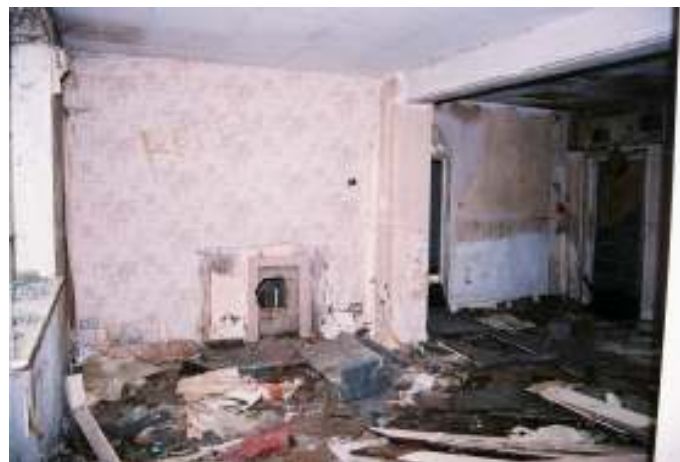
had access to the outside by a now blocked door. This may have once been subdivided into two as a joist spans the room from north to south (Plates 11 and 12). Access to the first floor is provided by a staircase located along the southern wall.

Plate 11 – Room E, looking south

Plate 12 – Room E, looking north

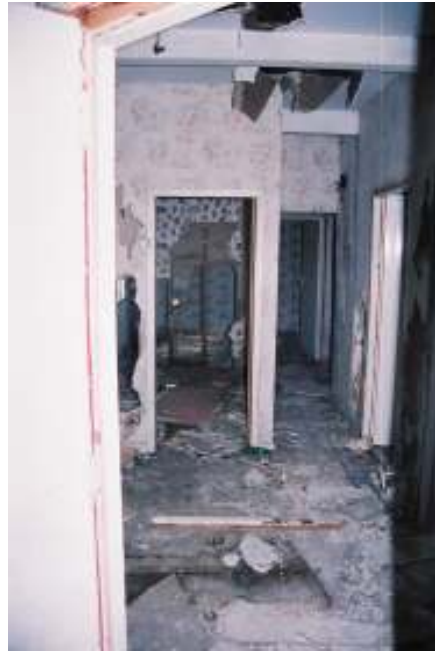
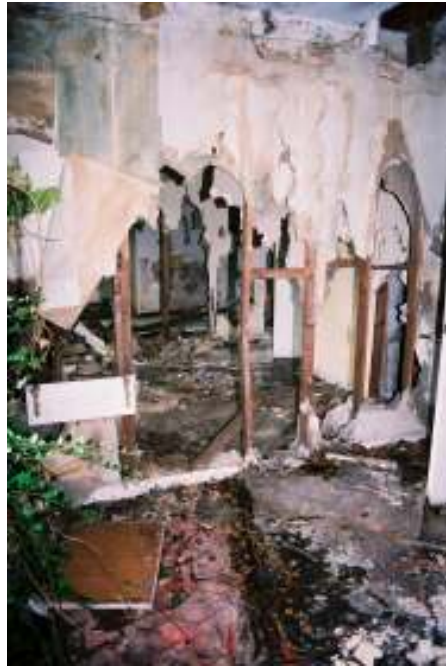
On the first floor level, all original walls have been removed apart from those associated with the central chimney and a small area above room F on the ground floor. Apart from the sash windows there are no original features apparent. A crissall window has been inserted at the top of the stairwell.

Plate 13 – View of the first floor, looking north
from the stairwell

Plate 14 – View of the first floor, looking
southwest
