**HISTORIC BUILDING RECORDING
ON SAWPIT AND DUTCH BARN
AT THE WOODYARD,
BELTON HOUSE,
LINCOLNSHIRE**

Work Undertaken For The
National Trust

May 2018

APS Report No. **36/18**

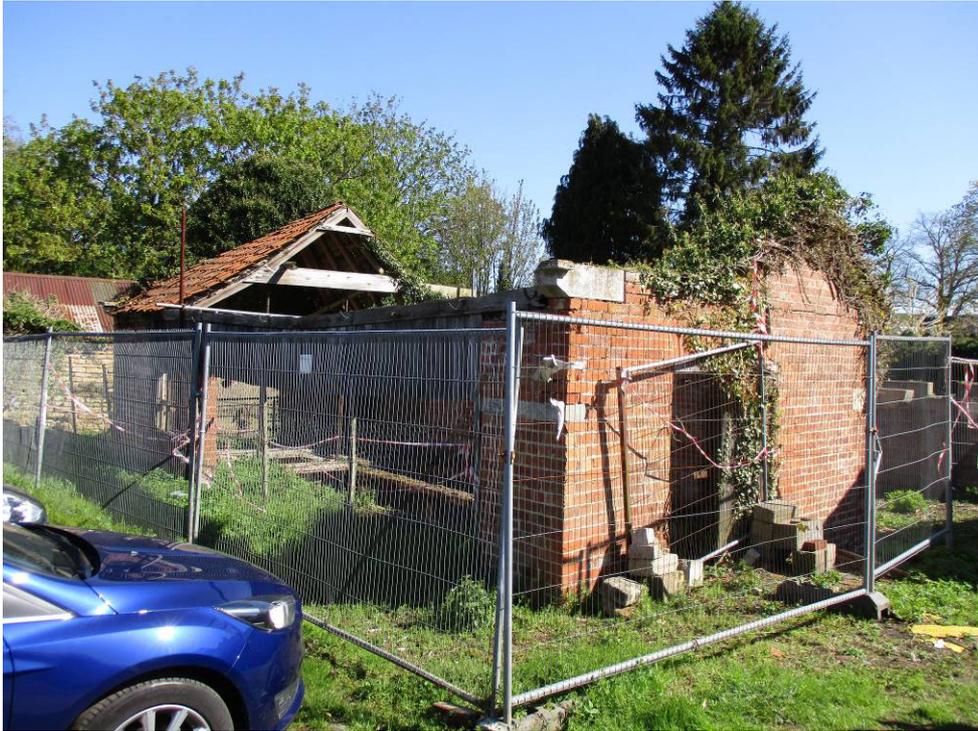
Plate 1 General view of the sawpit from southwest

The sawpit comprises a rectangular northnorthwest-southsoutheast building of English garden wall brickwork and timber. A single internal space is partly open to a large pit below ground level. Only the north portion of a pantile roof survives (Plate 1).

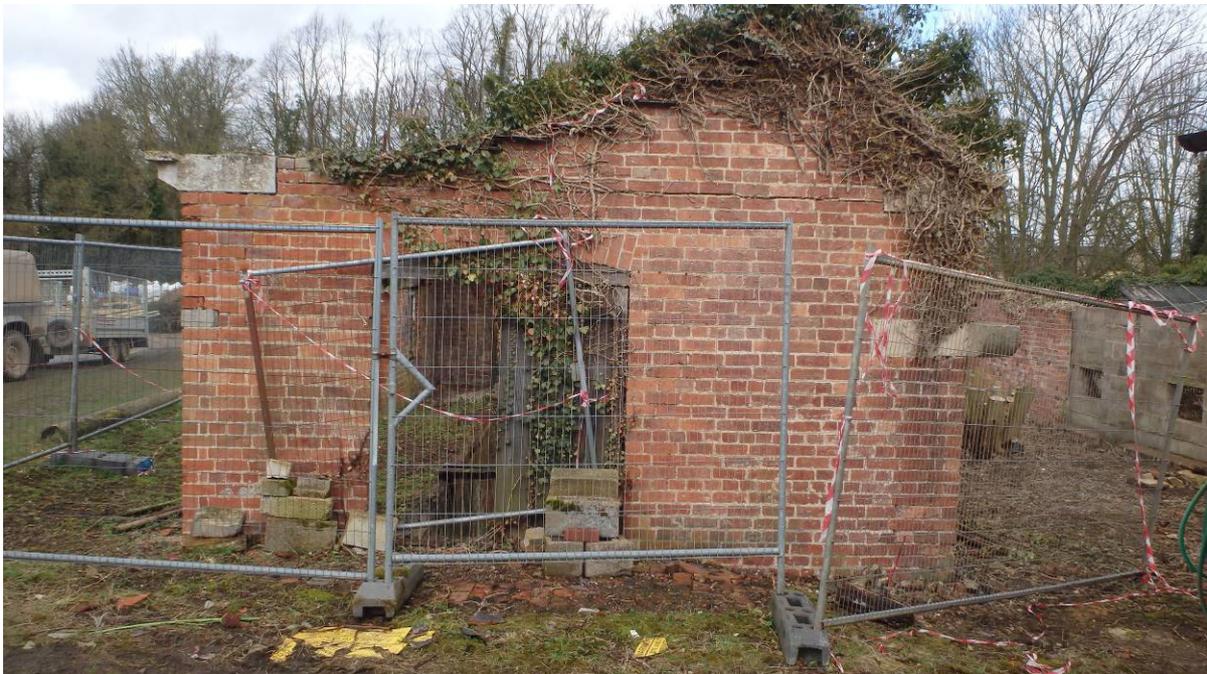
The south gable end of the sawpit is in brick with stone detailing (Plate 3). The height of the eaves has been reduced here, presumably when the roof was removed, and slates have been used to cap part of the wall to provide some weatherproofing. The original eaves level is marked by matching decorative stone kneelers at both sides of the south elevation (Plates 3 & 4).

Plate 3 South gable of sawpit

A single opening is present in the south elevation, an off-centre doorway with an alternating soldier and rowlock brick segmental arch over it (Plate 3). One of a former pair of double doors in this opening survives, and comprises a planked wooden door supported on external iron hinges on pintles (Plate 5). A small area of brick surfacing is visible beneath vegetation just outside the south door of the sawpit (Plate 3).

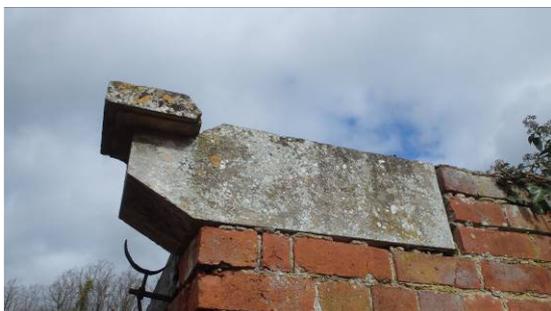
Plate 4 Decorative stone kneeler at west side of south elevation of sawpit

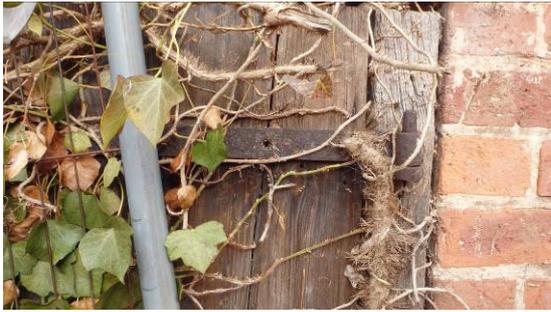
Plate 5 Iron hinge and pintle of south door of sawpit

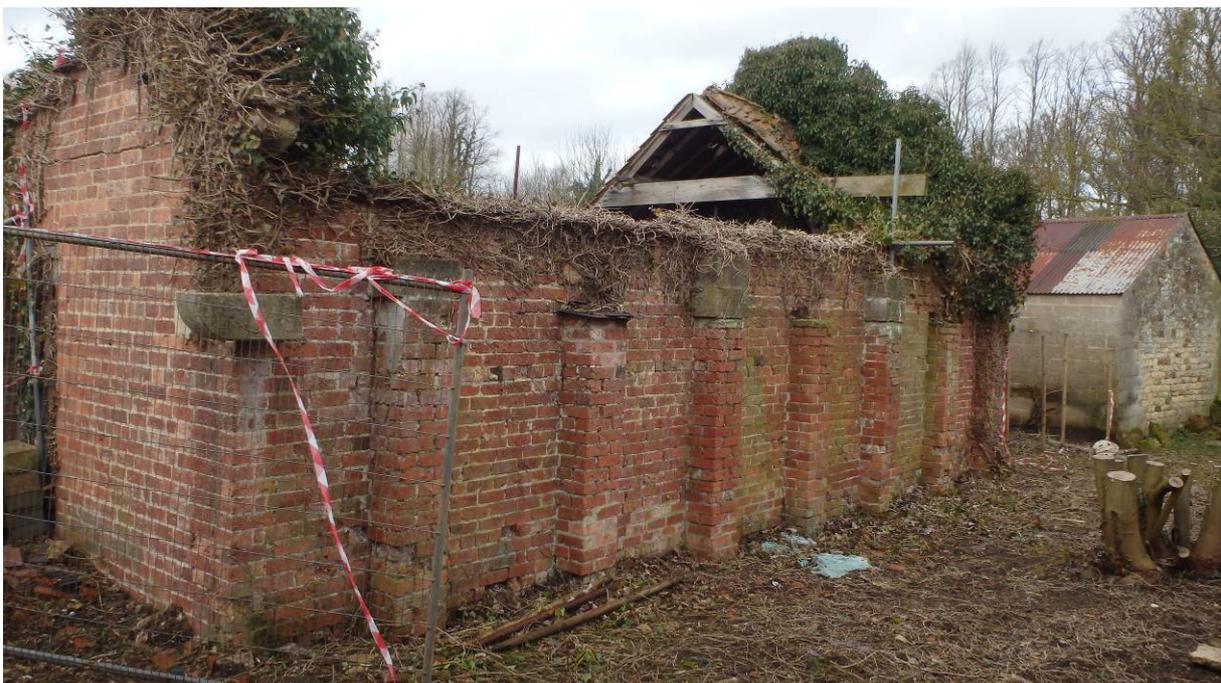
The east elevation of the sawpit is of brick with seven contemporary brick buttresses along its length (Plates 9 & 10).

Plate 9 East elevation of sawpit, looking northwest

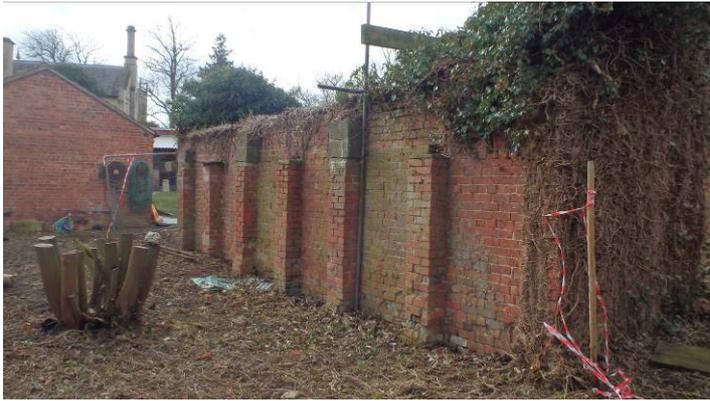
Plate 10 East elevation of sawpit, looking southwest

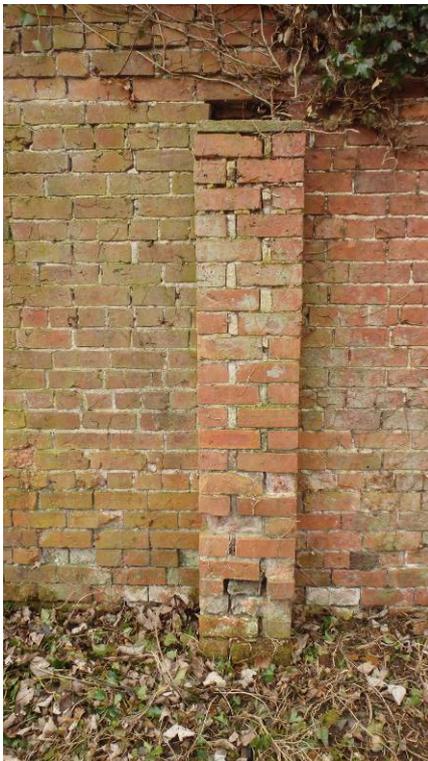
Some of these buttresses retains a stone cap, which appears to be original (Plate 11), whilst others have obvious signs of repair and have been capped with slate (Plate 12) or breeze blocks (Plate 9). Where present, the upper surface of the original capping stones matches the level of the corbel at the southeast corner of the buildings (Plate 9). The buttresses presumably provide additional support adjacent to the deep pit inside the building, but together with the corbel may have also served as supports for a former structure to the east side of the sawpit.

Plate 11 Brick buttress of east elevation of sawpit with stone capping and aperture above

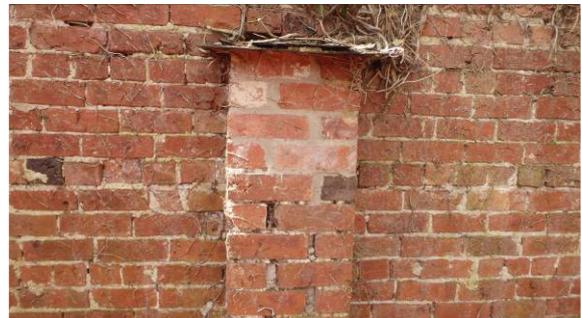
Plate 12 Repaired buttress of east elevation of sawpit, with fresh mortar and slate capping

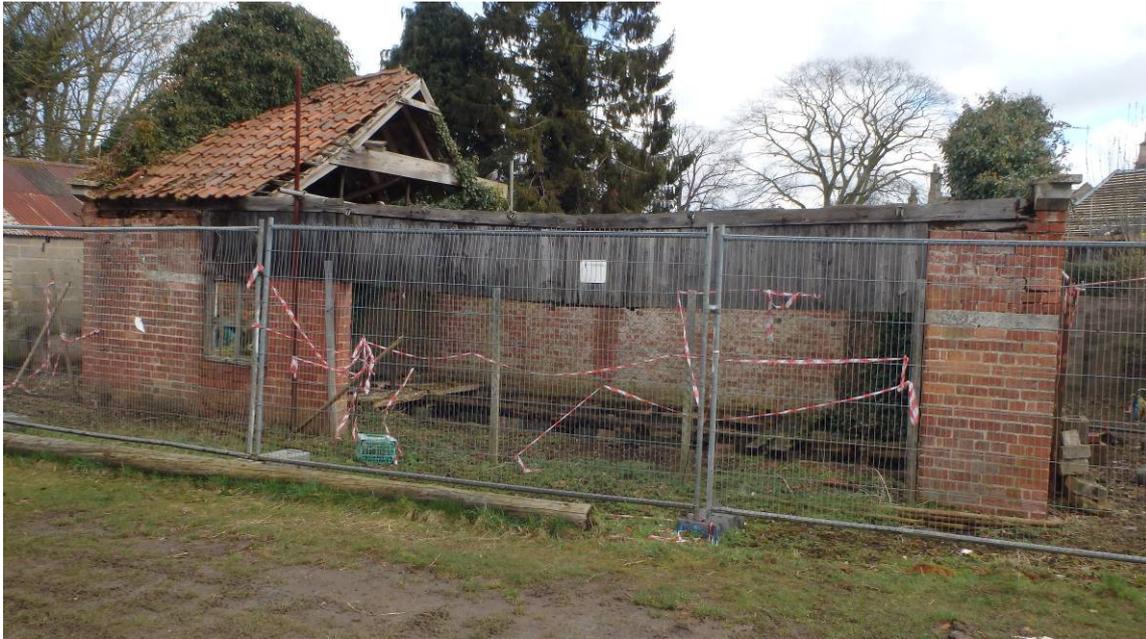
The north and south ends of the west elevation are of brick with the majority of this elevation being open at ground level (Plate 15).

Plate 15 West elevation of the sawpit

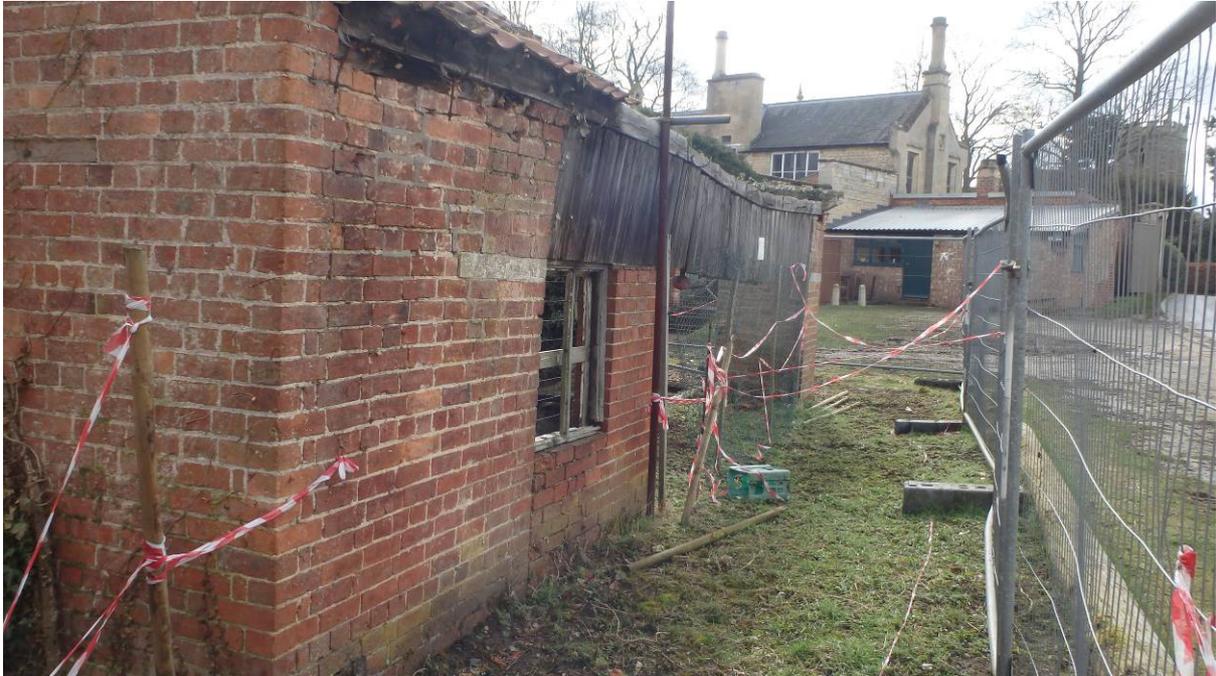
An area of brickwork at the north side of the large central opening in this elevation is a later addition, infilling part of the opening, and including a timber-framed un-glazed window

(Plates 17 & 18). Aside from this brick infill, the elevation beneath the weatherboard is open. The additional brickwork may have been inserted to provide additional support to this wall and roof above. The original brickwork at the north of the west elevation appears to have been deformed and repaired above the masonry course adjacent to the inserted brickwork, and the timbers of the open span of this elevation are bowed. Both are likely the results of a heavy pantile roof above this wide opening.

Plate 17 West elevation of sawpit showing brick infill with inserted window

The sawpit appears to be largely original, with an area of brickwork infill in the west elevation being the most notable alteration (Plate 17). The building retains many original features, although much of the pantile roof has been lost.

An area of brick infill in the west wall was presumably in response to stress on the west wall and roof caused by the large opening here under the heavy pantile roof. As most of the west opening remained open after this infilling, reduced to 5.6m wide, it is presumed that the sawpit was still in use at the time of this repair.

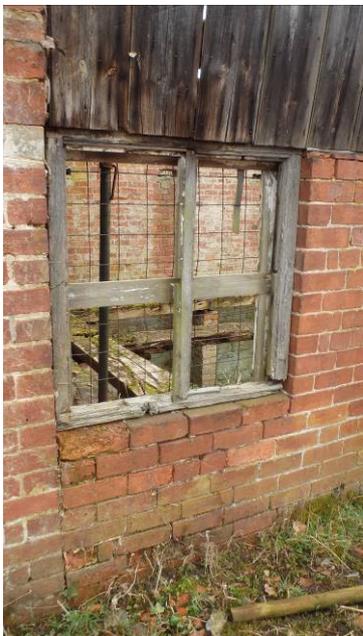
Plate 18 West elevation of sawpit, detail of inserted brickwork and window

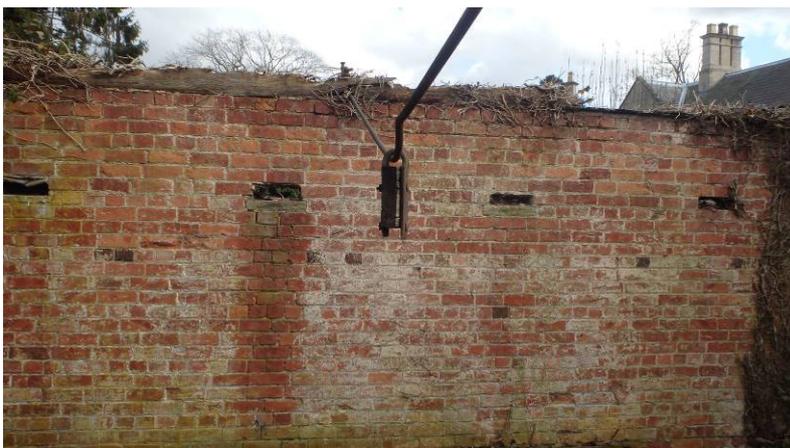
A bent iron bar spans the width of the sawpit, at eaves level (Plate 27). This includes an iron device with attached fragment of timber. It seems probable that this part of a lifting aid for manoeuvring heavy timbers, possibly part of a chain block, gantry crane or similar device.

Plate 27 Iron bar spanning sawpit with iron device attached

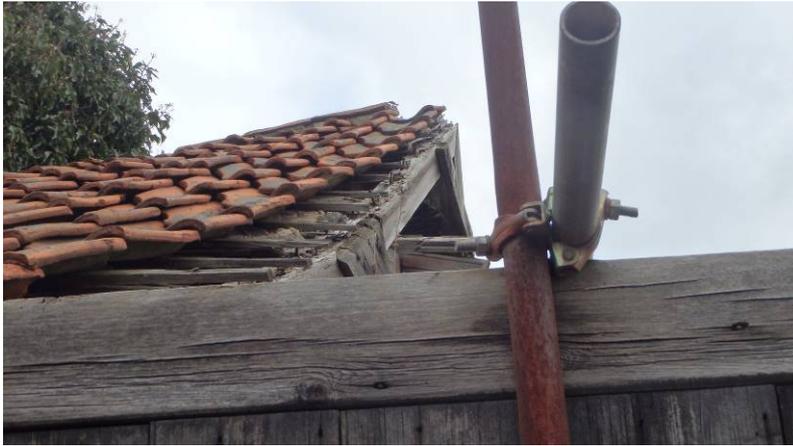
Plate 28 Detail of sawpit roof structure externally

Only a small area of the roof of the sawpit survives, at the north end of the building (Plate 28). Presumably the roof has survived here due to the brick walling on three sides providing better support than above the long west opening of the building.

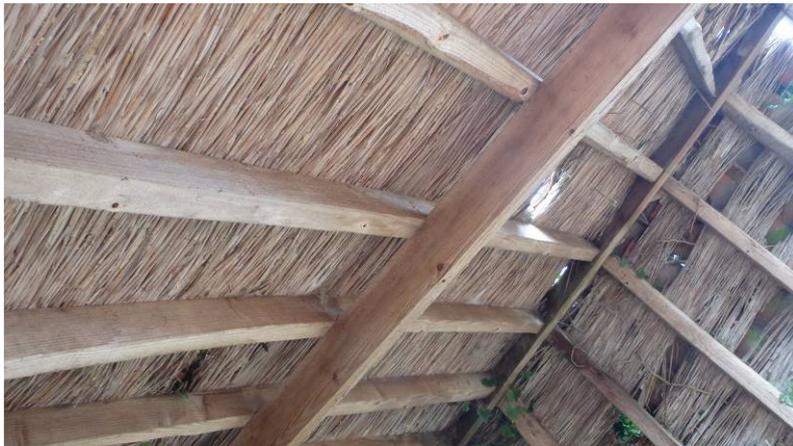
The room is open to the rafters which are supported on purlins and a ridge board (Plate 29). Over the rafters is a layer of reeds (Plate 29), above which laths are visible externally, nailed to the rafters, with plaster between the laths (Plate 28).

Plate 29 Detail of sawpit roof structure internally

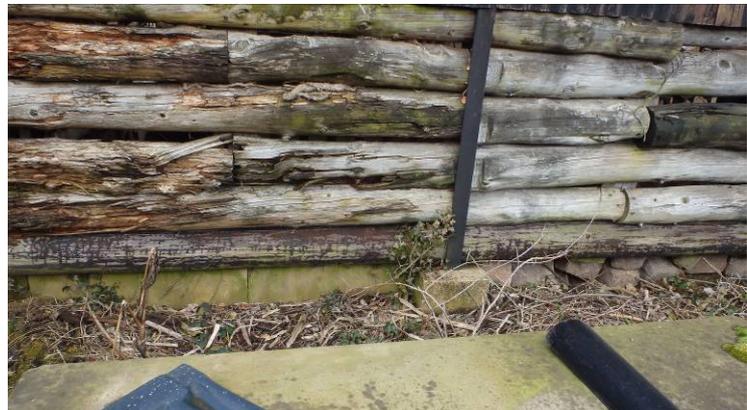
Plate 35 Detail of south elevation of Dutch barn showing iron frame on concrete pad and timber walling

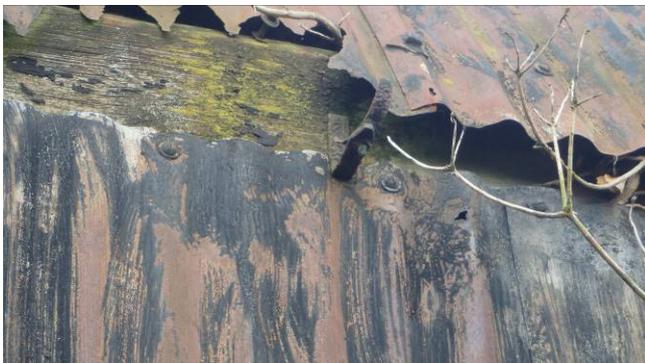
Plate 41 Iron guttering fixing attached to Dutch barn

Iron fixings for guttering are located at the eaves of the Dutch barn (Plate 41).
