**HISTORIC BUILDING RECORDING ON
FARM BUILDINGS AT
117 STATION ROAD
SNETTISHAM
NORFOLK
(51884)**

Work Undertaken For
D.H. Williams,
Architectural Consultant to
Mr and Mrs South

November 2008

A.P.S. Report No. **123/08**

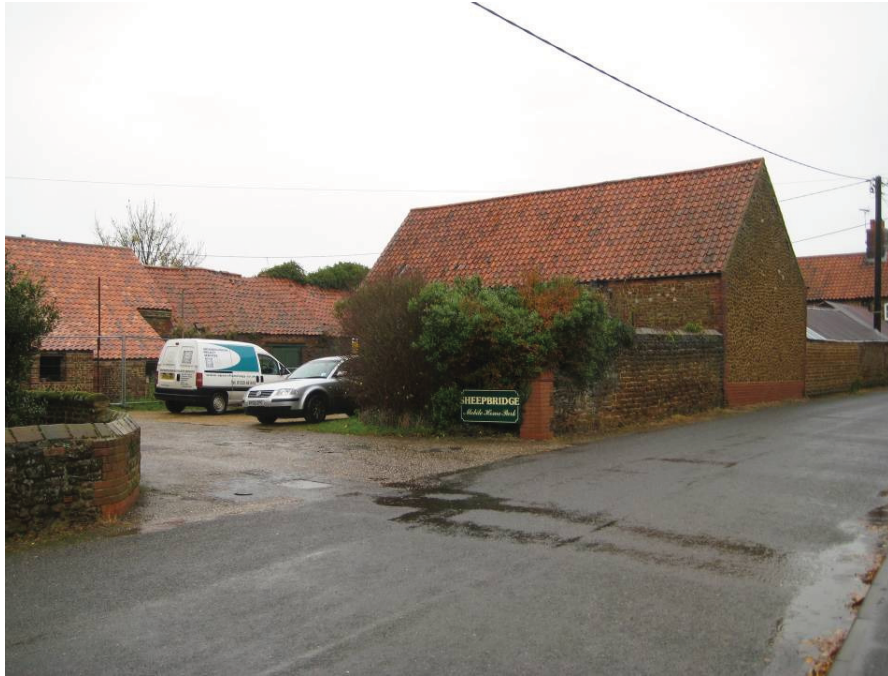
Plate 1
General
view of
buildings
from
Station
Road,
looking
northeast

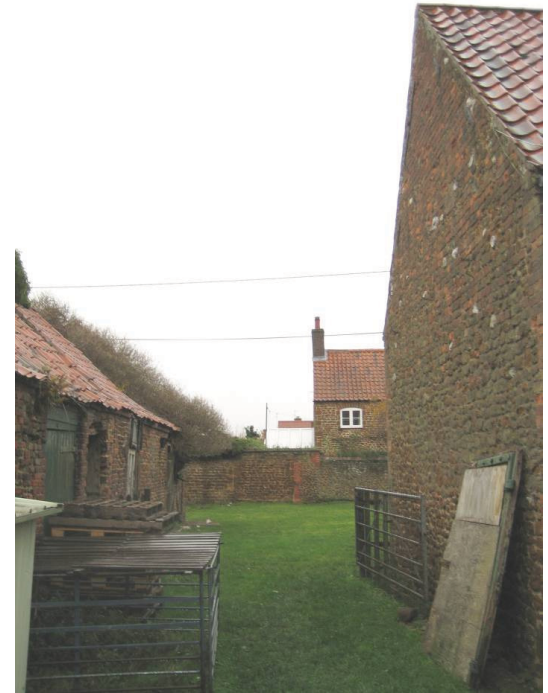
The northern external gable end was of carrstone at ground level, containing progressively more brick, also of late handmade type, towards the roofline (Figure 4, Plates 3 & 4). Above eaves level this wall was predominantly of brick although at the roofline it was topped by

Plate 3
North
elevation of
main barn
and
adjacent
stable and
dairy range,
looking
east

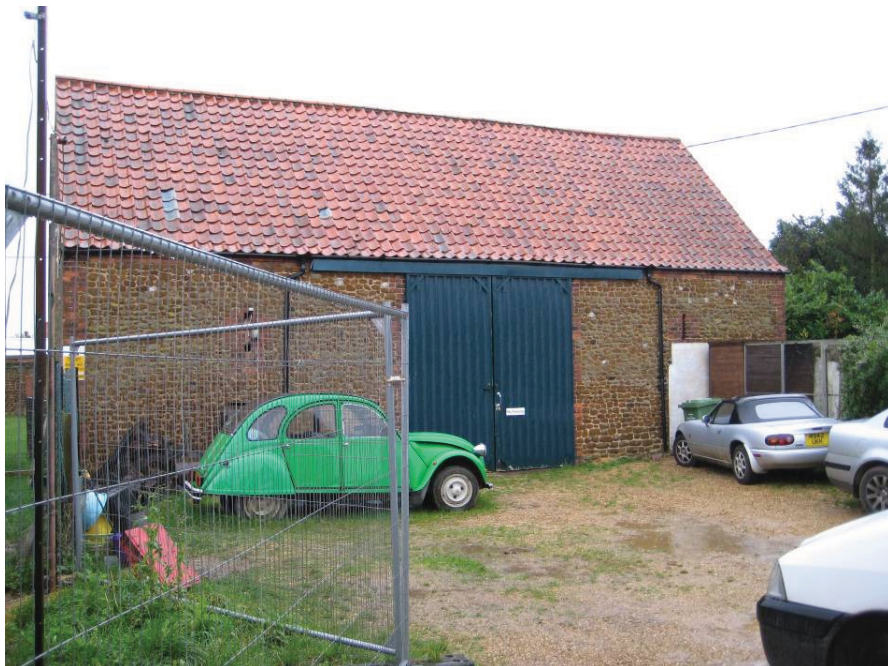
Two breather slits were evident on the western elevation, with a further one being located in the eastern wall (Figure 4, Plates 2 & 5). Each of these was surrounded by brickwork, of the same style and brick type as the corners of the barn and door surround.

Although the large paired doors of the western elevation are modern, the brick quoins to either side of this doorway indicate this opening is original to the building. Similarly, the three breather slits in the east and west elevations seem to be original features. In combination with the overall form of the building, these features are typical of a barn used for hand-threshing and grain storage, and indicate that it was likely to have been built for this function. Such buildings usually feature large opposed threshing doors, and so it would be expected that an opening mirroring that of the west elevation would be present in the east wall. Although no direct evidence of such an opening in the east elevation was identified during the survey, this wall was much-altered and repaired, and a short straight join on the external elevation and a change in the wall build internally may indicate alterations and the infilling of such an opening.

Plate 2
Main barn,
west
elevation,
looking
east

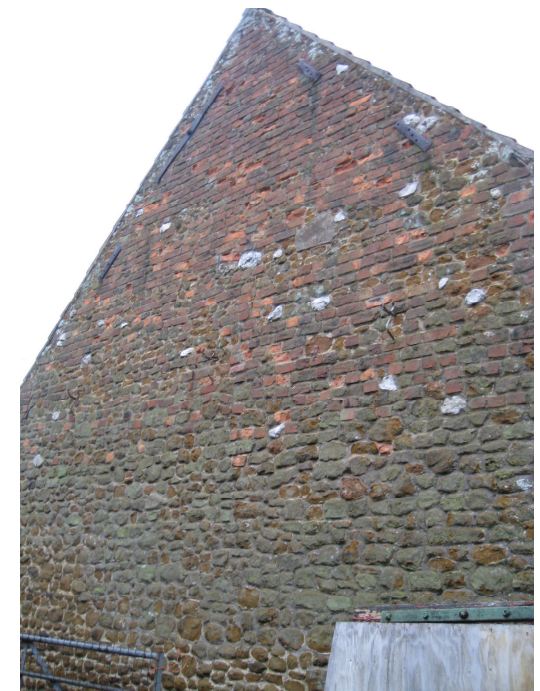
Plate 4
North
elevation of
main barn
looking
south

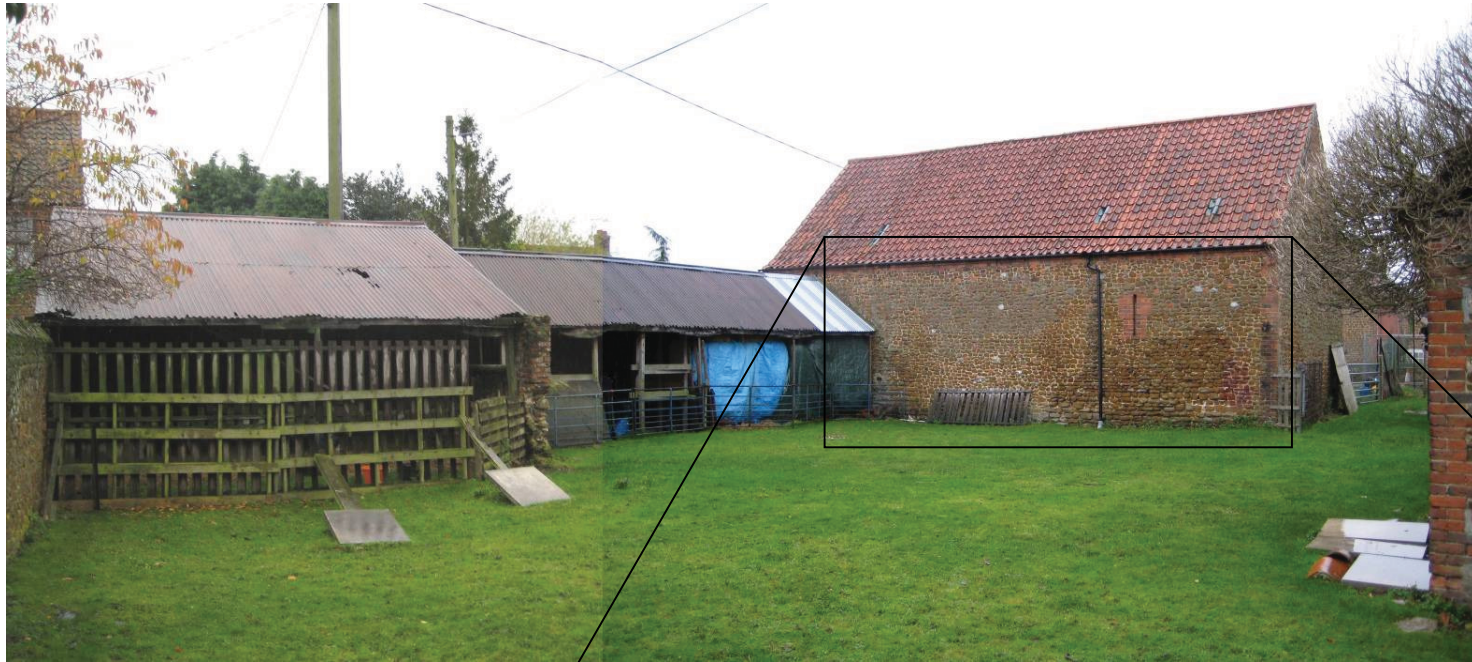
There were numerous variations in the coursing and mortar of the eastern external elevation. However, a straight join was recorded, and although this extended for only part of the height of the building, it might represent the faint traces of a former opening in this elevation, perhaps mirroring the large double doors of the western side (Figure 4, Plate 5).

Plate 5
East elevation of
main barn showing
detail of masonry
and general view
of surveyed ranges

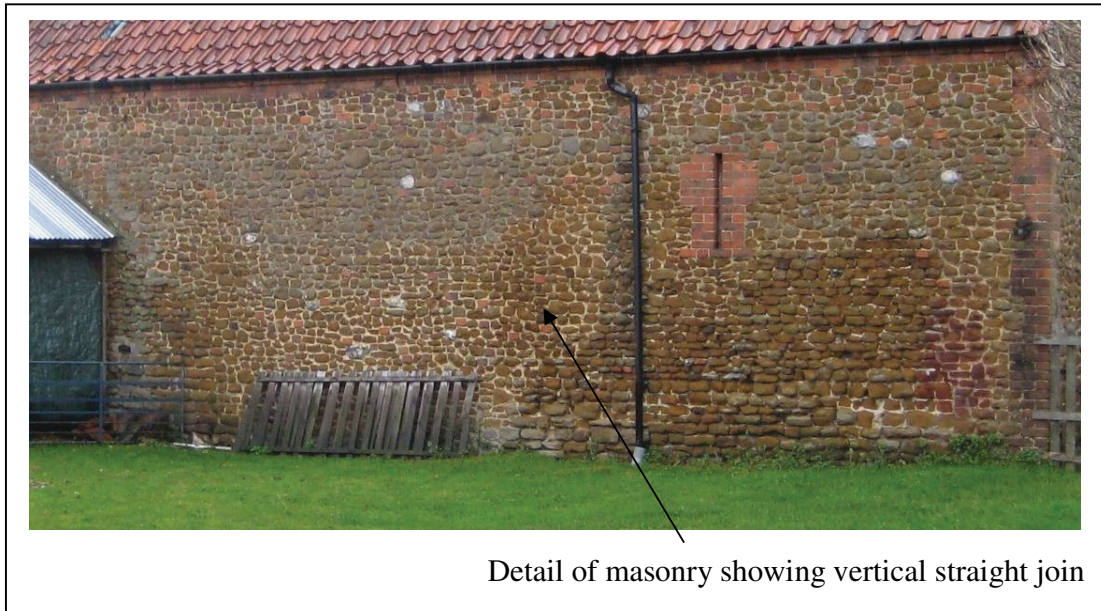
Detail of masonry showing vertical straight join

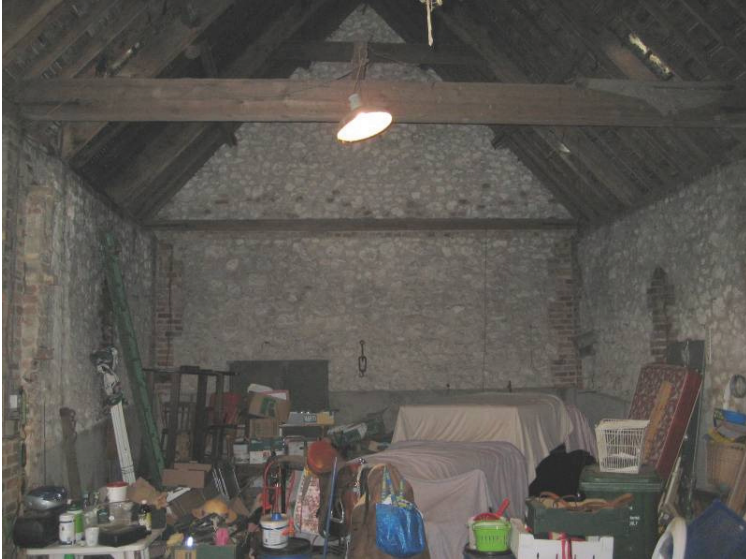
As the walls were whitewashed internally, and the lower *c.*1m covered in concrete, little detail was evident (Plates 6-8). However, a change in the construction of the eastern wall was evident corresponding to the position of the internal plinth attached to this wall. The wall to the south of this plinth included two courses of

Plate 6
Interior of main barn, looking north

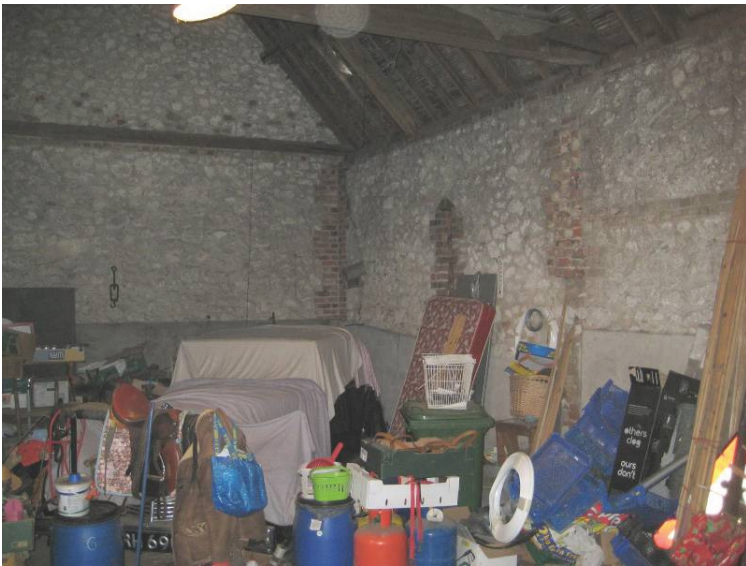
The remnants of two opposing plinths within the building might represent the previous location of a partition, or supports of a former first floor area to the northern part of the barn (Figure 3, Plate 7). Alternatively, these may have acted as buttresses.

horizontal brickwork at *c.* $\frac{2}{3}$ the height of the wall (Plate 7). These brick courses extended to the southeast corner of the building. The change in the construction of this wall approximately corresponded to the location of the straight join, already noted, on the external elevation.

Plate 7
Interior of main barn, looking northeast, showing detail of breather slit, brickwork and plinth in eastern wall

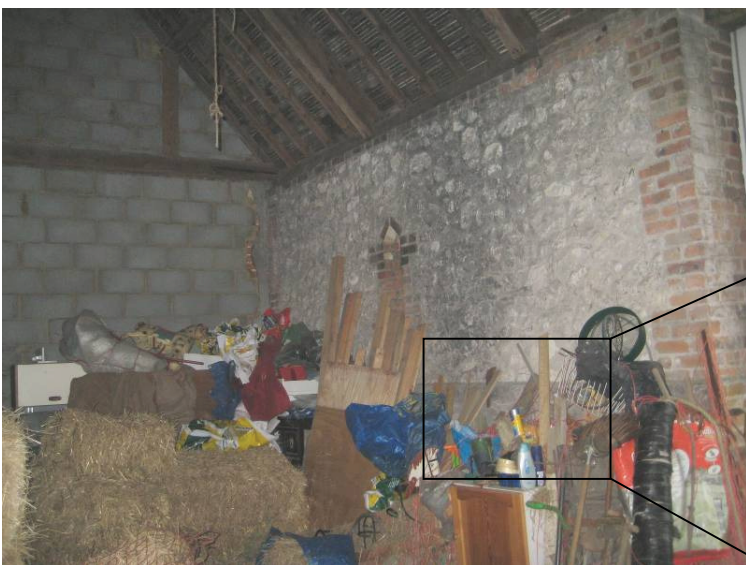
The southern gable end had been almost entirely rebuilt, probably in the recent past, although the brick corner quoins as noted elsewhere in the building had been retained. Internally this wall was of breeze block construction (Plate 8), and externally of uncoursed carrstone rubble with occasional brick and fresh mortar, all of which appeared to be of a single phase, representing the total re-building of this wall (Plate 1). The base of this wall comprised eight to nine visible courses of modern red brick.

Plate 8
Interior of main barn, looking southwest, showing south and east walls

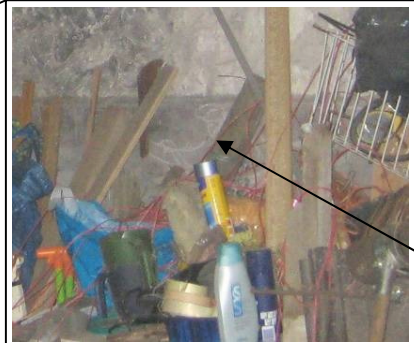
Chalk drawings were noted on part of the concrete of the internal western wall, just to the south of the doorway, although these were largely obscured by stored materials. These depicted swags of material or ribbon and a woman in a bathing suit, and were apparently decoration associated with village dances held in the barn in the second half of the 20th century (Mr and Mrs South, *pers. comm.*) (Plate 8).

Detail
of chalk
drawing
on wall

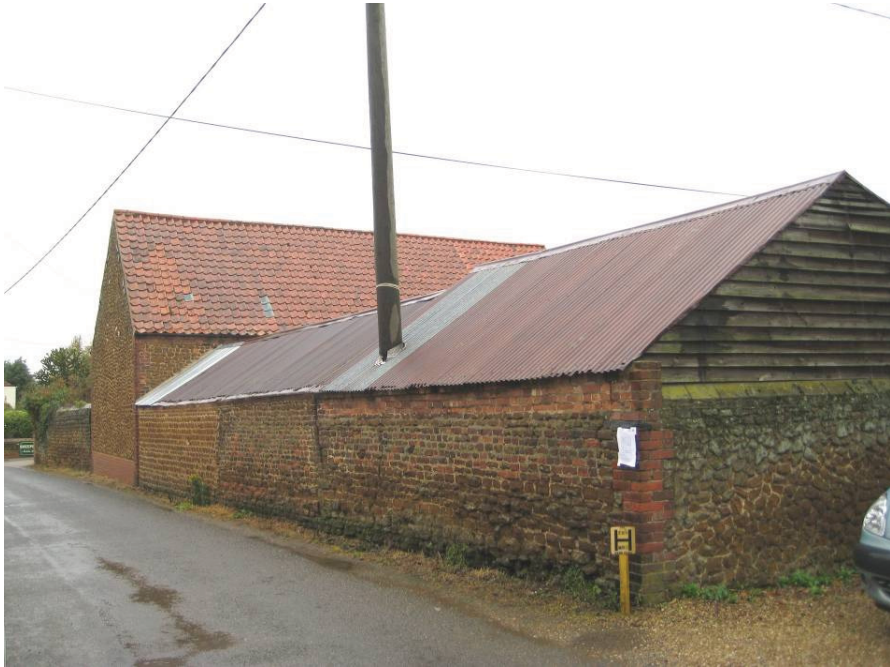
The southern wall of the building abutted the southern wall of the main barn, both forming the boundary of the property along Station Road (Figure 4, Plate 9). At its eastern end, this wall comprised various layers of coursed carrstone and late handmade brick, with the remnants of brick quoins at its eastern edge. The mixed nature of this wall is likely to reflect the use of any materials which came to hand during its construction and a series of repairs or alterations.

A telegraph pole was located within the building, projecting through the corrugated iron roof, and close to Station Road (Plate 9).

Plate 9 General view of buildings from Station Road, looking northwest

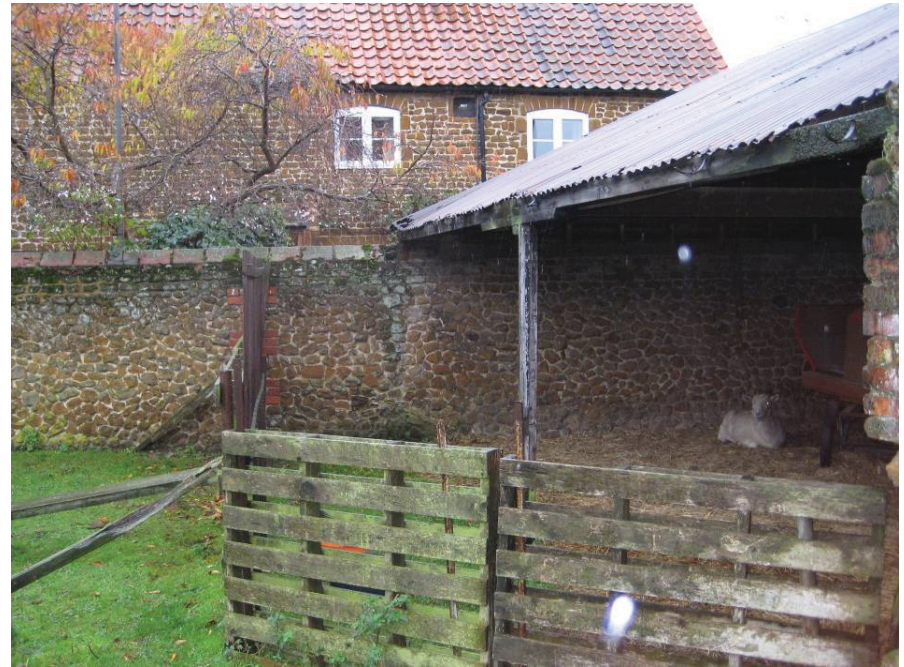
formed part of the boundary wall of the neighbouring property and was of carrstone rubble construction (Plates 9 & 10). Brick quoins formed the southeast corner of this building. Further brick pillars or quoins were identified in the eastern wall, beyond the northern extent of the surveyed building, level with the wooden fencing (Figure 3, Plate 10). This quoining may be an indicator of the former extent of buildings in this area.

Plate 10 Animal shelter shed, looking east

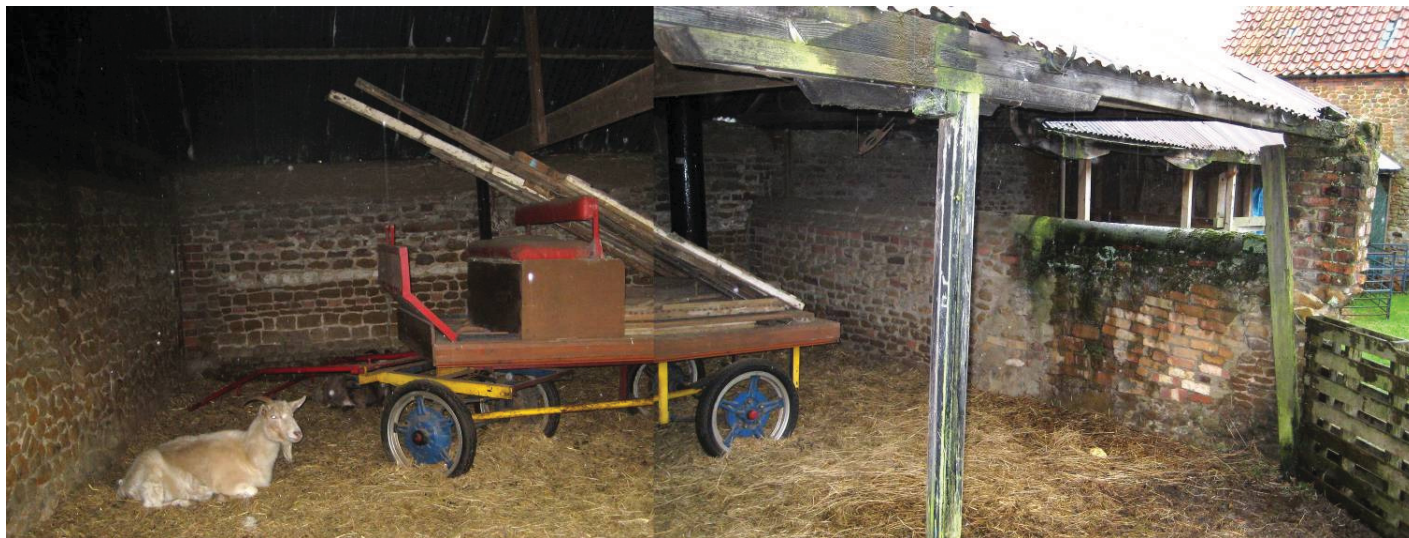
The western edge of the building was formed by a low carrstone rubble and brick wall, separating this from the adjacent shelter shed. At its southern end this was predominantly of carrstone, with several repairs including 20th century brickwork to the northern end. At its northern extent this wall was surmounted by a brick pillar forming the corner of the building (Plate 11).

Plate 11
Animal
shelter
shed,
looking
south and
southeast
