**HISTORIC BUILDING RECORDING ON
FARM BUILDINGS AT
1-7 BARNES COURT
BARNES ROAD
PULHAM MARKET
NORFOLK
(52681)**

Report Compiled by
Vicky Mellor BSc (Hons)

A.P.S. Report No. **21/09**

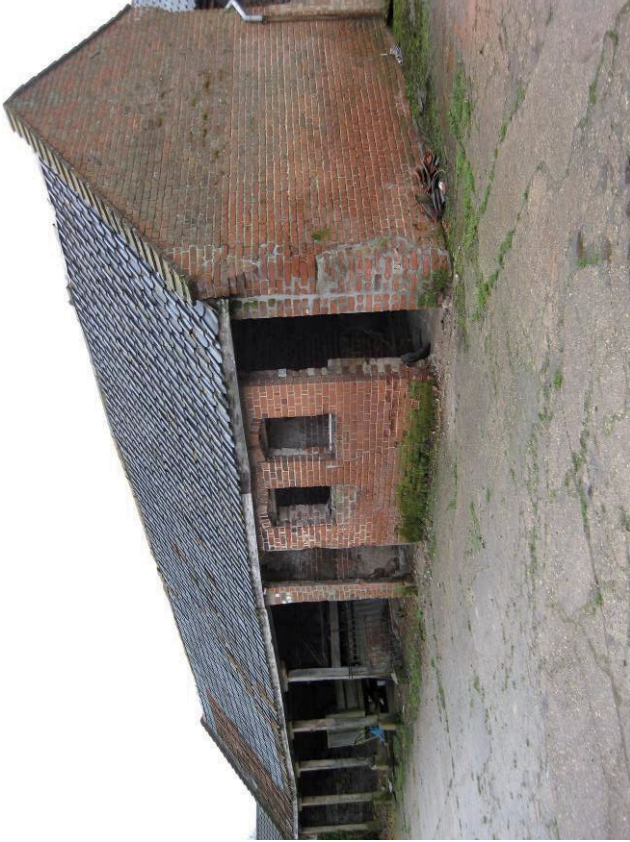
Plate 2 View of cart shed and stables or loose boxes, looking southwest

At the northern end of the cart shed, this range narrowed slightly and comprised two probable stables or loose boxes (Figure 3, Plate 2).

Although asymmetrical, the northern gable end was apparently of the same construction as the south gable end of the cartshed (Plate 2). As for the southern cartshed gable end, the north gable was in Flemish bond externally and English bond internally. The gable was again raised slightly above the roofline with kneelers of brick at each side. Modern repairs were noted externally, at the northwest corner of the range.

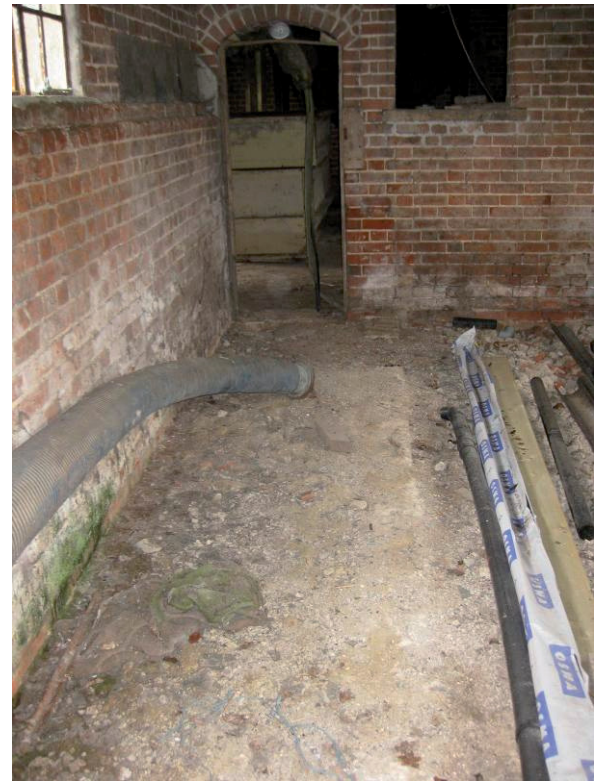
Plate 17 Interior of northwestern range of animal accommodation showing brick and unfired clay block traces marking location of passageway, looking east

Traces of unfired clay lump and brick were noted adjacent to the northern wall, and formed a strip parallel to it (Plate 17). This probably represents the extent of a former passageway here, linking doorways in the eastern and western walls.

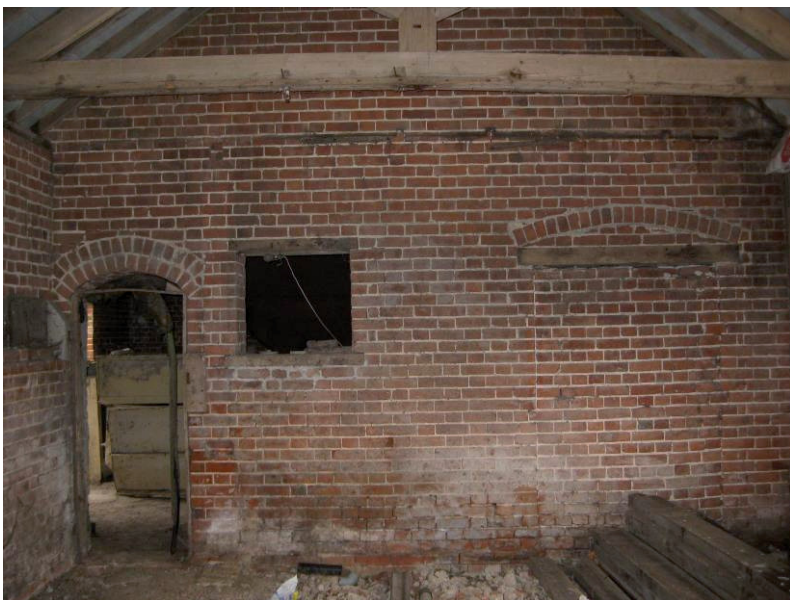
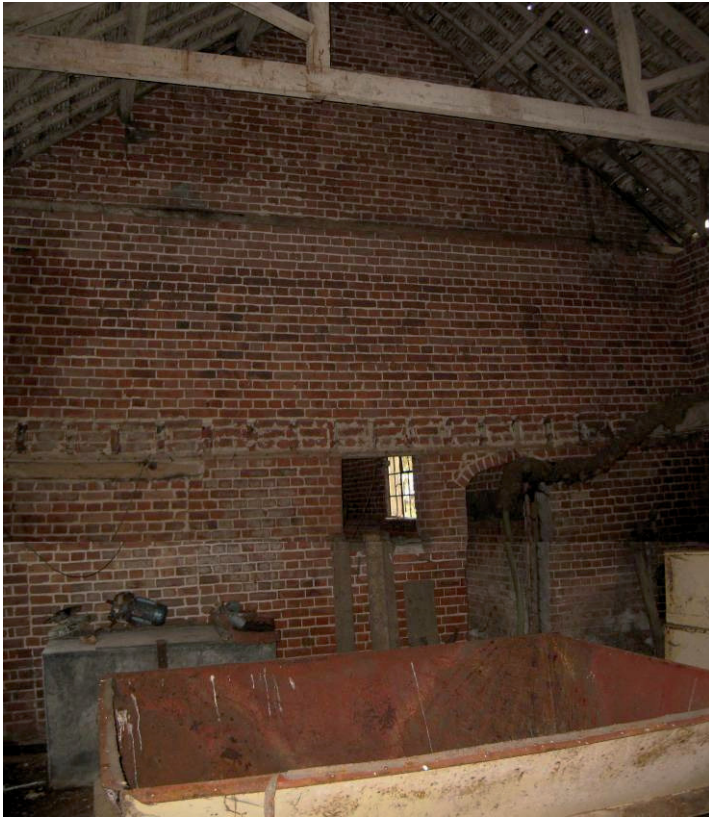
A doorway and opening noted on the western side of the west gable end, inside the adjacent animal accommodation, were also noted internally, although the segmental brick arch over the doorway was single internally (Plates 16 and 20). The blocked doorway already noted in this wall was also evident inside the barn, although here no brick arch was present, and only the timber lintel was visible (Plates 16 and 20). The position of this lintel, immediately beneath the level of the rafters to the upper storey, suggests that this upper floor may have been inserted, the upper arched part of the doorway infilled at this time.

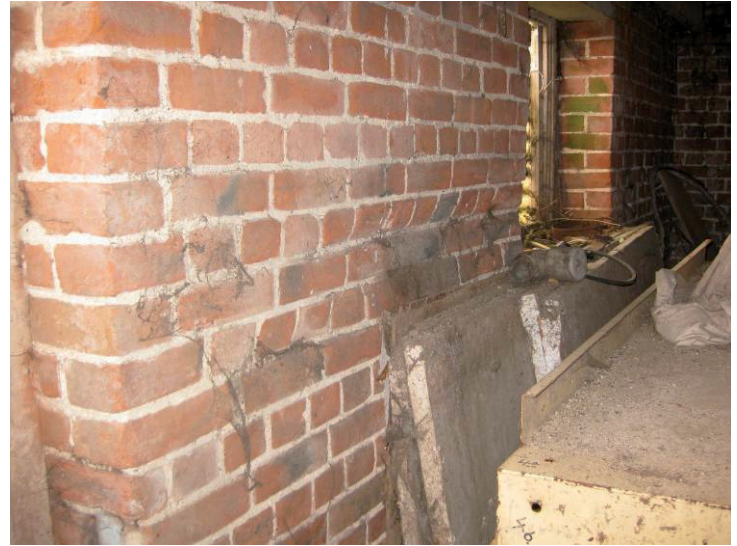
Plate 22 Detail of walling, northern wall inside west room of main barn, showing wear pattern of bricks, perhaps due to machinery, looking northeast

Each of the north and south walls of this room were in Flemish bond internally. Part of the brickwork of the northern wall, between the doorway and ground floor window, was apparently worn (Plate 22), perhaps as the result of wear from machinery.

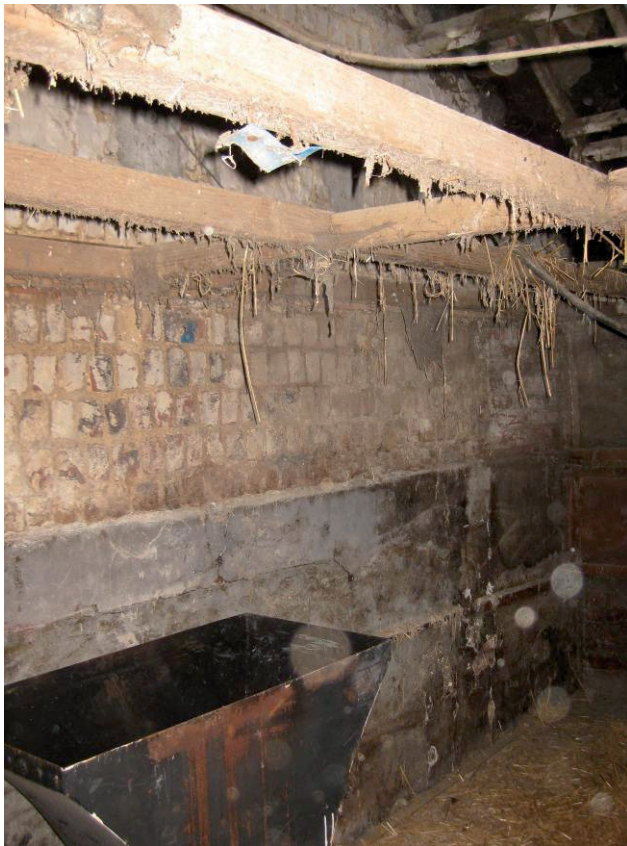
Plate 32 Interior of westerly room of east-west range of animal accommodation, showing brick coursing of wall, looking southeast

The western wall of the room was of similar unusual construction to walls already noted in the southern room of the easterly range. The lower portion was rendered, above which brick laid in header rows on edge was visible, the top few rows being stretcher rows (Plate 32).

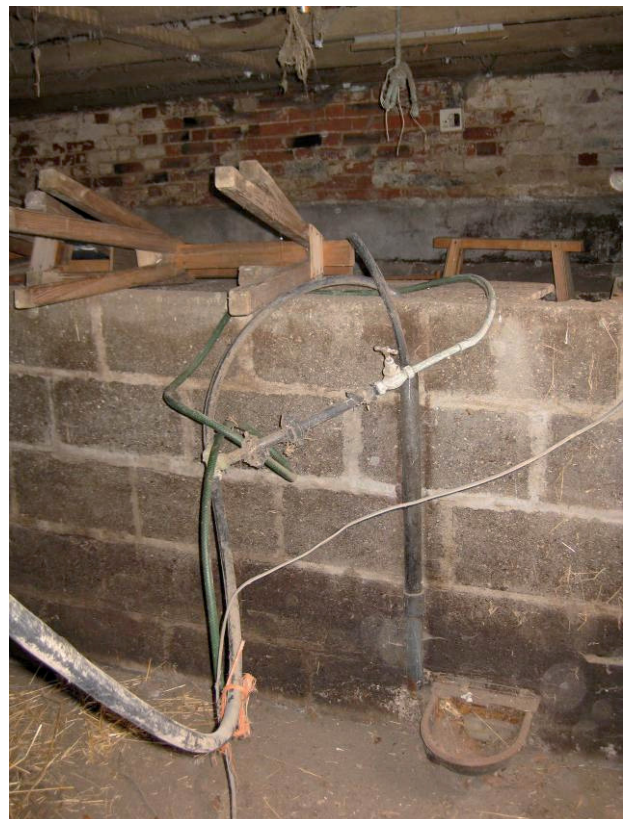
Plate 33 Partition wall separating two animal pens in westerly room of east-west range of animal accommodation showing animal drinker, looking west

The western room of the range was divided into two animal pens by a low breeze block wall. Low level drinkers were noted in each of these, whilst flooring was of concrete, whilst traces remained of straw animal bedding (Plate 33).

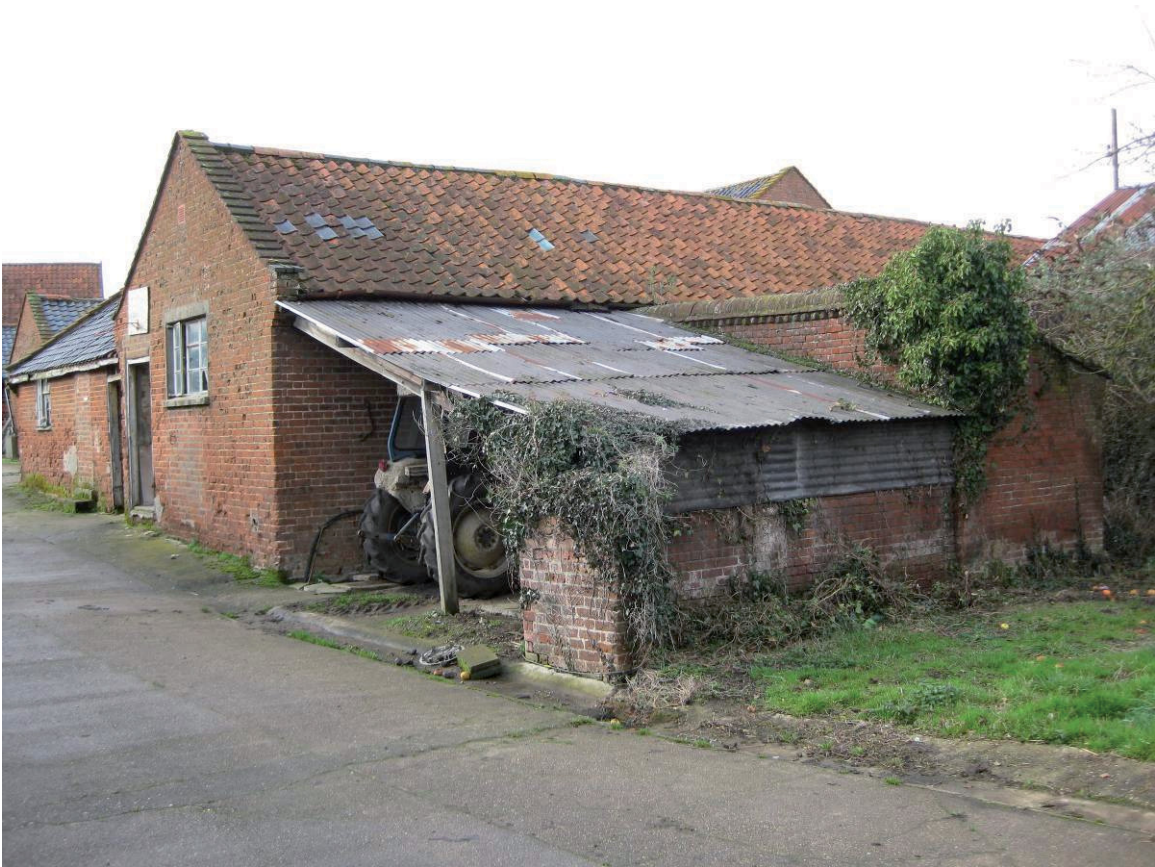
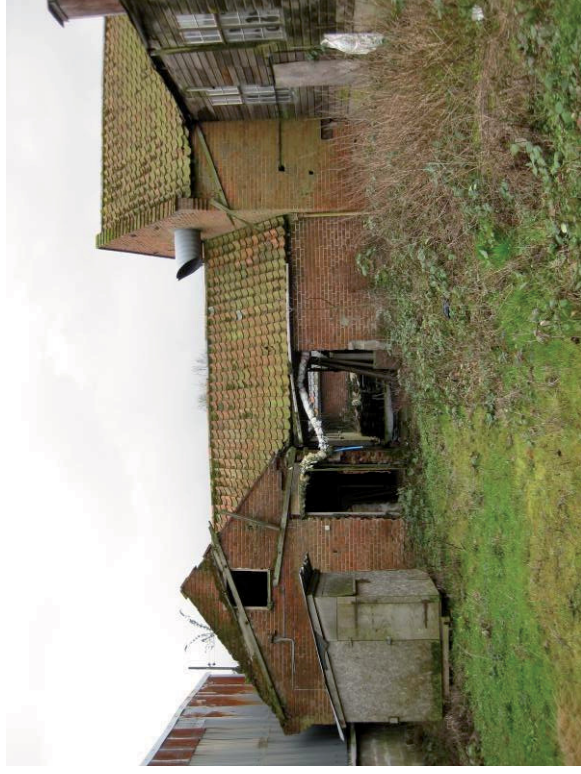
The eastern wall and the north and south gable ends were of brickwork in Flemish bond. The gable ends were raised and had brick kneeler detailing, although this had been damaged at the northwest corner (Plates 34 & 26).

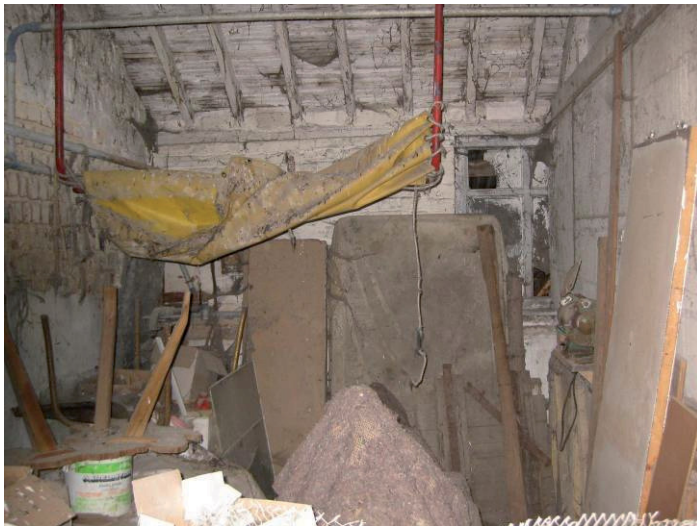
Plate 35 Interior of southern room of eastern range, showing breeze block partition wall, looking east

The unusual brick bonding noted in the north wall was repeated in the western wall of the room. The southeastern corner of this room had been further partitioned off by breeze block walls, this room containing a sink and being used for storage (Plate 35).

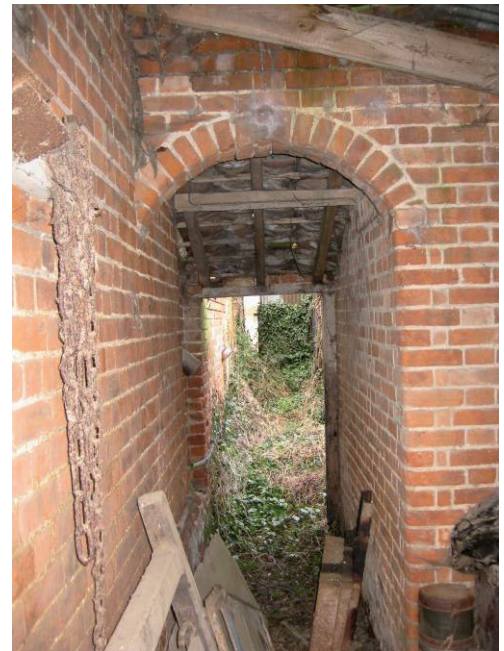
Plate 36 Covered passageway at western edge of east range, looking north

A slight recess was noted in the eastern wall of this building, the exterior of this being beneath a covered passageway of an adjacent building (Plate 36). The dimensions of this recess in the eastern wall suggest this is likely to be a blocked door, although no clear change in brickwork or materials was evident.

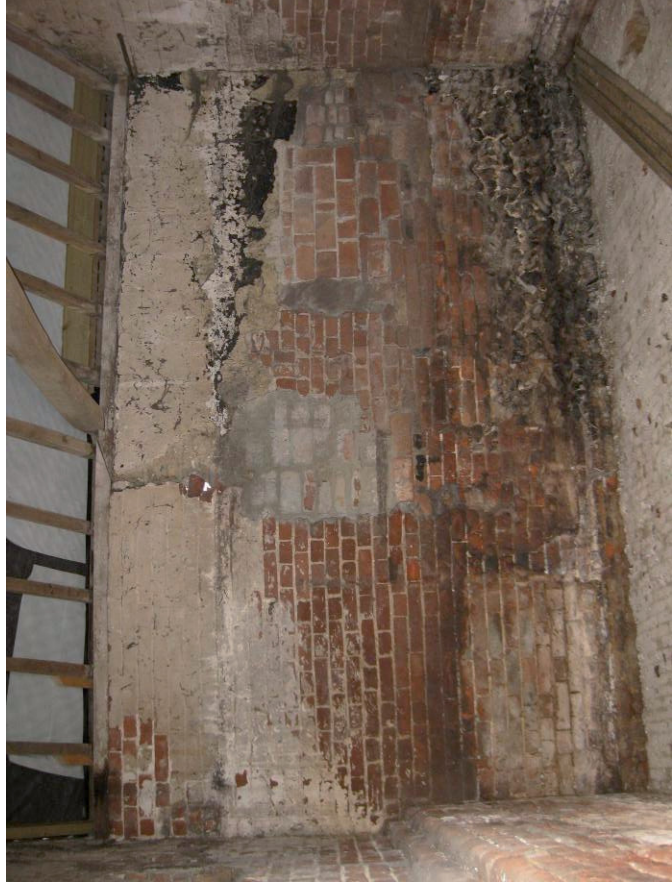
Plate 8 Garage range, easterly room internal, showing patching of southern wall including flint cobble, unfired clay block and brick, looking south

Flemish bond brickwork was evident inside this room, and was noted in the northern, western and eastern walls, the northern and eastern walls each being thicker near the base. The southern wall of this room was heavily patched and much repaired (Plate 8). Whilst this was again partly in Flemish bond brickwork, some flint cobble was present at the base, and various patches of modern brick repair were evident above this. The upper part of this wall included unfired clay lump containing straw.

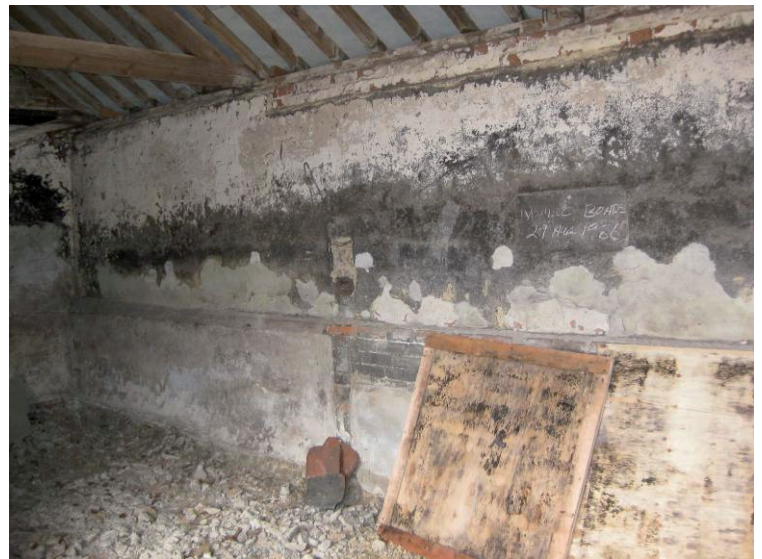
Plate 10 Western animal accommodation range internal, west wall partly of brick and unfired clay block, with slate attached to wall, looking southwest

Low vertical scars were noted in each of the southern and western walls, apparently marking the location of former animal pens. Numerous slates were also attached to the western wall, several of which contained chalk notes, some being legible and referring to boards and dates, one such being '1986' (Plate 10).

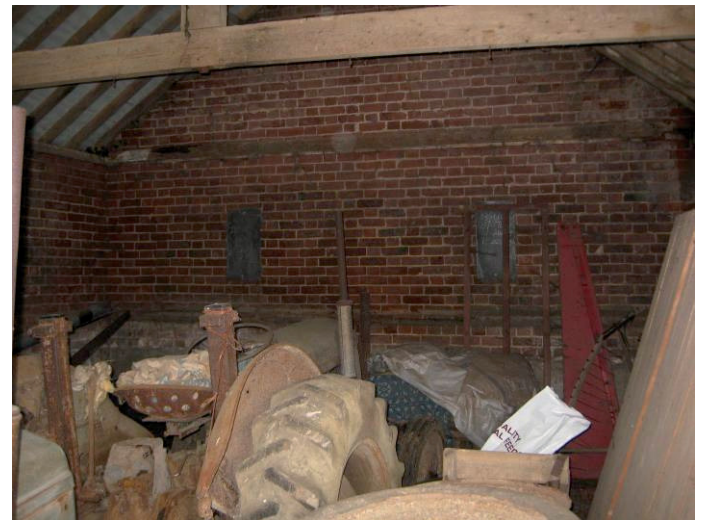
Plate 14 Northern room of western animal accommodation range, north gable end, slates attached to wall, looking north

The northern gable end was largely of Flemish bond brickwork, this wall being thicker and rendered towards the base (Plate 14). This walling was apparently continuous with the northern part of the west wall, but further to the south walling of mixed flint cobble, brick in stretcher rows and unfired clay lump was evident (Plate 13). Some 20th century brick was also evident in the upper parts of this wall internally. Externally, the gable end was raised above the glazed pantile roof, and detailing was again noted in the form of
