**HISTORIC BUILDING RECORDING ON  
FARM BUILDINGS AT  
WARREN FARM  
SANDY LANE  
SOUTH WOOTTON  
NORFOLK  
(52880)**

July 2009

A.P.S. Report No: **66/09**

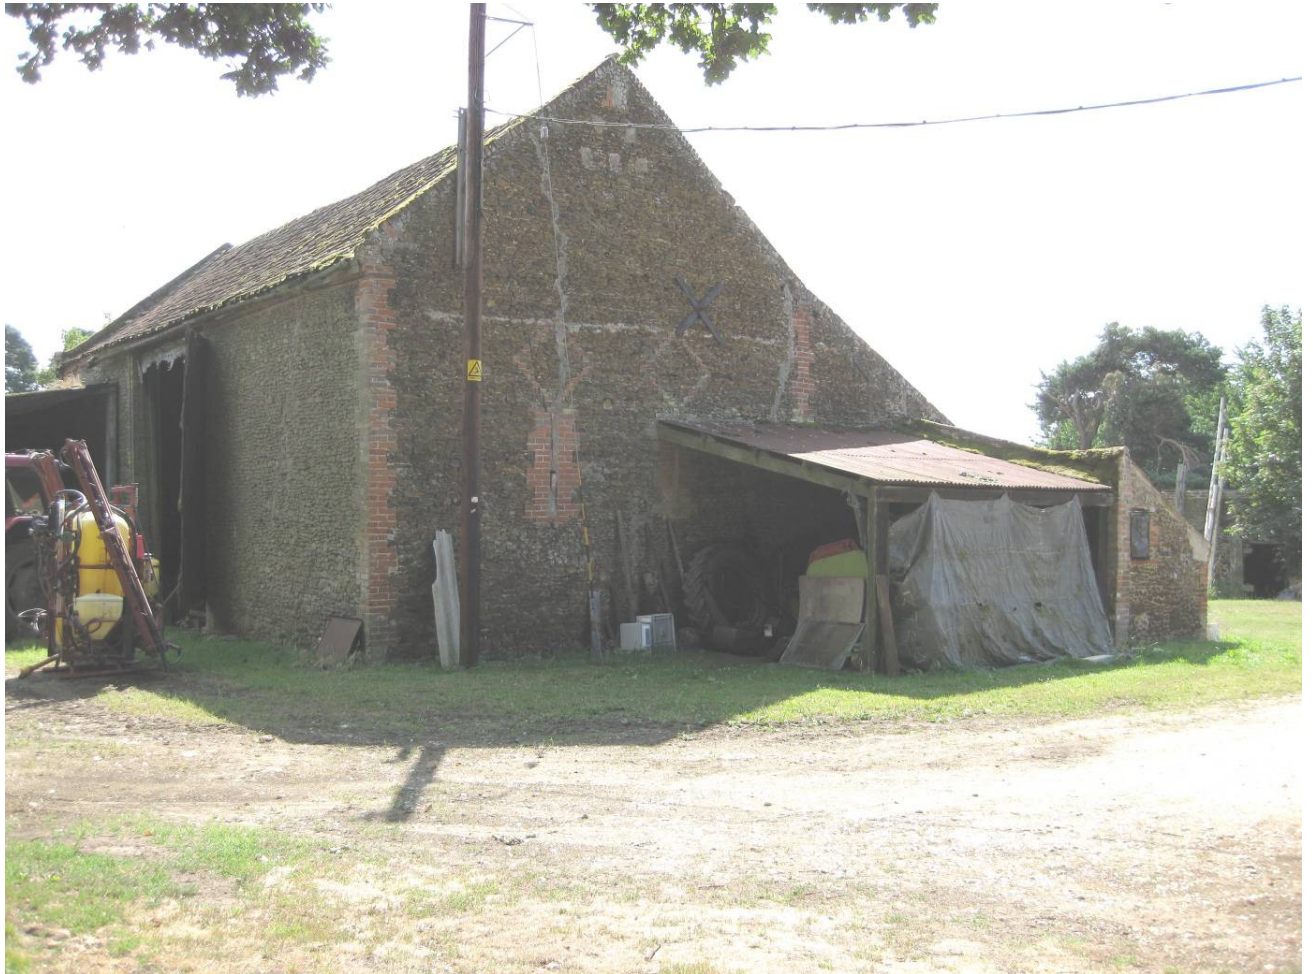
Further detailing was noted in both gable ends of the barn, with two breather slits at each end being surrounded by brick (Plates 2, 3, 12 & 13). Above each of the two breather slits in the western elevation were decorative brick diaper patterns (Plates 2 & 3), although these were not present in the east elevation.

Plate 2 West gable end of main barn, lean-to store 4 and west gable end of tack room, looking southeast.

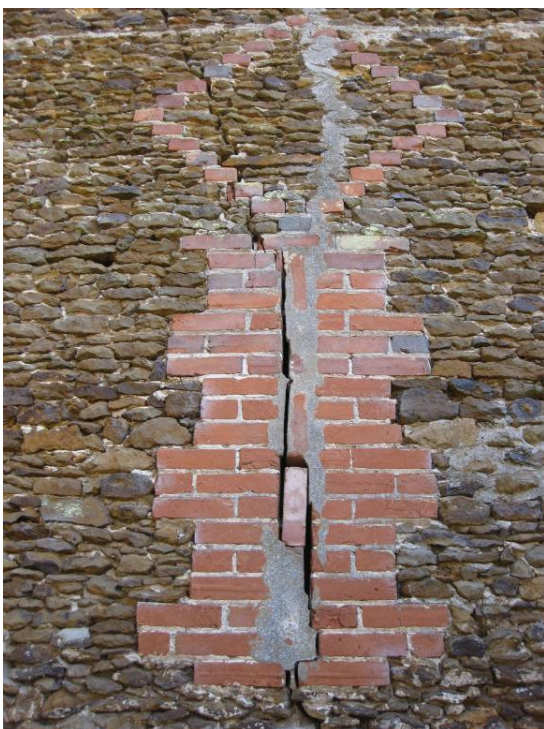
Plate 3  
Detail of west gable end of  
main barn showing  
brickwork of breather slit  
and decorative diaper above.  
Note also horizontal  
skintlings on several bricks,  
looking east.

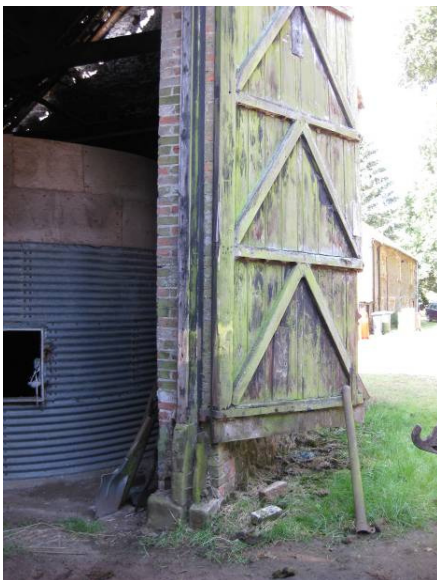
One of a pair of doors to the large northerly opening of the barn survived, the former presence of the easterly door being evidenced by extant hinges. The surviving wooden door did not extend for the full height of the building, the lower c.0.50m being absent (Plate 5). This door may be original to the barn, and the gap at the base of it may also have been part of the original design. At each side of the northern doorway slots were noted in the door jambs which would have held in place the threshold.

Plate 5 Wooden door of northern wall of main barn. Possibly an original feature, note gap at base of door, looking west.

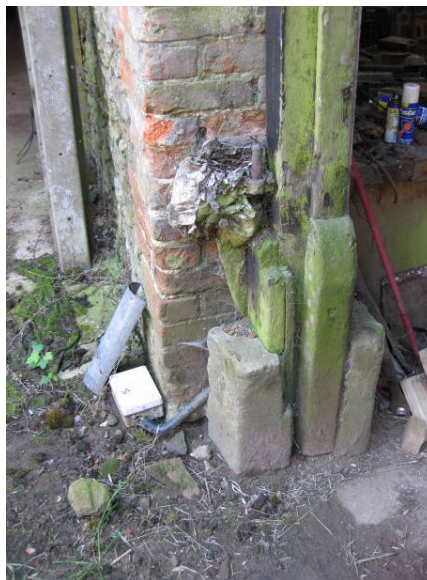
Plate 6 Detail of northern wall of main barn. Stone and wood slot at base of threshold. See also similar detailing in opposing side (Plate 5), looking east.

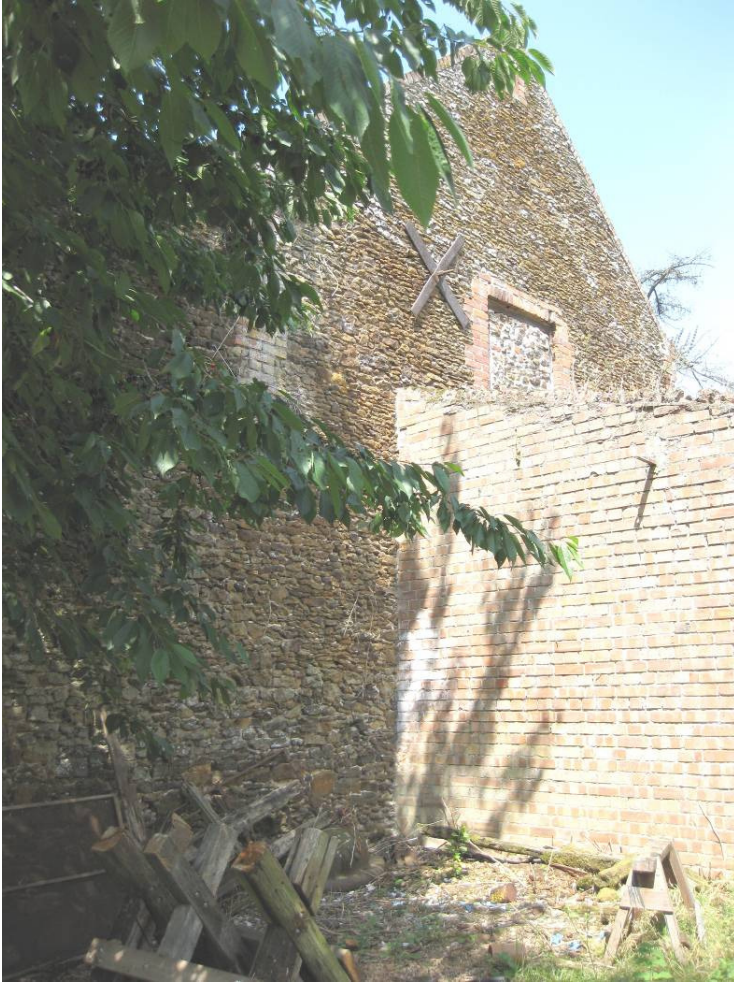
A single blocked opening noted in the eastern gable end was likely to have been a pitching hole (Plates 11 & 13). This

Plate 11 East gable end of main barn and south wall of chemical store. Note blocked pitching hole in gable end of barn, looking northwest.

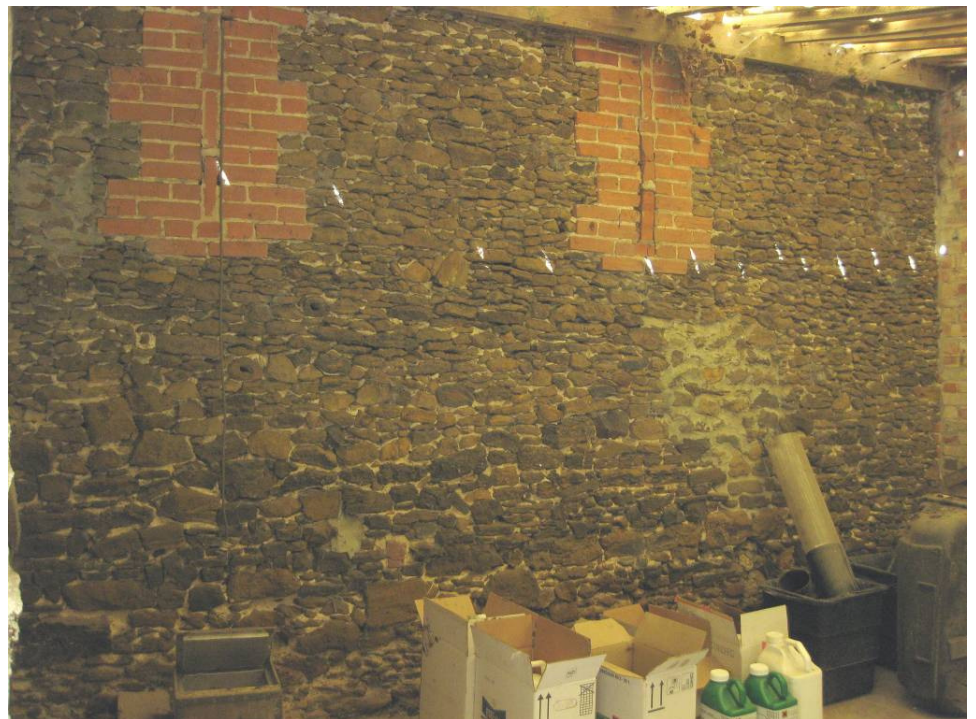
Plate 12 Lower part of east gable end of main barn as seen from interior of chemical store. Note blocked breather slits, looking northwest.

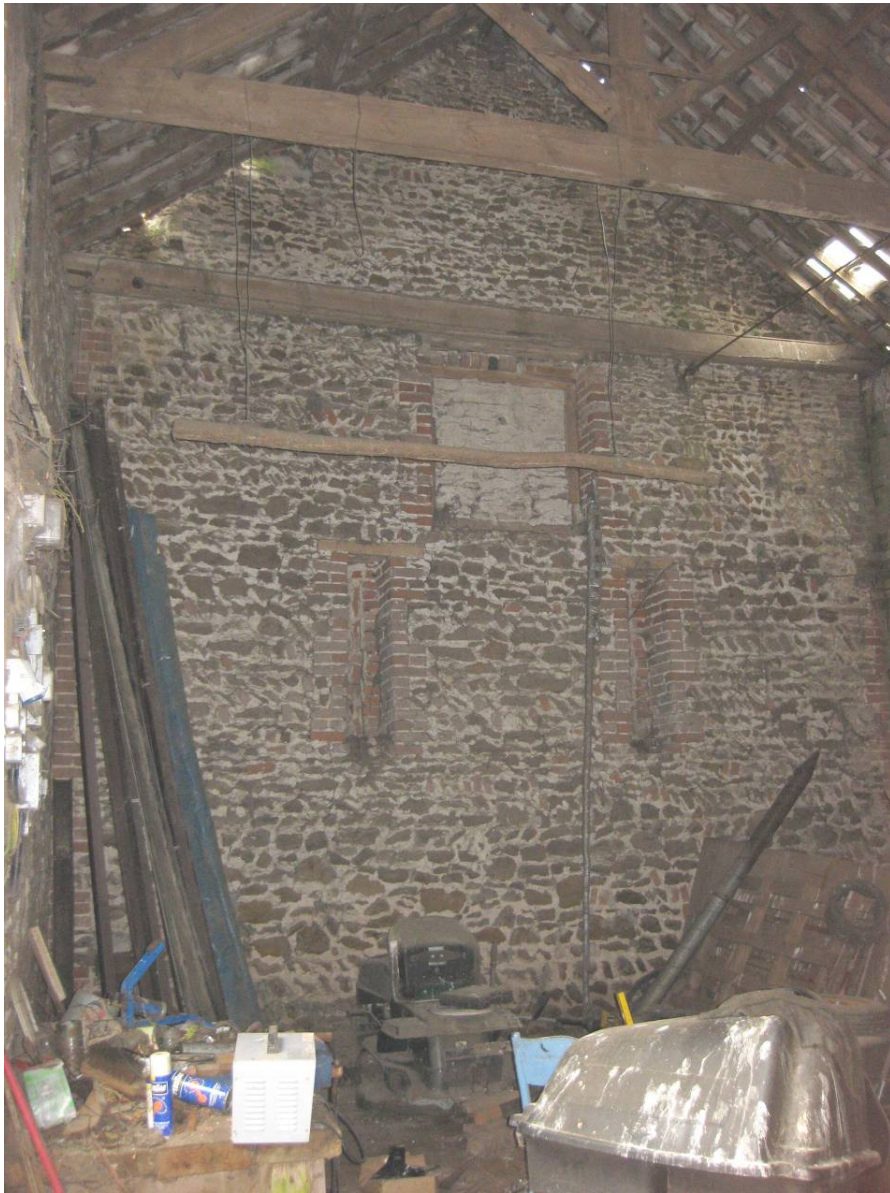
Plate 13 East gable end of main barn from interior of barn. Note blocked pitching hole and breather slits, looking east.

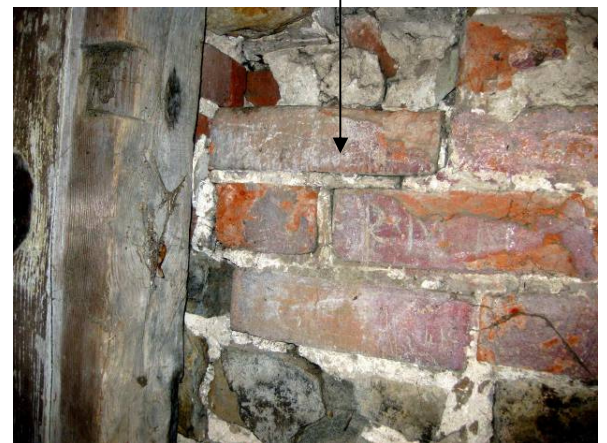
Vertical scratches were noted in one of the quoin bricks adjacent to the porch door internally (Plate 20).

Plate 20 Detail of quoin inside barn porch, at west side of wooden doors showing vertical scratches on brick, possibly relating to number of sacks loaded or similar. Also further graffiti including initials, looking southwest.

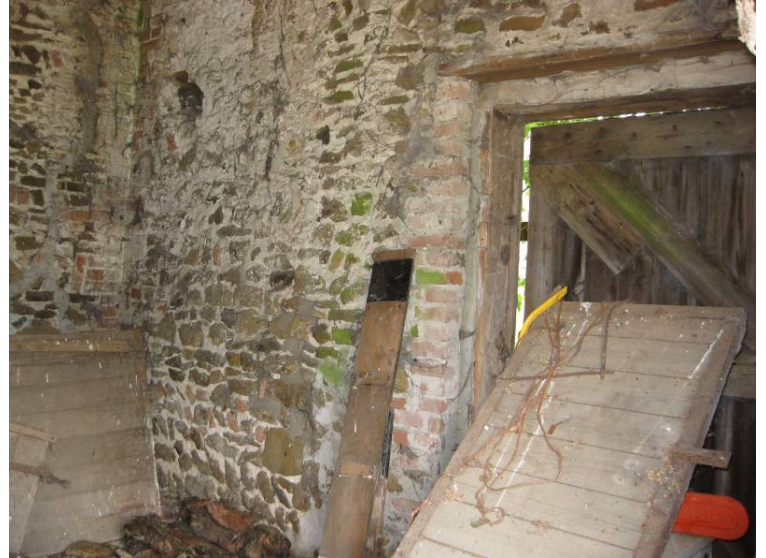
Plate 22 Interior of stable/loose box 2. Note hole in wall close to corner of room, possibly marking location of former hay rack, looking northeast

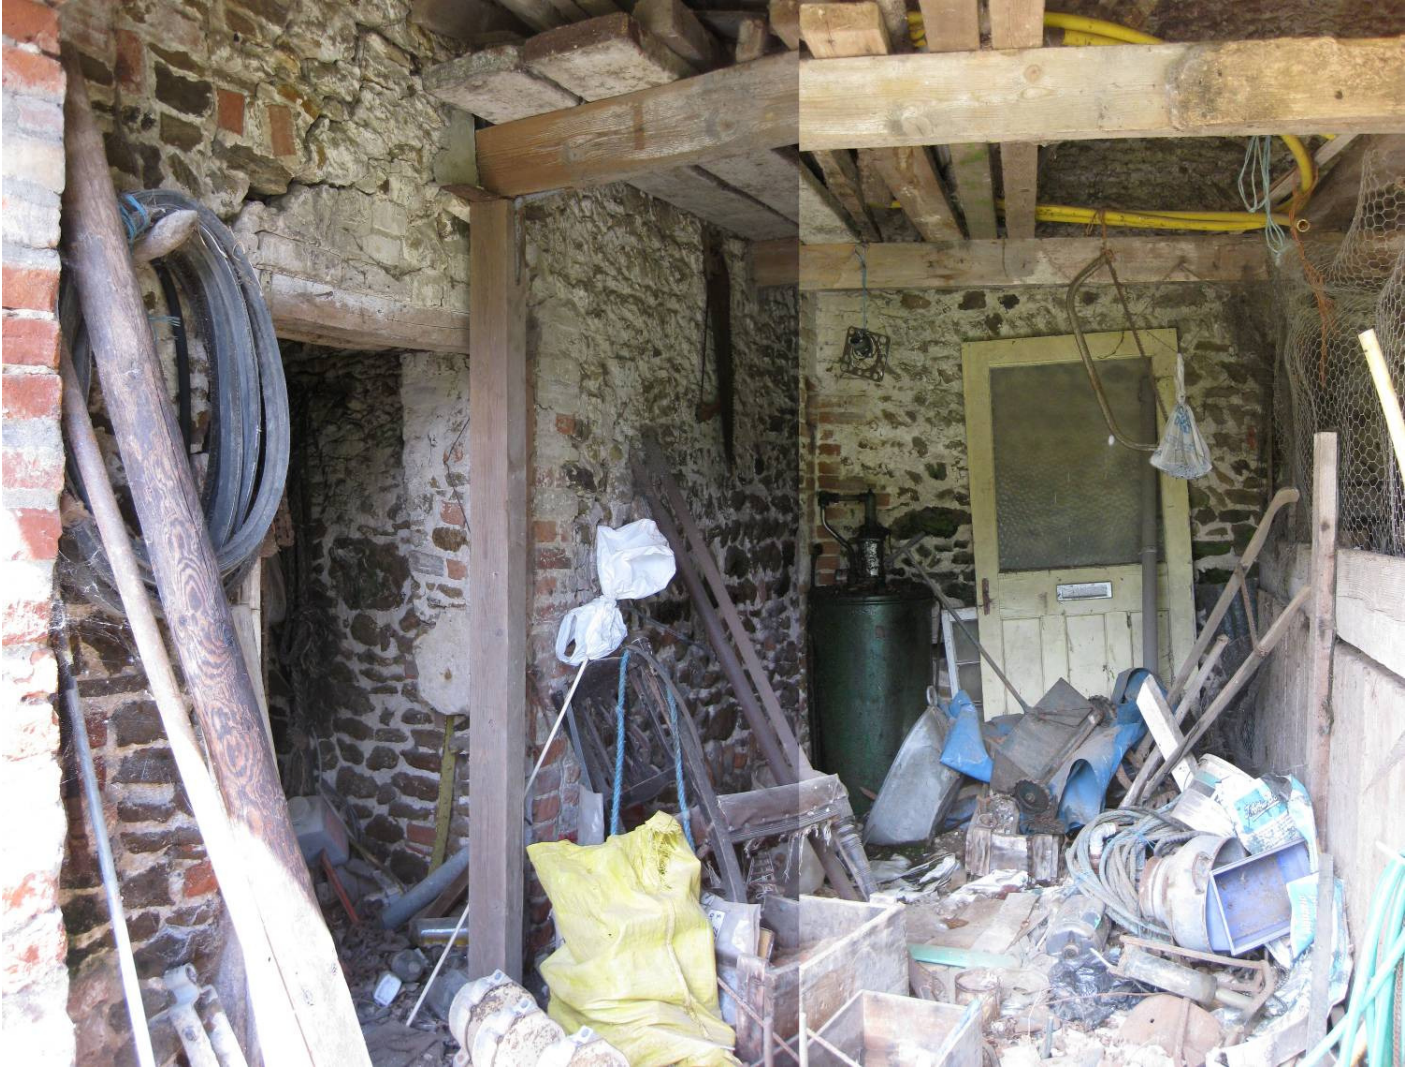
A further possible tack peg was noted to the west of the southern opening, adjacent to a doorway leading to a small tack room (Plate 25).

Plate 25 General interior view of stable 1 from entrance. Note wooden tack peg next to door, wooden partition and loft above, also note hole in wall close to corner of room, possibly marking location of former hay rack, looking northwest and north.

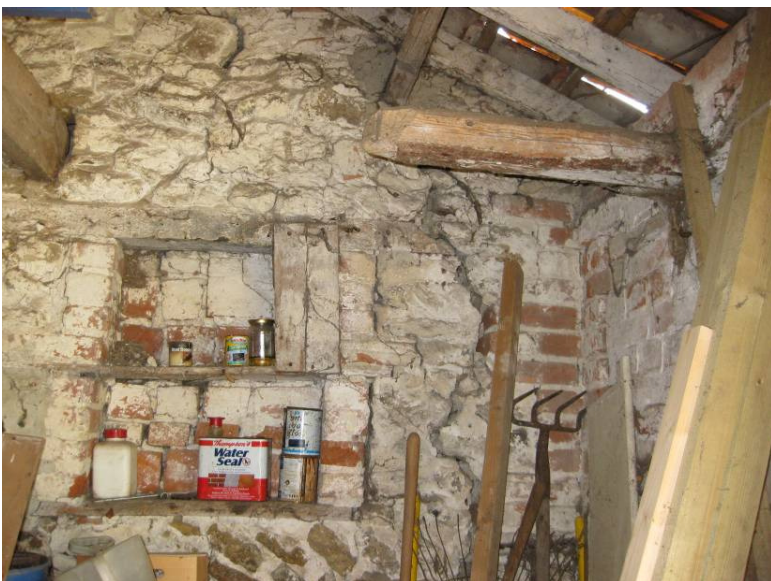
A small recess was noted in the east wall of the room, forming a small cupboard with a shelf (Plate 26). Adjacent to this, in the southern wall next to the southern door, was a wooden tack peg (Plate 26).

Plate 26 Interior of stable 1, detail of recessed cupboard in east wall and wooden tack peg at east of entrance, looking east.

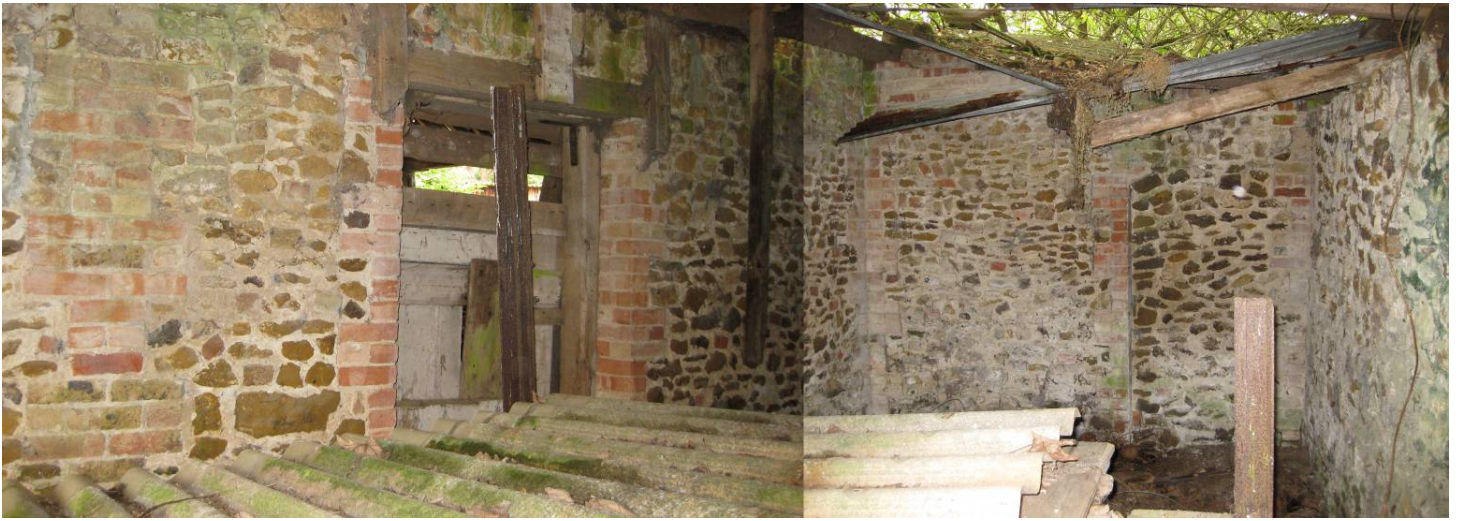
diagonal skintling marks were observed, in addition to yellowish irregular bricks. Internally, some 20<sup>th</sup> century brick was evident in each of the quoins of the western wall, around the cartshed door and at the cartshed join (Plate 35).

Plate 35 Interior of store 1 showing detail of door in south wall and quoins in west wall, looking southwest and west.

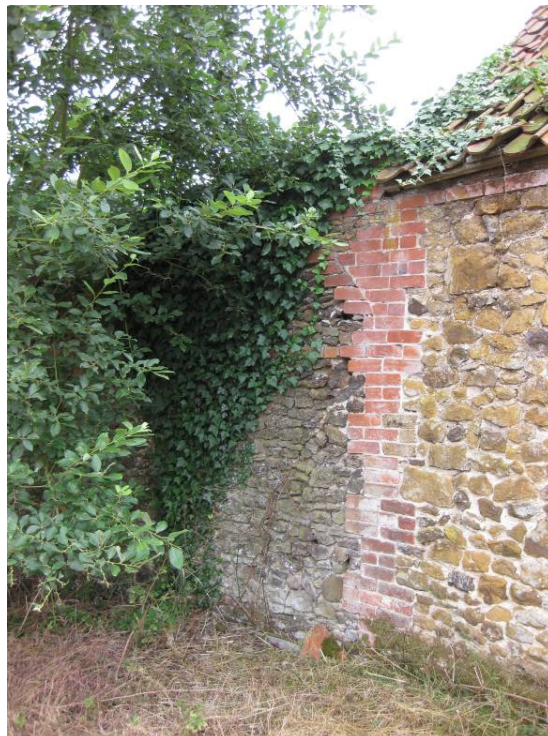
Plate 37 Detail of join between southeast corner of cart shed and store 2. Note traces of former roofline in brickwork, looking southwest.

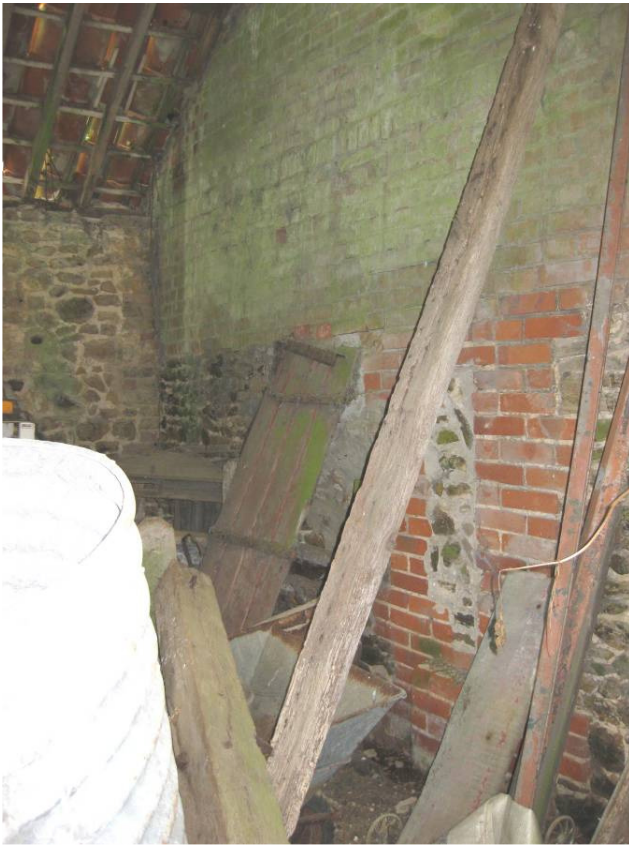
Brick quoins were recorded at each corner of the building, and near the centre of the east wall (Plates 40 & 42). The bricks used in this detailing varied, many being apparently similar to those of the main barn with horizontal skintlings being noted at the southwest corner. At the northwest corner were similar bricks, but here these had some possible diagonal skintlings (Plate 42). Occasional yellowish and irregular bricks were included in several of the quoins, whilst some 20<sup>th</sup> century bricks were noted at the northeast corner and in the southern wall. The upper half of the southern wall was entirely of 20<sup>th</sup> century brick (Plate 39).

Plate 39 Cartshed interior showing south gable end with 20<sup>th</sup> century brickwork above eaves level, looking southeast.

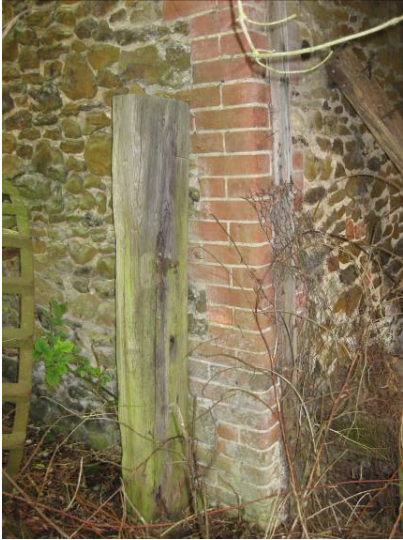
Occasional bricks with possible diagonal skintlings were noted in part of the cart shed. Such marks indicate dating before c.1780 (James and Rose, ND), but given the mixed brick types and numerous repairs to this building, do not provide evidence of an early date, and are likely to be reused.

Plate 42 Detail of quoins at northwestern corner of cartshed at join with store 1. Some possible diagonal skintling marks in these bricks although these do not show in this photograph, looking northeast.
