**HISTORIC BUILDING RECORDING AT
MANOR FARM
SHOULDHAM THORPE
NORFOLK
(29980)**

August 2009

A.P.S. Report No: **84/09**

**ARCHAEOLOGICAL
PROJECT
SERVICES**

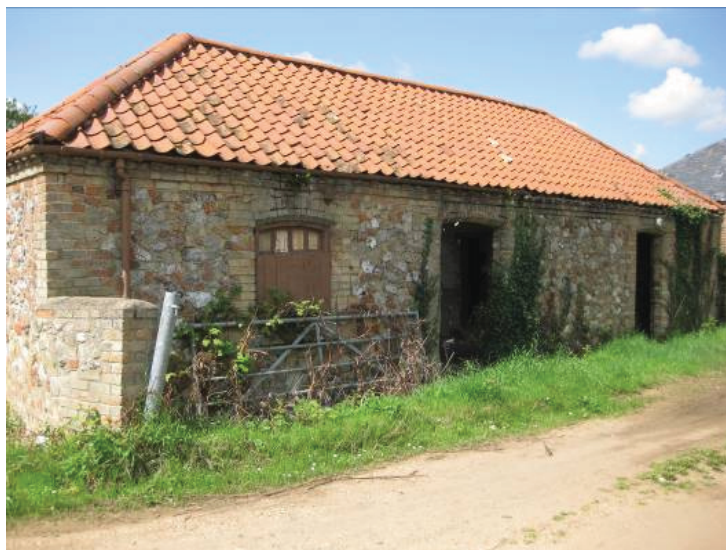
This room was accessed via two opposing doors at the east and west sides (Plate 3). A shuttered window, including the original shutter, was present in the southern wall, and a half-glazed window was recorded in the eastern wall (Plate 4). Internally the floor was of modern concrete and the room was divided by a breeze block wall, forming an animal pen. A 20th century doorway had been inserted at the northern end of the room, leading into Room B. The western doorway of Room A led out to Yard 1, and evidence of 20th century widening was noted at its northern edge. The western wall of the room featured the 19th century detailing at its top, but was largely of 20th century brick, indicating it had been rebuilt.

Plate 3 - Exterior of Room A, showing half-glazed window, with walling and detail typical of the surveyed range, looking north

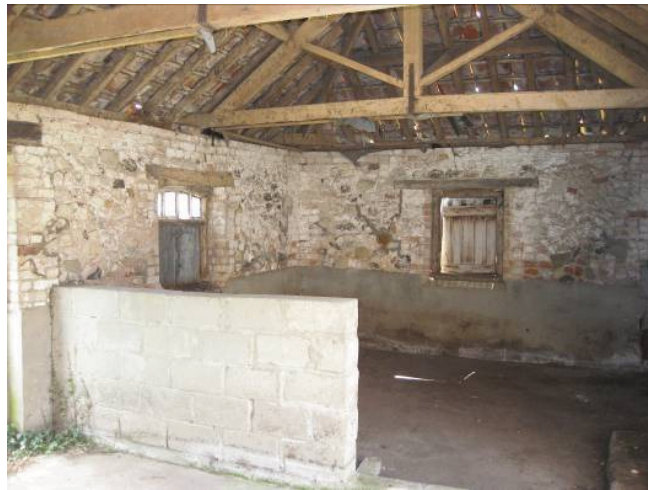
Plate 4 - Interior of Room A, showing original half-glazed window and shuttered window and modern breeze block pens, looking south

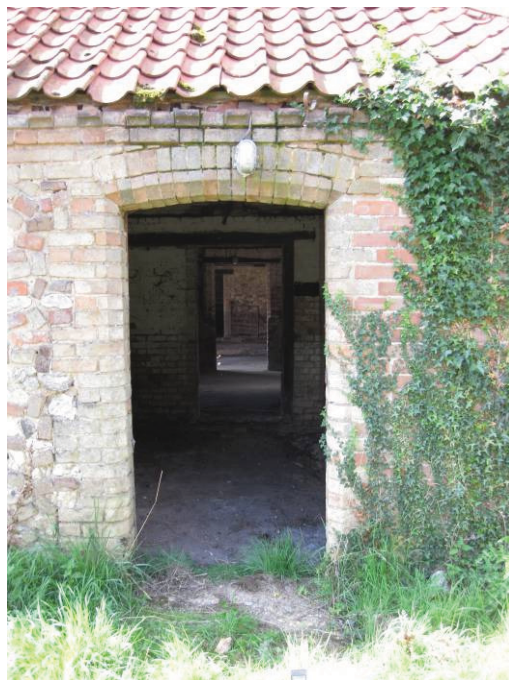
A doorway led into this room from its eastern side (Plate 5), and further doors at either end of Room C formed a continuous corridor with this (Figure 4). The remains of a half-glazed window survived at the northern end of this room, in addition to the only probable original brick flooring noted in the range during the survey (Plate 7). A protruding portion of the wall in this room may be part of a chimney (Plate 61). However, this could be related to a modern repair evident externally in this area, and there was no indication as to whether the protruding section of walling may have originally extended up through the pantile roof, leaving the interpretation of this feature uncertain.

Plate 5 - Eastern doorway to Room B, showing corridor through to Rooms C and D, looking west

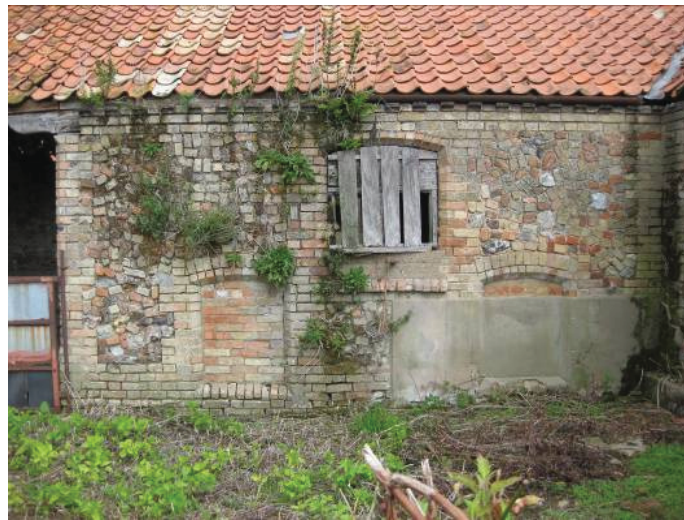
Plate 8 - Exterior of Room C from Yard 1, showing blocked low openings and half-glazed window, looking north

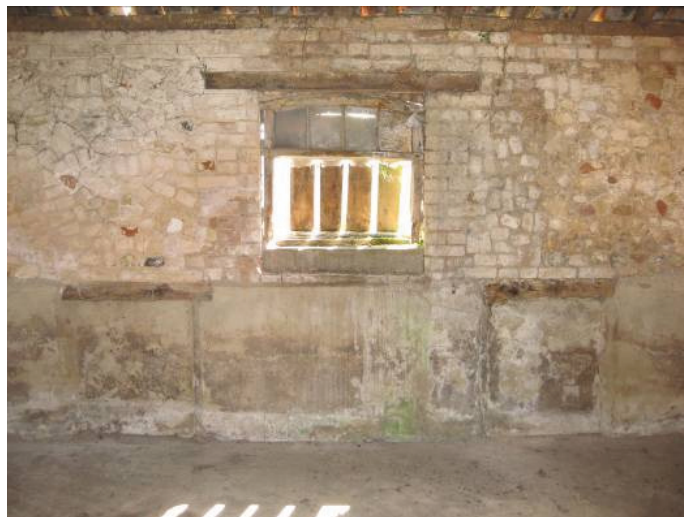
Plate 9 - Interior of Room C (reverse of wall shown in Plate 8), showing blocked low openings, looking south

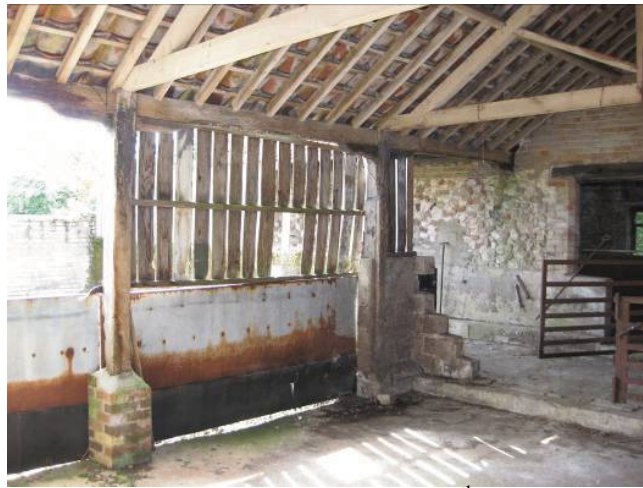
Plate 10 - Interior of open-sided shelter D showing 19th century wooden stanchions and pillows with modern infilling, looking west

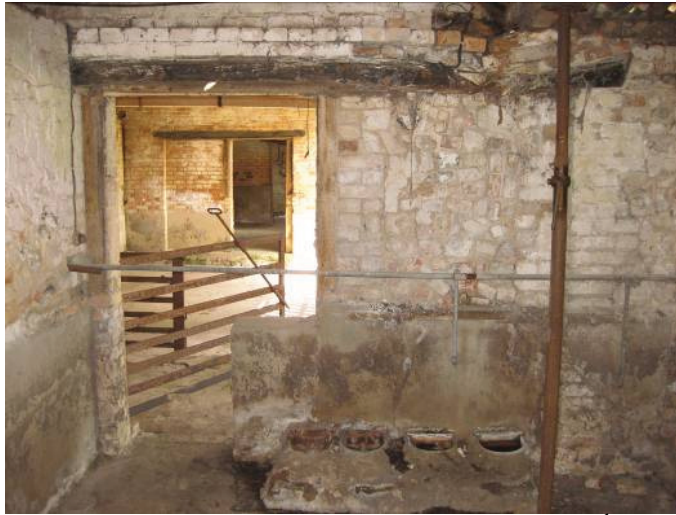
Plate 13 - Detail of doorway in Room E, showing probable 19th century doorway for sliding door with modern alterations to create smaller opening for pigs or similarly-sized animals, view through doorway into open-sided shelter D, looking east

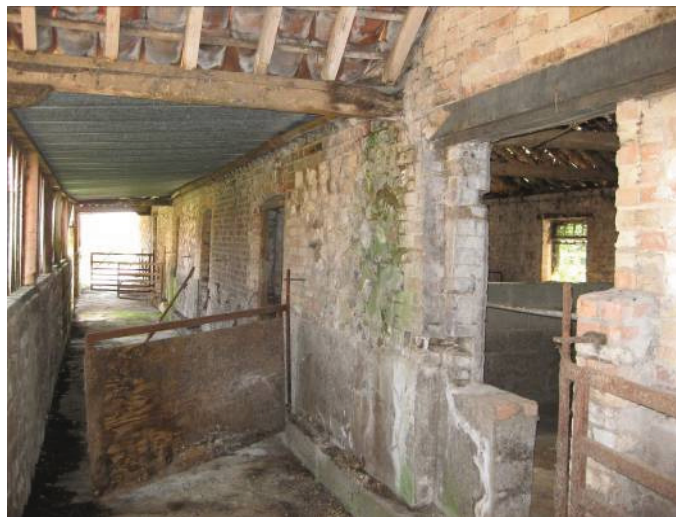
Plate 14 - Modern open-sided covered corridors H and F, showing 19th century sliding doors of Rooms G and E altered to create smaller openings, and modern animal gates, looking south

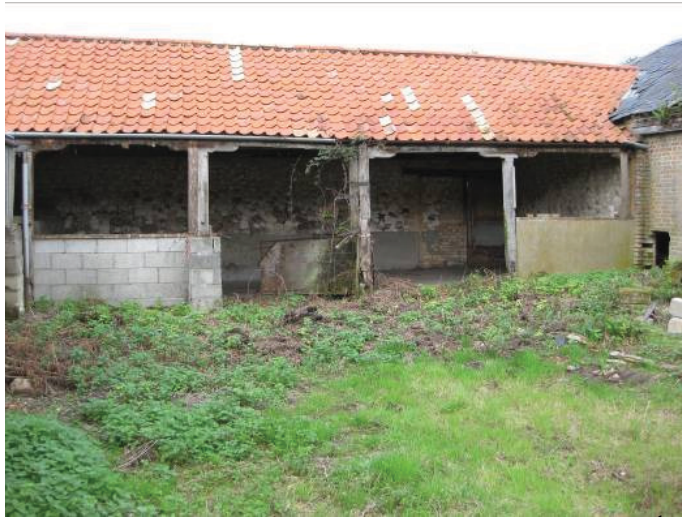
Plate 16 - Open-sided shelter I viewed from Yard 2, showing 19th century timber stanchions and pillows infilled with modern breeze block, looking west

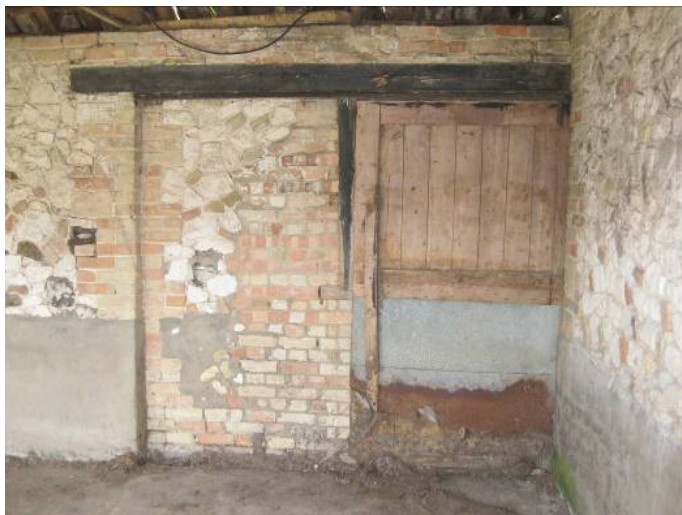
Plate 18 - Detail of 19th century sliding door in north wall of open-sided shelter I with some modern repairs to brickwork, looking north

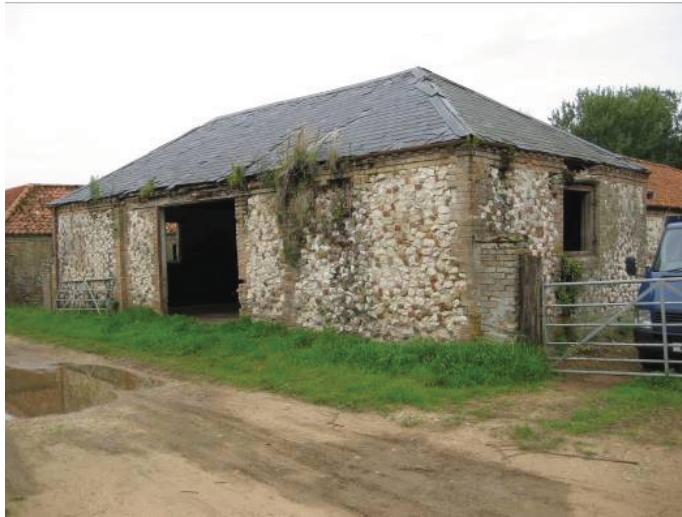
The southern wall of Room J had clearly been substantially renewed in the 20th century, and the entire roof had been replaced with slate (Plates 19 & 20).

Plate 19 - Frontage of Room J, showing large double doorway, the roof of this building having been replaced by slate, looking southwest

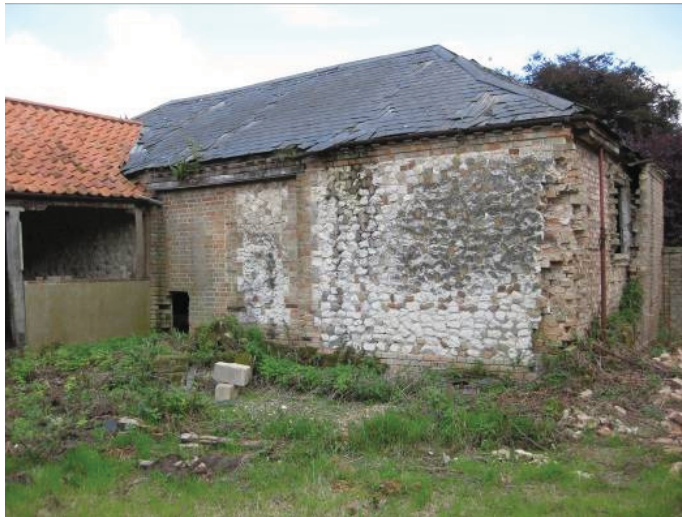
Plate 20 - Rear of Room J, showing collapse and 20th century repairs to southern elevation, 19th century doorway for sliding door with modern infill and insertion of smaller opening for pigs or similarly-sized animals, looking east

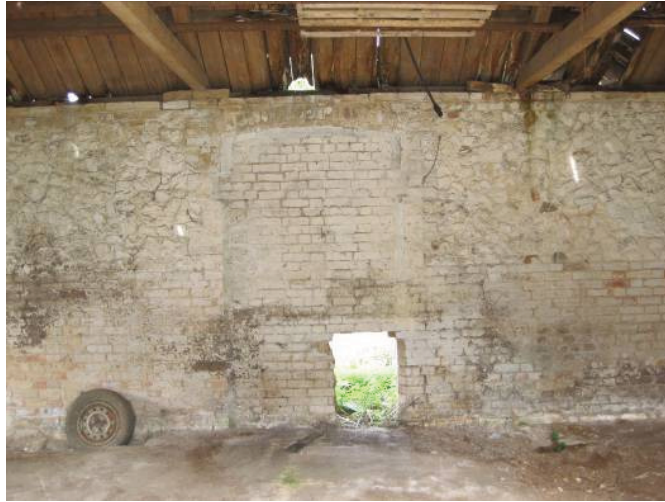
Plate 22 - Blocked doorway and inserted small opening in western wall of Room J, looking west

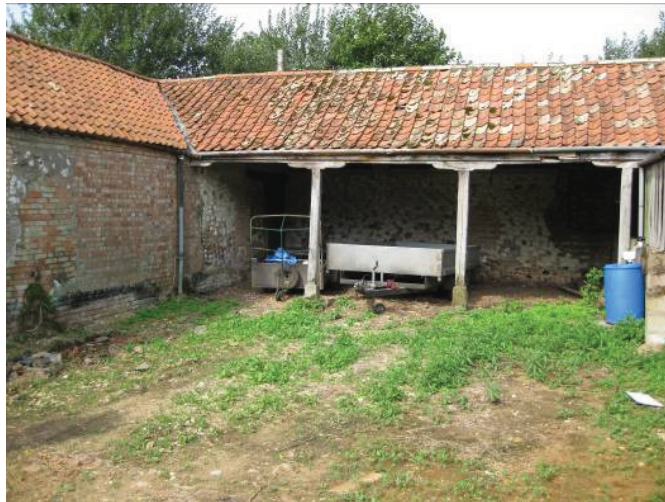
Plate 23 - Open sided shelter K and 20th century walling at western end of building I, viewed from Yard 3, looking west

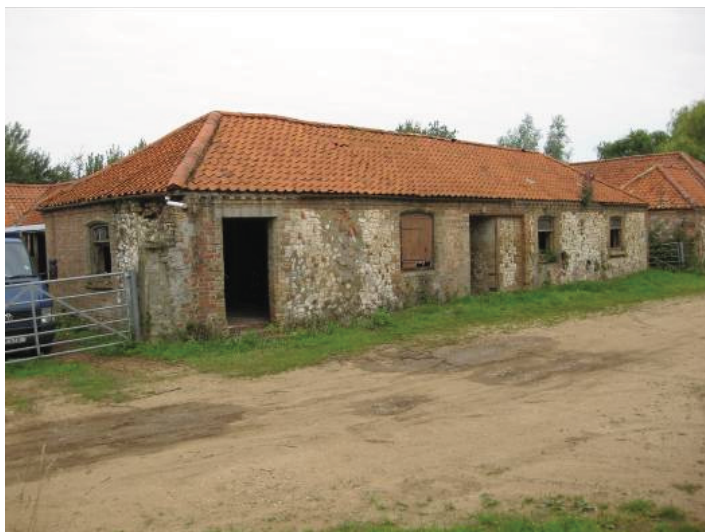
Two half-glazed windows were located in the eastern wall of this room (Plates 27 & 30). Numerous small 20th century repairs to the eastern wall were evident in addition to the rebuilding of the northern wall and northwestern corner of the room. A window opening was noted in the rebuilt northern wall, and repeated the style of the 19th century windows.

Plate 27 - Frontage of rooms N, O and P, showing 19th century shuttered window, half-glazed windows and doorways for sliding doors, looking north

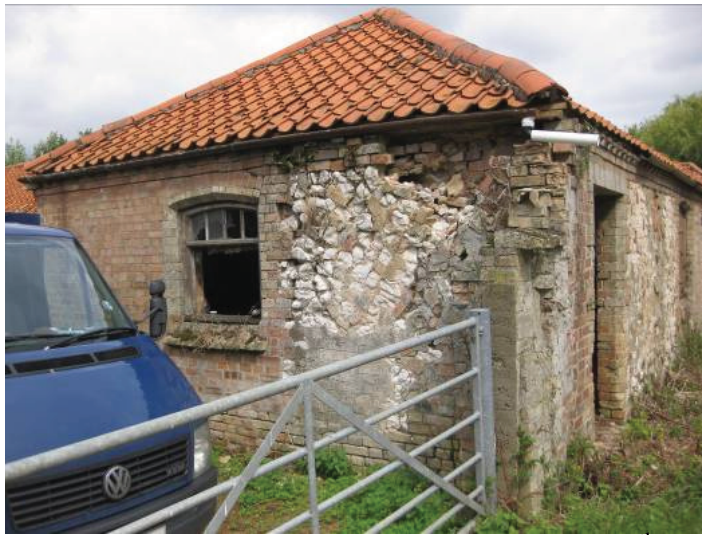
Plate 28 - Southern elevation of Room N, showing substantial 20th century repairs and half-glazed window, looking north

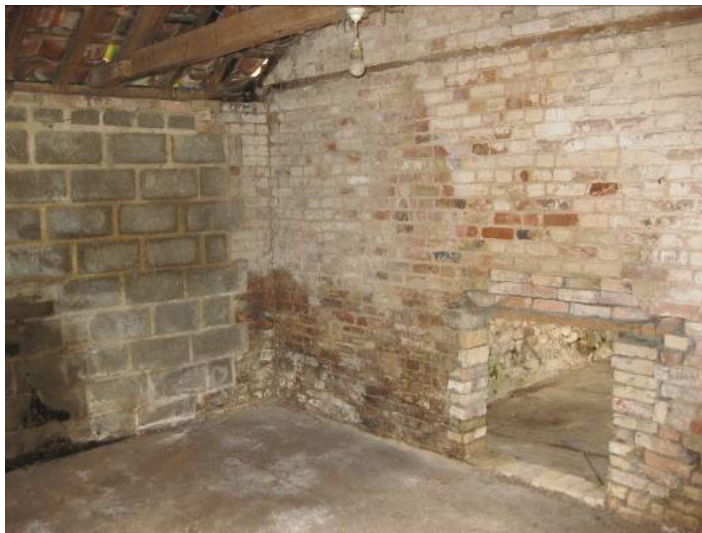
Plate 29 - Interior of Room N showing 19th century walling at right with probable modern low opening, and modern breeze block western wall, looking north

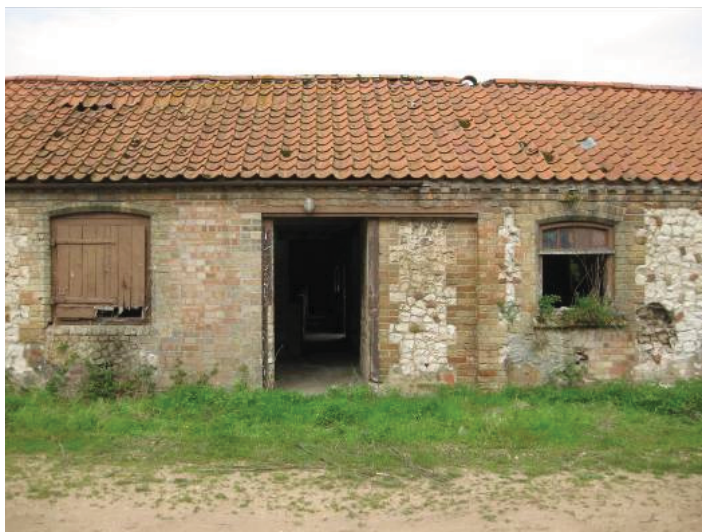
Plate 30 - Frontage of Rooms O and P, showing shuttered window and sliding door to Room O and half-glazed window to Room P, looking west

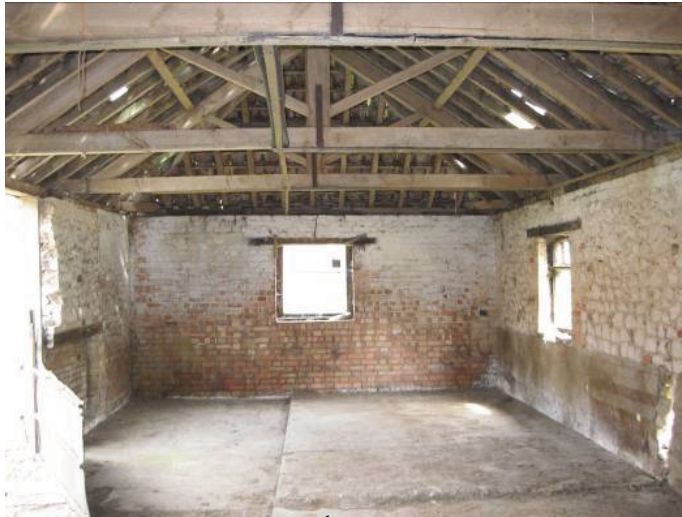
Plate 31 - Interior of Room P, showing 19th century half glazed window at right, modern rebuilding of northern wall at centre and blocked low openings at left, looking north

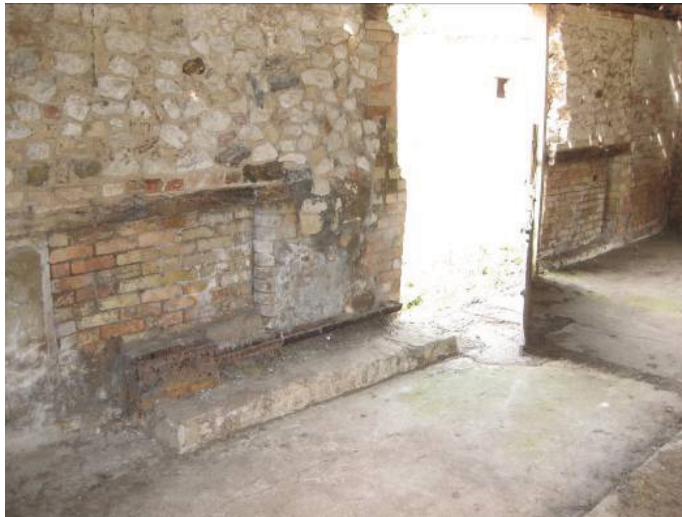
A central doorway in the western wall had been widened or damaged at its northern edge, but retained its original southern edge (Plates 32 & 35).

Plate 32 - Detail of western wall of Room P, showing recently widened central doorway and infilled low openings, probably 19th century openings for pigs or similarly-sized animals, looking north

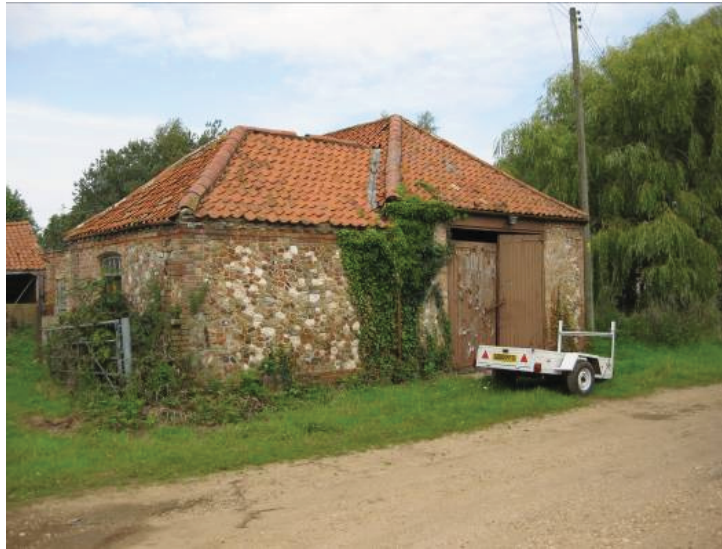
This room (Plates 34 & 47) had been much repaired at its west and south in the 20th century, and a window-like opening inserted into its northern wall, into Room S.

Plate 34 - Frontage of Rooms R and S showing large modern doors to Room S, looking north

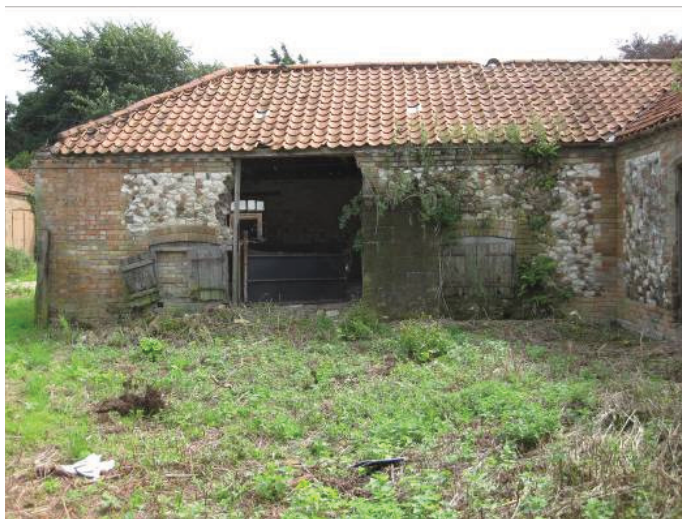
Plate 35 - Room P as viewed from Yard 4, showing 20th century repair to walling at left and opening widened in 20th century. Blocked low openings of 19th century date with probable original shutters flank doorway, looking east

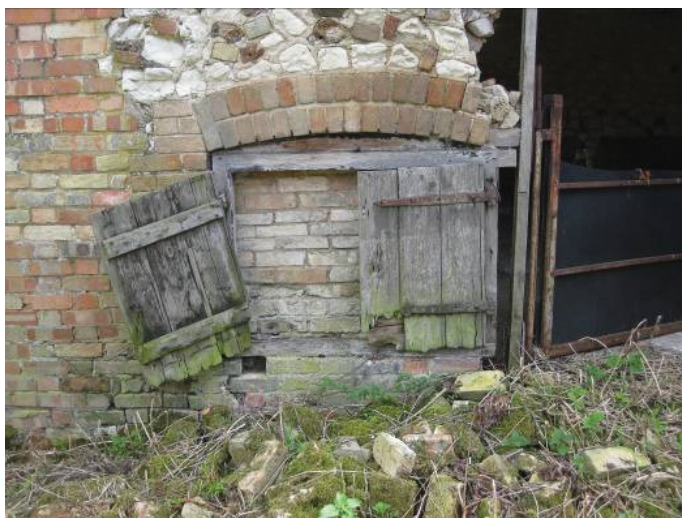
Plate 36 - Detail of blocked opening to Room P, showing probable 19th century brickwork surround and shuttering, looking east

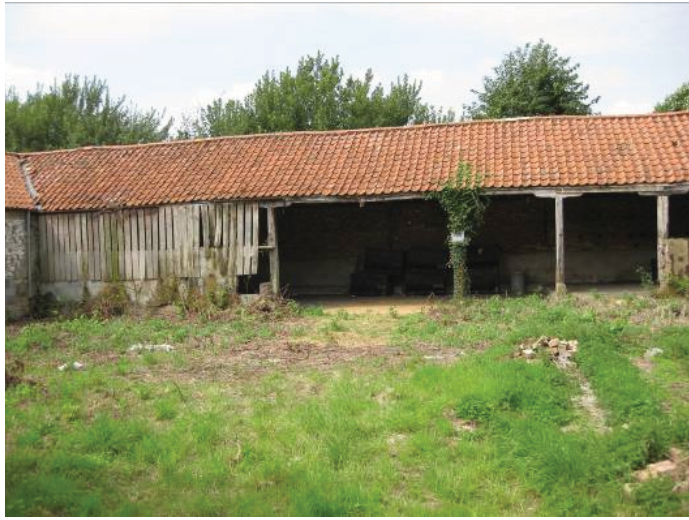
Plate 37 - Open-fronted shelter T at west of Yard 4, showing original 19th century timber stanchions and pillars with modern infilling, looking west

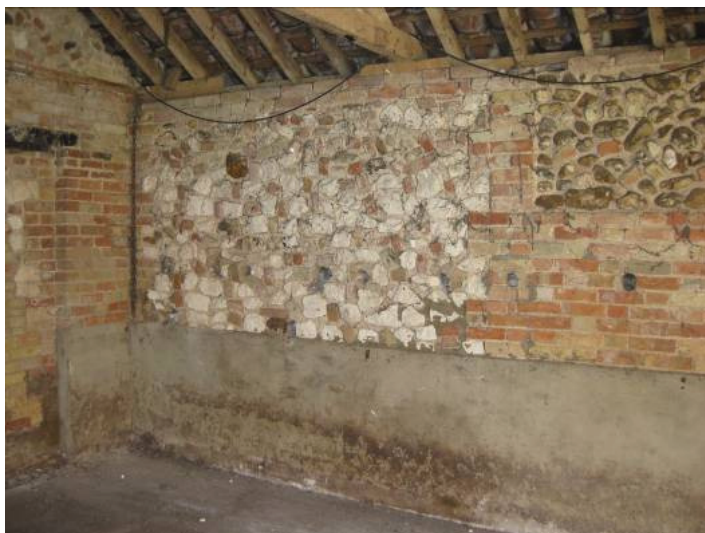
Several holes were noted in the north and south ends of the western wall of the room (Plates 39 & 40). These may reflect the former presence of hay racks.

Plate 39 - Interior of open-fronted shelter T, showing series of holes in western wall possibly relating to former hay rack, looking southwest

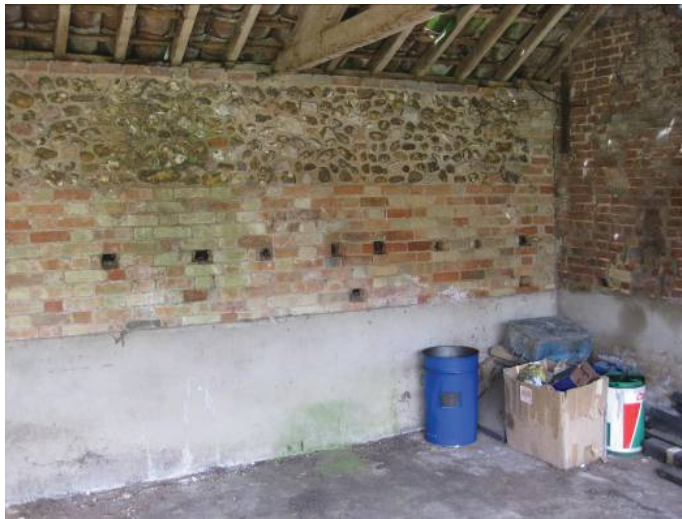
Plate 40 - Interior of open-fronted shelter T, showing series of holes in western wall possibly relating to former hay rack, looking north

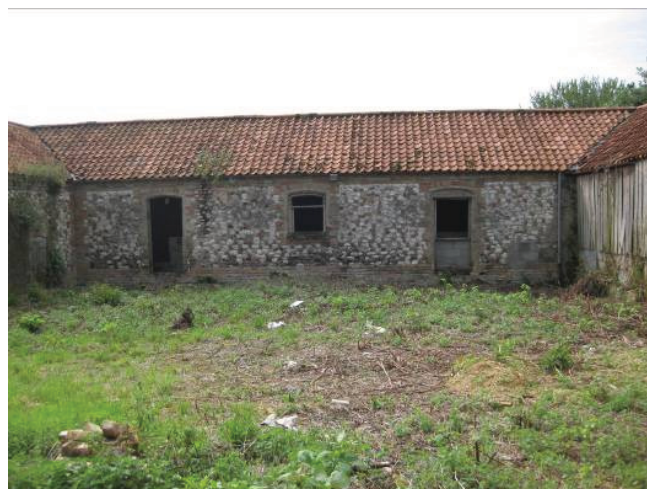
Plate 42 - Northern wall of Room L, viewed from Yard 4, showing 19th century walling, window opening and doorways, one recently partially blocked, looking south

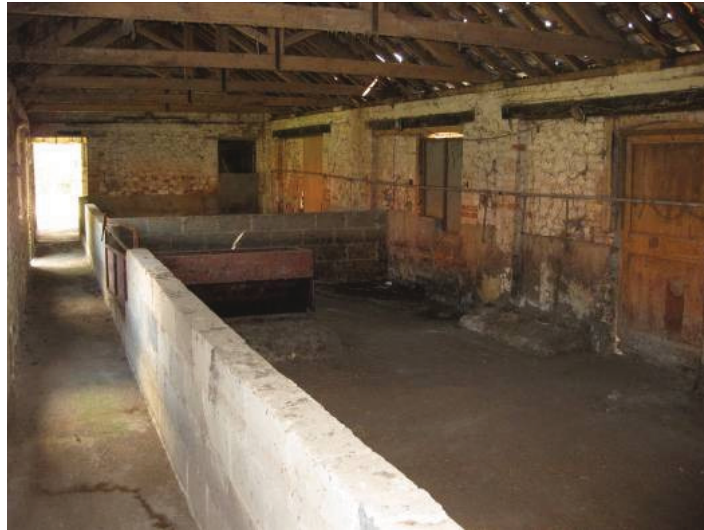
The southern wall of this room had four doorways for sliding doors original to the building. These had been partially repaired and altered in the 20th century, and animal pens of concrete and breeze block filled the room (Plate 44).

Plate 44 - Interior of Room L showing original doorways for sliding doors of southern wall, original corridor through to Room O and modern animal pens, looking southeast

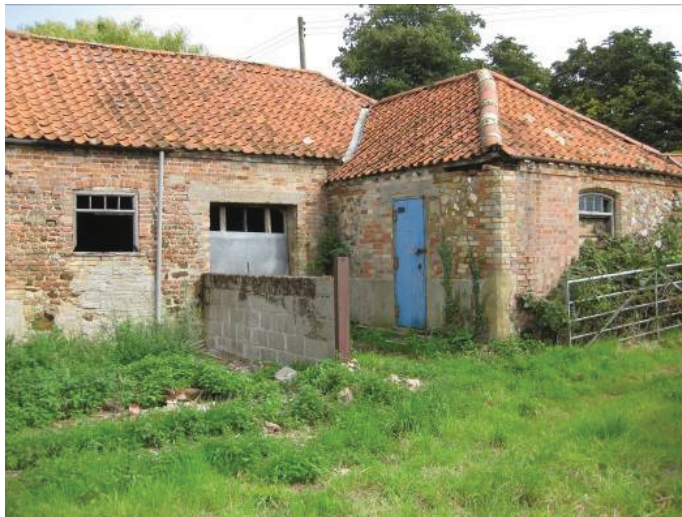
Plate 47 - Rooms S and R viewed from Yard 4, showing modern repairs to Room R, looking east

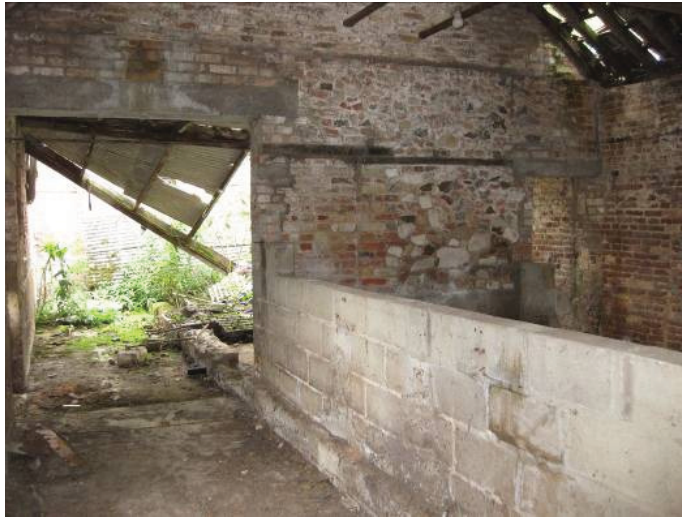
Two dividing walls within Room S were of mixed cobble and early brick (Plates 49 & 52), some of the brick having clear diagonal skintlings. Recesses were noted in each of these walls, with a timber lintel over in each case, and it seems likely that these represent doorways of sliding type, contemporary with the main phase of the building, which were later infilled. This suggests a corridor close to the southern edge of the room. Openings of 20th century date were present at the north and south ends of each of the dividing walls, and relate to its recent use as animal accommodation. The area between these openings included breeze block walling of animal pens (Plate 49).

Plate 49 - Interior of Room S, showing modern breeze block animal pens, late 18th century or earlier dividing wall with probable 19th century doorway, subsequently blocked, and modern openings, looking northwest

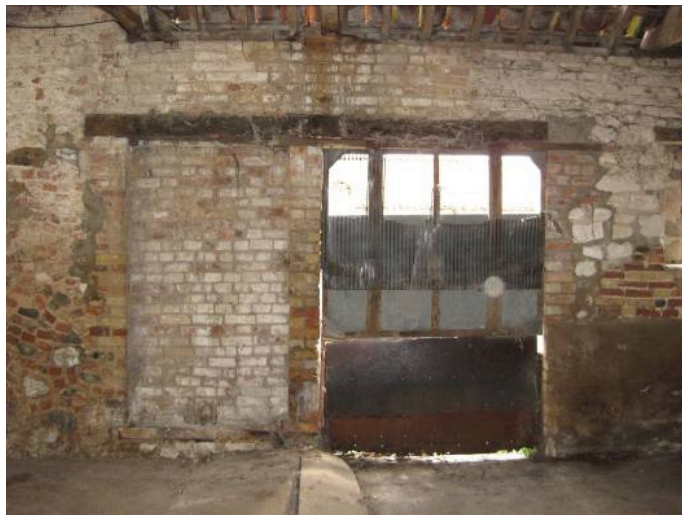
At the eastern end of the southern wall of the room was a door with modern repairs, but which shared similarities with sliding doors identified elsewhere, and may have originally been one such (Plates 50 & 46). This wall includes many 19th century and modern alterations and repairs (Plates 46 & 51). These include two straight joins visible externally, the southernmost of which seems to align with the easterly internal dividing wall (Figure 4). This does not however appear to align with the straight join evident in the northern wall. A further straight join in the southern wall seems to indicate a blocked doorway, close to the westerly internal wall (Plate 51). Three windows in this wall were of uncertain age due to the use of various material and numerous repairs, although they might possibly be of 19th century date (Plate 46). This range probably initially served as animal accommodation, and this function was maintained in later phases of construction and use, with a half-glazed ventilator window inserted in the west wall.

Plate 50 - Doorway in southern wall of Room S with partially modern surround, but possibly being a 19th century doorway for a sliding door, looking south

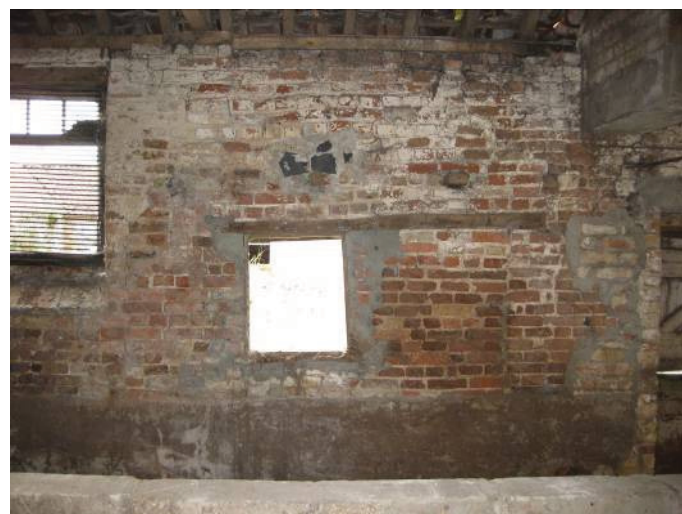
Plate 51 - Detail of southern wall of Room S showing openings including possible 19th century window at left, probable late 18th century or earlier brickwork, and blocked opening, looking south

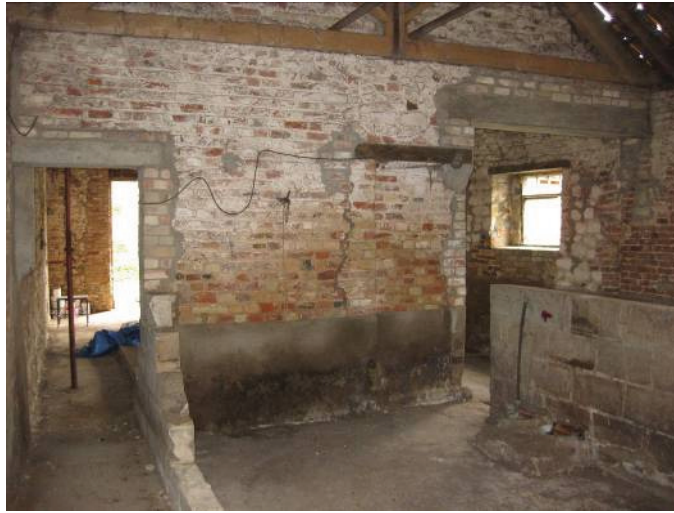
Plate 52 - Interior of Room S, showing modern breeze block animal pens, late 18th century or earlier dividing wall with probable 19th century doorway, subsequently blocked, and modern openings, looking northwest

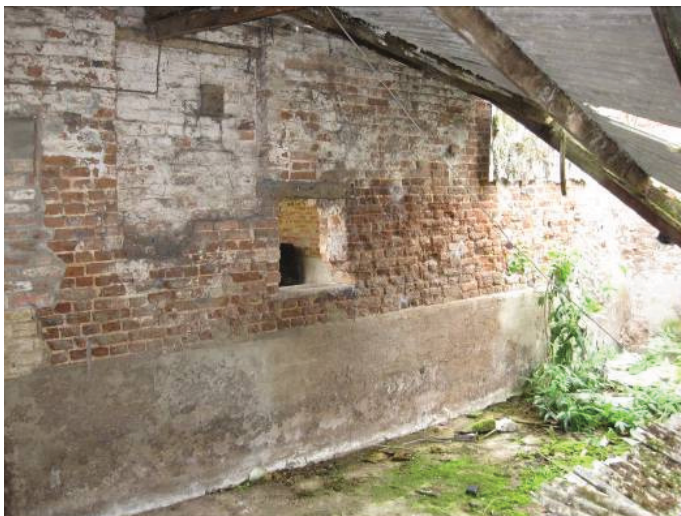
Plate 54 - Detail of southern wall of Room S showing late 18th century or earlier walling, blocked opening and possibly inserted opening, looking northwest

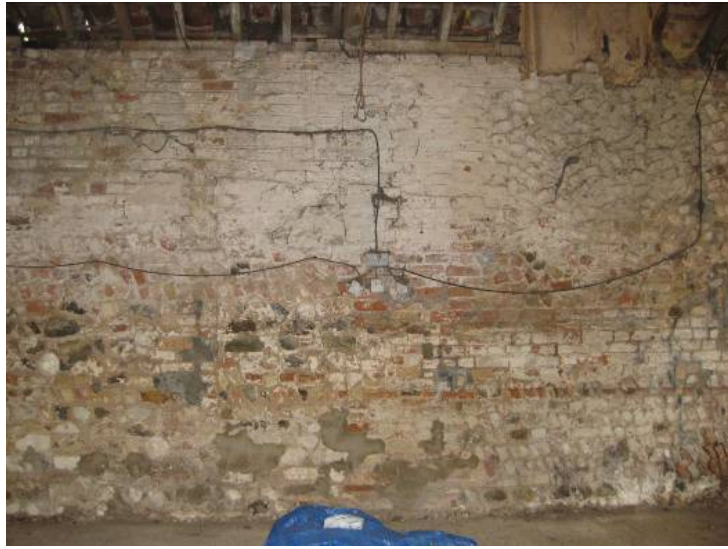
Externally, the northern wall comprised various phases of brickwork, largely of early type but with several 20th century repairs. A clear join was evident approximately half way along the northern wall, with a distinct change in brick coursing (Plate 57). This indicates some phasing within the early building, although the sequence is unknown. Internally the northern wall of the room comprised a mix of cobble, early and later brickwork, and was somewhat confused (Plate 55).

Plate 55 - Detail of northern wall of Room S showing variation and patching of 18th, 19th and 20th century date, looking north

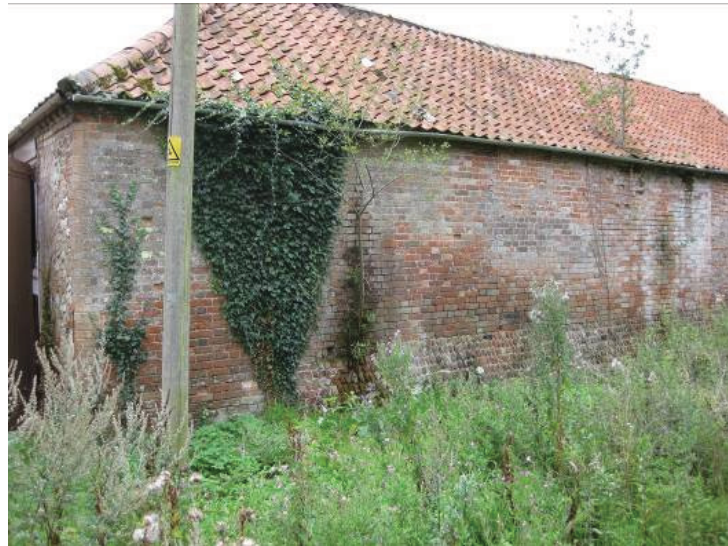
Plate 56 - Northern wall of Room S, showing 20th century repair at left and late 18th century or earlier walling at right, looking southwest

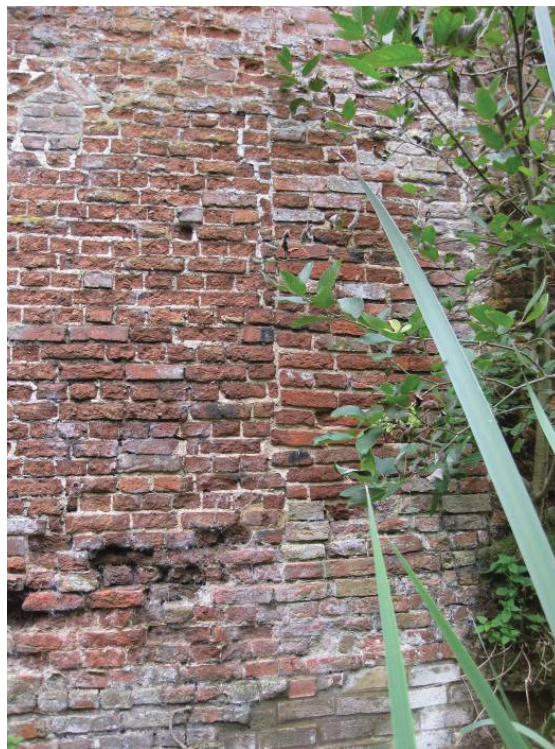
Plate 58 - Detail of northern wall of Room S showing right edge of infilled opening and smaller blocked opening within this infill, all of late 18th century or earlier brick, looking south

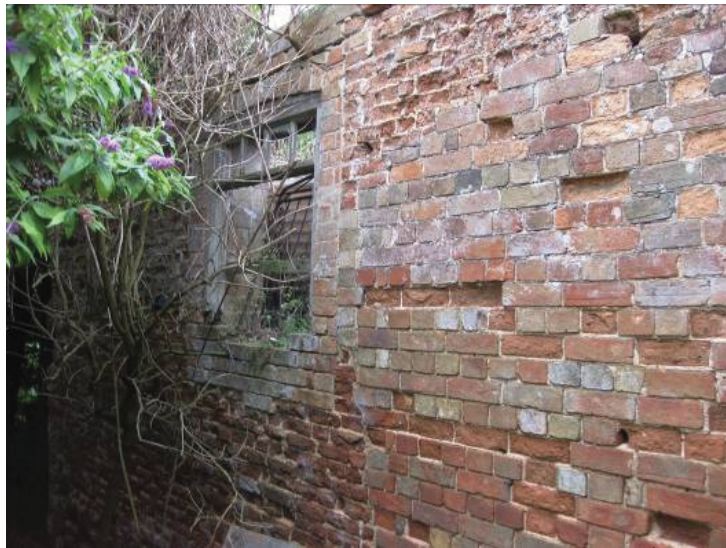
Plate 59 - Exterior of western wall of Room S showing late 18th century or earlier brickwork with 19th century half-glazed window, and 19th century brickwork blocking an earlier doorway, looking east
