**HISTORIC BUILDING RECORDING AT
THE OLD RECTORY
RECTORY ROAD
OUTWELL
NORFOLK
(46871)**

Work Undertaken For
Brand Associates
On behalf of
Dr G Cowley, EDC Holdings Ltd

September 2009

A.P.S. Report No: **104/09**

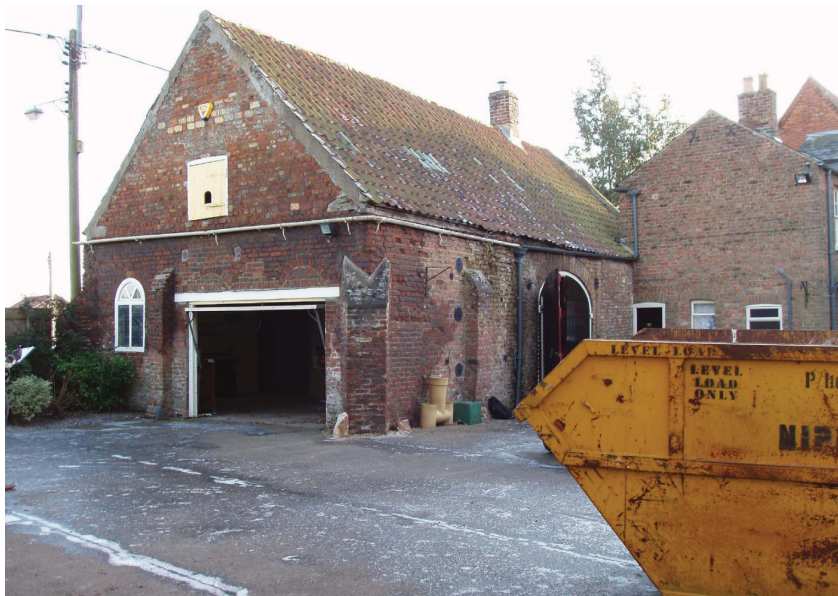
The northern gable end has corner buttresses that are bonded with, and clasp, the angles of the walls. Towards the centre of the wall is another buttress that is butted against the elevation (Plates 2 and 3).

Plate 2 North and west elevations of recorded building, looking south

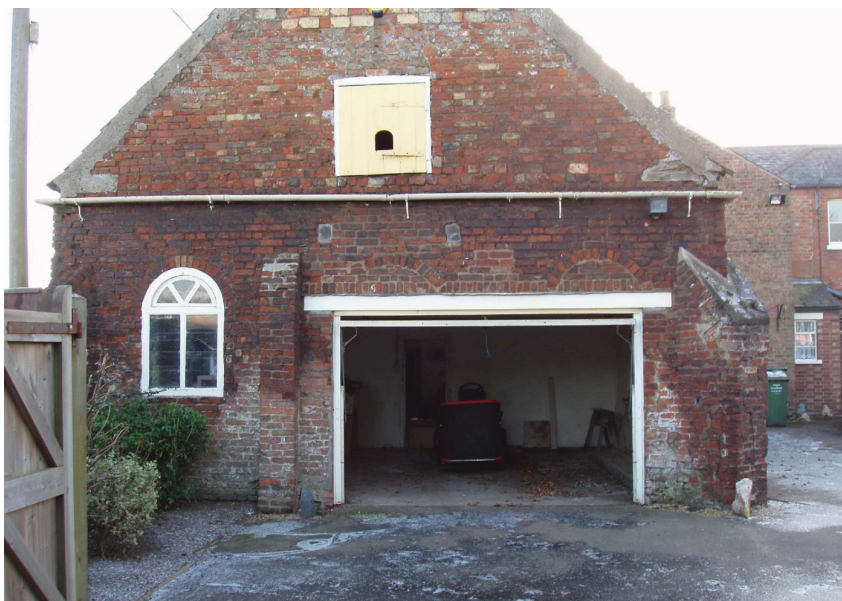
Toward the east end of the elevation is a window with a semi-circular top and brick arch above. To the west, beyond the buttress, are two further semi-circular brick arches (Plate 3). Both of these are asymmetrical, and the easterly example has been truncated on its east side. These probable windows have been infilled and the lower parts removed by the insertion of a modern garage door.

Surviving brick arches in the northern gable end indicate this elevation originally had three lunette windows (with semi-circular tops), the most easterly of these still surviving. The central and western windows indicated by the arches were later blocked. It is possible that all three of these windows were semi-circular openings, without lights below, as such D-shaped openings are traditionally associated with stables (Wade Martins 1991, 173). Such semi-circular windows

Plate 3 North elevation, showing blocked window arches, looking southwest

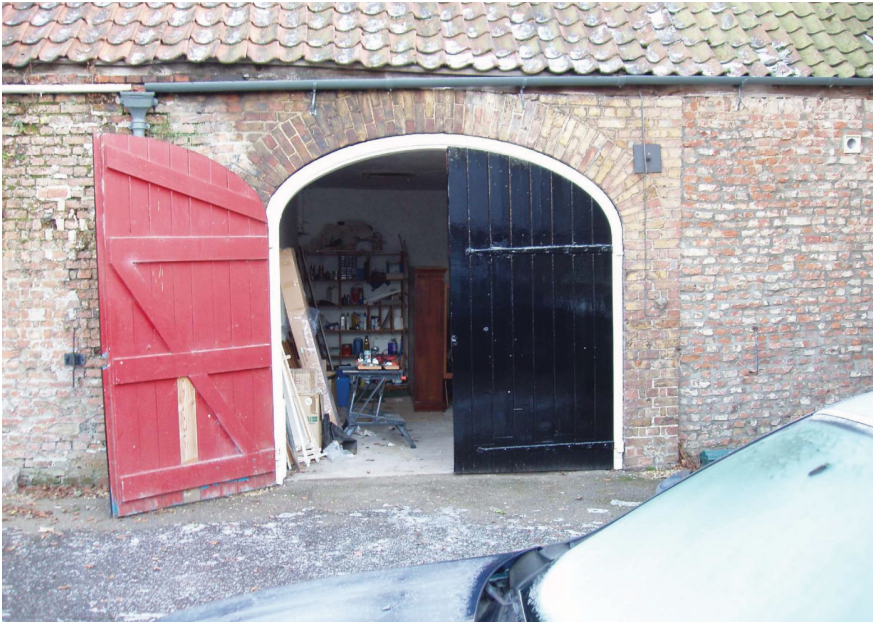
buttress is a partially blocked entrance or inserted doorway (Plate 4). This is defined by two straight joins which delimit an area infilled with yellowish-pinkish brick, in contrast to the orange-red brick of the rest of the walls. Within this brick infill is the present entrance which has planked double doors and a flatted brick arch above. South of the infill the wall continues and is butted against by the attached house.

The central bay has a large double door in its western elevation and a pair of buttresses on its eastern side. Straight joins and a variation in the brick indicate that the western doorway is inserted, or a

Plate 4 Western elevation, inserted doorway, looking southeast

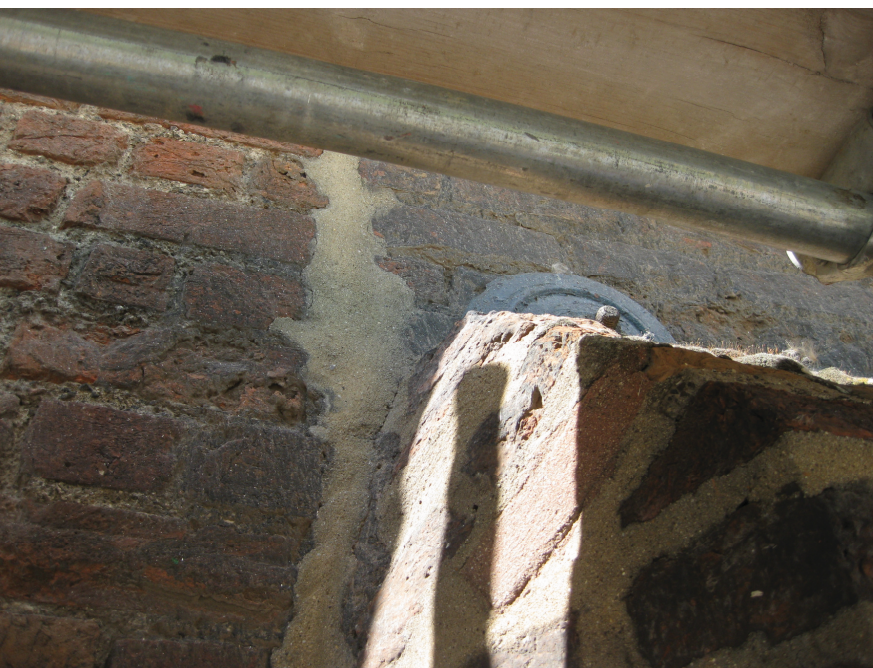
The eastern, street-side, elevation has two corner buttress and three others in between (Plates 5 and 8). All of them bond with the wall. There are inclined triangular flagstones set low in the corners between the buttresses and wall. The outer sides of the second and third buttresses from the south end are square to the elevation but their inner sides are angled to the wall. On the south side of the central buttress is a possible straight join (Plate 6). The top of this buttress overlaps a circular tie plate.

Plate 6 Detail of straight joint adjacent to buttress, looking west

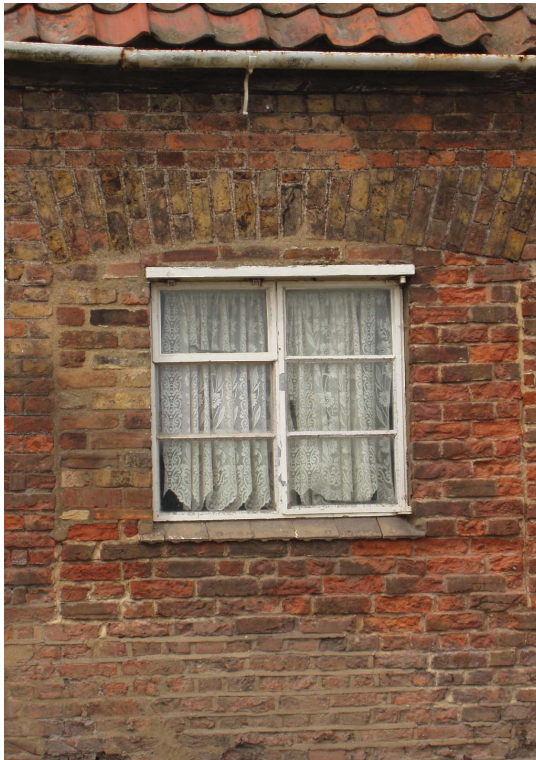
Between the south corner buttress and the next to the north is an infilled window with a gauged arch of yellowish brick. Within the blocking is a crittall window of probable mid 20th century date (Plate 7).

The southern bay is incorporated within the house and was not internally accessible. However, the east wall contains a window, later blocked. This window has an arch of yellowish brick and it is possible that this is an insertion made around about the mid 19th century when the adjacent house was constructed. This window was subsequently blocked, perhaps in the mid 20th century when a smaller crittall window was inserted.

Plate 7 Detail of inserted and blocked window, eastern elevation, looking west

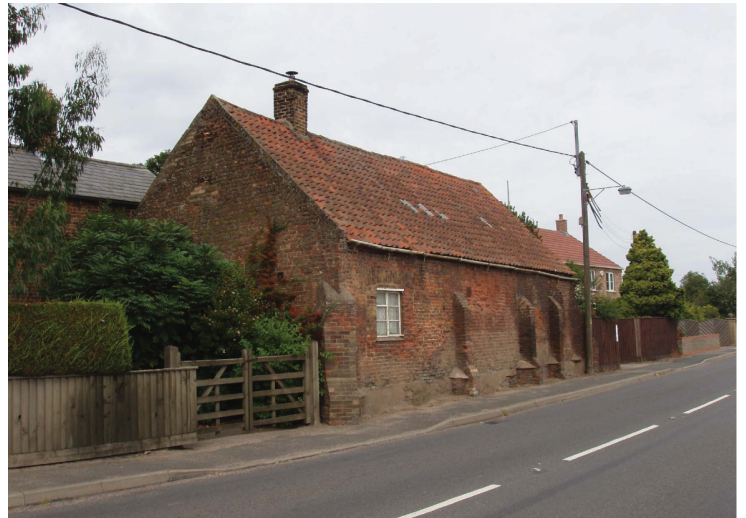
Vegetation obscures much of the southern elevation (Plate 8). However, the wall appears to be fairly plain. Alongside and rising about 0.2m above the southeastern corner buttress is a straight join. At the top of this are indications of an eaves scar that extends about 0.6m to the west (Plate 9).

Plate 8 South and east elevations, looking north

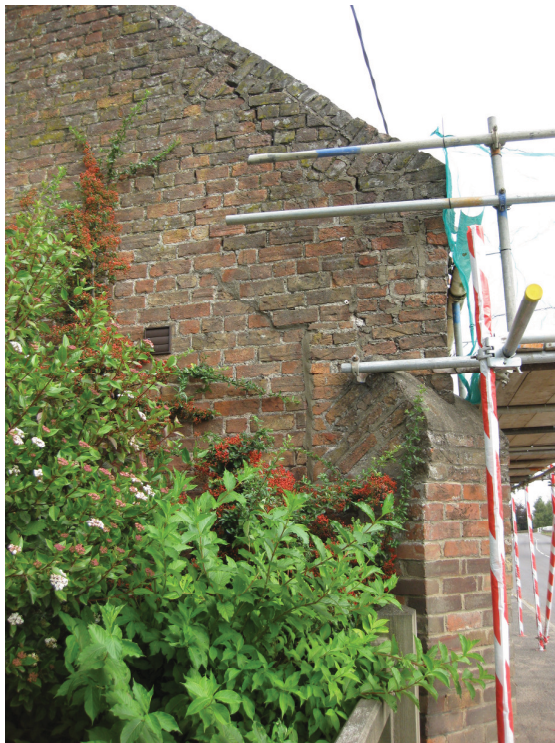
In the lower part of the east side of the gable is tumbled brickwork. Gault brick appears to have been used to repair the western side of the roof line. There is also a patch of gault brick near the middle of the gable.

displays indications of roof repair, particularly on the west side, and the wall was raised to link to the adjacent house when that was built in the mid 19th century. An eaves scar indicates there was previously another building attached to the south side of the recorded structure.

Plate 9 Southern elevation, east side, showing detail of straight joint, eaves scar and tumbling, looking northeast

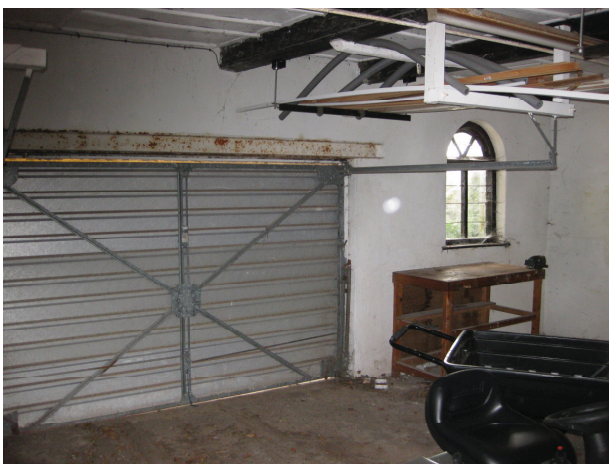
The northern ground floor room also has a concrete floor and all the walls are rendered. The north wall contains the window and garage door evident on the exterior (Plate 14). Two beams cross the room north-south at ceiling height and flank the southern doorway (Plate 15). The ceiling appears to be a 20th century replacement or refurbishment but contains a trapdoor at the junction of the western beam and south wall (Plate 16).

Plate 14 Ground floor, north room, showing window and garage door, looking east

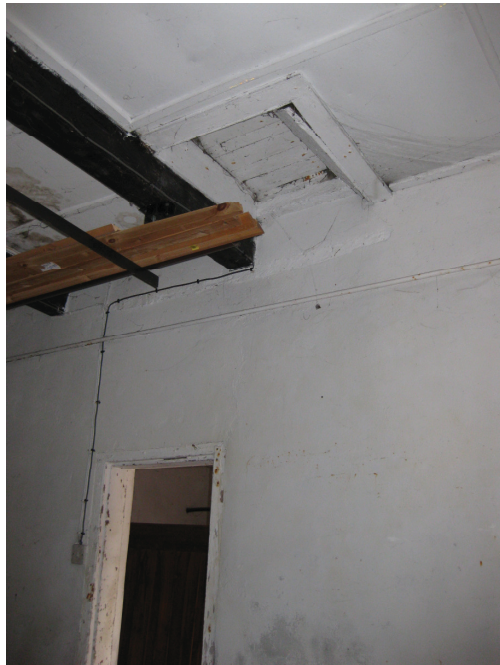
Plate 16 Ground floor, north room, showing trapdoor in ceiling, looking south

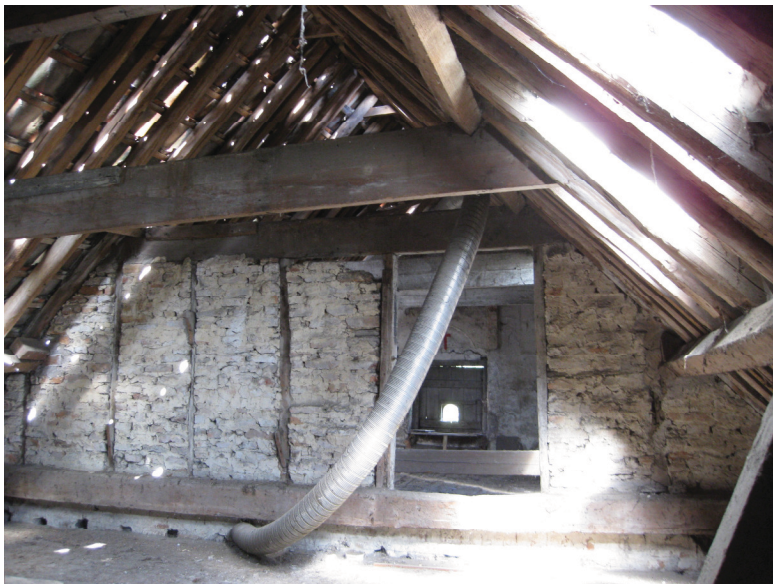
The southern, accessible, room is crossed by an original tie beam just above the floor. Raking struts from the tie beam support the lower purlins. Two collar trusses also cross the room, the collars clasping the purlins (Plate 17). These collars, purlins and struts are all replacements of probable 20th century date,

Sitting on a tie beam, the north wall of the room only extends to the height of the collars and the top of the door to the room beyond. The southern face of this wall is of brick with regularly-spaced timber studs and contains an off-centre doorway (Plate 17).

Plate 17 Upper storey, southern surveyed room, looking northeast

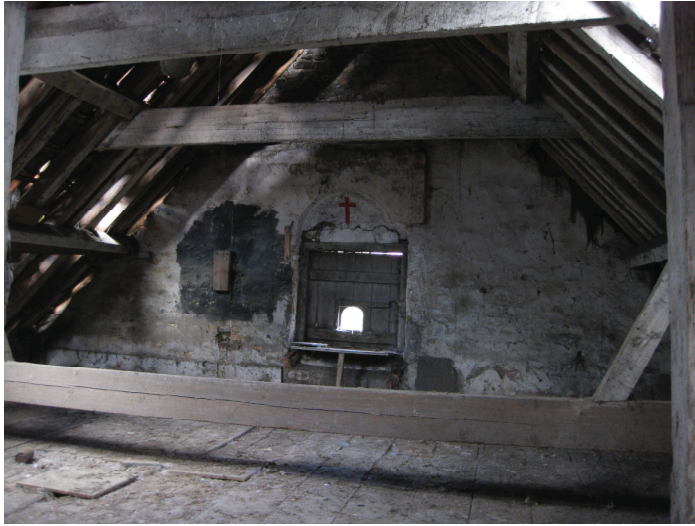
Crossing the northern room are a low tie beam and two collars (Plate 18). As with the southern room, the tie beam supports sloping struts that carry the lower purlins, while the upper purlins are clasped by the collars. However, all of these timber members, including the tie beam, are relatively recent replacements, with only the majority of the rafters being original.

Both the north and south walls of this room are covered in render or thick whitewash (Plate 19). The north wall reduces in thickness and is set back above the level of the upper purlins (Plate 18).

There is a centrally-positioned window in the north wall. Above this is a semi-circular recessed arch, this arch being narrower than the full width of the window (Plate 18). The recessed area below the arch has recently been painted with a cross of red. An improvised ledge or small table has been set up at the base of the window in the recent past.

Adjacent to the eastern side of the window is a small plinth of brick that runs from the bottom of the window arch up to the point where the wall is set back (Plate 18).

Plate 18 Upper storey,
northern room, looking north

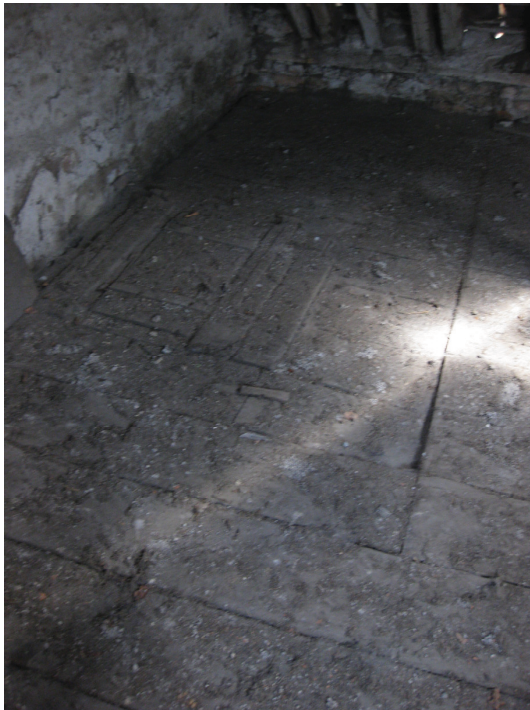
There are two trapdoors in the floor, one against the north wall to the east of the window (Plate 20) and the other alongside the south wall, to the west of the door (Plate 21). This latter trapdoor is the one

Hay lofts over stables tend to date from before 1800 as, prior to this time, it was thought to be a good arrangement. However, it was found that the hay chamber floors tended to rot very quickly, probably due to a combination of the weight of the hay and the warm damp air rising from the horses. As a result, hay loft floors needed repair, often frequently (*loc. cit.*). Much of the patching of the upper storey floor probably reflects such repairs.

Plate 20 Upper storey,
northern room, trapdoor and
patched floor in northeastern
part of room, looking east

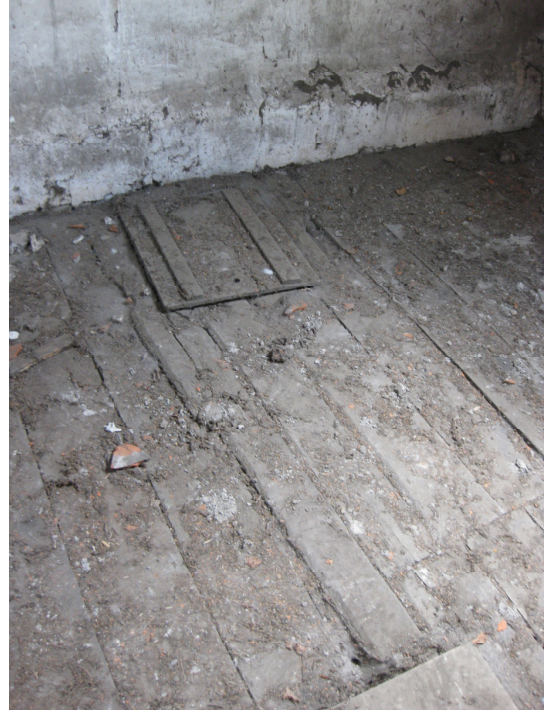
evident in the ceiling of the ground floor room (see above). There are also several areas where the floorboards have been cut out or patched. One of the largest of these areas is in the northeast corner of the room and encloses the northern trapdoor. A further large patch is located in the northwestern corner of the room, and there are two adjacent small patches near the centre of the room, and another in the southwestern corner.

Plate 21 Upper storey,
northern room, trapdoor
and patched floor in
southwestern part of room,
looking west
