**HISTORIC BUILDING RECORDING
AND ARCHAEOLOGICAL WATCHING BRIEF
ON AND AROUND FARM BUILDINGS AT
ABBAY FARM
OLD BUCKENHAM
NORFOLK
ENF 125186**

Planning Application: 3PL/2007/1445/F
National Grid Reference: TM 0703 9252
OASIS Reference Number: archaeo11-95351

A.P.S. Report No: **24/11**

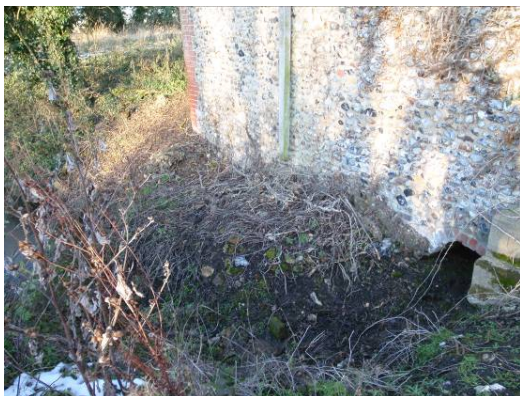
Plate 5 Detail of drain culvert with segmental brick arch at base of wall 4a, draining into moat system, looking north

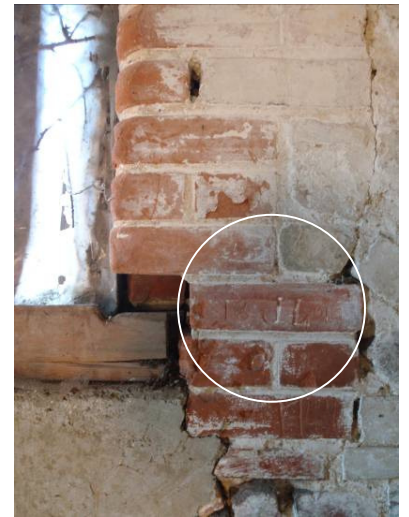
Plate 9 Interior of southern room, Range 3, detail showing graffiti "J L 1801" on brick, looking southeast

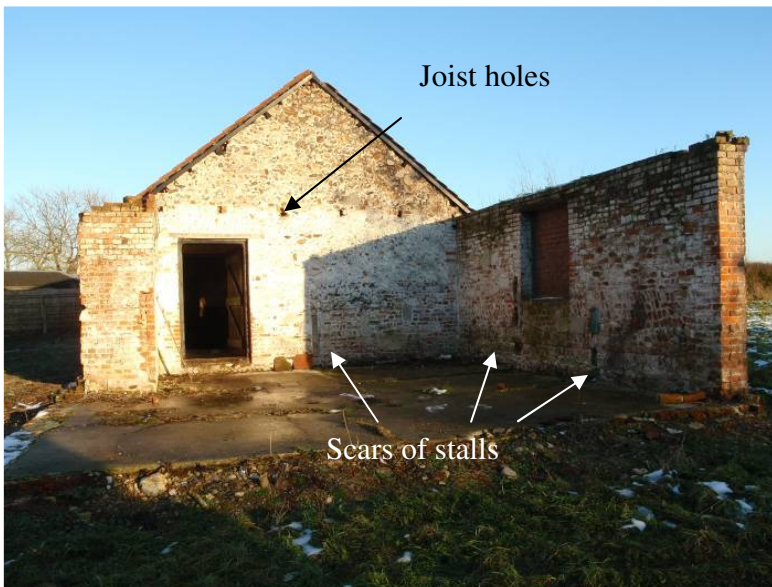
Plate 19 Range 2 showing former room at southwest end of range, walls 2d and 2c, showing joist holes, blocked window and concrete scars of stalls, looking southeast

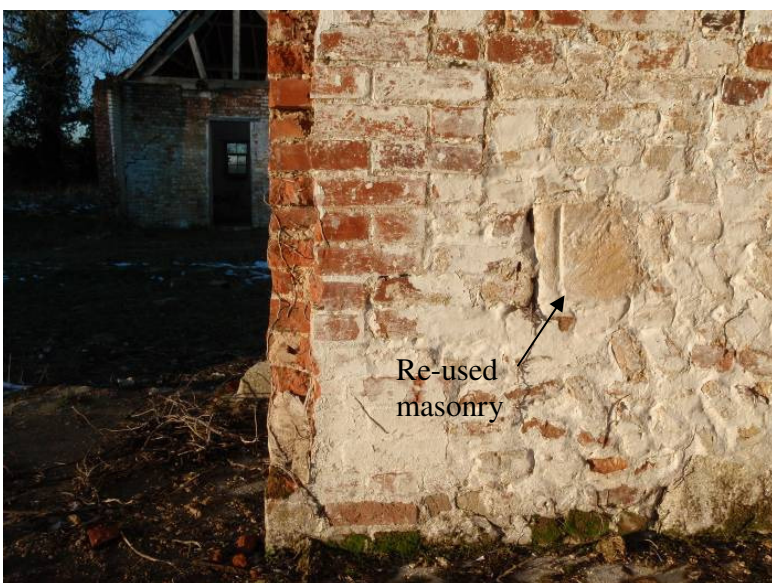
Plate 20 Range 2 showing re-used masonry in Wall 2a, with rolled moulding, perhaps part of a Medieval or later door jamb, Range 1 in background, looking northwest

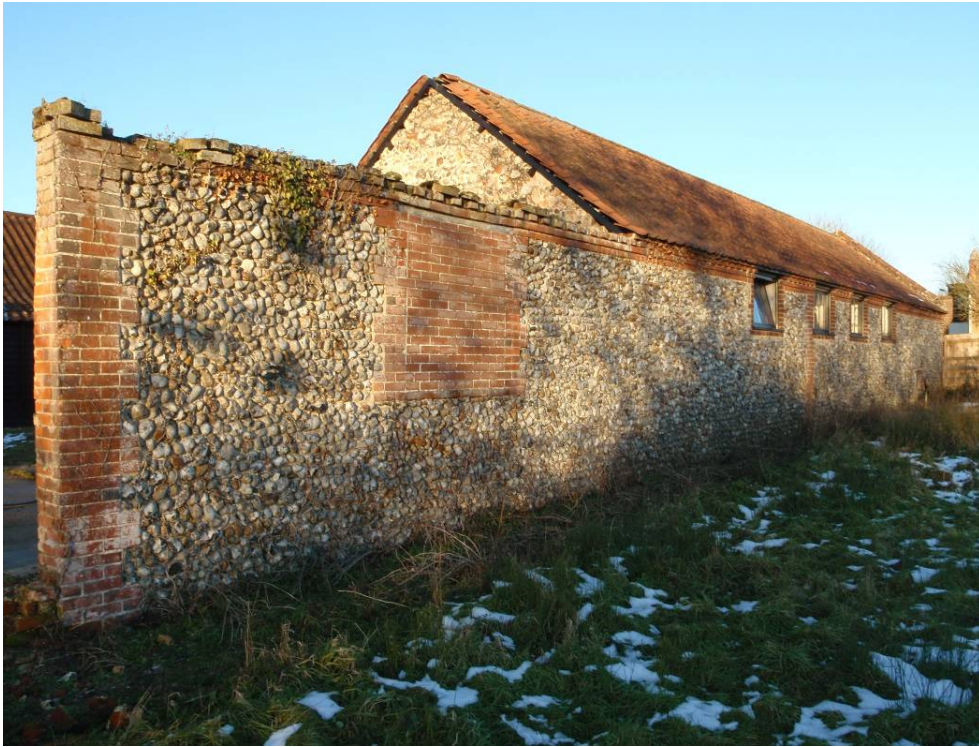
Plate 21 Exterior view of Range 2, wall 2c, showing blocked window, looking northeast

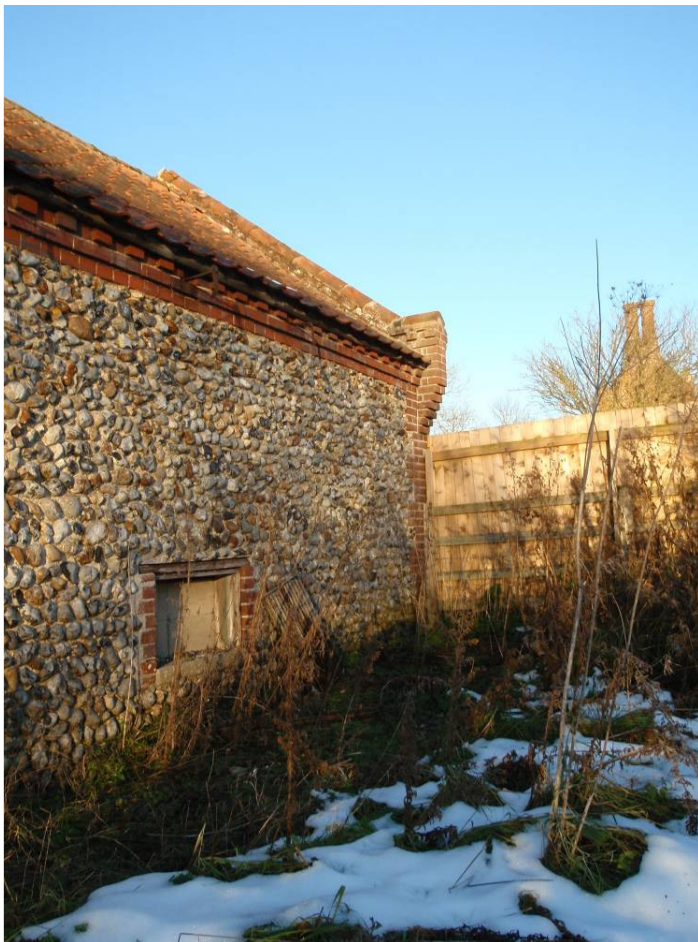
Plate 22 Exterior of Range 2, wall 2c, showing detail of small opening, perhaps for animal fodder or small animals, looking northeast

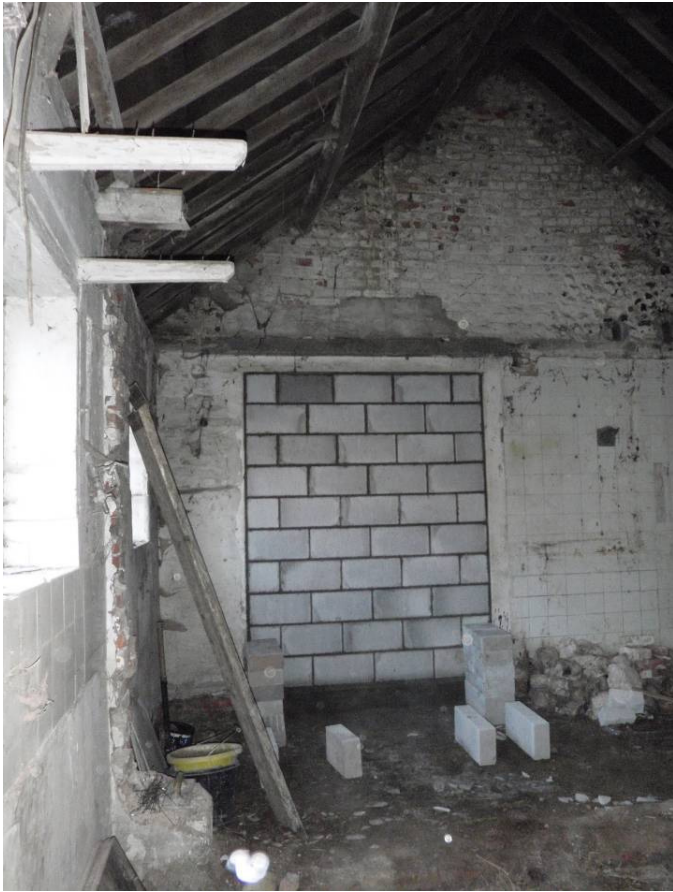
being a late insertion (Plate 23). Although these bore a similarity to tack hooks often found in stables, they were rather high up on the wall and, given the tiling of this room, and the modern date of this window, are more likely to have once supported a cistern.

Plate 23 Interior of Range 2, northeasterly room, wall 2b, showing blocked doorway and wooden pegs, possible tack hooks or cistern supports, looking northeast

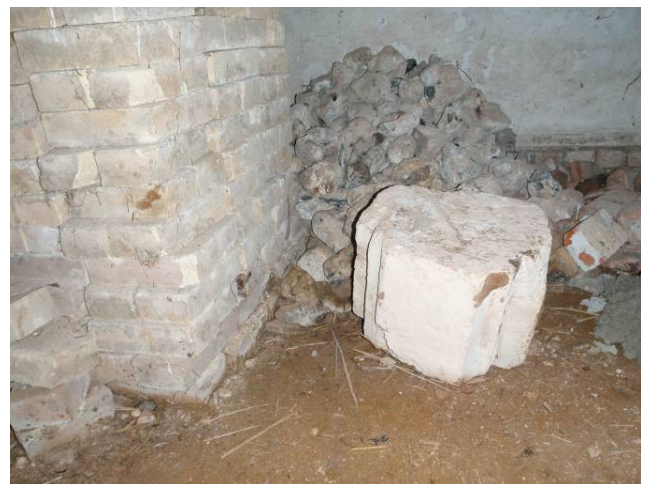
Various salvaged building materials were piled in this room, including flint cobbles and bricks. A substantial masonry fragment was also noted, perhaps part of a Medieval or later door jamb (Plate 26) (P. Cope-Faulkner, *pers. comm.*).

Plate 26 Masonry fragment found in interior of Range 2 northeasterly room amongst further reclaimed materials, presumably retained from nearby building, possible Medieval or later door jamb, looking southwest

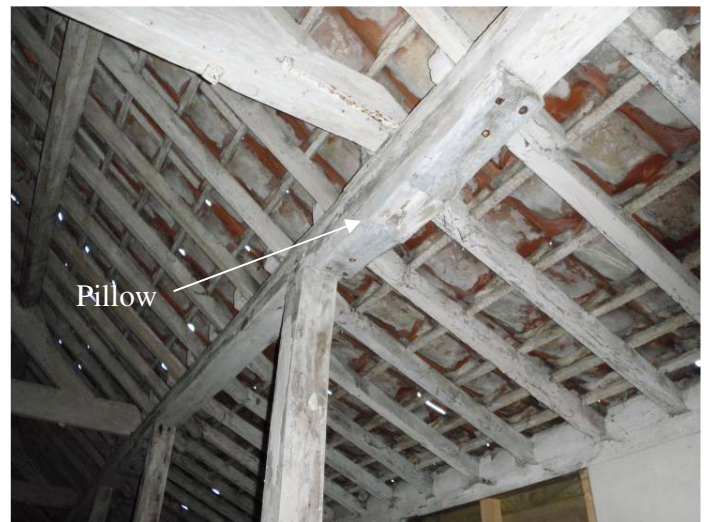
The change in slope of the catslide of the Range 1 roof corresponded internally with a purlin, beneath which was a series of five wooden pillows (Figure 5, Plates 38 & 40). These pillows would each have originally been set on a stanchion, the original stanchions having been removed and replaced with more closely-spaced uprights by the time of the survey. The original stanchions would have formed the open southeastern side of the building, prior to the insertion of weatherboard wall 1c. It was unclear on what the roof of the open front of the catslide, now above the weatherboard, would have originally been supported, but it seems probable that this was on a further series of stanchions. However, as only the modern weatherboarding was visible, this remains unproven. The reason for the catslide was also unclear, although this might be partly cosmetic, and a means by which the northeast gables of Ranges 1 & 2 (walls 1b & 2b) would be more symmetrical as viewed from the farmhouse, with the roofline at these gables being similar despite the greater width of Range 1.

Plate 40 Interior of main room, Range 1, showing change in slope of roofing and retained original wooden pillow, looking east

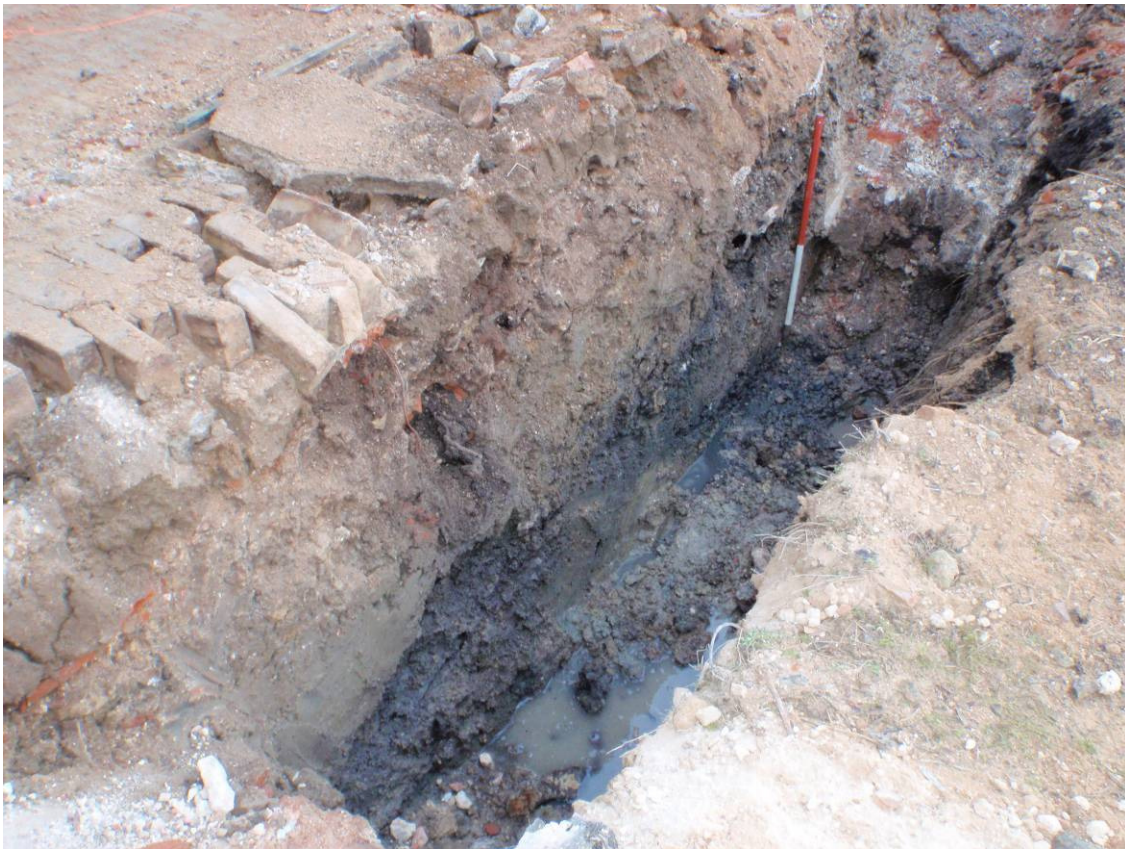
A pit [037] was recorded near the northern edge of the footings trenches (Figure 8, Figure 9: Section 1, Plate 45). This possibly sub-circular feature was more than 4.00m by 1.50m in area and up to 0.80m deep, with steep sides and a flattish base. The earliest fill of pit [037] was (011), a 0.31m thick deposit of soft black silty clay which appeared to have formed by natural silting, probably in standing water conditions. Sealing this was fill (035), a 0.66m thick firm mid grey, clayey silt with moderately frequent small fragments of mid red fired clay.

A second feature [036] in this area, possibly a ditch, may have truncated [037], although the watching brief conditions meant that this section could not be thoroughly cleaned and this was uncertain. This northeast-southwest aligned feature appeared to align, approximately, with one of the existing open drains to the west of the standing buildings (Compare Figures 8 and Figure 5: Inset). This possible ditch was undated, but may be a continuation of the extant ditch. It is possible that the line of this ditch is of medieval or post-medieval origin and associated with the system of drains and moats associated with the former Castle and Abbey and the later farm. The earliest fill of this feature had been deposited in standing water conditions, suggesting it was originally left open.

Plate 45 Section 1, possible ditch [036], pit [037] and wall 029, looking southeast

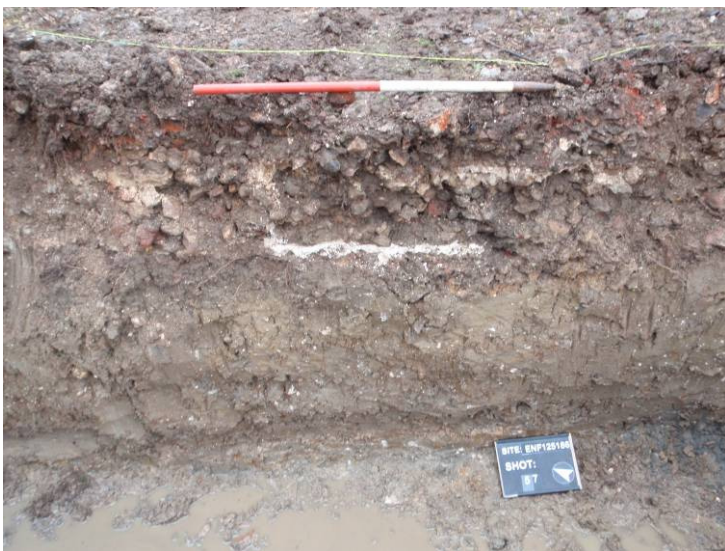
Plate 46 Section 2, representative section showing deposits truncated by oblique drain cut [040], looking southeast

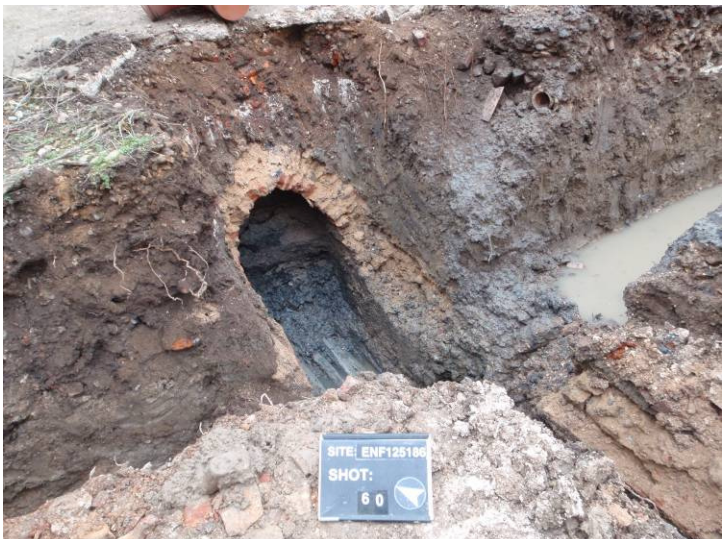
Plate 48 Brick culvert 041, drain within [040] visible at top right, looking south

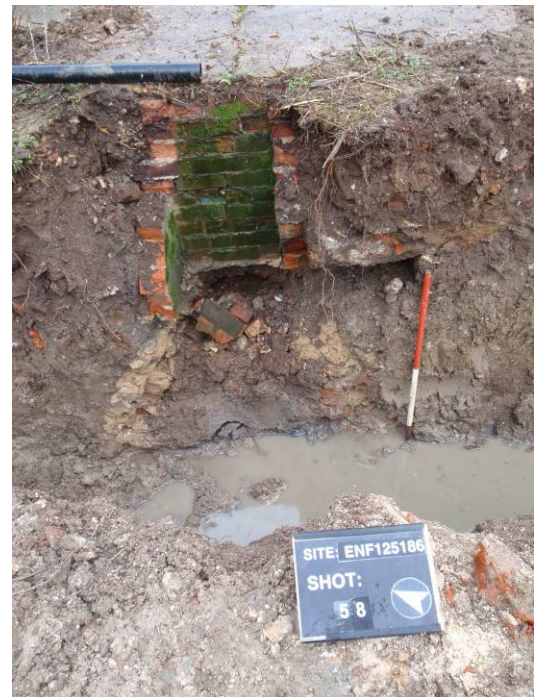
Plate 47 Brick manhole above culvert 041 prior to removal of manhole (see Plate 48), looking southeast

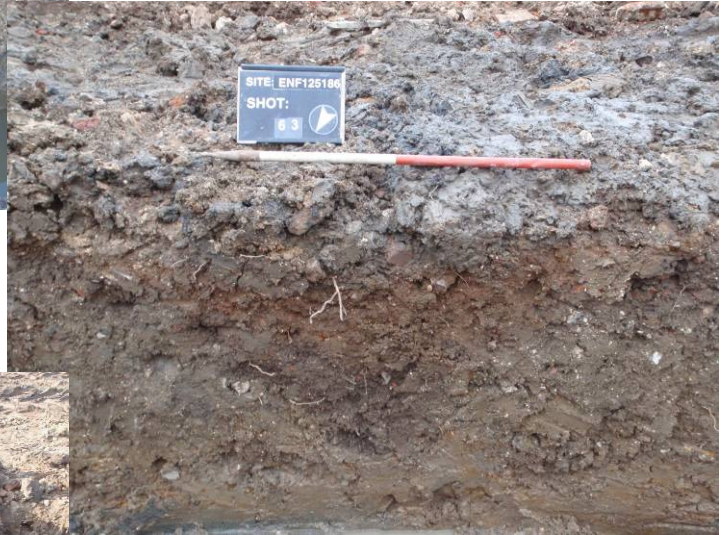
A northwest-southeast aligned linear feature [016] was observed cutting into some of these possible natural layers (Figure 9: Section 4, Figure 8, Plate 50). Linear [016] was over 15m long, 1.00m wide and 0.76m deep with steep sides and narrow base and an overall 'V-shaped' profile. It contained a fill (017) of firm to plastic dark brown clayey silt with occasional brick flecks and occasional flints. No artefacts were retrieved from this fill, and the function of this linear was uncertain, although it may have been a ditch or drain.

An undated linear feature [016] was recorded within the footprint of the new building. No pipe was observed within this feature, and this indicates that it is unlikely to be a drain. This feature appeared to be overlain by both Buildings 1 & 2, suggesting that linear [016] predates their construction, probably in the late 19th century. The 1838 Tithe Map does not show any ditch in this position, but former earlier buildings are shown in this general area (Figure 7). It is possible that [016] might be a minor boundary associated with these buildings, or may mark the location of a robbed-out wall forming part of one of the buildings shown on the 1838 map. Alternatively, [016] may be earlier than

Plate 50 Linear [016], looking southwest
