**HISTORIC BUILDING RECORDING & BUILDING WATCHING BRIEF:  
PATCHETTS GREEN FARMHOUSE (THE COACH HOUSE)**

**PATCHETTS EQUESTRIAN CENTRE**

**DRAFT REPORT**

May 2012

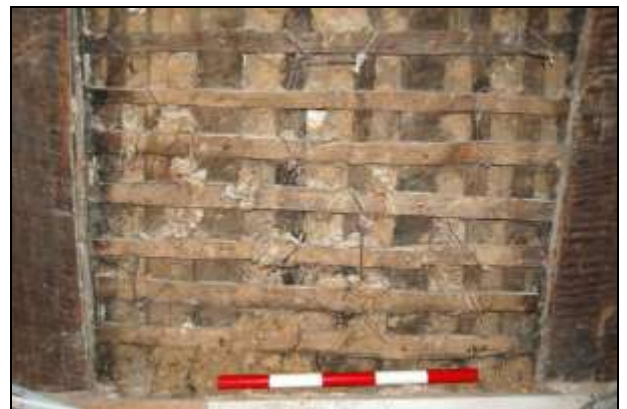
**Plate 72:** Room F4: north wall detail

The north wall was fully exposed during the building works revealing a jowlpost with an iron repair above, a smoke blackened brace, tie beam and panelling to the right of the post. The studs exposed above the tie beam are of slender scantling. All the major timbers have hollow chamfers some 5cm wide.

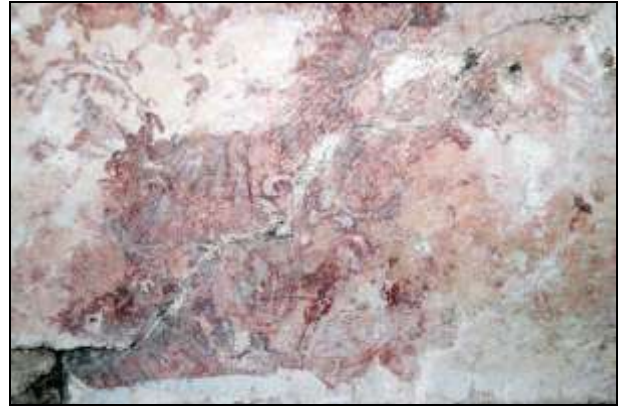
**Plate 74:** Room F4: painted plaster on the south wall

Painted plaster was revealed on the south wall, which consisted of white curlicues within a lozenge shaped border on a red background (App. 3). The wall painting appeared to be of early 17<sup>th</sup> century date and following specialist advice was stabilised to minimise further degradation.

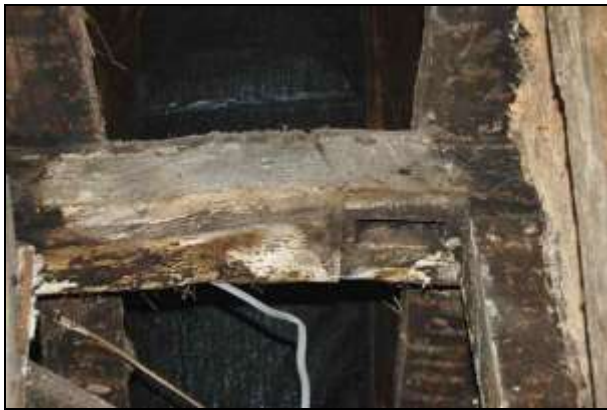
**Plate 81:** Room F3: scarf joint in the collar purlin

A splayed scarf joint and a mortice were observed in the soffit of the collar purlin at the north end of Room F3. Further mortices were noted in the lowered collar purlin in Room F4, which may be indicative of a partition wall.
