## **HISTORIC BUILDING RECORDING:**

**THE BUNGALOW  
ROSARY PRIORY  
ELSTREE ROAD  
BUSHEY  
HERTFORDSHIRE**

March 2012

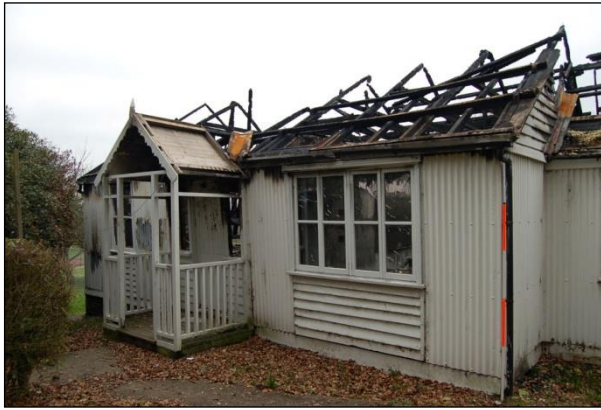
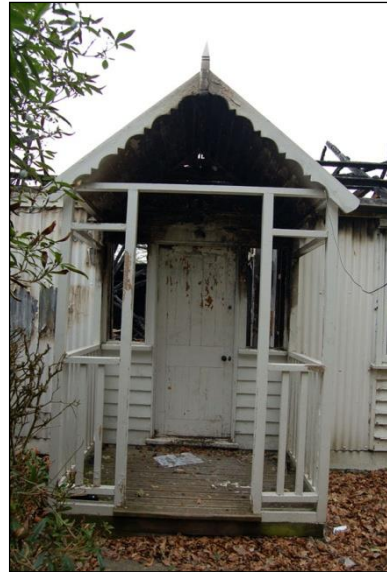
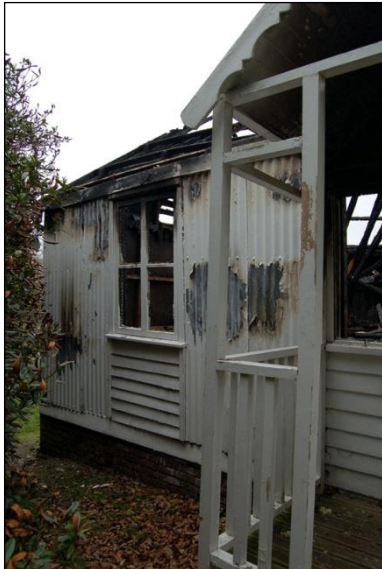
This is the front elevation of the building and has a gabled porch leading to a 4-panelled door with flanking windows. There is a 2-light casement window to the west of the door and a 4-light casement to the east. The area below both windows is weatherboarded; a theme found elsewhere in the building. The window in the recessed eastern end of the elevation is set entirely within corrugated cladding and has a simple metal strip forming a hood. The window itself has 2-lights with tilting upper openings.

A brick supporting dwarf wall approximately 30cm high is visible to the west of the porch. The porch is entirely timber built with half height railings, a gabled roof with decorative bargeboards and roof post. The floor of the porch is raised and made of timber.

**Plate 1:** Building 1; south elevation

**Plate 2:** Building 1; porch

**Plate 3:** Building 1; west end of south elevation

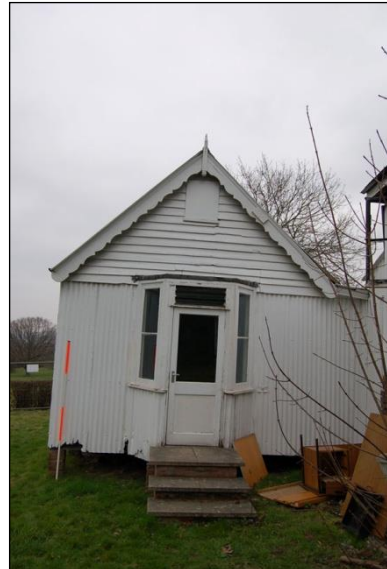
The core of Building 2 is orientated north to south and has a modern Fletton brick and concrete stair leading up to a bay containing a half glazed door flanked by windows. Above this is a boarded window. Little of the eastern addition is evident from the south.

**Plate 4:** Building 2; south elevation

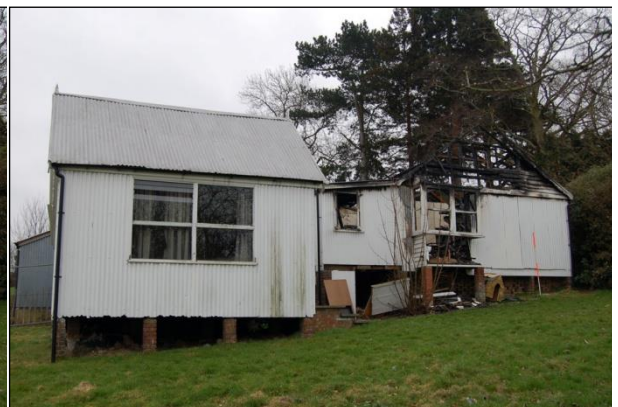
This has a large window with venting slats in the upper pane of the northern light. The brick piers below the structure are fully exposed and are similar to those beneath the main core of Building 1. The piers are 22cm<sup>2</sup>, built of hand made bricks measuring c.22 x 10 x 7cm (8<sup>5</sup>/<sub>8</sub> x 4 x 2<sup>3</sup>/<sub>4</sub> inches) and have horizontal skintlings and a fair amount of inclusions. They are set in a stony mortar.

**Plate 6:** Building 2; west elevation

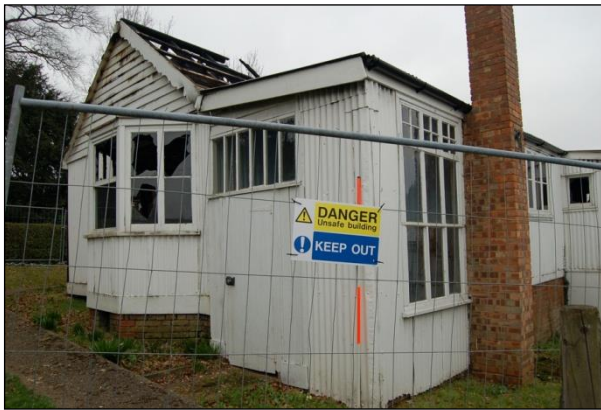
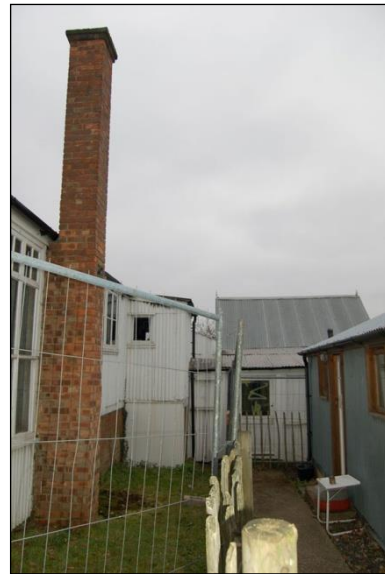
The brick supporting dwarf wall is exposed below a bay window which is offset to the north. A service room has been added to the northeast corner of Building 1, which has a 6-light window below the eaves.

This is part of a lean to addition to the core of Building 2 and has a half glazed door flanked by boarded up windows.

**Plate 7:** Building 1 from the northeast

**Plate 8:** Building 1 and 2 looking eastwards

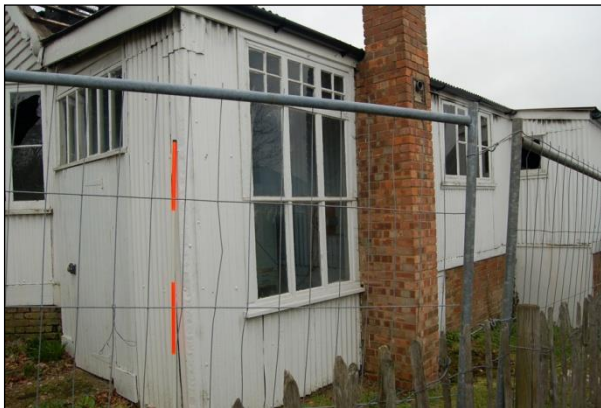
The eastern part of this elevation is that of the service room added later. It rests on a more substantial dwarf wall, c.1m high, which houses a small door. The wall above is clad in the same way as the rest of the building and has a 6-light window to the west of the brick chimney. The chimney itself is of modern Fletton bricks. To the west of the chimney is a 4-light window beyond which the northern end wall of the WC (G6) protrudes.

**Plate 9:** Building 1; north elevation

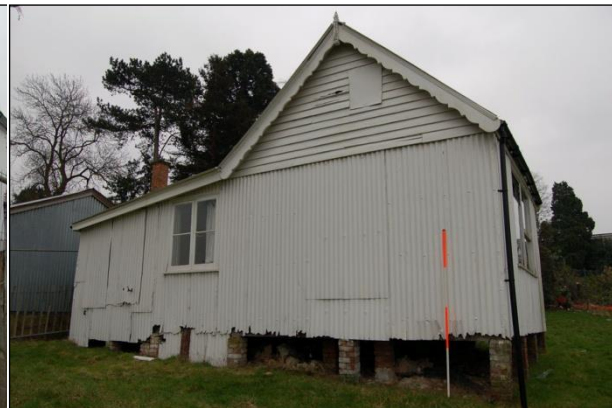
The core of Building 2 has a section of cladding bolted on presumably where the chimney breast once stood. Offset to the right of this is a window that has been boarded up.

To the east of the core of Building 2 are two additional structures, defined by a pair of brick piers immediately next to each other and a join in the fascia above. There is a 2-light window in the western section and additional sheets of corrugated metal cladding bolted on to the eastern section.

**Plate 10:** Building 2; north elevation

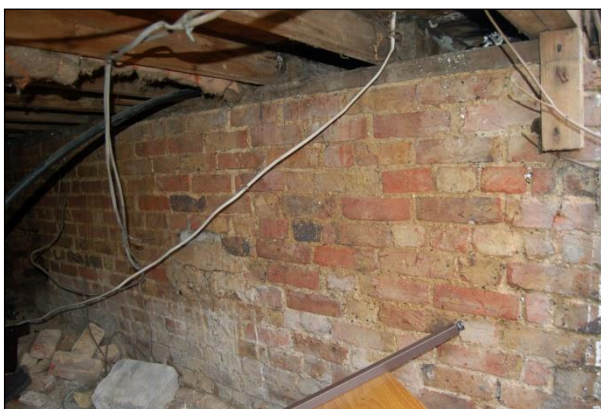
The northern supporting brick dwarf wall beneath the core of Building 1 and that beneath the lean to addition to it are slightly different. The former has bricks measuring 22 x 10 x 7cm (8<sup>5</sup>/<sub>8</sub> x 4 x 2<sup>3</sup>/<sub>4</sub> inches) set in a sand based stony mortar. The bricks beneath the addition are slightly narrower and set in a very loose stony mortar.

**Plate 11:** Detail of brick base beneath Building  
1

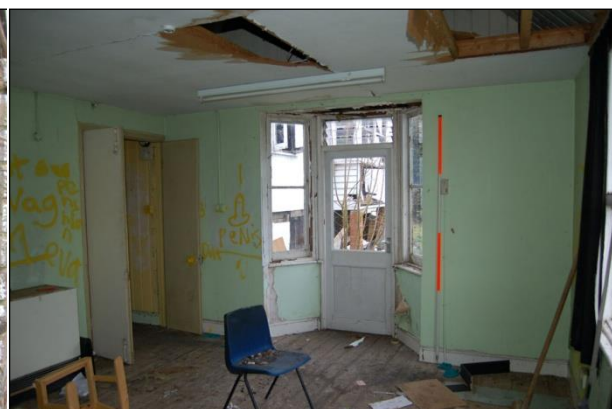
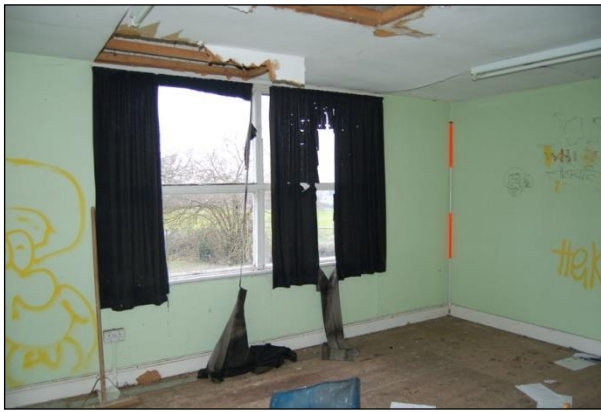
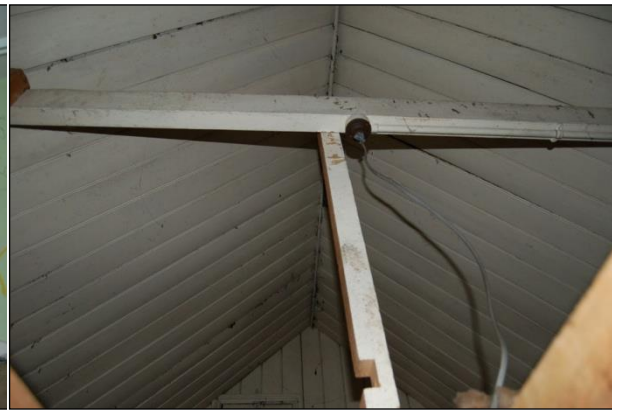
*Description:* This is the core of Building 2 with a bay window/door in the south wall and a 2-light window in the west wall. Double door in the east wall give access to the passage (G2). The walls are papered and painted as is the inserted ceiling. The roof above has matchline boarding and a T-shaped truss. The timber floor is orientated north-south.

**Plate 12:** Room G1; west wall

**Plate 13:** Room G1; northeast corner

**Plate 14:** Room G1; roof

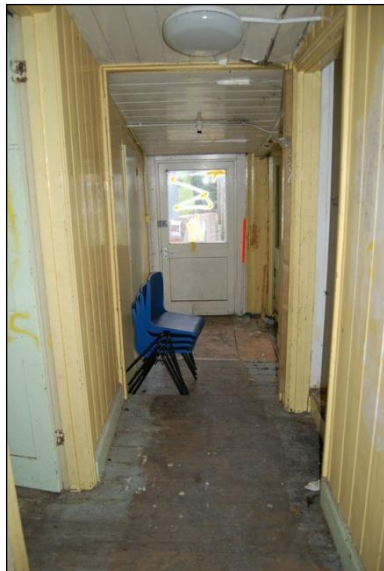
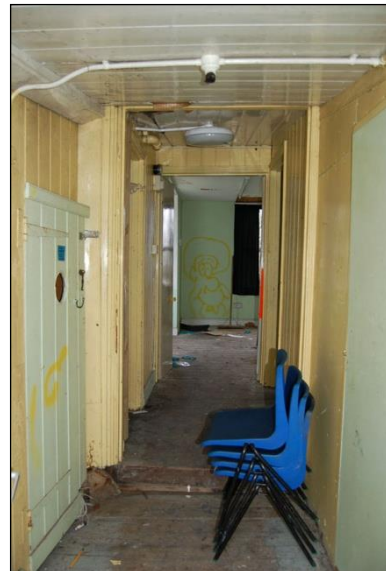
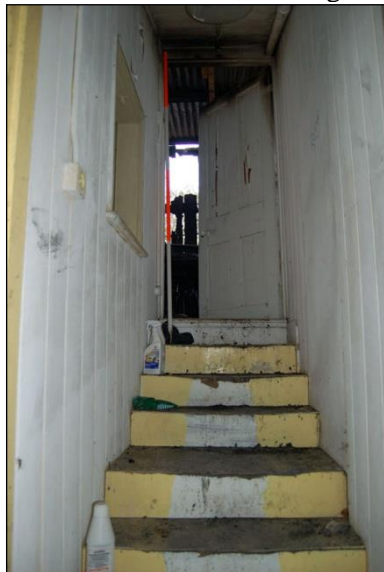
*Description:* Passage and stair linking Buildings 1 and 2. It has a half glazed external door at the east end, a step up just before the stairs at the western end of the room. The timber staircase is enclosed, with 8 risers and a casement window in the east wall. The timber floor is a continuation of that in Room G1. Some planks have been replaced by large boards by the outside door.

The walls are panelled except for the north wall to the east of the step. This is painted plasterboard. Here as elsewhere in the building is a mixture of plain and torus moulded skirting boards. The ceiling has matchline panelling throughout, but it is orientated north-south to the east of the step and east-west to the west.

**Plate 15:** Room G2; looking east

**Plate 16:** Room G2; looking west

**Plate 17:** Room G2; stairs to Building 1

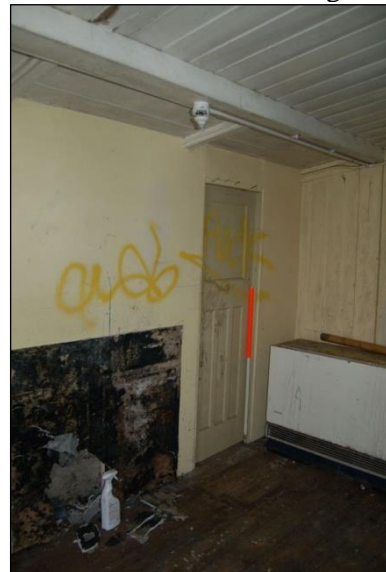
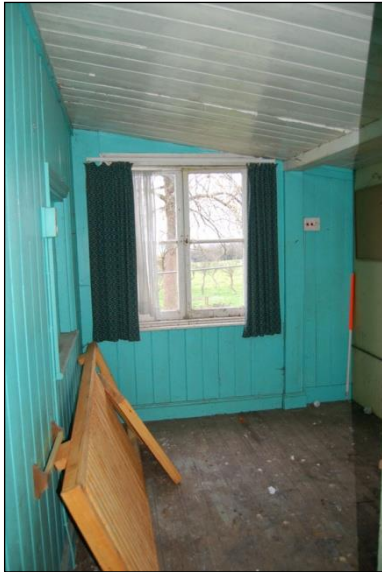
*Description:* This room displays aspects of both additions to the core of Building 2. Piers approximately 80cm from the east end of the room demarcates the extent of the first addition. The 14cm wide matchline panelling in the ceiling to the west of this is orientated east-west; that to the east, which is 16cm wide, run north-south. The east wall is painted plasterboard but the others have matchline panelling.

There is a door in the east wall to the adjoining bathroom (G4). To the west of this is the shadow of a former mantelpiece. There is no indication of a chimney breast or flue. The west wall has a blocked opening into G1, which was presumably once a window and may later have served as a hatch. There is a 2-light casement window in the north wall. The timber floor is orientated north-south.

**Plate 18:** Room G3; southeast corner

**Plate 19:** Room G3; north wall

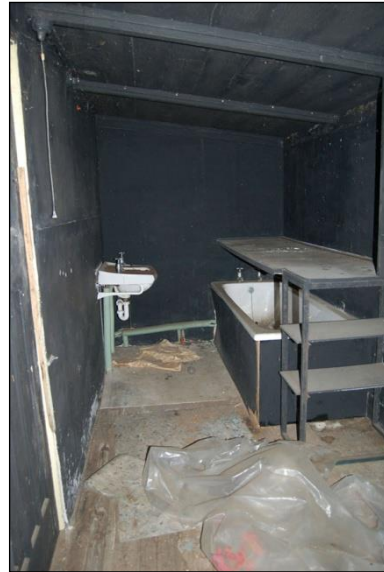
*Description:* This can be accessed from the passage to the south (G2) and from Room G3 to the west. The southern door has a step down to the passage beyond. There is blocked window in the east wall, timber flooring and a matchline panelled ceiling that runs north-south. The walls are painted black.

**Plate 20:** Room G4; north wall

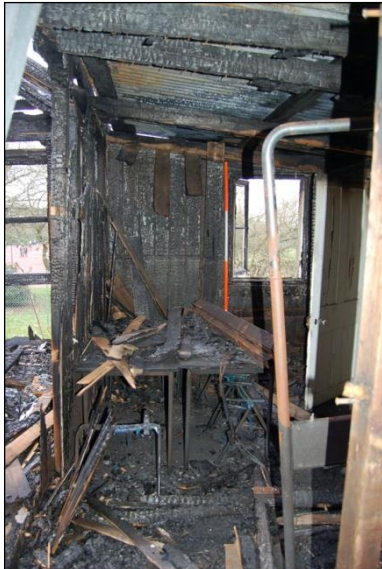
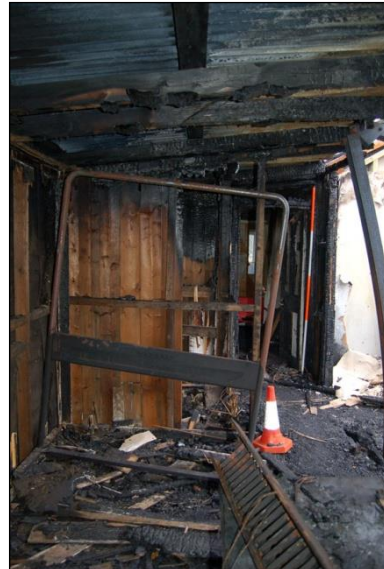
*Description:* This forms the western end of the lean-to addition to Building 1. Although severely damaged by fire, the timber framing, corrugated cladding and internal insulation and matchline panelling are still evident. There is a 2-light casement in the west wall and the staircase up from Building 2 opens in the north wall. The east wall and its door have been lost to the fire.

**Plate 21:** Room G5 looking west

**Plate 22:** Room G5 looking east

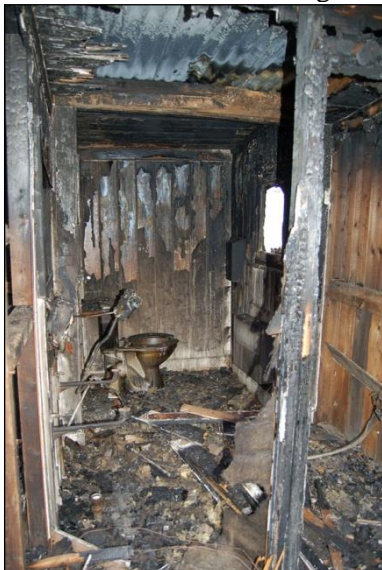
*Description:* This is a small WC, orientated north-south with windows at the north end of the east and west walls, which extend beyond the north wall of the rest of the addition. This room is also heavily damaged by fire.

**Plate 23:** Room G6 looking north

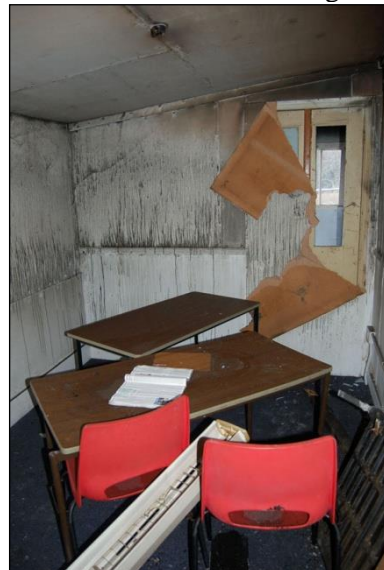
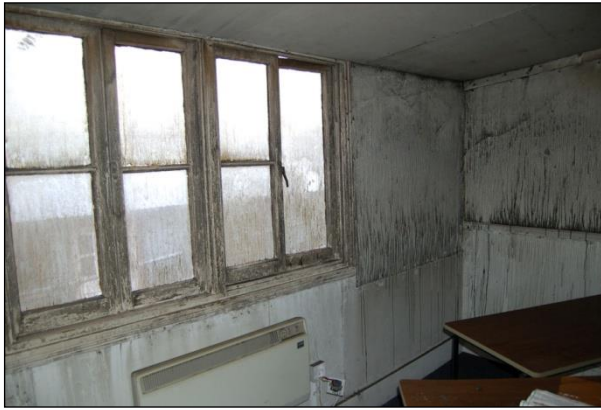
*Description:* Latterly a classroom, this room has a 4-light casement in the north wall, a blocked 4-panelled door in the east wall and a 4-panelled door in the west wall. The south, west and east walls have dado rails but matchline panelling is only present to the south and west. The ceiling is plaster board, the floor carpeted.

**Plate 24:** Room G7; east wall

**Plate 25:** Room G7; northeast corner

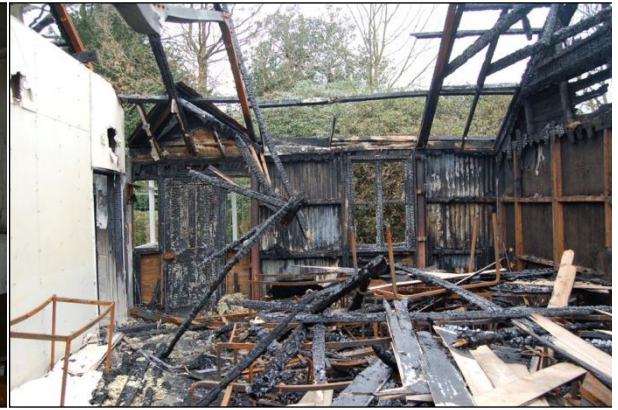
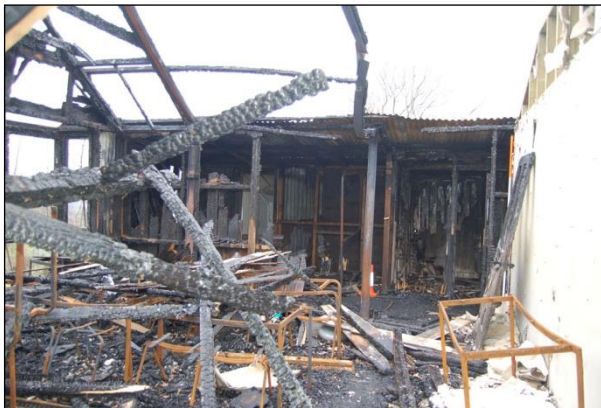
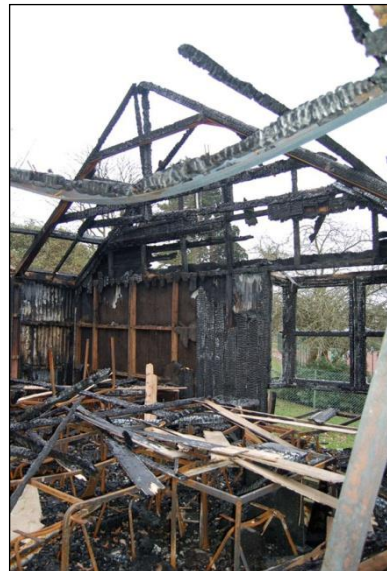
*Description:* The roof has gone and the walls have survived to a variable degree. There is a bay window in the west wall and a 2-light casement window in the south wall. To the east of this is a half glazed door giving access to the porch. A door at the south end of the east wall opens into Room G9.

**Plate 26:** Room G8 looking south

**Plate 27:** Room G8 looking north

**Plate 28:** Room G8 looking southwest

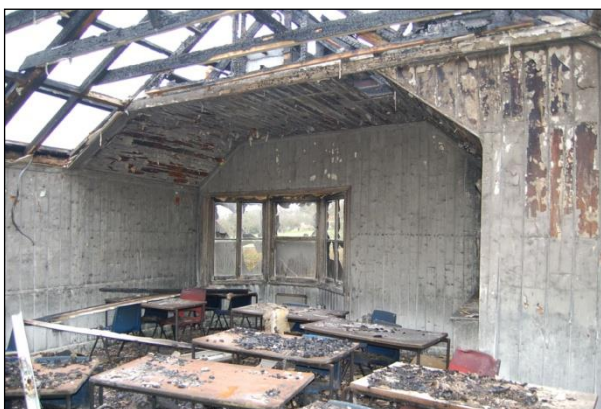
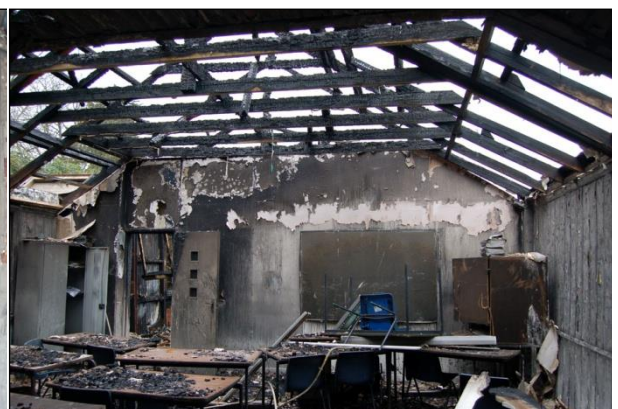
*Description:* This former classroom is L-shaped with a door in the west wall, a 4-light casement in the south wall and a 2-light window with tilting upper panes in the offset south wall to the east of it. There is also a bay window in the east wall. The walls have matchline panelling and the floor is carpeted. The ceiling has only survived at the eastern end of the room

**Plate 29:** Room G9; east wall

**Plate 30:** Room G9; west wall
