**HISTORIC BUILDING RECORDING AND WATCHING BRIEF:
EAST BARN AND STABLES
THROCKING HALL
THROCKING
HERTFORDSHIRE**

NGR: TL 33835 30055

November 2012

ASC: 1522/TTH/2

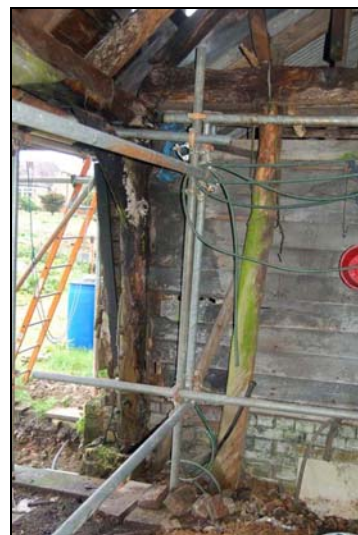
The north elevation consists of an incomplete series of posts and braces. The eastern corner of the barn is supported by a pole with some bark still surviving and a 19th-century brace (Plates 11-12). The post and braces for Truss 1 are also 19th or 20th century but Trusses 2 and 3 retain earlier posts although they are missing opposing braces. The tiebeam of Truss 3 also has some bark on it and is collapsed at northern end. Both end posts of Trusses 2 and 3 have been painted.

Plate 12: Pole posts in the northeast corner

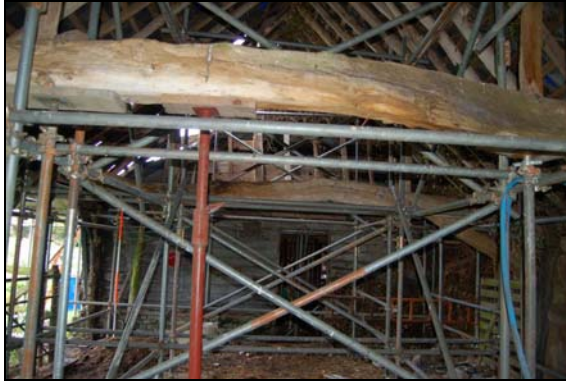
The east end of the barn abuts directly against the stable wall and is supported at the north and south ends by a pole. The tiebeam and some of the studs above are all that survives of the original barn wall (Plates 13-14).

Plate 13: East Barn: looking east

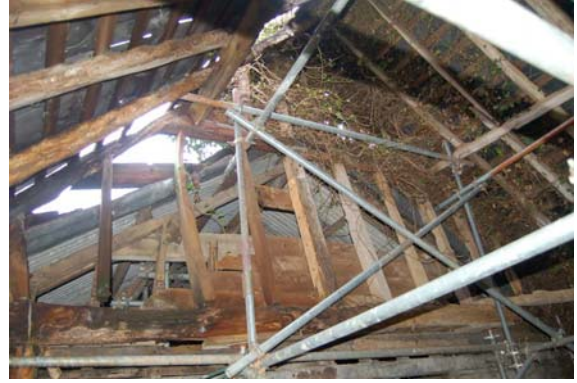
Plate 14: East Barn: east wall

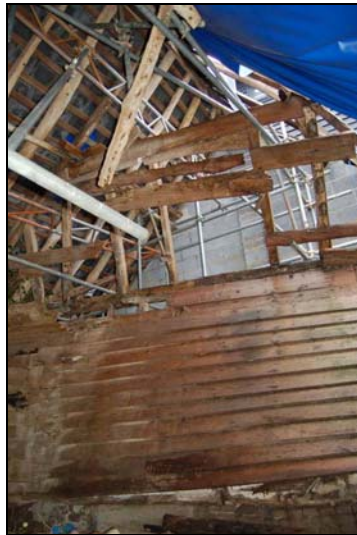
The west wall of the barn comprises a brick dwarf wall and a largely collapsed timber frame with primary bracing (Plate 15). It divides Bay 4 from the slightly elevated passage between the two barns.

Plate 15: East Barn: west wall

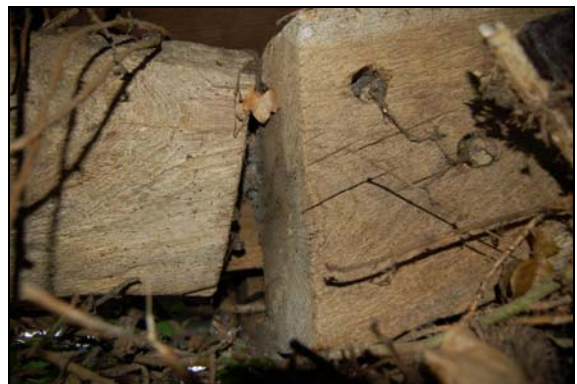
Plate 18: East Barn: bridled scarf joint

The use of edge halved and bridled scarf joints as well as the counterbladed scarf joint in conjunction with primary bracing suggest that East Barn is 17th century. Whereas the building containing the stables is complete inasmuch as all the outer walls are intact, East Barn has no east wall as it abuts the stables and the weatherboarding on the west wall is on the inside. This could suggest that this was originally an external wall for a building or sub-structure to the west of East Barn. This is further supported by the more robust timberwork in the south wall to the west of Bay 4, which is of late medieval appearance and the fact that this is on a different level to the remainder of the barn.

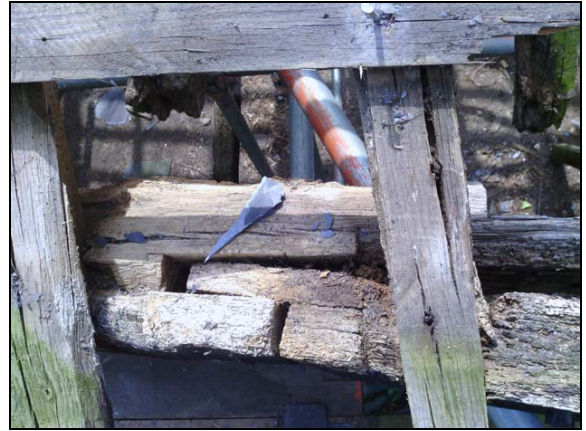
The roof timbers were exposed during the watching brief. A failed edge halved and counterbladed scarf joint was observed in the northern wallplate (Plate 44).

Plate 44: Failed scarf joint in northern wallplate of east barn
