**HISTORIC BUILDING RECORDING & WATCHING BRIEF:
THE MANOR HOUSE
THE GREEN
CULWORTH
NORTHAMPTONSHIRE**

NGR: SP 5425 4708

December 2012

ASC: 1566/CMH/1

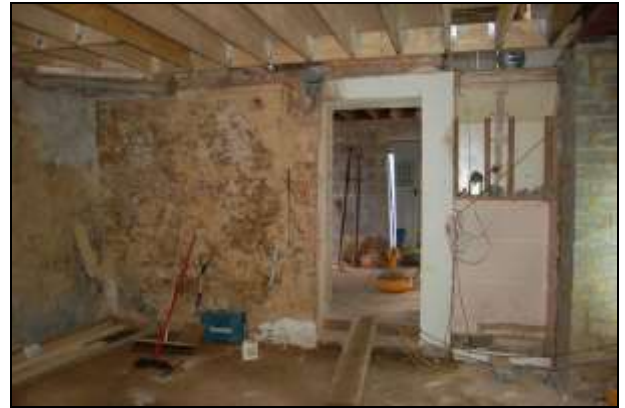
Plate 100: Room G1: east wall during building works

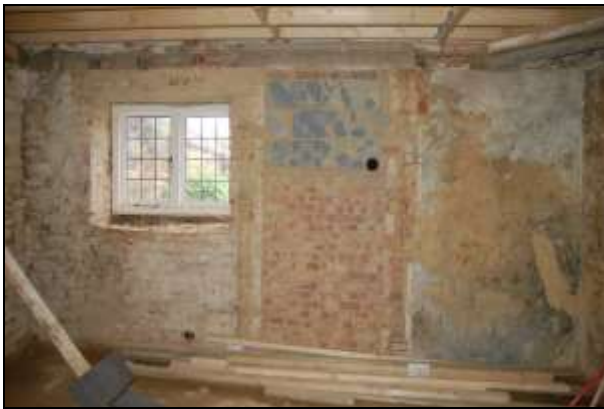
Plate 101: Room G1: north wall during building works

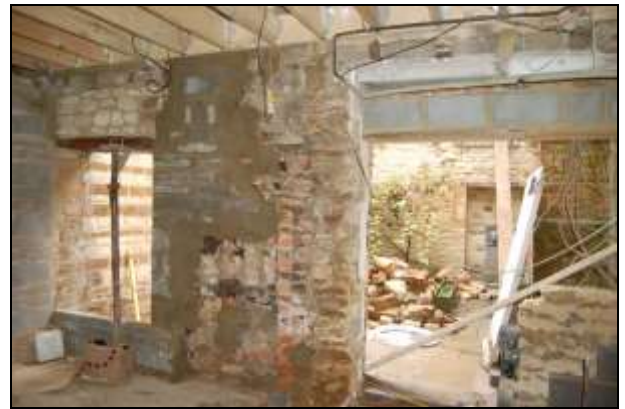
Plate 102: Room G2: extensive modern building fabric revealed in the east wall

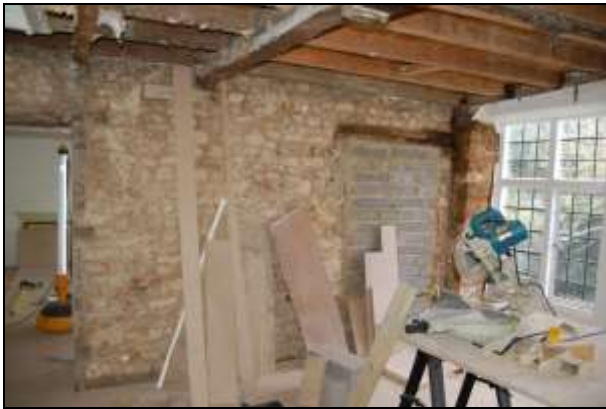
Plate 105: Room F4: blocked door in south wall

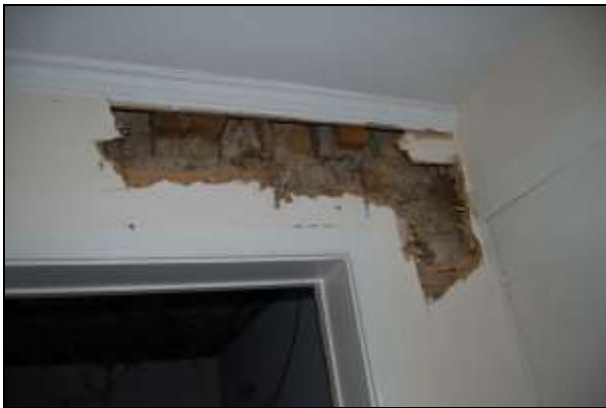
The wall between Rooms F6 and F7 was found to incorporate a substantial tiebeam that makes up part of the gable end of the east-west range. Although not fully exposed during the monitoring visit, some of the verticals and the pegs fixing them to the tiebeam were revealed. Lath and plaster was also evident to the north of the bathroom door.

Plate 107: Room F6: partially exposed tiebeam

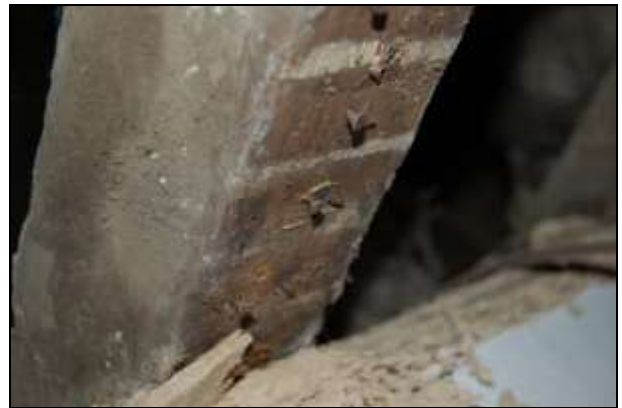
During the building works the joists were found to simply rest on the wallplate. Although close inspection was not possible and the fixing of the joists to the bridging beam above the wall between F7 and F8 could not be ascertained, the laths had clearly been attached to the joists with modern machine cut nails.

Plate 108: Room F7: modern nails in ceiling joist
